# SAN FRANCISCO PLANNING DEPARTMENT

## Discretionary Review Analysis Residential Demolition/New Construction

*Date:* May 3, 2012  
*Case No.:* 2010.0636D / 2012.0259D  
*Project Address:* 622 – 27<sup>TH</sup> AVENUE  
*Zoning:* RH-2 (Residential House, Two-Family) District  
 40-X Height and Bulk District  
*Block/Lot:* 1569/031  
*Project Sponsor:* Wah Wong  
 622 – 27<sup>th</sup> Avenue  
 San Francisco, CA 94121  
*Staff Contact:* Glenn Cabreros – (415) 588-6169  
[glenn.cabreros@sfgov.org](mailto:glenn.cabreros@sfgov.org)  
*Recommendation:* **Do not take DR and approve demolition and new construction as proposed.**

<u>Title</u>	<u>Page</u>
Soundness Report.....	2
Appendix A – Existing Floor Plans & Elevations .....	7
Appendix B – Room-By-Room Inspection Report .....	13
Appendix C – Photographs – Existing Conditions of Building .....	27
Appendix D – Cost Estimate of Electrical Repair .....	42
Appendix E – Cost Estimate of Plumbing Repair .....	45
Appendix F – Cost Estimate of Heating Repair .....	48
Appendix G – Cost Estimate of Framing & Foundation Repair.....	51
Appendix H – Cost Estimate of Sidewalk & Driveway Repair .....	55
Appendix I– Cost Estimate of Termite Repair

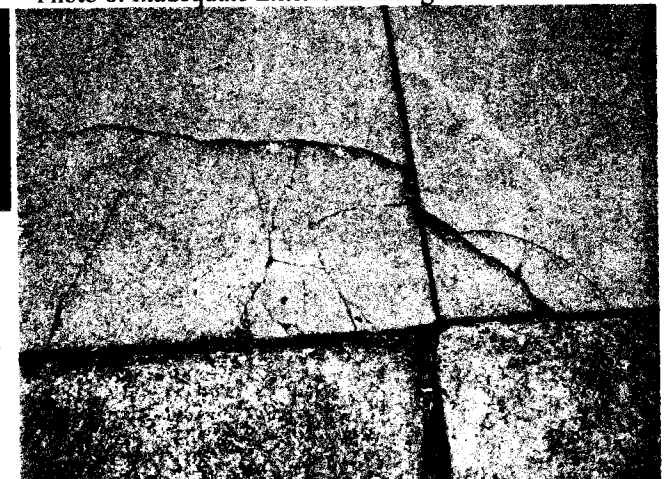
Photo 10: Damaged Driveway & Sidewalk Slab

24. Repair or replace broken and rusty gutters and downspout pipes and correct drainage slope for exterior concrete slab.
25. Repair or replace damaged concrete slab in garage and driveway.

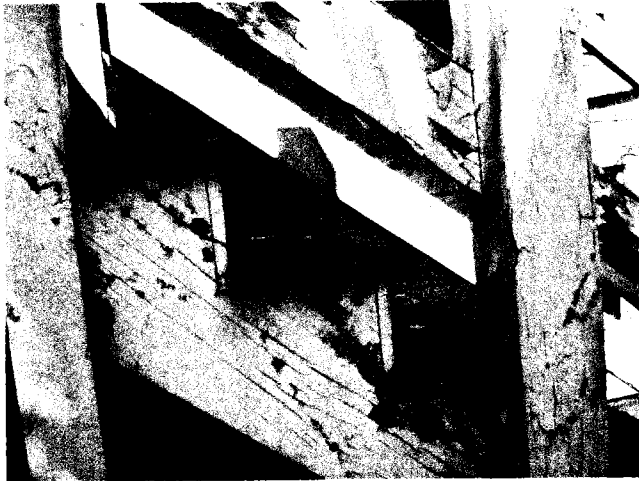
Both front and rear exterior stairs show signs of deterioration, dry rot, fungus and wood boring beetle damages. And the rear stairs and deck are not safe to use during the time of inspection.

Photo 13: Deteriorated Rear Stairs

12. Repair or rebuild damaged and deteriorated front and rear exterior stairs.
13. Install insulation in roof, floor and exterior walls that have finish material being removed during construction.

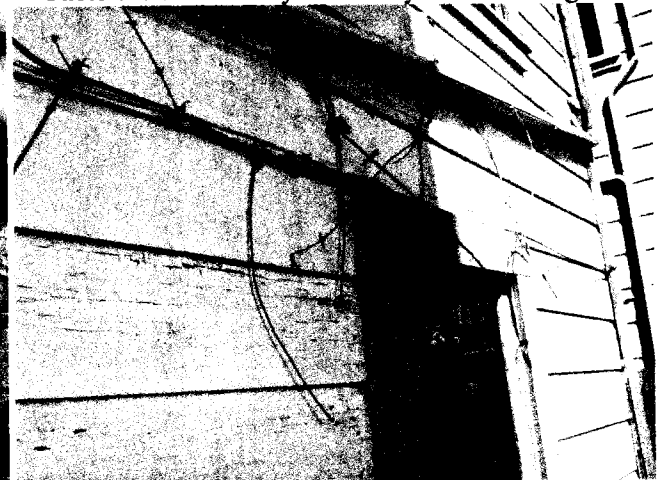
Photo 16: Damaged Window Casing

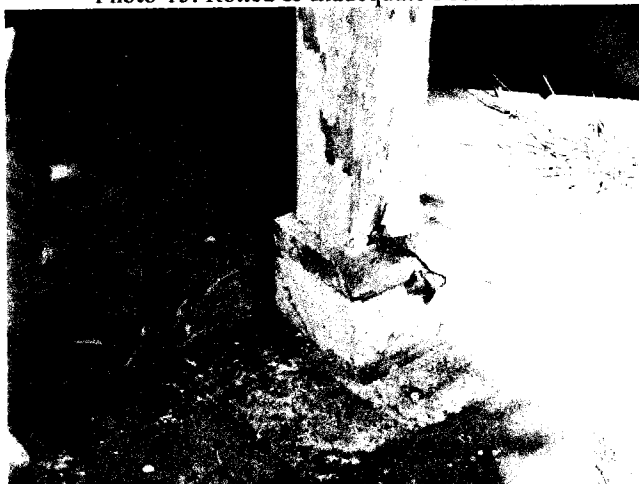
The foundation sill lacks of sill anchor bolts and property line walls are not constructed to be one-hour rated fire protection. There was no beam-post and post base connector throughout the entire level.

Photo 17: Inadequate Post Base Connection

1. Correcting lack of flashing.
2. Provide operable windows for entire house and repair damaged window framing.
3. Add sill plate and bolts to foundation, and add metal connectors to posts and beam-post connections.

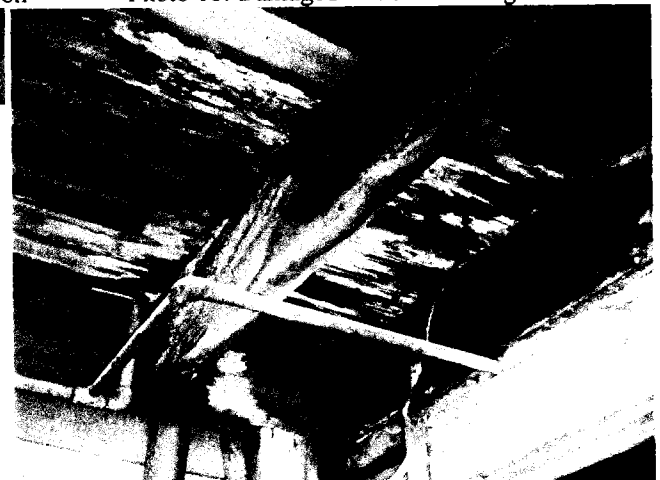
Photo 18: Rotted Laundry Room Floor Framing

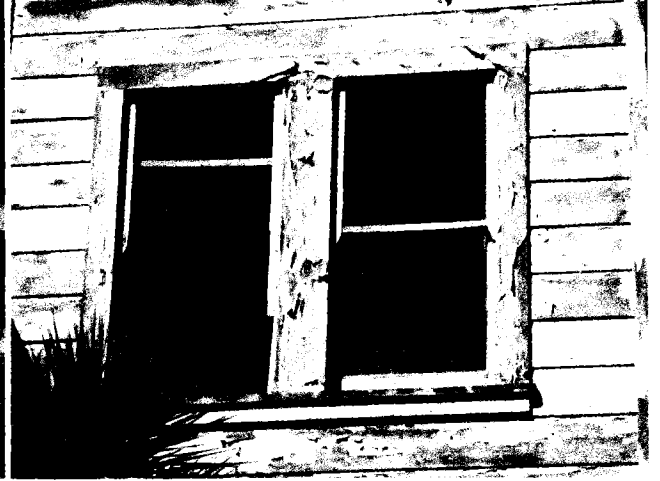
Photo 20: Damaged & Deteriorated Rear Windows

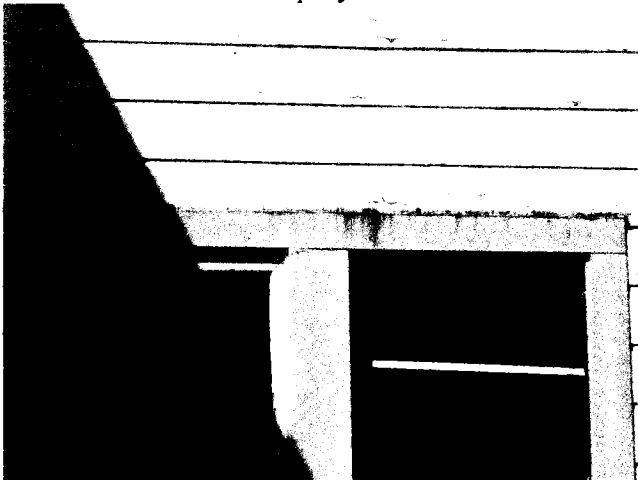
Photo 21: Rusted Window Flashing

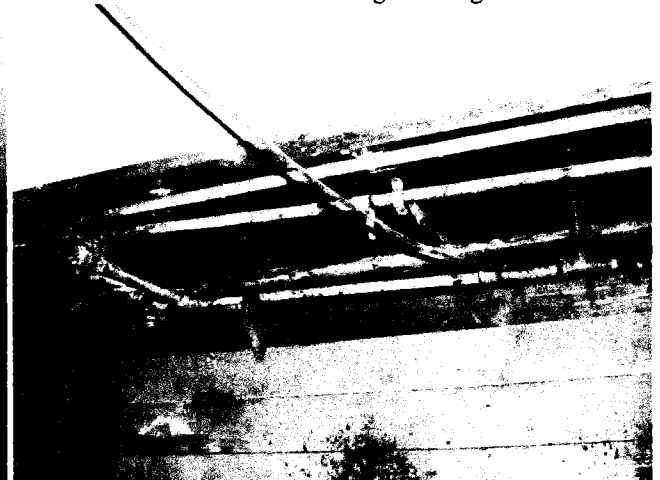
Photo 24: Rusted Pipes & Possible Mold on Garage Wall

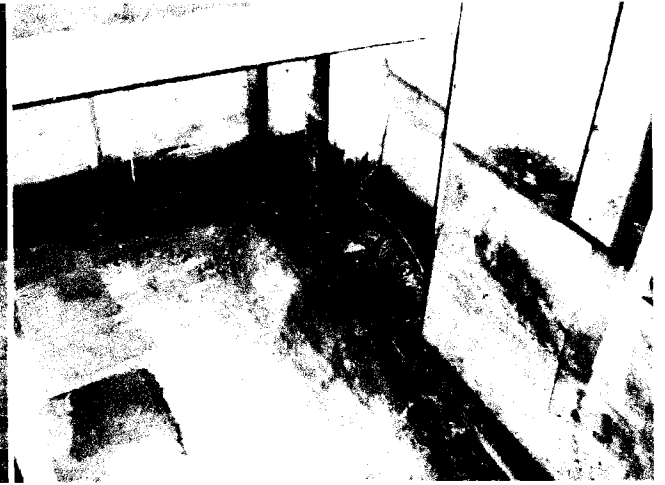
Photo 26: Rotted Wall Framing & Missing Sill Bolt

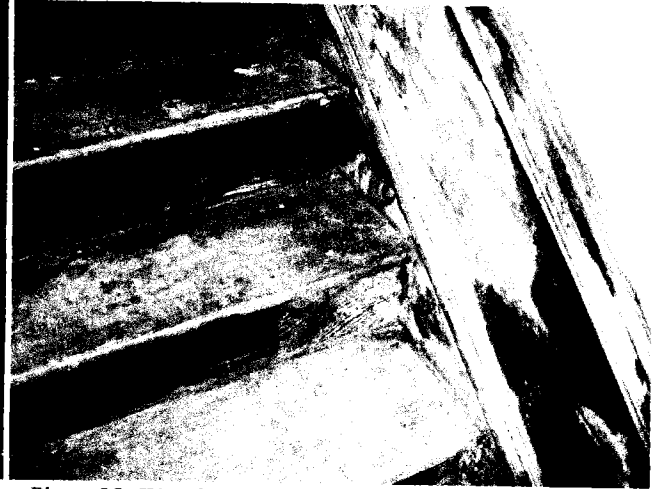
Photo 38: Wood Decay at Interior Stairs

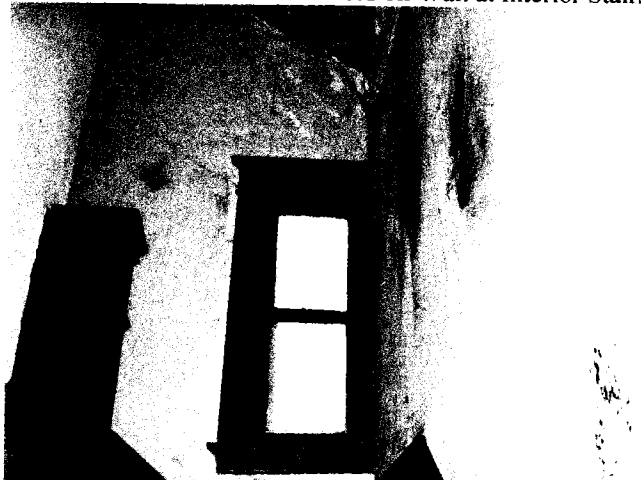
Photo 41: Wall & Ceiling Damage at Interior Stairs

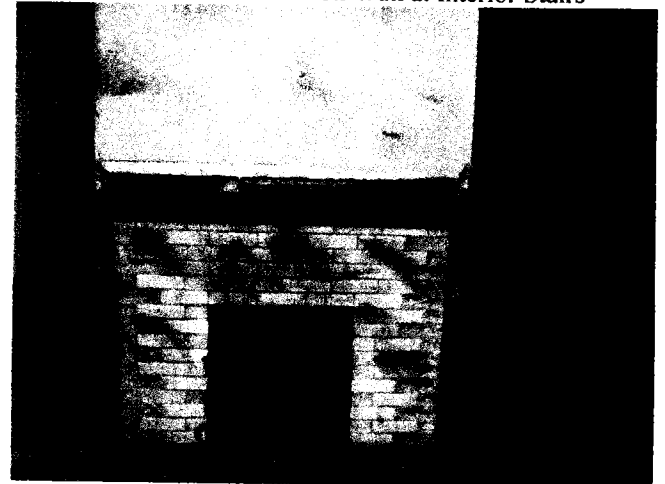
Photo 42: Fireplace Damage

13. Repair or replace damaged wall and floor framing.
14. Repair or replace damaged fireplace mantel and sweep chimney.
15. Provide mold and mildew remediation at various locations.

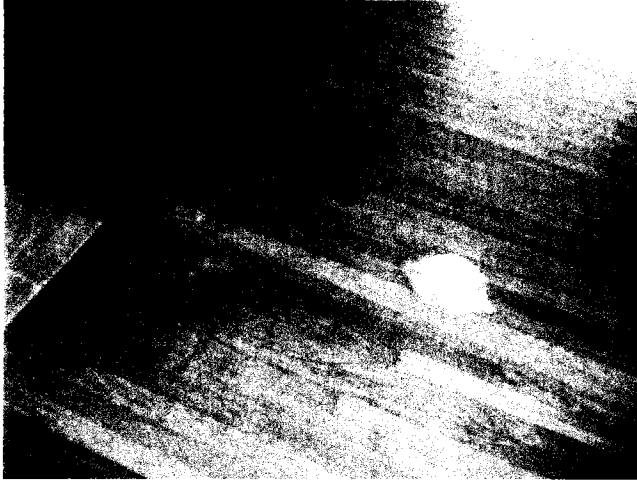
Photo 43: Decay and Sagging on Living Room Floor

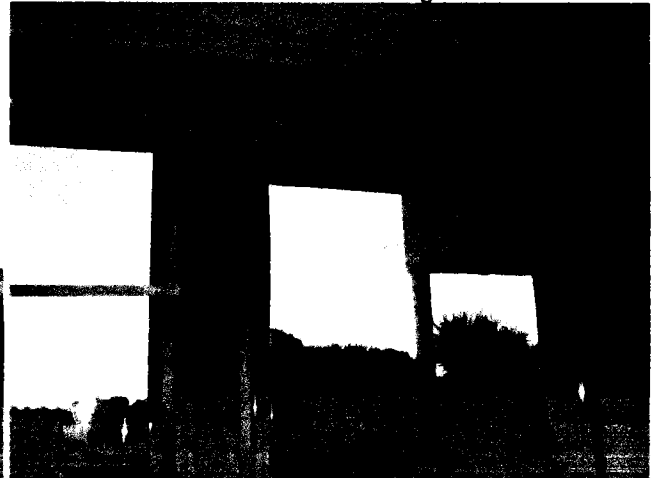
Photo 48: Cracks on Wall & Ceiling of Dining Room

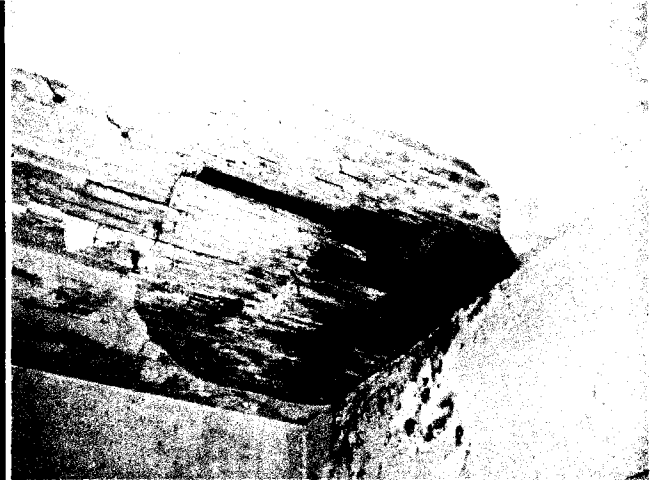
Photo 50: Wood Decay and Damage on Kitchen Ceiling

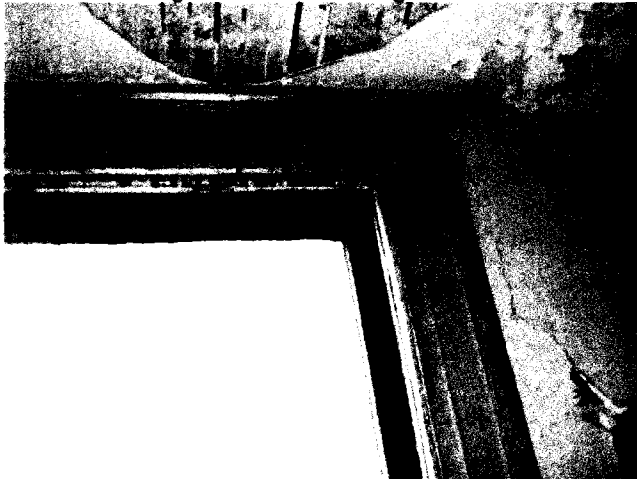
Photo 51: Wood Decay at Kitchen Window

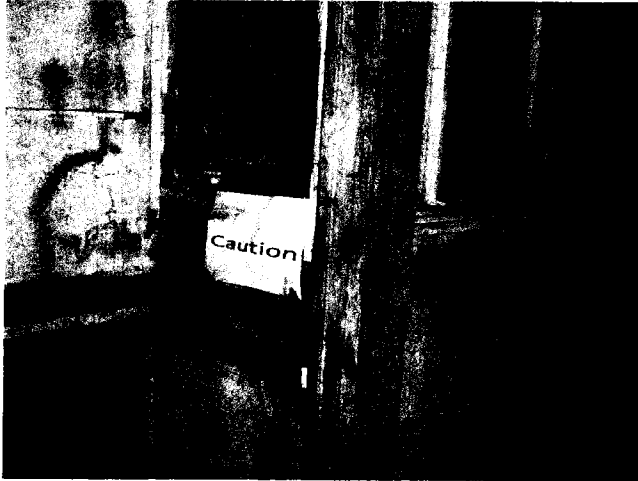
Photo 55: Wood Decay and Damage at Kitchen Window

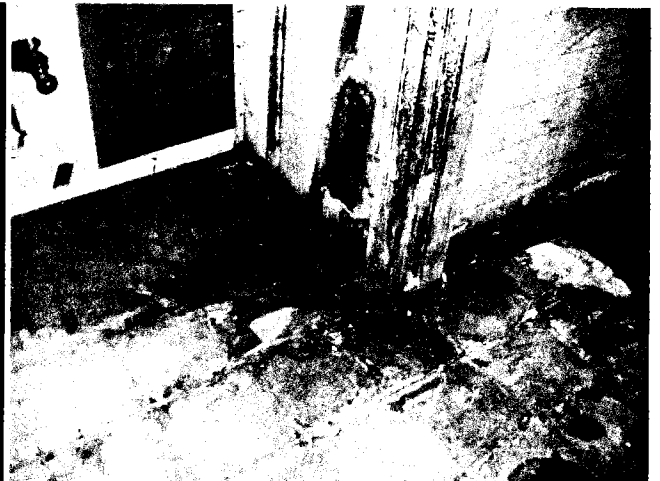
Photo 56: Wood Decay and Damage on Kitchen Floor2.

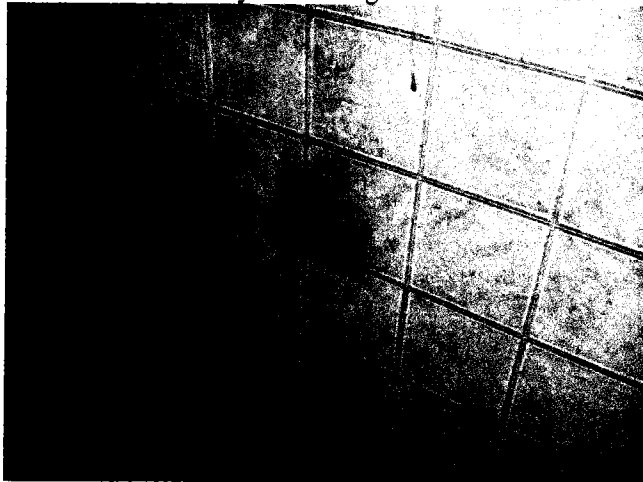
The second floor is about 28'-6" long and 25'-0" wide. It consists of Living Room, Dining Room, Kitchen, Laundry and Powder Room. There are damages on the entry door and rust on the hardware. The wood flooring shows wear, tear and water marks at many places. The Kitchen, Laundry and Powder Room lack water resistant floor finish. Cracks show on ceilings and walls throughout the floor. The Kitchen, Laundry and Powder Room are all stripped off all appliances and plumbing fixtures. Severe water damage on wall and floor framing around the lightwell of the Kitchen that causes floor settled on second and third floor. All the windows on second floor show signs of different level of deterioration, dry rot and water damages. The built-in cabinets and wall paneling in Dining Room shows deterioration and dry rot at several spots. There is only one electrical outlet in Kitchen and it lacks grounding.

Photo 57: Non GFCI & Grounded Elec. Outlet in Kitchen

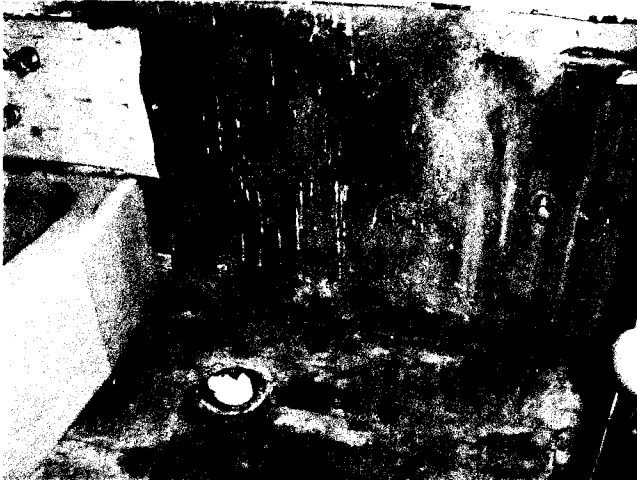
Bathroom on third floor missing finish floor covering and water resistant wall covering around tub and behind vanity. The shower head is missing. The tub is unsanitary. The vanity cabinet and toilet are missing. The walls around windows shows severe dry rot damage.

Photo 61: Missing Toilet & Molded Wall in Bathroom

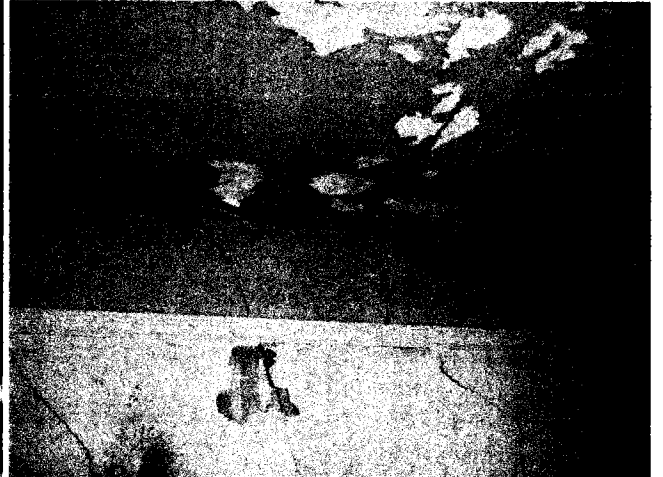
Photo 64: Cracks & Damages on Front Bedroom Ceiling

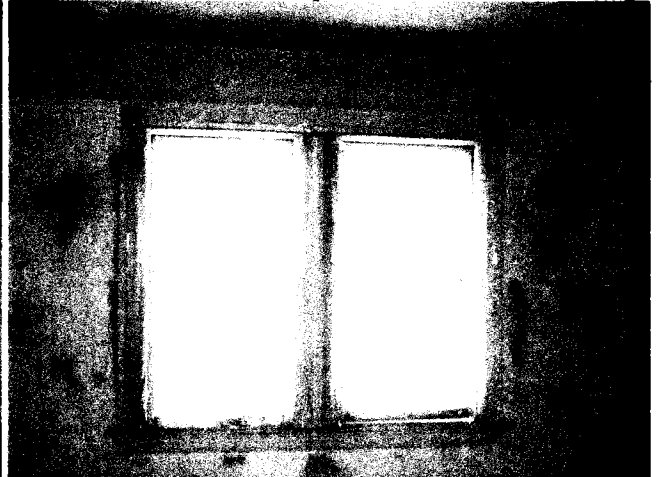
Photo 66: Damaged Windows in Front Bedroom

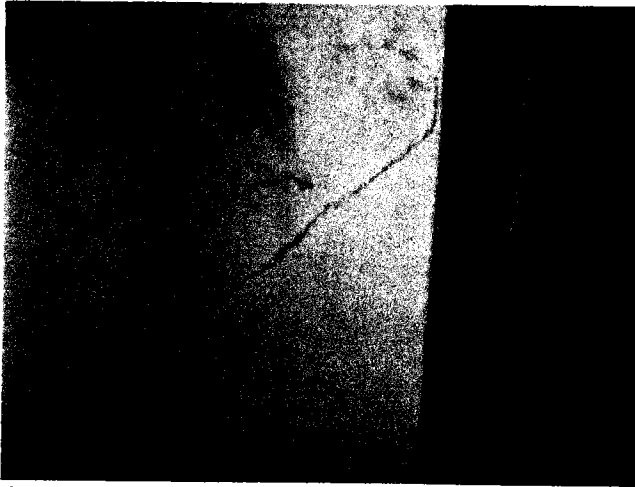
Photo 67: Damages on the Wall in Front Bedroom Closet

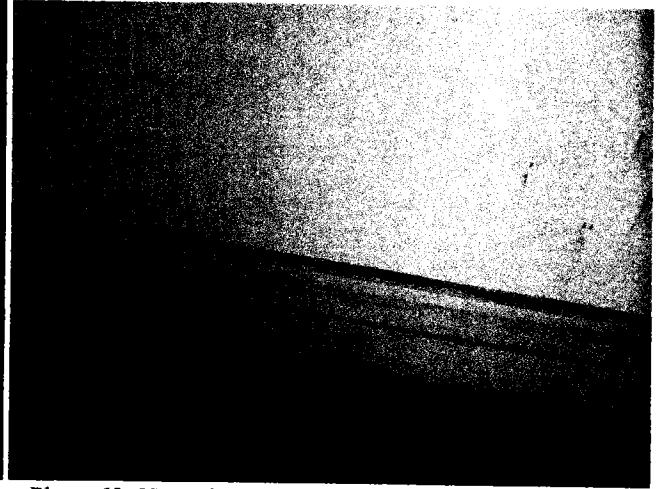
Photo 68: Hazardous Wiring in Front Bedroom

10. Repair or replace hazardous electrical wiring and damaged light fixtures.
11. Repair or replace rusty and damaged water supply line.
12. Repair or replace rusty and leaky plumbing.

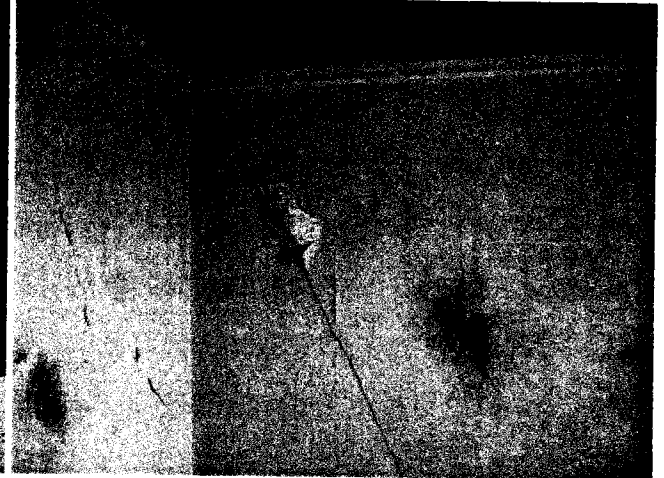
Photo 70: Damages & Cracks on Rear Bedroom Wall

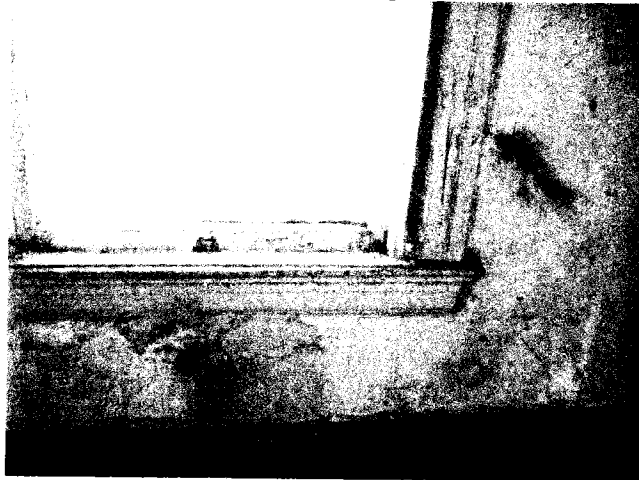
Photo 71: Damaged Windows in Rear Bedroom

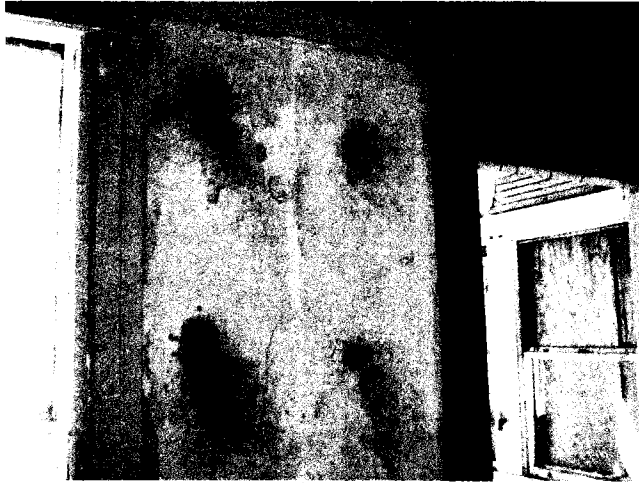
Photo 73: Damages on Rear Bedroom Wall

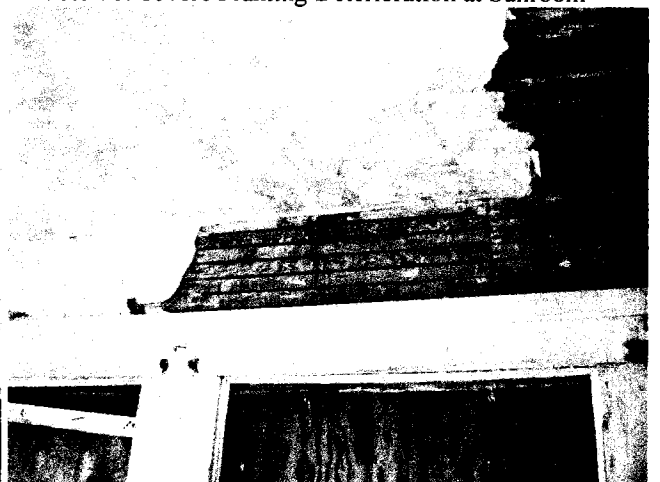
Photo 78: Sagged & Damaged Sunroom Ceiling

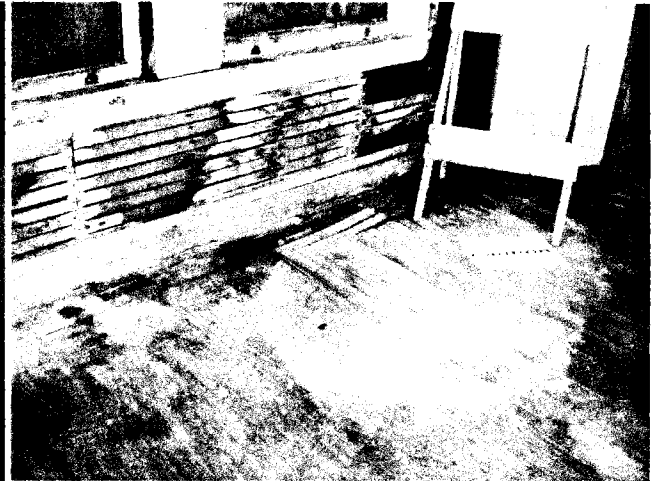
Photo 80: Deterioration & Sagging of Sunroom Floor

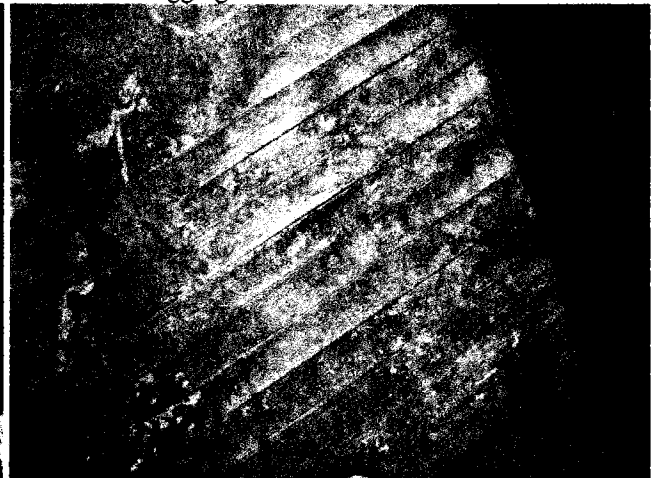
Photo 84: Sagging Floor at Hall
