SAN FRANCISCO PLANNING DEPARTMENT

MEMO

DATE: January 26, 2011
TO: Architectural Review Committee of the Historic Preservation Commission
FROM: Tim Frye, Acting Preservation Coordinator, (415) 575-6822
RE: **Review and Comment for 706 Mission Street – The Aronson Building Case No. 2008.1084E**

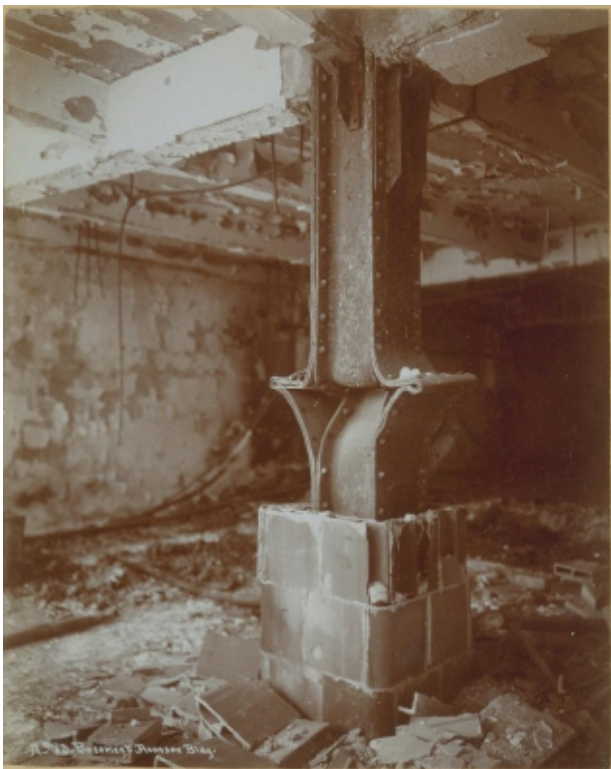
One of the columns in the basement on the east side has buckled. In the southwest corner of the first story, two columns have buckled near the ceiling. The failure of one of these was caused by the bulging of pipes within the fire-proof protection. In the northwest corner in the fifth story, one of the columns buckled so that the floors settled about 18". On the eighth floor, in the northwest corner of the building, another column is badly buckled. The same column on the tenth story buckled also. One column deflected slightly in this story.

Figure 13. Buckled I-beam encased in failed hollow tiles in the basement, 1906. Source: Bancroft Library.

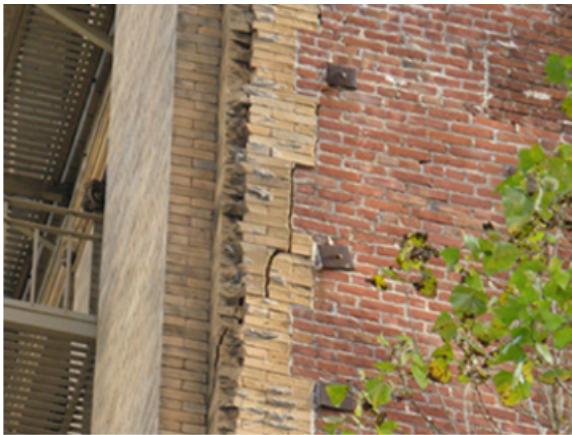
- Vertical cracking at the northeast corner where the brick wall meets the terra cotta clad 3rd Street façade (**Figure 35**);
- Evidence of abrasive blasting of the brick face at the exterior, confirmed by an annotation in the 1979 construction documents (**Figure 36**);
- Evidence of moisture at roof parapet, as seen by organic growth (**Figure 37**);
- Evidence of abrasive blasting of brick face at the interior, resulting in loss of mortar, pitting of the brick face, and rounded brick edges (**Figure 38**);
- Poor joint condition due to abrasive blasting.

Figure 35. Cracking at terra cotta to brick interface.
Source: Page & Turnbull, March 2010.

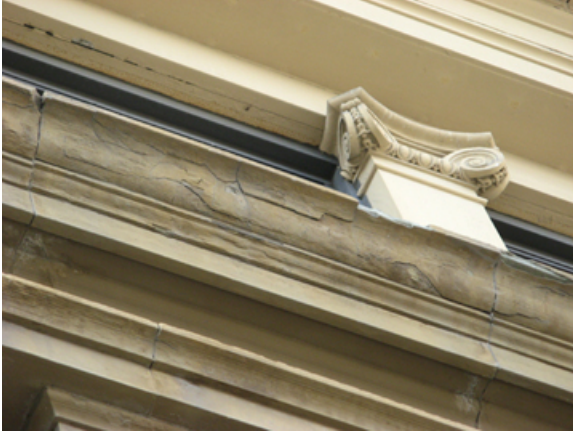
Figure 39. Cracking and spalling of sandstone at edge. Source: Page & Turnbull, March 2010.

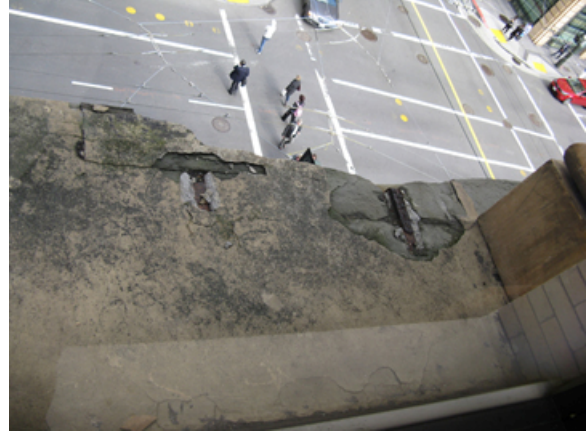
Figure 40. Cracking/spalling of concrete at steel corrosion. Source: Page & Turnbull, March 2010.

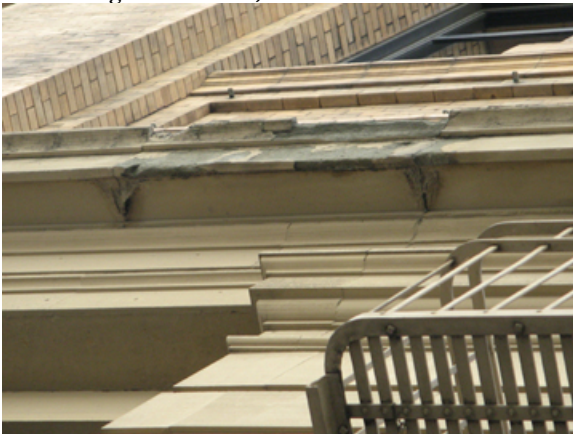
Figure 41. Spalling of sandstone at edge. Source: Page & Turnbull, March 2010.

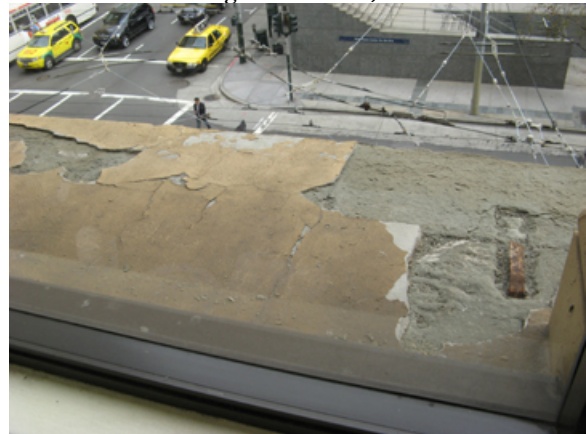
Figure 42. Exfoliation of crust. Source: Page & Turnbull, March 2010.

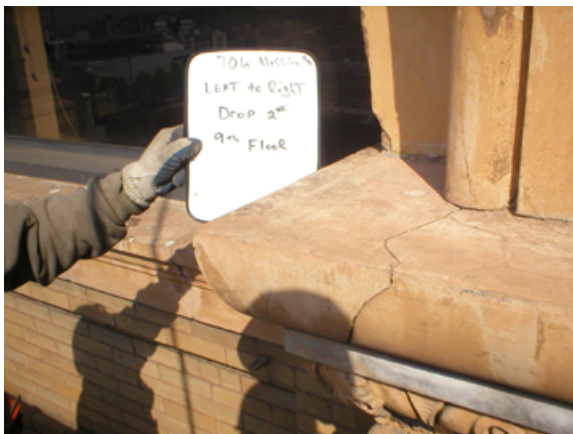
Figure 44. Cracking at cornice. Source: Rainbow Waterproofing, 2006.

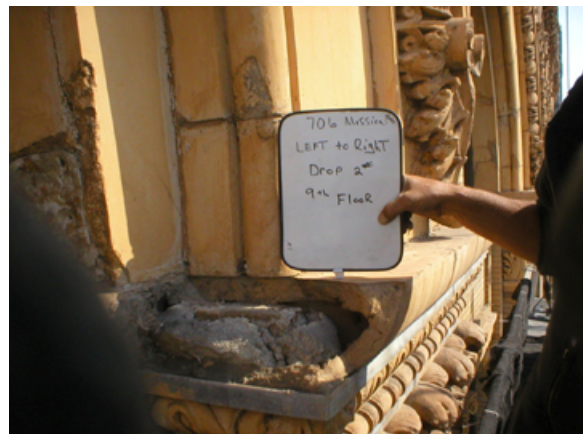
Figure 45. Removal of cracked piece shown at left. Source: Rainbow Waterproofing, 2006.

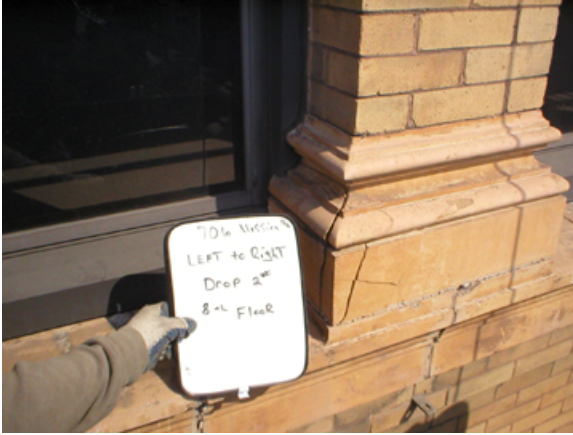
Figure 46. Cracking at column base.
Source: Rainbow Waterproofing, 2006.

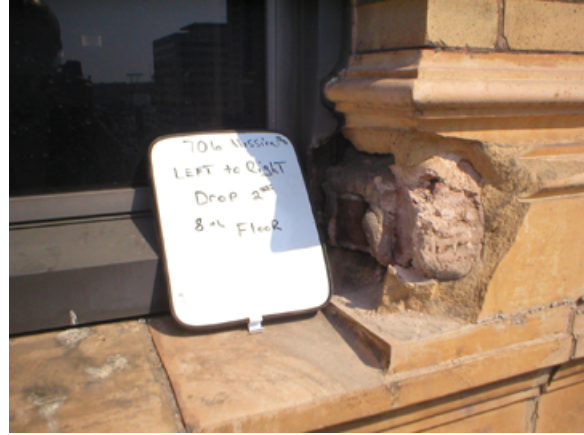
Figure 47. Removal of cracked piece shown at left.
Source: Rainbow Waterproofing, 2006.

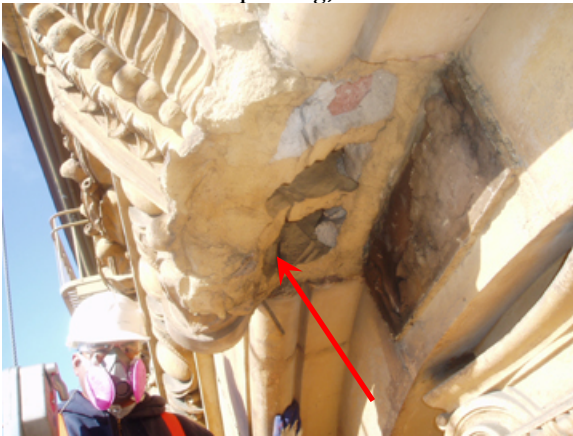
Figure 48. In-plane cracking of keystone.
Source: Rainbow Waterproofing, 2006.

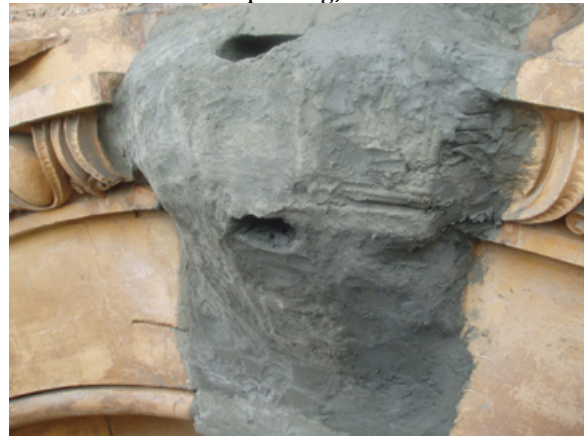
Figure 49. Removal of cracked and mortar patch of piece shown at left. Source: Rainbow Waterproofing, 2006.

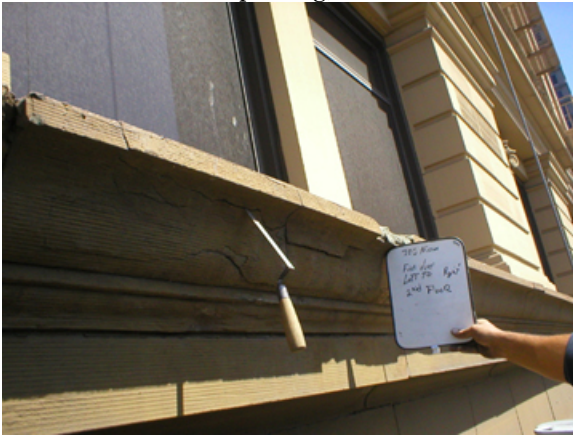
Figure 50. Cracking of sandstone.
Source: Rainbow Waterproofing, 2006.

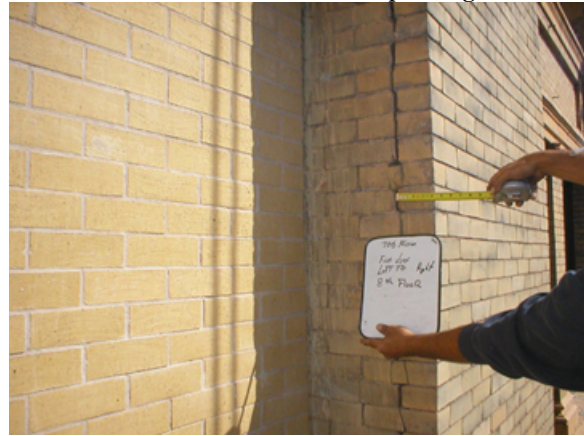
Figure 51. Cracking of terra cotta brick.
Source: Rainbow Waterproofing, 2006.

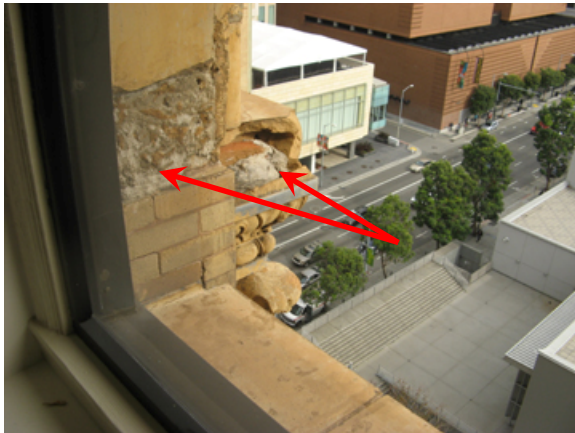
Figure 52. Deep bisque spall exposing void filler.
Source: Page & Turnbull, March 2010.

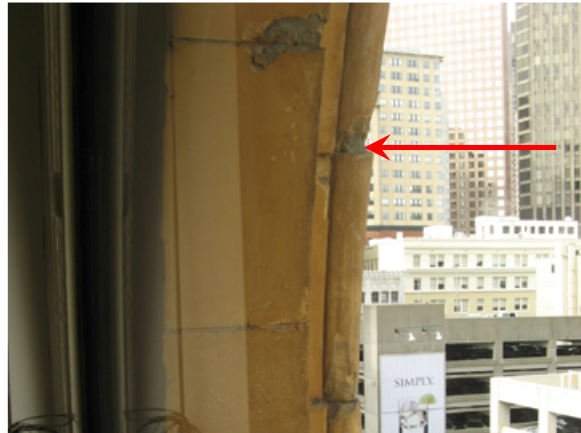
Figure 53. Shallow bisque spalls at joints.
Source: Page & Turnbull, March 2010.

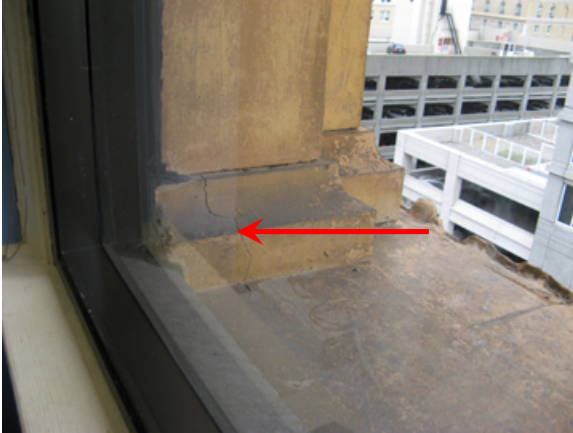
Figure 54. Cracking at column base.
Source: Page & Turnbull, March 2010.

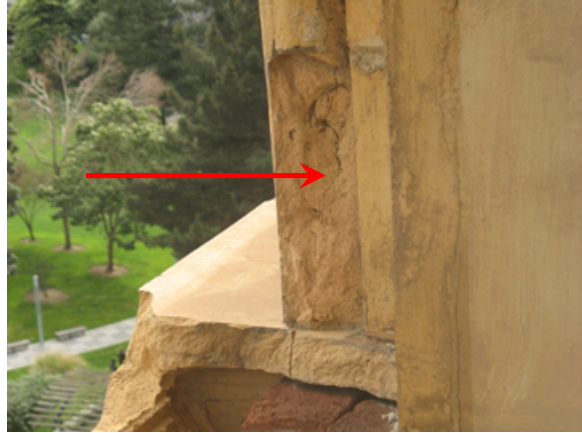
Figure 55. In-plane cracking at bisque spall.
Source: Page & Turnbull, March 2010.

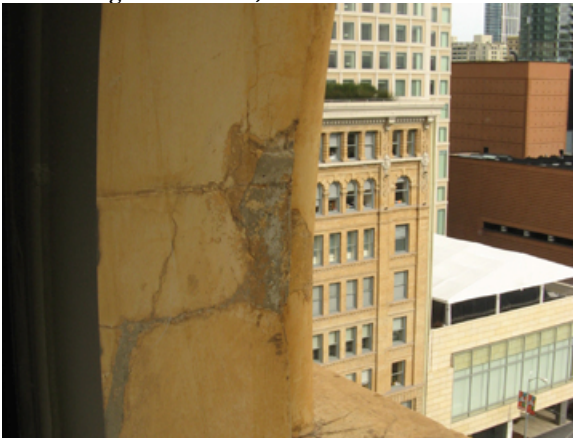
Figure 56. Previous repair.
Source: Page & Turnbull, March 2010.

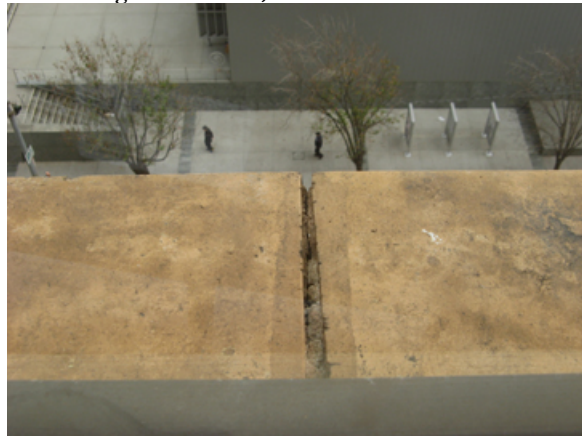
- Mortar joints were observed to be in fair-to-poor condition with cracked and missing mortar (**Figure 57**). In some areas joints have been pointed with non-matching mortar. Additionally some joints have been repaired with sealant, which has dried, cracked, and deteriorated.

Figure 57. Cracking and missing mortar at sill joint.
Source: Page & Turnbull, March 2010.

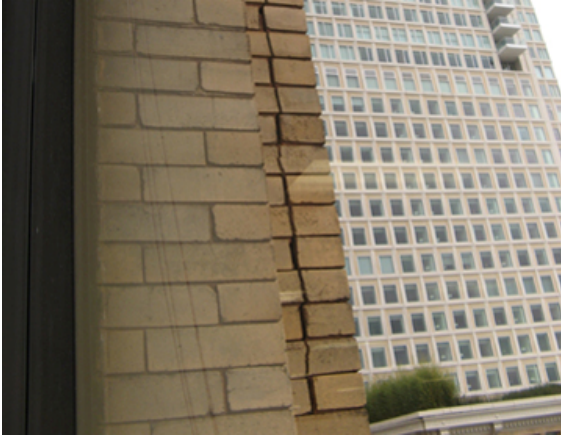
- Cracking of the glazed brick can be seen at vertical corners of the building, for example, at the columns which extend between the fourth and eighth floors. In some areas these cracks are continuous and extend multiple floor levels (**Figure 58**);
- Spalling of the brick occurs at the cracked areas described above. Localized to the corners of the window openings;
- Missing brick units also occur at the cracked areas described above. Localized to the corners of the window openings (**Figure 59**).

Figure 58. Cracking at column corner.
Source: Page & Turnbull, March 2010.

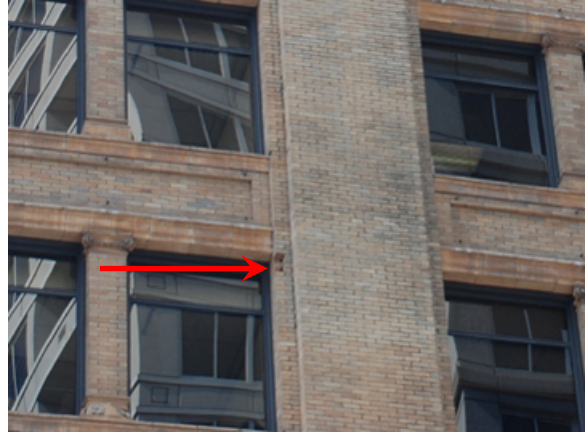
Figure 59. Missing brick.
Source: Page & Turnbull, March 2010.

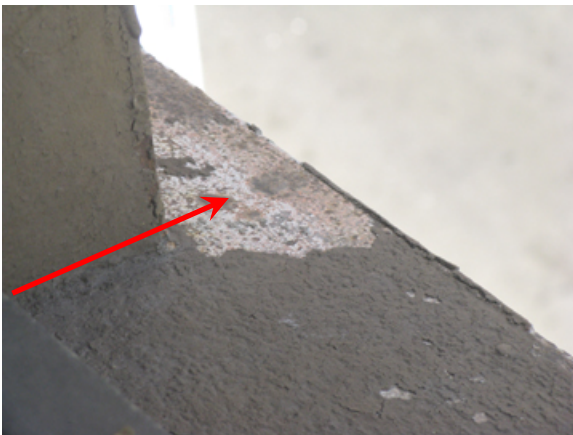
- Minor corrosion due to oxidization located at areas of paint failure (**Figure 60**);
- Paint failure, particularly at the second story horizontal surfaces (**Figure 61 & 62**);
- Missing elements (**Figure 63**).

Figure 60. Corrosion of cast iron.
Source: Page & Turnbull, March 2010.

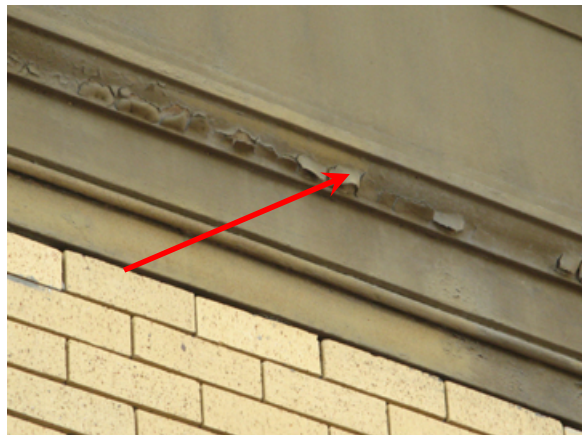
Figure 61. Delaminating paint.
Source: Page & Turnbull, March 2010.

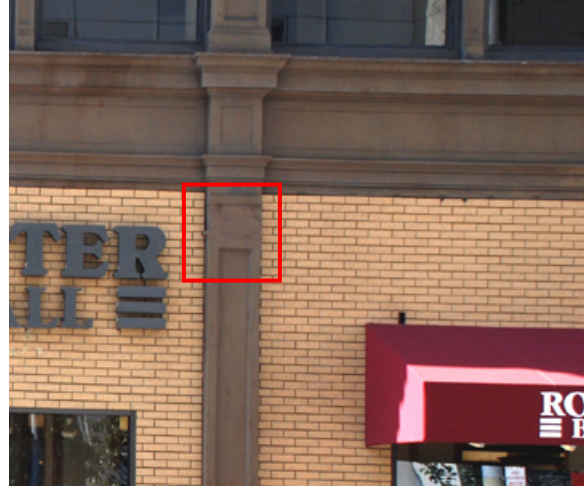
Figure 63. Missing scroll at column capital on 3rd Street facade. Source: Page & Turnbull, March 2010.

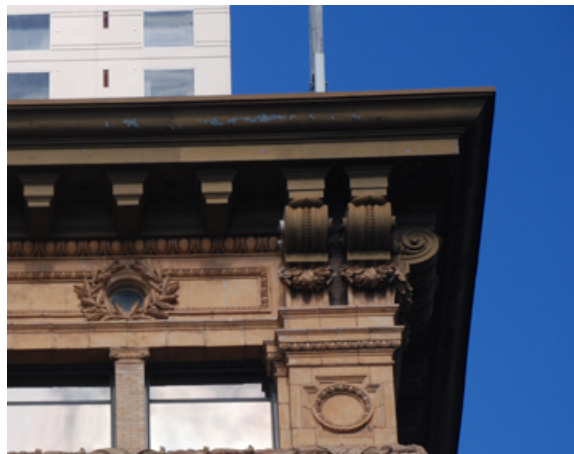
- o Minor corrosion due to oxidization located at areas of paint failure;
- o Paint failure, particularly at the second story horizontal surfaces (**Figure 64**);

Figure 64. Area of exposed sheet metal with no paint.
Source: Page & Turnbull, March 2010.

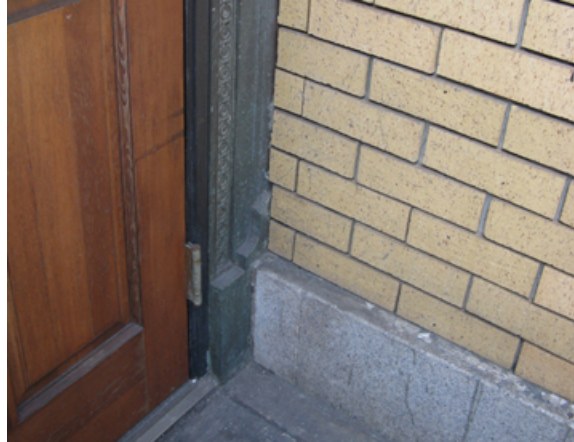
- General loose particulate soiling;
- Active corrosion in the form of greenish streaks and pits in the bronze surface (**Figure 65**);

Figure 65. Corrosion of bronze frame.
Source: Page & Turnbull, March 2010.

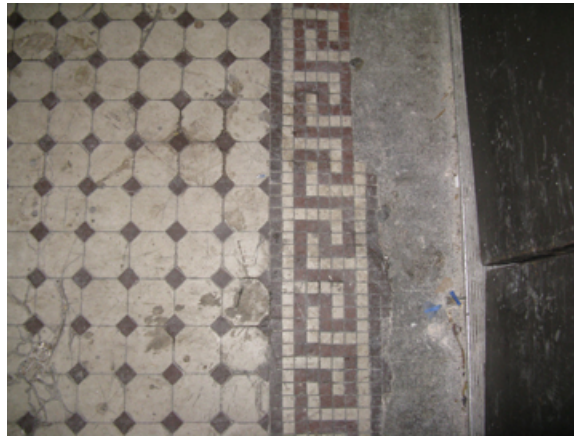
- Cracking of tile, likely due to function of space as freight transport, allowing large loads to bear on the tile;
- Staining, soiling and over coat of concrete at elevator threshold. **(Figure 67);**

Figure 67. Cracking and soiling of ceramic tile.
Source: Page & Turnbull, March 2010.
