SAN FRANCISCO PLANNING DEPARTMENT

Certificate of Appropriateness Case Report

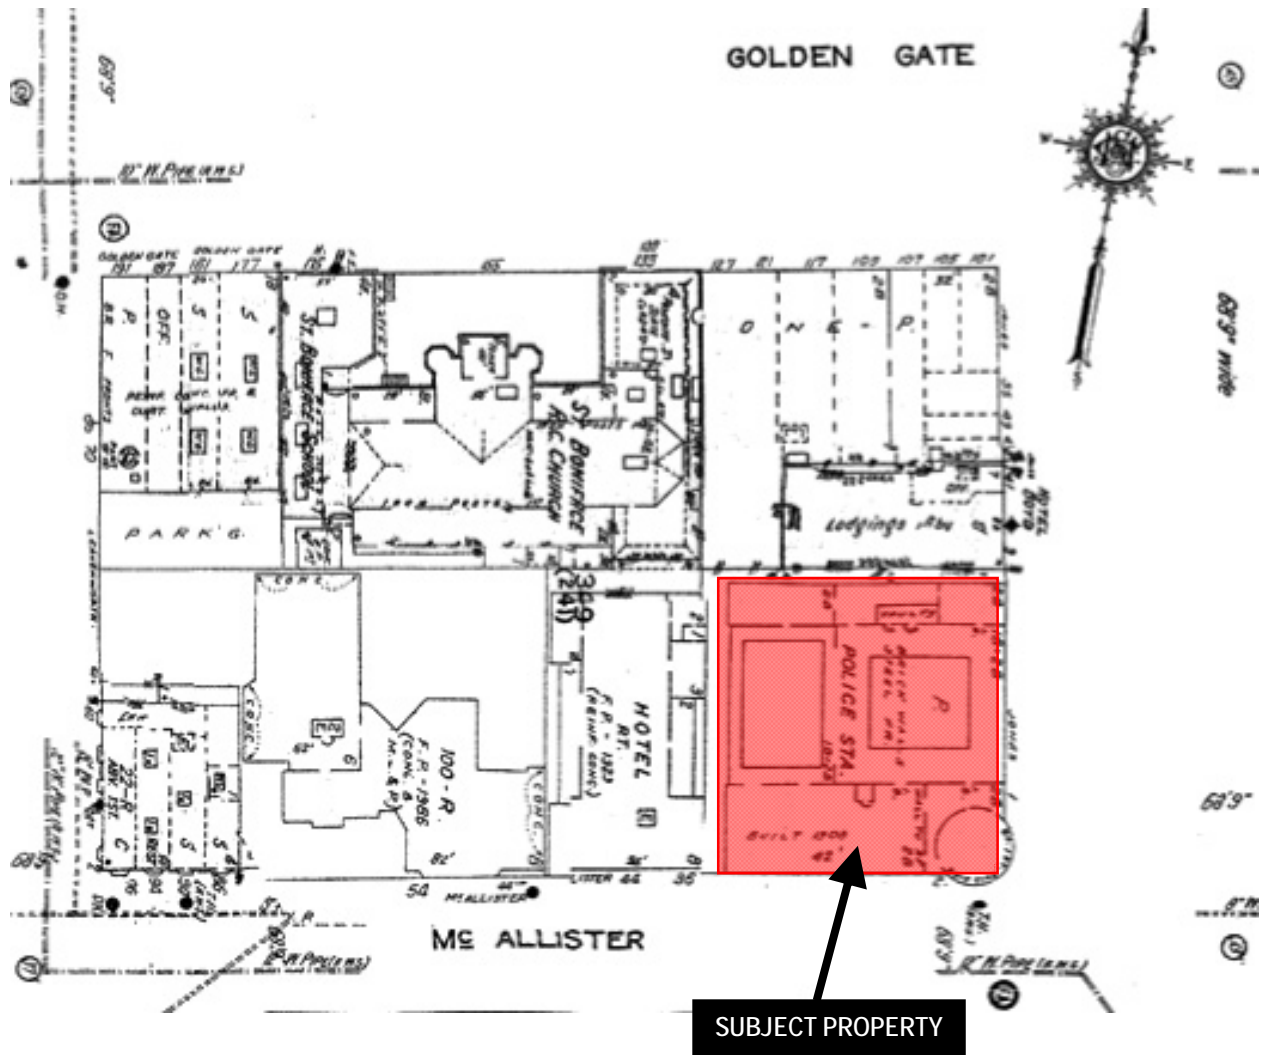
*The Sanborn Maps in San Francisco have not been updated since 1998, and this map may not accurately reflect existing conditions.

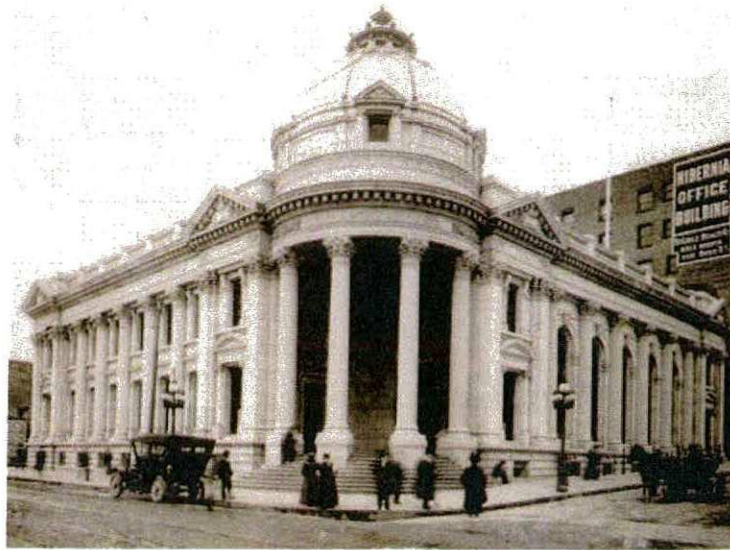
HIBERNIA BANK BUILDING

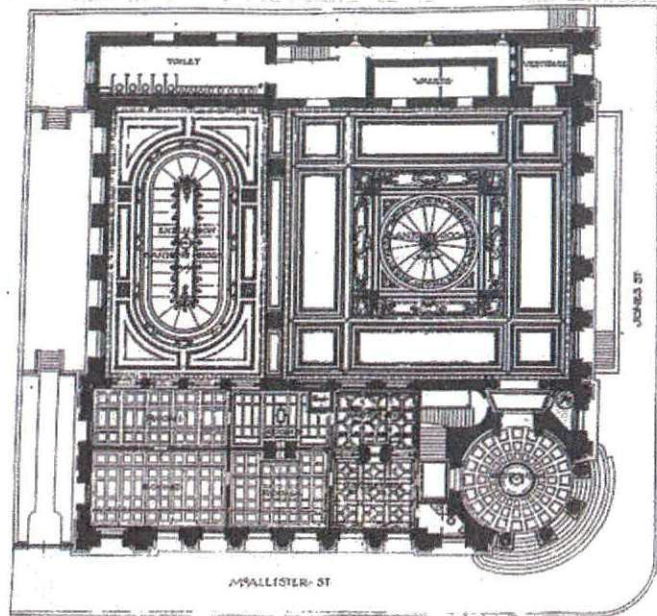
Figure 7. Reflected ceiling plan showing the 1905 addition to Hibernia Bank Building. Source: *Architect and Engineer*, July 1909.

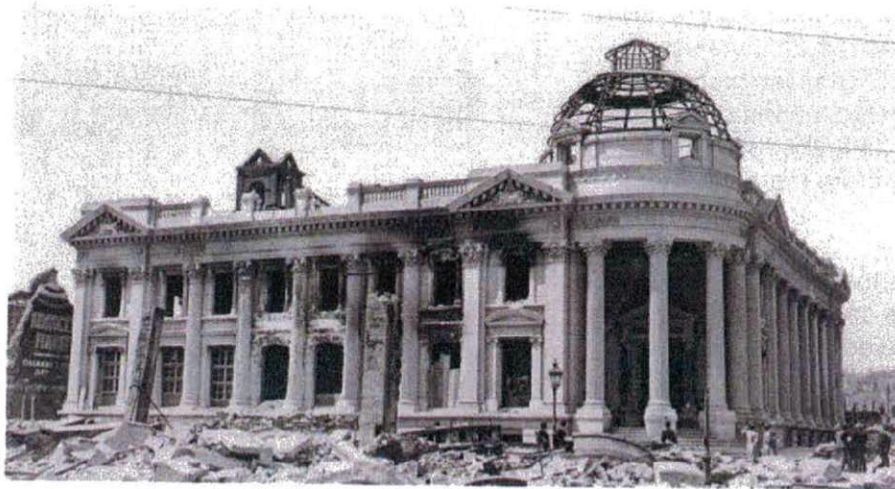
Figure 8. Hibernia Bank Building, April 18, 1906. Note smoke and fire damage above windows and damage to rotunda. Source: California Historical Society.

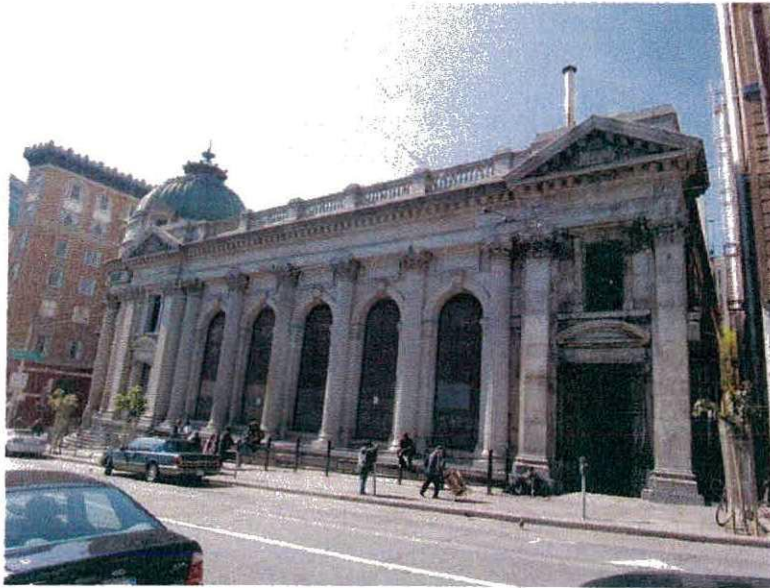
Figure 9. East facade facing Jones Street. Source: KVP 2009.

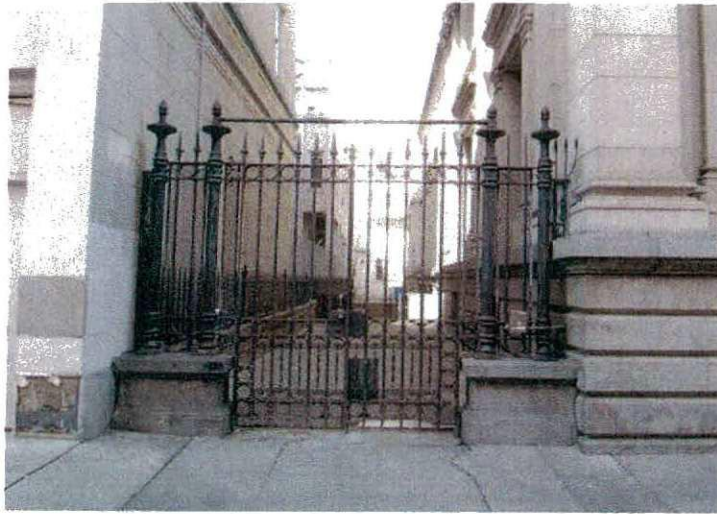
Figure 11. Cast iron and wrought iron security gate located just west of the building. Source: KVP 2009.

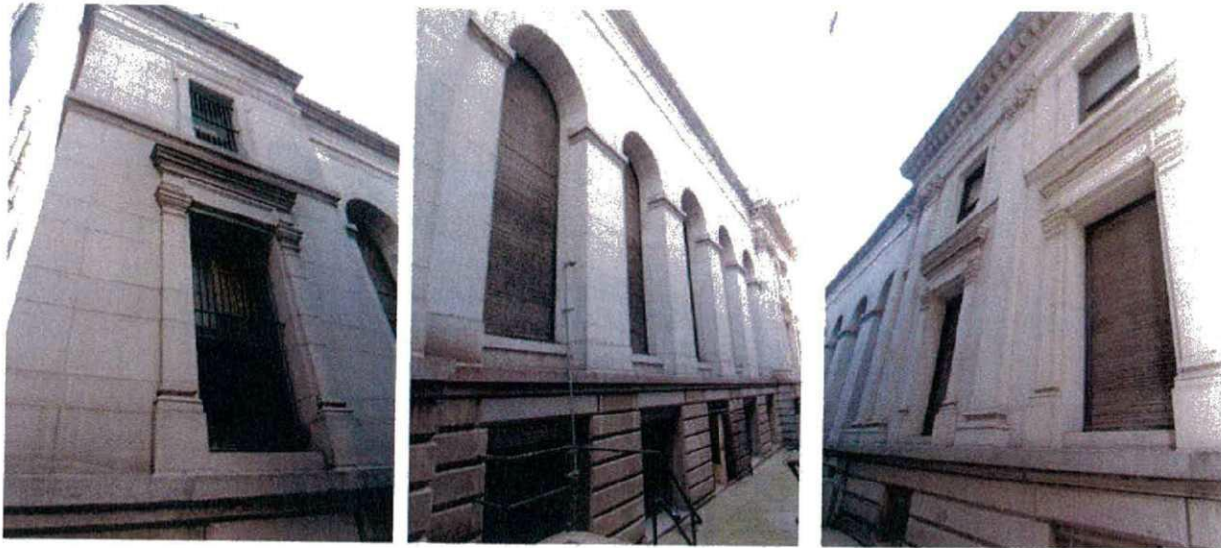
Figure 12. Details of west facade. From left to right: north bay, center bays and south bays.

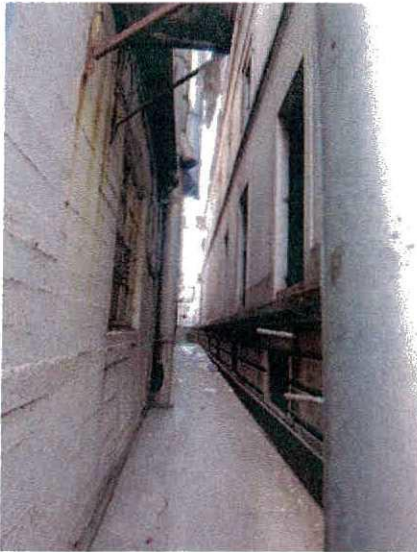
Figure 13. North facade. Source: KVP 2009.

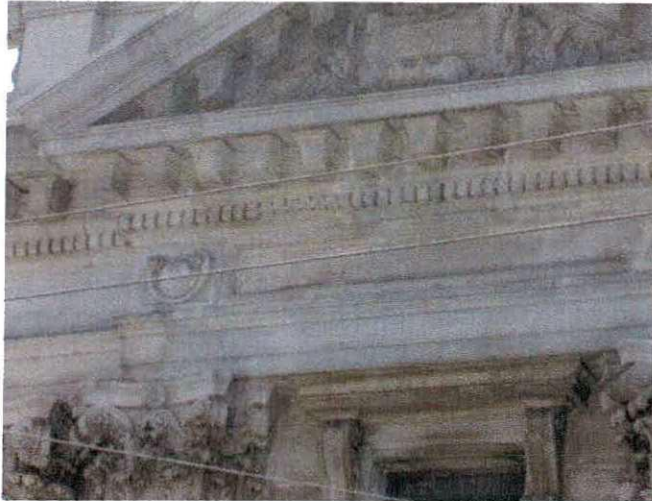
Figure 19. One of two areas of broken dentil molding on the east facade

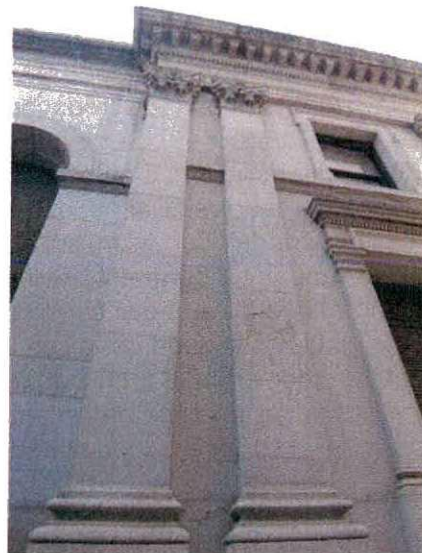
Figure 20. Spalling granite on west facade. Source: KVP 2009.

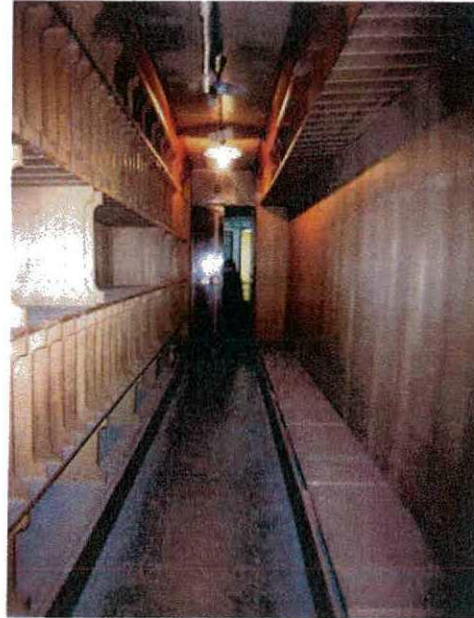
Figure 22. Document Vault (B-5) located in the basement. Source: KVP 2009.

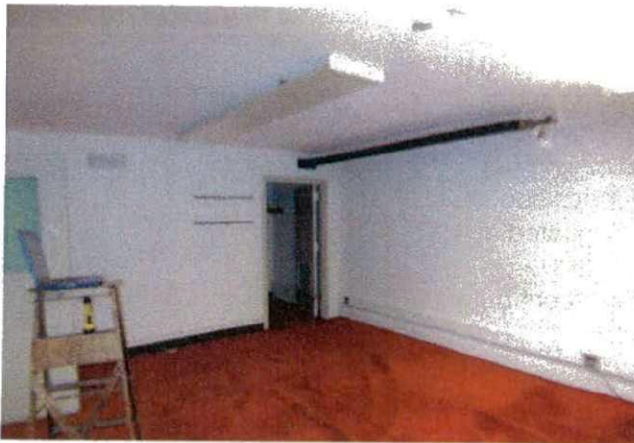
Figure 23. Office #2 (B-8) located in the basement.
Source: KVP 2009.

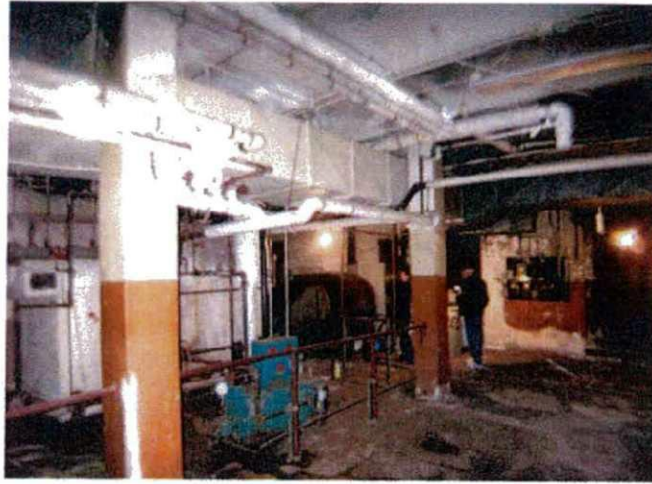
Figure 24. Mechanical Room (B-15) located in the basement. Source: KVP 2009.

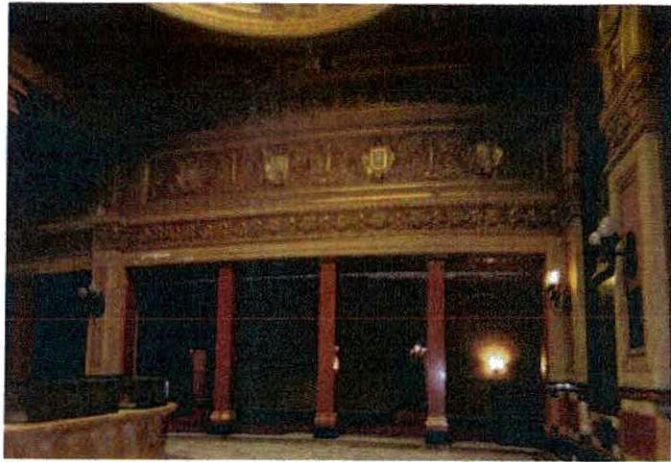
Figure 34. Customer waiting area (F-9) located on the first floor south of the Banking Hall (F-8).
Source: KVP 2009.

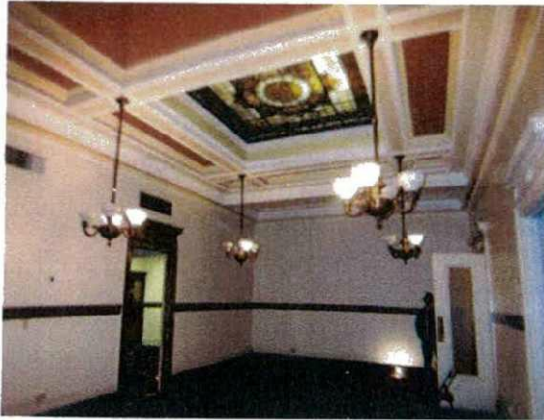
Figure 40. Waiting/Reception Room (S-9) located on the second floor south. Note historic light fixtures and skylight. Source: KVP 2009.

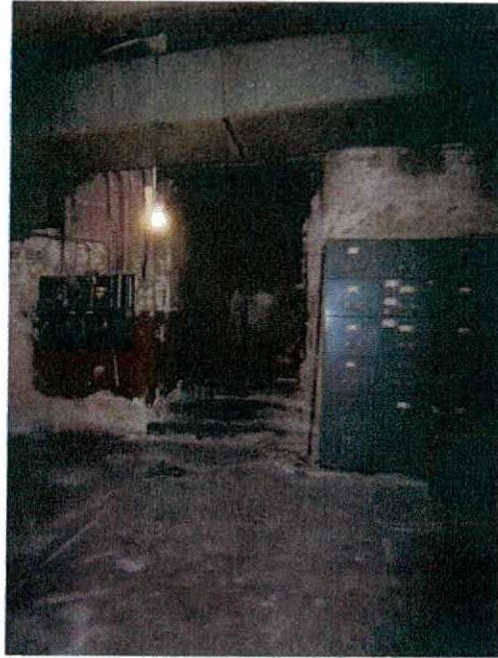
Figure 48. Mechanical Room (B-15) in the basement shows signs of bubbling and spalling plaster concentrated around the window and door openings. Source: KVP 2009.

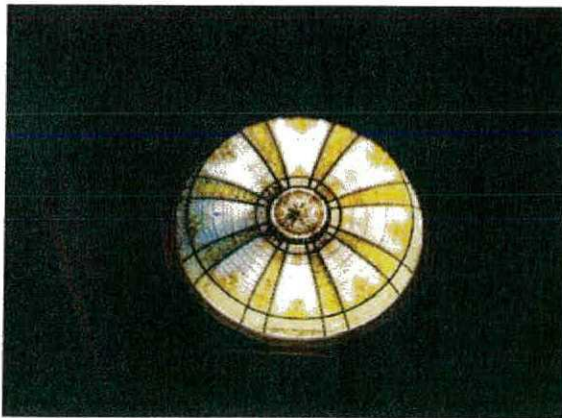
Figure 51. Round art glass skylight located in the Banking Hall (F-8). Source: KVP 2009.

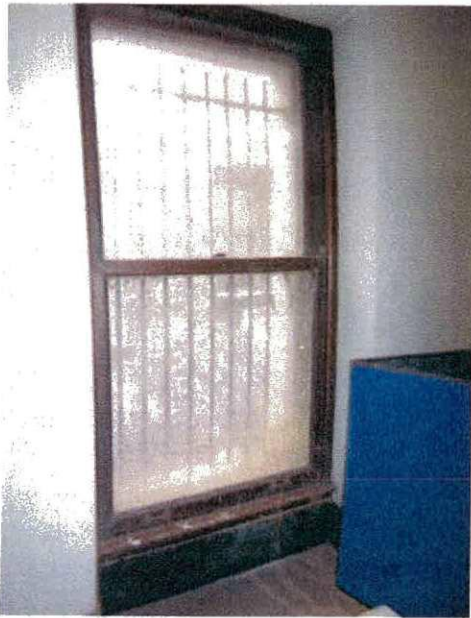
Figure 53. Typical double-hung, sheet bronze over steel sash window that dates from the 1907 reconstruction. Source: KVP 2009.

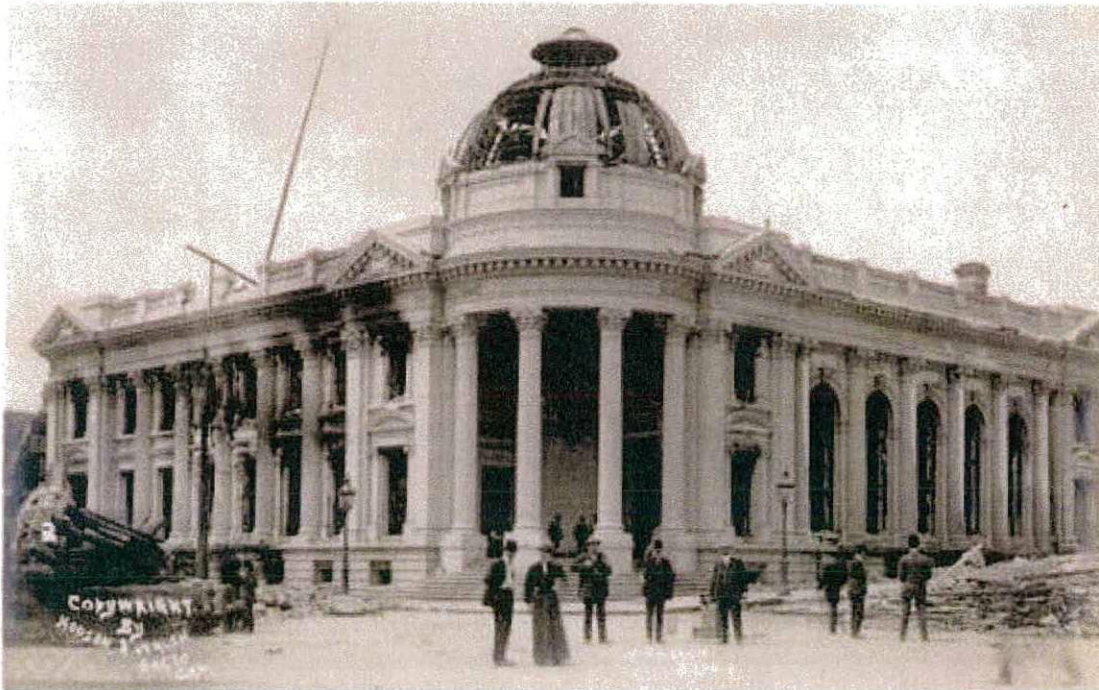
Item 17. Hibernia Bank Building, 1906. Note smoke damage at left dome beginning to be reconstructed. Source: San Francisco History Center, San Francisco Public Library.

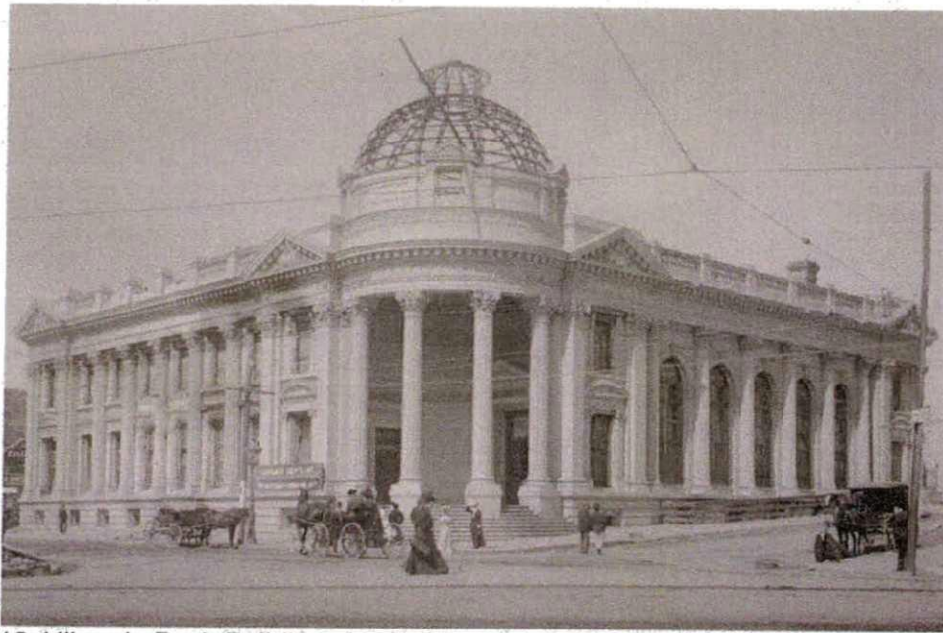
Item 18. Hibernia Bank Building, 1906. Courtesy California State Library, Stanley Mosk Library and Courts Building.

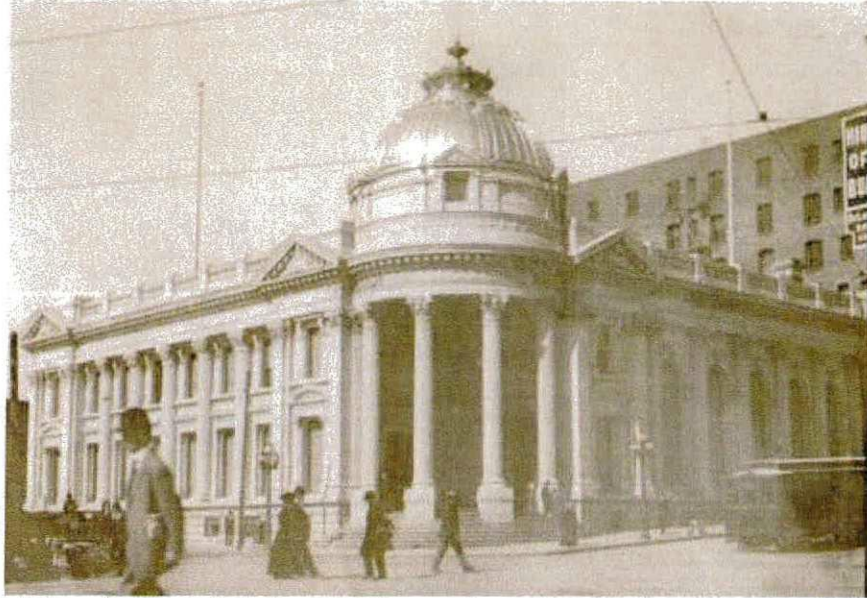
Item 20. Hibernia Bank Building, 1908, repaired after the fire. Note the gleam of the gilded dome. Source: San Francisco History Center, San Francisco Public Library.

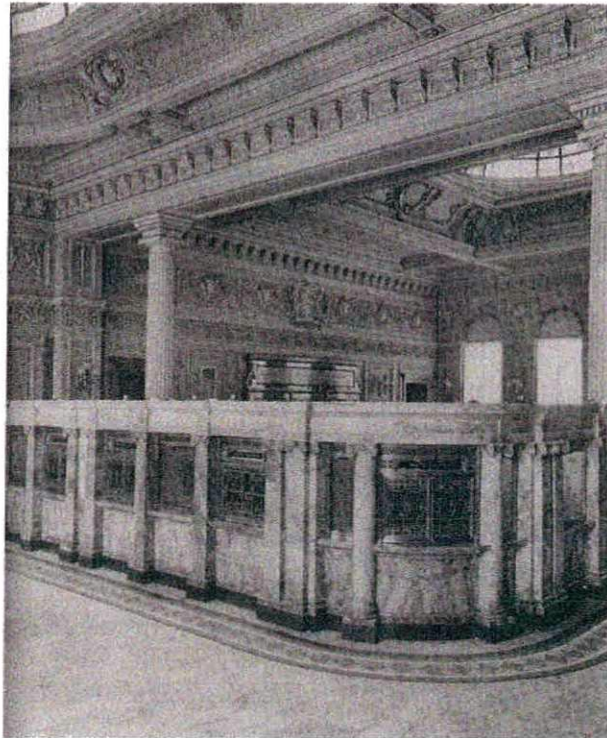
Item 21. Interior of repaired Hibernia Bank Building, c. 1908.

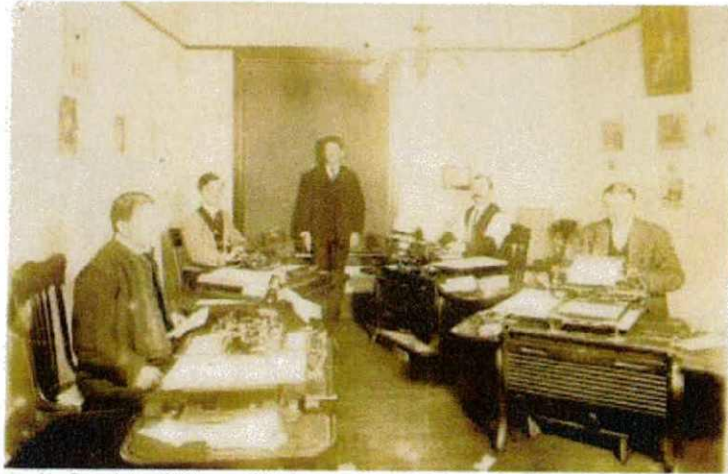
Item 22. County Clerk's Office; Hibernia Bank Building, Feb. 4, 1911. Source: San Francisco History Center, San Francisco Public Library.

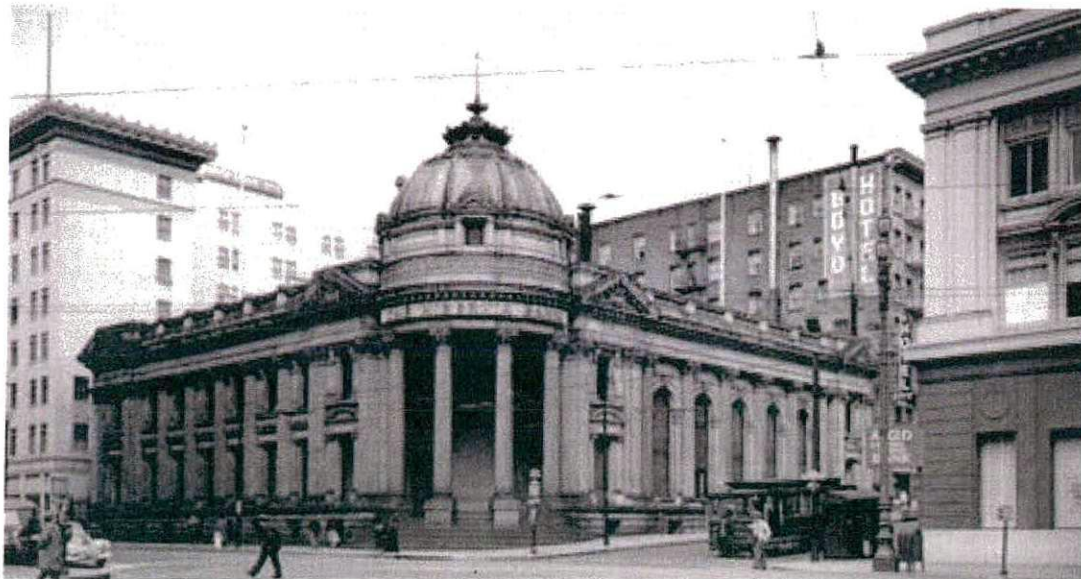
Item 25. Hibernia Bank Building, c. 1957. Source: San Francisco History Center, San Francisco Public Library.

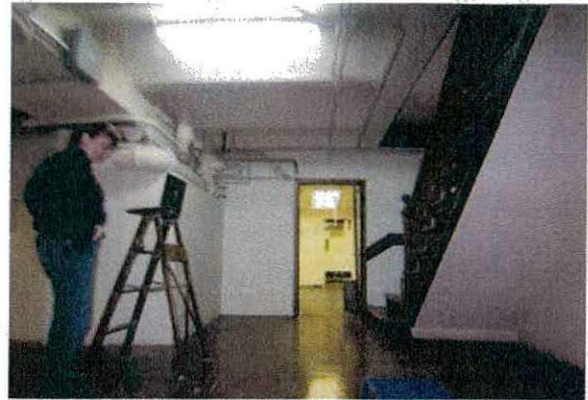
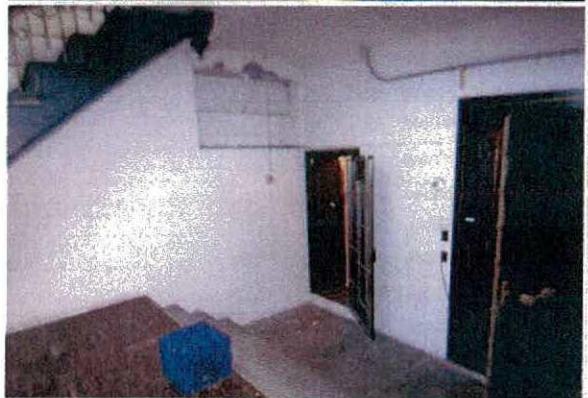
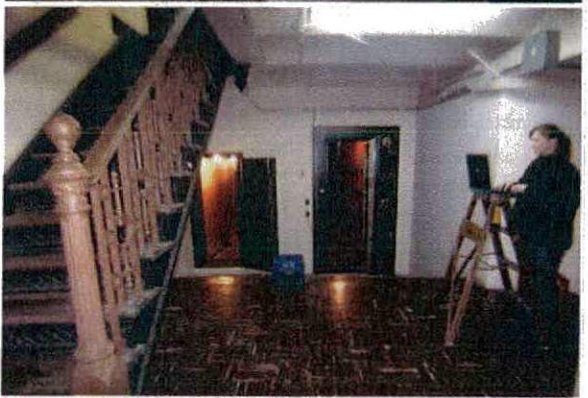
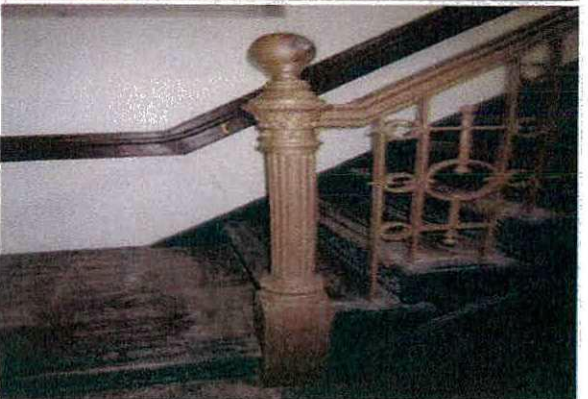
Fire protection	none		
Mechanical grilles	none		
Mechanical diffusers	none		
Visible piping or ducts	piping gas and air ducts	F	NC
Signage	none		
Miscellaneous	decorative iron railing for stairs	G	S

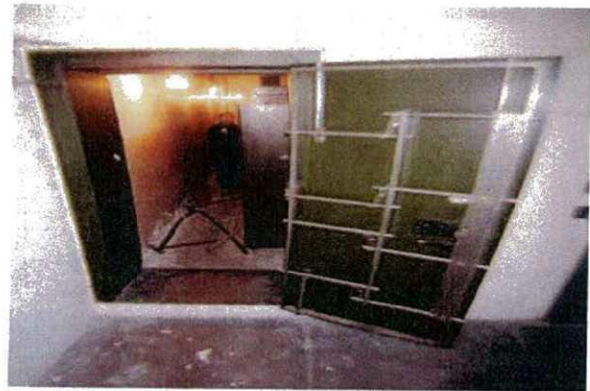
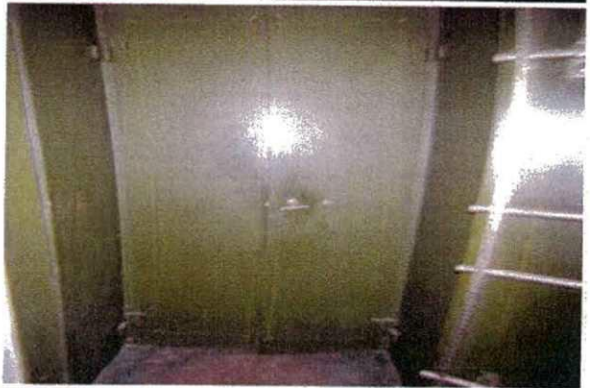
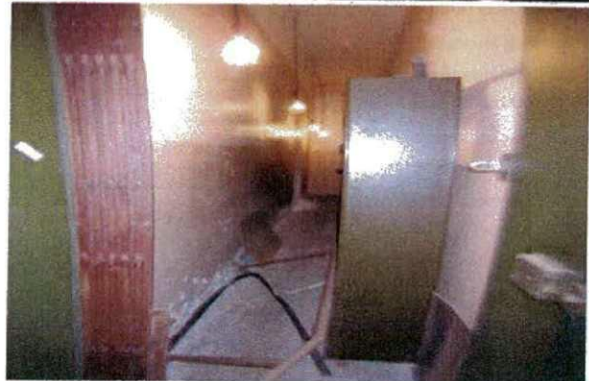
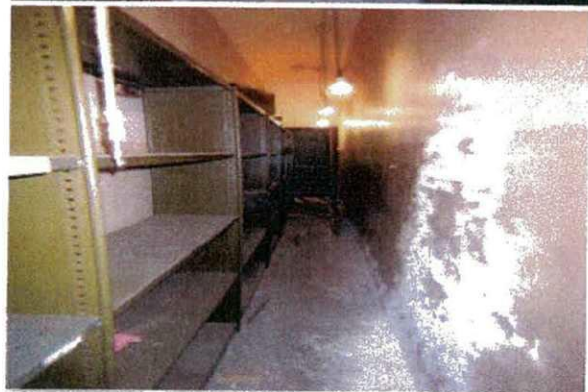
Mechanical diffusers	none		
Visible piping or ducts	none		
Signage	none		
Miscellaneous	significant water damage on north wall

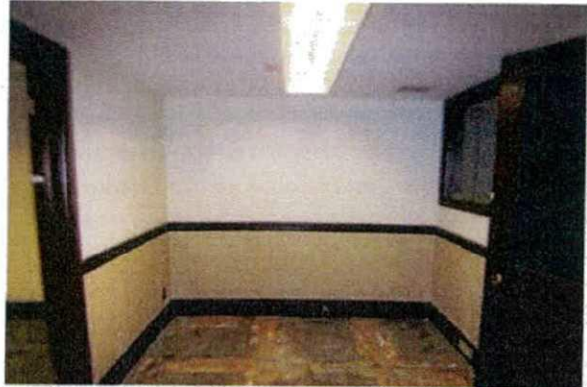
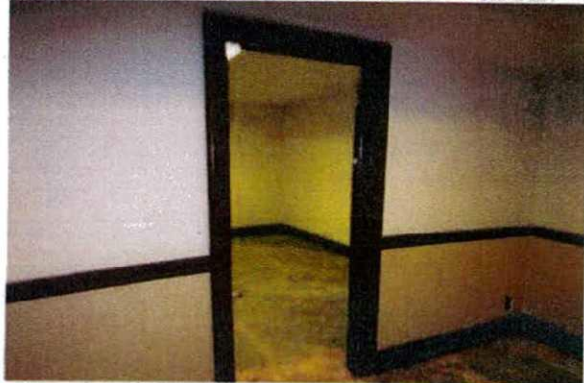
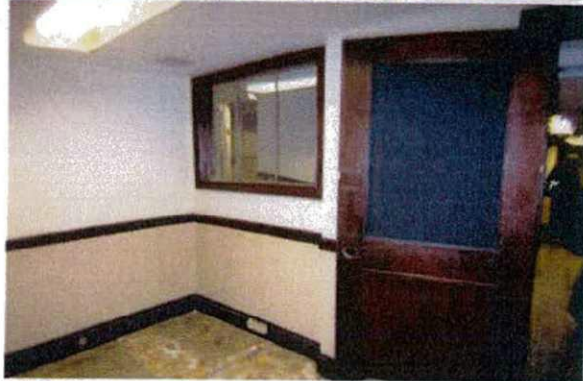
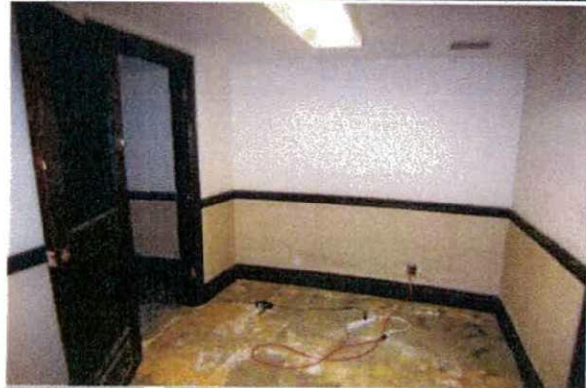
Plumbing partitions	none		
Fire protection	none		
Mechanical grilles	ceiling		
Mechanical diffusers	none		
Visible piping or ducts	none		
Signage	none		
Miscellaneous	none

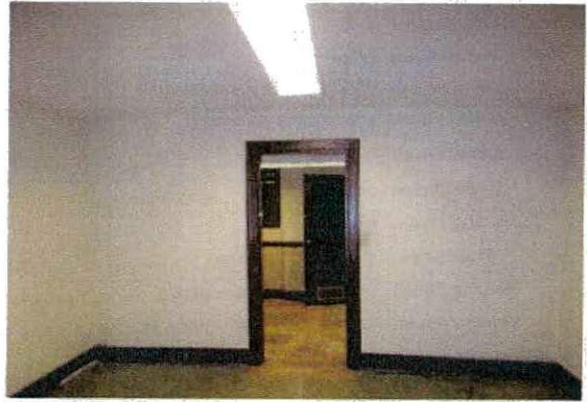
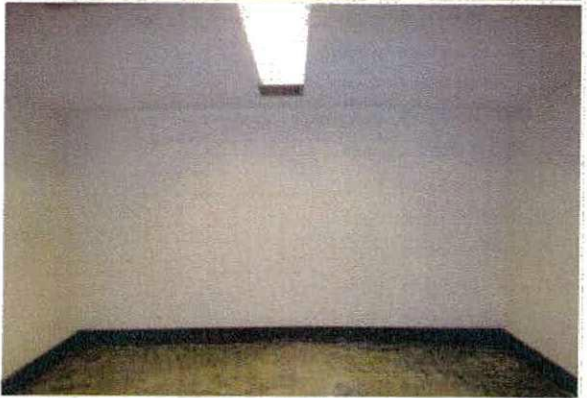
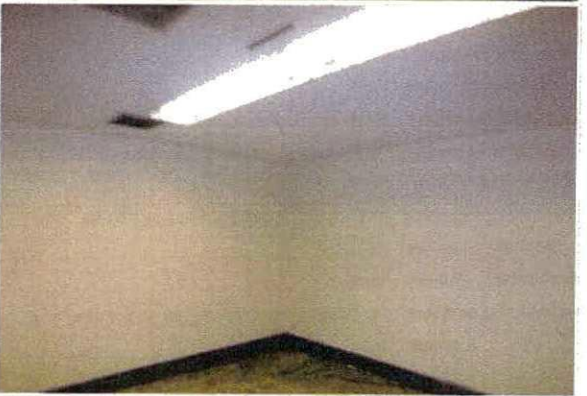
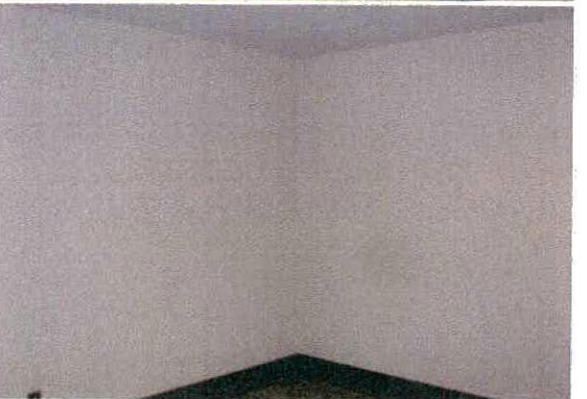
Signage	none		
Miscellaneous	water damage hidden in walls and ceiling

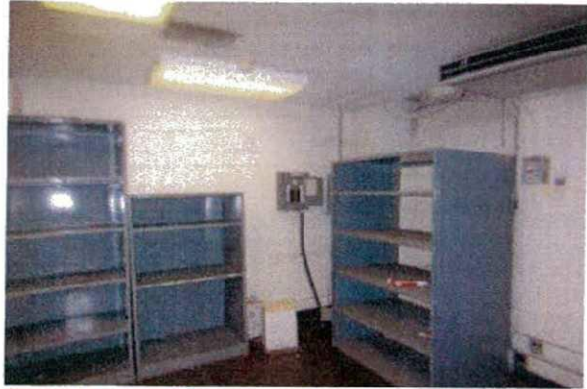
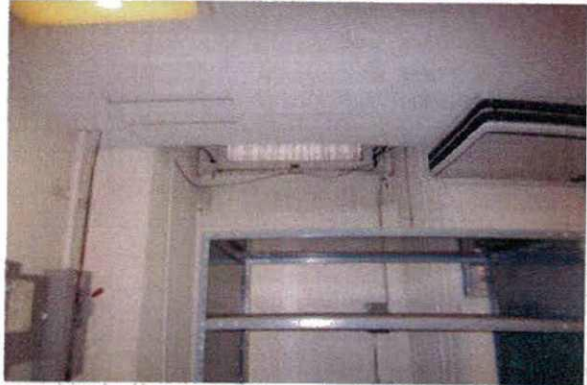
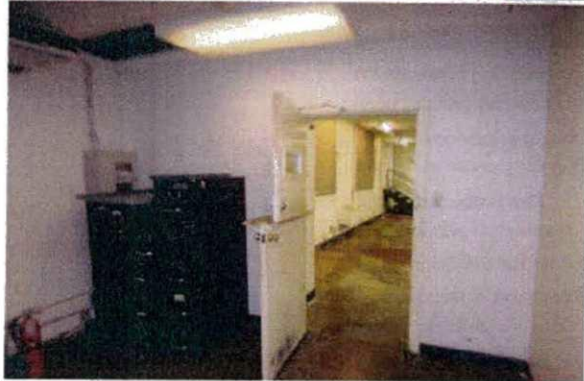
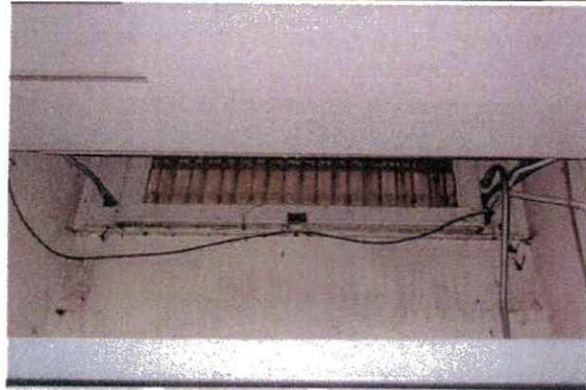
Fire protection	modern fire detection ceiling and panel	F	NC
Mechanical grilles	modern	F	NC
Mechanical diffusers	none		
Visible piping or ducts	gas radiator west wall ceiling air conditioner	F	NC
Signage	none		
Miscellaneous	several electrical panels and piping for conduit	G	NC

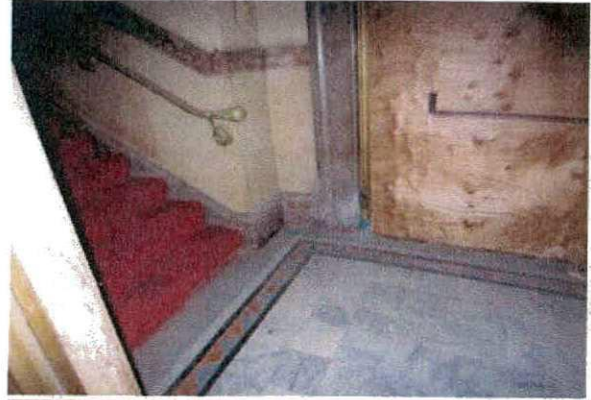
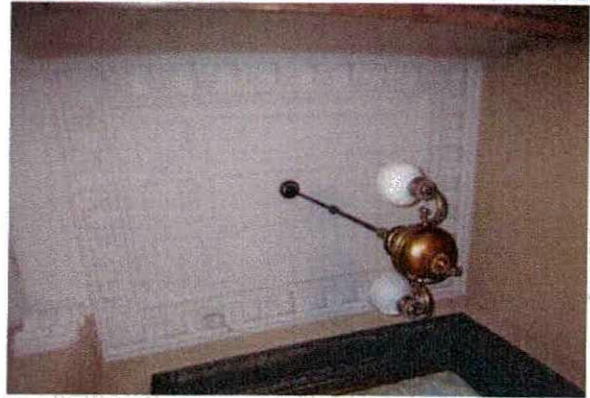
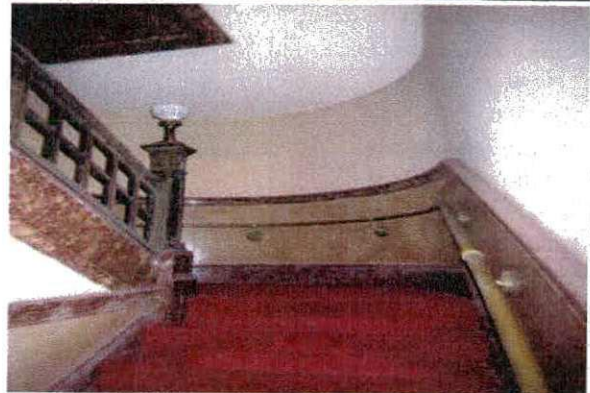
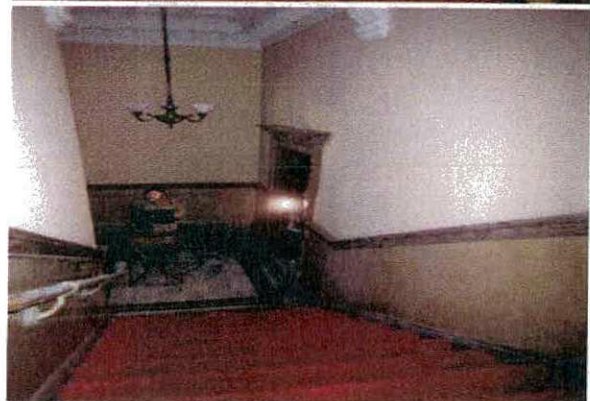
Plumbing urinals	none		
Plumbing accessories	none		
Plumbing partitions	none		
Fire protection	none		
Mechanical grilles	none		
Mechanical diffusers	none		
Visible piping or ducts	none		
Signage	outside of transom	G	VS
Miscellaneous	transom opens working mechanism, brass handrail on stairs, stairs are carpeted marble wainscoting on wall with plaster

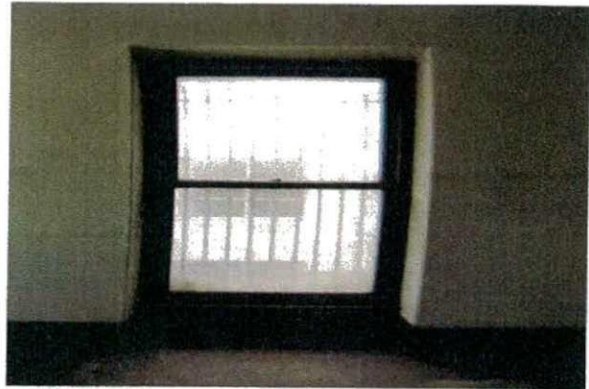
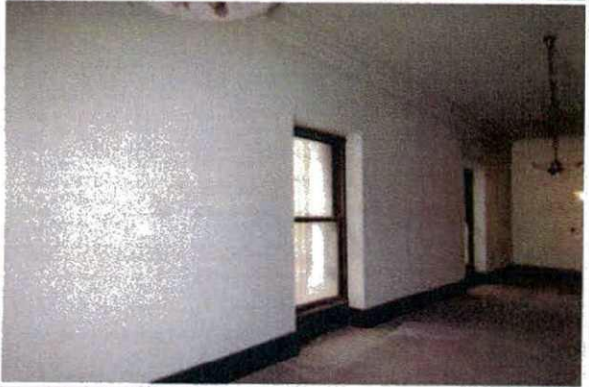
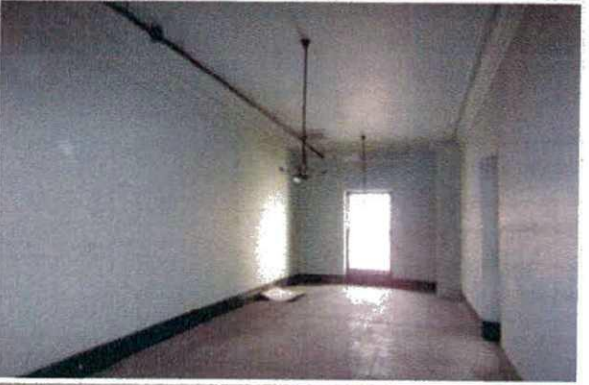
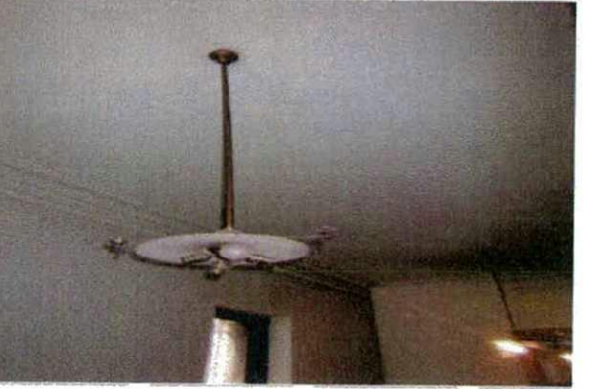
Plumbing toilets	none		
Plumbing urinals	none		
Plumbing accessories	none		
Plumbing partitions	none		
Fire protection	none		
Mechanical grilles	none		
Mechanical diffusers	none		
Visible piping or ducts	painted capped gas pipe		
Signage	none		
Miscellaneous	pulley system length of room left side one roller still intact floor plate missing	G	C

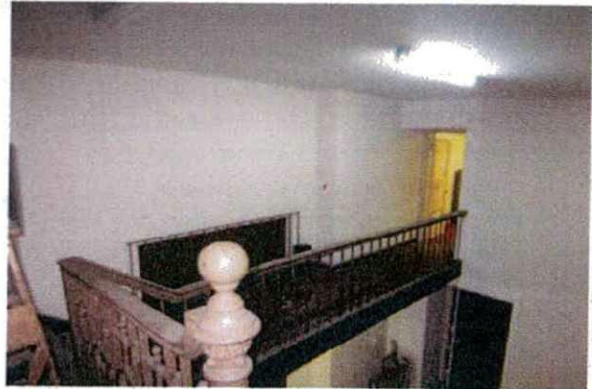
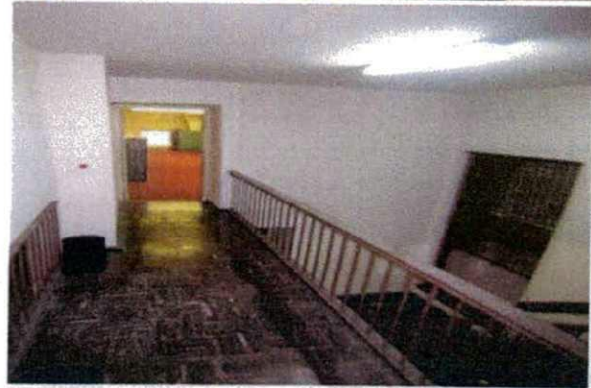
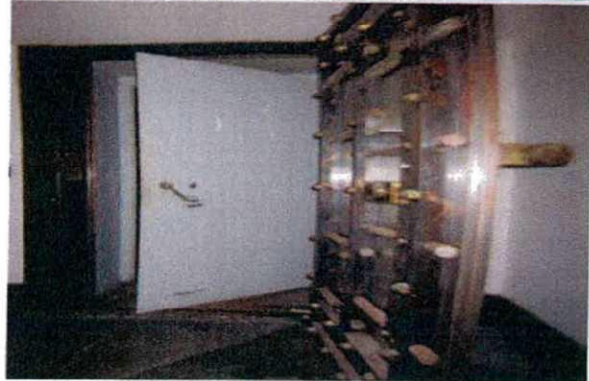
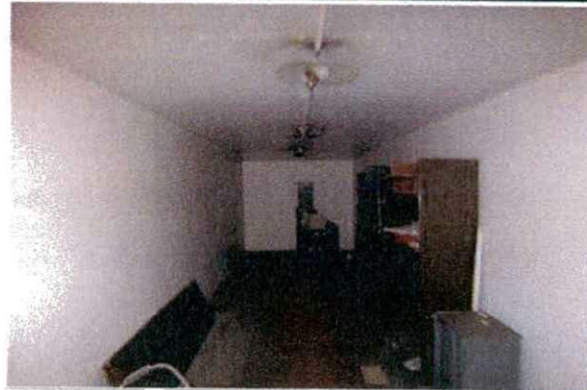
Electrical outlets	three prong modern with exposed conduit	F	NC
Plumbing lavatories	none		
Plumbing toilets	none		
Plumbing urinals	none		
Plumbing accessories	none		
Plumbing partitions	none		
Fire protection	none		
Mechanical grilles	none		
Mechanical diffusers	none		
Visible piping or ducts	gas piping behind vault door		
Signage	none		
Miscellaneous	vault lined with steel, iron railings decorative and modern 2'.8.5" height - catwalk has contemporary rail	G	C

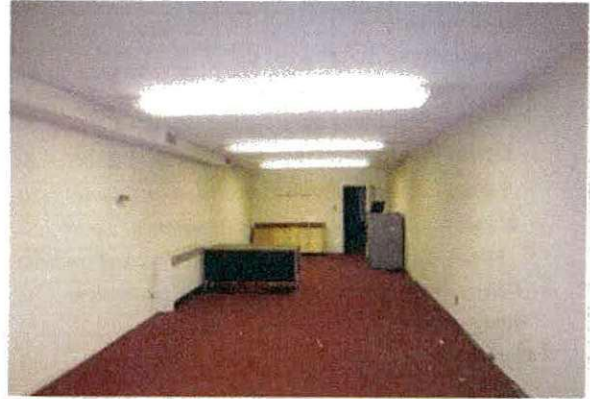
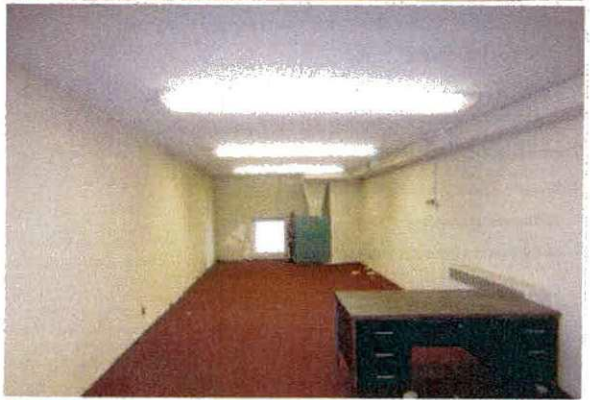
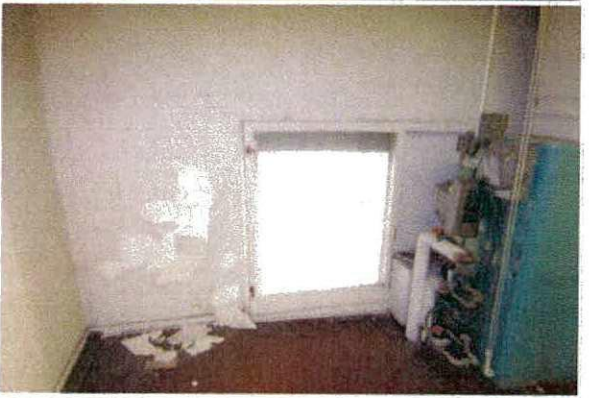
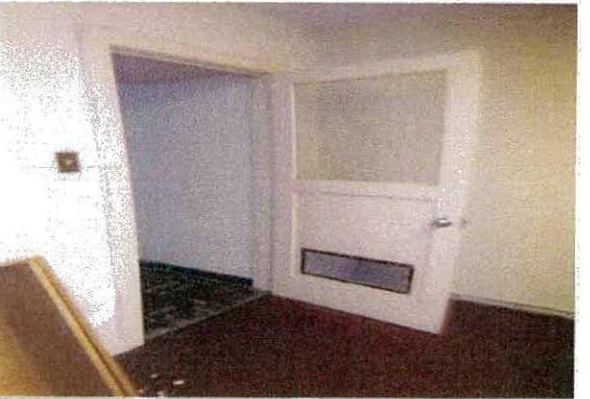
Plumbing urinals	none		
Plumbing accessories	none		
Plumbing partitions	none		
Fire protection	none		
Mechanical grilles	none		
Mechanical diffusers	none		
Visible piping or ducts	air ducts on north wall, radiator on north	F	NC
Signage	none		
Miscellaneous	furnace on west wall 'Carrier', extreme water on west wall		NC

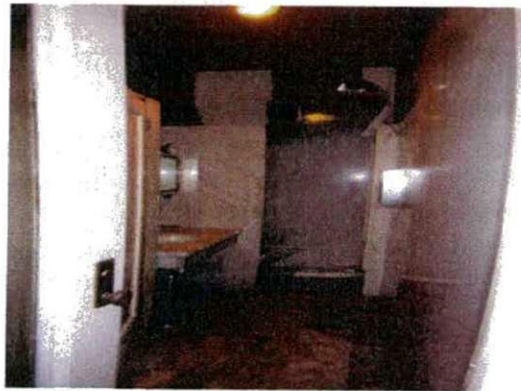
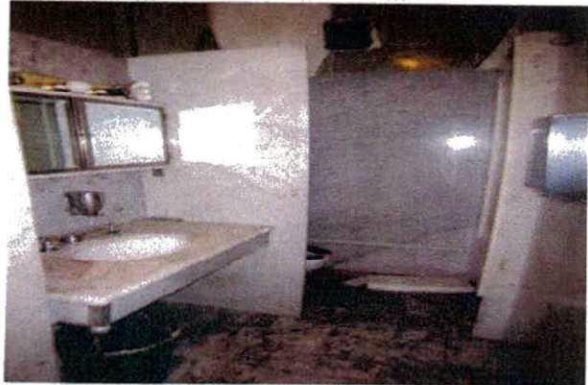
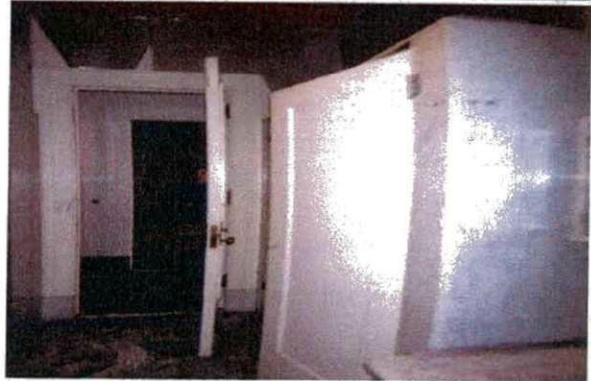
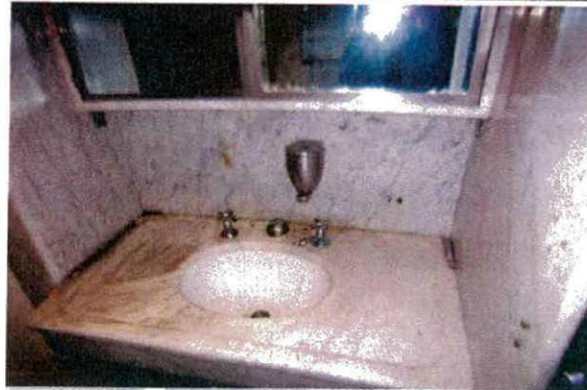
Fire protection	none		
Mechanical grilles	none		
Mechanical diffusers	none		
Visible piping or ducts	modern capped water above toilet		
Signage	none		
Miscellaneous	mirrored medicine cabinet and coat closet with wood doors	G/F	C/N

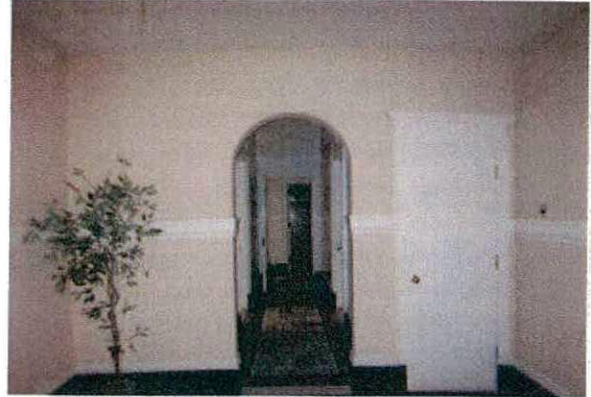
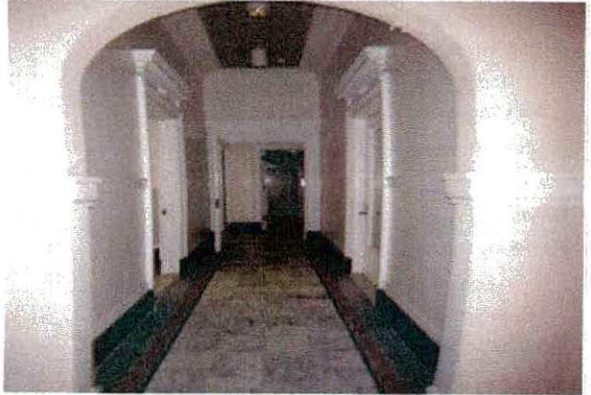
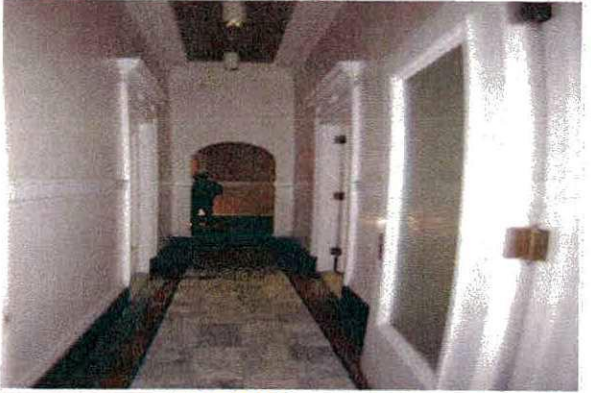
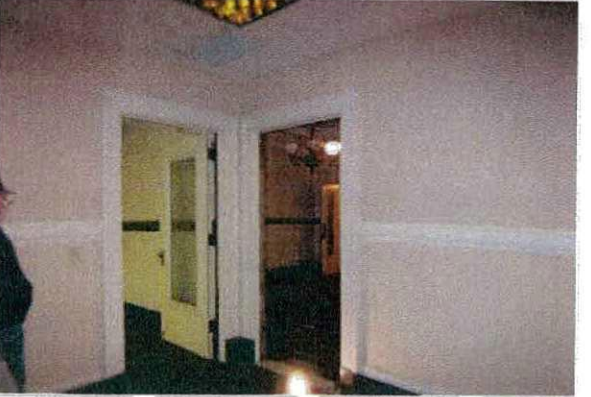
Plumbing toilets	none		
Plumbing urinals	none		
Plumbing accessories	none		
Plumbing partitions	none		
Fire protection	none		
Mechanical grilles	none		
Mechanical diffusers	none		
Visible piping or ducts	none		
Signage	none		
Miscellaneous	closet for air conditioner electrical 2nd record for just square area before hallway	G	NC

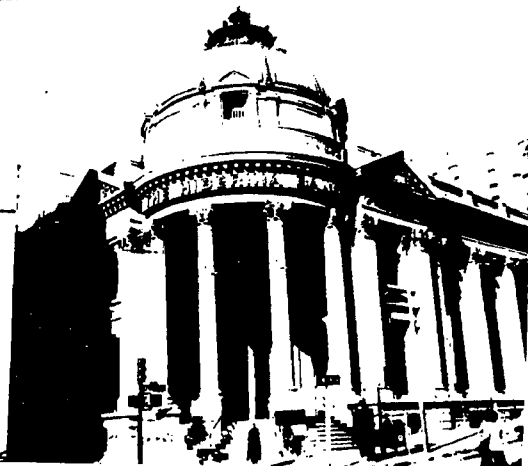
From material submitted by Patrick McGrew
