SAN FRANCISCO PLANNING DEPARTMENT

Certificate of Appropriateness Case Report

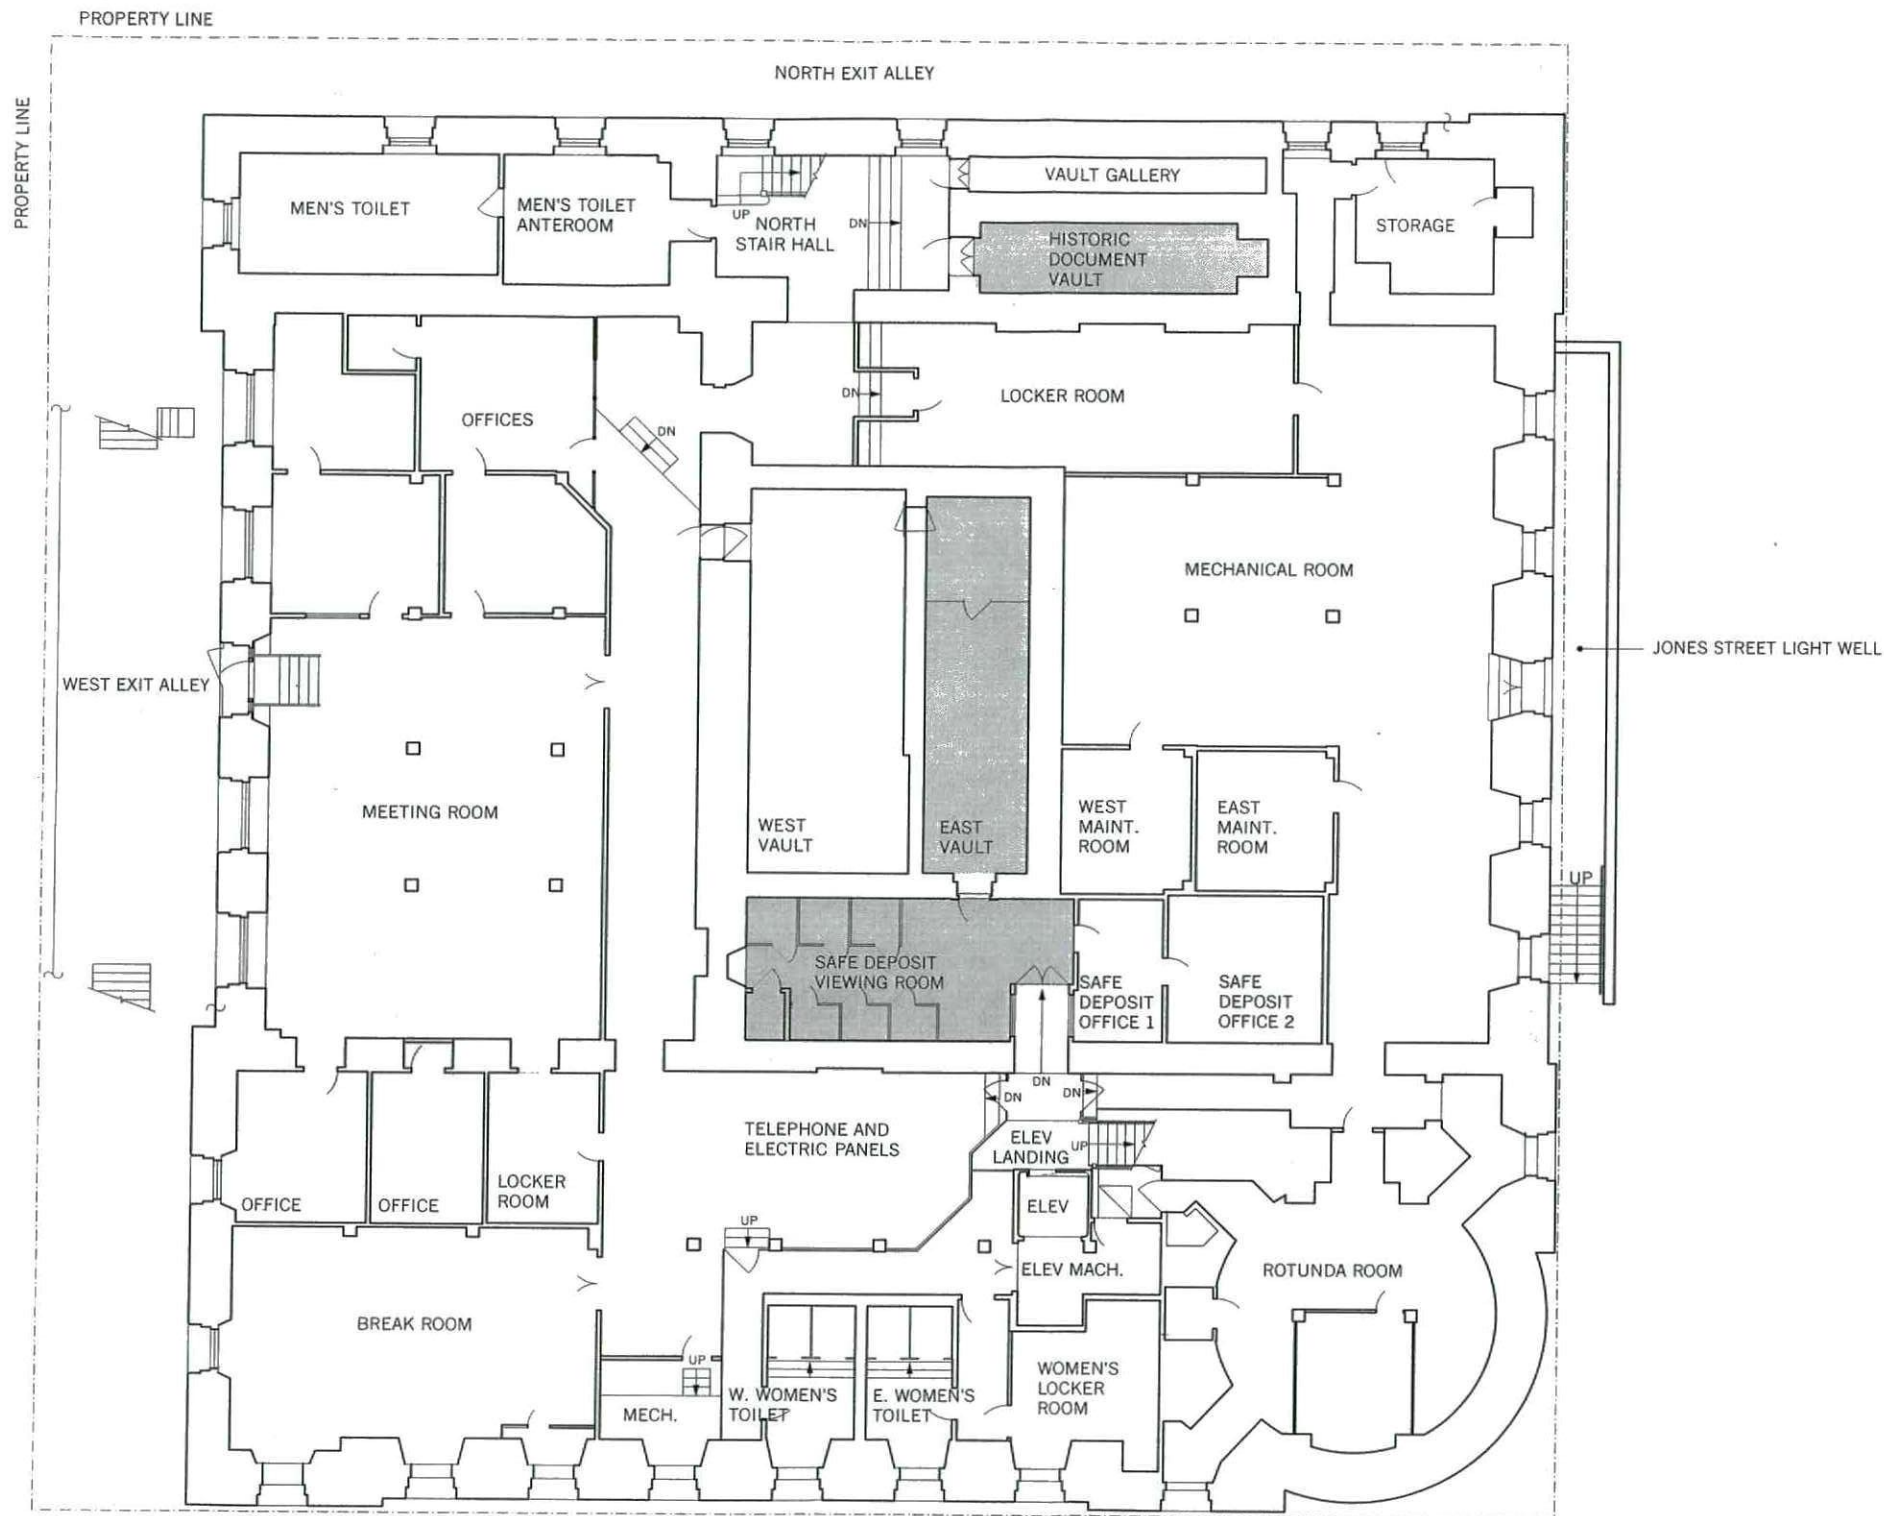
1 EXISTING BASEMENT PLAN
Scale: 1/8" = 1'-0"

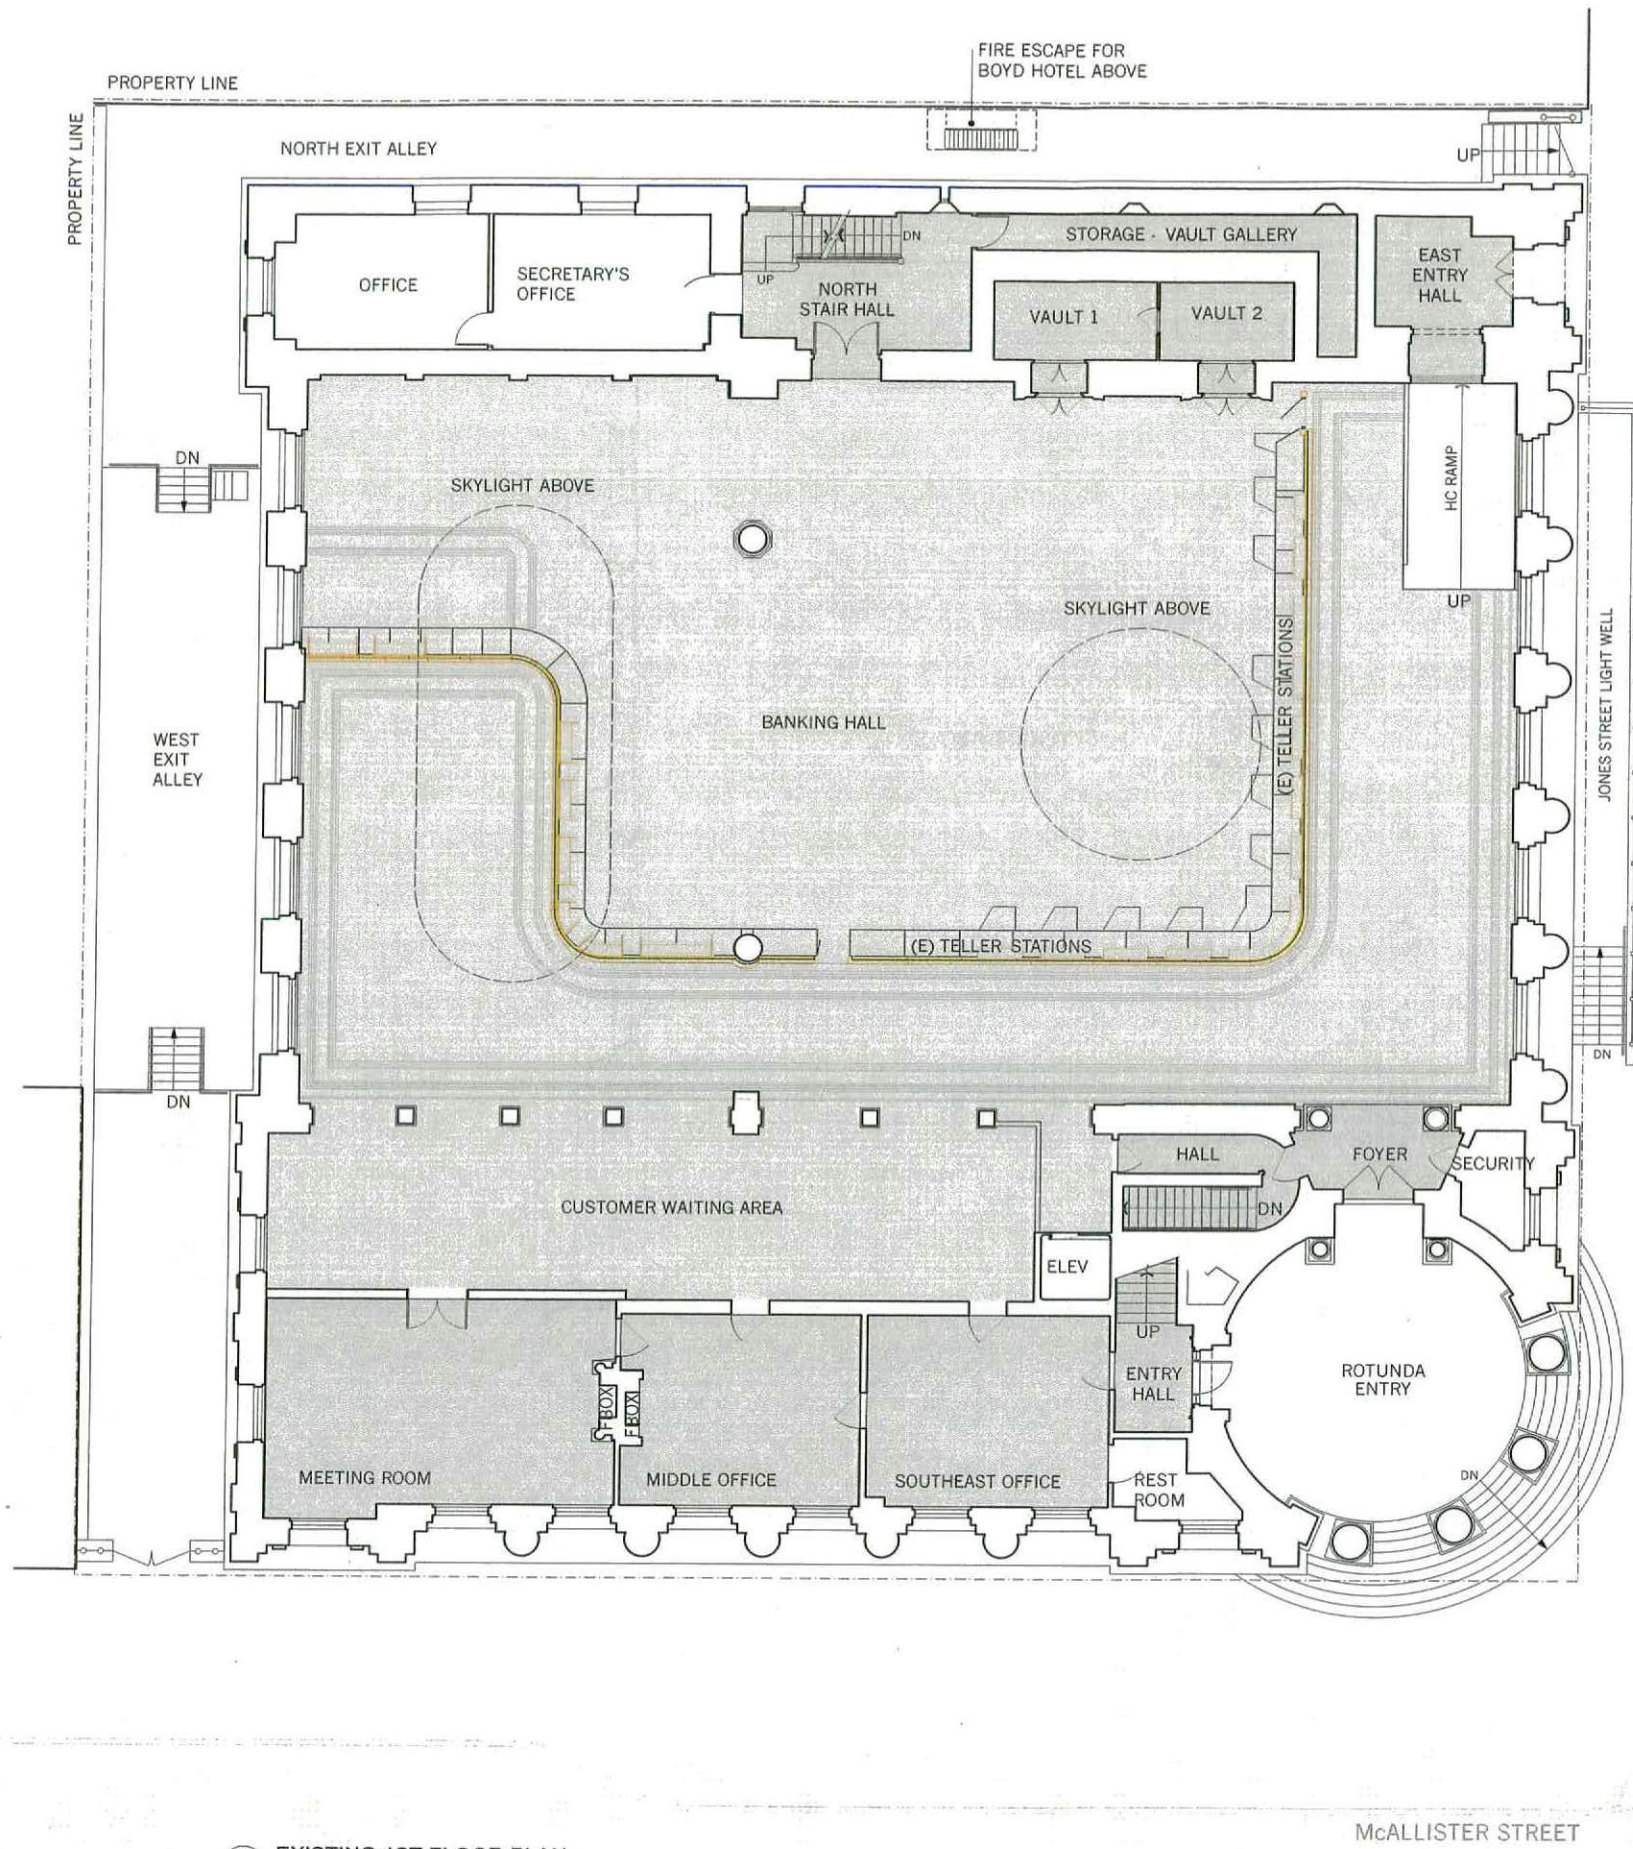
1 EXISTING 1ST FLOOR PLAN
Scale: 1/8" = 1'-0"

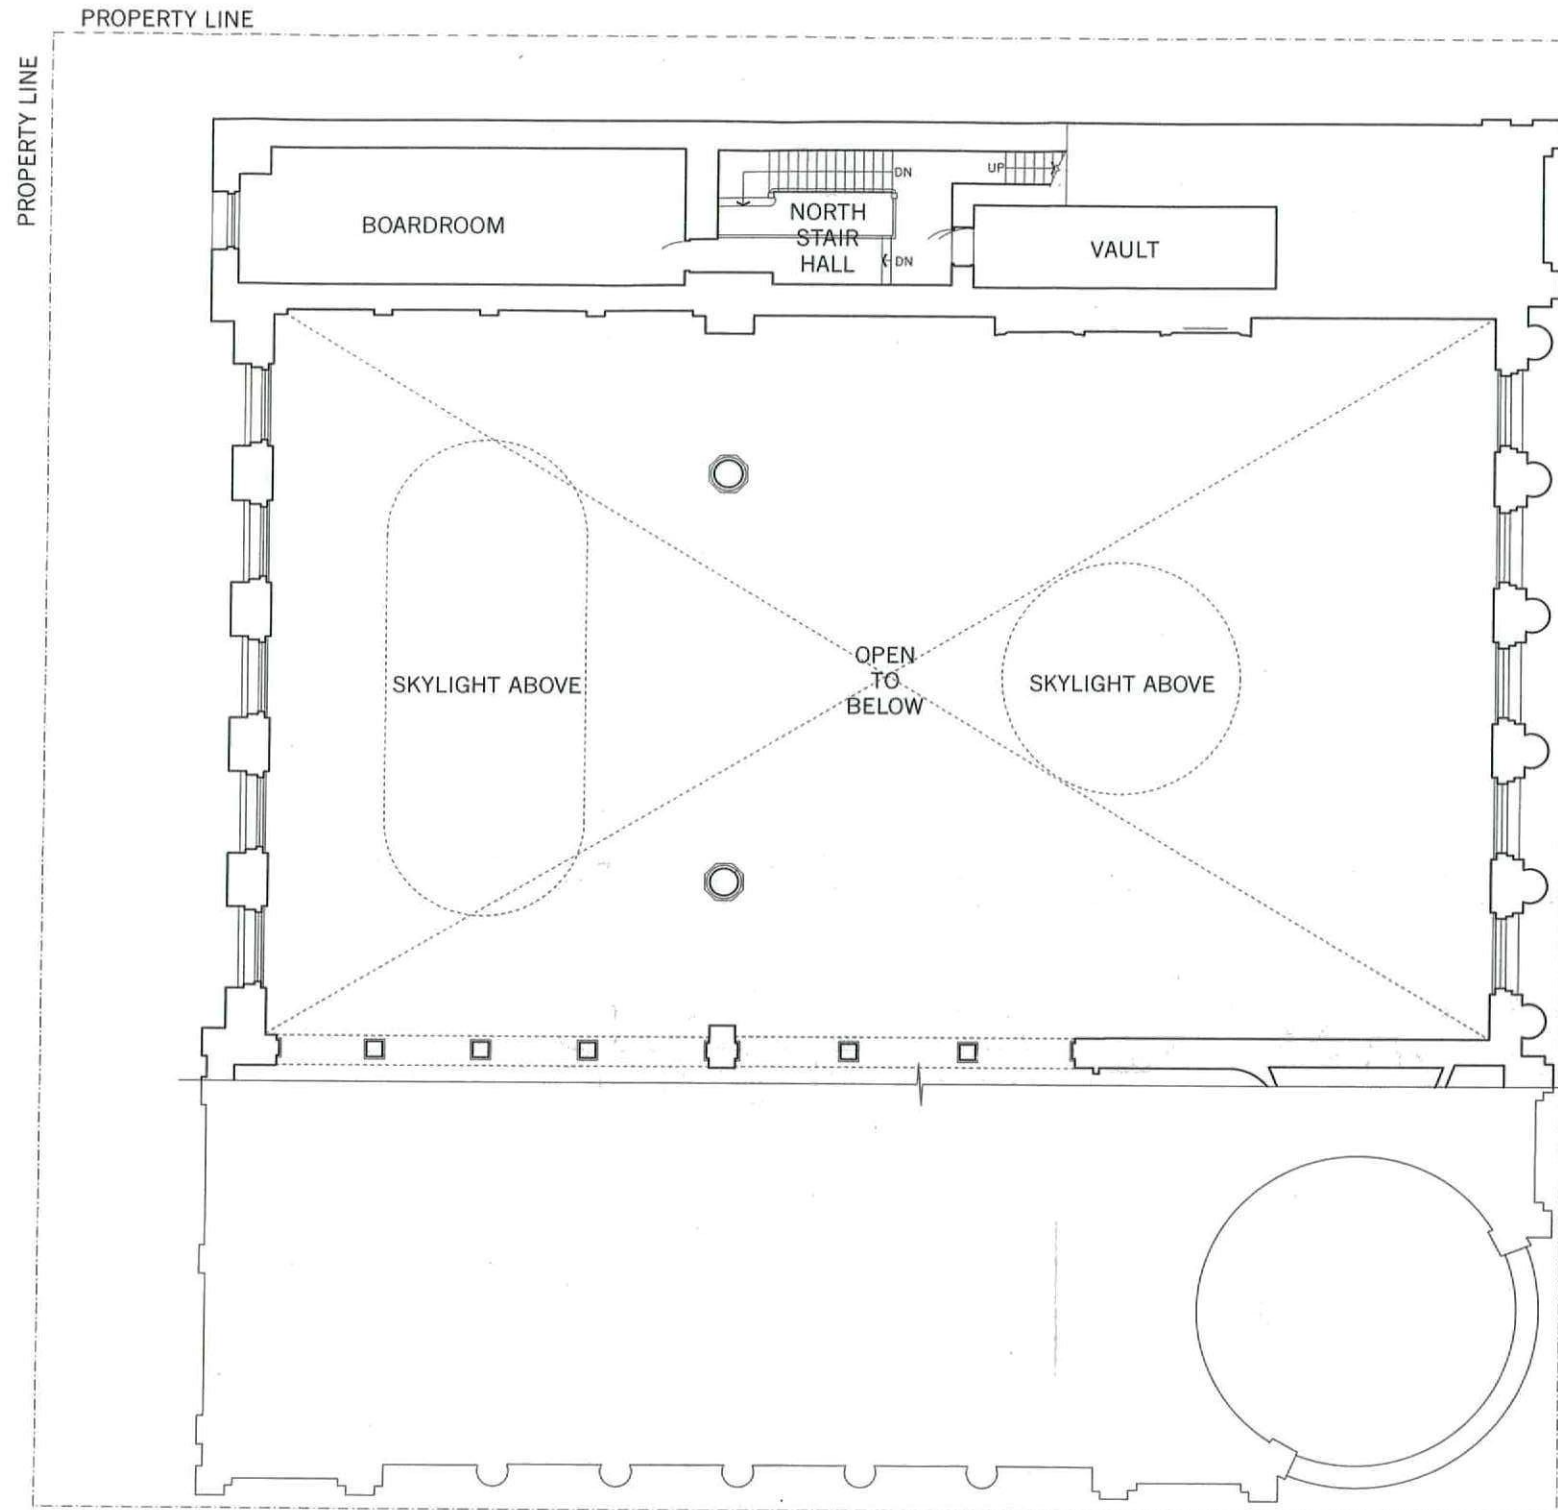
1 EXISTING MEZZANINE PLAN
 Scale: 1/8" = 1'-0"

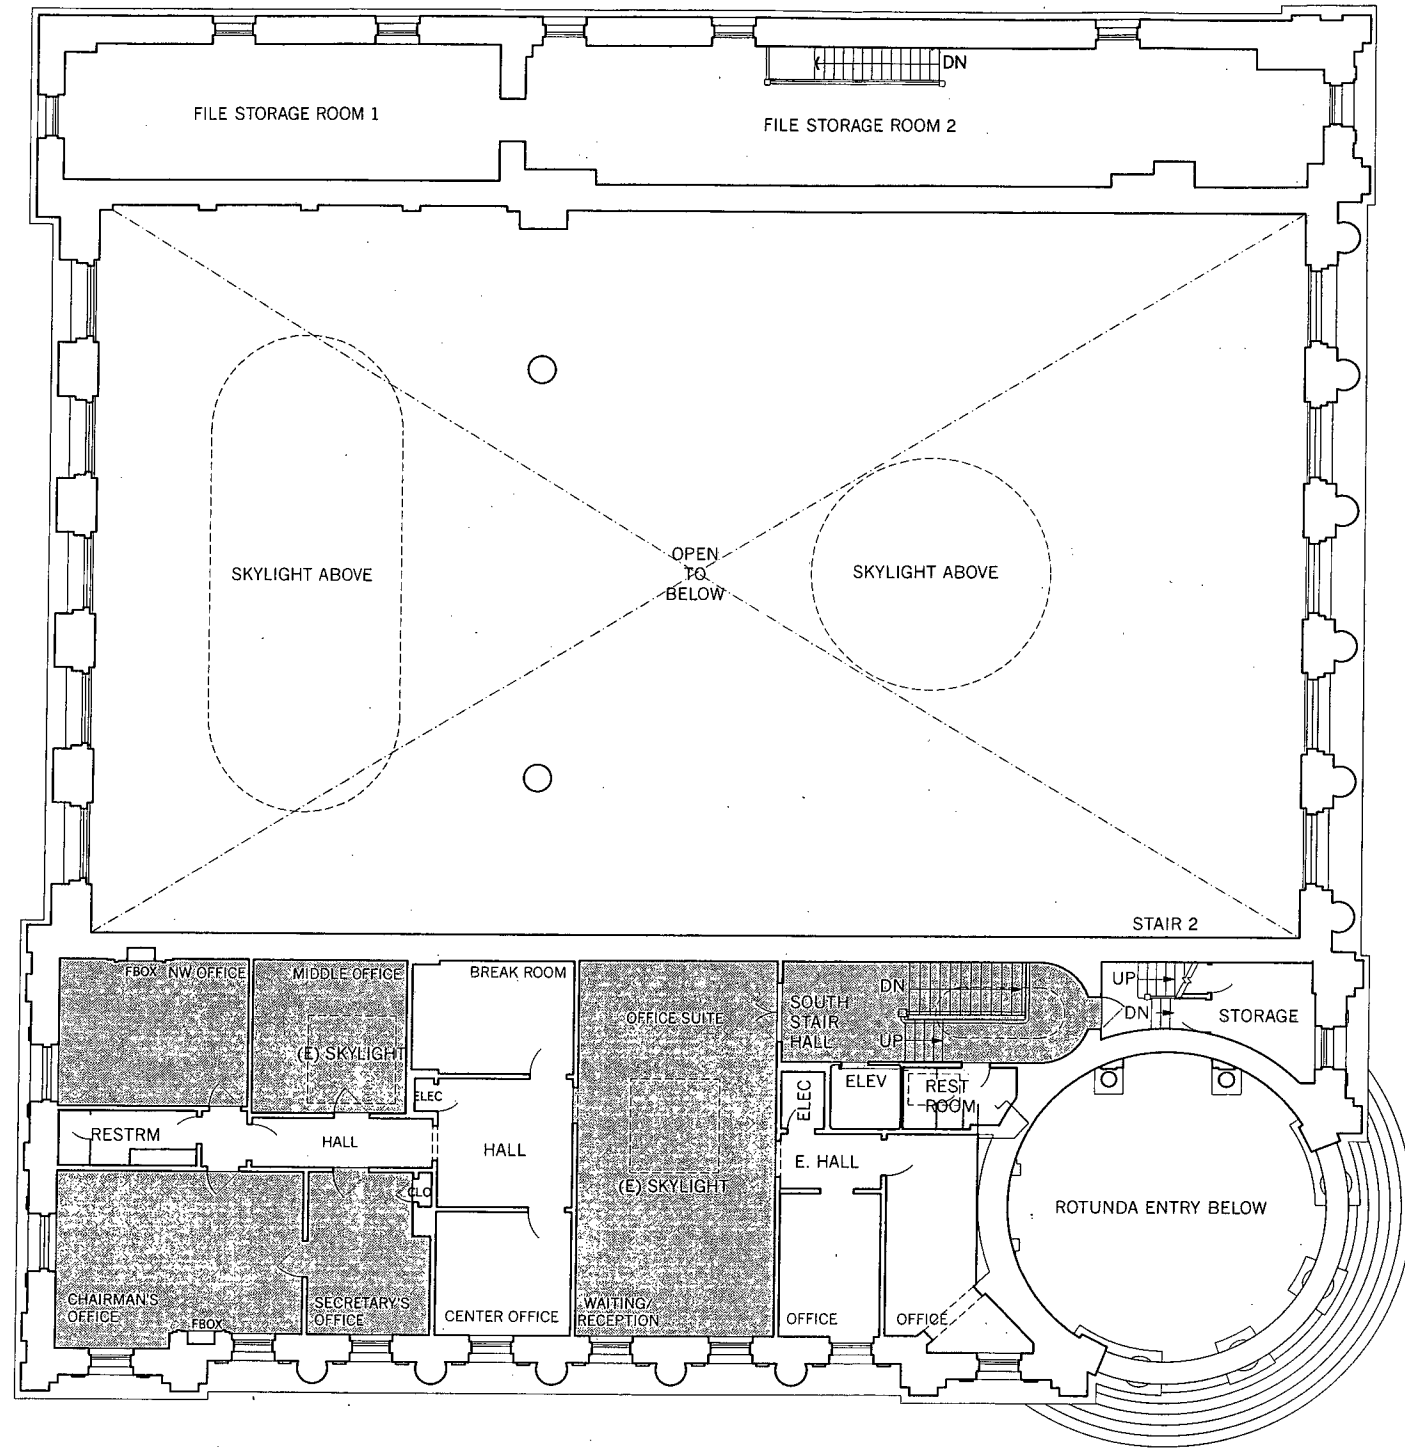
1 EXISTING 2ND FLOOR PLAN
Scale: 1/8" = 1'-0"

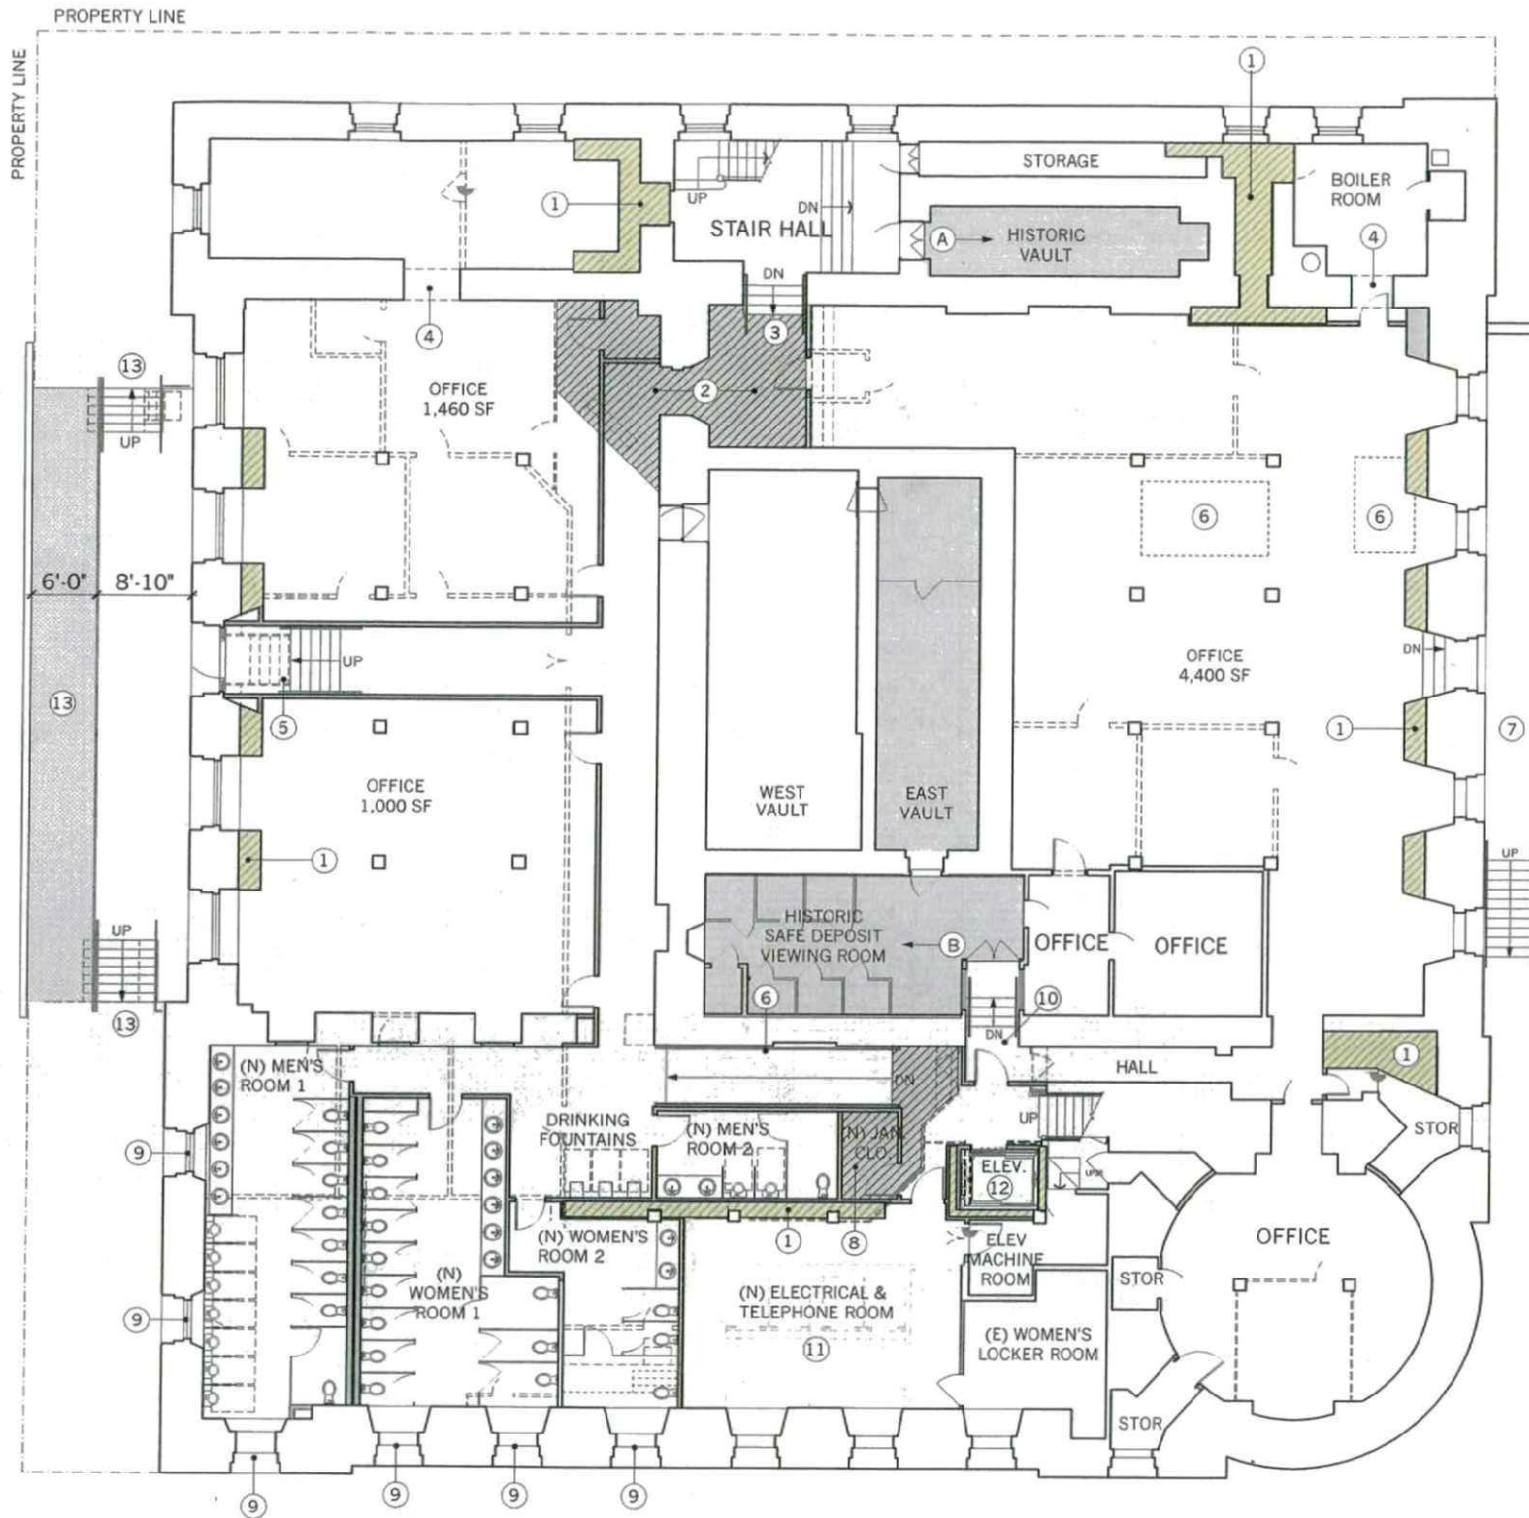
13. WEST EXIT ALLEY WALKWAY
New metal grating with metal guardrail to be built over sunken area of west exit alley, providing a level surface for north exit alley access. Existing concrete stairs to sunken area to be demolished and replaced with metal stairs with metal guard and handrails.

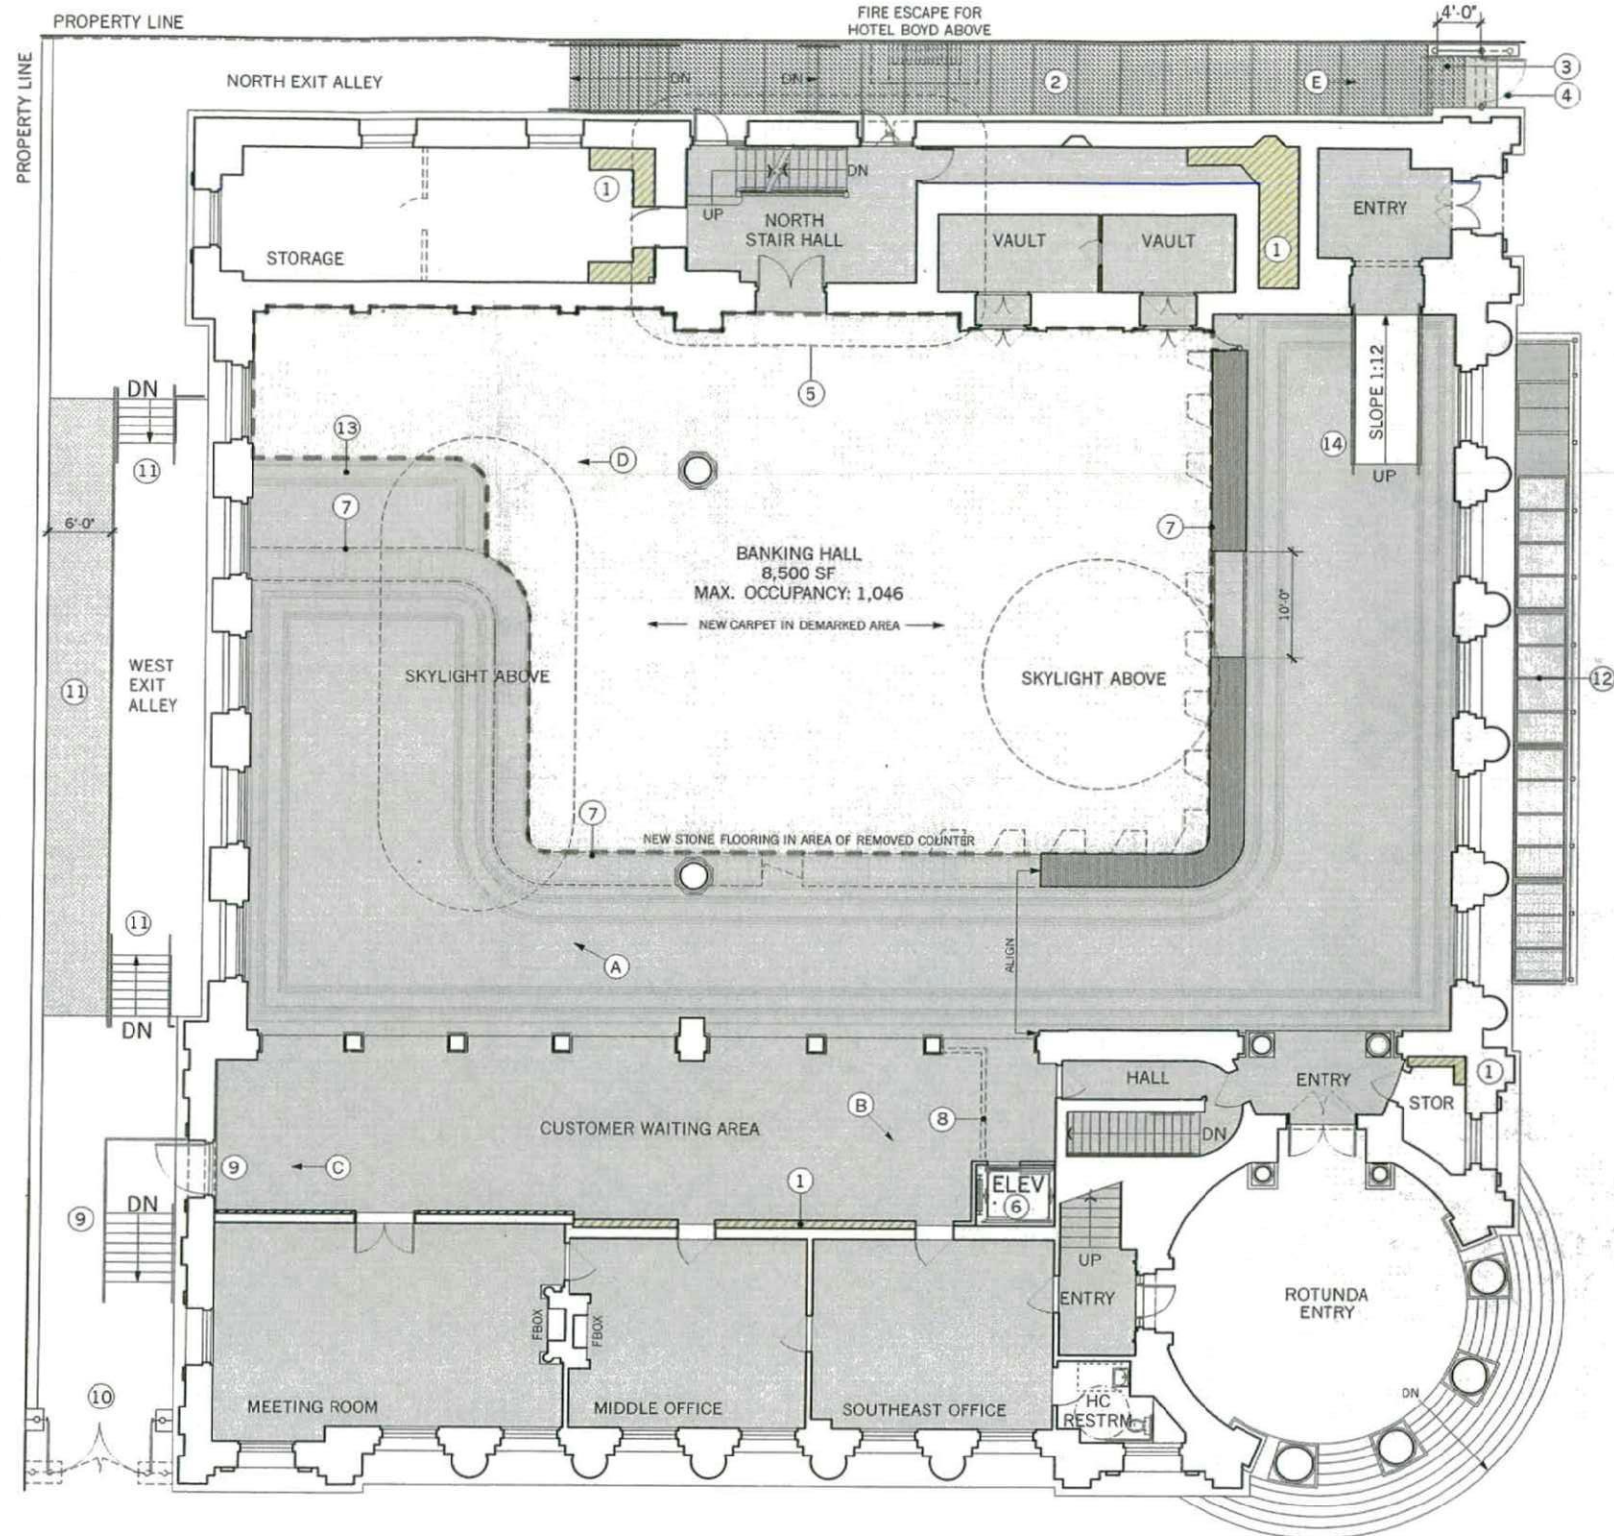
15. HC RAMP AT NORTHEAST ENTRANCE
The HC ramp installed in a 1990 remodel will be removed. A new ramp with a slope of 1:12 will be installed with wheel guides and painted steel hand railings. The new ramp will be constructed so it can be removed in the future with no damage to the structure.

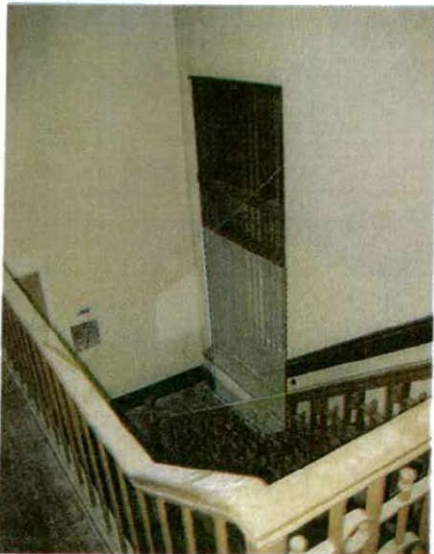
C: Looking down from the Mezzanine landing to the first floor exit at the landing below. The lower sash of the window to be removed as well as the area below the sill and replaced with a new exit door to the north exit alley.

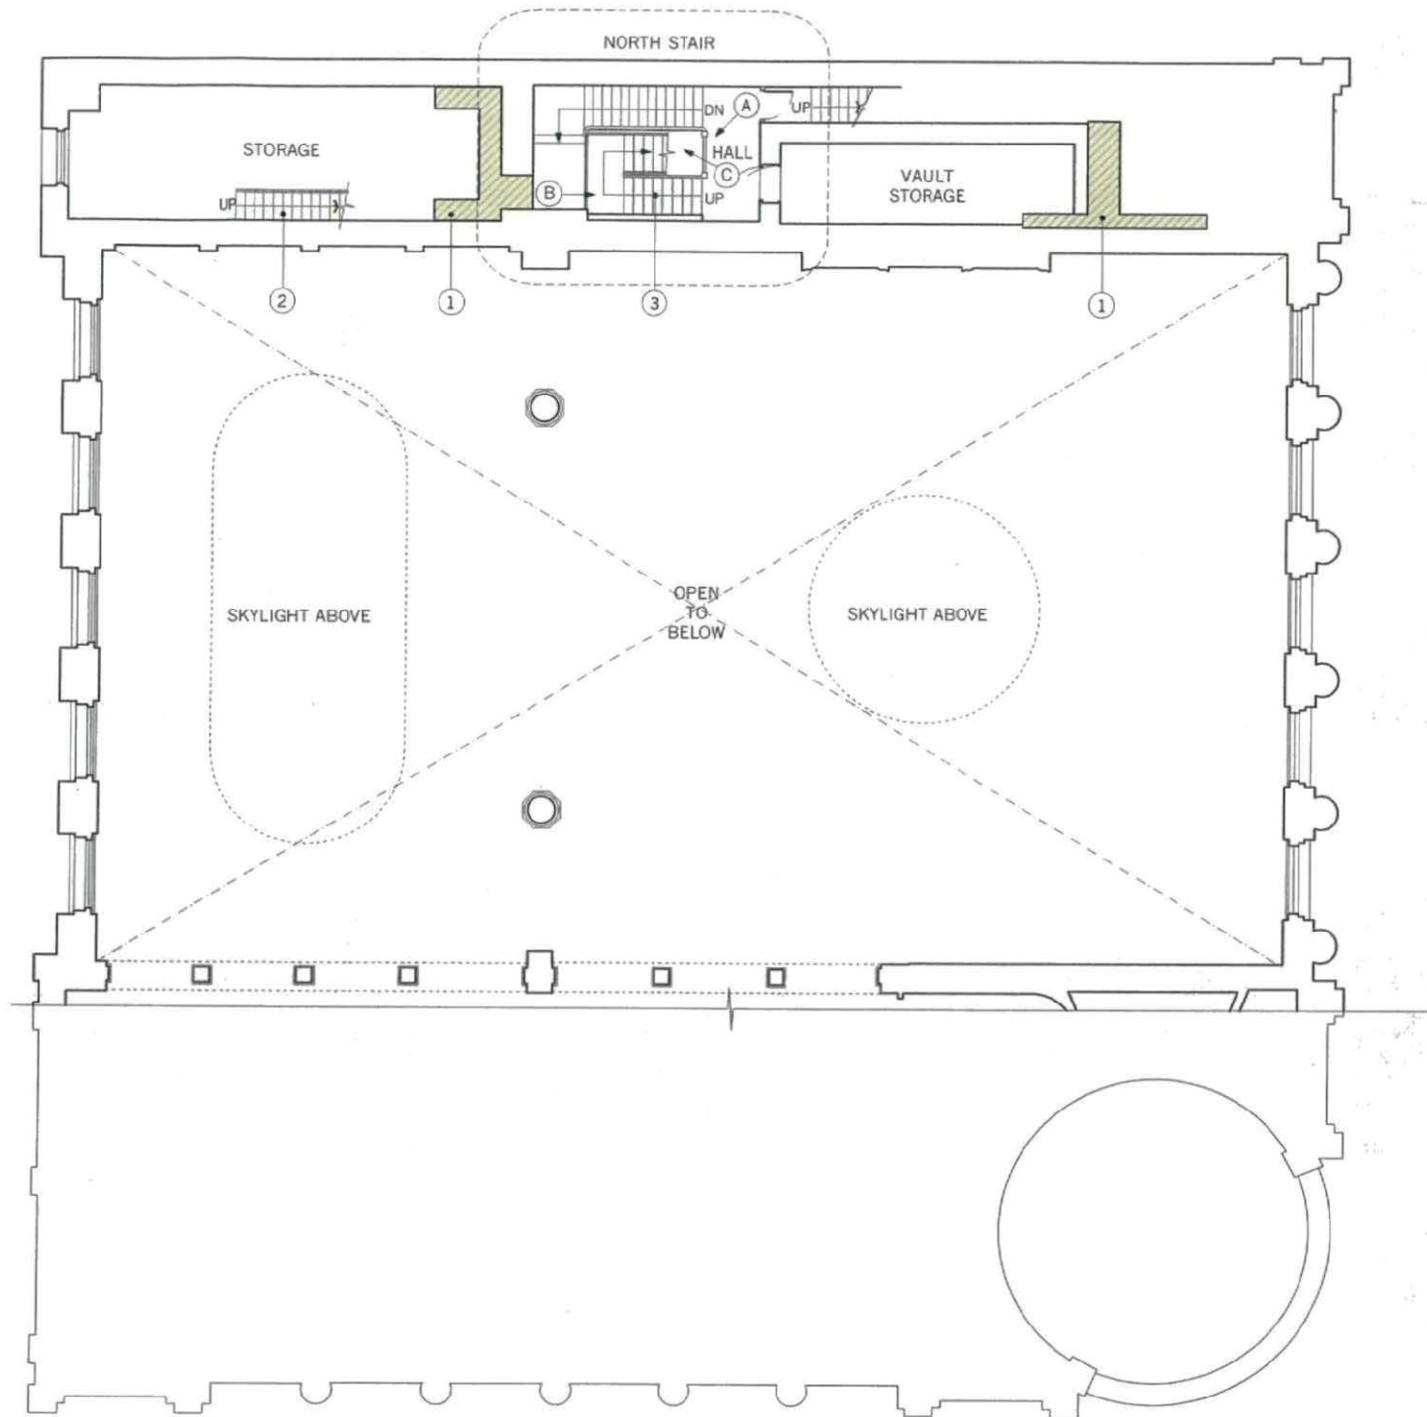
WALL KEY	
	EXISTING WALL TO REMAIN
	EXISTING WALL TO BE DEMOLISHED
	NEW WALL
	SPACES NOTED AS SIGNIFICANT OR VERY SIGNIFICANT IN THE HISTORIC STRUCTURES REPORT

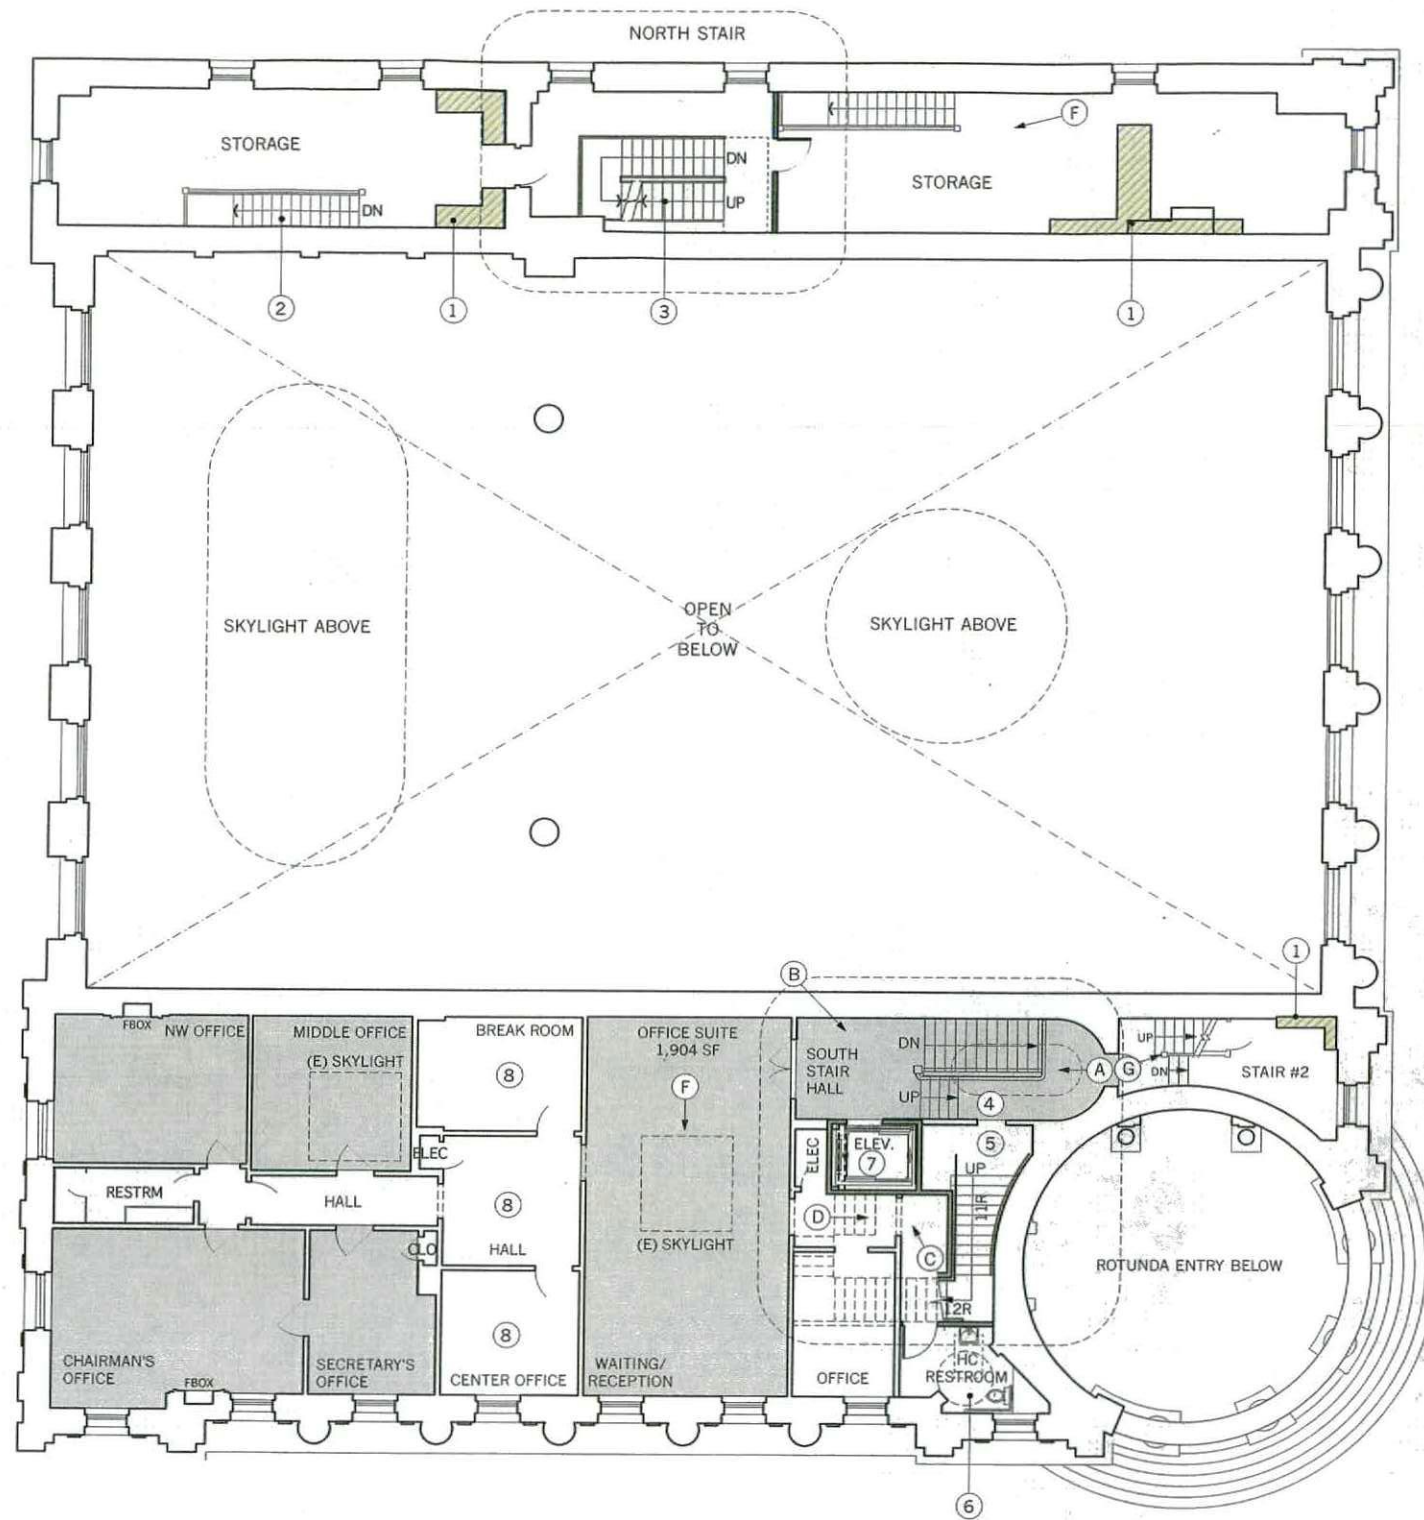
WALL KEY	
	EXISTING WALL TO REMAIN
	EXISTING WALL TO BE DEMOLISHED
	NEW WALL
	SPACES NOTED AS SIGNIFICANT OR VERY SIGNIFICANT IN THE HISTORIC STRUCTURES REPORT

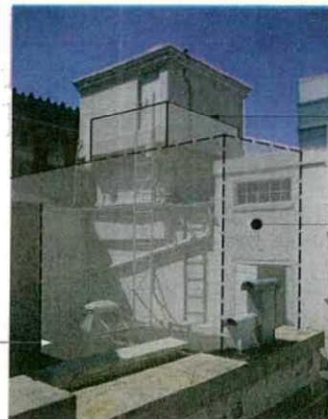
New elevator penthouse
New east hall
F: View of location of new east hall. Small skylight and vent to be removed. Elevator penthouse to be reconstructed.

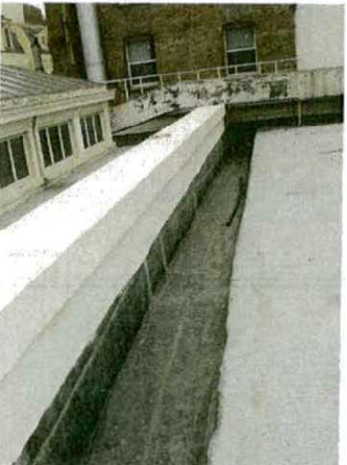
C: Detail of typical roof gutter. All gutters to be inspected and repaired.

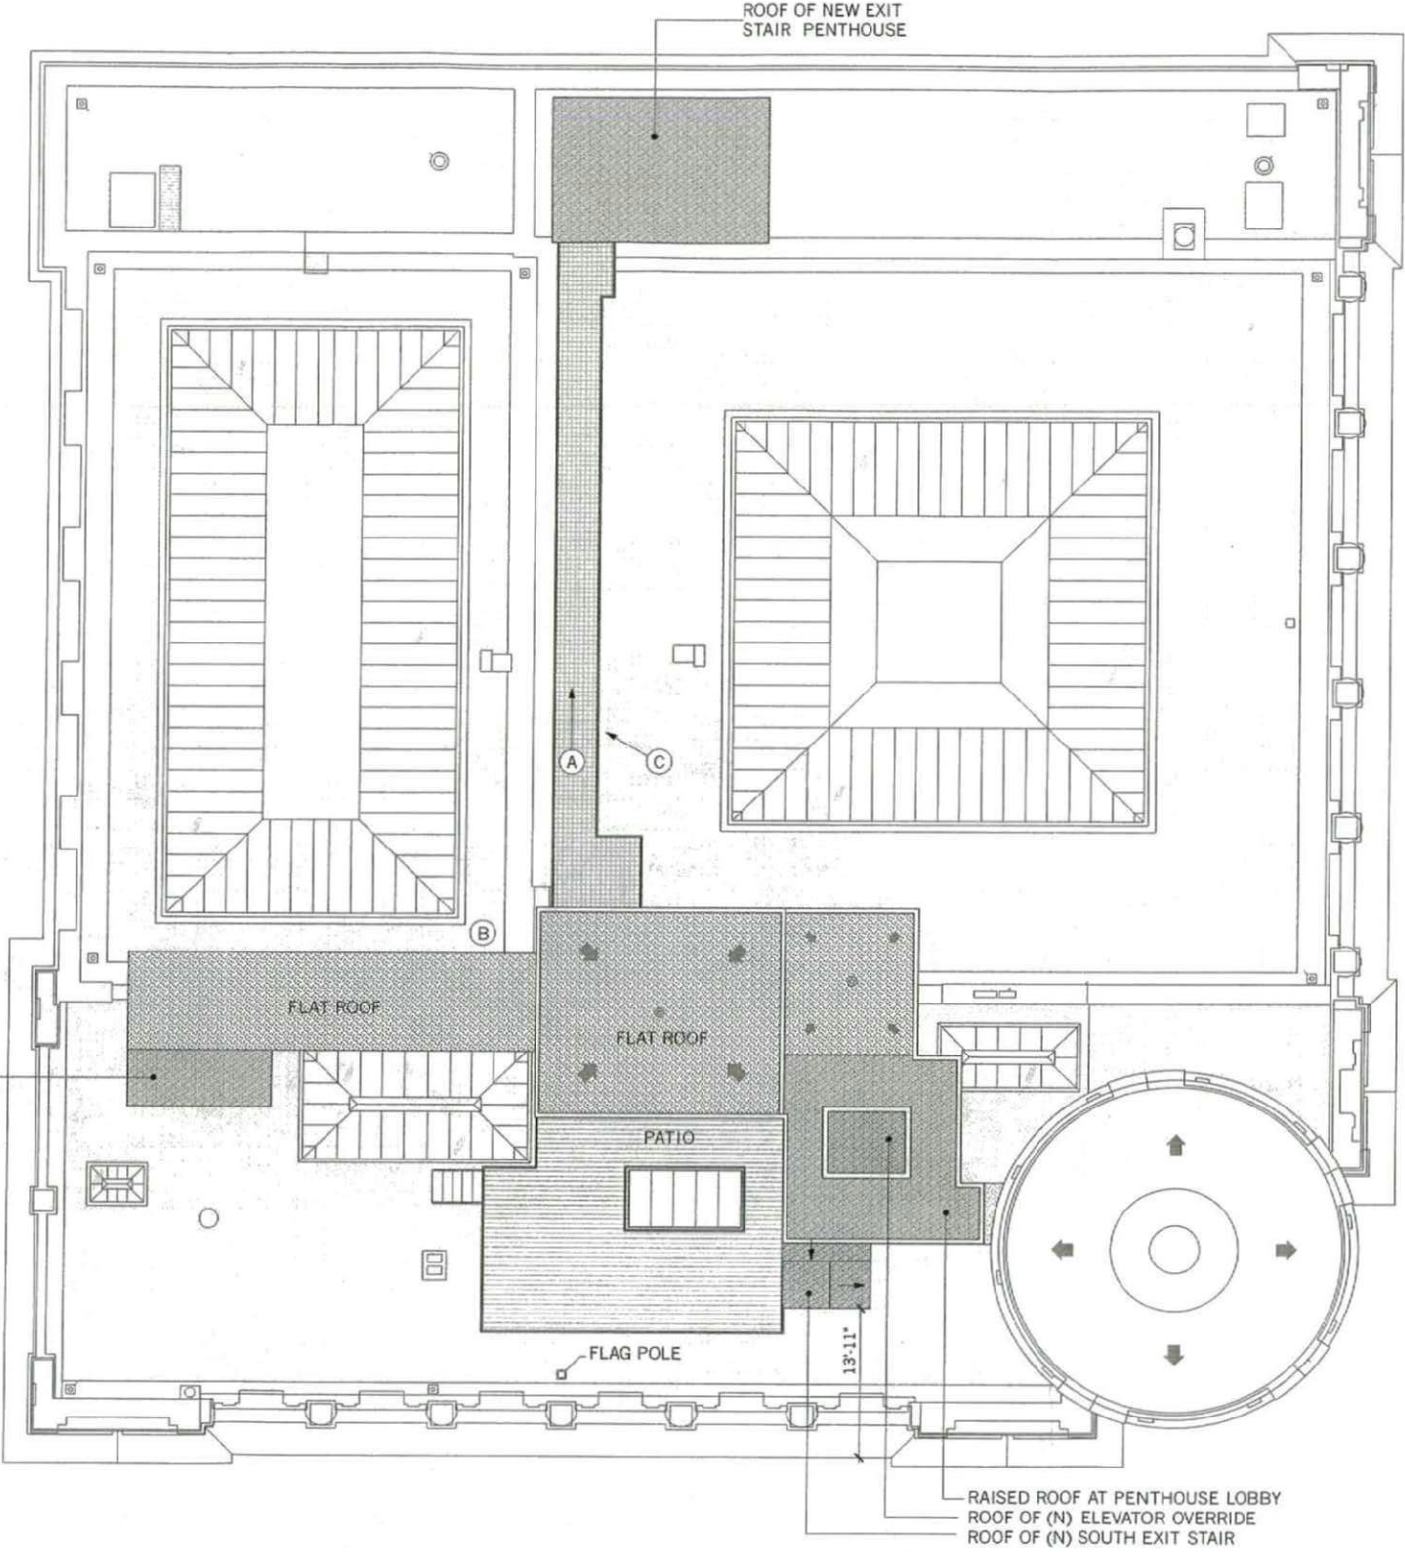
ELEVATIONarchitects
 1099 - 23rd Street
 Suite 18
 San Francisco, CA 94107
 415.537.1125 :v
 415.821.1121 :f
 www.elevationarchitects.com :w
