SAN FRANCISCO PLANNING DEPARTMENT

Certificate of Appropriateness Case Report

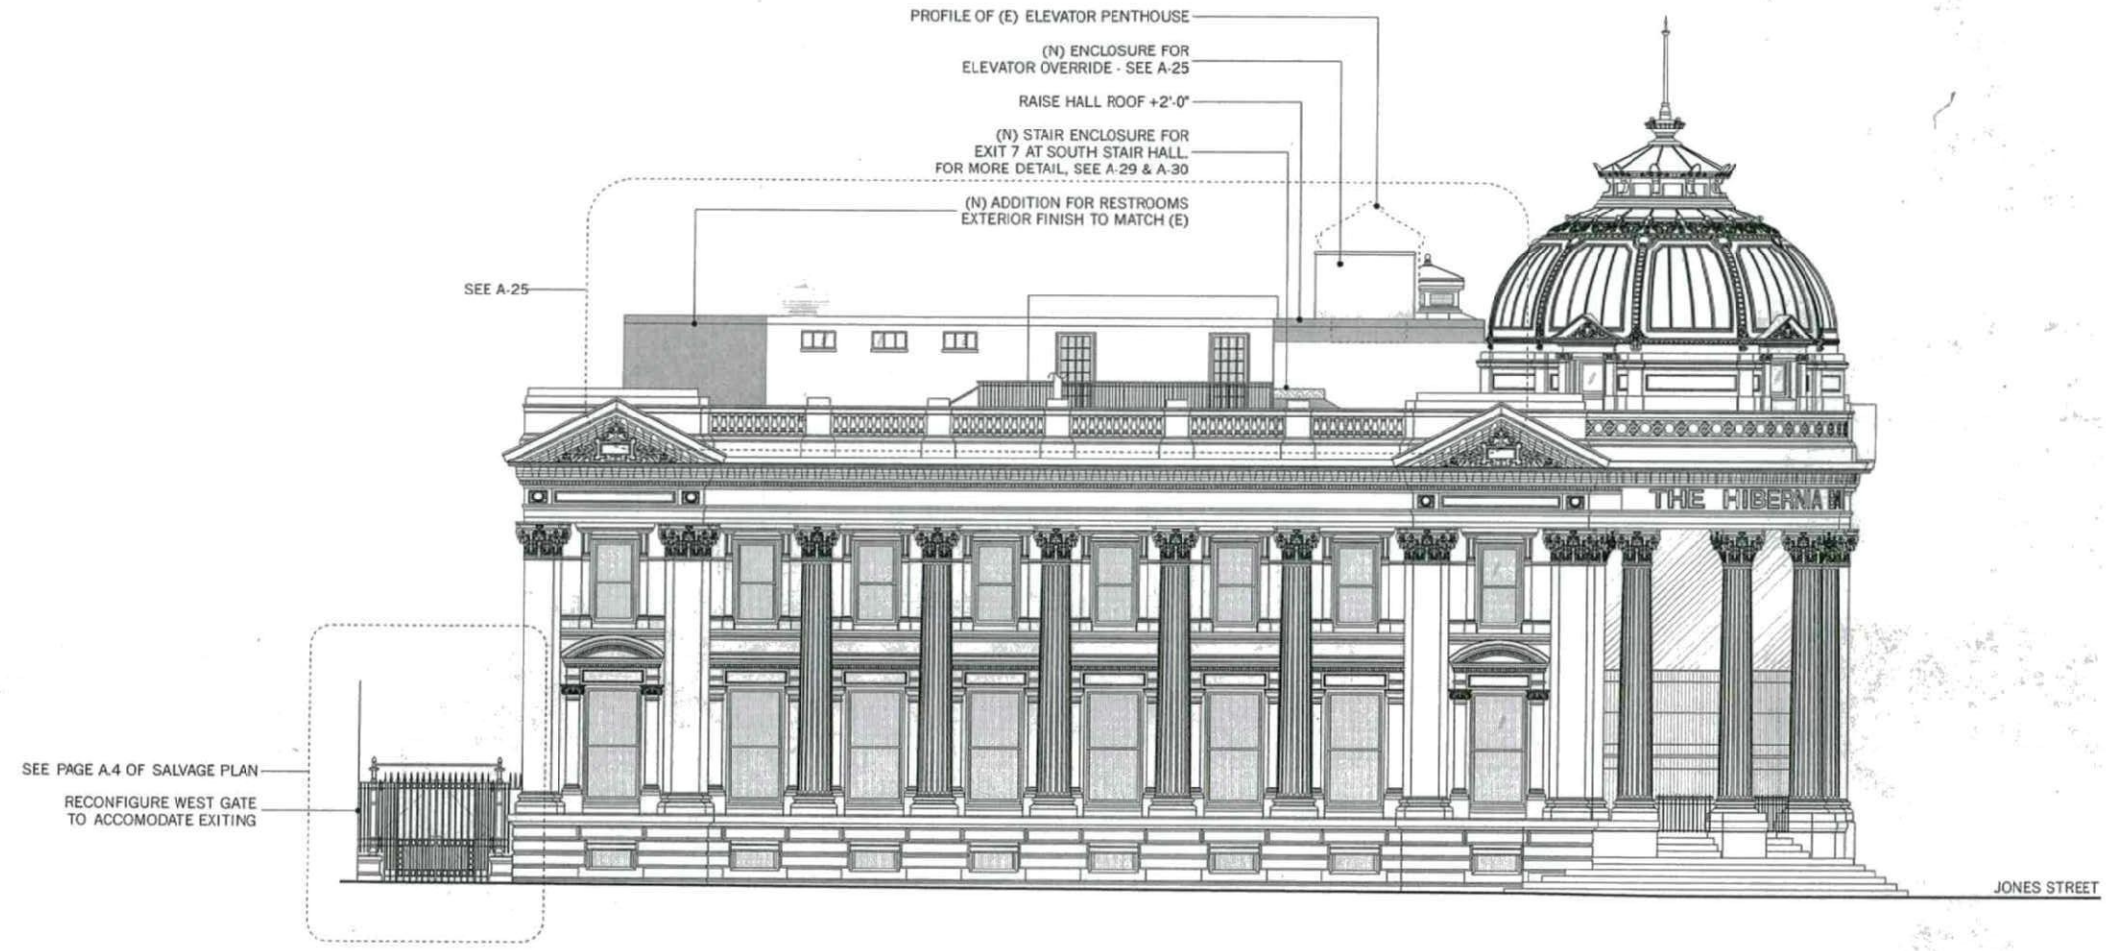
SEE PAGE A.4 OF SALVAGE PLAN
 RECONFIGURE WEST GATE
 TO ACCOMMODATE EXITING

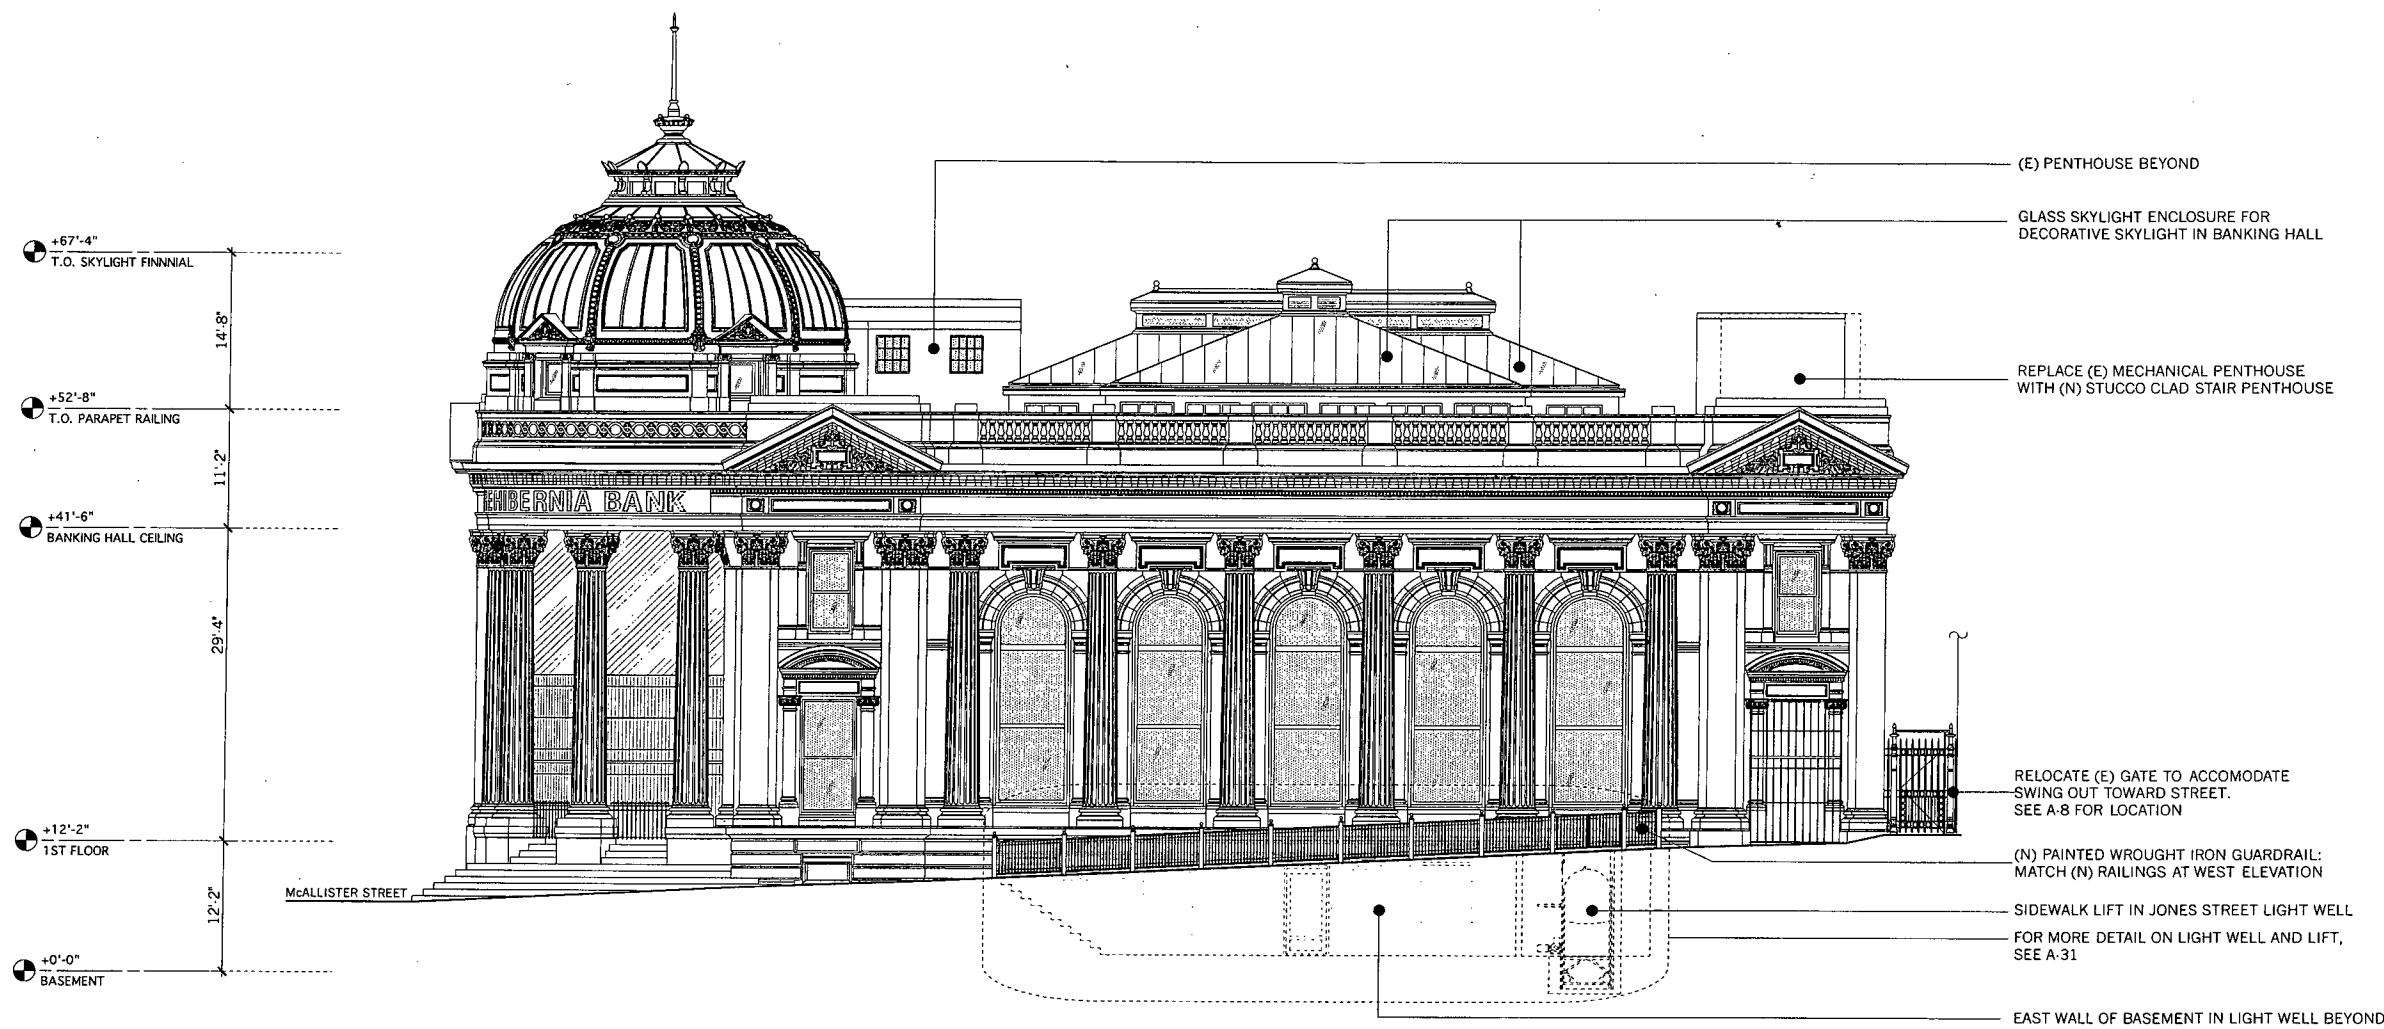
NOTE:
ALL EXTERIOR STONE, WINDOWS, DOORS AND SHUTTERS TO BE CLEANED AND REPAIRED

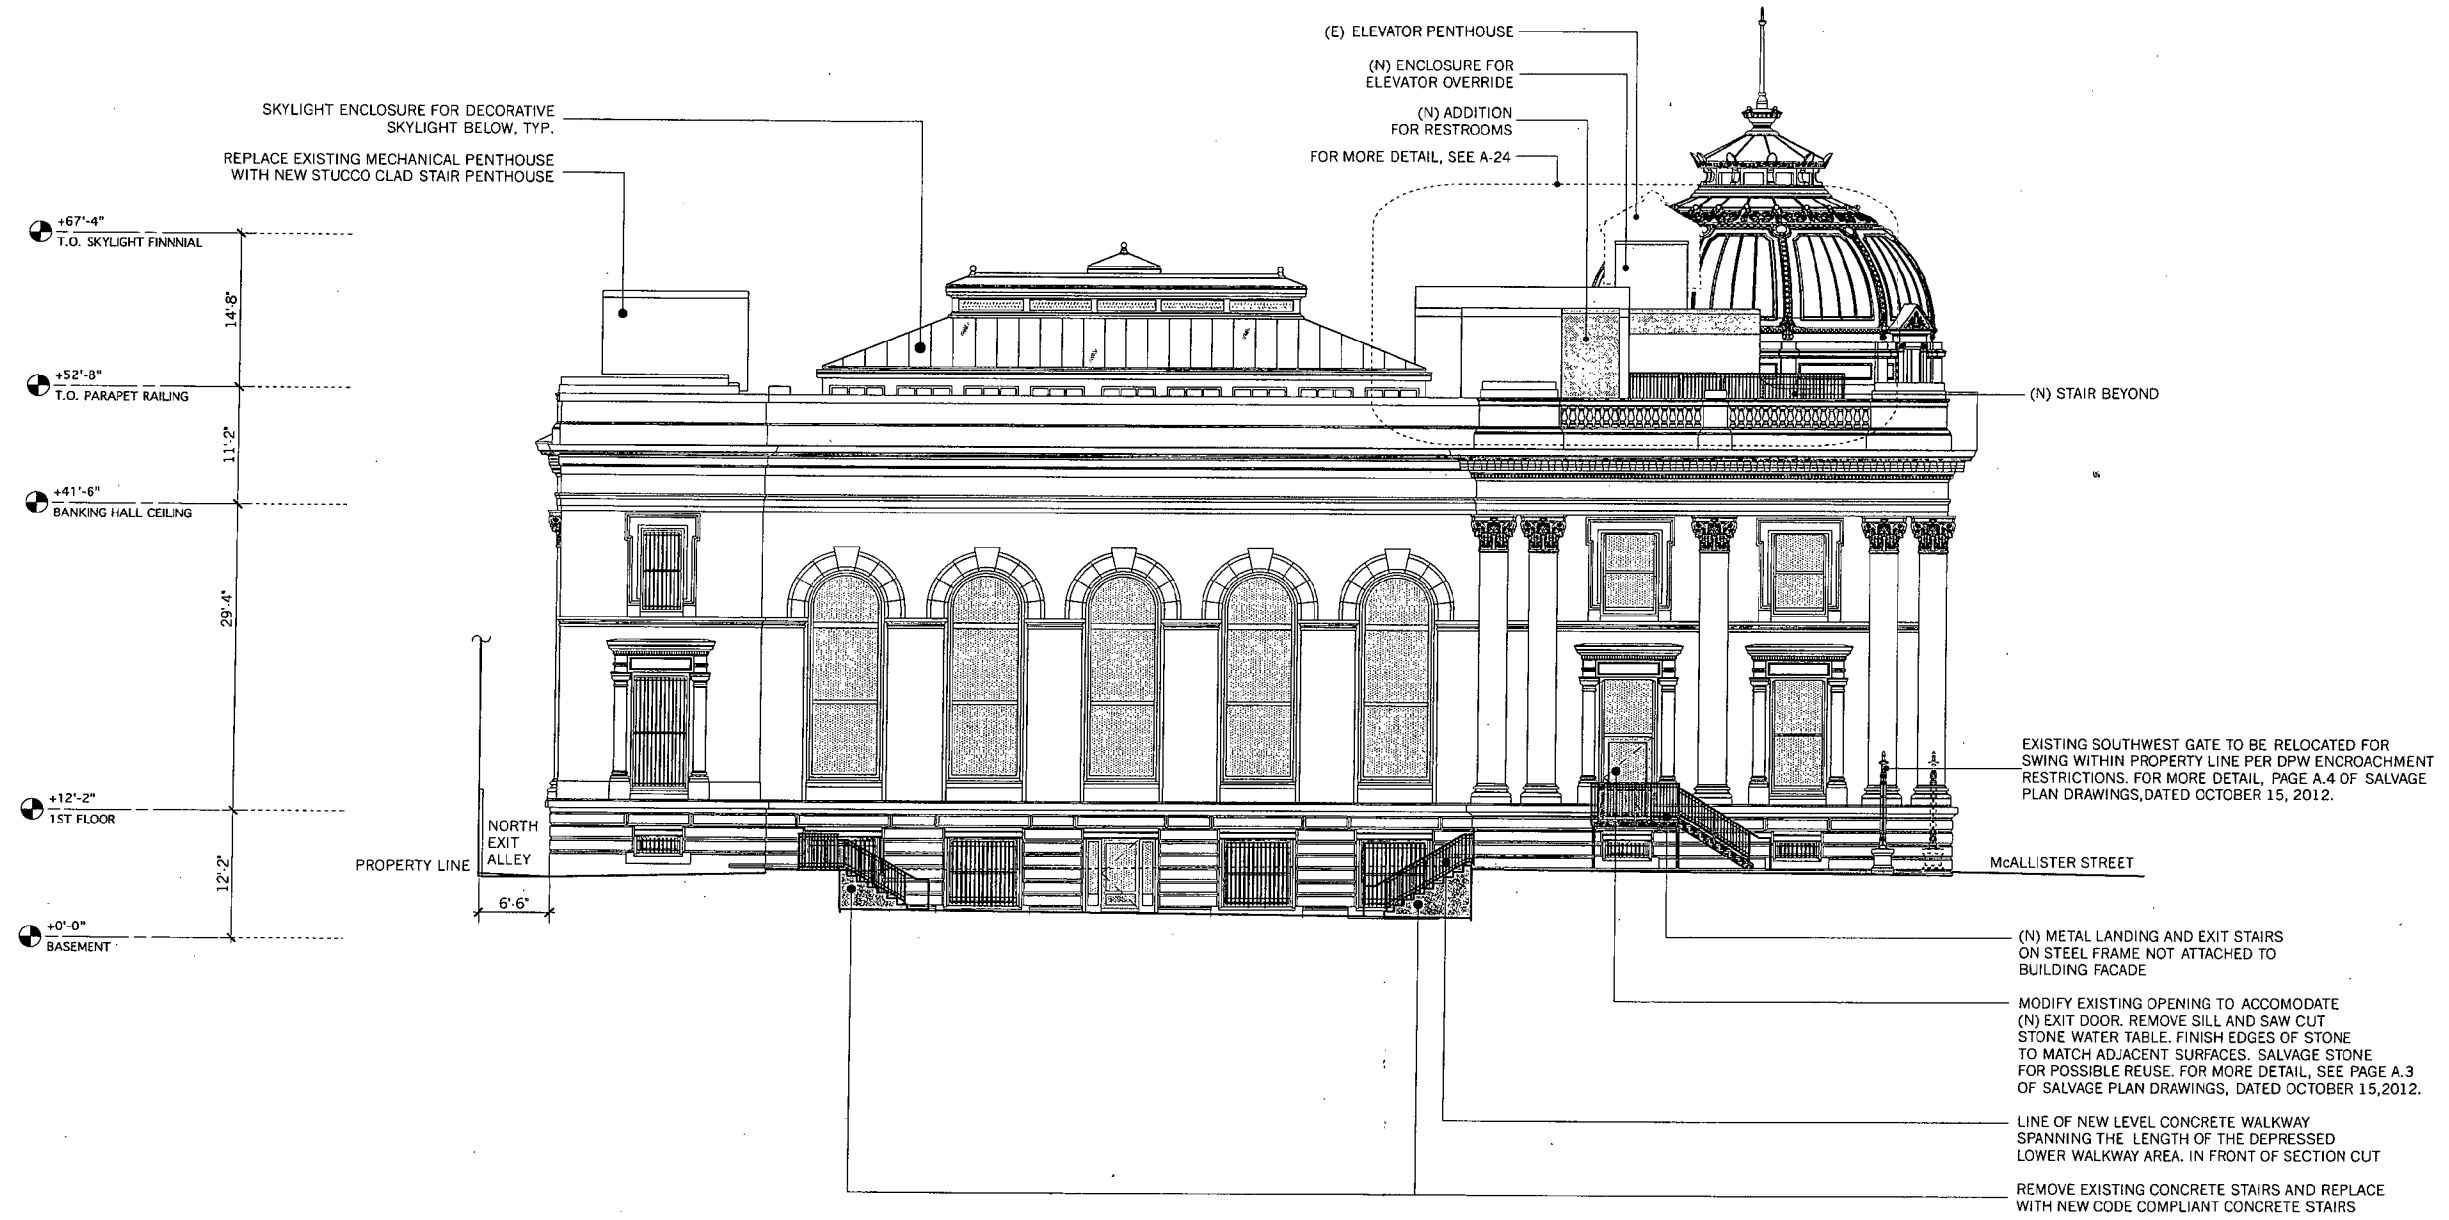
NOTE:
 ALL EXTERIOR STONE, WINDOWS, DOORS AND SHUTTERS TO BE CLEANED AND REPAIRED

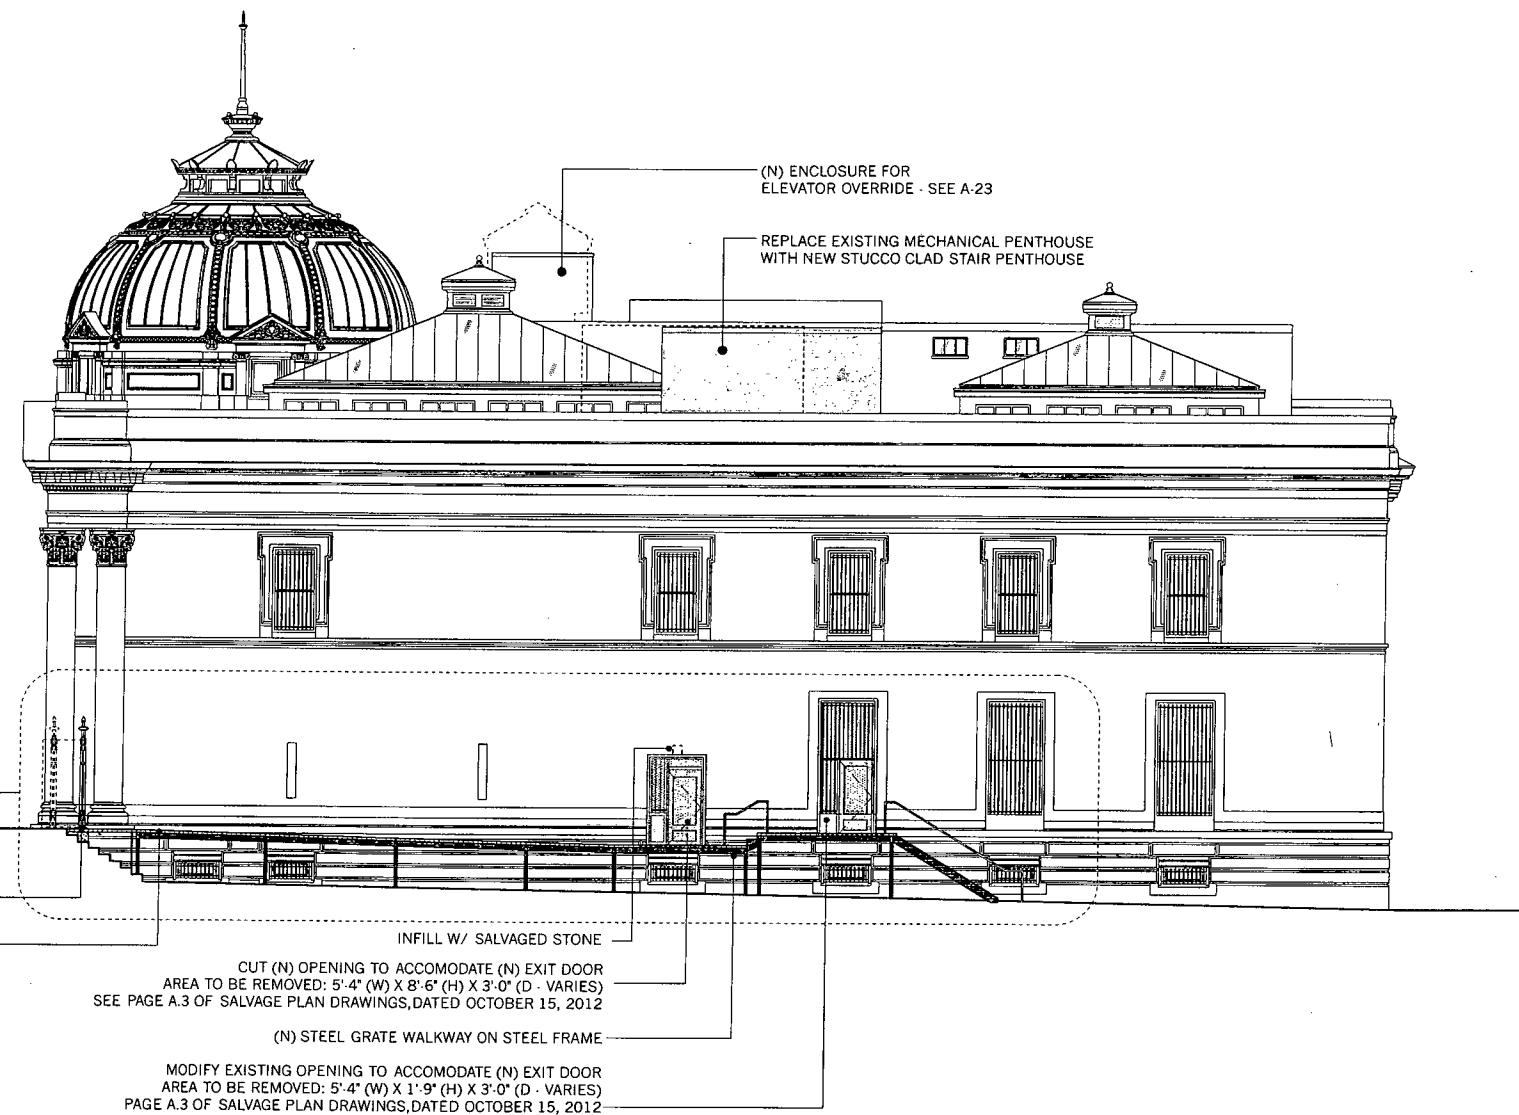
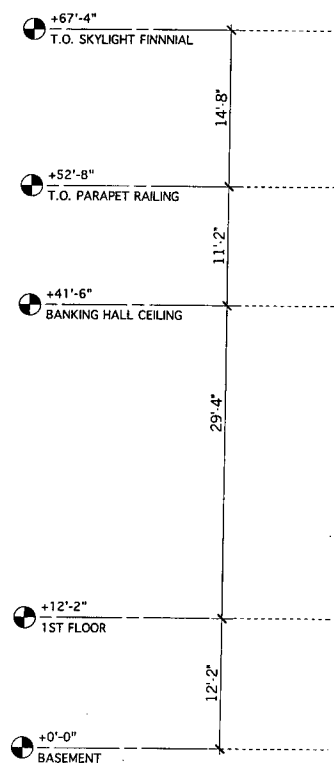
1 NORTH ELEVATION
Scale: 1/8" = 1'-0"

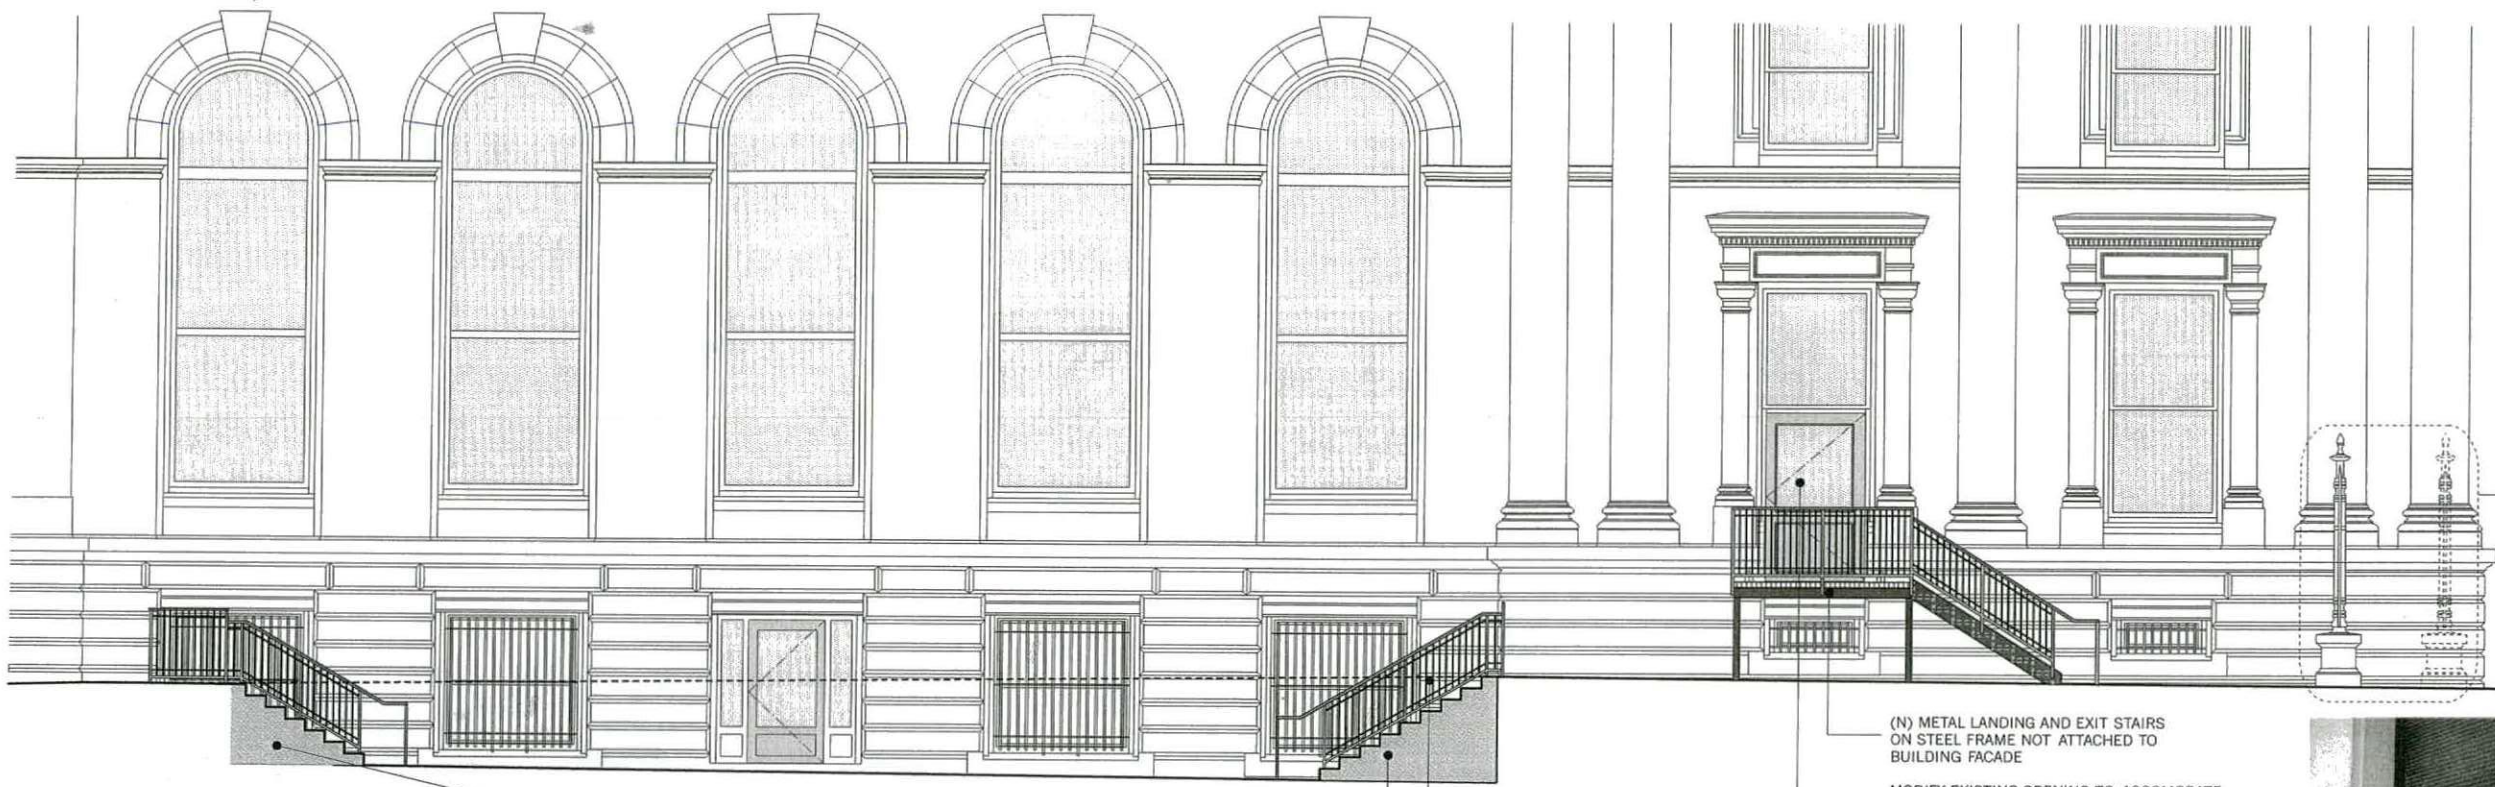
RELOCATE SOUTH GATE. SEE: SALVAGE PLAN DRAWINGS, PAGE A.4

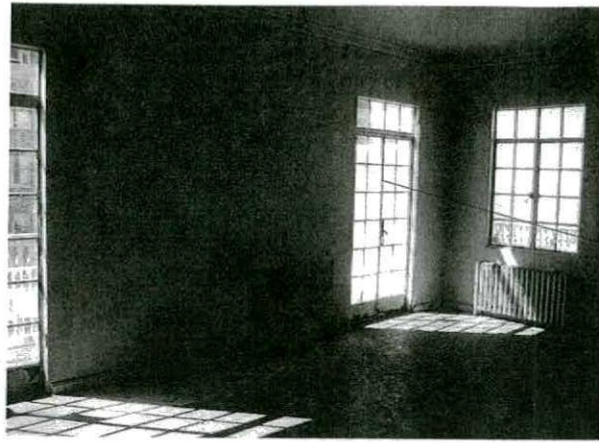
A: View of existing southern side of penthouse where existing pair of doors will be replaced by single exit door.

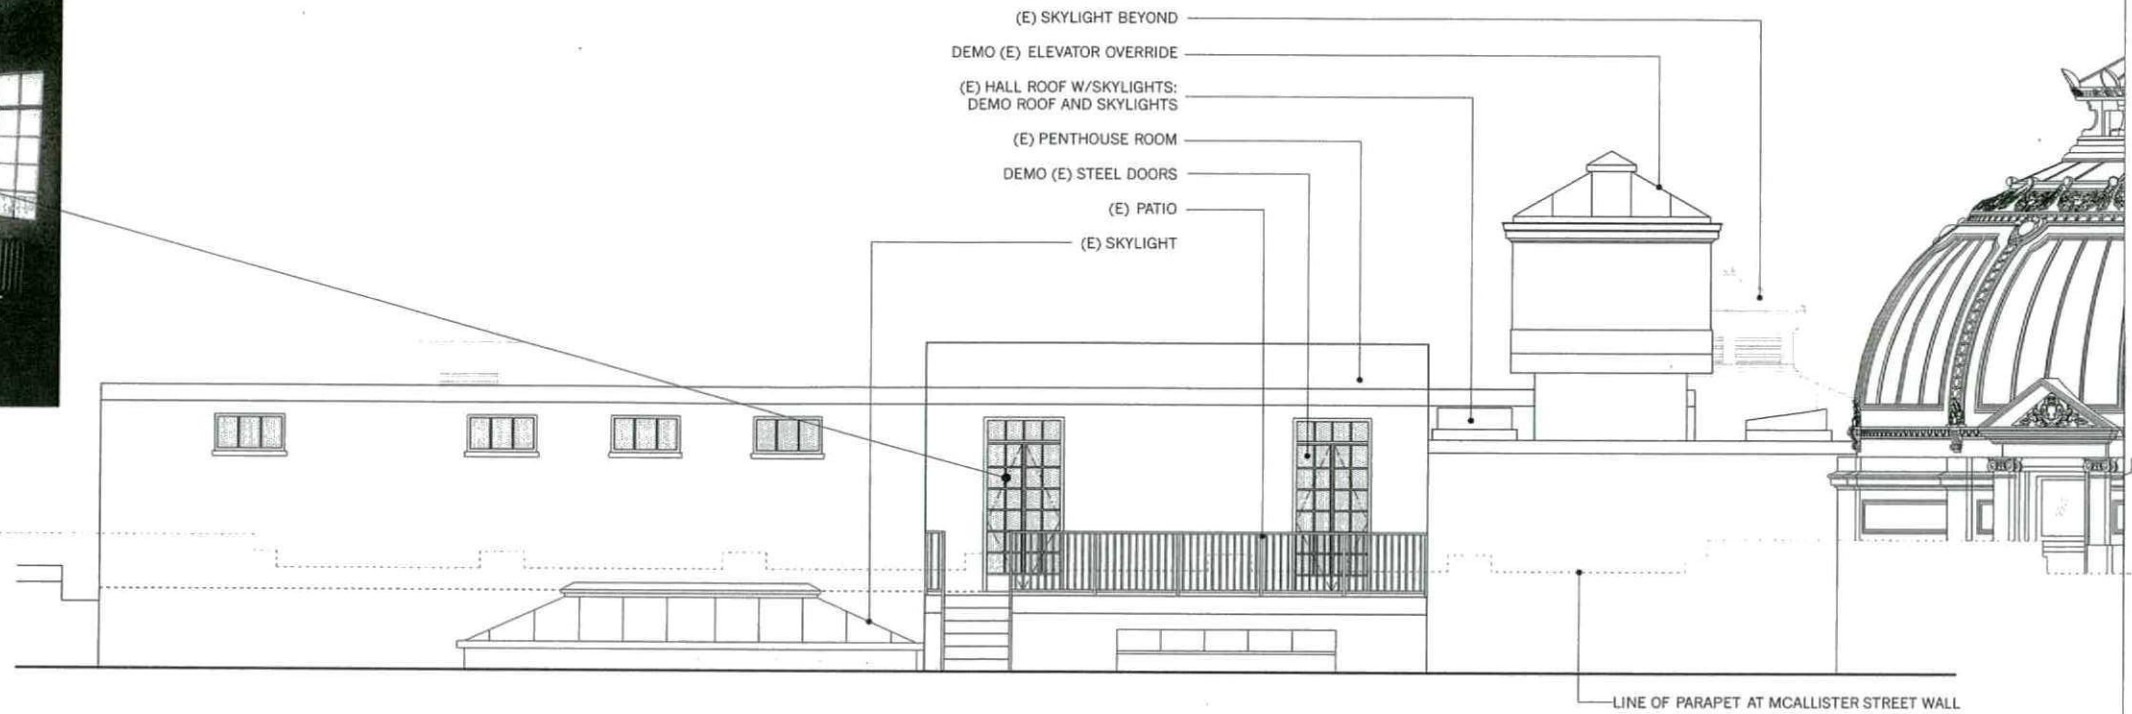
1 EXISTING PENTHOUSE ELEVATION SOUTH
Scale: 1/4" = 1'-0"

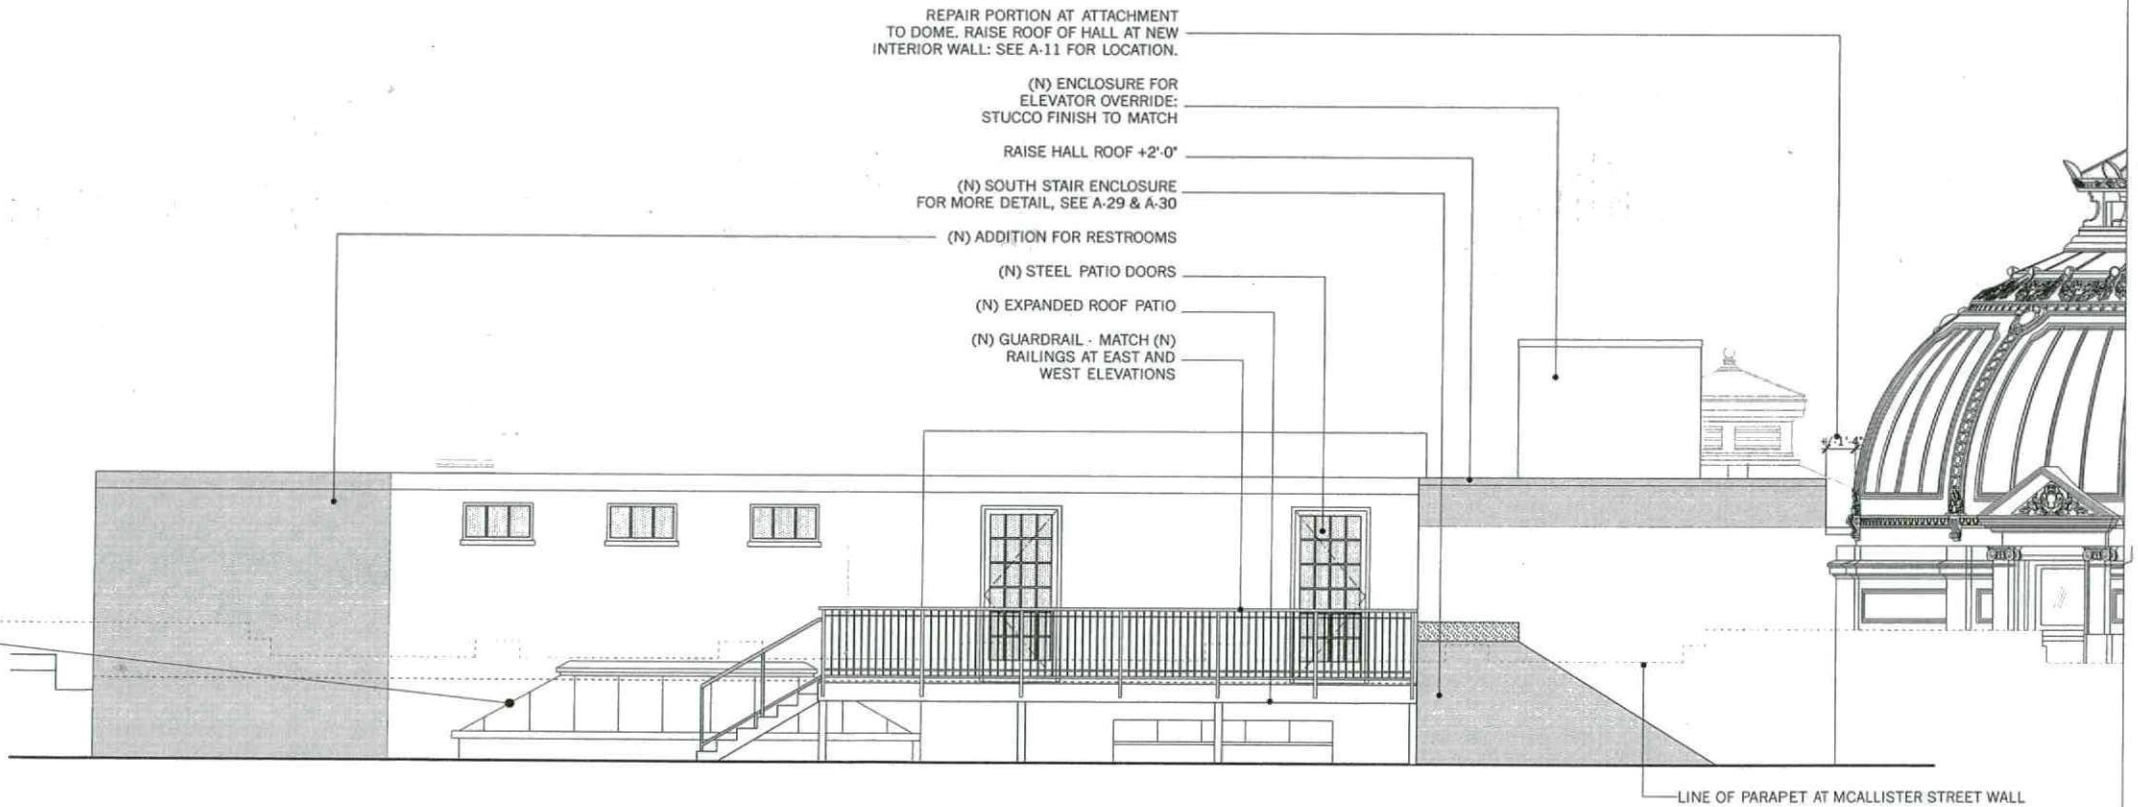
2 PROPOSED PENTHOUSE ELEVATION SOUTH
Scale: 1/4" = 1'-0"

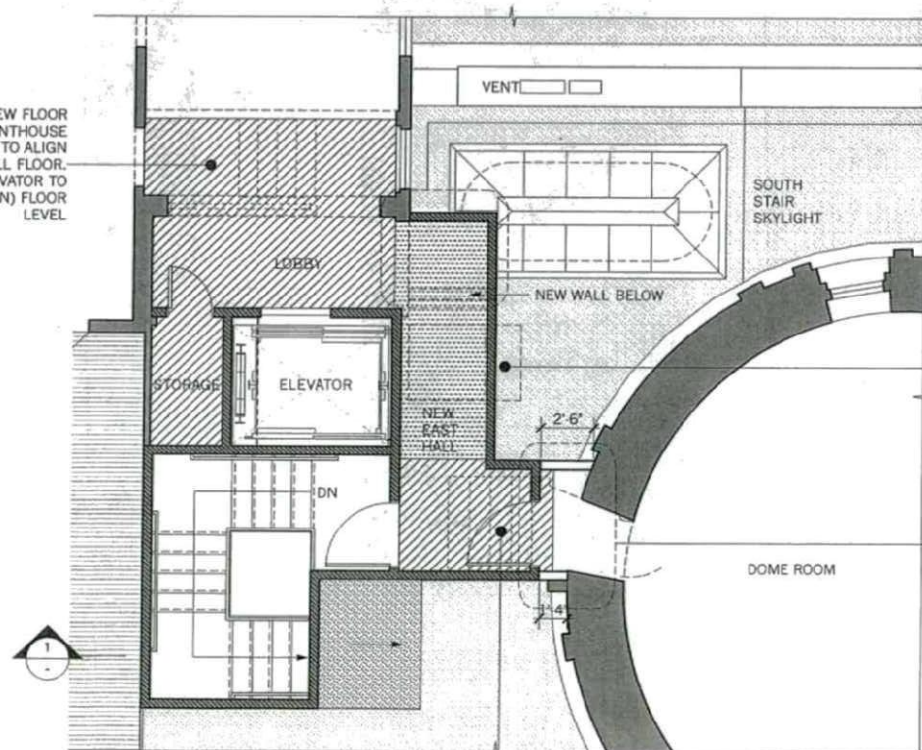
PROPOSED PENTHOUSE PLAN

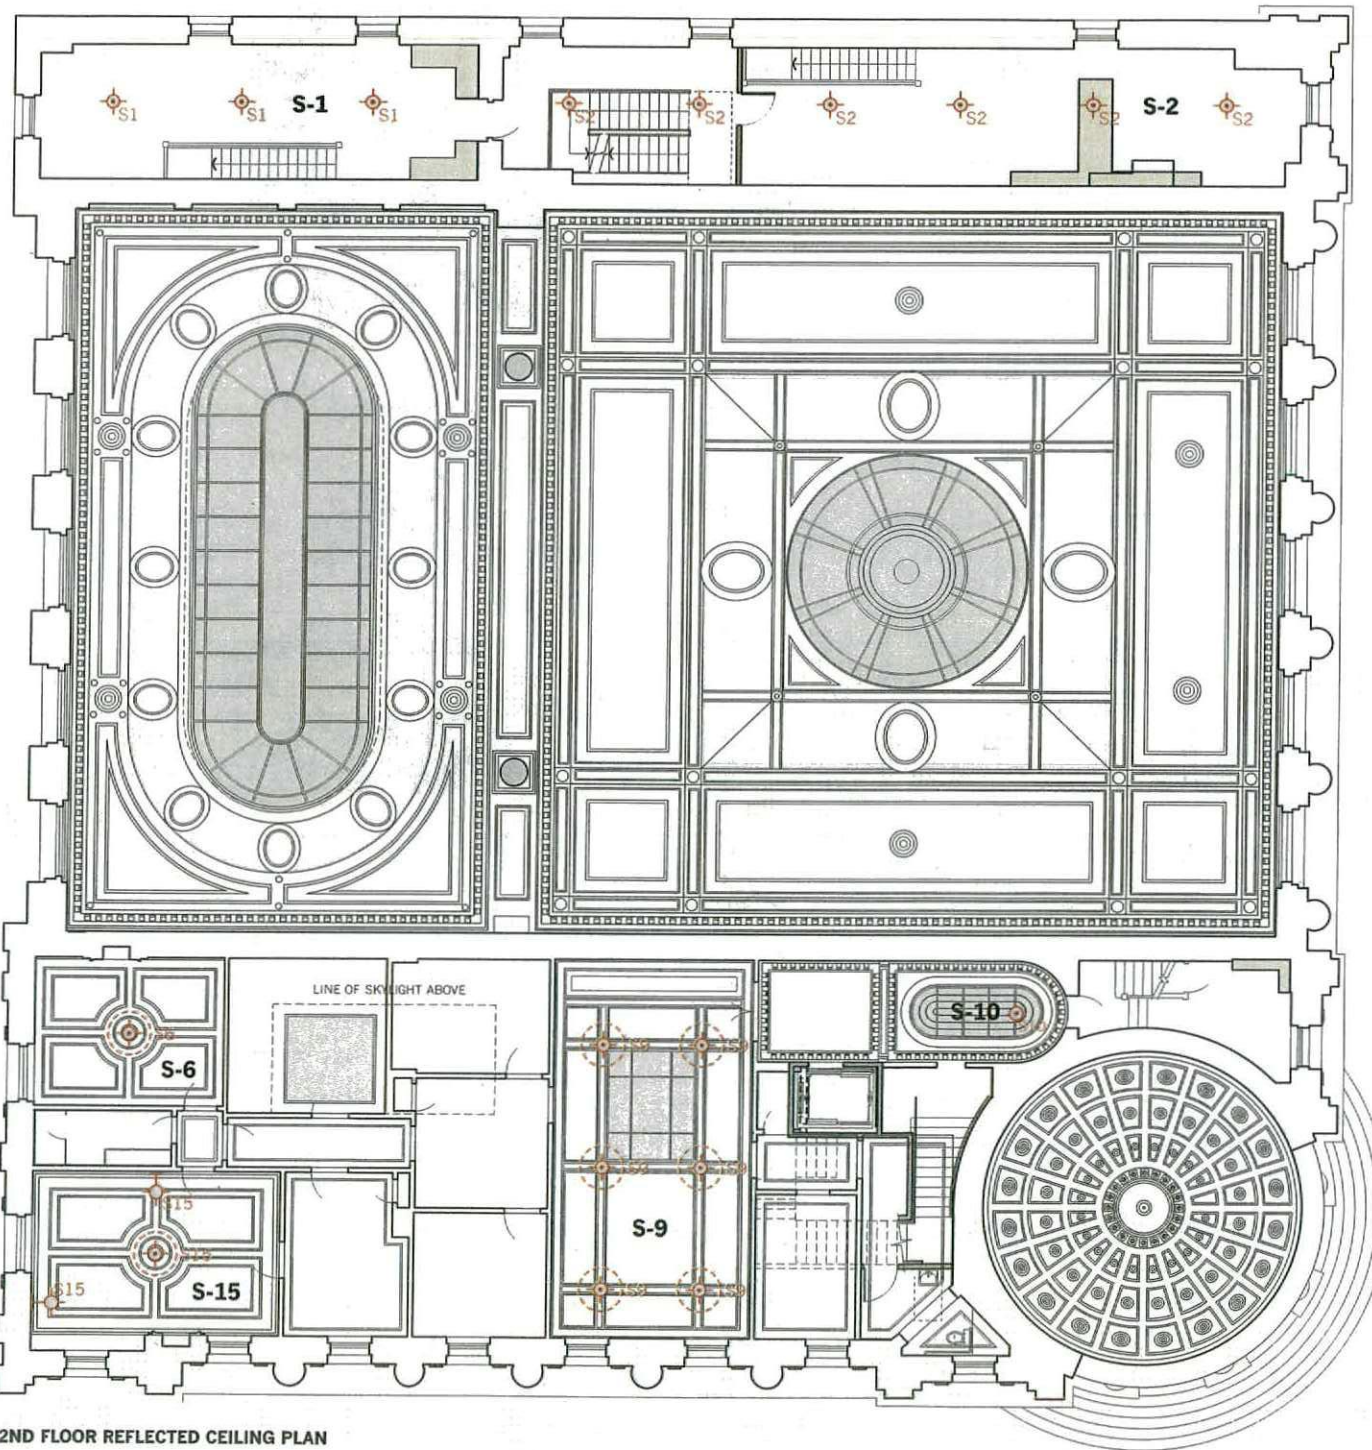
2ND FLOOR REFLECTED CEILING PLAN

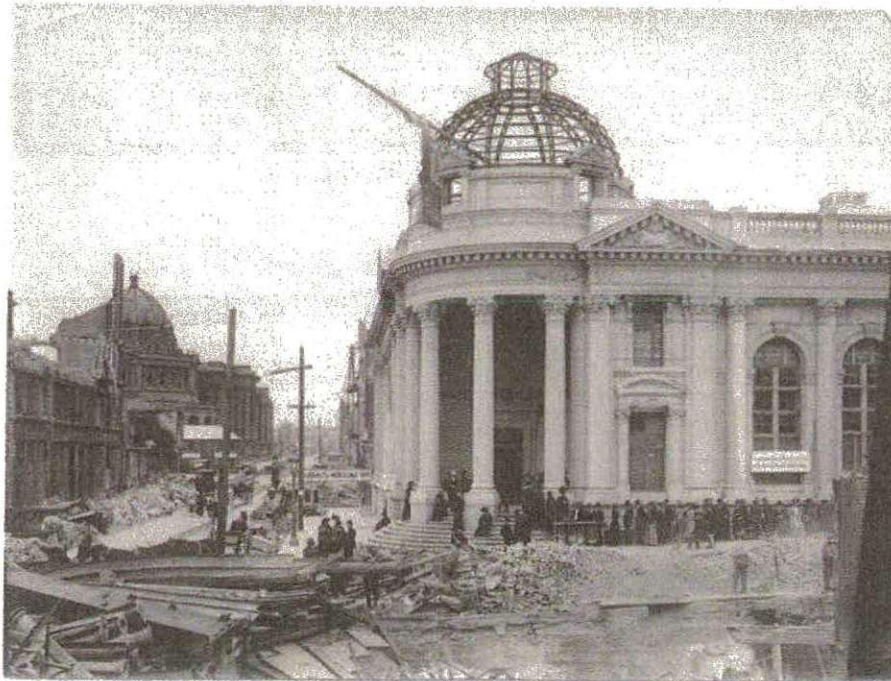
Figure 1. "Hibernia 1906 Opening Day" - after the earthquake and fire

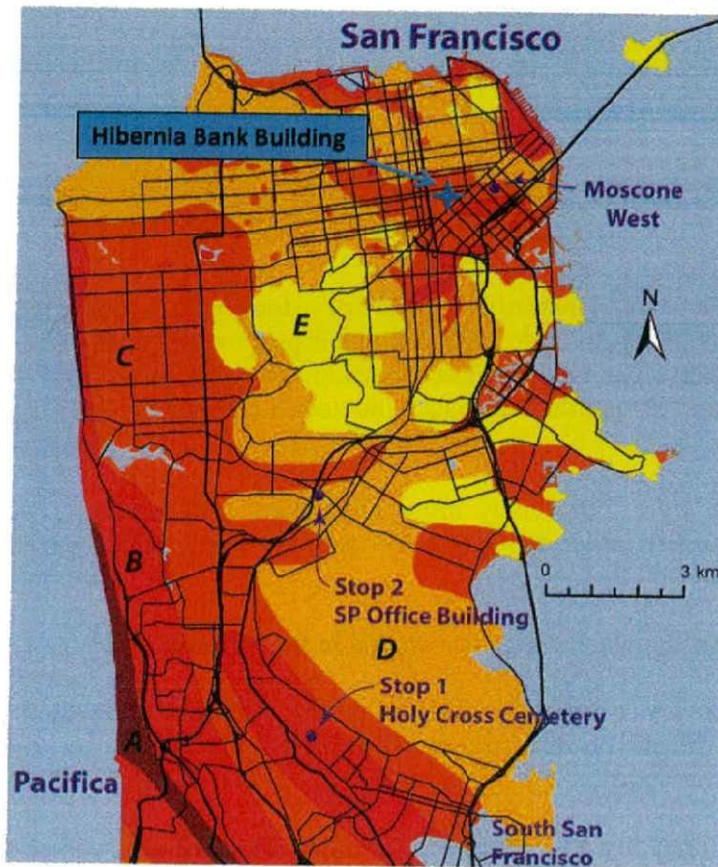
POTENTIAL DAMAGE	Light	Moderate	Moderate/Heavy	Heavy	Very Heavy
SAN FRANCISCO INTENSITY	E	D	C	B	A

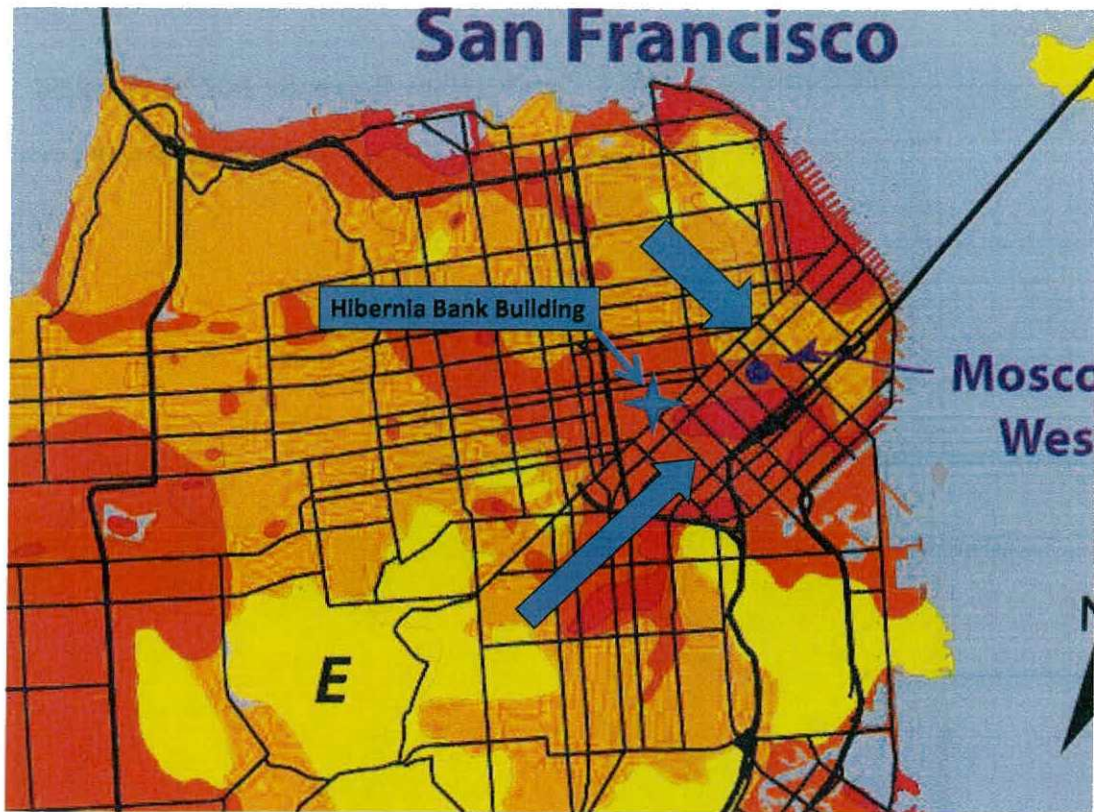
Figure 6. Detail of Lawson/Boatwright Intensity Map

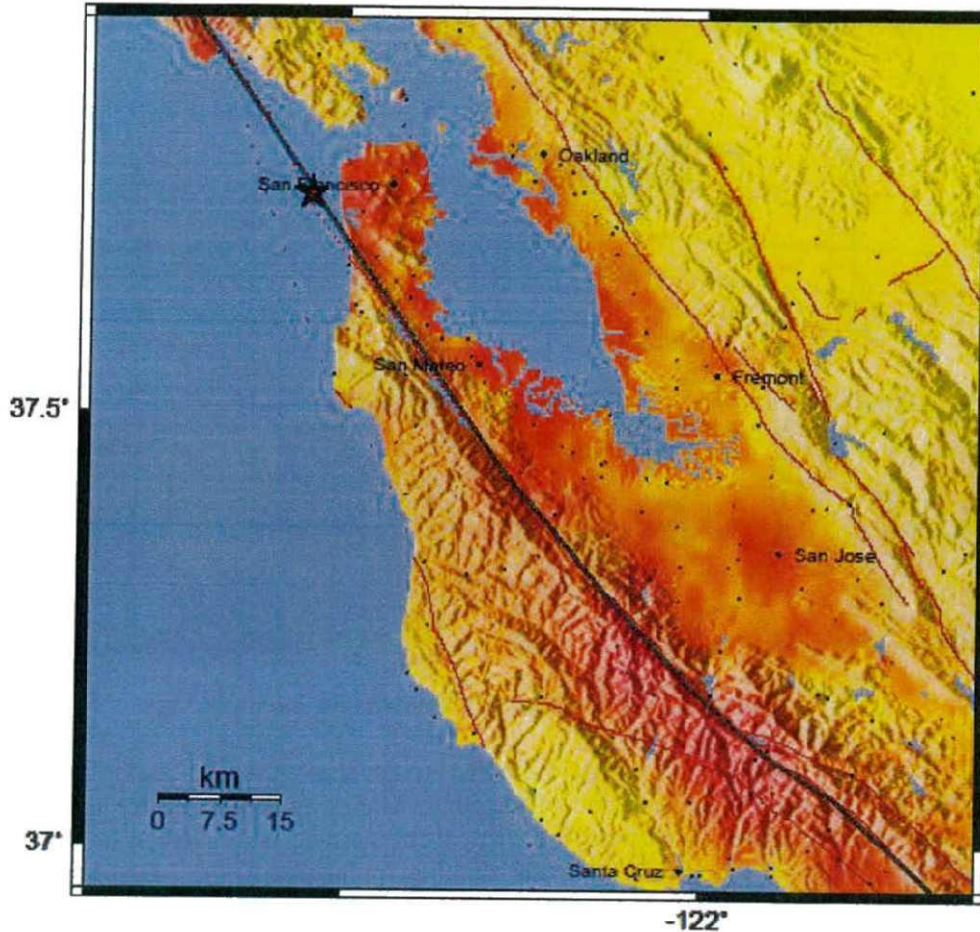
PERCEIVED SHAKING	Not felt	Weak	Light	Moderate	Strong	Very strong	Severe	Violent	Extreme
POTENTIAL DAMAGE	none	none	none	Very light	Light	Moderate	Moderate/heavy	Heavy	Very Heavy
PEAK ACC. (%g)	<.17	.17-1.4	1.4-3.9	3.9-9.2	9.2-18	18-34	34-65	65-124	>124
PEAK VEL. (cm/s)	<0.1	0.1-1.1	1.1-3.4	3.4-8.1	8.1-16	16-31	31-60	60-116	>116
INSTRUMENTAL INTENSITY	I	II-III	IV	V	VI	VII	VIII	IX	X+
