DATE: November 22, 2010
TO: Historic Preservation Commission
FROM: Timothy Frye, Acting Preservation Coordinator, (415) 575-6822
RE: Informational Presentation on Emergency Work at 130 Sutter Street

**Subject: Structural Observation Report - Fire Escapes and Balconies
130 Surter Street, San Francisco**

Subject: Fire Escape and Balcony Testing for Corrosion
130 Sutter Street, San Francisco, CA¹

EMERGENCY REHABILITATION OF THE
2ND FLOOR BALCONY OF
THE HALLIDIE BUILDING

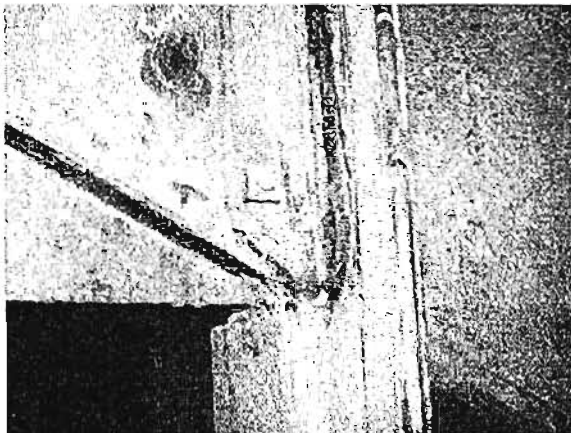
Photo A - Second floor at Line M:

As described in our previous report, the condition of the steel outriggers supporting the fire escapes and balconies is of considerable concern. Pieces of the outriggers have deteriorated to the point where they are no longer functional. In some cases, testing of the steel was not practical due to the delaminated condition. A sampling of typical conditions are shown below and additional photos and a reference elevation are on following pages

Enclosed please find a copy of the test results from Applied Materials Engineering. As can be noted from the test results the deterioration of the structural support system has resulted in a loss of 70% of the original structural capacity. Not only does this result in a structure that is incapable of providing adequate support for the intended use but also presents a serious concern of imminent falling hazards. It was determined during the field work that certain sections of the fire escapes and walkways are unsafe and were not tested. Access to these areas will require full exterior scaffolding.

We recommend that corrective action be taken immediately. Falling protection, some of which we noted has been installed, should be reviewed and complemented if found necessary. Removal of all badly deteriorated elements should begin as soon as possible.

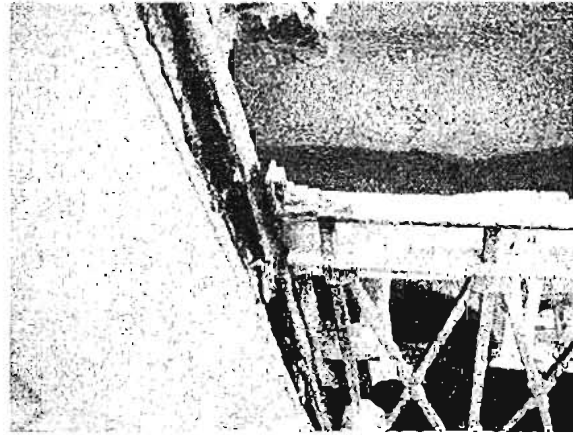
Photo D - Third floor at Line O:

As shown on the Photo D, the connection of the railings to the steel window mullion system has also suffered extensive deterioration.

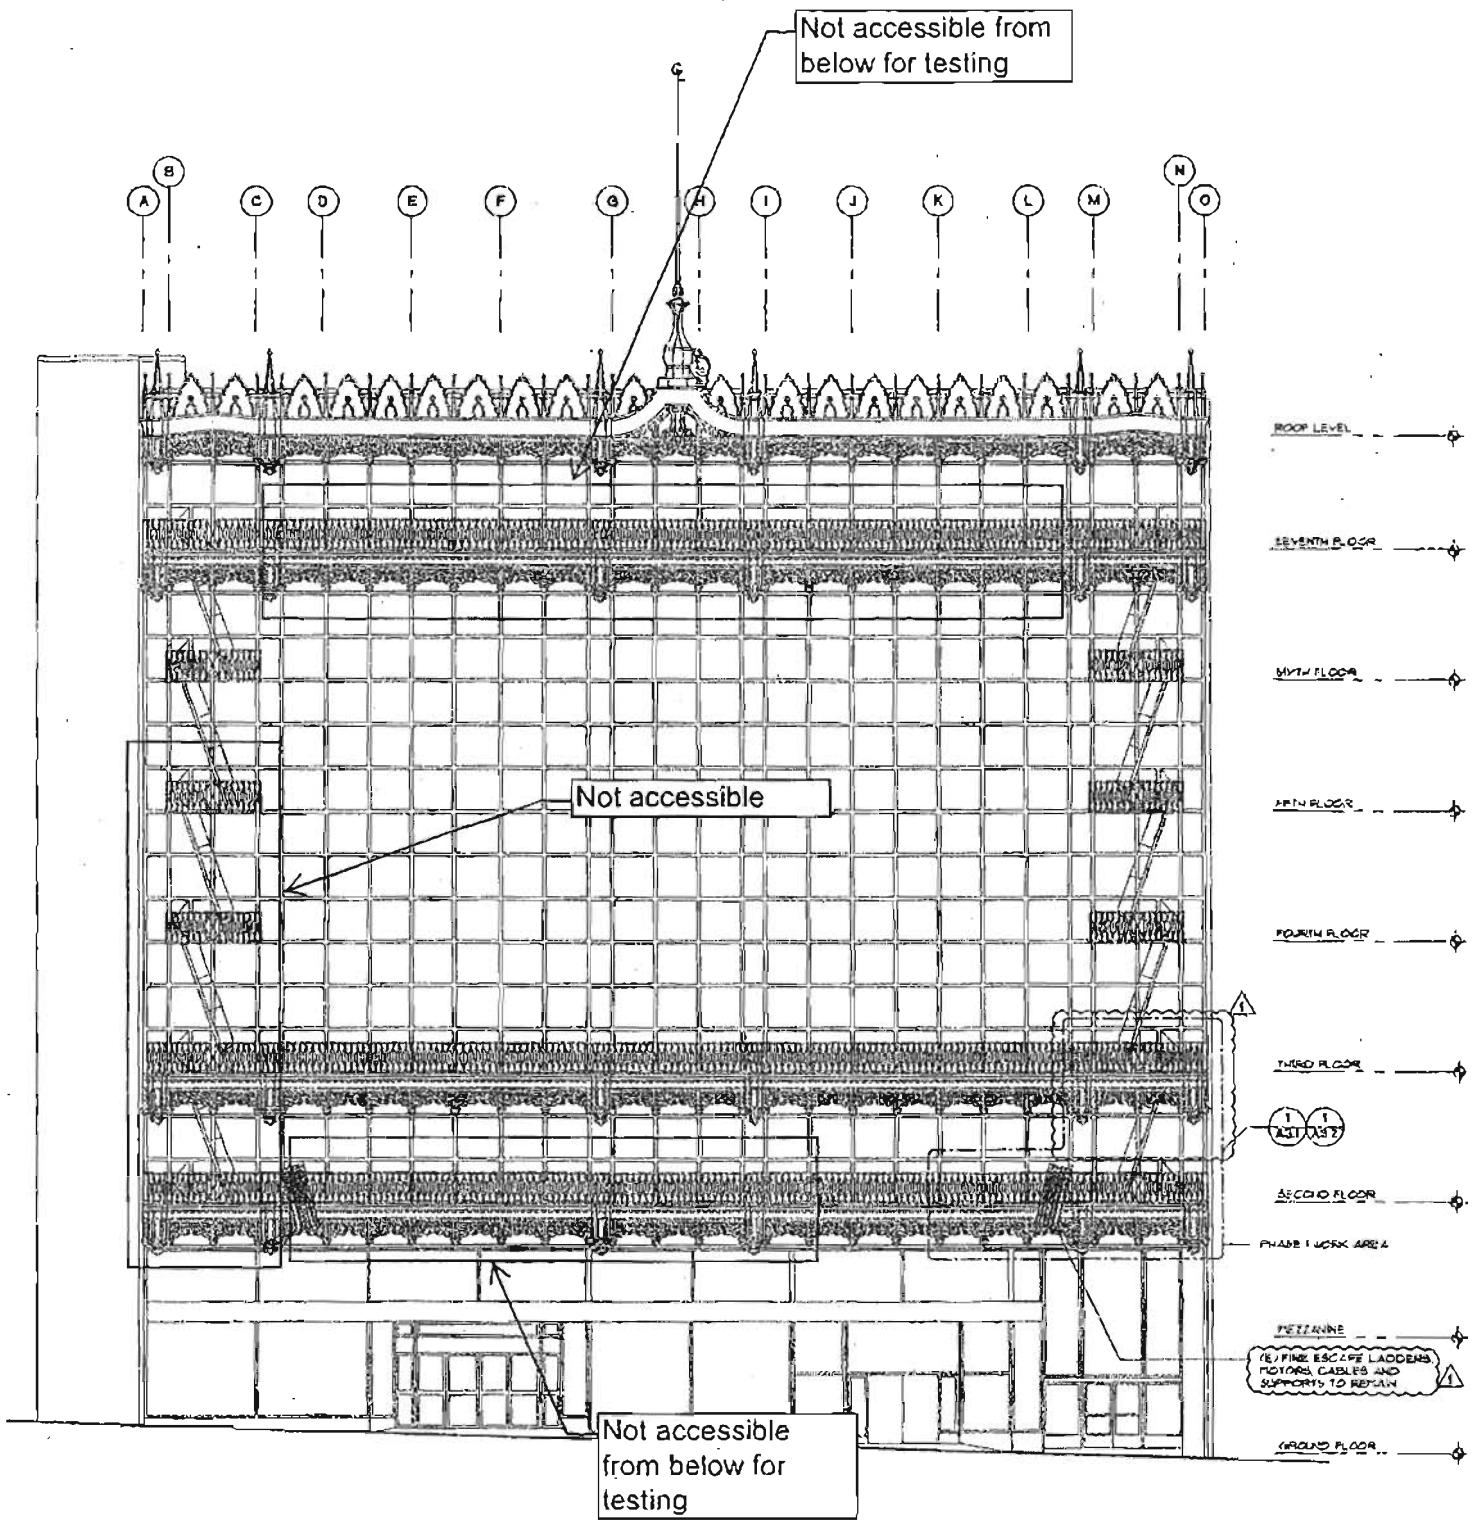
1 SOUTH ELEVATION

Access to the façade was by means of scaffolding between Lines J and O to the 3rd floor (see attached elevation) and through windows at the 7th floor balcony. Other fire escapes were accessed by the fire escapes themselves where possible. Areas not accessible due to field conditions are noted on the attached elevation.

Note: 2nd – 5th floor balconies at west end (Lines B-C), partial 2nd level walkway and 7th level walkway were not accessible due to field conditions.

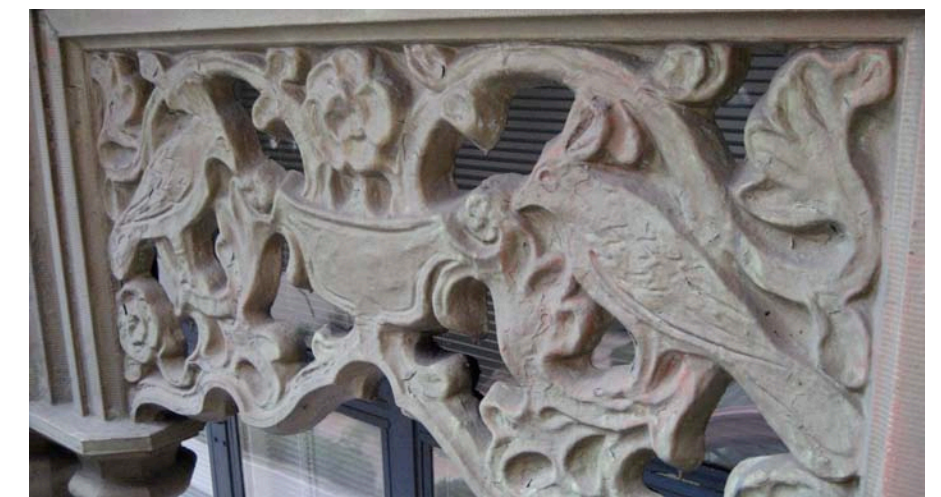
Decorative sheet metal below balconies

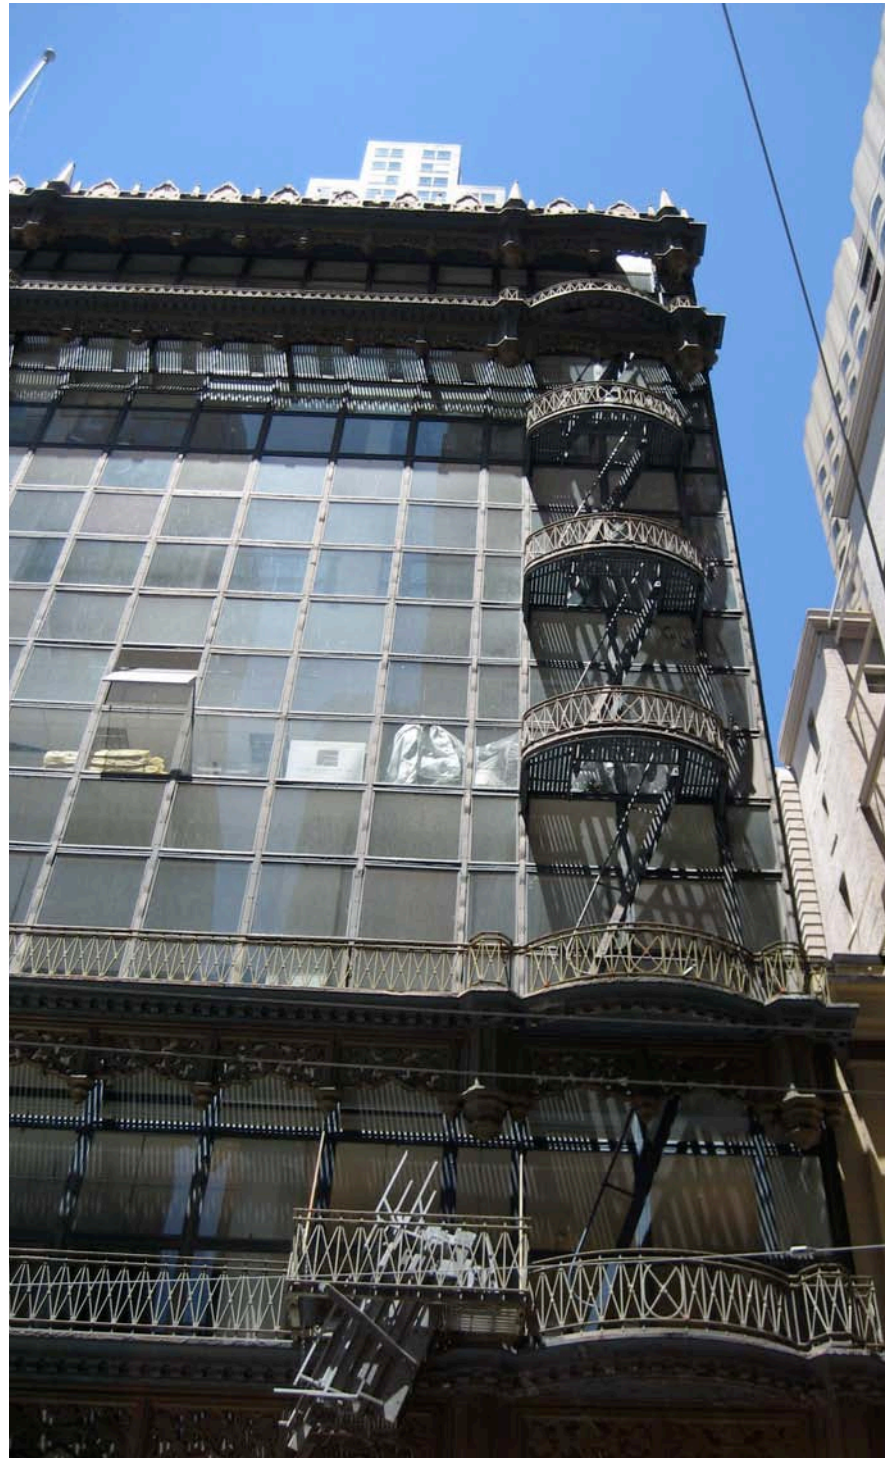
Area of work will include the second and third floor balconies on the easternmost side of the building

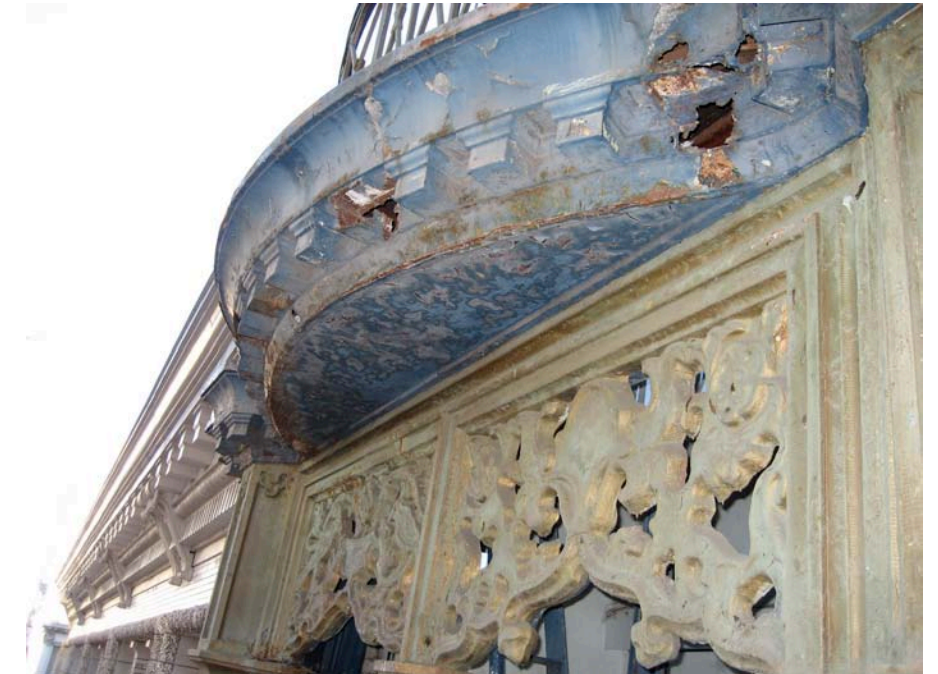
Deterioration at decorative sheet metal

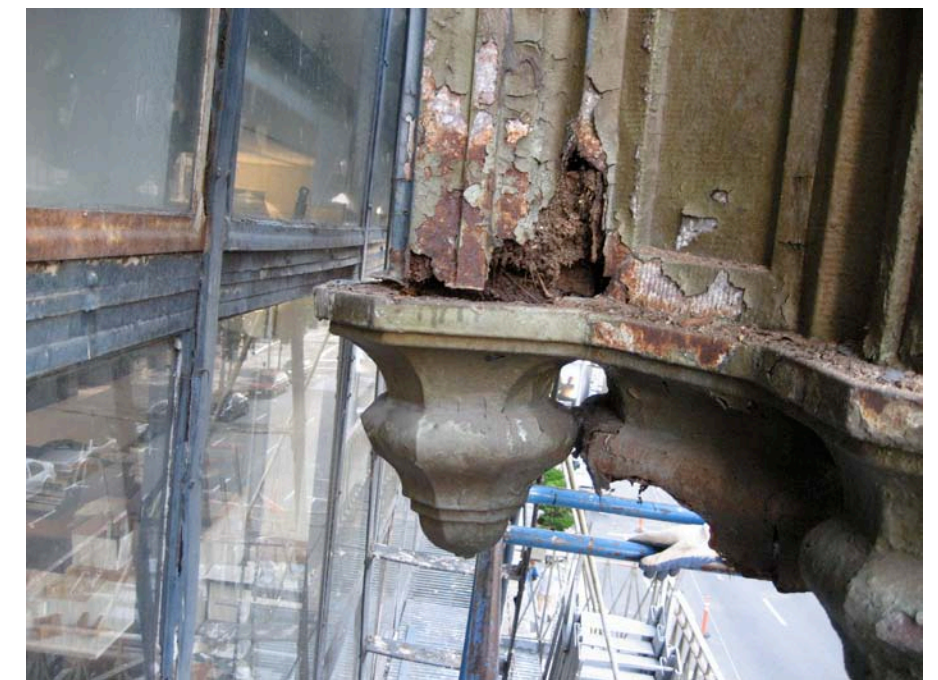
Deterioration at decorative sheet metal

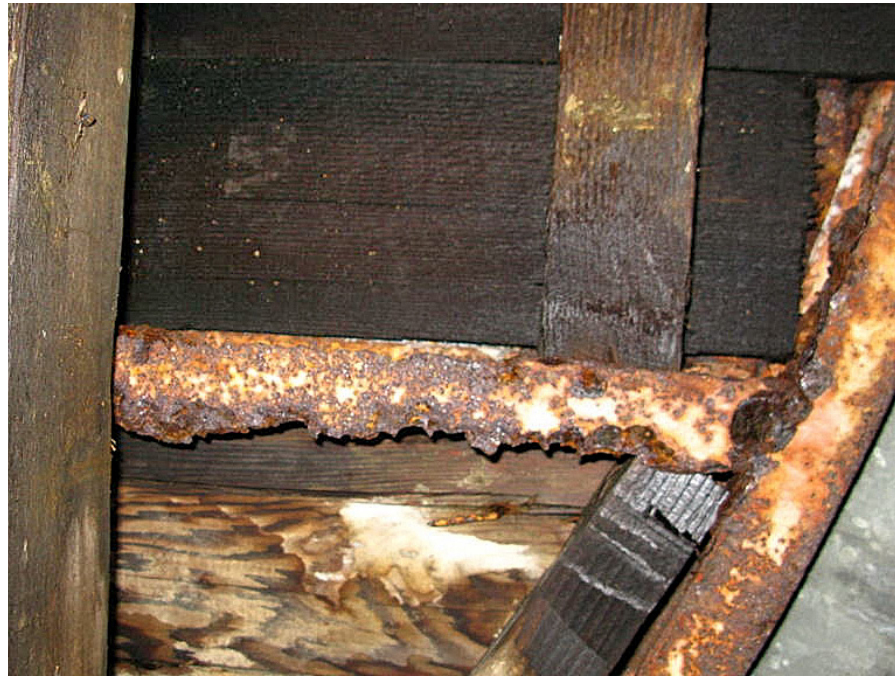
Deterioration at structural framework

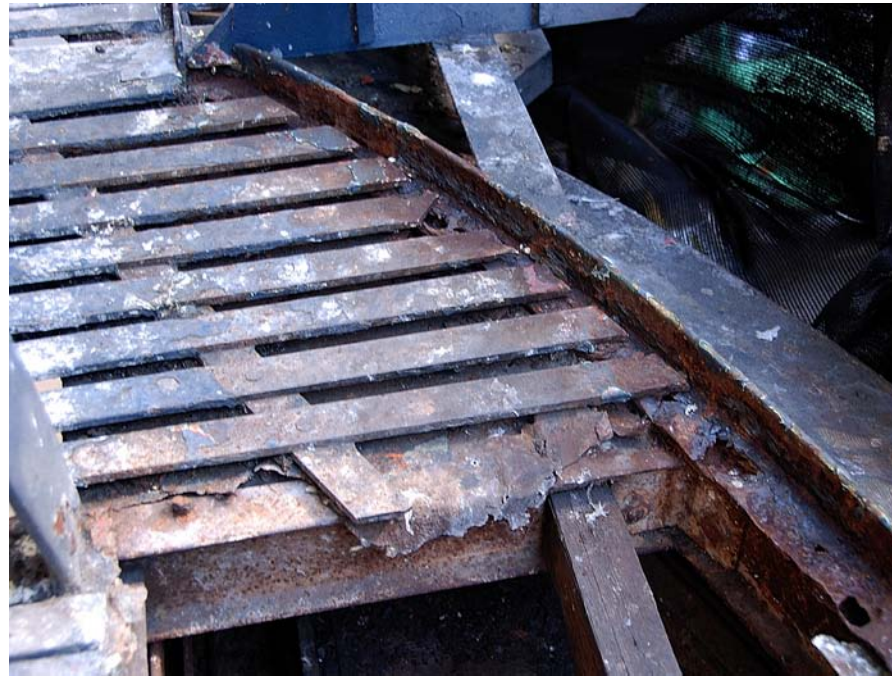
Deterioration at balcony

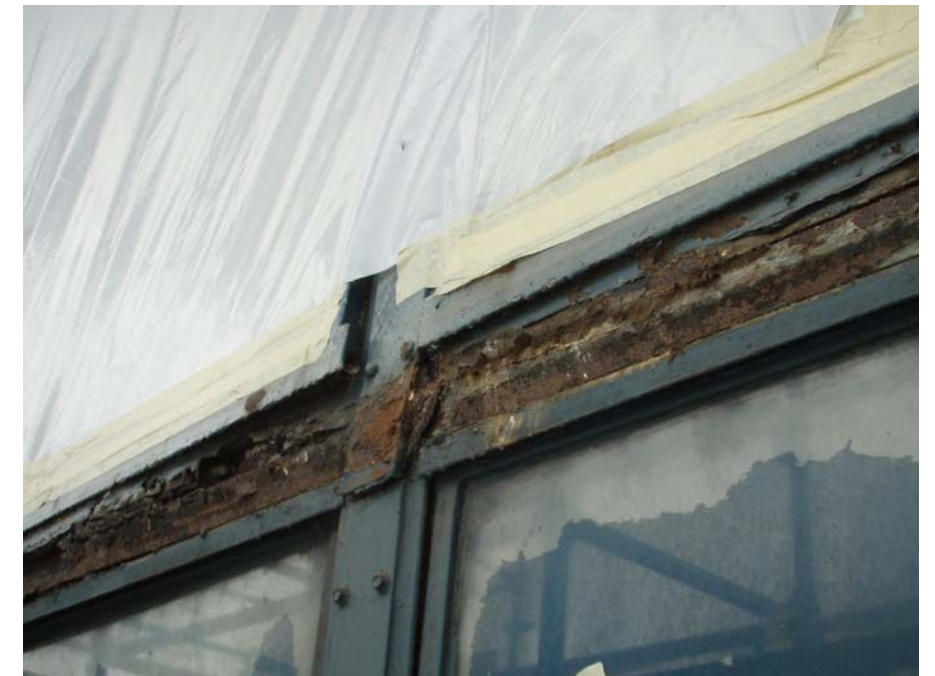
Deterioration at windows

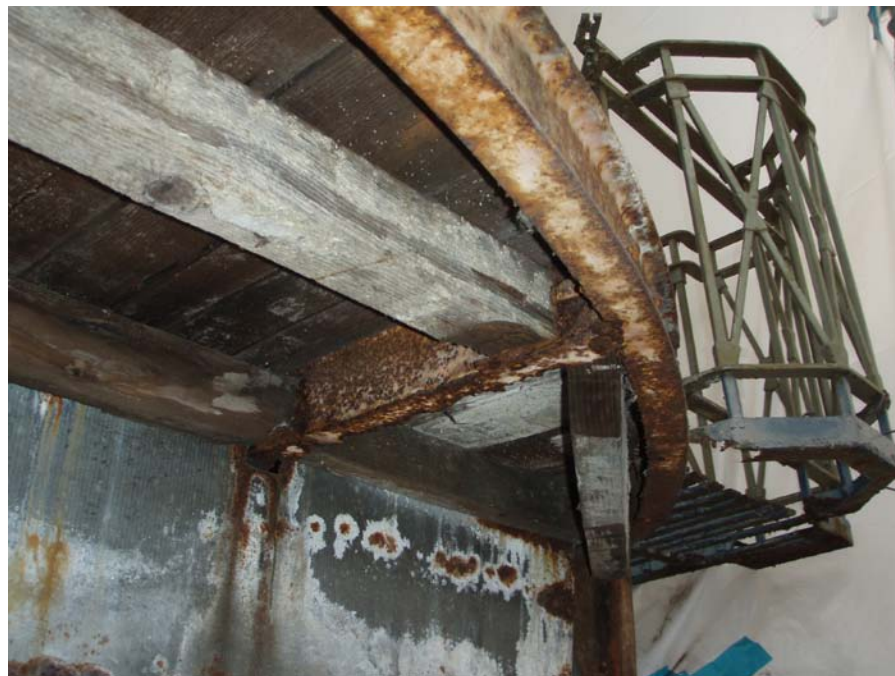
Deterioration at balcony

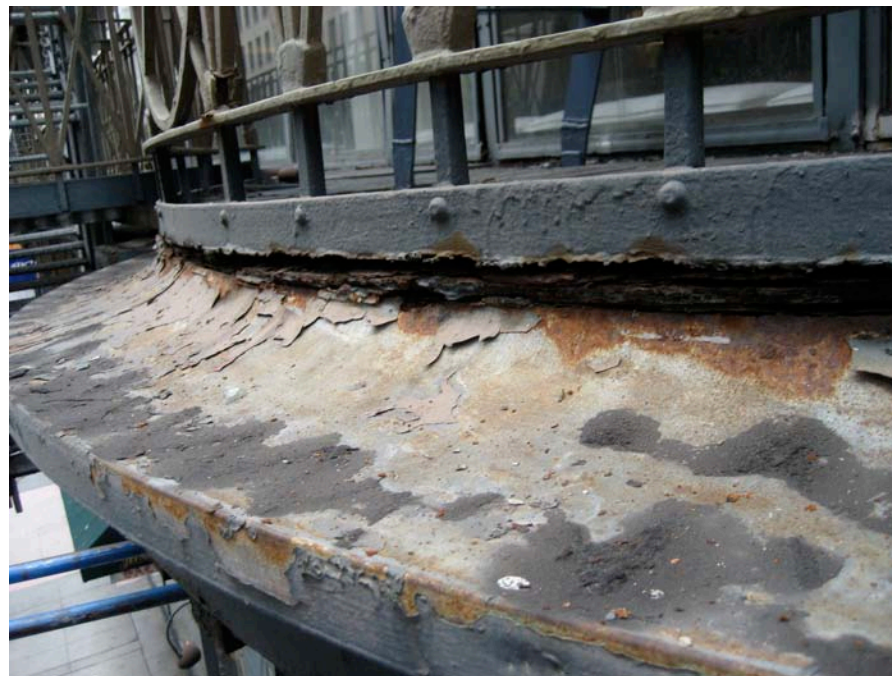
Deterioration at balcony

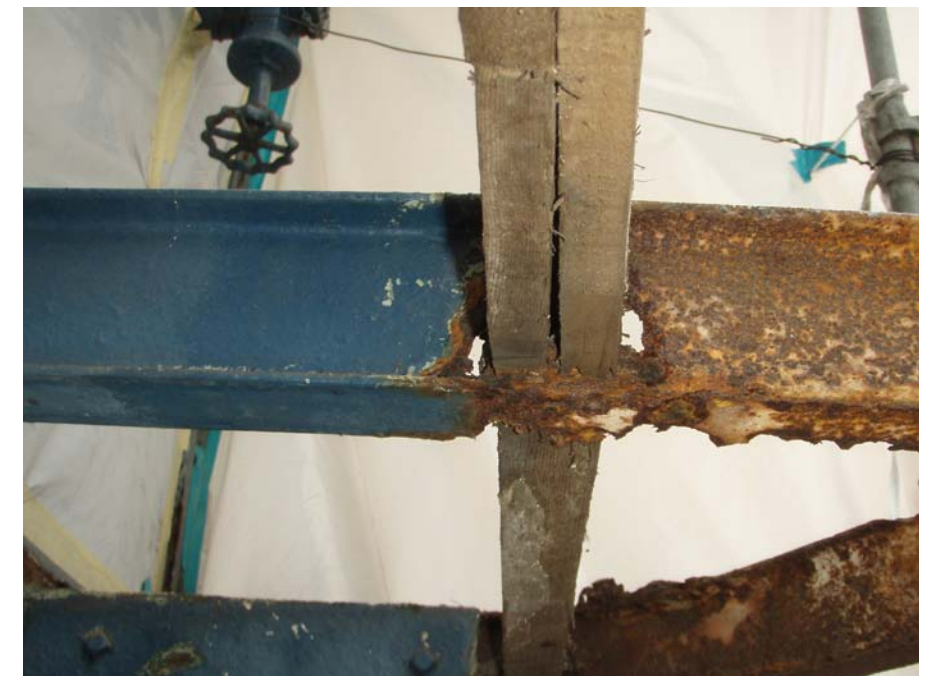
Deterioration of framing
