SAN FRANCISCO PLANNING DEPARTMENT

MEMO

DATE: May 27, 2010
TO: Historic Preservation Commission
FROM: Shelley Caltagirone, Preservation Staff, tel. (415) 558-6625
REVIEWED BY: Tim Frye, Acting Preservation Coordinator
RE: **June 2, 2010 Hearing**
1269 Lombard Street
Case No. 2009.0443DDEV/2010.0165DD

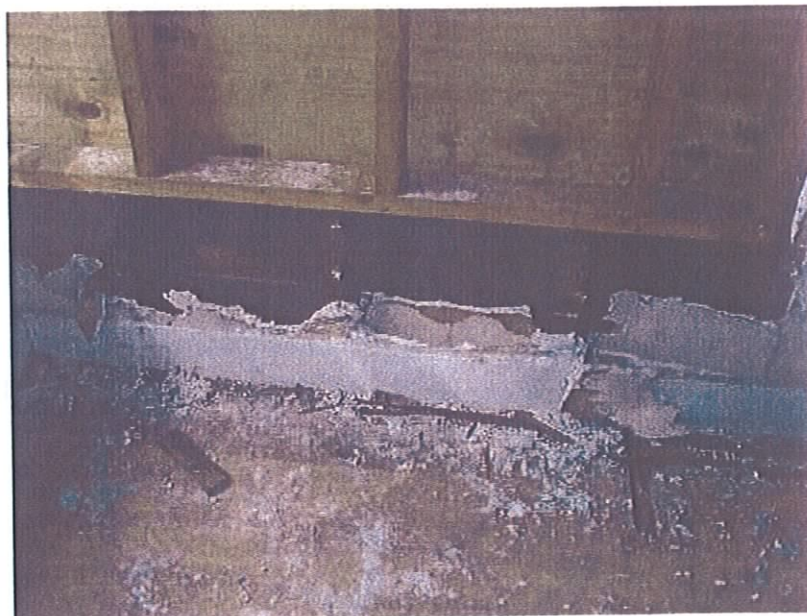
Image 14. Infill at rear west wall of second floor, prior condition unknown. Photo Frederic Knapp, 2007.

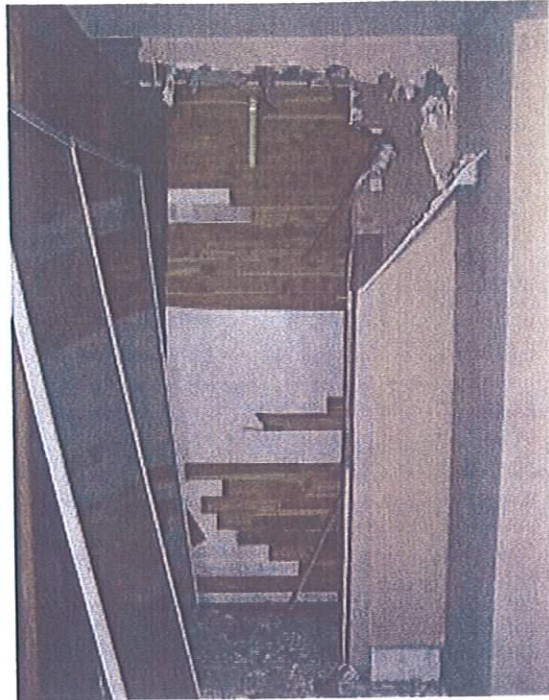
Image 15. Altered interior construction, first floor. Photo Frederic Knapp, 2007.

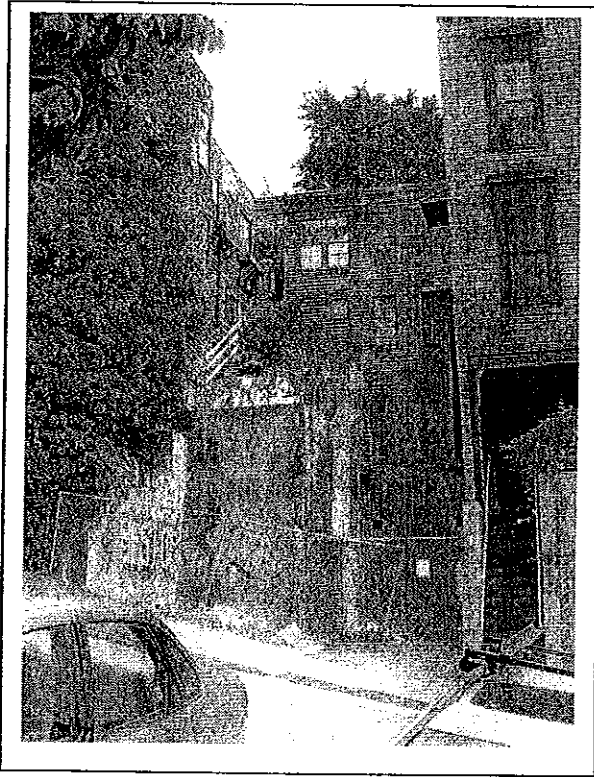
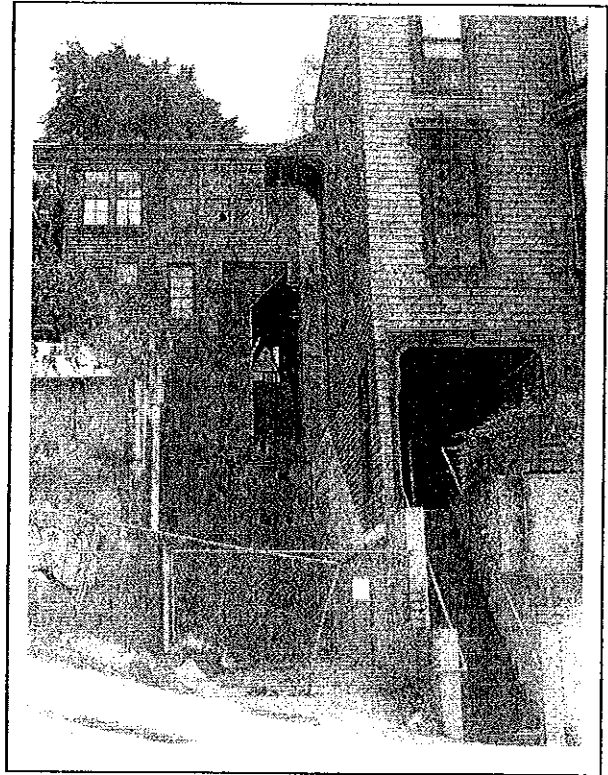
Photo 1: Front Elevation (facing south) of 1269 Lombard Street. Notice steel-tie backs in retaining walls. Notice west property line wall (to the right) of 1269 Lombard is missing at the 1st floor.

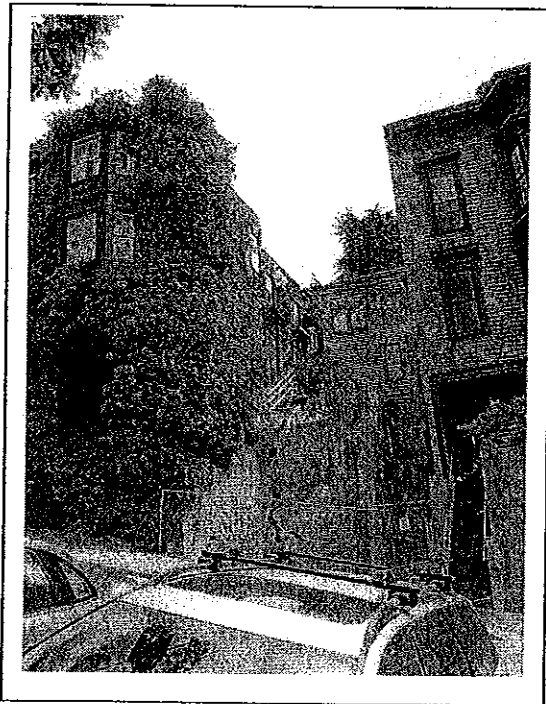
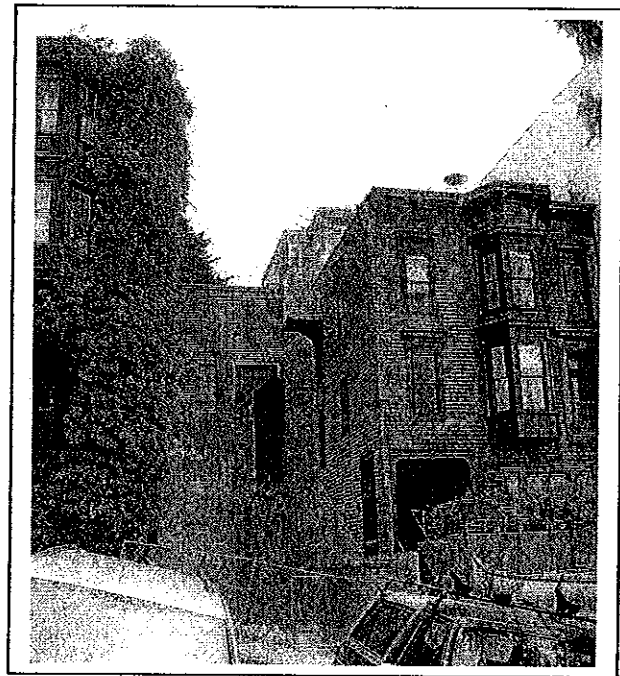
Photo 2: Same view as previous photo. Neighbors to the east and west (left and right, respectively) are 3-stories in height with a basement level. Notice 1269 Lombard is directly adjacent to the west neighbor (photo on right).

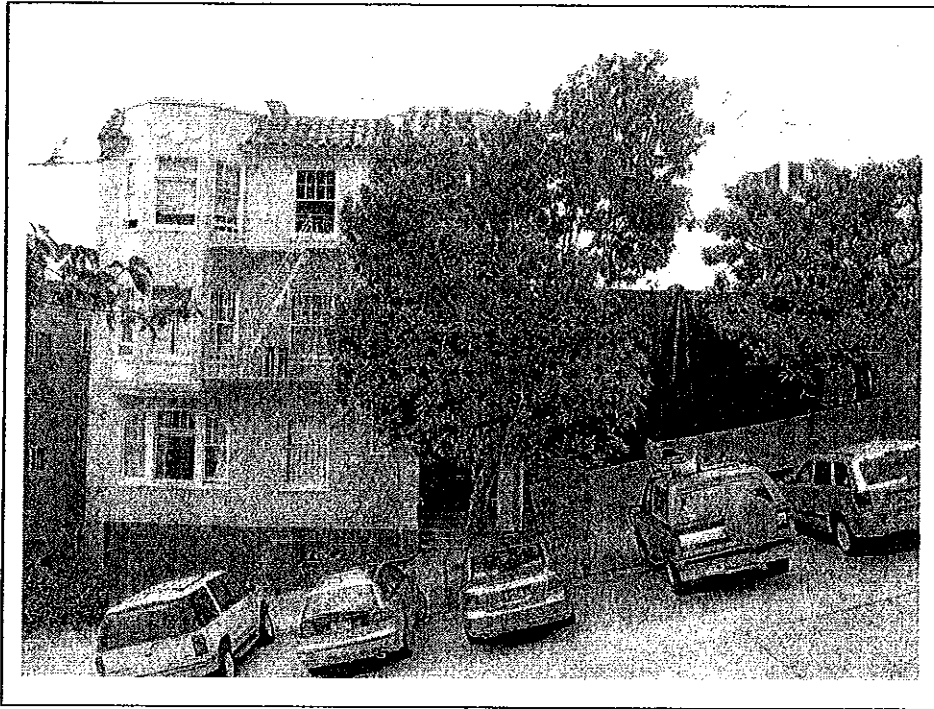
Photo 3: Neighbor's directly across the street of 1269 Lombard. View is facing north (towards Lombard Street).

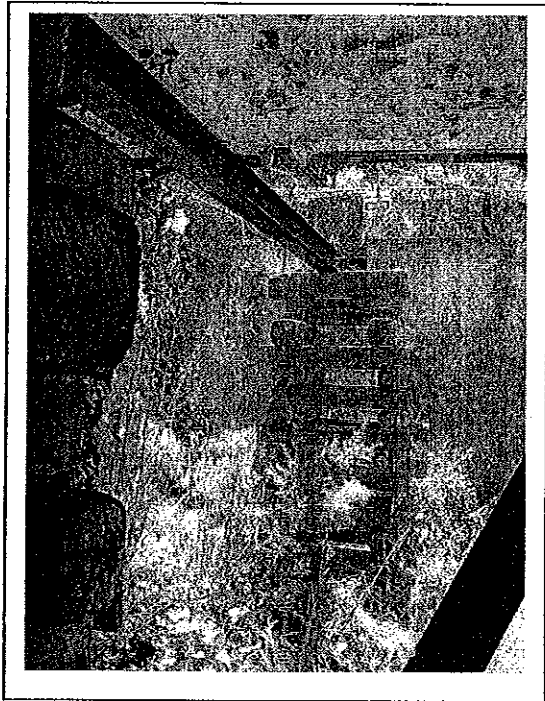
Photo 5: View is from the 1st floor, taken from the interior of the building facing south. Exterior walls of the 1st floor are missing, as per previous photo. Notice the minimal 4x4 cribbing members used for shoring, and the rusted steel beam. The backyard's retaining wall is visible in the background.

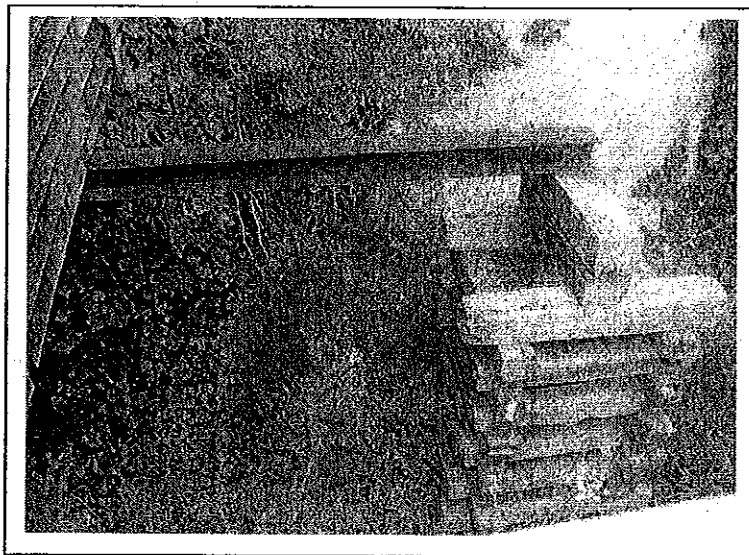
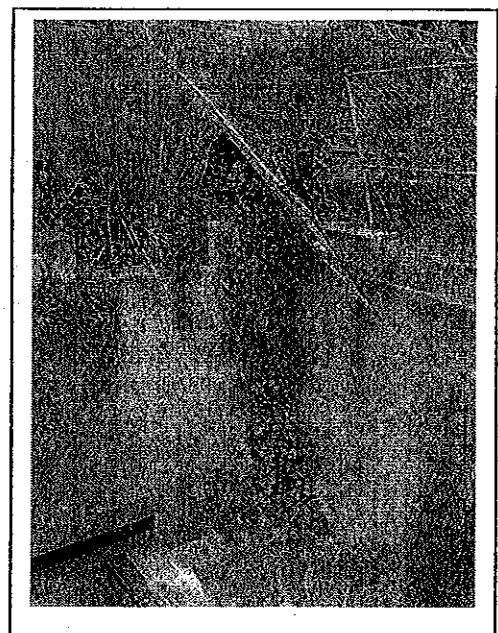
Photo 6: View of backyard, looking down (another view of previous photo). Photo on left is looking down, and a portion of the rear elevation is visible on the left. Photo on the right shows the existing backyard's retaining wall (view is facing southeast).

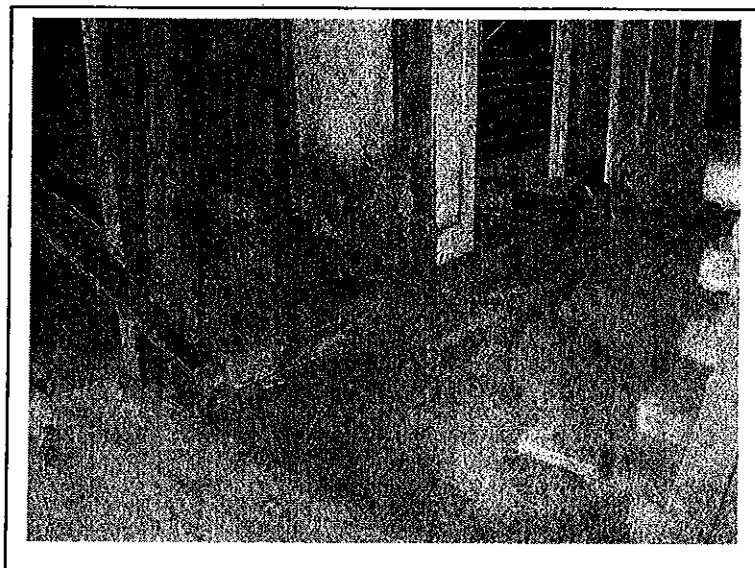
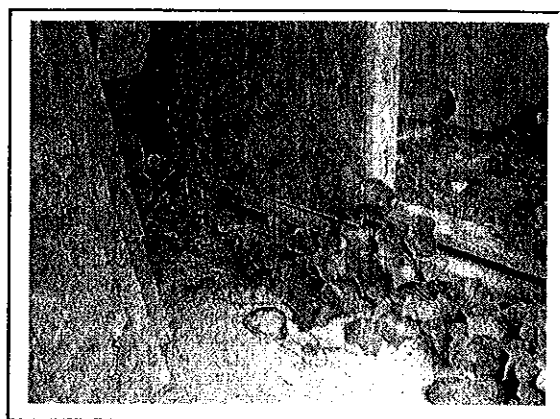
Photo 9: 1st floor's floor framing set directly into ground. Top of retaining wall is visible in the foreground of the far left photo. Views are facing northeast.

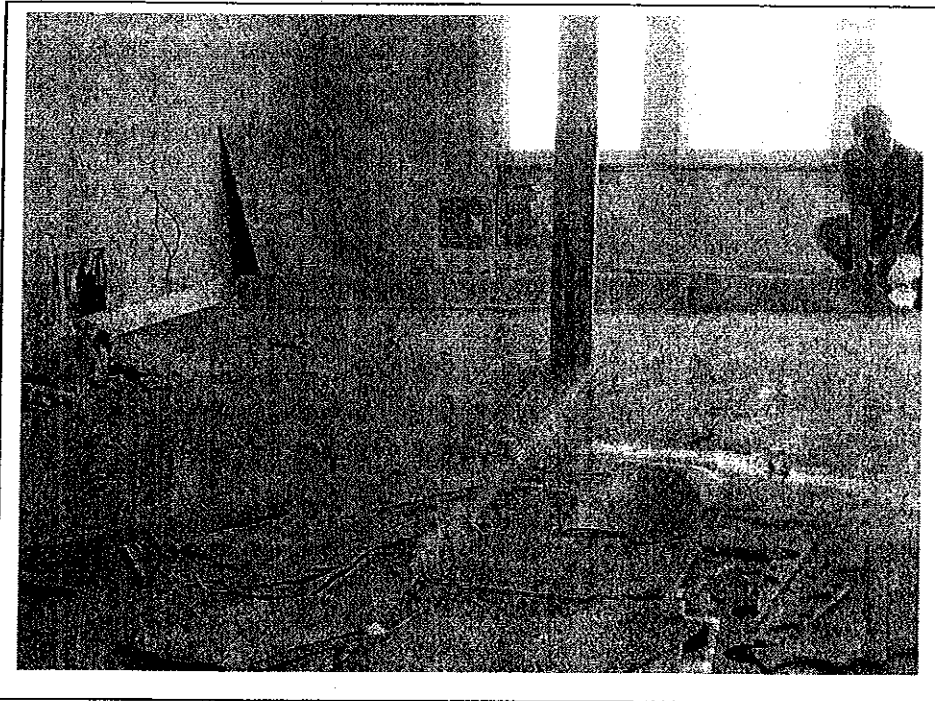
Photo 16: View of 2nd floor Living Room, facing north. Shoring post is in the middle of the room. Notice 1x6 board is laid on its side to demonstrate the floor out of level, with a visible gap at the far west end (left end). The left end is the sagging area shown in photo 8.

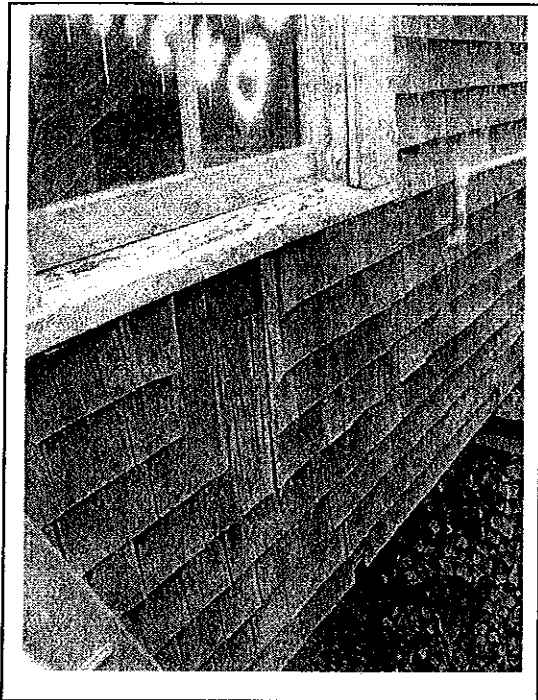
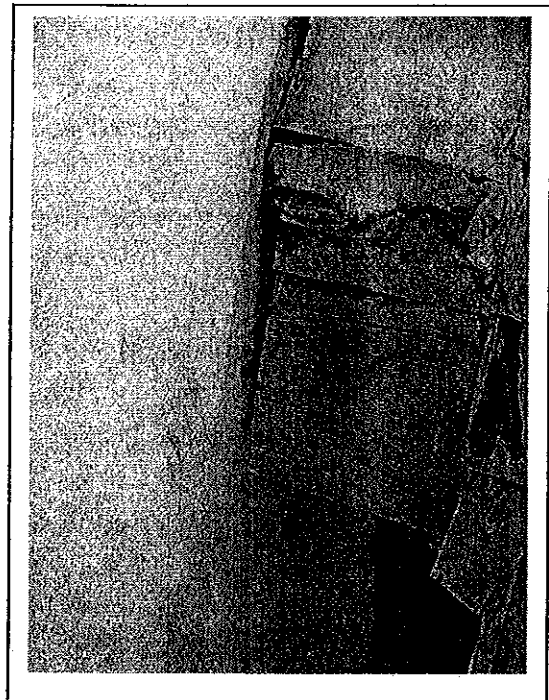
Photo 20: Exterior of the 2nd floor's south elevation . Shingles have rotted per Markoff Pest Report. Photo on the right is a close-up of the west property line condition's shingles.

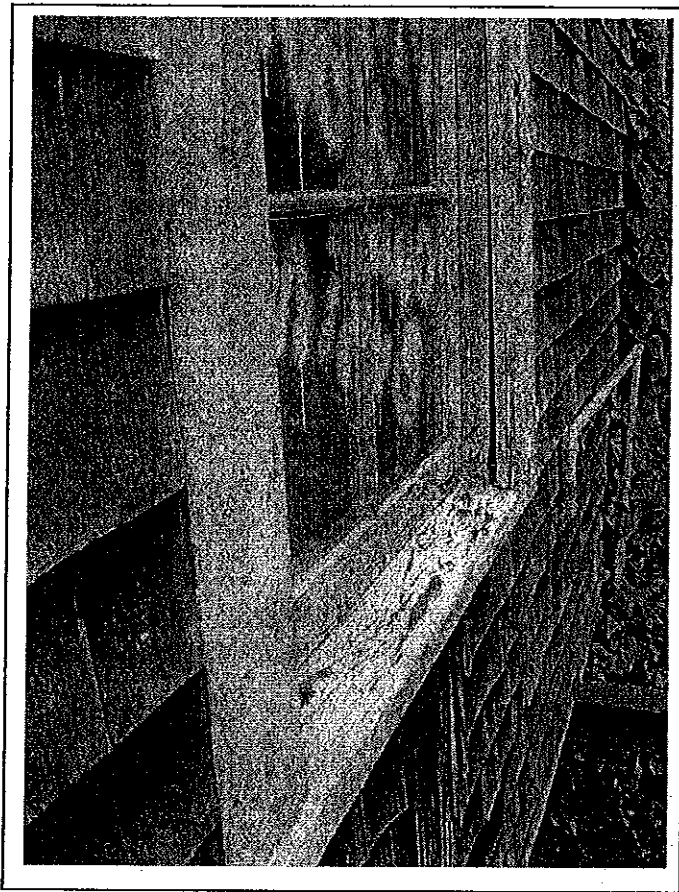
Photo 21: Close-up of previous photo. Notice framing around window has split and deteriorated.
