## Certificate of Appropriateness Case Report

*Filing Date:* April 4, 2011  
*Case No.:* **2011.0310A**  
*Project Address:* **201 Buchanan Street**  
*Landmark:* No. 47 - Nightingale House  
*Zoning:* RTO (Residential Transit-Oriented)  
40-X Height and Bulk District  
*Block/Lot:* 0858 / 002  
*Applicant:* Christopher Yerke, Restoration Workshop, Ltd.  
630 Treat Avenue  
San Francisco, CA 94110  
*Staff Contact* Shelley Caltagirone - (415) 558-6625  
shelley.caltagirone@sfgov.org  
*Reviewed By* Tim Frye – (415) 575-6822  
tim.frye@sfgov.org

## Historic Preservation Commission Draft Motion No. #####

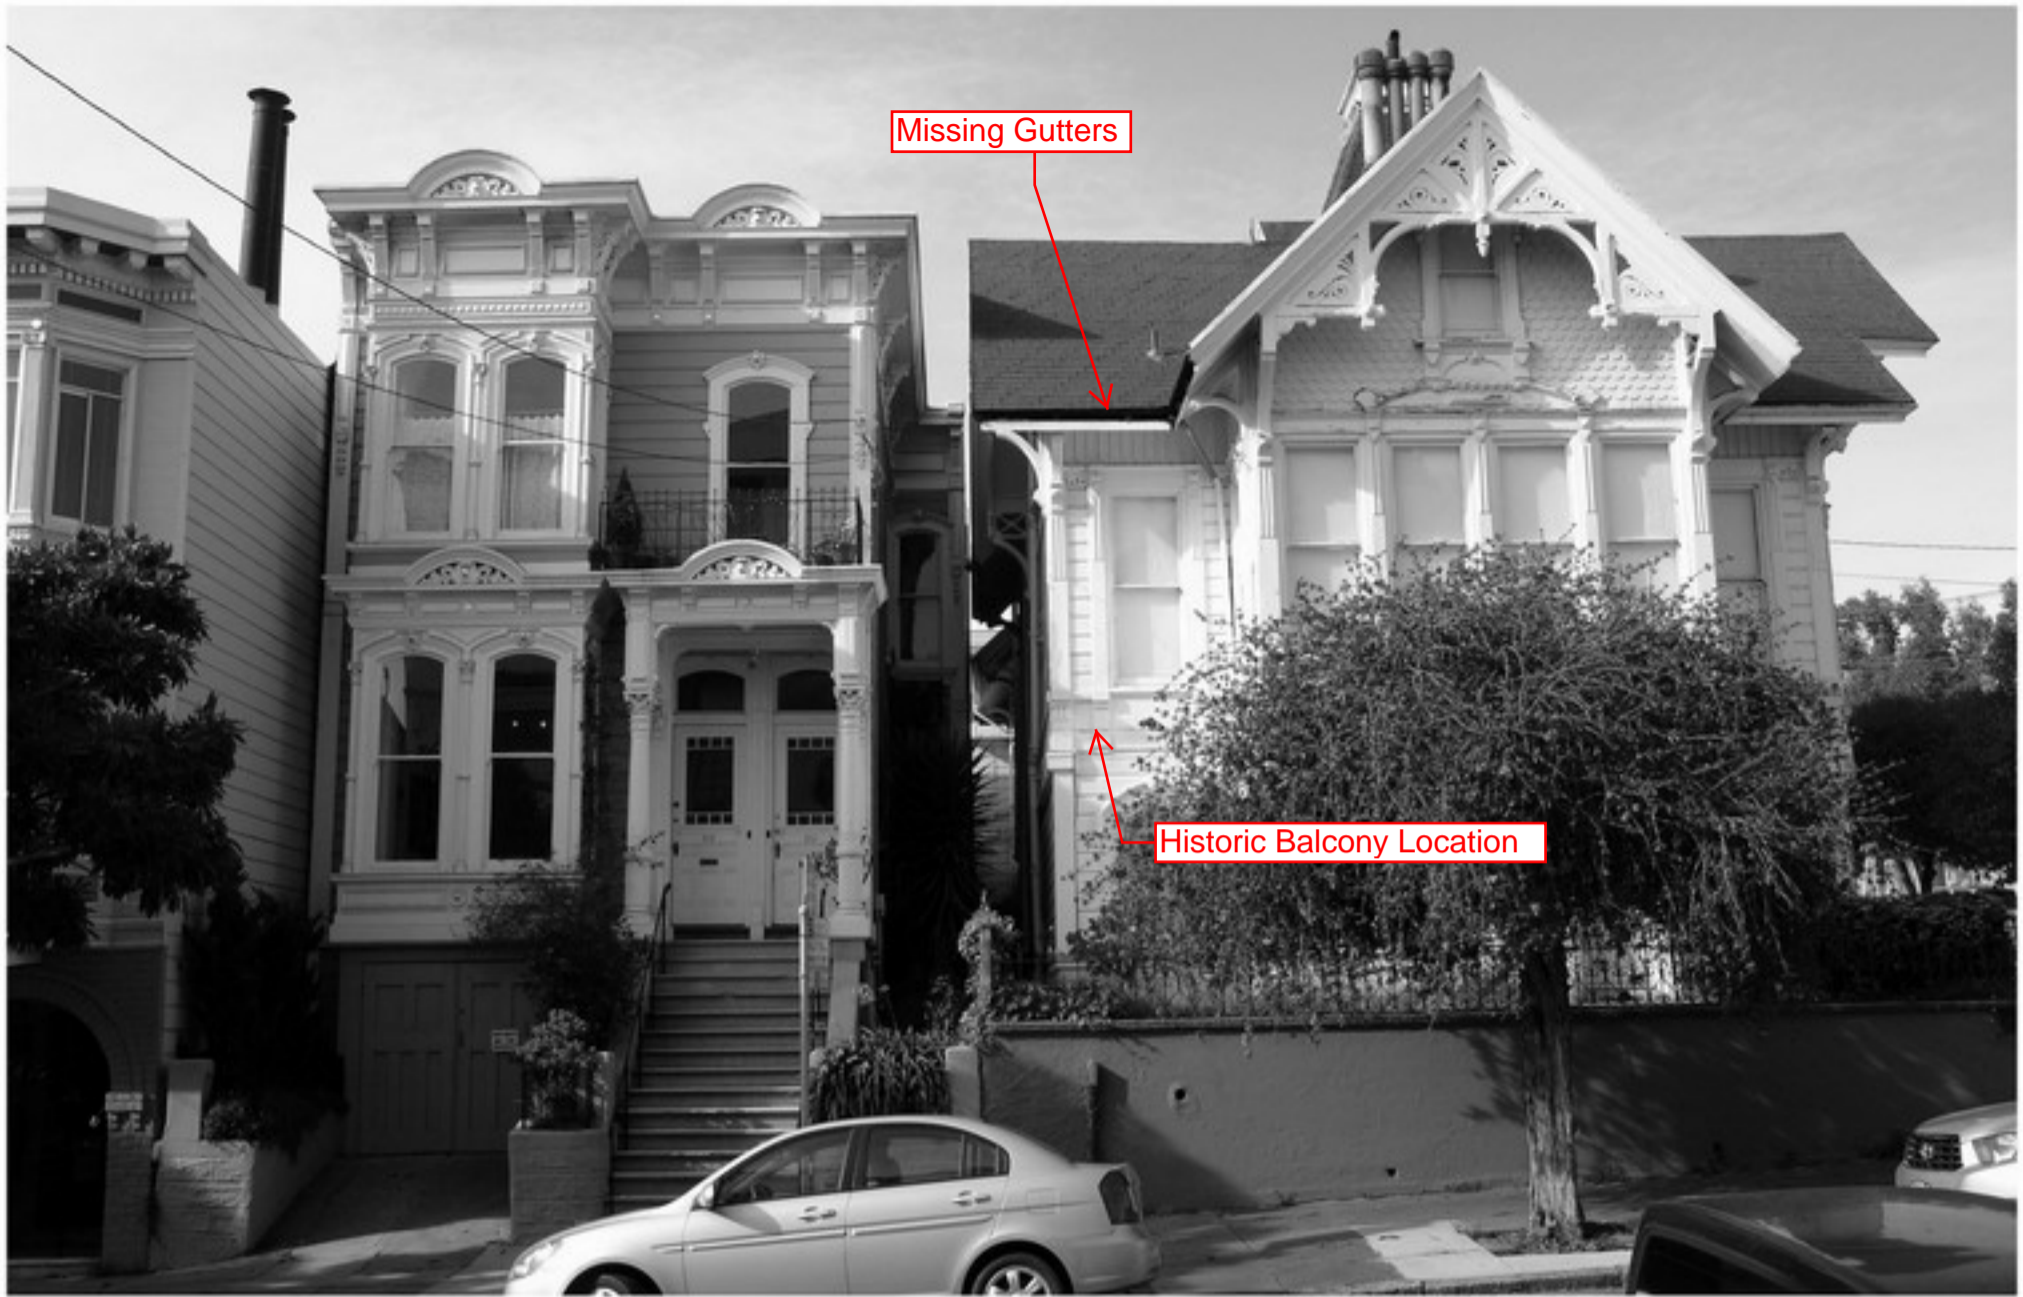
201 Buchanan: Waller Street facade and adjacent residence. Note the sheltered western facade.

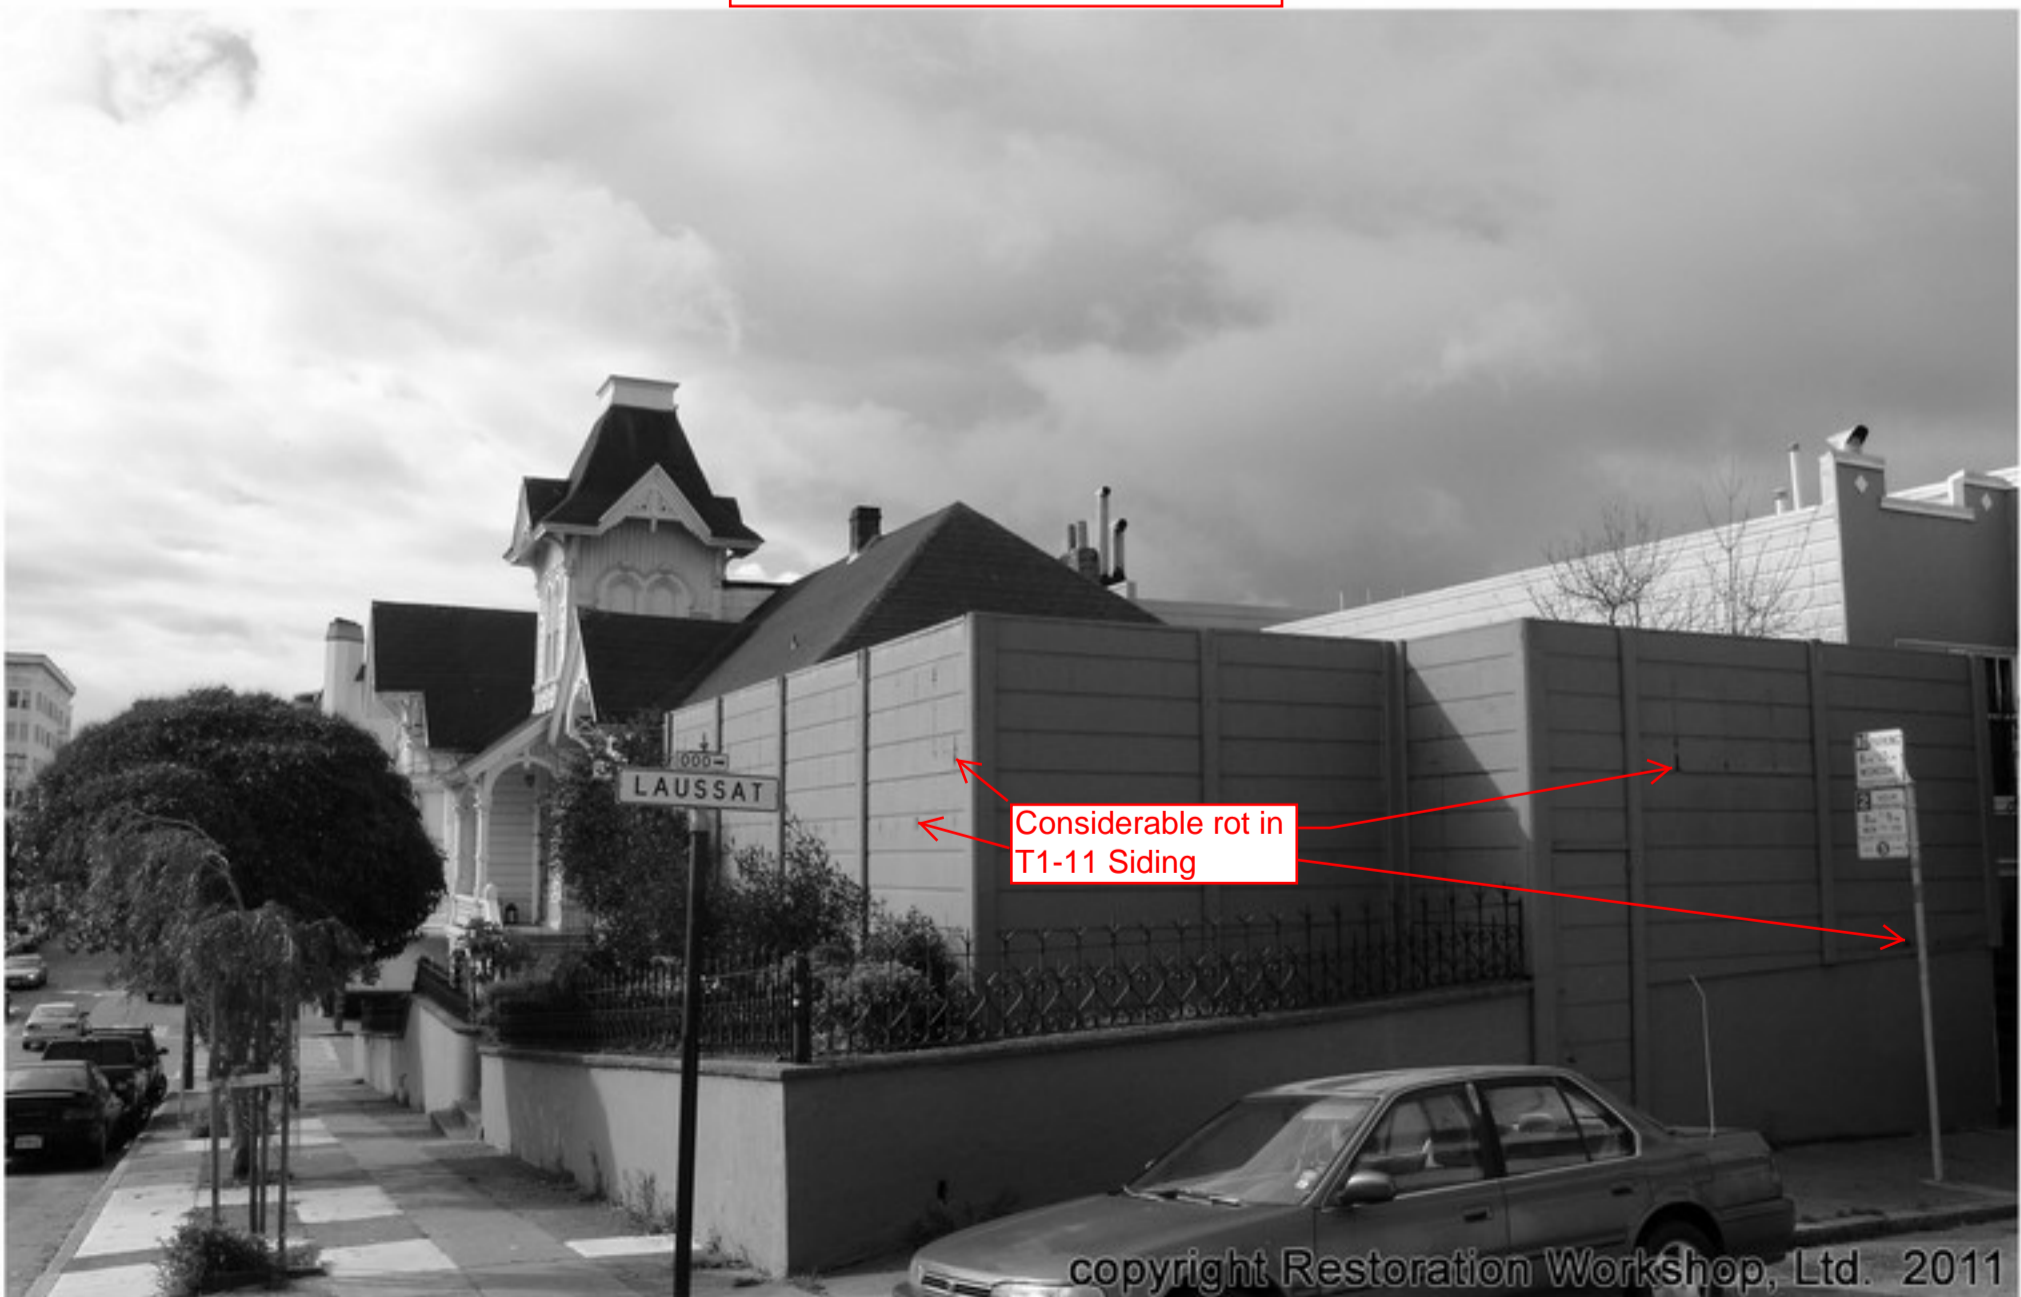
201 Buchanan Street: South elevation, non-historic addition and rear fence.

Remove and replace deteriorating T1-11 siding with lap siding on non-historic addition and rear fence.

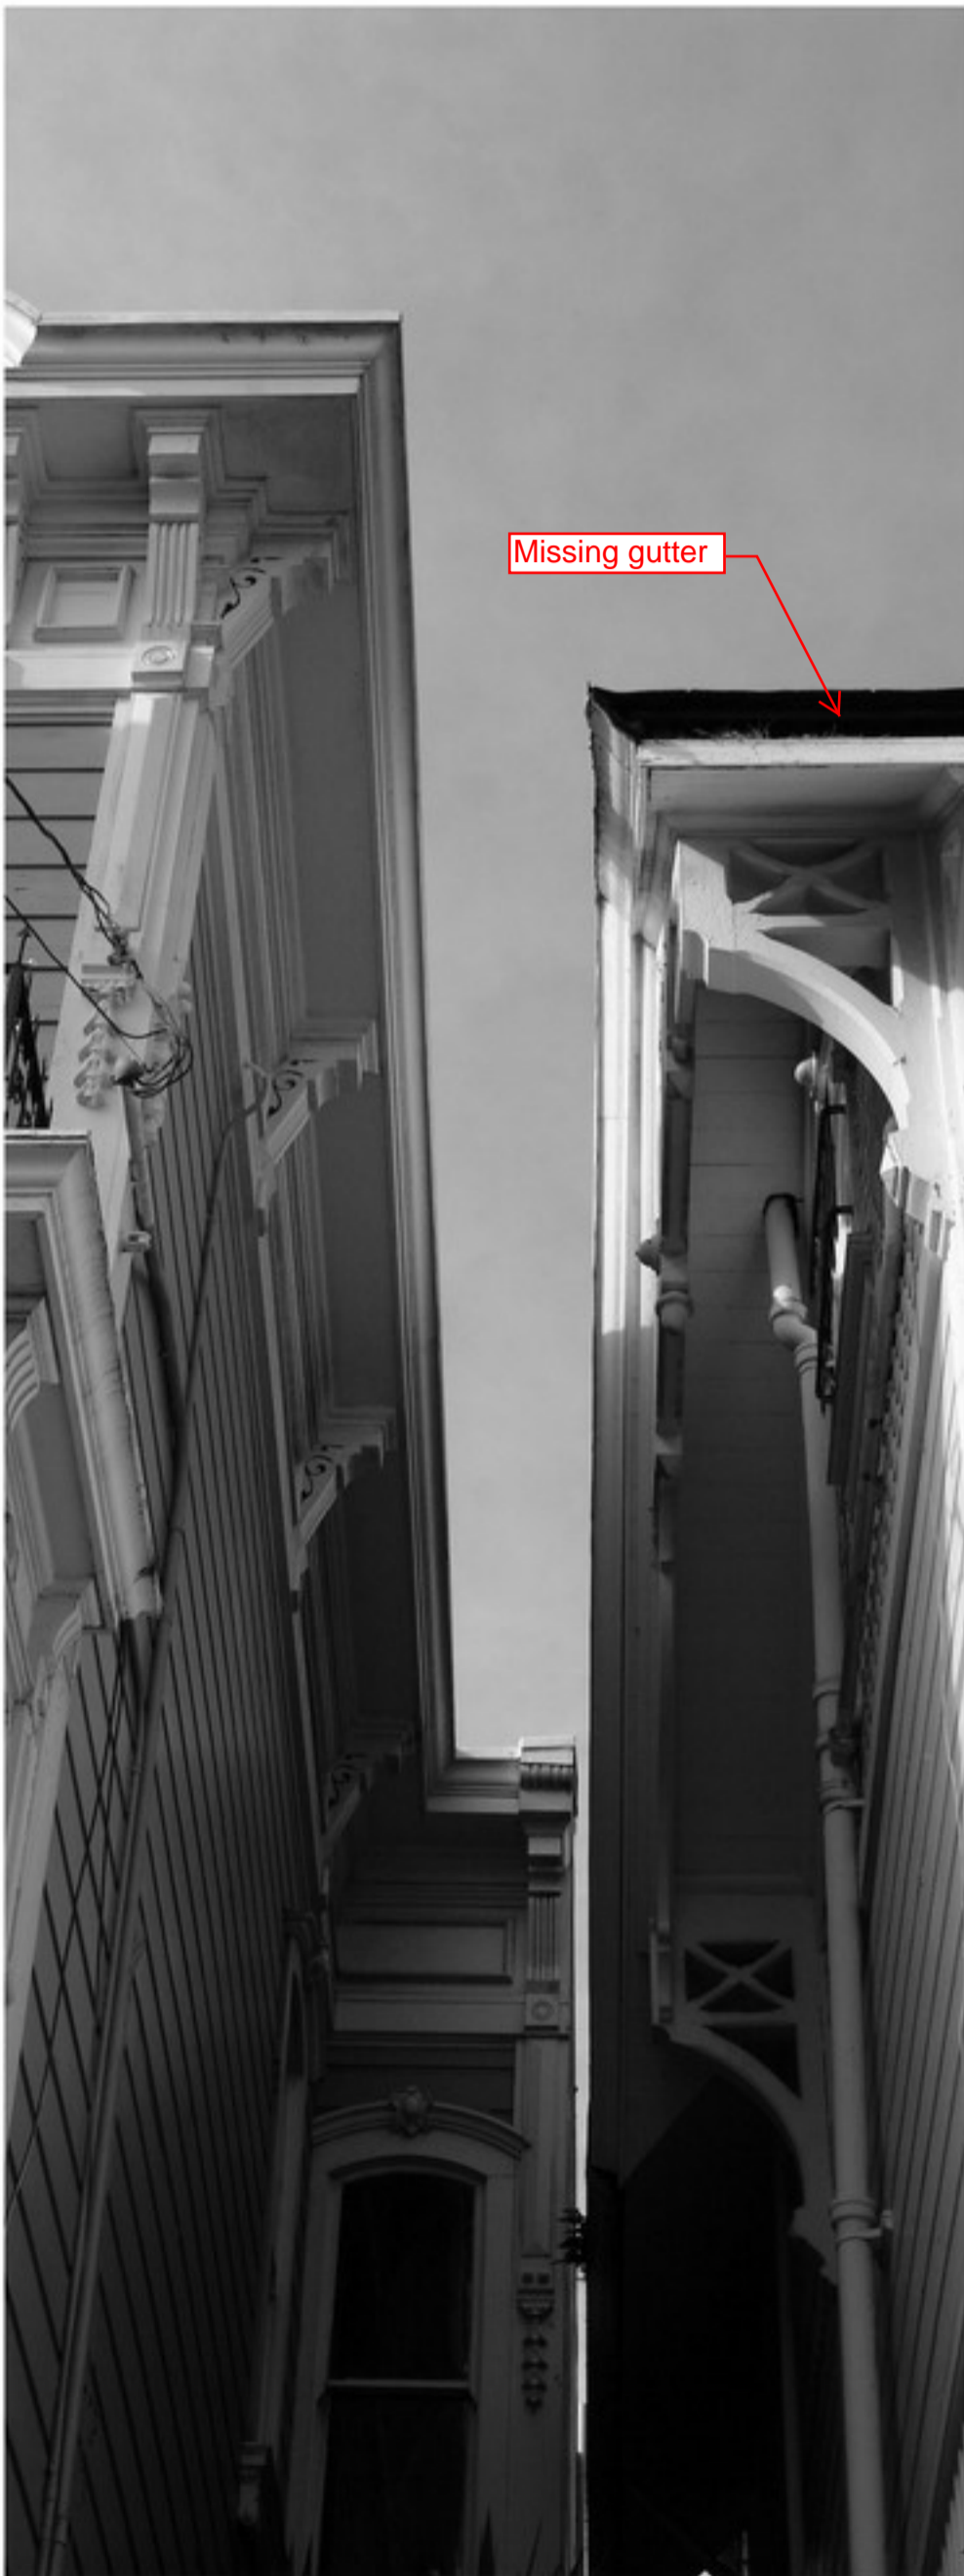
Missing gutter

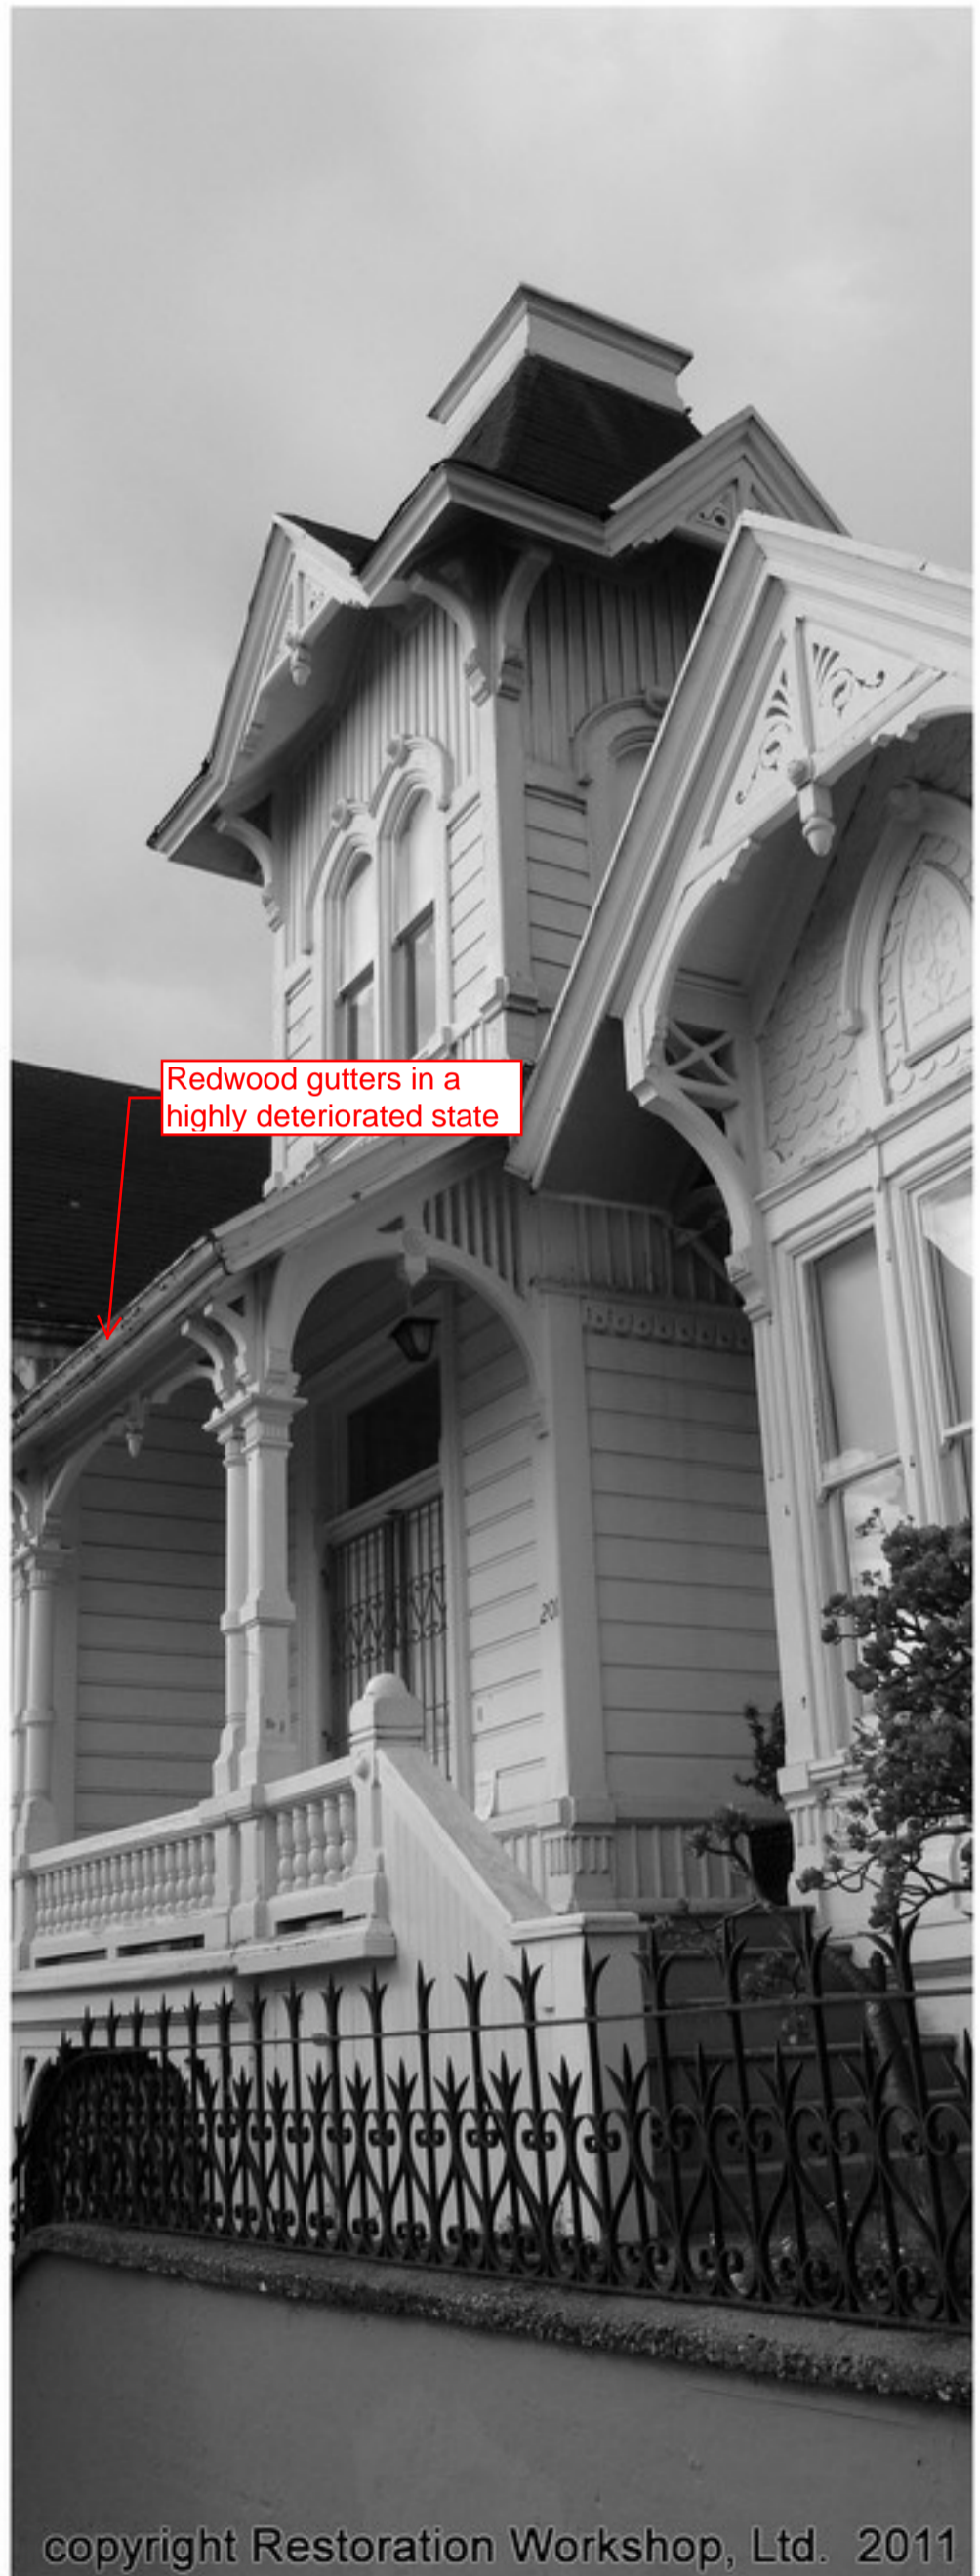
Redwood gutters in a highly deteriorated state

Gutters	All remaining redwood gutters are in an advanced state of decay and no longer functioning properly. In certain areas, they have been replaced with aluminum gutters which bear no aesthetic relationship to the original gutters. The gutters function as a principal molding of the cornice and cope into the crown molding at the rakes. Thus, they are important to the appearance of the exterior. All gutters will be replaced with new redwood gutters made to match the existing profile. These redwood gutters will then be lined with 20 oz copper and new copper downspouts will be attached at existing downspout locations. (see attached schematics)	\$22917.00
Soffits	Do to failing roofing and leaking gutters there are areas of damage to wooden soffit planks. These will be repaired or replaced in-kind as is most appropriate. Repairs will be done with high quality, marine epoxies and rot-resistant CPES. Replacements will be done in old growth material which meets or exceeds the quality of the original wood used.	\$5400.00

Redwood gutters to be replaced in kind and lined with 20 oz copper

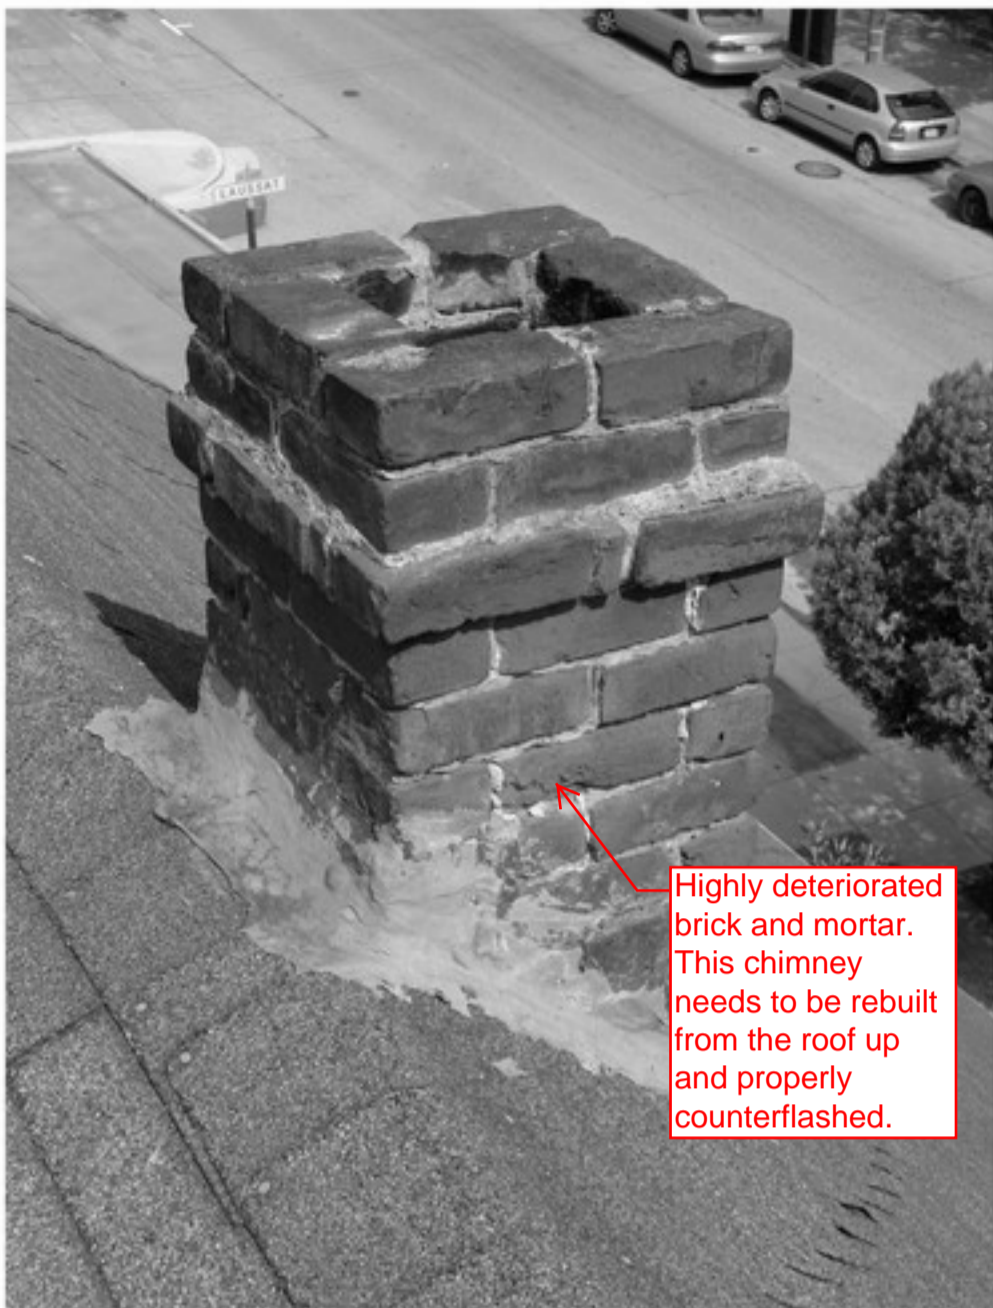
Dining room Chimney

Highly deteriorated brick and mortar. This chimney needs to be rebuilt from the roof up and properly counterflashed.

Dining Room chimney to be dismantled to the roofline and rebuilt.

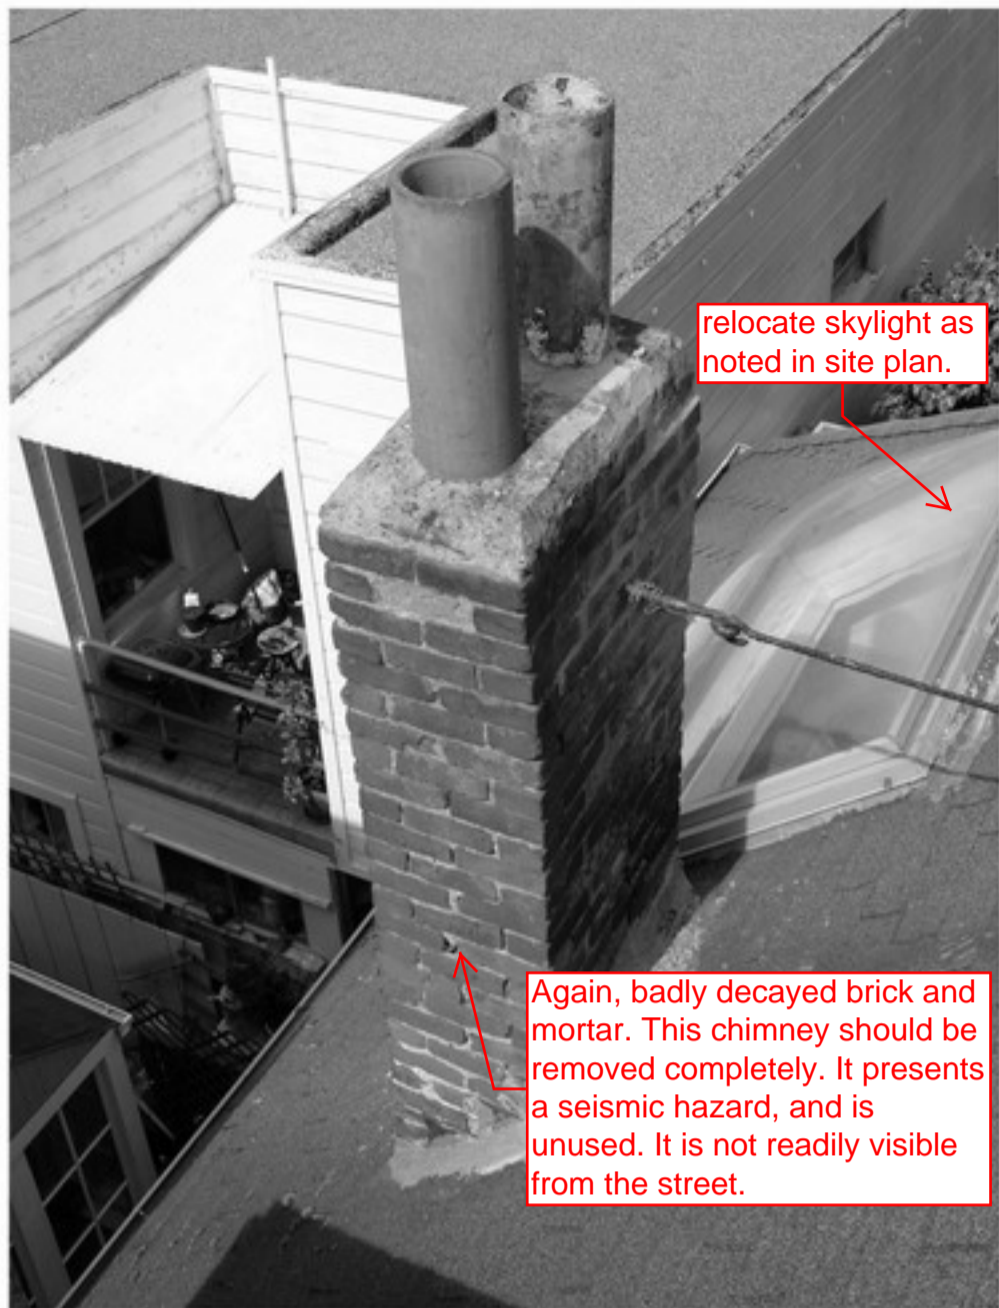
Kitchen Chimney

Again, badly decayed brick and mortar. This chimney should be removed completely. It presents a seismic hazard, and is unused. It is not readily visible from the street.

relocate skylight as noted in site plan.

Proposed change: Remove superfluous existing brick chimney all the way to the base. It is a flue only with no fireplace attached. It is in unsound condition and thus presents a danger in the event of an earthquake.

Reposition existing skylight approximately 4 feet to the south, and farther from the property line. (up roof slope).

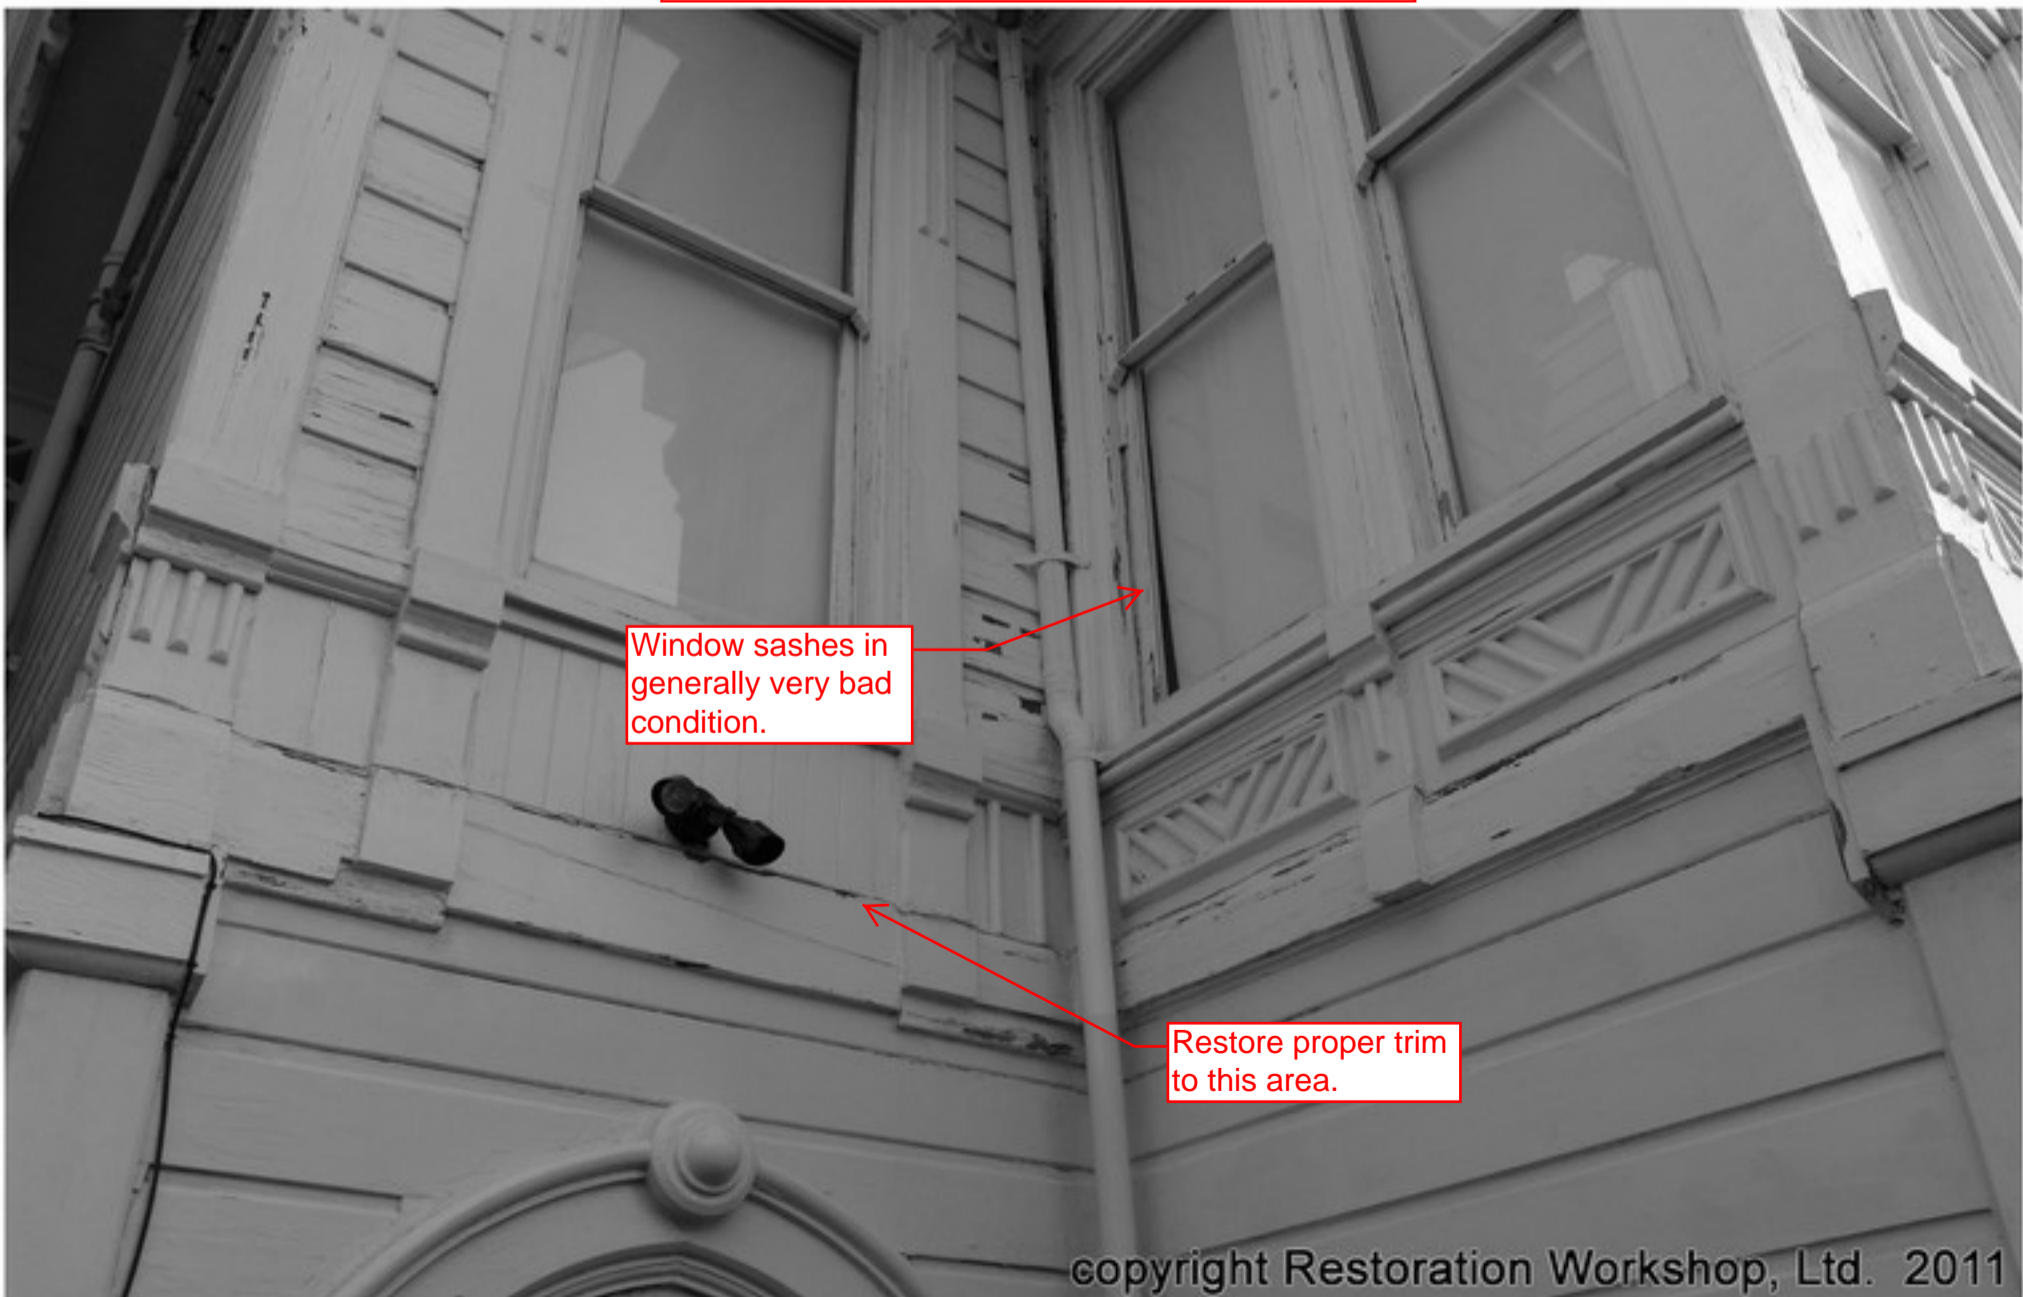
Former balcony location at west side of sun room.

Window sashes in generally very bad condition.

Restore proper trim to this area.
