SAN FRANCISCO PLANNING DEPARTMENT

Certificate of Appropriateness Case Report

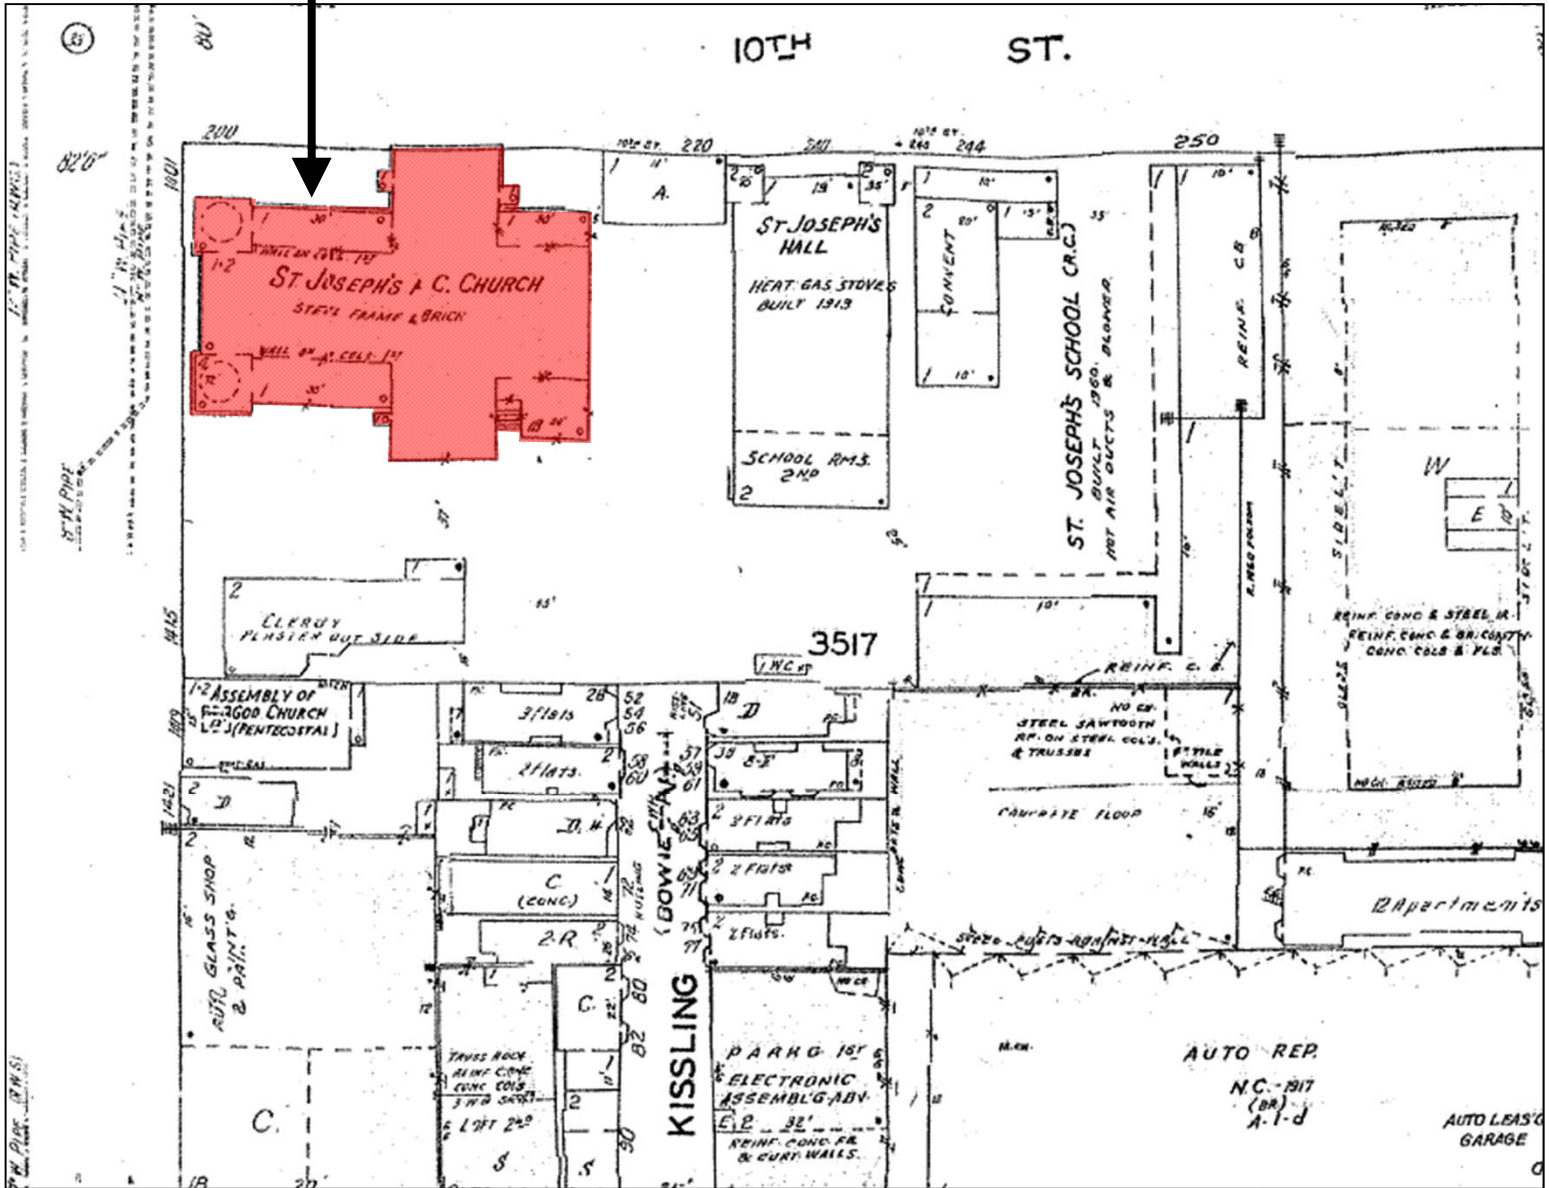
*The Sanborn Maps in San Francisco have not been updated since 1998, and this map may not accurately reflect existing conditions.

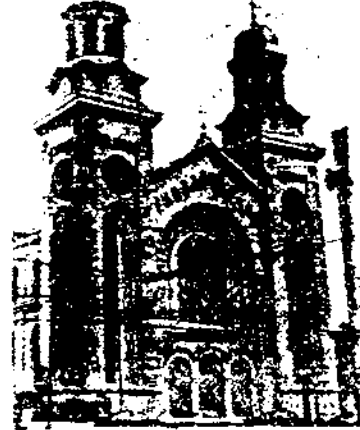
See attached page for map.

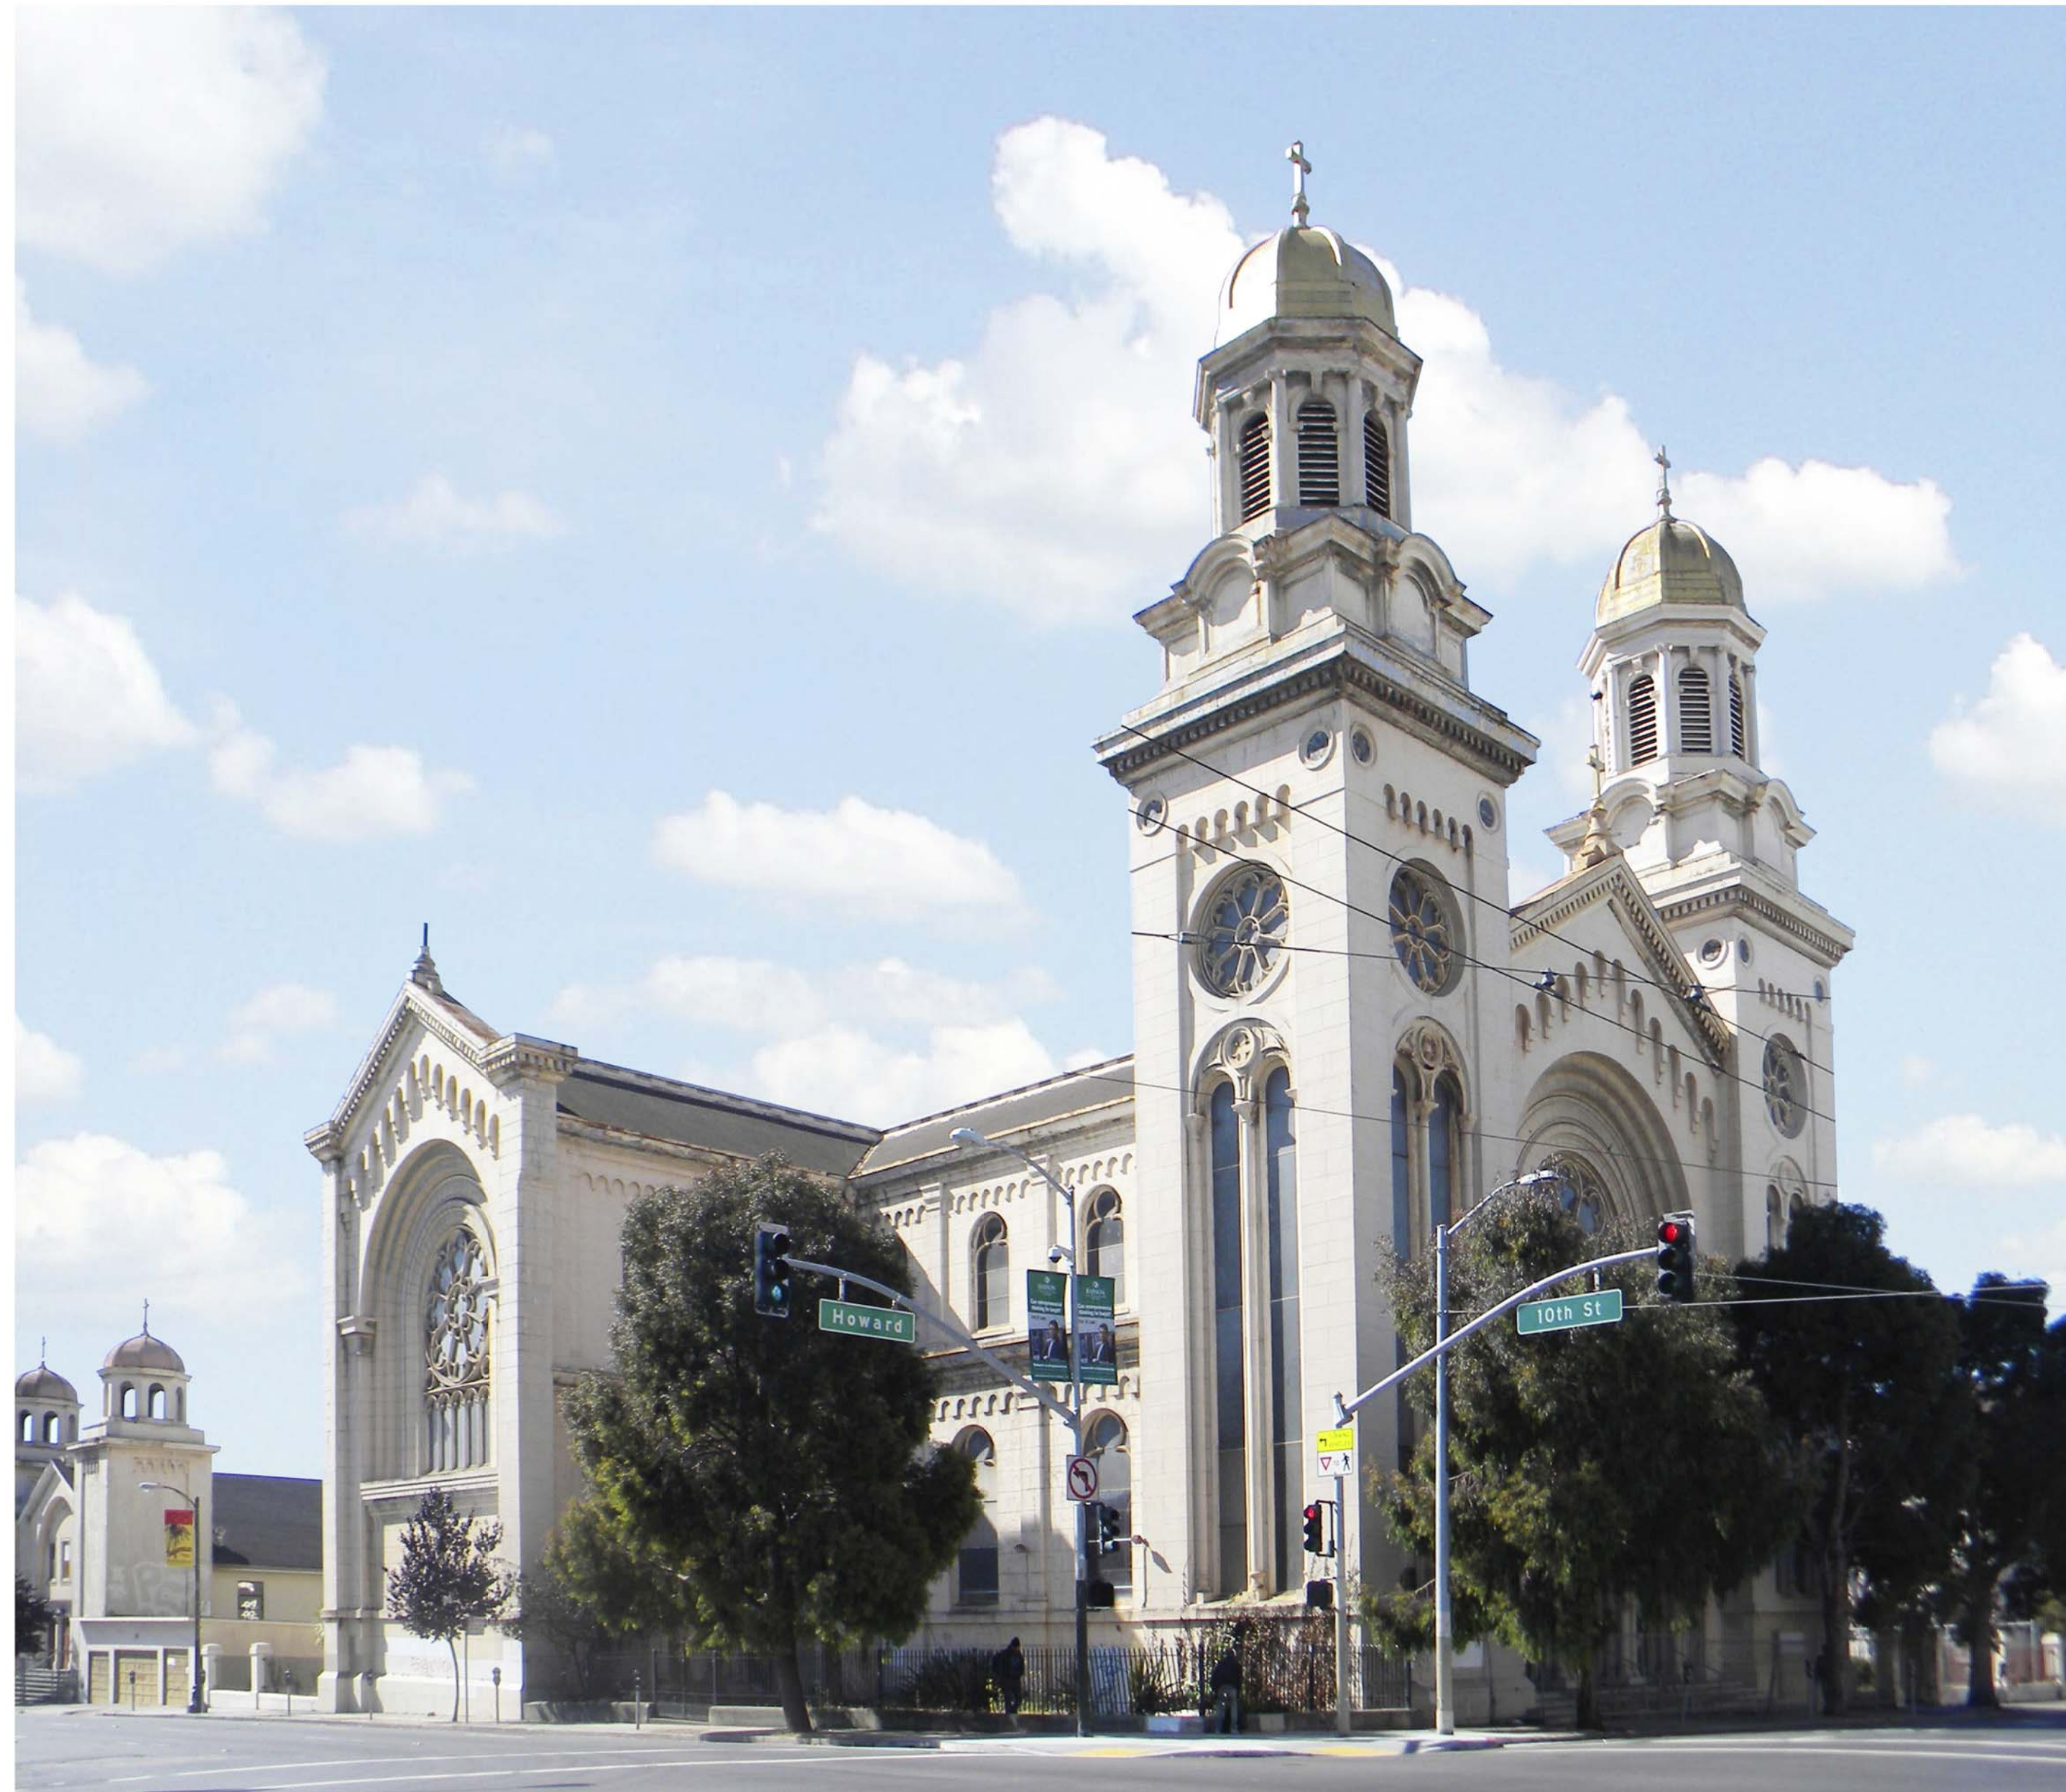
CONDITIONAL USE AND CERTIFICATE of APPROPRIATENESS APPLICATION

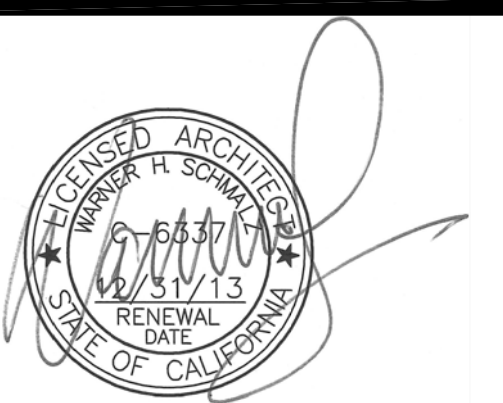
CONDITIONAL USE &
CERT. OF APPROPRIATENESS
SUBMITTAL

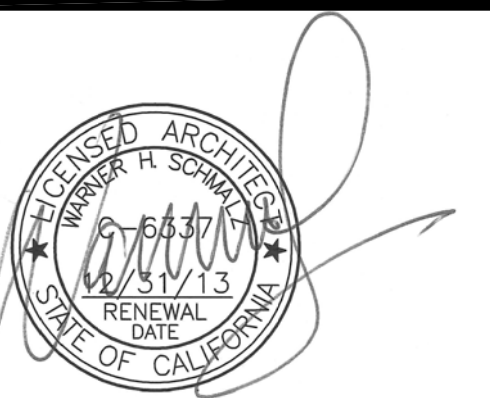
CONDITIONAL USE &
CERT. OF APPROPRIATENESS
SUBMITTAL

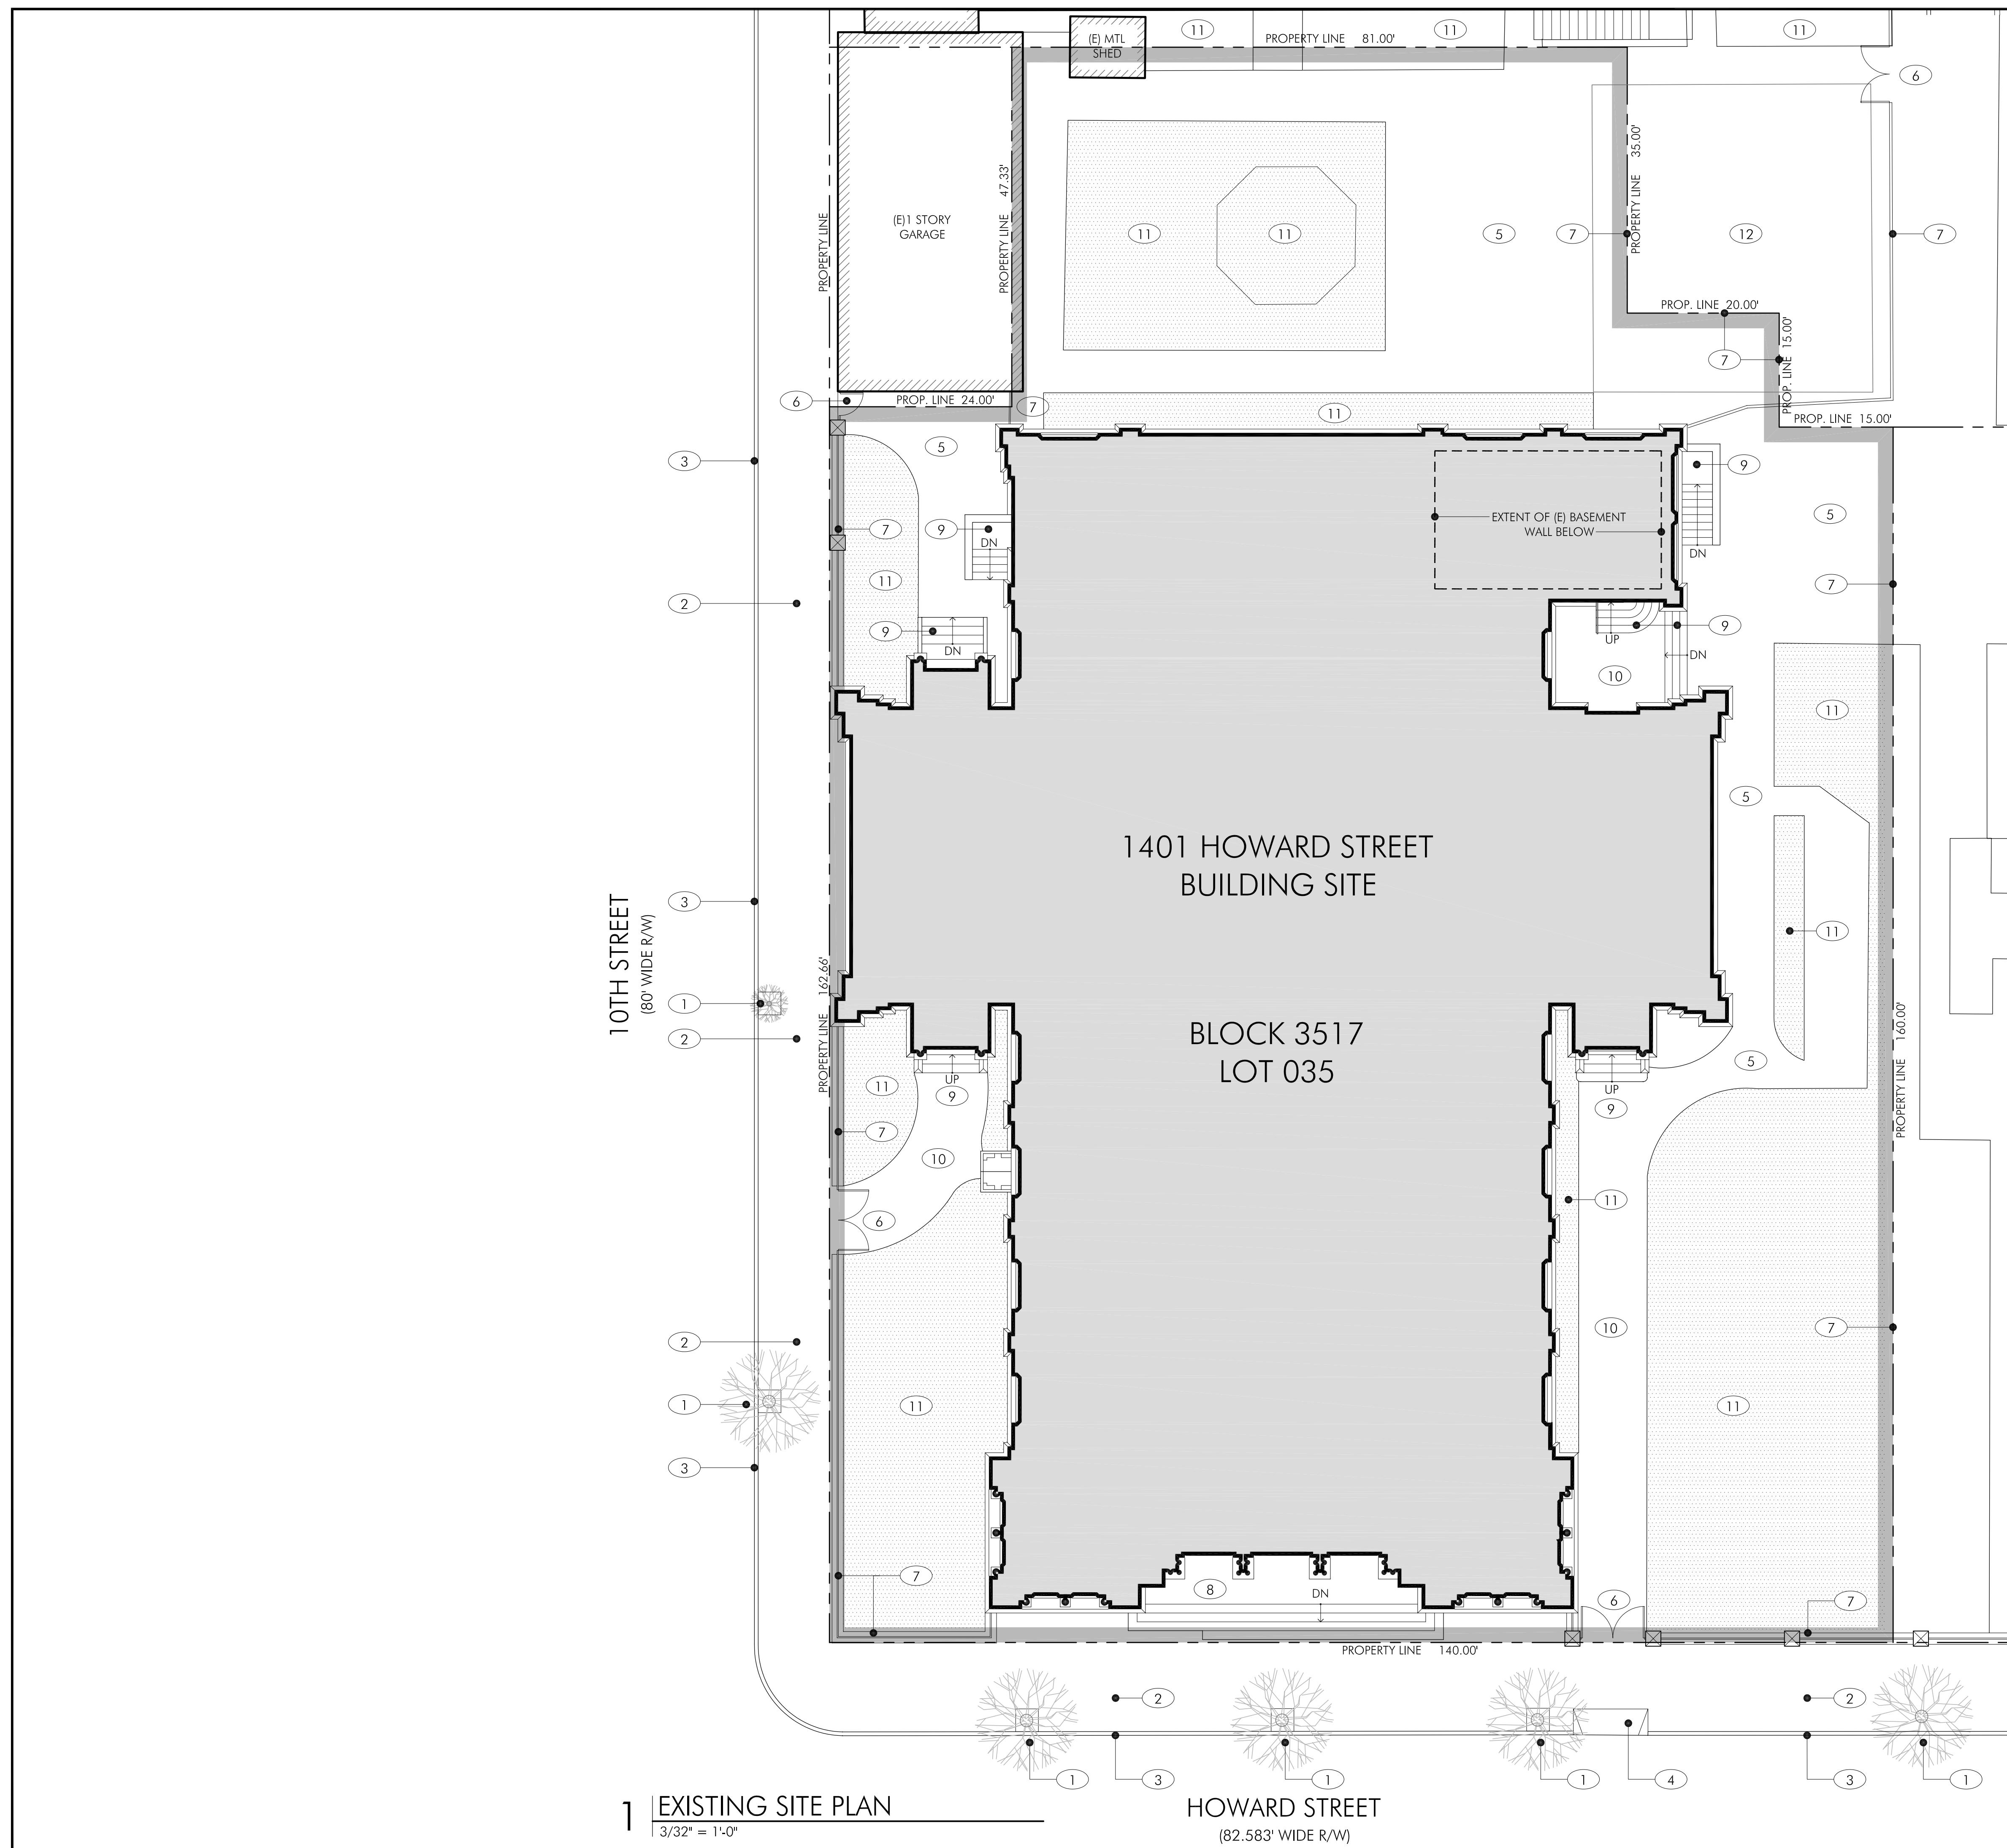
- KEY NOTES:**
- ① (E) STREET TREE
 - ② (E) SIDEWALK; REPAIR AND REPLACE AS REQUIRED PER CITY APPROVED STANDARDS
 - ③ (E) CURB & GUTTER
 - ④ (E) DRIVEWAY CURB CUT
 - ⑤ (E) CONC. WALKWAY
 - ⑥ (E) MTL. GATE; REPAIR AND PAINT AS REQUIRED
 - ⑦ (E) MTL. FENCE; REPAIR AND REPLACE TO MATCH (E)
 - ⑧ (E) MAIN ENTRANCE EXTERIOR STAIRS
 - ⑨ (E) EXTERIOR STAIRS
 - ⑩ (E) EXTERIOR LANDING
 - ⑪ (E) PLANTER / LANDSCAPING; SEE LANDSCAPE PLANS
 - ⑫ (E) PLAY AREA (PLAY STRUCTURE NOT SHOWN)
 - ⑬ (N) 24" BOX (MIN.) STREET TREES, SPECIES SELECTED PER LANDSCAPE ARCHITECT'S RECOMMENDATIONS OR CITY APPROVED STANDARDS
 - ⑭ (N) MTL. GATE TO MATCH EXISTING
 - ⑮ (N) MTL. FENCE TO MATCH (E) HISTORIC FENCE
 - ⑯ (N) ADA RAMP
 - ⑰ (N) STAIRS W/ MTL. GRABRAILS
 - ⑱ (N) EXTERIOR LANDING W/ MTL. GUARDRAIL
 - ⑲ (N) PLANTER / LANDSCAPING; SEE LANDSCAPE PLANS

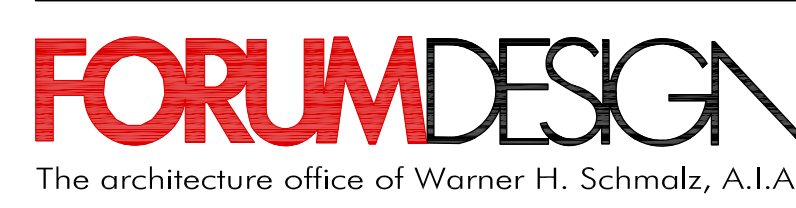
1014 Howard Street San Francisco, CA 94103
 F 415 . 252.9020 T 415 . 252.7063

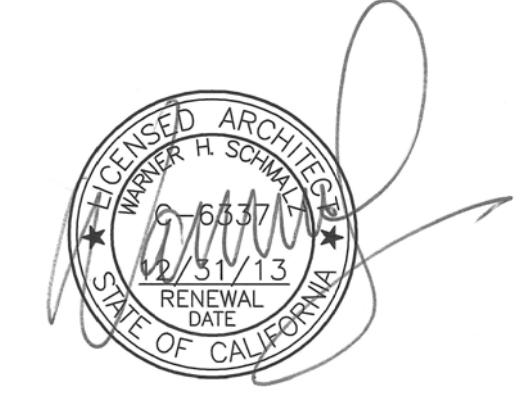
**CONDITIONAL USE &
 CERT. OF APPROPRIATENESS
 SUBMITTAL**

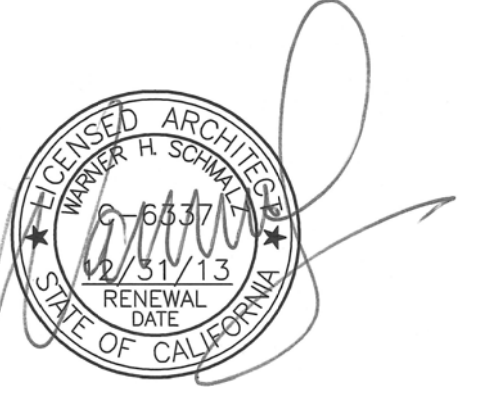
CONDITIONAL USE & CERT. OF APPROPRIATENESS SUBMITTAL

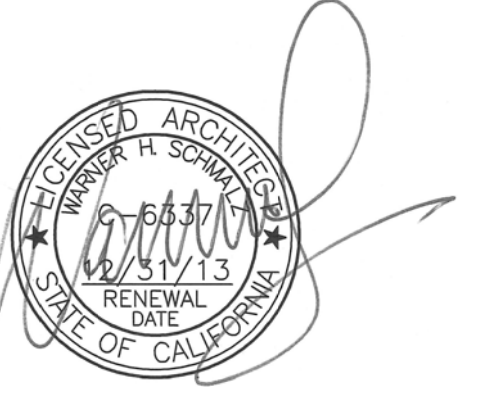
CONDITIONAL USE & CERT. OF APPROPRIATENESS SUBMITTAL

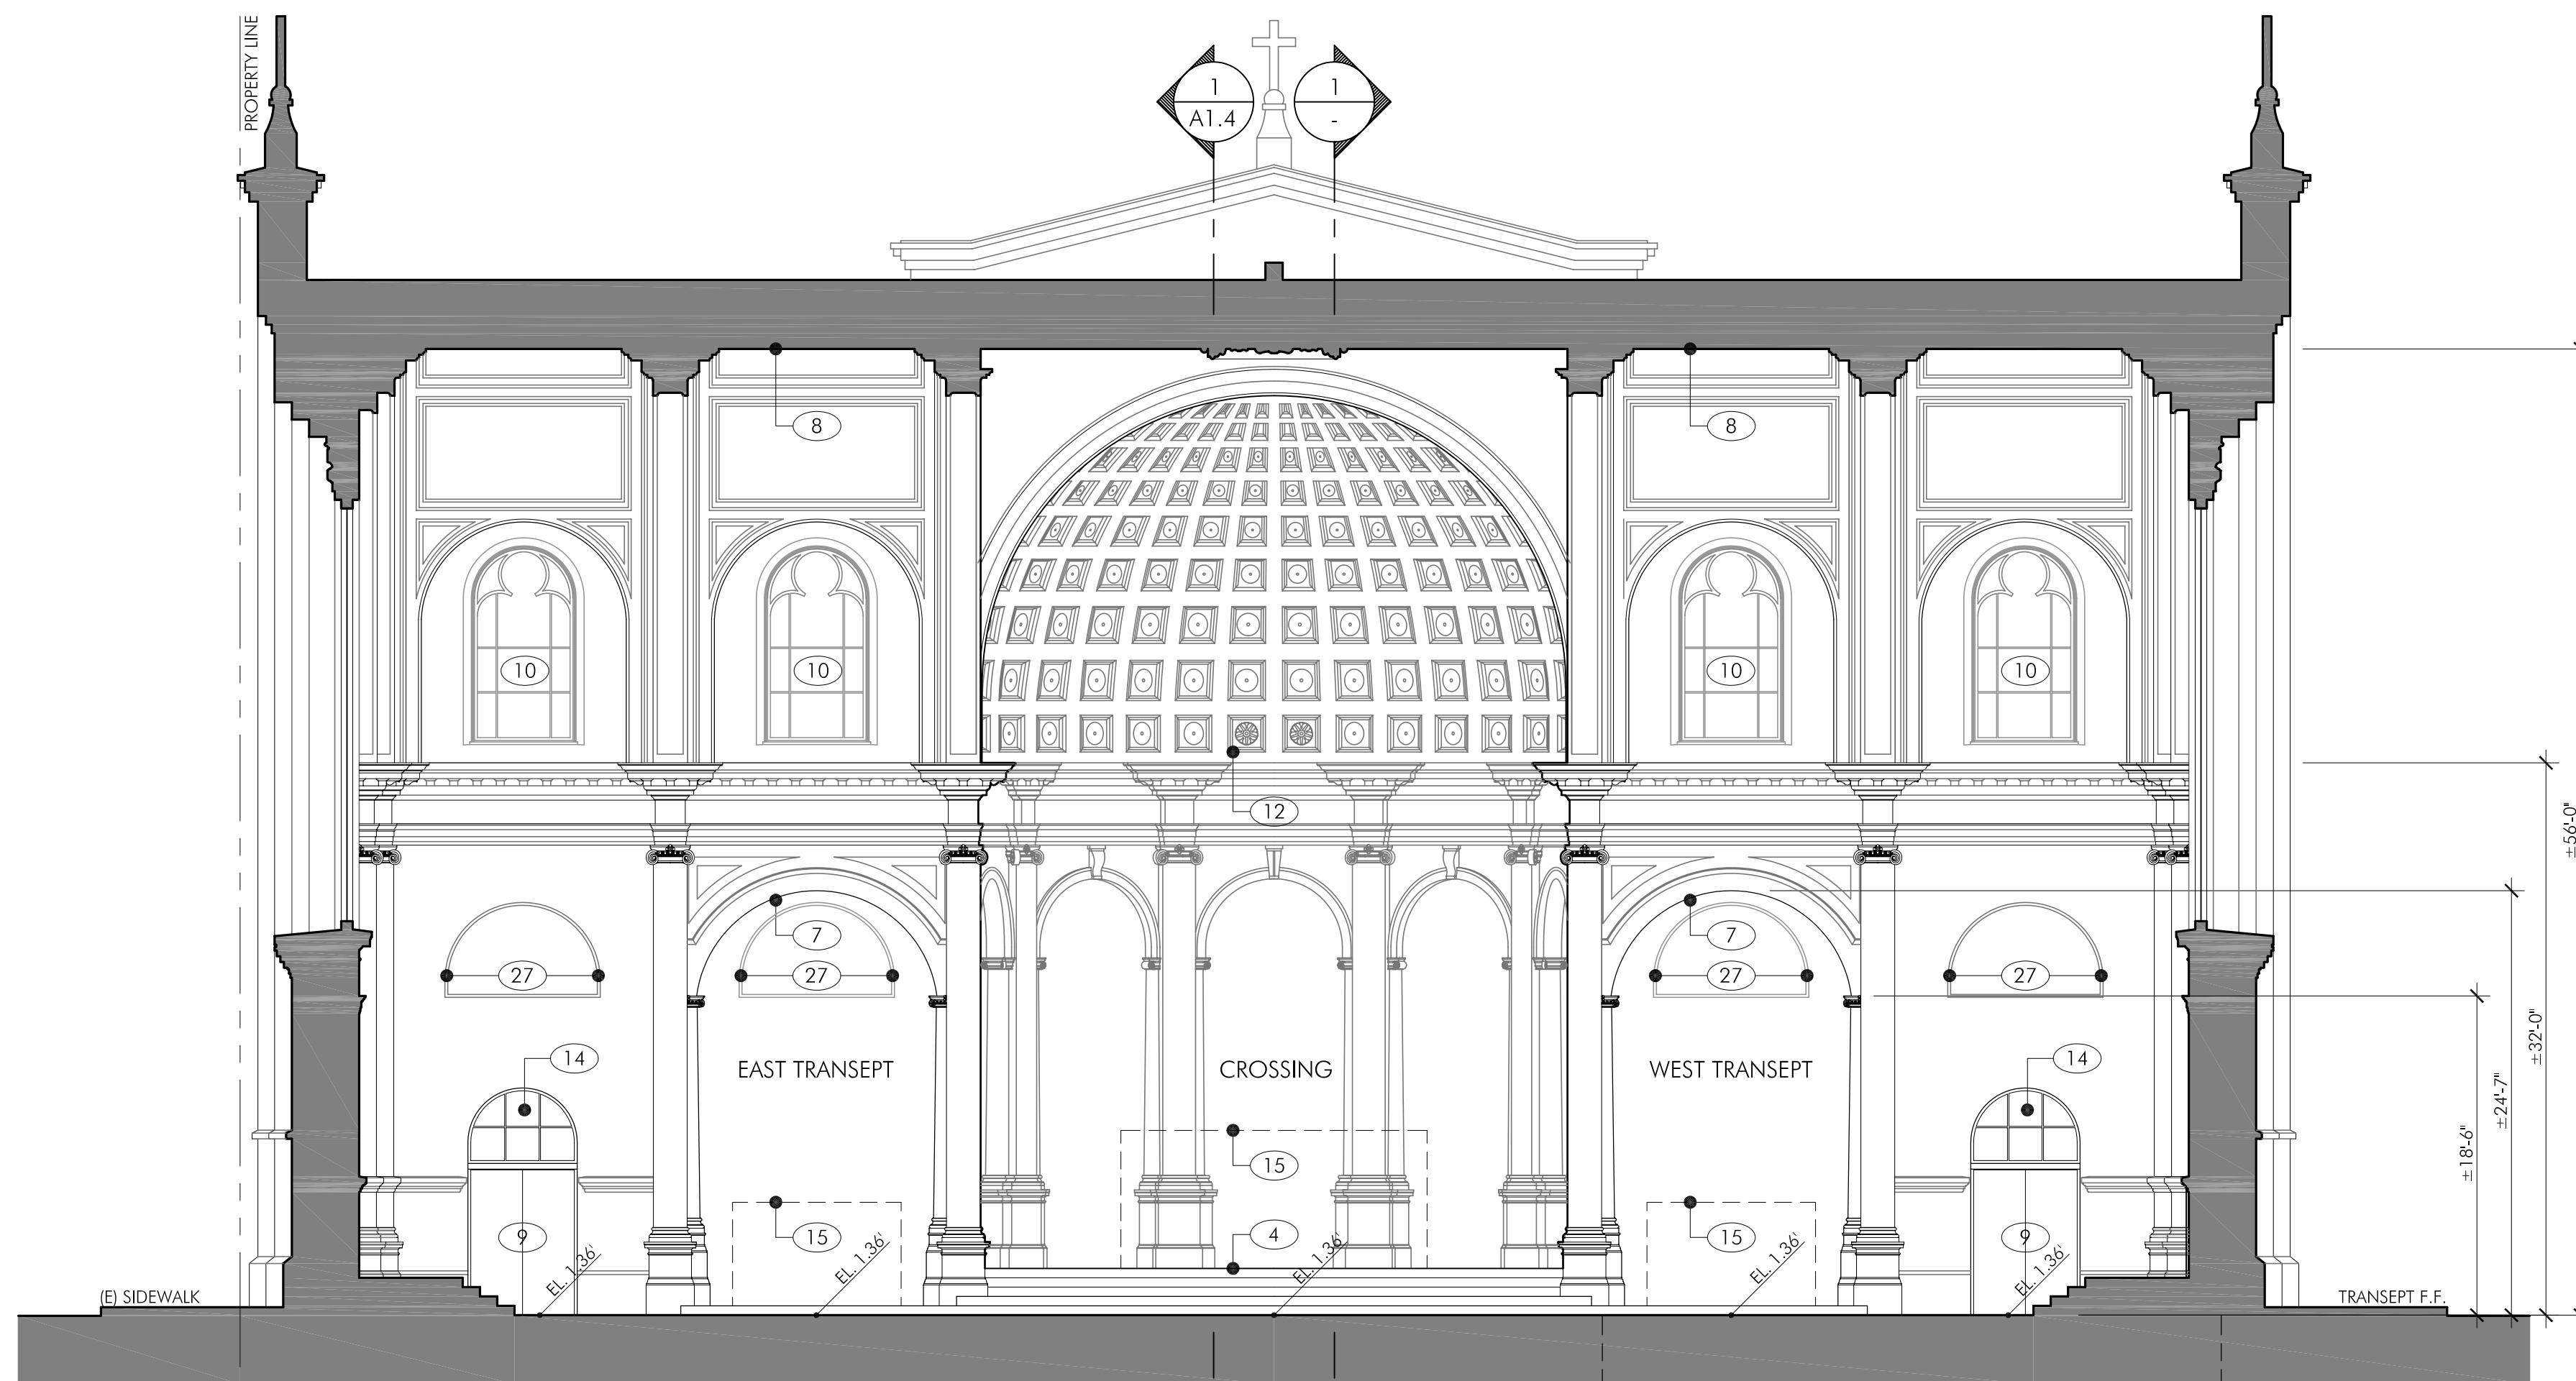
2 EXISTING INTERIOR ELEVATION / BUILDING SECTION
1/8" = 1'-0"

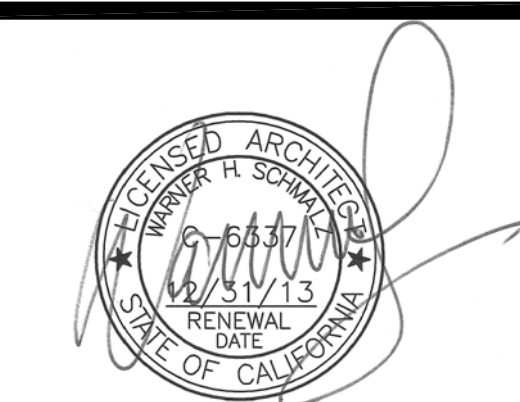
CONDITIONAL USE &
CERT. OF APPROPRIATENESS
SUBMITTAL

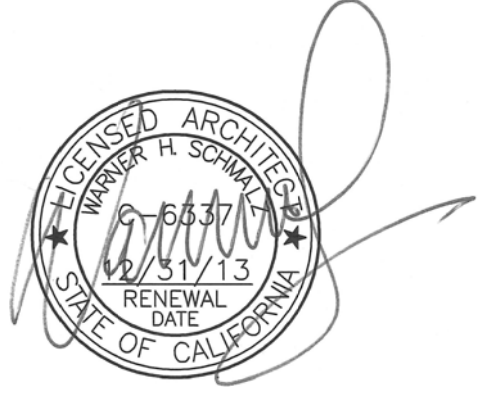
CONDITIONAL USE & CERT. OF APPROPRIATENESS SUBMITTAL

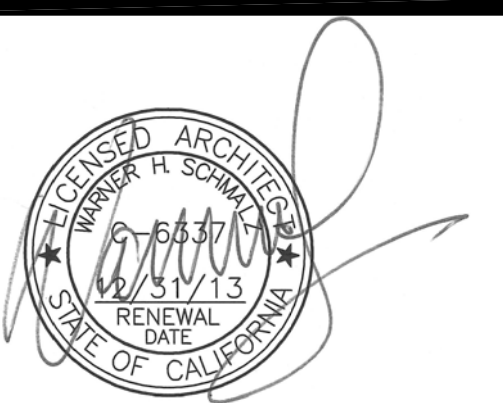
CONDITIONAL USE &
CERT. OF APPROPRIATENESS
SUBMITTAL

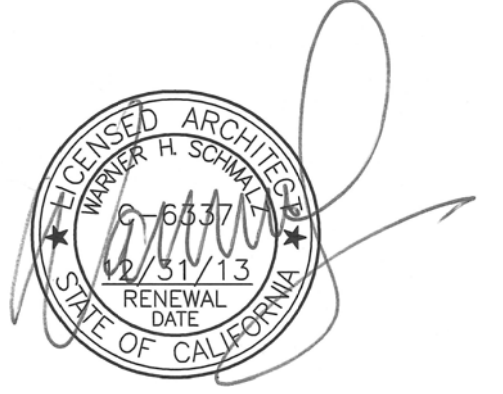
CONDITIONAL USE & CERT. OF APPROPRIATENESS SUBMITTAL

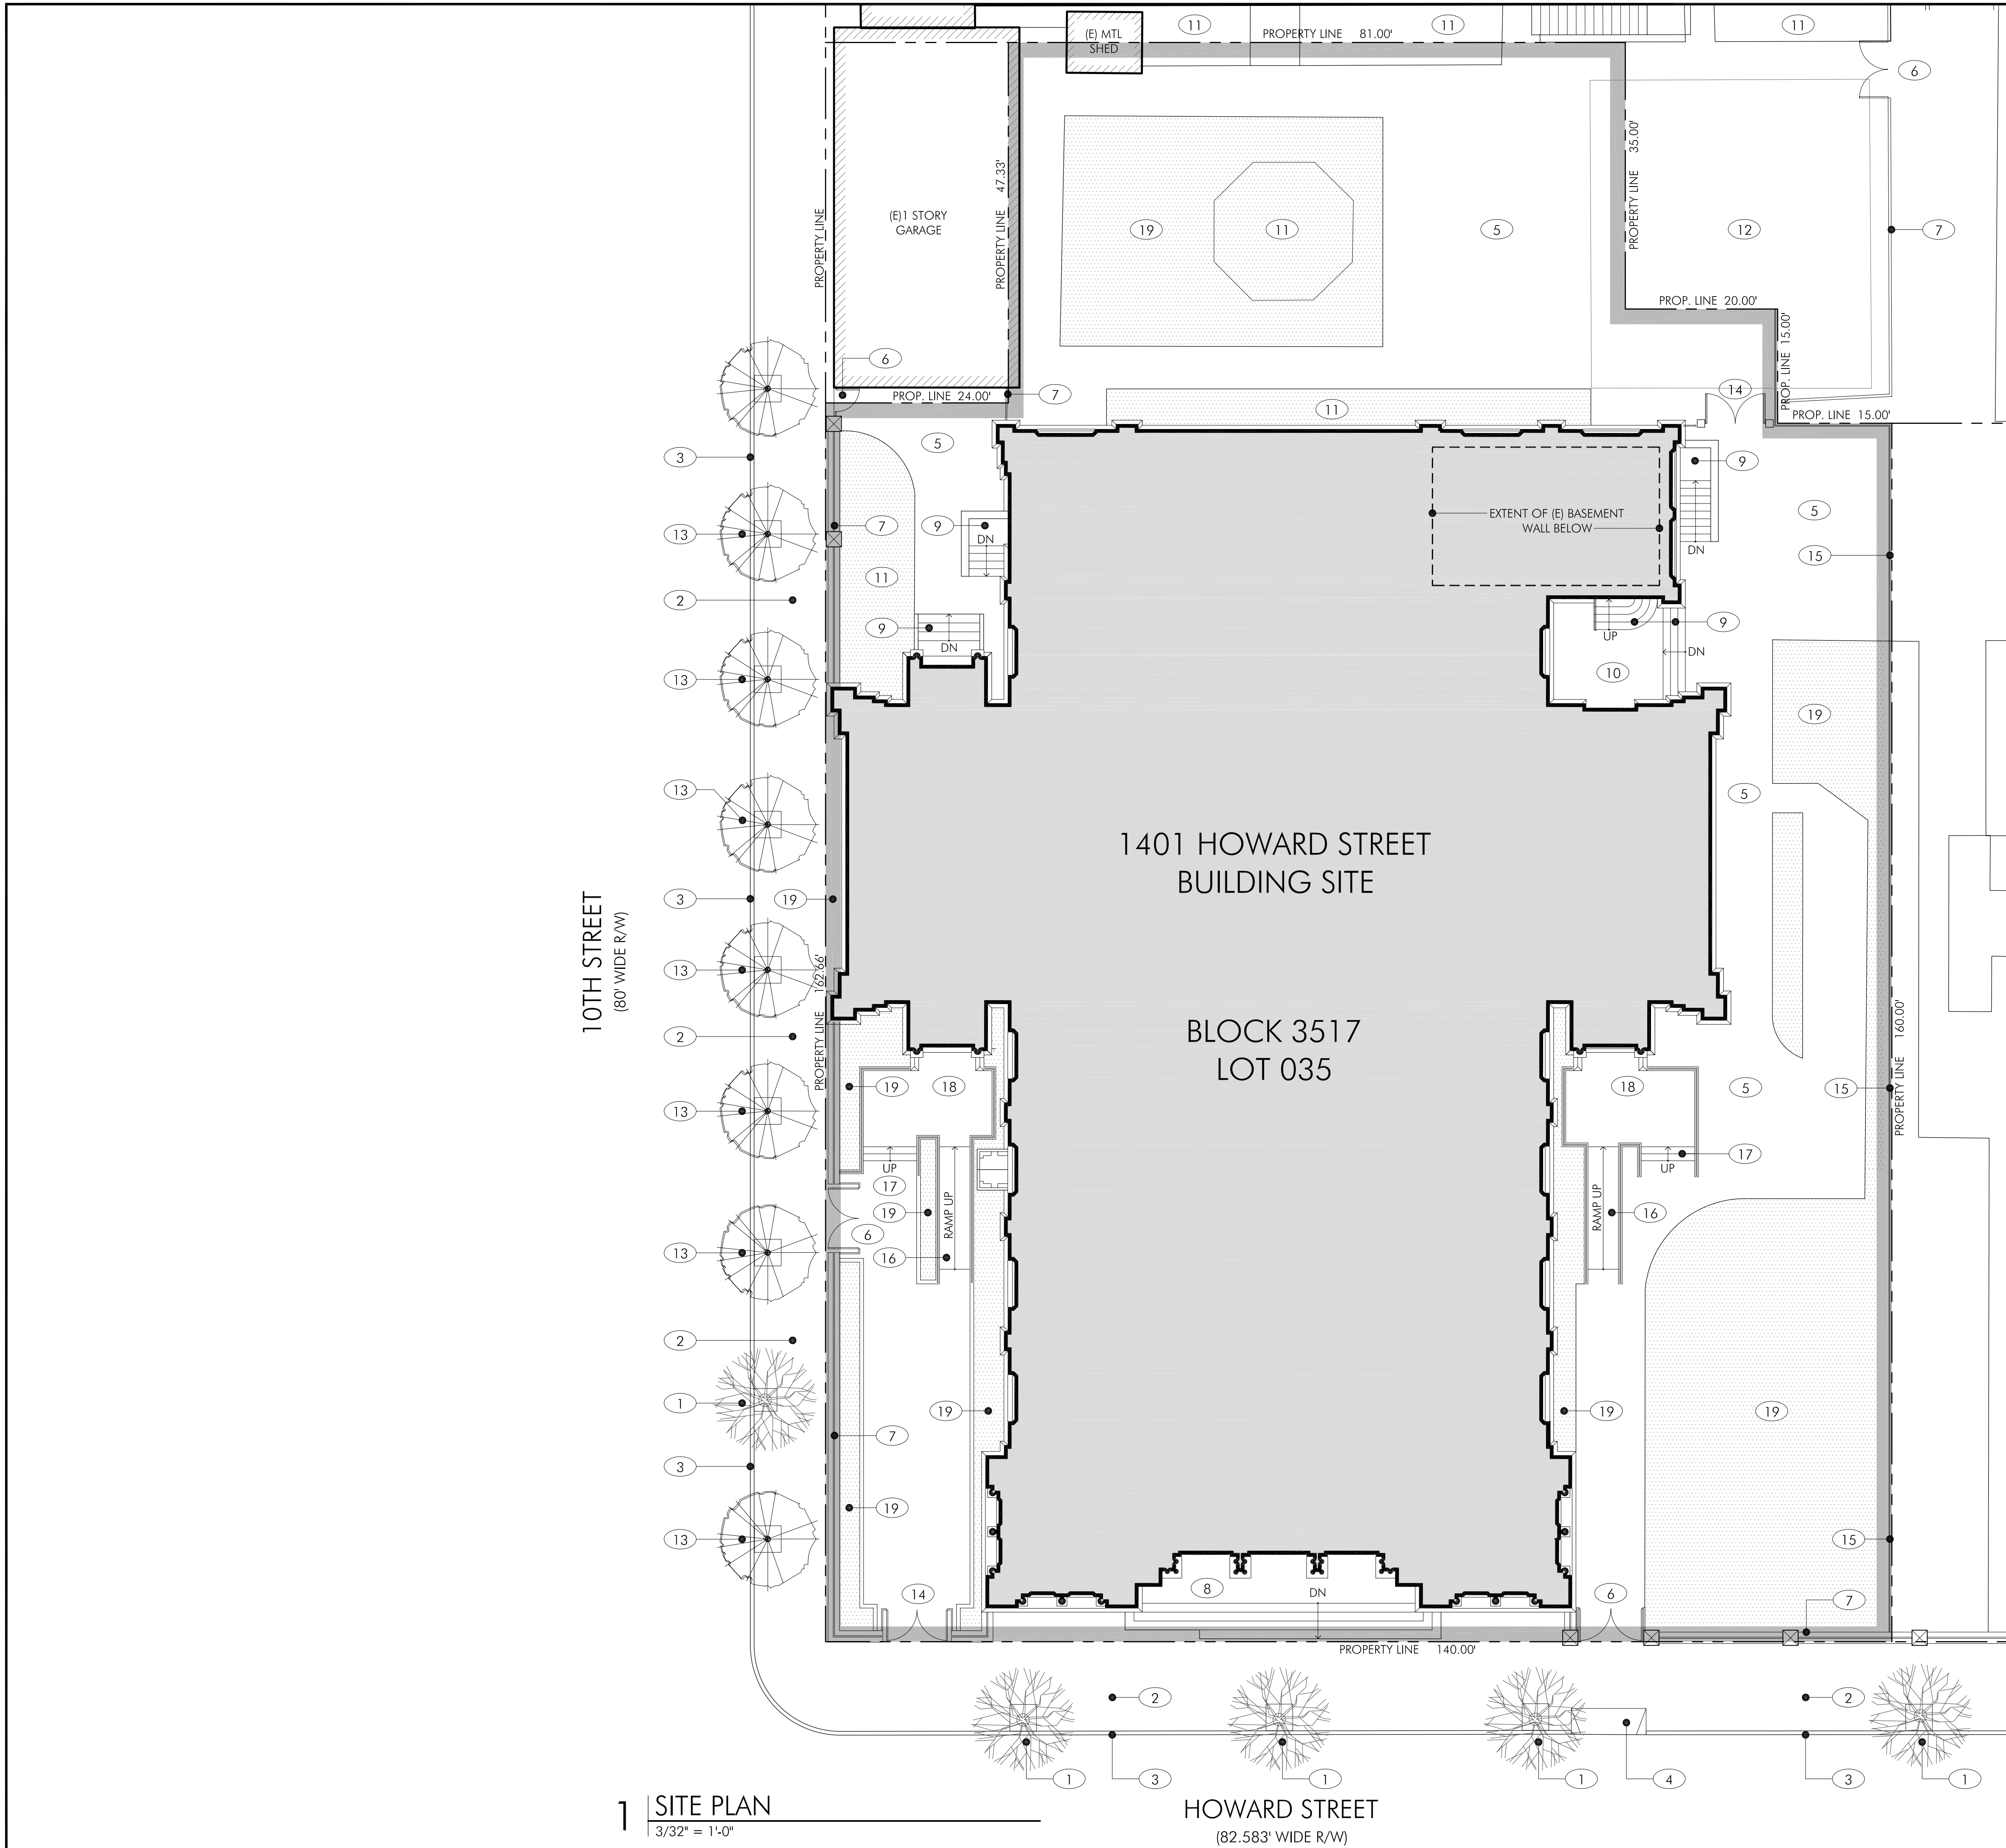
- KEY NOTES:**
- ① (E) STREET TREE
 - ② (E) SIDEWALK; REPAIR AND REPLACE AS REQUIRED PER CITY APPROVED STANDARDS
 - ③ (E) CURB & GUTTER
 - ④ (E) DRIVEWAY CURB CUT
 - ⑤ (E) CONC. WALKWAY
 - ⑥ (E) MTL. GATE; REPAIR AND PAINT AS REQUIRED
 - ⑦ (E) MTL. FENCE; REPAIR AND REPLACE TO MATCH (E)
 - ⑧ (E) MAIN ENTRANCE EXTERIOR STAIRS
 - ⑨ (E) EXTERIOR STAIRS
 - ⑩ (E) EXTERIOR LANDING
 - ⑪ (E) PLANTER / LANDSCAPING; SEE LANDSCAPE PLANS
 - ⑫ (E) PLAY AREA (PLAY STRUCTURE NOT SHOWN)
 - ⑬ (N) 24" BOX (MIN.) STREET TREES, SPECIES SELECTED PER LANDSCAPE ARCHITECT'S RECOMMENDATIONS OR CITY APPROVED STANDARDS
 - ⑭ (N) MTL. GATE TO MATCH EXISTING
 - ⑮ (N) MTL. FENCE TO MATCH (E) HISTORIC FENCE
 - ⑯ (N) ADA RAMP
 - ⑰ (N) STAIRS W/ MTL. GRABRAILS
 - ⑱ (N) EXTERIOR LANDING W/ MTL. GUARDRAIL
 - ⑲ (N) PLANTER / LANDSCAPING; SEE LANDSCAPE PLANS

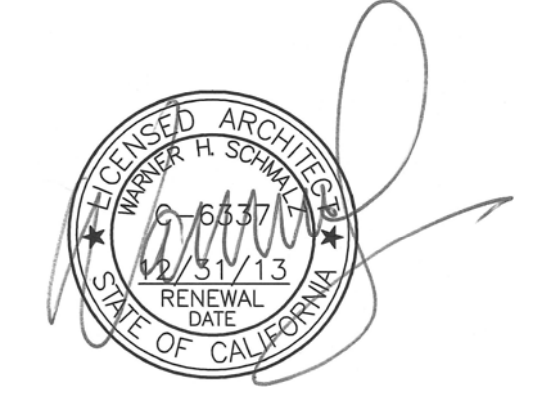
CONDITIONAL USE & CERT. OF APPROPRIATENESS SUBMITTAL

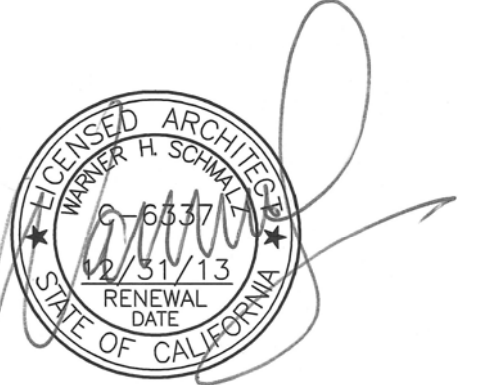
CONDITIONAL USE & CERT. OF APPROPRIATENESS SUBMITTAL

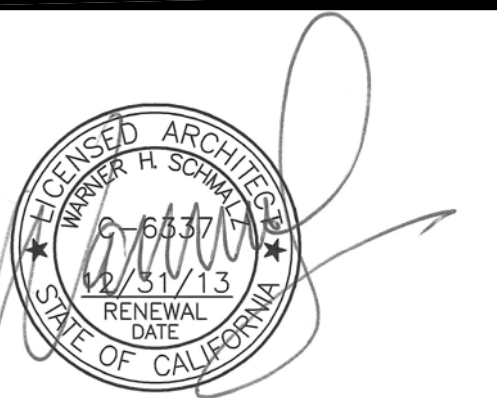
CONDITIONAL USE & CERT. OF APPROPRIATENESS SUBMITTAL

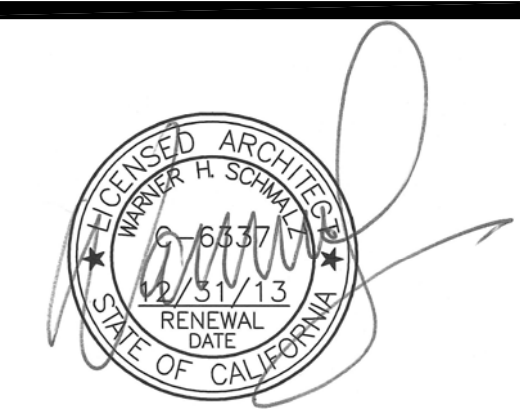
CONDITIONAL USE &
CERT. OF APPROPRIATENESS
SUBMITTAL

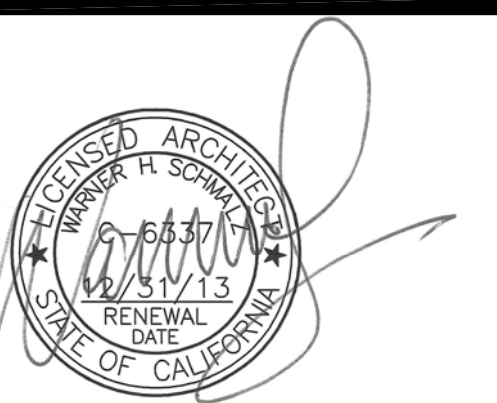
CONDITIONAL USE &
CERT. OF APPROPRIATENESS
SUBMITTAL

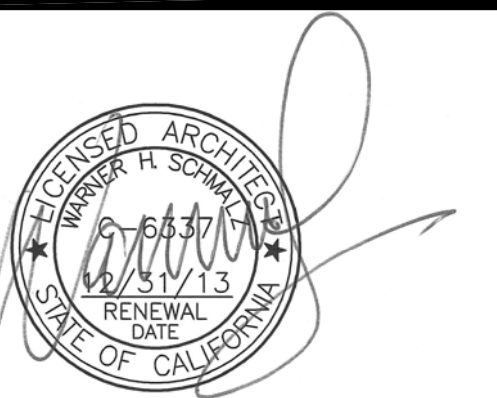
CONDITIONAL USE & CERT. OF APPROPRIATENESS SUBMITTAL

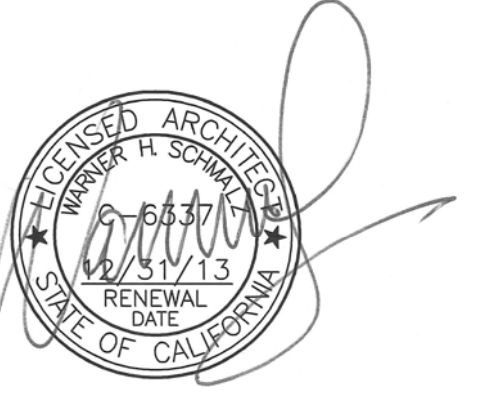
CONDITIONAL USE & CERT. OF APPROPRIATENESS SUBMITTAL

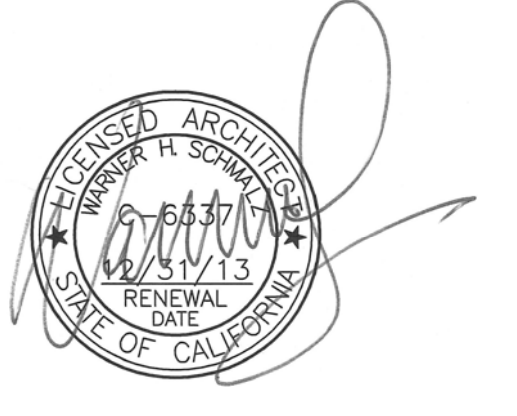
CONDITIONAL USE & CERT. OF APPROPRIATENESS SUBMITTAL

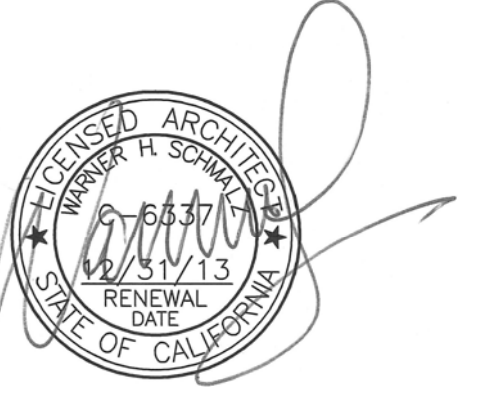
CONDITIONAL USE &
CERT. OF APPROPRIATENESS
SUBMITTAL

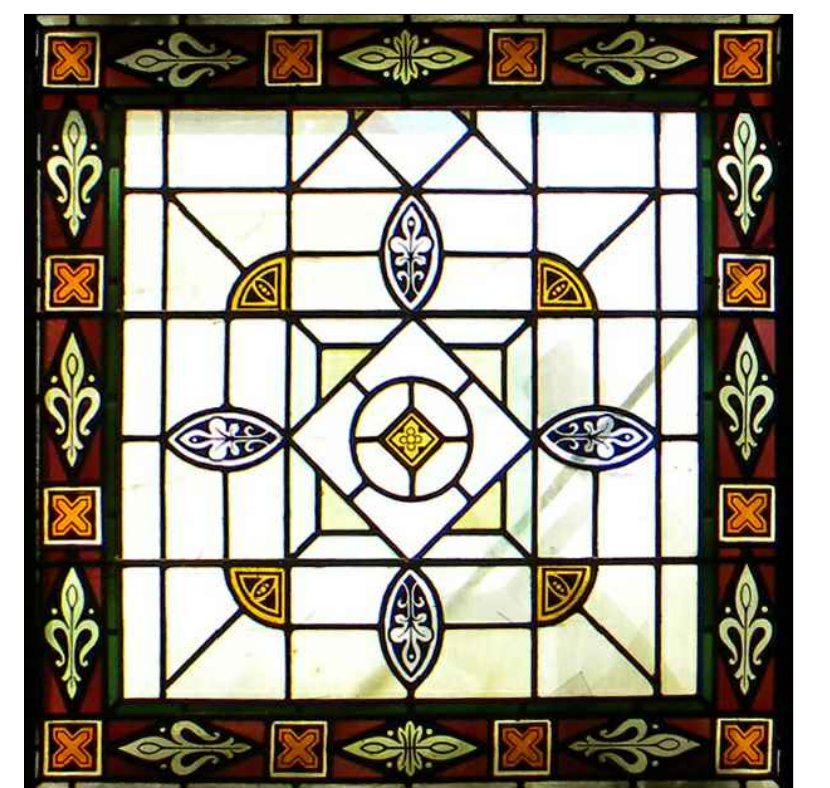
Copyright © 2011 FORUM DESIGN LTD.
This drawing and written material constitute the original work of this Architect and may not be used, duplicated or disclosed without the Architect's written consent.
