SAN FRANCISCO PLANNING DEPARTMENT

Certificate of Appropriateness Case Report

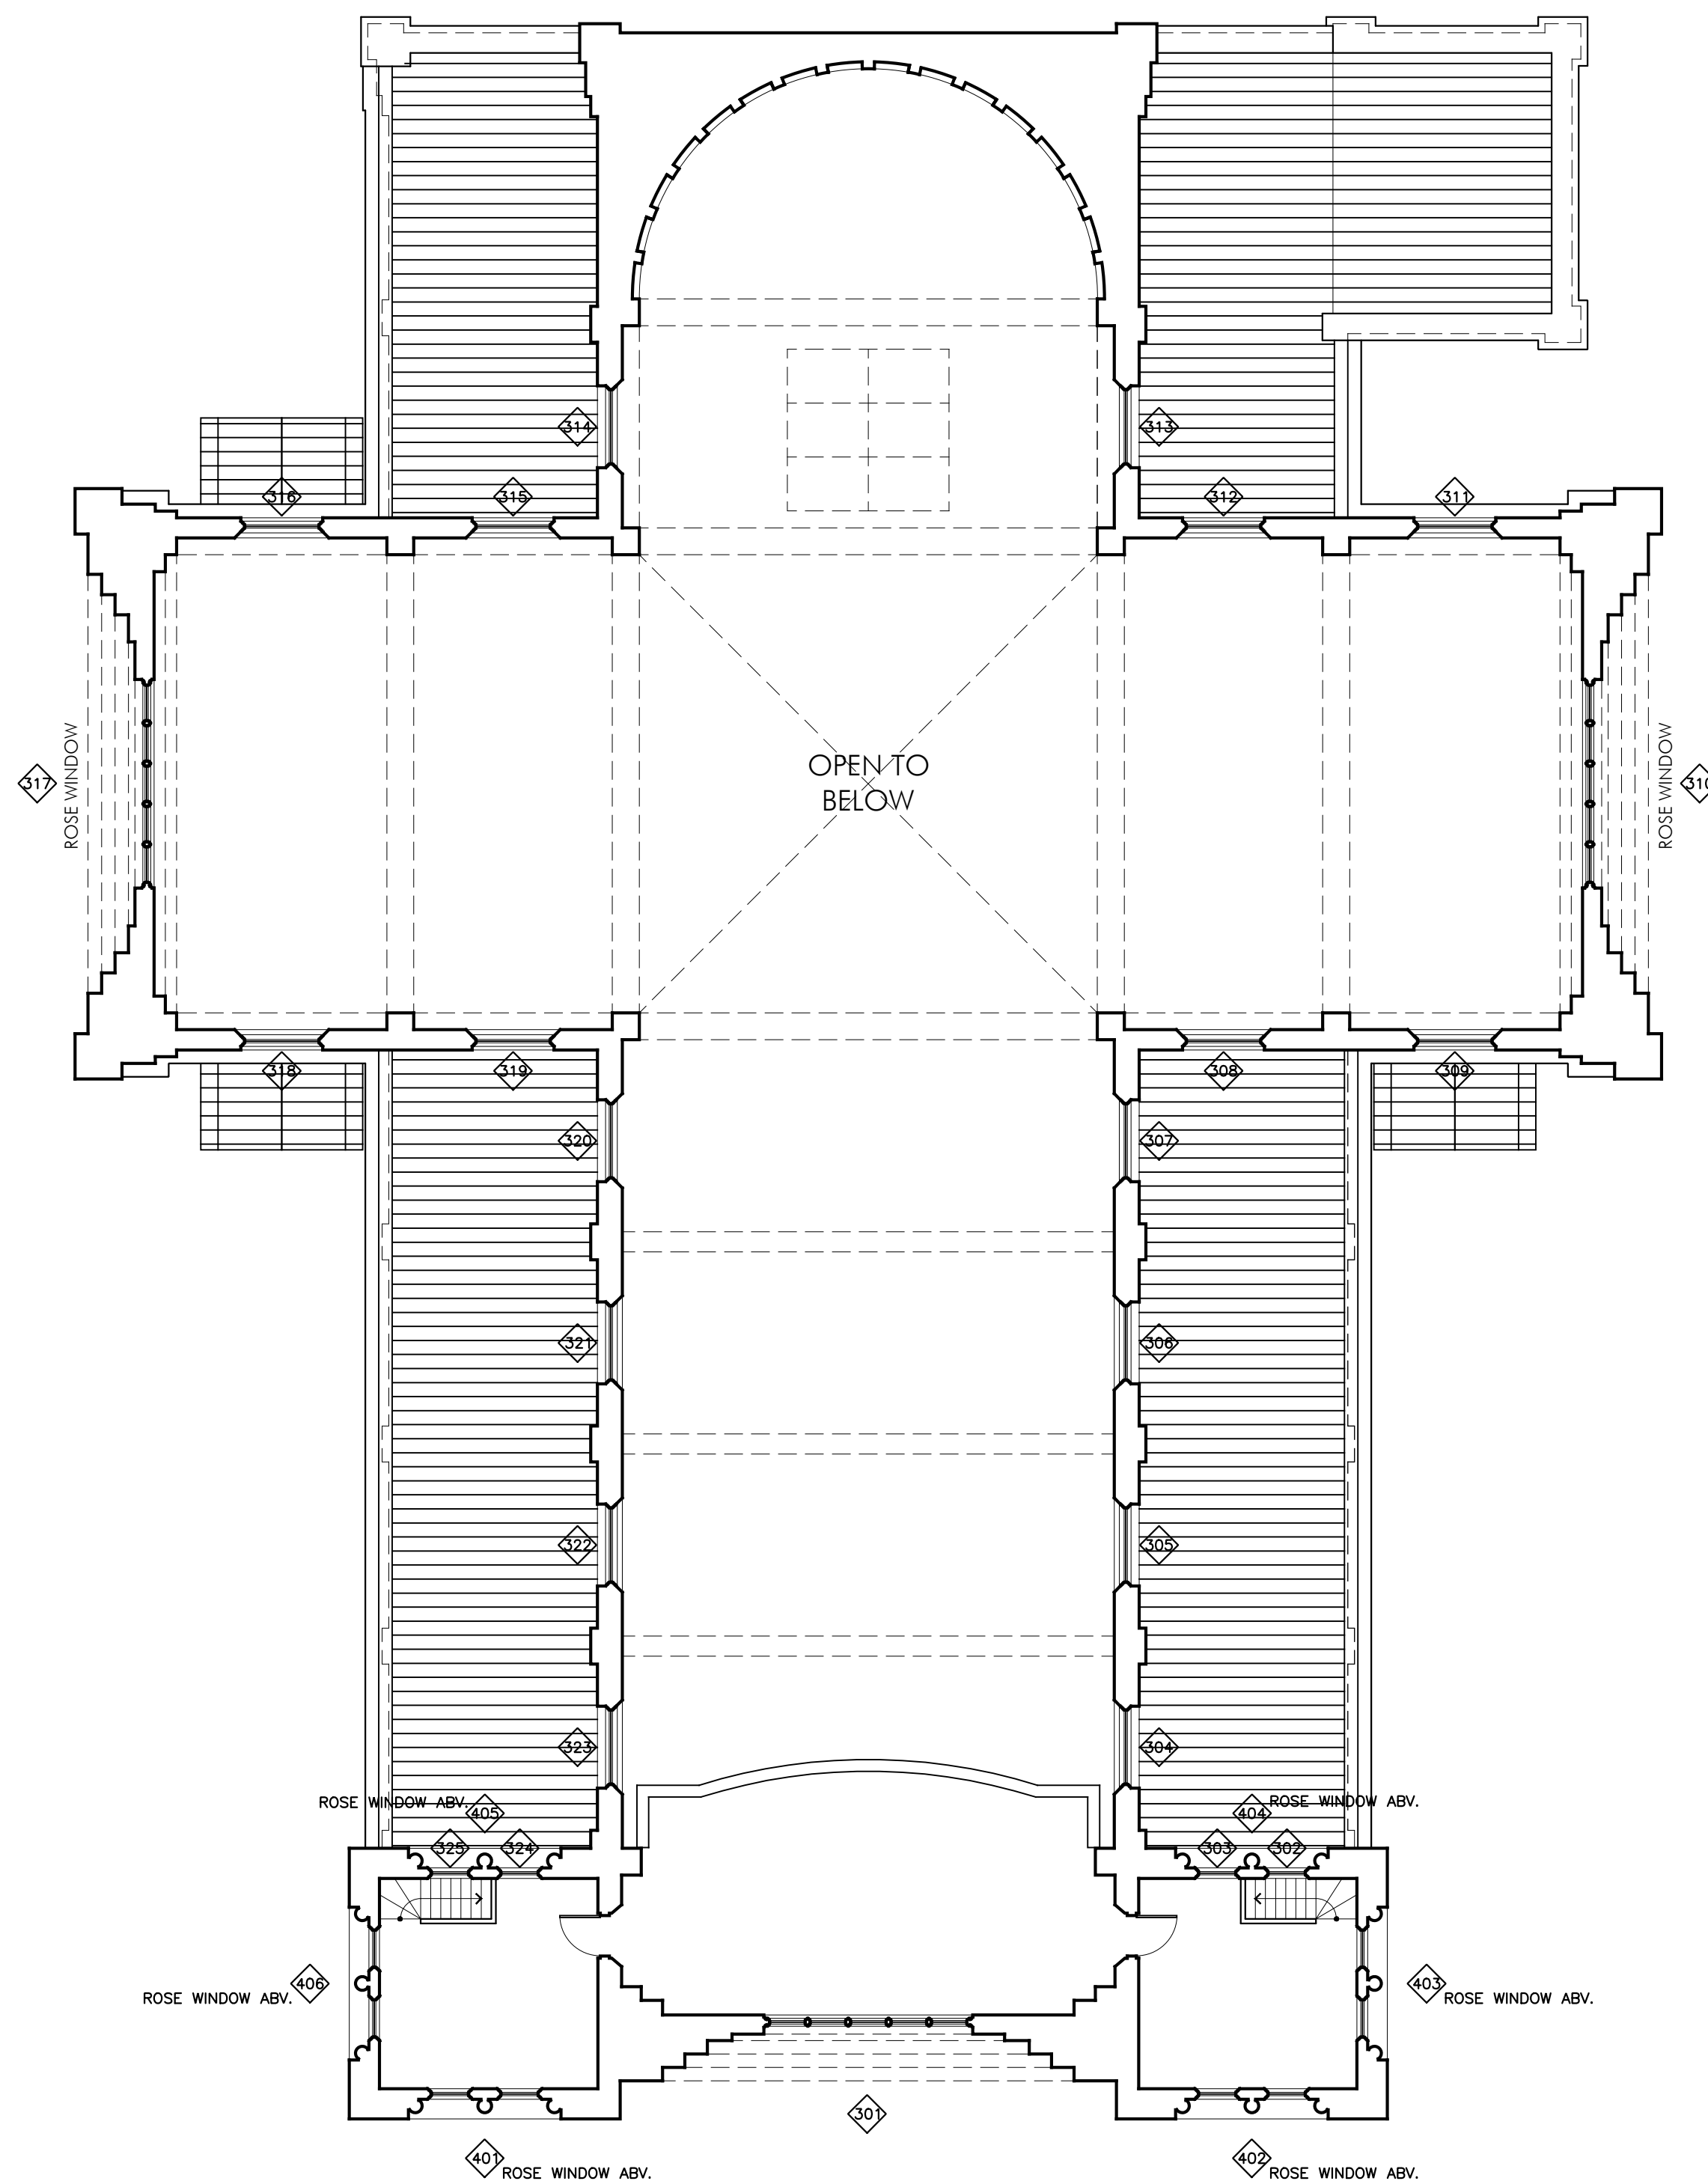
10 BELFRY & MECHANICAL PLAN
SCALE: 3/32"=1'-0"

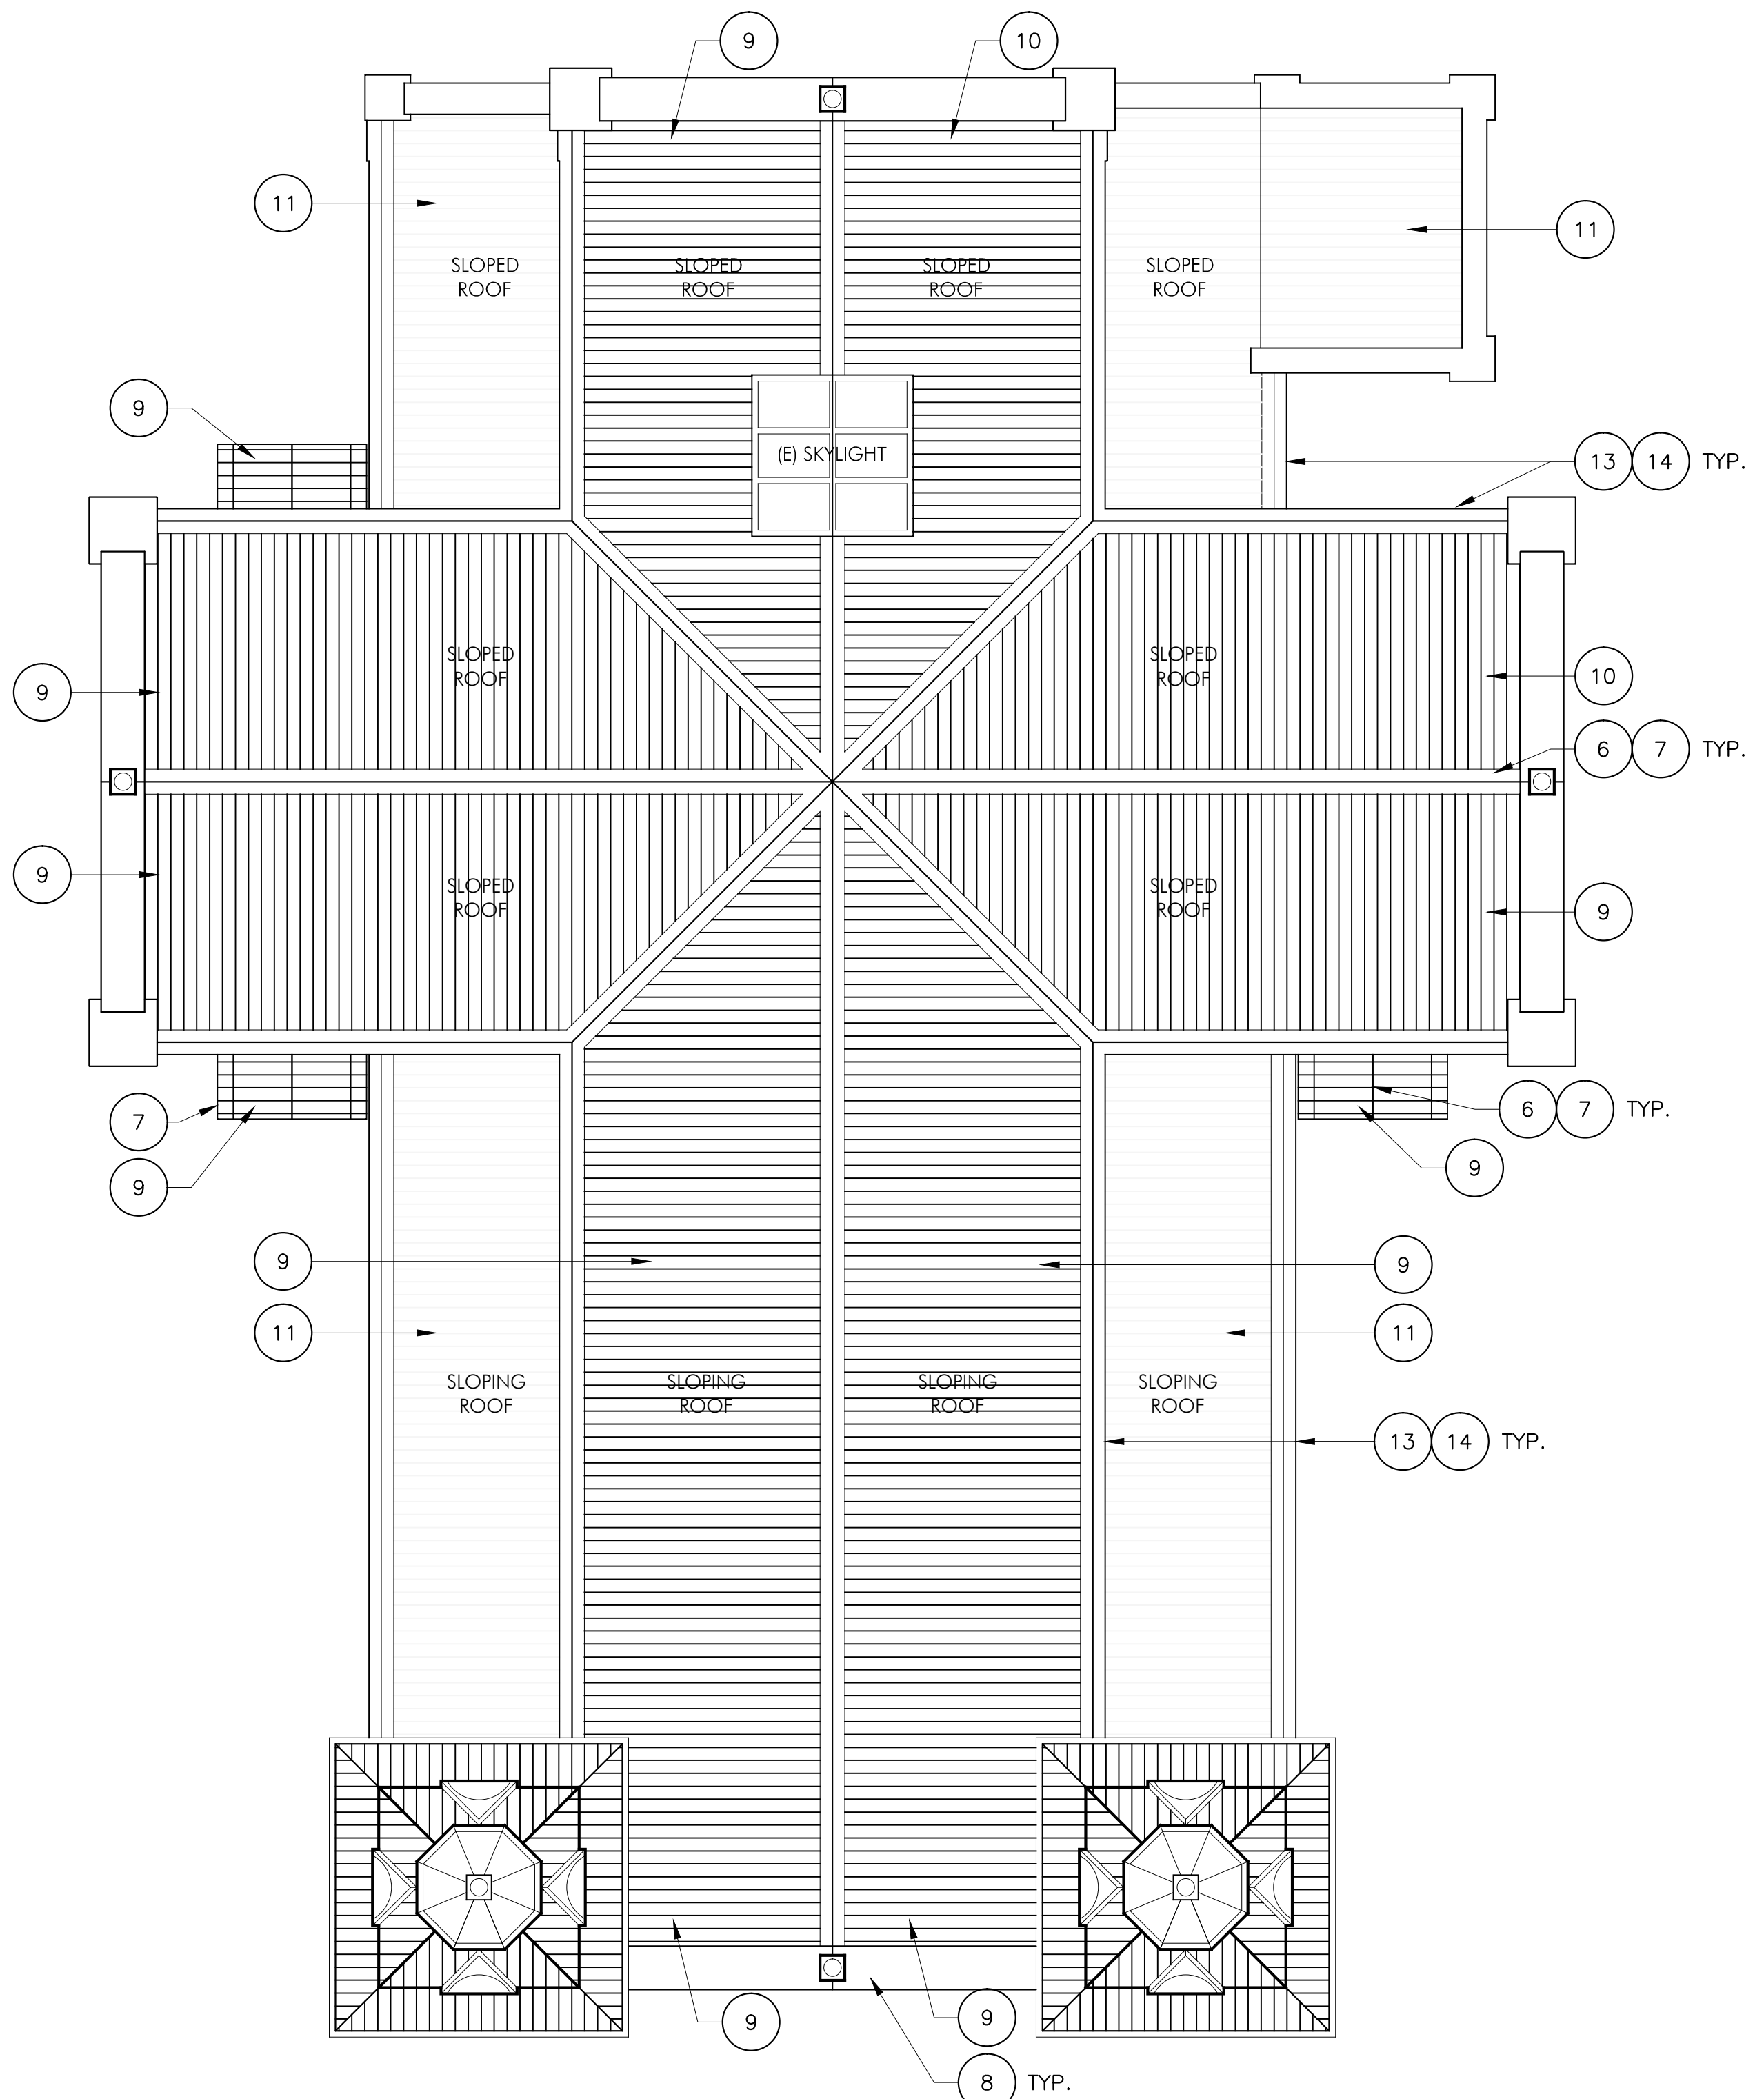
10 ROOF PLAN
SCALE: 3/32" = 1'-0"

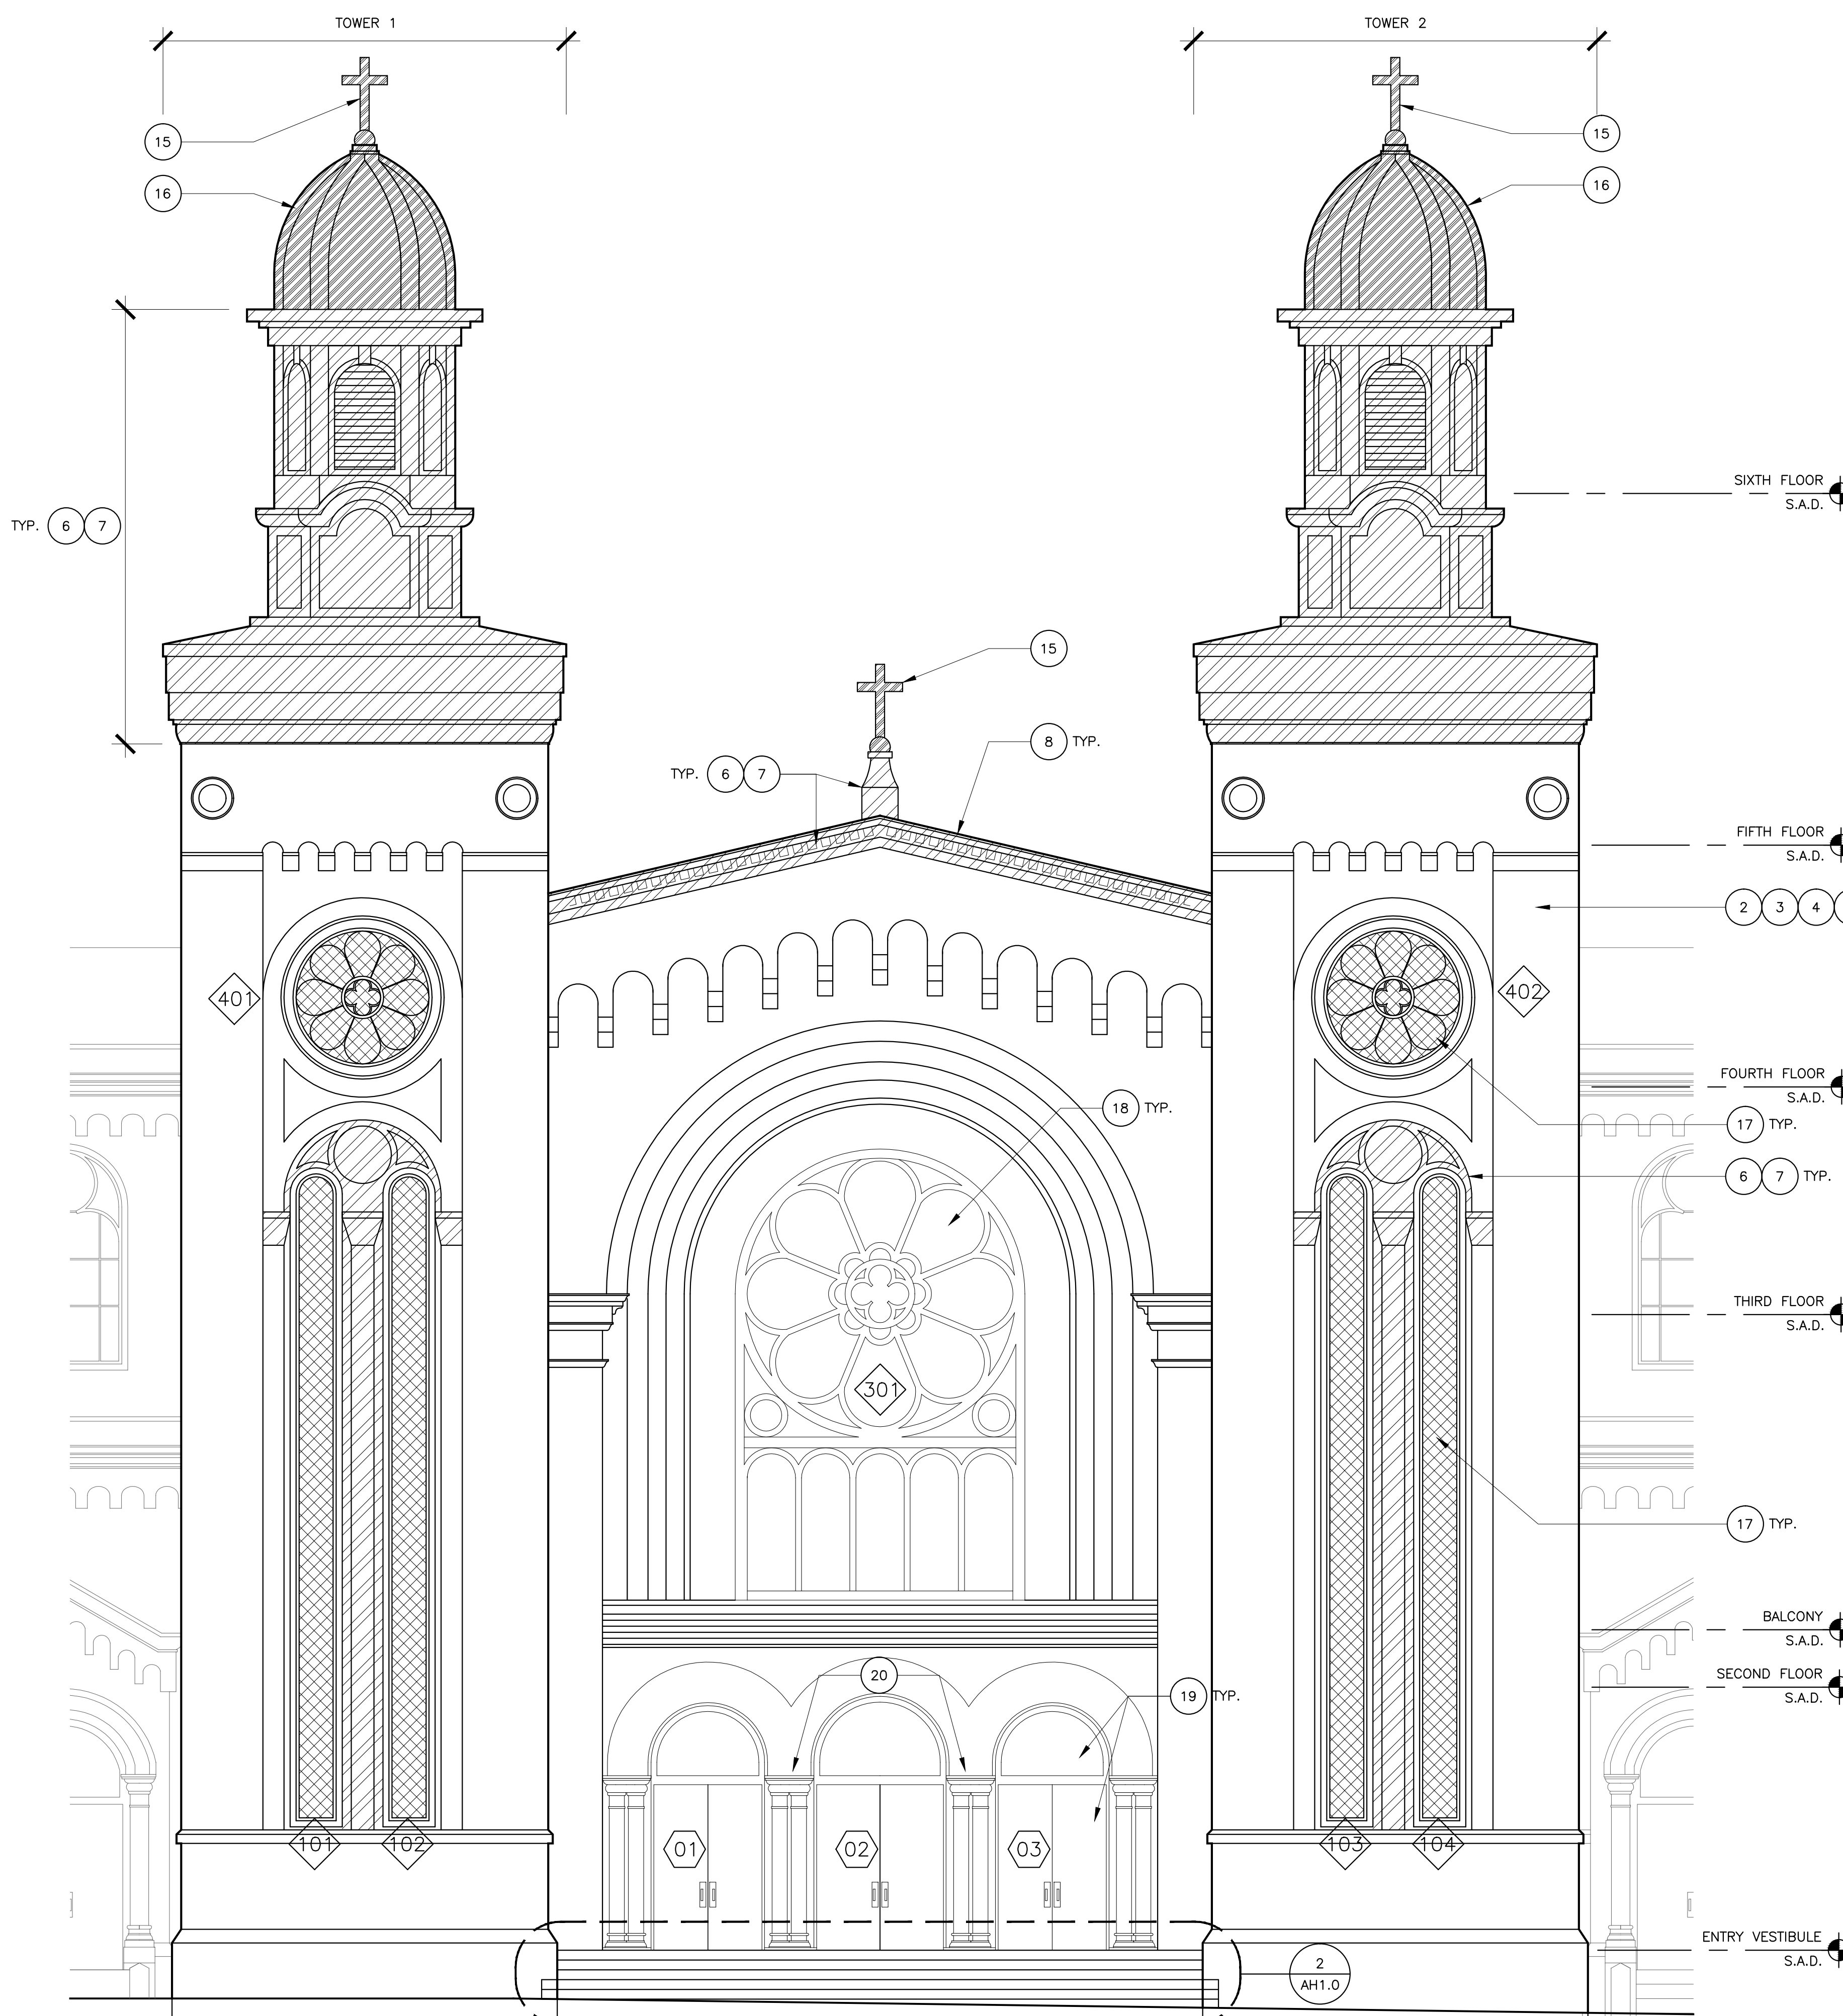
10 NORTH ELEVATION
SCALE: 3/16"=1'-0"

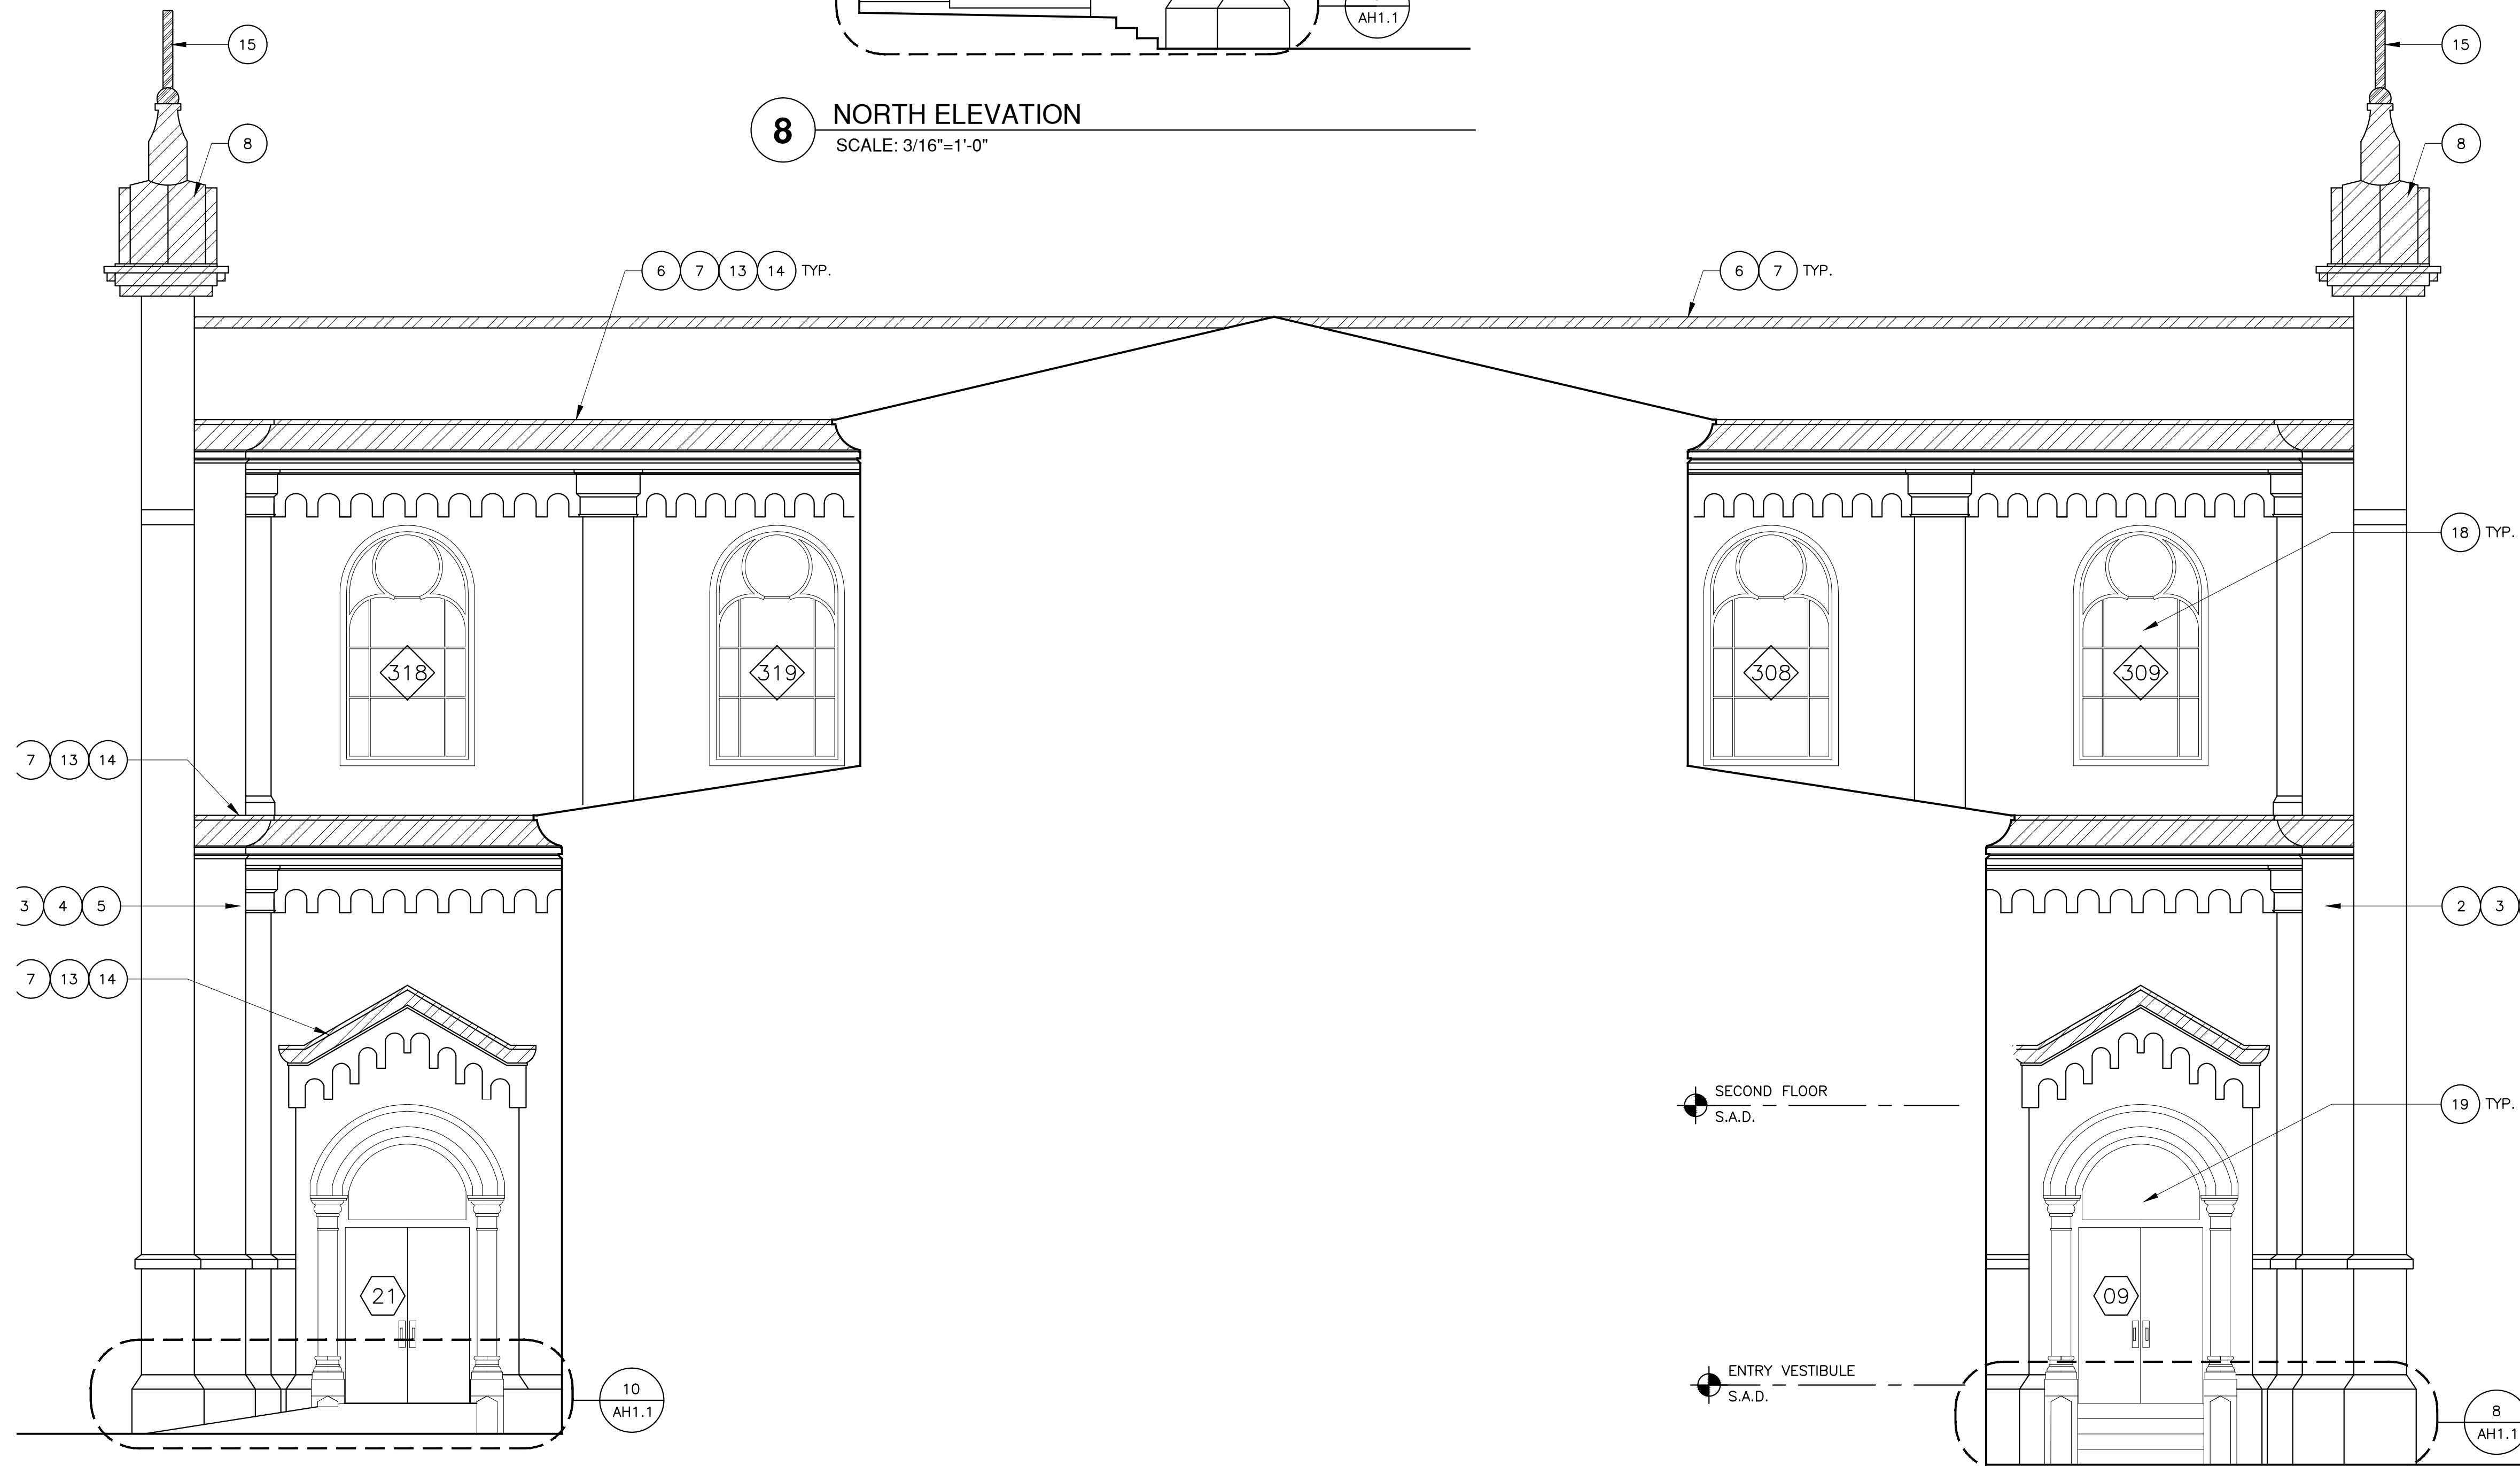
10 NORTH ELEVATION
SCALE: 3/16"=1'-0"

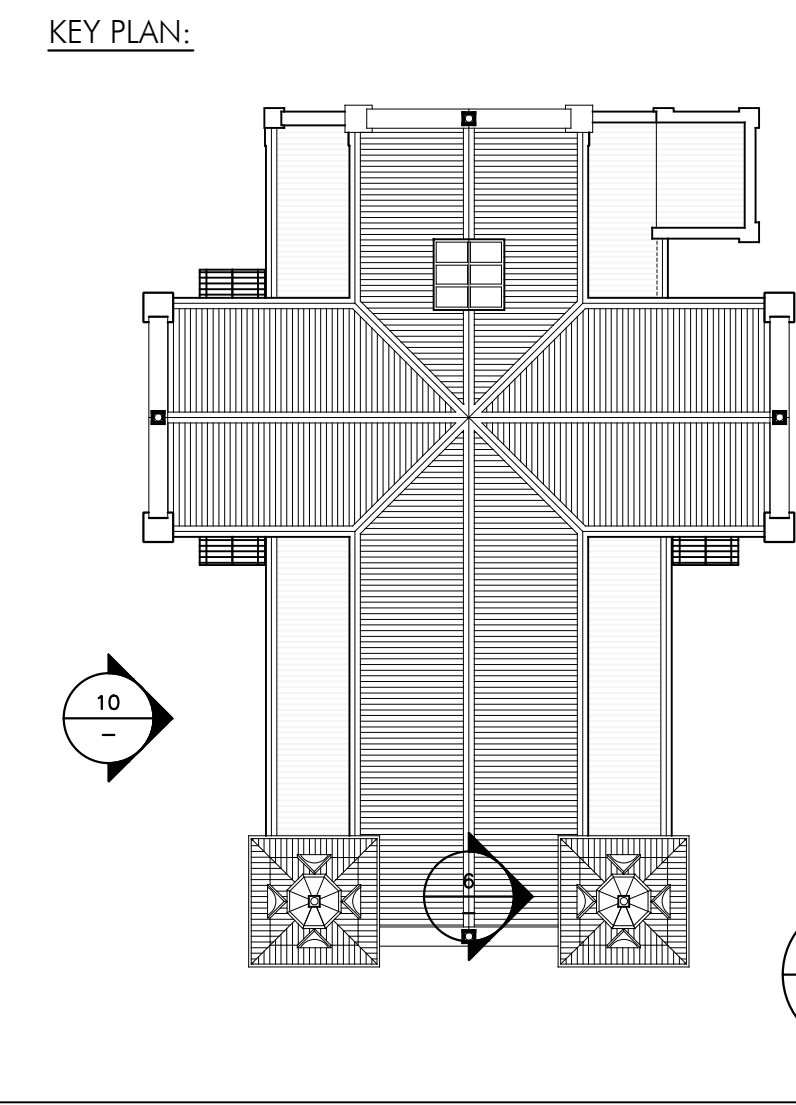
- MATERIALS LEGEND**
- EXISTING GILDED SHEET METAL
 - EXISTING PAINTED DECORATIVE SHEET METAL
 - EXISTING STAINED GLASS BEHIND PROTECTIVE GLAZING

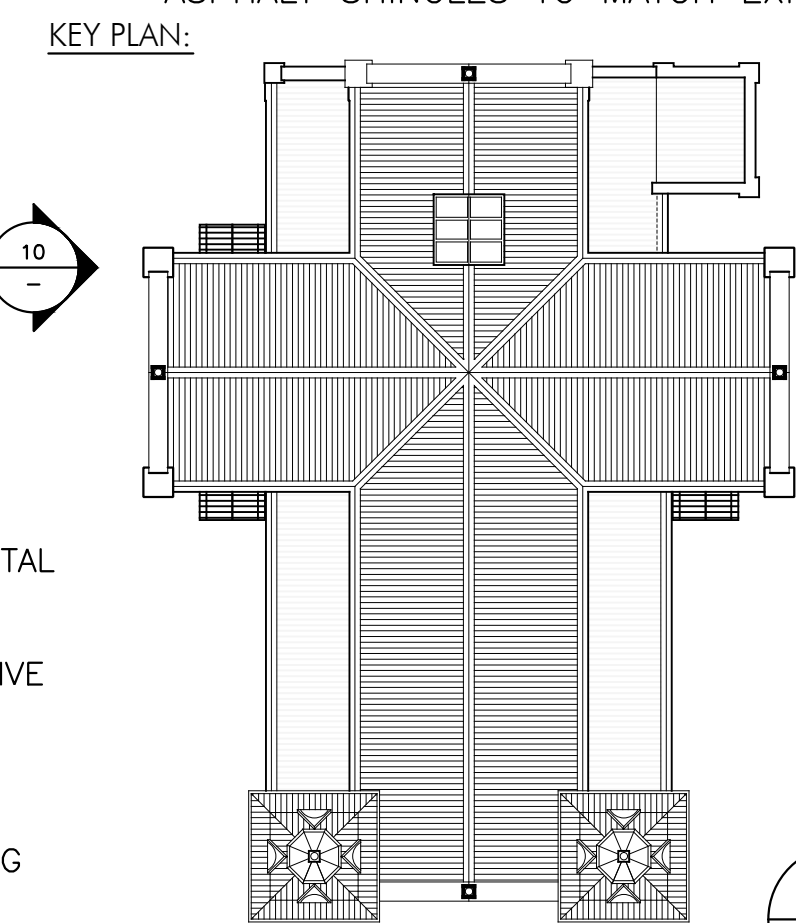
10 NORTH ELEVATION
SCALE: 3/16"=1'-0"

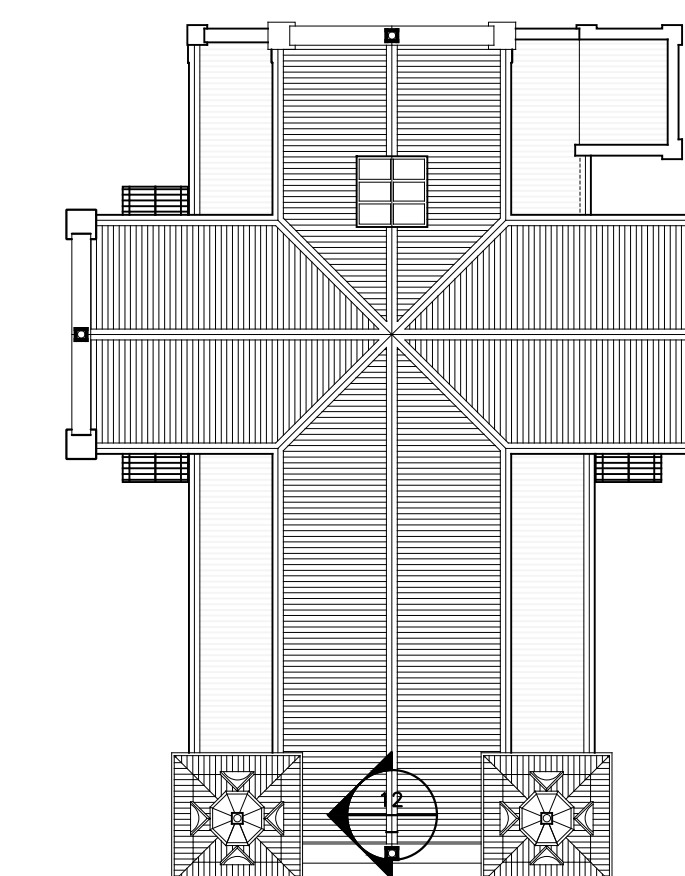
PRESERVATION ARCHITECT
PAGE & TURNBULL
1000 SANSOME STREET, SUITE 200
SAN FRANCISCO, CA 94111
T: 415.382.5154 F: 415.382.5560
www.page-turnbull.com

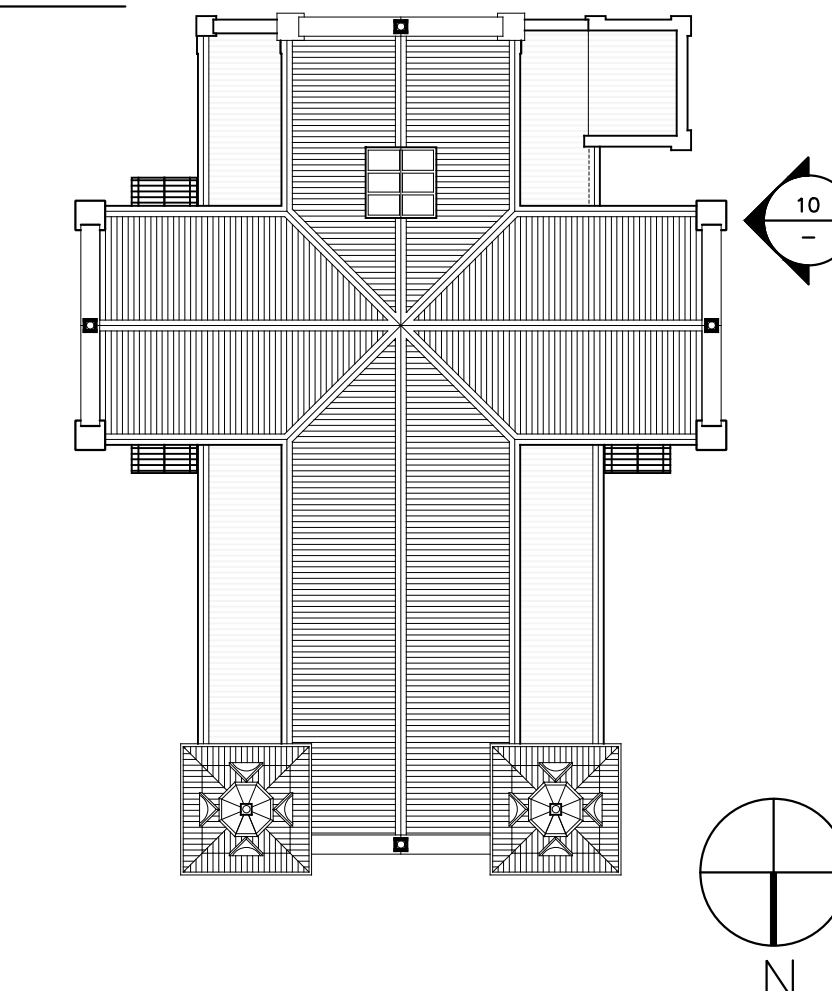
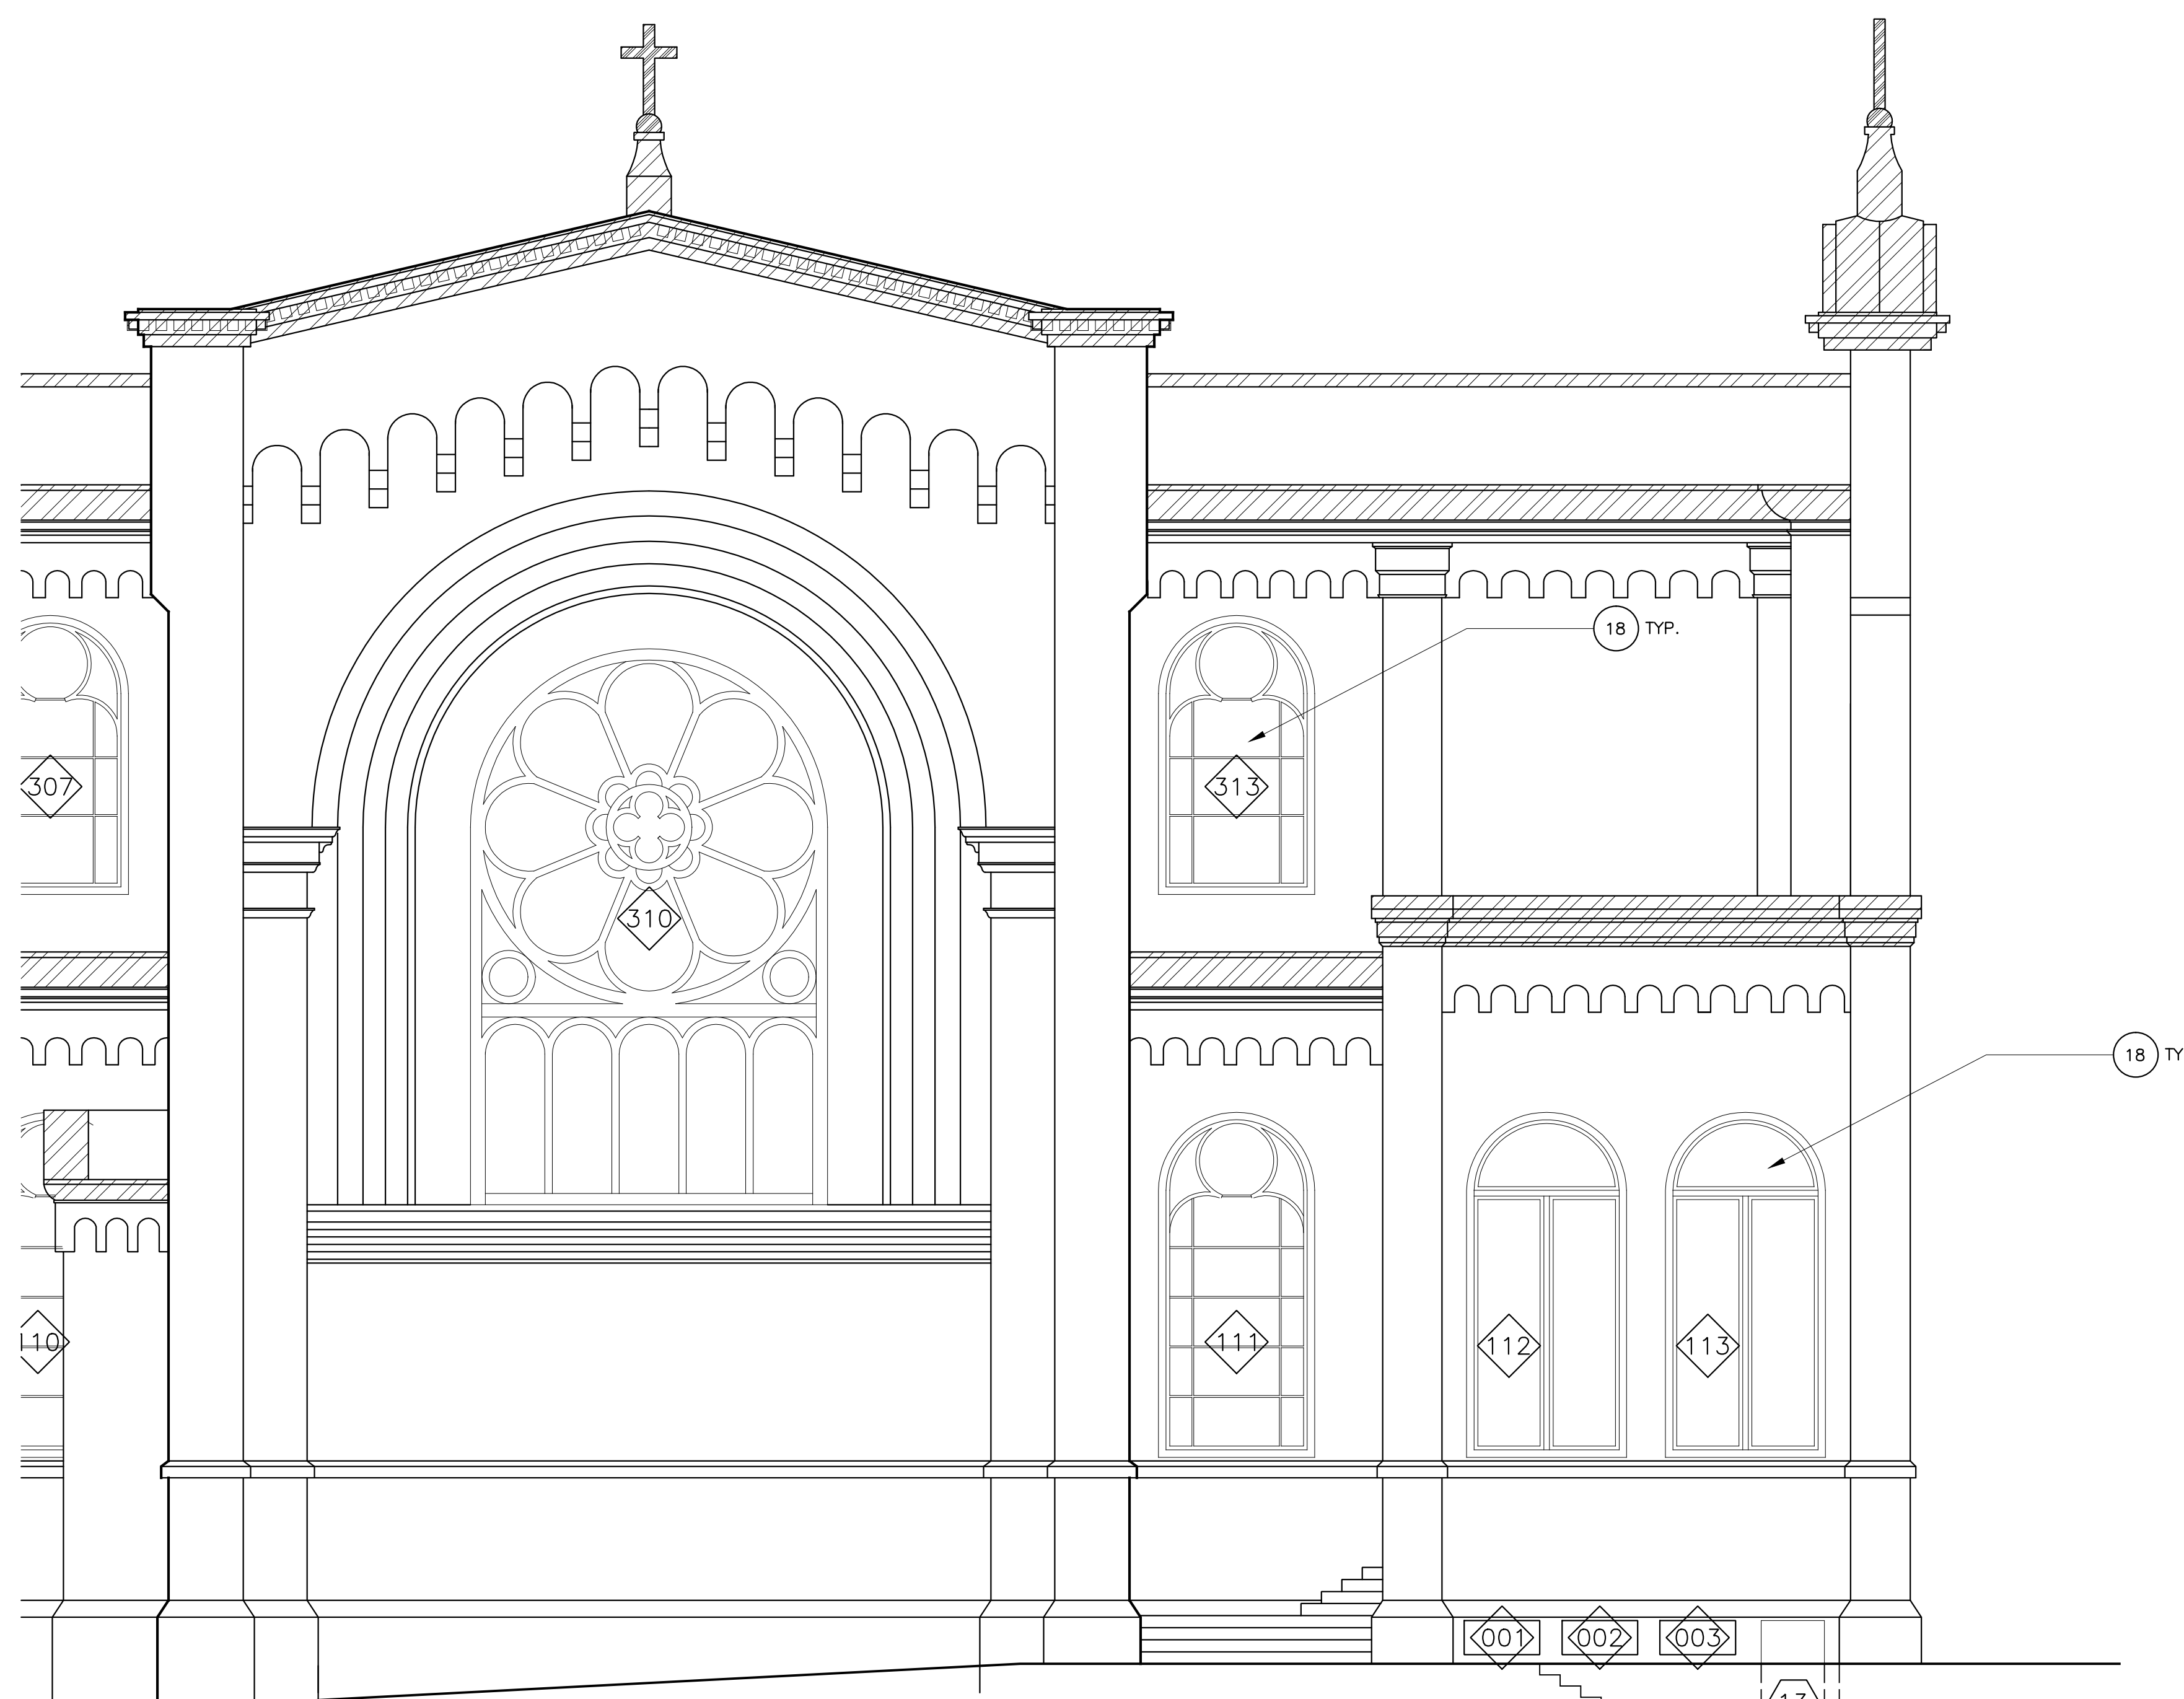
10 WEST ELEVATION
SCALE: 3/16"=1'-0"

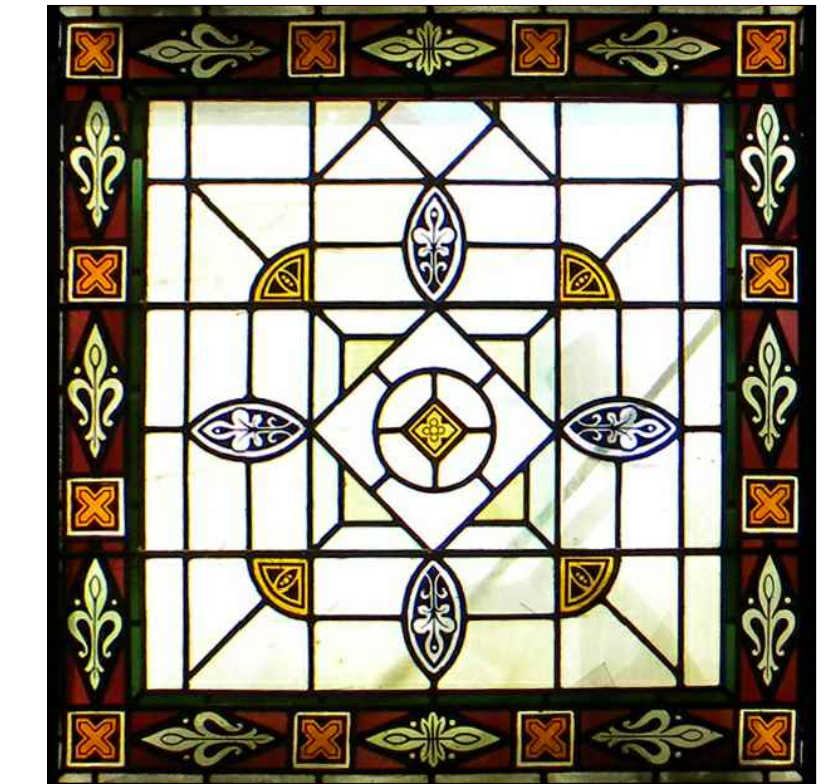
Copyright © 2011 FORUM DESIGN LTD.
This drawing and written material constitute the original work of this Architect and may not be used, duplicated or disclosed without the Architect's written consent.
