SAN FRANCISCO PLANNING DEPARTMENT

Certificate of Appropriateness Case Report

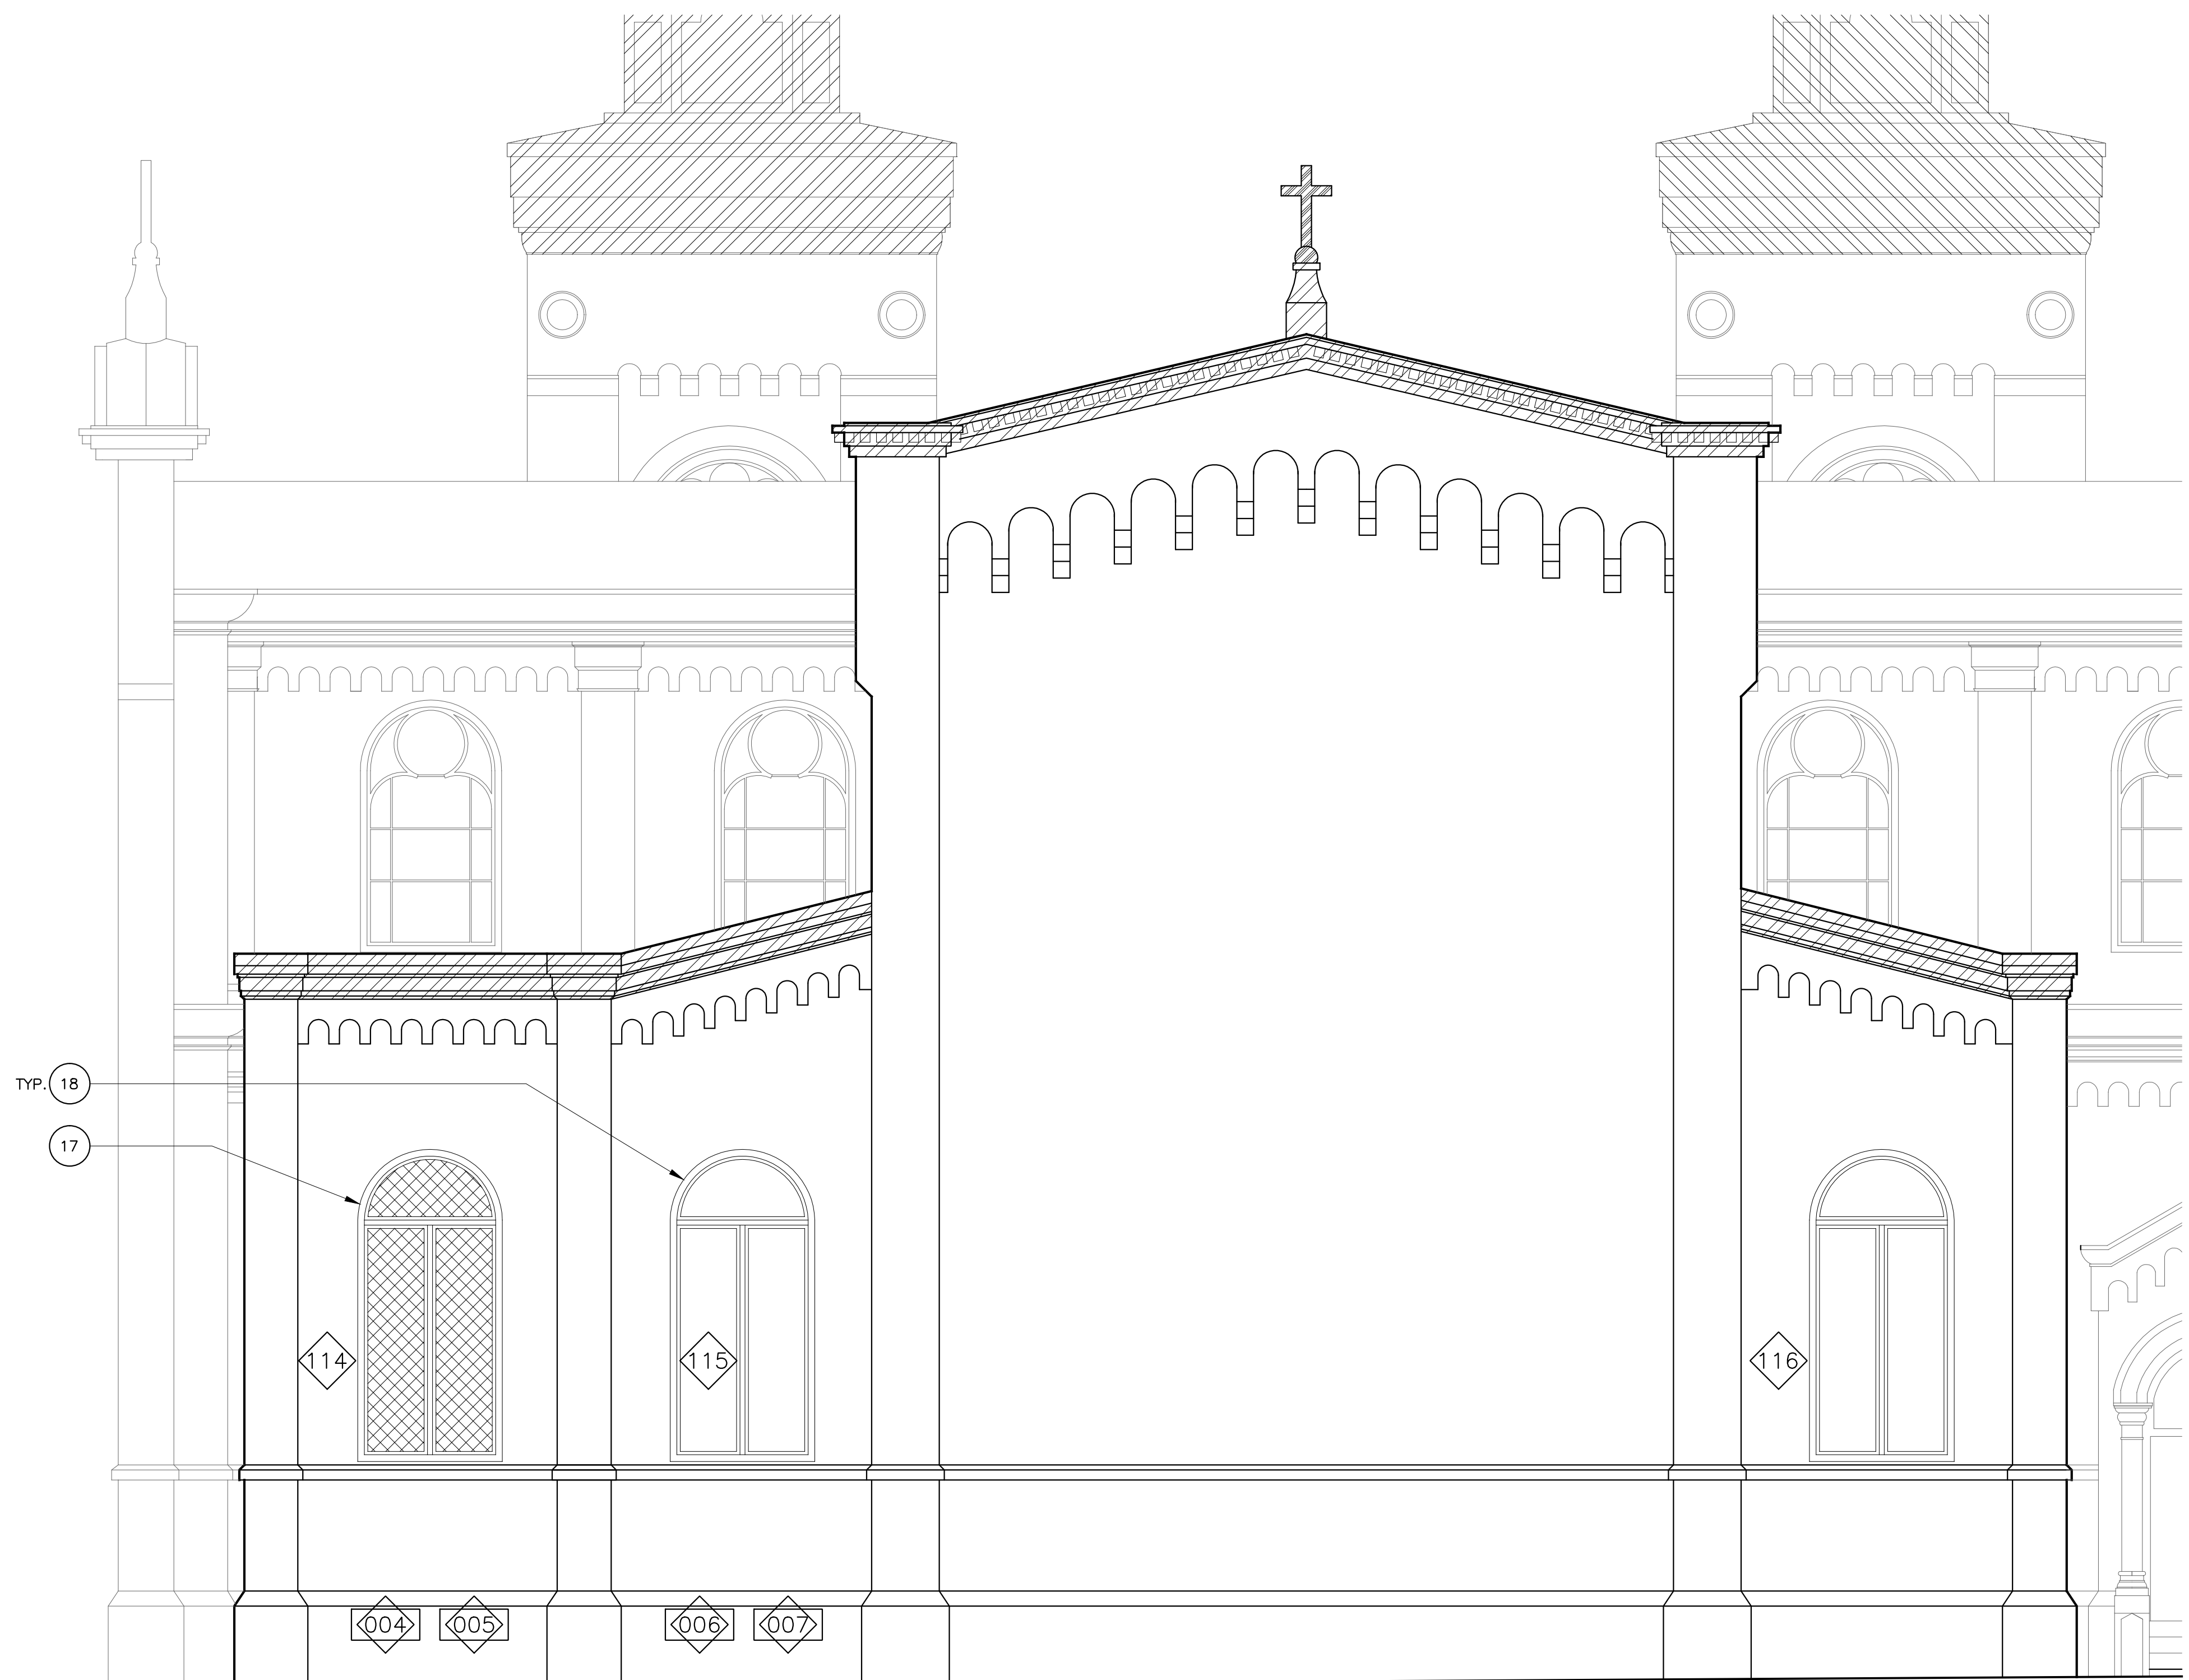
- MATERIALS LEGEND**
- EXISTING GILDED SHEET METAL
 - EXISTING PAINTED DECORATIVE SHEET METAL
 - EXISTING STAINED GLASS BEHIND PROTECTIVE GLAZING

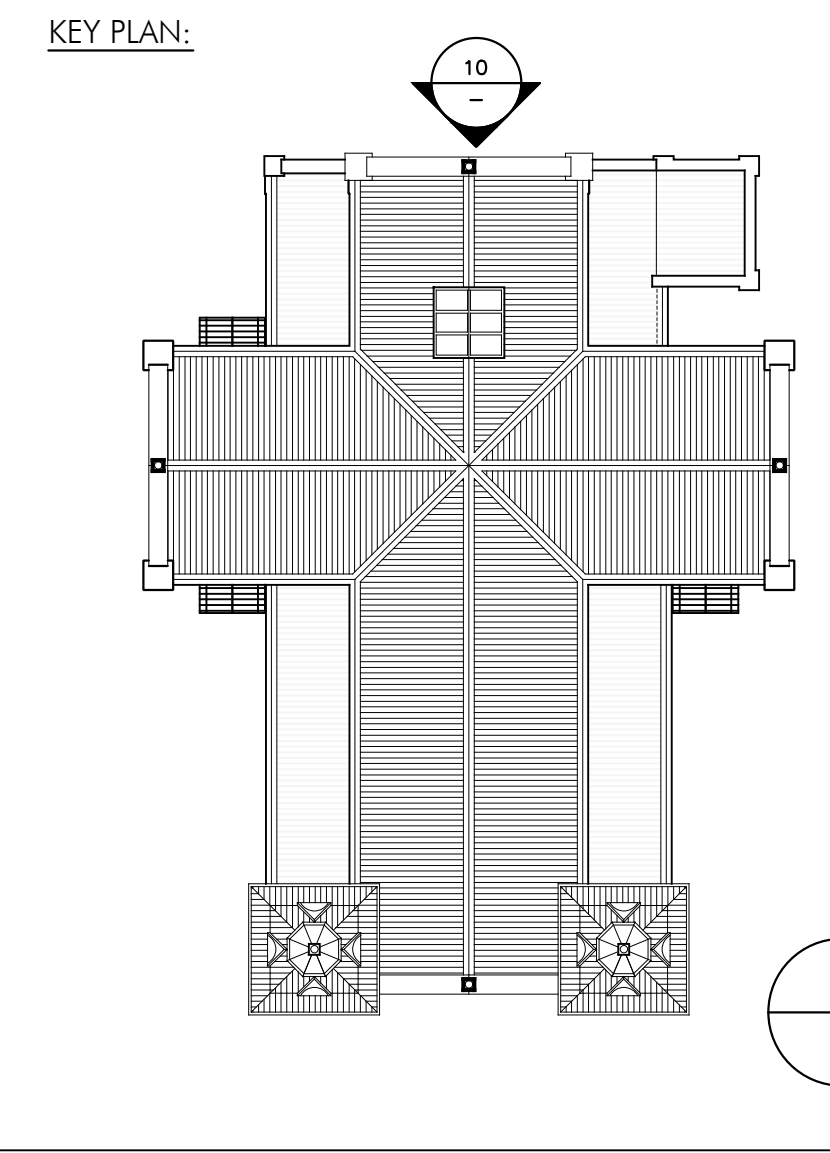
10 SOUTH ELEVATION
SCALE: 3/16"=1'-0"

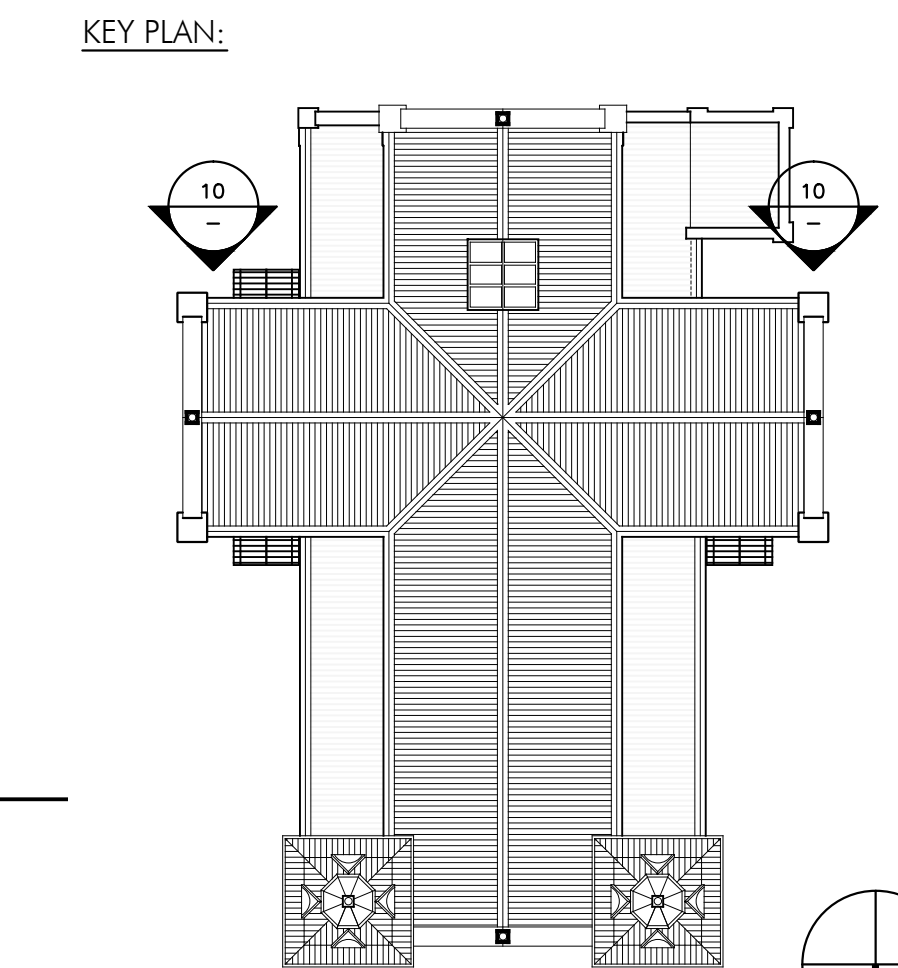
10 SOUTH ELEVATION
SCALE: 3/16"=1'-0"

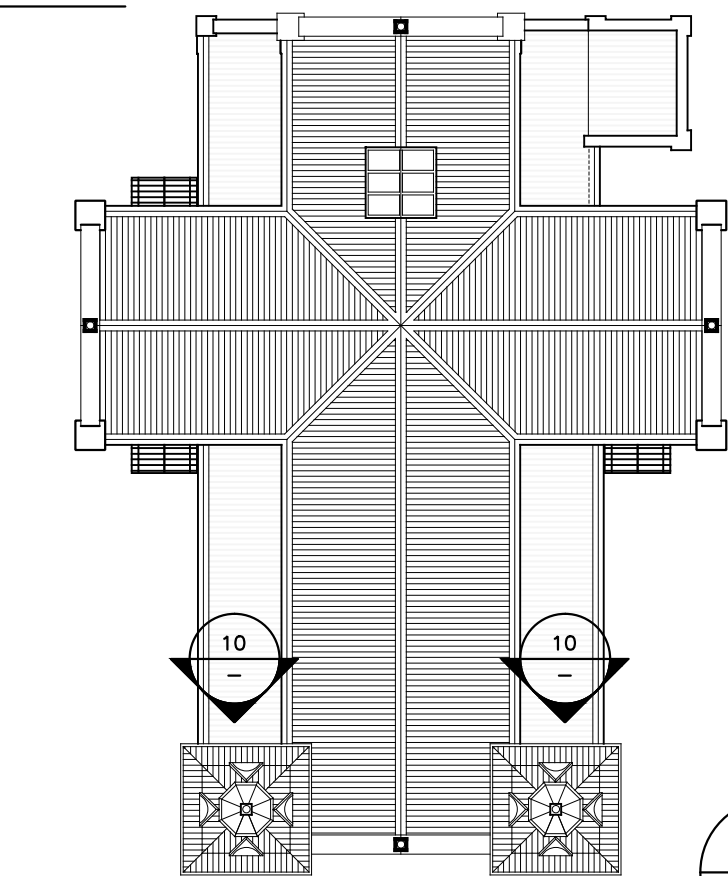
ST. JOSEPH
 1401 HOWARD ST.
 SAN FRANCISCO, CA 94103

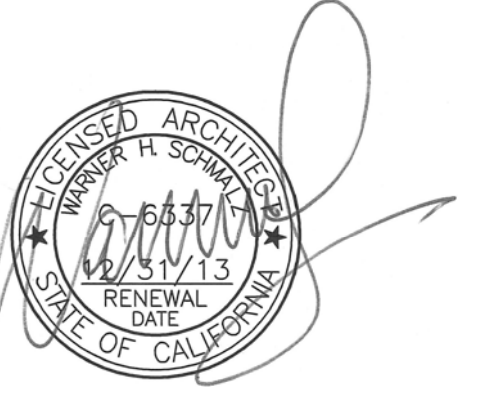
CONDITIONAL USE &
CERT. OF APPROPRIATENESS
SUBMITTAL

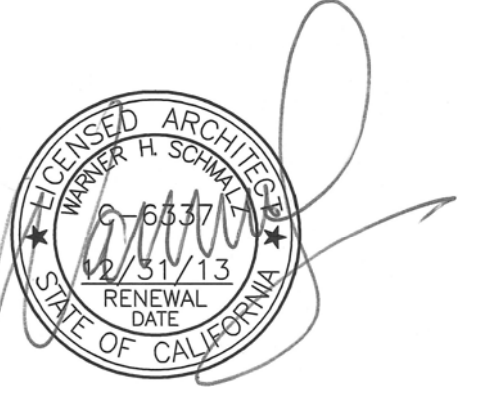
CONDITIONAL USE &
CERT. OF APPROPRIATENESS
SUBMITTAL

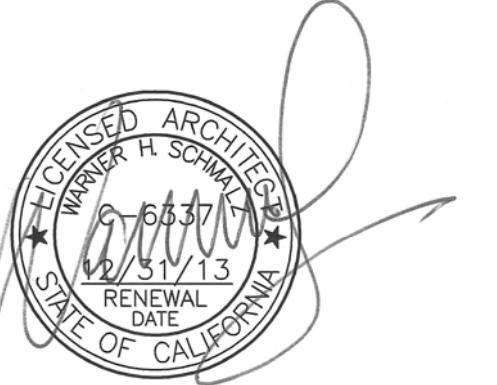
CONDITIONAL USE & CERT. OF APPROPRIATENESS SUBMITTAL

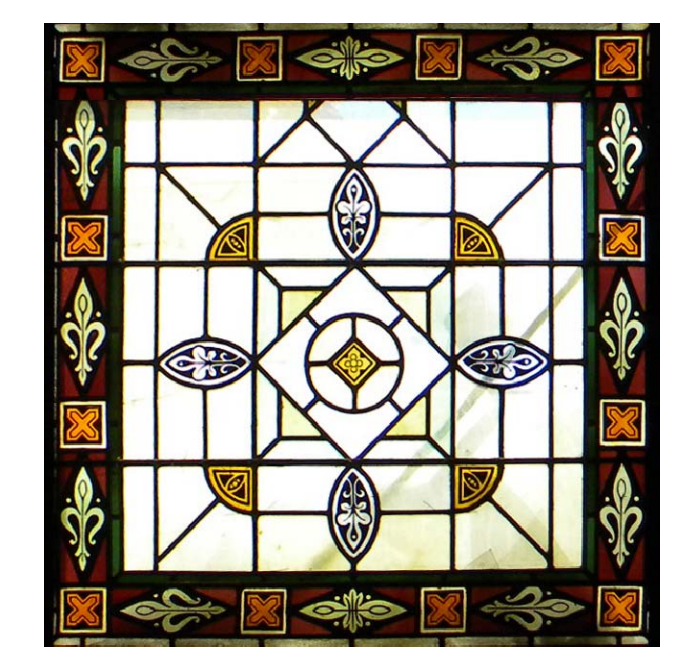
01/23/2012	C.U. / COA SUBMITTAL W/ MINOR REVISIONS

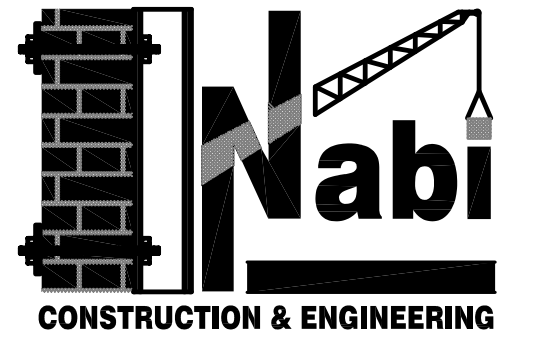
SEISMIC & STRUCTURAL
ENGINEERING
340 DIVISION STREET
SAN FRANCISCO, CA 94103
TEL: (415) 552-2215
FAX: (415) 552-2885

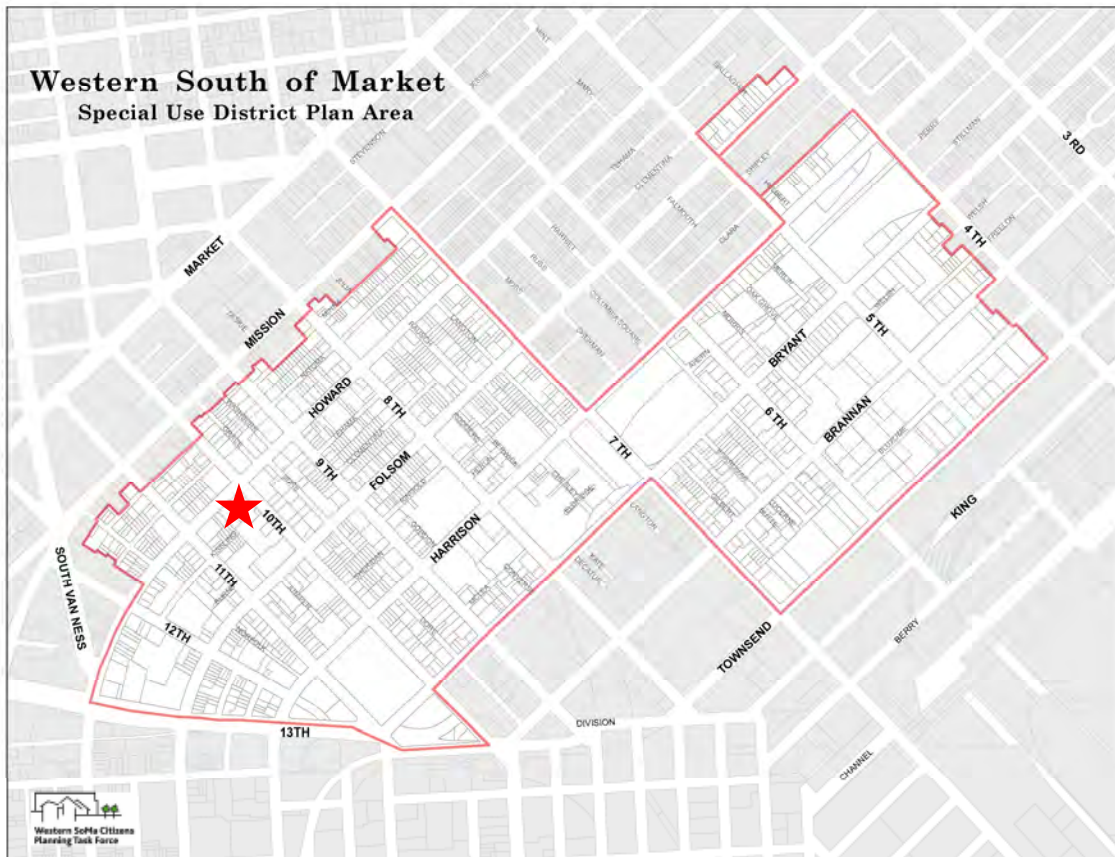
Figure 2. Parcel map of the Western SoMa Community Plan area, with St. Joseph's Church marked with a star.
Source: San Francisco Planning Department; altered by author.

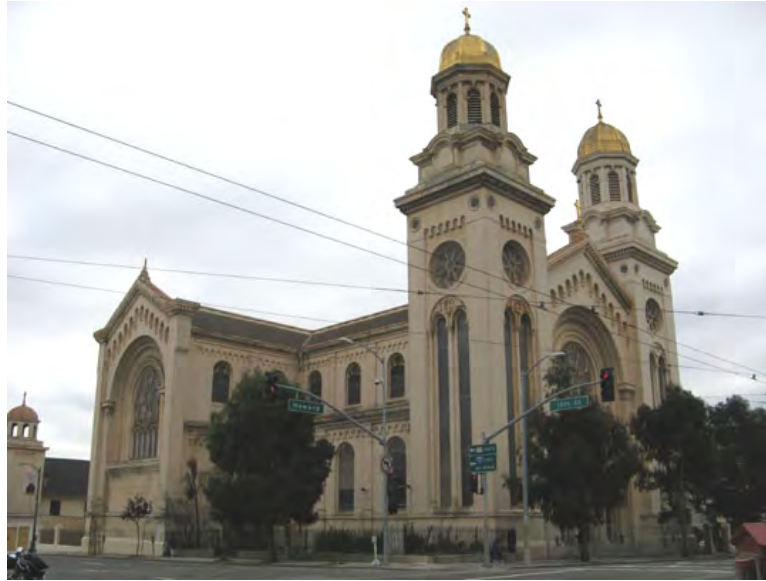
Figure 3. St. Joseph's Church. View south from Howard Street.
Source: Page & Turnbull, November 2007.

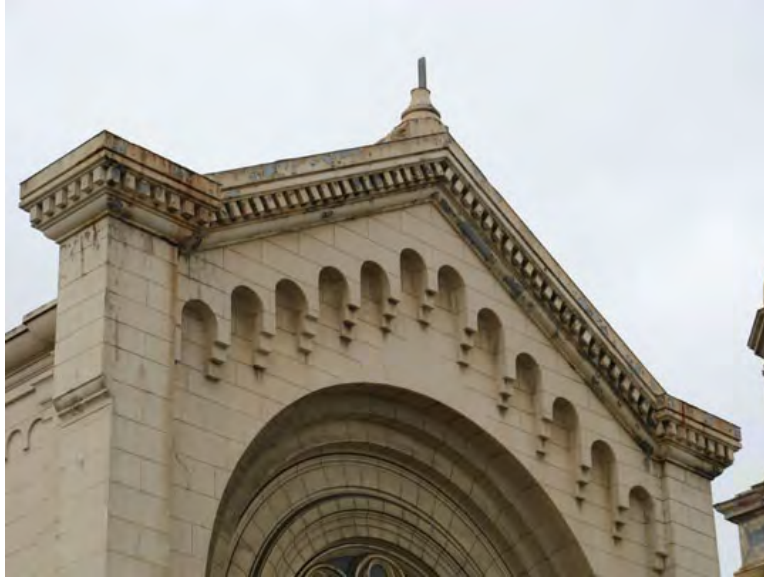
Figure 4. Detail of corbel table and cornice on east transept.
Source: Page & Turnbull, November 2007.

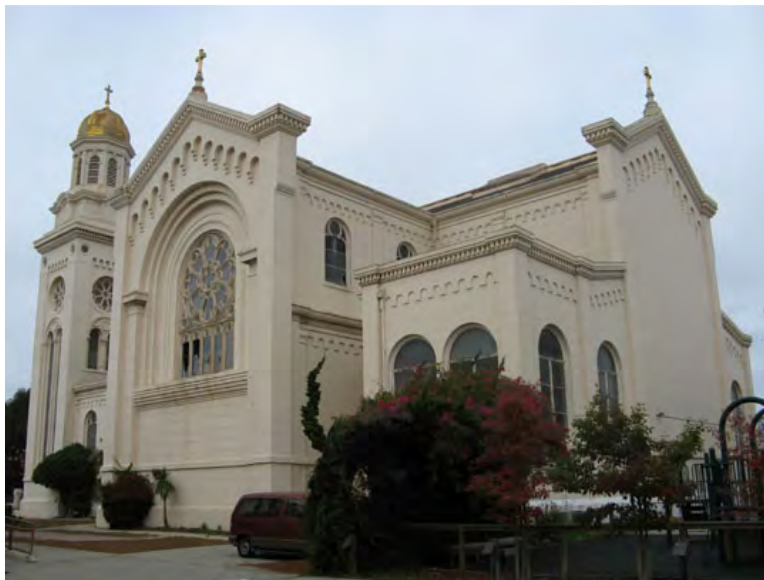
Figure 5. St. Joseph's Church, south and west façades. View north from courtyard.
Source: Page & Turnbull, November 2007.

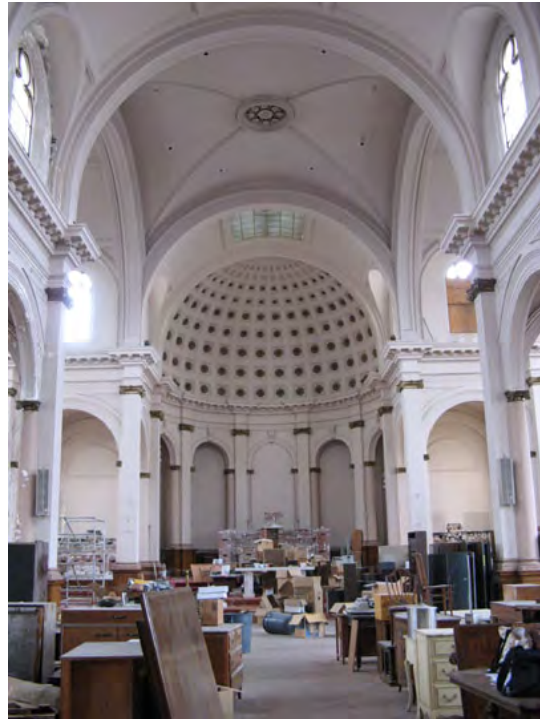
Figure 7. St. Joseph's Church interior. View south of apse from central nave.
Source: Page & Turnbull, November 2007.

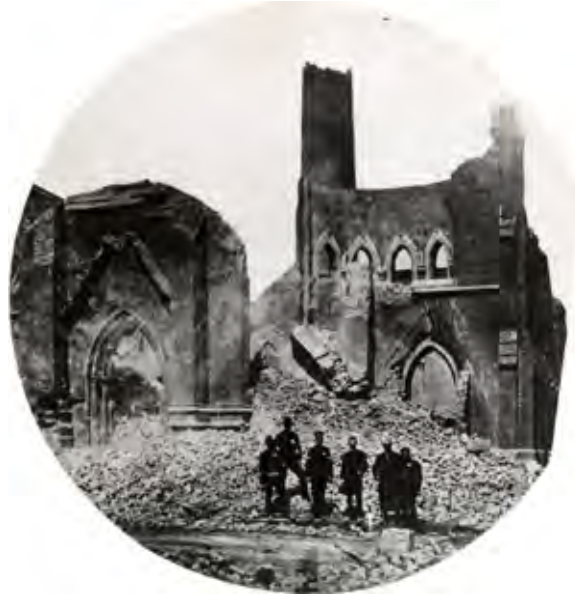
Figure 23. Ruins of St. Patrick's Church, 1906.
Source: San Francisco Historical Photograph Collection, #AAB-0972.

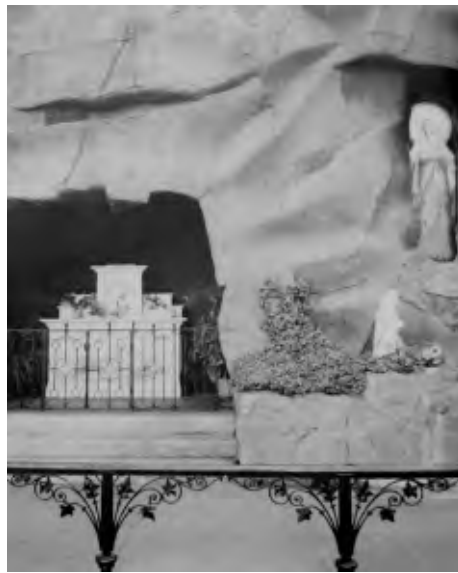
Figure 28. Grotto in courtyard, n.d.
Source: Willard, *Sacred Places of San Francisco*, 108.

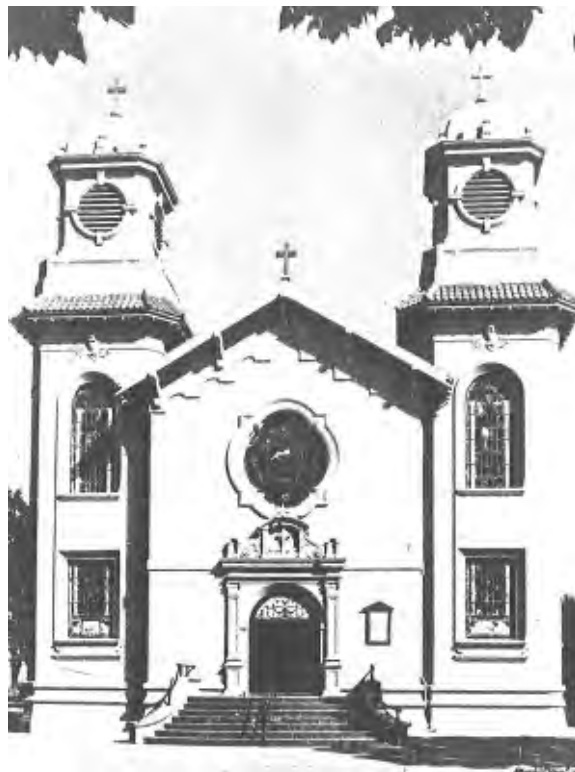
Figure 30. St. Stanislaus Church, Modesto (1914).

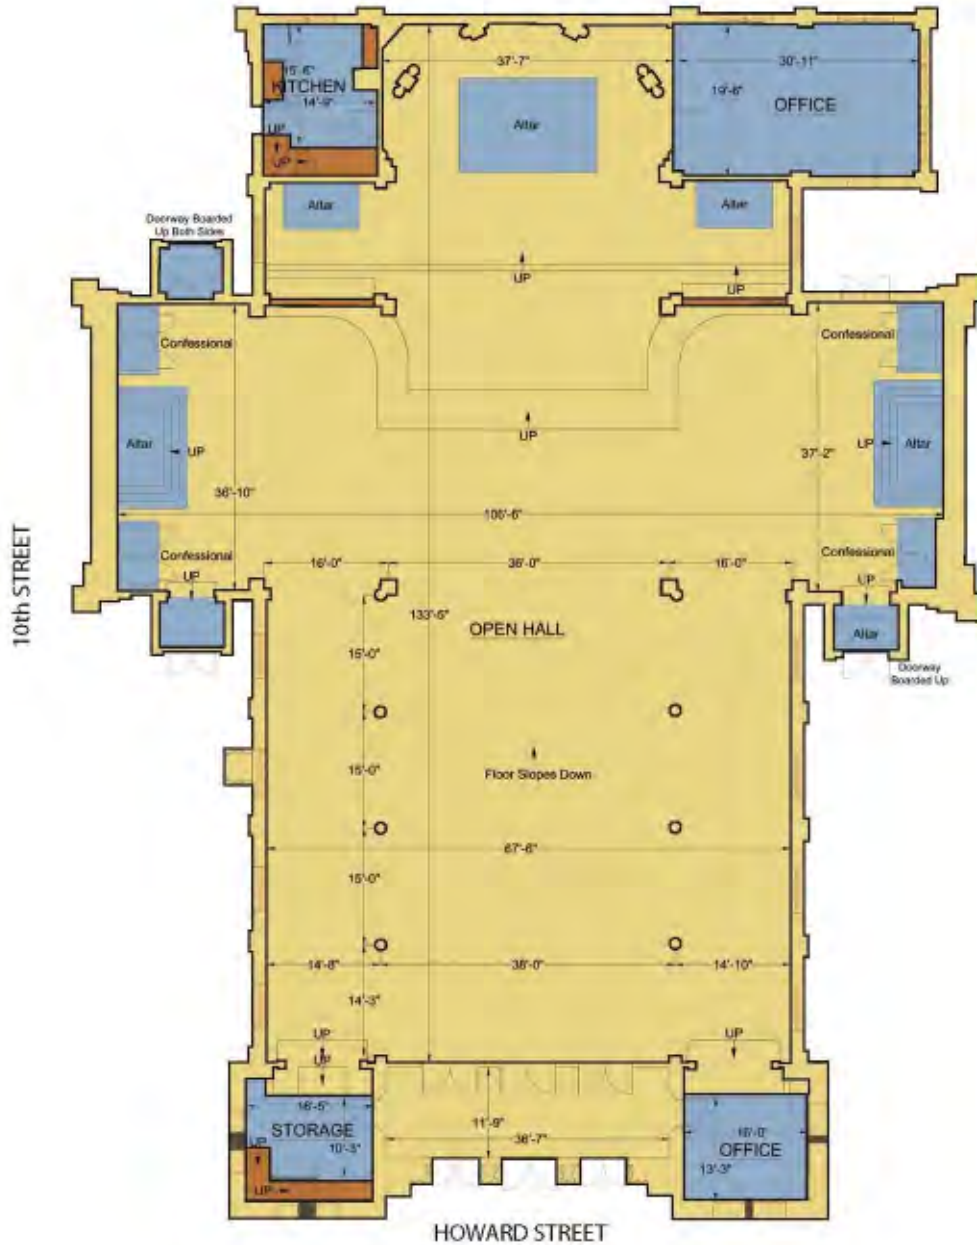
- Significant
- Contributing
- Non-Contributing

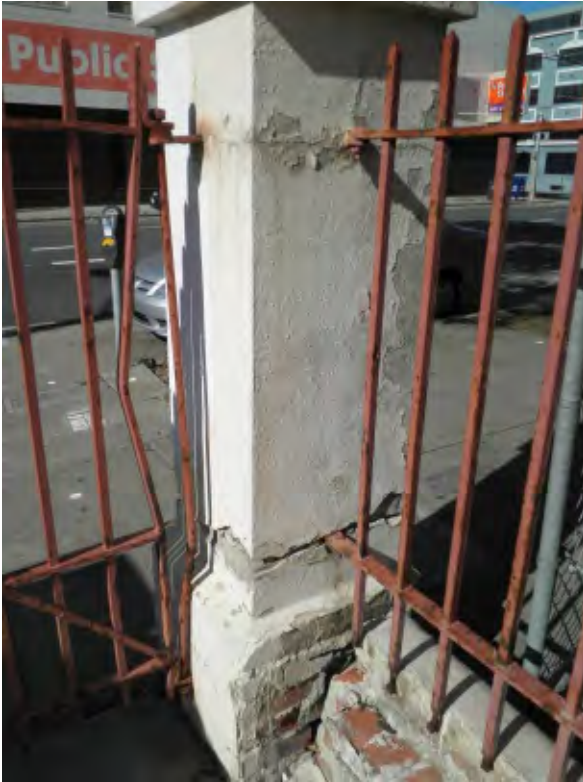
Figure 1a. Pier near west tower, showing large cracks and displaced areas of brick (arrow) and corroded metal fence.

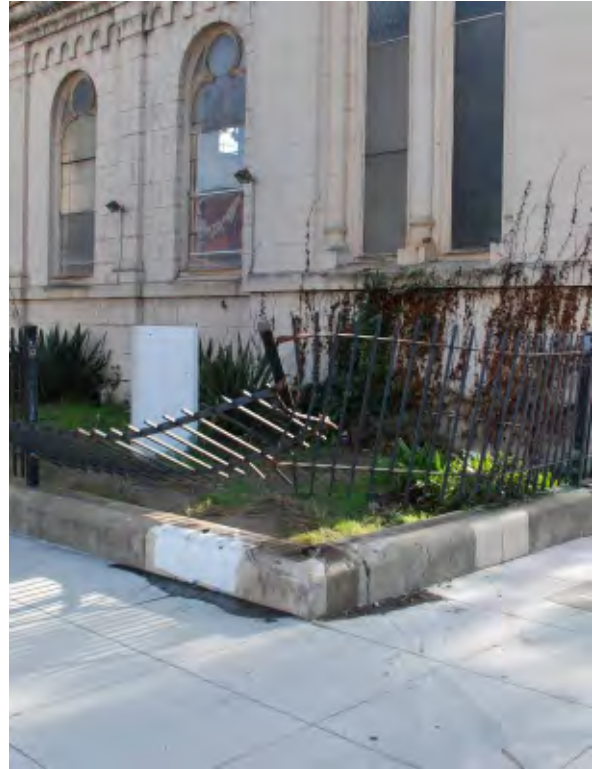
Figure 1b. Damage to metal fence at northeast corner of property.

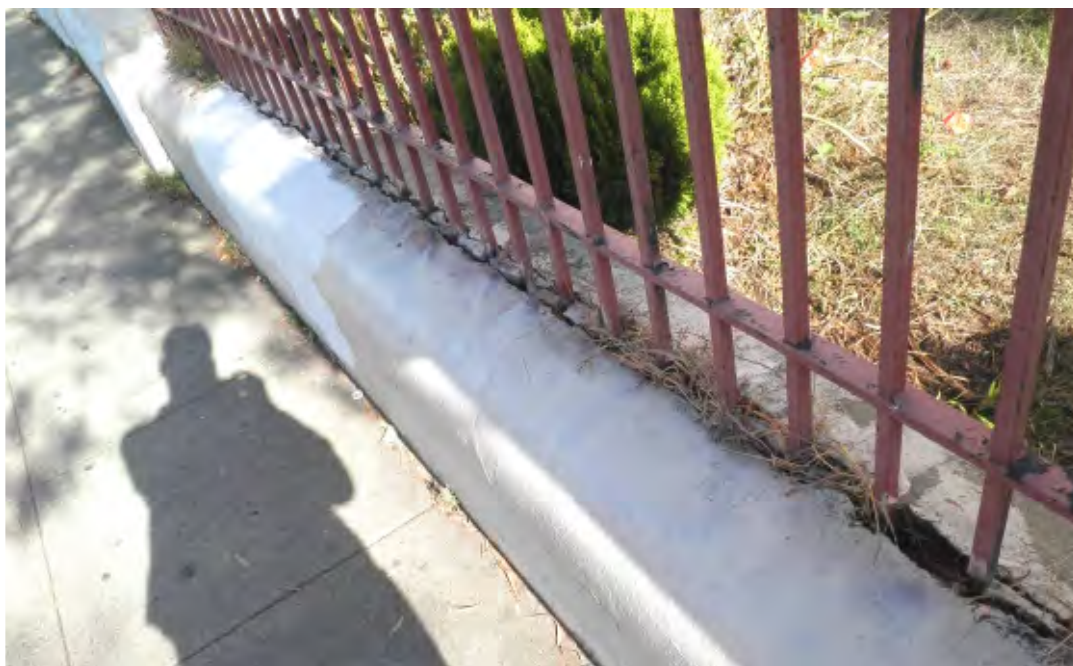
Figure 1c. Low brick wall along Howard Street, showing gaps and voids, corroded metal fence, and graffiti (painted over with mismatched paint).

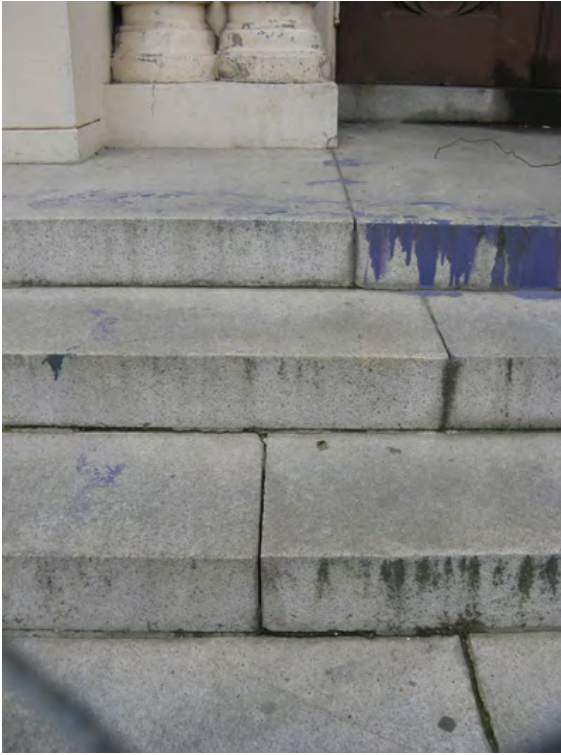
Figure 2a. Main portal steps, showing soiling, paint stains and vertical joints without mortar.

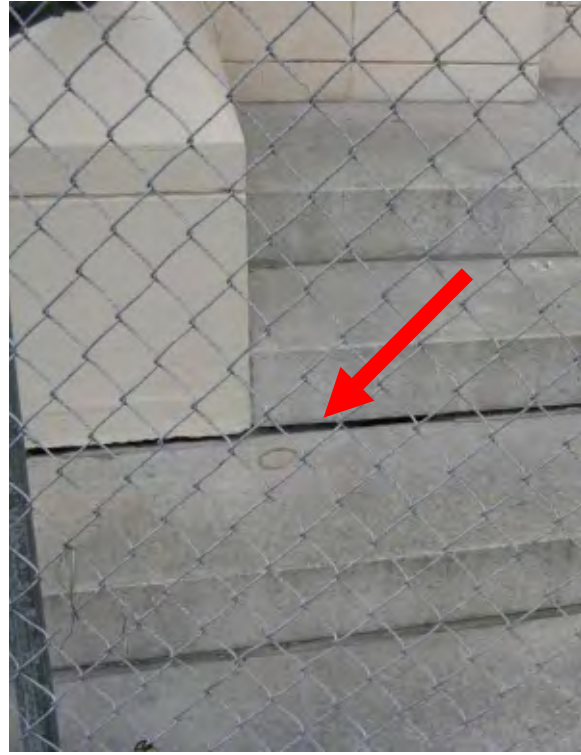
Figure 2b. Detail, east side of main portal steps, showing gap between blocks (arrow) due to uneven settling.

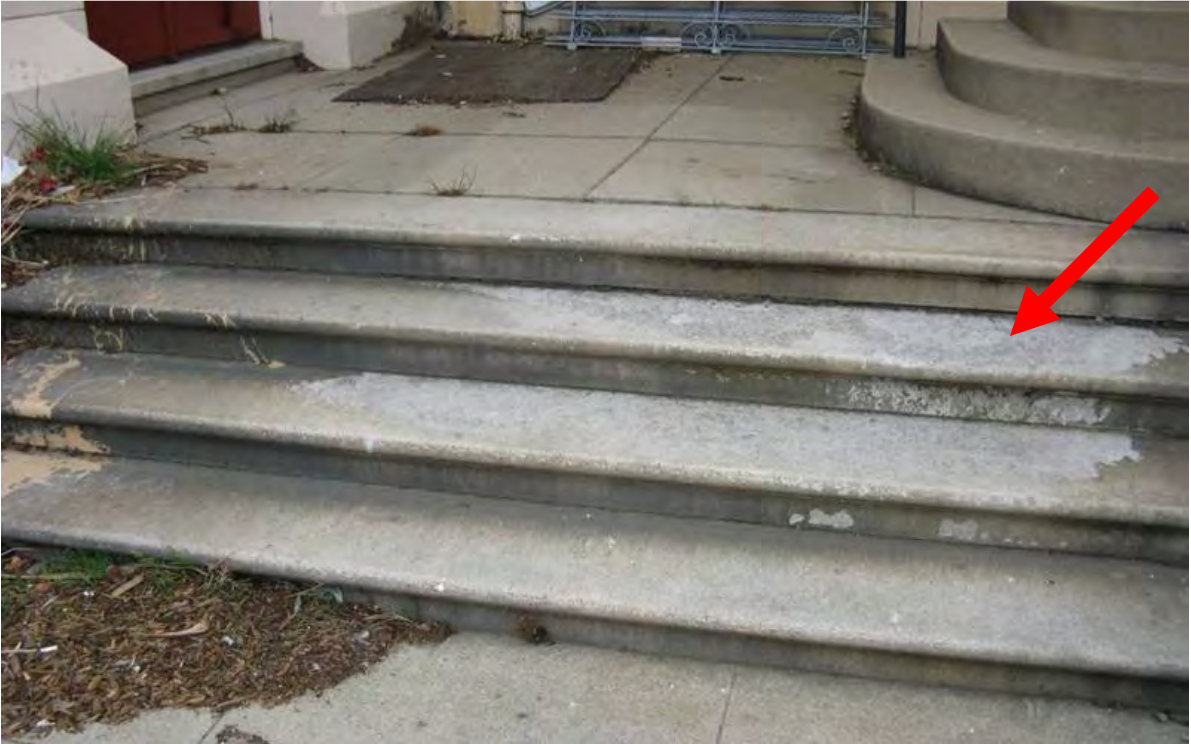
Figure 2d. West transept, south portal steps, showing paint stains (left), soiling and spalling surface (arrow).

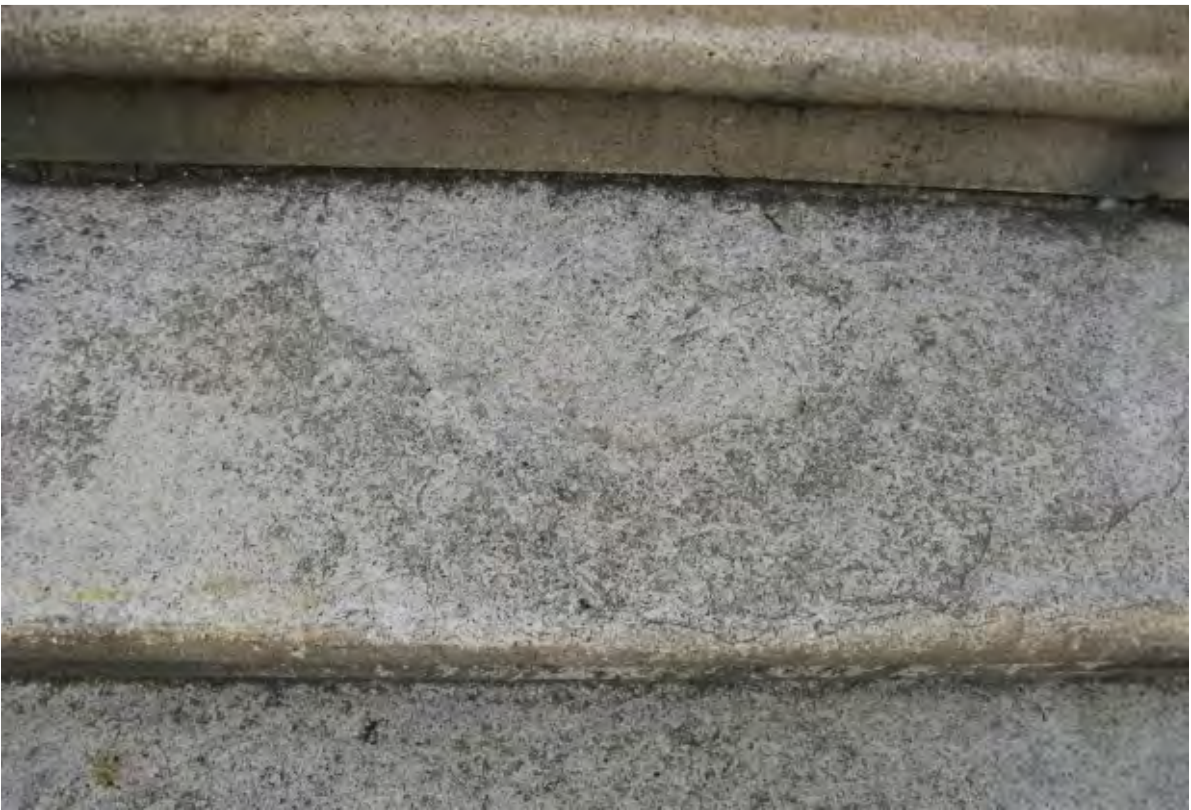
Figure 2e. Detail, south portal steps, spalled surface of granite tread.

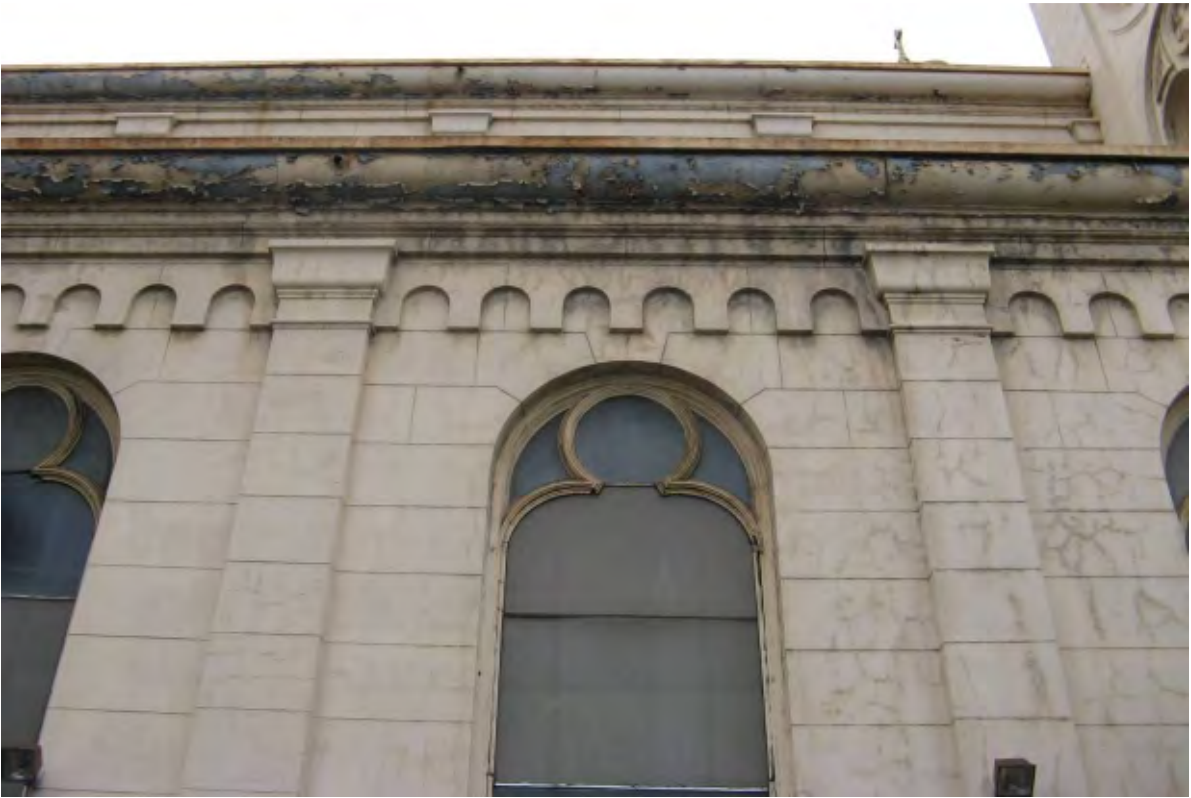
Figure 3a. East nave façade, showing soiling, water staining and hairline cracking of stucco.

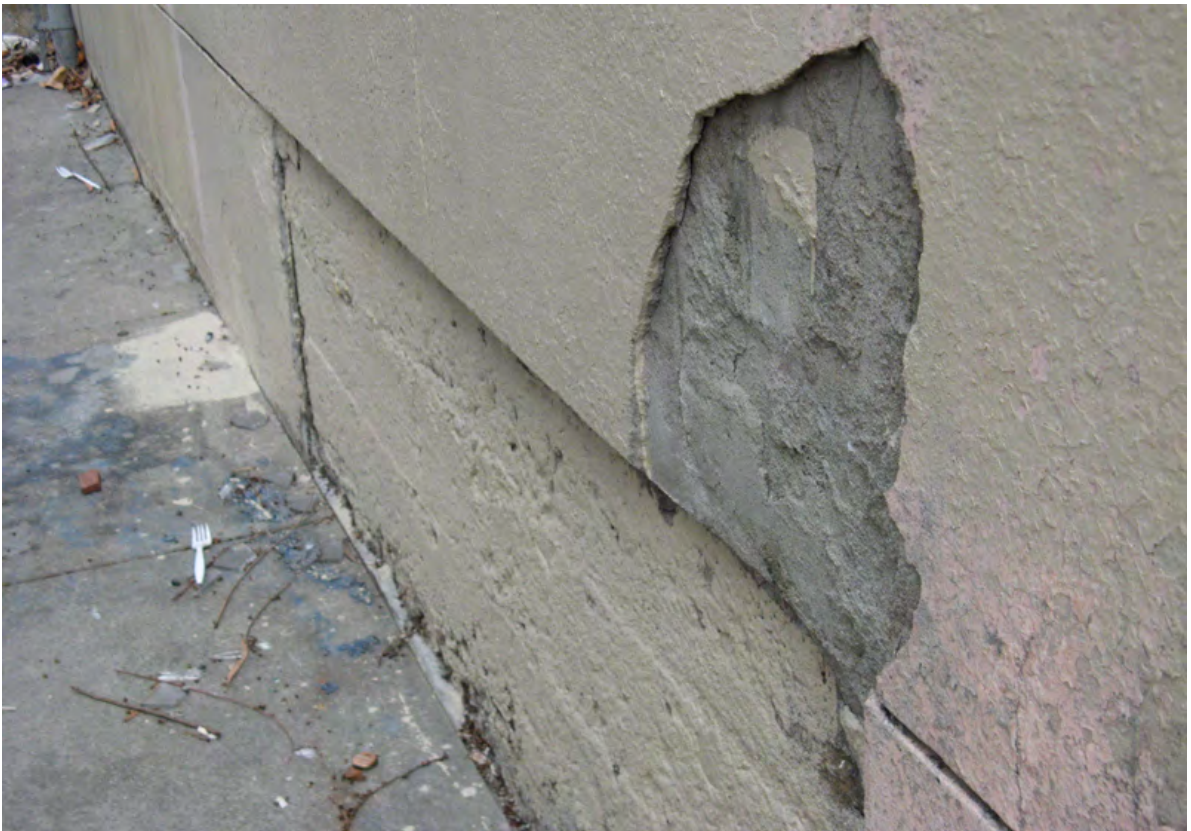
Figure 3b. East tower, north façade, showing loss of stucco at ground level.

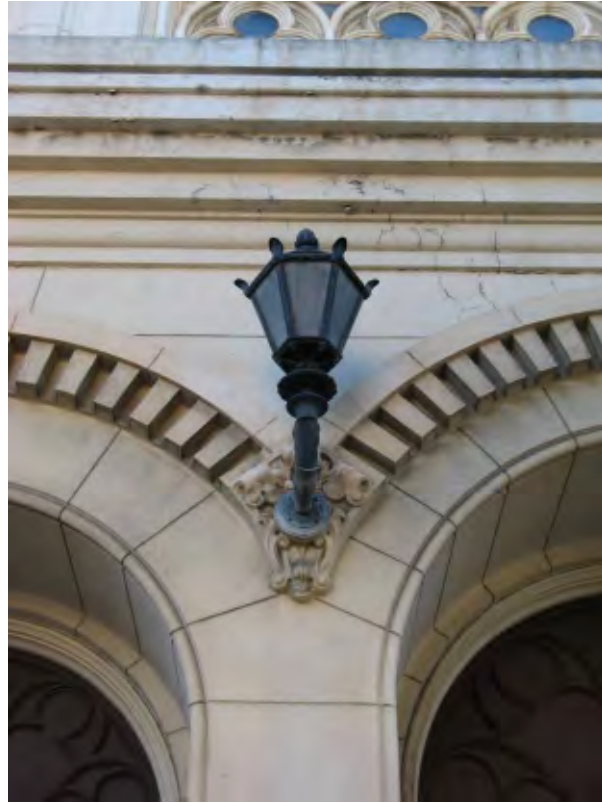
Figure 4a. Light fixtures (now missing) at main entry on north façade in 2007.

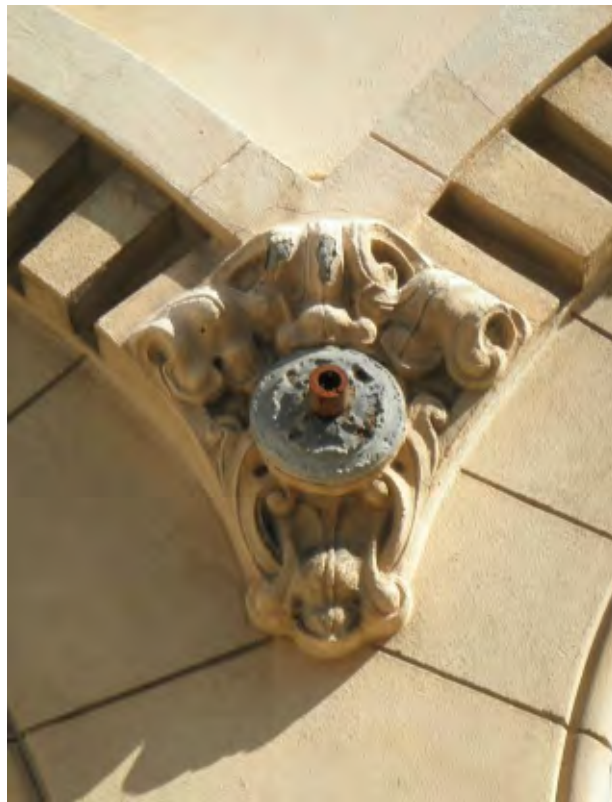
Figure 4b. Detail, original mounting hardware is all that remains in place.

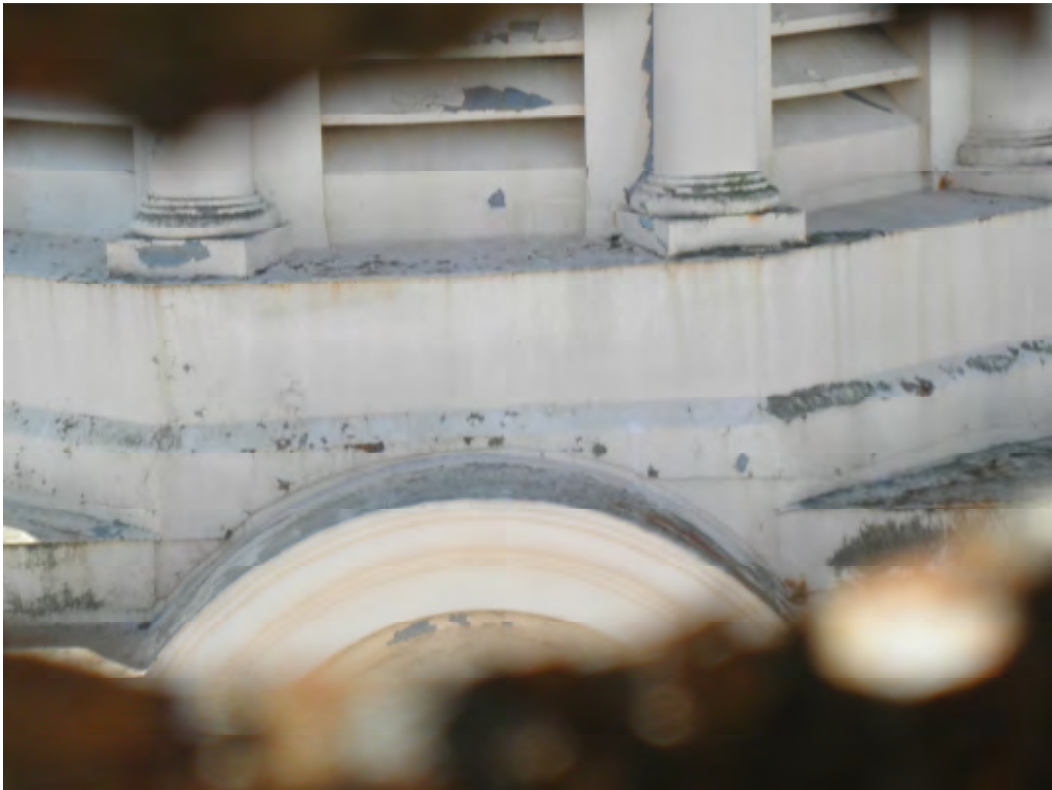
Figure 5a. Detail, rust-through at painted sheet metal cupolas.

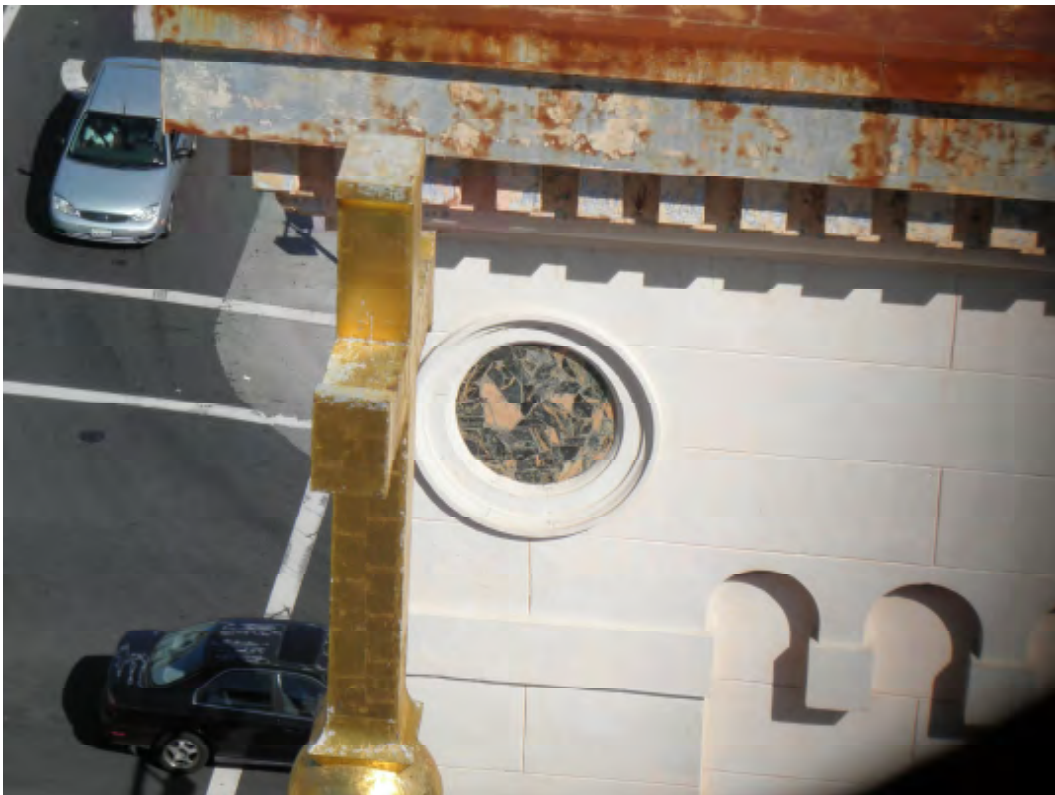
Figure 5b. The rooftop crosses require minor sheet metal and gilding repair.

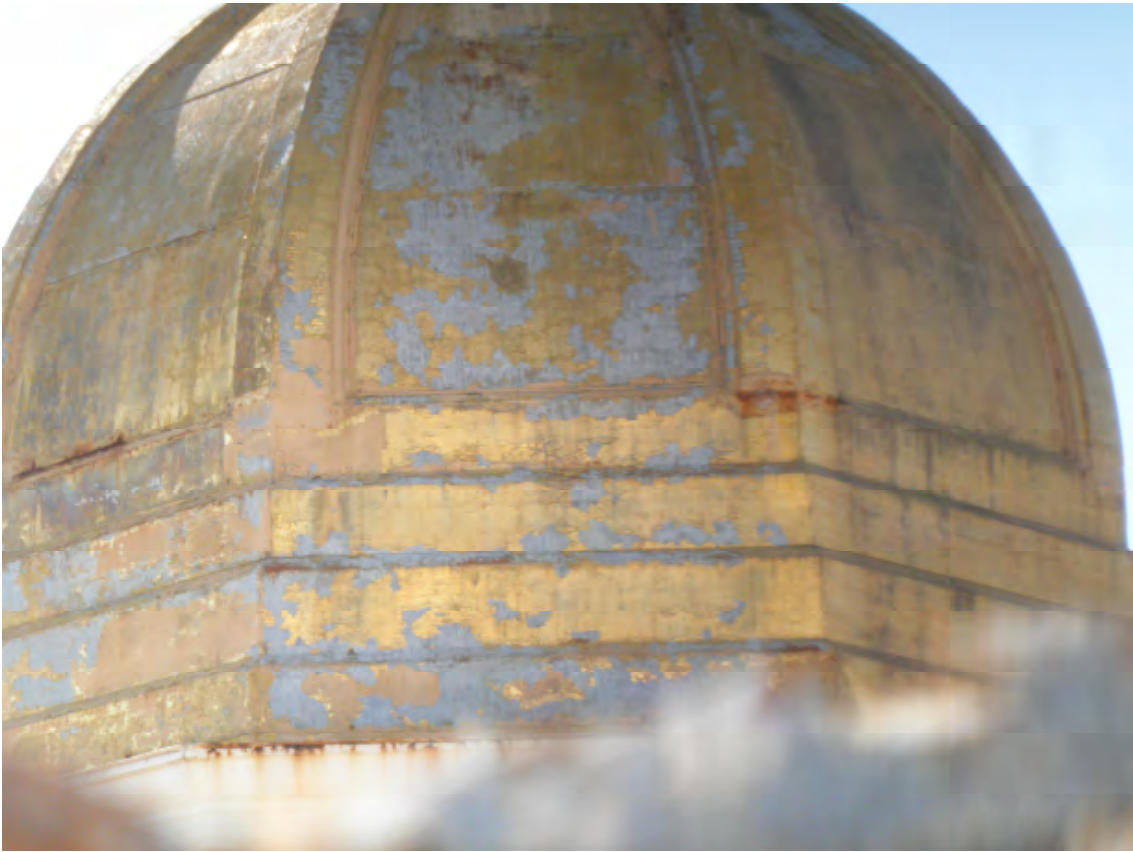
Figure 5c. Detail, corrosion and loss of paint and gilding at domes.
