SAN FRANCISCO PLANNING DEPARTMENT

Certificate of Appropriateness Case Report

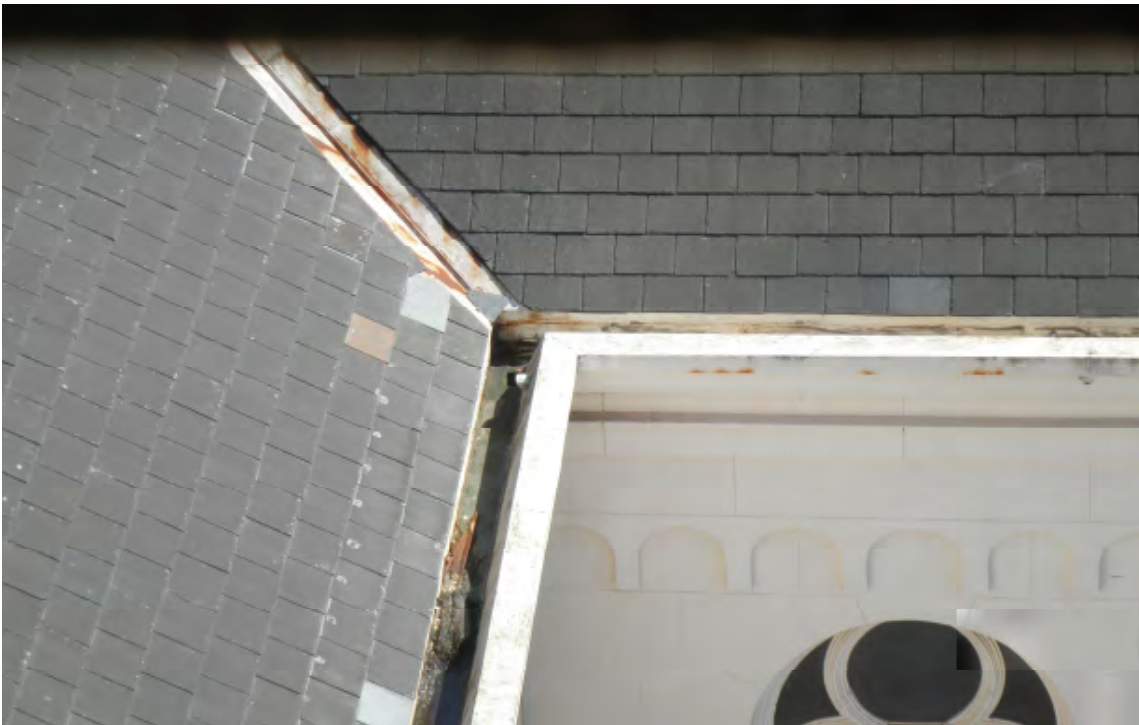
Figure 5d. Broken, loose, and missing slate tiles at main roof.

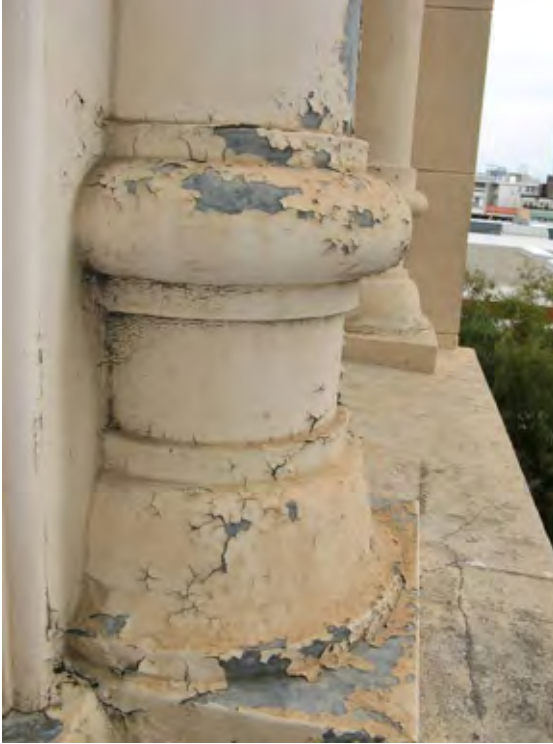
Figure 6a. Column base, south side of east tower, showing flaking and loss of protective paint layer.

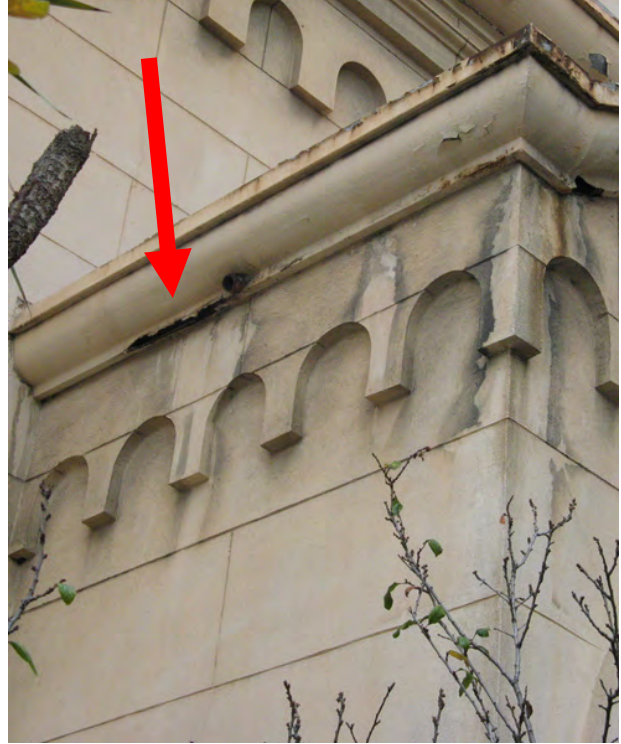
Figure 6b. Cornice above north portal, east transept, showing perforation (arrow) of the metal due to corrosion.

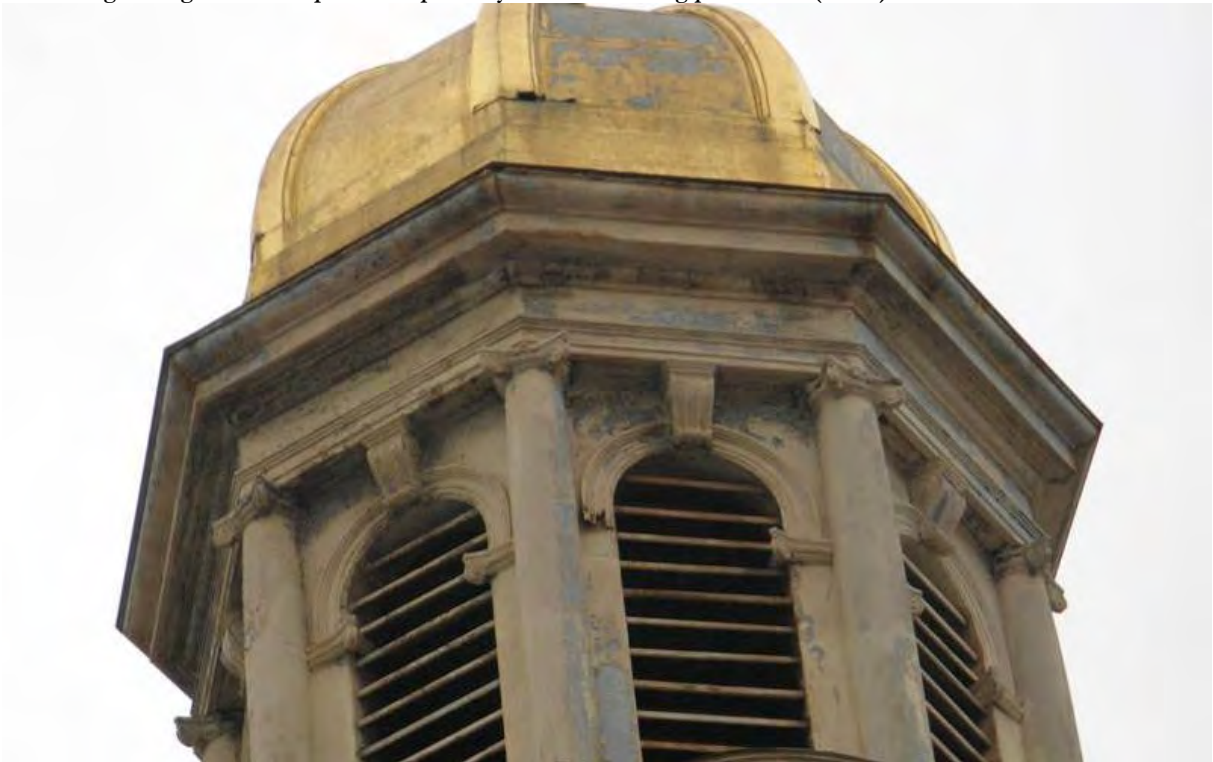
Figure 6c. East tower detail, constructed entirely of pressed sheet metal, showing missing architectural detail, loss of gilding and protective paint, and corrosion stains.

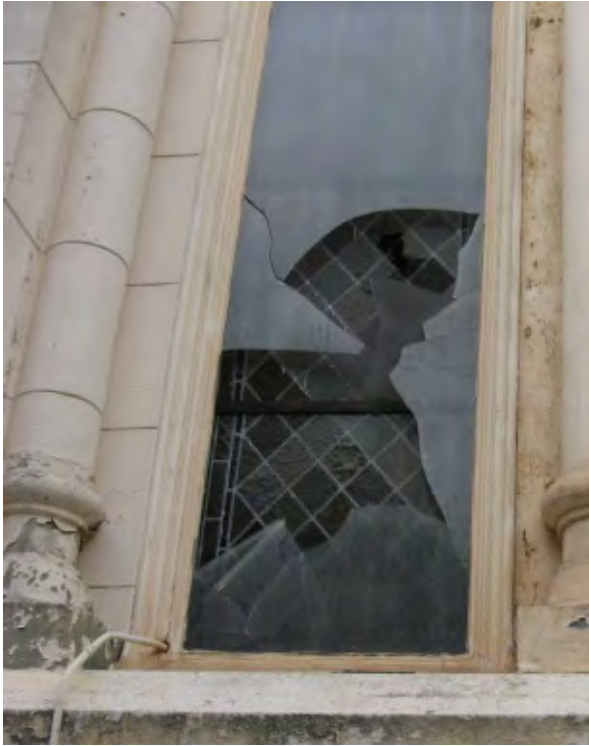
Figure 7a. West tower, north window, showing broken protective glazing.

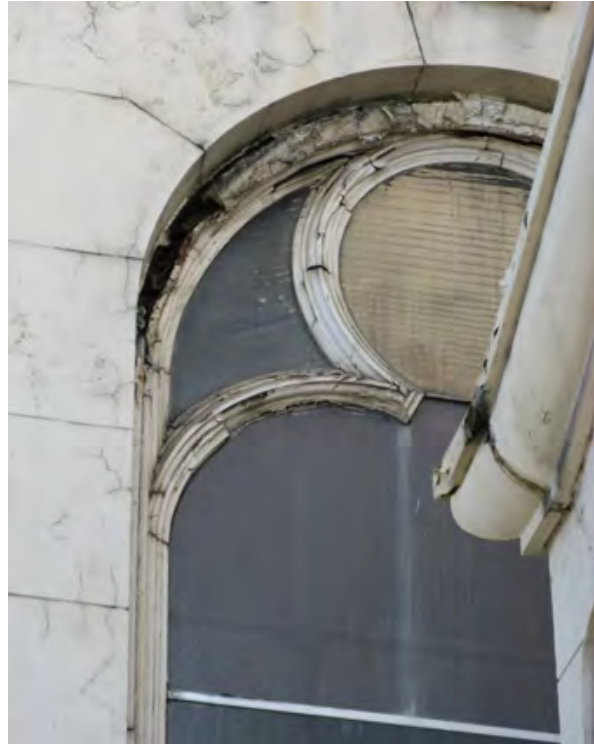
Figure 7b. East façade, transept window, showing soiling, paint loss and rotting/loss of tracery elements.

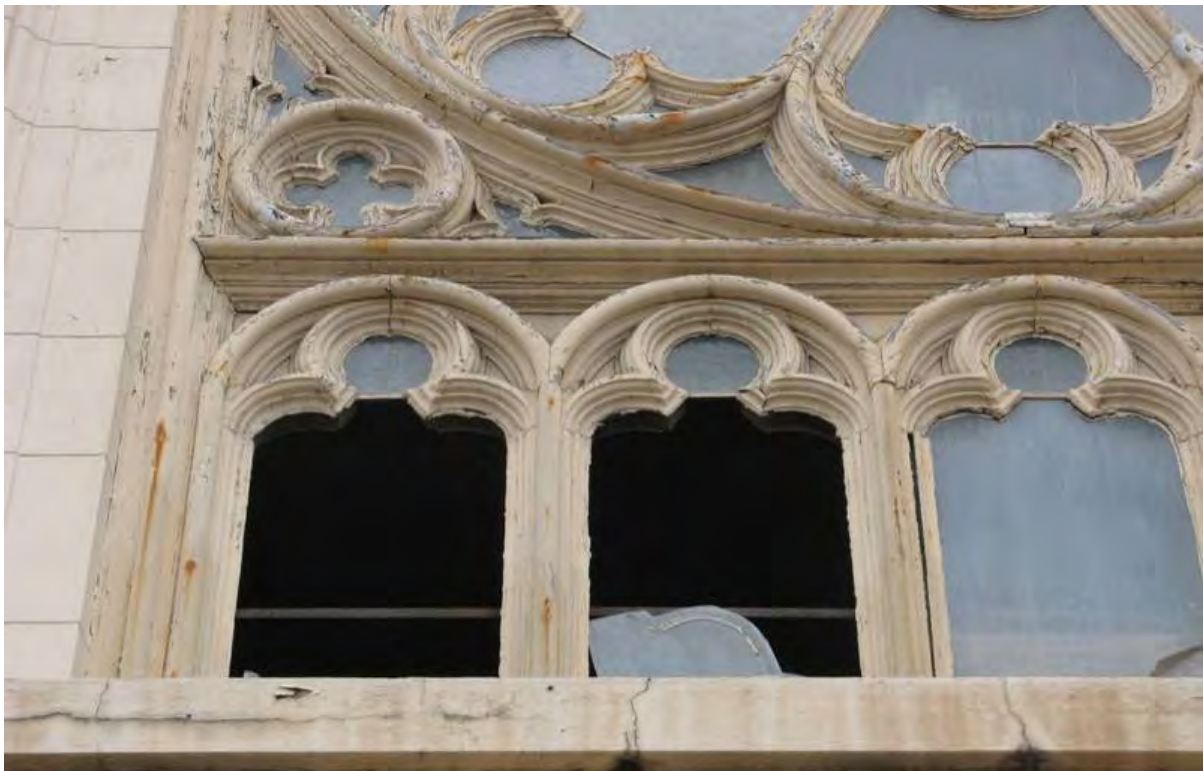
Figure 7c. West transept rose window, showing paint loss and missing glazing.

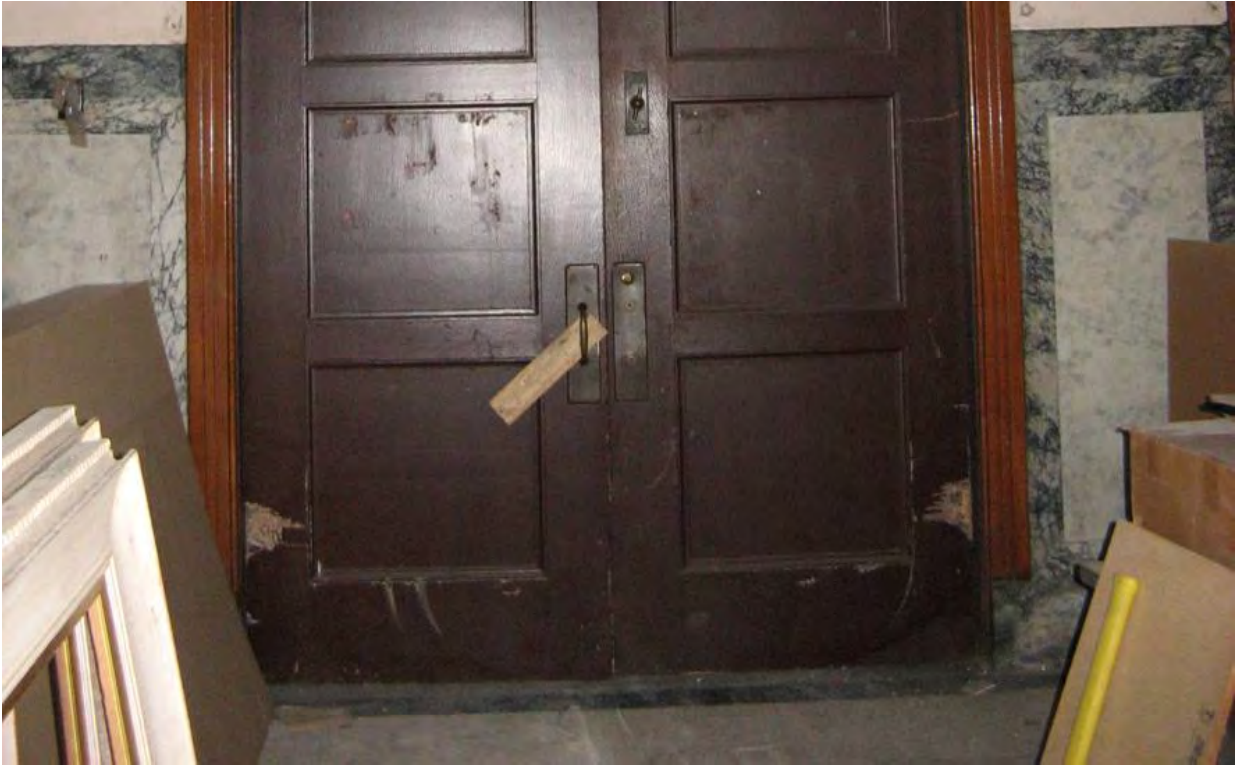
Figure 8a. Marble wainscoting of the narthex, showing soiling of the baseboard, wear of polished surface, and adhered tape.

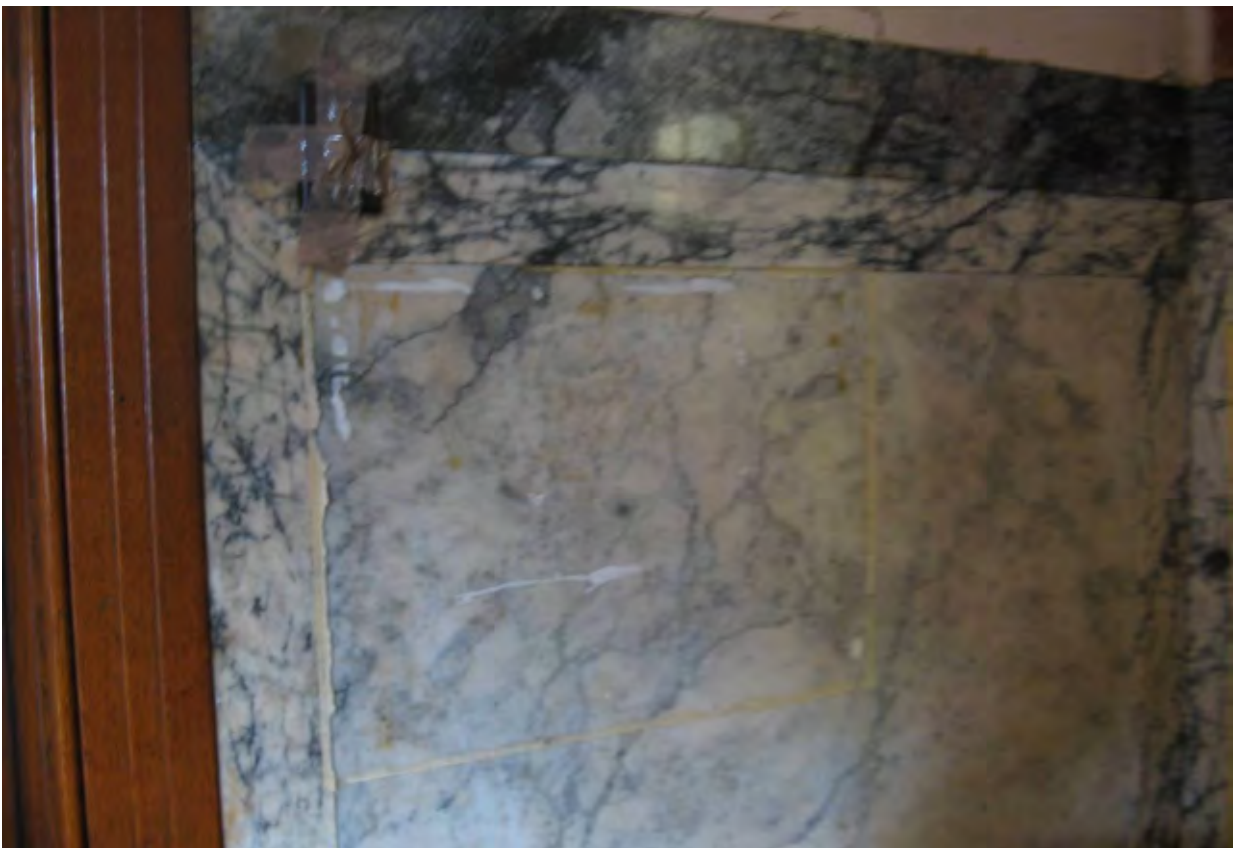
Figure 8b. Detail, showing tape and adhesive residue.

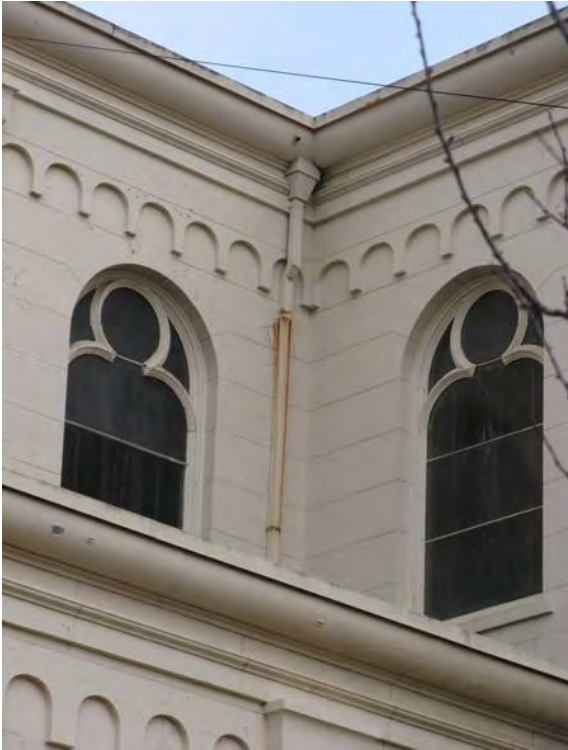
Figure 9a. West façade, showing blocked or perforated drainage which is causing damage to interior plaster.

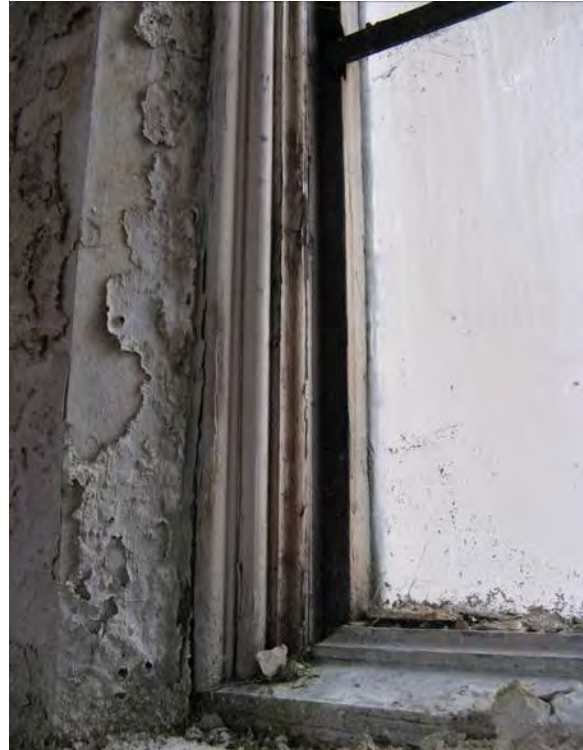
Figure 9b. Deterioration of plaster caused by moisture from poorly sealed window.

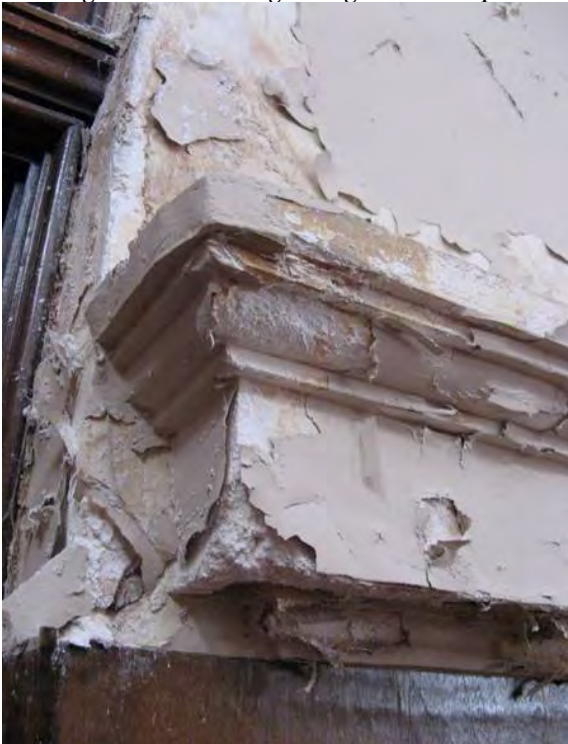
Figure 9c. Softening and deterioration of decorative plaster elements caused by moisture from faulty roofing.

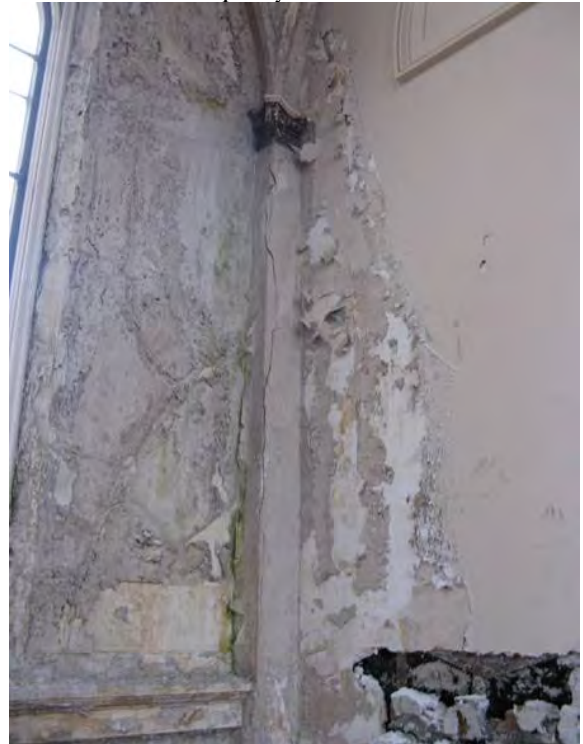
Figure 9d. Structural cracking and separation of plaster details from masonry substrate caused by moisture from blocked drains.

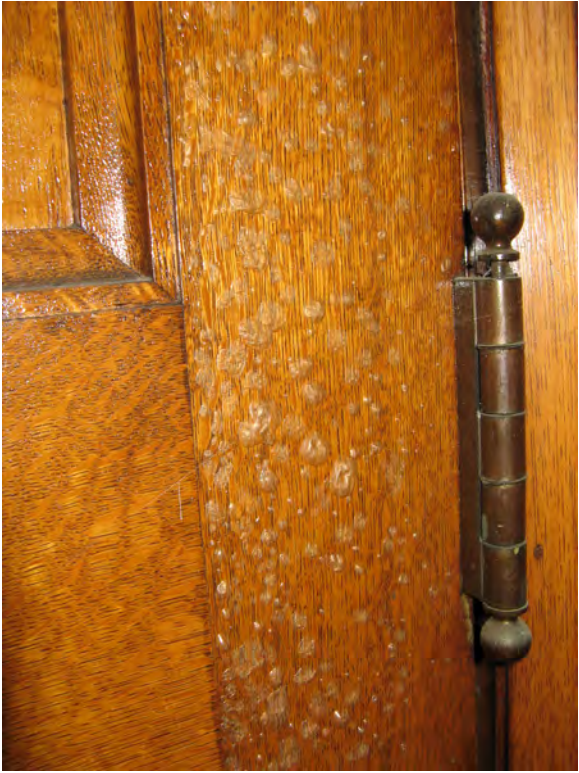
Figure 10a. Blistering of varnish on an oak door caused by moisture penetration.

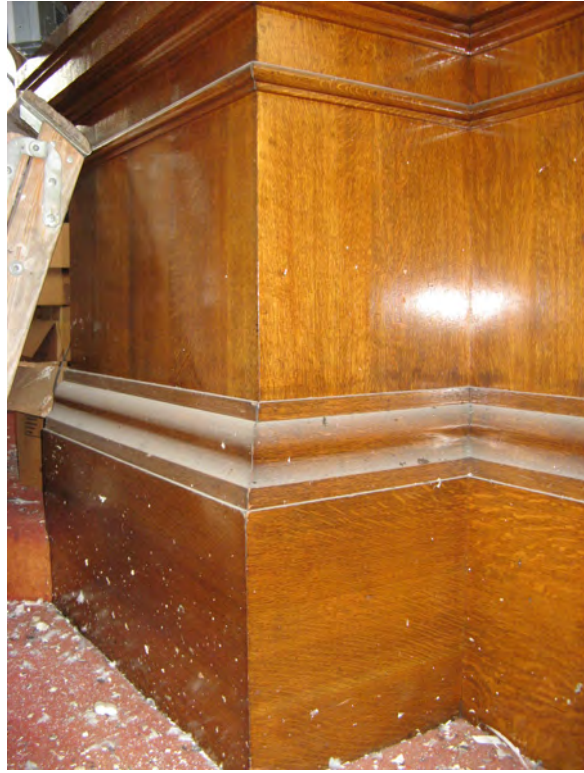
Figure 10b. Dust (on molding) and paint/guano spatters can cause permanent damage to wood finish.

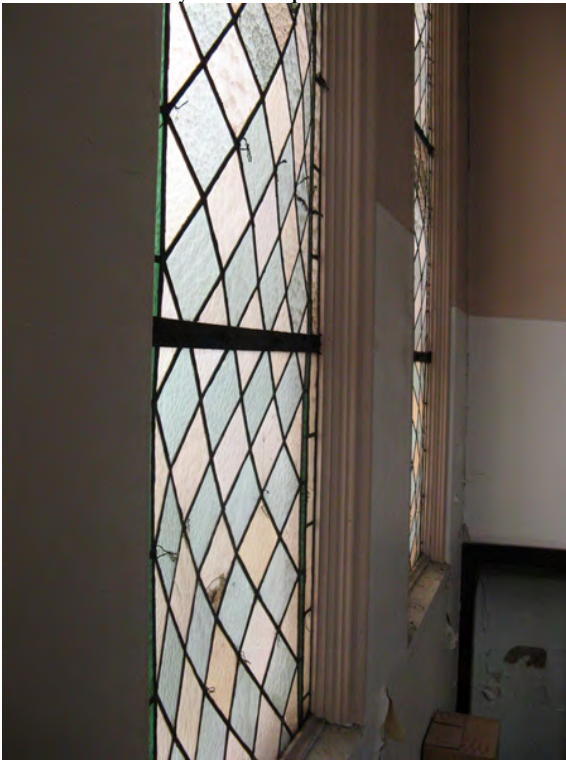
Figure 11b. East tower, east windows, showing bowing of windows due to sagging lead cames or detachment from saddle bars.

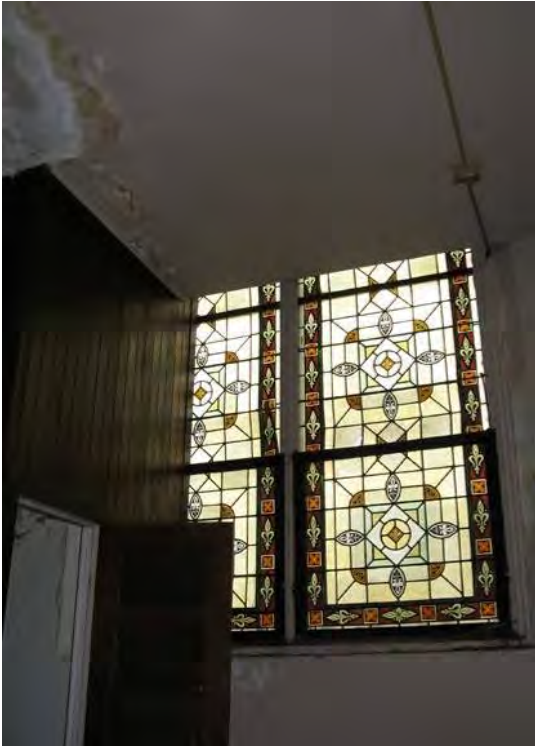
Figure 11d. Kitchen window, showing partition partially covering painted stained glass.

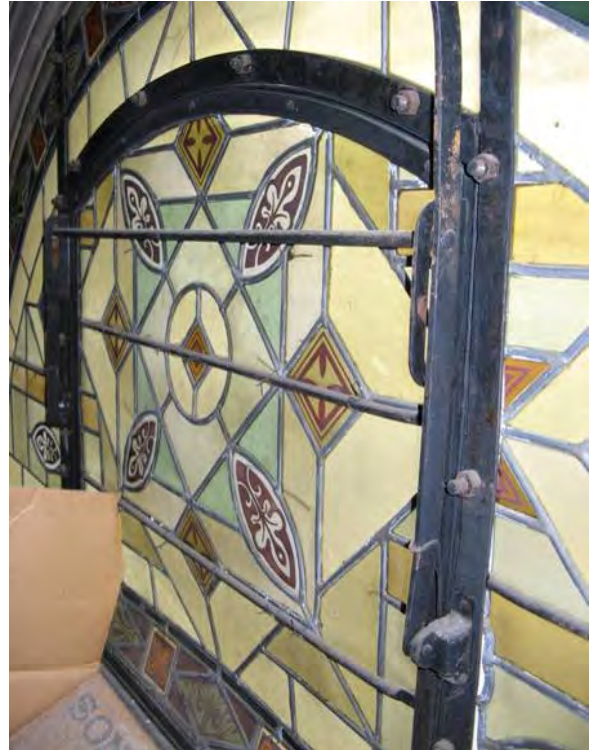
Figure 11e. Upper portion of window showing corroded hopper-type opening assembly.

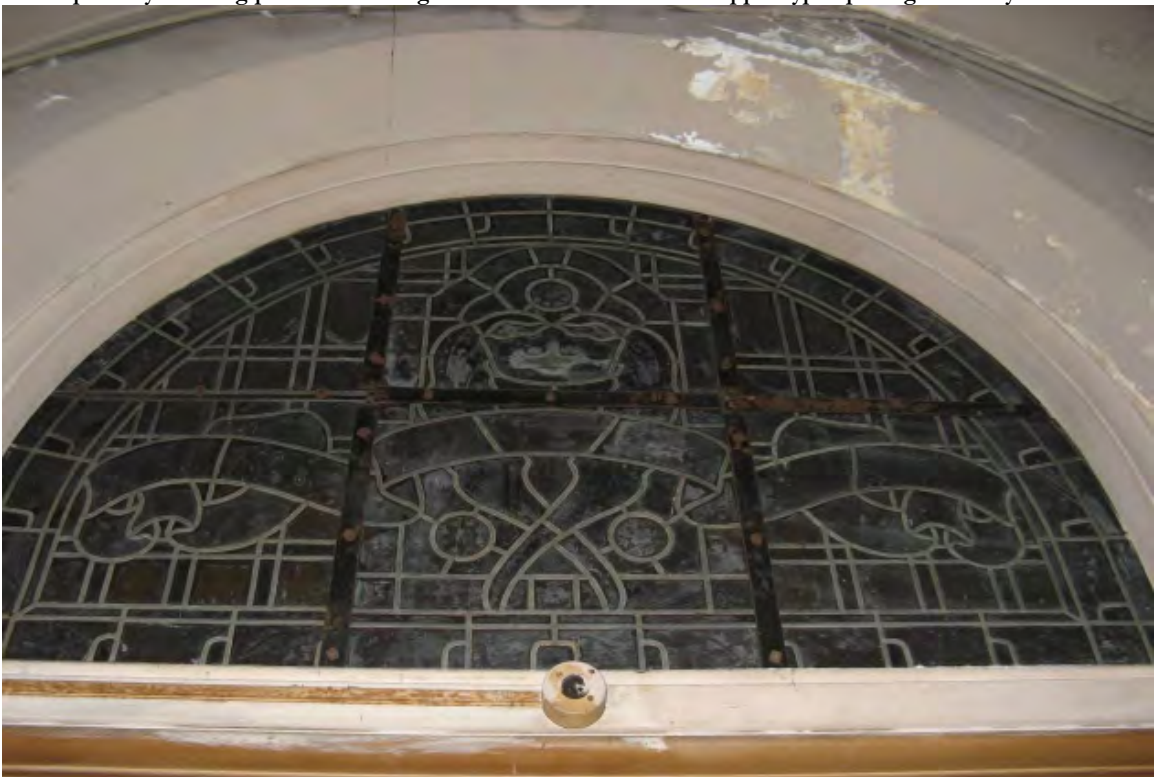
Figure 11a. North-east transept portal, showing blocked figurative stained glass window with heavy soiling and corrosion of steel frame

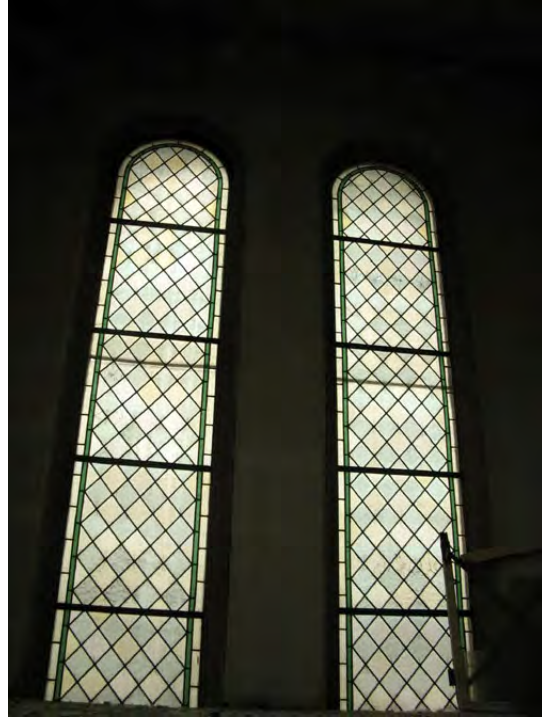
St. Joseph's Church interior. Detail of stained glass window in corner tower.
Source: Page & Turnbull, November 2007.

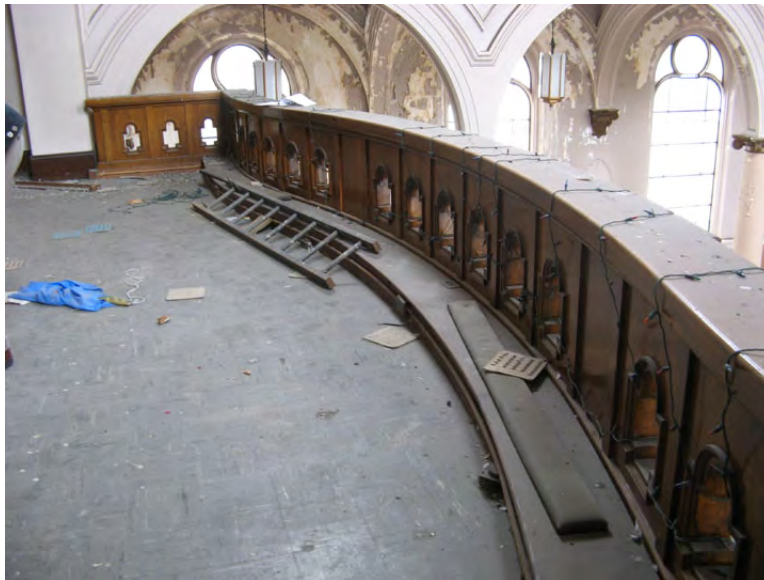
St. Joseph's Church interior. Detail of second-floor choir railing.
Source: Page & Turnbull, November 2007.

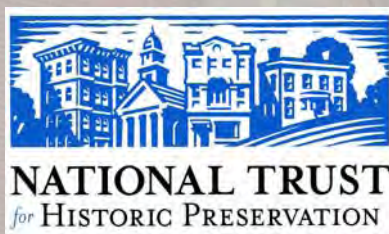
Starting a restaurant can be a daunting venture for any small time businessperson. Luckily, the former St. John the Baptist Catholic Church provided the perfect space for a restaurant and brewery. Now open for eight years, the Church Brew Works has been voted Pittsburgh's best eatery due to the rave reviews for cuisine and ambience from local and national visitors.

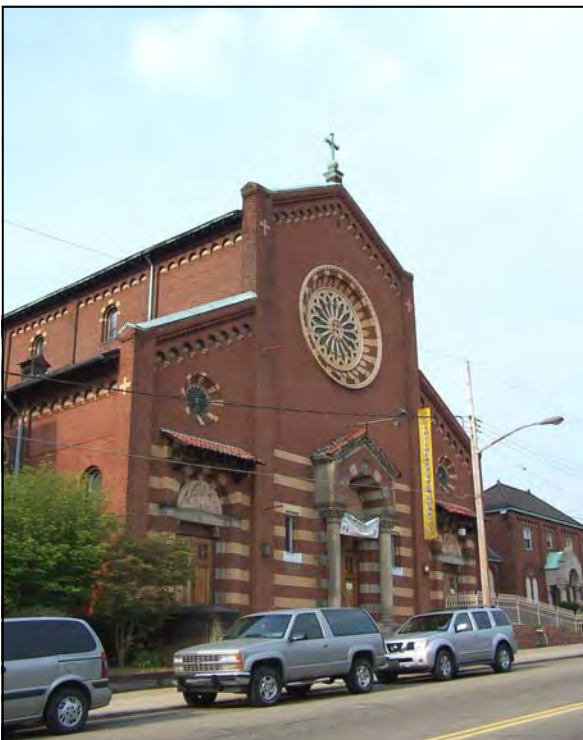
Adrian Scott Fine/NTHP

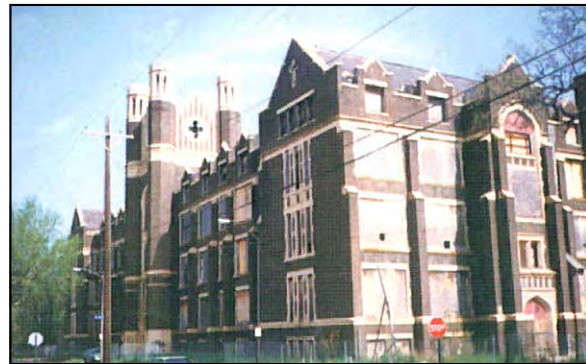
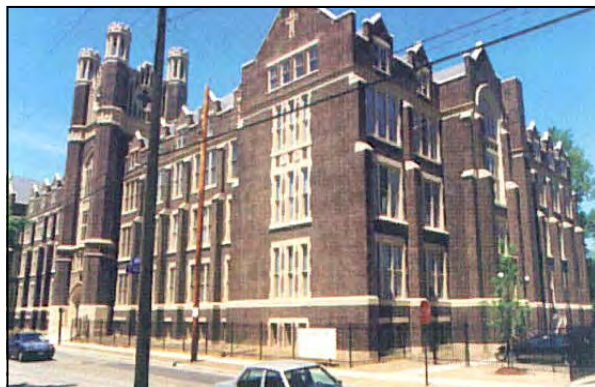
Sandvick Architects, Inc.

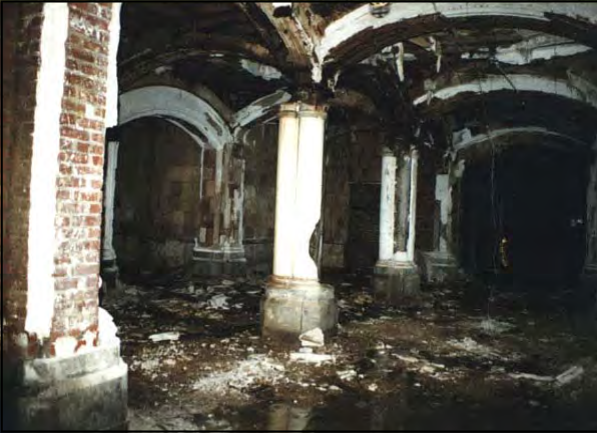
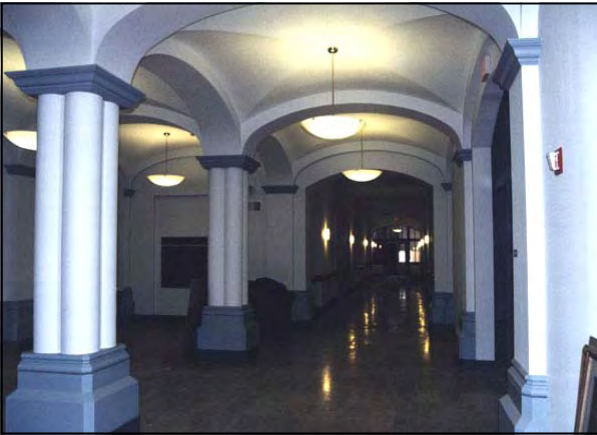
Sandvick Architects, Inc.

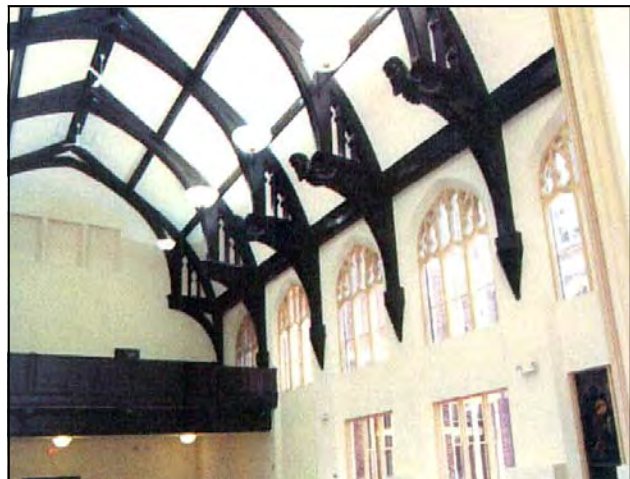
Sandvick Architects, Inc.

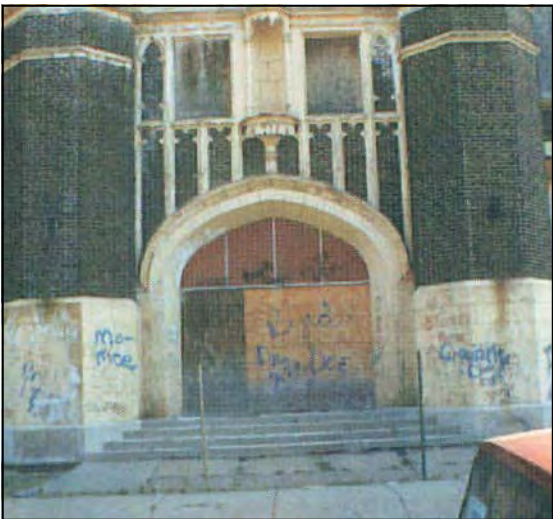
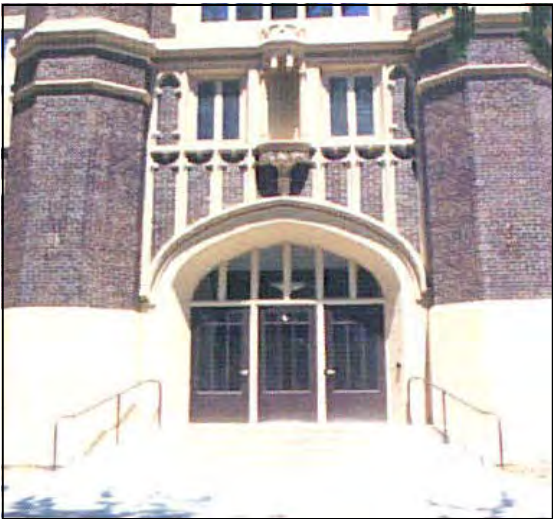
Sandvick Architects, Inc.

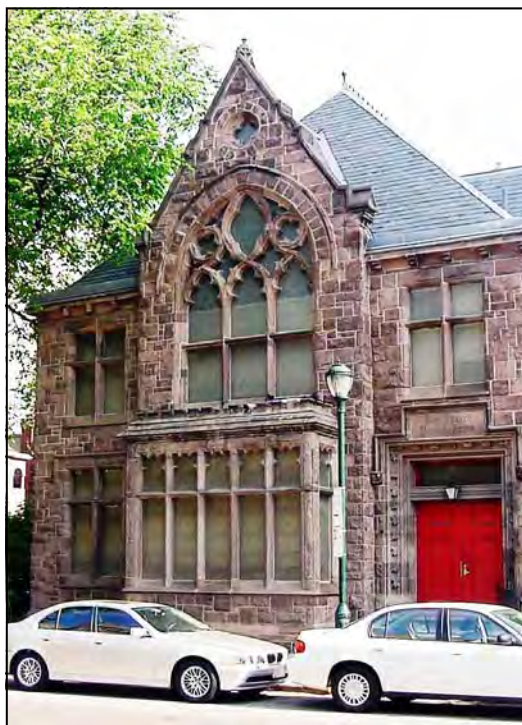
Neeta McCulloch/NTHP

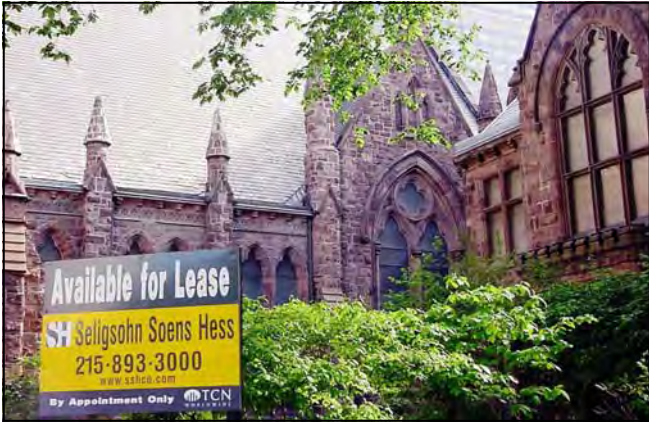
Several tenants have occupied the former church since its conversion in 1989, initially as Graduate Health System Corporate Headquarters.

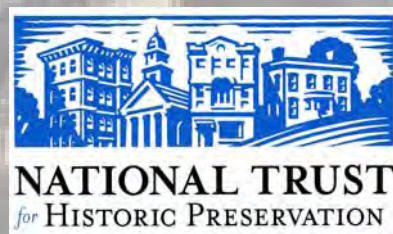
Neighbors and local leaders who may have been primarily interested in the community uses of a church building also became advocates for its preservation through the creation of the King Center Charter School. The formidable landmark stands at the corner of Genesee and Rich Streets in Buffalo's East Side neighborhood. The former St. Mary of Sorrows Roman Catholic Church was built in 1891 for a primarily German congregation in a unique Rhenish Romanesque Revival style with local quarried blue limestone. The church building is one of many that dot the skyline of the neighborhood in an area that was previously the home of a wide mixture of first generation immigrants from Germany and Poland. Over time, the surrounding neighborhood has changed with many of the original residents moving to the outlying suburbs.

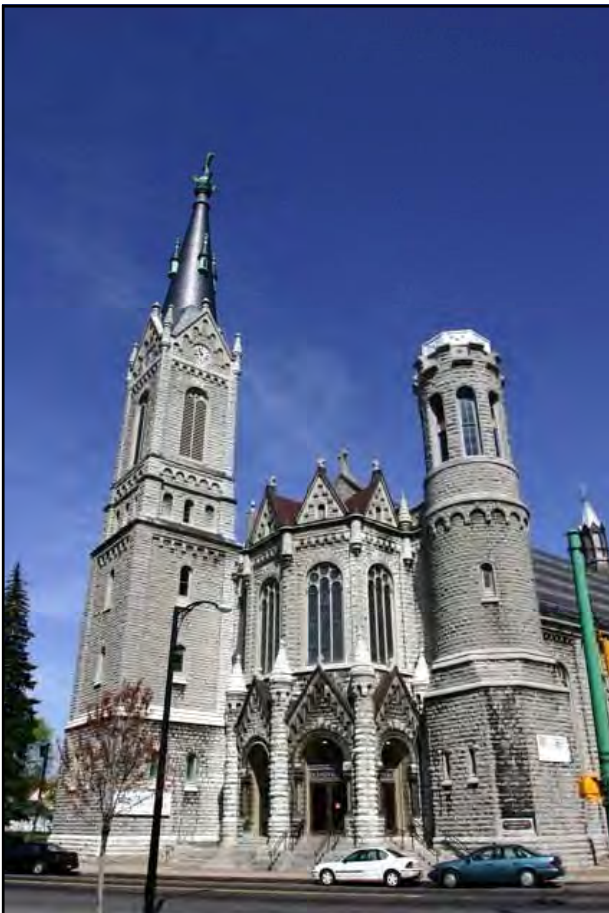
By the 1980s, the congregation had dwindled to 120 families and the diocese began consolidating parishes in the area. Plans were made to demolish the building due to the building's deteriorated state. As word of the plans

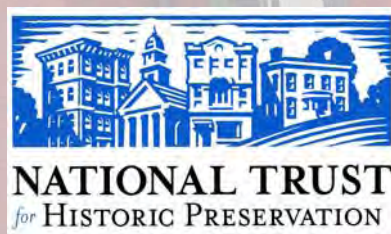
When the diocese of Portland, ME announced the closure of St. Dominic's parish in 1997, many of the congregation and community members were fearful of what would happen to the historic building. The perseverance of the citizens who wanted the building to be used as an active meeting space caused public officials and social service agencies to support a new use. Their tenacity has meant that the former Catholic church will be used as a vibrant collaboration of social programs, affordable housing, a community center, and an educational heritage facility.

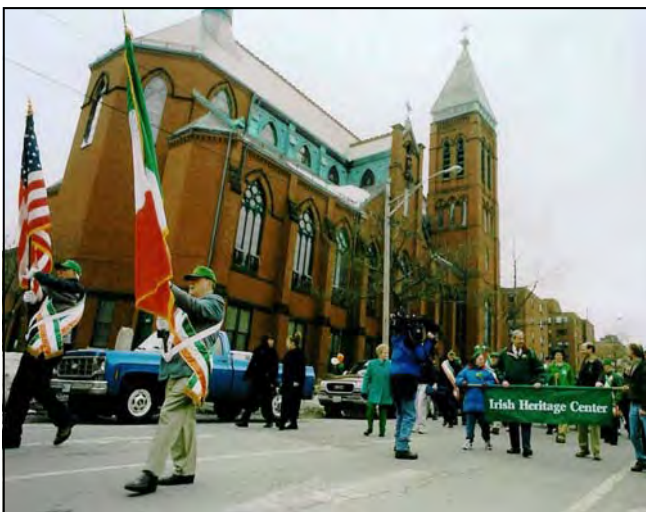
The former St. Dominic's Church building has become an effective backdrop for the Irish Heritage Center and their goal to promote the Irish heritage throughout Maine.

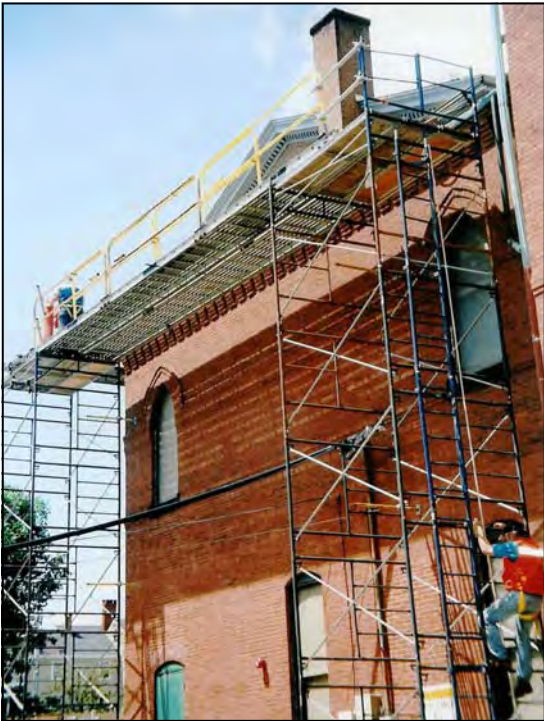
Maine Irish Heritage Center

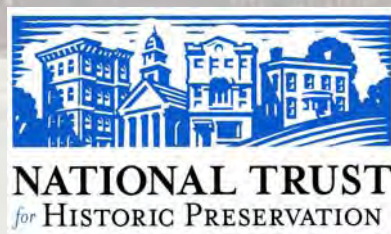
The village of Oak Park is located in the first inner ring of suburbs directly west of downtown Chicago. Although the population size of Oak Park is not comparable to major metropolitan cities, its relationship and proximity to Chicago causes it to experience many of the problems that larger cities do. The history and location have made the village desirable to many new residents, especially because it is the former home of Frank Lloyd Wright and his studio as well as the birthplace of Ernest Hemingway.

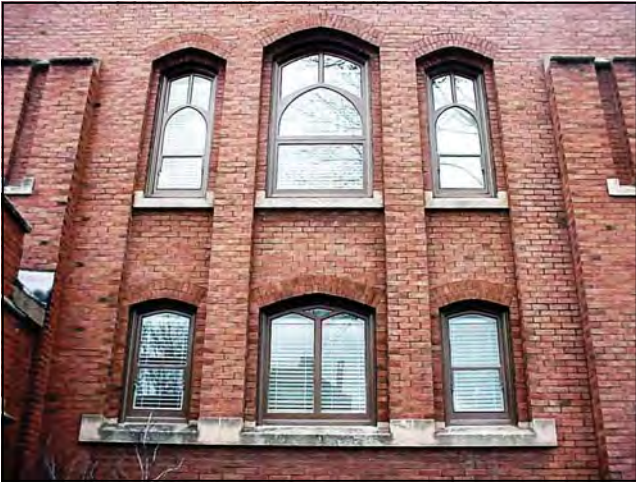
Preservation and retaining important historical features were the goals of the project. In order to achieve this, repairs to the roof needed to be done to stop the long-term leakage that had caused the sanctuary floors to buckle.

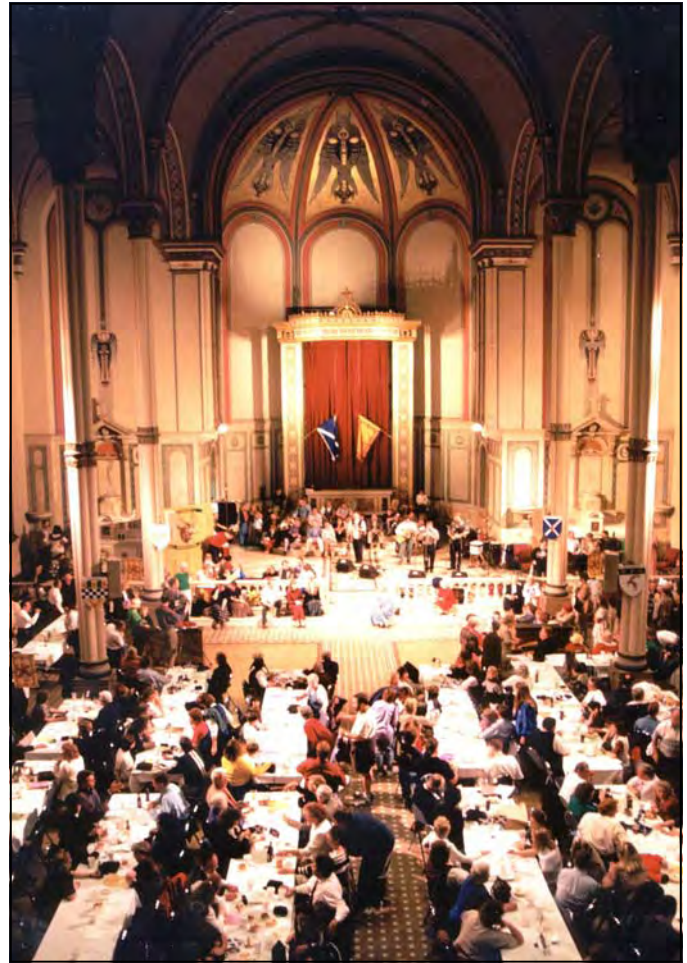
The team who purchased Old St. George has spent the past decade raising dollars and restoring the church with more than \$350,000 invested to date on renovations. Exterior work has included slate roof repairs, new box gutters and downspouts. On the interior there has been new plaster and paint, restoration of original church doors and the installation of a high-end performance space in the former sanctuary with acoustic curtains and sound system.

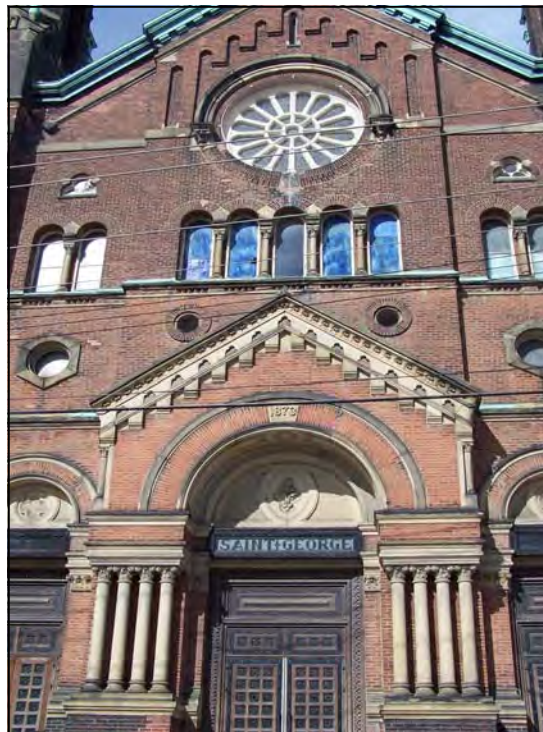
Adrian Scott Fine/NTHP

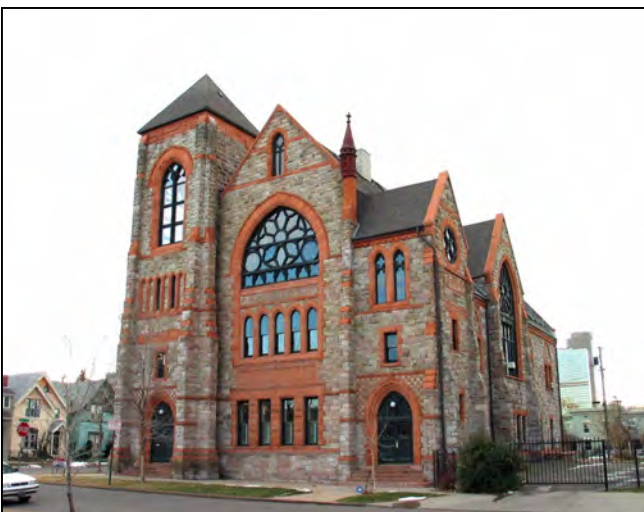
Sanctuary Lofts, housed within the former 1889 Methodist Episcopal Church in Denver, Colorado.

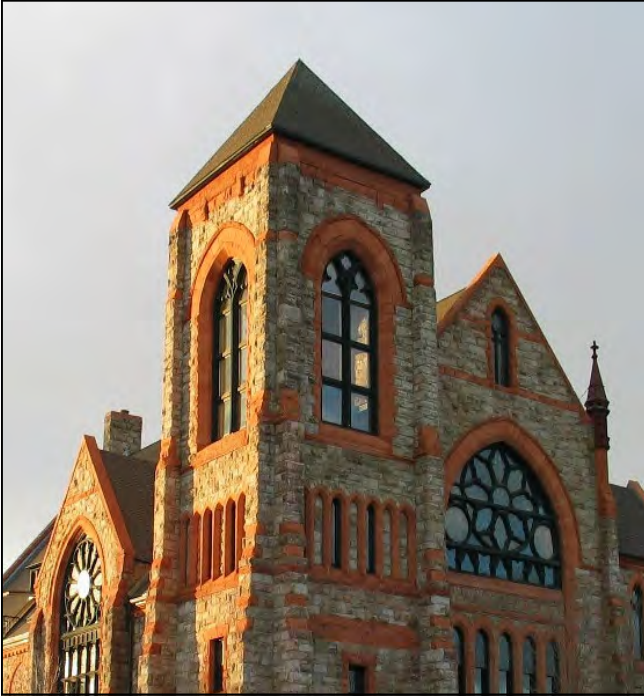
All of the lofts are individual, high-end units that feature stained glass windows, hand-crafted woodwork and high ceilings. First floor units are on one level while those on the second and third floors have two and three stories. Great care was taken to retain architectural features despite the new interior configuration. One loft features the church's ornate Rose Window in a living room space. Others include soaring vaulted spaces.
