State of California — The Resources Agency
 DEPARTMENT OF PARKS AND RECREATION
PRIMARY RECORD

*Resource Name or #: 612 Arlington Street

c. Address: 612 Arlington Street City: San Francisco Zip: 94131

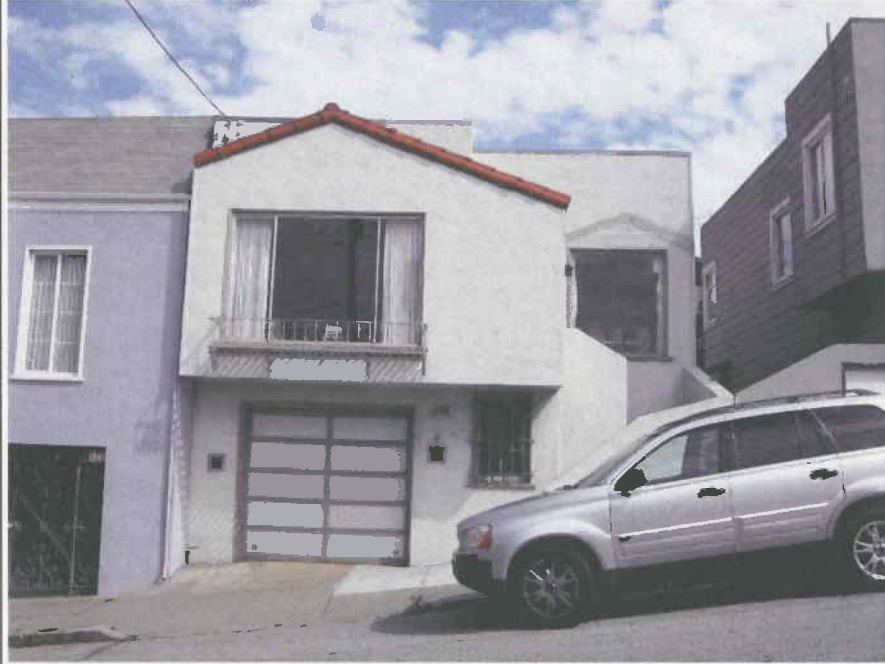
P5a. Photo or Drawing

This two-story, single-family residence is rectangular in plan. The wood-frame building has stucco cladding and a flat roof with a parapet. Notable features on the façade's first story include a single-car garage with a roll-up door, a wood-sash fixed window with a metal grille, and an exterior staircase with a closed rail that leads to the second-story entrance. An asymmetrical gabled bay with a clay tile-clad roof projects over the first story garage and contains a tripartite window with metal-sash, slider and a metal balcony below. Alterations to the residence include the replacement of the garage door and select windows. A ghost outline over the second-story, wood-sash fixed window and main entrance indicates additional gables may have been removed.

P5b. Description of Photo:
 View of the façade from Arlington Street;
 June 2, 2009.

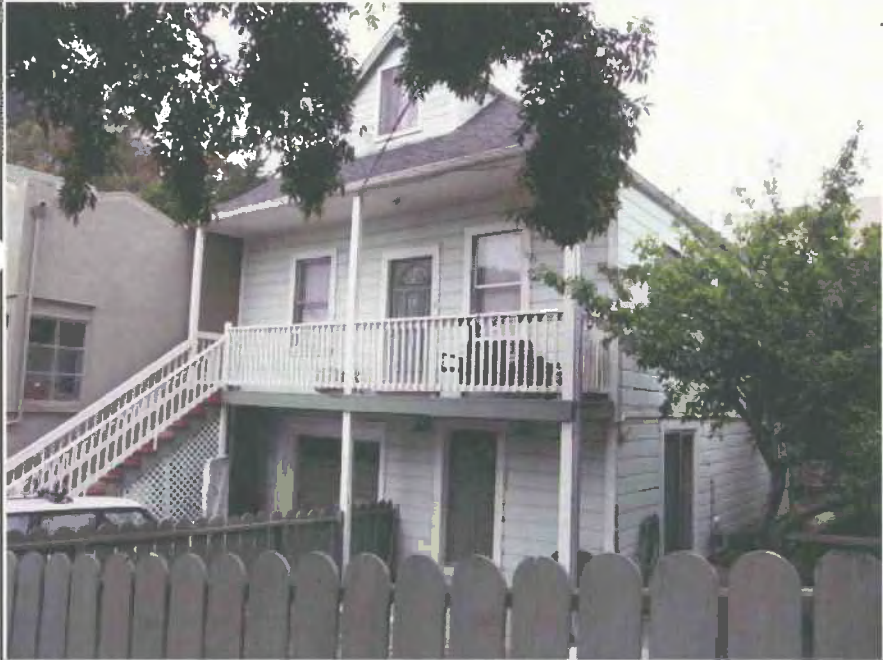
P5a. Photograph or Drawing (Photograph required for buildings, structures, and objects.)

P5b. Description of Photo:
View from Burnside looking west

Built in 1908, 20 Burnside is a semi-attached wood frame single family dwelling on a slightly irregular 36 x 56 foot lot on the west side of Burnside Avenue. The 2 1/2 story structure faces east, and is clad in wood shiplap siding, and is set back approximately 20 feet from the property line. The ground floor in two building bays contains a straight run of wooden steps leading to the main entry on the second floor, and a single wood sectional overhead garage door on the left. The right bay contains a single paneled door. The second floor is characterized by a full width porch supported by square wooden posts, and consists of a centrally located paneled door flanked by single 1/1 wood windows. The hipped roof contains a front facing gabled dormer with a single aluminum replacement sash.

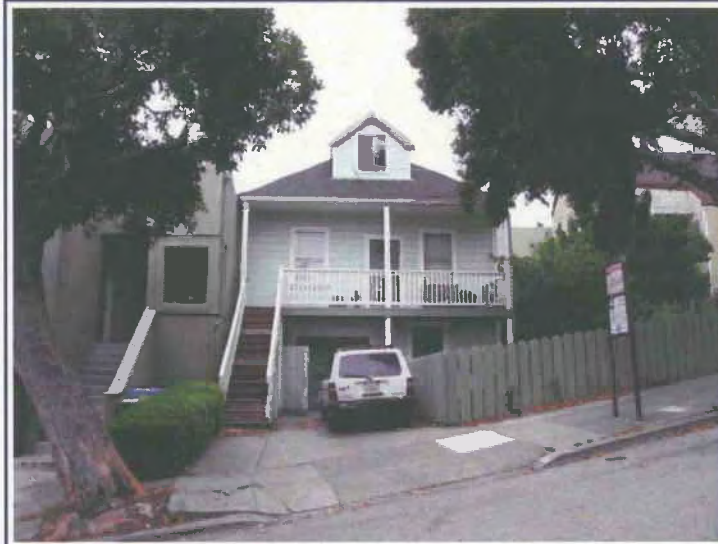
Description: View from burnside looking northwest
Photo Date: 07/17/2009

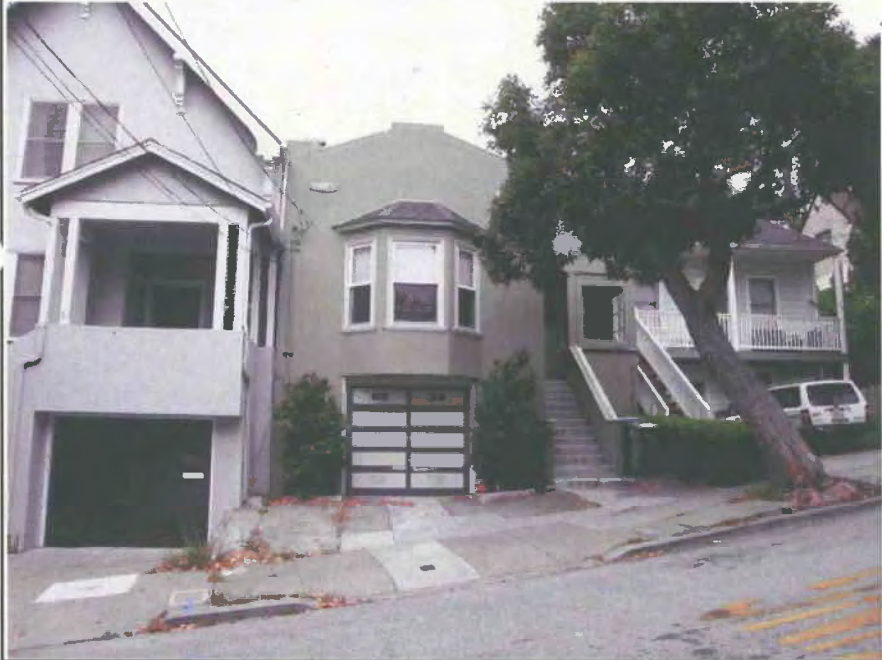
P5a. Photograph or Drawing (Photograph required for buildings, structures, and objects.)

P5b. Description of Photo:
 View from burnside looking west

Built in 1908, 26 Burnside is a wood frame single family rowhouse on a slightly irregular 25 x 77 foot lot on the west side of Burnside Avenue. The stucco-clad primary facade faces east and consists of two building bays. The ground floor contains a single wood sectional garage door in the first building bay, and a concrete set of stairs leading to the main entry on the second floor in the second. The upper floor contains a semi-hexagonal bay window in the left building bay containing three vinyl replacement sashes within the original openings. Asphalt shingles cover the roof the projecting bay. The right building bay contains a small entry porch with a single door and a single window. There is a shallow shaped parapet.

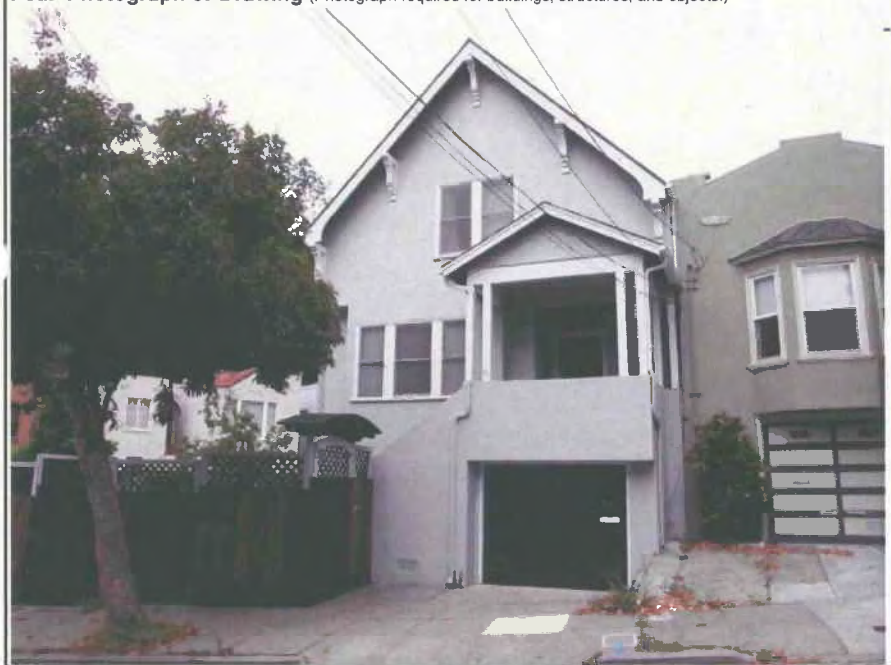
P5a. Photograph or Drawing (Photograph required for buildings, structures, and objects.)

P5b. Description of Photo:
View from burnside looking west

uilt in 1910, 30 Burnside is a 2 1/2 story wood frame semi-attached single family dwelling on an irregular triangle-shaped 44 x 73 foot lot on the west side of Burnside Avenue. The stucco-clad primary facade faces east and consists of two building bays. The ground floor contains a run of stairs leading to the main entry on the second floor in the first building bay, and a sectional overhead garage door in the second. The upper floor contains a row of three single windows in the first bay, and a projecting porch in the second, with the main entry consisting of a single wood door flanked by sidelights and transom. The third floor contains a pair of windows. A raked cornice is supported by single carved brackets at the peak, mid-point, and gable ends. The south elevation is visible from Paradise Avenue. The ground floor is obscured by a solid fence, the second floor in three building bays, contains a pair of windows in the first, and a semi-hexagonal bay window in the second and third. The third floor contains a set of three windows in the first bay, and a pair of windows in the second. The roof is gabled. A rear elevation is also visible from the street, and contains paired and single windows. All windows are vinyl replacement sash within original openings.

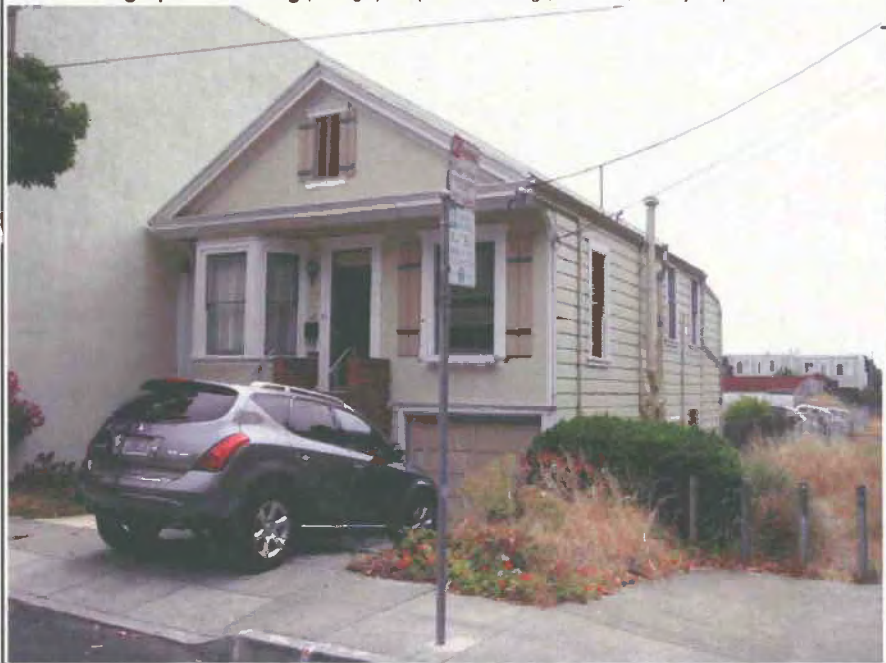
P5a. Photograph or Drawing (Photograph required for buildings, structures, and objects.)

P5b. Description of Photo:
 View from burnside looking southeast

5 Burnside is a one and a half story over raised basement, wood frame, single family dwelling on a 25 X 100 foot lot, built to the side lot lines. The primary facade faces northwest and is sheathed in flush wood siding, and consists of three building bays. The raised basement contains a single window in the base of a projecting bay window; a set of brick stairs leading to a centrally placed main entry on the main floor; and a single wood sectional garage door in the third building bay. The first floor contains a semi-hexagonal bay window in the first building bay containing three double hung 1/1 wood windows. The central bay contains a single wood door and transom, and the third bay contains a single wood 1/1 double hung window with decorative wood shutters. The forward facing gable projects over the depth of the projecting bay window, and is supported by scrolled brackets at the end walls. A simple raked cornice frames the gable which contains a single aluminum replacement sash within the original opening flanked by decorative shutters.

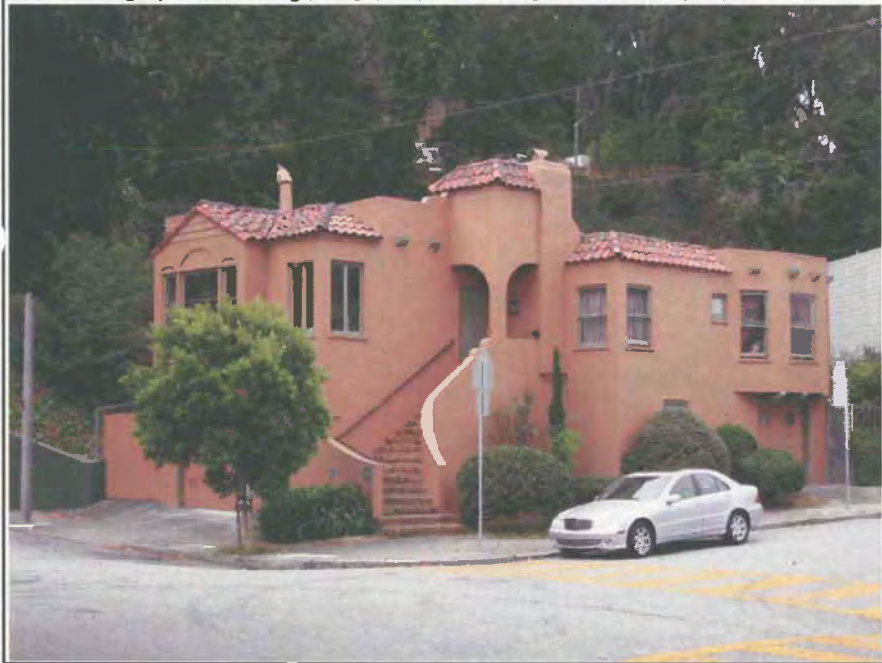
P5a. Photograph or Drawing (Photograph required for buildings, structures, and objects.)

View from burnside looking southwest

Built in 1938, 50 Burnside is a wood frame single family rowhouse on an irregular 36 x 80 foot lot on the southwest corner of Burnside and Paradise Avenues. The two-story, stucco-clad primary façade consists of two building bays, and faces east on Burnside. The ground floor of the primary façade features a single sectional wood garage door in the first building bay, and a brick and stucco stair leading to the main entry on the upper level. The upper floor has an articulated projecting square bay with three wood 1/1 double hung sash windows and a pair of wood casement windows. The secondary elevation on Paradise Avenue reveals the complex form of the structure as two interlocking rectangular forms, with a small tower like structure at the juncture of the forms. The form to the east (Burnside) contains the aforementioned stair on the lower level, and a casement window above. The main entry is located on the second level, at the intersection of the forms, under a tower like structure capped with a clay tile pent roof. To the west, the lower level contains a gated service door and a single garage door. The upper level contains a two single windows and a projecting semi hexagonal window above the garage. The roof is flat.

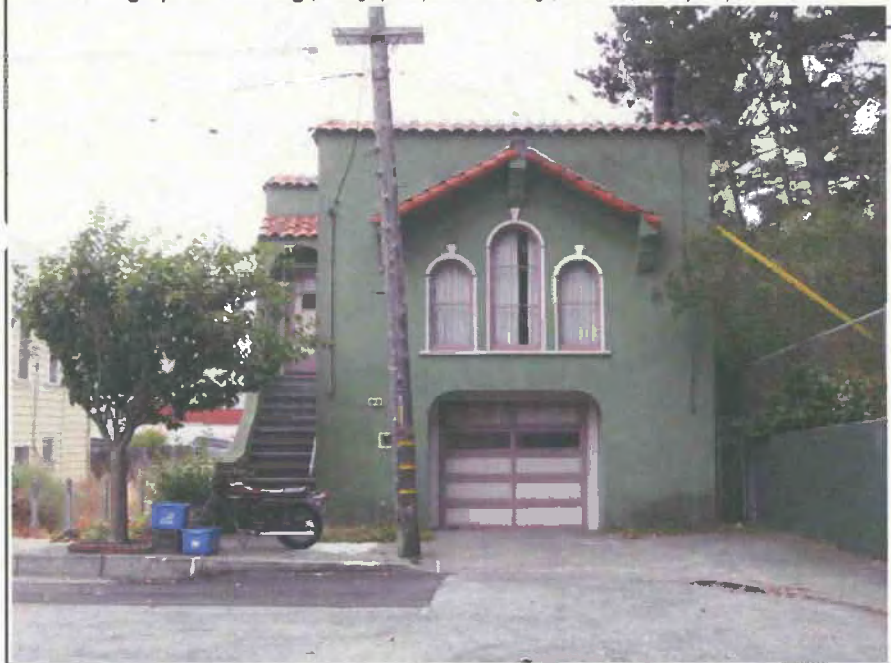
P5a. Photograph or Drawing (Photograph required for buildings, structures, and objects.)

P5b. Description of Photo:
View from burnside looking southeast

9 Burnside is a free-standing, two-story, wood frame, stucco-clad single family dwelling on a 25 X 100 foot lot, built to the side lot lines. The primary facade faces northwest and consists of one building bay. The ground floor contains a centrally placed single wood sectional garage door. A partial side setback on the northeast side contains terrazzo stairs leading to the primary entrance on the upper floor. The upper floor features a small entry porch at the top of the stairs, with a red tile roof, and shaped openings. The main building bay contains three single windows each with a half-round top and keystone and a decorative false gable clad in red tiles.

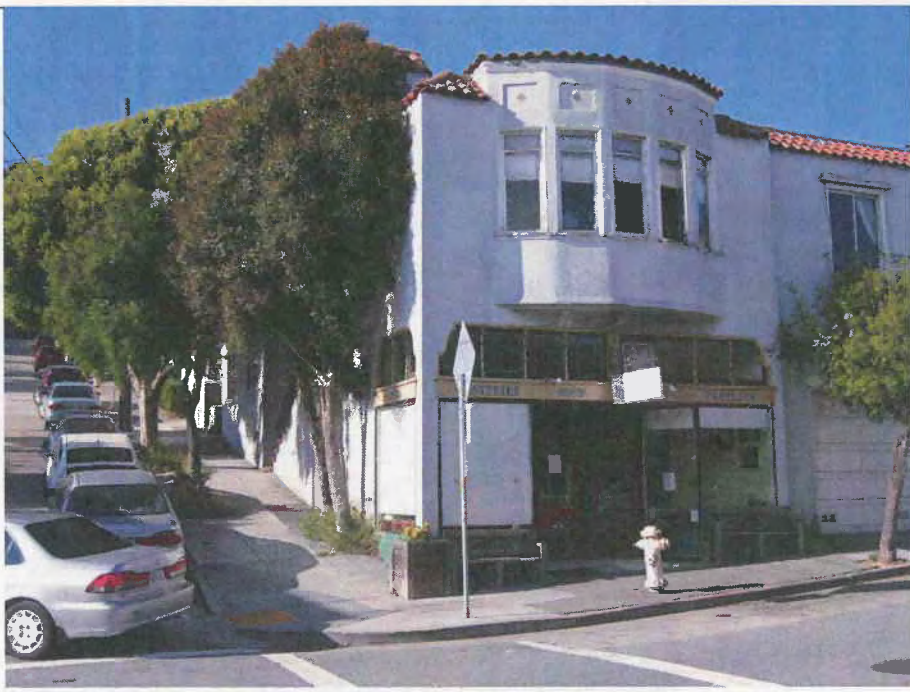
P5a.

***P3a. Description:** (Describe resource and its major elements. Include design, materials, condition, alterations, size, setting, and boundaries.) 3121-3125 Castro Street is a two-story, wood-frame, stucco-clad, residential-over-commercial mixed-use building at the corner of Chenery and Castro Streets in the Glen Park neighborhood of San Francisco. Built in 1931, the building displays elements of a Mediterranean eclectic style in both the storefront and the residential level. At the Chenery Street elevation, the building contains two symmetrical commercial storefronts, now combined into a single space on the ground floor. The storefronts display a green and black glazed tile base with plate-glass storefronts set in a bronze frame, and four-light wooden transoms set within shaped openings, divided by turned wooden muntins. At the second floor, a red tile-clad parapet surmounts a 5-faceted bow window with replacement aluminum casement sash and fixed aluminum transoms. The lot slopes upward from Chenery Street.

The roof is flat. This building appears to be in good condition. Visible alterations include aluminum replacement sash and the construction of the garage at the rear.

P5b. Photo: (view and date)
Looking north from Chenery St.

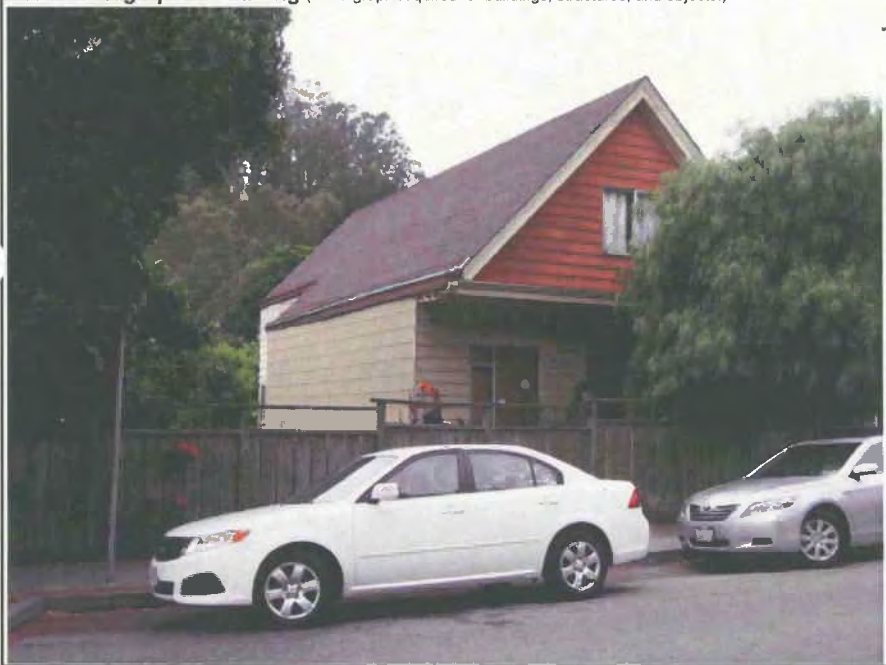
P5a. Photograph or Drawing (Photograph required for buildings, structures, and objects.)

View from Chenery looking south

uilt in 1908, 951 Chenery is a free standing wood frame single family dwelling clad in cement shingles, on a slightly irregular 50 x 63 foot lot at the southwest corner of Chenery Street and Burnside Avenue. The front elevation facing Chenery is 1 ½ stories tall, the ground floor contains a centrally located entry door, flanked by an aluminum replacement sash on the left, and a projecting bay window on the right. The gabled upper floor projects over the lower floor the depth of the projecting bay window, and contains a single aluminum replacement sash. A secondary elevation facing Burnside is largely unadorned, but contains a single sectional wood garage door in the exposed basement level on the down sloping lot. The gabled roof is clad in 3-tab shingles.

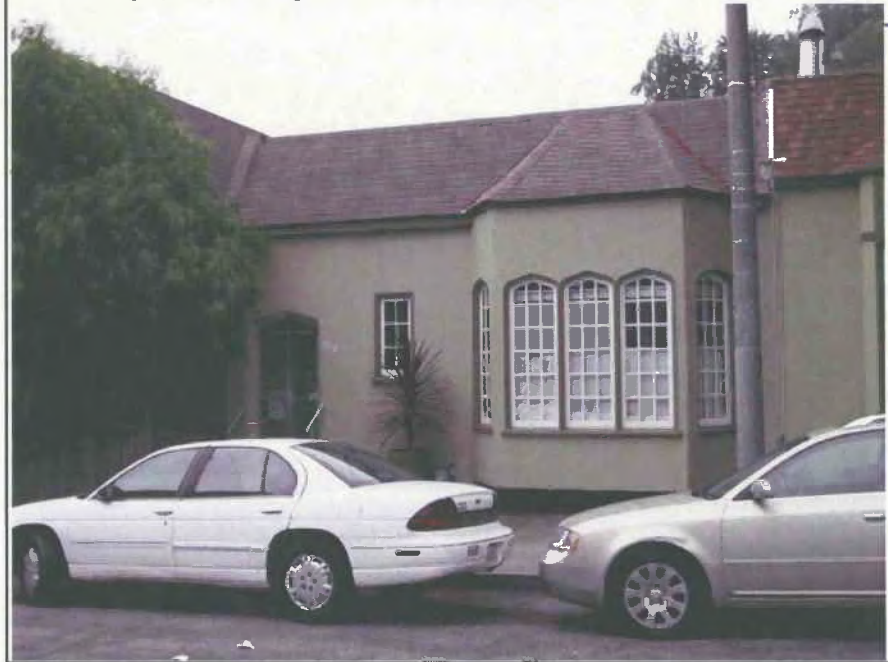
P5a. Photograph or Drawing (Photograph required for buildings, structures, and objects.)

View from Chenery looking southwest

uilt in 1929, 959 Chenery st. is a wood frame single family rowhouse on an irregular 25 x 127 foot lot on the south side of the street. One of 12 similar buildings on Chenery Street between Elk and Burnside, each with a single story to Chenery Street, and two stories on Paradise, due to the downslope of the lots exposing the basement containing a garage entry accessed from Paradise Avenue. Rear facades are generally without ornament, and have landscaped yards. The stucco clad primary façade contains a recessed gated entry and a small multi-light casement window in the left building bay, and a wide bay window in the second. The five windows in the bay window are all wood multi-light casement sash with shaped heads. A pent roof parapet follows the profile of the façade and projecting bay window. The roof is flat.
