**D1. Historic Name:** Mission Miracle Mile

**D2. Common Name:** Mission Street

**\*D3. Detailed Description** (Discuss overall coherence of the district, its setting, visual characteristics, and minor features. List all elements of district.):

**\*D8. Evaluator:** Matt Weintraub, Preservation Planner

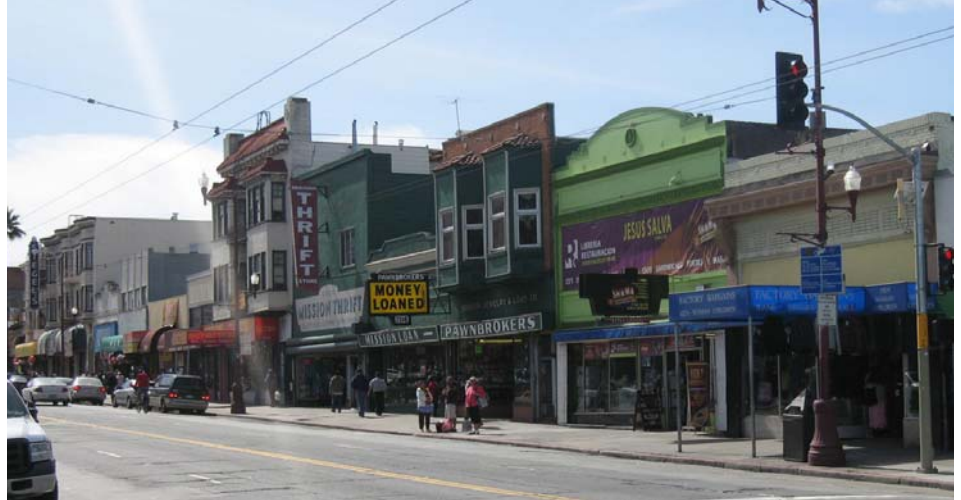
Mission Street in 2011. View southwest towards 20<sup>th</sup> Street. The commercial buildings that are located here within the historic district are similar to those that are shown in the photograph to the left. *San Francisco Planning Department.*

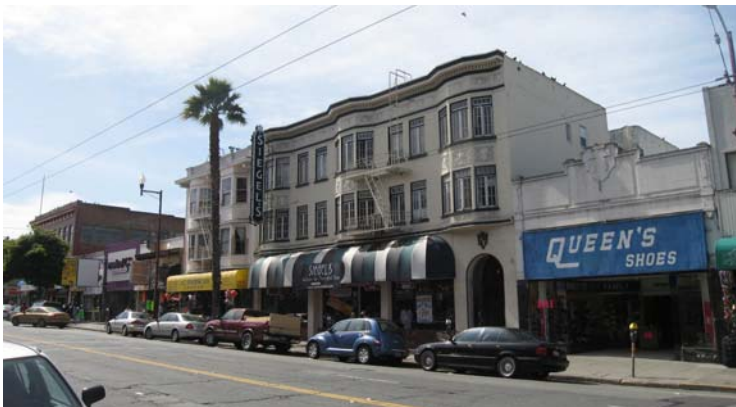
West side of Mission Street. View southwest towards 20<sup>th</sup> Street. San Francisco Planning Department.

The historic district is comprised of a row of one-story, two-story, and three-story commercial/mixed-use buildings. The single-story buildings and the multiple-story buildings are distributed approximately evenly throughout the historic district, such that the row exhibits a mixed character in terms of scale and roofline heights. Nearly all of the buildings occupy narrow lots that are 25 feet or 30 feet wide, as well as a single lot that is 35 feet wide. The two lots that are wider than that, at 50 feet and 60 feet, contain buildings that were constructed in the 1920s, whereas the majority of lots contain contributing buildings were constructed between 1906 and the mid-1910s. Despite the varying heights and types of buildings, the tightly packed arrangement of mostly narrow structures uniformly built out to the fronts of lots, and containing storefronts of similar widths, results in an overall development pattern that is consistent with the early 20<sup>th</sup> century commercial corridor. Overlaid upon this streetscape are the modernizations to some storefronts, façades, signs, and sidewalks that occurred between the 1920s and approximately 1960, which contributed to the physical development of the premier urban retail shopping corridor that became known citywide as the “Mission Miracle Mile”.

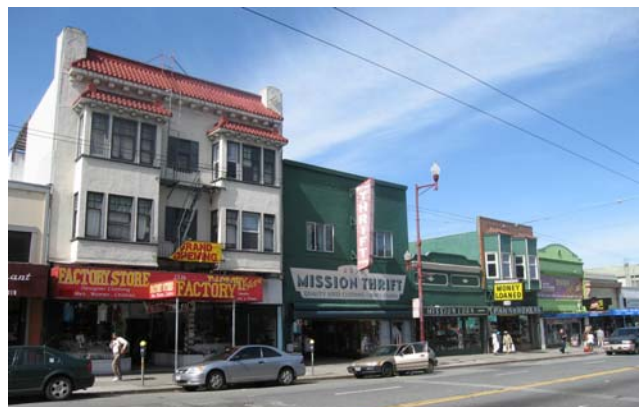
West side of Mission Street. View northwest towards 19<sup>th</sup> Street. San Francisco Planning Department.

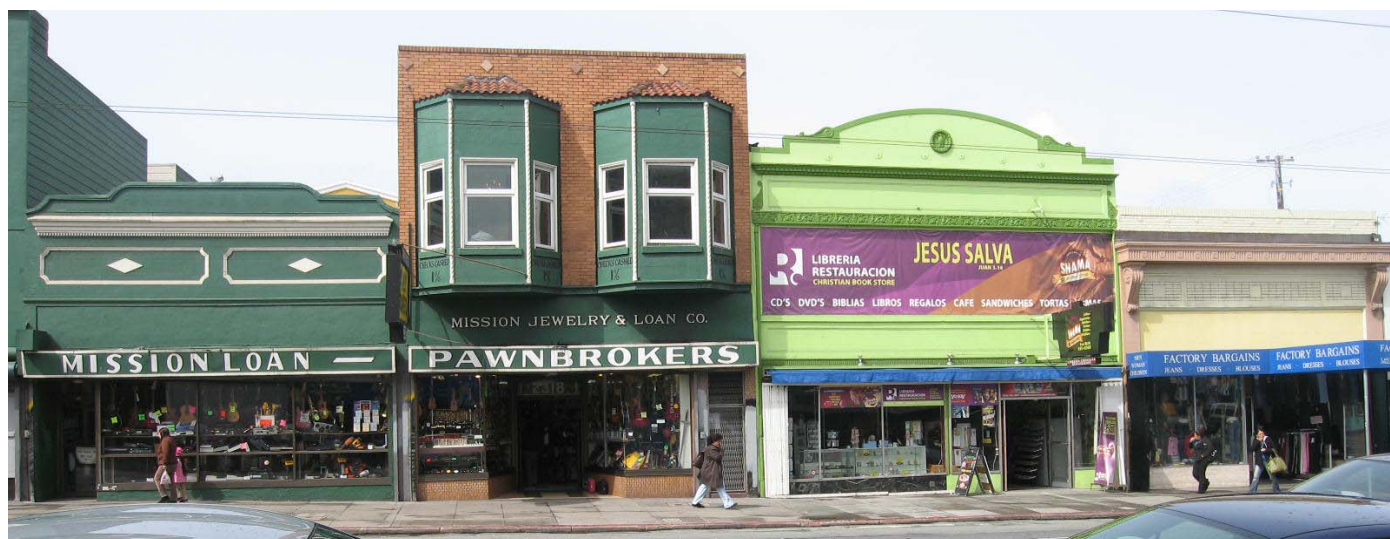
Grouping of four adjacent commercial buildings, including a mixed-use building, that were constructed in 1906 on the west side of Mission Street, just south of 19<sup>th</sup> street. View west. *San Francisco Planning Department.*

The historic district contains a rare grouping of mostly intact, small-scale commercial buildings that were erected within the first year of post-fire reconstruction. At the northern end of the row stand four structures that were erected only a few weeks or months after the disaster in April 1906. Three of these relief-era commercial buildings were designed as single-story with similar façades that consisted simply of shaped parapets with cornices located above the storefronts. A fourth building followed an Edwardian-era two-story mixed-used plan with bay windows and cornice at the upper story, which was stylistically remodeled with a Spanish Colonial Revival theme in 1927. As the reconstruction transitioned to recovery, these buildings housed staple businesses such as photos, tableware and china, and groceries. By mid-century, they contained mostly apparel stores and a jeweler, which indicated that the retail sector on Mission Street had shifted away from neighborhood goods and services and towards specialized in-demand retail products.

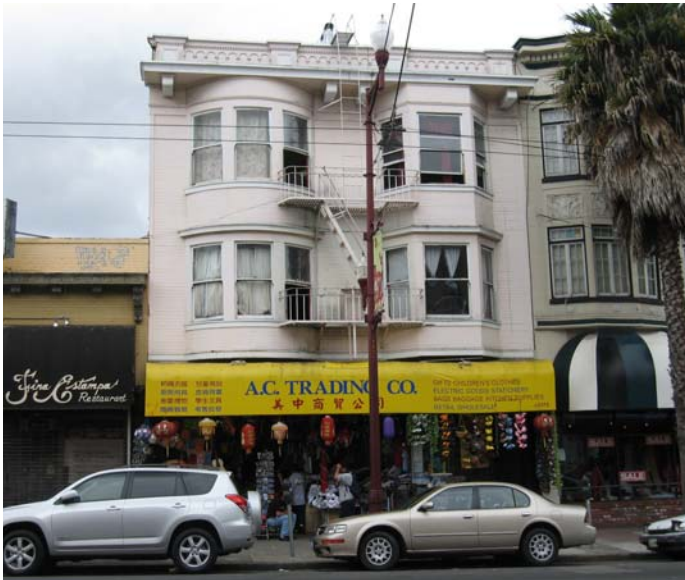
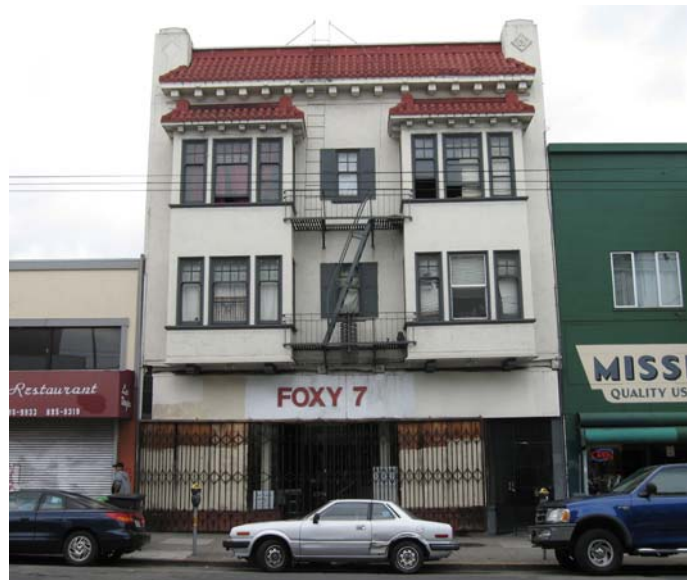
Mixed-use buildings that were constructed in 1907 (left) and 1912 (right), on the west side of Mission Street at mid-block locations. Views west. *San Francisco Planning Department.*

As the reconstruction progressed, property owners benefited from increased supplies of labor and materials, as well as availability of architects, with which to facilitate the rebuilding. Consequently, buildings constructed only one or more years after the 1906 disaster tended to be larger, more substantial, and/or more elaborate in design. By 1907, the upbuilding of three-story buildings with multiple-family residential floors located above storefronts became common, as did the application of architectural flourishes. These mixed-use buildings followed a typical design that included bilateral arrangements of bay windows and fenestration on street façades, and Edwardian-era ornamentation that spanned a range of Beaux Arts-influenced styles. Within the historic district, examples included: the building constructed in 1907 at 2370 Mission Street, which displayed Classical features such as a rooftop balustrade integrated with the cornice, and a combination of angled and curved bay windows; and the building constructed in 1912 at 2332-2336 Mission Street, which adapted Craftsman and Mission Revival features. During the first half of the 20<sup>th</sup> century, the stores in these buildings sold ladies goods, corsets, millinery, and gifts.

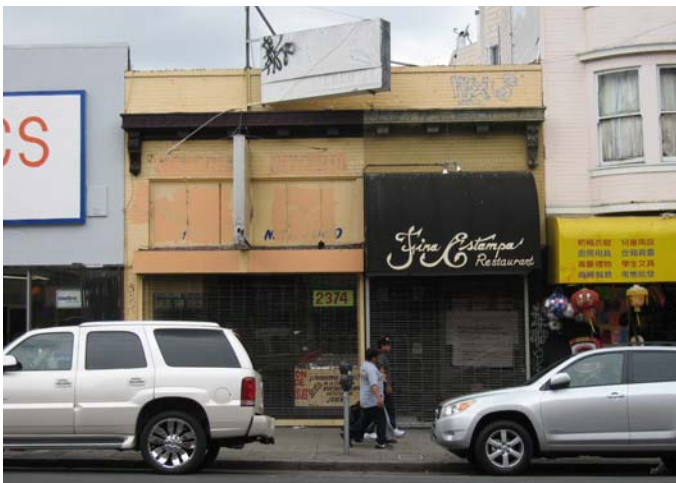
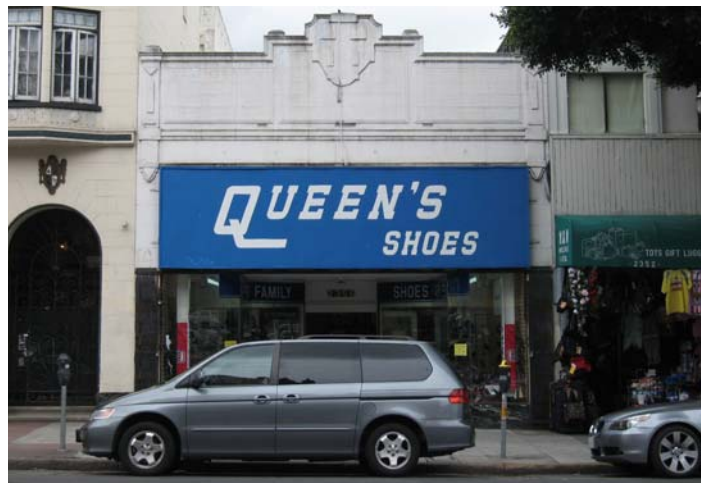
Small commercial buildings that were constructed in 1915, on the west side of Mission Street at mid-block locations. Views west. *San Francisco Planning Department.*

In addition, the construction of economical, single-story commercial buildings continued to occur, even as nearby properties were upbuilt. Though small-scale, these later post-fire small commercial buildings displayed architectural elaboration. For instance, two small structures that were constructed in 1915 at 2356 and 2374 Mission Street, which housed uses such as a bakery/lunch diner, a market, a hardware store, apparel, and optometry, featured upper façades that were decorated with Classical cornices, brackets, shaped parapets, and applied ornament.

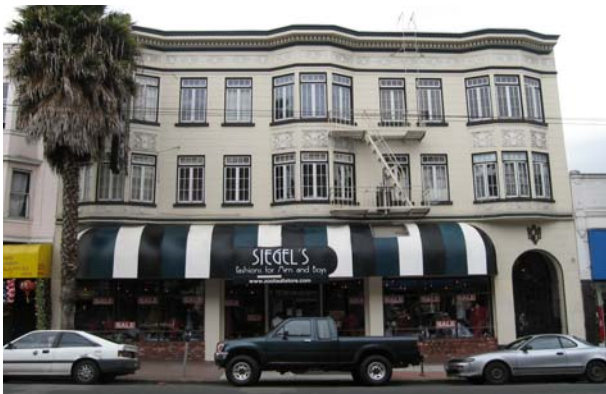
Mixed-use apartment building that was constructed in 1926, on the west side of Mission Street at a mid-block location. View west. *San Francisco Planning Department.*

Within the historic district, two larger lots on the west side of Mission Street were upbuilt during the 1920s. In 1926, a reinforced concrete mixed-use apartment building was erected at 2360-2366 Mission Street, at mid-block. It replaced two single-story commercial buildings that were constructed in the aftermath of the 1906 disaster, similar to those that are still extant within the historic district. The construction of apartment buildings such as this indicated the continued growth of the neighborhood's residential population during the post-fire era, when the working classes of the city became consolidated in the Mission District, due in large part to the industrial/commercial reconstruction of the South-of-Market, a former mixed-use neighborhood. This three-story, 14-unit apartment building was designed by Albert W. Burgren, an engineer who had previously designed several residential hotels in San Francisco in partnership with architects, for owner E.J. Lubble. This building's styling was a later example of Classicism that dominated the post-fire reconstruction. Its broad street façade was scored to resemble cut stone blocks, and it was richly dressed in cartouche panels, medallion bands, triglyphs, and a broad denticulated cornice. Other architectural features included the arched residential entrance, wide bay windows, and divided wood casements.

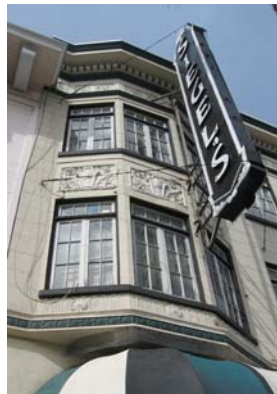
Apartment building façade details and commercial blade sign. View west. *San Francisco Planning Department.*

At the tall ground floor, Siegel's apparel store has occupied a commercial space since at least 1937, when neon tube lettering was added to the store's existing vertical double-faced sign. In 1941, Siegel's store expanded to fill the entire ground floor, and the storefront was unified. Over the years, Siegel's utilized visual merchandising techniques such as neon lettering that announced "For Dad and Lad" to passers-by. More recently, Siegel's installed new display windows, aluminum doors, and stucco fascia to the storefront in 1978, and installed a curved canvas canopy in 1979. The brick bulkheads and water tables, as well as the angled vestibule and the divided transom that is located over the store entrance, may remain intact from the mid-century makeover of the storefront. Siegel's apparel store still occupies the commercial ground floor of the building and still sells men's and boys clothing, as it has in this location on Mission Street for at least 75 years.

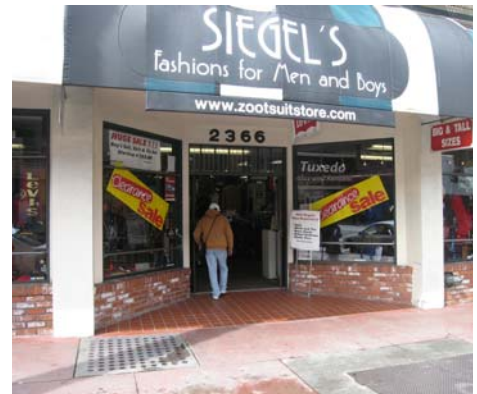
Mixed-use apartment building storefront entrance. View west. *San Francisco Planning Department.*

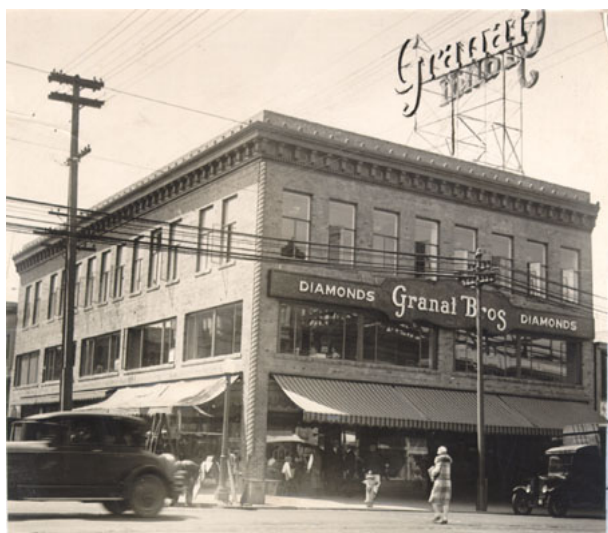
The Granat Bros. building in 1927. View northwest. San Francisco History Center, San Francisco Public Library (Historical Photograph Collection Photo Id# AAC-6823).

building was designed to carry the load of two additional stories had that been desired. The building was designed by architect Arthur T. Ehrenpfort for owner Wm. C. Ehrenpfort, though an earlier application for a construction permit, which was cancelled, listed the Granat Bros. as owners. Ehrenpfort's simplified Classical/Renaissance Revival design incorporated elements such as a cornice lined with acroterion, a flat parapet/balustrade, rope molding at the corners, a keystone-arched entrance on 20<sup>th</sup> Street, and wood-frame windows that varied from wide horizontal bands at the mezzanine to rows of narrow windows at the upper story. When construction was completed, the Granat Bros. jewelers took ownership of the building and relocated from their previous site, one block to the north on Mission Street. The Granat Bros. used the lower story for display and sales, and converted the upper story into a jewelry manufacturing workshop. The Granat Bros. jewelry operation anchored this corner location at Mission and 20<sup>th</sup> Streets for several decades. In addition to makers of fine jewelry, the Granats regularly sponsored and organized winning baseball teams in the San Francisco Midwinter League, for which games were played at nearby Recreation Park on Valencia Street.

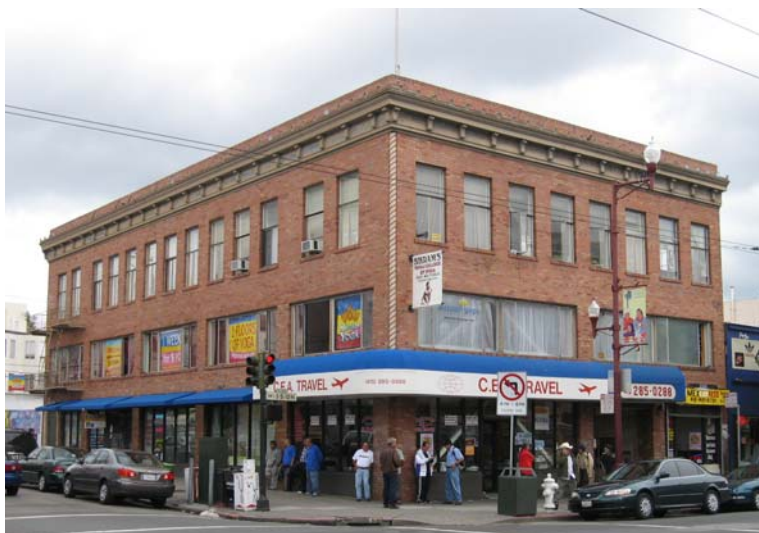
The Granat Bros. jewelry manufacturing shop and store building in 2011, located at the northwest corner of Mission and 19<sup>th</sup> Streets. View northwest. San Francisco Planning Department.

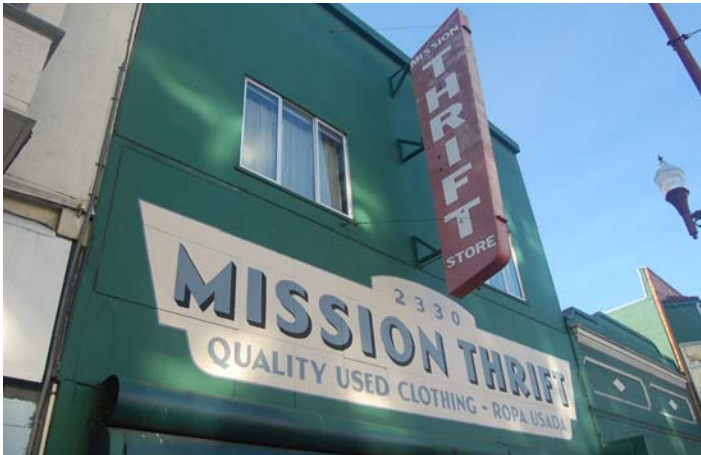
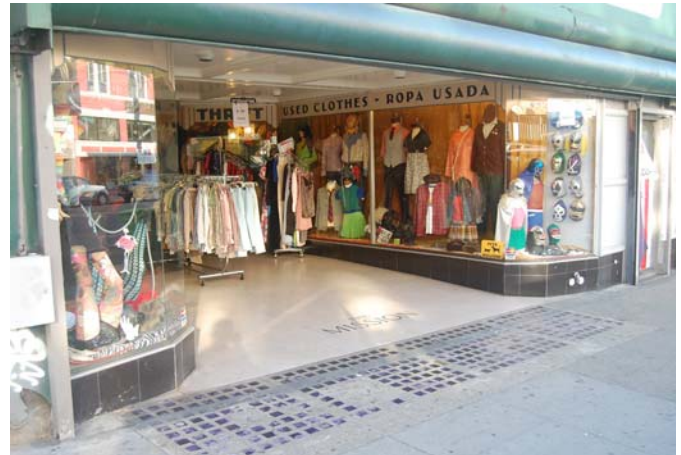
The building located at 2326-2330 Mission Street, with "Visual Front" façade and storefront that were installed in the 1930s and 1950s. Views northwest. *San Francisco Planning Department.*

Within the historic district, several buildings display alterations, modifications, and improvements that related to the period of modern visual merchandising and the "Mission Miracle Mile" shopping district. One building that was originally constructed in 1911 demonstrates the results of a total mid-century makeover. Located at 2326-2330 Mission Street, the building initially followed a typical Edwardian-era design with bay windows at the upper story. In 1934, the early 20<sup>th</sup> century storefront was renovated to include a wide outdoor lobby with angled, corner-less plate-glass display windows, bulkheads clad in structural glass panels, and ceramic tile floor paving with a "Mission" custom signature. In 1952, the transformation of the structure was completed when the bay windows and other extrusions (except for the double-faced blade sign) were removed from the upper story façade and it was re-faced with Vitrolite panels and stucco. The resulting appearance of the commercial building included many of the elements that typified a mid-20<sup>th</sup> century "Visual Front", including the open, glass-filled articulated storefront and the clean lines, blank surfaces, simple square windows of the upper façade, and projecting signage.

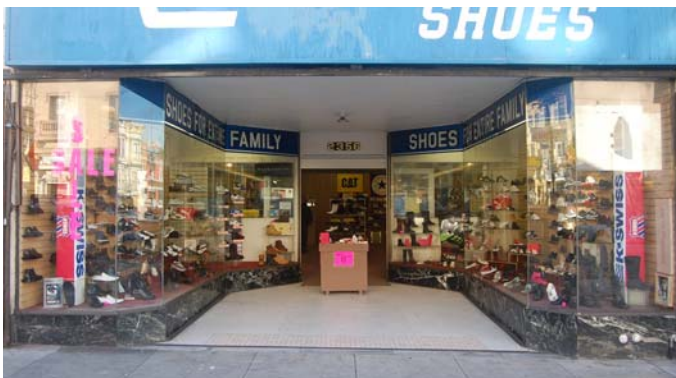
The "Visual Front" storefront that was installed circa 1930s at 2356 Mission Street. *San Francisco Planning Department.*

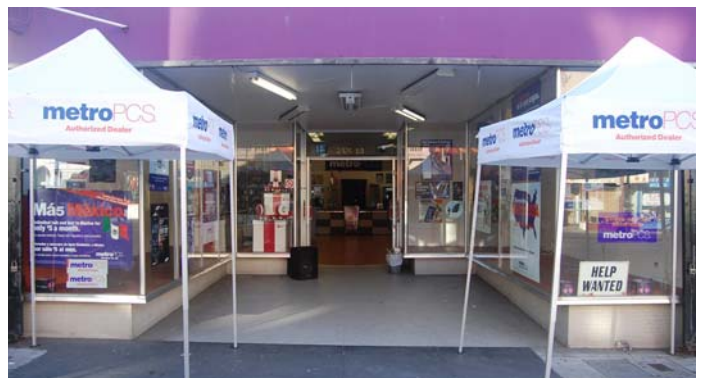
The "Visual Front" storefront that was installed in 1959 by the Regal Mfg. Co. at 2376-2380 Mission Street. *San Francisco Planning Department.*

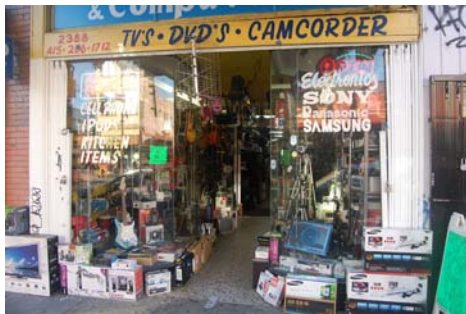
The “Visual Front” storefront that was installed in 1931 at 2388 Mission Street. *San Francisco Planning Department.*

The adjacent commercial building located at 2386-2388 Mission Street, which was divided into two exceptionally narrow commercial spaces, also contains “Visual Front” modernizations. The southern storefront at 2388 Mission Street was altered in 1931 by L. Salomon with very tall corner-less plate-glass windows that returned at angles into the vestibule, forming a glass corridor/anteroom as an entryway into the store. The height of the northern storefront platform was altered in 1954, and “rustic” was installed to replace stucco, which presumably referred to the installation of brick bulkheads with decorative vents below corner-less plate-glass displays with metal flashing. Another narrow storefront was altered approximately in the 1930s to feature a small outdoor lobby with angled corners, which made efficient use of the limited space. The storefront at 2336 Mission Street also included corner-less plate-glass windows, wood paneled bulkheads, double sash wood doors with border outlines painted onto the glass, and marble tile flooring with the storefront’s street number inlaid at the sidewalk edge.

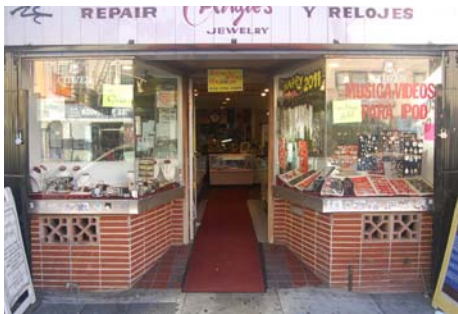
The “Visual Front” storefront that was installed circa 1954 at 2386 Mission Street. *San Francisco Planning Department.*

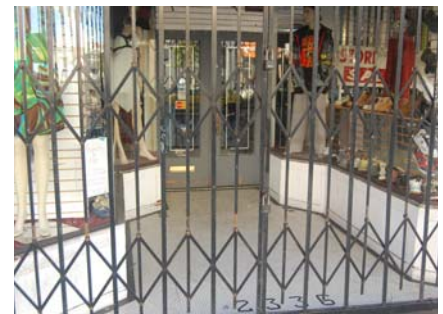
The “Visual Front” storefront that was installed circa 1930s at 2336 Mission Street. *San Francisco Planning Department.*

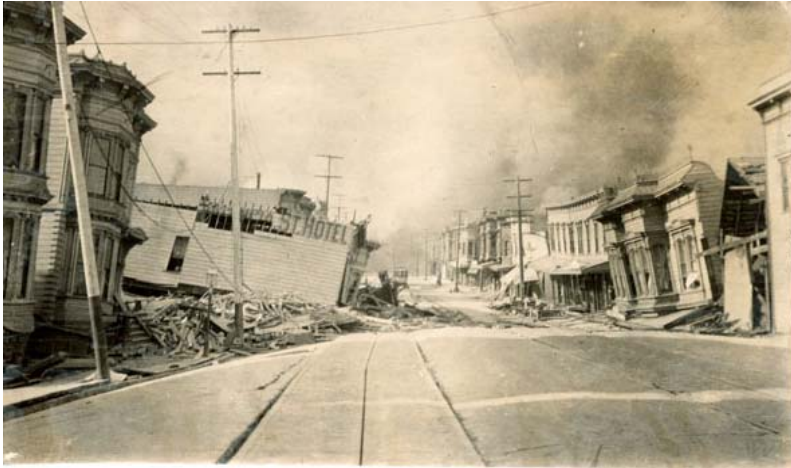
Valencia Street lay in ruins one day after the 1906 earthquake. View north towards 18<sup>th</sup> Street. When this photograph was taken, the firestorm was visibly approaching from the north, and apparently it had already reached the next block. All of the buildings shown in this photograph burned within hours, as seen in the photograph to the right. *San Francisco History Center, San Francisco Public Library (Historical Photograph Collection Photo Id# AAC-3549).*

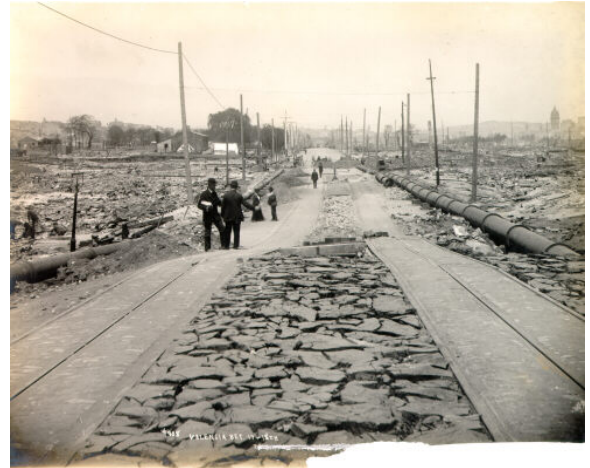
Valencia Street in the aftermath of the 1906 earthquake and fires. View north from approximately the same location as in the photograph to the left. There was total destruction of structures, roads, transit lines, and utility lines. *San Francisco History Center, San Francisco Public Library (Historical Photograph Collection Photo Id# AAC-3252).*

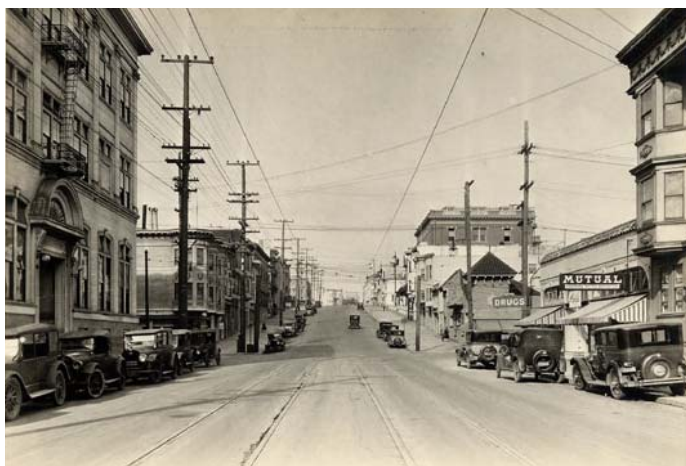
Guerrero Street in 1928. View north towards 14<sup>th</sup> Street. All of the buildings that appear in the photograph were constructed to replace properties destroyed in the 1906 fires. *San Francisco History Center, San Francisco Public Library (Historical Photograph Collection Photo Id# AAB-3941).*

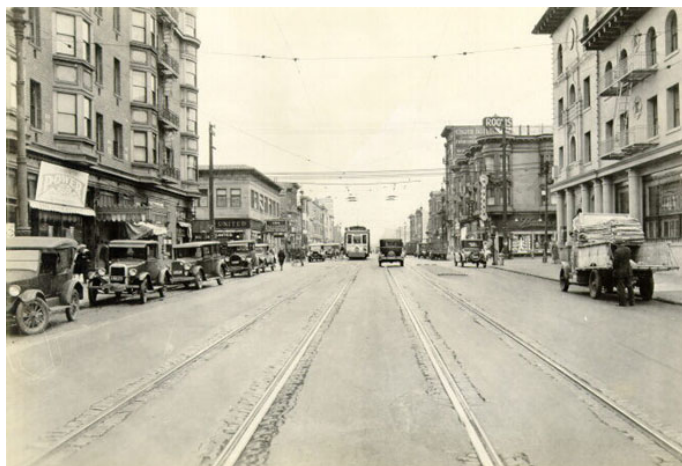
Valencia Street in 1927. View south towards 16<sup>th</sup> Street. All of the buildings that appear in the photograph were constructed to replace properties destroyed in the 1906 fires. *San Francisco History Center, San Francisco Public Library (Historical Photograph Collection Photo Id# AAB-5930).*

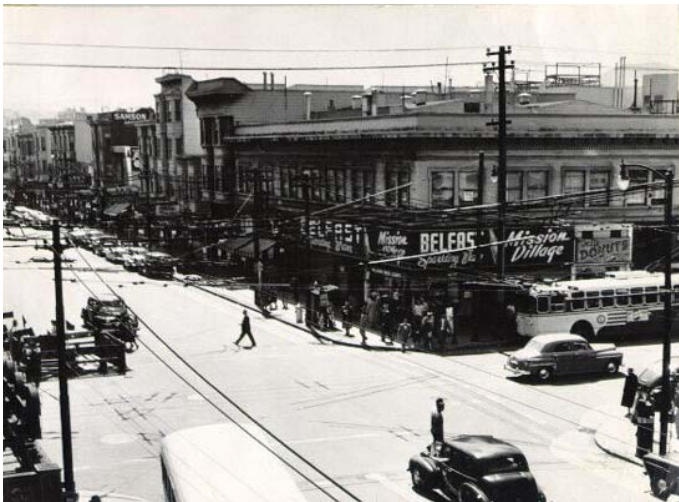
Mission Street at 16<sup>th</sup> Street in 1935. View southwest. The commercial corridors were reconstructed during the early 20<sup>th</sup> century, following the 1906 fires. *San Francisco History Center, San Francisco Public Library (Historical Photograph Collection Photo Id# AAB-4590).*

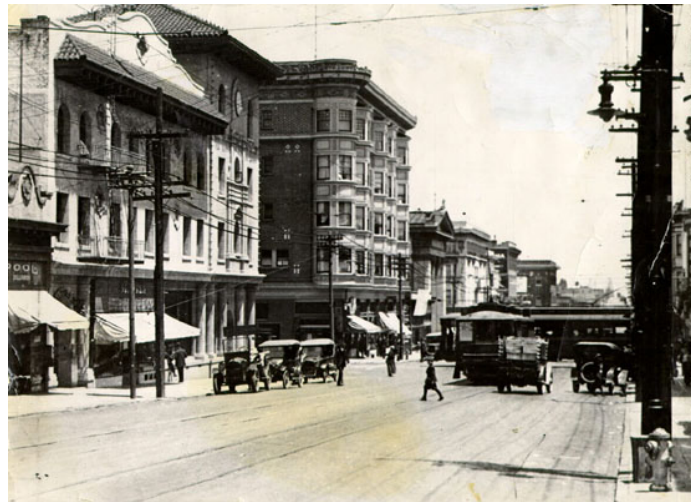
Valencia Street at 16<sup>th</sup> Street in 1949. View northeast towards 16<sup>th</sup> Street. The commercial corridors were reconstructed during the early 20<sup>th</sup> century, following the 1906 fires. *San Francisco History Center, San Francisco Public Library (Historical Photograph Collection Photo Id# AAB-5926).*
