The Woodward Street Reconstruction Historic District is a medium-scale residential enclave located along Woodward Street, a narrow one-block street near the northern edge of San Francisco's Inner Mission District. It features a largely uniform streetscape of two- to three-story Classical Revival style buildings constructed in the years immediately following the 1906 Earthquake and Fire: 14 of the 19 district contributors (74%) were constructed between 1906 and 1908, while the remaining 6 District Contributors (26%) were constructed by 1912, resulting in a consistent streetscape in terms of scale, massing, style, form, use, and materials. In addition to its association with post-1906 reconstruction, the Woodward Street Historic District represents an unusual clustering of "Romeo" flats, a building style endemic to San Francisco and constructed only in the years immediately following the 1906 Earthquake and Fire. "Romeo" flats are characterized by wide, angled bay windows, a common central stairwells providing access to individual flats (usually 4-6 units), and most prominently, the presence of open wrought-iron balconies at staggered levels of the stairwell. On occasion, the stairwe

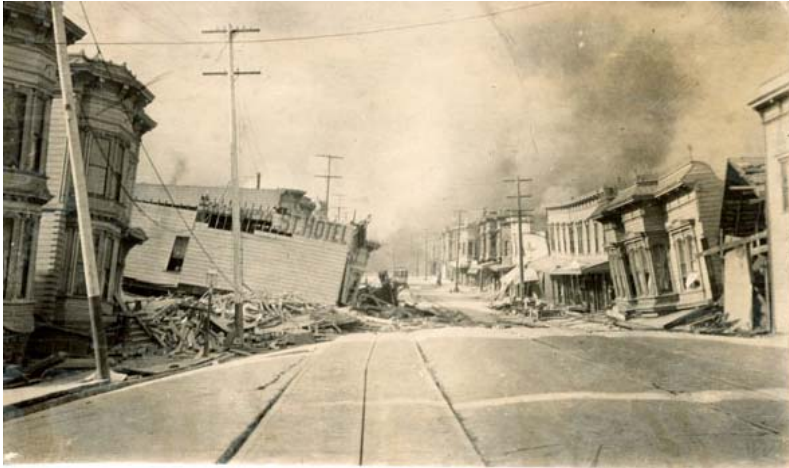
Valencia Street lay in ruins one day after the 1906 earthquake. View north towards 18<sup>th</sup> Street. When this photograph was taken, the firestorm was visibly approaching from the north, and apparently it had already reached the next block. All of the buildings shown in this photograph burned within hours, as seen in the photograph to the right. Courtesy of the San Francisco Public Library Historical Photograph Collection (Photo Id# AAC-3549).

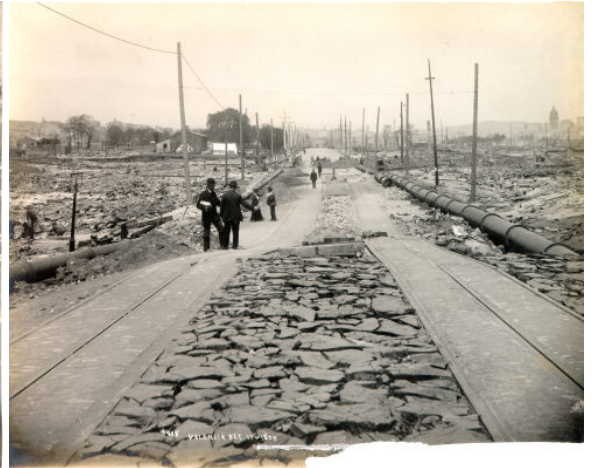
Valencia Street in the aftermath of the 1906 earthquake and fires. View north from approximately the same location as in the photograph to the left. There was total destruction of structures, roads, transit lines, and utility lines. Courtesy of the San Francisco Public Library Historical Photograph Collection (Photo Id# AAC-3252).

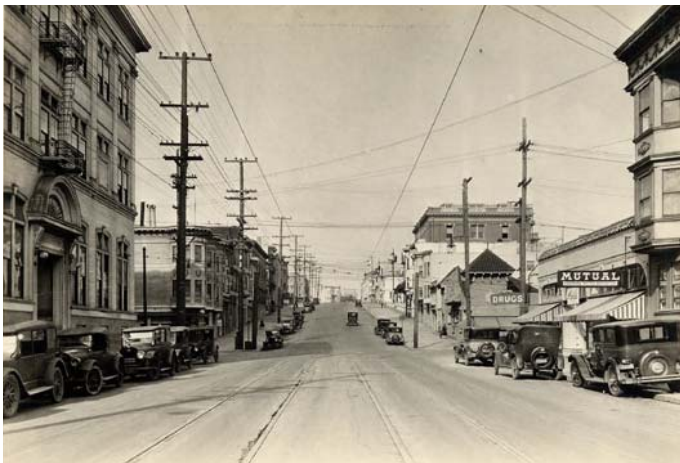
Guerrero Street in 1928. View north towards 14<sup>th</sup> Street. All of the buildings that appear in the photograph were constructed to replace properties destroyed in the 1906 fires. Courtesy of the San Francisco Public Library Historical Photograph Collection (Photo Id# AAB-3941).

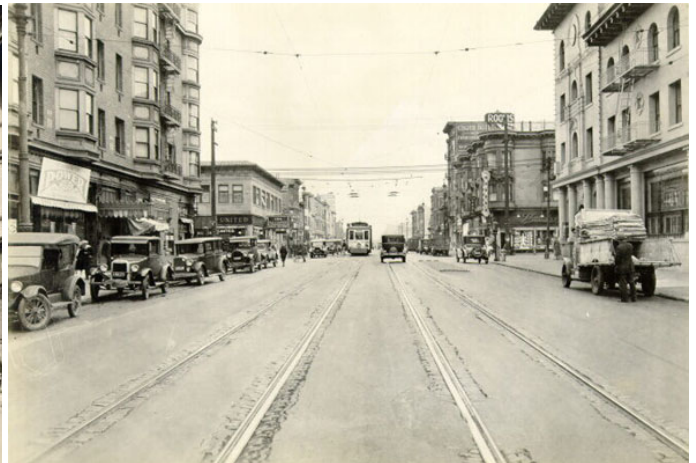
Valencia Street in 1927. View south towards 16<sup>th</sup> Street. All of the buildings that appear in the photograph were constructed to replace properties destroyed in the 1906 fires. Courtesy of the San Francisco Public Library Historical Photograph Collection (Photo Id# AAB-5930).
