Historic Preservation Commission Executive Summary Historic Resource Survey Findings INFORMATIONAL PRESENTATION: JUNE 1, 2011 ADOPTION HEARING: JUNE 15, 2011

Date: May 25, 2011
Case No.: **2011.0401U**
Project: Showplace Square / Northeast Mission Historic Resource Survey
Staff Contact: Moses Corrette – (415) 558-6295
moses.corrette@sfgov.org
Reviewed By Tim Frye – (415) 575-6822
tim.frye@sfgov.org
Recommendation: **Adoption of survey findings**

**SHOWPLACE SQUARE SURVEY
SAN FRANCISCO, CALIFORNIA
FINAL**

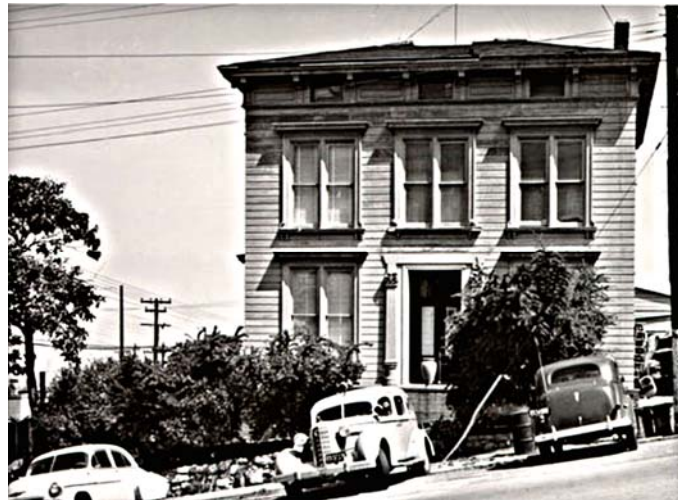
Figure 6. Richards House, ca.1940
Source: San Francisco Public Library

Sansome streets.⁴¹ Richards was also a poet and writer who frequently contributed his poems to the *Alta California*. The Richards House remained in the family until 1908, when it was purchased by Bethlehem Steel for use as a hospital by employees of Union Iron Works. Although missing its widow's walk/cupola, the Richards House remains one of the most architecturally significant non-industrial structures in the survey area (Figure 6).

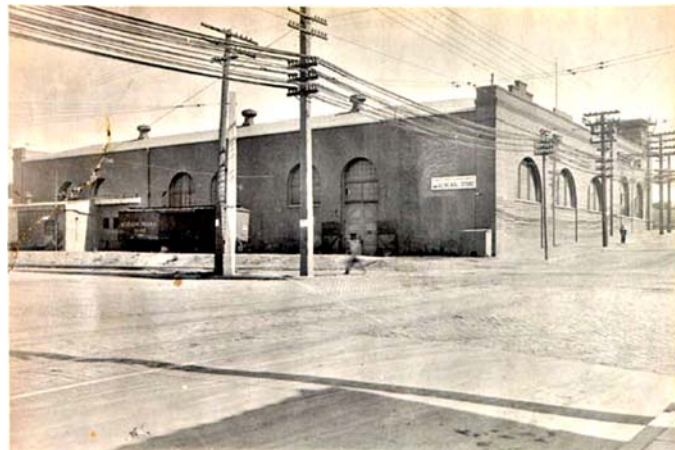
Figure 9. Market Street Railway Powerhouse, n.d.
Source: San Francisco Public Library

The post-1893 conversion of the Market Street Railway to electricity and the accompanying system-wide expansion necessitated the construction of additional infrastructure to provide electrical power and maintenance space. The oldest surviving non-residential building within the survey area is the Market Street Railway Steam Powerhouse located at 1401 Bryant Street (**Figure 9**). Constructed in 1893 by the Market Street Railway, the heavy timber frame and brick power house generated electricity by means of coal, and later petroleum-fired boilers. Used to power electric streetcar lines south of Market Street until 1944, the facility is an excellent example of an industrial plant within the survey area and one of the only facilities associated with the Market Street Railway Company remaining within the city.

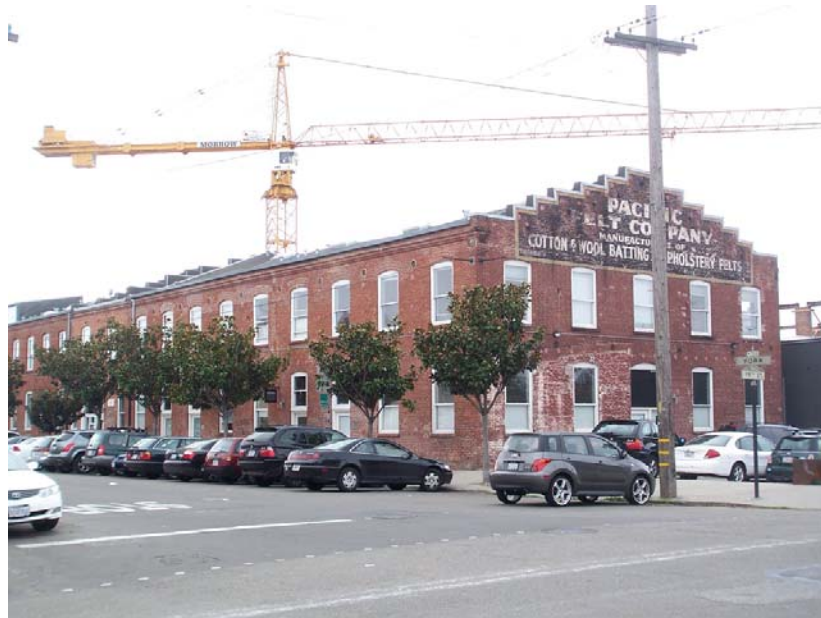
Figure 10. Golden Gate Woolen Mills
Source: KVP Consulting, LLC

Other categories of industry in the Mission District section of the survey area included those related to the processing of animal products into clothing and soap, such as the Mission Soap and Candle Works, located at the southwest corner of 18th and Harrison streets; and the massive Golden Gate Woolen Manufacturing Company Mills, located on two blocks bounded by 18th, York, 20th, and Bryant streets. The Golden Gate Woolen Mills complex, much of which still stands today, was initially built before 1887. The heavy timber frame warehouse that stands today dates to ca. 1895 (Figure 10).

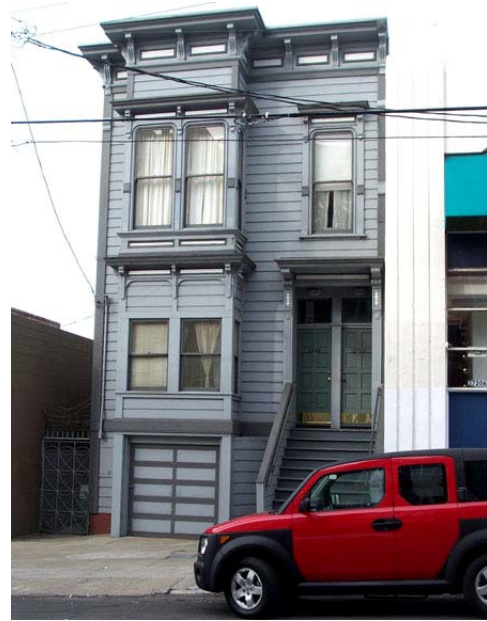
Figure 11. 2712 17th Street
Source: KVP Consulting

During the nineteenth and early twentieth centuries, residential construction within the Mission District section of the Showplace Square survey area remained the densest along Mission Street and other transit-rich streets in the western portion of the neighborhood, particularly Bryant and Shotwell streets. Much of the housing stock consisted of two- or three-family frame flats designed in the Italianate, Stick/Eastlake, or Queen Anne styles. Although mostly replaced by industrial uses throughout the early twentieth century, several pre-quake flats survive within the survey area. One of the oldest and best-preserved is the San Francisco Stick/Eastlake-style flat at 2712 17th Street. Built ca. 1890, this remnant is indicative of a once-plentiful residential building type in the Mission District portion of the survey area (**Figure: 11**).

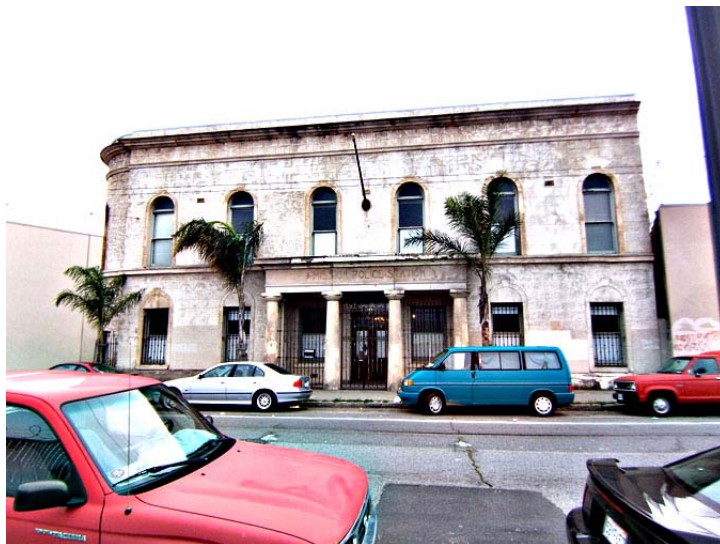
Figure 12. Mission, or Southern, Police Station
Source: KVP Consulting, LLC

Very few public buildings or sites appear on the 1899 Sanborn maps in the Mission District section of the survey area. The maps show only one public school – Buena Vista School – at 610 York Street (no longer extant). The only other municipal building within the survey area was the Southern District Police Station at 3057 17th Street. Built in 1899, the two-story concrete police station was designed by the firm of Shea & Shea. Damaged in 1906, the police station was repaired –minus its original corner turret – and placed back into service. It remained in service as the Southern District station until 1950 when the SFPD moved to a new district headquarters at 1240 Valencia Street (**Figure 12**).

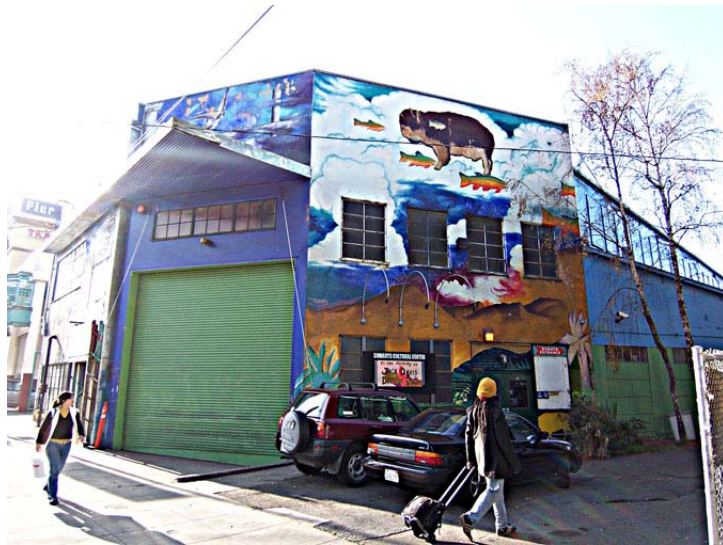
Figure 21. Western Pacific-built machine shop at 934 Brannan
Source: KVP Consulting

take advantage of the situation. On May 3, 1906, San Francisco Board of Trade secretary Martin Triest announced that the Southern Pacific, Santa Fe, and Western Pacific railroads had all set aside land in the Potrero and Mission districts to lease to businesses displaced by the disaster. The Southern Pacific set aside the blocks bounded by 6th, Irwin, Eureka, and 7th streets (outside the survey area) to lease to wholesale merchants at the cost of 12 cents per square foot. Meanwhile, the Santa Fe followed suit with a large tract bounded by 18th, Minnesota, 22nd, and Indiana streets (outside the survey area). The Western Pacific also offered a tract bounded by Division, Kansas, and 16th streets and San Bruno Avenue (a tract that lay entirely within the survey area) to industrialists. In addition to providing land, the railroads offered, for an additional charge of 5 cents per square foot, to build temporary corrugated steel buildings for their new tenants.⁹¹ At least one of these “temporary” structures survives within the Showplace Square survey area, a corrugated steel structure located at 934 Brannan Street. Built in 1906 by the Western Pacific Railway, the steel structure was the longtime home to the Union Machine Shop (Figure 21).

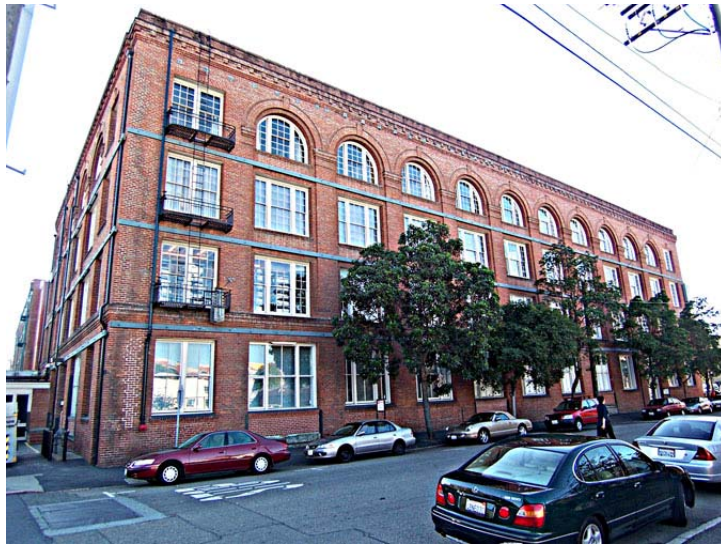
Figure 22. John Hoey warehouse, 101 Kansas Street
Source: KVP Consulting

Industrial development within the Showplace Square survey area dramatically increased after the 1906 Earthquake. Construction activity was heaviest from 1906 to 1913, with additional growth preceding the First World War. Of the roughly 525 buildings within the survey area, 84 were built from 1906 until 1913. Several were large American Commercial style timber-frame warehouses similar to the Pacific Steel & Hardware (Baker & Hamilton) Building constructed in 1905 at 7th and Townsend streets. Other excellent examples of this type include the complex of three adjoining warehouses built by the San Francisco Development Company on the block bounded by Alameda, Rhode Island, 15th, and Kansas streets. From north to south, the three largely identical brick warehouses are: the Bernhard Mattress Company/John Hoey warehouse at 101 Henry Adams (Kansas) Street, the Pacific Implement warehouse at 131 Henry Adams (Kansas) Street, and the General Electric warehouse at 398 15th Street. All three were designed by the San Francisco architectural firm of Meyers & Ward and completed in 1906 (Figure 22). They are all extant and currently comprise the

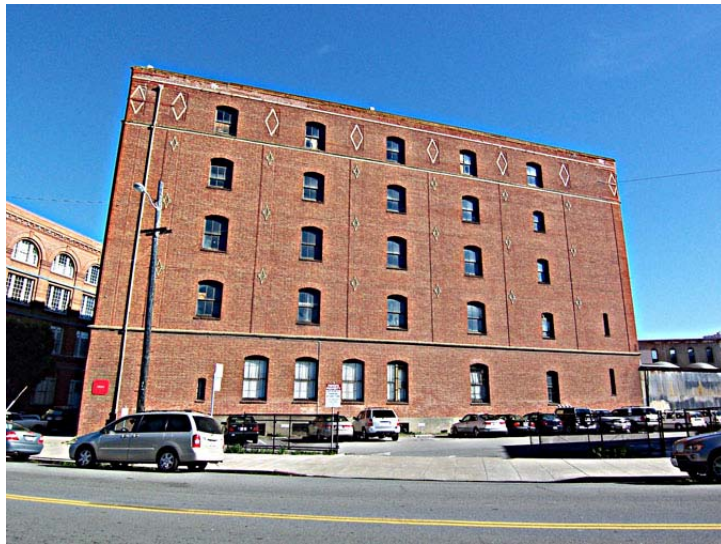
Figure 23. J.I. Case Threshing Co. Building, 200 Rhode Island St.
Source: KVP Consulting

Several other notable early examples of American Commercial style, heavy-timber frame brick industrial buildings include the J.I. Case Threshing Machinery warehouse at 200 Rhode Island Street (1912) and the Charles Harley Warehouse at 650 7th Street (1911). The former is a five-story brick warehouse designed by the San Francisco-based architect G. Albert Lansburgh and built on land belonging to George Center (**Figure 23**). The latter is a three-story brick warehouse designed by the well-known Mexican-born architect Albert Pissis and built on land belonging to James L. Flood. Another example is a section of the David Woerner Cooperage Company plant in the Mission District. Several parts of this plant survive from this era, including the brick warehouse at 1820 Harrison Street. Most of the buildings mentioned thus far were built as warehouses for wholesale hardware companies or as wood-working enterprises. This heavy concentration of wholesale hardware companies, with a smattering of manufacturing, provides evidence in support of contemporary newspaper articles that discuss the exodus of such companies from the vicinity of 2nd and Mission streets to the survey area. All three of these buildings are extant.

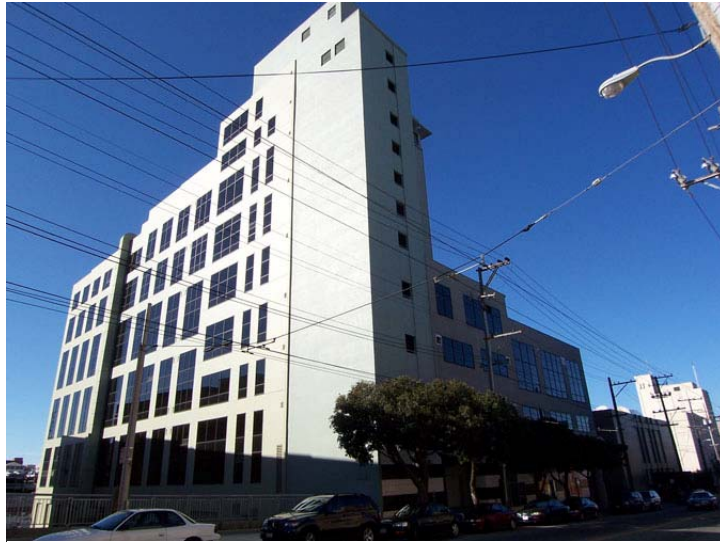
Figure 24. Hamm's Brewery Building, 1550 Bryant St.
Source: KVP Consulting

In addition to wholesale and woodworking businesses, brewers and food processing businesses built several plants in the Showplace Square survey area during the initial post-1906 reconstruction era. Examples include the substantially enlarged Enterprise Brewing Company at 1 Enterprise Street, of which only the office building survives. Another example is the Hamm's Brewery Company facility, a massive, nine-story concrete brewery complex located at 1550 Bryant Street. This building is an early example of concrete construction within the survey area and the 1915 building remains extant, although heavily remodeled (**Figure 24**).

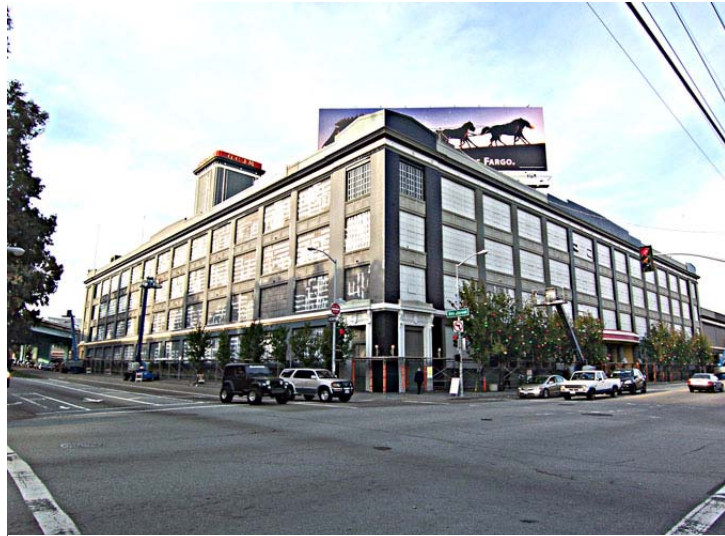
Figure 25. National Carbon Co. Building, 545 8th St.
Source: KVP Consulting

By the end of the First World War, concrete-frame construction had become the norm in San Francisco for industrial architecture. Notable examples of this type include: the National Carbon Company Building at 545 8th Street, a massive concrete industrial building designed by engineer Maurice Couchot and completed in 1916 (Figure 25). Brick was still used occasionally for exterior work, a prime example being the Dunham, Carrigan, & Hayden warehouse at 2 Henry Adams (Kansas) Street, designed by Leo Devlin and completed in 1915. Another major important concrete daylight-frame plant includes the American Can Company plant, which occupies the northern half of a block bounded by 19th, Harrison, and 20th streets, and Treat Avenue. Built in 1913, the concrete frame warehouse at 3101 19th Street is an excellent example of this building type.

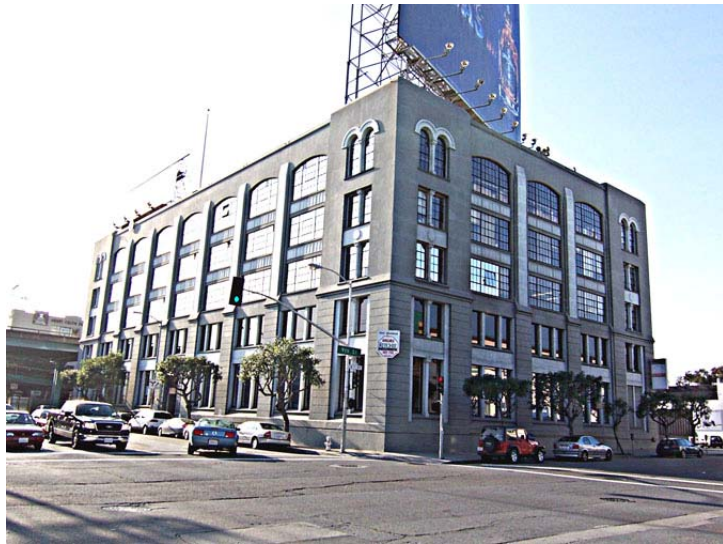
Figure 35. Standard Sanitary Mfg. Co., 1000 Brannan St.
Source: KVP Consulting

The Showplace Square survey area acquired several important concrete industrial buildings, during the 1920s-era building boom. Examples include the Standard Sanitary Manufacturing Company building, a five-story concrete factory and warehouse designed by the firm of Weeks & Day and erected in 1924 at 1000 Brannan Street (**Figure 35**); the Richmond Sanitary Manufacturing Company building, a four-story concrete industrial building designed by Powers & Ahnden and constructed in 1924 at 290 Division Street; the Pacific States Electric Company building, a three-story concrete warehouse designed by the company’s engineering division and constructed in 1927 at 530 10th Street (**Figure 36**), and the Ames, Harris & Neville factory, a four-story concrete factory designed by Miller & Pflueger and constructed in 1926 at 375 Alabama Street.

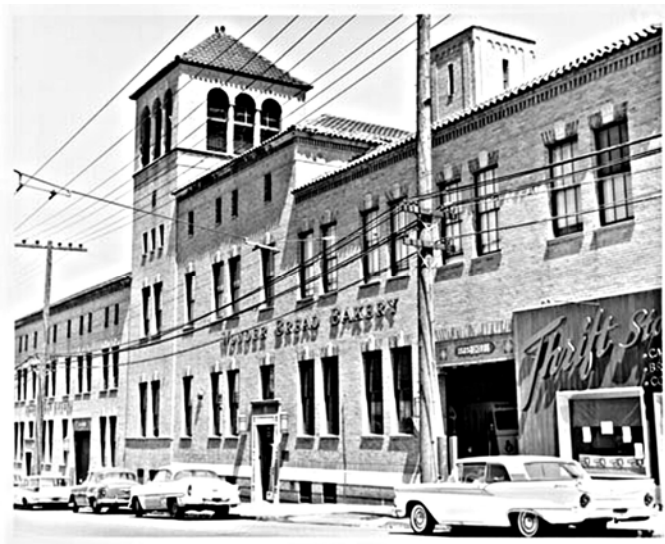
Figure 37. Continental Baking Co., 1525 Bryant St.
Source: KVP Consulting

Although concrete construction almost wholly displaced heavy timber-frame brick construction, brick continued to be used either for decorative purposes or as infill material. A primary example of this usage of brick is embodied by the Renaissance Revival-style Continental Baking Company building, a four-story industrial bakery built in 1929 at 1525 Bryant Street (**Figure 37**). Although constructed of concrete, yellow face brick is used as a decorative veneer. Another example of non-structural brick being used in a 1920s-era industrial building is the sprawling American Can Company plant, a multi-structure facility built in 1925 at 475-99

Alabama Street. The American Can Company plant – San Francisco’s second – is a good example of a daylight-frame building, with its exposed concrete frame and brick infill used within the spandrel regions.

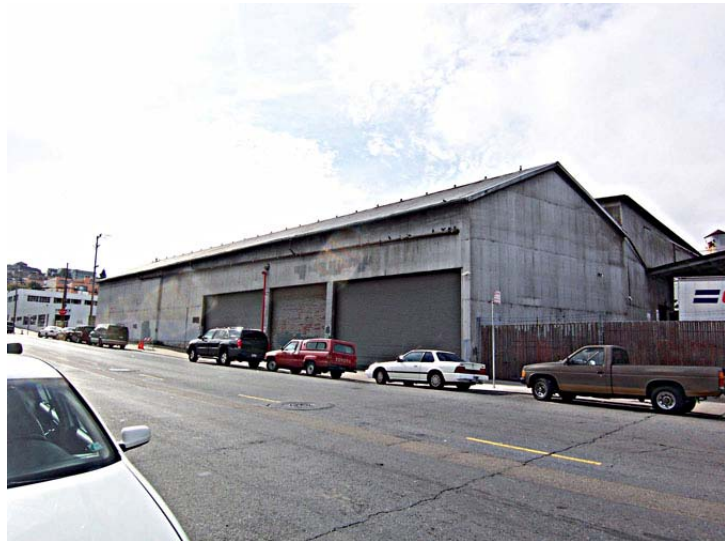
Figure 40. Pacific Mills Rolling Mills, 1200 17th St.
Source: KVP Consulting

Despite the ever-present danger of fire, wood-frame industrial buildings continued to be constructed within the Showplace Square survey area, particularly for special-purpose buildings or temporary structures. Examples include the Flynn & Enslow Iron and Steel Manufacturing Company’s facility, built in 1923 at 1550 17th Street (**Figure 39**). Wood-frame structures were commonly erected to house offices or temporary shops within larger industrial complexes. Other lower-cost construction methods included steel or wood-frame structures clad in corrugated steel, a lightweight and relatively inexpensive cladding material. Examples of this latter type of structure include a large gable-roofed warehouse located at the former Pacific Rolling Mills plant at 17th and Mississippi streets (**Figure 40**).

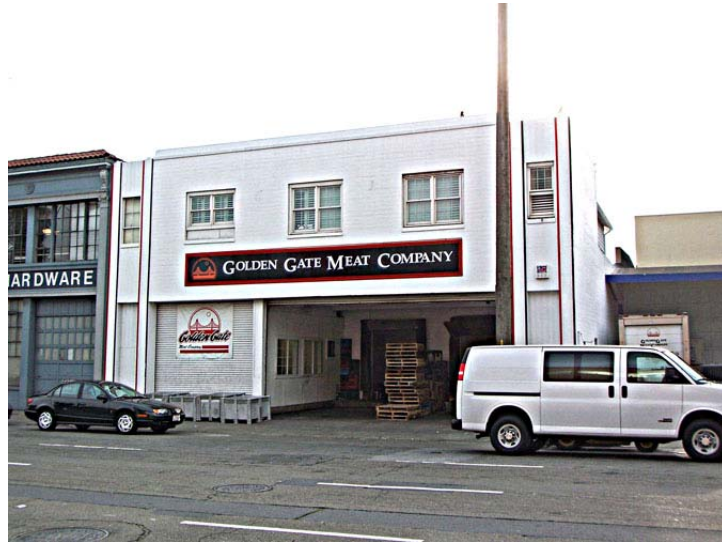
Figure 41. Golden Gate Meat Company, 550 7th St.
Source: KVP Consulting

Good examples of concrete industrial buildings constructed during the 1930s include the Golden Gate Meat Company warehouse at 550 7th Street. Built in 1936, the two-story Moderne-style concrete warehouse featured rail access along 7th Street as well as an integral vehicular loading dock (Figure 41). Other examples include the Schweitzer Wholesale Meat Company building at 828 Brannan Street. Built in 1936, the concrete Moderne-style facility features a bank of truck loading docks along Brannan Street. The building also had access to a spur track running along Langton Street. The Braun-Knecht-Heiman building at 1400 16th Street is one of the more architecturally significant factories within the survey area. Built in 1938, the one-story (with two-story office wing), reinforced-concrete, Art Deco-style chemical plant occupies an entire city block bounded by 15th, Carolina, 16th, and De Haro streets (Figure 42).

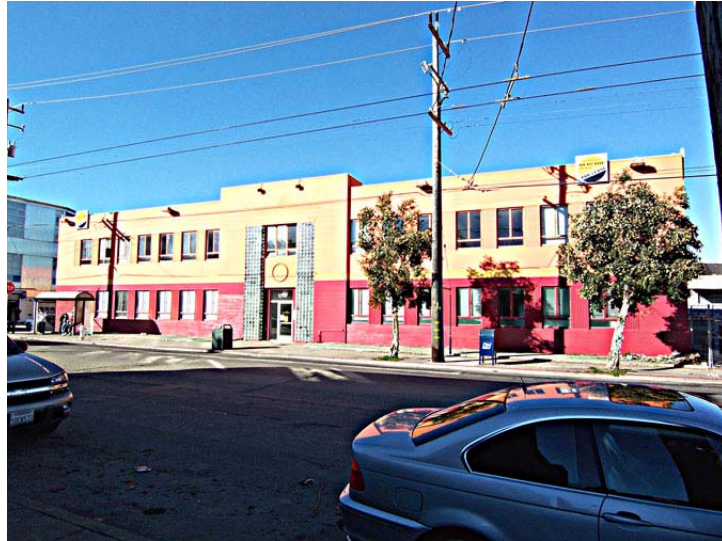
Figure 43. John A. Roebling & Sons Wire Rope Co., 1740 17th St.
Source: KVP Consulting

Late Moderne style, a composite of Streamline Moderne and the International Style. Its hallmarks include flat concrete canopies, extruded bezel moldings, and bands of ribbon windows. One of the best examples is the John A. Roebling & Sons Co. wire rope factory at 1740 17th Street. Built in 1941, the, two-story, reinforced-concrete, Late Moderne-style manufacturing facility occupies the majority of a block bounded by 16th, Carolina, 17th, and De Haro streets. The building originally had its own rail siding along De Haro and a truck loading dock along 16th Street (Figure 43).

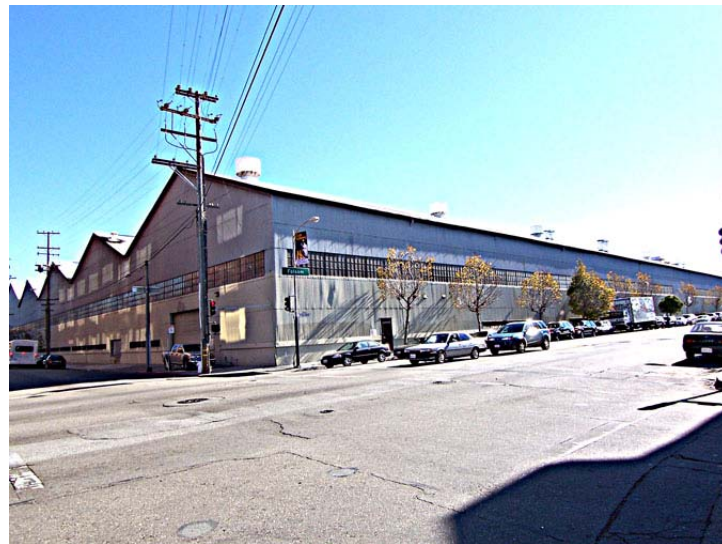
Figure 44. United States Steel Co. Warehouse, 1940 Harrison St.
Source: KVP Consulting

16th, and Folsom streets, the building is composed of seven parallel gable-roofed bays clad in corrugated steel. The southeast corner is chamfered to accommodate an office building and rail spur (**Figure 44**). Another even more utilitarian example is the Atlas Wood Products plant located at 3030 17th Street. A wood-frame structure, the building is composed of six shed-roofed pavilions linked to a warehouse.

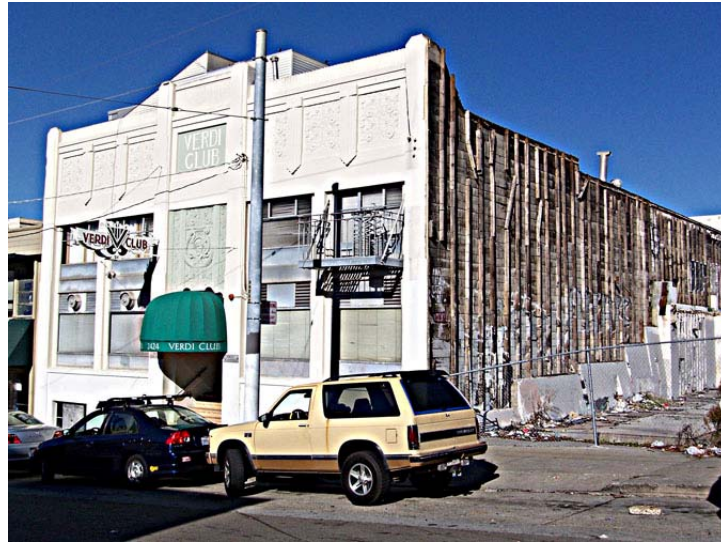
Figure 45. Verdi Club, 2424 Mariposa St.
Source: KVP Consulting

During the Depression and World War II virtually no non-industrial buildings were erected within the Showplace Square survey area. One important exception is the Verdi Club – an Italian-American men’s social club – built in 1935 at 2424 Mariposa Street. Built of reinforced-concrete, the one-story, Art Deco-style commercial building is a rare example of a commercial building erected in the survey area during the period of significance. With its molded concrete “Mayan Deco” frieze, spandrel panels, and other ornament, it is an excellent example of the Art Deco style as well (**Figure 45**).

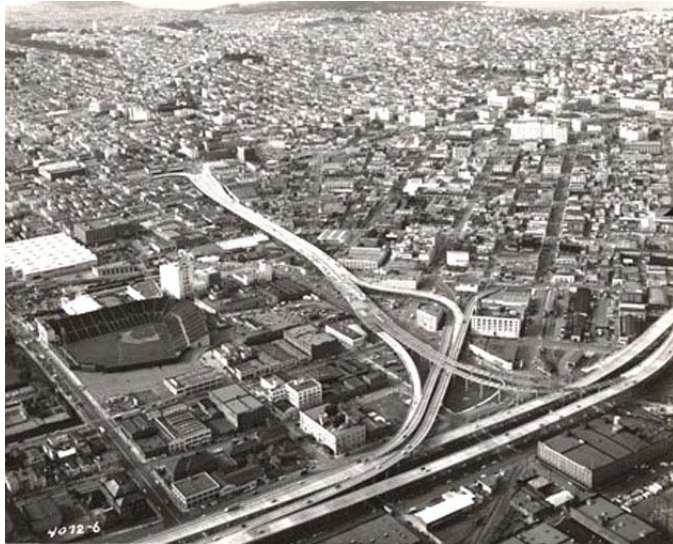
Figure 47. Aerial view of the Bayshore and Central freeways in the survey area, looking northwest
Source: San Francisco Public Library

The Bayshore Freeway was the first installment in a network of freeways that the State Division of Highways (now the California Department of Transportation, or "Caltrans") planned to provide fast and efficient transportation for suburban commuters at the expense of city residents. Construction did not reach San Francisco proper until 1950 when the southernmost segment of the Bayshore – the James Lick Freeway – was begun. The Bayshore wrought tremendous physical changes in the Showplace Square survey area. South of the survey area the Bayshore terraced the western slope of Potrero Hill, resulting in the forced sale and clearance of hundreds of properties. As the highway entered the survey area at Mariposa Street it became a multi-level steel-frame viaduct. The right-of-way below the viaduct occupied a swatch of land one-block wide for five blocks and most buildings below it had to be cleared to make way for viaduct's columns. The decision to elevate the freeway instead of building it at grade was supported for several reasons. First, the viaduct maintained the freeway at a consistent grade with Potrero Hill and the Bay Bridge approach. Second, the viaduct avoided interrupting most of the surface streets below. Finally, the elevated "Bayshore Skyway" was described by the State Division of Highways as a way to provide San Francisco with a dramatic approach from the south, facilitating the motorists' enjoyment of the skyline while cruising along high above the less-than-scenic industrial zone at 50+ miles per hour (Figure 47).¹²³

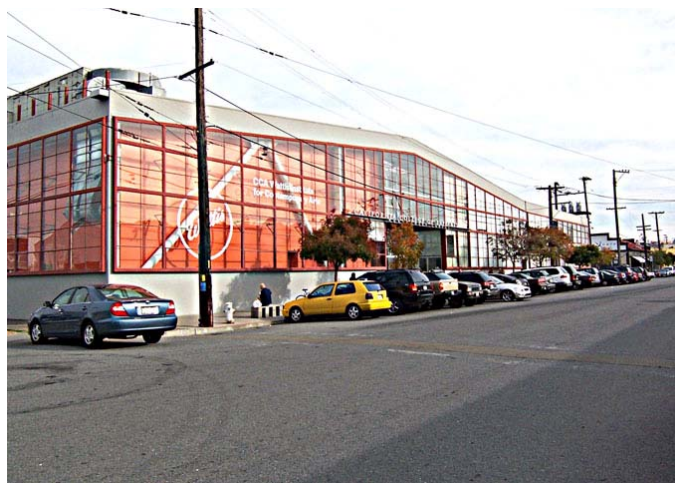
Figure 49. Greyhound garage, 450 Irwin St.
Source: KVP Consulting

One of the most architecturally significant buildings built within the Showplace Square survey area during the immediate postwar period is the Greyhound Bus Lines garage at 450 Irwin Street. Designed in 1950 by Skidmore Owings & Merrill (SOM) and built in 1951, the Greyhound garage is an excellent example of the International Style applied to a utilitarian, industrial facility (**Figure 49**). The exterior of the building is almost entirely glazed using steel industrial sash windows to facilitate the diffusion of natural light throughout the interior. Skylights placed throughout the gently pitched gable roof introduced additional light and aided in elimination of exhaust and other noxious fumes. Used for this purpose for decades, the building was successfully converted into the campus of the California College of Arts (CCA).

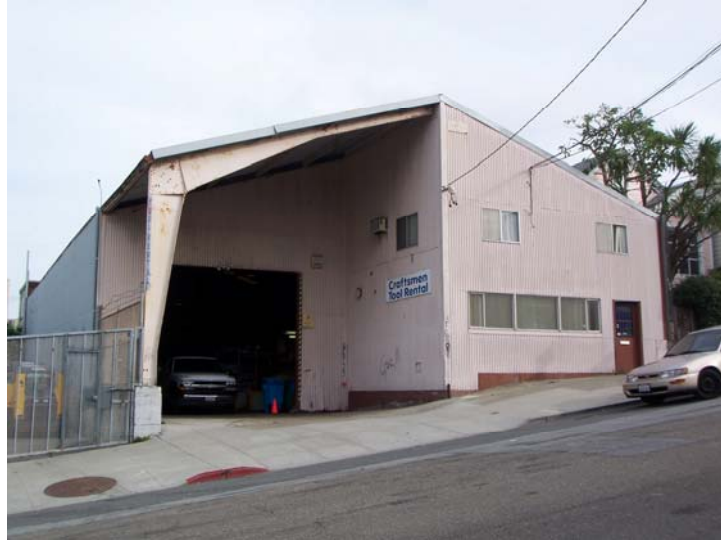
Figure 50. 131 Missouri St.
Source: KVP Consulting

structure, modular corrugated steel structures could be configured for virtually any size parcel and for any type of business and they were also much easier to dismantle and move. Examples within the survey area include the simple gable-roofed former cabinet shop at 2757 16th Street (1950) and a modular corrugated steel shop at 131 Missouri Street (1960) (Figure 50).

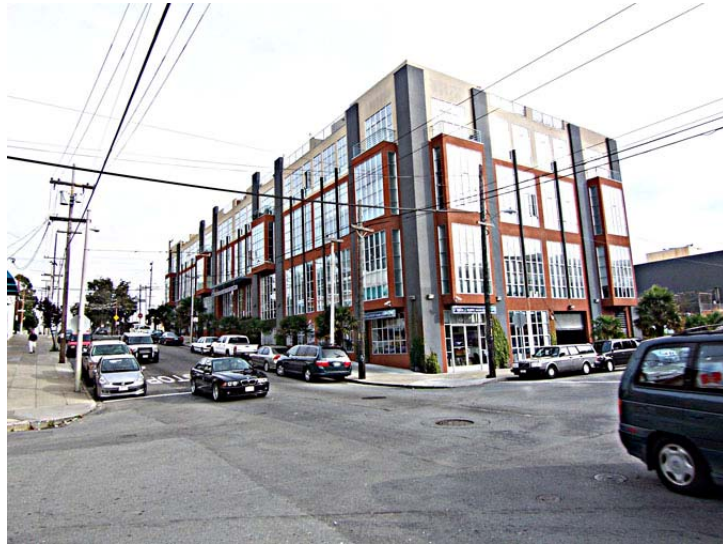
Figure 54. 1800 Bryant St.
Source: KVP Consulting

developed first. Examples include the massive Franklin Square Lofts located at 1800 Bryant Street (**Figure 54**). Built in 2000 and designed in a contemporary vocabulary incorporating “industrial” materials such as aluminum, glass, and corrugated steel, this four-story loft structure is similar to dozens of others constructed throughout the survey area during the dotcom boom. The survey area also contains several live-work projects that were built on top of abandoned rail spurs and associated-rights-of-way. An imaginative approach to infill development, buildings like the 370 De Haro Street Lofts (**Figure 55**) present the classic face of a 1990s live-work loft contorted to fit an irregularly-shaped parcel that was once part of the Western Pacific alignment.

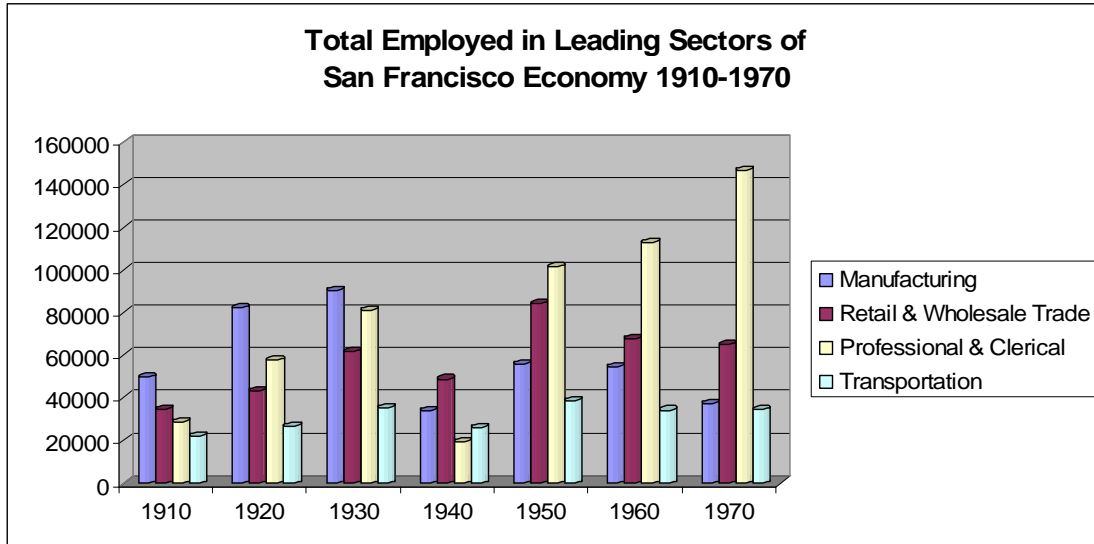
Figure 56. Leading Sectors of Employment, 1910-1970 from Censuses of Population, San Francisco

As can be seen in **Figure 56**, Manufacturing employment reached its historic peak in the 1930 census, then declined both in absolute numbers of workers and in relative importance to the San Francisco economy. Although Retail and Wholesale Trade figures, which included Distribution workers, continued to increase until the 1950 census, the numbers of Distribution workers, even when added to manufacturing probably did not offset the steadily increasing importance of Professional and Clerical employment in the local economy and the relative decline in importance of industrial employment. This can be seen more clearly in **Figure 57**, where the percentage of the workforce employed in manufacturing is seen to decline steadily over time from a high of 35.8% in 1880 to 12.7% in 1970.

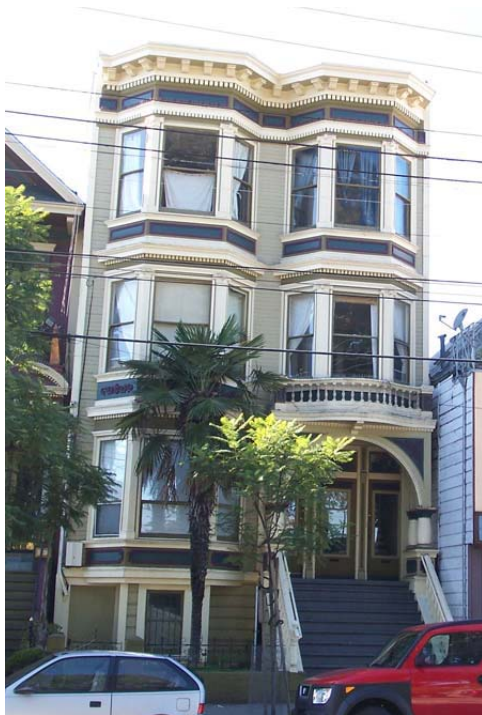
Figure 63. 1730 Bryant Street
 Source: KVP Consulting

Flats are found in almost all of San Francisco's older residential neighborhoods. Typically built of wood (although some are faced in brick), flats in San Francisco are often recognizable by their recessed porches sheltering individual entrances for each unit. Most flats in San Francisco (except for Romeo flats) contain two or three units per module, with each flat occupying an entire floor. Although most flats consist of a single stack of units, some are comprised of two parallel stacks connected at the center (double flats), or if land allows this module can be expanded to include additional stacks comprising triple, quadruple, or even quintuple flats. Flats in San Francisco are often built atop a raised concrete or brick foundation/podium where either a garage (if built after the First World War) or an additional residential unit may be located. Flats are designed in any architectural style popular during this period, including the Classical Revival, Mission Revival, Craftsman, and Colonial Revival styles. One of the most intact examples within the Showplace Square survey area is a three-flat building constructed in 1900 at 1730 Bryant Street. It is located within a small enclave of residential structures located on the west side of Franklin Square, its park-side location remaining the most desirable area for residential development within the survey area (**Figure 63**).

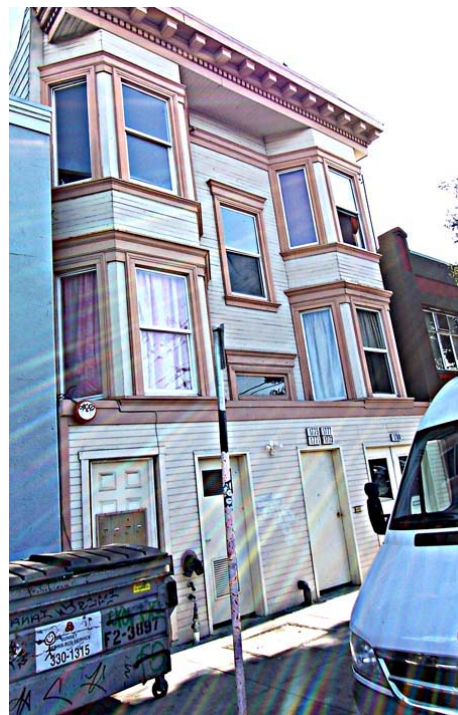
Figure 64. 1771 Folsom Street
 Source: KVP Consulting

Romeo Flats are easily distinguishable from their conventional counterparts. In contrast to the façades of conventional flats, which are typically divided into an even number of bays, Romeo flats typically feature an odd number of bays – often three – with bay windows located in the outer bays. The central bay is easily recognizable as the location of the stair because it is usually open or if enclosed the fenestration aligns with the stair landings and not the adjoining bay windows of the residential units. Because there are multiple units on each floor, units in Romeo flats are typically smaller and narrower than conventional flats. In the survey area, the only remaining example of a true Romeo flat is a structure at 1771 Folsom Street. Built in 1911, this building is located near the southwestern corner of the survey area in the Mission District (**Figure 64**).

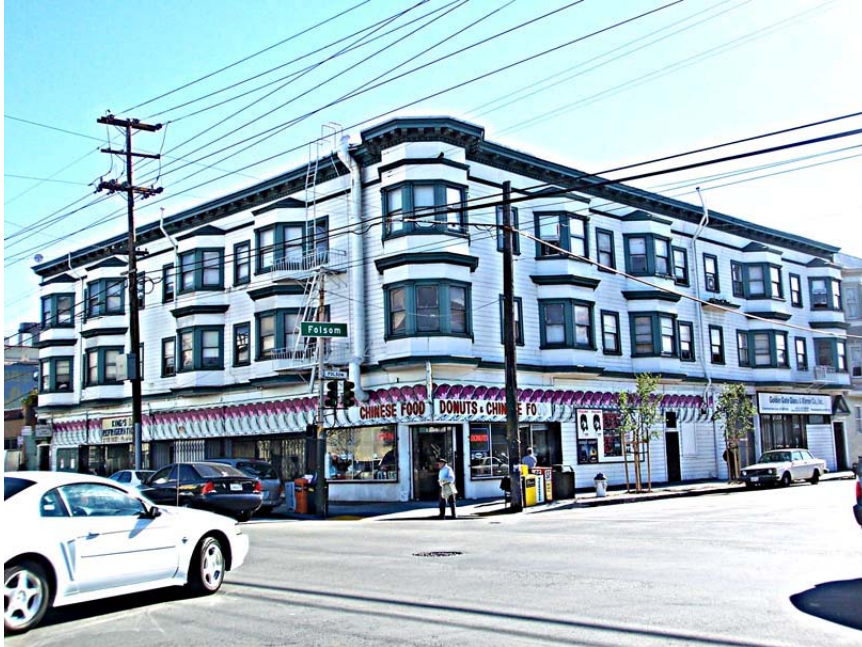
Figure 65. Wagner Hotel, 2011 Folsom Street
Source: KVP Consulting

The exterior façades of residential hotels typically display a regular pattern of window openings reflecting the interior arrangement of guest rooms. Floor levels are sometimes demarcated by intermediate cornices and most residential hotels are capped by a wood or sheet metal cornice and a flat roof. The Showplace Square survey area contains a handful of residential hotels. All are wood-frame structures – three-to-four stories in height – and designed in a simplified version of the Classical Revival style. The largest and most characteristic example is the Wagner Hotel, built in 1911 at 2011 Folsom Street (**Figure 65**).

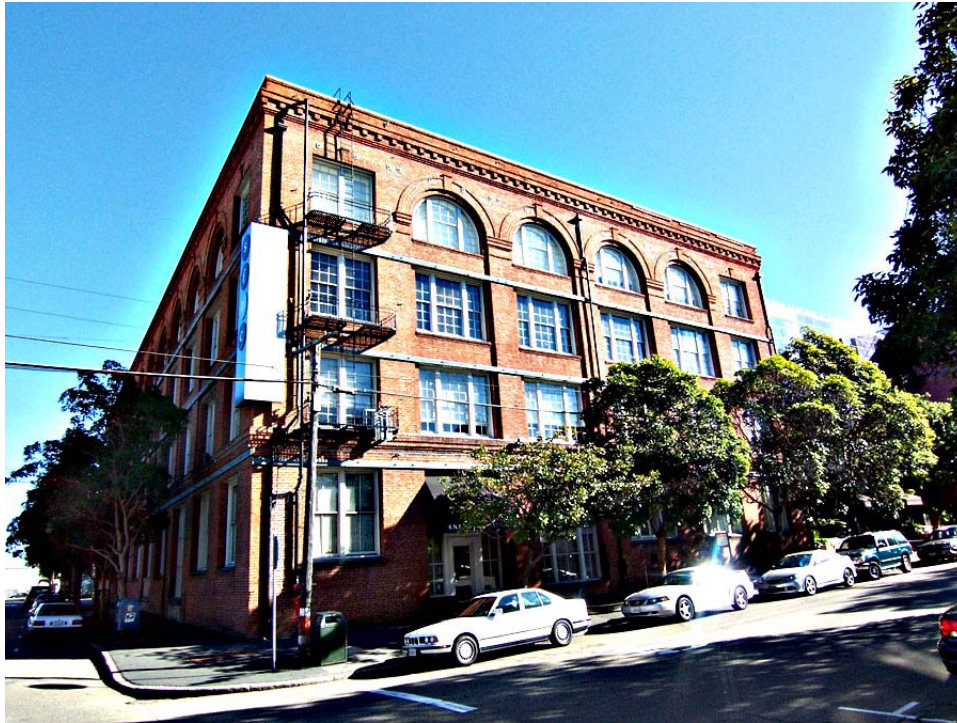
Figure 67. John Hoey & Co. warehouse, 101 Henry Adams Street
Source: KVP Consulting

The most iconic industrial building type within the survey area is the brick American Commercial style warehouse/factory, concentrated in two main clusters on either side of the Bayshore/Lick Freeway, with another cluster at 7th and Townsend streets. All feature heavy timber or steel-frame “mill construction” with brick exterior load-bearing walls punctuated by a grid of deeply recessed and jack-arched or segmental-arched window and door openings. Ornament is typically classically derived with extruded brick string courses, simple pilasters, arched window and door moldings, and corbelled friezes and cornices. Other common features of this type include integral rail spurs, exterior loading docks, and within the interior, undifferentiated work floors with offices located near the main pedestrian entrance. This type continued to be built in large numbers after the 1906 Earthquake and Fire. By the end of the First World War, brick began to be displaced by concrete construction. The earliest American Commercial style industrial building in the survey area is the Golden Gate Woolen Mills Company, built ca. 1895 at 720 York Street. The Baker & Hamilton warehouse at 7th and Townsend was constructed five years later in 1905. This massive heavy timber-frame brick building served as a model for several major factories and warehouses erected after the 1906 Earthquake within the survey area, including the John Hoey Warehouse, part a complex of three identical warehouses that occupy the block bounded by Alameda, Rhode Island, 15th, and Kansas streets (**Figure 67**) and the J.L. Case Threshing Co. plant located at 200 Rhode Island Street.

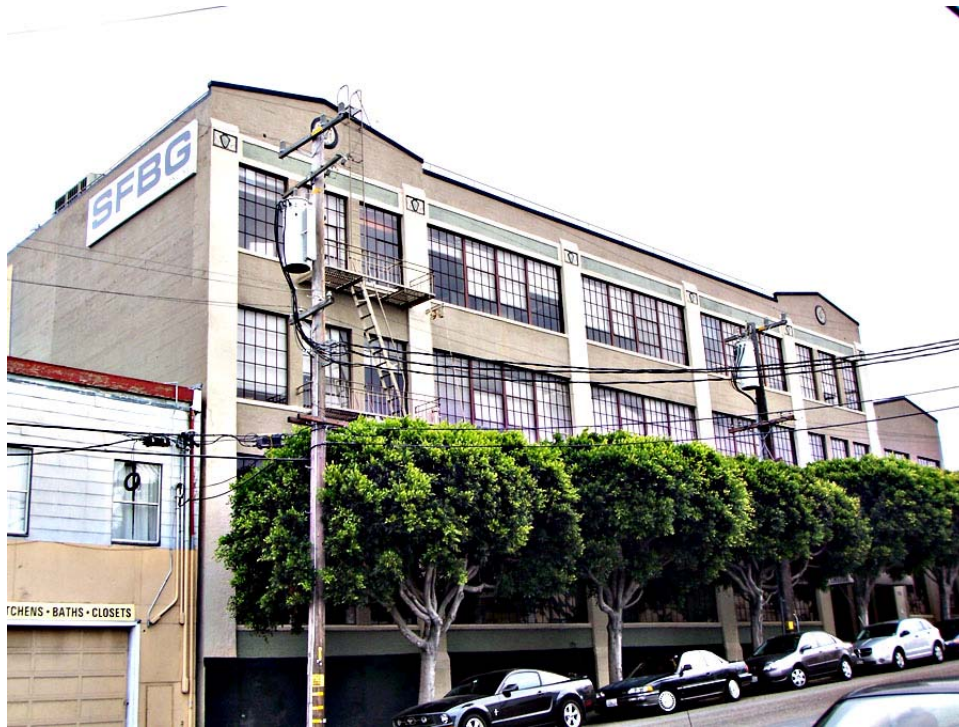
Figure 68. Berger & Carter Warehouse, 135 Mississippi Street
Source: KVP Consulting

The concrete “daylight” frame industrial building is another prominent industrial building type within the Showplace Square survey area. The term “daylight factory” arose in the early twentieth century to describe the application of reinforced-concrete techniques to large industrial buildings. As opposed to brick mill construction, concrete construction featured an integral structural frame which allowed for an abbreviated exterior envelope and for an extensive portion of the exterior to be devoted to fenestration. In addition, concrete was fireproof, earthquake-resistant, and more flexible than brick construction, providing more interior space by reducing the thickness of perimeter walls and the number of interior columns. Similar to the brick industrial buildings of the pre-World War I era, most early concrete buildings in the survey area are between three and five stories high with flat roofs. Many were also built around their own integral rail spurs or sidings. By the end of the First World War, concrete construction had become the dominant mode in the survey area. Unlike brick, which was relatively expensive to manipulate for decorative effects, concrete could be molded to create ornament in a variety of historicist and modern styles, including Gothic Revival, Renaissance Revival, Art Deco, and Streamline Moderne. Important early examples within the survey area include the National Carbon Company Building, built in 1916 at 545 8th Street; the Standard Sanitary Manufacturing Company Building, built in 1924 at 1000 Brannan Street; and the Berger & Carter warehouse, built in 1925 at 135 Mississippi Street (**Figure 68**).

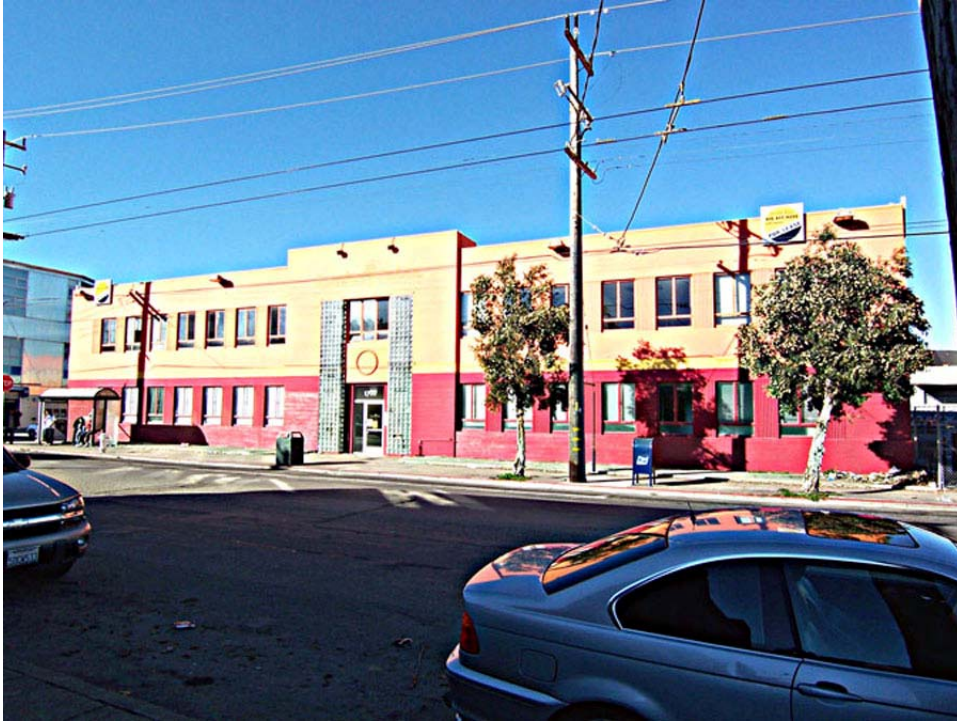
Figure 69. John A. Roebling & Sons Wire Rope Factory, 1740 17th St.
Source: KVP Consulting

Concrete was used for industrial buildings in the survey area throughout the end of the period of significance. Later examples built in the 1940s and 1950s were more often one or sometimes two-stories in height with a two-story office wing in the front, the work space to the rear, and exterior loading docks arrayed along the streets to accommodate both trains and trucks. Dozens of this latter type continue to stand within the survey area, including the John A. Roebling & Sons Wire Rope Factory, built in 1941 at 1740 17th Street (**Figure 69**).

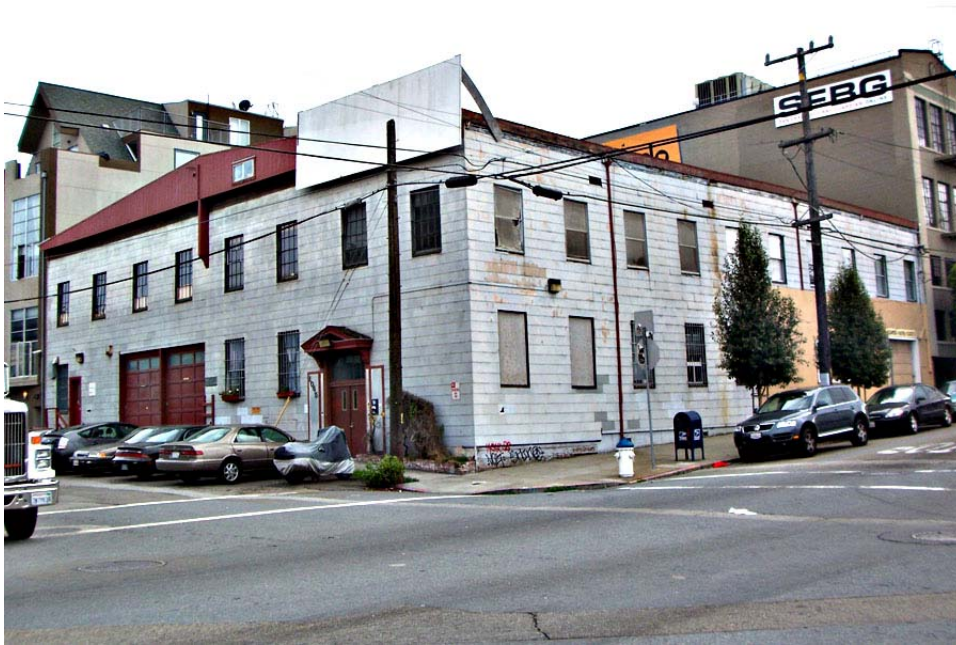
Figure 70. Berger & Carter Hardware Co., 1045 17th St.
Source: KVP Consulting

Although not as common as brick or concrete, wood-frame industrial buildings are also present within the Showplace Square survey area. Some early examples are of heavy-timber frame construction – similar to the American Commercial style – but clad in wood siding instead of brick. Built before insurance company guidelines were revised after the 1906 Earthquake and Fire, examples of this type are rare and nearly always predate 1906, such as the Berger & Carter Hardware Co. Building, constructed ca. 1900 at 1045 17th Street (**Figure 70**).

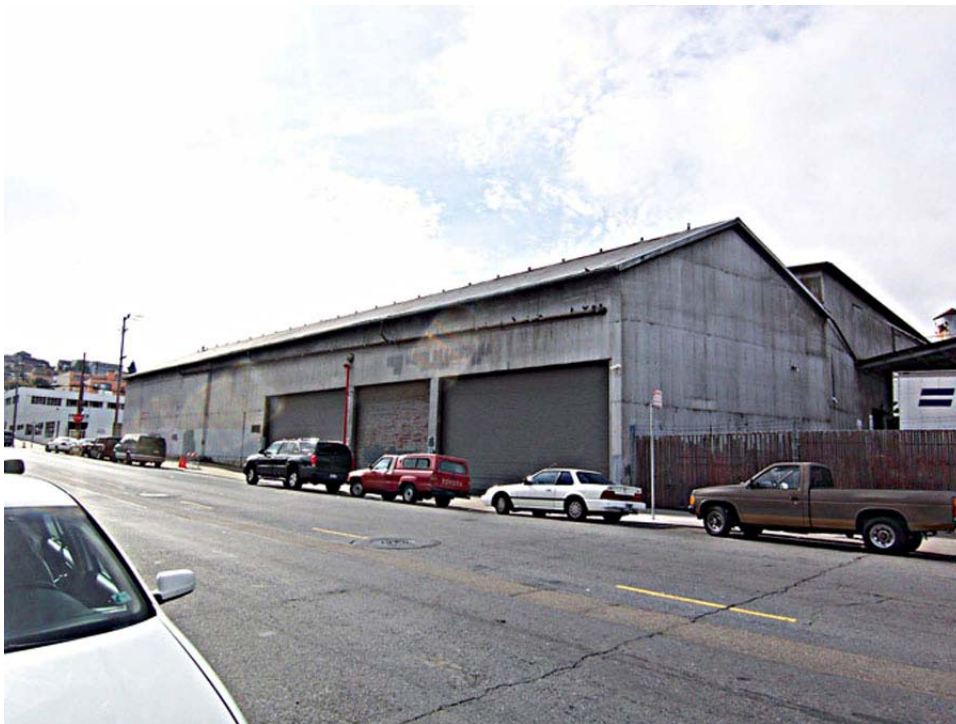
Figure 71. Pacific Rolling Mills warehouse, 1200 17th St.
Source: KVP Consulting

Wood-frame construction was also used for temporary structures, offices, or for buildings constructed during the Second World War when the Federal government enacted restrictions on the civilian use of steel and concrete. More common are wood-frame structures clad in corrugated steel siding. Much less expensive than either concrete or brick, corrugated steel structures were ideal for a variety of industrial applications because they were comparatively easy to build, somewhat fire resistant, and easily adaptable to changing needs. Within the Showplace Square survey area, examples of wood-frame, steel-clad buildings range from small machine shops to colossal manufacturing operations such as the Pacific Rolling Mills (Owens-Illinois Glass Warehouse) facility constructed ca. 1913 at 1200 17th Street (**Figure 71**).

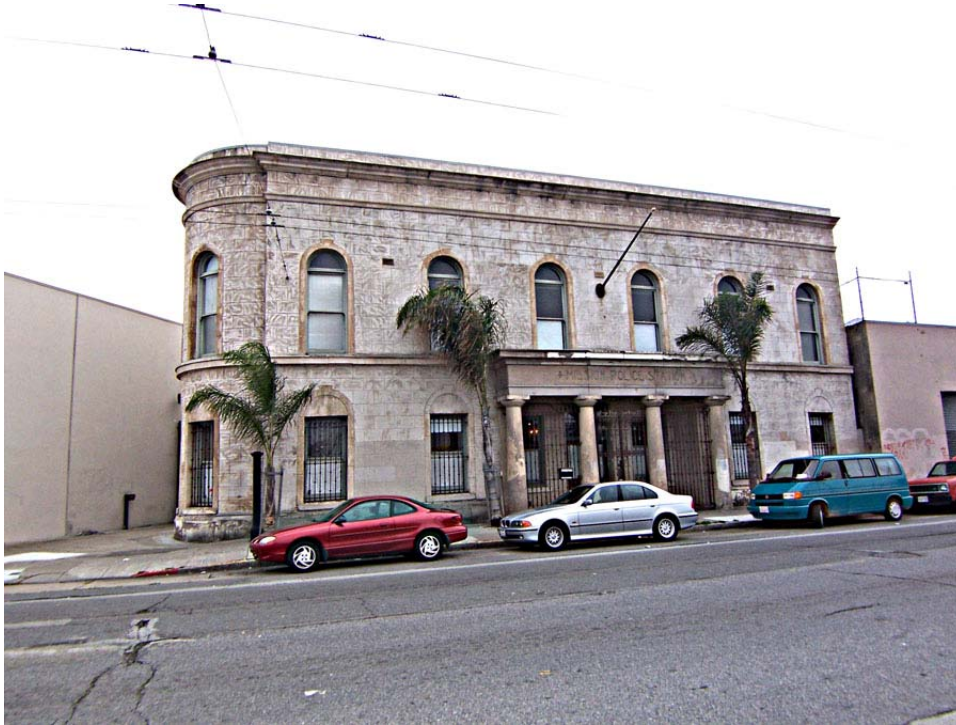
Figure 72. Southern (Mission) Police Station, 3057 17th St.
Source: KVP Consulting

With only a small permanent residential population, the Showplace Square survey area was never home to more than a few civic/institutional properties. Accordingly, all methods of construction and several architectural styles are represented. One of the most notable civic buildings in the survey area is the Southern (Mission) Police Station, constructed in 1899 at 3057 17th Street (**Figure 72**). Designed by the politically well-connected architecture firm of Shea & Shea, the two-story concrete and brick building is one of the most architecturally significant buildings within the survey area.
