Historic Preservation Commission Executive Summary Historic Resource Survey Findings INFORMATIONAL PRESENTATION: JUNE 1, 2011 ADOPTION HEARING: JUNE 15, 2011

Date: May 25, 2011
Case No.: **2011.0401U**
Project: Showplace Square / Northeast Mission Historic Resource Survey
Staff Contact: Moses Corrette – (415) 558-6295
moses.corrette@sfgov.org
Reviewed By Tim Frye – (415) 575-6822
tim.frye@sfgov.org
Recommendation: **Adoption of survey findings**

**SHOWPLACE SQUARE SURVEY
SAN FRANCISCO, CALIFORNIA
FINAL**

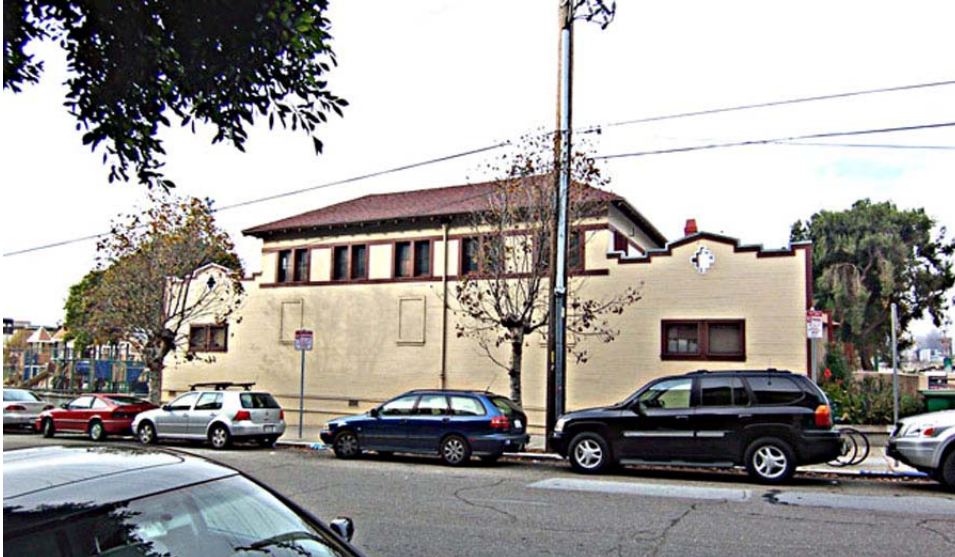
Figure 73. Jackson Playground
Source: KVP Consulting

The survey area also contains two public parks: Franklin Square and Jackson Playground. Long neglected, Franklin Square was not fully completed until after the 1906 Earthquake. Jackson Playground, once a swamp, was not filled and improved until 1913. Aside from some concrete retaining walls and stairs from 1911, Franklin Square does not retain historic fabric. Jackson Square contains an intact Mission Revival style wood-frame clubhouse built in 1913 (**Figure 73**).

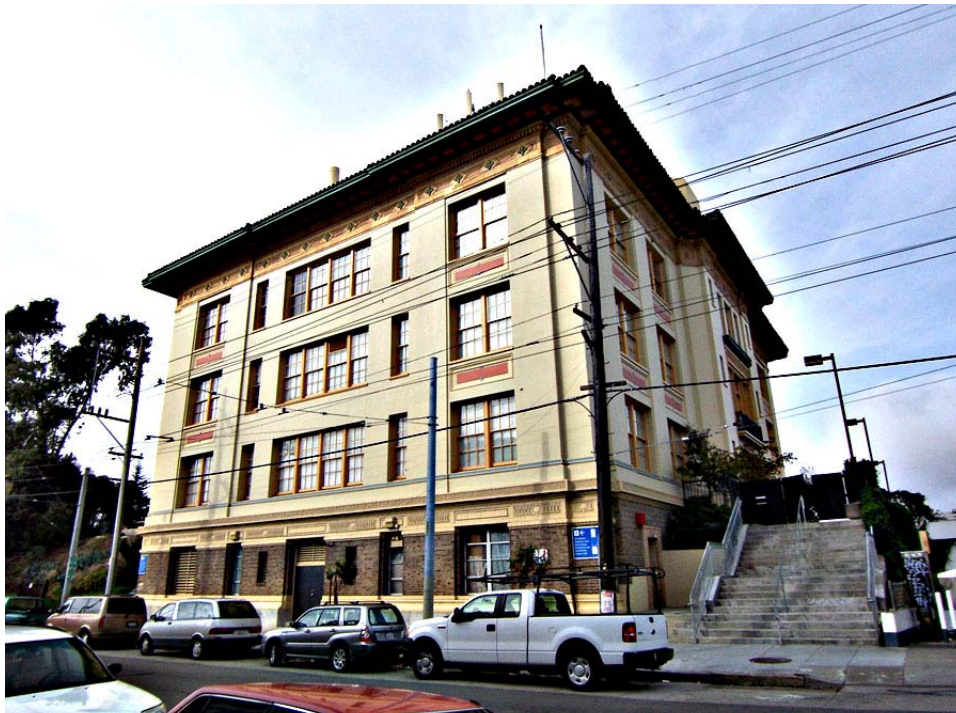
Figure 74. Lux School for Industrial Training, 2450 17th St.
Source: KVP Consulting

Although they are not public buildings, the survey area was once home to several important early trade schools, one of which still exists, the concrete Lux School for Industrial Training, built in 1913 at 2450 17th Street (**Figure 74**).

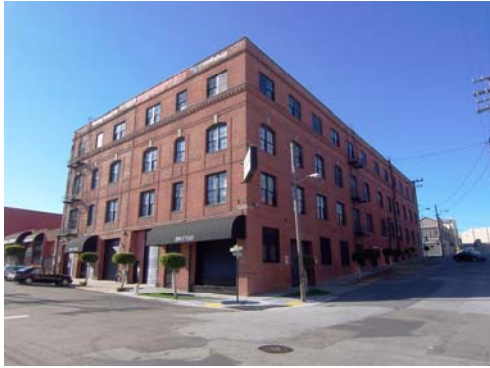
Figure 2. Abel Hosmer warehouse at 212 Utah Street
Source: KVP Consulting

Two of the most characteristic examples of the American Commercial style in the proposed district including the Abel Hosmer warehouse at 212 Utah Street (**Figure 2**) and the Pacific Implement Co. building at 131 Henry Adams Street (**Figure 3**).

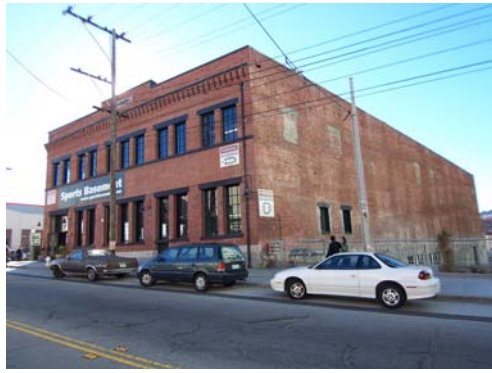
Figure 8. M. Friedman & Co. warehouse
Source: KVP Consulting

Construction of new buildings continued apace throughout the post-quake reconstruction period of 1906-1913. In addition to speculative buildings, individual companies – many burned out of the South of Market Area – began constructing brick industrial buildings within the survey area. In need of large floor plates to store bulky goods and convenient access to rail spurs, most of these companies erected large multi-story brick structures with integral rail sidings or spurs. One of the largest and most architecturally distinctive buildings within the proposed historic district is the J.I. Case Threshing Co. complex (1912) at 200 Rhode Island Street (**Figure 7**). Designed by famed San Francisco-based architect J. Albert Lansburgh, the five-story warehouse housed a wholesale hardware company specializing in farm equipment. Another example, designed in a more traditional Renaissance-Baroque style is the Friedman & Co. Furniture Company warehouse (1907) at 1590 Bryant Street (**Figure 8**). This building, constructed of brick with a heavy timber frame, is the westernmost contributor to the district. Although it did not have its own rail spur, it was located within two blocks of the Southern Pacific's Mission freight depot.

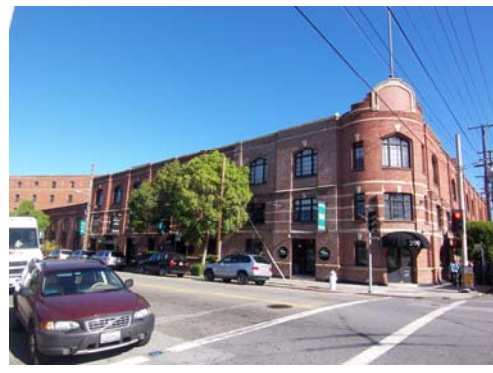
Figure 9. Schlessinger & Bender winery
Source: KVP Consulting

In addition to hardware and furniture wholesalers, the historic district contains several buildings built as food or beverage-processing plants. These range from the supremely utilitarian San Francisco Salt Refinery (1908) at 550 15th Street to the architecturally elaborate Schlessinger & Bender Winery at 1616 16th Street. Designed by G. Albert Lansburgh, the Schlessinger & Bender complex is notable for its prominent curved corner entry and elaborate polychromatic brickwork laid in Flemish bond and detailed with terra cotta and tile work (**Figure 9**).

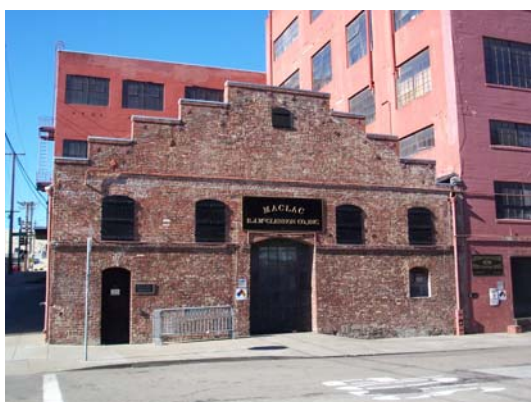
Figure 10. R.N. Nason Paint Co. building
Source: KVP Consulting

The post-quake reconstruction period also witnessed the construction of smaller and less prominent American Commercial-style brick buildings on less valuable lots located at the periphery of the spur track network that historically tied the survey area together. One of the best examples in the historic district is the small brick shop that predated the rest of the large R. N. Nason paint company complex at 198 Utah Street (ca. 1907) (**Figure 10**). Others are only one-story in height and appear that to have

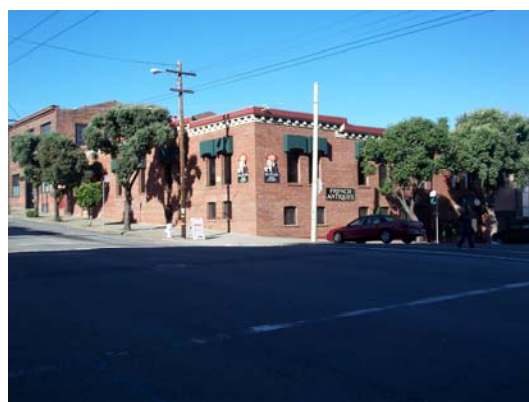
Figure 11. E.W. Bennett Chemical Co. building
Source: KVP Consulting

been designed to be added on to. Examples of this latter type in the proposed historic district include the E.W. Bennett Chemical Company building (1907) at 2000 16th Street (**Figure 11**).

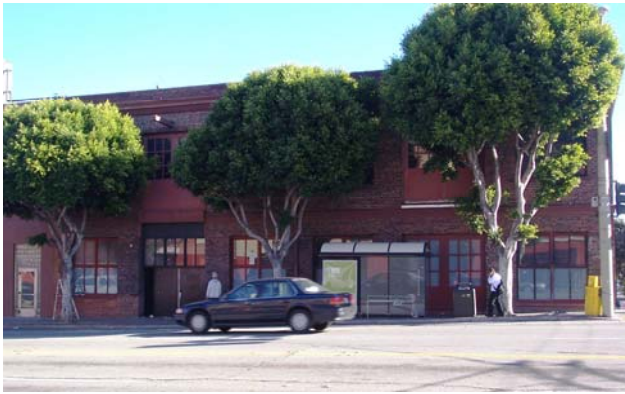
Figure 14. Forderer Cornice Co. building
Source: KVP Consulting

Construction within the survey area slowed again for a few years after World War I, resuming again in the early 1920s with the nationwide 1920s-era building boom. Although several American Commercial-style brick buildings were completed during the 1920s, by this time reinforced-concrete had become the preferred material of choice within the survey area. Later examples within the proposed historic district include the Westinghouse Electric Supply Co. warehouse (1922) at 225 Potrero Avenue and the Forrerer Cornice Works Co. building (1924) at 255 Potrero Avenue (**Figure 14**). The latter building was one of the last buildings in the survey area constructed with a heavy timber frame and load-bearing brick walls, hallmarks of the American Commercial style. Brick continued to be used in the survey area even after the demise of the American Commercial style and the survey area contains one late transitional example that merges concrete and brick construction techniques into one building, the Continental Baking Company building at 1525 Bryant Street (1928-29) (**Figure 15**). Constructed at the end of the 1920s building boom and designed in a transitional style merging elements of the American Commercial and the Renaissance Revival styles, the bakery features a concrete frame with brick exterior cladding. Despite its sophisticated concrete structural system, the building’s exterior retains the rhythmic punched windows and heavy mural qualities of the heavy timber-frame buildings that preceded it. This building is the newest contributor to the Showplace Square Heavy Timber and Steel-frame Warehouse and Factory District.

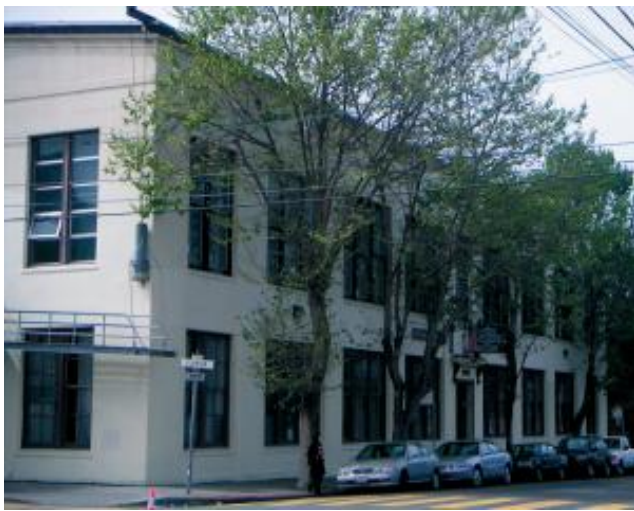
Photo: 2929 19th St. Pelton Factory. Production type plant.

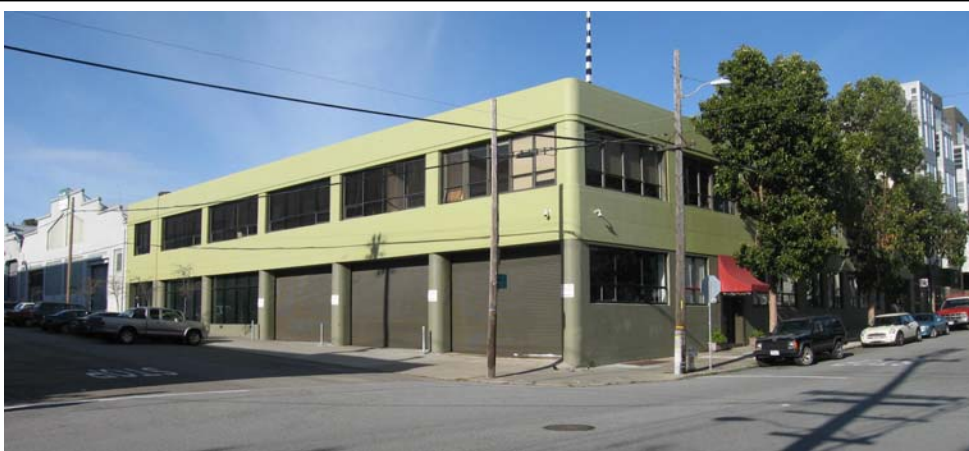
Photo: 2650 18th St. Challenge Butter & Cream Association. Distribution type.

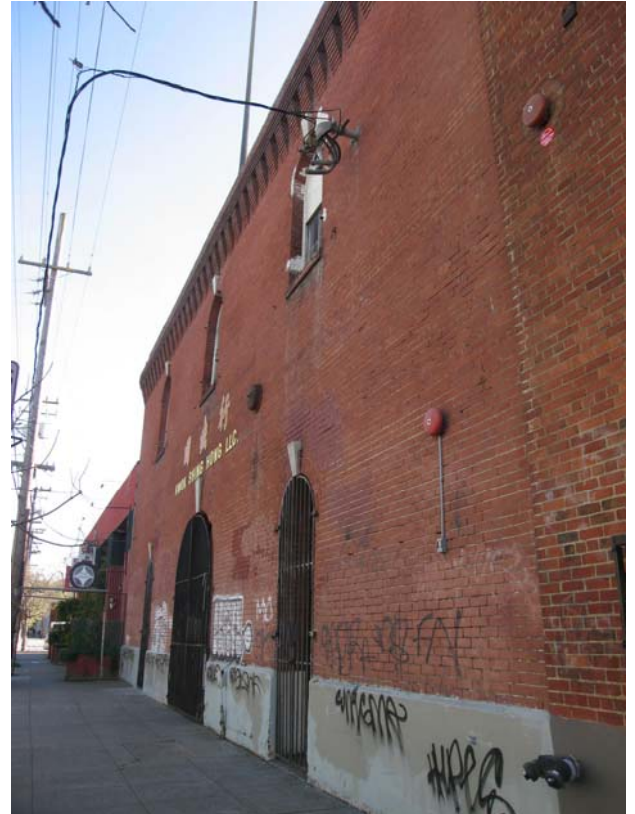
The most iconic industrial building type within the survey area is the brick American Commercial style warehouse/factory. All feature heavy timber or steel-frame "mill construction" with brick exterior load-bearing walls punctuated by a grid of deeply recessed and jack-arched or segmental-arched window and door openings. Ornament is typically classically derived with extruded brick stringcourses, simple pilasters, arched window and door moldings, and corbelled friezes and cornices. Other common features of this type include integral rail spurs, exterior loading docks, and within the interior, undifferentiated work floors with offices located near the main pedestrian entrance. This type continued to be built in large numbers after the 1906 Earthquake and Fire. By the end of the First World War, brick began to be displaced by concrete construction. The earliest American Commercial style industrial building in the survey area is the Golden Gate Woolen Mills Company, built ca. 1878 at 720 York Street. Other notable examples include: 1820 Harrison was built in 1900 for David Woerner's cooperage and the Baker & Hamilton warehouse (not in this area) at 7th and Townsend was constructed in 1905. These massive heavy timber-frame brick building served as a model for several major factories and warehouses erected after the 1906 Earthquake within the survey area.

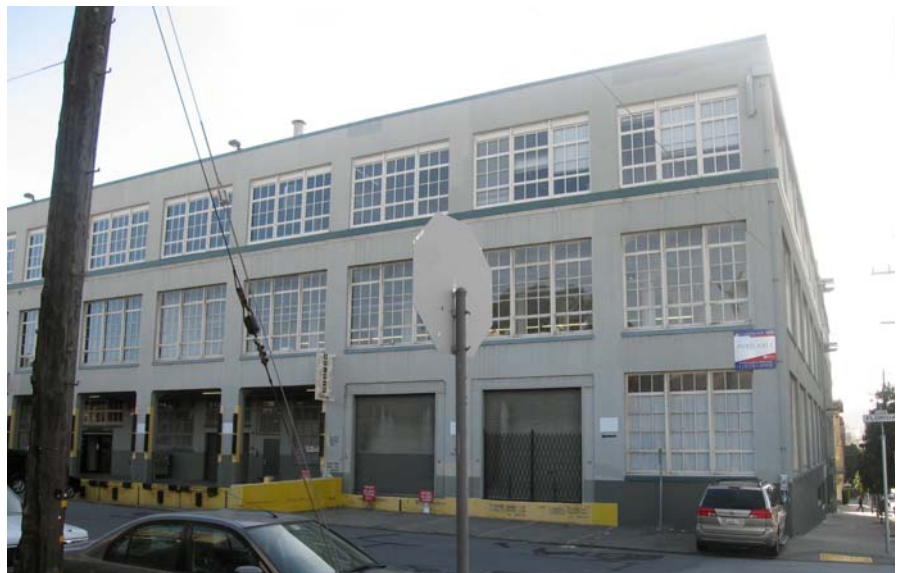
The concrete "daylight" frame industrial building is another prominent industrial building type within the Showplace Square survey area. The term "daylight factory" arose in the early twentieth century to describe the application of reinforced-concrete techniques to large industrial buildings. As opposed to brick mill construction, concrete construction featured an integral structural frame,

fenestration. In addition, concrete was fireproof, earthquake-resistant, and more flexible than brick construction, providing more interior space by reducing the thickness of perimeter walls and the number of interior columns. Similar to the brick industrial buildings of the pre-World War I era, most early concrete buildings in the survey area are between three and five stories high with flat roofs. Many were also built around their own integral rail spurs or sidings. By the end of the First World War, concrete construction had become the dominant mode in the survey area. Unlike brick, which was relatively expensive to manipulate for decorative effects, concrete could be molded to create ornament in a variety of historicist and modern styles, including Gothic Revival, Renaissance Revival, Art Deco, and Streamline Moderne. Examples of concrete "daylight" frame industrial building within the area include: 2929 19th street, the Pelton Water Wheel factory office and laboratory; and 2030 Harrison, the McRosky & Co. Mattress Factory from 1907 with later additions.

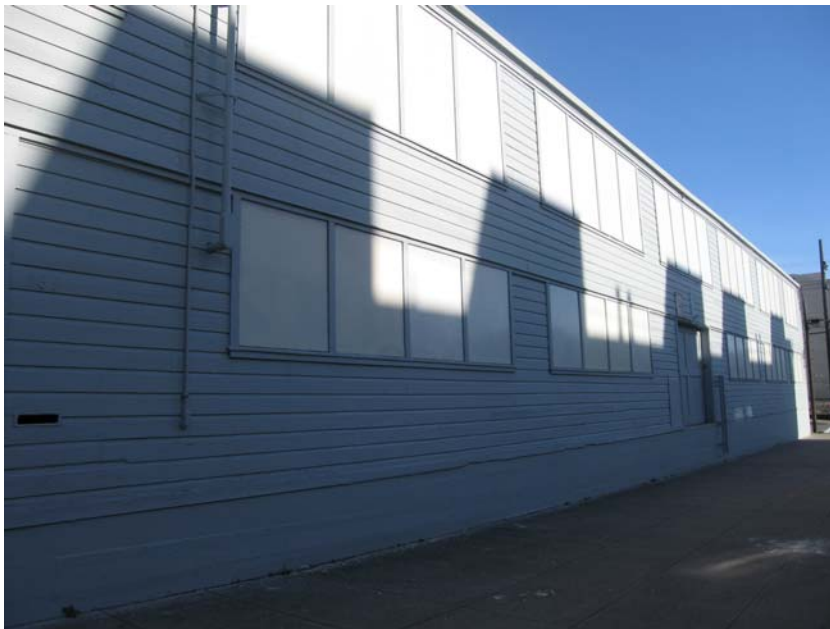
Although not as common as brick or concrete, wood-frame industrial buildings are also present within the Showplace Square survey area. Some early examples are of heavy-timber frame construction – similar to the American Commercial style – but clad in wood siding instead of brick. Built before insurance company guidelines were revised after the 1906 Earthquake and Fire, examples of this type are rare and nearly always predate 1906, such as the Berger & Carter Hardware Co. Building, constructed ca. 1900 at 1045 17th Street and the Pioneer Trunk Factory from 1902 at 3180-3198 18th st, designed by Thomas Welsh, it is listed on the National Register.

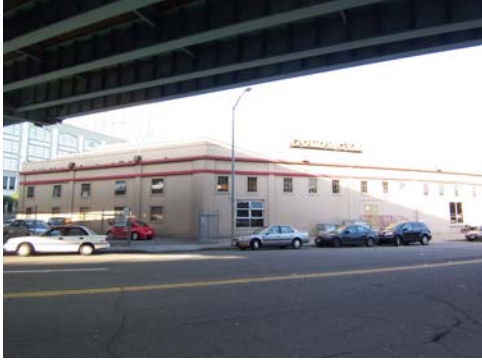
View toward north, 11.27.07, 100_2647.JPG

Structurally, 1001 Brannan is a traditional heavy timber frame (slow-burning) structure with poured-in-place concrete walls. As such, it represents a transitional type spanning the divide between the prevalent post-quake mill construction typology and the concrete-frame, "daylight" construction of the 1920s. Based on a comparison of the building with historic photographs, it is evident that 290 Division has undergone few if any major exterior alterations. It retains integrity of location, design, setting, materials, workmanship, feeling, and association.

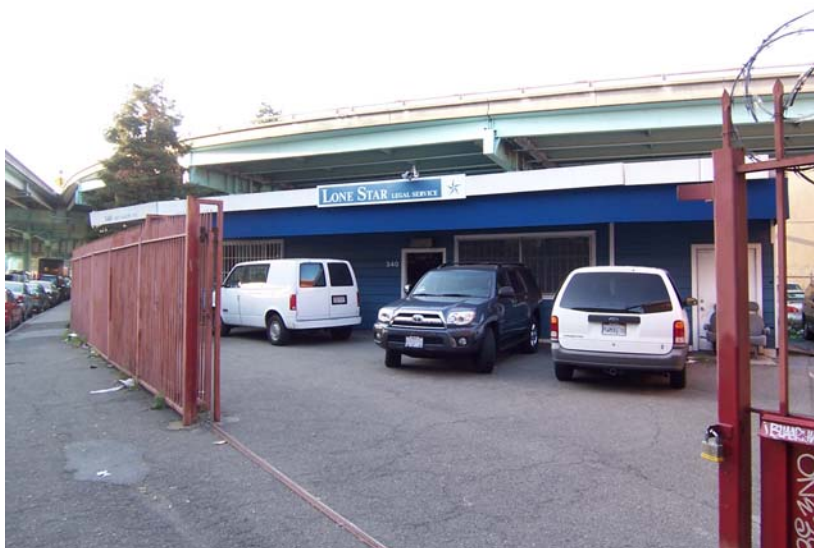
340 Division Street is a one story, wood-frame industrial building clad in drop wood siding and capped with a flat roof. The building is located on a triangular shaped 4,774 sq ft parcel. The primary façade faces southeast on Division Street and features two aluminum sash windows with security gates and two pedestrian entrances with wooden doors. The building terminates with an overhanging box cornice. The building appears to be in good condition.

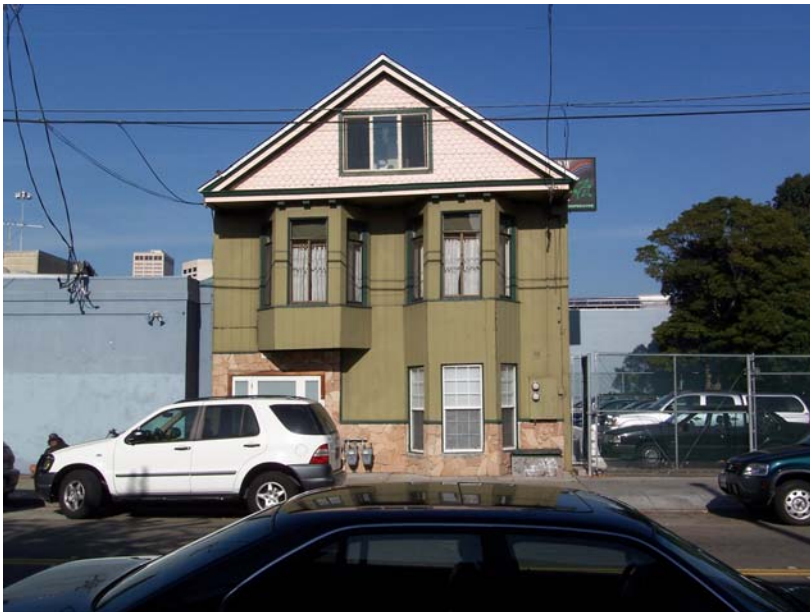
64-66 14th Street occupies an approximately 83 x 25 square-foot lot on the north side of 14th Street between Trainor and Folsom streets. Built in 1907, it is a two and one-half story, wood-frame residence. The rectangle-plan building, clad in plywood and stone veneer, rests on a concrete foundation and is capped by a front-gabled roof. The primary facade, which is 2 bays wide, faces south; the secondary facade, which is 3 bays wide, faces east. The first floor of the primary facade is partially finished with stone veneer, with its left bay featuring a 3-light, wooden door flanked by 3-light sidelights and wood surrounds. The right bay features a 2-story chamfered bay window composed of double-hung vinyl windows with false muntins and wood surrounds at the first floor, while the second features 1-over-2 sliding, metal-sash windows with wood surrounds. The left bay of the second floor features another chamfered bay window with the same fenestration pattern; both bay windows are topped by false beam ends. The secondary facade features a blank wall face that looks out onto the surface parking lot to the east. The primary facade terminates with a boxed cornice and fish scale shingles at the gable end, which is further distinguished by a tripartite, sliding window with wood surrounds. The heavily altered building appears to be in fair condition.

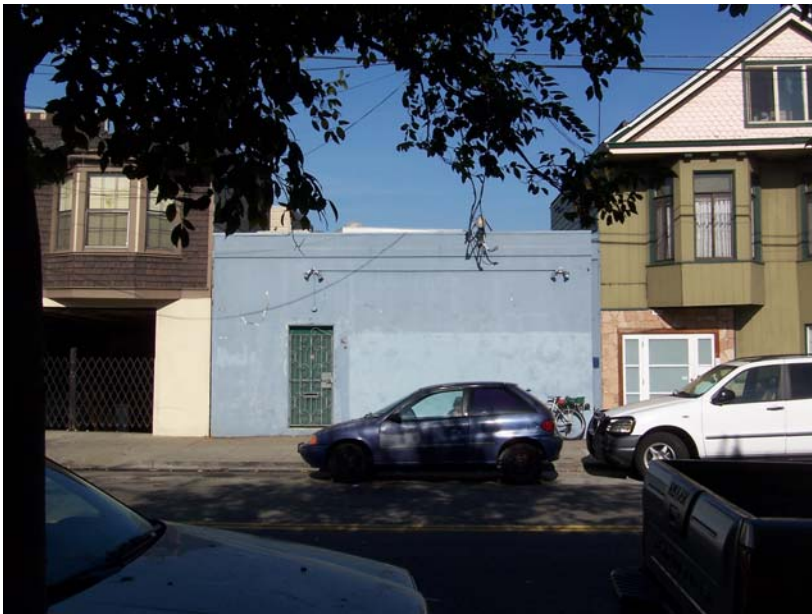
70 14th Street occupies an approximately 25 x 83 square-foot lot on the north side of 14th Street between Trainor and Folsom streets. Built in 1945, it is a 1-story, wood-frame industrial building. The rectangle-plan building, finished in stucco, rests on a concrete foundation and is capped by a flat roof. The primary facade, which is 2 bays wide, faces south. The left bay features a recessed, wooden door with wood surrounds behind a wrought iron gate. The right bay presents a blank wall face, and the facade terminates with a string course and metal coping. The heavily altered building appears to be in good condition.

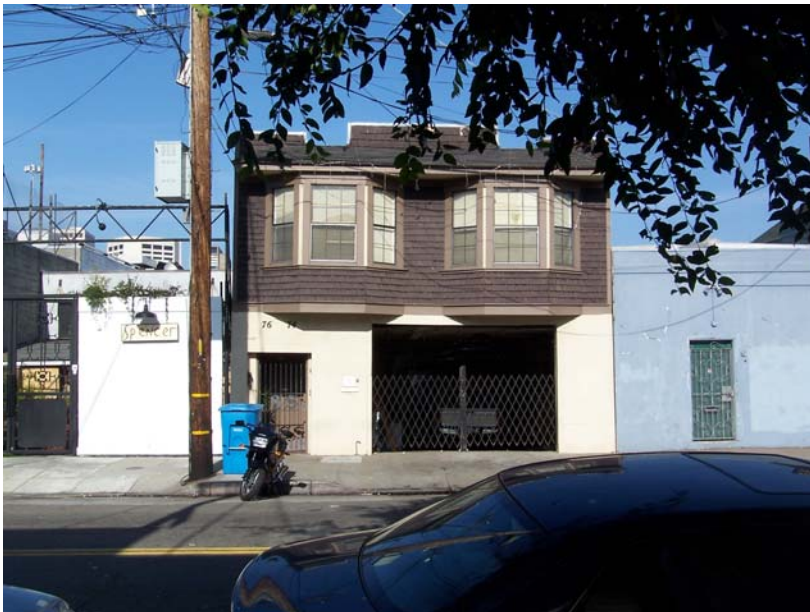
76 14th Street occupies an approximately 25 x 110 square-foot lot on the north side of 14th Street between Trainor and Folsom streets. Built in 1919, it is a 2-story, wood-frame residence. The rectangle-plan building, clad in stucco at the first floor and wooden shingles at the second, rests on a concrete foundation and is capped by a flat roof. The primary facade, which is 2 bays wide, faces south. The left bay of its first floor features a recessed entryway with an iron gate, while the right bay features a garage. Both bays of its second floor feature chamfered bay windows with multi-light, double-hung fenestration with wood surrounds. The primary facade terminates with a boxed cornice, as well as a stepped parapet with metal coping. The minimally altered building appears to be in good condition.

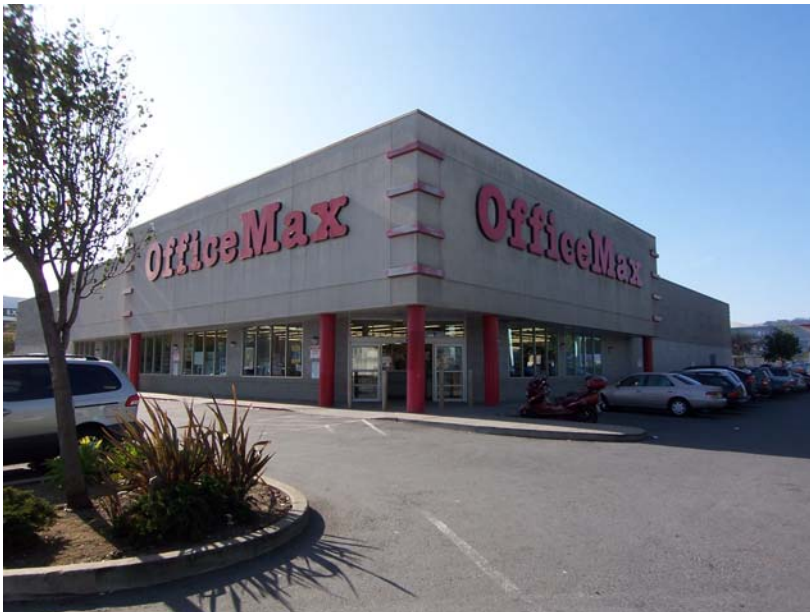
1750 Harrison is a one-story, steel-frame concrete and masonry block clad commercial building that occupies the southwest portion of a 57,508 sq ft lot on the northeast corner of 14th and Harrison streets. It was built in 1996 to house an Office Max store. The northeast portion of the parcel contains a landscaped parking lot. The building appears in good condition.

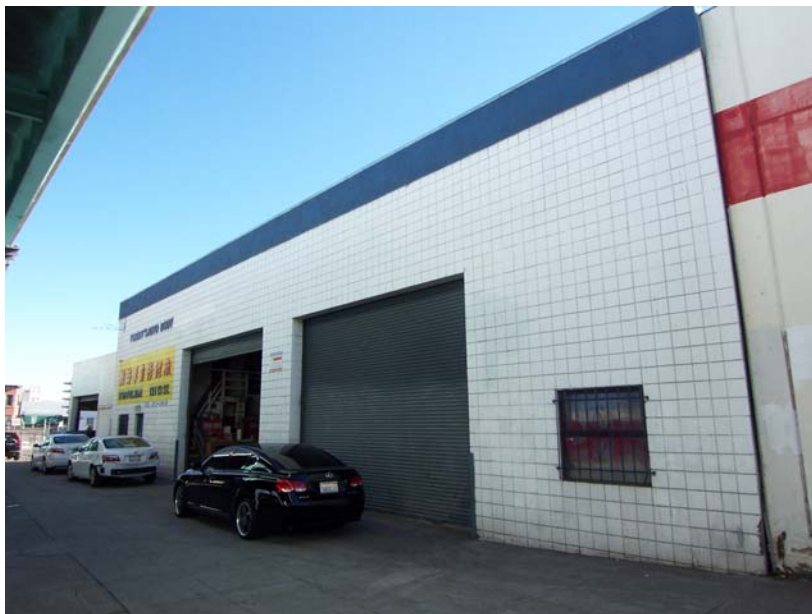
135 13th Street is a one-story, reinforced-concrete industrial building clad in tile and capped with a flat roof. The utilitarian building, which is used as an auto repair garage, occupies an irregularly shaped, 7,749 square-foot lot on the south side of 13th Street between South Van Ness Avenue and Folsom Street. The primary facade, which is 5 bays wide, faces north. Built in 1986, the exterior facades contain a varied assortment of fixed aluminum sash windows and large vehicular doors containing metal roll-up doors. The primary facade terminates with a metal coping. The building appears to be in good condition.

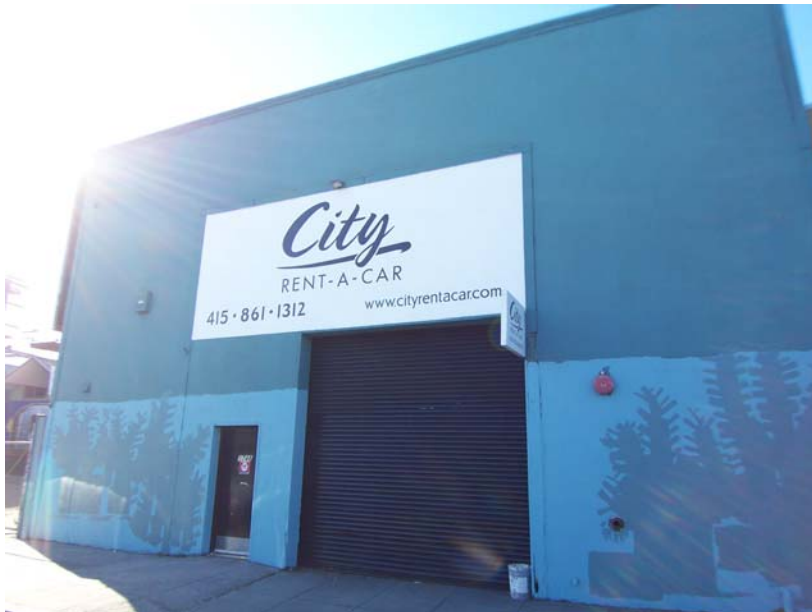
1748 Folsom Street is a one-story, wood-frame industrial building finished in stucco and capped with a flat roof. The building faces east on Folsom Street and fills the 4,948 sq ft lot. The primary façade features a vehicular bay containing a metal roll-up door and a flush metal pedestrian door. The facade terminates in a plain flush parapet. The heavily altered building appears to be in good condition.

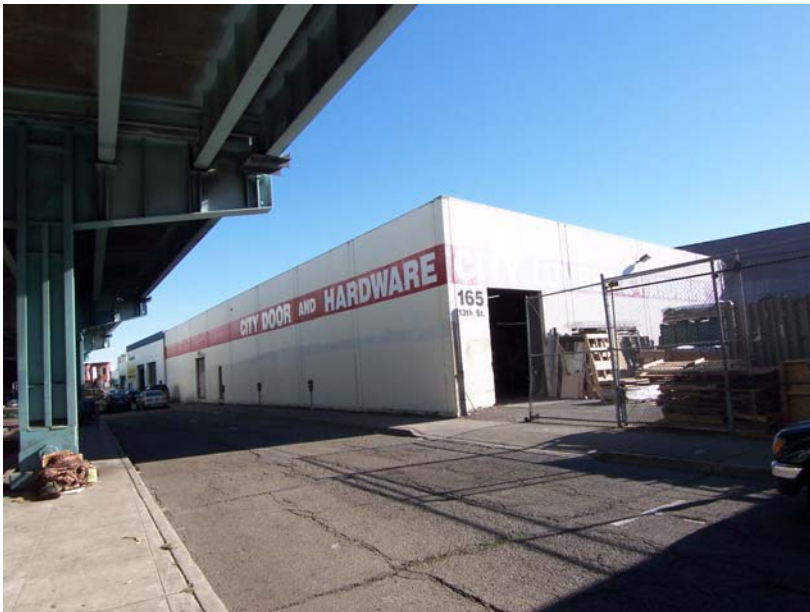
157 13th Street is a one-story, reinforced-concrete industrial building capped by a flat roof. The utilitarian building occupies an irregularly shaped, 13,625 square-foot lot on the south side of 13th Street between South Van Ness Avenue and Folsom Street. The primary facade, which is 8 bays wide, faces north. The virtually windowless building is articulated by a series of large vehicular bays containing metal roll-up doors. The primary facade terminates with a flush parapet and a metal coping. The building appears to be in fair condition.

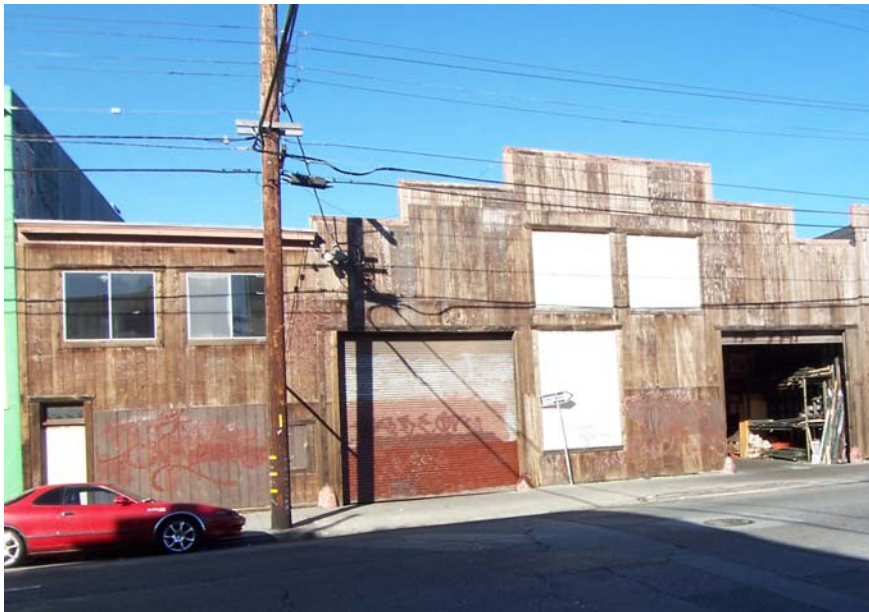
114 14th Street occupies a 15,328 square-foot flag lot on the north side of 14th Street between Folsom Street and South Van Ness Avenue. Built in 1942, it is a 1-story, wood-frame industrial building. The ell-plan building, clad in wood, rests on a concrete foundation and is capped by a flat roof. The primary facade, which is 3 bays wide, faces south. The secondary facade, or interior of the ell, is 6 bays wide and faces east and south. The left and right bays feature window openings that have been replaced with corrugated metal, while the middle bay features a vehicular entrance with a metal, roll-up door. The primary facade terminates with a stepped parapet with two window openings at the middle bay. Like the windows at the left and right bays, these have been filled in with corrugated metal. The building appears to be in fair condition.

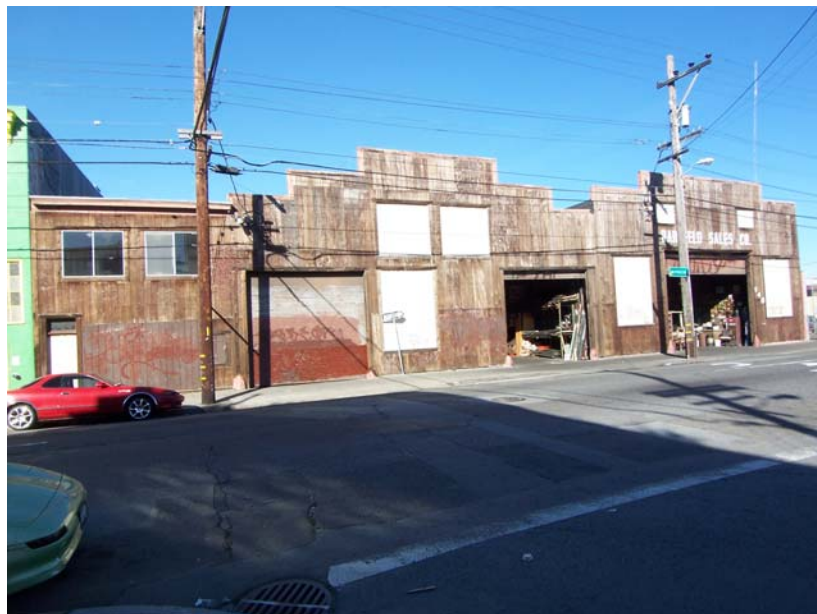
The western building, constructed in 1923, is a one-story, wood-frame structure, clad in plywood, and capped with a partial second story office office mezzanine. The utilitarian building rests on a concrete foundation and is capped by a low pitch, front-gabled roof. The primary facade, which is 4 bays wide, faces south. The leftmost, or first, bay at the first floor features a recessed, wooden pedestrian door with a transom and wood surrounds, while the second and fourth bays feature vehicular openings with metal, roll-up doors. The third bay features a window opening that has been filled in with corrugated metal. The leftmost, or first, bay of the second floor features two pairs of fixed vinyl-sash windows, while the third bay features two window openings that have been filled in with corrugated metal. The second and fourth bays feature blank wall faces. The primary facade terminates in a stepped parapet. The building appears to be in fair condition

The eastern building, constructed in 1942, is a one-story, wood-frame industrial building. The ell-plan building, clad in wood, rests on a concrete foundation and is capped by a bow truss roof. The primary facade, which is 3 bays wide, faces south. The secondary facade, or interior of the ell, is 6 bays wide and faces east and south. The left and right bays feature window openings that have been replaced with corrugated metal, while

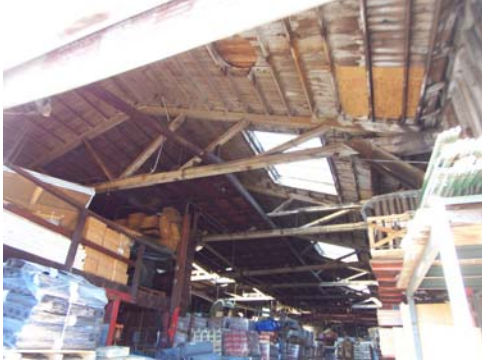
100_6422.JPG, 11/28/07, view to N, interior western building

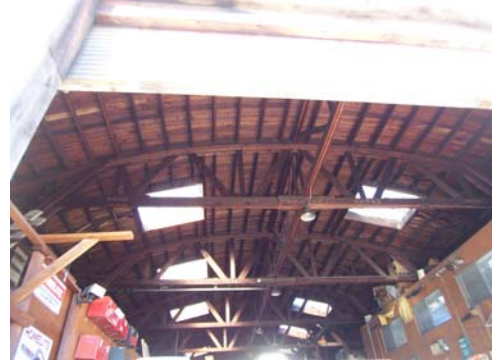
100_6421.JPG, 11/28/07, view to N, interior eastern building

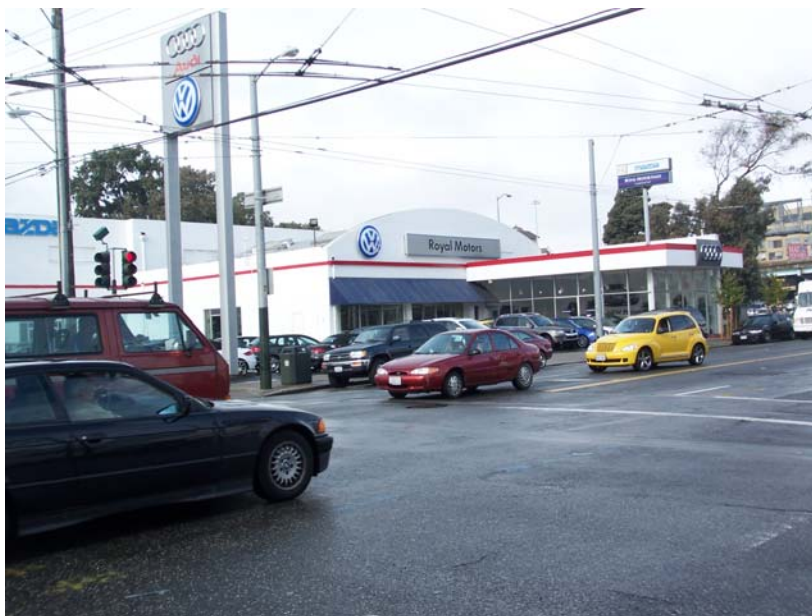
288 South Van Ness Avenue is a one-story, reinforced-concrete commercial building finished in stucco and capped by a compound bowstring-truss and flat roof. The utilitarian building, used as an auto dealership, has an L-shaped plan and occupies a rectangular 6,490 sq. ft. lot on the west side of South Van Ness Avenue between 14th and Erie streets. The main section of the building is rectangular in plan and used as the repair/service center. This portion of the building is nearly windowless and capped by the bowstring truss roof. Its facades are penetrated by vehicular bays. The flat-roofed section to the east is the showroom; it features full-height display windows divided into a grid by aluminum mullions. The facades terminate with a flush parapet. The building appears in good condition.

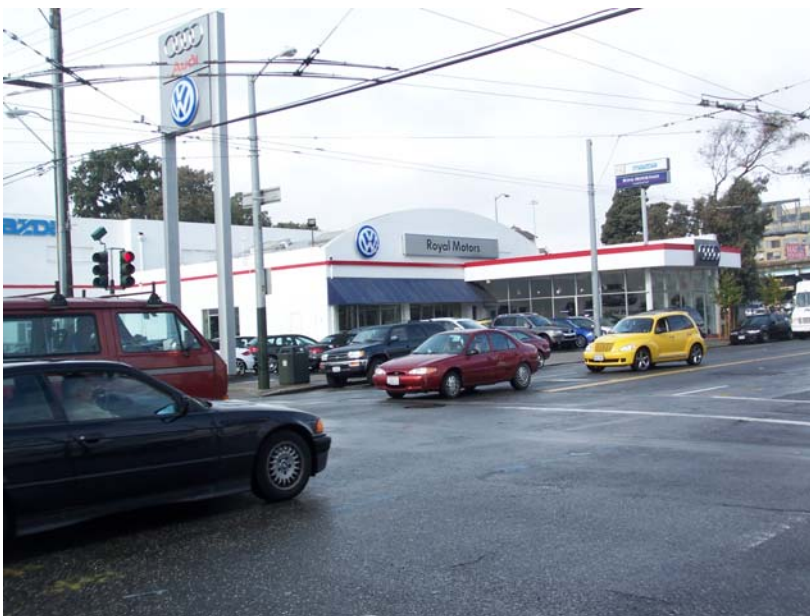
This is a one story bowstring-truss roofed concrete car dealership building with flat-roofed additions, occupying a rectangular 6,490 sq.ft. lot on the west side of South Van Ness Avenue between 14th and Erie streets. The main building is rectangular in plan, and a rectangular addition with full height display windows projects from the right side. The main structure is also joined at the rear with a stucco clad frame building facing on 14th Street. All together, the structure has an inverted L plan, with parking lots in the throat of the L. The building appears in good condition.

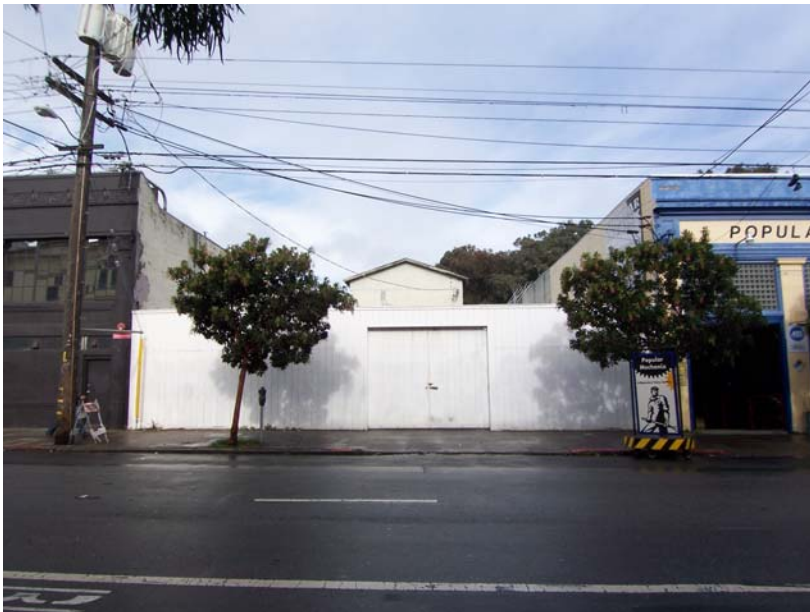
256 14th Street is a one-story, wood-frame, industrial building clad in rustic wood siding and capped by a flat roof with a central monitor. The utilitarian building occupies an approximately 5,750 sq ft lot on the north side of 14th Street between South Van Ness Avenue and Mission Street. The building is deeply set back from the street near the north lot line, creating a paved area at the front now used as a surface parking lot. A wood wall serves to secure the site, blocking views from the street. The primary facade, which is three bays wide, faces south. The center bay contains a sliding wooden vehicular entrance door, and the left bay has a large fixed window. The moderately altered building appears to be in fair condition.

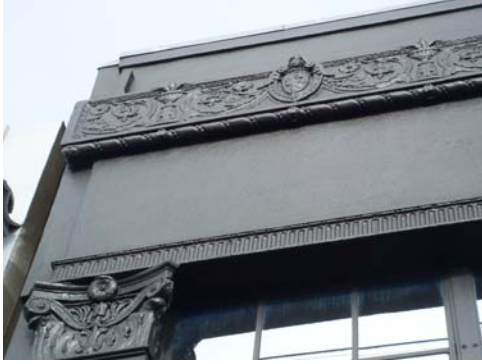
100_6536.JPG, 12/4/07, view to N, cornice & capital detail

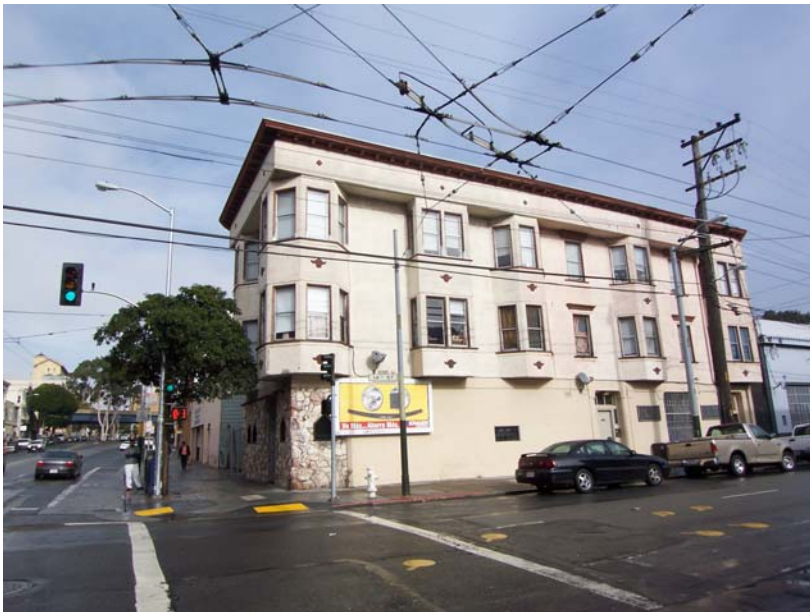
290-292 14th Street is a 3-story, wood-frame residential building finished in stucco and capped by a flat roof. The heavily altered building occupies an approximately 2,000 sq ft lot at the northeast corner of 14th and Mission streets. Built in 1907, it is a The rectangle-plan building exhibits 3 types of cladding: faux stone at the first floor of its primary facade, as well as the first bay of the secondary facade; rustic redwood siding at its east elevation; and textured stucco elsewhere. The primary facade, which is 2 bays wide, faces west. The secondary facade, which is 8 bays wide, faces south. The left bay of the primary facade's first floor features two, fixed windows, while the right bay features a recessed entryway with a 3-light transom, iron gate, and, to its right, a fixed window. The left and right bays of the second floor feature 2-story chamfered bay windows with one-over-one, double-hung, wood-sash windows with wood surrounds and winged crest ornaments. The leftmost, or first, bay of the secondary facade's first floor features a fixed window, while the second bay presents a blank wall face. The third bay displays a fixed, multi-light window, while the fourth, sixth, and eighth bays feature arched, recessed entryways with wooden doors with wood surrounds, sidelights, and 3-light transoms. An iron gate further distinguishes the sixth bay. The fifth and seventh bays feature fixed windows protected by iron grilles. The first, fourth, and sixth bays of the second floor features 2-story chamfered bay windows, while the second bay displays a blank wall face. The third and eighth bays feature 2-story boxed bay windows, while the fifth and seventh bays feature one-over-one, double-hung, wood-sash windows with wood surrounds, hood molding, and lug sills. The primary facade terminates with a boxed cornice, brackets, stress

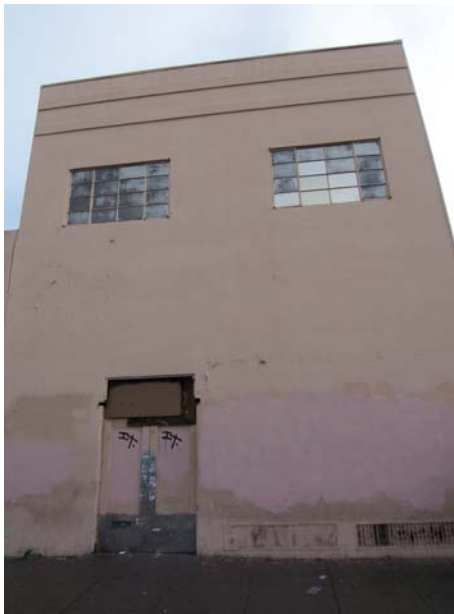
1789 Mission Street is a two-story, wood-frame industrial building finished in stucco and capped with a flat roof. The utilitarian building occupies a 2,000 sq. ft. lot on the east side of Mission between 14th and Erie streets. It is joined internally with the one-story building to the north, with which it shares an address. On the ground floor is a boarded up pedestrian entrance. On the second floor are two multi-lite steel industrial sash windows. The facade terminates with a simple cornice of two flat boards and a flush parapet. The altered building appears to be in fair condition.

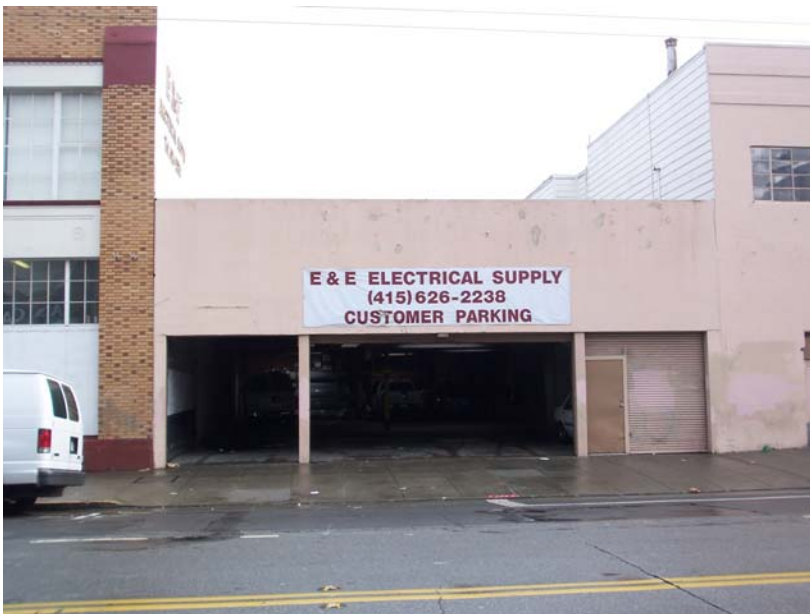
1789 Mission Street is a one-story, wood-frame industrial building finished in stucco and capped by a gable roof concealed behind a straight raised parapet. The utilitarian building occupies a 5,500 sq. ft. lot on the east side of Mission between 14th and Erie streets. It is built to the lot lines and joined internally with the building to the south, with which it shares an address. Three vehicular entrances span the entire facade, separated by two wooden posts. The heavily altered building appears to be in fair condition.

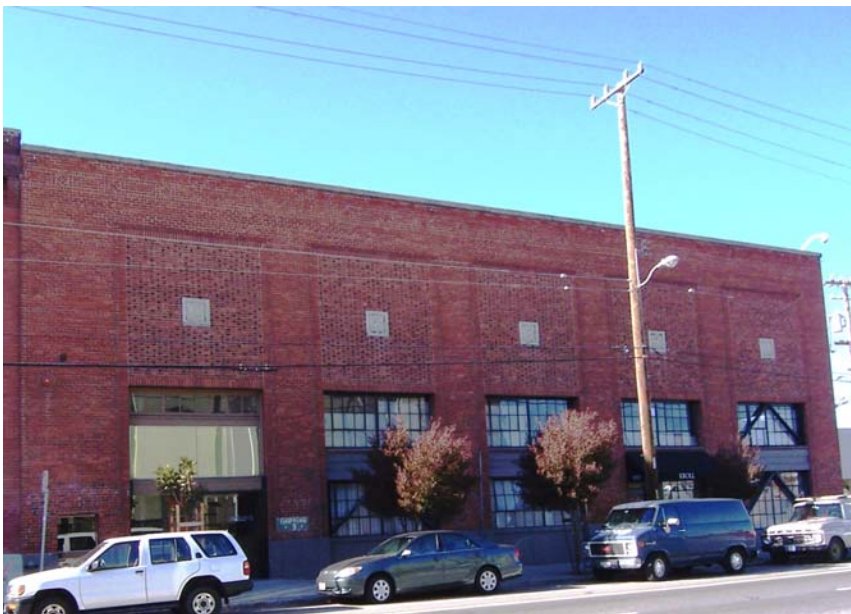
1 14th Street occupies an approximately 100 x 90 square-foot corner lot on the west side of Harrison Street between 14th and 15th streets. Built in 1924, it is a 3-story, concrete-frame industrial building. The rectangle-plan building, clad in running bond brick, rests on a concrete foundation and is capped by a flat roof. The primary facade, which is 6 bays wide, faces east; the secondary facade, which is 4 bays wide, faces north. The leftmost, or first, bay at the primary facade's first floor features a recessed, multi-light door that acts as a secondary entrance, while the third, fourth, and sixth bays feature multi-light, metal-sash fixed and awning windows and concrete spandrel panels above and below them. The windows at the third and sixth bays are set behind seismic bracing. The second and fifth bays each feature storefront entries, with the second distinguished by paired, glass doors and the fifth distinguished by a single-light, wooden door with sidelights and a transom beneath a fabric awning. Except for the first bay, which presents a blank wall face, second-floor bays are distinguished by recessed, fixed and awning windows with metal surrounds; seismic bracing distinguishes the sixth bay from the others. Like the second floor, the first bay of the third floor presents a blank wall face; the remaining bays feature Flemish bond bricks with a decorative terra cotta element at their centers. The secondary facade mimics the primary facade. The primary facade terminates with concrete coping. The building appears to be in good condition.

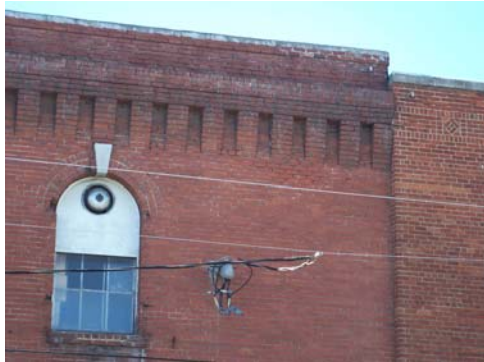
100_5920.JPG, cornice detail

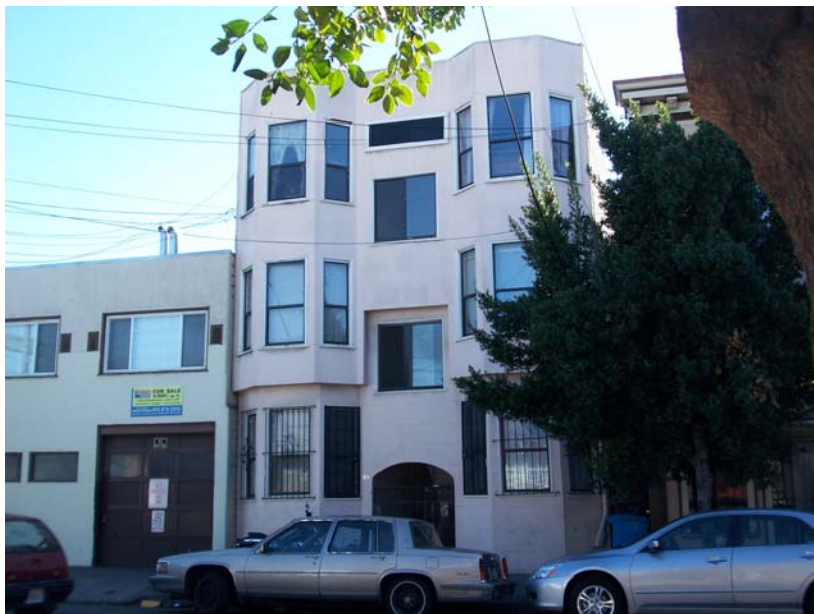
85 14th Street occupies a 25 x 100 square-foot lot on the south side of 14th Street between Folsom and Harrison streets. Built in 1914, it is a 3-story, wood-frame enclosed Romeo flats apartment building. The rectangle-plan building, clad in stucco at its south elevation and rustic redwood siding elsewhere, rests on a concrete foundation and is capped by a flat roof. The primary facade, which is 3 bays wide, faces north. The left and right bays of the first floor feature chamfered bay windows with one-over-one, double-hung, wood-sash fenestration with lug sills behind wrought iron grilles. The middle bay features an arched, recessed entryway with a wrought iron gate and steps to the residential units above. The left and right bays of the second floor feature overhanging, 2-story, chamfered bay windows. One-over-one, double-hung, wood-sash fenestration with wood surrounds and lug sills characterize them. The middle bay at the second and third floors features sliding windows with wood surrounds and lug sills. The primary facade terminates in a false parapet. The building appears to be in good condition.

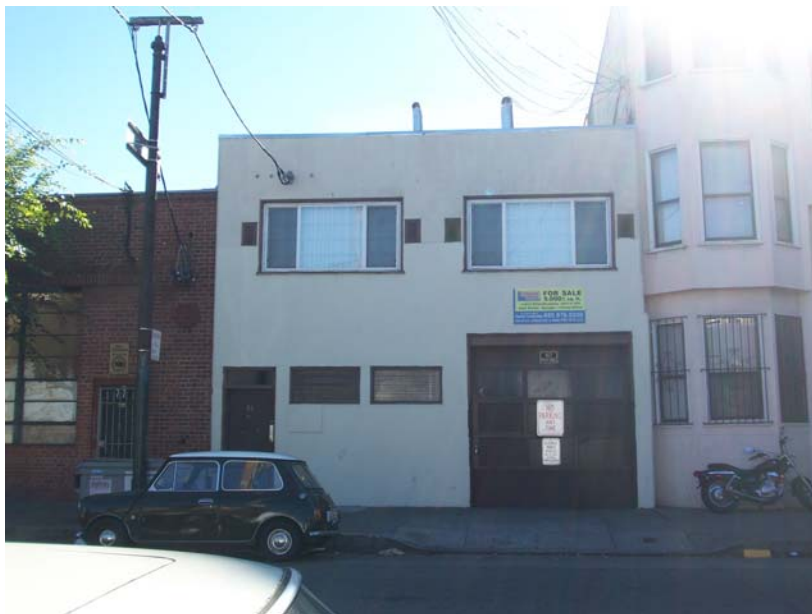
*P5b. Photo (view, date, accession #
100_5899.JPG, 11/21/2007

81 14th Street occupies a 100 x 25 square-foot lot on the south side of 14th Street between Folsom and Harrison streets. Built in 1906, it is a 2-story, wood-frame industrial building. The rectangle-plan building, clad in stucco, rests on a concrete foundation and is capped by a flat roof. The primary facade, which is 2 bays wide, faces north. The left bay of its first floor features a recessed, wooden door with a transom and wood surrounds. To its right are two, fixed windows with wood surrounds. The right bay features a garage. Each bay of the second floor features a multi-light, wood-sash, tripartite window with wood surrounds and lug sills. The primary facade terminates with a false parapet and metal coping. The building appears to be in good condition.
