Historic Preservation Commission Executive Summary Historic Resource Survey Findings INFORMATIONAL PRESENTATION: JUNE 1, 2011 ADOPTION HEARING: JUNE 15, 2011

Date: May 25, 2011
Case No.: **2011.0401U**
Project: Showplace Square / Northeast Mission Historic Resource Survey
Staff Contact: Moses Corrette – (415) 558-6295
moses.corrette@sfgov.org
Reviewed By Tim Frye – (415) 575-6822
tim.frye@sfgov.org
Recommendation: **Adoption of survey findings**

**SHOWPLACE SQUARE SURVEY
SAN FRANCISCO, CALIFORNIA
FINAL**

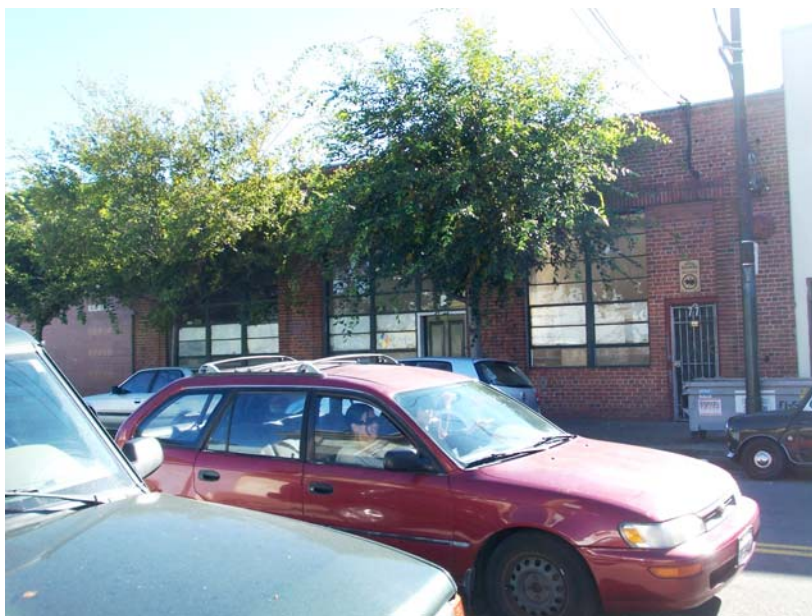
75 14th Street occupies an approximately 146 x 54 square-foot lot on the south side of 14th Street between Folsom and Harrison streets. Built in 1927, it is a 1-story, concrete-frame industrial building. The rectangle-plan building, clad in running bond and Flemish bond brick, rests on a concrete foundation and is capped by a flat roof. The primary facade, which is 3 bays wide, faces north. Each bay features multi-light, wood-sash, fixed and awning windows with brick surrounds, with the middle bay presenting a modern, paneled wood door with wood surrounds. Another entrance characterizes the right bay, where there is a wooden door with wood surrounds behind a wrought iron gate. The primary facade terminates with metal coping. The building appears to be in good condition.

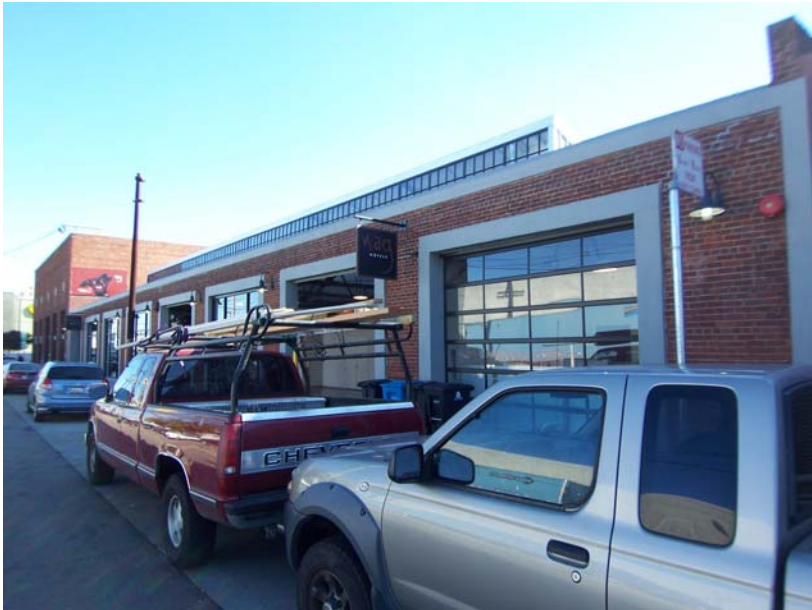
25 14th Street occupies an approximately 161 x 146 square-foot lot on the south side of 14th Street between Harrison and Folsom streets. Built in 1924, it is a 2-story, concrete-frame industrial building. The rectangle-plan building, finished in running bond brick, rests on a concrete foundation and is capped by a sawtooth roof. The primary facade, which is 8 bays wide, faces north. Its leftmost, or first, bay features the building's recessed main entrance, an anodized aluminum storefront. The second, third, fourth, and sixth bays feature enframed window-walls of fixed, 9-light windows with metal surrounds, while the fifth, seventh, and eighth bays feature vehicular openings with multi-light, automatic garage doors. Wall-mounted faux historic light fixtures and painted signage further distinguishes the primary facade, which terminates with a side-gabled monitor with multi-light windows and industrial steel sashes. The building appears to be in good condition.

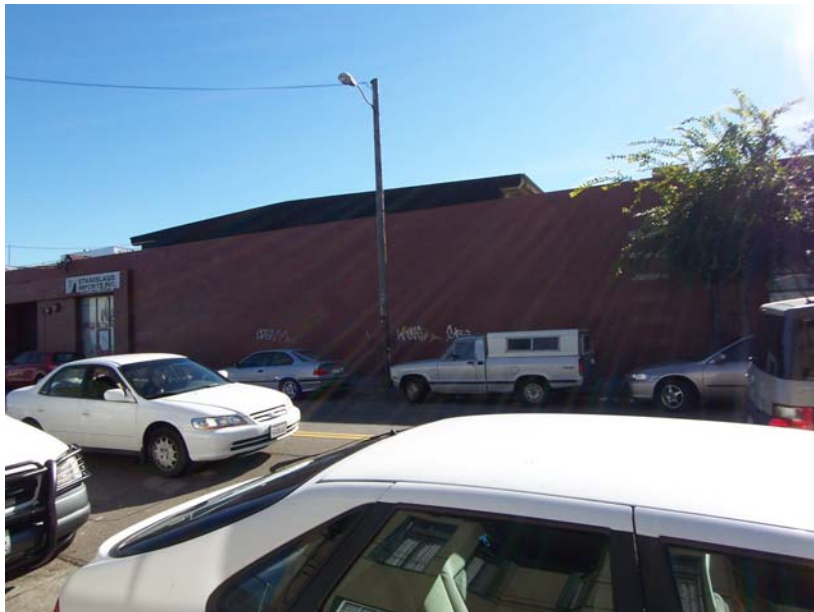
41 14th Street occupies an irregularly shaped, 32,042 square-foot lot on the south side of 14th Street between Folsom and Harrison streets. Built in 1953, it is a 1-story, concrete-frame industrial building. The rectangular-plan building, finished in stucco, sits atop a concrete foundation and is capped by a compound flat and monitor roof. The primary facade, which is 6 bays wide, faces north. The leftmost, or first, bay features a vehicular opening with a metal, roll-up door, while the second bay features a recessed, brushed aluminum storefront. The remaining bays feature blank wall faces. The building appears to be in good condition.

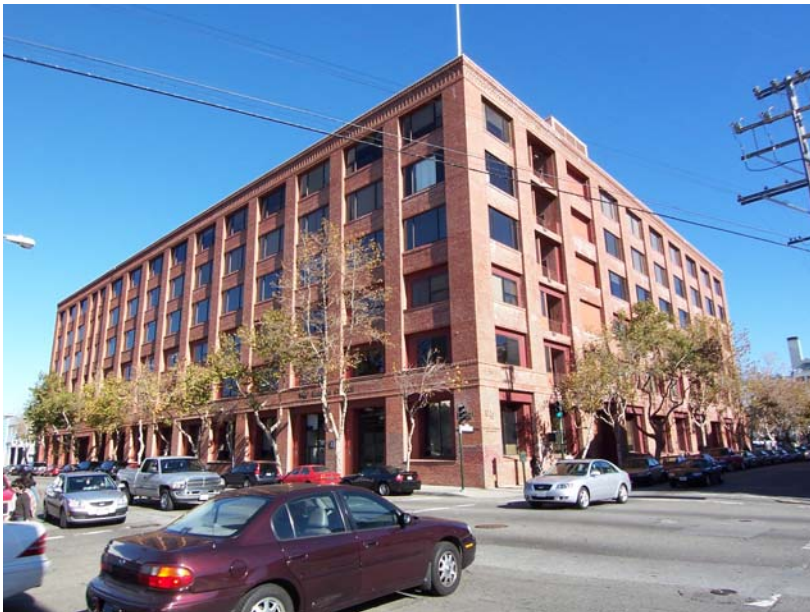
1855 Folsom Street is a six-story, reinforced concrete and brick industrial building finished in brick and capped by a flat roof. The utilitarian daylight-frame building occupies an irregularly shaped, 11,688 square-foot lot at the northeast corner of Folsom and 15th streets. The rectangular-plan building sits atop a concrete foundation. Its primary facade, which is 15 bays wide, faces west onto Folsom Street; its secondary facade, which is 10 bays wide, faces south toward 15th Street. The first, or leftmost, bay of the primary facade's first floor features a recessed, modern, glass door with metal surrounds; these surrounds frame each bay, which are dominated by paired, fixed windows with metal surrounds. Exceptions include the thirteenth and fourteenth bays, which feature the building's main entrances: glass, double doors flanked by sidelights beneath a 4-light transom. A belt course separates the first floor from those above it. Each bay of the second and third floors consists of recessed, paired windows; the right window is fixed, while the left is one-over-one. Each bay of the remaining floors showcases recessed, fixed, tripartite windows. Metal surrounds characterize all building fenestration. The secondary facade follows the same door and window treatment. The primary facade terminates with a decorative brick frieze, denticulated entablature, and copper coping. The building appears to be in good condition.

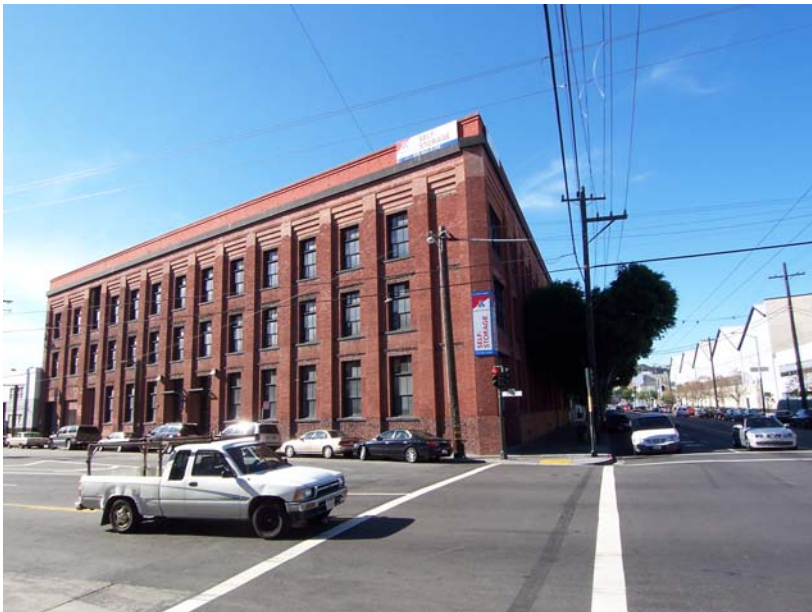
2701 16th Street is a three-story, heavy timber-frame brick industrial building capped by a flat roof. The American Commercial style building occupies an irregularly shaped, 23,387 square-foot corner lot on the north side of 16th Street between Treat Avenue and Folsom Street. The irregular-plan building, built of brick laid in stretcher bond, sits atop a concrete foundation. The primary facade, which is 14 bays wide, faces east on to Treat Avenue; the secondary facade, which is 10 bays wide, faces north onto 16th Street. The primary facade presents a 3-part vertical block compositional format. Clinker brick distinguishes its first floor, and three-over-three, double-hung, wood-sash windows with wood surrounds and concrete lug sills beneath 3-light transoms and clinker-brick shelf pediments dominate its bays. The exceptions include the leftmost, or first, bay, which has been filled in with concrete. The second and third bays have also been filled in. Double doors replaced the former, while a single door replaced the latter. The eighth and ninth bays also differ; both present recessed entryways with paired, 2-light, metal-sash doors beneath cantilevered metal projections and transoms. The rightmost, or fourteenth, bay also differs, offering a blank wall face at floors one through three. Otherwise, second-floor bays present the same fenestration pattern found at the first floor, except the panels below them display stretcher bond, not clinker, brick. That fenestration pattern repeats at the third floor, except for the clinker-brick shelf pediment, which has been replaced by a soldier-course brick corbel. Pilasters divide each bay of this facade, which terminates with a corbelled frieze and sheet metal box cornice. The building appears in good condition.

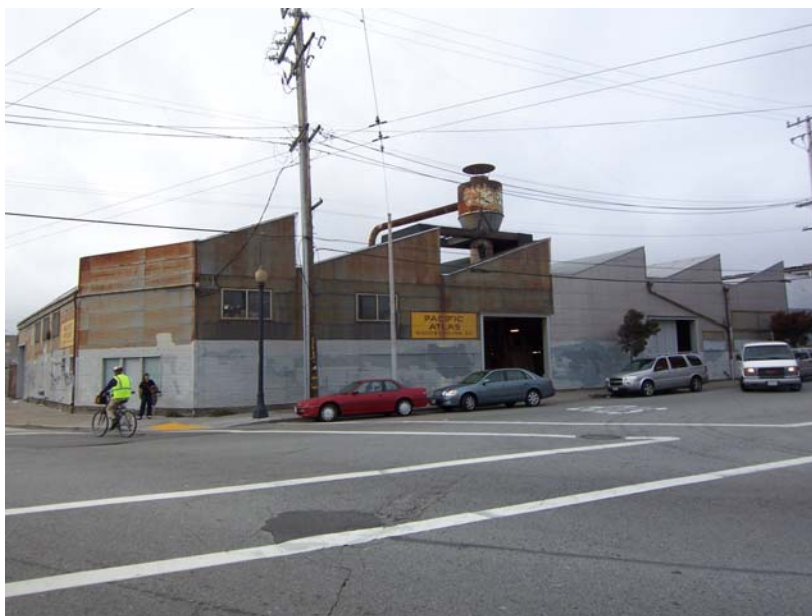
3030 17th Street is a two-story, wood-frame, corrugated steel industrial building capped by a sawtooth roof. The utilitarian building occupies a 10,001 square-foot, irregularly shaped lot on the southwest corner of 17th Street and Treat Avenue. The irregular-plan building sits atop a concrete foundation. The primary facade, which is six bays wide, faces east onto Treat Avenue; the secondary corner facade, which is one bay wide, faces southeast; and the tertiary facade, which is six bays wide, faces south onto 17th Street. Blank wall faces dominate the primary facade, except for double-height garages found at the third and fifth bays of the first floor when counting from the leftmost bay. Paired, fixed-pane windows with wood surrounds at the first and second bays of the second floor offer the facade's only fenestration. A large, metal, rooftop tower above the third bay further distinguishes the facade. The single-bay, corner (45-degree), secondary facade offers the building's only pedestrian entrance: a wooden door flanked by multi-light, fixed-pane windows with wood surrounds, while the tertiary facade mimics the primary by offering mostly blank wall faces. A double-height garage at the first floor of its leftmost bay breaks the wall plane, while paired, fixed-pane windows with wood surrounds at the third through fifth bays of its second floor offer the facade's dominant fenestration. The building appears to be in fair condition.

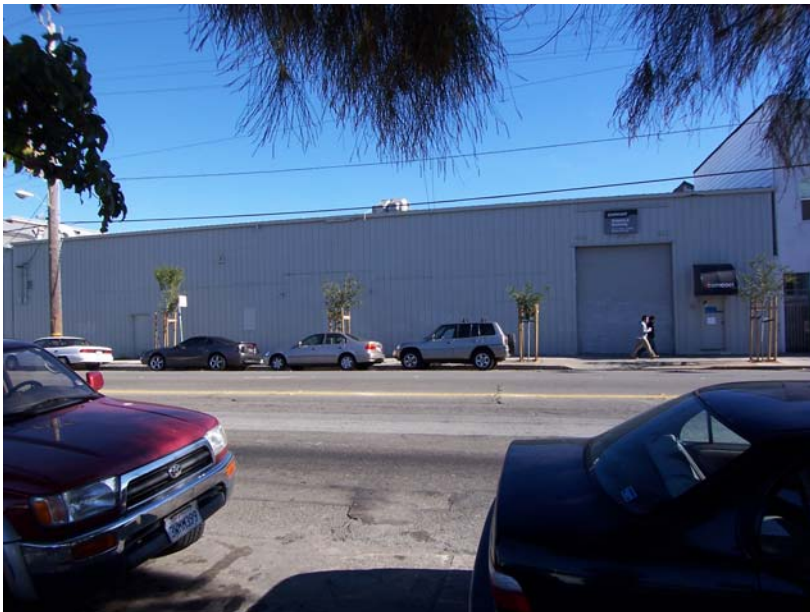
2075 Folsom Street is a one-story, wood-frame industrial building clad in metal corrugated siding and capped with a flat roof. The utilitarian building occupies the western half of the 14,251 sq ft lot. The primary facade faces Folsom Street to the west. This facade features one flush metal door on the left side and a metal roll-up door adjacent to a flush metal door with awning on the right side. The facade terminates with a flush parapet. The building appears in good condition.

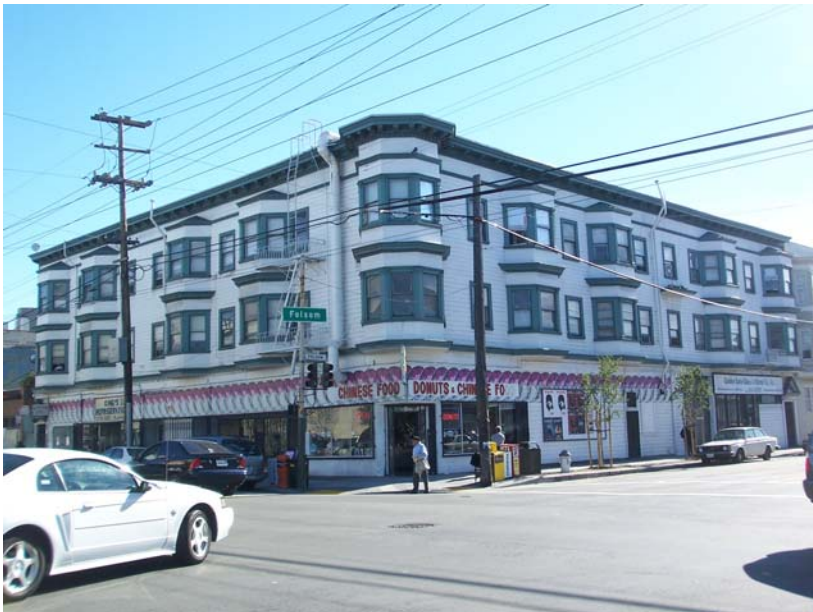
2011 Folsom Street is a three-story, wood-frame, residential hotel with commercial storefronts on the first floor level. The Classical Revival-style building is clad in rustic wood siding and capped with a flat roof. The building occupies a 10,944 sq ft lot on the southeast corner of 16th and Folsom streets. Both facades are six bays wide. The main entrances for the apartments are located on the far right side of the west façade and the far left side of the north façade. The main entrances feature recessed doors with a raked cornice pediment above the entry. The first story of the north side features two retail storefronts with glass and aluminum framed windows and doors. The corner of the building features the entrance to a restaurant with a glass and aluminum framed door with sidelights and transom flanked by fixed aluminum framed windows. The second and third stories are nearly identical on both facades and feature two-story chamfered bay windows with three 1/1 double-hung wooden windows. The bay windows are flanked by one 1/1 double-hung wooden window with the exception of the center, which has three windows. The corner bay window features four double-hung wooden windows. The upper stories project over the first story. Projecting molded intermediate cornices separate the second and third stories of the bay windows, which are capped with hip roofs. The west façade features one retail store on the left side flanked by the main entrance to the apartments and a flush wood maintenance door. The facades terminate with dentil moldings and bracketed projecting cornices. The minimally altered building appears to be in good condition.

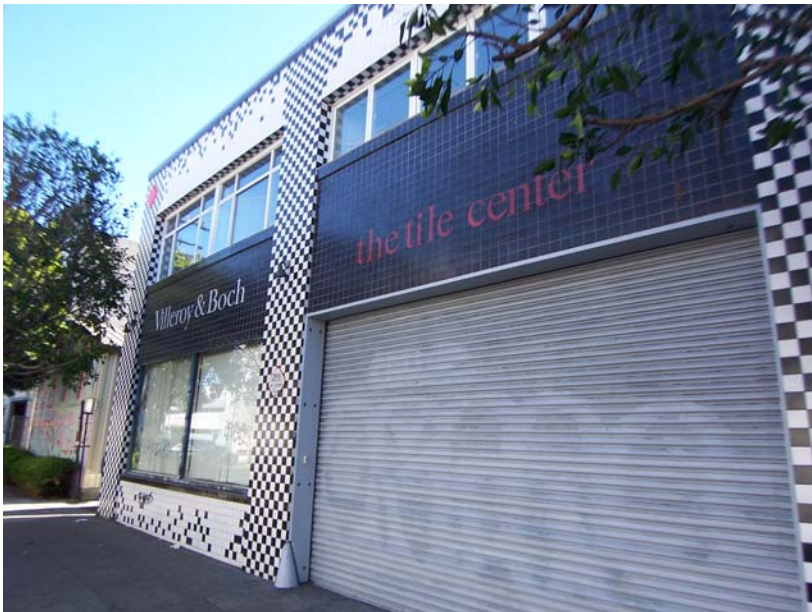
2765 16th Street is a two-story, reinforced-concrete industrial building clad in tile and capped by a flat roof. The utilitarian building occupies a 200 x 104 square-foot lot on the south side of 16th Street between Treat Avenue and Folsom Street. The rectangular-plan building, finished in non-historic tile at its north elevation and concrete elsewhere, sits atop a concrete foundation. The primary facade, which is 5 bays wide, faces north. The leftmost, or first, bay of its first floor is an enframed window-wall composed of paired, fixed windows with wood surrounds, while the second bay features a vehicular opening with a metal, roll-up door. The remaining bays are identical to the first, except for the third, which features a door. Second-floor bays feature pairs of three-over-three windows with spandrel panels beneath them, except for the second bay, which features a horizontal band of fixed windows. Wall-mounted light fixtures between each bay of the first and second floors further distinguish the building. It appears to be in good condition.

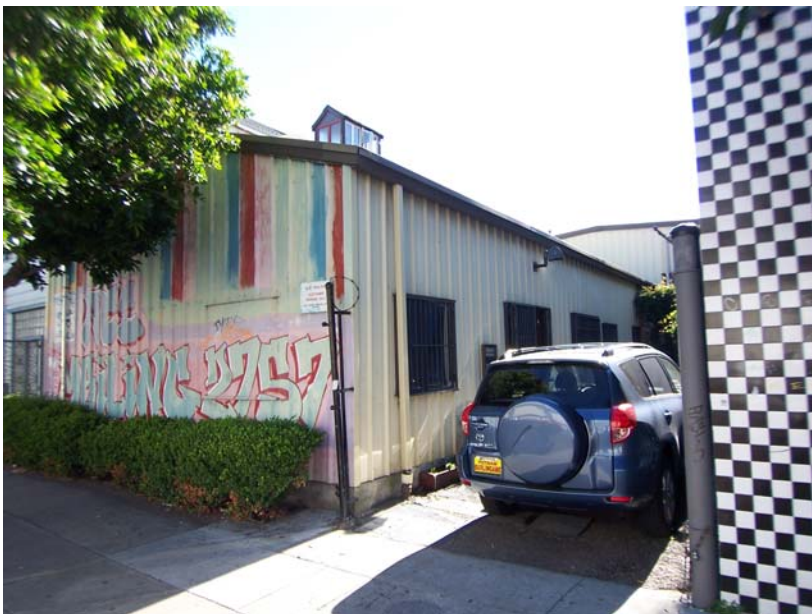
This parcel features two buildings. The first occupies the front of a 200 x 38 square-foot lot on the south side of 16th Street between Treat Avenue and Folsom Street. The first is a one-story, light framed industrial building facing 16th Street. The rectangle-plan building, clad in corrugated metal, rests on a concrete foundation and is capped by a compound monitor and shallow-pitched gabled roof with overhanging eaves. The primary facade, which is 4 bays wide, faces west; the secondary facade, which is 2 bays wide, faces north toward 16th Street. The leftmost, or first, bay features metal-sash, sliding windows with metal surrounds behind an iron grille, while the second bay features a door beneath a wall-mounted light fixture. The remaining bays display the fenestration of the first. The secondary facade presents a blank wall face because a window at its right bay has been filled in. The building appears to be in good condition.

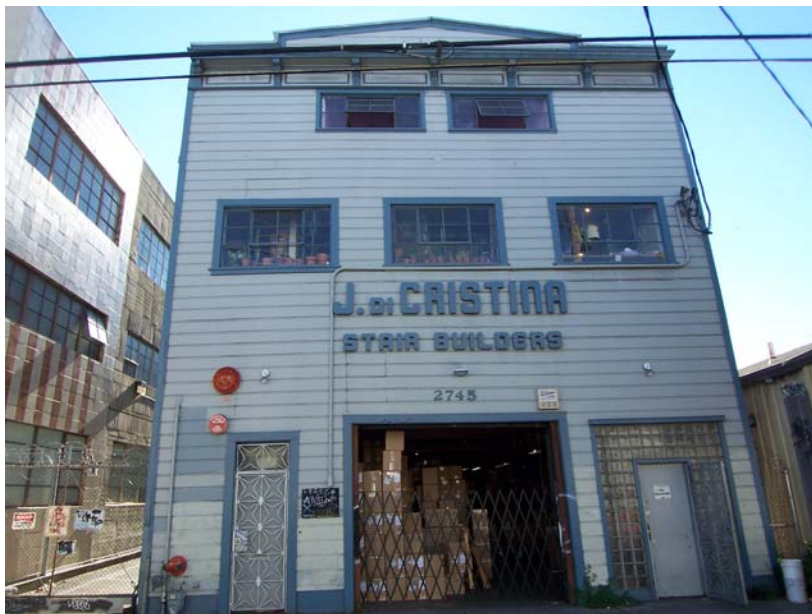
2745-2747 16th Street is a three-story, wood-frame industrial building clad in rustic channel siding and capped by a flat roof. The Italianate-style building occupies an irregularly shaped 7,196 square-foot lot on the south side of 16th Street between Treat Avenue and Folsom Street. The rectangle-plan building sits atop a concrete foundation. The primary facade, which is 3 bays wide, faces north toward 16th Street. The left bay of its first floor features an iron gate protecting a wooden door with a transom and wood surrounds, while the middle bay features a vehicular entrance. The right bay is a twin of the left, except the transom and wood surrounds have been replaced with glass blocks. Each bay of the second floor features a 4-light, metal-sash, awning window surrounded by fixed lights. Wood surrounds and lug sills further distinguish the windows. The left and right bays of the third floor feature blank wall faces, while the middle bay features paired tripartite windows composed of 4-light, awning windows flanked by 2-light, fixed windows, all with metal sashes and wood surrounds. The primary facade terminates with a bracketed Italianate cornice. The minimally altered building appears to be in good condition.

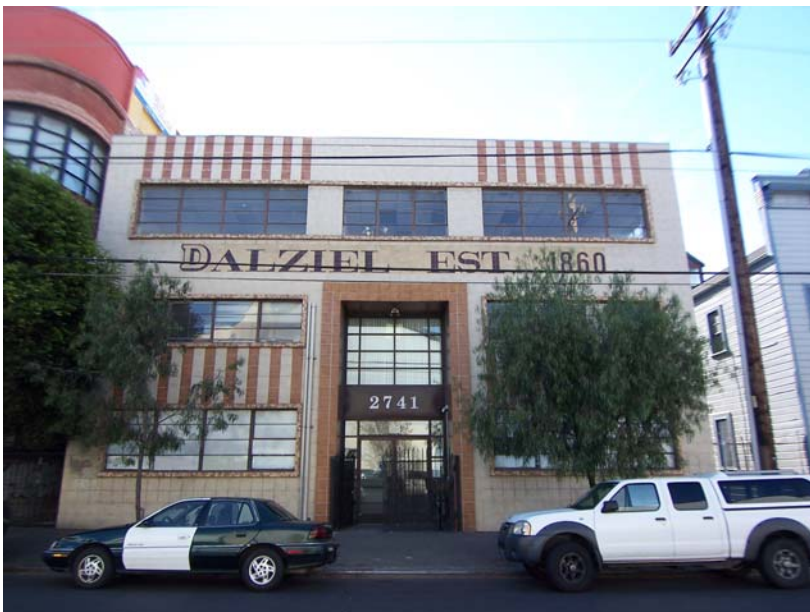
2741 16th Street is a three-story, reinforced-concrete industrial building capped with a flat roof. The Late Moderne-style building occupies an irregularly shaped, 39,552 square-foot lot on the south side of 16th Street between Treat Avenue and Folsom Street. The ell-plan building, faced with tile at its primary facade, rests on a concrete foundation and is capped by a flat roof. The primary facade, which is 3 bays wide, faces north. The left and right bays of the first two floors are identical, with the second floor displaying a horizontal band of 2-light, awning windows over one fixed window and the first floor displaying a multi-light, fixed window. A spandrel panel divides the fenestration of the two floors. The middle bay of both floors features a recessed, double-height, gated entryway with paired, glazed, metal-sash doors with sidelights and a multi-light transom. Each bay of the third floor features a band of fixed and awning windows similar to those found at the other floors. Metal sashes and mosaic-tile surrounds characterize all fenestration. The primary facade terminates with metal coping. The building appears to be in good condition.

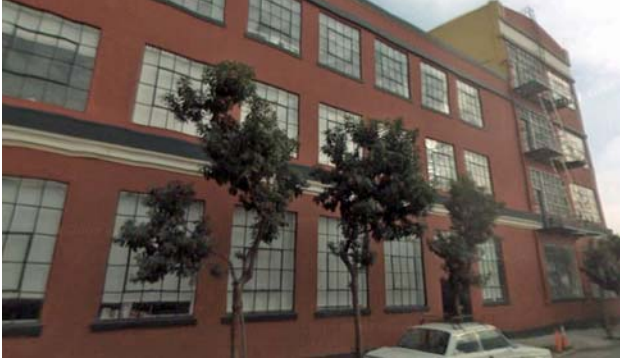
100_5339.T.JPG, 11/16/2007, view to E, Treat St elevation

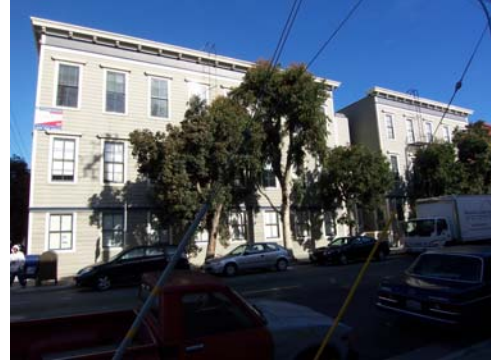
100_5762.JPG, 11/21/07, view to N, two buildings & connector

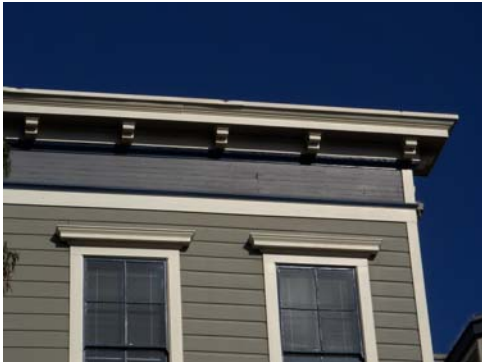
100_5764.JPG, 11/21/07, view to N, cornice detail

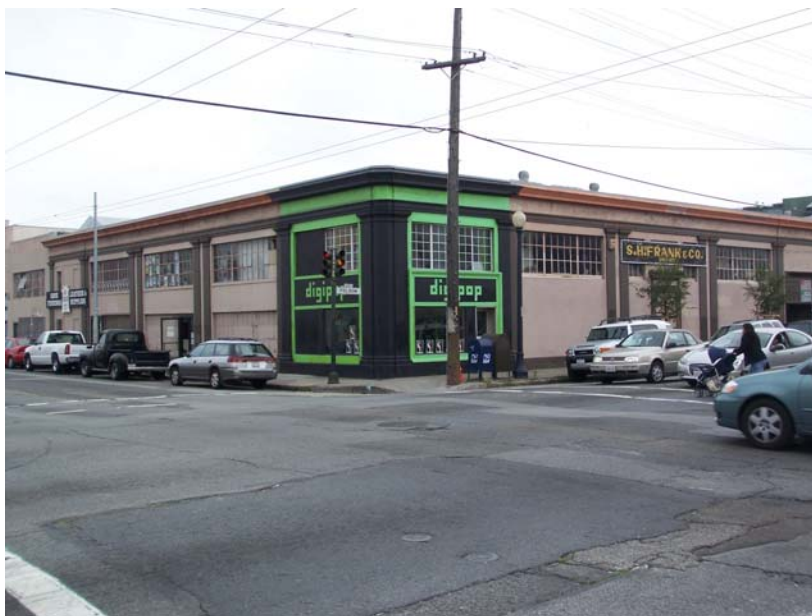
The first and largest section of the building is located at the southeast corner of Folsom and 17th streets. It is one story plus mezzanine, rests on a concrete foundation and is capped by bow truss roofs. The 17th Street and Folsom Street facades each present five bays, marked by rectangular Tuscan order pilasters. Along Folsom Street, the southernmost bay has a roll up garage door, while the middle three bays are plain concrete topped by steel sash multi-lite windows at the mezzanine. The northern bay contains the primary entrance, a modern single aluminum door at right with a plate glass window at left. This bay is also topped by steel sash multi-lite windows. The 17th Street facades are characterized by steel sash multi-lite windows at the first story and the mezzanine, with the exception of the easternmost bay, which has two one-over-one wood sash windows at both the first story and the mezzanine. This section of the building terminates with a molded cornice and appears to be in good condition.

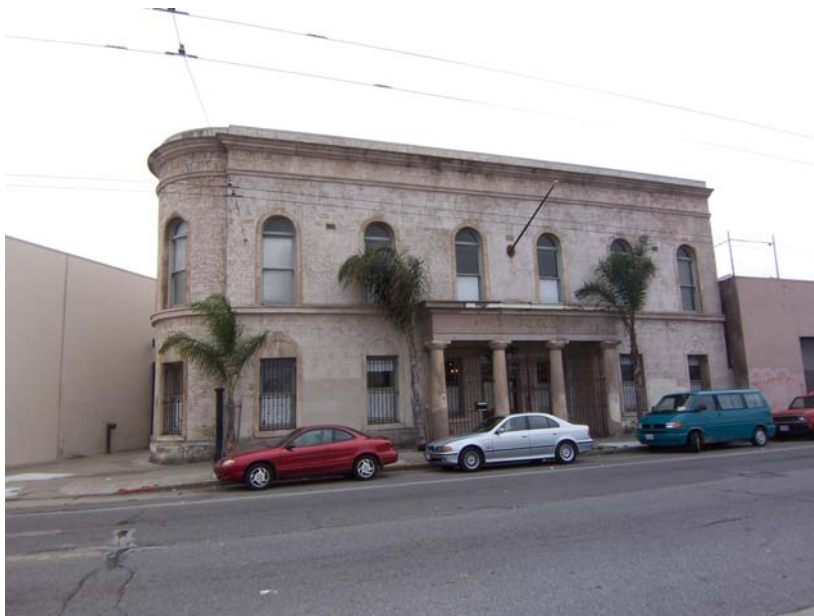
3057 17th Street occupies a 12,079 square-foot, irregularly shaped lot on the north side of 17th Street between Folsom and Shotwell streets. Built in 1899-1900, it is a two-story, concrete institutional building finished in stucco scored to resemble ashlar masonry. The irregular-plan building rests on a concrete foundation and is capped by a flat roof. The primary facade, which is six bays wide, faces north; the secondary facade, which is four bays wide, faces east. Except for the middle three bays of the primary facade's first floor, each bay of the primary facade features one-over-one, double-hung, wood-sash windows with concrete, round-headed archways topped by a keystone. Wrought iron grilles protect the first-floor windows. The middle three bays of the first floor are sheltered beneath a portico consisting of four Tuscan columns beneath an entablature with a frieze marked by carved lettering reading, "Mission Police Station." Located within the portico is the building's main entrance: paired, single-light, wood doors beneath a transom. One-over-one, double-hung, wood-sash windows flank the entrance. Wrought iron fencing joins the columns together. The leftmost bay distinguishes the secondary facade; its remaining bays stairstep westward and are not visible from the street. The leftmost bay offers a rounded, continuous bay window composed of fenestration similar to that found elsewhere on the building. The building terminates in a false parapet and an entablature with a projecting cornice. The minimally altered building appears to be in good condition.

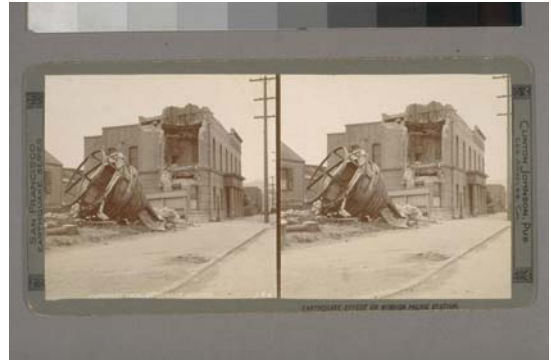
1906, showing earthquake damage

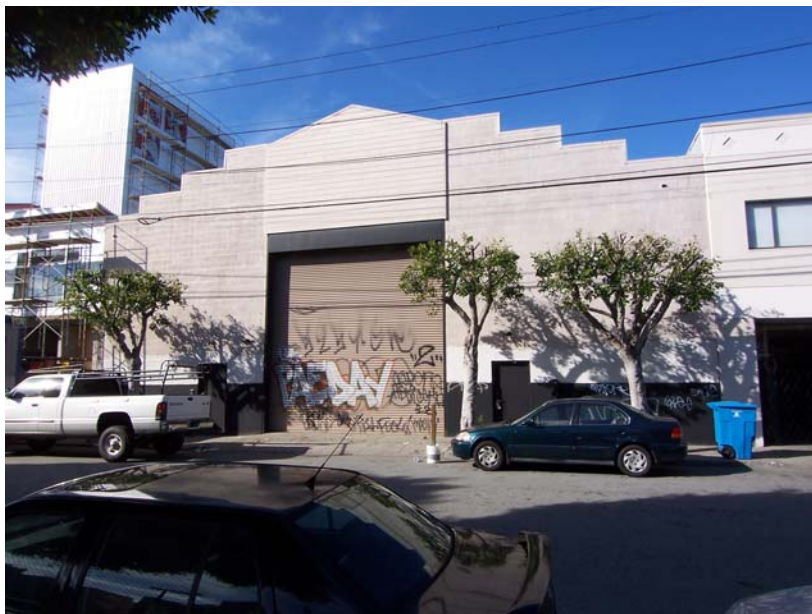
This is a tall one-story, concrete block industrial building capped by a gable roof. The utilitarian building occupies a 4,748 trapezoidal lot on the west side of Treat Avenue between 17th and 18th streets. The unadorned facade terminates in a stepped and gabled parapet. There is a large central vehicular entrance with a roll-up metal door, and two pedestrian entrances with metal doors. The building appears in good condition.

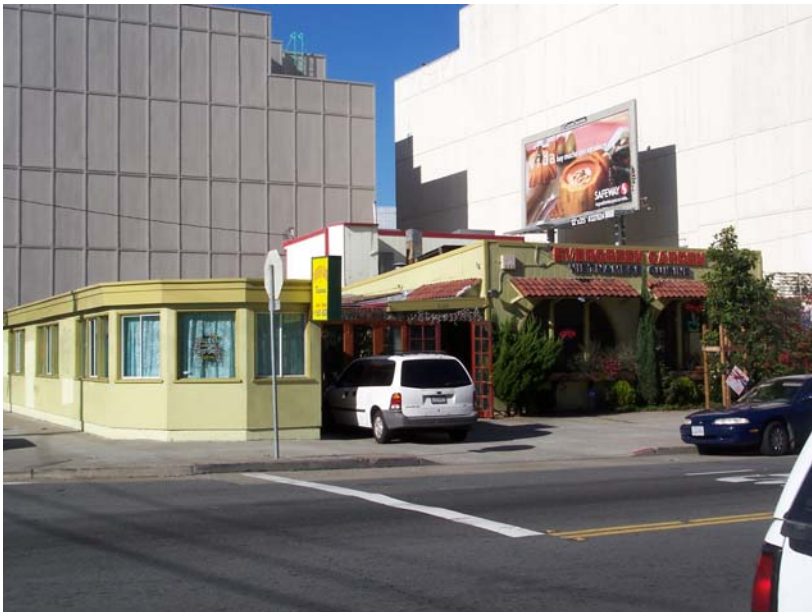
3100 18th Street, a 5,390 square-foot lot on the southeast corner of 18th and Harrison streets, contains three commercial buildings. The first is a one-story, rectangle-plan, wood-frame building at the lot's northeast corner. The second is a one-story, irregular-plan, stucco-finished building at the lot's southeast corner. The third is a two-story, square-plan building at the lot's northwest corner. The latter is not visible from the street. Concrete foundations and flat roofs characterize each structure. These buildings are recorded together.

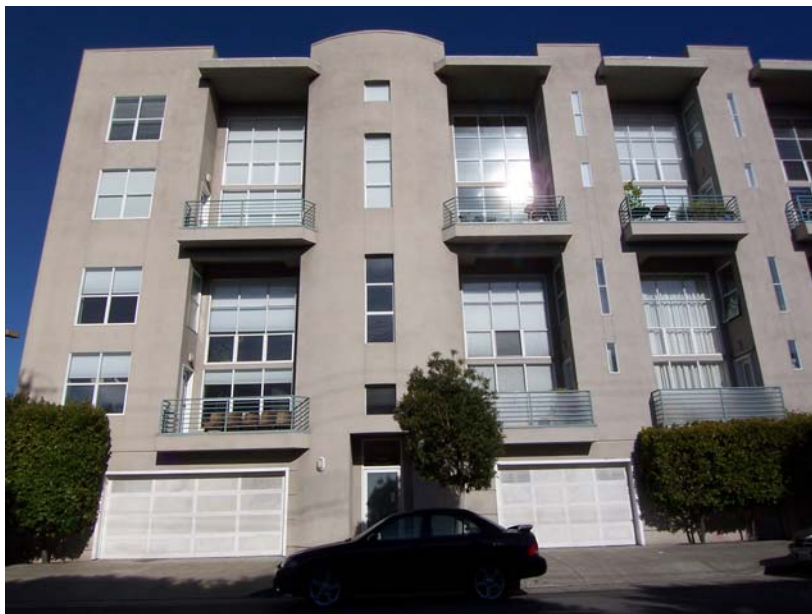
3118 18th Street is a three-story, wood-frame, residential building. It occupies a 6,000 square-foot lot on the north side of 18th Street between Treat Avenue and Harrison Street. The rectangular-plan building, finished in stucco, sits atop a concrete foundation. Its primary facade, which is eleven bays wide, faces south; its secondary facade, which is seven bays wide, faces west. The middle bay of the primary facade's first floor features the building's main entrance: a pair of double doors beneath a fabric awning. The bays flanking it feature five-light, fixed-pane, metal-sash windows. The remaining bays feature wooden, double doors, except for the leftmost bay, which features a blank wall face. Except for the leftmost bay, which presents a blank wall face, each bay of the second floor features metal-sash, sliding windows beneath a two-light transom. This fenestration dominates the upper floors of the remaining facades, with the bays at the third floor of the primary facade differing through their offer of eight-light, metal-sash, awning windows at the center of multi-light, fixed-pane, metal-sash windows. The first-floor bays of the secondary and tertiary facades mostly offer blank wall faces occasionally interrupted by secondary entrances. The building appears to be in good condition.

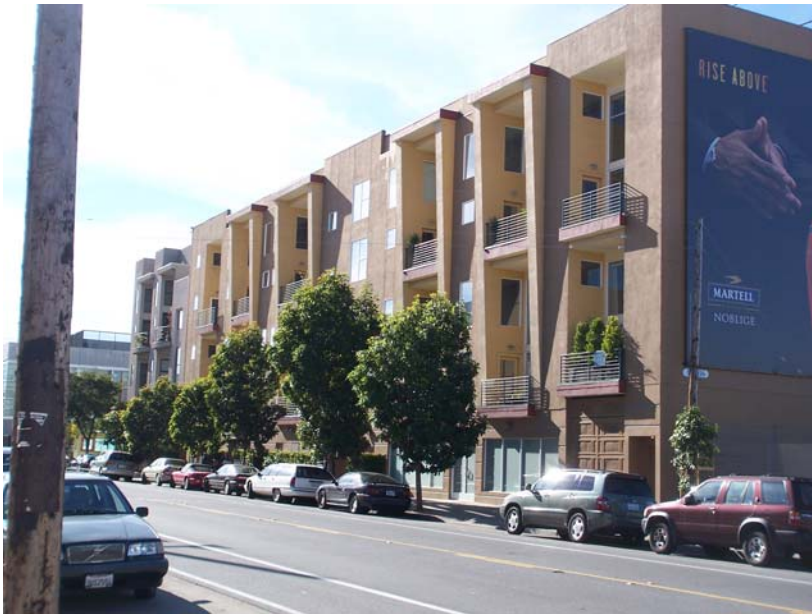
This is a three-story, wood-frame, multiple-family residential building finished in stucco and capped by a flat roof. It occupies a trapezoidal lot on the west side of Harrison Street between 17th and 18th streets. The building appears to be in good condition.

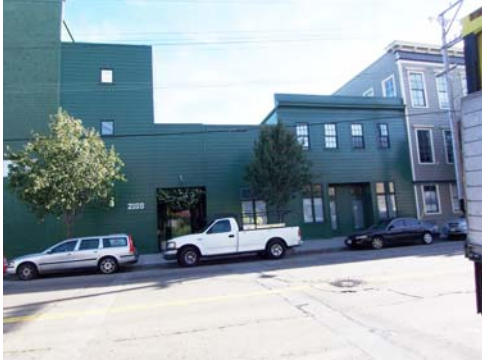
100_5749.JPG, 11/21/07, view to E, south building

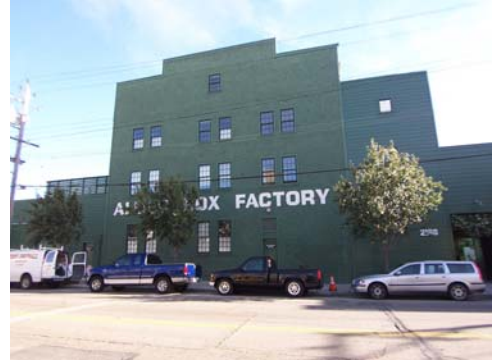
100_5750.JPG, 11/21/07, view to E, central building

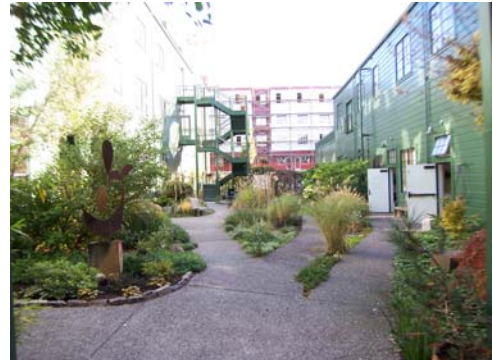
100_5756.JPG, 11/21/07, view to E, interior courtyard

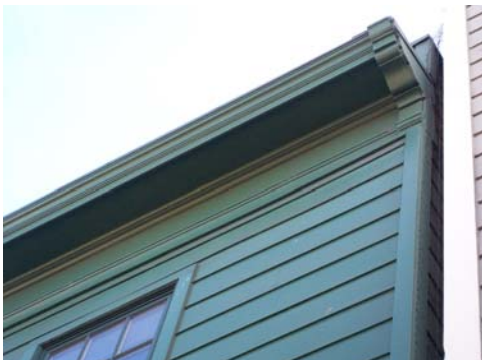
100_5758.JPG, 11/21/07, cornice detail

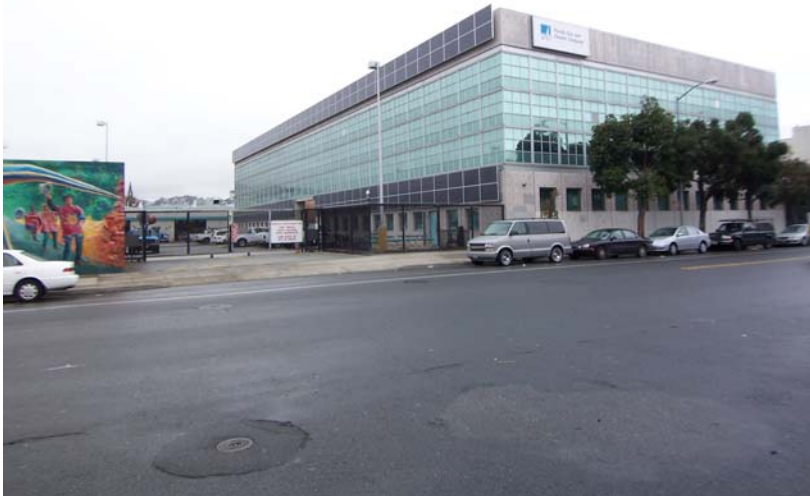
3101 18th Street is one of two buildings occupying a 128,167 sq ft block bounded by 18th Street to the north, Harrison Street to the east, 19th Street to the south, and Treat Avenue to the west. The building pictured is a four-story, concrete-frame, commercial building set back from the lot's north lot line, creating space for a surface parking lot with perimeter fencing. The rectangle-plan building, clad in concrete panels, rests on a concrete foundation. Its primary facade, which is 27 bays wide, faces north; its secondary facade, which is fourteen bays wide, faces east; its tertiary facade faces south. The center bay of the primary facade's first floor houses the building's recessed main entrance, which consists of aluminum double doors flanked by sidelights and transoms. The remaining bays feature fixed-pane windows. Each bay on the floors above feature nine-light, fixed aluminum-sash windows. The remaining facades duplicate the primary facade. The building appears to be in good condition.

The second building is located along the lot's east edge. It is a one-story, concrete-frame building likely used for storage. Constructed in 1988, the rectangle-plan building, clad in brick, sits atop a concrete foundation and is capped by a flat roof. A brightly colored mural decorates its blank wall faces along the north, east, and south elevations. It appears to be in good condition.

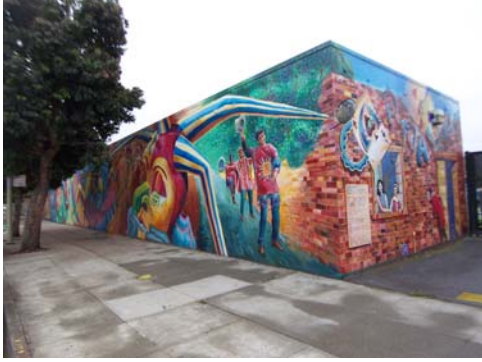
Resource Name or # (Assigned by Recorder) 3101 18TH ST
Date 6/12/08

100_5475.JPG, 11/19/07, view to SW

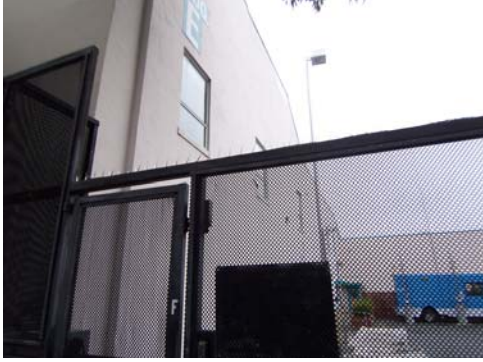
100_5446.JPG, 11/19/07, west elevation

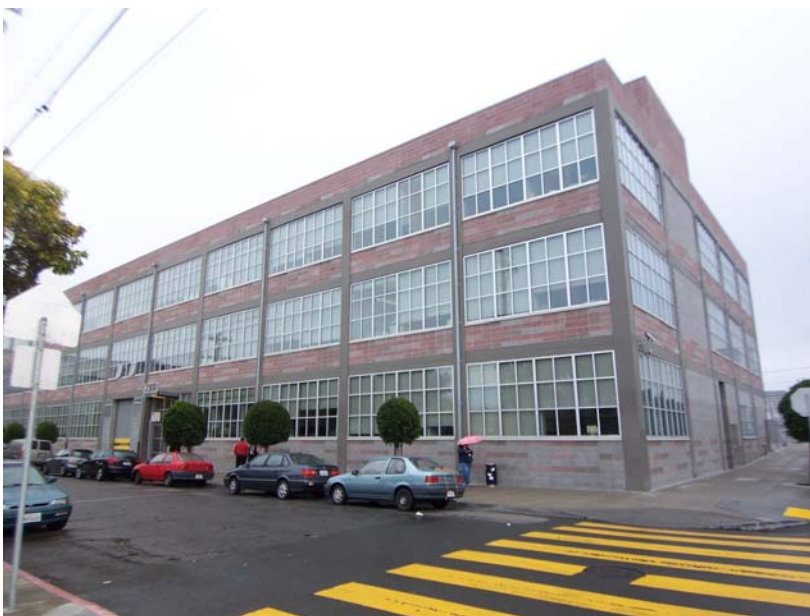
3101-3149 19th Street occupies an approximately 245 x 157 foot, full-block lot bounded on the north by 19th Street, to the east by Harrison Street, to the south by Mistral Street, and to the west by Treat Avenue. Built in 1913, it is a three-story, reinforced concrete-frame, industrial building. The rectangle-plan building sits atop on a concrete foundation and is capped by a flat roof. Its primary facade, which is eleven bays wide, faces north; its secondary facade, which is five bays wide, faces east; and its tertiary facade, also five bays wide, faces west. Counting from the left, the sixth bay of the primary facade's first floor features a garage with a metal, roll-up door, while the fifth bay offers the building's main entrance: paired, single-light, aluminum-sash doors with sidelights and a transom. The facade's remaining bays feature multi-light, fixed-pane, aluminum-sash windows. This fenestration characterizes almost every bay of the remaining facades. The building appears to be in good condition.

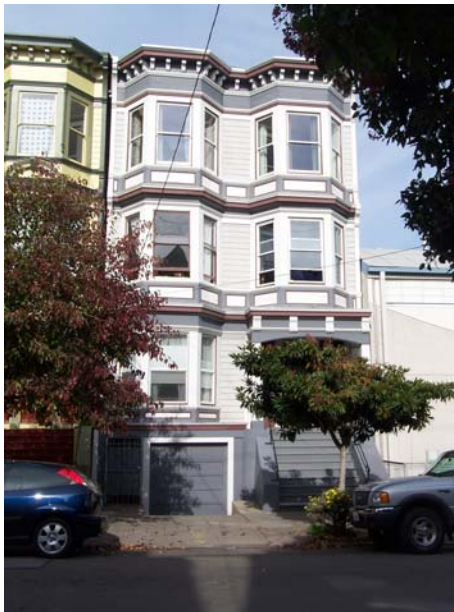
3264-3268 20th Street occupies a 95 x 25 foot lot on the north side of 20th Street between Harrison and Folsom streets. Built in 1909, it is four-story, wood-frame, multi-family building. The rectangle-plan building, clad in shiplap, rests on a concrete foundation and is capped by a low pitch, hipped roof. The primary facade, which is two bays wide, faces south. The left bay of the first floor features a garage and, to its left, a gated, secondary entrance. The right bay features a straight flight of stairs with metal-pipe railings atop concrete knee walls. They lead to the building's main entrance at the second floor: two, single-light, paneled wood doors beneath transoms. Two, square columns supporting the bracketed entablature of a door hood further distinguishes the entryway. The remaining bays of the facade feature bowed bay windows composed of one-over-one, double-hung, wood-sash windows above spandrel panels. The third-floor bay windows are distinguished by a denticulated entablature, while a simple cornice tops the fourth-floor bay windows. The facade terminates in a false parapet, paneled frieze, bracketed projecting cornice, and metal coping. The building appears to be in good condition.

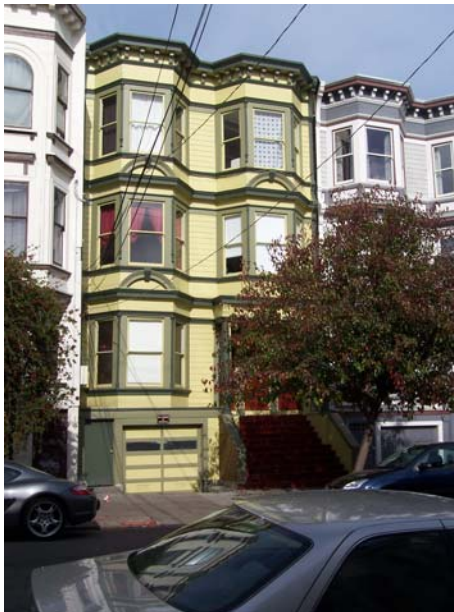
3270-3274 20th Street occupies a 95 x 25 foot lot on the north side of 20th Street between Harrison and Folsom streets. Built in 1909, it is four-story, wood-frame, multi-family building. The rectangle-plan building, clad in shiplap, rests on a concrete foundation and is capped by a low pitch, hipped roof. The primary facade, which is two bays wide, faces south. The left bay of the first floor features a garage and, to its left, a wooden door that acts as the building's secondary entrance. The right bay features a straight flight of stairs with a closed, wooden balustrade leading to the building's main entrance at the second floor: three, wooden doors. Two, Tuscan columns supporting a door hood further distinguishes the entryway. The remaining bays feature canted bay windows composed of one-over-one, double-hung, wood-sash windows topped by a cornice and flanked by fluted pilasters. An arched pediment with a keystone above the center windows further distinguishes the bay windows. The facade terminates in a false parapet, brackets, and a projecting cornice. The building appears to be in good condition.

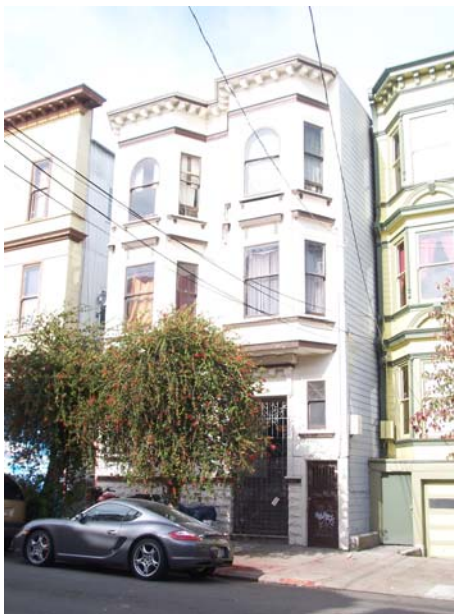
3275-3280 20th Street occupies a 95 x 25 foot lot on the north side of 20th Street between Harrison and Folsom streets. Built in 1909, it is a three-story pluss raised basement, wood-frame, multi-family building. The rectangle-plan building, clad in ornamental concrete block and stucco at its south elevation and shiplap elsewhere, rests on a concrete foundation and is capped by a flat roof. The primary facade, which is two bays wide, faces south. The right bay of the first floor features a gated, recessed entryway and, to its right, a gated, secondary entrance. The entryway features a straight flight of stairs leading to the building's second-floor, main entrance. The remaining bays feature canted bay windows composed of one-over-one, double-hung, wood-sash windows. Hood molding above spandrel panels top the third-floor bay windows, while an arched center window and bracketed lug sills distinguish the fourth-floor bay windows. The facade terminates in a false parapet, oversized dentils, projecting cornice, and metal coping. The building appears to be in good condition.

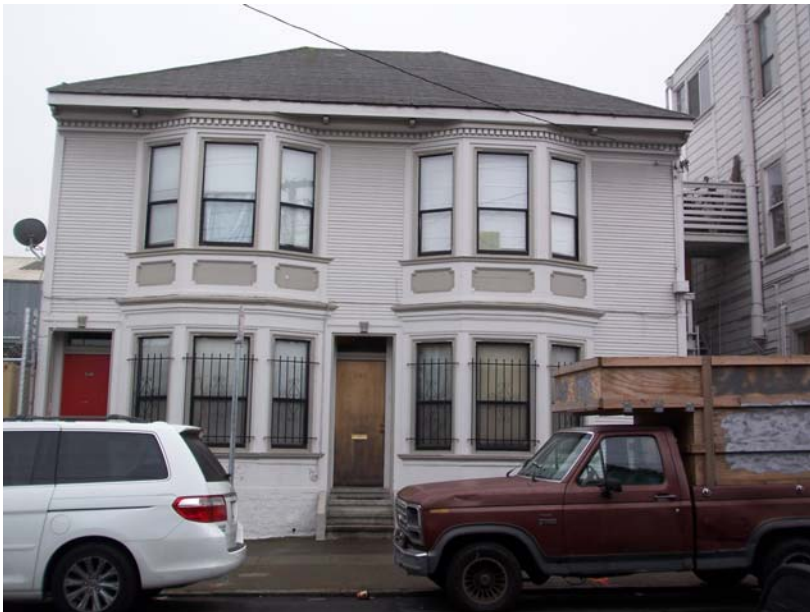
This is one of two buildings occupying a 2,500 sq.ft. lot at the southeast corner of 19th and Folsom streets, each recorded separately. This record is for the two story frame multi-family structure with a hipped roof on a concrete foundation, located at the east end of the lot, facing 19th Street. The primary elevation has two stacks of canted bay windows, with a central recessed entrance and another recessed entrance at the far left. A molded cornice and paneled frieze separate the two levels of windows. Each face of the bays contains a 1/1 double hung wooden sash. There is an overhanging closed eave on this elevation, with dentil ornament. The building appears in good condition.

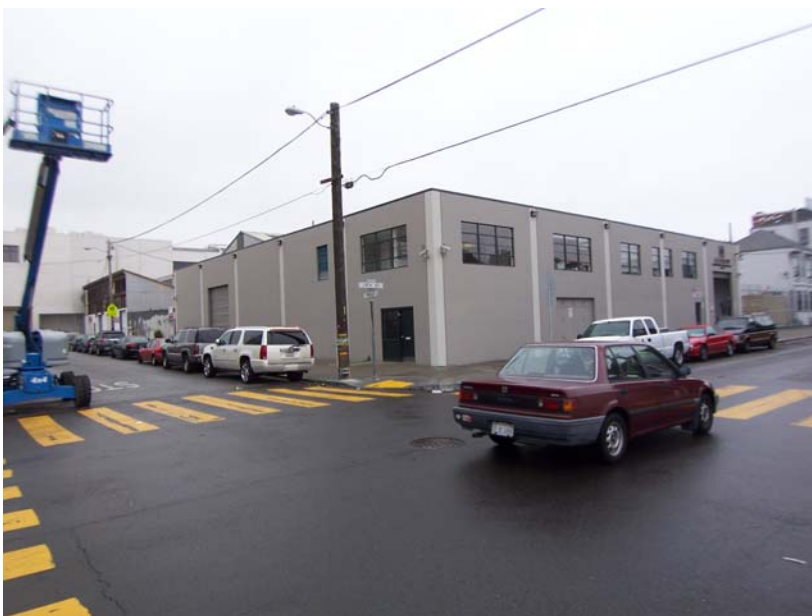
600 Treat Avenue is one-story-and-mezzanine, reinforced-concrete industrial building capped by a flat roof. The utilitarian building occupies a 14,496 sq. ft. lot at the southwest corner of Treat Avenue and 19th Street. The primary facade is five bays wide and faces Treat Avenue to the east. There are vehicular and pedestrian entrances on both visible elevations. Windows, all at the mezzanine level, are 3/3 fixed metal sash. The building appears in good condition.

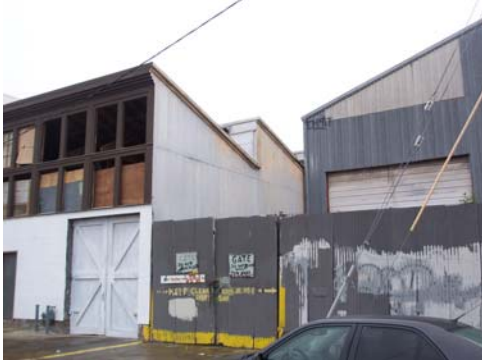
Resource Name or # (Assigned by Recorder) 630 TREAT AVE
Date 6/12/08

100_5461.JPG, 11/19/07, view to SW

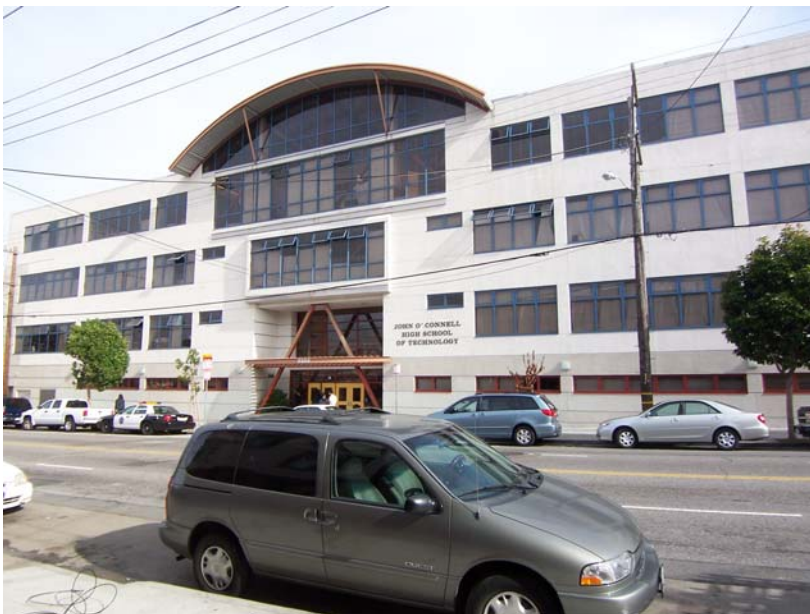
2355 Folsom Street is a four-story, reinforced-concrete public high school finished in stucco and capped by a flat roof. The utilitarian building occupies an L-shaped, 155,000 sq. ft. lot on the west side of Folsom Between 19th and 20th streets. The building occupies the western half of the lot, with the eastern portion devoted to sports fields. Constructed in 2001 according to SFUSD, the building may incorporate part of an older post-1950 structure. The building appears in good condition.

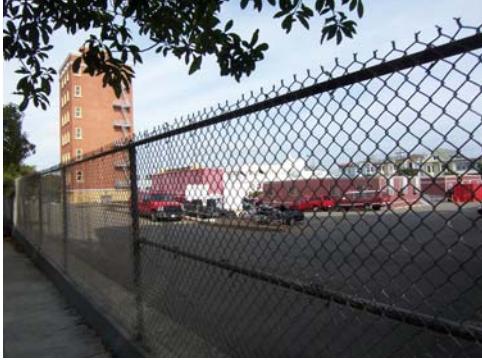
100_5270.JPG, 11/19/07, view to NE

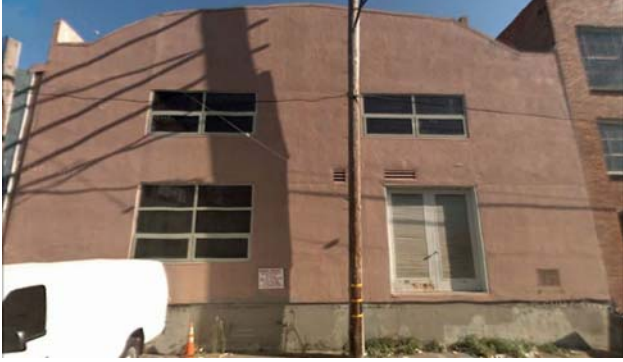
100_2534.2.JPG, view to E, 11/26/07, Langton
St. elevation
