Historic Preservation Commission Executive Summary Historic Resource Survey Findings INFORMATIONAL PRESENTATION: JUNE 1, 2011 ADOPTION HEARING: JUNE 15, 2011

Date: May 25, 2011
Case No.: **2011.0401U**
Project: Showplace Square / Northeast Mission Historic Resource Survey
Staff Contact: Moses Corrette – (415) 558-6295
moses.corrette@sfgov.org
Reviewed By Tim Frye – (415) 575-6822
tim.frye@sfgov.org
Recommendation: **Adoption of survey findings**

**SHOWPLACE SQUARE SURVEY
SAN FRANCISCO, CALIFORNIA
FINAL**

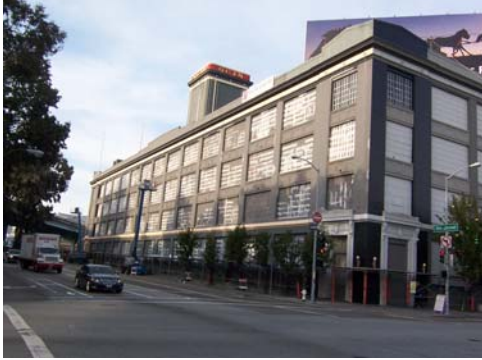
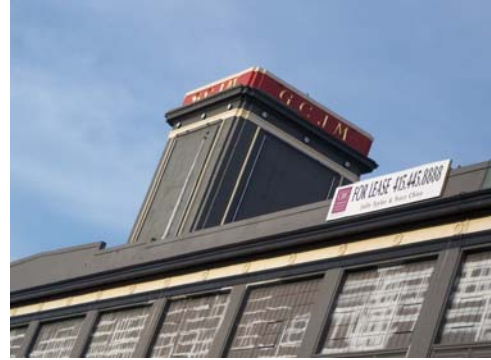
545 8th Street has undergone several alterations, including replacement of storefronts, painting over the exterior windows, and infill of a rear courtyard. These alterations, all of which are easily reversible, do not detract from the overall integrity of the building, which retains the aspects of location, design, materials, workmanship, feeling, and association.

View toward northeast, 11.26.07, 100_2573.JPG Detail of cornice and water tower, 11.26.07, 100_2575.JPG

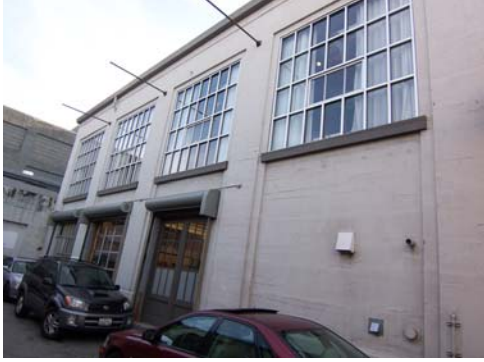
100_2587.JPG, 11/26/2007, view to SW, Kate
St. elevation

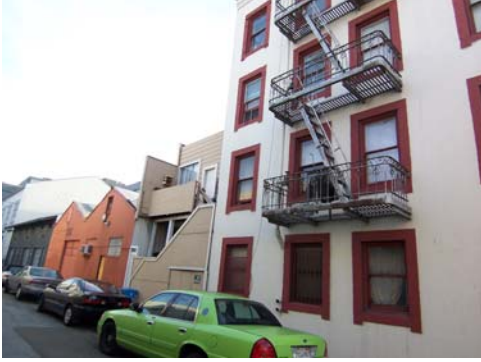
100_2585.JPG, 11/26/07, view to SW, Kate St.
elevation

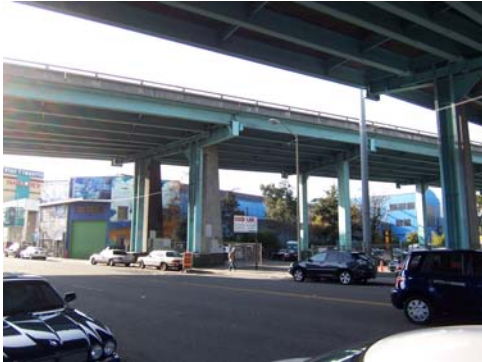
View toward northwest, 11.26.07, 100_2617.JPG

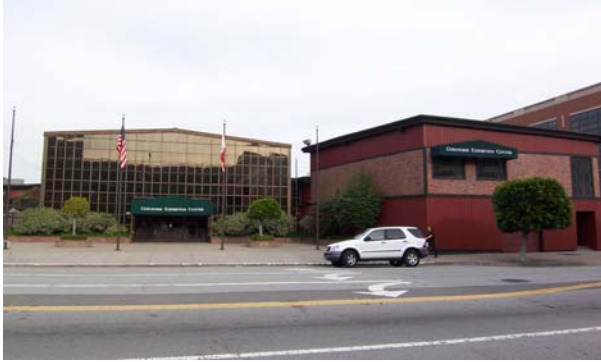
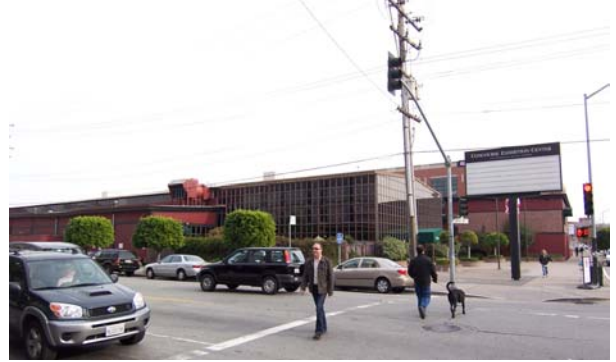
View toward northeast, 11.26.07, 100_2524.JPG View toward southeast, 11.26.07, 100_2521.JPG

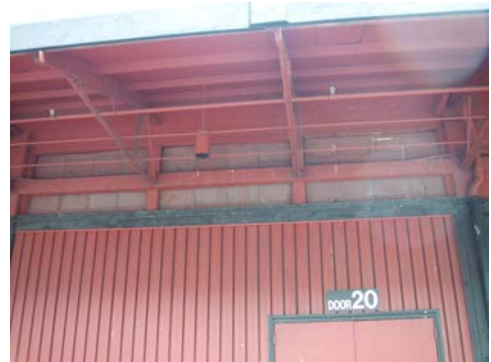
Ssq_005.JPG, 11/12/08, detail, W elevation

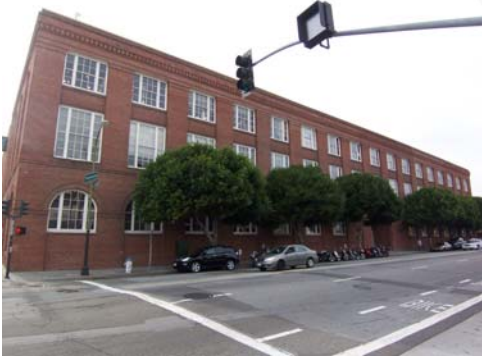
View toward northwest, 11.26.07, 100_2511.JPG

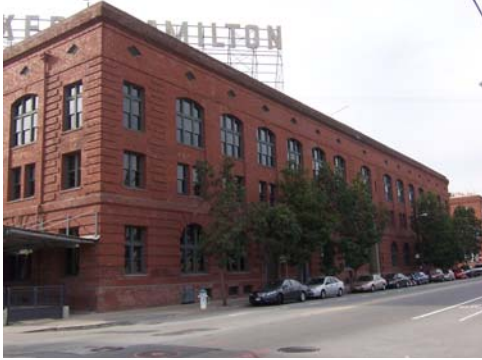
100_2499.JPG, 11/26/07, view to NW

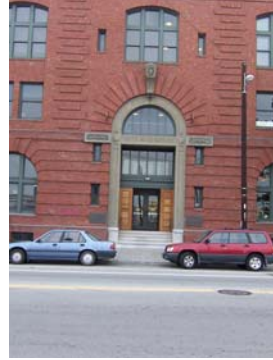
100_2501.JPG, 11/26/07, view to W, entrance detail

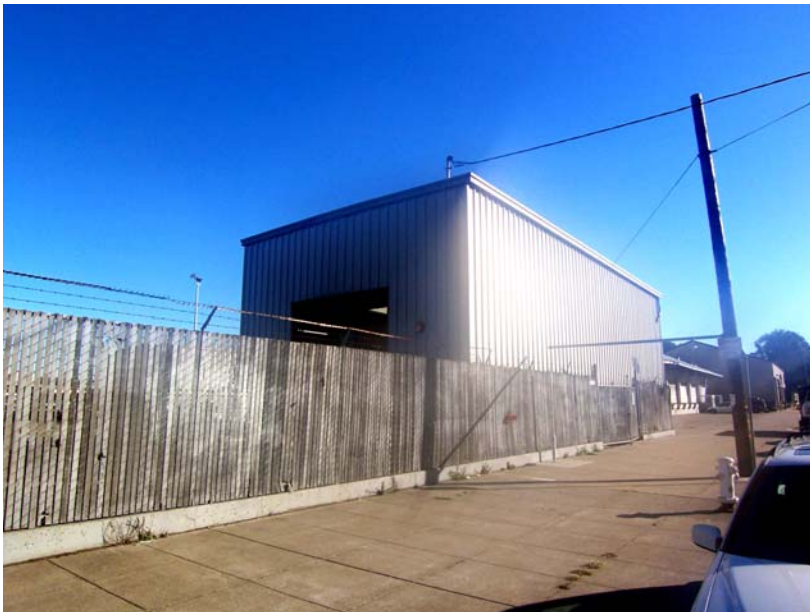
575 Berry Street is a 25,635 square-foot lot on the south side of Berry Street between 7th and De Haro streets. The parcel is primarily devoted to surface parking. There is a corrugated steel shed constructed in 1985 on the southwesternmost corner of the property. The building appears to be in good condition.

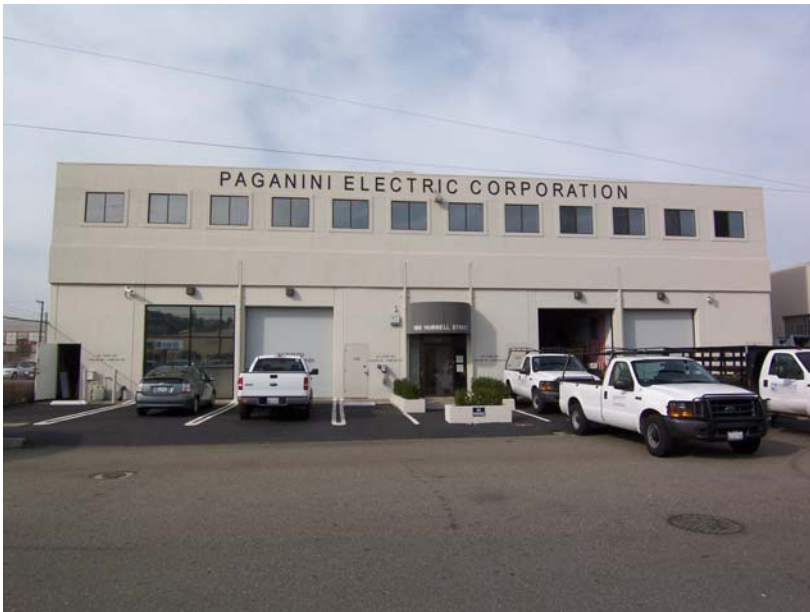
455 Irwin occupies a portion of a rectangular lot located on the south side of Irwin Street between 7th and 8th streets. Built in 1979, the building is a two-story concrete industrial structure designed in a utilitarian mode. The first floor of the primary facade features four vehicular bays and a primary pedestrian entrance. The second floor features a row of aluminum sliding windows. The building appears to be in good condition.

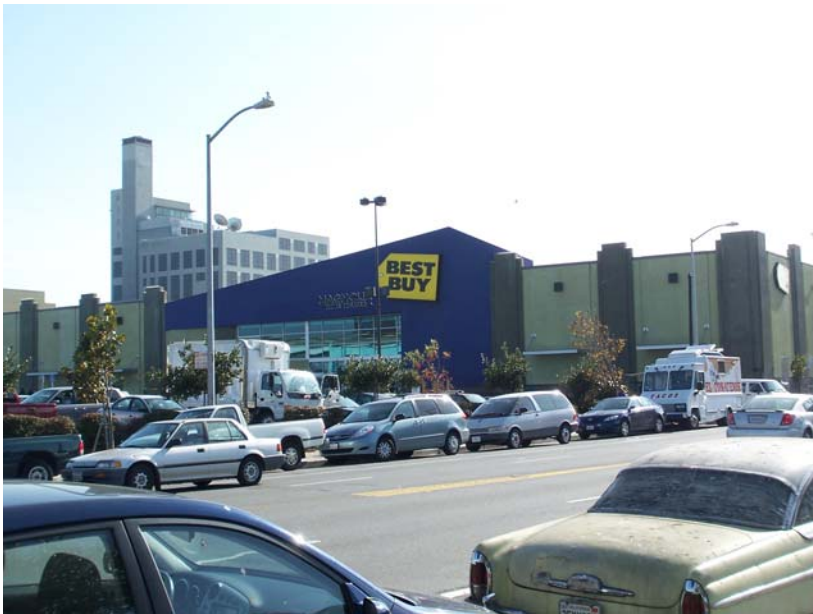
This is a flat roofed contemporary concrete commercial building occupying a 58,000 sq.ft. lot plus associated parking lots. It has elevations on Harrison and Treat streets between 13th and Alameda streets. The building appears in good condition.

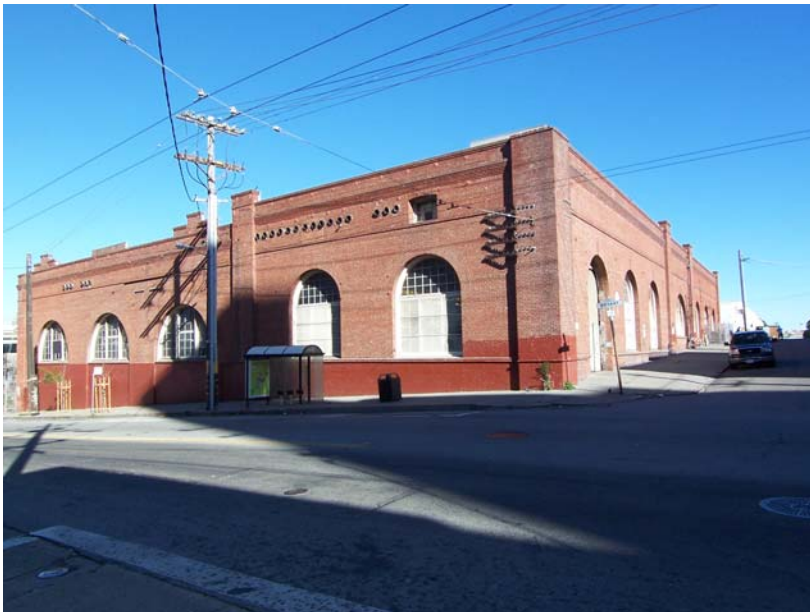
1401 Bryant Street occupies a 200 x 240 square-foot, sloped corner lot on the east side of Bryant Street between Division and Alameda streets. Built in 1900, it is a two-story, steel-frame, brick utility building with load-bearing brick walls which rest on a concrete perimeter foundation. The building is capped by a flat roof. The primary facade, which is 5 bays wide, faces west on Bryant Street; the secondary facade, which is 7 bays wide, faces south on Alameda Street; the tertiary facade faces north onto a surface parking lot. Each bay of the primary facade consists of an arched, double-height, multi-lite, fixed window with wood surrounds. Exceptions include the third and fourth bays from the left, which are divided by pilasters, also found at the southwest corner of the building. The same window treatment characterizes the secondary facade, except for its leftmost bay. There the windows have been replaced with corrugated metal, creating a wall inset with a metal door. Pilasters flank the fourth, or middle bay, as well as the southeast corner of the building. The tertiary facade differs from the primary and secondary facades because its windows are not double-height. They instead occupy the building's second floor. The second and seventh bays from the left also differ because they feature recessed wall openings with concrete surrounds. The primary and secondary facades terminate with exposed tie rod ends, a corbelled cornice, stepped parapet, and brick coping; the tertiary facade terminates with brick coping. The minimally altered building appears to be in good condition.

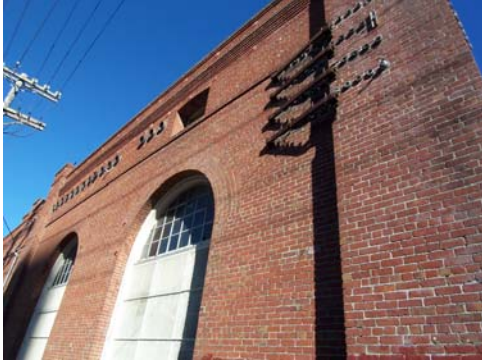
Detail window & brickwork, 11.23.07,
100_6216.JPG,

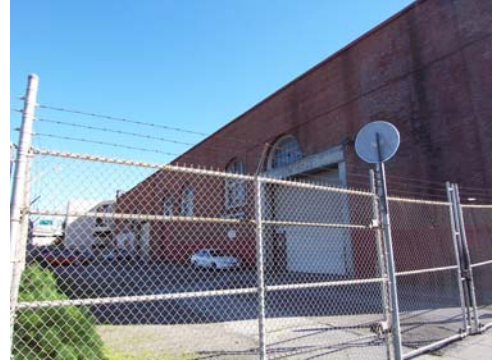
North facade, 11.23.07, 100_6217.JPG

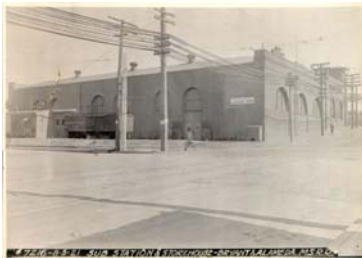
Sub Station & Storehouse - Bryant & Alameda.
M.S.R.R.
1901

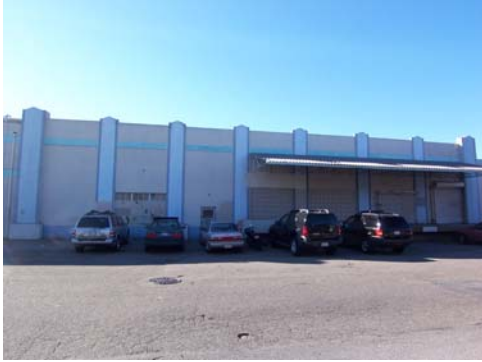
100_2346.JPG, 11/26/07, view to W, 2 story section

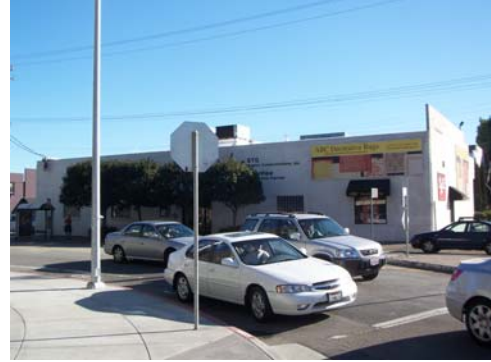
100_2347.JPG, 11/26/07, view to NW, 1 story section

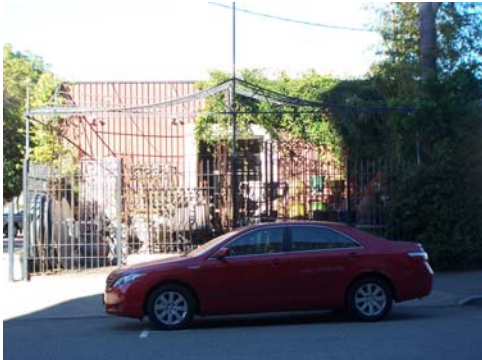
100_2342.JPG, 11/26/07, view to N, corrugated metal section

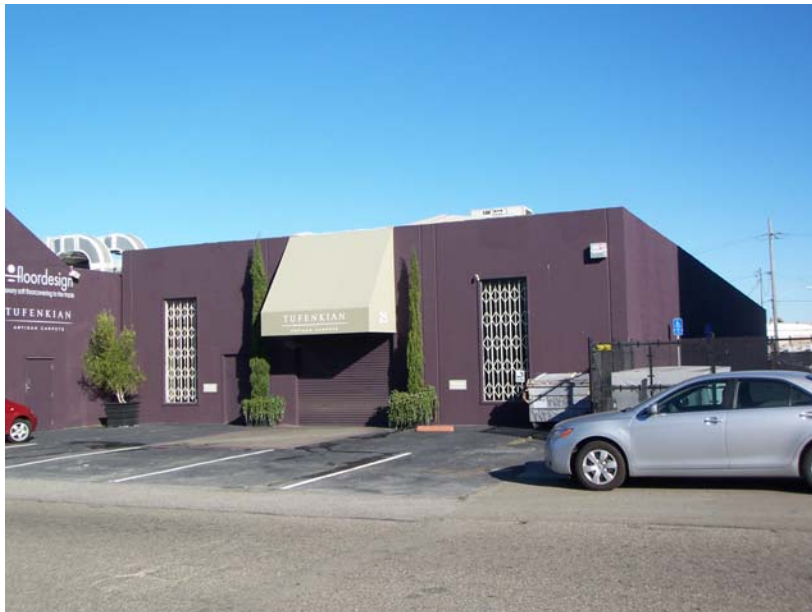
45 Rhode Island Street is a one-story, reinforced-concrete industrial building capped with a shallow barrel truss roof and is located on a 9,997 sq ft lot. The primary façade faces west on Rhode Island Street and is three bays wide. Two fixed windows with metal security gates flank a loading dock with metal roll-up door and canvas awning. The center bay also features a flush metal door to the left of the loading bay. The facade terminates with a flush parapet. The minimally altered building appears in good condition.

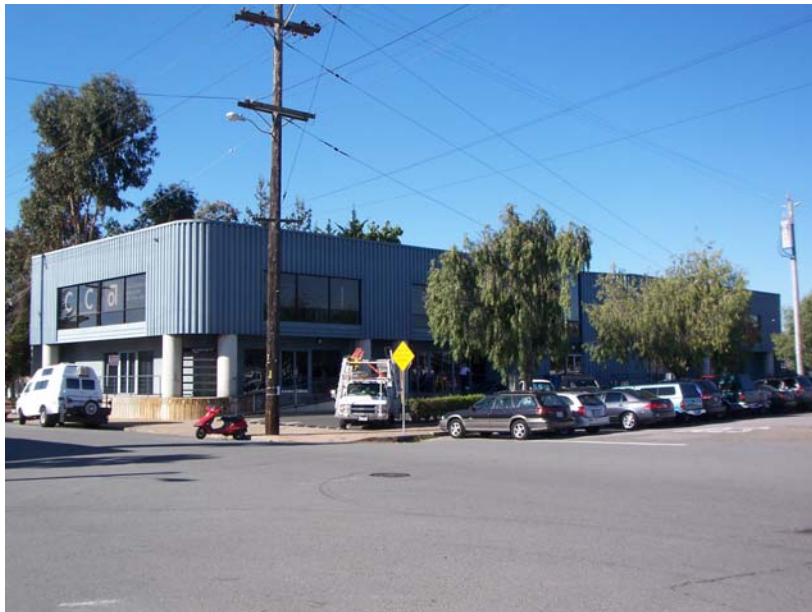
80 Carolina Street occupies a portion of a 20,000 square-foot lot on the northwest corner of 15th and Carolina streets. Constructed in 1984, the building is a concrete commercial structure designed in a utilitarian mode. The first floor features an arcade supported by pairs of round concrete columns. The arcade shelters several anodized aluminum windows and an entrance. The second floor is clad in corrugated steel paneling and it is articulated by anodized aluminum ribbon windows. The building appears to be in good condition.

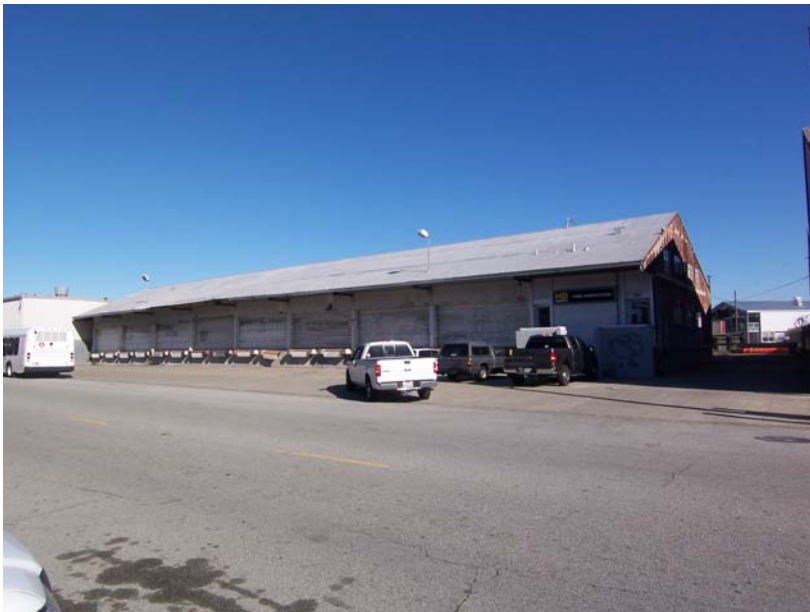
155 De Haro is a 40,741 square-foot property on the east side of De Haro Street, between Berry and Hooper streets. The Parcel contains a pair of corrugated steel garage/auto and truck repair buildings constructed in 1969. Both are wood-frame, steel-clad structures with gable-roofs. Both are articulated on their long sides by a row of vehicular loading docks. A large paved surface parking lot occupies the rest of the parcel. The buildings appear to be in fair condition.

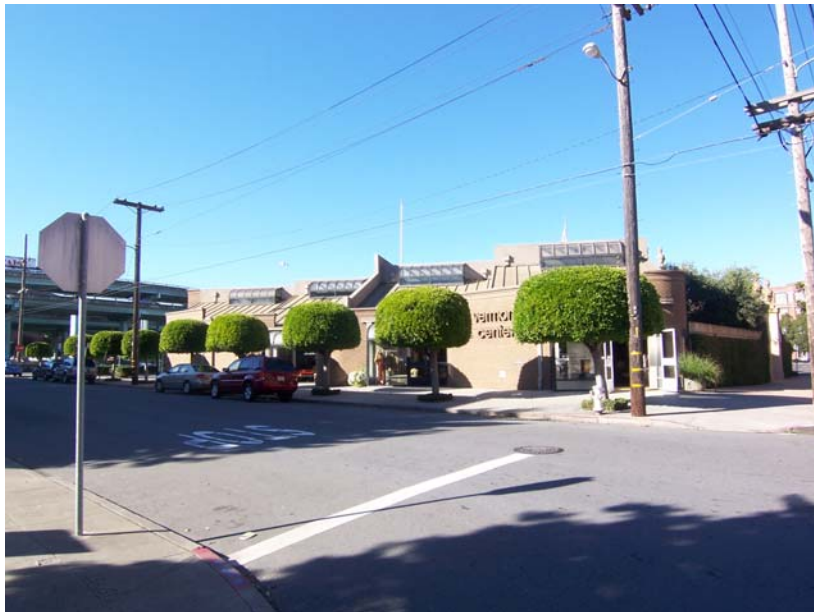
320 15th Street is located on the north side of 15th Street between Vermont and Kansas streets. It is a one-and-two-story concrete and brick commercial building designed in the Postmodern style. The irregular footprint accommodates the triangular-shaped lot, allowing for ample display area and surface parking. The building appears to be in good condition.

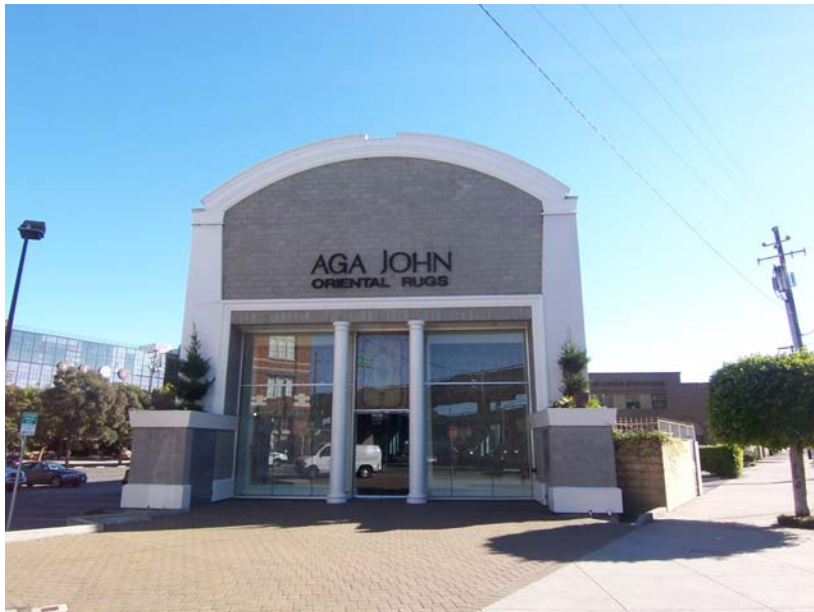
135 Vermont Street is an irregularly shaped parcel on the east side of Vermont Street between Alameda and 15th streets. The parcel, which was historically part of the Southern Pacific Railroad's right-of-way, is presently occupied by a one-story concrete block commercial building completed in 1998. The building appears to be in good condition.

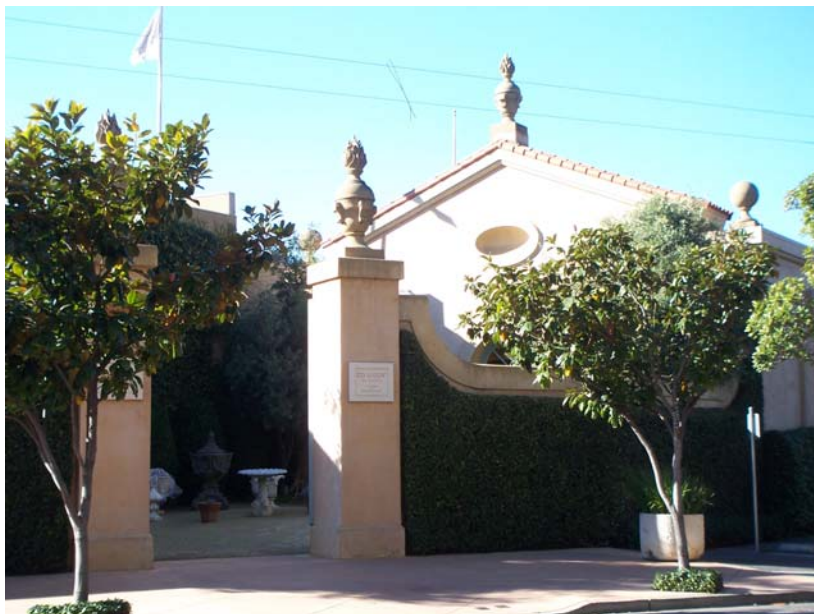
188 Henry Adams occupies a 9,540 square-foot lot on the west side of Henry Adams (Kansas) Street between Alameda and 15th streets. The parcel was once part of the Southern Pacific Railroad right of way. The existing building on the property is a one-story concrete block commercial structure designed in the Mediterranean Revival style. The building appears to be in good condition.

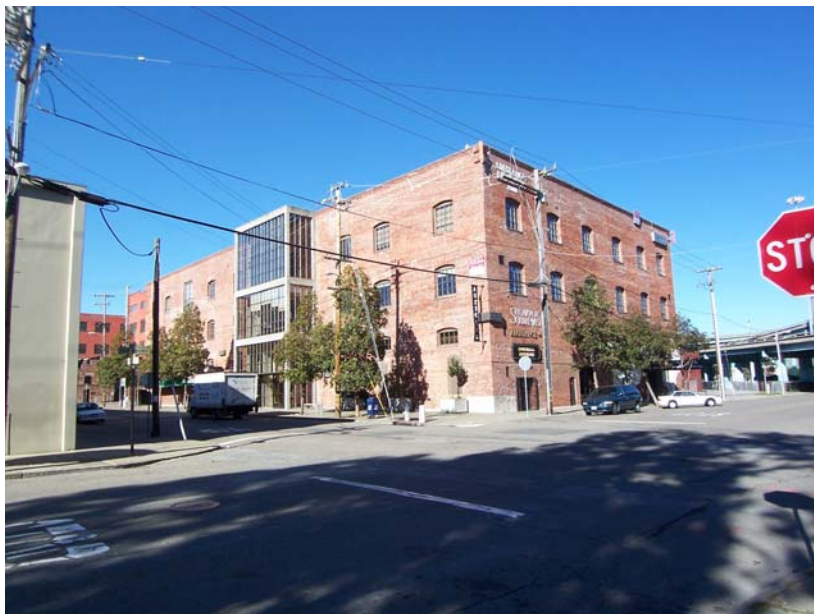
550 15th Street occupies an approximately 116 x 200 square-foot corner lot on the north side of 15th Street between San Bruno Avenue and Utah Street. Built in 1906, it is a 3-story, heavy timber-frame industrial building. The American Commercial style, rectangle-plan building sits atop a concrete foundation and is capped by a flat roof. The primary facade, which is 9 bays wide, faces south; it is set back from the lot line. The secondary facade, which is 7 bays wide, faces east; the tertiary facade faces west. The leftmost, or first, bay of the primary facade's first floor features a blank wall face, while the second bay features a fixed, multi-light window. Bays three through five feature a rectangular, flat-roofed, brick addition built out to the south lot line. The third and fourth bays present blank wall faces beneath a curved, fabric awning, while the fifth features a recessed entryway with a glass door and, to its right, a band of fixed, shed-roofed windows with steel sashes. The sixth bay features another flat-roofed addition built out to the south lot line. Unlike the addition to its left, this reaches to the third floor and is composed of window-walls. Its first floor is distinguished by a recessed, anodized aluminum entryway. The seventh bay features a recessed, segmental arched, multi-light, fixed window, while the eighth and ninth bays feature the same fenestration behind wooden shutters. The bays of the second and third floors feature segmental arched, paired, 6-light steel-sash fixed windows over paired, 2-light awning windows with flat, radiating, header brick arches and slip sills, except for the third bay from the left, which consists of a fixed, multi-light, steel-sash window. The second and third floors of the secondary and tertiary facades display the same fenestration. The minimally altered

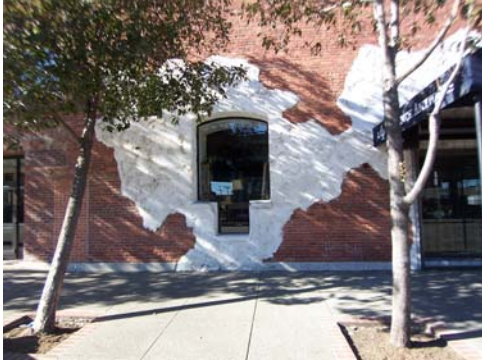
100_6064.JPG, 11/23/07, detail east elevation

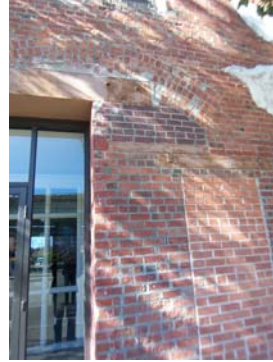
100_6068.JPG, 11/23/07, detail brickwork & window

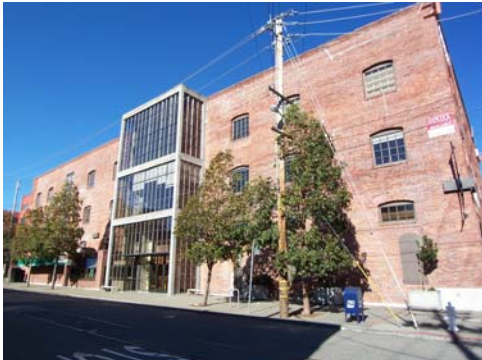
100_6071.JPG, 11/23/07, view to NW

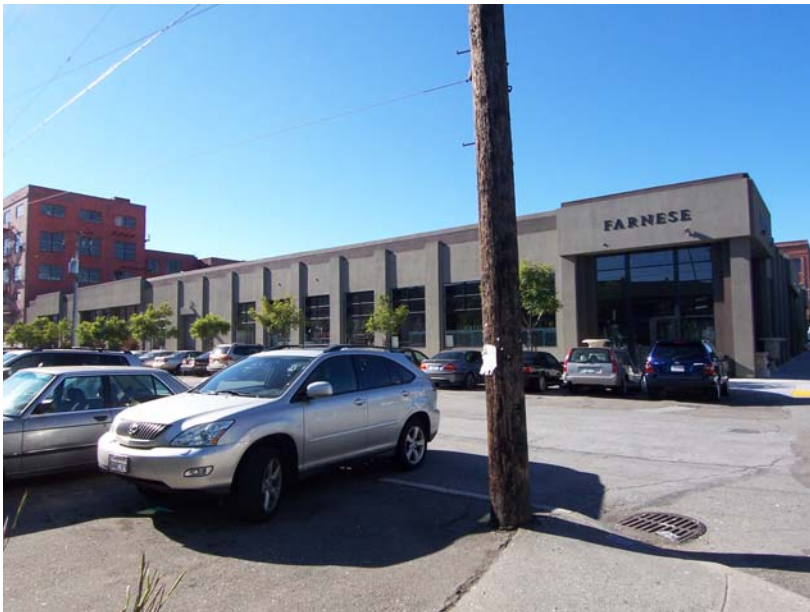
This is a one story flat roofed concrete commercial building occupying a 55,334 sq.ft. lot on the southwest corner of Utah and Alameda streets, with an elevation also on Potrero Avenue. It is rectangular in plan with a small cutout at the southeast corner. Full height concrete piers create bays infilled with fixed metal display windows. Projecting cornices mark entrances at the corner of Utah and Alameda, as well as on the three main elevations. Finish is smooth stucco over concrete, with no ornamentation. The building appears in good condition.

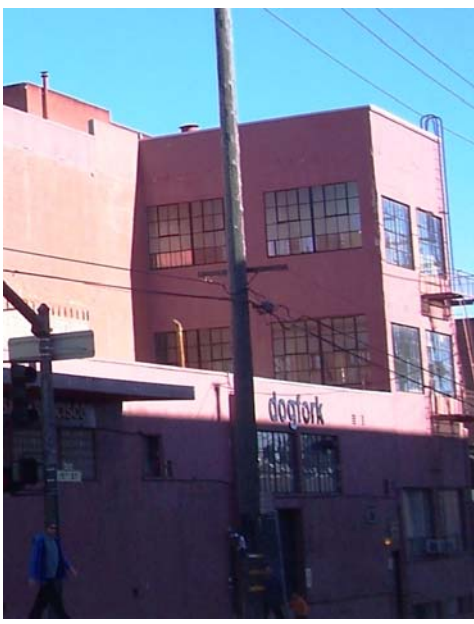
This form records the three story concrete light industrial building occupying mostly an interior position in the complex, with a small elevation on 15th Street between Potrero Avenue and Utah Street. It has an L plan, and a grid of window openings with multi-lite steel industrial sash windows, 8 x 4. A metal fire escape runs the full height of the building on the two bay wide south elevation. The building appears in good condition.

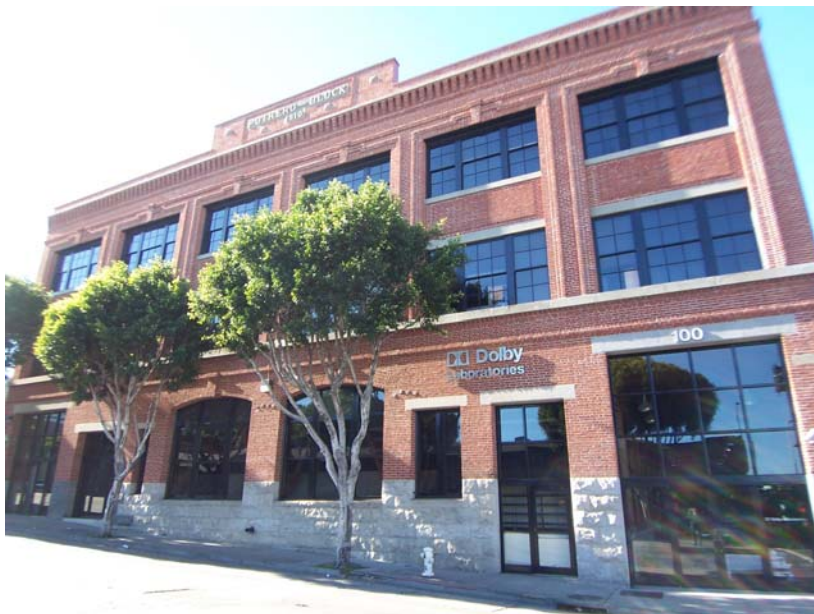
100 Potrero Avenue is a three-story, heavy timber-frame, brick industrial building. It is built of red brick laid in Flemish bond with a rusticated granite base and granite lintels and sills. The building occupies a 22,000 sq. ft. lot at the southwest corner of Potrero Avenue and Alameda Street, with an elevation also on Hampshire Street. It has a low pitched gable roof concealed behind parapets. The building is a two-part vertical composition, with a one story base separated by a granite and brick intermediate cornice from the two story shaft. There are six bays on the primary Potrero Avenue elevation, and ten on the Alameda elevation, defined by brick piers, rectangular in the base. The third and fourth bays from the left in the base have large windows beneath rowlock segmental arches. The other base bays have rectangular openings with granite lintels. The upper section has tripartite windows on each floor, enframed in flat arches formed by projecting rowlock and header courses. The arches have keystone shapes also formed by projecting headers. All windows are 4/4 double hung wooden sash. The building terminates with a corbelled cornice and stepped parapet. In the center bay of the parapet, raised lettering reads "Potrero Block 1910." The Alameda and Hampshire elevations are both finished much as the primary Potrero elevation. The minimally altered building appears to be in good condition.

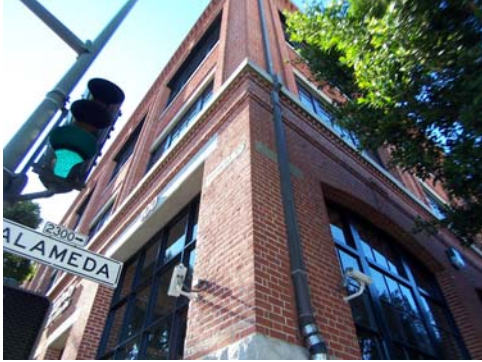
100_6122.JPG, 11/23/07, detail NE corner

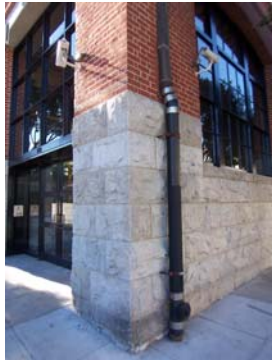
100_6123.JPG, 11/23/07, detail NE corner,
base

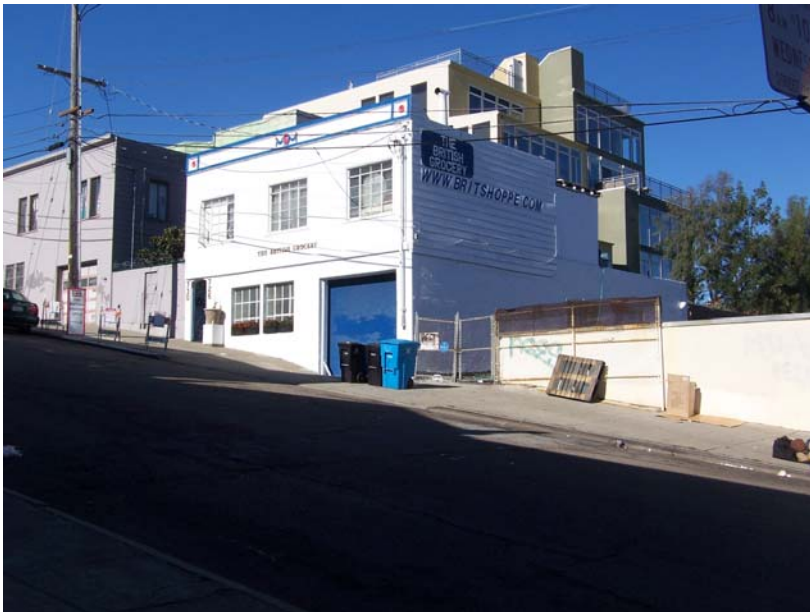
720 15th Street occupies a 34.5 x 58 square-foot lot on the north side of 15th Street between Potrero Avenue and Hampshire Street. Built in 1924, it is a 2-story, wood-frame commercial building. The rectangle-plan building, finished in stucco except for the second floor of its secondary facade, which is clad in rustic redwood siding, rests on a concrete foundation and is capped by a flat roof. The primary facade, which is 3 bays wide, faces south. The left bay features an arched, recessed entryway with a wooden door behind an iron gate, while the middle bay features two, 12-light, fixed windows behind planter boxes. The right bay features a vehicular opening with a metal, roll-up door. Each bay of the second floor features tripartite fenestration consisting of a fixed, 8-light center window flanked by 4-light, casement windows. A 4-light transom and lug sills further distinguishes the fenestration. The secondary facade presents a blank wall face. The primary facade terminates with a spandrel parapet decorated with button ornaments at the left and right corners and a garlanded cartouche at the center. The building appears to be in good condition.

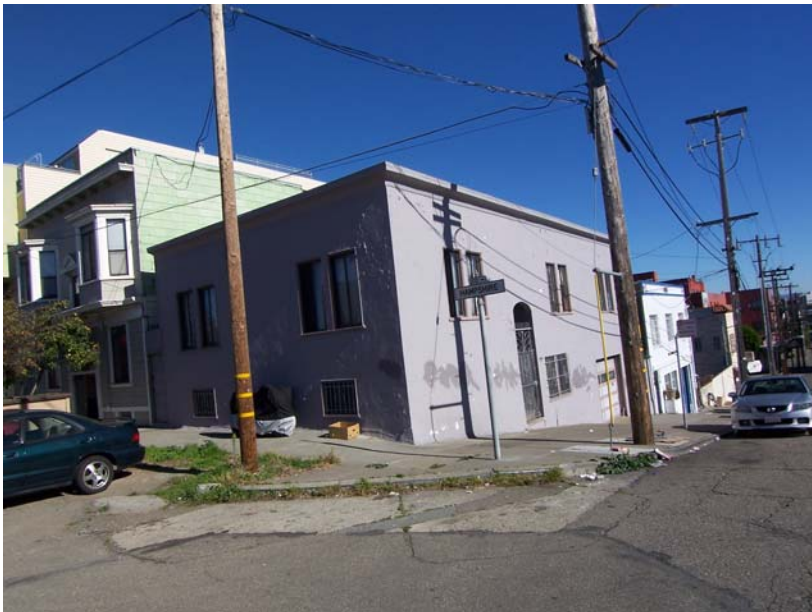
740 15th Street occupies a 29.8 x 64.5 square-foot corner lot on the north side of 15th Street between Potrero Avenue and Hampshire Street. The site is set back from its east lot line. Built in 1910, it is a 2-story, wood-frame, utilitarian apartment building. The rectangle-plan building, clad in shiplap at its east elevation and textured stucco elsewhere, rests on a concrete foundation and is capped by a flat roof. The primary facade, which is 4 bays wide, faces south; the secondary facade, which is 3 bays wide, faces west. The leftmost, or first, bay of the primary facade's first floor presents a blank wall face, while the second bay features an arched, recessed, double-height entryway with an iron gate and steps to the second-floor entrance. The third bay features paired windows with lug sills behind an iron grille, while the fourth features a garage. All bays of the second floor feature paired, sliding windows with lug sills. This fenestration characterizes the secondary and tertiary (east) facades, except for the first floor of the secondary facade, which features fixed windows behind iron grilles. The primary and secondary facades terminate with a boxed cornice. The moderately altered building appears to be in good condition.

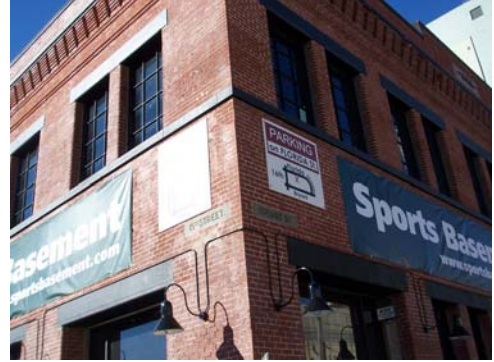
100_6249.JPG, 11/23/07, detail

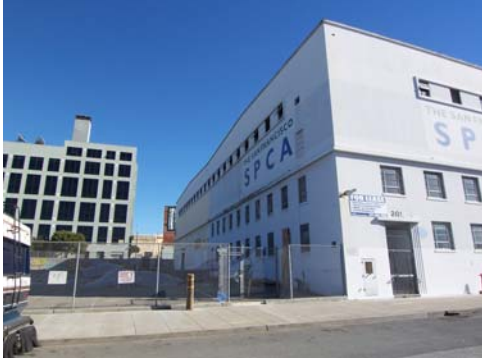
100_6201.JPG, 11/23/07, view to SE

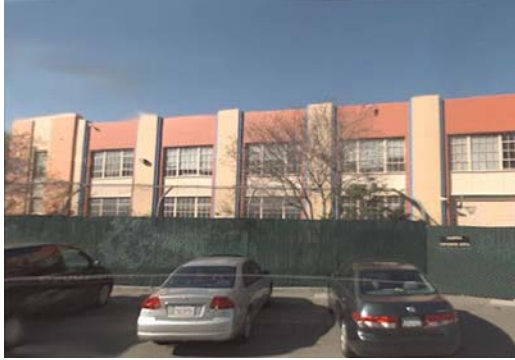
DCP3504.JPG, 11/23/2007, view to W

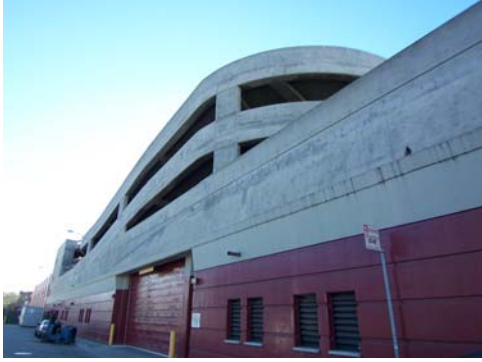
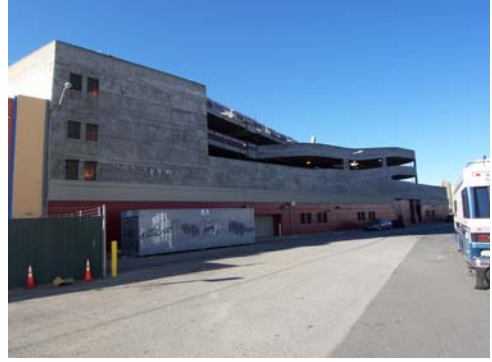
100_6283.JPG, east elevation view towards SW 100_6284.JPG, east elevation, view towards NW

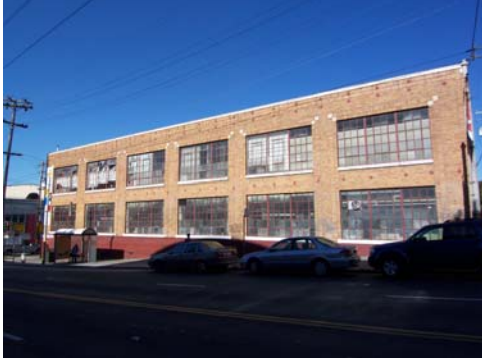
2600 16th Street is a three-story, reinforced concrete-frame, brick industrial building. The utilitarian rectangular-plan building, clad in English bond brick, rests on a concrete foundation and is capped by a flat roof. The building occupies an irregularly shaped, 18,410 square-foot, sloped corner lot on the north side of 16th Street between Harrison and Alabama streets. The primary facade, which is 6 bays wide, faces south toward 16th Street. The first floor of the primary facade presents blank wall faces. All other bays feature enframed window-walls composed of 6-light, awning windows surrounded by fixed, multi-light windows with metal sashes and concrete slip sills. The remaining facades consist of multi-lite steel industrial sash windows with loading docks at the first floor level. All facades terminate with a frieze of soldier-course brick, a parapet, and concrete coping. The building appears to be in good condition.

100_6369.JPG, 11/28/07, view to N

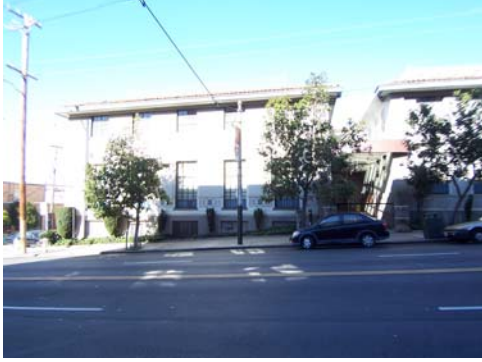
2500 16th Street occupies a 27,996 square-foot, sloped corner lot on the north side of 16th Street between Alabama and Florida streets. Built in 1925, it is a 2-story, concrete-frame, Mediterranean-style institutional building. Originally a U-plan building, additions (described in B10) have given it an irregular plan. Finished in stucco, it rests on a concrete foundation and is capped by a 3/4 hip roof. The primary facade, which is 16 bays wide, faces south; the secondary facade, which is 17 bays wide, faces west; the tertiary facade faces east. The five leftmost bays of the primary facade's first floor duplicate bays seven through nine and bays eleven through thirteen on the east and west elevations; all of which feature multi-light wood sash windows with lug sills and protective iron grilles. Decorative panels with vegetal ornament separate the bays. These panels appear again on the rightmost bays of the building's secondary facade. The sixth bay forms the interior of the U, a gated, recessed, tiled entryway leading to an 8-light, wooden door with sidelights and a transom. The tenth bay consists of three, segmental arched, 6-light wood sash windows, while the recessed fourteenth bay bridges the original building to an addition; it features three, multi-light steel sash windows. The remaining rightmost bays present enframed anodized aluminum sash window-walls beneath an arched arcade shaded by an oversized, hipped rooflet with a boxed cornice and terra cotta tiles. All second floor bays feature paired, 6-light steel sash casement windows with concrete lug sills. The building appears in good condition.

100_6186.JPG, 11/23/07, view to N

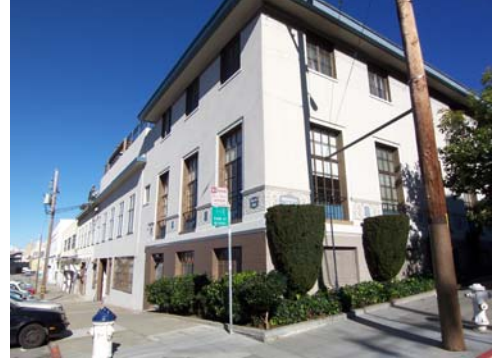
100_6192.JPG, 11/23/07, view to NE

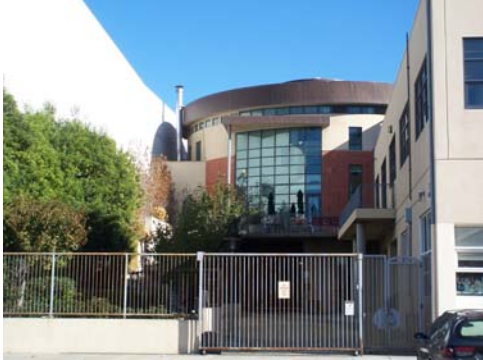
The cylindrical building, at the center of the lot slightly closer to Florida Street, is three stories, made of concrete and masonry block and capped with a flat roof. The primary entrance is located at the west facade and is obscured by landscaping. The building is characterized by a wall of multi-pane glass windows at the second story and the band of small fixed windows that runs below the roofline. The building terminates with a simple block cornice and appears to be in good condition.

100_6197.JPG, 11/23/07, view to E, round building

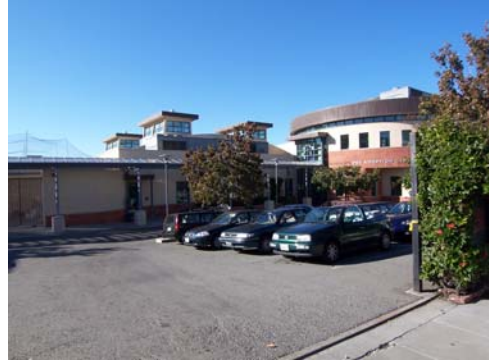
100_6235.JPG, 11/23/07, view to W, one story portion

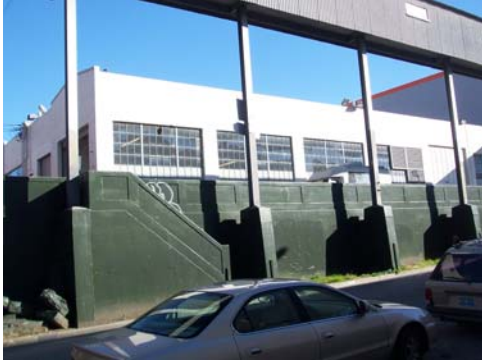
100_6237.JPG, 11/23/2007, view E from Florida St.

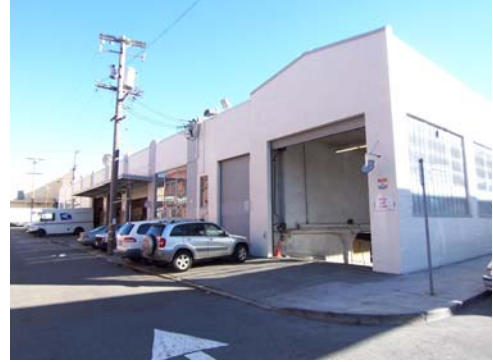
100_6239.JPG, 11/23/2007, view SE

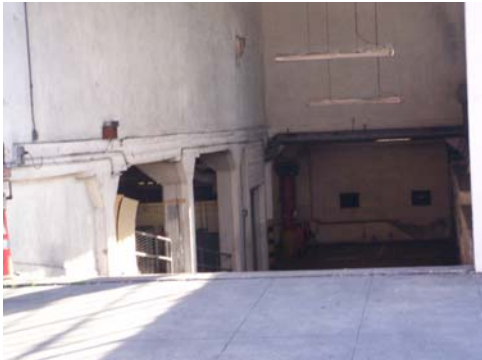
100_6240.JPG, 11/23/2007, detail, 15th St. vehicular entrance

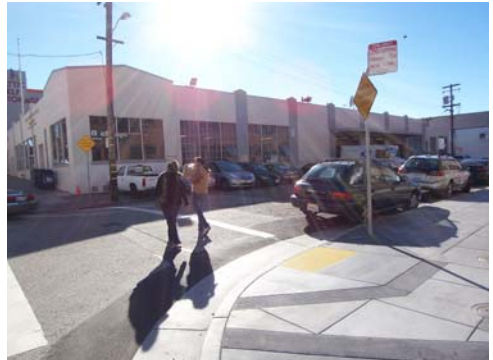
100_6242.JPG, 11/23/2007, 15th St. elevation

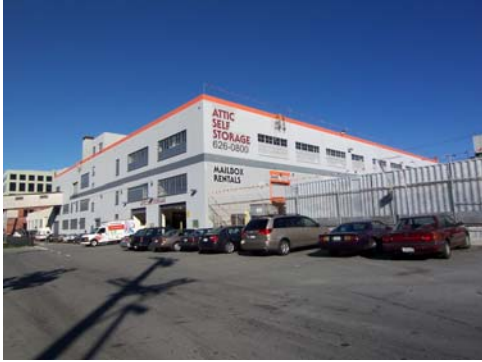
100_6234, 11/23/2007, view to NE

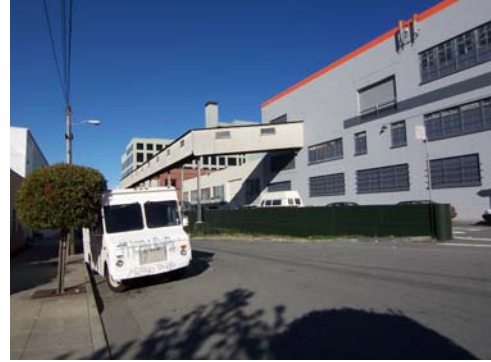
100_6236.JPG, 11/23/2007, view to NE,
enclosed bridge on Florida St.

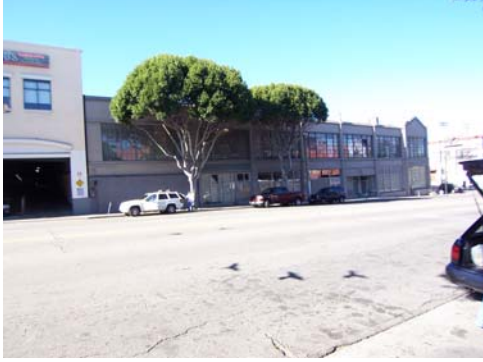
100_6169.JPG, 11/23/07, view to NW

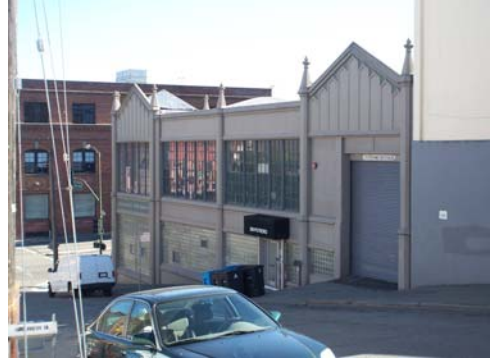
100_6163.JPG, 11/23/07, view to SE

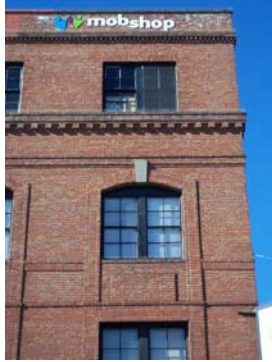
100_6047.JPG, 11/23/07, detail NE corner

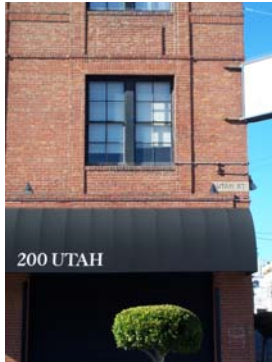
100_6048.JPG, 11/23/07, detail NE corner

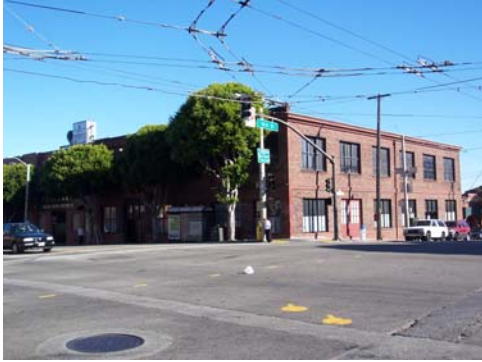
100_6026.JPG, 11/23/07, view to NE

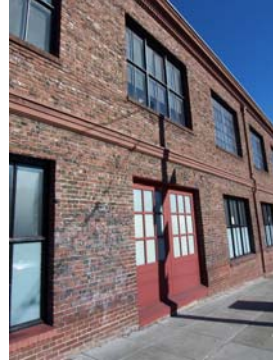
100_6030.JPG, 11/23/07, detail south elevation

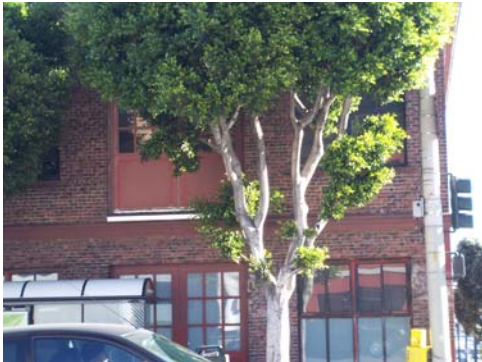
100_6029.JPG, 11/23/07, detail west elevation

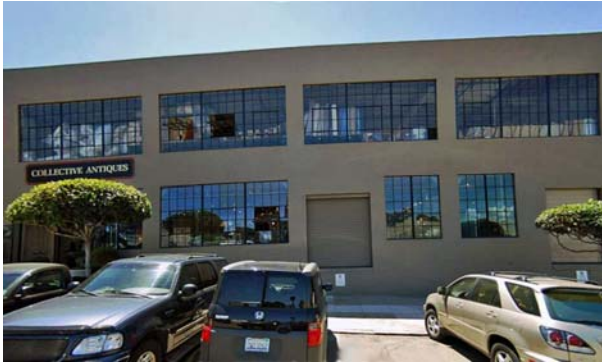
100_6051A.JPG, Utah St. elevation, 11/23/2007

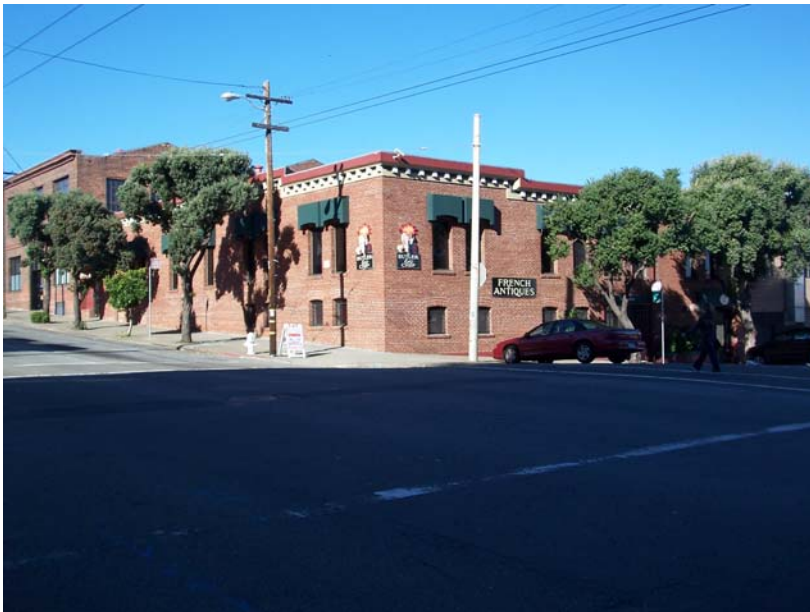
290 Utah Street occupies a 75 x 100 square-foot corner lot on the west side of Utah Street between 15th and 16th streets. Built in 1907, it is a 2-story, brick industrial building capped by a flat roof. The American Commercial-style building, made of brick laid in American Bond, sits atop a concrete foundation. The primary facade, which is 6 bays wide, faces east; the secondary facade, which is 5 bays wide, faces south. The leftmost, or first, bay of the primary facade's first floor feature two, segmental arched, fixed windows behind iron grilles. They are distinguished by lug sills and flat, radiating, queen closer brick arches. This fenestration is also found at the third bay. The second and fifth bays present blank wall faces, while the fourth and sixth bays present recessed, anodized aluminum storefronts; a boxed awning distinguishes the sixth bay. Except for the second bay, which presents a blank wall face, second-floor bays are characterized by two, segmental arched, one-over-one anodized aluminum sash windows with lug sills and boxed awnings. The leftmost, or first, bay of the secondary facade features a recessed, anodized aluminum storefront beneath a boxed awning; otherwise, the facade features the building's dominant fenestration. The primary and secondary facades terminate with oversized dentils and a boxed cornice. The minimally altered building appears to be in good condition.

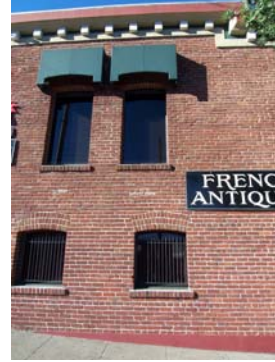
100_6018.JPG, 11/23/07, detail east elevation

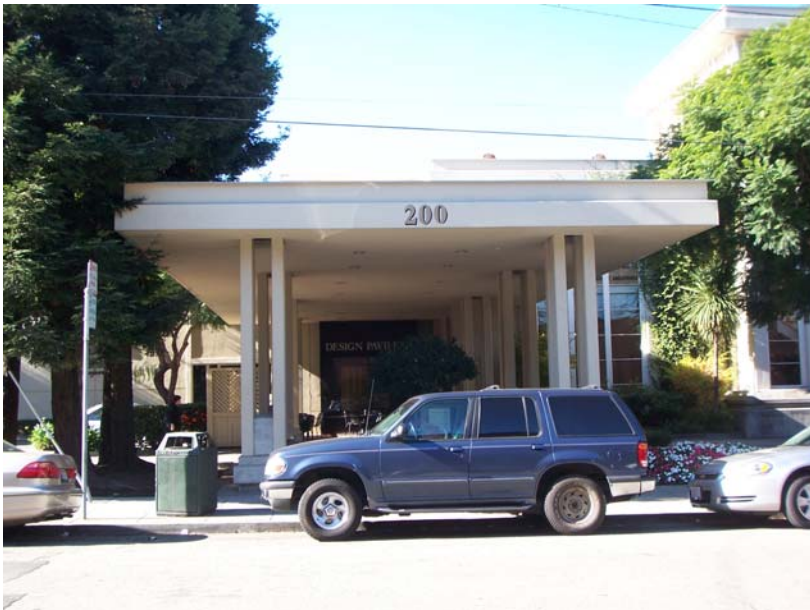
200 Kansas Street occupies a portion of a 67,602 square-foot lot bounded on three sides by Kansas, 15th, and Vermont streets. The lot is occupied by a two-story concrete commercial building designed in a utilitarian mode. The building appears to be in good condition.

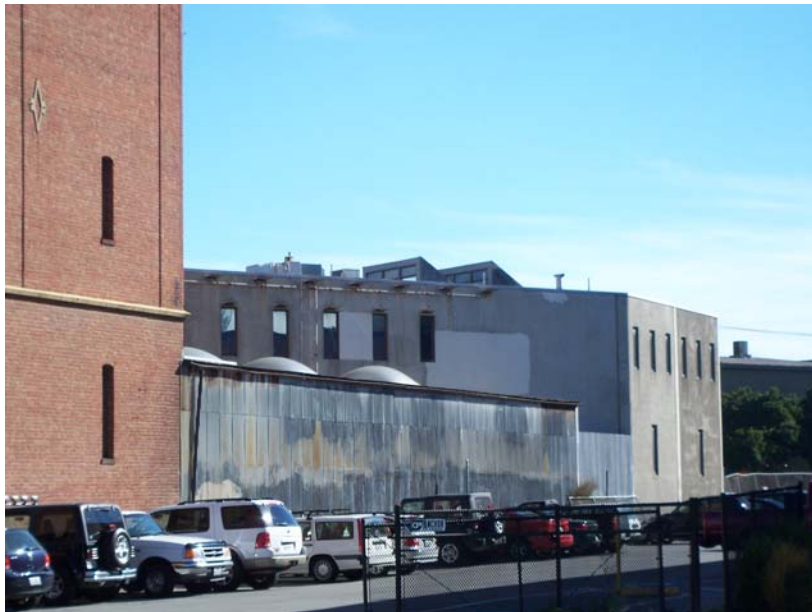
200 Rhode Island Street is located on a triangular 29,093 sq ft lot on the southwest corner of Rhode Island and 15th Streets and contains four structures, each recorded separately. This record is for the corrugated metal shed at the west edge of the parcel. It is a flat roofed utilitarian structure with no visible openings, triangular in plan to fit between two more substantial buildings. The building appears in fair condition.
