Historic Preservation Commission Executive Summary Historic Resource Survey Findings INFORMATIONAL PRESENTATION: JUNE 1, 2011 ADOPTION HEARING: JUNE 15, 2011

Date: May 25, 2011
Case No.: **2011.0401U**
Project: Showplace Square / Northeast Mission Historic Resource Survey
Staff Contact: Moses Corrette – (415) 558-6295
moses.corrette@sfgov.org
Reviewed By Tim Frye – (415) 575-6822
tim.frye@sfgov.org
Recommendation: **Adoption of survey findings**

**SHOWPLACE SQUARE SURVEY
SAN FRANCISCO, CALIFORNIA
FINAL**

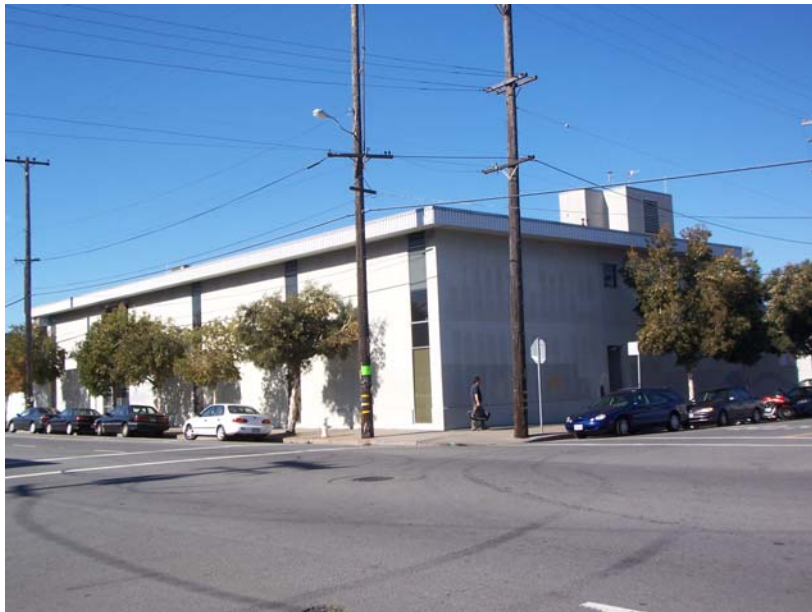
*P5b. Photo (view, date, accession #
100_2273.JPG

1330 16th Street is a two-story, steel-frame building clad in concrete and asbestos panels. The utilitarian building is located on the north side of 16th Street between Carolina and 8th streets. The exterior facades feature vertical bands of fenestration at regular intervals. The building is capped by a flat roof with a narrow overhanging soffit. The rest of the parcel consists of a paved parking lot surrounded by a corrugated steel wall. The building appears in good condition.

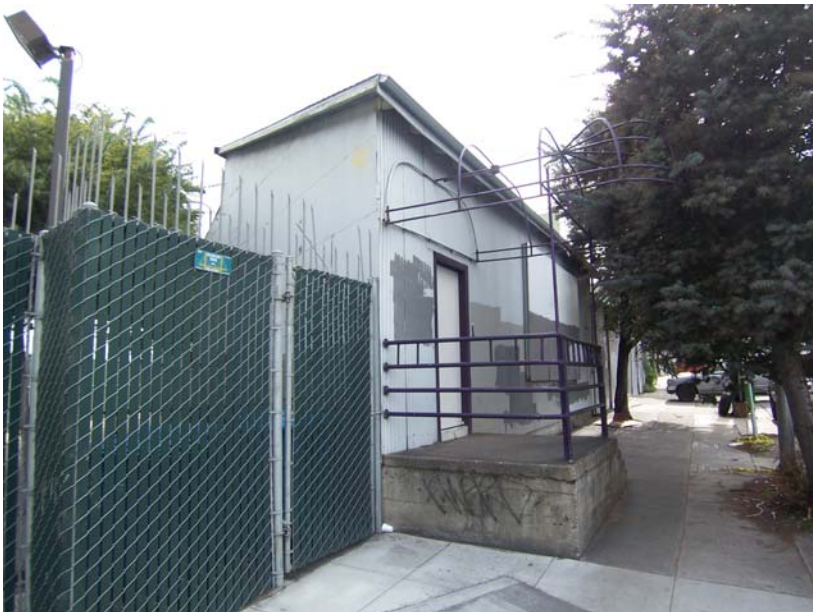
1500 7th Street occupies a portion of a small 3,540 square-foot lot partially bounded by 7th and Mississippi streets and Pennsylvania Avenue. The property contains a a one-story, wood-frame warehouse designed in a utilitarian mode. the exterior is clad in corrugated steel and windowless. The heavily altered building appears to be in fair condition.

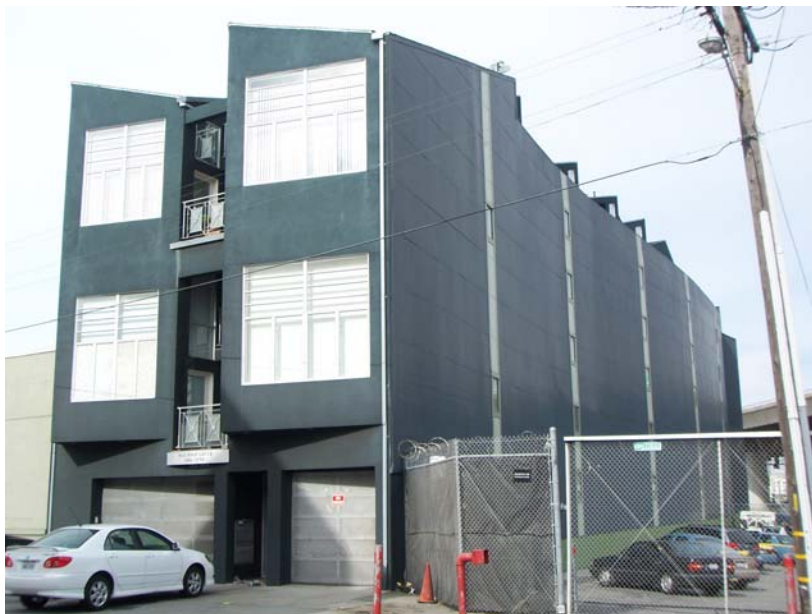
1050 17th Street occupies an abandoned railroad right-of-way through the center of its block with frontage on both 17th and 16th streets. Extending the length of the block and curving to fit its irregular lot, the parcel is occupied by a 1999-built contemporary "live-work" loft built of concrete and wood-framing. The building appears to be in good condition.

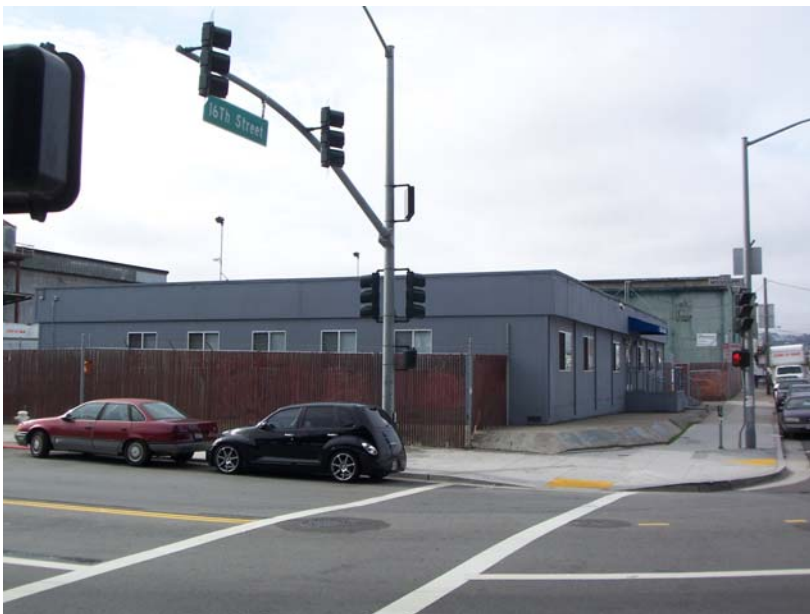
941 16th Street is located on a large 200' x 192' lot on the southwest corner of 16th and Mississippi streets. It is a paved parking lot/marshaling yard containing a temporary modular office building. The building appears in good condition.

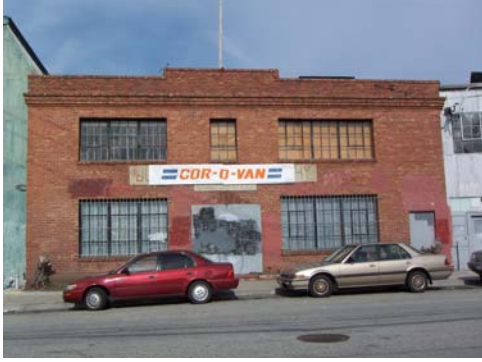
View toward north, 11.16.07, 100_1866.JPG

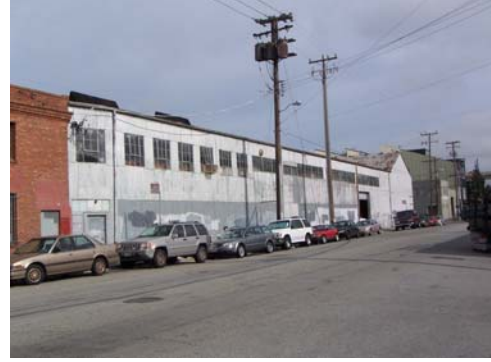
View toward northeast, 11.16.07, 100_1865.JPG

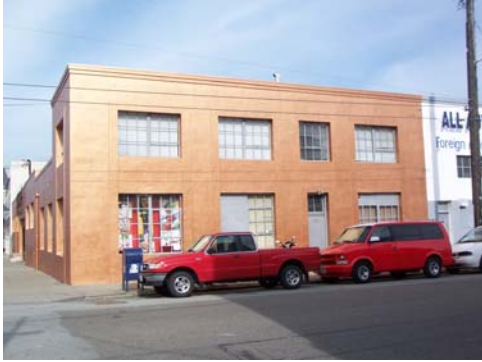
South elevation, 11/16/07, 100_1875.JPG

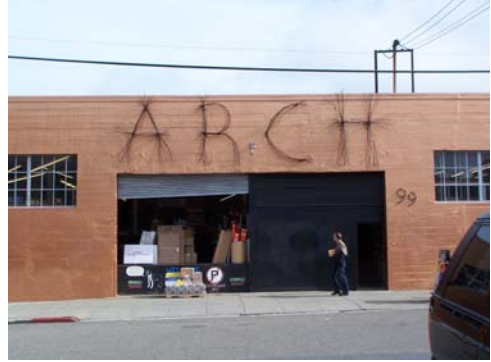
Vehicular entrance, 11/16/07, 100_1873.JPG

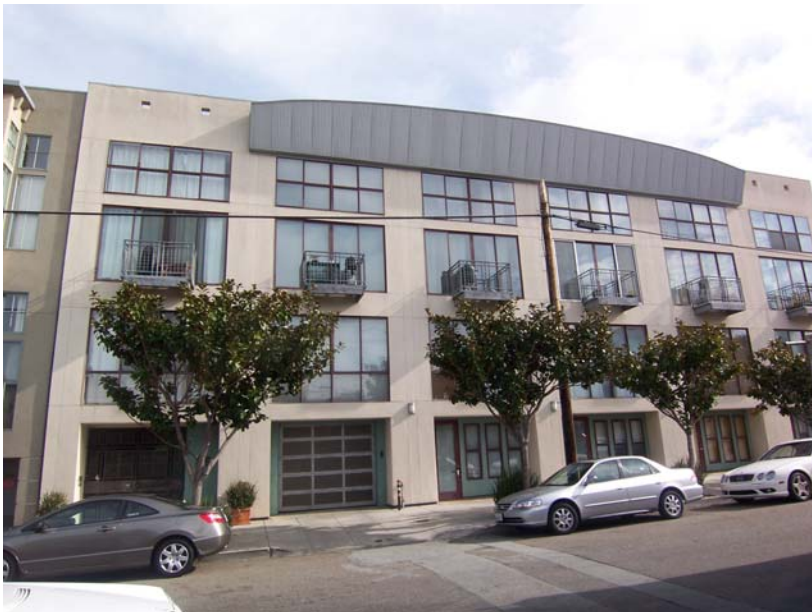
49 Missouri occupies a large rectangular lot on the northeast corner of 17th and Missouri streets. The property contains a four-story, wood-frame "live-work" building. The building appears to be in good condition.

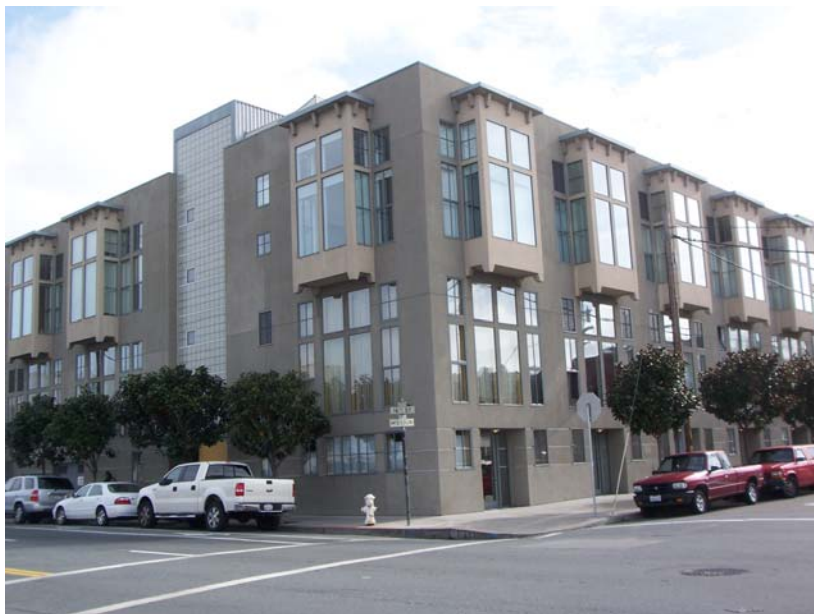
999 15th Street is located on the southeast corner of 16th and Missouri streets. Formerly used for industrial purposes, the property now contains a three-story "live-work" loft built in 1998. The building appears to be in good condition.

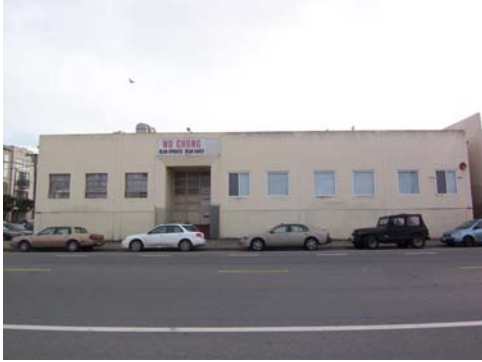
16th Street elevation, 11/16/07, 100_1928.JPG

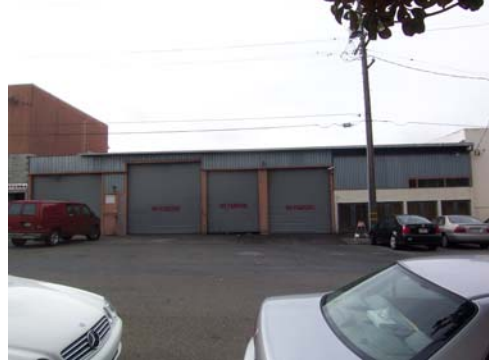
Loading Dock, 11/16/07, 100_1926.JPG

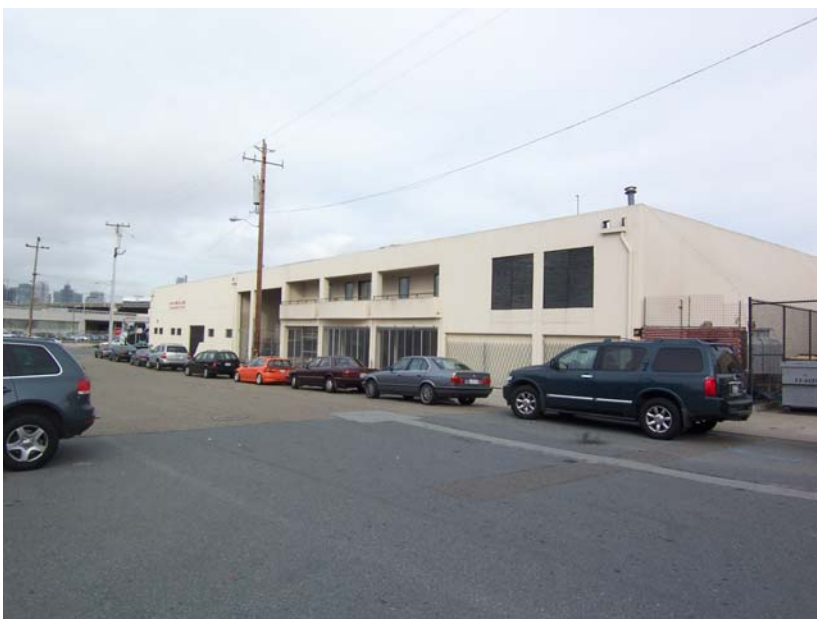
This parcel contains part of a building located on the adjacent parcel 3951004. The building is located on two lots (3951003 & 3951004) on the southeast corner of 16th and Connecticut streets that together measure 100' x 200'. The property contains a one-story, utilitarian concrete warehouse built in 1990. The building appears in good condition.

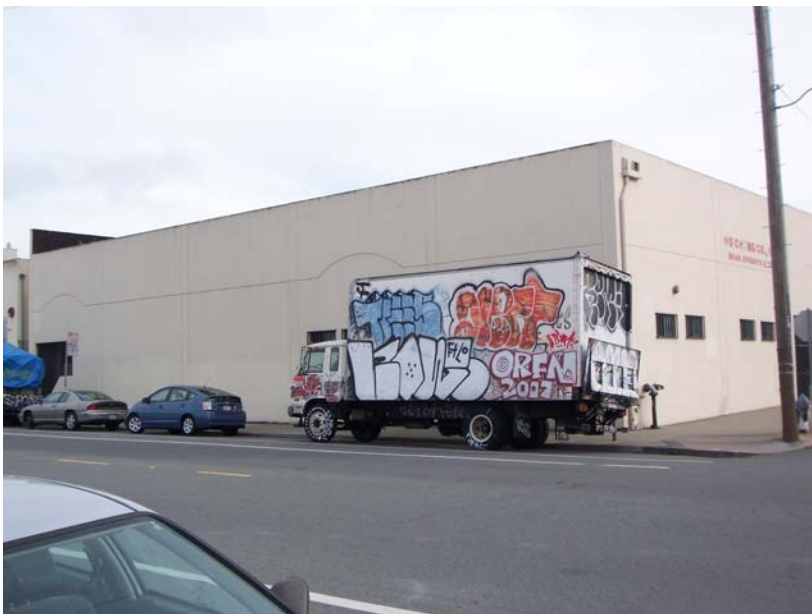
1079 16th Street is located on two lots (3951003 & 3951004) on the southeast corner of 16th and Connecticut streets that together measure 100' x 200'. The property contains a one-story, utilitarian concrete warehouse built in 1990. The building appears in good condition.

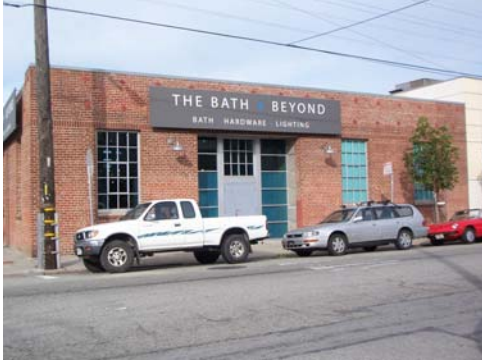
100_1919.JPG, 11/16/07, view to N, western building

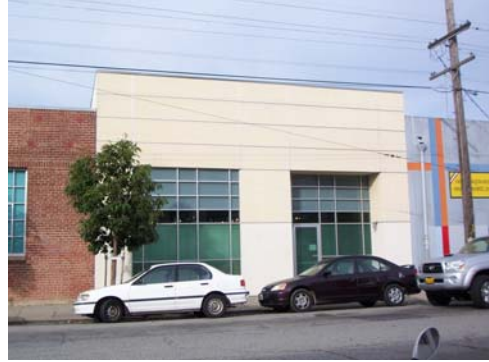
100_1920.JPG, 11/16/07, view to N, eastern building

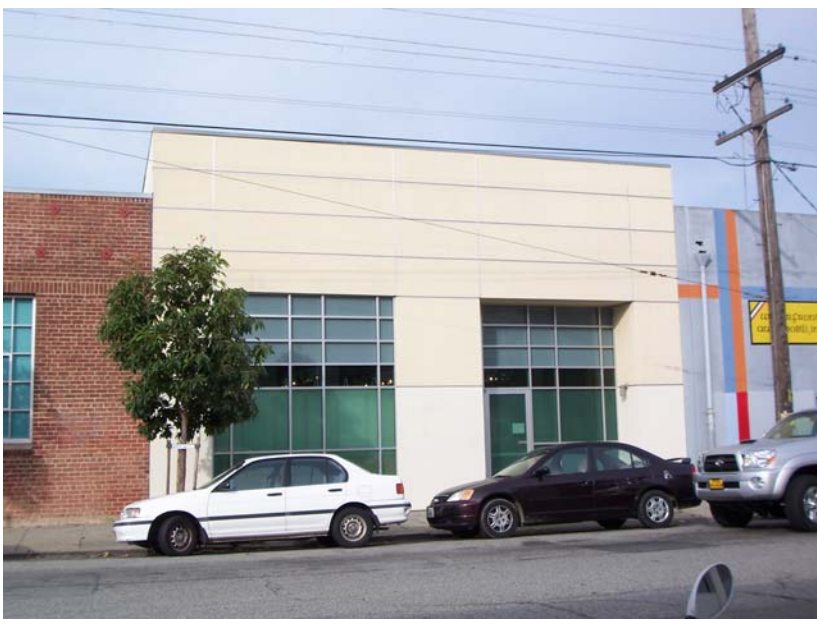
This parcel has two buildings, each recorded separately. This record is for the one-story concrete commercial building capped with flat roof that occupies the eastern part of a 20,000 sq ft lot on the northeast corner of 17th and Connecticut Streets. The building faces south and features two windows containing green and gray glass divided by aluminum mullions. The right bay includes a single door. The building terminates with a scored concrete frieze and metal coping. It appears to be in good condition.

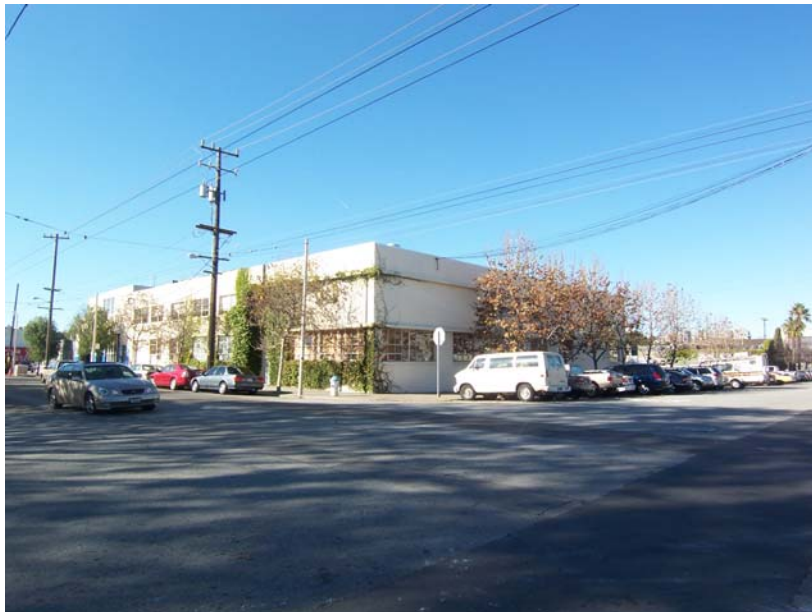
1500 17th Street is a two-story, concrete block industrial building finished in stucco and capped with a flat roof. The Late Moderne-style building occupies a 19,998-foot lot at the northwest corner of 17th & Arkansas streets. The facades are articulated by bands of 16-lite steel industrial ribbon windows with operable hopper sash. A loading dock is located at the southwest corner of the building. The minimally altered building appears to be in good condition.

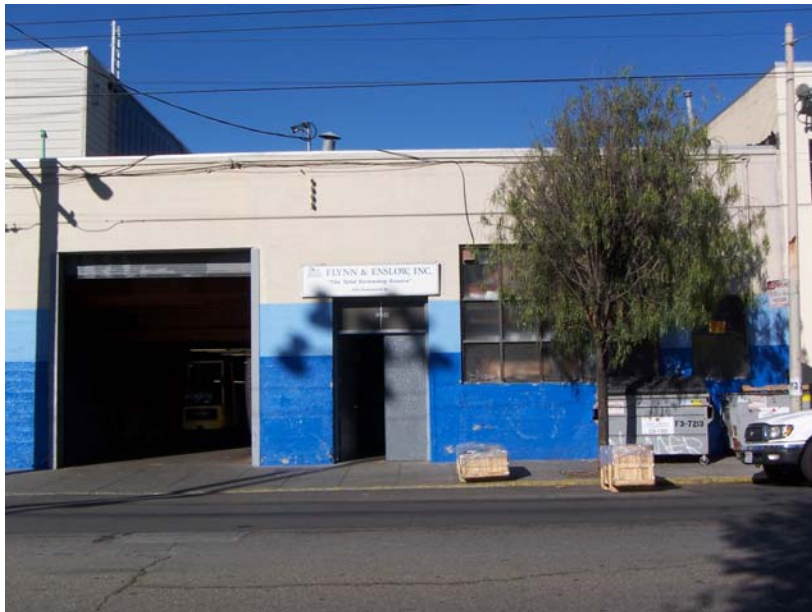
1530 17th Street is a one-story, reinforced-concrete industrial building with a flat roof. The utilitarian building occupies a 10,000-foot lot on the north side of 17th Street, between Arkansas and Wisconsin streets. It is rectangular in plan and built to the lot lines. The facade consists of a vehicular opening on the left, a pedestrian entry in the center, and a multi-light steel industrial window and a second pedestrian entrance on the right. The facade terminates in a simple parapet molding. The minimally altered building appears in good condition.

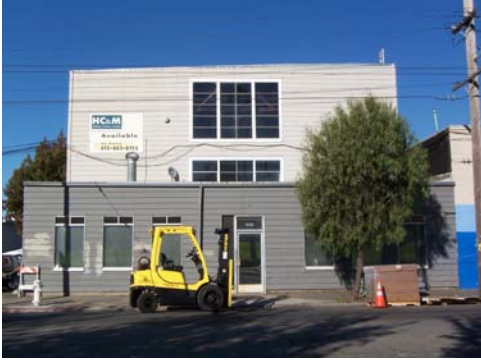
South elevation, entrance, 11/20/07,
100_2084.JPG

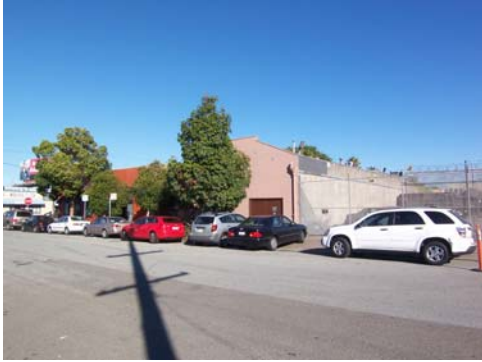
West elevation, 11/21/07, 100_2090.JPG

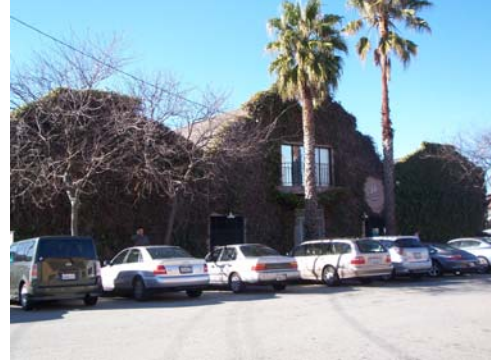
East elevation, 11/21/07, 100_2095.JPG

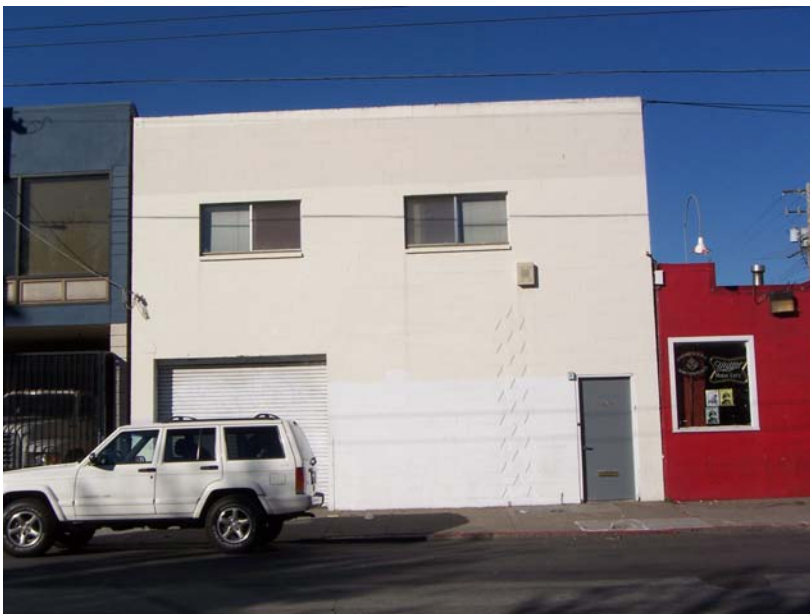
1604 17th Street is a two-story concrete block building capped with a flat roof. The utilitarian building occupies a 3,000 square-foot lot on the north side of 17th Street between Wisconsin and Carolina streets. The building is composed of two sections: a two-story office wing facing the street and a one-story industrial space toward the rear of the lot. The facade features an overhead rolling door and a steel man door at the first floor level and a pair of aluminum sliders at the second floor. The heavily altered building appears to be in good condition.

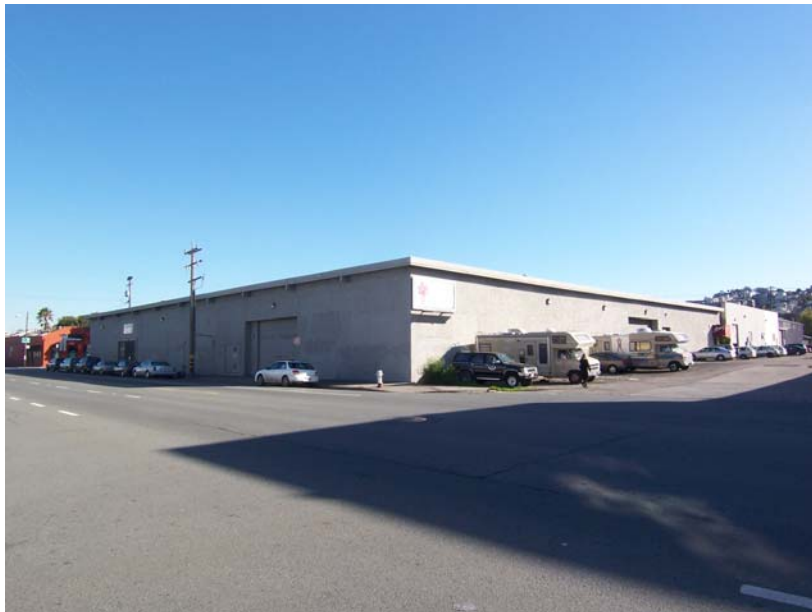
130 Wisconsin is a massive one-story concrete warehouse capped by a flat roof. It occupies a large square property partially bounded by Wisconsin, 16th, and Carolina streets. The building is utilitarian and contains few openings aside from several large loading docks on each elevation. The building appears in good condition.

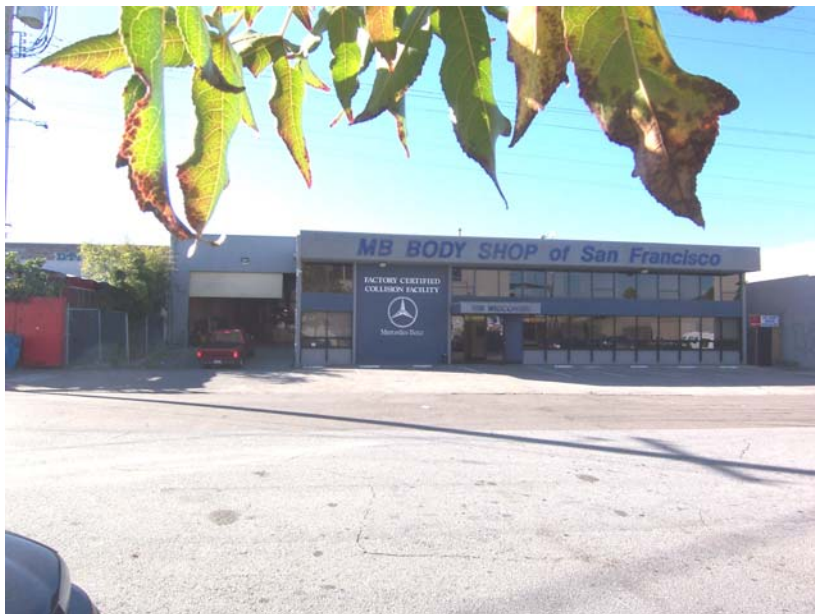
166 Wisconsin is a two-story steel-frame industrial building clad in glass and aluminum panels. The utilitarian building occupies a large 21,400 square-foot lot on the west side of Wisconsin Street between 16th and 17th streets. The facade, which faces Wisconsin Street, is a glazed window wall divided into a grid by narrow anodized aluminum mullions. The vehicular entrance is located at the south end of the primary facade. The building appears to be in good condition.

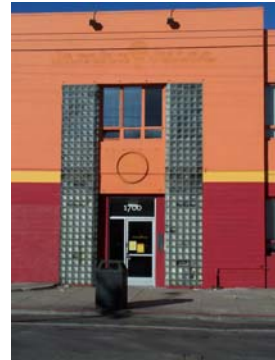
100_2114.JPG, 11/20/07, view to N, entrance pavillion

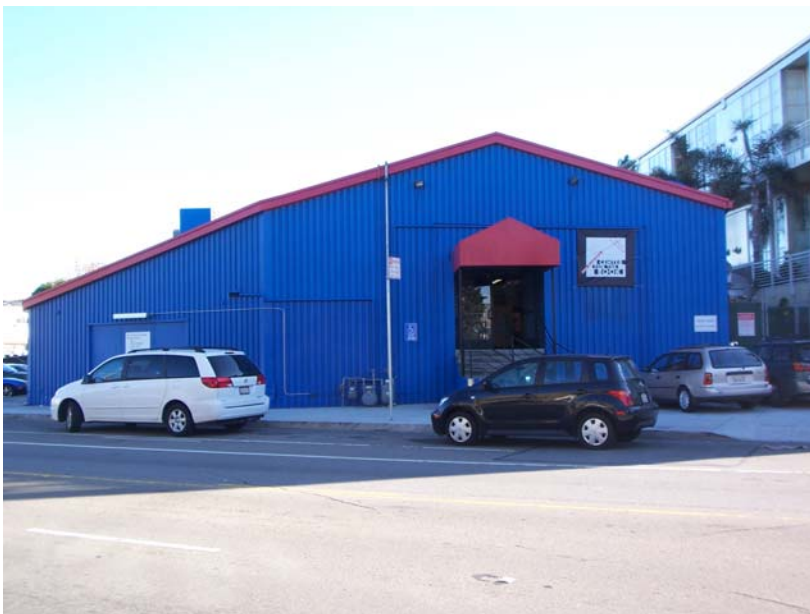
300 De Haro is a one-story, steel-frame, corrugated steel-clad commercial building capped by a gable roof. The utilitarian building occupies a triangular, 26,907 square-foot lot on the southwest corner of 16th and De Haro streets. The facades are characterized by randomly placed anodized aluminum windows and storefronts. The building appears to be in good condition.

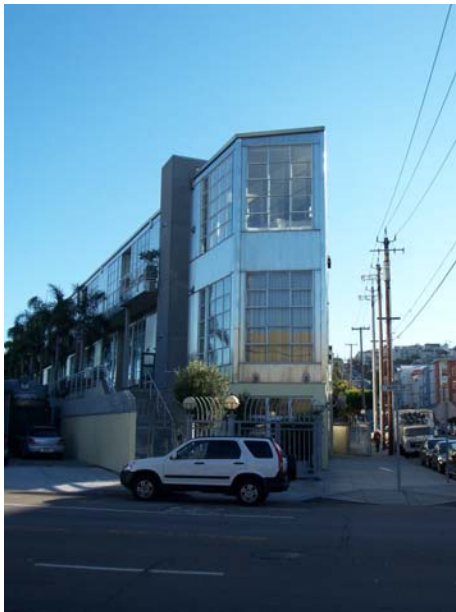
370 De Haro Street is located on an abandoned Southern Pacific right-of-way at the center of a block bounded by 16th, De Haro, 17th, and Rhode Island streets. Built in 2001, the building is a residential "live-work" loft. The three-story building is clad in corrugated steel and features multi-lite aluminum windows and storefronts. The building appears to be in good condition.

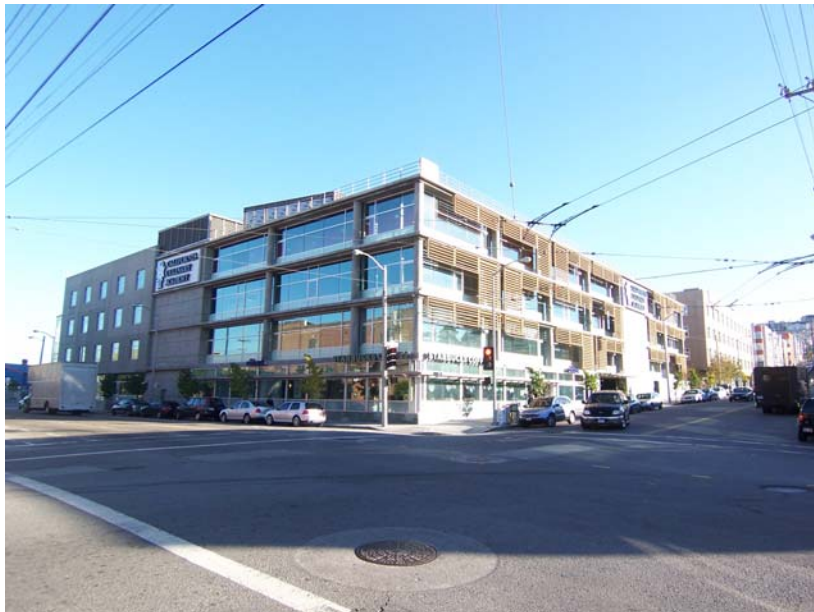
1950 17th Street occupies an entire city block bounded by 17th, Rhode Island, 16th, and Kansas streets. Formerly occupied by a 1941 concrete warehouse, the facility was demolished and replaced by the existing mixed-use commercial structure in 2002. The building appears to be in good condition.

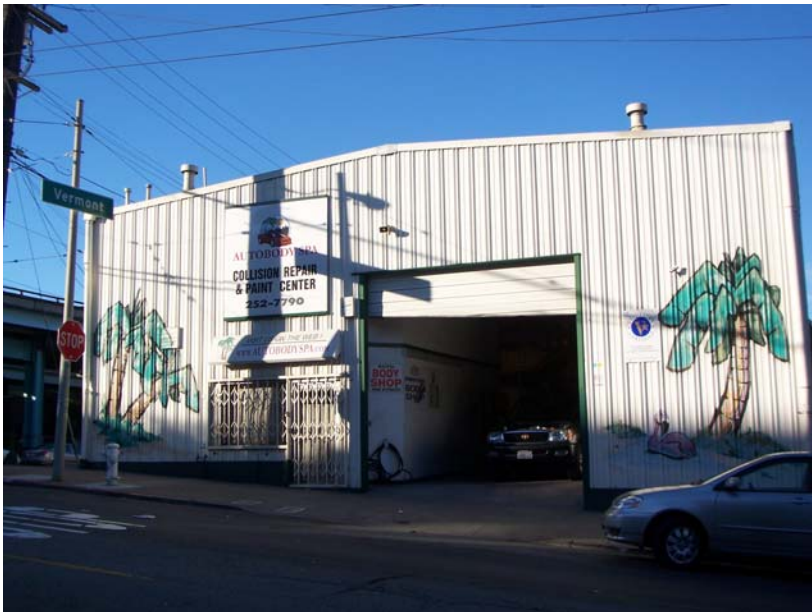
375 Vermont Street is a one-story, wood-frame industrial building clad in corrugated steel siding and capped by a shallow gable roof. The utilitarian building occupies a 3,996 square-foot parcel on the northeast corner of 17th and Vermont streets. The building appears in good condition.

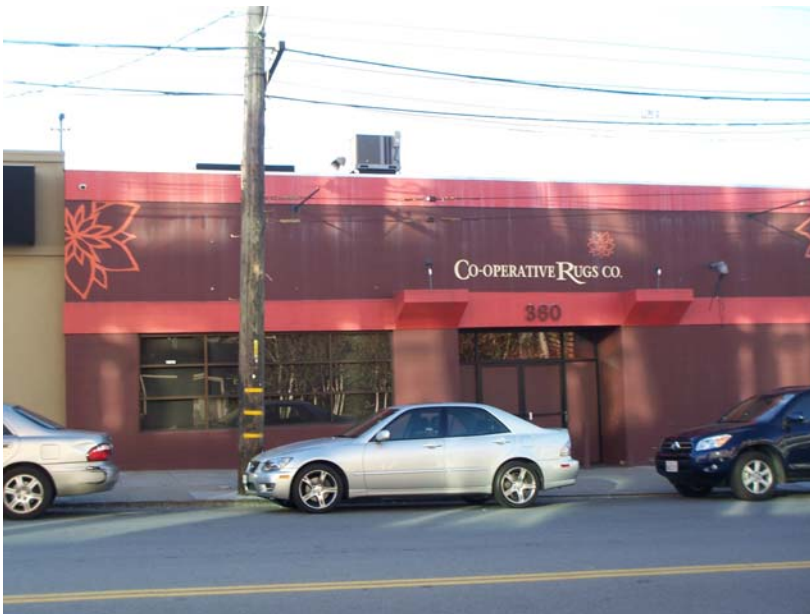
350 Kansas Street is a one-story, reinforced-concrete industrial building capped with a bow truss roof. The utilitarian building occupies a 5000 sq.ft. lot on the west side of Kansas Street between 16th and 17th streets. Its facade is unified with 350 Kansas Street to its north. Both facades are largely windowless and feature multi-lite aluminum sash display windows and glass and aluminum framed double doors with sidelights and transoms. The glass doors and sidelights are currently painted over. The facade terminates in a flush parapet. The building appears to be in good condition.

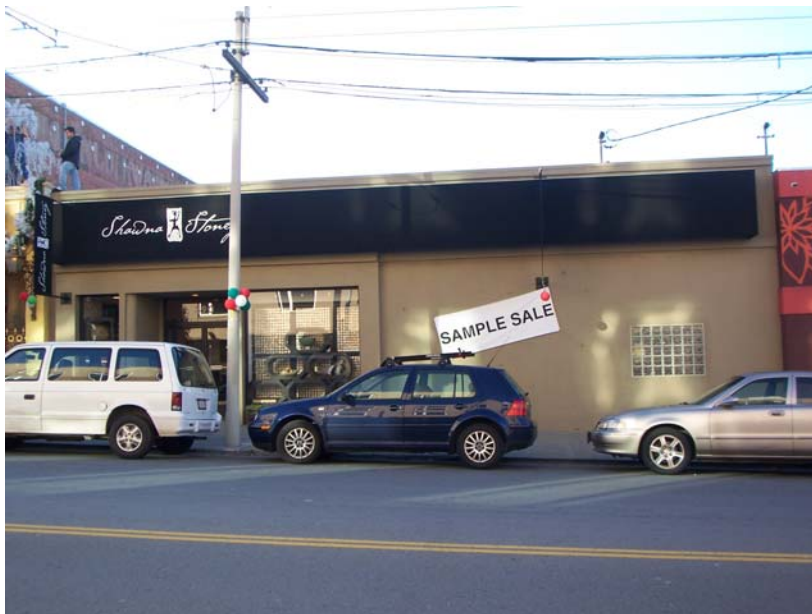
390 Kansas Street is a one-story, reinforced-concrete industrial building finished in stucco and capped with a flat roof. The building faces east on Kansas Street and fills the 5,000 sq ft lot. The left side features a glass and aluminum double door with transom flanked by two display windows. The window on the left is smaller than the window on the right. The right side of the building features window openings filled with glass block. The facade terminates in a canvas awning and a plain cornice. The moderately altered building appears to be in good condition.

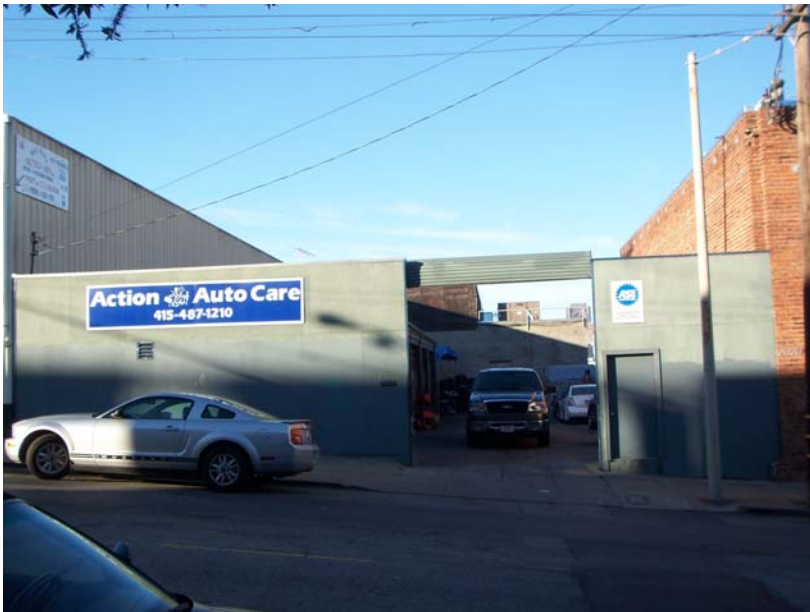
2040 17th Street is a one-story, wood-frame, partially enclosed auto repair facility. The utilitarian structure is located on the north side of 17th Street between Vermont and Kansas streets. The complex consists of what appears to be a wood-frame wall enclosing three garage bays and an open-air lot.

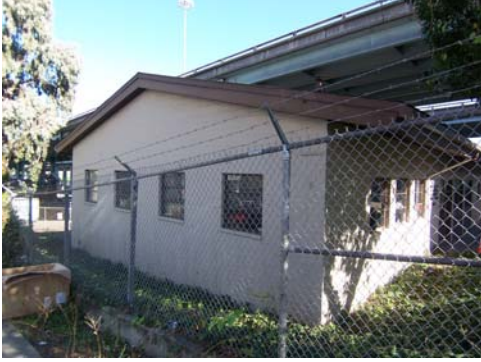
100_2200.JPG, 11/21/07, concrete block utility building

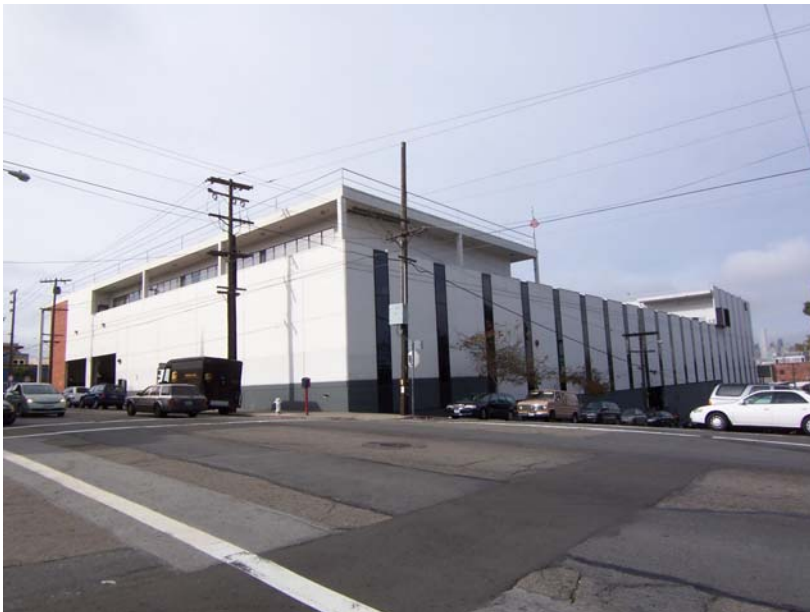
2222 17th Street occupies a 200 x 400 square-foot, full-block lot bordered to the north by 16th Street, to the east by San Bruno Avenue, to the south by 17th Street, and to the west by Utah Avenue. Built in 1961, it is a four-story, reinforced concrete, rectangular-plan, commercial building of varying volumes currently used as a post office. Finished in stucco, it rests on a concrete foundation, with its primary and secondary volumes respectively anchoring the southern and northern portions of the lot. The primary facade, which is 12 bays wide, faces west and encompasses two building volumes. The first volume is set back from the western lot line, which is demarcated for the first several rightmost bays by a fenced ramp leading to the rooftop parking lot. It offers the site's signature architectural element: the building's southwest corner where International-style details are found, such as an aluminum-sash window wall. It is also distinguished by variegated, stretcher bond brick cladding that wraps around the leftmost bay of the secondary facade, which faces south. The building is further distinguished by double-height vehicular openings that punctuate the first-floor levels of each facade. The building appears to be in good condition.

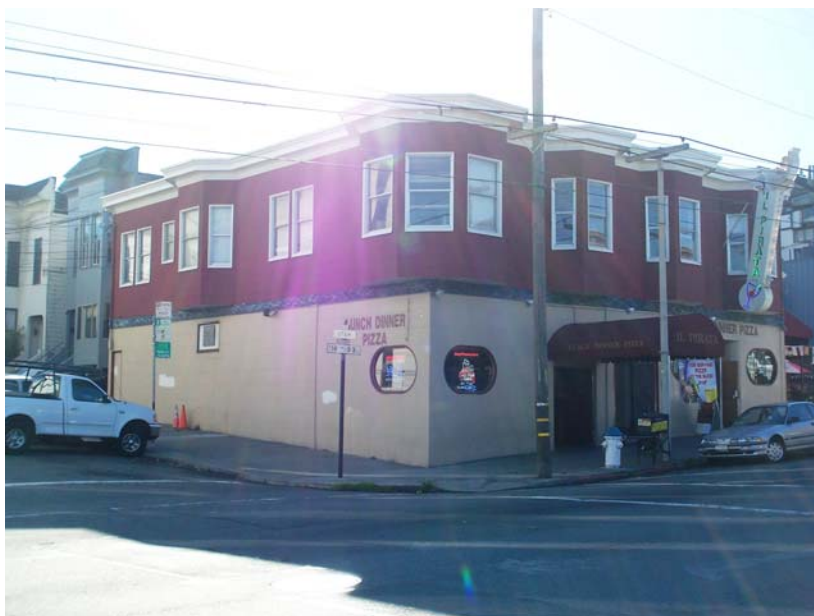
2001-2009 16th Street occupies a 55 x 100 foot corner lot on the south side of 16th Street between Utah and Potrero streets. Built in 1908, it is a 2-story, wood-frame, residential-over-commercial building. The rectangle-plan building, clad in stucco at the first floor and wood elsewhere, rests on a concrete foundation and is capped by a flat roof. The primary facade, which is 4 bays wide, faces north; the secondary facade, which is 4 bays wide, faces east; the tertiary facade faces west. The leftmost, or first, bay of the primary facade's first floor features a fixed, oval window, while the second bay features a recessed entryway with paired wooden doors beneath a barrel-vaulted canopy spanning the length of the sidewalk. The third bay features a segmental arched, recessed entryway with a 2-light transom, iron gate, and steps to a wooden door for the residential units above. The fourth bay features a recessed entryway with a wooden door; fixed, oval windows flank the entryway. A slate belt course divides the first from the second floor, which is composed of chamfered bay windows with one-over-one, double-hung, wood-sash windows with wood surrounds and slip sills. A wall-mounted, lighted sign for the first-floor restaurant divides the third and fourth bays. The leftmost, or first, bay of the secondary facade's first floor features a wooden door, while the second presents a window opening that has been replaced with a HVAC unit. The third bay presents a blank wall face, while the fourth bay features a fixed, oval window. The first and third bays of the second floor present paired, one-over-one, double-hung, wood-sash windows with wood surrounds and slip sills, while the second and fourth bays present chamfered bay windows composed of the building's dominant fenestration. The tertiary facade presents a blank

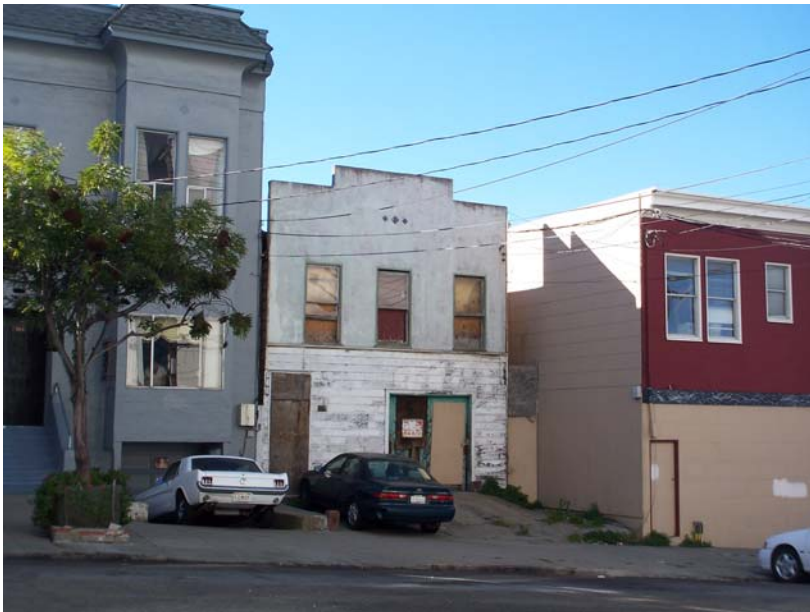
This is a two story frame multi family residence occupying a rectangular 2284 sq.ft. lot on the west side of Utah Street between 16th and 17th streets. It has a gabled roof concealed behind a stepped parapet. There are three double hung wooden sash windows on the second floor, and a garage entrance and pedestrian entrance on the ground floor. All openings are boarded over. The upper floor is clad in stucco, while the ground floor is horizontal rustic siding. The building appears in poor condition.

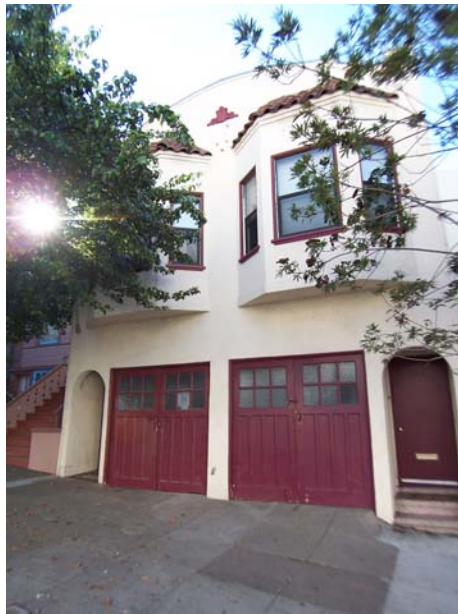
This is a hipped-gable roofed two story multi family residence occupying a rectangular 2466 sq.ft. lot on the west side of Utah Street between 16th and 17th streets. It is stucco clad with an arched parapet concealing the gable. The facade is composed in two bays, with glazed double garage doors and an arched pedestrian entrance on each side, and two canted bay windows on the upper level with double hung wooden sash and red clay tile roofs. The stucco cladding, garage, and red roof tiles appear to be not original. The building appears in good condition.

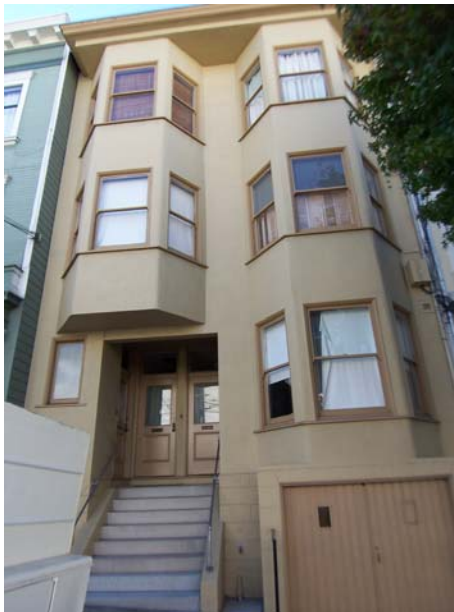
This is a flat roofed stucco clad frame multi-family residential building, four stories, occupying a rectangular 2456 sq.ft. lot on the west side of Utah Street between 16th and 17th streets. It has a recessed entrance up a short flight of steps at the left of the primary elevation, with three wood and glass doors. Above the entrance are stacked canted bays with a double hung wooden sash in each face, with another stack on the right above the garage entrance. The building is crowned by a projecting cornice, and appears in good condition, altered by the stucco cladding.

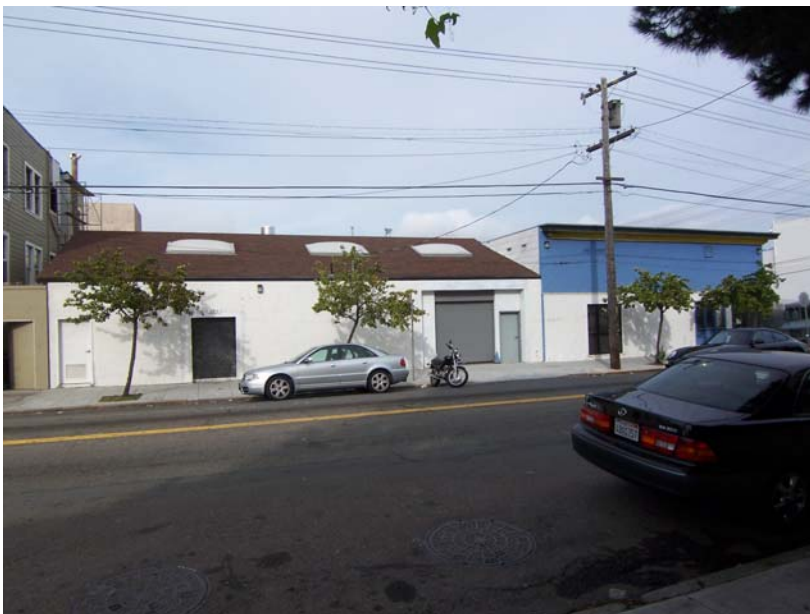
This is a one story concrete light industrial building occupying a rectangular 3909 sq.ft. lot on the northwest corner of Utah and 17th streets. The building has two sections, a gable roofed one story section on 17th Street and a double height one story flat roofed section at the corner, with the upper portion of frame construction and displaying a projecting cornice. There is an angled pedestrian entrance at the corner, and a vehicular door and pedestrian entrances in the gabled portion on 17th Street. The gabled roof has large skylights. Large fixed windows are found at ground level in the corner portion. The flat roofed section appears to be an alteration. Overall, the building appears in good condition.

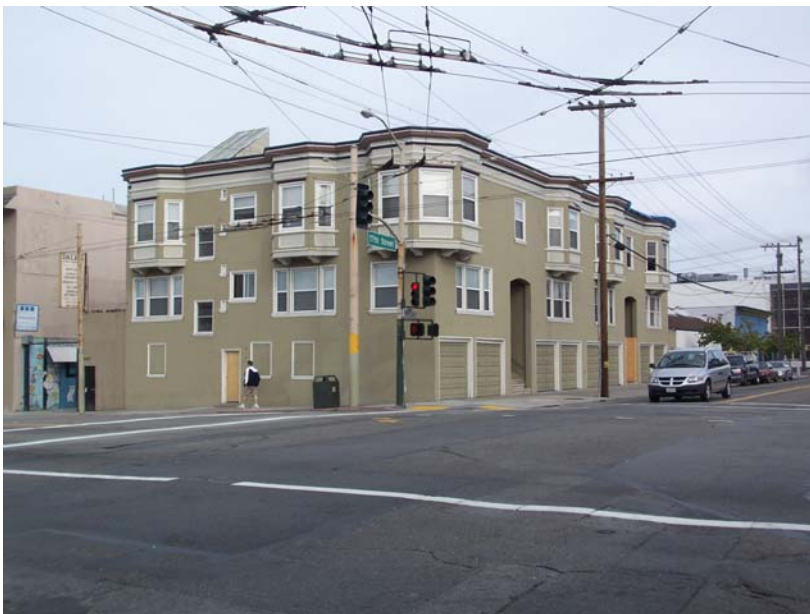
2330-2346 17th Street occupies a 50 x 100 square-foot lot at the southwest corner of Potrero Avenue and 17th Street. Built in 1922, it is a three-story, wood-frame, apartment building. The rectangle-plan building, clad in stucco at its southern and western elevations and shiplap elsewhere, rests on a concrete foundation and is capped by a flat roof. The primary facade, which is 10 bays wide, faces south; the secondary facade, which is 4 bays wide, faces west. Garages with wood surrounds occupy all bays of the primary facade's first floor, except for the third and eighth bays, which feature double-height, recessed, segmental arched entryways with steps. Except for the third and eighth bays, all bays of the primary facade's second floor feature tripartite fenestration composed of one-over-one, double-hung vinyl replacement windows with wood surrounds and lug sills. Except for the third and eighth bays, which feature one-over-one, double-hung windows with lug sills, all bays of the primary facade's third floor feature bowed bay windows supported by oversized scrolled brackets. Spandrel panels and hood molding above the center windows further distinguish the bays. The secondary facade offers the same fenestration, though the first-floor windows have been filled in. Both facades terminate in a frieze with egg-and-dart molding and an overhanging boxed cornice. The building appears to be in good condition.

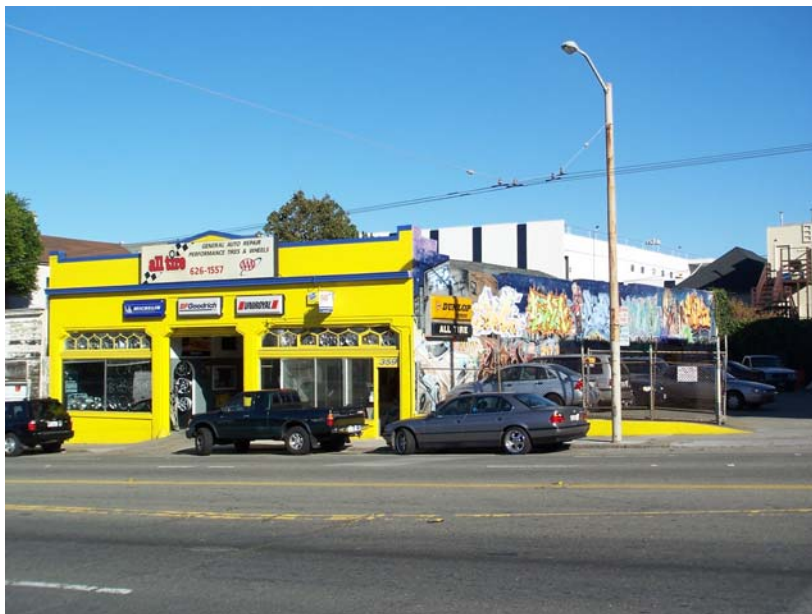
This is a one story concrete industrial building, flat roofed with a large gabled monitor. It is rectangular in plan, built to the lot lines of a 5,000 sq.ft. lot on the east side of Potrero Avenue between 16th and 17th streets. The facade is composed in three bays, a central vehicular entrance with rollup metal door flanked by retail display windows. The bays are defined by concrete piers with molded corners, and the display windows have multi-lite transoms in fish scale shapes. A roofline cornice and stepped and gabled parapet terminate the facade. The building appears in good condition.

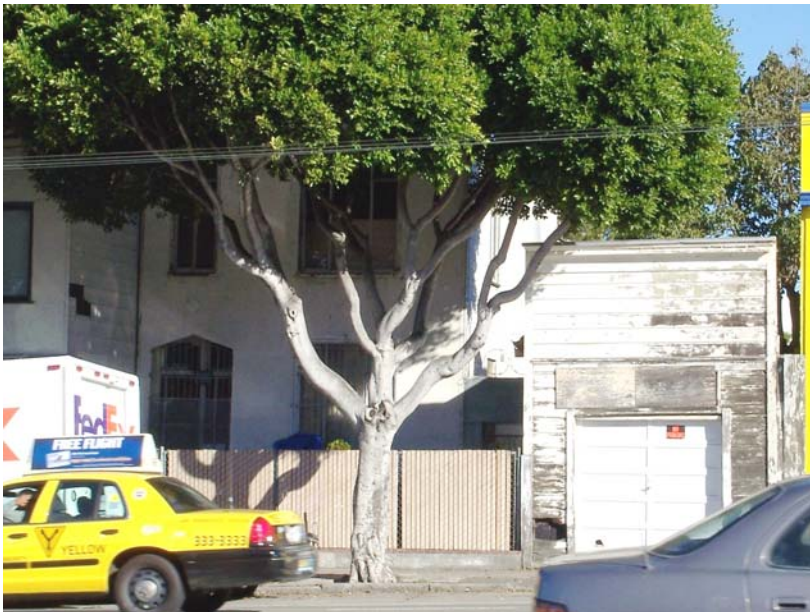
This is a two story frame multi family residence with a front gabled roof concealed behind a tall parapet. The primary west elevation is clad in stucco, with rustic redwood siding on the remainder. A recessed ground floor entrance is at the left, with a tall window to its right. On the second floor are two windows. All windows are sliding aluminum sash. There is also a frame single car garage at the right front of the property, with a segmental rollup wooden door. The garage also has a front gabled roof behind a tall parapet. The main building is set back from the sidewalk, with a wooden fence at the sidewalk line. The building appears in fair condition.

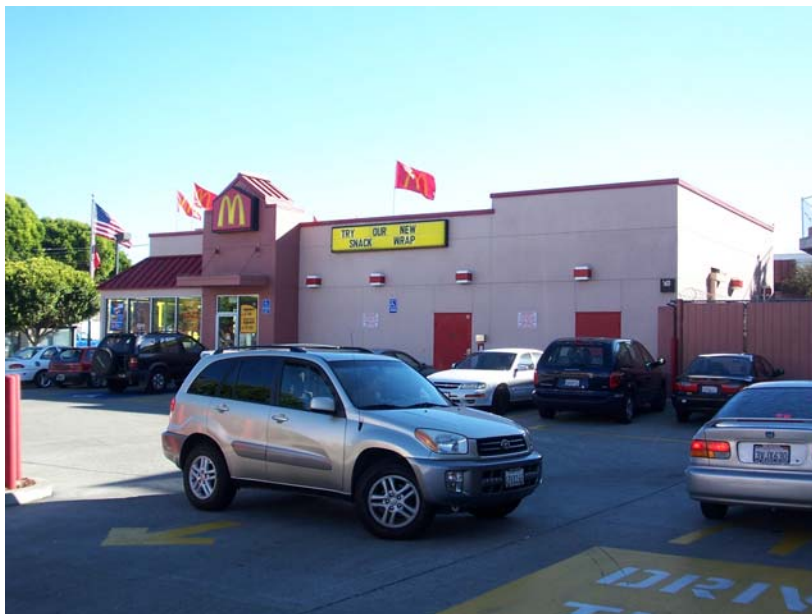
2101 16th Street occupies a 125 x 125 square-foot corner lot southwest corner of 16th and Potrero streets. The site showcases McDonald's, a fast food, drive-through restaurant. Built in 1996, it is a 1-story, wood-frame commercial building. The ell-plan building rests on a concrete foundation and is capped by a flat roof. The primary facade, which is 2 bays wide, faces east; the secondary facade, or interior of the ell, faces north and east. The building appears to be in good condition.

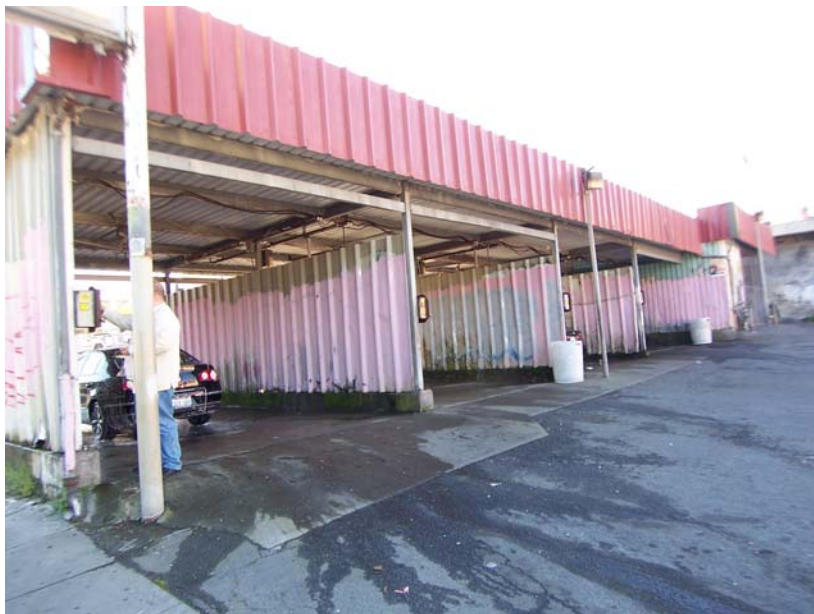
This is a self service car wash occupying an 11,250 sq.ft. lot on the west side of Potrero Avenue between 16th and 17th streets. It is a frame structure clad in sheet metal with a flat roof and five open bays. There is a small metal clad shack at the rear of the lot housing machinery. The remainder of the lot is paved. The structure appears in fair condition.
