Historic Preservation Commission Executive Summary Historic Resource Survey Findings INFORMATIONAL PRESENTATION: JUNE 1, 2011 ADOPTION HEARING: JUNE 15, 2011

Date: May 25, 2011
Case No.: **2011.0401U**
Project: Showplace Square / Northeast Mission Historic Resource Survey
Staff Contact: Moses Corrette – (415) 558-6295
moses.corrette@sfgov.org
Reviewed By Tim Frye – (415) 575-6822
tim.frye@sfgov.org
Recommendation: **Adoption of survey findings**

**SHOWPLACE SQUARE SURVEY
SAN FRANCISCO, CALIFORNIA
FINAL**

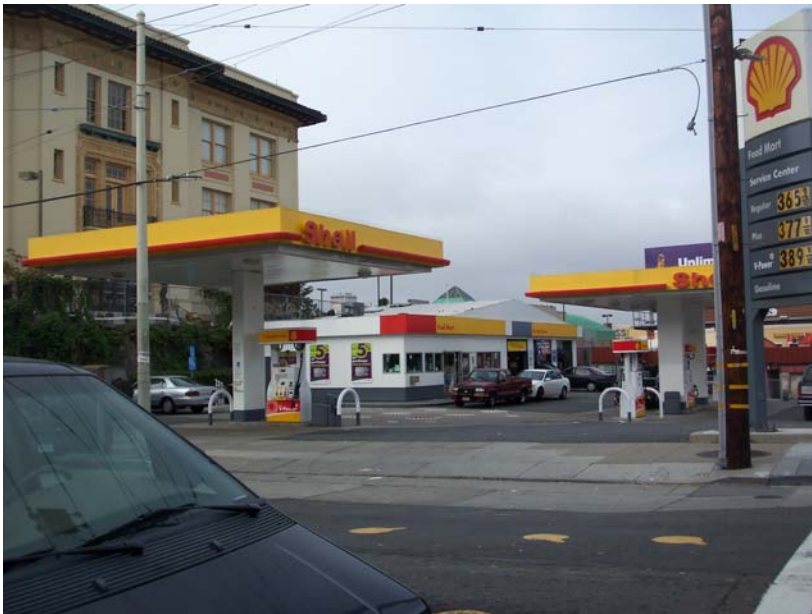
This is a modern gas station complex consisting of a one story front gabled concrete building, gas pumps and islands with canopies, and large signs. It occupies a rectangular 14,100 sq.ft. lot on the northwest corner of Potrero Avenue and 17th Street. The building has three vehicular bays with rollup metal doors and a pedestrian entrance in a section with retail display windows. The building appears in good condition.

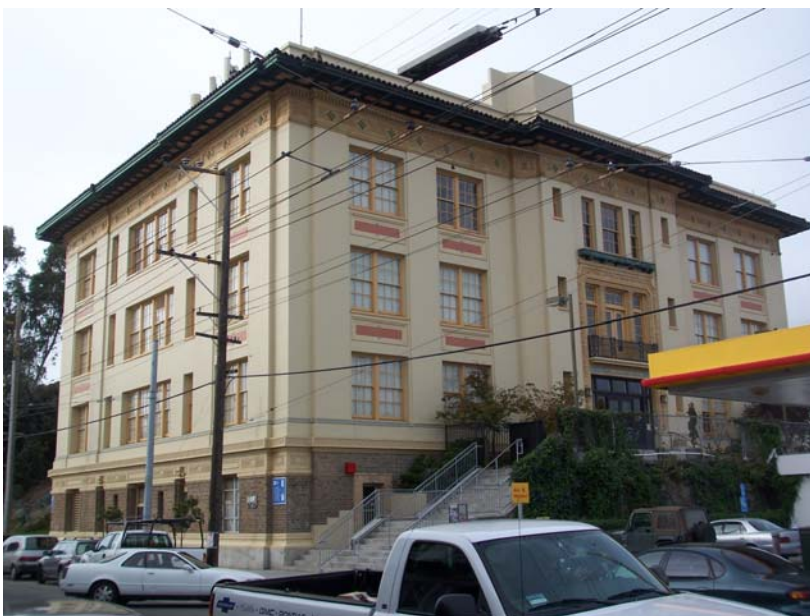
2450 17th Street occupies a 38,000 square-foot lot on the north side of 17th Street between Potrero Avenue and Hampshire Street. It is a four-story, concrete, institutional building. The square-plan building, clad in English bond brick at its first-floor base and stucco with tile and terra cotta accents elsewhere, rests on a concrete foundation and is capped by a flat roof. The primary facade, which is 5 bays wide, faces south toward 17th Street Street; the secondary facade faces west toward Hampshire Street; and the tertiary facade faces north toward 16th Street. A staircase with metal railings spans the length of the primary facade's first floor; its landing is bordered by an ivy-covered, chain-link fence protecting the building's second-floor main entrance, located at the projecting middle bay. This entrance consists of double doors flanked by sidelights and a 3-light transom. The two bays on either side of the middle bay mirror one another, with each bay presenting six-over-six, double-hung, wood-sash windows. Spandrel panels below the third- and fourth-floor windows further distinguish the fenestration. The middle bay of the third and fourth floor differs from the others, with the third floor showcasing multi-light French doors flanked by wood surrounds, pilasters, and multi-light sidelights beneath a multi-light transom. A balconet with wrought iron railing fronts the span, while concrete surrounds embossed with ballflower ornament outline the second- and third-floor center bays. The fourth-floor center bay features an eight-over-eight, double-hung, wood-sash window flanked by two-over-two, double-hung, wood-sash windows.

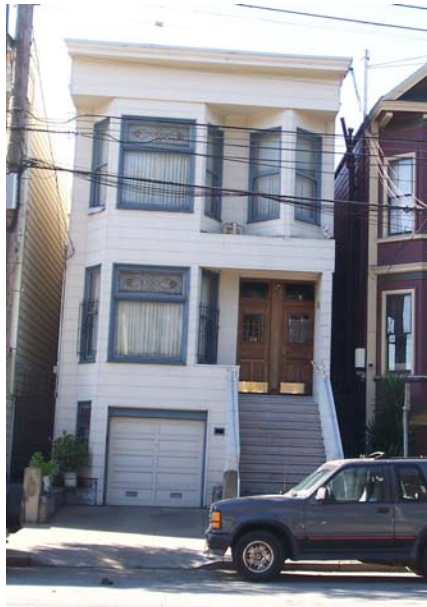
*P5b. Photo (view, date, accession #
100_5966.JPG, 11/21/2007,
view to W

1740-1742 Bryant Street is a three-story, wood-frame, multiple-family building clad in asbestos shingle siding, capped with a flat roof and designed in the Classical Revival style with the ornamentation removed. The building is located on a 2,500 sq ft lot on the west side of Bryant Street. The ground level features a garage with a wood panel garage door and wooden steps that lead to the primary entrance. Above the garage is a two story chamfered bay window. The primary entrance features two recessed glazed wood panel doors with transoms. The bay windows feature wood windows with stain-glass inserts in the center of the bay and 1/1 double hung wooden windows on the sides. A two-sided bay window in the right bay of the third floor, above the entrance, and features 1/1 double hung wooden windows. The building terminates with a plain frieze and a projecting cornice. The building appears to be in good condition.

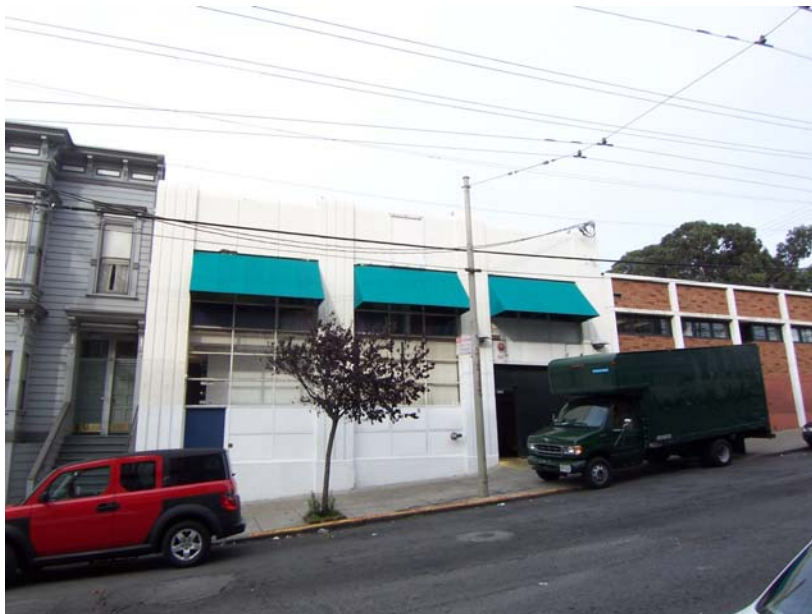
2720 17th Street occupies a 50 x 100 square-foot lot on the south side of 17th Street between Florida and Bryant streets. Built in 1938, it is a two-story, concrete-frame, industrial building designed in the Art Deco style. The rectangle-plan building, clad in concrete, rests on a concrete foundation and is capped by a flat roof. The primary facade, which is three bays wide, faces south. The bays are divided by scored pilasters. The left bay of the first floor features a modern door and a band of fixed-pane windows that have been filled in. The middle bay offers the same fenestration, also filled in. The right bay features a garage. Each bay of the second floor features a band of fixed-pane windows shaded by awnings. The facade terminates with a parapet, and the building appears to be in good condition.

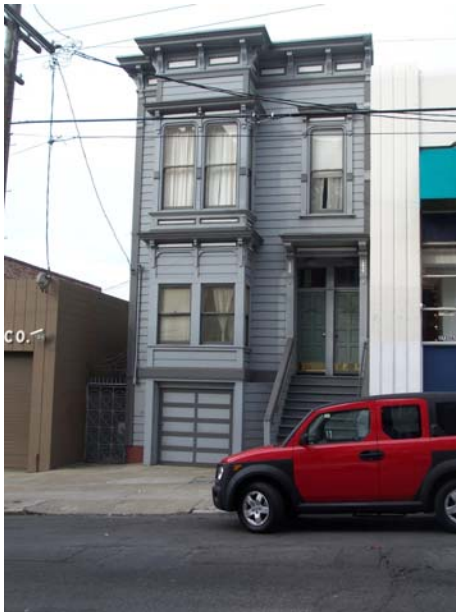
2712-2714 17th Street occupies a 100 x 25.25 square-foot lot on the south side of 17th Street between Florida and Bryant streets. Built circa 1890, it is a three-story, wood-frame, residential building designed in the Stick/Eastlake style. The rectangle-plan building, clad in shiplap, rests on a concrete foundation and is capped by a flat roof. The primary facade, which is two bays wide, faces south. The left bay of the first floor features a garage with a paneled wood door, while the right bay features wooden stairs leading to the second floor where there are two paneled wood doors beneath transoms. This entryway is further distinguished by a bracketed, flat door hood and pilasters topped by button ornament. The right bay of the third floor features a single one-over-one, double-hung, wood-sash, segmented window with a flat window hood. The left bay of the second and third floors features a continuous boxed bay window. One-over-one fenestration characterizes second-floor fenestration, while third-floor fenestration mimics that found at the third-floor right bay. The facade terminates in a parapet, paneled frieze, and bracketed cornice. The building appears to be in good condition.

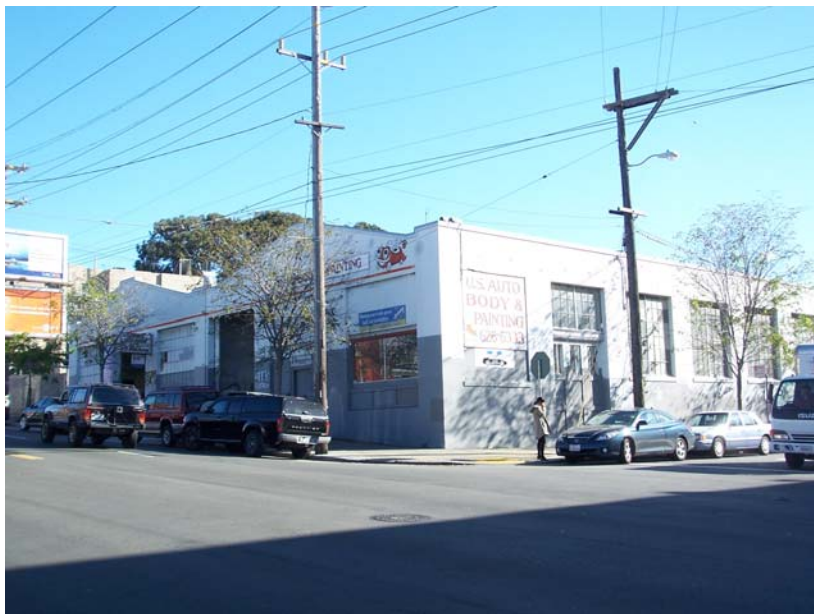
2445 16th Street is a one-story, reinforced-concrete industrial building finished in stucco and capped by a pair of parallel gable roofs. The utilitarian building occupies a 9,997 square-foot corner lot on the south side of 16th Street between Bryant and Florida streets. The rectangle-plan building sits atop a concrete foundation. The primary facade, which is 6 bays wide, faces north; the secondary facade, which is 7 bays wide, faces west. The leftmost, or first, third, fifth, and sixth bays of the primary facade feature fixed, multi-light steel windows with concrete lug sills. The original fenestration of the fifth bay has been filled in and a doorway cut into the opening. The sixth bay has also been filled in, with 2-light, fixed windows partially occupying the original window opening. The second and fourth bays each feature a garage with wooden, pocket doors. Each bay of the secondary facade displays the original fenestration of the primary facade, with exceptions found at the leftmost, or first, bay, which has been filled in, as well as the second bay, which displays a pair of paneled wood doors beneath a multi-light transom. The sixth bay mimics the second, though a loading dock replaces the doors. The primary facade terminates with a parapet and metal coping. The garage interiors are distinguished by trussed ceilings and multi-light skylights. The building appears to be in good condition.

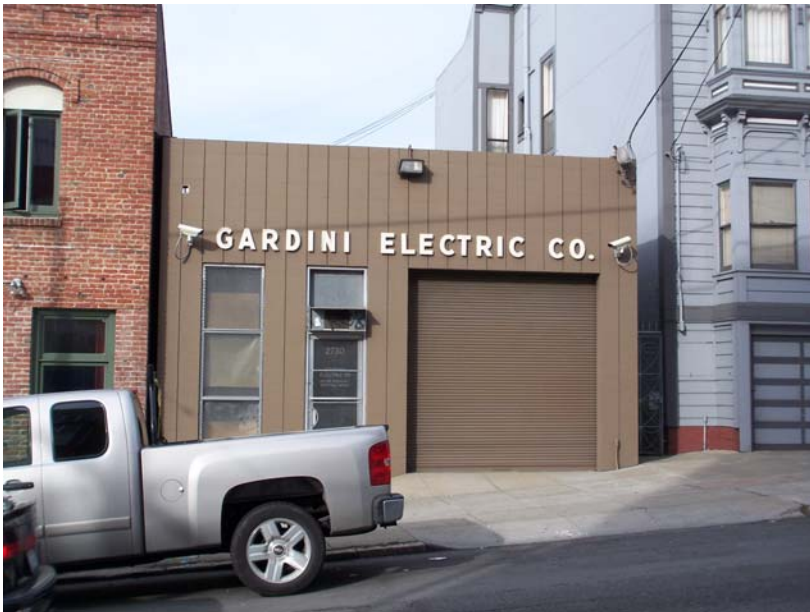
2730 17th Street occupies a 3,097 square-foot flag lot on the south side of 17th Street between Florida and Bryant streets. Built in 1966, it is a one-story, wood-frame, industrial building. The rectangle-plan building, clad in T-111 siding, rests on a concrete foundation and is capped by a flat roof. The primary facade, which is three bays wide, faces south. The left bay features a three-light, fixed-pane, metal-sash window, while the middle bay features a multi-light, metal-sash door beneath a transom. The right bay features a garage with a metal roll-up door. The facade terminates in a parapet featuring applied lettering reading, "Gardini Electric Co." The building appears to be in good condition. A parking lot occupies the Florida Street portion of the lot.

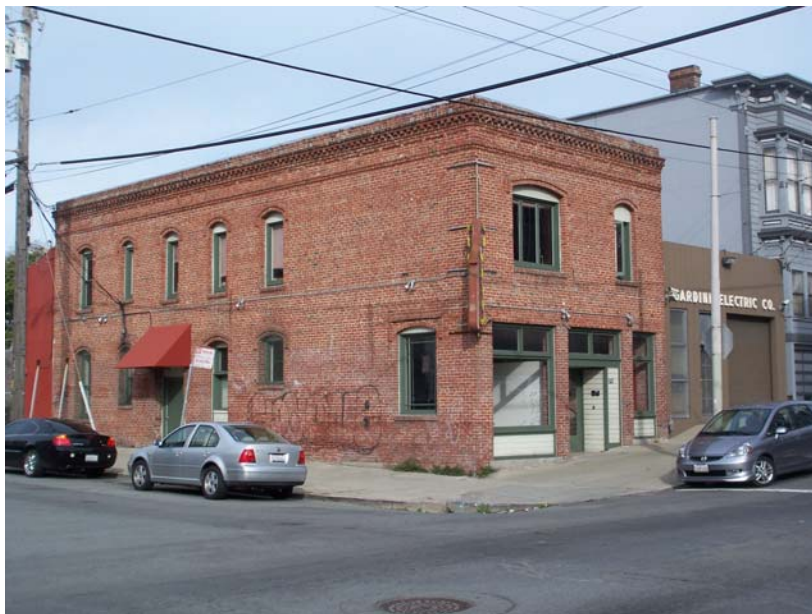
2742 17th Street occupies a 25 x 75 square-foot corner lot on the northeast corner of 17th and Florida streets. Built in 1907, it is a two-story, steel reinforced brick, industrial building. The American Commercial style building, built of brick laid in American bond, rests on a concrete foundation and is capped by a flat roof. The primary facade, which is three bays wide, faces south; the secondary facade, which is seven bays wide, faces west. The left bay of the primary facade's first floor features a fixed-pane, wood-sash window beneath a two-light transom, while the middle bay features the building's recessed, paneled main entrance: a single-light, wood door beneath a two-light transom. The right bay features a fixed-pane, wood-sash window with a transom. Both windows on this floor feature spandrel panels. The left bay of the second floor features a tripartite, fixed-pane window with flat, radiating, arched brick surrounds. The same window treatment can be found at the right bay where there is a single, fixed-pane window. The middle bay offers a blank wall face. Single, fixed-pane, wood-sash windows with flat, radiating, arched brick surrounds dominates the secondary facade, which also features the building's secondary entrance: a single door beneath a shed-roofed awning found at the third rightmost bay of the first floor. Both facades terminate with a paneled frieze, dentils, and metal coping. The building is further distinguished by a shed-roofed, two-story addition with wood siding at its north elevation. The building appears to be in good condition.

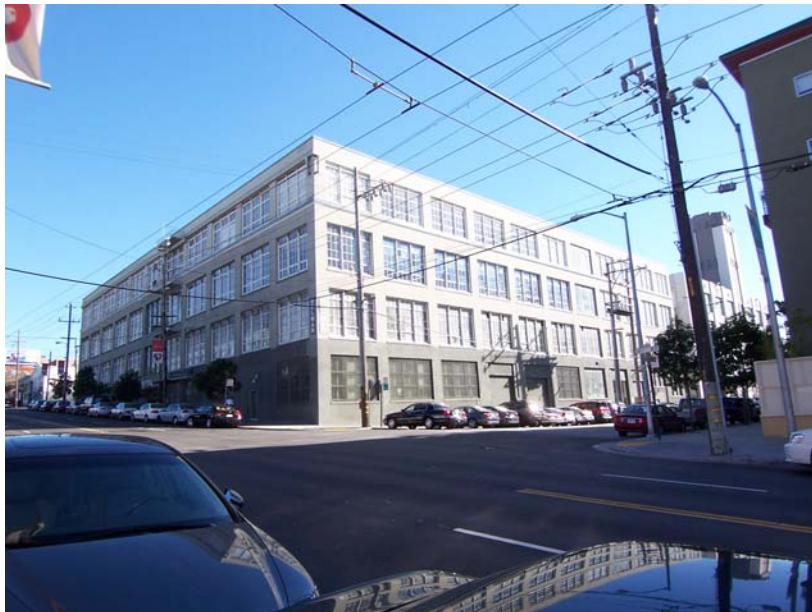
2545 16th Street is a four-story, reinforced concrete, daylight-frame industrial building finished in stucco and capped by a flat roof. The utilitarian building occupies a 41,996 square-foot corner lot on the northern half of the block bound by 16th, 17th, Alabama, and Florida streets. The square-plan building sits atop a concrete foundation. The primary facade, which is 11 bays wide, faces north; the secondary and tertiary facades face Alabama and Florida streets respectively. The three rightmost bays of the primary facade's first floor features blank wall faces, with the fourth bay featuring a recessed band of fixed windows. The fifth bay features a band of 6-light, fixed windows, while the sixth features the building's recessed main entrance, an aluminum-sash, double-door with sidelights and a transom. The remaining bays feature a band of 9-light, fixed windows, except for the tenth bay, which has been filled in and a wooden door cut into it. The upper floors present a regular grid of tripartite multi-lite steel industrial sash windows, each part containing 3x5 lites, and each window with a concrete lug sill. The Florida Street elevation has 8 open loading bays and two vehicular entrances with roll-up metal doors. The eleventh bay, at the north end, has a tripartite window. The building appears in good condition.

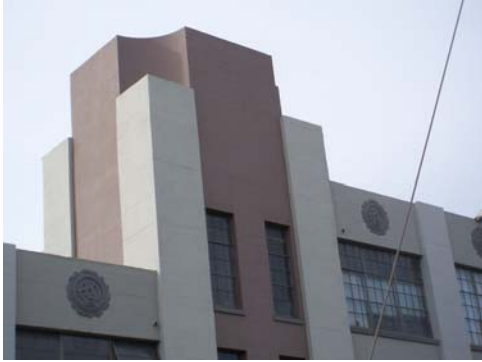
100_5325.JPG, 11/16/2007, tower detail

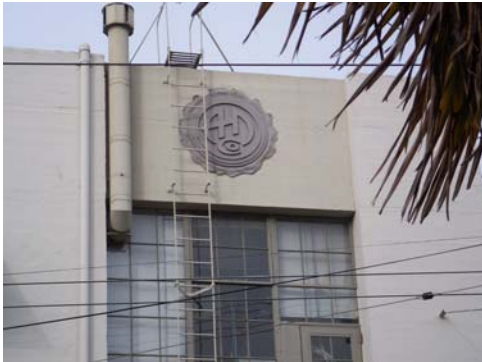
100_5328.JPG, 11/16/2007, parapet detail

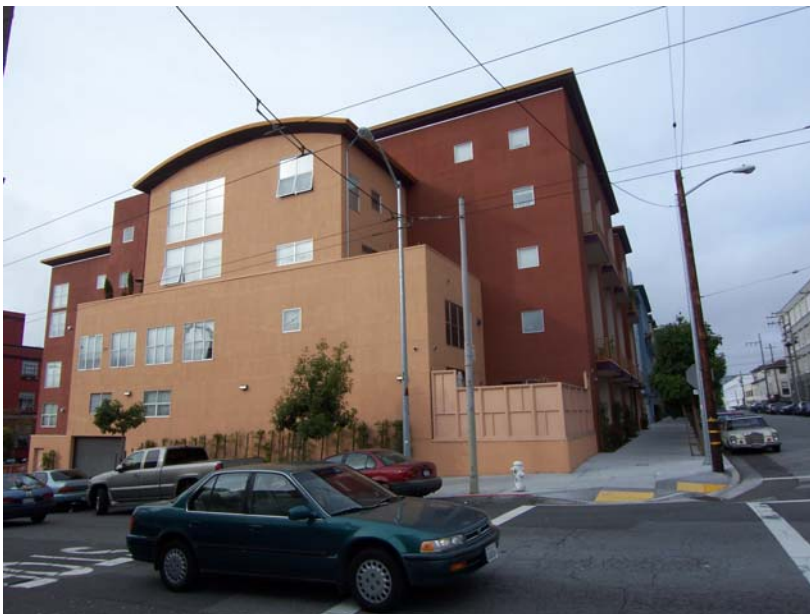
380 Alabama Street is a four-story, wood-frame residential building finished in stucco and capped by a flat and barrel-vaulted roof. It is part of a six-building complex of similar condominium structures. The building appears to be in good condition.

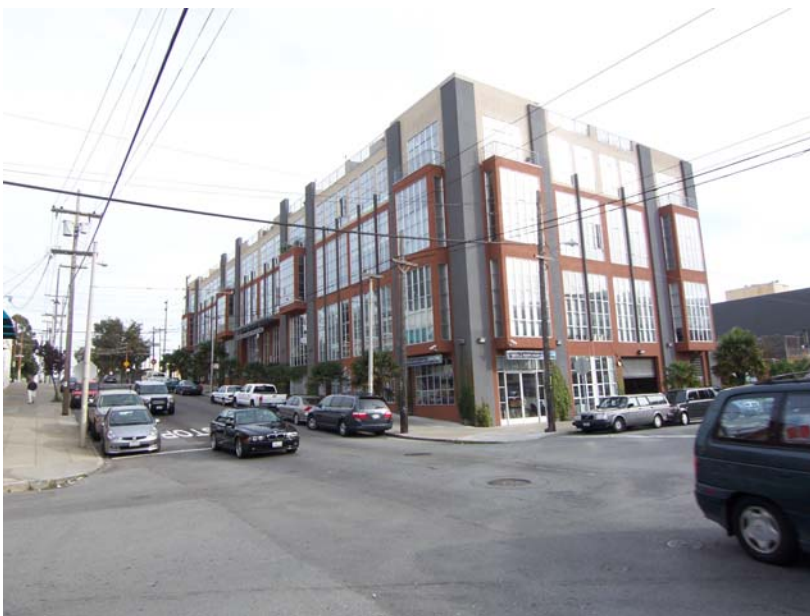
This is a new three-story, wood-frame residential loft building with retail and parking on the ground floor. It is rectangular in plan and occupies the entire 15,000 sq. ft. lot on 17th Street extending from Florida to Bryant Street. The building appears in good condition.

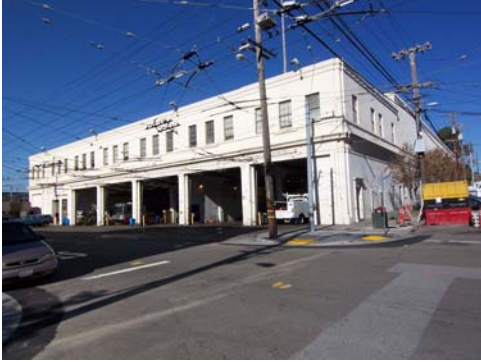
100_5706.JPG, 11/20/2007, view to SW

2501 17th Street occupies a portion of a 191,999 square-foot block bounded by 17th, Hampshire, Mariposa, and Bryant streets. Owned by San Francisco's Municipal Railway (MUNI), the property is primarily utilized as surface storage for MUNI's Potrero Division's fleet of trackless trolleys. Located at the southeast corner of the property is at two-story concrete, L-plan structure utilized as shops and garage space. The building, partially finished in stucco, rests on a concrete perimeter foundation and it is capped by a flat roof with skylights. The primary facade, which is set back from Mariposa Street, is seven bays wide. The secondary facade, which is three bays wide and built to the lot line, faces east toward Hampshire Street. The leftmost bay of the primary facade features a one-story addition built out to the south lot line. This addition is distinguished by ribbon fenestration beneath an oversized, boxed soffit. It obscures the building's original main entrance, which can still be distinguished by an entablature with oversized dentils and a frieze of carved lettering reading, "Municipal Railway AD 1915." The main entrance is now located in the next bay to the right, which contains a vehicular opening and a modern pedestrian entrance with multi-light sidelights and transom. Vehicular openings characterize the remaining bays, each with enough space to accommodate two city buses. Molded pilasters divide each bay at the first floor level. A belt course divides the first and second floors. Every bay of the second floor level is articulated by three six-over-six, double-hung, wood-sash windows.

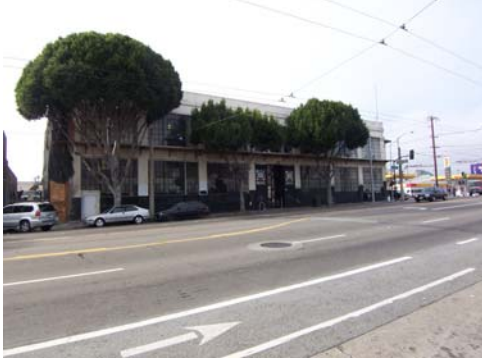
100_5305.JPG, 11/16/07, Potrero Ave.
elevation

2401-2425 17th Street is a two-story, concrete-frame, industrial building finished in stucco and capped by a flat roof. The utilitarian building occupies a 150 x 200 foot lot on the northern portion of the block bounded by 17th, Potrero, Hampshire, and Mariposa streets. The rectangle-plan building sits atop a concrete foundation. The primary facade, which is 11 bays wide, faces north; the secondary and tertiary facades, which face east and west respectively, are 7 bays wide. Each facade is dominated by enframed window-walls composed of metal-sash, fixed-pane and awning windows above spandrel panels. Pilasters divide each bay, with the first floor of the primary facade distinguished by vehicular openings at the fourth, eighth, and tenth bays on 17th St. when counting from the left. A bracketed awning dividing the first and second floors further distinguishes the building. All facades terminate with a parapet decorated with garland and button ornamentation. The building appears to be in good condition.

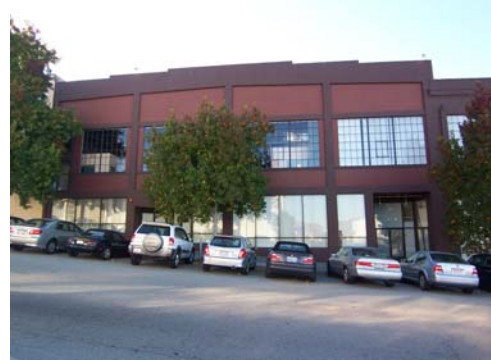
100_2145.JPG, 11/20/07, view to W, concrete addition

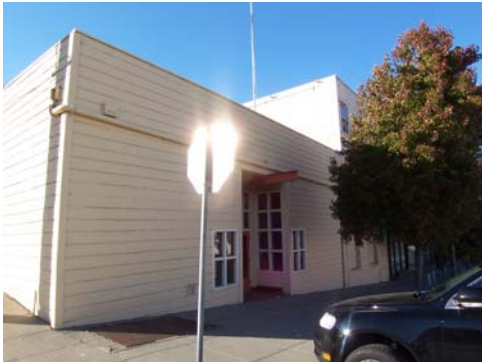
100_2146.JPG, 11/20/07, view to W, frame addition

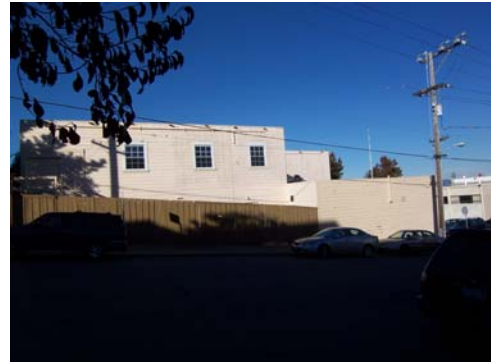
100_2148.JPG, 11/20/07, view to N, frame addition

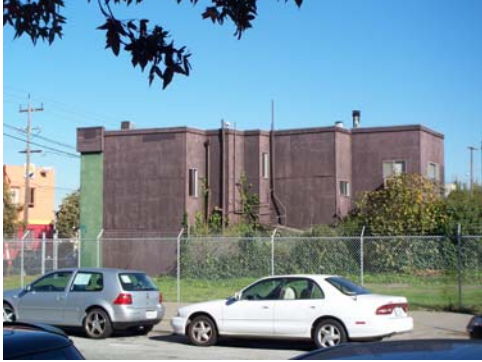
100_2073.JPG, 11/20/07, view to E, frame building

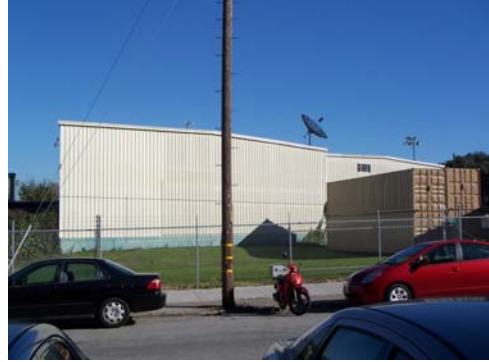
100_2074.JPG, 11/20/07, view to E, steel building

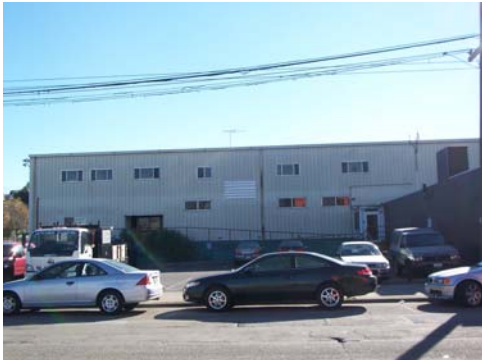
100_2076.JPG, 11/20/07, view to S, steel building

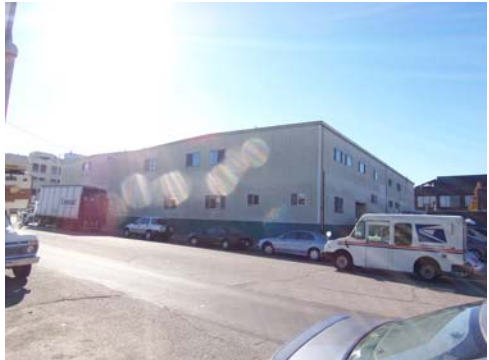
100_2077.JPG, 11/20/07, view to SW, steel building

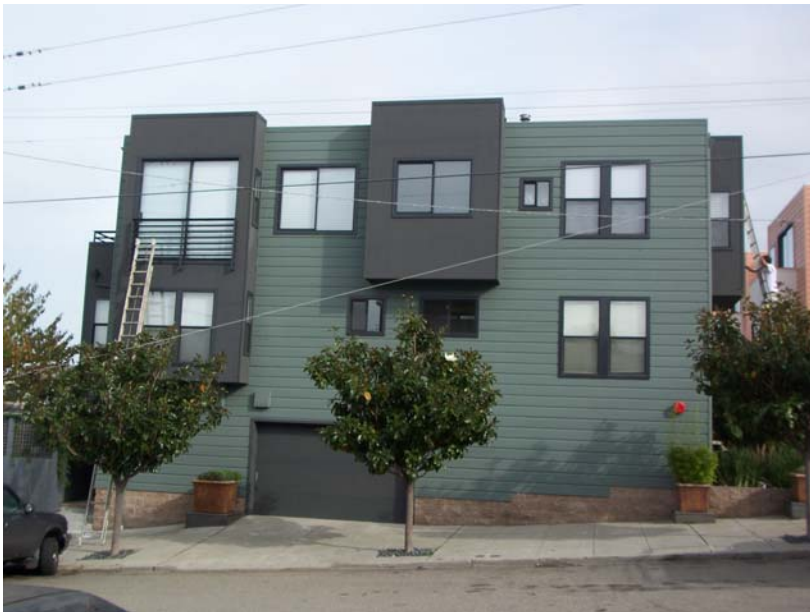
165 Texas Street is a small rectangular property on the east side of Texas Street between 17th and Mariposa streets. The building on the parcel is a three-story wood-frame "live-work" loft. The building appears to be in good condition.

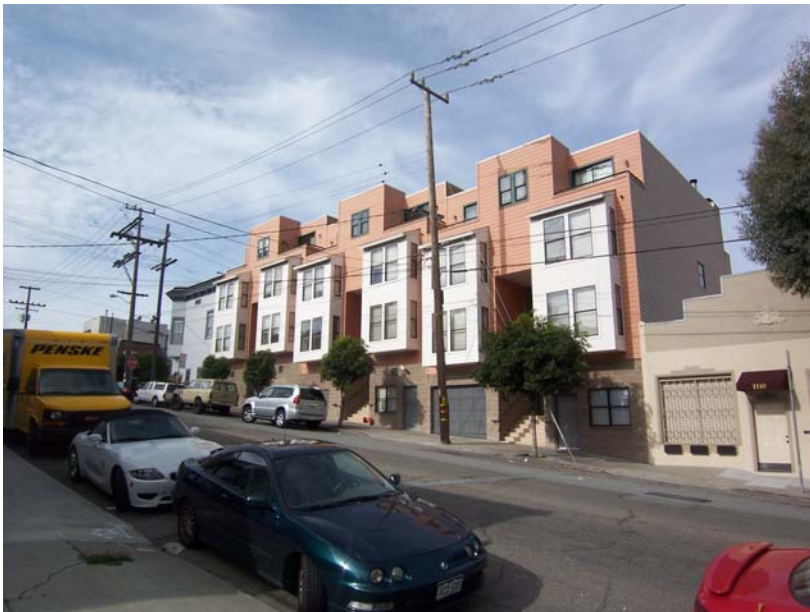
1130 Mariposa Street occupies a rectangular lot on the north side of Mariposa Street between Mississippi and Texas streets. The property contains a four-story, wood-frame "live-work" loft building constructed in 1999. The building appears to be in good condition.

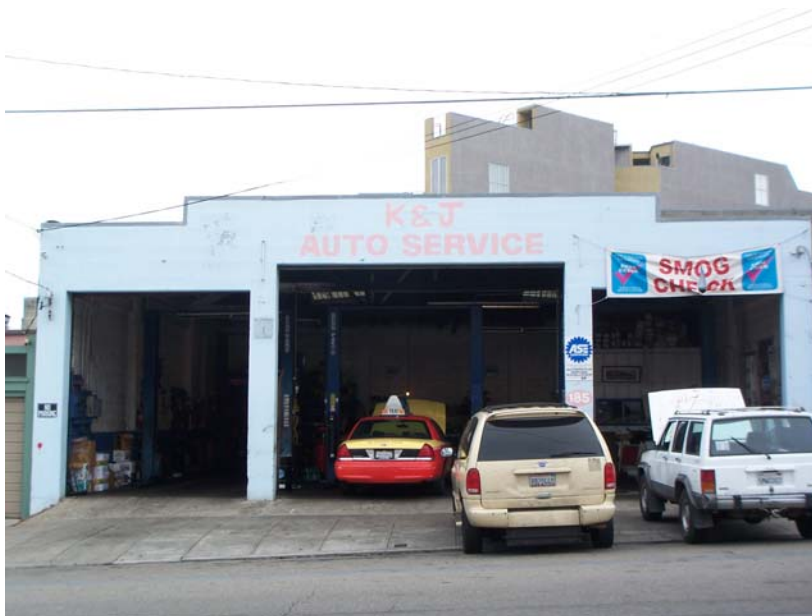
185 Mississippi Street is a one-story, reinforced-concrete industrial building capped with a barrel truss roof. Designed in a utilitarian mode, the building occupies a 2,395 sq ft lot and faces west on Mississippi Street. The primary façade consists of three oversize vehicular bays and terminates with a stepped parapet. The minimally altered building appears to be in good condition.

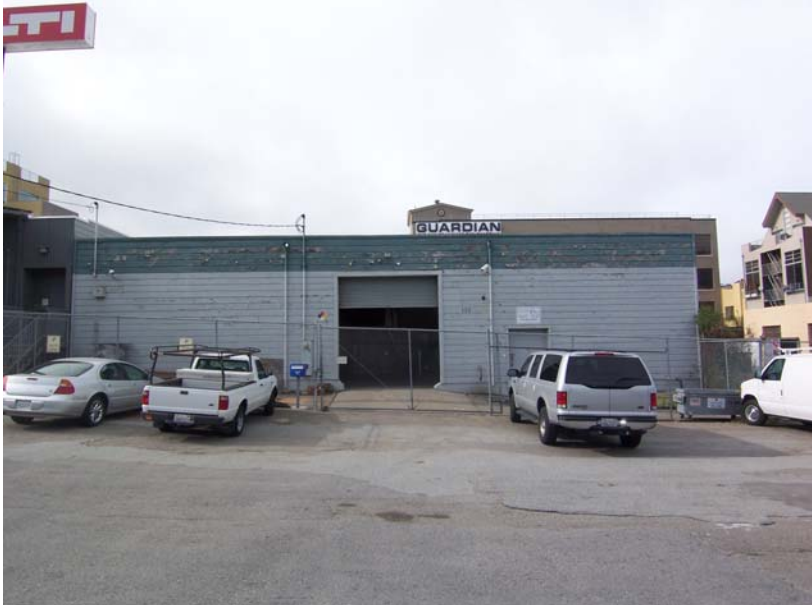
150 Pennsylvania Avenue is a one-story, wood-frame industrial building clad in drop wood siding and capped with a flat roof. The utilitarian building occupies a 6,250 sq ft lot and faces east on Pennsylvania Avenue. The primary façade features a loading dock with a metal roll-up door in the center and a flush wood door on the right. The facade terminates with a flush parapet. The minimally altered building appears to be in good condition.

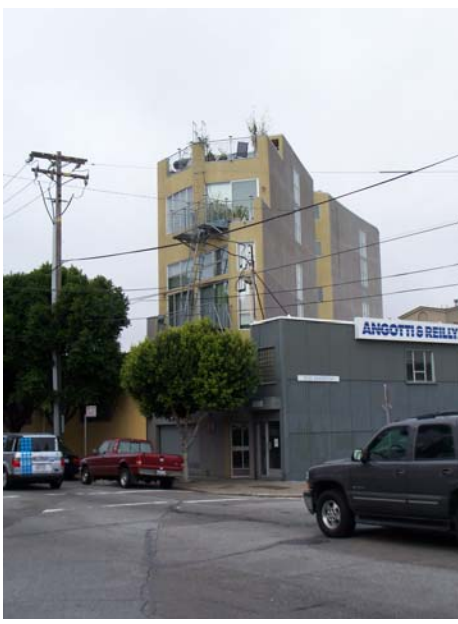
1020 Mariposa occupies an irregularly shaped lot on the south side of Mariposa Street, between Pennsylvania Avenue and Mississippi Street. Occupying the former Southern Pacific Railroad right-of-way is a four-story wood-frame "live-work" loft building. The building appears to be in good condition.

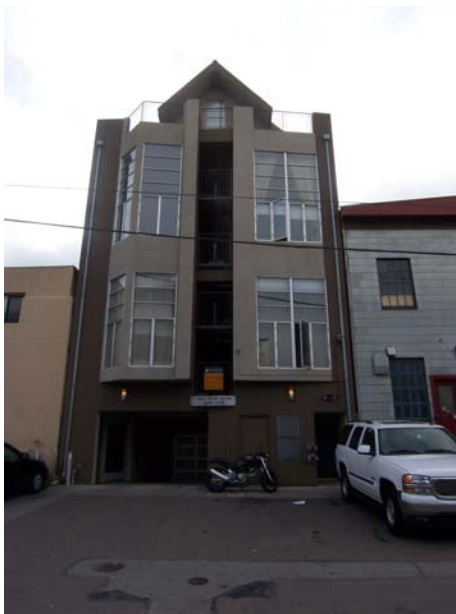
1025 17th Street occupies an abandoned railroad right-of-way through the center of its block with frontage on both 17th and Mariposa streets. Extending the length of the block and curving to fit its irregular lot, the parcel is occupied by a 1999-built contemporary "live-work" loft built of concrete and wood-framing. The building appears to be in good condition.

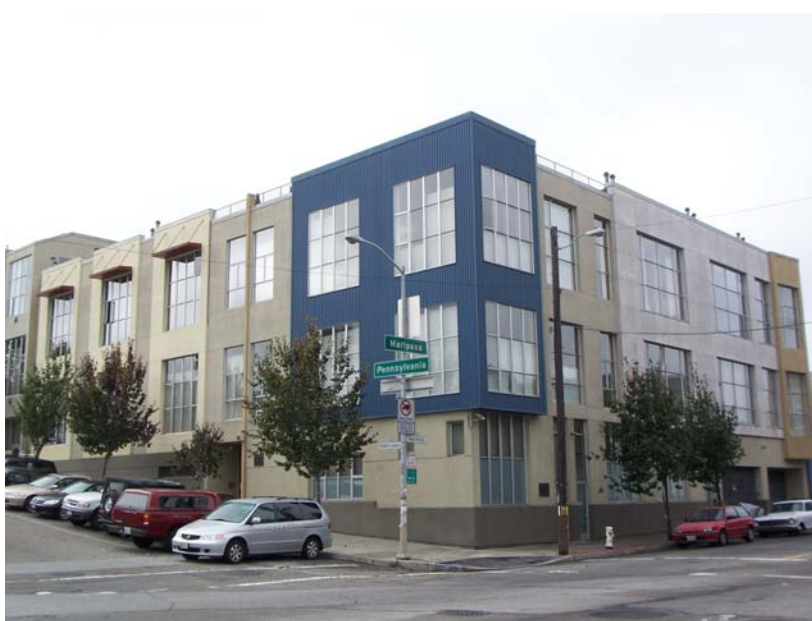
1001 Mariposa occupies a large square lot at the southwest corner of Mariposa Street and Pennsylvania Avenue. It is a three-story, wood-frame "live-work" loft built in 2000. The building appears to be in good condition.

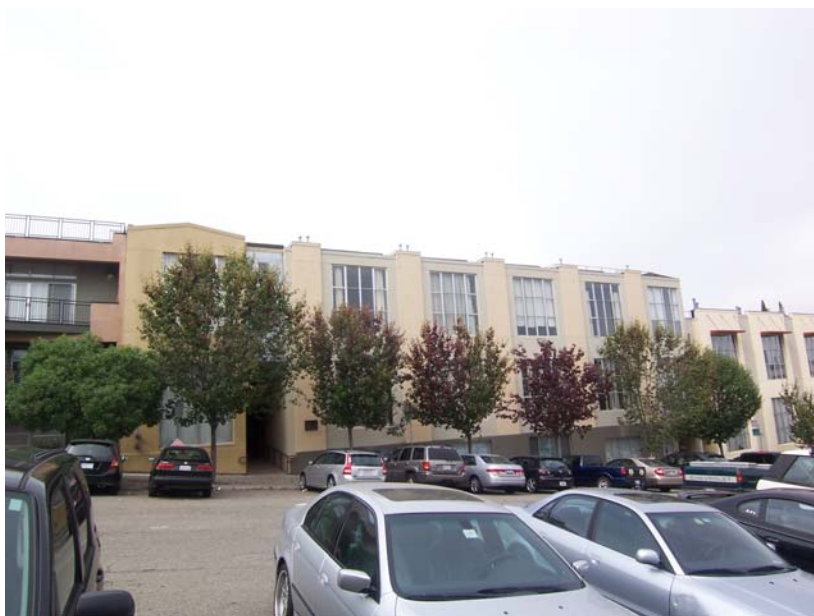
Located on the southwest corner of Mariposa Street and Pennsylvania Avenue, this property is occupied by a large, two-story concrete or steel-frame "live-work" loft building constructed ca. 1999. The building appears to be in good condition.

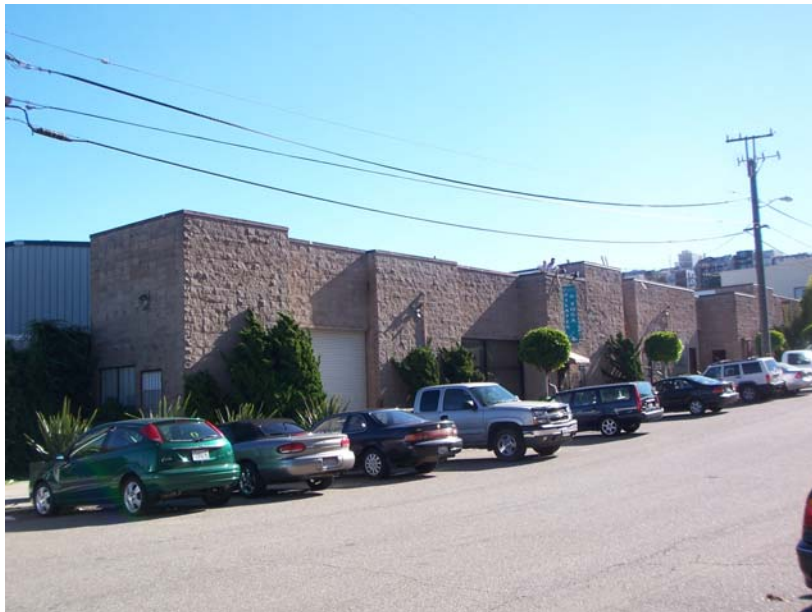
485 Carolina is a one-story, concrete block warehouse capped with a flat roof. The utilitarian building occupies a triangular 17,508 sq ft lot on the east side of Carolina Street between Mariposa and 18th streets. The primary facade faces west toward Carolina Street. The virtually windowless building features several overhead roll-up vehicular doors and anodized aluminum and glass pedestrian entrances. The building appears to be in good condition.

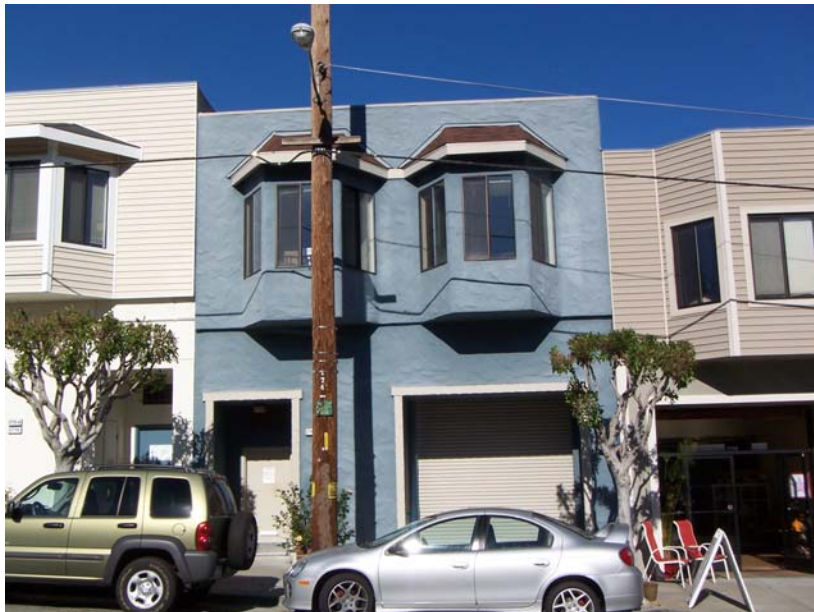
1766 18th Street is a two-story, wood-frame commercial building finished in stucco and capped by a flat roof. The utilitarian building occupies a portion of a 1,875 square-foot lot on the north side of 18th Street between Carolina and Wisconsin streets. The facade is two bays wide and faces south toward 18th Street. The first floor consists of a recessed pedestrian entry in the left bay and an overhead rolling garage door in the right bay. The second floor consists of two narrow chamfered bay windows containing three aluminum sliders. The building appears to be in good condition.

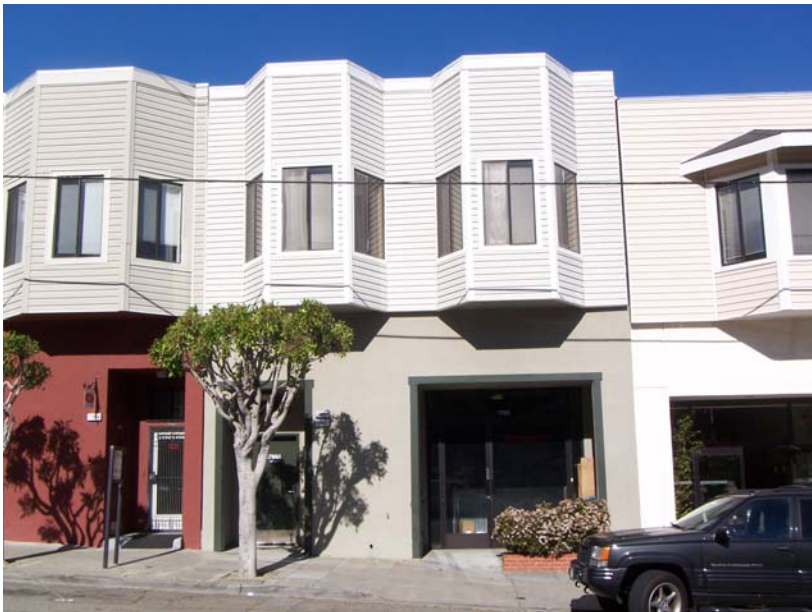
1786 18th Street is a two-story, wood-frame commercial building finished in stucco and vinyl siding and capped with a flat roof. The utilitarian building occupies a portion of a 1,875 square-foot lot on the north side of 18th Street between Carolina and Wisconsin streets. The facade is two bays wide and faces south. The first floor consists of a recessed pedestrian entry in the left bay and a recessed anodized aluminum storefront in the right bay. The second floor consists of two narrow chamfered bay windows containing three aluminum sliders. The building appears to be in good condition.

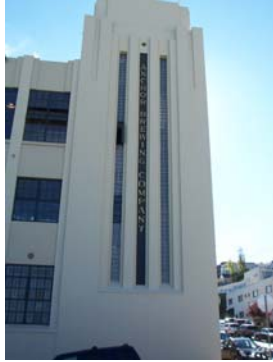
100_2036.JPG, 11/20/07, tower detail

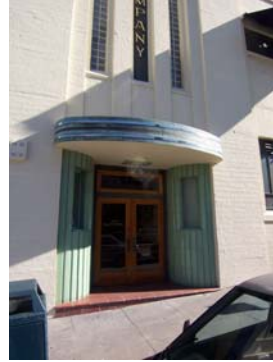
100_2039.JPG, 11/20/07, entrance detail

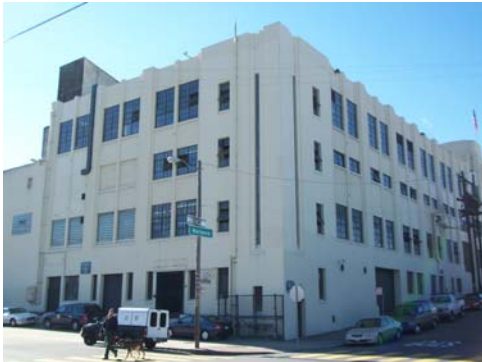
100_2034.JPG, 11/20/07, Mariposa and Carolina elevations

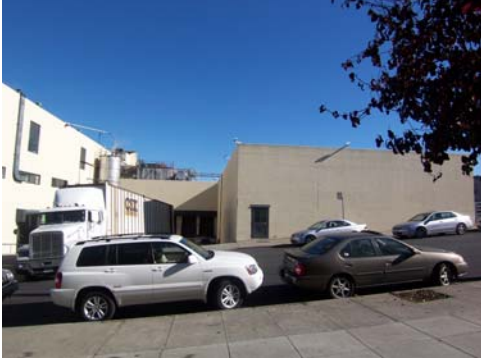
100_2042.JPG, 11/20/07, DeHaro elevation

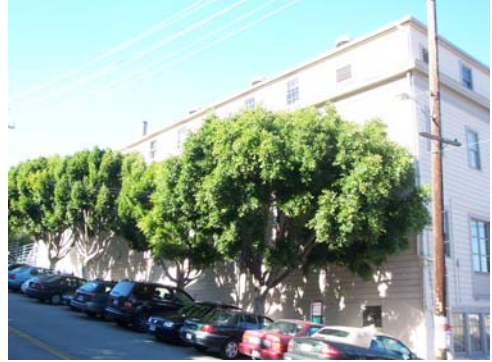
100_2048.JPG, 10/20/07, 18th St. south elevation

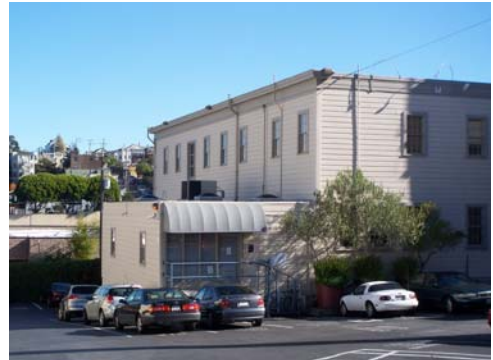
100_2056.JPG, 10/20/07, north elevation

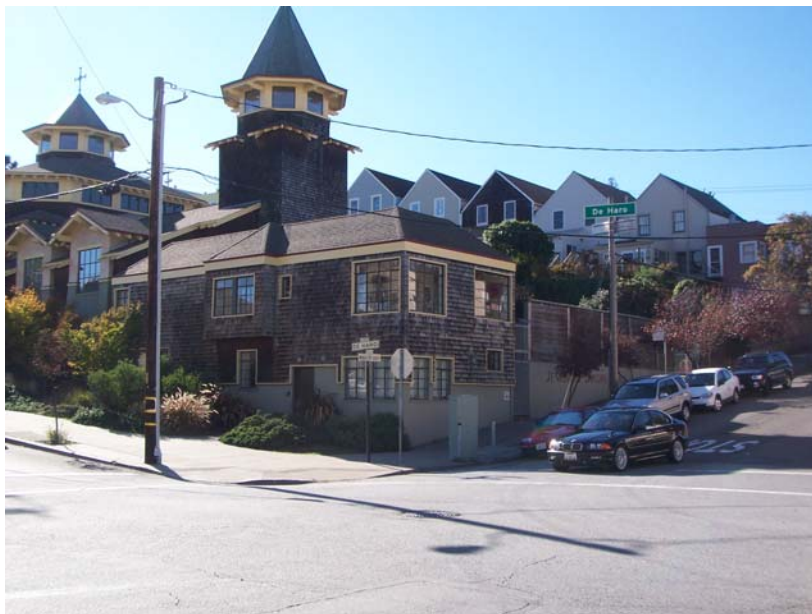
500 De Haro Street is a two-story, wood-frame residential building clad in wood shingles and capped by a hipped roof. It is used as a rectory and playground for St. Gregory's Church. The building occupies a 7,496 sq ft lot on the southwest corner of De Haro and Mariposa streets. The primary façade faces a steeply sloping block of De Haro Street to the east, exposing a large portion of the concrete foundation on the north side of the building. The ground level features a multi-lite wooden window and flush wood door on the left side. The center features a multi-lite wooden window followed by a flush wood door and two multi-lite windows on the right. The second story features a six-lite wooden window on the far left. A square bay window with two multi-lite wooden windows and a small 1/1 double-hung wooden window characterize the center. The right side features a large multi-lite wooden window. The secondary facade faces Mariposa Street to the north. This elevation displays a continuation of the window configuration of the east façade with two multi-lite wood windows on the ground level and two large multi-lite windows on the second story. The building terminates with a molded wood cornice. The minimally altered building appears to be in good condition.

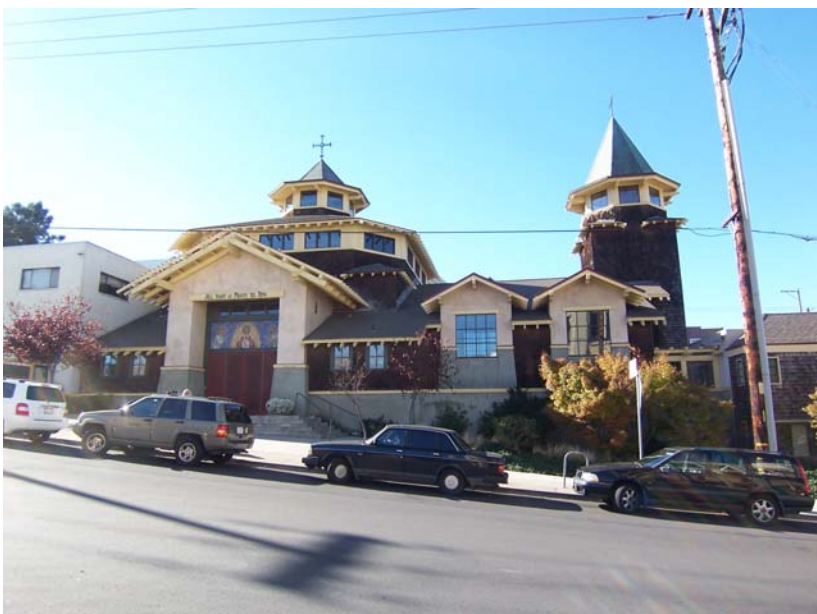
1801 Mariposa Street occupies a pair of lots on the west side of De Haro Street between Mariposa and 17th streets. Built in 1995, the neo-Byzantine/Arts and Crafts building is a visual landmark for the surrounding community. The building appears to be in good condition.

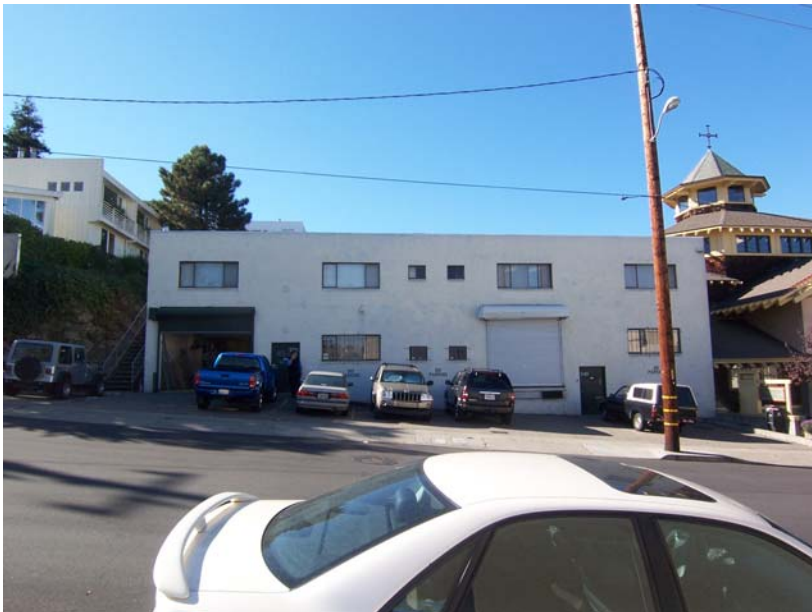
540 De Haro Street is a two-story, concrete block industrial building capped with a flat roof. The utilitarian building occupies a 10,000 sq ft lot on the west side of De Haro Street between Mariposa and 18th streets. It is set back from the street with a parking lot at the front of the lot. The primary facade faces De Haro Street to the east and is five bays wide. The facade features two loading docks and several anodized aluminum ribbon windows. The building appears to be in good condition.

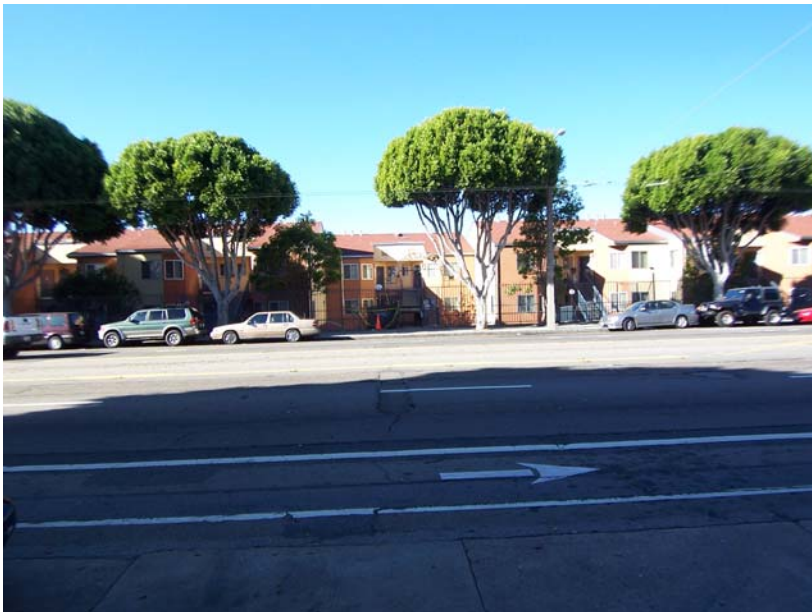
This is a modern residential complex consisting of twelve two story stucco clad frame duplex buildings with side gabled roofs arranged around a central open space. It occupies a 51,705 sq.ft. parcel with faces on Potrero Avenue, Mariposa and Hampshire streets. One building on Potrero is set back, providing a gated entrance to the complex. The buildings appear in good condition.

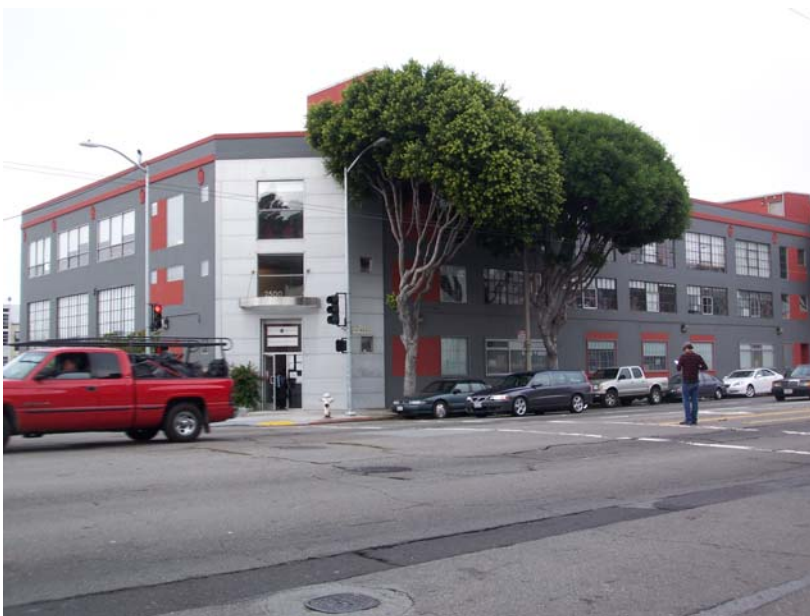
2500 18th Street is a three-story, reinforced concrete, industrial building finished in stucco and capped by a flat roof. The utilitarian building occupies a 14,048 square-foot lot on the northwest corner of Potrero Avenue and 18th street. The rectangular-plan building sits atop a concrete foundation. The primary facade, which is eight bays wide, faces east; the secondary facade, which is five bays wide, faces south; the tertiary facade faces west. The leftmost bay of the primary facade consists of a cutaway main entrance: two-light, metal-sash, double doors beneath a transom and cantilevered, semi-elliptical, metal awning. The two floors above it are characterized by one-over-one, fixed-pane, metal-sash windows. The remaining bays consist of a four- or six-light, metal-sash awning window surrounded by multi-light, fixed-pane, metal-sash windows. Iron grilles protect those on the first floor.

The two rightmost bays of the secondary facade's first floor present blank wall faces; the leftmost bay is a one-story, shed-roofed addition offering double doors. The second rightmost bay offers a garage with a metal, roll-up door and, to its right, a recessed entrance with a single door. The three leftmost bays of the second floor feature fenestration similar to that found at the primary facade; third-floor fenestration consists of a trio of one-over-one, fixed-pane, metal-sash windows. The rightmost bays of both floors have been mostly filled in, with a handful of window openings punctuating blank wall faces. These openings consist of small, fixed-pane windows or multi-light, fixed-pane windows.

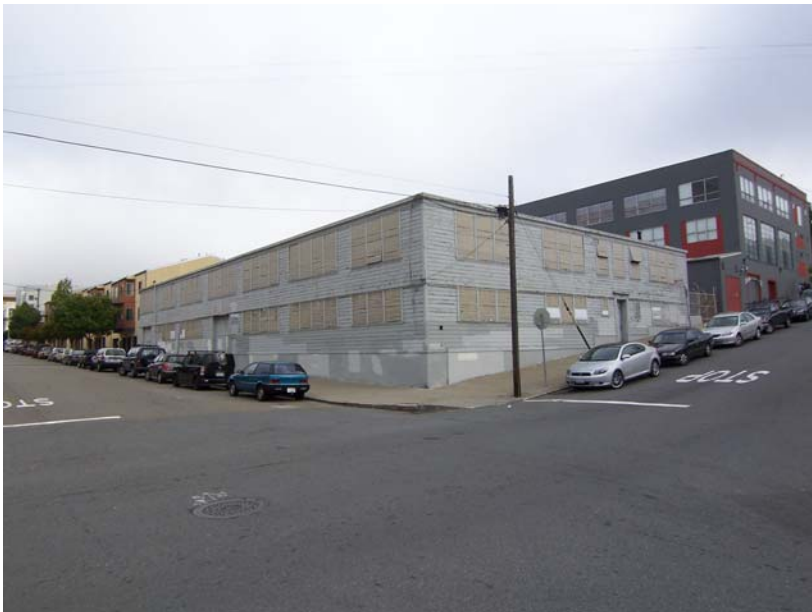
2530 18th Street is a two-story, wood-frame, industrial building clad in rustic wood siding and capped by a flat roof. The utilitarian building occupies a 13,433 square-foot lot on the northeast corner of Hampshire and 18th streets. The rectangular-plan building sits atop a concrete foundation. The primary facade, which is four bays wide, faces south; the secondary facade, which is seven bays wide, faces west. The second rightmost bay of the primary facade's first floor offers the building's main entrance: a recessed, wood door with wood surrounds beneath hood molding. The remaining bays offer a trio of window openings with wooden surrounds and lug sills; all have been filled in with corrugated metal. The leftmost bay of the secondary facade's first floor features paired, paneled wood doors, also found three bays to its right. A band of four window openings with wooden surrounds and lug sills characterize the remaining bays of this facade; like those on the primary facade, all have been filled in with corrugated metal. Both facade terminate in a slightly projecting cornice. The building appears to be poor condition.
