Historic Preservation Commission Executive Summary Historic Resource Survey Findings INFORMATIONAL PRESENTATION: JUNE 1, 2011 ADOPTION HEARING: JUNE 15, 2011

Date: May 25, 2011
Case No.: **2011.0401U**
Project: Showplace Square / Northeast Mission Historic Resource Survey
Staff Contact: Moses Corrette – (415) 558-6295
moses.corrette@sfgov.org
Reviewed By Tim Frye – (415) 575-6822
tim.frye@sfgov.org
Recommendation: **Adoption of survey findings**

**SHOWPLACE SQUARE SURVEY
SAN FRANCISCO, CALIFORNIA
FINAL**

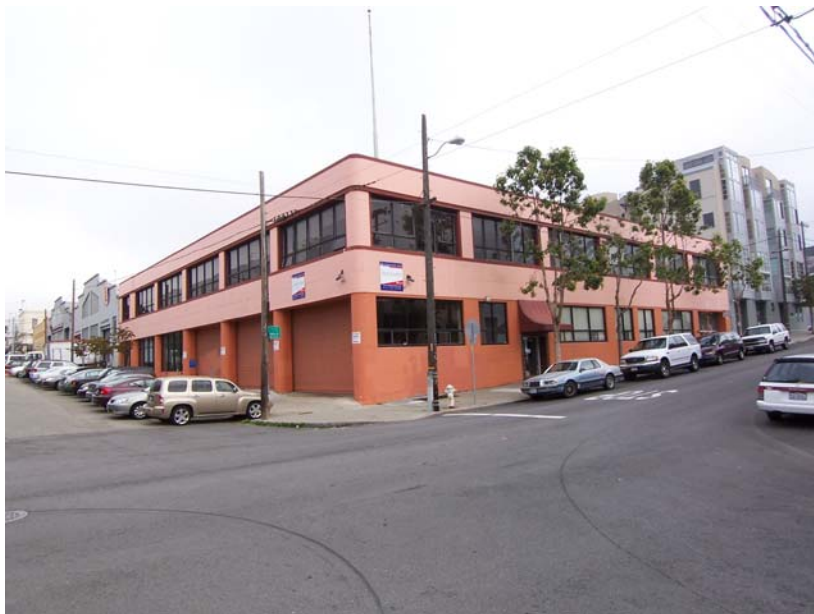
2650 18th Street is a two-story, reinforced-concrete, industrial building finished in stucco and capped by a flat roof. The utilitarian building occupies a 39,996 square-foot lot on the southwest corner of York and 18th streets. The square-plan building sits atop a concrete foundation. The primary facade, which is six bays wide, faces south; the secondary facade faces west. The second leftmost bay of the primary facade's first floor offers the building's main entrance: a pair of single-light, metal-sash doors beneath a fabric awning. Its rightmost bay offers a double-wide garage opening. The remaining bays of both floors offer a band of three one-over-one, fixed-pane, metal-sash windows. The three rightmost bays of the secondary facade's first floor features double-wide garages with metal, roll-up doors. The remaining bays offer bands of windows similar to those found at the primary facade. Both facades terminate with concrete coping. The building appears to be in good condition.

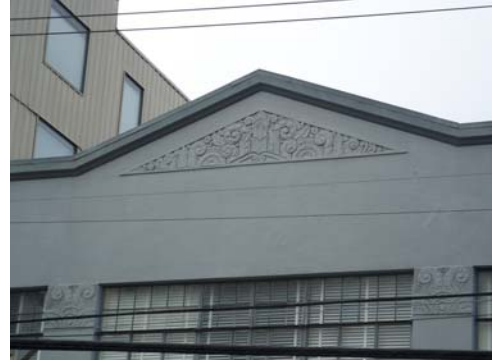
100_5156.JPG, 11/16/2007, parapet detail

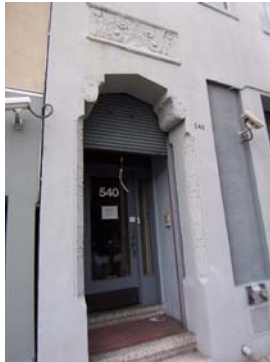
100_5154.JPG, 11/16/07, entrance detail, east elevation

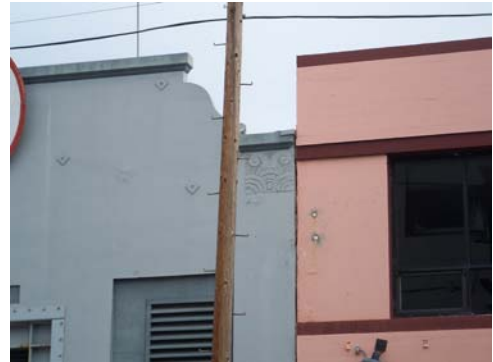
100_5152.JPG, 11/16/2007, parapet detail, west elevation

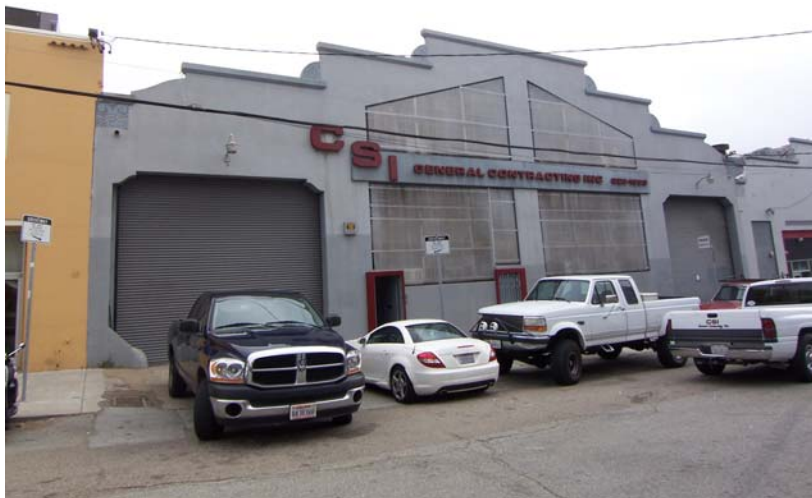
517 York Street is a one-story, reinforced-concrete industrial building finished in stucco and capped by a gable roof. The Art Deco-style building occupies an 8,749 sq.ft. lot on the east side of York Street between Mariposa and 18th streets. Two large roll-up vehicular doors flank a central bay with fixed glazing in large trapezoidal openings, and two pedestrian entrances. The stepped parapet has a concrete coping and radiused brackets with incised Mayan motifs. The building appears in good condition.

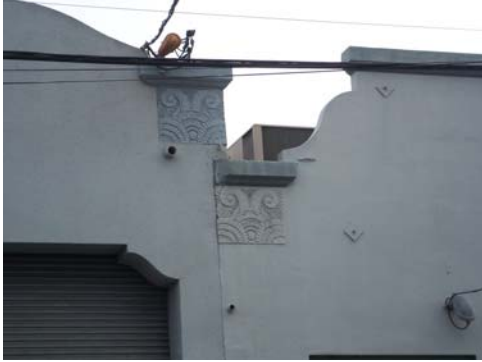
100_5170.JPG, 11/16/2007, parapet detail

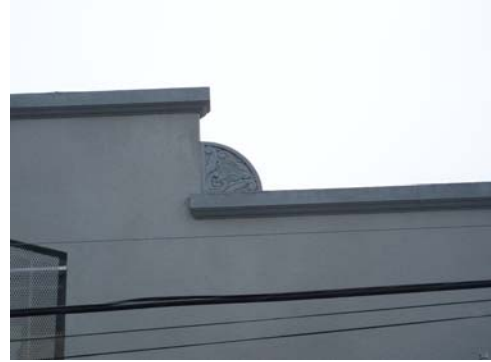
100_5171.JPG, 11/16/2007, parapet detail

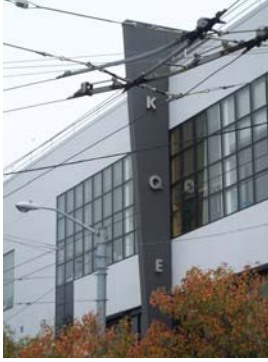
100_5174.JPG, 11/16/2007, blade sign

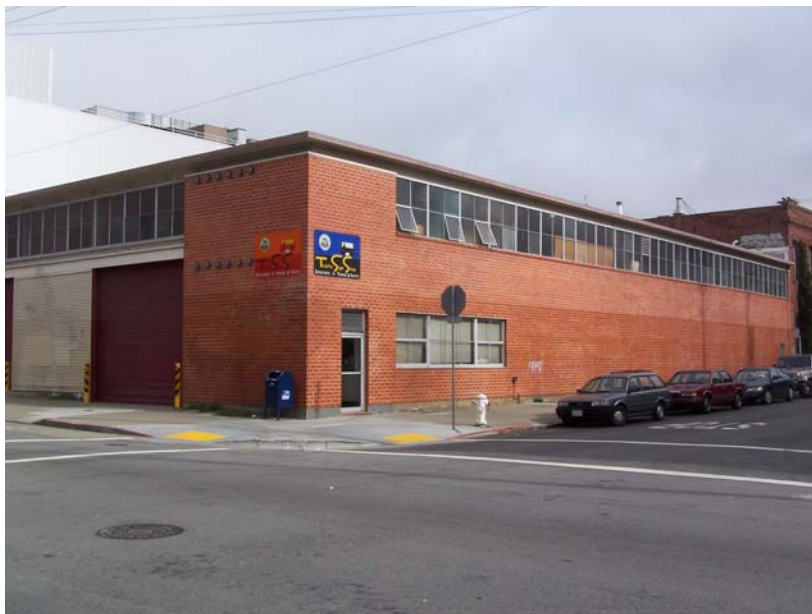
1999 Bryant Street is a two-story, steel-frame and brick industrial building capped by a flat roof. The Modernist building occupies a 9,200 sq. ft. lot at the northeast corner of 18th and Bryant streets. It is rectangular in plan and sits atop a concrete foundation. The building is clad in red brick veneer laid in common bond. Both facades have a steel industrial sash windows at the second floor level. There are three large vehicular entrances with metal roll-up doors on the west facade. On the south facade is a glazed aluminum pedestrian entrance near the corner, with a group of three aluminum sash windows to the right, fixed and awning hinged. The building terminates with a narrow cornice and plain frieze. The building appears to be in good condition.

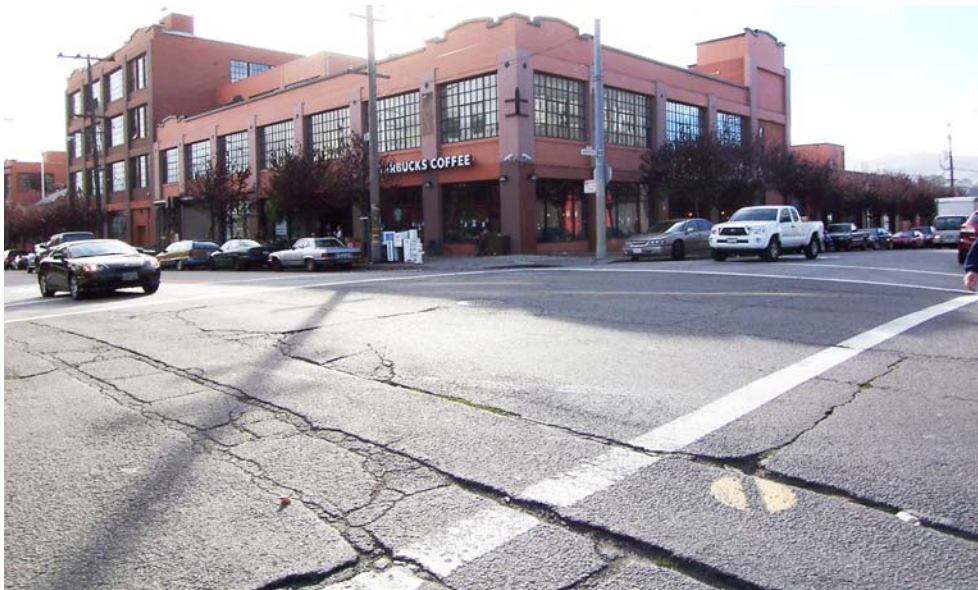
Parcel 4017002 is 30,993 sq ft and contains two buildings on the south side of Mariposa Street between Bryant and Florida Streets. Both are reinforced-concrete, finished in stucco, and loosely designed in the Mission Revival style. The primary building is a two stories and capped by a flat roof. The first floor level along the Bryant and Mariposa street facades feature modern retail storefronts with steel sash industrial windows on the second story. Concrete piers separate the windows and storefronts. This facade terminates with stepped parapets. The north facade features a second building that wraps around to the west facade along Florida Street. This building is a partial two-story, reinforced-concrete industrial building with a compound flat and gable roof. The first story of the north and west facades feature segmented aluminum framed plate glass windows. The west facade sits back from the public sidewalk to provide space for a loading dock. Concrete steps and a concrete ramp access the loading dock, which is shaded by a metal canopy. The right side of the first story features a second set of metal stairs leading to the loading dock and a glazed aluminum double door. A driveway slopes down to a loading bay. This facade also has a penthouse characterized by steel sash industrial windows and walkway with a glass and steel railing leads to an annex building. The annex projects farther out

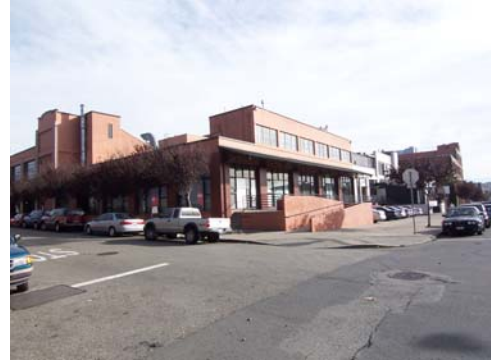
100_5607.JPG, 11/19/07, view to SE, western building

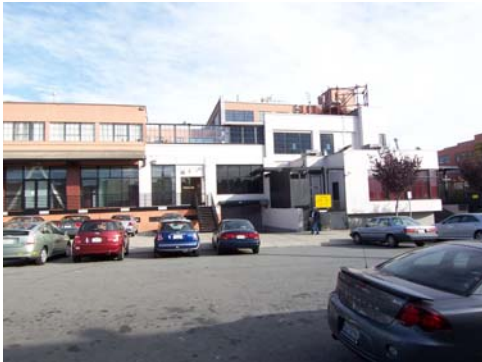
100_5609.JPG, 11/19/07, view to E, annex

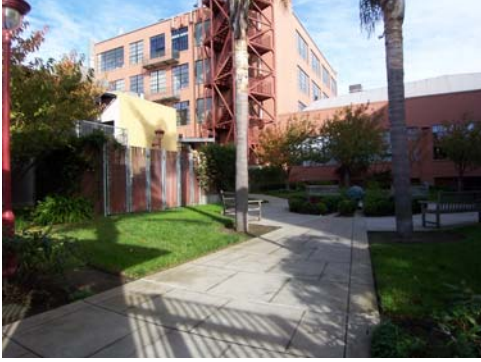
100_5614, 11/19/07, view to NE, south & west elevations

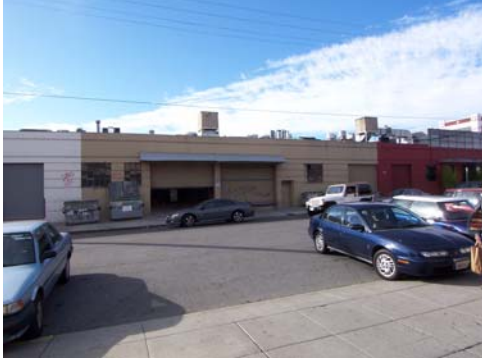
100_5618.JPG, 11/19/07, view to E, Florida elevation

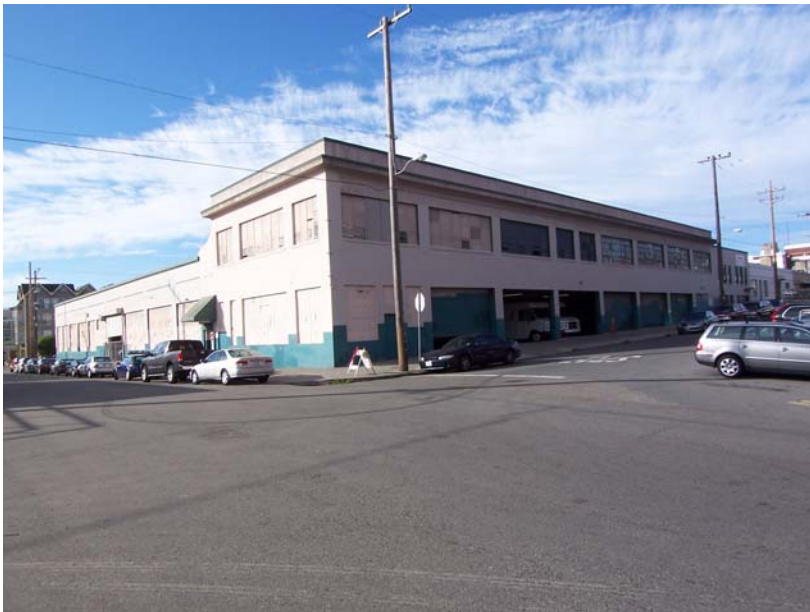
The primary facade, which is fourteen bays wide, faces east on Florida Street; the secondary facade, which is also fourteen bays wide, faces south on 18th Street; the tertiary facade faces west on Alabama Street. The six rightmost bays of the primary facade compose a shallow hip-roofed, two-story volume that houses the building's main entrance: a gated entryway located at the facade's rightmost first-floor bay. A concrete canopy shades it. Fenestration characterizes the remaining bays, with paired, casement windows with concrete lug sills and protective iron grilles found at the first floor. Second-floor fenestration consists of paired casement windows over a single, fixed-pane window. Transoms and concrete lug sills further characterize these. This portion of the primary facade terminates with a false parapet and concrete coping.

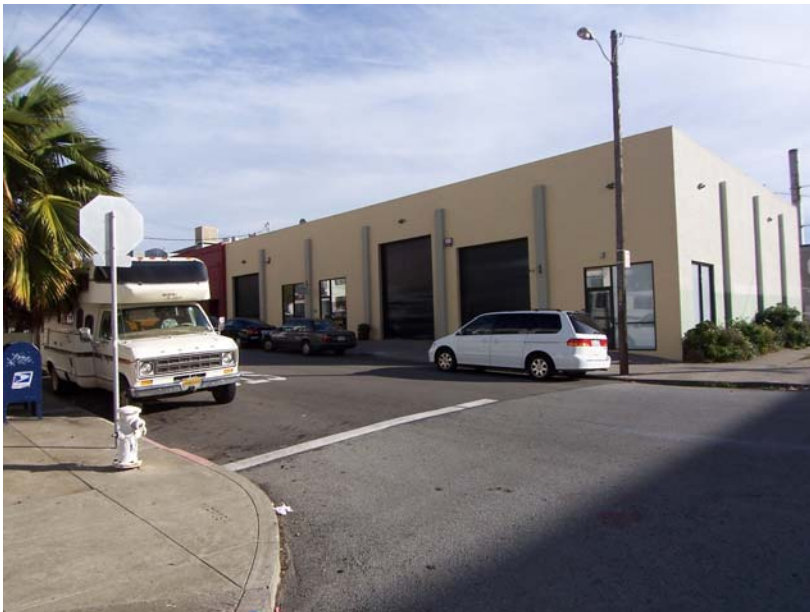
2885 Mariposa Street is a one-story, wood-frame industrial building finished in stucco and capped by a flat roof. The utilitarian building occupies a 6,800 sq. ft. lot at the southeast corner of Alabama and Mariposa streets. The building is divided into five bays on Mariposa and four on Alabama by projecting buttresses. Fenestration is irregular, with three vehicular entrances on Mariposa, each with metal roll-up door, and pedestrian entrances at the corner and on Mariposa of anodized sash and mirrored glass. The building appears in good condition.

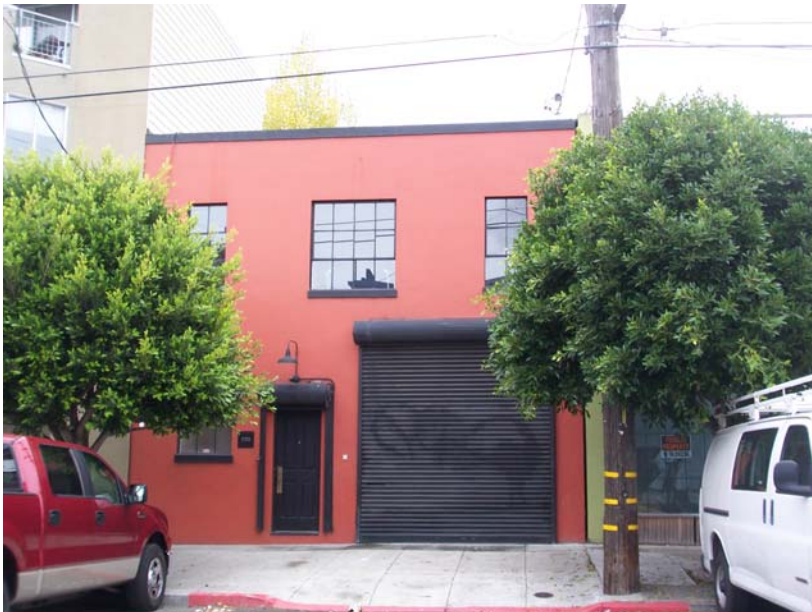
570 Alabama Street is a two-story, reinforced-concrete industrial building finished in stucco and capped by a flat roof. The building has been rehabilitated to multi-family residential use. The building fills the 1,550 sq ft lot and faces east on Alabama Street. The first story features a multi-lite steel sash window, a wood panel door and a metal roll-up garage door. The second story features a central steel sash industrial window flanked by six-pane steel sash windows. The building terminates with a plain roofline. The building appears in good condition.

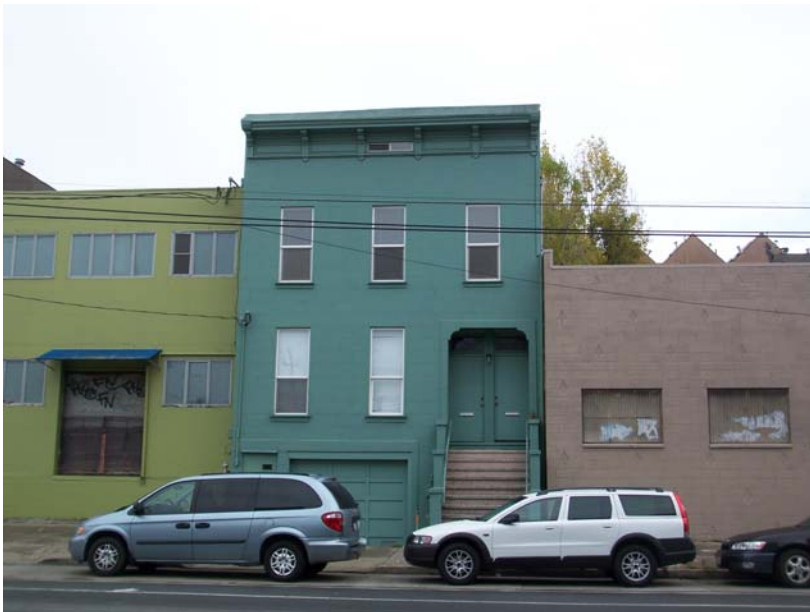
2185 Harrison Street is a three-story, wood-frame, multiple-family dwelling finished in stucco and capped by a gable roof concealed behind a false parapet. The altered Italianate-style building occupies a 1,500 sq. ft. lot on the east side of Harrison Street between Mariposa and 18th streets. The facade, now covered with non original stucco scored to imitate ashlar, has three bays, with a flight of stairs on the right accessing a recessed entrance with two solid wood doors. The remainder of the bays on both levels each contain a narrow 1/1 vinyl double hung replacement window. There is a garage entrance with a wooden segmented door left of the stairs, and a solid wood pedestrian door. The facade terminates with a bracketed projecting cornice. The moderately altered building appears to be in good condition.

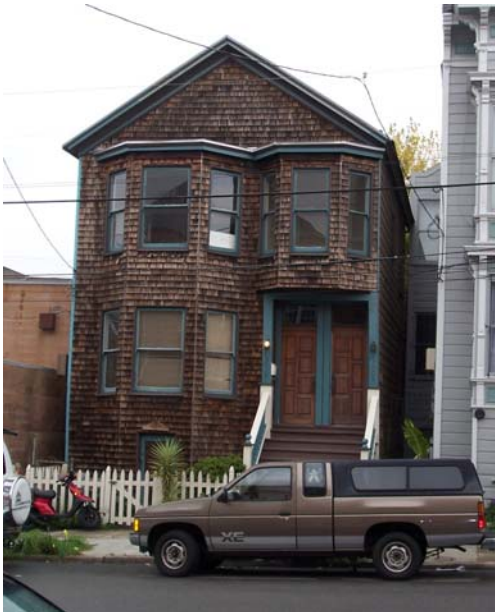
3008-3010 18th Street is a three-story, wood-frame, multiple-family residence clad in wood shingles and capped by a gable roof. The vernacular building occupies a 2,408 square-foot lot on the north side of 18th Street between Harrison and Alabama streets. It is set back from the front lot line, which is demarcated by a wooden, picket fence enclosing a yard with minimal landscaping. The rectangular-plan building sits atop a concrete foundation. The primary facade, which is two bays wide, faces south. The left bay of the first floor features a secondary entrance: a wooden door beneath stacked canted bay windows, while the right bay features a straight flight of wooden stairs with a wooden balustrade and newel posts. The stairs lead to the right bay of the second floor or the building's main entrance: two paneled wood doors with wood surrounds beneath transoms. The left bay window features one-over-one, double-hung windows with wood surrounds and slip sills. The right bay of the third floor also offers a canted bay window with the same fenestration. A cornice with metal coping tops both bay windows. The building appears to be in good condition.

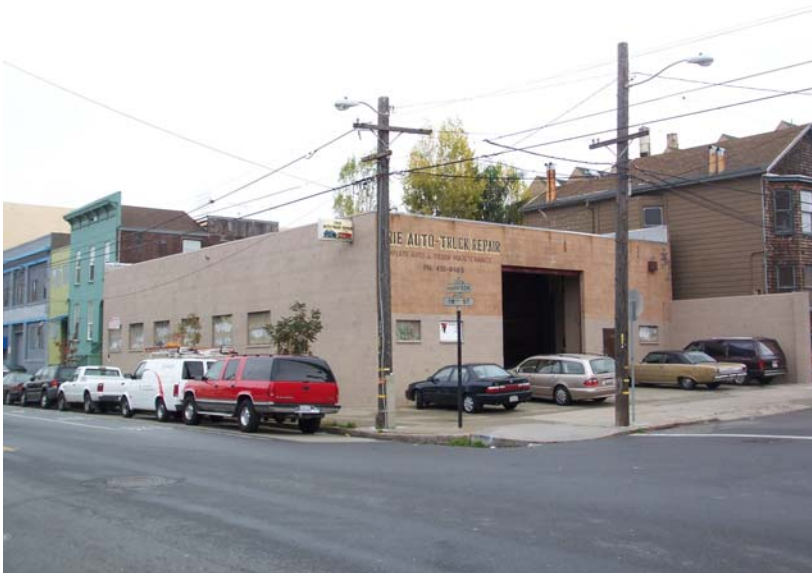
3014 18th Street is a one-story, reinforced-concrete, industrial building capped by a flat roof. The utilitarian building occupies a 4,847 sq ft lot on the northeast corner of 18th and Harrison streets and is set back from the south lot line. The rectangular-plan building sits atop a concrete foundation. The primary facade, which is three bays wide, faces south; the secondary facade, which is eight bays wide, faces west. The left bay of the primary facade features two window openings with concrete slip sills; these have been in-filled. The middle bay features a double-height garage, while the right bay features the building's main entrance—a metal door—and, to its right, a window opening similar to that found at the left bay. Except for the two rightmost bays of the secondary facade, which present blank wall faces, the secondary facade features in-filled fenestration such as that found on the primary facade. Both facades terminate in a false parapet with metal coping. The building appears to be in good condition.

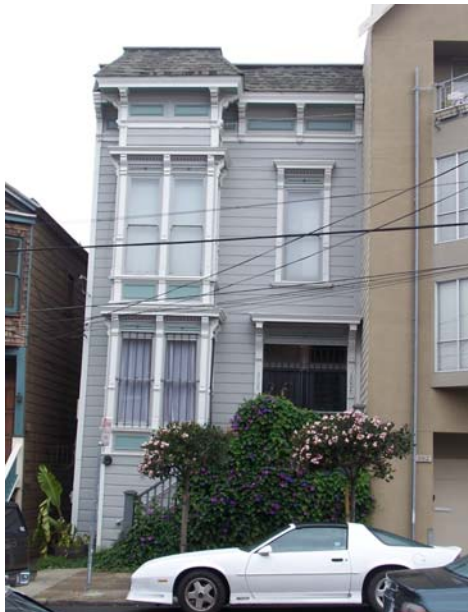
3004 18th Street is a two-story, wood-frame, multiple-family residential building clad in rustic channel siding and capped by a flat roof. The San Francisco Stick/Eastlake-style dwelling occupies a 2,367 square-foot lot on the north side of 18th Street between Harrison and Alabama streets. The ell-plan building sits atop a concrete foundation. The primary facade, which is two bays wide, faces south. Stairs with a wooden balustrade lead to the building's gated, recessed main entrance on the right bay of the first floor: two, single-light, wooden doors beneath transoms and bracketed hood molding. The left bay offers a boxed bay window composed of one-over-one, double-hung, wood-sash windows above spandrel panels but below denticulated, bracketed entablatures with button ornament. This bay window extends to the second floor. The right bay of the second floor features a single one-over-one, double-hung, wood-sash window with wooden surrounds, a lug sill, and a denticulated, bracketed entablature with button ornament. The facade terminates in a paneled frieze, brackets, dentils, cornice, and a shingled, shed-roofed false parapet with metal coping. The building appears to be in good condition.

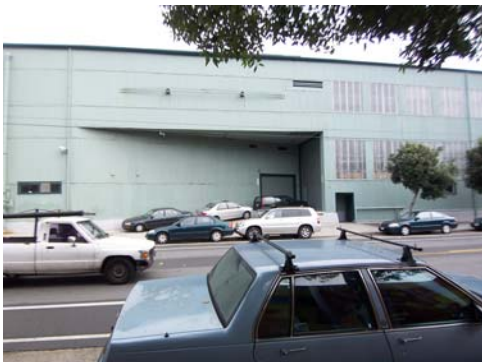
100_5520.JPG, 11/19/2007, west elevation rail car entrance

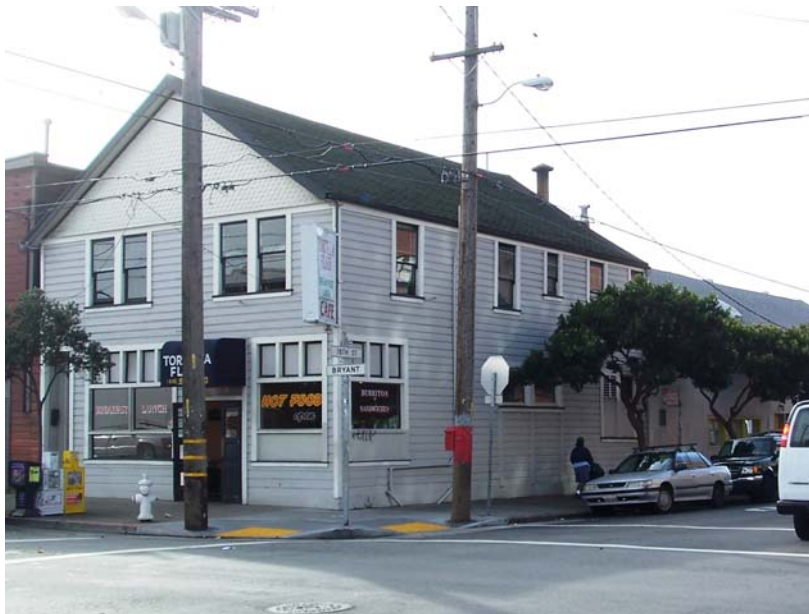
2000 Bryant Street is one of five buildings, each recorded separately, that occupy a 20,000 sq. ft. lot spanning from Bryant Street to Florida Street along the south side of 18th Street. This record is for the two story front gabled frame residential over commercial building at the southwest corner of Bryant and 18th streets. Cladding is horizontal rustic redwood, with fish scale shingles in the gable area. The ground floor has a central retail entrance on Bryant Street, with display windows flanking and wrapping the corner to 18th Street, featuring multi-lite transom windows. There is a recessed entrance at the left of the Bryant Street elevation, accessing the upper floor. The upper floor has wooden sash double hung windows 1/1: two pairs in the east facade and five single windows in the north facade. On the 18th Street facade there are two fixed sash windows and a display window that has been concealed. The building appears in good condition.

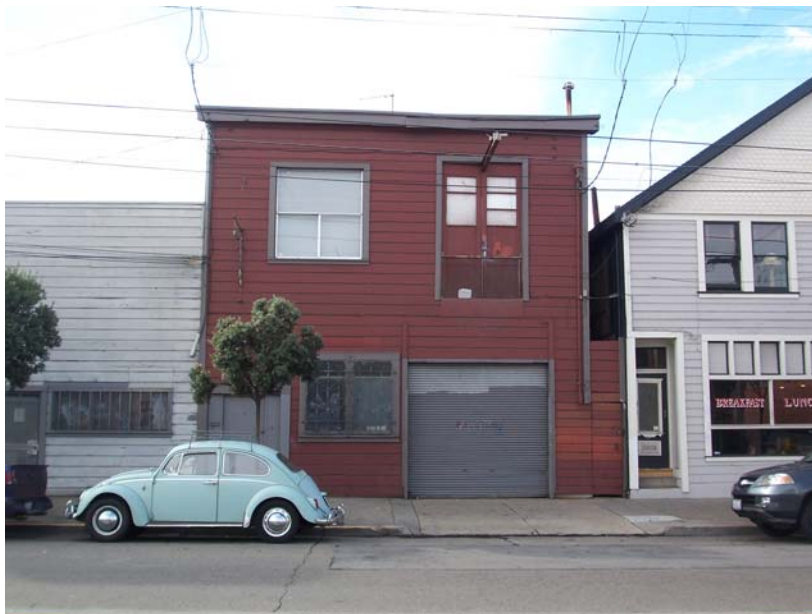
2010 Bryant Street is one of five light industrial buildings, each recorded separately, on a 20,000 sq.ft. lot spanning from Bryant Street to Florida Street along the south side of 18th Street. This record is for the two-story, wood-frame industrial building facing Bryant Street in the middle of the parcel. It has a butterfly roof behind a parapet on the east elevation. Cladding is horizontal rustic wood. There is a vehicular entrance at the right, with rollup metal door, a pedestrian entrance at the left with a wooden door and sidelights. On the second floor at the right is a loading bay with double glazed wooden doors and a projecting lift beam. To the left is a window with sliding aluminum sash, 1/2. The building appears to be in good condition.

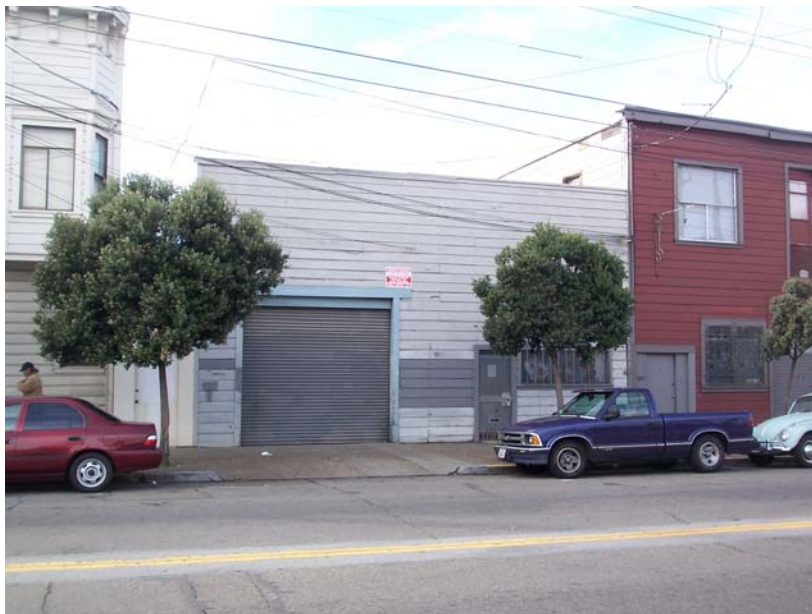
2014 Bryant Street is one of five light industrial buildings, each recorded separately, on a 20,000 sq.ft. lot spanning from Bryant Street to Florida Street along the south side of 18th Street. This record is for the one-story, wood-frame industrial building facing on Bryant Street at the south side of the parcel. It has a front gabled roof concealed behind a parapet on the east elevation. Cladding is horizontal rustic siding. There is a vehicular entrance with roll-up metal door at the left, and a pedestrian entrance and window at the right. A security gate and bars cover the entrance and window. The rear of the building has light metal shed extensions. The building appears to be in fair condition.

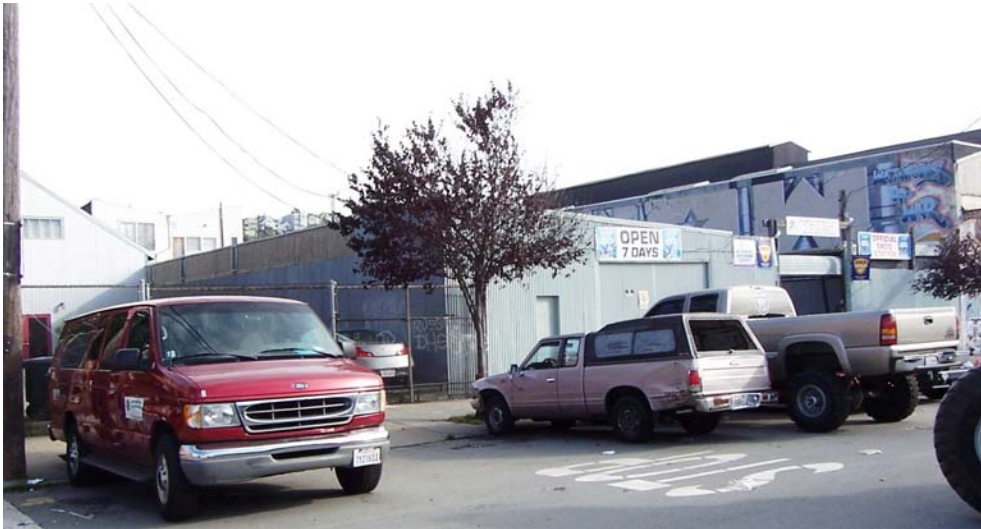
*P5b. Photo (view, date, accession #
100_5586.JPG, 11/19/2007,
view to E

689 Florida Street is one of five light industrial buildings, each recorded separately, on a 20,000 sq. ft. lot spanning from Bryant Street to Florida Street along the south side of 18th Street. This record is for the one-story, wood-frame flat roofed building clad in corrugated metal that faces on Florida Street in the middle of the parcel. It has a vehicular and a pedestrian entrance on Florida, both with metal doors. The building appears to be in fair condition.

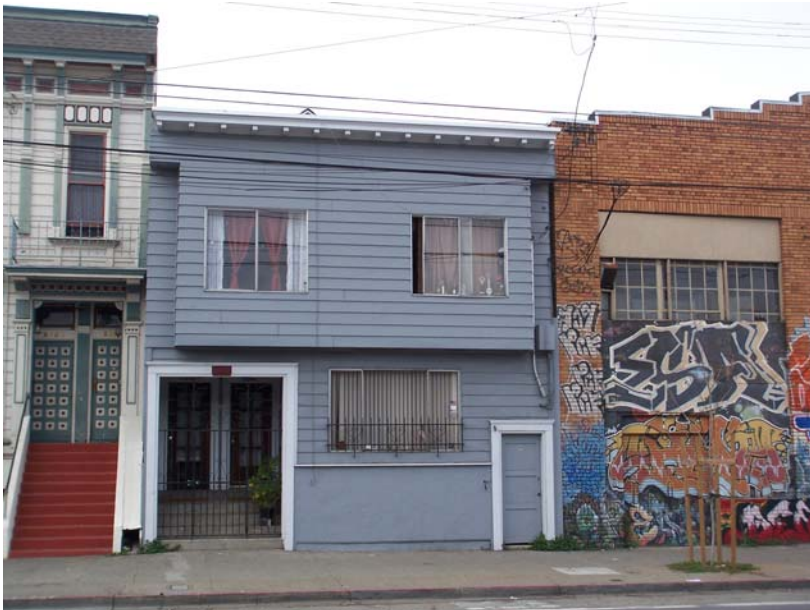
This is a two story multiple family building located on a 1,837 sq ft lot on the west side of Bryant Street between 18th & 19th streets. The building is clad in drop wood siding and capped with a flat roof and gable roof in the rear portion of the building. The first story features two recessed glass and wood panel doors accessed by terrazzo steps. An aluminum slider window is featured next to the entrances and a wood panel door is on the right side. The second story features two aluminum slider windows. The building terminates with a bracketed cornice. The building appears in good condition.

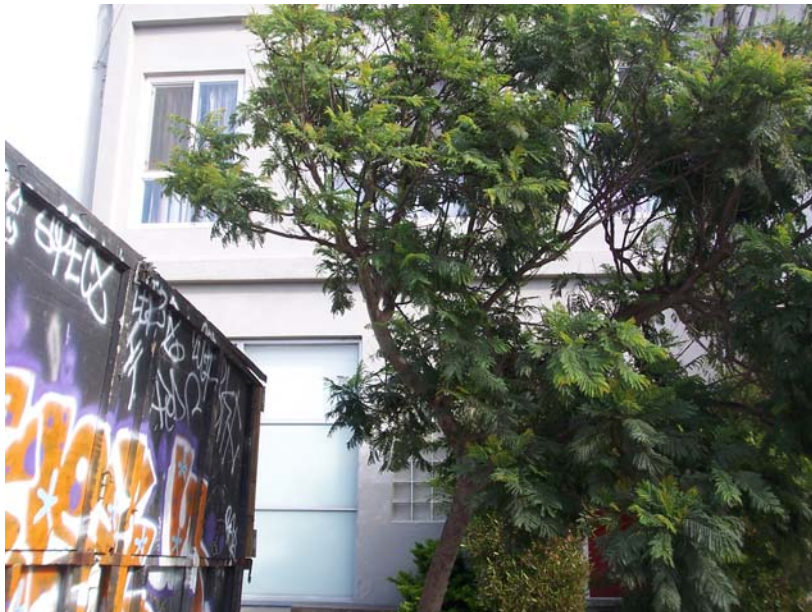
This is a two story multiple family building clad in stucco, capped with a flat roof and located on an L-shaped lot. The building faces west on Florida Street and a two-car garage occupies part of the property and faces south on 19th Street. The first story has a fixed large opaque six-pane aluminum framed window, glass block and a flush wooden door. The second story features three, tri-part aluminum framed windows. The building terminates with a plain stucco frieze above a box cornice. The building appears to be in good condition.

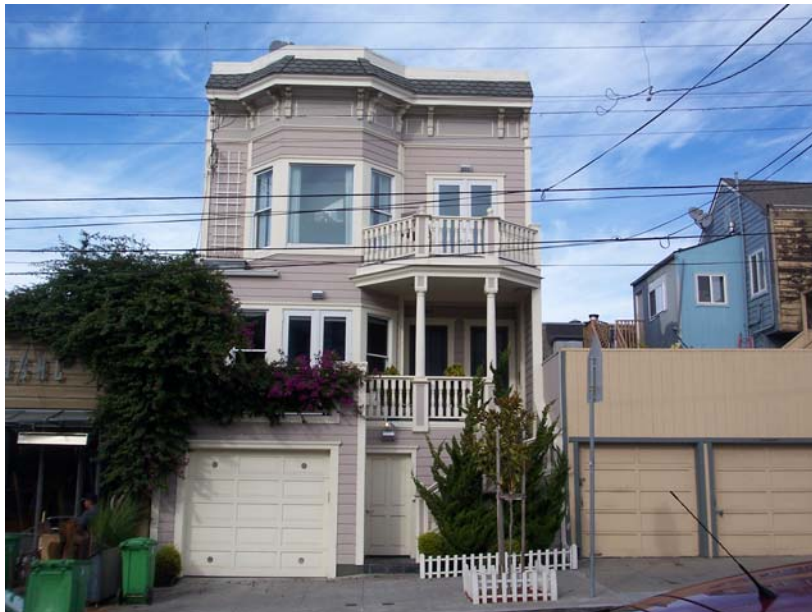
2810 19th Street occupies a 75 x 25 square-foot lot on the north side of 19th Street between Bryant and Florida streets. Built in 1900, it is a three-story, wood-frame, residential building. The rectangle-plan building, clad in shiplap, rests on a concrete foundation and is capped by a low-pitch, front-gabled roof. Its primary facade, which is two bays wide, faces south. The left bay of the first floor features a garage that extends to the lot's south lot line. The right bay features a secondary entrance—a paneled wood door beneath hood molding—and a quarter-turn staircase with a wooden balustrade and newel post. The steps lead to a turned portico balustrade supported by two Doric columns at the right bay of the second floor. The portico shades the building's main entrance: two, paneled wood doors with wood surrounds. The left bay of the second floor features single-light, vinyl, French doors flanked by one-over-one, double-hung, vinyl-sash windows. The doors lead onto the flat roof of the garage, which terminates in a stepped parapet. The left bay of the third floor features a bowed bay window composed of a fixed-pane, center window and, at the sides, one-over-one, double-hung, vinyl-sash windows. The right bay features single-light, vinyl-sash, French doors that open onto the turned portico balustrade. The facade terminates in a false parapet and shingled, hipped rooflet supported by brackets and an entablature with a paneled frieze and projecting cornice. The building appears to be in good condition.

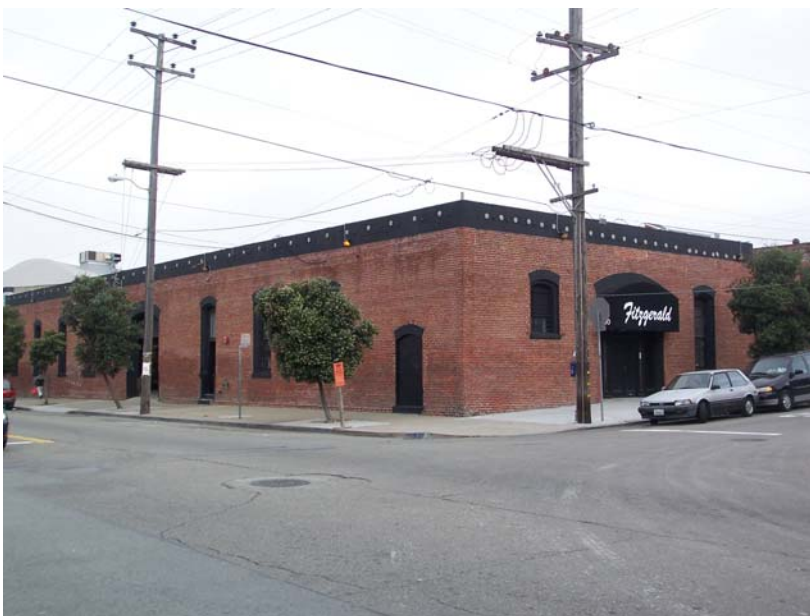
2750 19th Street is a complex of three related industrial buildings that occupy a 15,000 sq ft lot at the northeast corner of Bryant and 19th streets. This form records the one-story, heavy timber-frame brick industrial building capped by a flat roof. It is rectangular in plan and sits atop a brick foundation. Fenestration consists of deep-set wooden sash in rowlock arched openings with lug sills. There are six such windows on the Bryant elevation, along with a central vehicular entrance and two pedestrian doors. On the 19th Street elevation is a central pedestrian entrance with a canvas canopy, flanked by one window on each side. The southern window is at a mezzanine height, while the northern, and those on Bryant Street are full height. The building terminates with a low, unadorned parapet. The building appears to be in good condition.

East of the main building, facing on 19th Street, is a one-story frame building clad in horizontal rustic siding. There are three wooden sash windows, each 3x4 lites, at the south of the facade, and a vehicular pass-through at the northern end, with a roll-up metal door. This leads to an open space at the center of the parcel. The building appears in good condition.

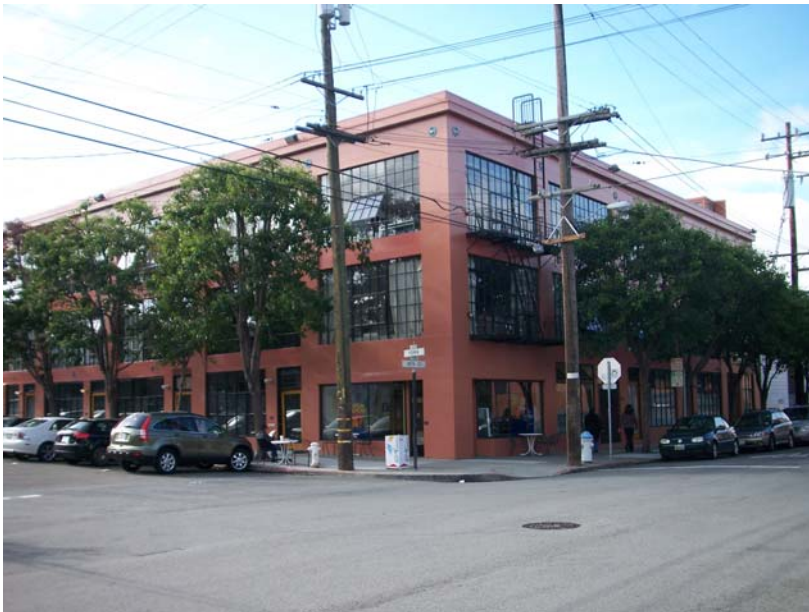
600 York Street is a three-story, reinforced-concrete industrial building finished in stucco and capped by a flat roof. The utilitarian building occupies a 9,875 sq. ft. lot at the southwest corner of York and 18th streets. It is square in plan, built to the lot lines with five structural bays on each side. Each bay on the upper floors contains a tripartite grid of metal framed industrial sash windows, and the ground floor has retail storefronts. The 18th Street elevation has metal fire escapes outside each set of windows. The building appears in good condition.

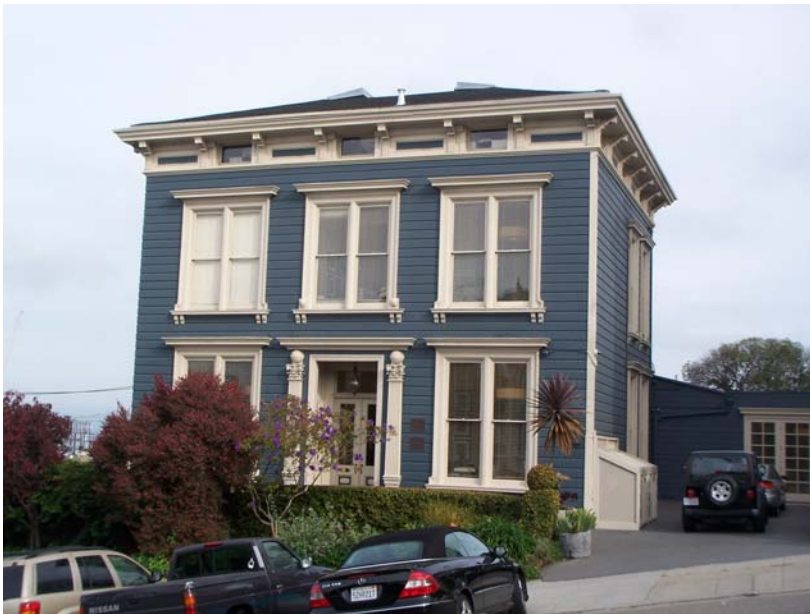
301 Pennsylvania Avenue is a two-story, wood-frame, Italianate-style dwelling clad in rustic wood siding and capped with a hipped roof. Originally used as a residence, the building has been used as a hospital and is presently used as office space. The building is located on the southeast corner of Pennsylvania Avenue and 18th Street and the primary façade faces west. The building sits in the center of a 10,000 sq ft lot and is surrounded by sloping landscaped garden. The first story features a recessed glass and wood paneled double door which is flanked by paired 1/1 double hung wood sash windows. The recessed entrance is framed by Corinthian pilasters and an entablature and shelters a pair of glazed wood doors crowned by a transom. The second story features three 1/1 double-hung wood sash windows with bracketed sills, wooden surrounds and projecting entablatures. The facade terminates with a paneled friezes penetrated by fixed windows and surmounted by a projecting bracketed cornice. The south side of the building features a paved driveway and a rehabilitated garage with non-historic, multi-pane French doors. Historic photographs indicate that the building originally had a cupola, or "widow's walk," at the roof level. The minimally altered building appears to be in good condition.

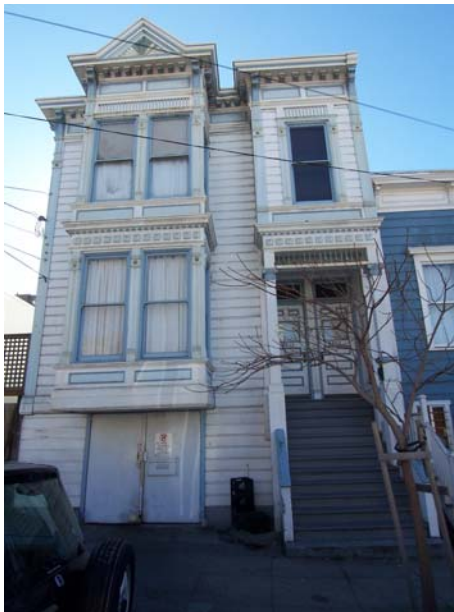
2813-2815 19th Street occupies a 50 x 30 foot lot on the south side of 19th Street between Bryant and Florida streets. Built in 1906, it is a three-story, wood-frame, residential building. The rectangle-plan building, clad in shiplap, rests on a concrete foundation and is capped by a flat roof. Its primary facade, which is two bays wide, faces north. The left bay of the first floor features wooden, double doors, while the right bay features a straight flight of wooden stairs with a closed, wooden balustrade. The stairs lead to the building's main entrance at the second floor: two, single-light, paneled wood doors beneath transoms. Two, square columns with Ionic capitals and spindlework, as well as an entablature with a paneled frieze, egg-and-dart molding, and cornice, further distinguish the entrance. The columns support the boxed bay window at the right bay of the building's third floor, which is distinguished by a one-over-one, double-hung, wood-sash window with wood surrounds, pilasters that terminate with button ornaments, hood molding, and spandrel panel. This same fenestration characterizes the left bays of the second and third floors, which offer a continuous boxed bay window topped by a gable pediment with a sunburst ornament. The facade terminates in a false front parapet, brackets, and an entablature with a paneled frieze and denticulated cornice. The building appears to be in good condition.

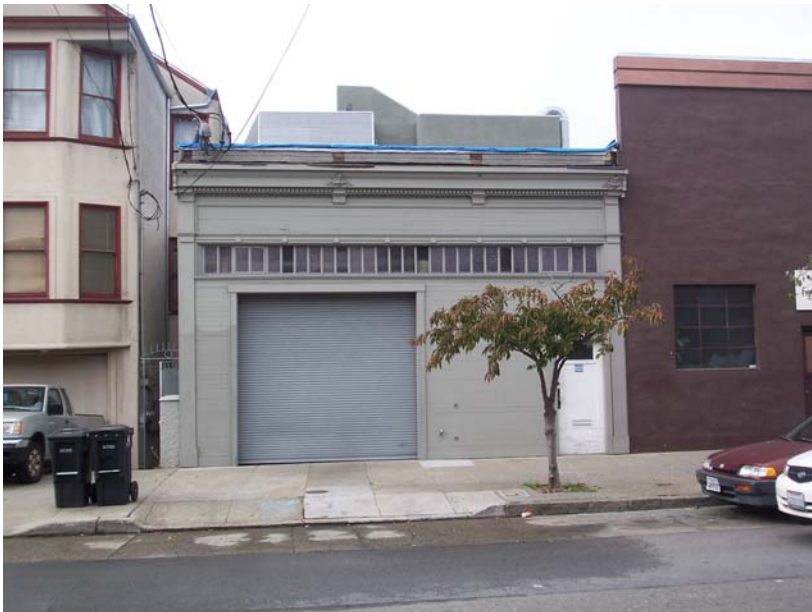
This is a one story commercial building clad in flush wood siding and capped with a flat roof. The building faces east on Bryant Street and fills the 2,500 sq ft lot. A metal rollup garage door and flush wood door characterize the front façade. Above the garage and door is a transom band of wooden sash windows. The building terminates with decorative molding, a plain frieze, dentil molding and cartouches on a molded cornice. The building appears to be in good condition.

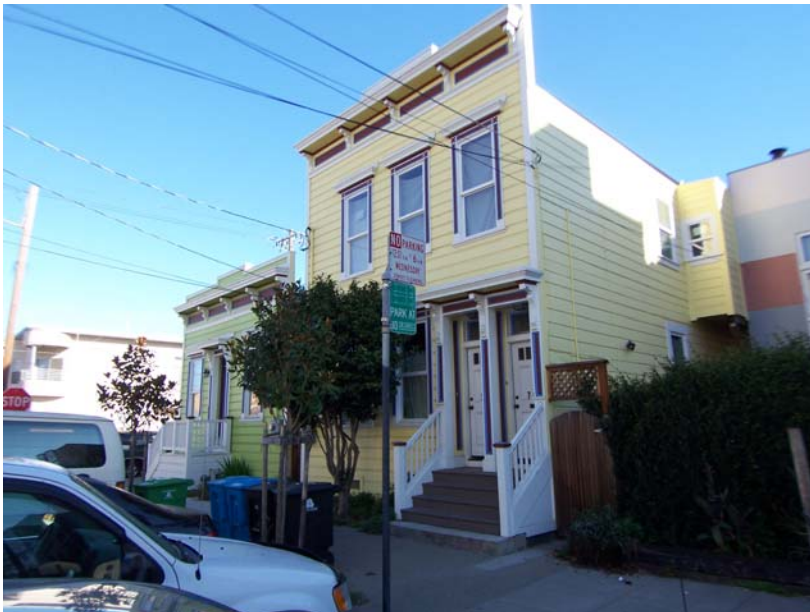
2817 19th Street occupies a 25 x 50 square-foot lot on the south side of 19th Street between Bryant and Florida streets. Built in 1880, it is a two-story, wood-frame, residential building. The rectangle-plan building, clad in clapboard, rests on a concrete foundation and is capped by a gabled roof. Its primary facade, which is three bays wide, faces north. The right bay of the first floor features paneled wood, double doors beneath a transom. The other two bays feature a quarter-turn staircase with wooden steps and an open, wooden balustrade leading to a paneled, recessed entryway at the middle bay of the second floor. Bracketed hood molding and a single-light, paneled wood door beneath a transom further distinguish the entryway. The left bay of the second floor offers a single one-over-one, double-hung, wood-sash window with hood molding, wood surrounds, and lug sills. The right bay of the second floor offers a paired version of the same window type. The facade terminates in a stepped parapet, brackets, and entablature with a paneled frieze and projecting cornice. The building appears to be in good condition.

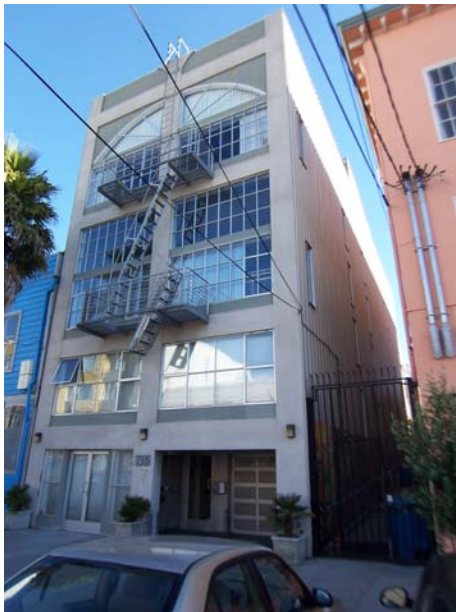
777 Florida Street is a three-story, wood-frame, industrial building, finished in stucco at its south and west elevations and shiplap elsewhere and capped by a flat roof. The utilitarian building, which has been rehabilitated for residential use, occupies a 133 x 117 foot lot at the northeast corner of 20th and Florida streets. The rectangular-plan building sits atop a concrete foundation. The primary facade, which is six bays wide, faces south; the secondary facade, which is eight bays wide, faces west; and the tertiary facade faces east. There is a one-story, flat-roofed addition with multi-light, fixed-pane windows on the eastern elevation. The building's recessed main entrance, in the third bay from the left on the primary facade, has a two-light, metal-sash door with wood surrounds and a transom. There is a secondary entrance in the sixth bay, with a two-light, metal-sash door beneath a three-light, metal-sash, awning-window transom. The remaining bays feature pairs of six-over-six, double-hung, wood-sash windows with wood surrounds and iron grills. Similar windows are found on the upper stories, paired on the primary elevation and single on all others. All facades terminate in a bracketed, projecting cornice. The building appears to be in good condition.

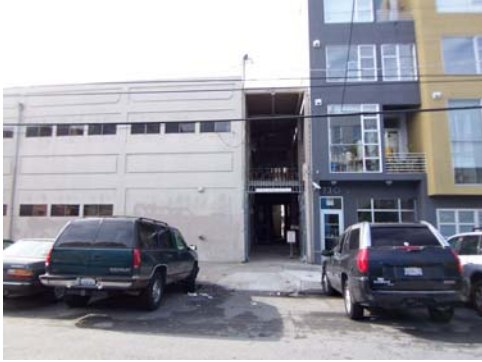
Resource Name or # (Assigned by Recorder) 750 FLORIDA ST
Date 6/12/08

100_5530.JPG, 11/19/07, view to W, pass through

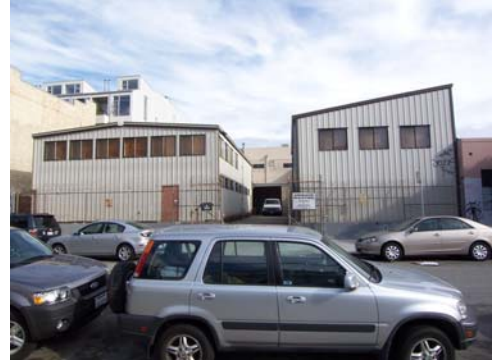
100_5529.JPG, 11/19/07, view to E, Alabama St. elevation

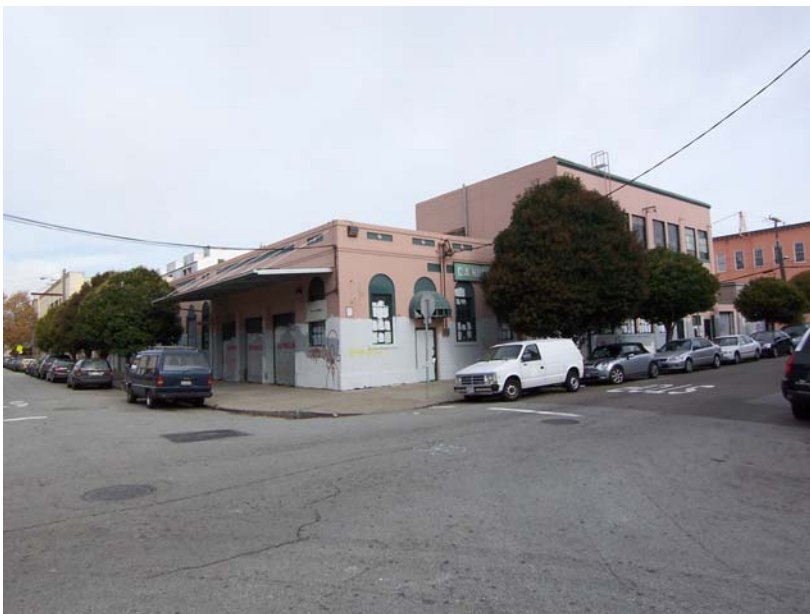
Four buildings occupy this 12,654 square-foot flag lot at the northeast corner of 20th and Alabama streets. The first is a one-story, concrete-frame, industrial building on the eastern portion of the lot. The square-plan building, finished in stucco, sits atop a concrete foundation and is capped by a flat roof. The primary facade, which is three bays wide, faces south; the secondary facade, also three bays, faces east. Pilasters divide each bay of both facades, with the primary facade presenting a blank wall in all but the rightmost bay, which features the building's main entrance: a gated door. All bays of the secondary facade offer nine-light, fixed windows with concrete lug sills. Both facades terminate in a parapet with molded coping. The building appears to be in good condition.

The second building, a three-story industrial building rectangular in plan oriented along an east-west axis, is connected to the first by a concrete wall with a large vehicular entrance, behind which is a small surface parking lot. The building, finished in stucco, sits atop a concrete foundation and is capped by a flat roof. The primary facade, which is four bays wide, faces south. Pilasters topped by carved eagles divide each bay. Except for the second leftmost bay, which features a blank wall face, each bay of the first floor features a door with wood surrounds. Each of the upper story bays feature two 16-lite, fixed windows with a lug sill connecting the paired windows. A fire escape fronts the two rightmost bays of the second and third floors. The facade terminates in a parapet with metal coping. The building appears to be in good condition.

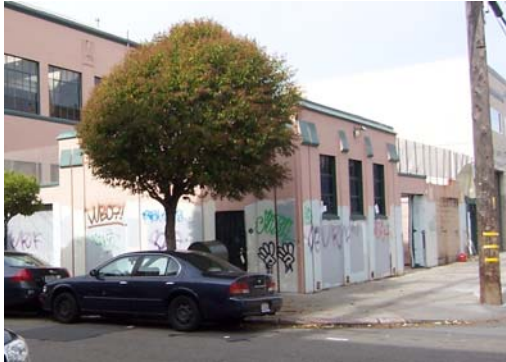
Resource Name or # (Assigned by Recorder) 3000 20TH ST
Date 6/12/08

100_5244-1.JPG, 11/16/07, view to NW,
building 1

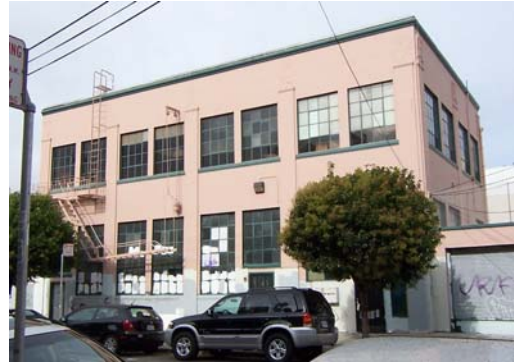
100_5245-1.JPG, 11/16/07, view to N, building
2

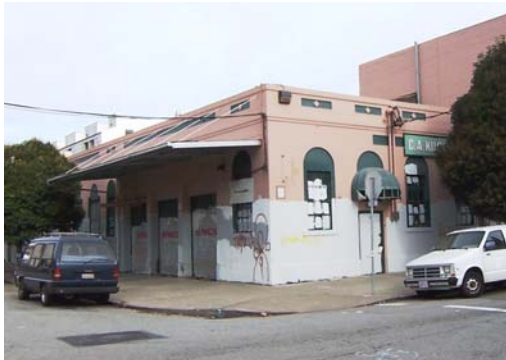
100_5246-1.JPG, 11/16/07, view to NE,
building 3

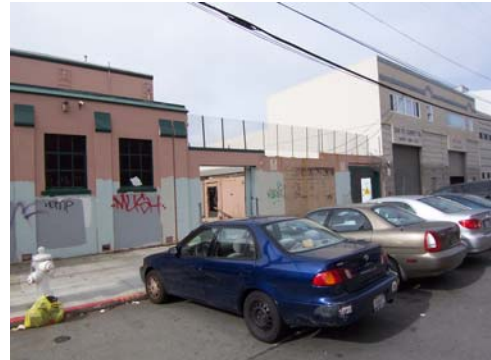
100_5243.JPG, 11/16/07, view to W, building 4
behind wall
