Historic Preservation Commission Executive Summary Historic Resource Survey Findings INFORMATIONAL PRESENTATION: JUNE 1, 2011 ADOPTION HEARING: JUNE 15, 2011

Date: May 25, 2011
Case No.: **2011.0401U**
Project: Showplace Square / Northeast Mission Historic Resource Survey
Staff Contact: Moses Corrette – (415) 558-6295
moses.corrette@sfgov.org
Reviewed By Tim Frye – (415) 575-6822
tim.frye@sfgov.org
Recommendation: **Adoption of survey findings**

**SHOWPLACE SQUARE SURVEY
SAN FRANCISCO, CALIFORNIA
FINAL**

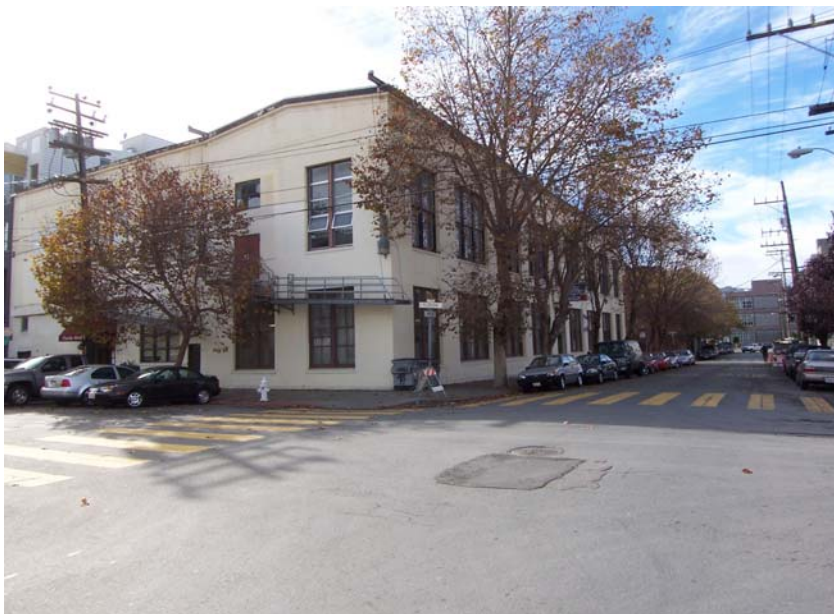
2929 19th Street is a two-story, reinforced-concrete, industrial building finished in stucco and capped by a sawtooth roof. The utilitarian building occupies a 17,532 square-foot flag lot on the south side of 19th Street between Alabama and Florida streets. The ell-plan building sits atop a concrete foundation. Its primary facade, which is nine bays wide, faces north to 19th Street; its secondary facade, which is five bays wide, faces east to Florida; and its tertiary facade faces west to Alabama Street. The left and rightmost bays of the primary facade's first and second floors feature paired four-over-four, double-hung, wood-sash windows with wood surrounds and concrete lug sills. The remaining bays feature trios of the same window type, not pairs, except for the center bay of the first floor, which offers the building's main entrance: a tile, recessed, gated entryway with scrolled brackets, denticulated hood molding, and paired, single-light, metal-sash doors beneath a transom. The bay above it contains a six-over-six, double-hung, wood-sash window above a boxed sign projecting from the building. The second leftmost bay of the secondary facade's first floor features a recessed entryway beneath a fabric awning reading, "Florida Street Cafe." Except for the leftmost bays of the first and second floor, which feature blank wall faces, the remaining bays feature different fenestration. The two rightmost bays of the first floor feature paired four-over-four, double-hung, wood-sash windows with wood surrounds and concrete lug sills, while the bay to the left offers a multi-light, fixed-pane window with wood surrounds. Second-floor fenestration features fixed-pane, vinyl-sash windows above vinyl-sash, awning windows; also found are double doors that open onto fire escapes. The tertiary facade offers a mix of these window

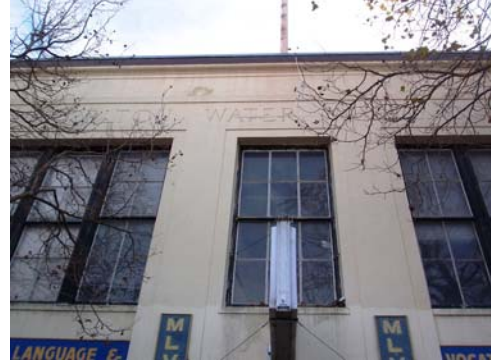
100_5542.JPG, 11/19/2007, detail, Pelton Water Works

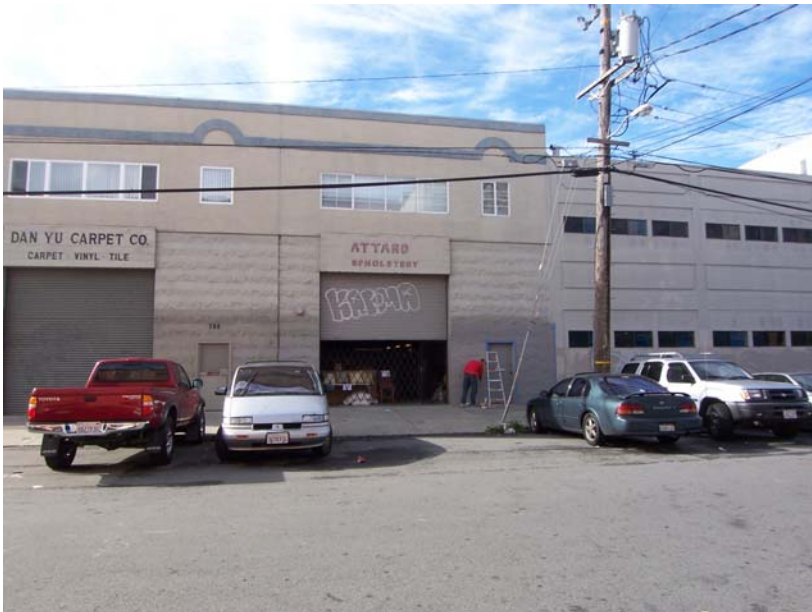
770 Florida Street is a two-story, reinforced-concrete industrial building capped with a flat roof. The building is located on the west side of Florida Street between 19th and 20th streets. The primary façade features a loading bay with a metal roll-up door and a flush metal door. The second story features modern multi-pane vinyl windows. The building terminates with plain cornice. The building appears to be in good condition.

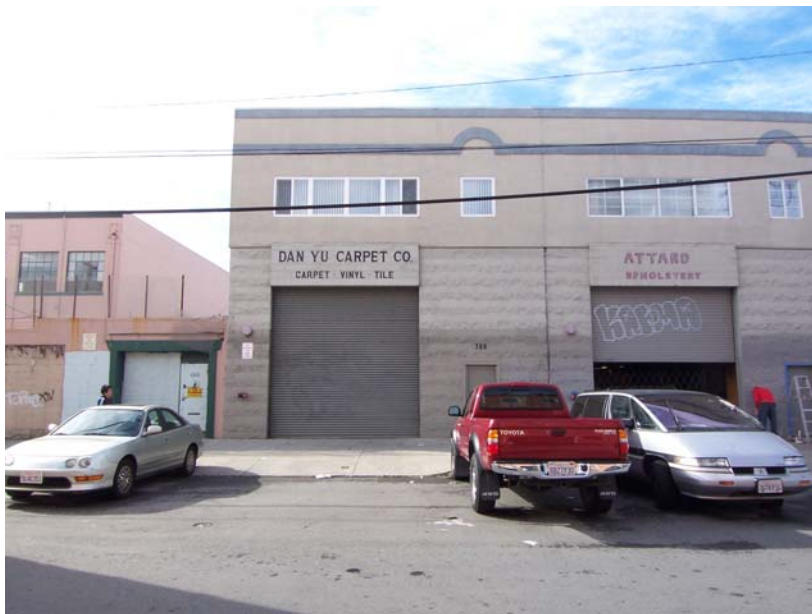
780 Florida Street is a two-story, reinforced-concrete industrial building capped with a flat roof. The building is located on the west side of Florida Street between 19th and 20th streets. The primary façade features a loading bay with a metal roll-up door and a flush metal door. The second story features modern vinyl slider windows. The building terminates with plain cornice. The building appears to be in good condition.

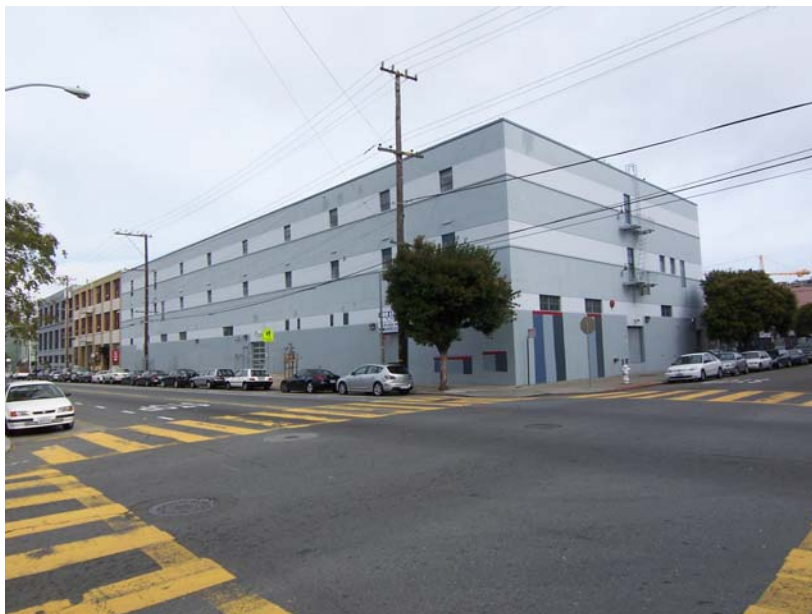
Two buildings occupy this 41,496 sq ft half-block lot on the north side of 20th Street between Harrison and Alabama streets. 3130 20th Street is a four-story, reinforced-concrete industrial building finished in stucco and capped by a flat roof. It occupies the western half of the block; the other half features a surface parking lot with chain-link fencing along its perimeter. The rectangle-plan building sits atop a concrete foundation. The primary facade, which is eleven bays wide and oriented towards the parking lot, faces east; the secondary facade, which is five bays wide, faces south toward 20th Street; the tertiary facade faces west toward Harrison Street. Blank wall faces dominate the primary facade's first floor, broken only by the occasional metal door. A cantilevered, shed-roofed awning shades the first floor, while the upper story bays feature a mix of three-lite, metal-sash, awning windows and multi-lite, fixed-pane, metal-sash windows, though blank wall faces dominate. Blank wall faces also dominate the secondary and tertiary facades, which are interrupted only by the type of fenestration previously described. The building is further distinguished by a thin, concrete belt course that divides each story. All facades terminate in concrete coping, and the building appears to be in good condition.

The second building can be found at the northeast corner of the lot. It is a one-story, concrete-frame building likely used for storage. Its primary facade, which is three bays wide, faces south. The right and middle bays feature two-light and single, fixed-pane windows, respectively. The left bay offers a blank wall face, and the

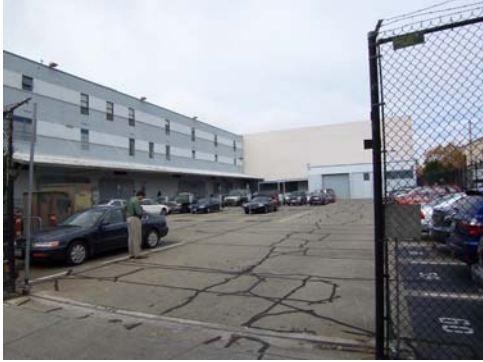
Resource Name or # (Assigned by Recorder) 3130 20TH ST
Date 6/12/08

100_5247.JPG, 11/16/07, view to NW,
ancillary building at rear

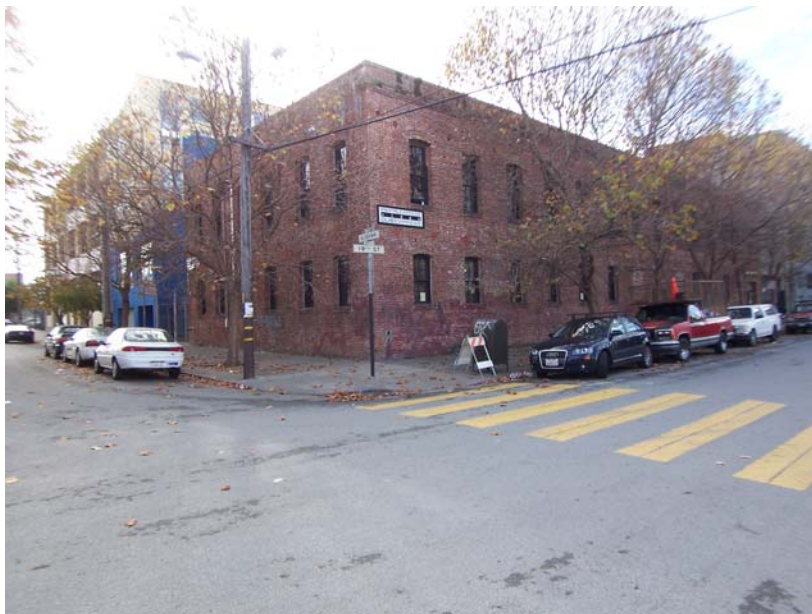
3001 19th Street is a two-story, heavy timber-frame, brick industrial building capped by a flat roof. The American Commercial-style building occupies a 9,875 square-foot lot at the southwest corner of Alabama and 19th streets. The rectangular-plan building sits atop a concrete foundation. Its primary facade, which is 14 bays wide, faces north; its secondary facade, which is six bays wide, faces east. The rightmost bay of the primary facade's first floor features the building's main entrance: a door with multi-light, glass-block sidelights and transom. Soldier-course brick surrounds and a sign reading, "John Longvy Co," above the door further distinguishes the entryway. The remaining bays feature arched, four-over-four, double-hung, wood-sash windows with radiating, brick surrounds, except for the center bay, which features a secondary entrance of paired doors. All bays of the secondary facade feature the same fenestration type found at the primary facade. The primary facade terminates in a brick cornice. The building appears to be in good condition.
