SAN FRANCISCO PLANNING DEPARTMENT

Certificate of Appropriateness Case Report

Filing Date: January 7, 2013
Case No.: 2013.0009A
Project Address: 130 Sutter Street
Historic Landmark: No. 37 – The Hallidie Building
Zoning: C-3-O (Downtown Office)
80-130F Height and Bulk District
Block/Lot: 0288/027
Applicant: Bruce Albert, The Albert Group
114 Sansome Street, Suite 710
San Francisco, CA 94104
Staff Contact Kelly H. Wong - (415) 575-9100
kelly.wong@sfgov.org
Reviewed By Tim Frye - (415) 558-6822
tim.frye@sfgov.org

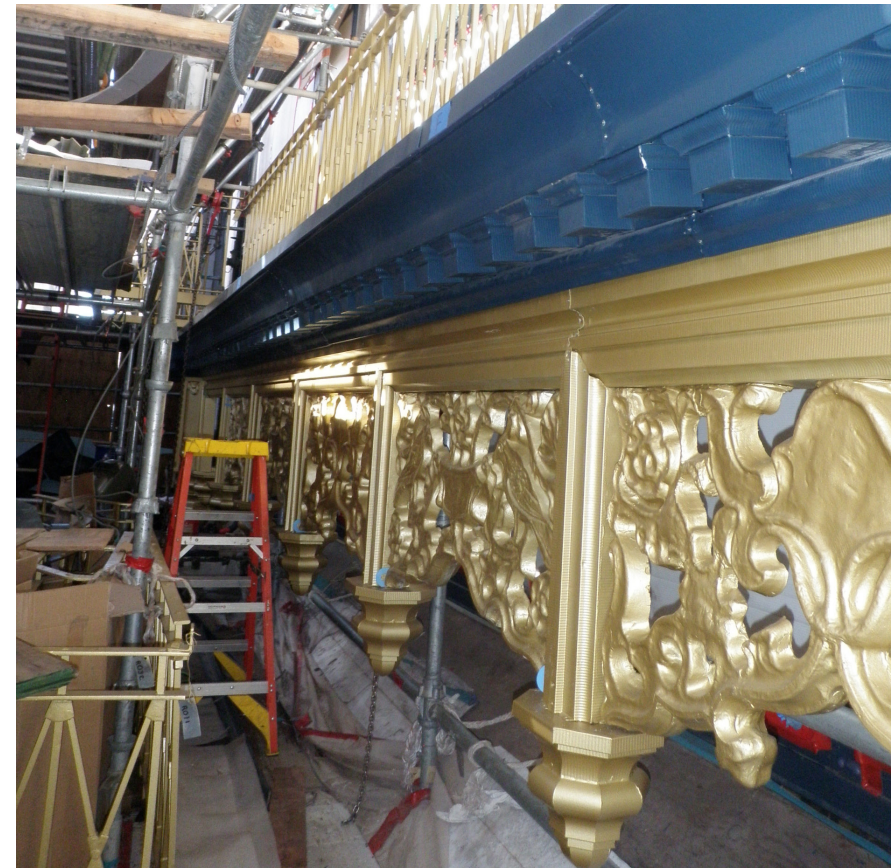
Phase 1 repairs to the Hallidie Building are nearing completion. The work included repairs to the decorative frieze panels, the sheet metal details, and the metal railings. Phase 1 also included replacement of the fire escape ladders, repairs to exterior structural steel framework, steel I-beam replacement. A request to add the necessary repairs to the outer perimeter of the curtain wall to Phase 1 was later granted in January 2012.

Current Repairs: Reinstallation of frieze panels and railings at second floor

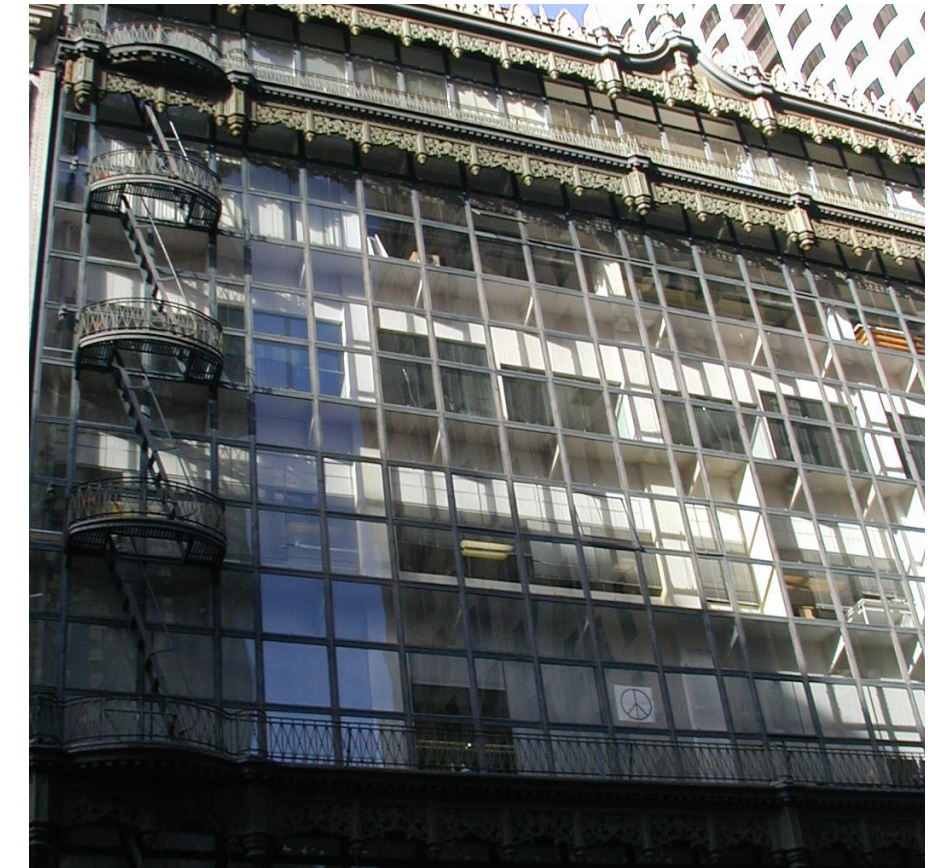
The curtain wall system exhibits both distortion and rusting cover plates. The corrosion was most severe at the balcony and fire escape locations. This deterioration is currently being addressed as part of the Phase 1 work which included the perimeter of the curtain wall.

Photo of curtain wall prior to Phase 1

Phase 2 will include the center portion of the curtain wall and address corrosion that exists beneath the vertical cover plates where the curtain wall windows meet. The cover plates are severely distorted and will be replaced in kind. Windows will largely be repaired, painted and reinstalled. Where windows have deteriorated beyond repair, they will be replaced in kind. New structural anchors will be installed to address deficiencies in the structural support of the curtain wall. The anchors will be installed on the interior side of the curtain wall and will not be visible. The curtain wall will be painted using the building's historical colors as approved as part of the Historic Preservation Commission Motion 0131.

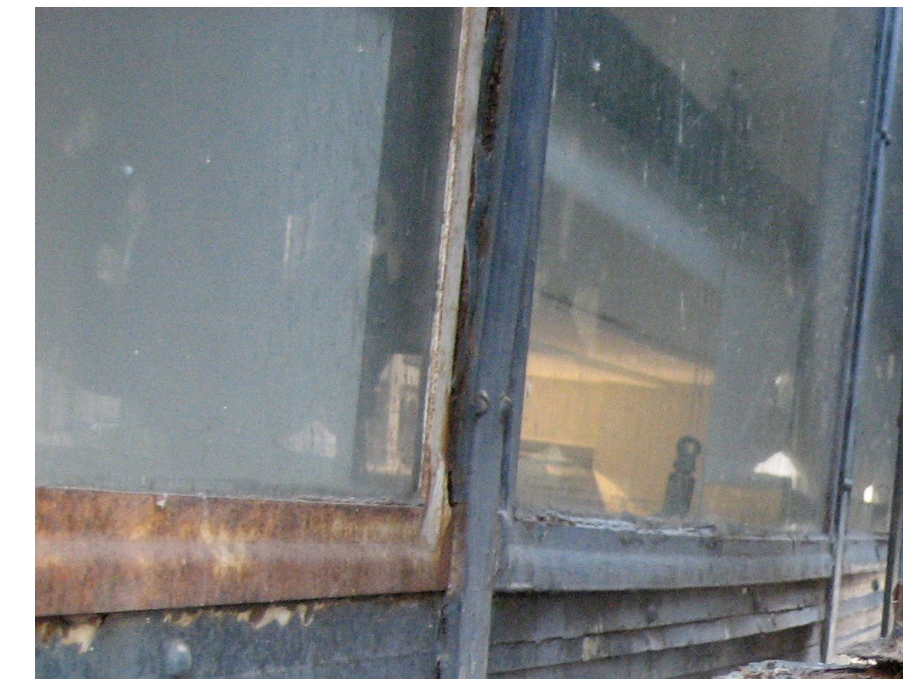
The windows located at the center of the curtain wall on the 4th, 5th, and 6th floors were not part of Phase I work and still require repair. These windows exhibit deterioration primarily along the steel vertical plates. The vertical plates are warped and have created pockets where water can accumulate and result in corrosion.

Rust at windows

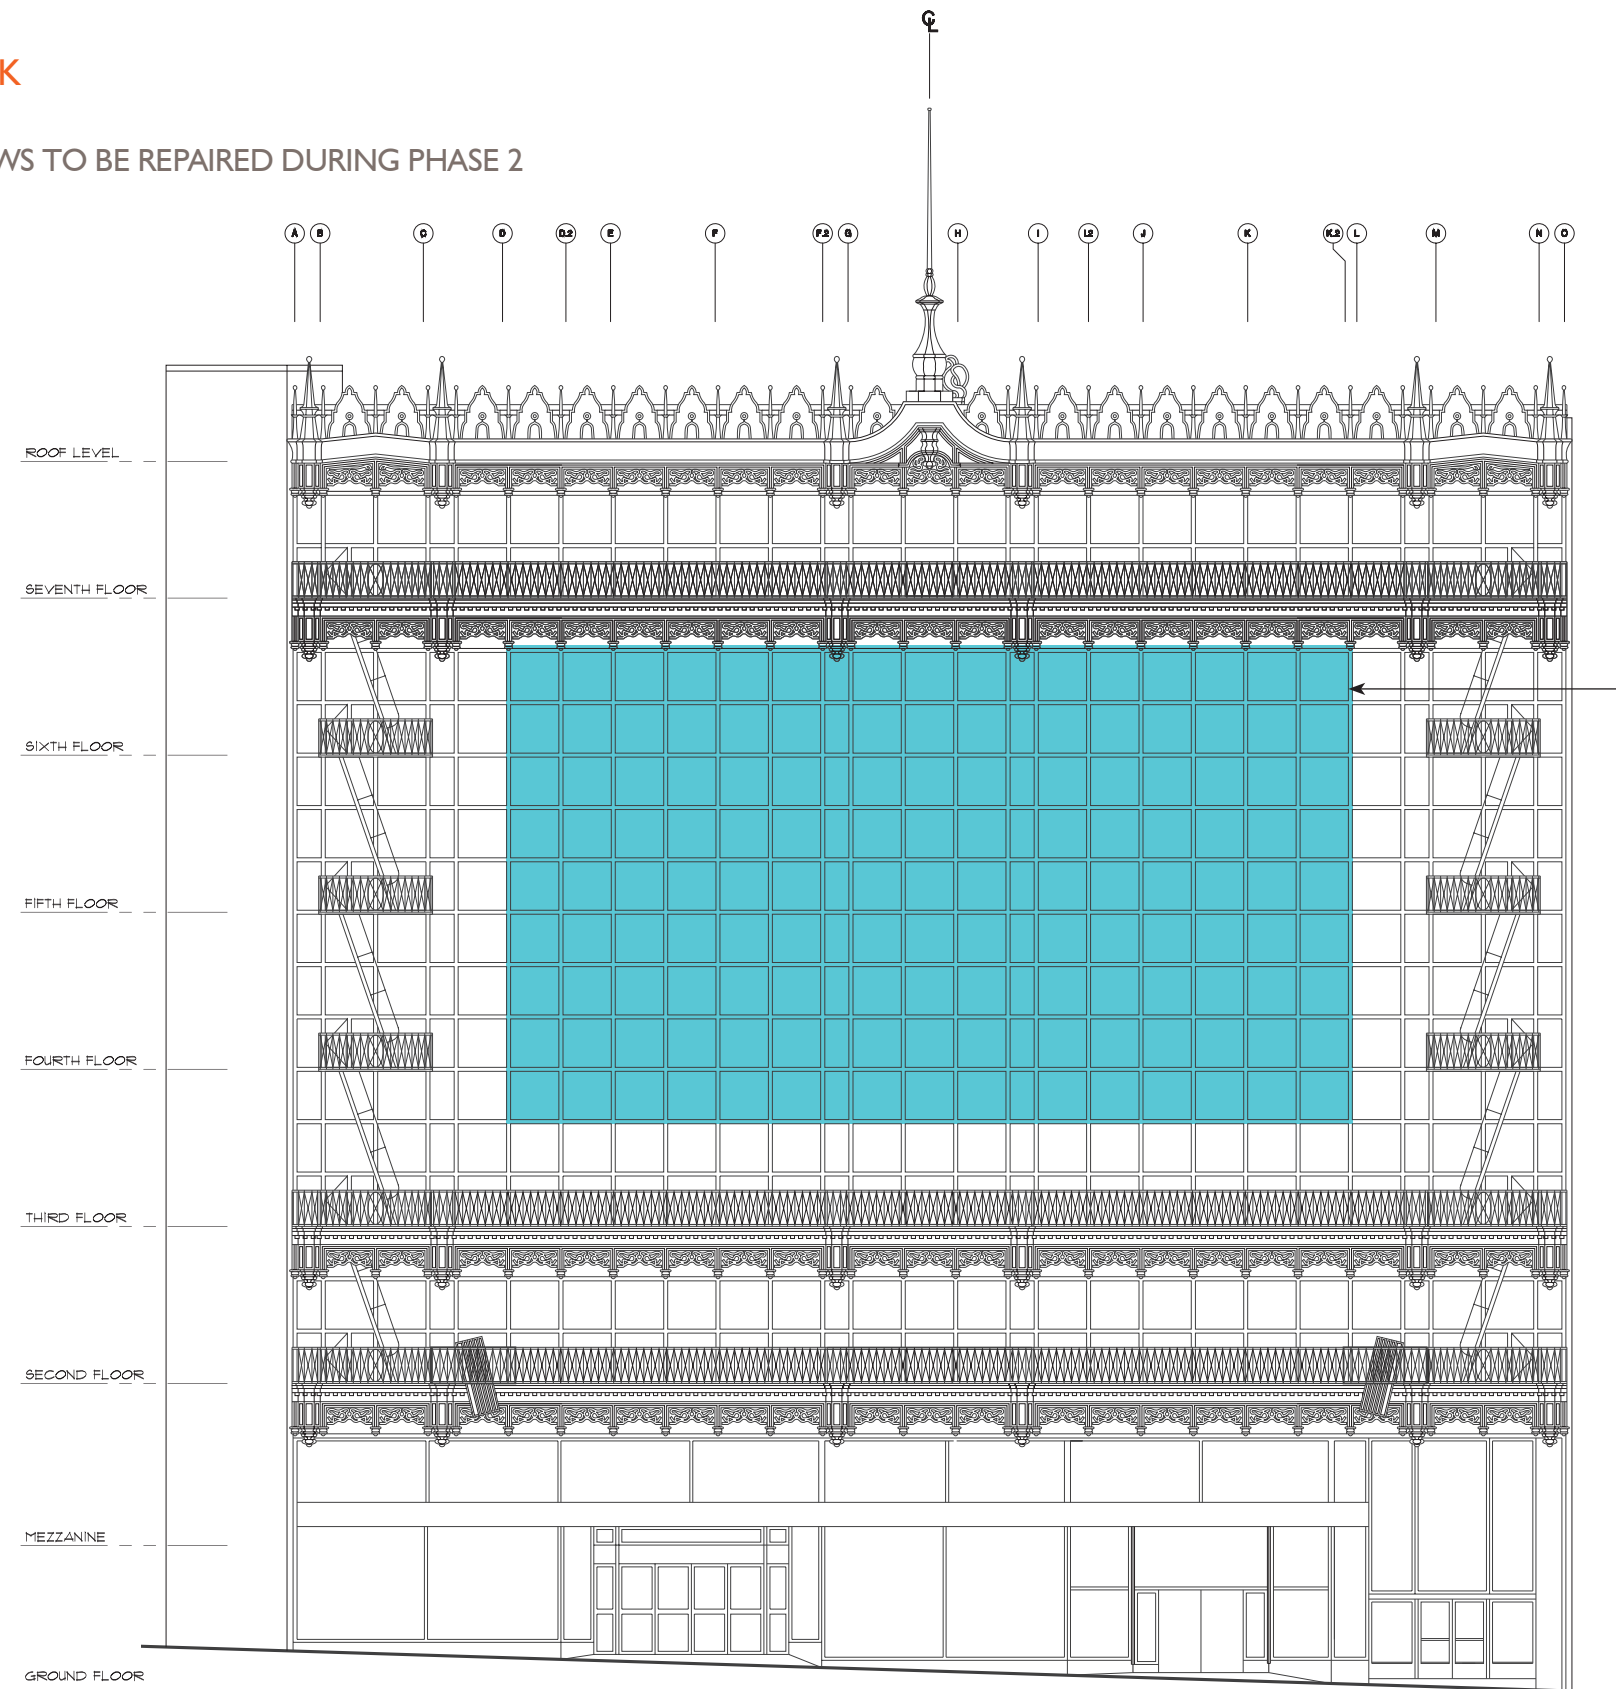
PROPOSED WINDOWS TO BE REPAIRED DURING PHASE 2

Curtain wall improvements will use the methods reviewed and reviewed by the Planning Department and Historic Preservation Commission in January 2012:

1. Silicone sealant will be applied to the curtain wall components to prevent water intrusion.
2. New structural anchors will be installed at the intermediate mullions of each floor to provide additional support of the curtain wall. The new anchors will be located on the interior side of the curtain and will not be visible.

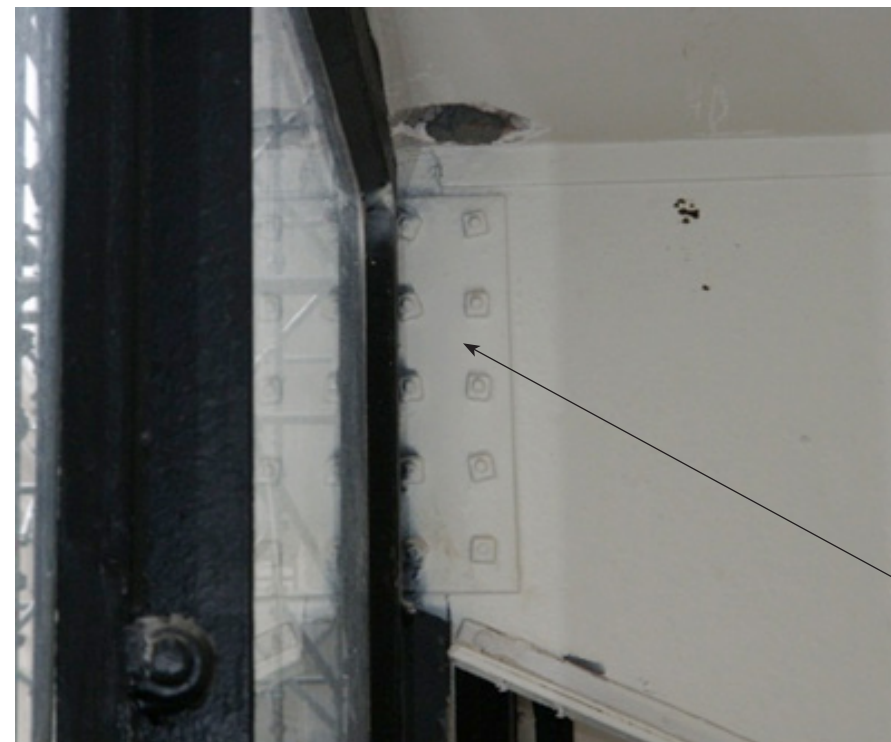
existing bolt plates connect T-mullion to outrigger plates; additional outriggers and bolt plates will match existing design

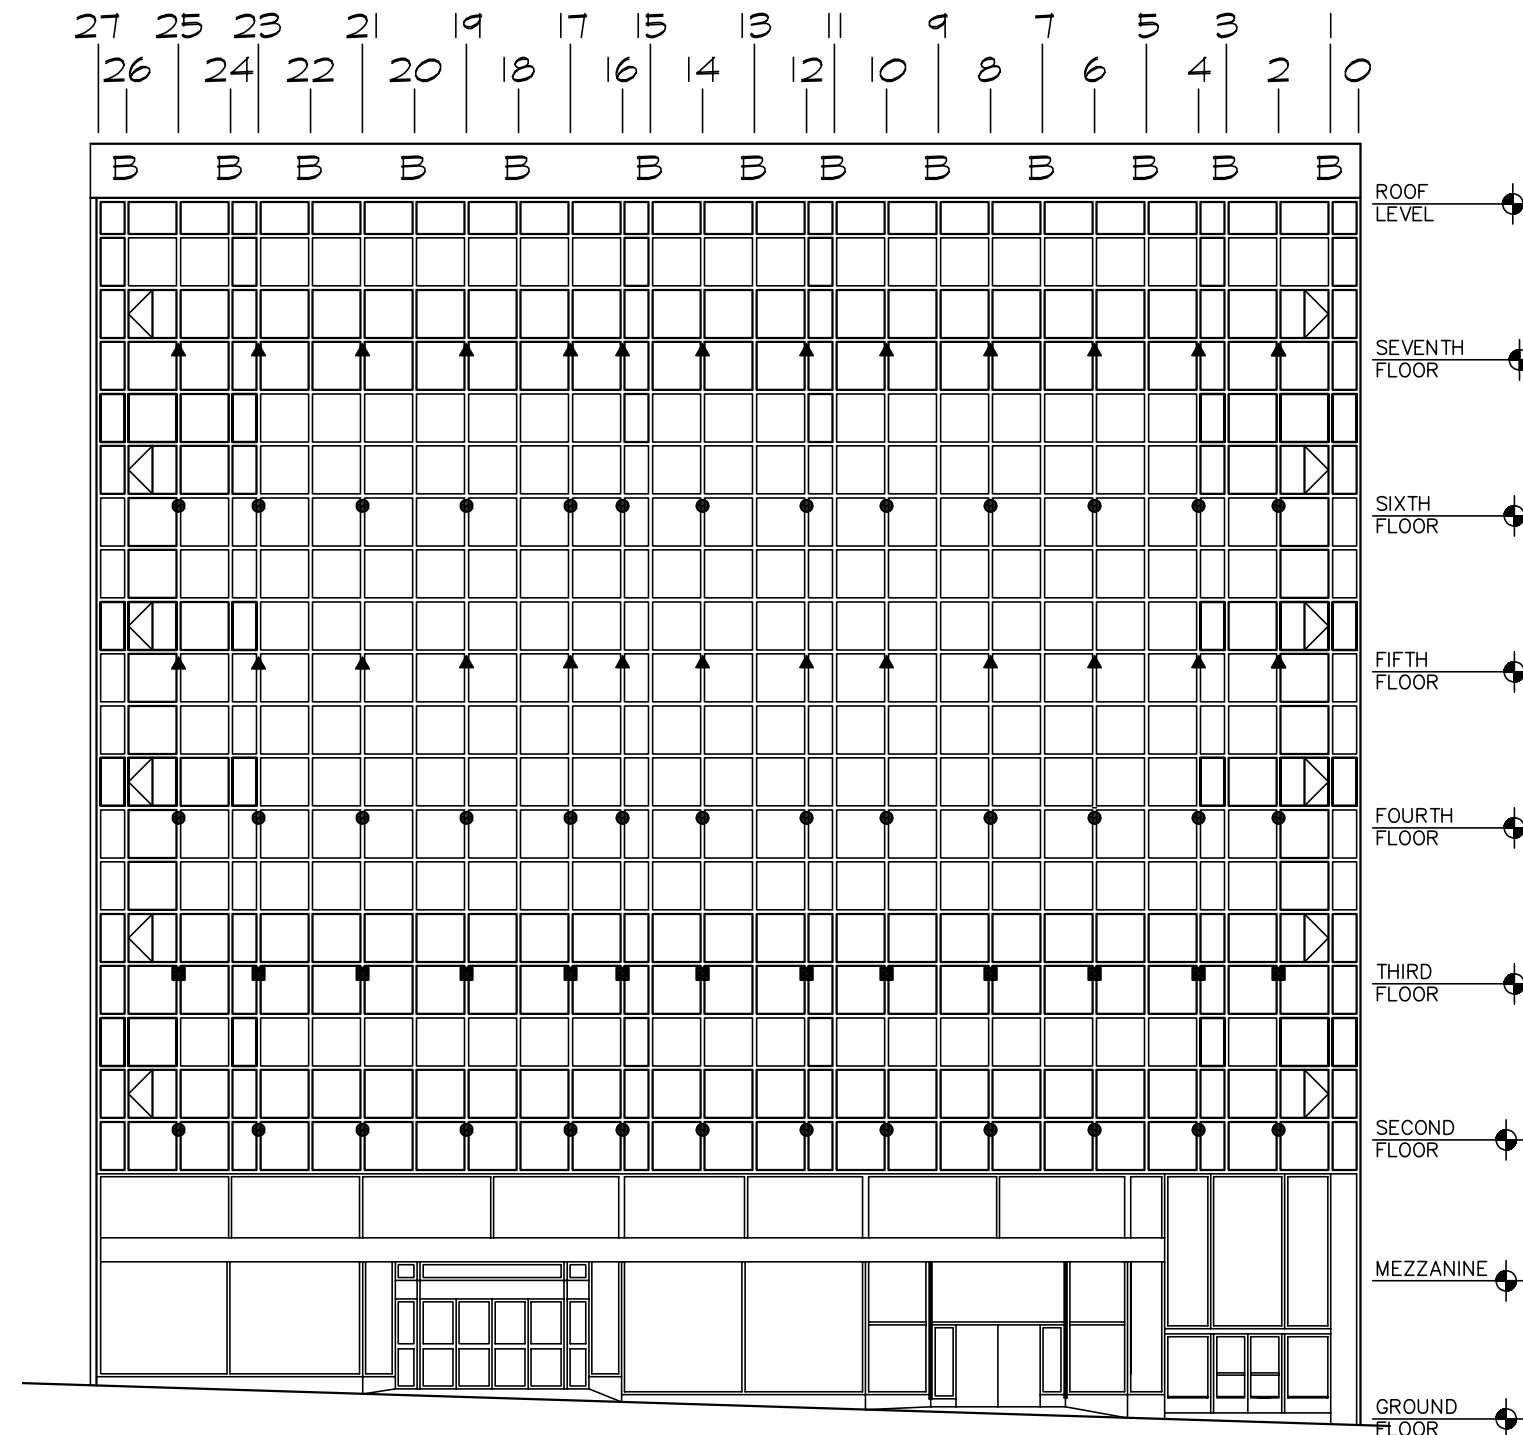
The alignment and existing supports of the curtain wall were evaluated by the team's structural engineer, Toft, de Nevers & Lee, and additional bearing and wind anchors at the interior of each floor were recommended to stabilize the facade. The anchors will be installed on the interior side of the building and will not be visible from the exterior. Two different types of anchors will be installed:

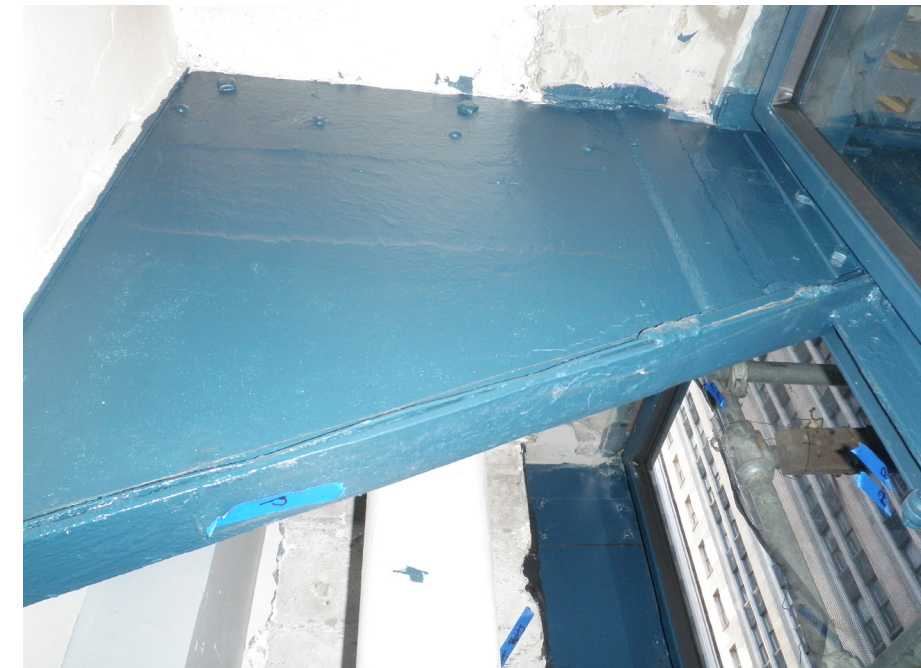
1. Bearing Anchors: these are similar to the original outriggers in design and scale. New bearing anchors will be different from the original in that the two steel plates that connect each bearing anchor to the T-mullion are approximately 2 inches wider than the steel plates located at the original outriggers.
2. Wind Anchors: these anchors are smaller in scale and have a different design than the existing outriggers.

Existing anchor

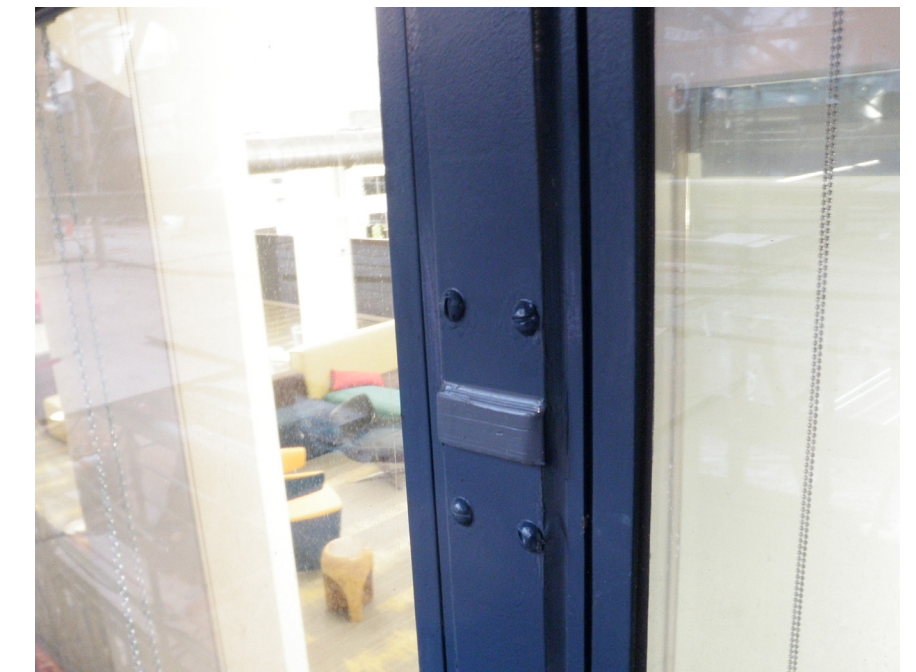
Splice at cover plate (photo from Phase 1)

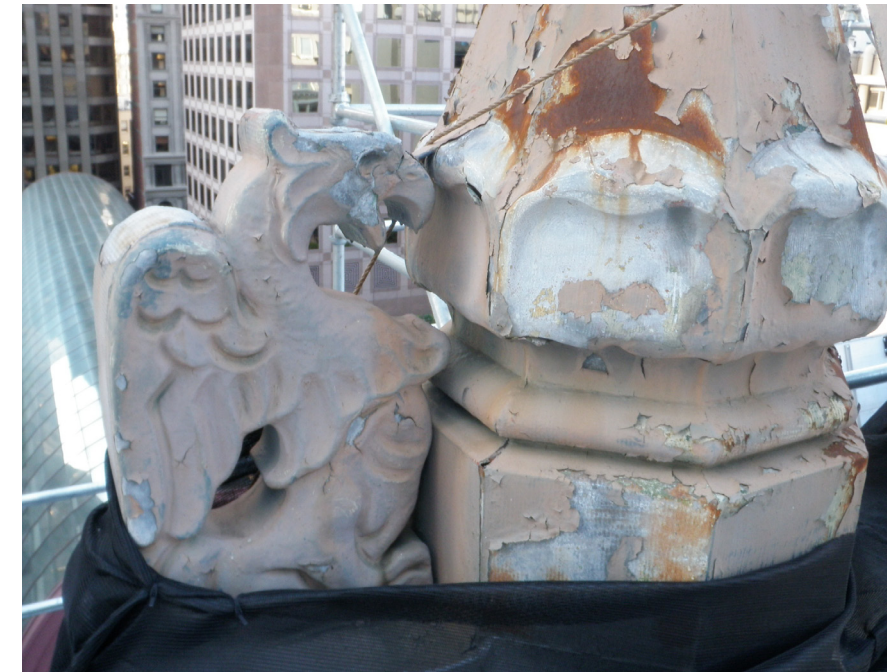
Griffin prior to repairs

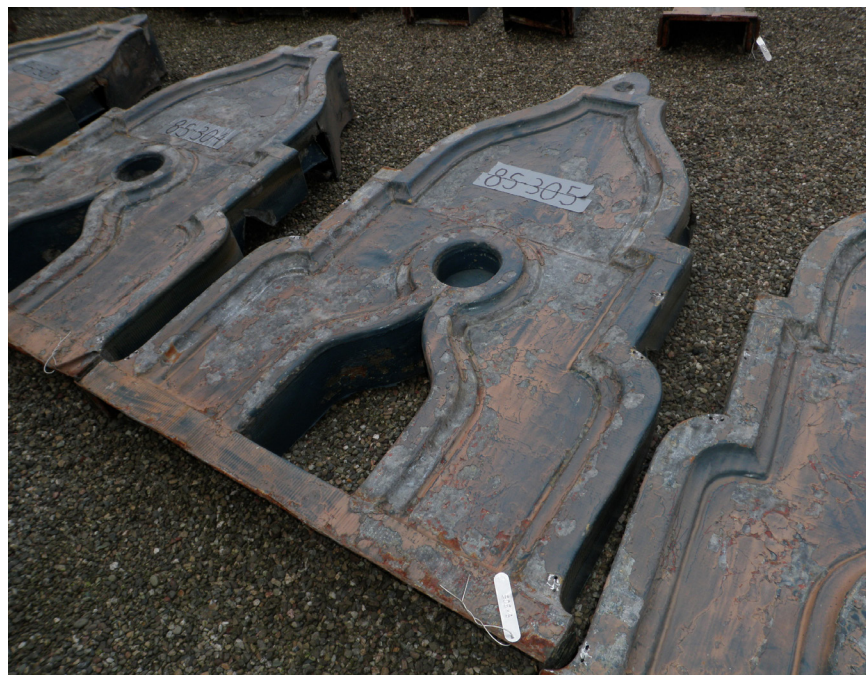
Roof cornice elements prior to repairs

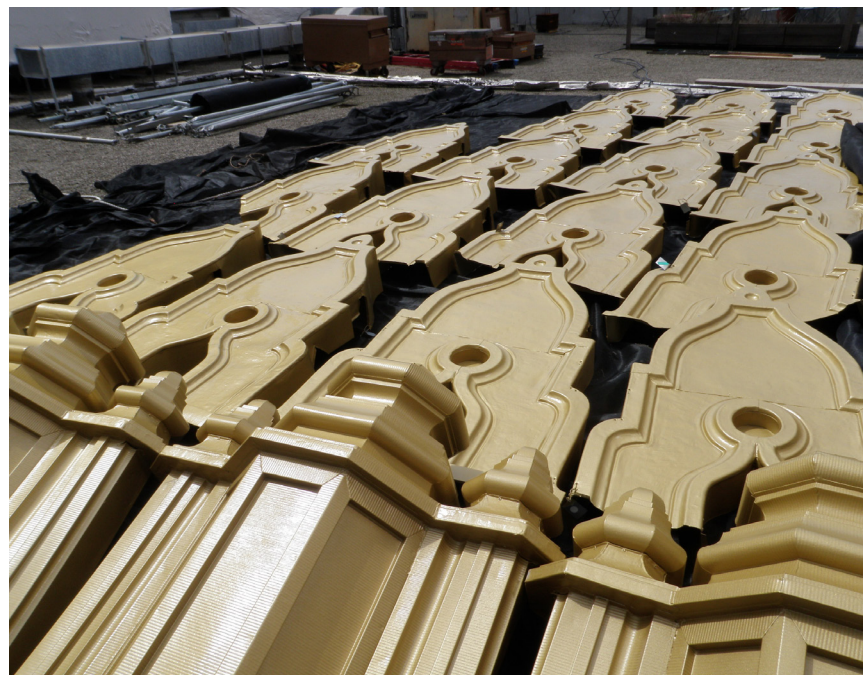
Roof cornice elements after repairs

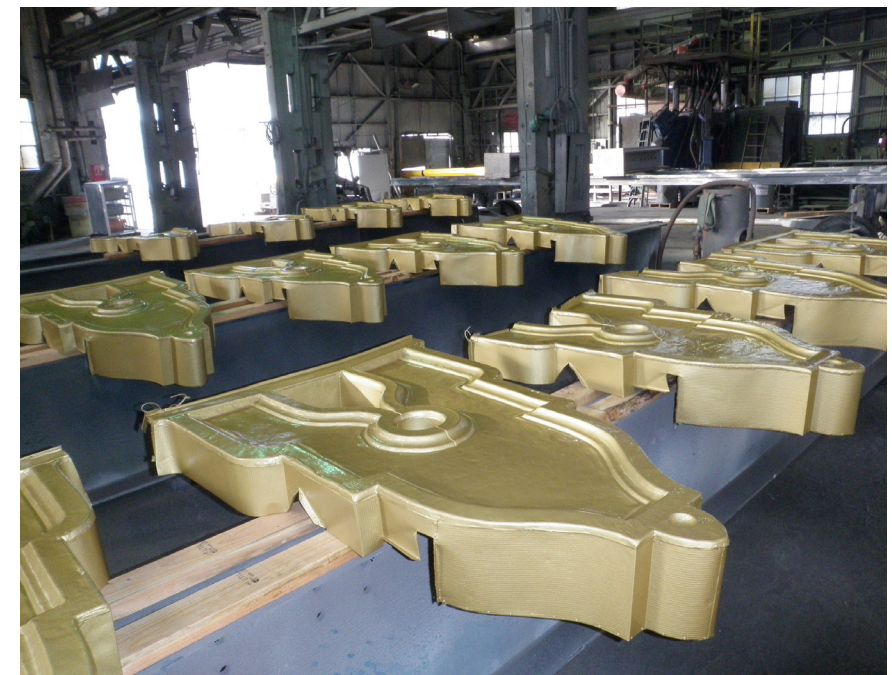
Roof cornice elements during repairs

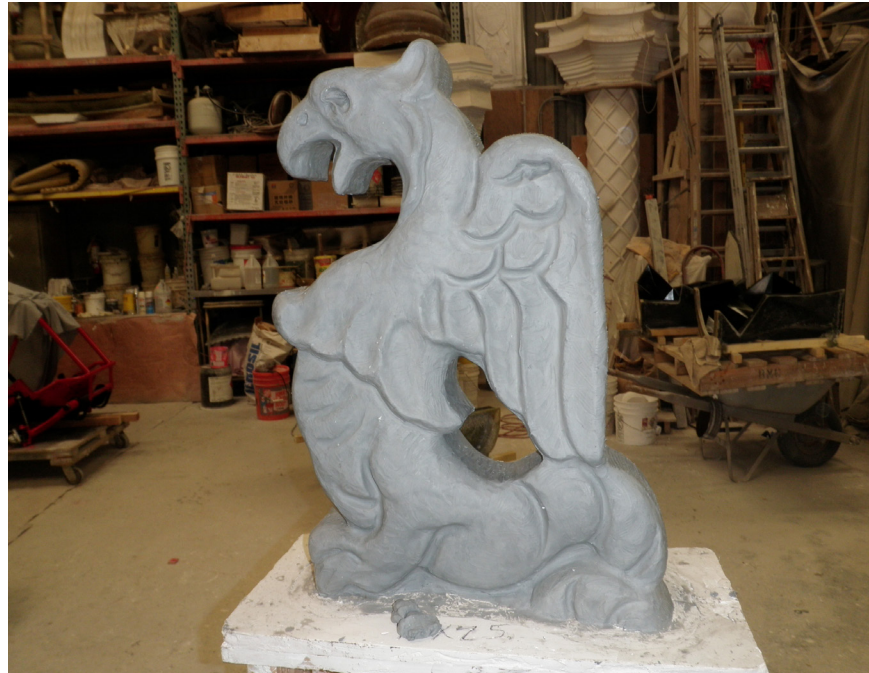
Griffin in the process of repair

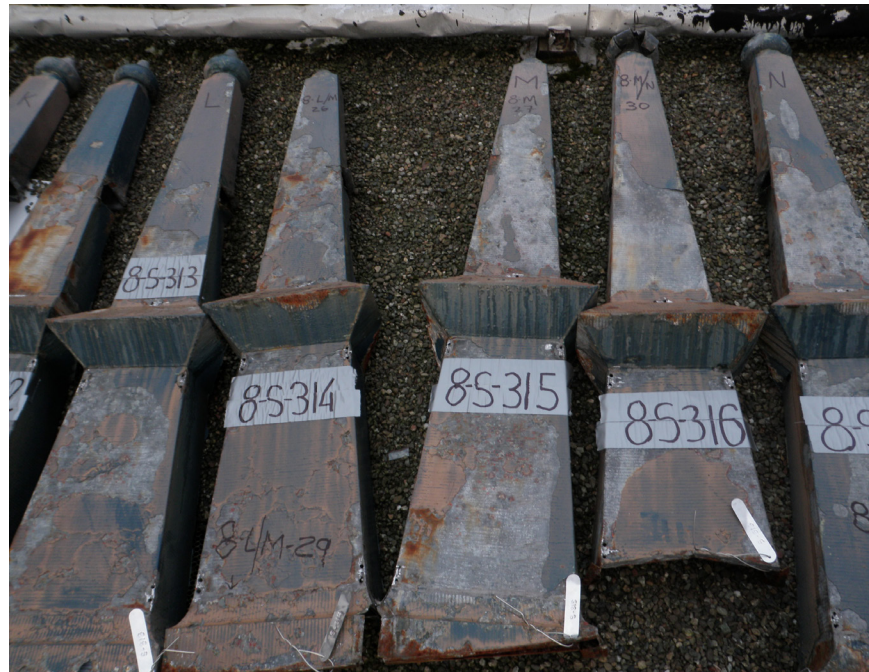
Roof cornice spires prior to repairs

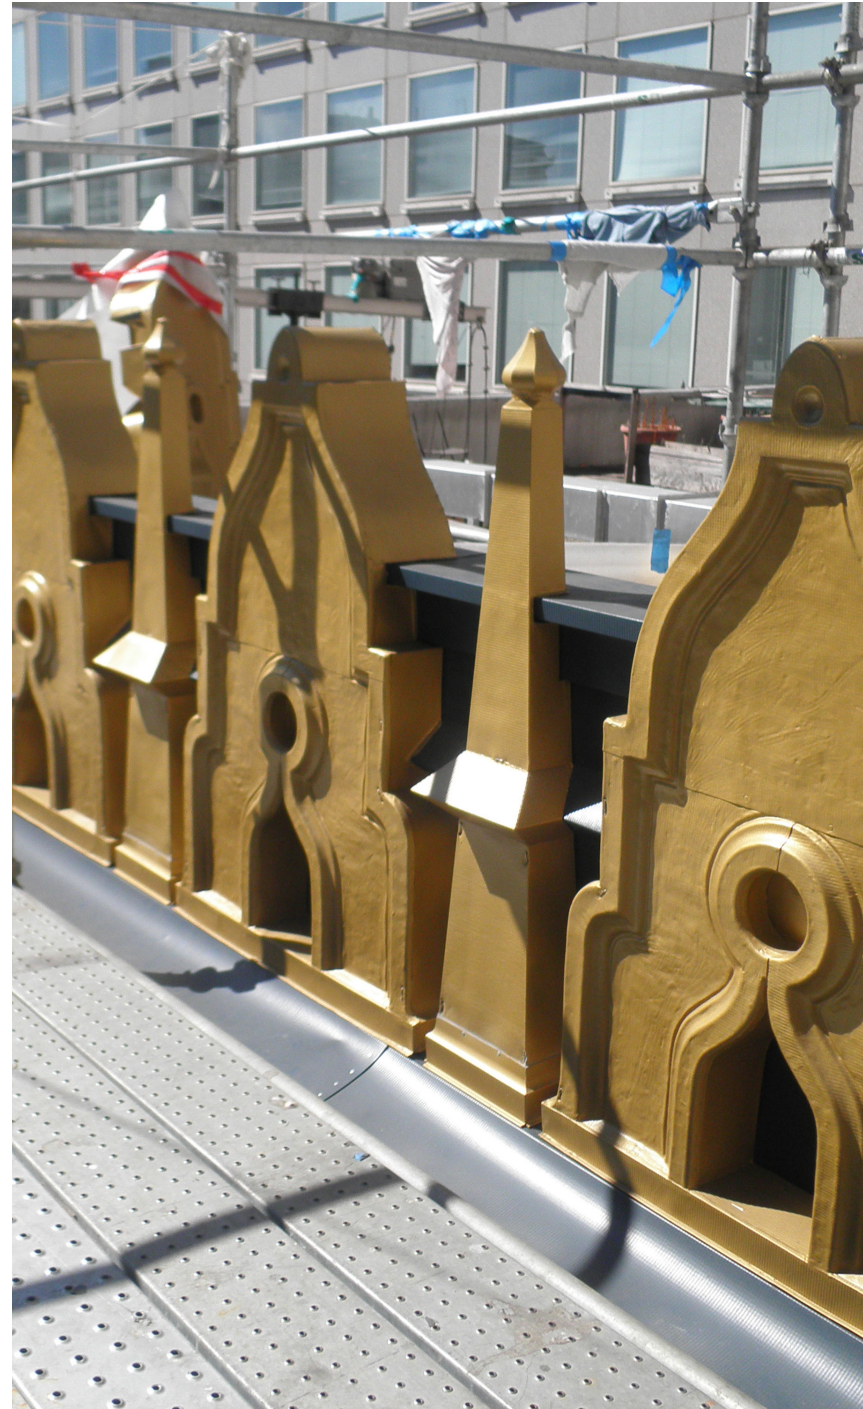
Roof cornice spires after repairs

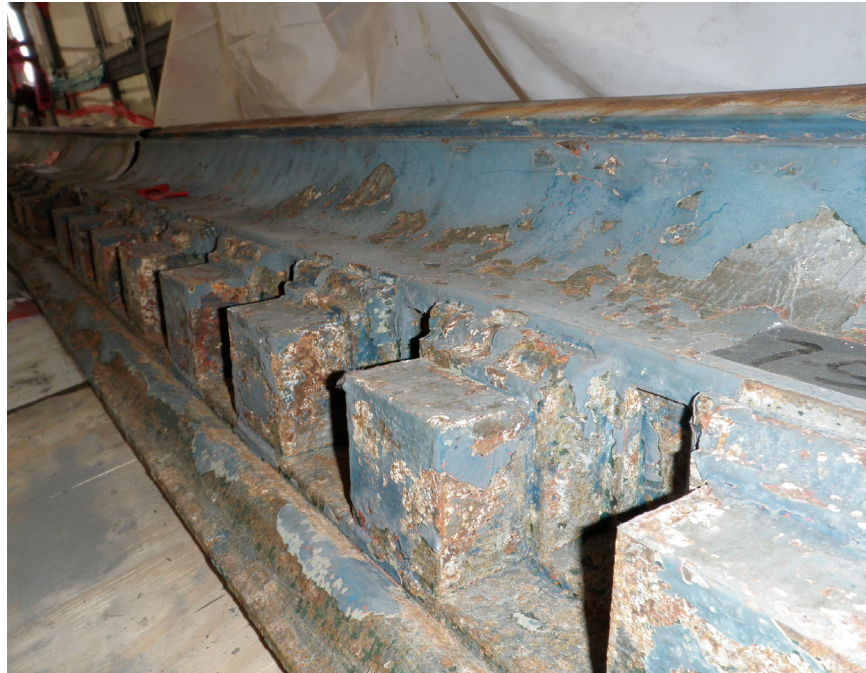
Dentils prior to repairs

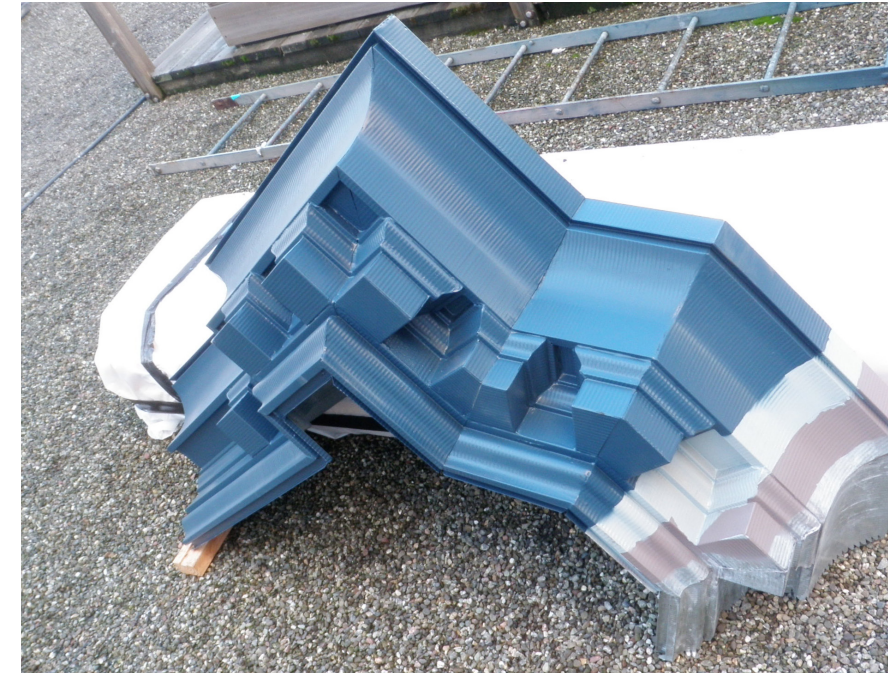
Dentil mock up showing the three paint layers

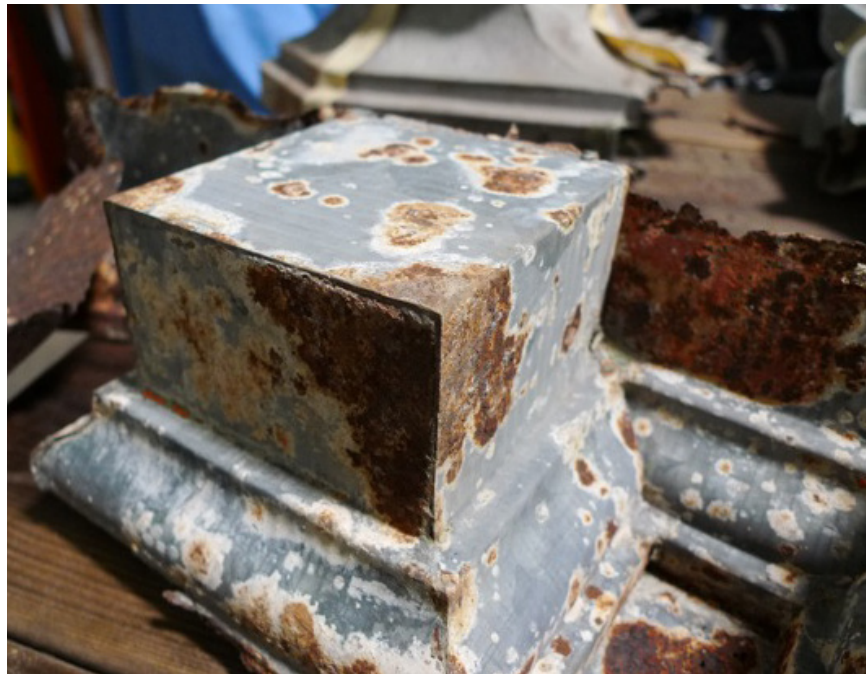
Dentils prior to repairs

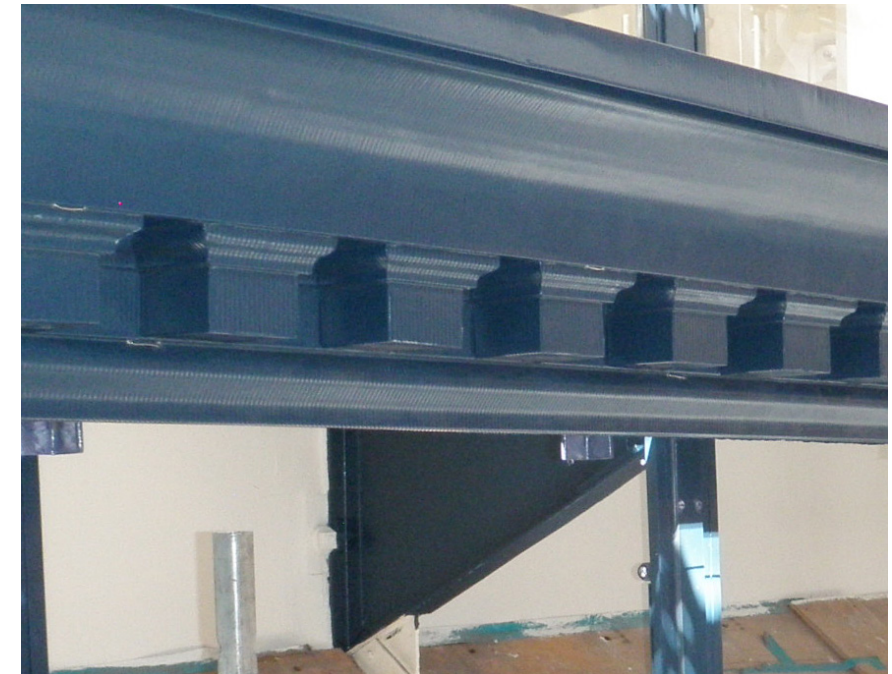
Dentils after repairs

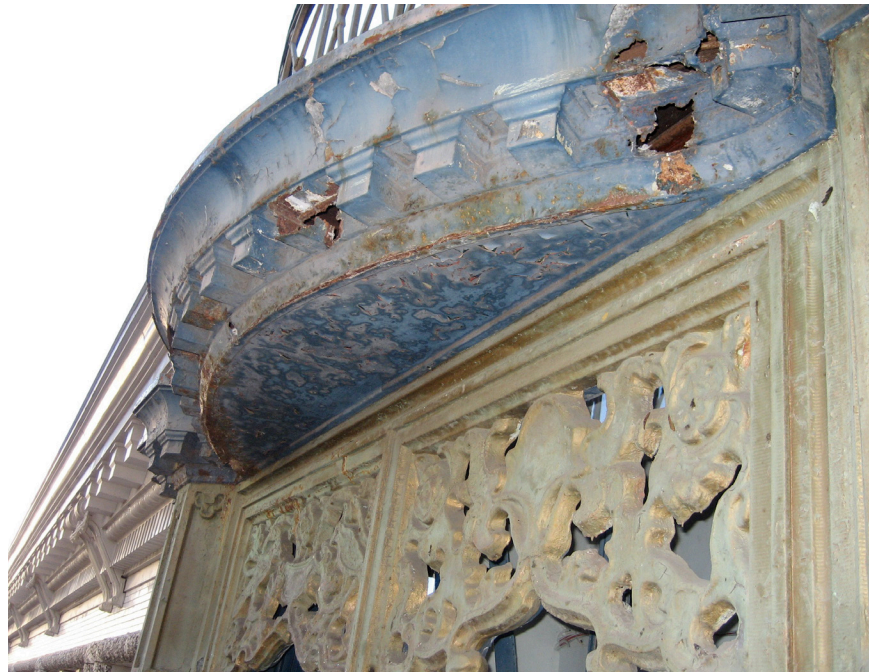
Balcony cornice prior to repairs

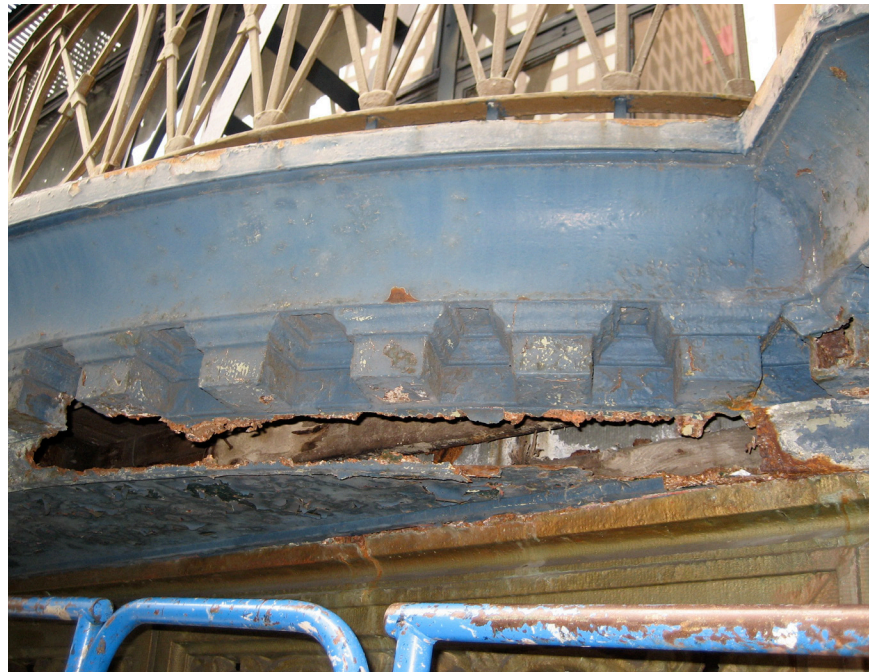
Balcony cornice prior to repairs

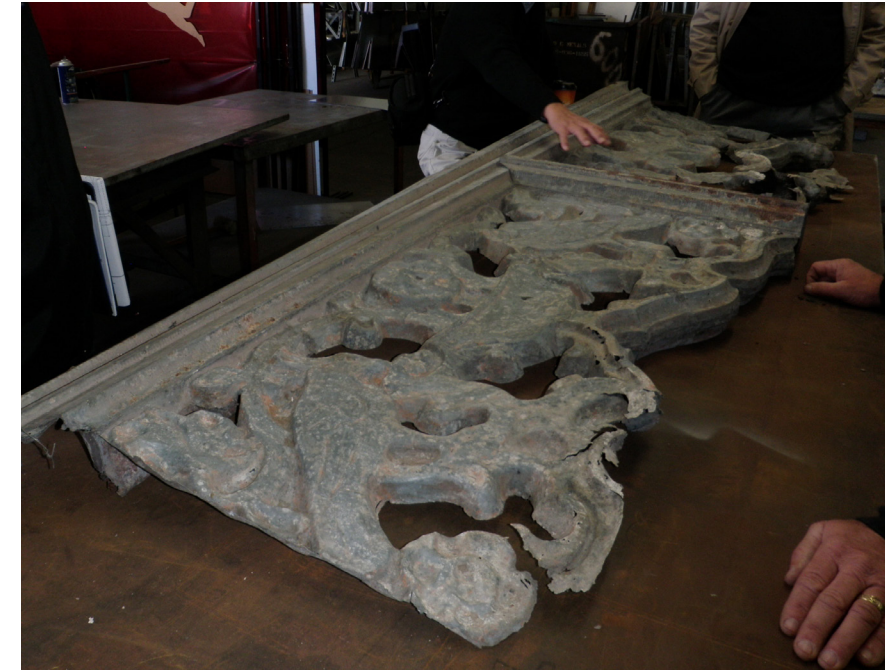
Frieze panel prior to repairs

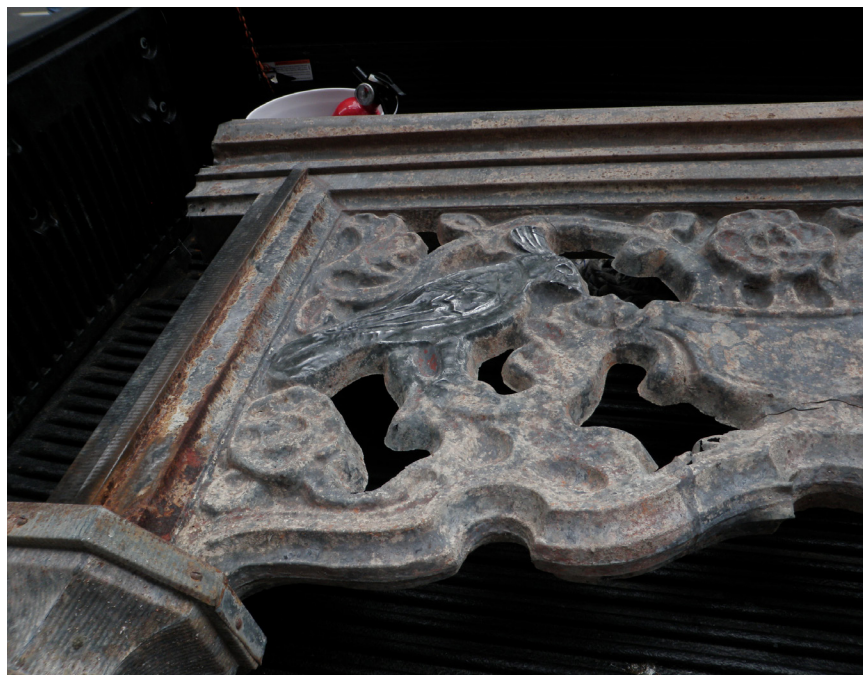
Frieze panel prior to repairs

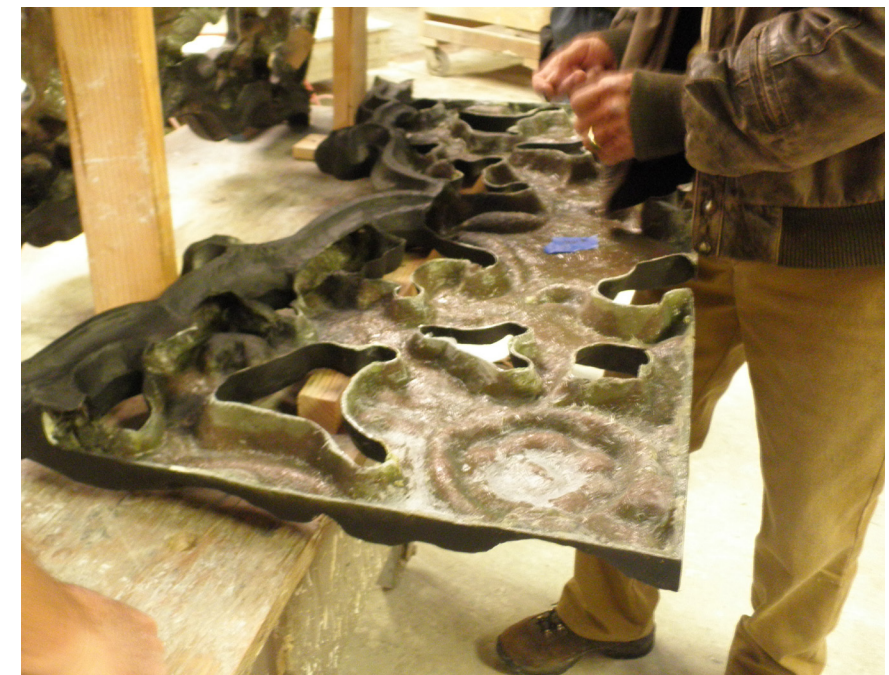
Frieze panel after fibreglass was applied to the backside

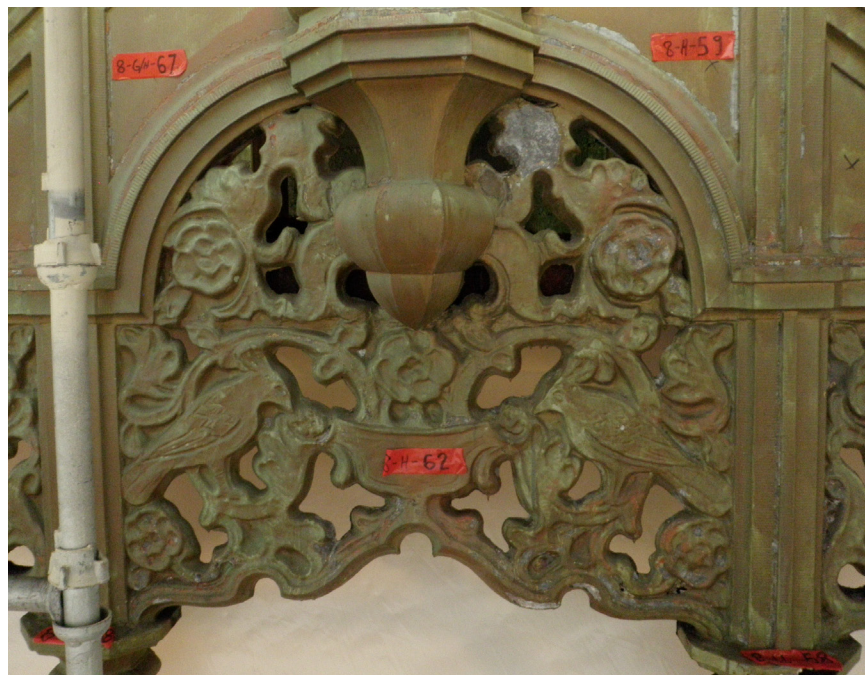
Frieze panel prior to repairs

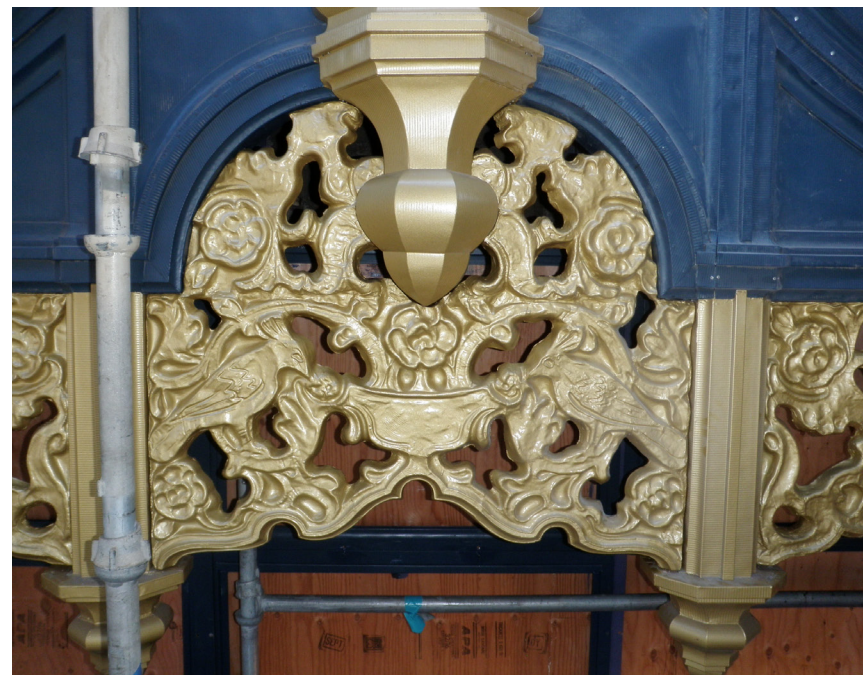
Frieze panel, repaired and installed

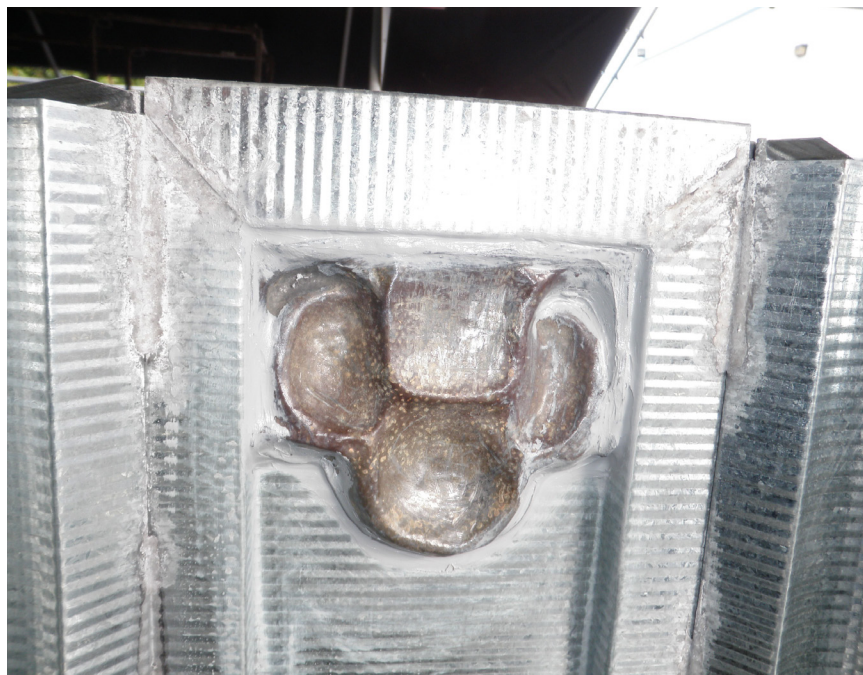
Florets on pendant, stripped, prior to painting

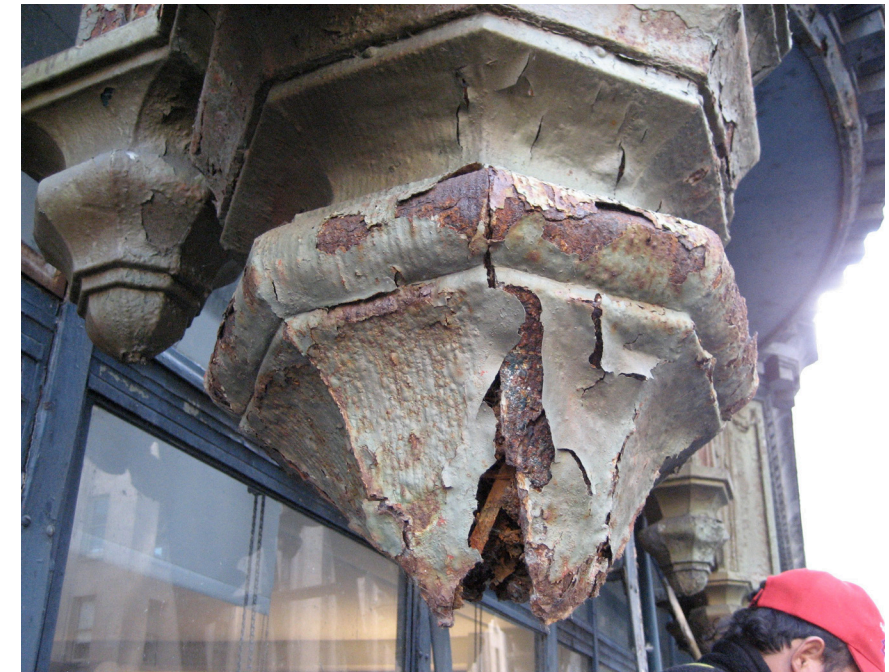
Large pendant prior to repairs

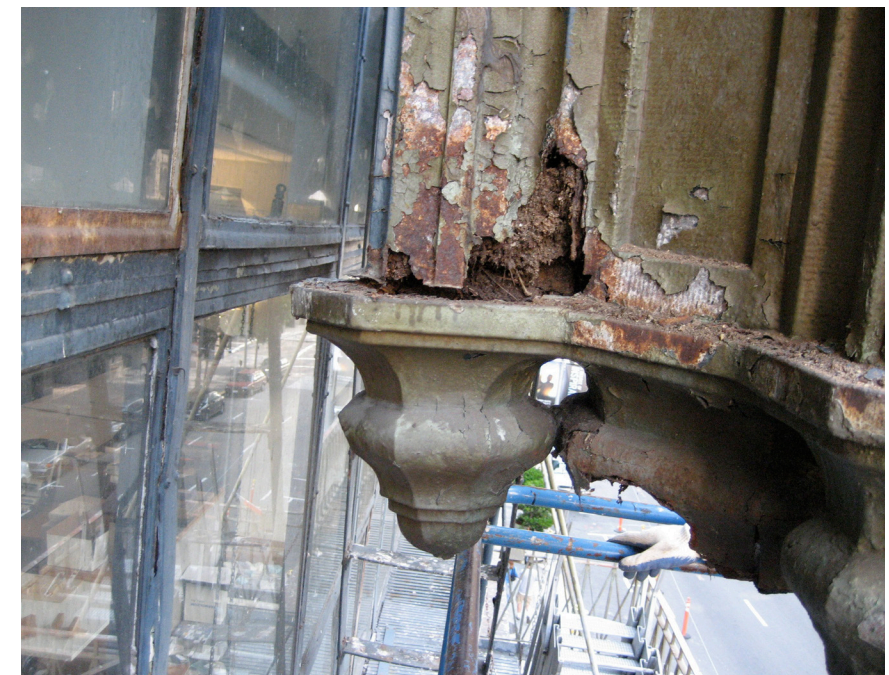
Large pendant prior to repairs
