SAN FRANCISCO PLANNING DEPARTMENT

Certificate of Appropriateness Case Report

Filing Date: January 7, 2013
Case No.: 2013.0009A
Project Address: 130 Sutter Street
Historic Landmark: No. 37 – The Hallidie Building
Zoning: C-3-O (Downtown Office)
80-130F Height and Bulk District
Block/Lot: 0288/027
Applicant: Bruce Albert, The Albert Group
114 Sansome Street, Suite 710
San Francisco, CA 94104
Staff Contact Kelly H. Wong - (415) 575-9100
kelly.wong@sfgov.org
Reviewed By Tim Frye - (415) 558-6822
tim.frye@sfgov.org

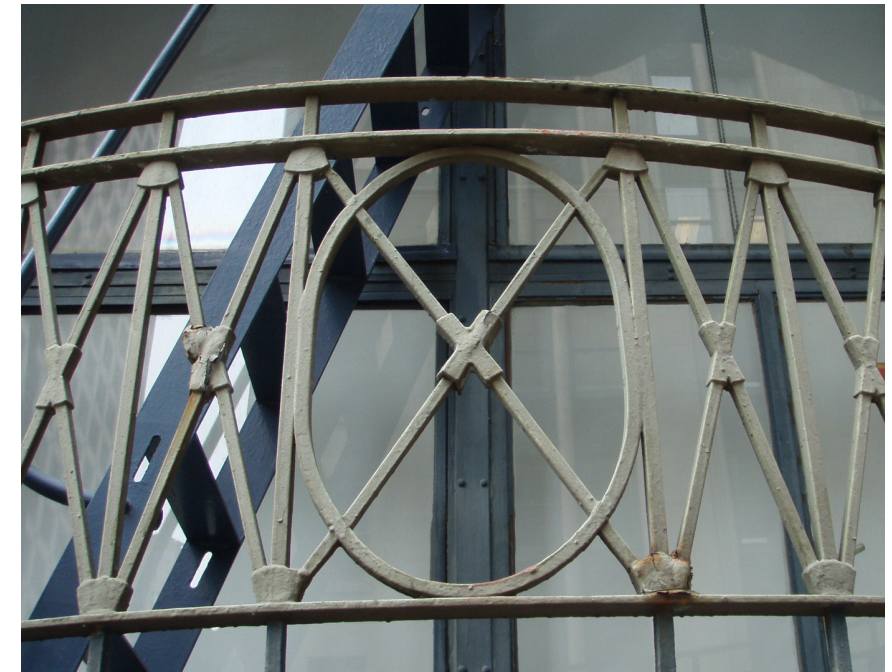
Railings prior to repairs

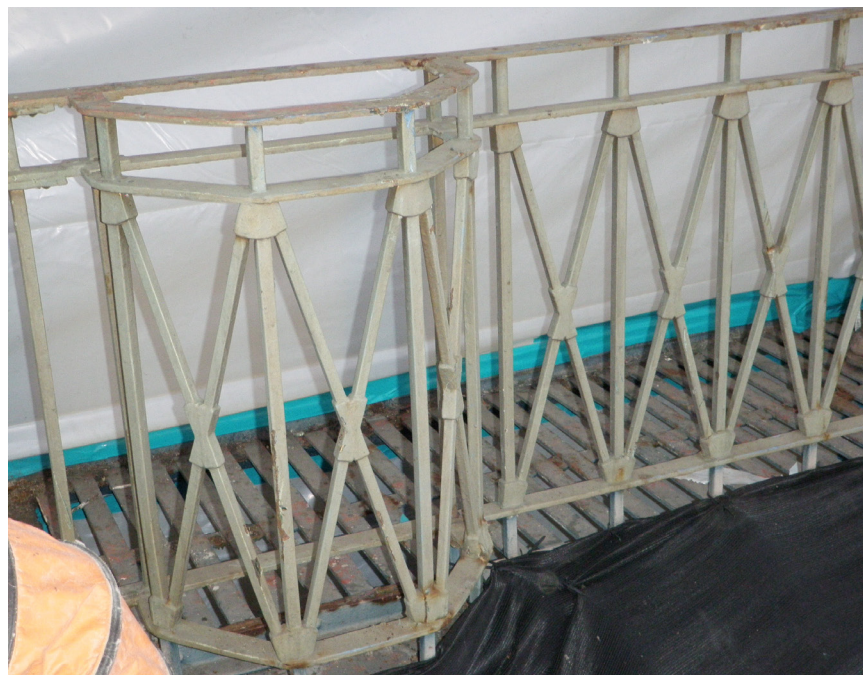
Railings prior to repairs

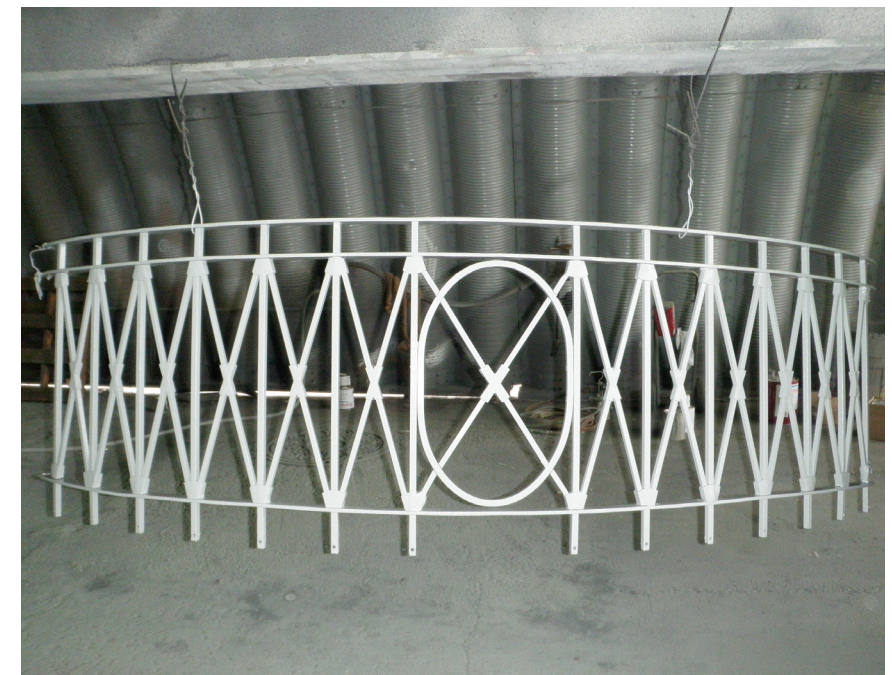
Railings during repairs

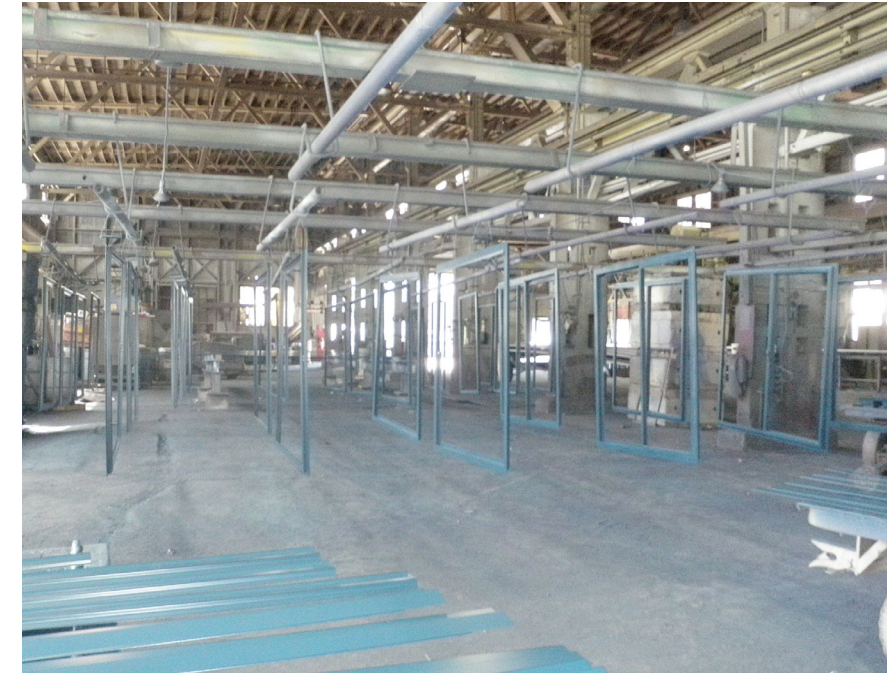
Windows during repairs

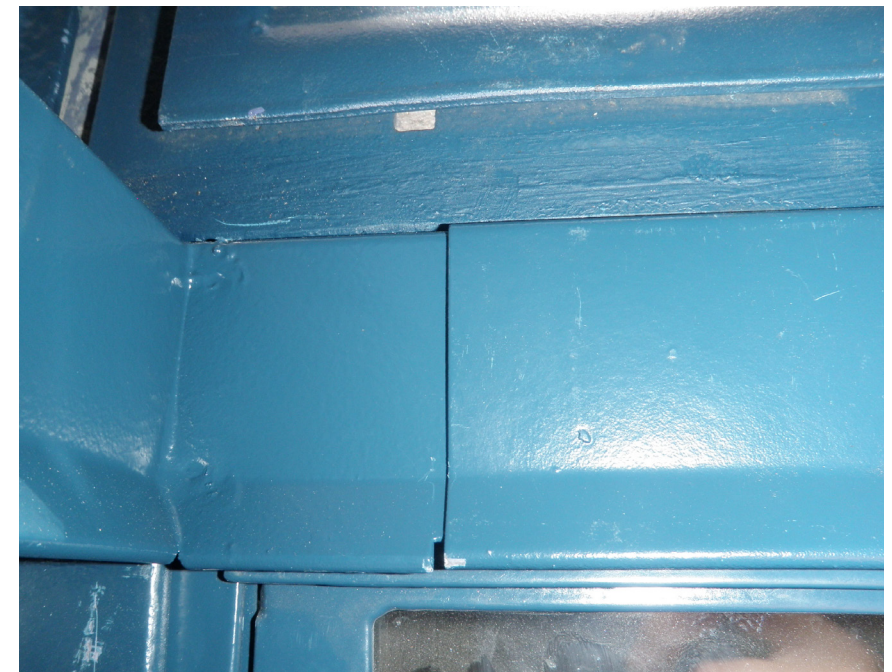
Flashing at windows aligned with balconies and fire escapes

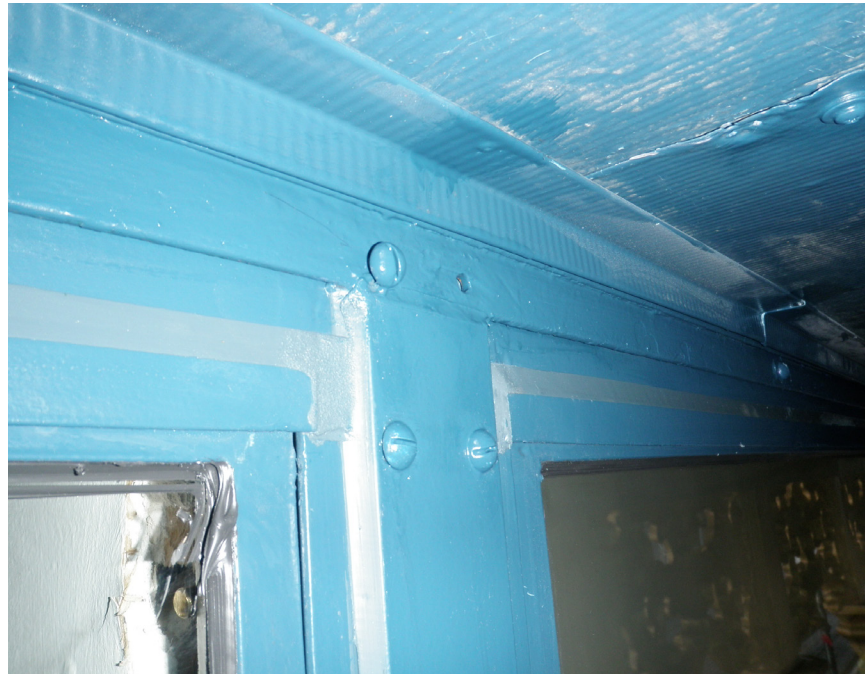
Soffit at 7th floor windows

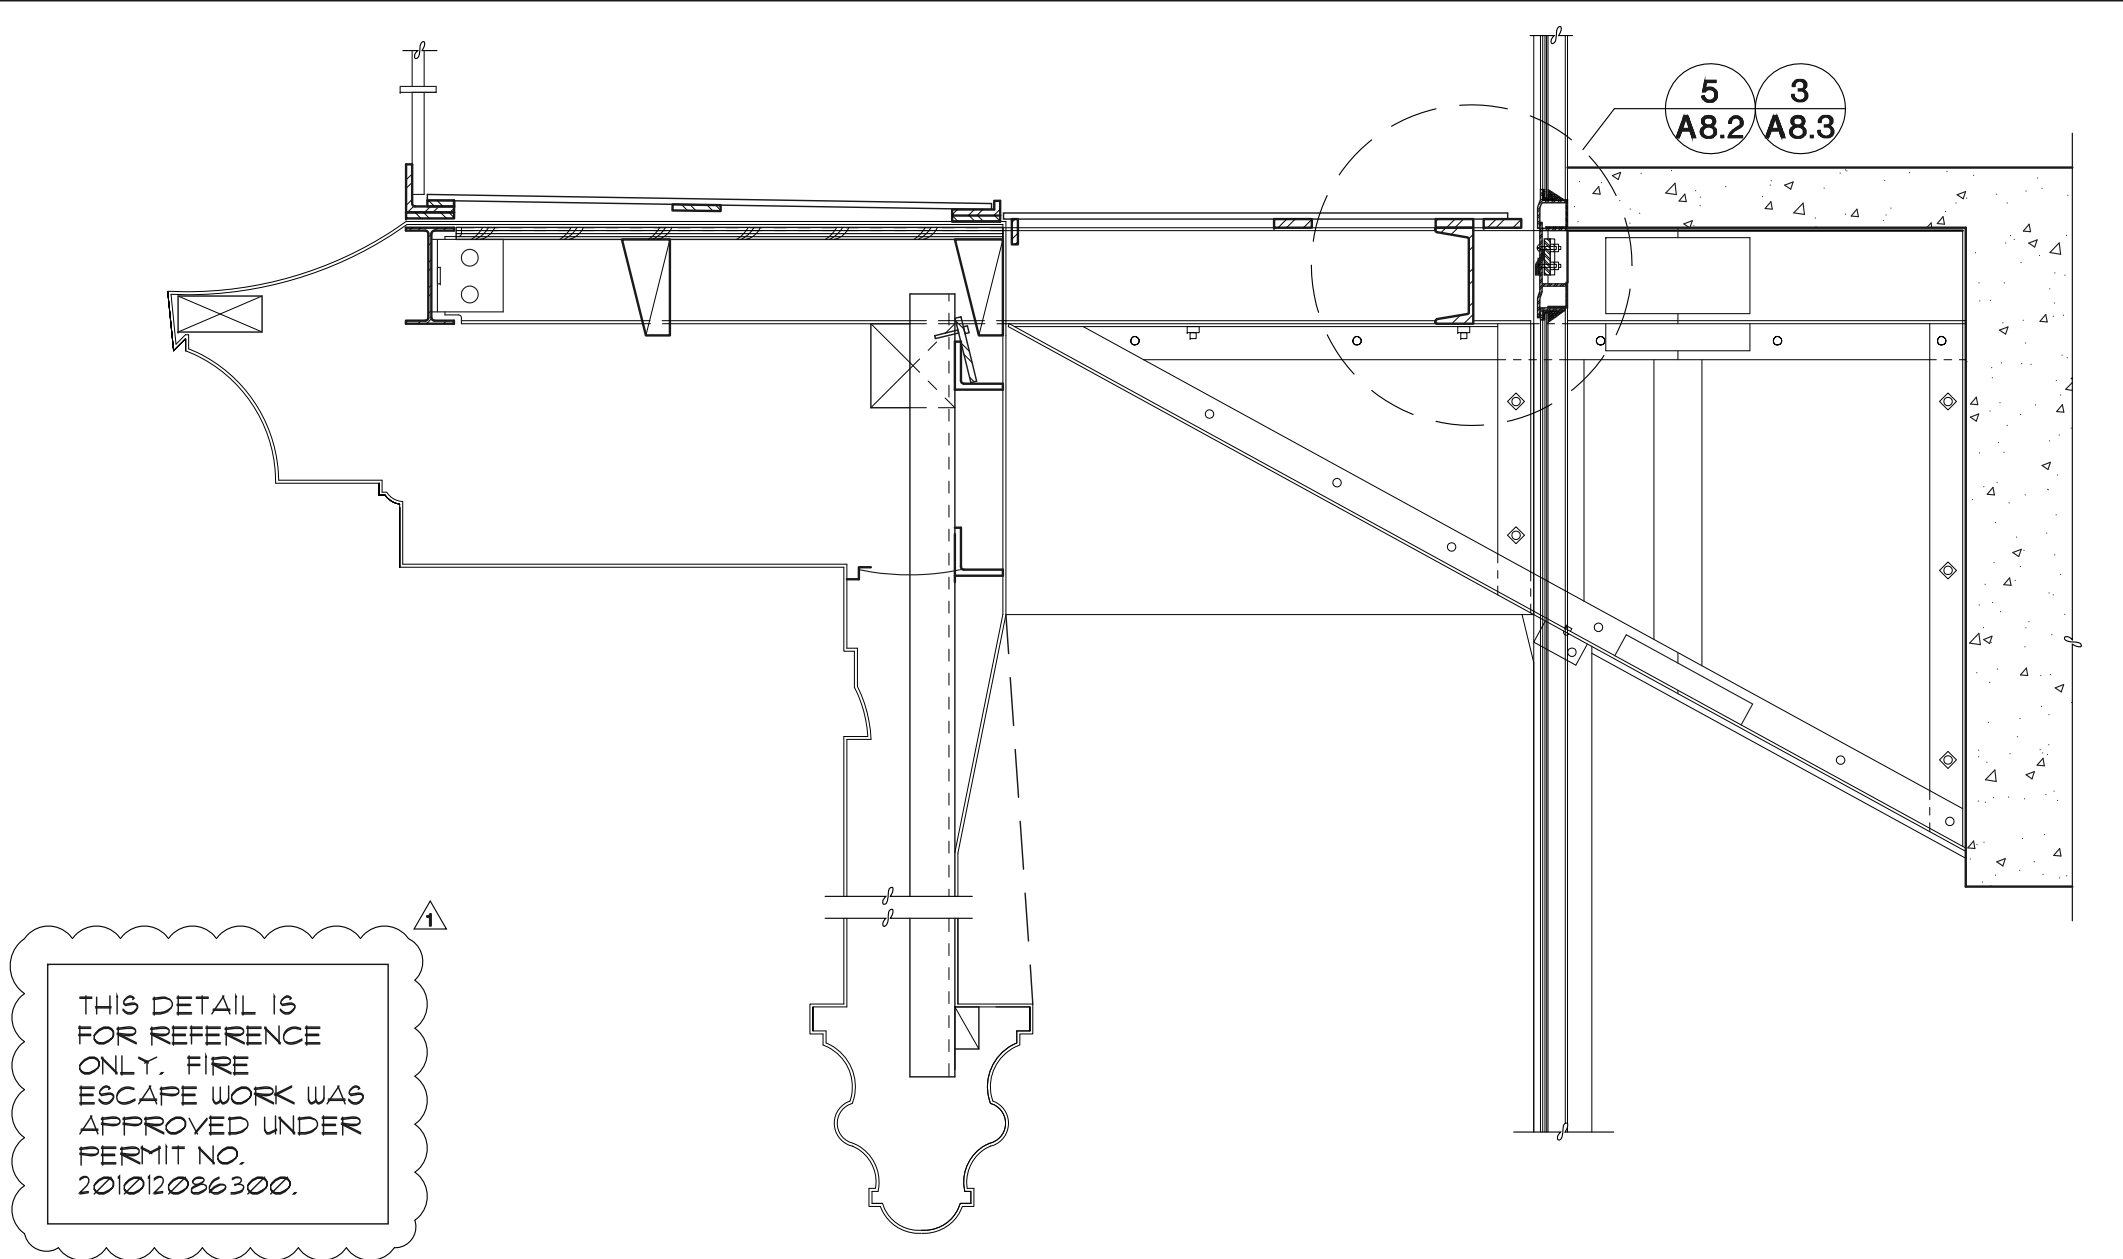
4 NEW DETAIL AT FIRE ESCAPE LANDING
 CENTER OF ROUND BALCONY, SEE DETAIL 1
 1-1/2" - 1'-0"

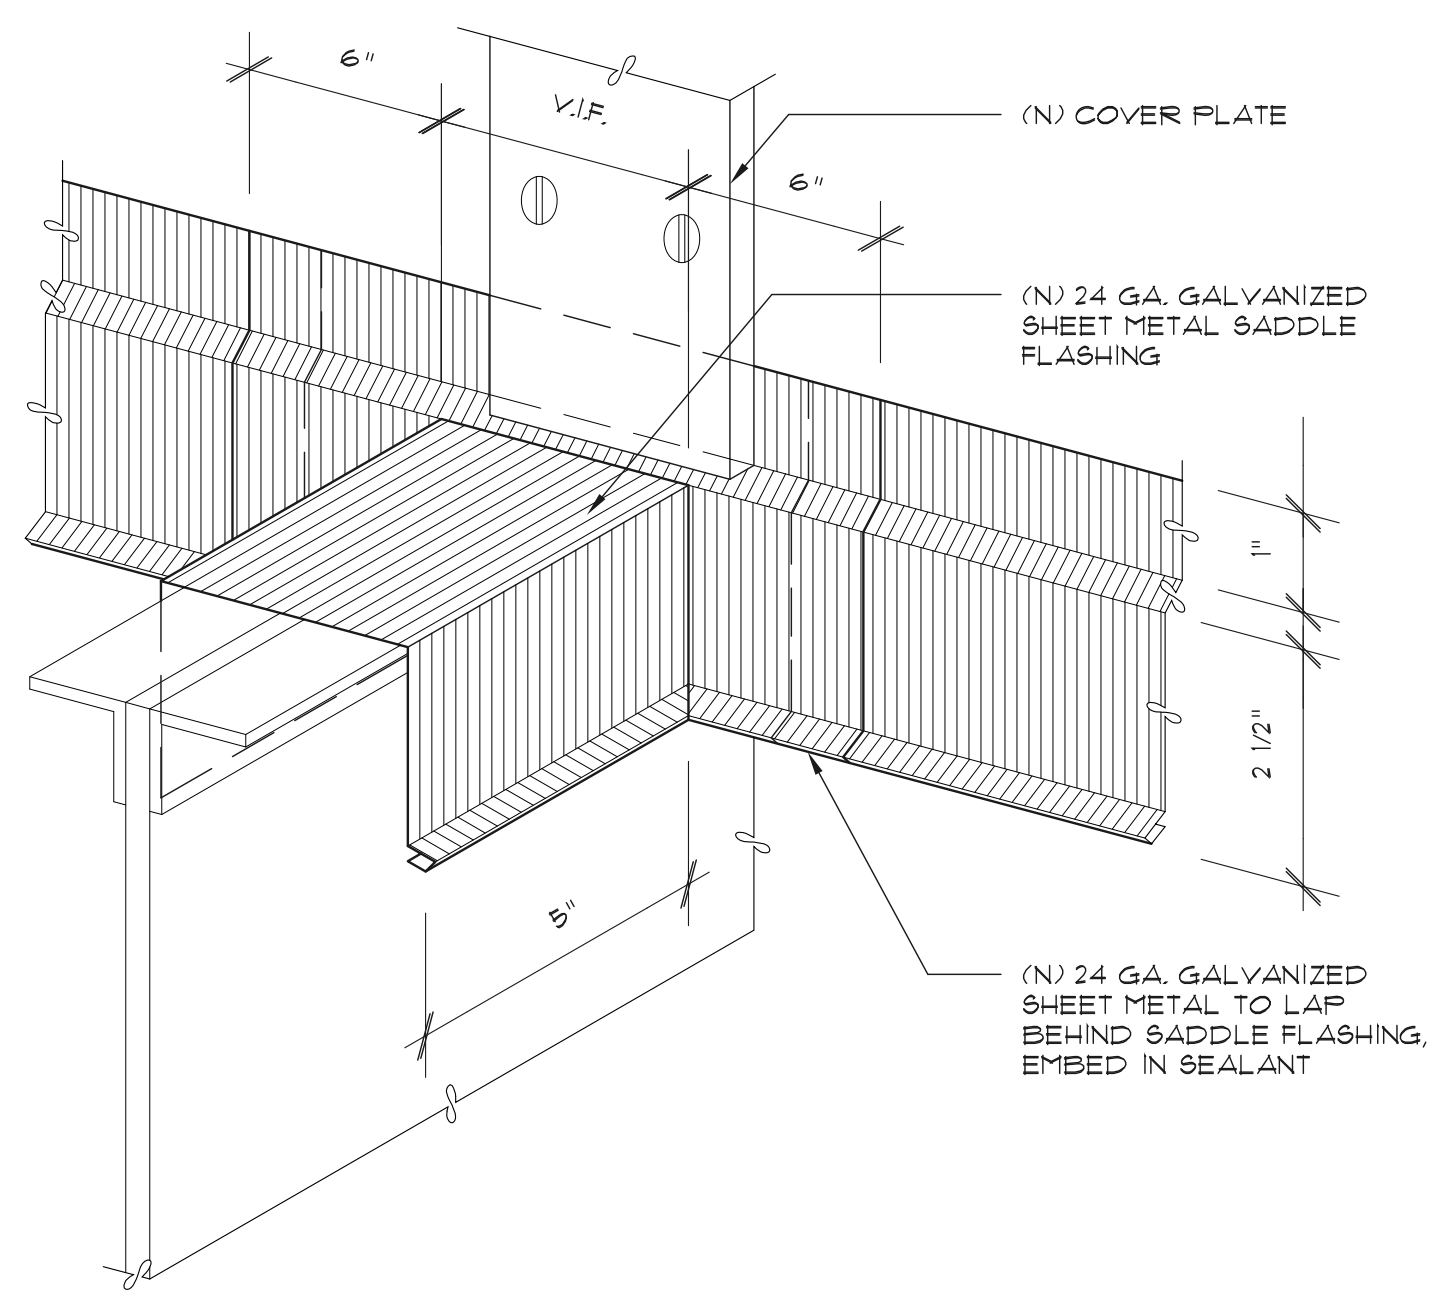
10 SADDLE FLASHING AT OUTRIGGER
NOT TO SCALE

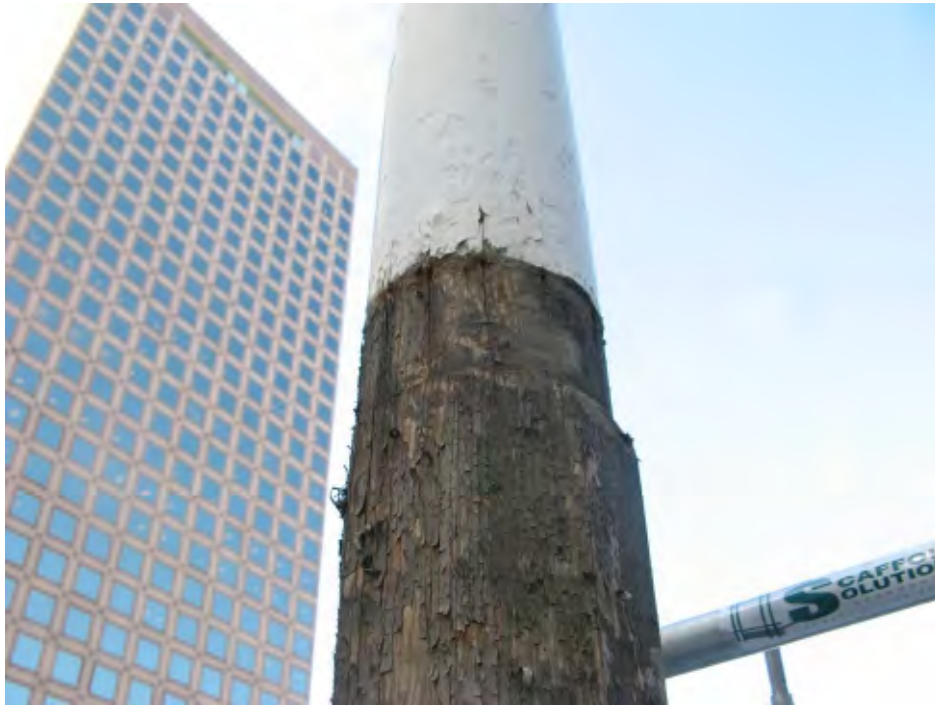
Figure 2: Detail of flagpole showing existing condition and color.

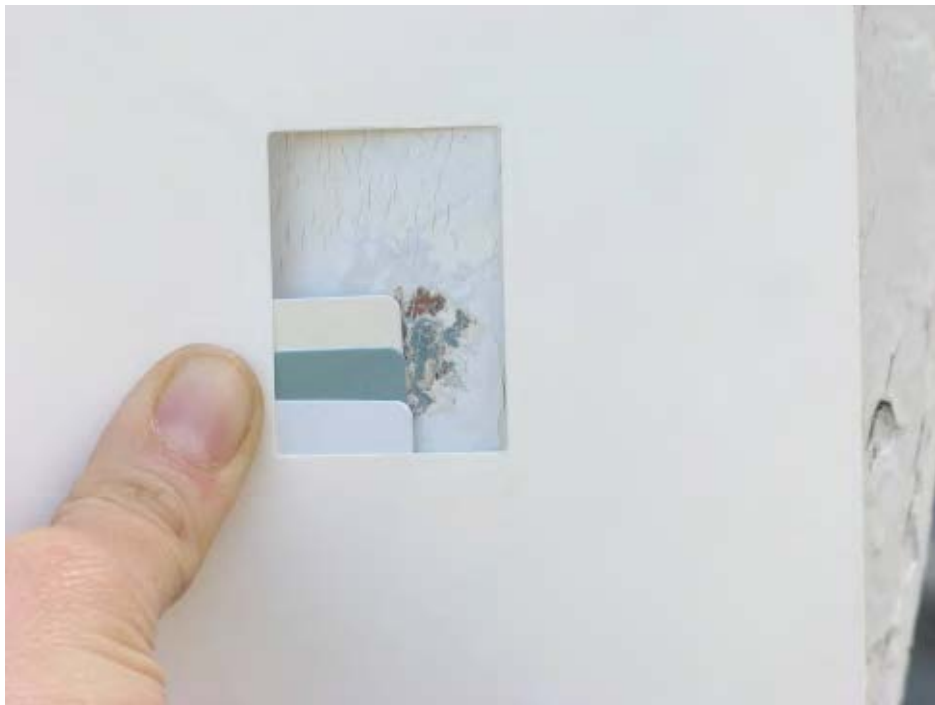
Figure 3: Paint scraping of layers with matching Munsell colors.

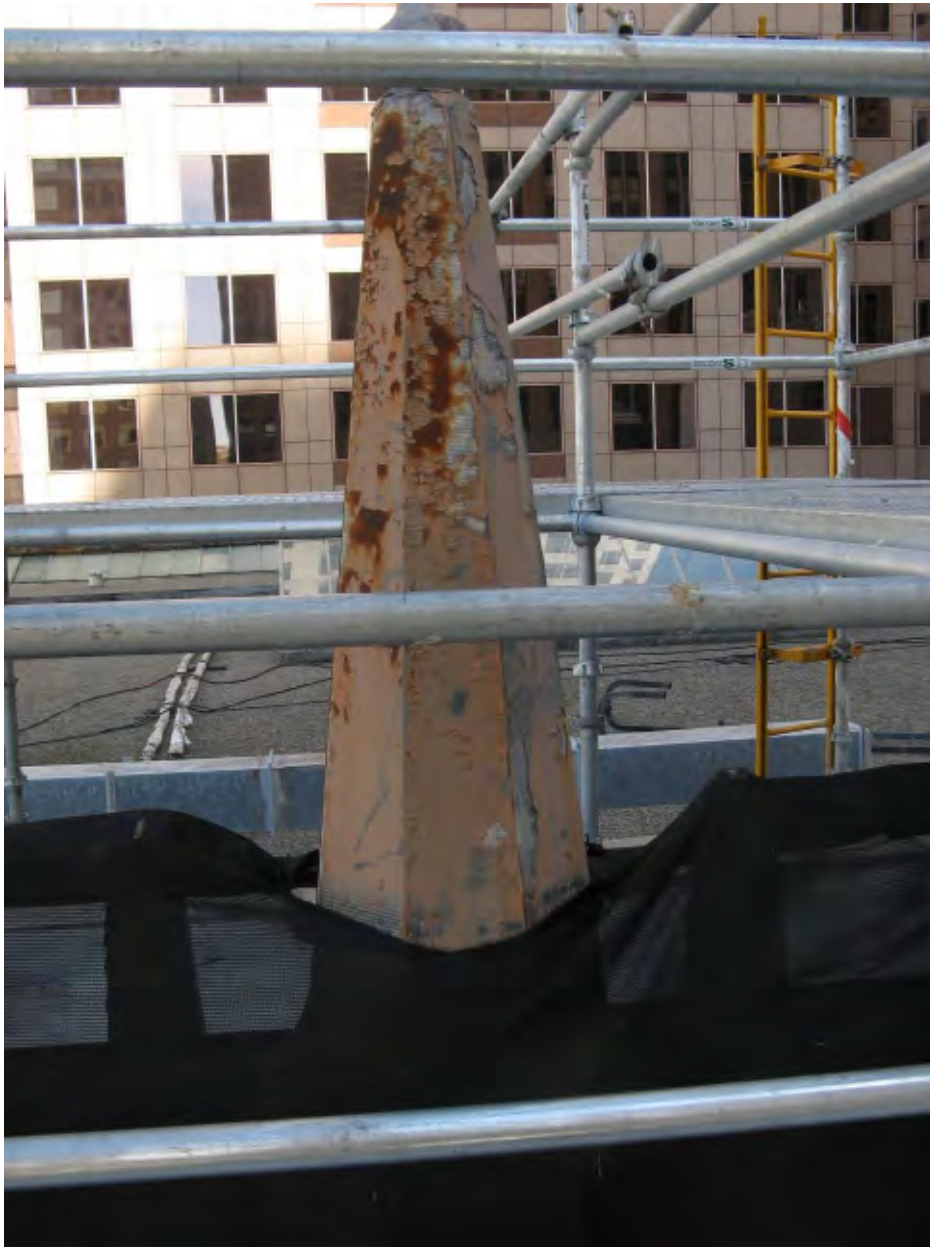
Figure 4: Spire at cornice showing existing condition and color.

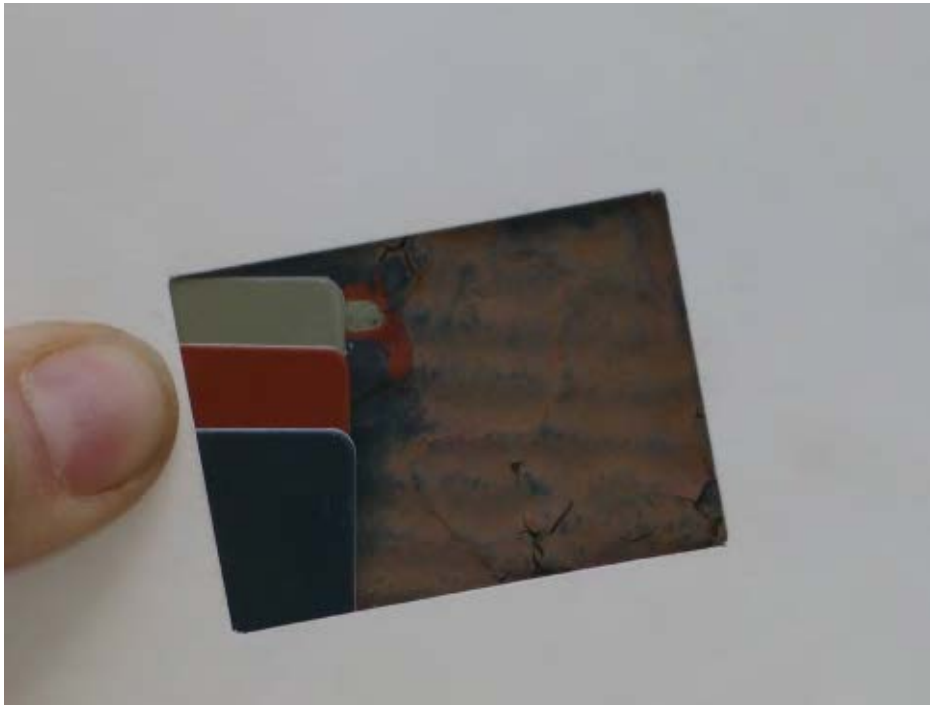
Figure 5: Sample 2 scrapings with matching Munsell colors.

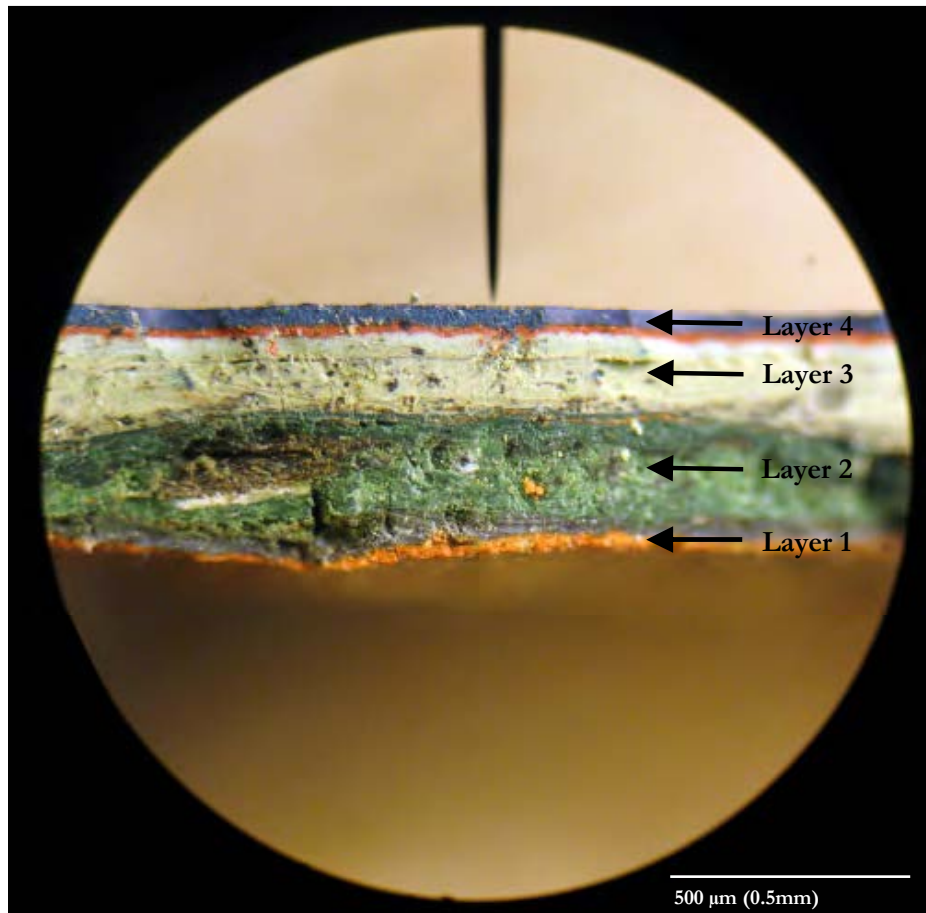
Figure 3: Cross Section of paint sample from window mullion magnified at 100X, showing at least four paint separate schemes. Black arrows show the earliest blue scheme (at bottom) and present blue scheme (top). Orange layers are corrosion inhibiting primer and were not meant to be seen.

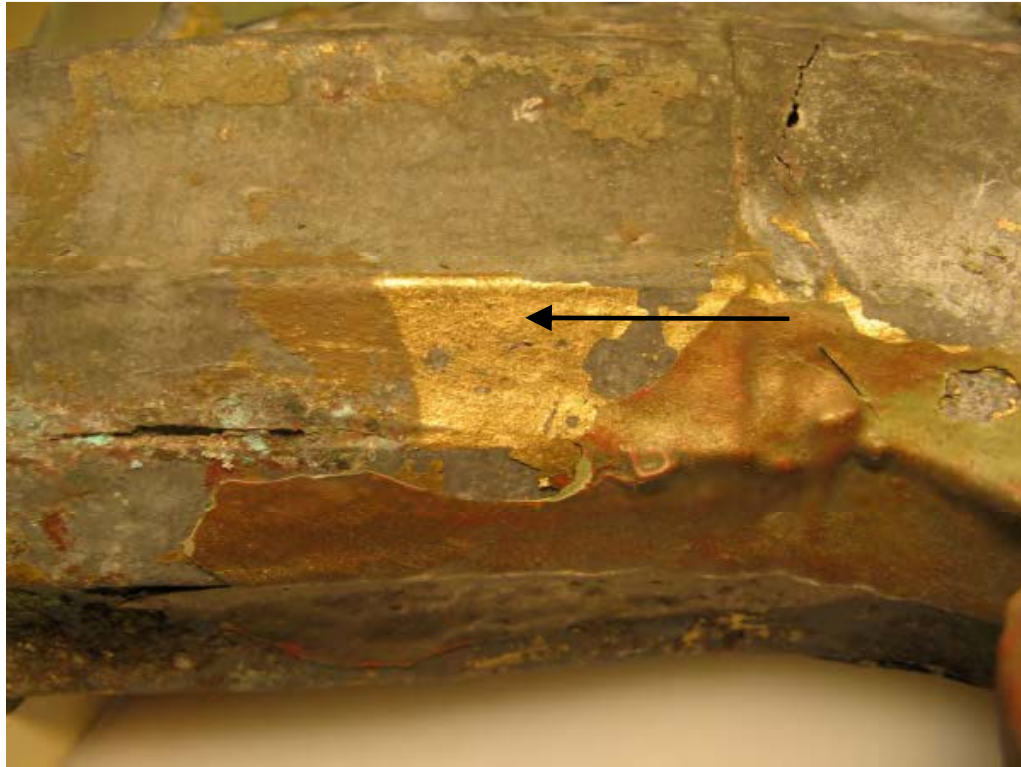
Figure 4: Detail of metal tracery showing historic gold leaf gilding revealed under later paint layers. The gold leaf was applied over a thin red clay bol preparatory layer.
