National Register Nomination Case Report

Date: June 13, 2013
Case No.: 2013.0570U
Project Address: 630 Sansome Street (U.S. Appraisers Stores and Immigration Station)
Zoning: C-2 (Community Business)
65-A Height and Bulk District
Block/Lot: 0197/002
Project Sponsor: General Services Administration
Beth L. Savage, Federal Preservation Officer
Office of the Chief Architect, Public Buildings Service
1800 F Street, NW, Room 3341
Washington, DC 20405
Staff Contact: Jonathan Lammers – (415) 575-9093
jonathan.lammers@sfgov.org
Reviewed By: Timothy Frye – (415) 575-6822
tim.frye@sfgov.org
Recommendation: **Send resolution of findings recommending that, subject to revisions, OHP approve nomination of the subject property to the National Register**

National Register of Historic Places Registration Form

Historic name U.S. Appraisers Stores and Immigration Station
Other names/site number U.S. Appraisers Stores and Immigration Building, Appraisers Building

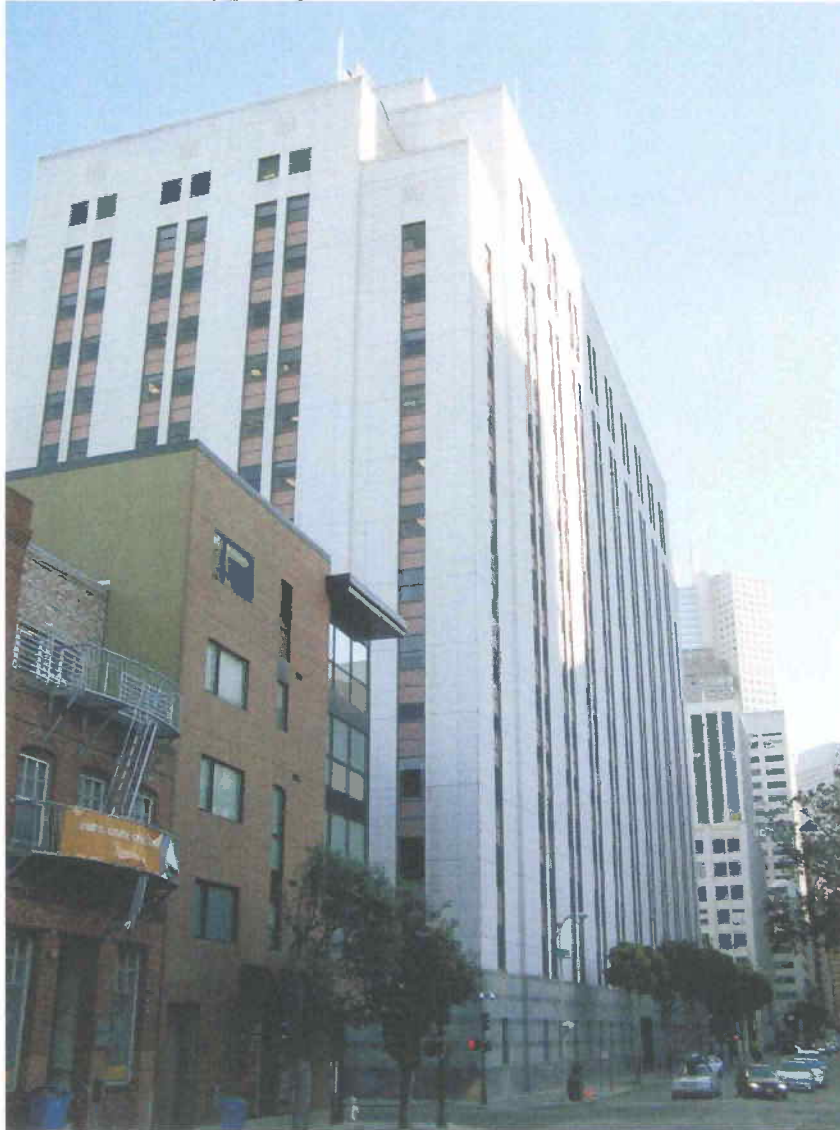
Photo number: CA_SanFranciscoCounty_ImmigrationStation1.tiff

Description of view: Upper floors of Jackson Street (north) elevation and Sansome Street (west) elevation looking south

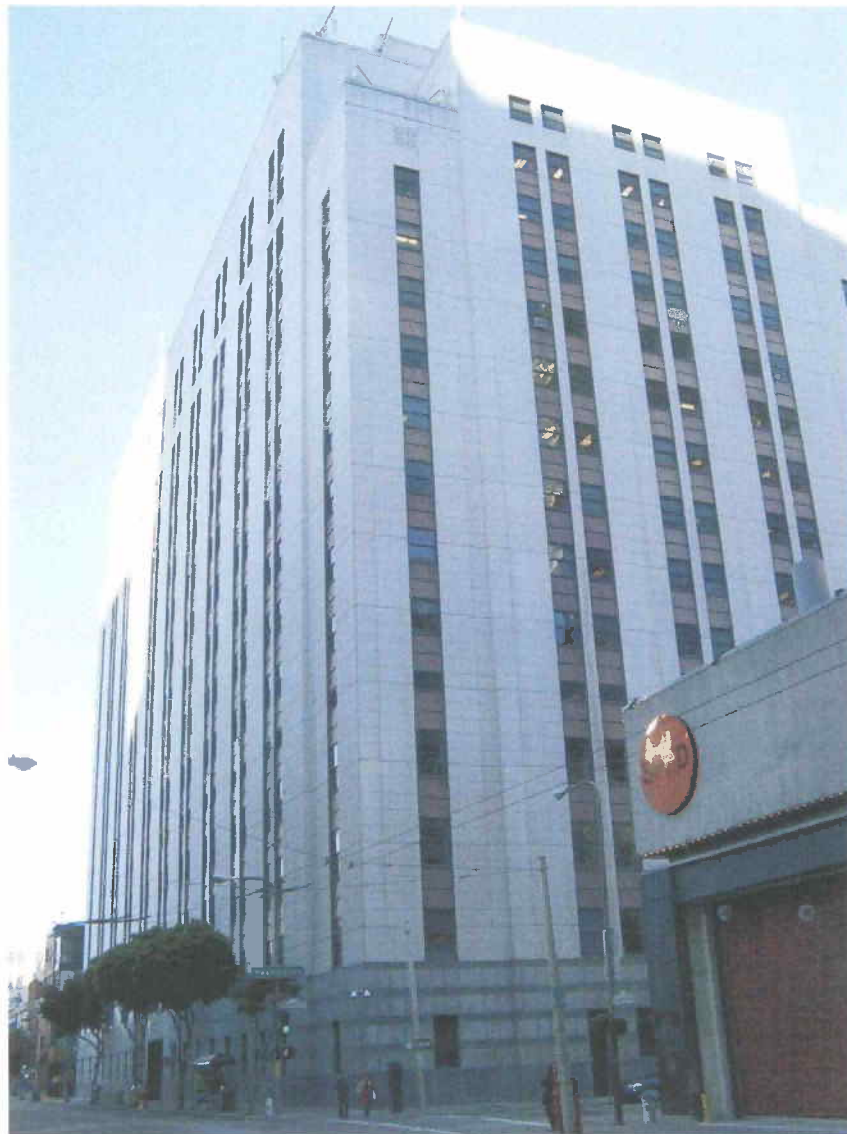
U.S. Appraisers Stores and Immigration Station
San Francisco County, California
Photographer: David Greenwood, Jones & Stokes
Date of photograph: November 30, 2006
Negative: GSA Headquarters
Description of view: South elevation showing replaced granite base
Photo number: CA_SanFranciscoCounty_ImmigrationStation2.tiff

Alterations to the building include the replacement of the building's original terra cotta panels and granite base due to extensive water damage behind the cladding. Beginning in 1986, a modernization plan was undertaken that narrowed the corridors to increase assignable tenant space. The main entrance was modified for handicapped access, which eliminated the original vestibule. Parapets were originally pierced with ceramic grilles for views to the outside. In 1986, these were replaced with precast elements approximating the same design, cast and installed along with the new exterior wall panels in 1987-1988. Window frames at the first floor were changed at the same time from steel to aluminum.

At the time of construction, the cladding was considered to be as durable as stone facing, and original drawings called for the material to be waterproofed. However, leakage began within a decade of construction and became progressively worse over time. In the early 1980s, the U.S. General Services Administration commissioned the architectural firm of Skidmore, Owings and Merrill, San Francisco, to assess the performance of the exterior wall and present a variety of replacement strategies. The alteration proposed substituting pre-cast concrete panels with a larger unit size to replace the original terra cotta, with care taken to score the new material to resemble the divisions of the original blocks. The design of the base of the building, which had been a ceramic veneer over a low granite base, was proposed as alternating bands of honed and polished granite for the full height of the base. This redesign program was carried out. The ornamental ceramic grilles were replaced in their original positions and designs with precast replacements after the re-cladding. The work began in 1985 and was finished in 1988.³

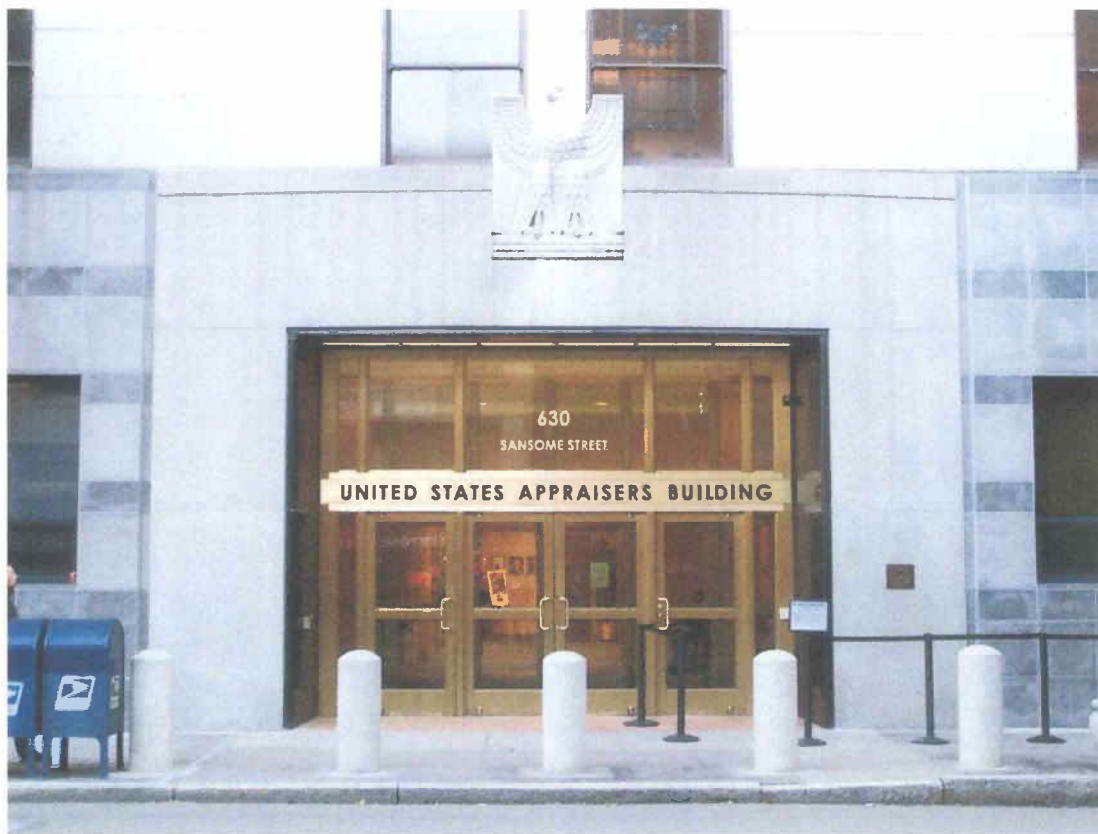
Photo number: CA_SanFranciscoCounty_ImmigrationStation3.tiff

Description of view: Building entrance: 630 Sansome Street, facing east.

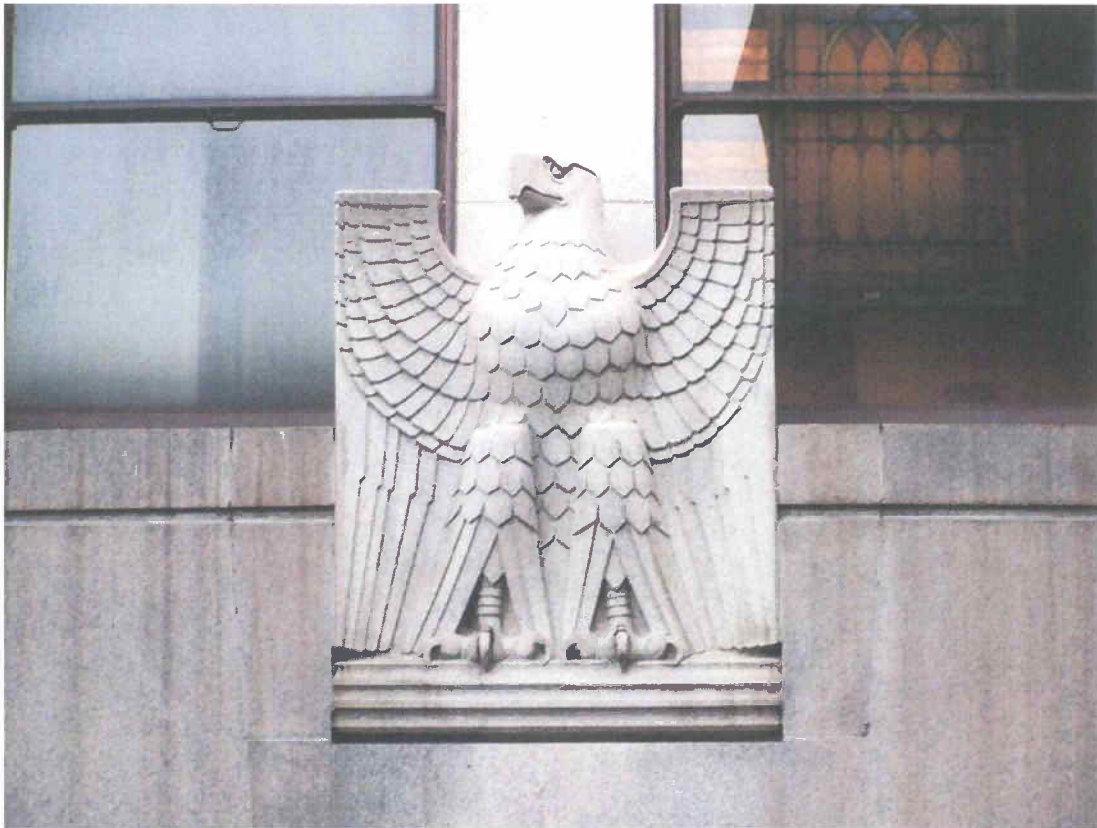
Photo number: CA_SanFranciscoCounty_ImmigrationStation4.tiff

Description of view: Detail, carved granite eagle above Sansome Street entrance, facing east.

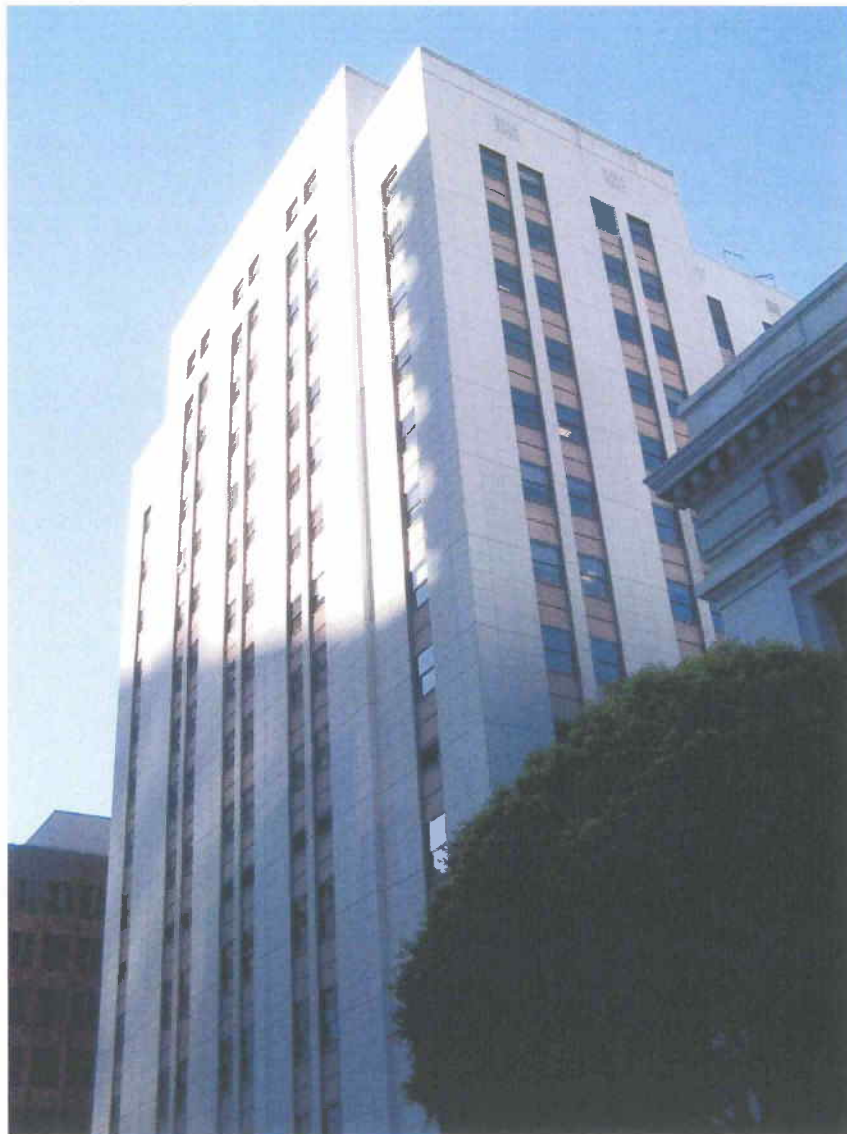
Photo number: CA_SanFranciscoCounty_ImmigrationStation5.tiff

Description of view: Upper floors of south and east elevations looking northwest from Custom House Place

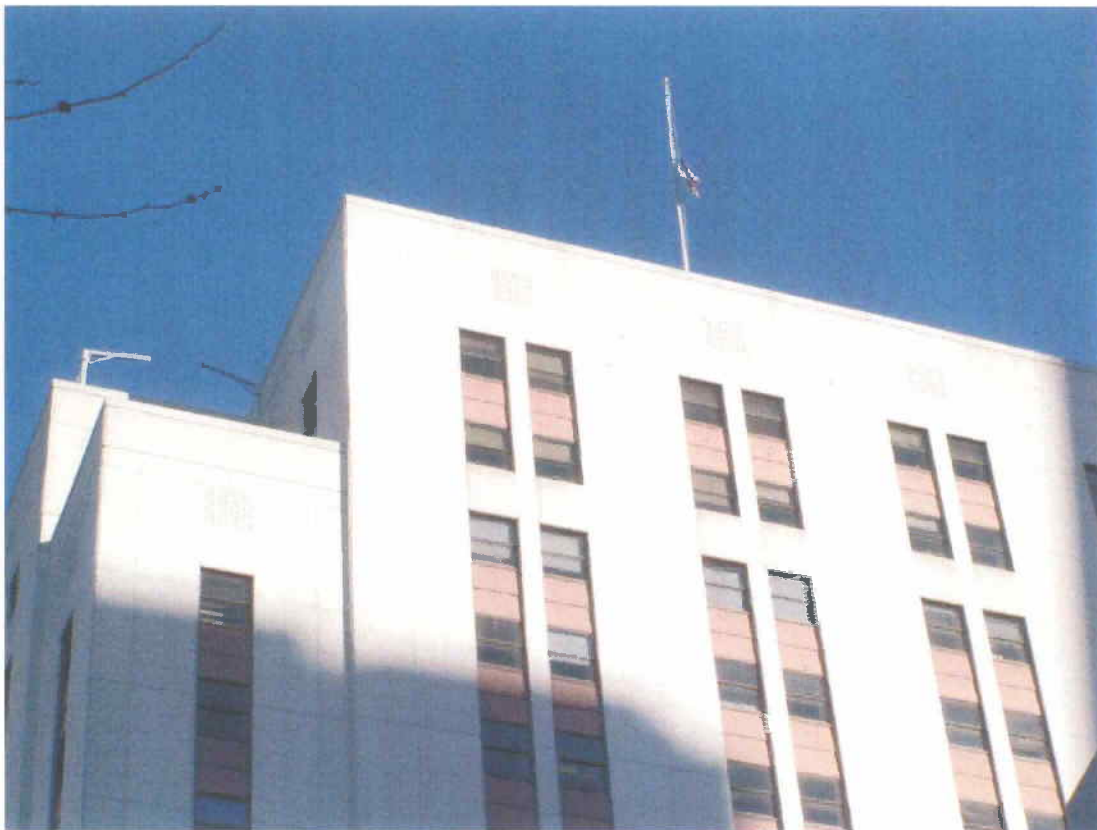
Photo number: CA_SanFranciscoCounty_ImmigrationStation6.tiff

Description of view: Detail, cornice of west elevation showing grill detail

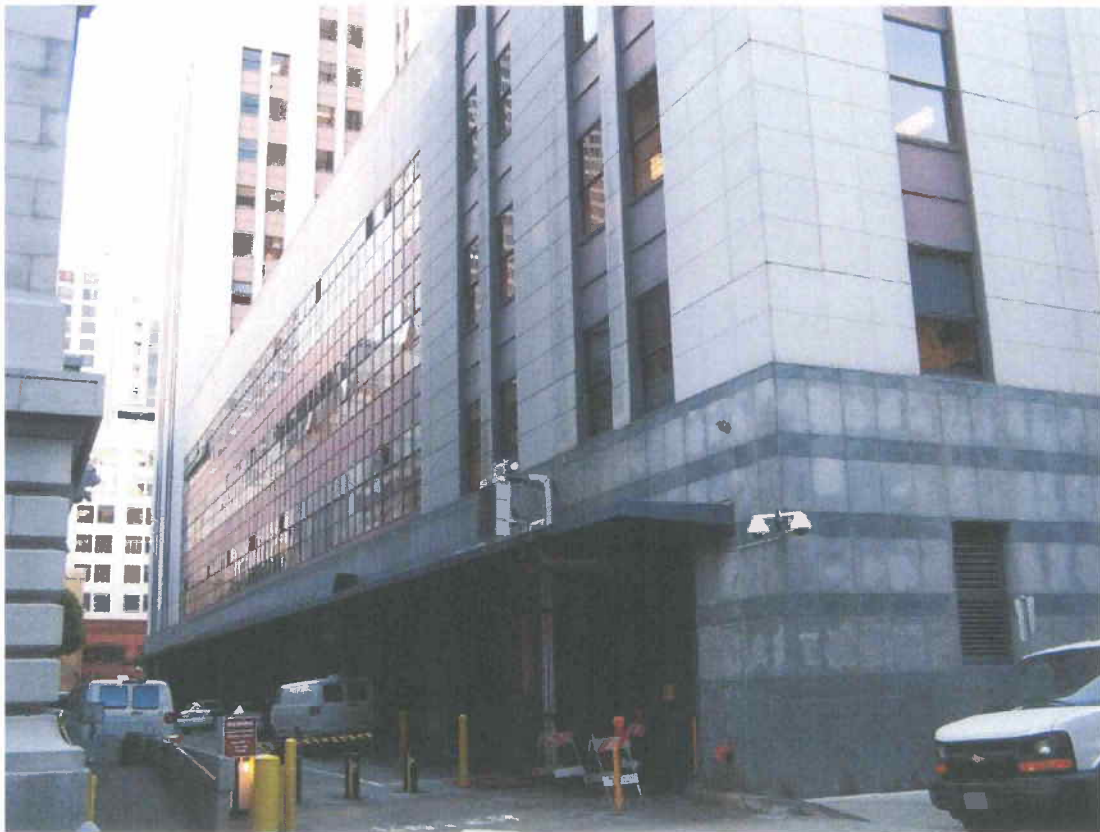
Photo number: CA_SanFranciscoCounty_ImmigrationStation8.tiff

Description of view: Loading dock along Custom House Place looking south from Jackson Street

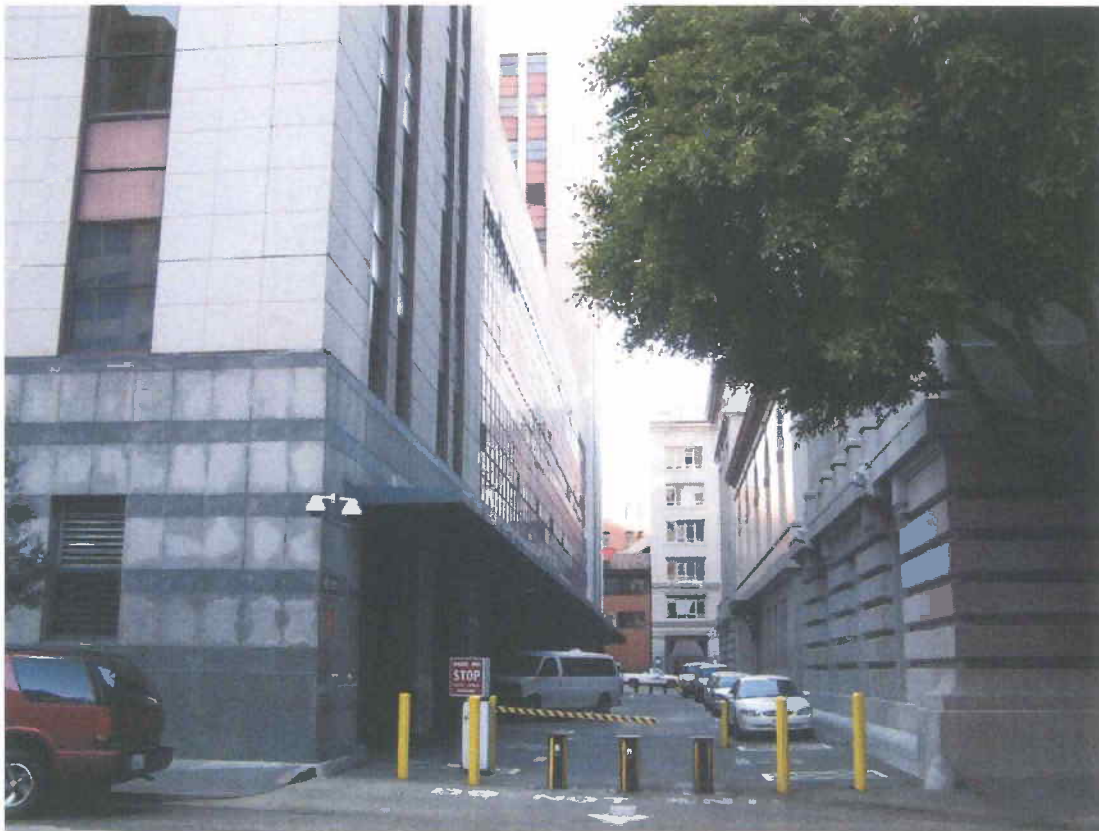
Photo Number: CA_SanFranciscoCounty_ImmigrationStation9.tiff

Description of view: Alley (Custom House Place) between Appraisers /Immigration Station and United States Custom House: looking north from Washington Street

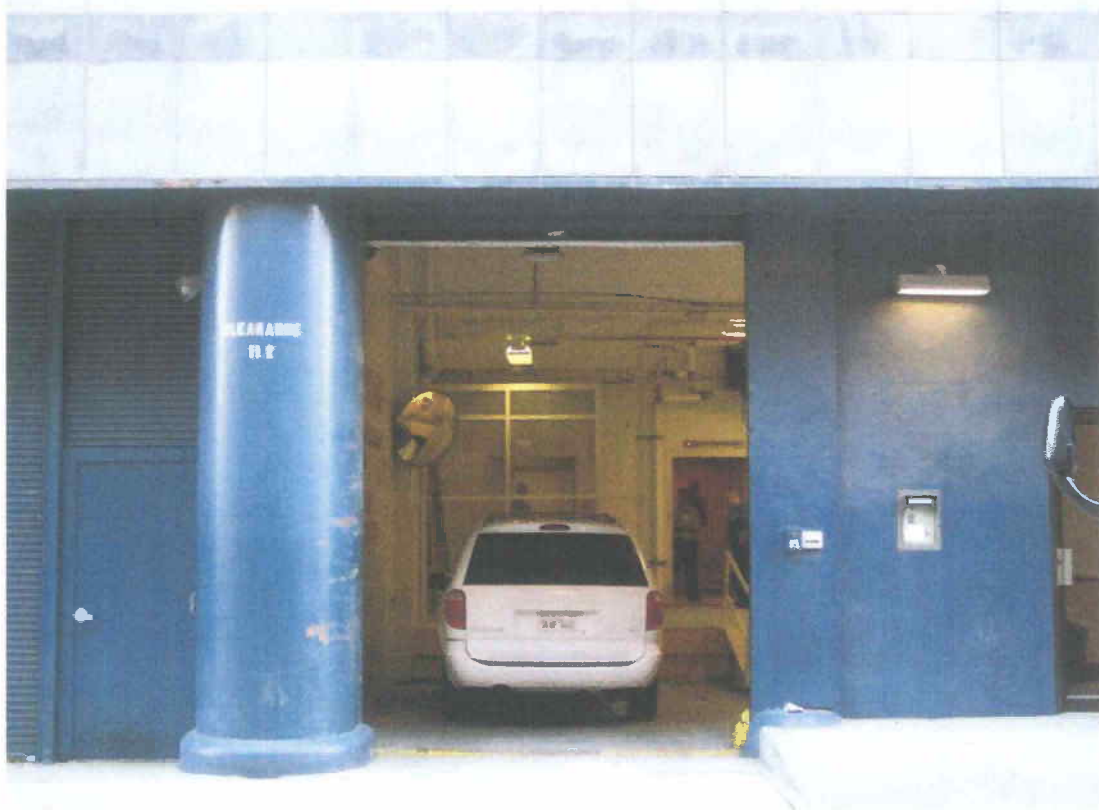
U.S. Appraisers Stores and Immigration Station
San Francisco County, California
Photographer: David Greenwood, Jones & Stokes
Date of photograph: November 30, 2006
Negative: GSA Headquarters
Description of view: Basement entrance from Custom House Place
Photo number: CA_SanFranciscoCounty_ImmigrationStation10.tiff

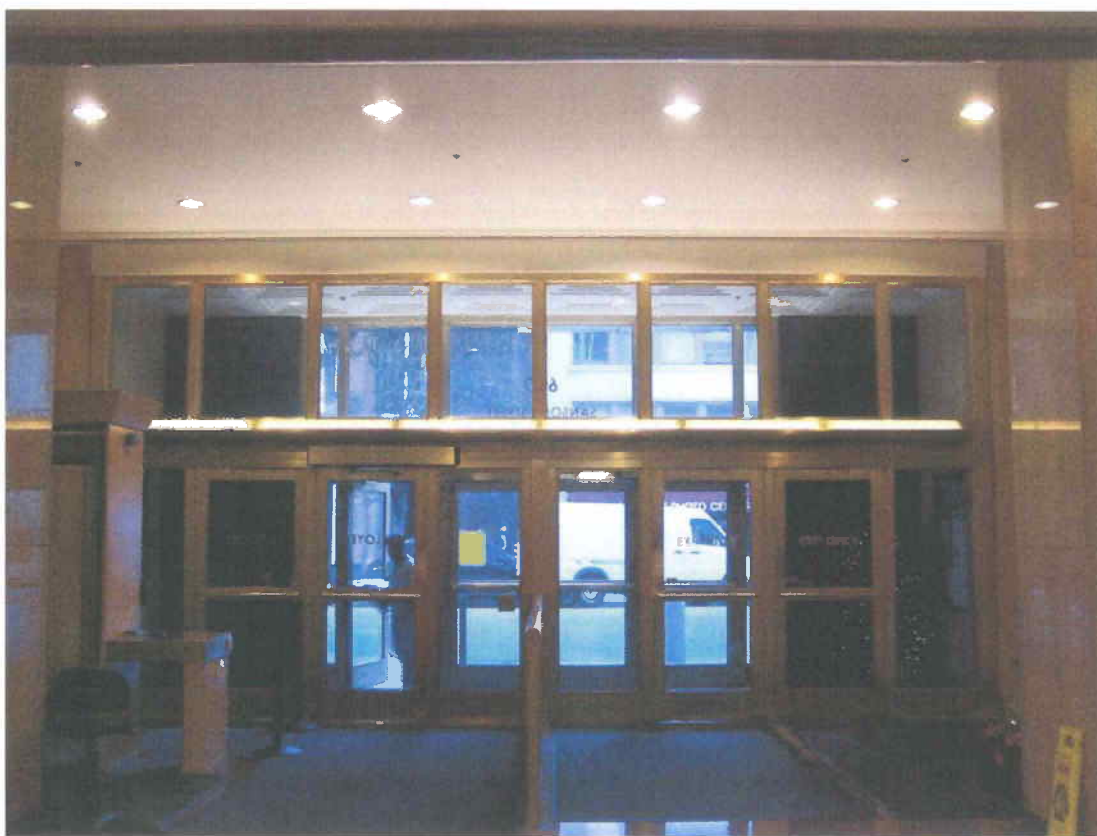
Photo number: CA_SanFranciscoCounty_ImmigrationStation11.tiff

Description of view: Lobby entry looking out onto Sansome Street, facing west.

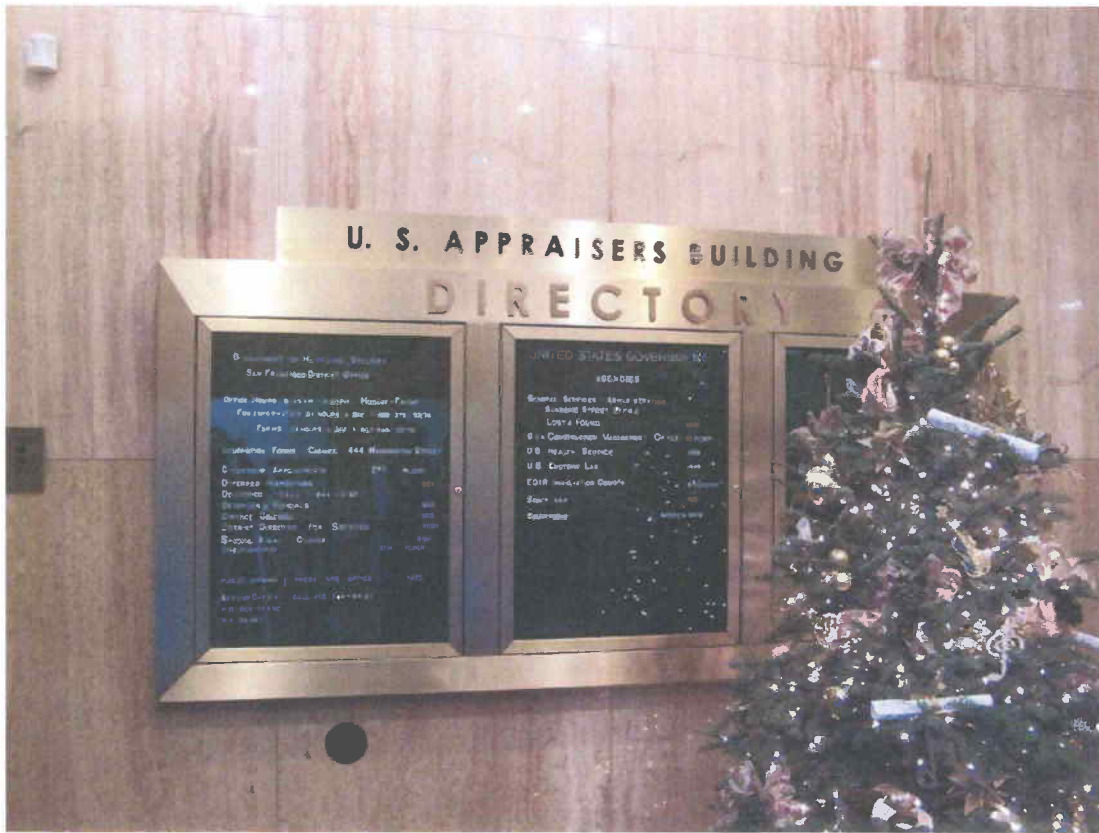
U.S. Appraisers Stores and Immigration Station
San Francisco County, California
Photographer: David Greenwood, Jones & Stokes
Date of photograph: November 30, 2006
Negative: GSA Headquarters
Description of view: Detail, brass directory, ground floor
Photo number: CA_SanFranciscoCounty_ImmigrationStation12.tiff

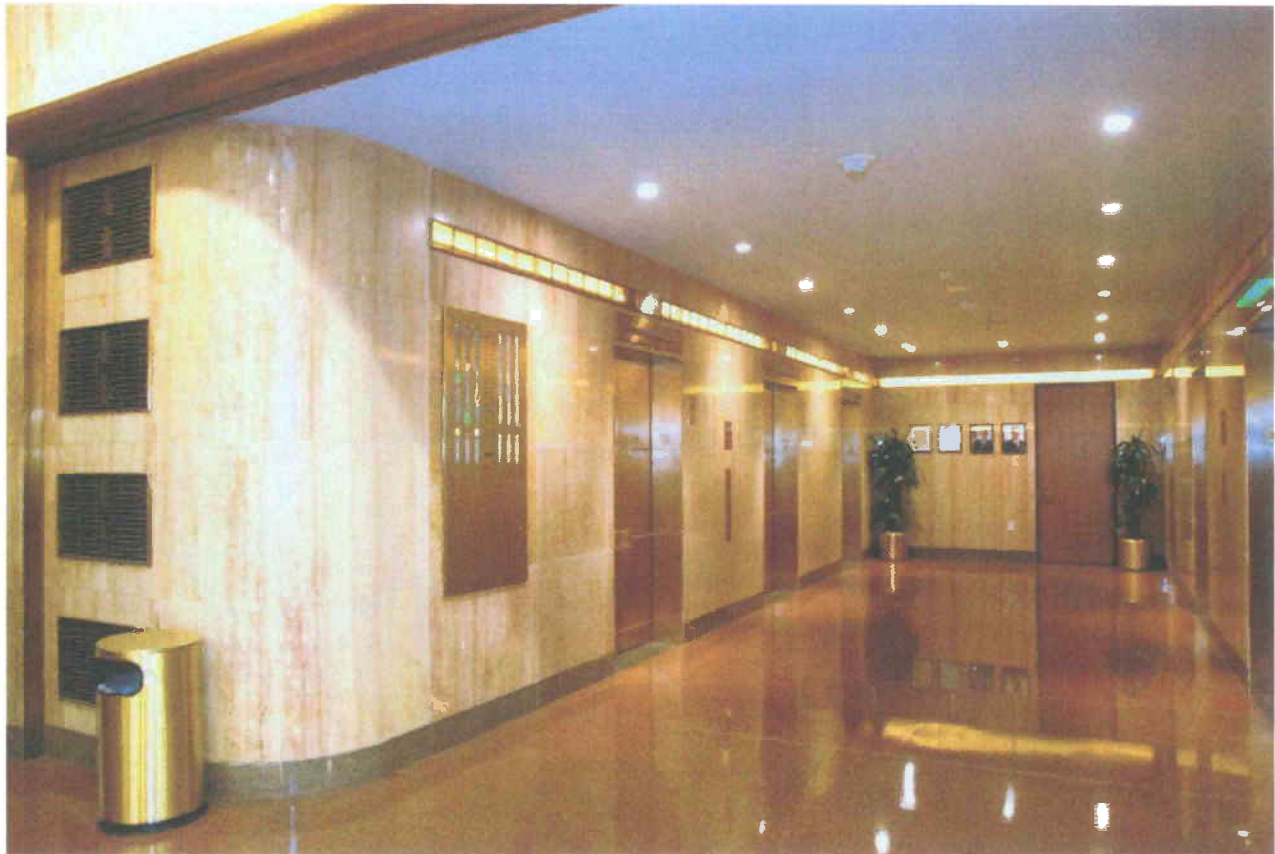
Photo number: CA_SanFranciscoCounty_ImmigrationStation14.tiff

Description of view: Ground floor elevator lobby

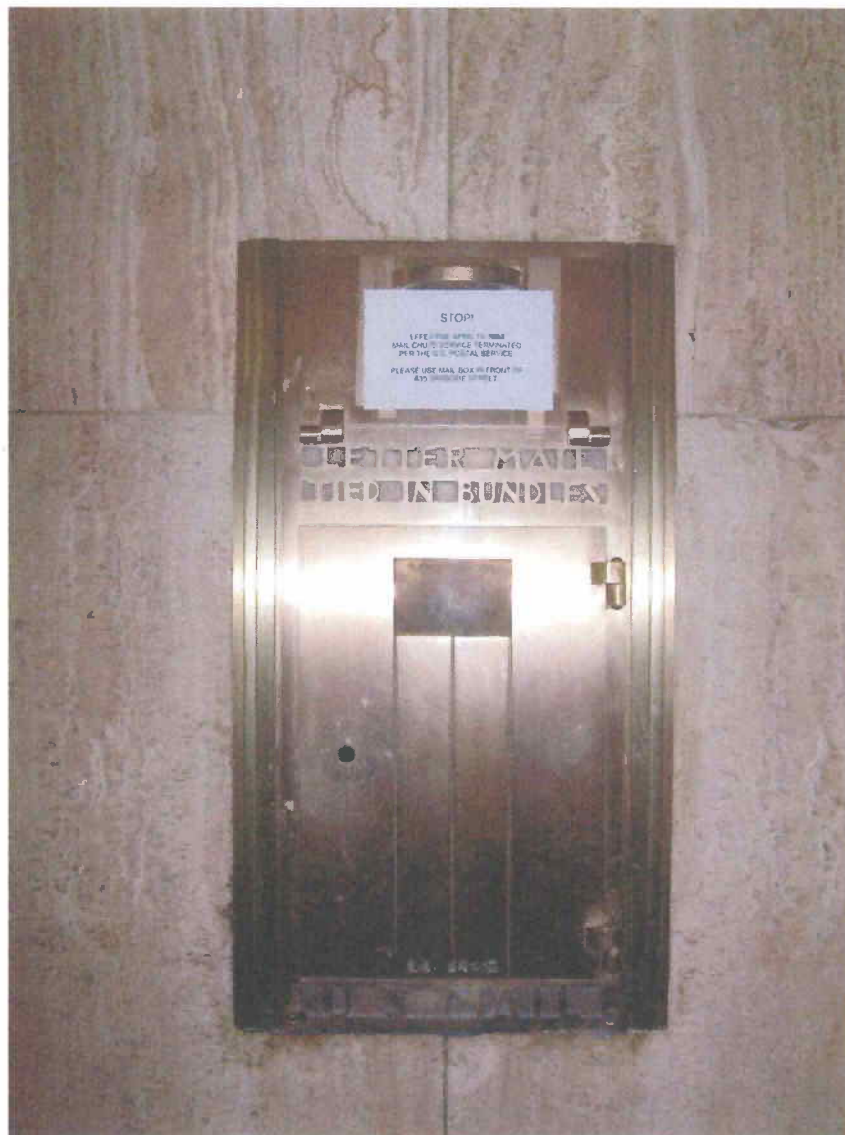
U.S. Appraisers Stores and Immigration Station
San Francisco County, California
Photographer: David Greenwood, Jones & Stokes
Date of photograph: November 30, 2006
Negative: GSA Headquarters
Description of view: Detail, brass mail box, ground floor lobby
Photo number: CA_SanFranciscoCounty_ImmigrationStation15.tiff

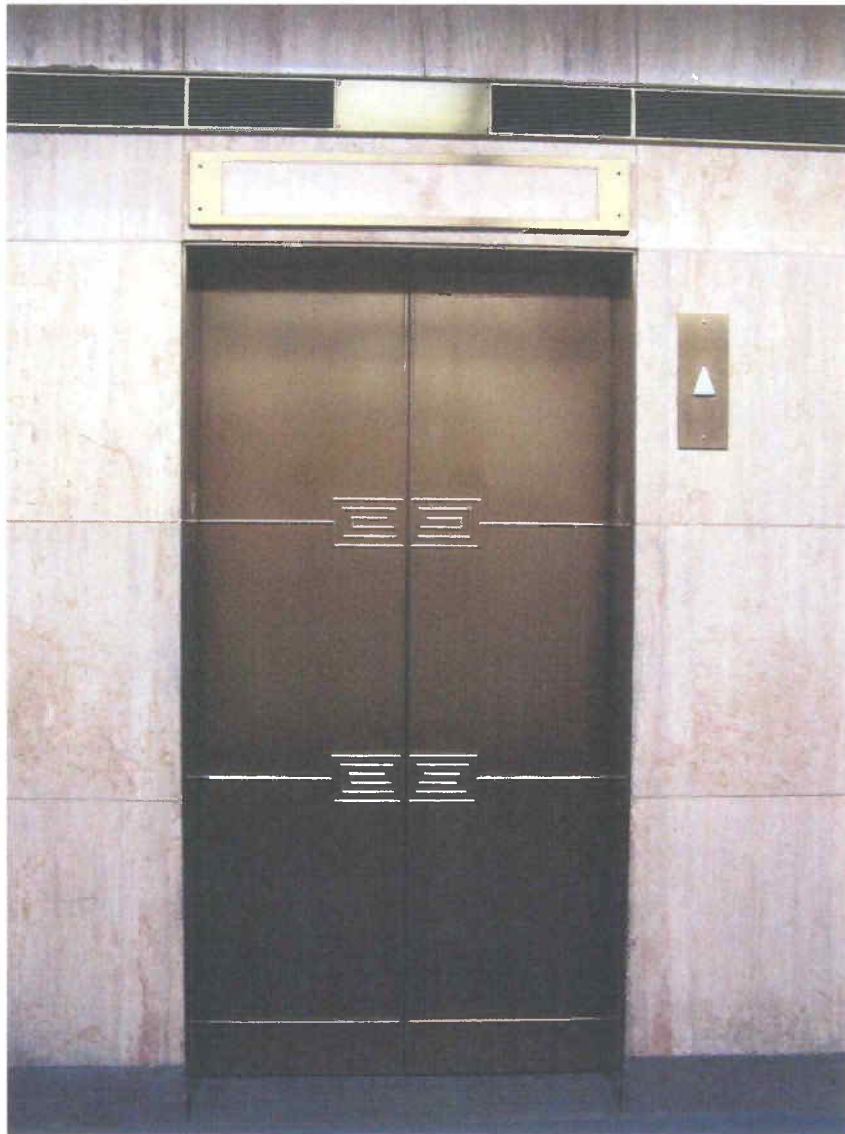
U.S. Appraisers Stores and Immigration Station
San Francisco County, California
Photographer: David Greenwood, Jones & Stokes
Date of photograph: November 30, 2006
Negative: GSA Headquarters
Description of view: Detail, brass elevator doors, ground floor lobby
Photo number: CA_SanFranciscoCounty_ImmigrationStation17.tiff

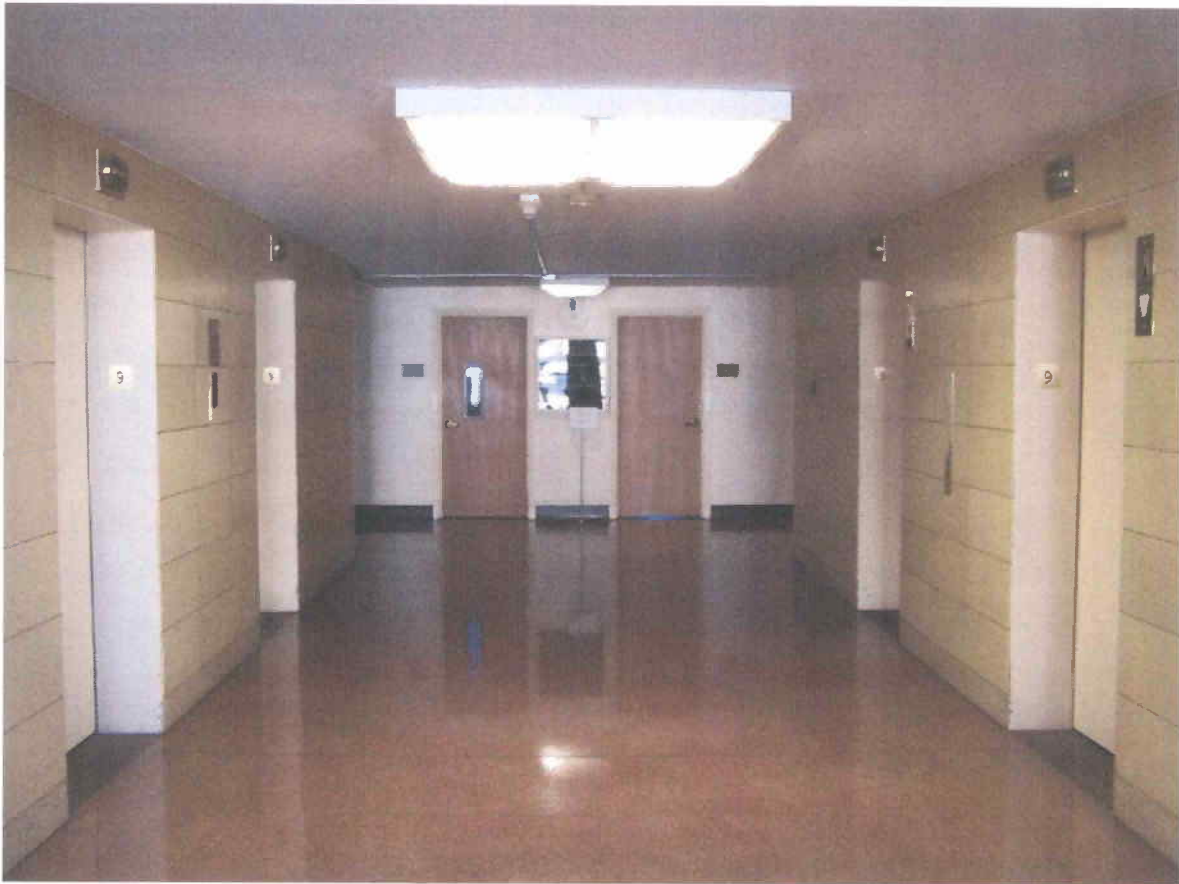
U.S. Appraisers Stores and Immigration Station
San Francisco County, California
Photographer: David Greenwood, Jones & Stokes
Date of photograph: November 30, 2006
Negative: GSA Headquarters
Description of view: 9th floor lobby, original wall cladding
Photo number: CA_SanFranciscoCounty_ImmigrationStation18.tiff
