State of California — The Resources Agency
DEPARTMENT OF PARKS AND RECREATION
PRIMARY RECORD

Page 1 of 4 *Resource Name or #: (Assigned by recorder) 364 Hayes Street

- P1. Historic name of building (if any):** Proben and Greeneischen garage
P2. Location: *a: County San Francisco Not for Publication Unrestricted
*b. USGS 7.5' Quad _____ Date _____ T _____; R _____; _____ ¼ of _____ ¼ of Sec _____; _____ B.M.
c. Address 364 Hayes Street City San Francisco Zip 94102
d. UTM: Zone _____; _____ mE/ _____ mN *e. Assessor's parcel #: Block 809, lot 11

P11. Report Citation*: (Cite survey report.) William Kostura. Van Ness Auto Row Support Structures. San Francisco Department of City Planning, 2010.

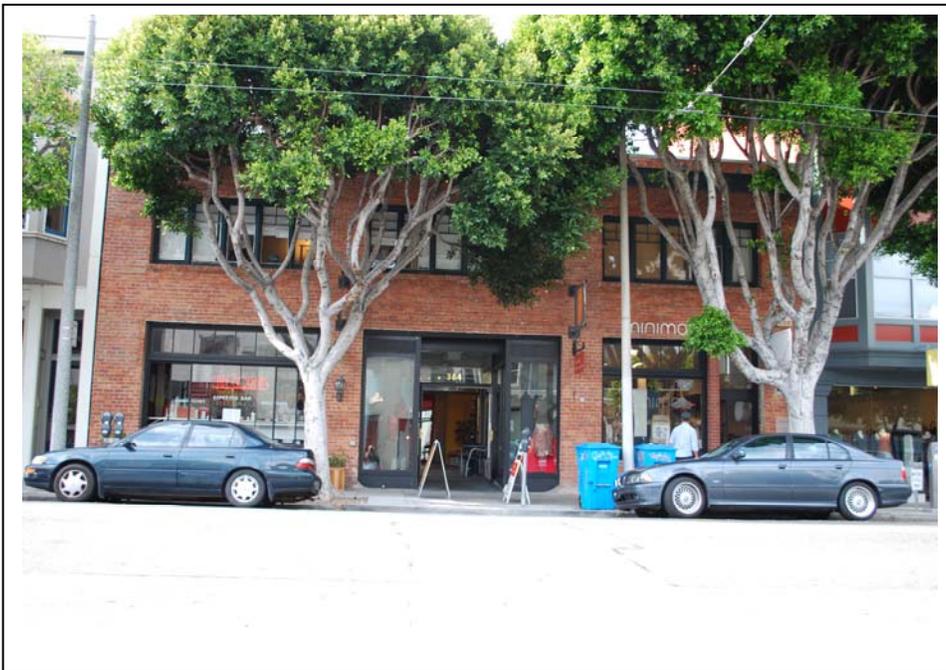
This is a two-story brick masonry building that fills its 50' by 120' lot, which extends through the block to Ivy Street. The façade is divided into three bays, with a middle bay of slightly greater width than the outer bays. The composition is topped by a modest wooden cornice with four supporting modillions. The three second story windows are casements, with windows of five-parts flanking a central window of six parts. In each of these parts four upper lights are placed over a large single light. In the first story one finds (from left to right): 1) a large fixed storefront window, with an apparently original wooden transom of many lights, and replacement metal framing below the transom; 2) a wooden storefront entrance that must have once been a vehicle entrance; and 3) in the far right, or easternmost bay, a wooden storefront window and transom that appears to be entirely original, plus a non-original metal door to the second story. The brick front has been sand-blasted.

P5b. Description of Photo:
(View, date, accession #)
View looking north
June 2009

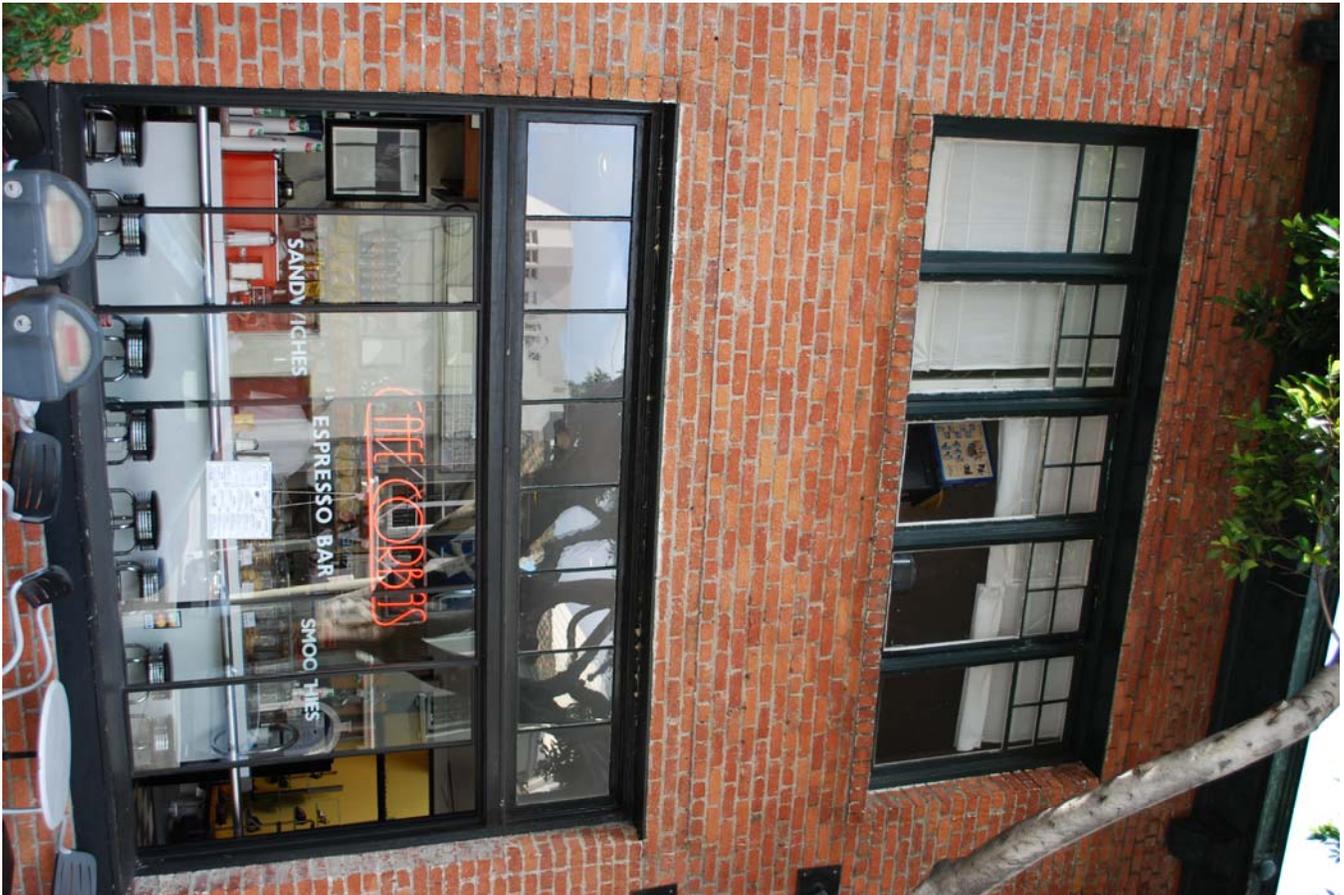
Detail of the far left (westernmost) bay. In the second story the frame, mullions, and muntins are wooden, and appear to be original. In the first story, transom muntins appear to be wooden, while the elements below are metal.

The principle alteration to the façade has been the sandblasting of the brick. One of the storefront windows appears to be entirely intact, while the other has an intact transom and replacement metal framing within the original opening. In sum, this building retains integrity of location, design, setting, feeling, and association. Integrity of materials and workmanship have been lessened through sandblasting.
