State of California — The Resources Agency
 DEPARTMENT OF PARKS AND RECREATION
PRIMARY RECORD

Page 1 of 7 *Resource Name or #: (Assigned by recorder) 66 Page Street

P1. Historic name of building (if any): Grand Central Garage
 P2. Location: *a: County San Francisco Not for Publication Unrestricted
 *b. USGS 7.5' Quad _____ Date _____ T _____; R _____; _____ ¼ of _____ ¼ of Sec _____; _____ B.M.
 c. Address 66 Page Street City San Francisco Zip 94109
 d. UTM: Zone _____; _____ mE/ _____ mN *e. Assessor's parcel #: Block 837, lot 8

B1. Historic Name: Grand Central Garage

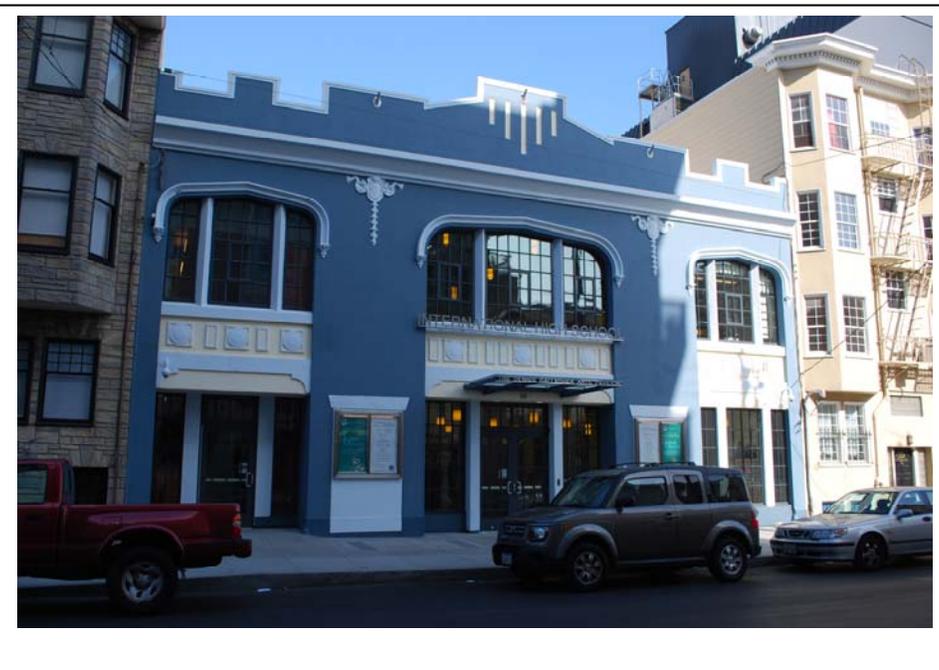
P5b. Description of Photo:
 (View, date, accession #)
 View looking north
 October 2009
 *P6. Date Constructed/Age and Source: Historic
 Prehistoric Both
 1924; building permit
 *P7. Owner and Address:
FRENCH AMERICAN INTRNL SCHOOL
150 OAK STREET
SAN FRANCISCO CA 94102
 *P8. Recorded by: (Name, affiliation, and address)
William Kostura
P. O. Box 60211
Palo Alto, CA 94306
 *P9. Date Recorded: _____
 October 2009
 *P10. Survey Type: (Describe)
intensive
 P11. Report Citation: (Cite survey report.) William Kostura.
Van Ness Auto Row Support

This two-story, reinforced concrete, stucco-clad garage fills the width of its 55-foot wide lot and extends 120 feet to the alley in the rear. The composition is symmetrical and divided into three bays. The general style is Tudor Revival, as exemplified in the pointed arches in the second story windows and in the castellated profile of the parapet. In the center of the parapet, which rises to a flattened peak, vertical grooves are incised in the stucco surface. At the base of the parapet is a simple, profiled cornice. Suspended from the cornice are two shields with swags and pendants, of plaster, that flank the center bay. Profiled drip moldings with foliated ends cover the Tudor arches in the second story. Within each Tudor window are two mullions that taper to a pointed edge. The spandrel beneath each window is slightly recessed from the wall plane and is decorated with small panels, three of which contain circles. Each of the first story openings originally had rounded upper corners, and the outlines of these corners are still visible, although the top several inches of each opening has been filled in.

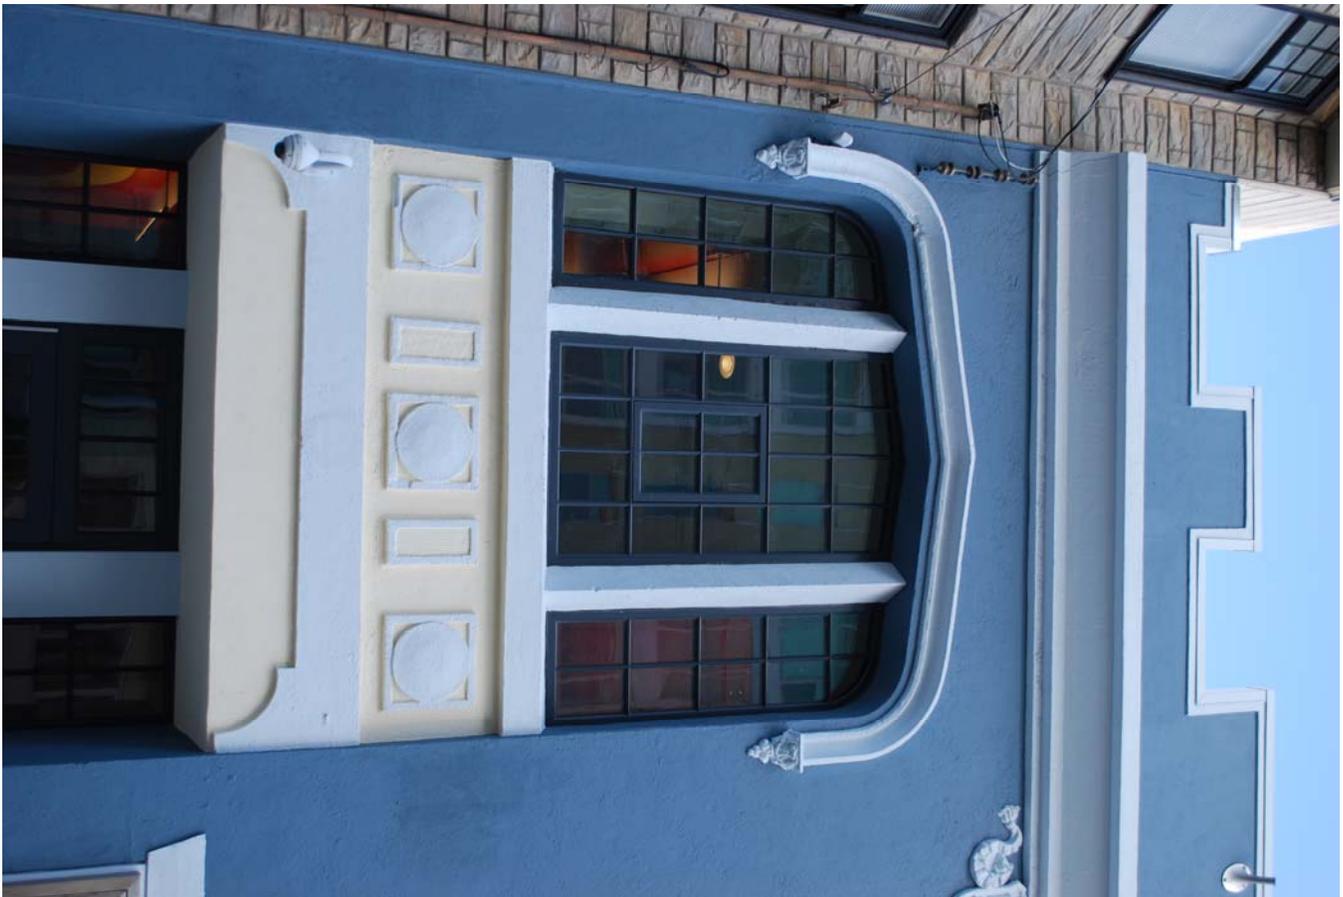
Window and cornice detail, showing new window sash that is virtually identical to the original. The parapet, cornice, drip molding, mullions, paneled spandrel, and lintel over the first story opening (with curved corners) are all original. The treatment of the other two bays is the same. Photo: October 2009.

All sash in the second story windows is metal, and divided into many lights; it is almost identical, in profile, reveal, and the number and arrangement of lights, with the original industrial steel sash that was in these windows until recently. The first story openings are now filled with similar sash of many lights that was also installed recently. The two outer bays, originally devoted to vehicle entrances, have become a pedestrian entrance (at left) and a window (at right). The opening in the center bay is now a pedestrian entrance with paired doors, sidelights, and a transom, all divided into many lights. Small windows between these larger openings were recently filled in, but retain their original lintels.

The second story window sash has been replaced with new sash that is very similar to the original, in profile, relief, and the number and arrangement of lights. The three large first story openings are filled with new window sash and doors. The two small windows in the first story have been filled in but retain their original lintels. All ornament and moldings remain intact. In sum, this building retains integrity of location, design, setting, feeling, and association, while integrity of materials and workmanship have been diminished.

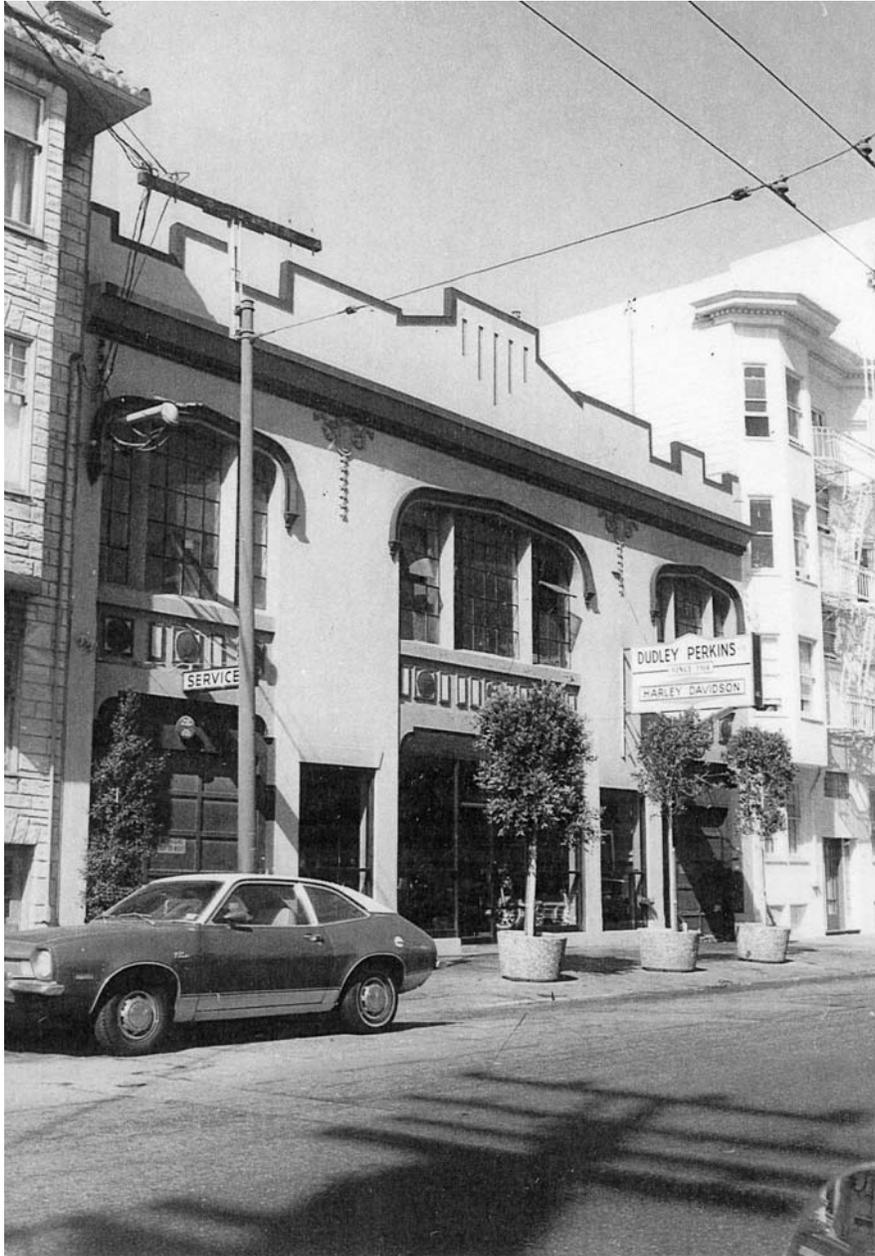
1976 photograph of 66 Page Street, from the Department of City Planning survey of historic buildings. The industrial steel sash in the second story windows, shown in this photo, was recently (mid-2009) replaced with new, almost identical sash with the same number and arrangement of lights. The roll-up garage doors in the outer bays of the first story have also been replaced with sash similar to that in the upper story. Small windows shown in this photo have recently been filled in, retaining the lintels.

Within the past year the building began to be rehabilitated for new occupancy. The original industrial steel window sash has been replaced with similar sash. Non-original garage doors and windows were removed from the first story as well, and replaced with new sash and doors similar to those in the upper story. The small first story windows were filled in, retaining the lintels.
