REVISED MISSION DOLORES NEIGHBORHOOD SURVEY VOLUME 2 OF 2

San Francisco, California November 11, 2009

Prepared for Mission Dolores Neighborhood Association

Prepared by Carey & Co., Inc.

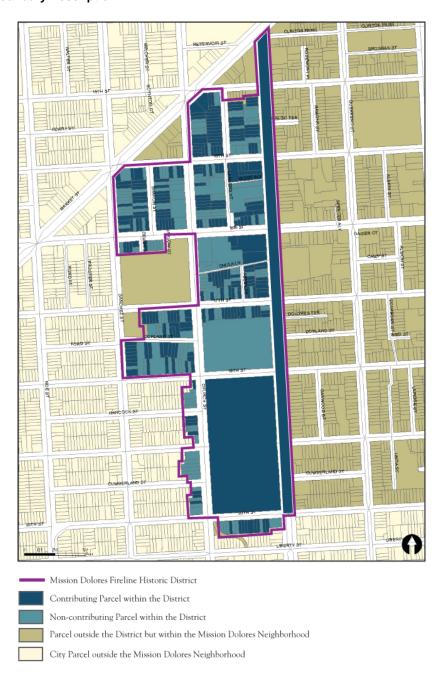
Map of the Mission Dolores Neighborhood 1906 Fire Survivors and Reconstruction Historic District.

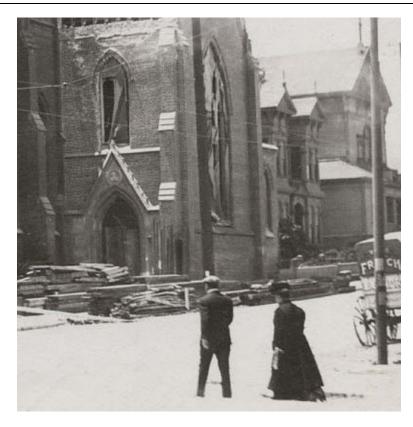
Fig. 1 Detail from a 1906 image of the ruins of the Mission Dolores Church (current site of the Mission Dolores Basilica). Note the rectory and school in the rear of the building, facing 16th Street.

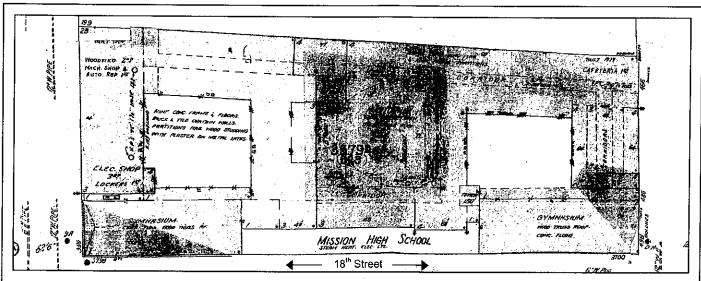
Image 3: The building plan, displaying the central auditorium and east and west wings. Source: Insurance Maps of San Francisco, California, Volume 7, Sanborn Map Company, 1998.

The generally symmetrical building plan displays similar east and west wings, each designed around an open-air courtyard with a tower at the southwest corner, and each with a single-story gymnasium to the south and taller buildings at the other three sides, flanking a central auditorium. The wings are distinct from each other in detail and treatment. The west wing was constructed earlier, from 1923 to 1925, and it is the more modest and altered of the wings. The west wing is three stories high behind the gymnasium, and displays sparse omamentation, most notably the 62-foot tall cupola tower that overlooks the west courtyard. The west wing contains the science, art, and vocational classrooms, and the boys gymnasium. The east wing was constructed later, as was the central auditorium and most of the front instructional and administrative building, from 1925 to 1927. At four stories high, the east wing is taller than the west wing, and it is heavily ornamented. The east wing features the school's signature architectural feature, the 127-foot tall bell tower overlooking the east courtyard, as well as the prominent main entrance. The east wing contains traditional academic classrooms as well the library, cafeteria, and girls gymnasium. (See Image 3)

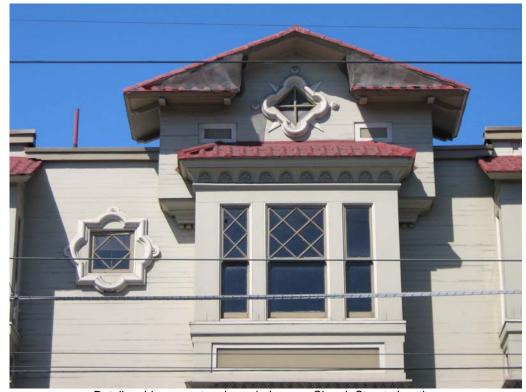
windows on the front faces with double-hung wood sash featuring four-over-one sash on the first story and diamond pane top sash on the second story. Small parapet walls with pent roofs clad in red clay tile extend above the roofline at each window. The bay window in the third bay has three-part windows with similar division patterns. These windows have roofs with corbelled cornices a parapet wall above the roofline with gable roof and center quatrefoil windows. The remaining bays have single, flush windows with four-over-one, double-hung wood sash and cornice caps, topped second and fourth bays with small fixed windows with quatrefoil surrounds. The corner bay has a five-sided corner bay window with pent roof clad in red clay tile and parapet with channeled decoration. The 15th Street elevation has a rectilinear bay window similar to those on the Church street elevation in the right bay. 300-308 Church Street is connected to the adjacent building at 310-312 Church Street by a three-story, wood-frame stair tower clad in stucco. The connector has a service door on the first story and wood-frame, fixed windows on the upper stories. The tower terminates in a shed roof clad in red clay tile. The building appears to be in good condition.

Detail, gable parapet on bay windows on Church Street elevation

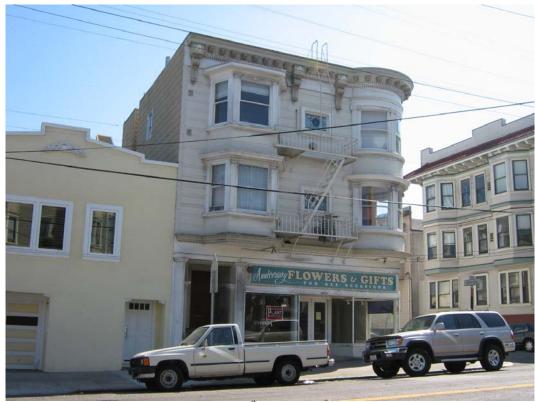
adjacent to it. The upper stories have paired and single flush windows in the first three bays and semi-hexagonal bay windows in the remaining bays. Windows are aluminum sliding sash on bay windows on the third floor. Window sashes on the building include undivided, double-hung wood sash unless otherwise noted. Both elevations terminate in a wide frieze with dentils and egg and dart molding and widely spaced, massive brackets supporting a modillion cornice. The remaining elevations are clad in wood drop siding. The building appears to be in fair condition.

View of 16th Street elevation

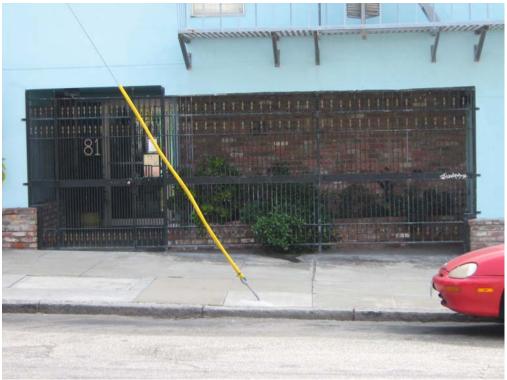
Right and center bays at the ground floor of 81 Landers Street.

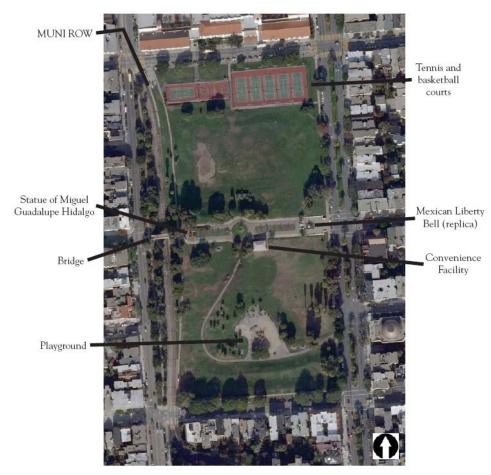
From the center circular median, a curvilinear, paved path leads south to a playground with an irregularly-shaped sand pit containing playground equipment. Picnic tables and benches area scattered around the playground. Tennis courts and one basketball court enclosed by chain link fences line the park's northern edge.

Site map of Mission Dolores Park, 2009.

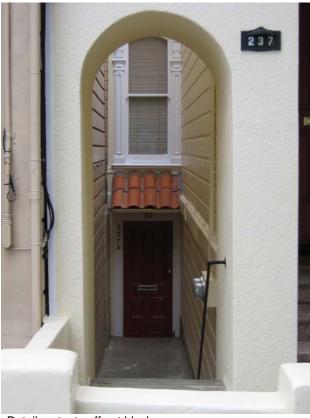
The primary façade terminates in a false parapet with a pent roof clad in Spanish tile featuring a dog toothed relief and cornice. All windows feature one-over-one, double-hung wood sashes with divide lights in the upper sash and molded surrounds unless noted otherwise. The side facades are clad in drop siding. The building appears to be in good condition.

Detail, entry to off-set block

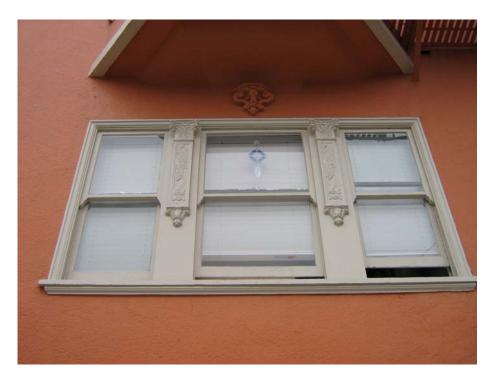
Detail, second-story window surround
