State of California — The Resources Agency  
DEPARTMENT OF PARKS AND RECREATION  
**DISTRICT RECORD**

\*Resource Name or # **Guerrero Street Fire Line**

\*D8. **Evaluator:** N. Moses Corrette **Date:** 10 September, 2003  
**Affiliation and Address:** City and County of San Francisco Planning Department  
1660 Mission Street, San Francisco, CA 94103

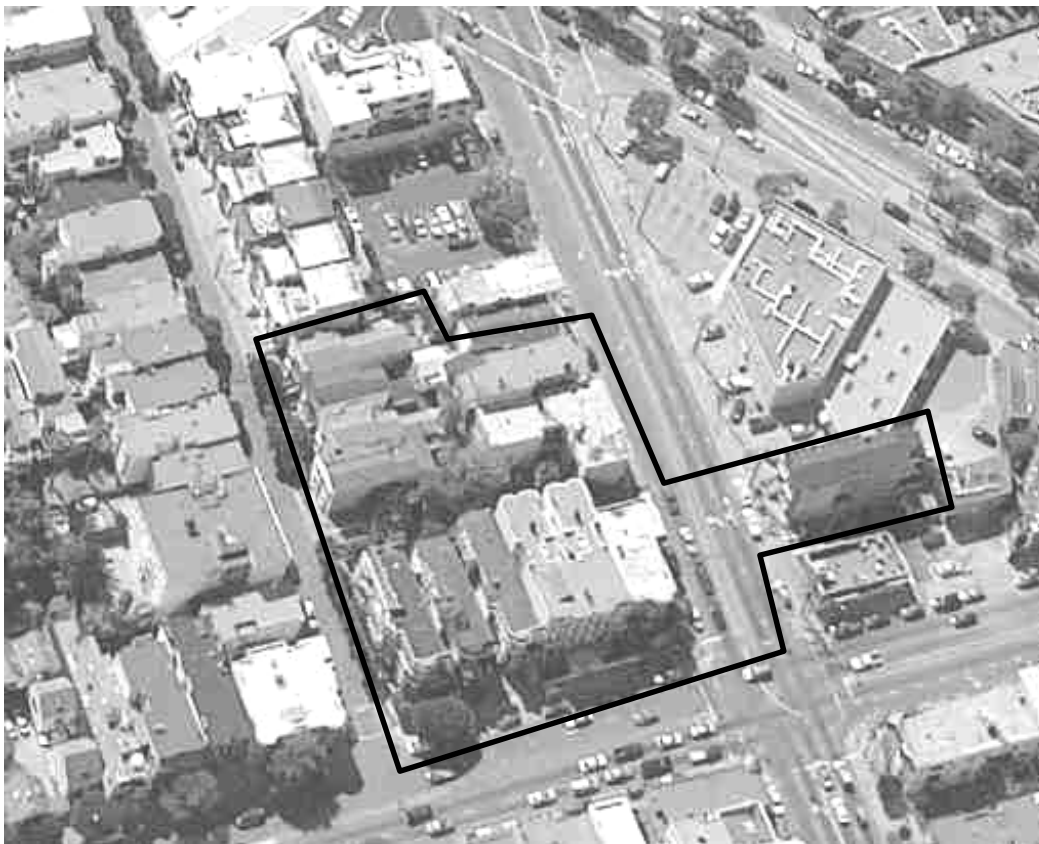
The integrity of the Guerrero Street Fire Line National Register Eligible District is high. There are only two non-contributory buildings in the boundaries. One non-contributory building is the result of a substantial alteration from the 1920s, and the other is a newer building erected in 1958. The row of buildings on Guerrero Street between Duboce and Clinton Park remains intact; with the only alterations to individual buildings are the insertions of garage doors on the primary facades of two of the five buildings.

Aerial oblique photograph of the Guerrero Street Fire line National Register eligible District, 2002.

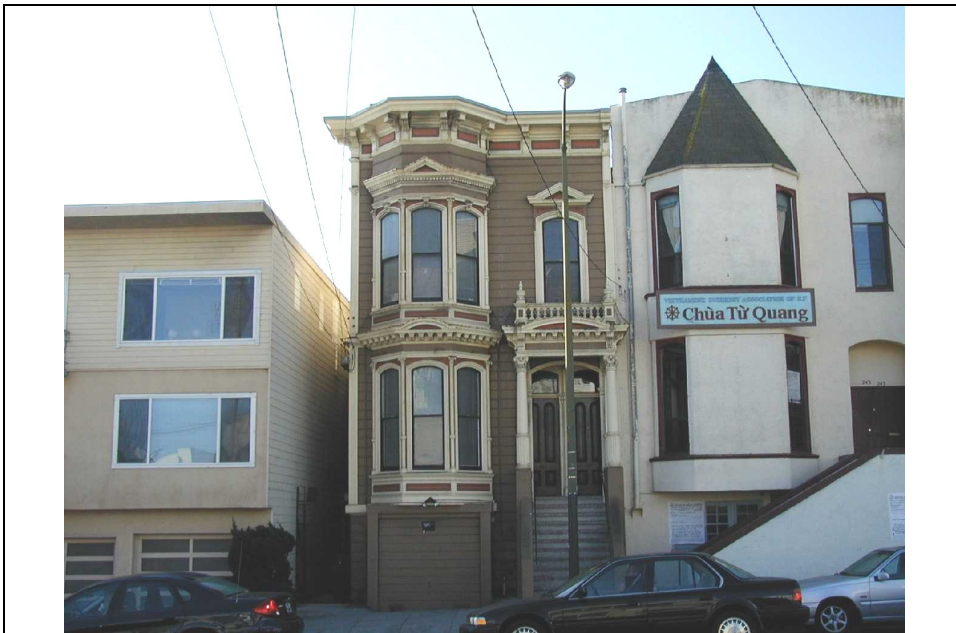
This is a three-story, two-bay, wood clad, frame Italianate residential flats building. The ground story features a single sectional steel garage door in the first bay and a terrazzo staircase to the second story. The second and third stories feature a heavily decorative sculpted bay in the first bay. The second story features an elaborate entry portico with Ionic columns and classical detailing. Two wooden paneled doors with arched transoms lead to the residences. The third story features a single window in the second bay with a pediment hood.

The windows are 1/1 wood double hung. The cornice and parapet are bracketed with panel molding. The roof is flat.

**P5b. Photo:** (view and date)  
View From Duboce Avenue  
looking south  
11/21/2001

**INTEGRITY:** The building appears to be in good structural and material condition. Materially it is little changed from the time it was erected in a dense urban fabric, this property retains integrity of location, design, workmanship, materials, and association. The setting and feeling abruptly changed in 1906, but have been fairly consistent since the 1910s.

**FEATURES:** Character defining features include, but may not be limited to: siting and relationship of the building to the street, the size and location of the automobile garage entry; cladding materials (rustic wood siding); roof configuration, materials and treatment; building plan; staircases and entry approach; windows and doors including surrounds and glazing; and architectural elements such as entry porch with columns, front doors, and bracketed parapet.

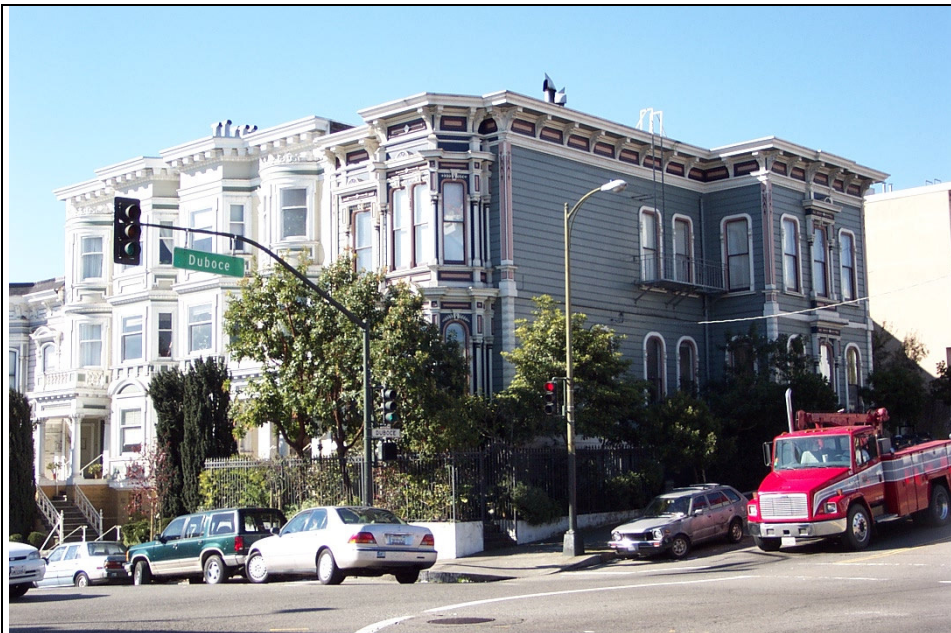
**P5b. Photo:** (view and date)  
View From Guerrero Street  
looking west  
11/21/2001

INTEGRITY: The building appears to be in good structural and material condition. Materially it is little changed from the time it was erected in a dense urban fabric, this property retains integrity of location, design, workmanship, materials, and association. The setting and feeling abruptly changed in 1906, but have been fairly consistent since the 1910s.

FEATURES: Character defining features that include, but may not be limited to: siting and relationship of the building to the street, the concrete retaining wall, with landscaped front and side yards; cladding materials (rustic wood siding); roof configuration, materials and treatment; building plan; staircases and entry approach; windows and doors including surrounds and glazing; and architectural elements such as the ornate carved moldings on the projecting bay window, and elsewhere, and bracketed and paneled parapet.

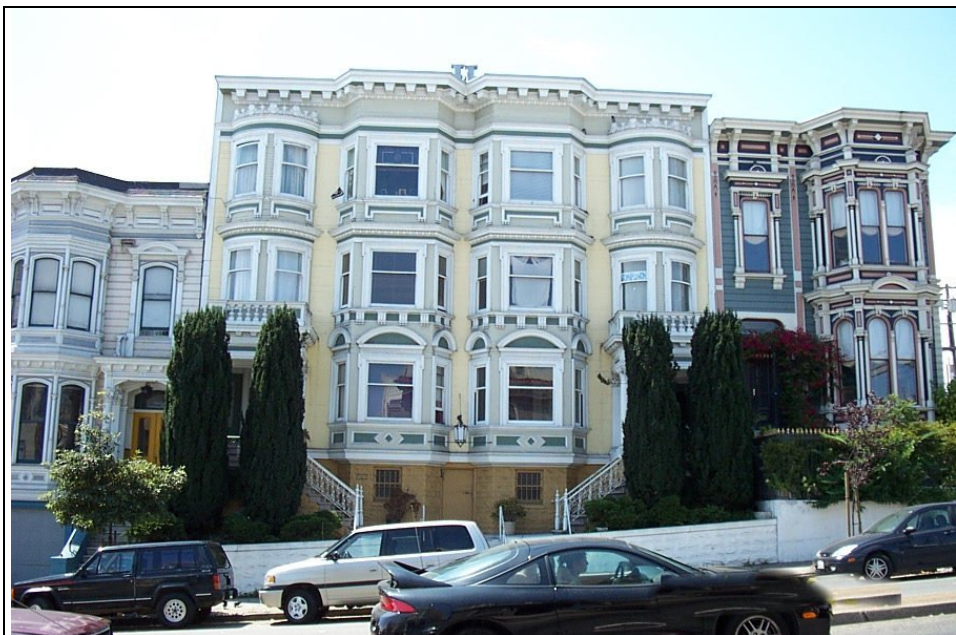
**P5b. Photo:** (view and date)  
View From Guerrero Street  
looking west  
8/29/2002

**INTEGRITY:** The building appears to be in good structural and material condition. Materially it is little changed from the time it was erected in a dense urban fabric, this property retains integrity of location, design, workmanship, materials, and association. The setting and feeling abruptly changed in 1906, but have been fairly consistent since the 1910s.

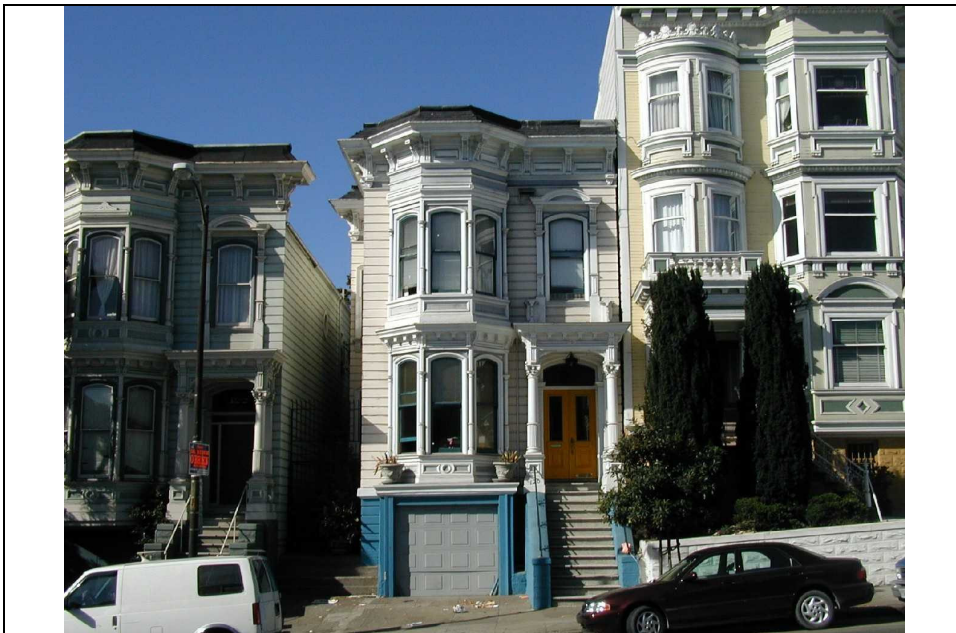
**P5b. Photo:** (view and date)  
View From Guerrero Street  
looking west  
11/21/2001

**INTEGRITY:** The building appears to be in good structural and material condition. Materially it is little changed from the time it was erected in a dense urban fabric, this property retains integrity of location, design, workmanship, materials, and association. The setting and feeling abruptly changed in 1906, but have been fairly consistent since the 1910s, save for the removal of the front retaining yard, and insertion of the garage at grade c. 1940.

**FEATURES:** Character defining features include, but may not be limited to: siting and relationship of the building to the street, the size and location of the automobile garage entry; cladding materials (rustic wood siding); roof configuration, materials and treatment; building plan; staircases and entry approach; windows and doors including surrounds and glazing; and architectural elements such as the entry porch with columns, and bracketed pent roof parapet.

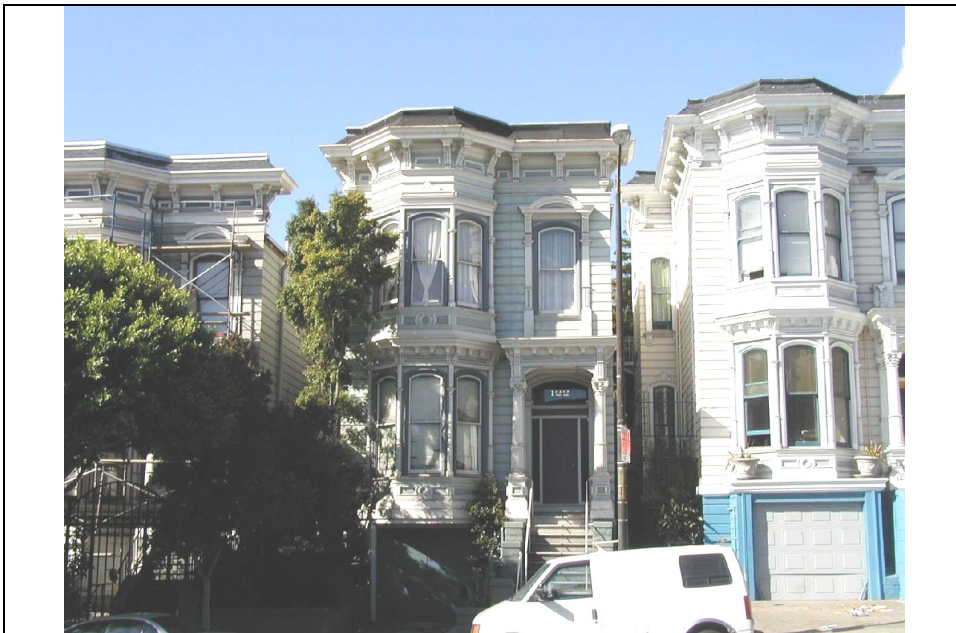
**P5b. Photo:** (view and date)  
View From Guerrero Street  
looking west  
11/21/2001

**INTEGRITY:** The building appears to be in good structural and material condition. Materially it is little changed from the time it was erected in a dense urban fabric, this property retains integrity of location, design, workmanship, materials, and association. The setting and feeling abruptly changed in 1906, but have been fairly consistent since the 1910s, save for the removal of the front retaining yard, and insertion of the garage at grade c. 1940.

**FEATURES:** Character defining features include, but may not be limited to: siting and relationship of the building to the street, the size and location of the automobile garage entry; cladding materials (wood rustic siding); roof configuration, materials and treatment; building plan; staircases and entry approach; windows and doors including surrounds and glazing; and architectural elements such as the entry porch with columns and large transom, and bracketed pent roof parapet.

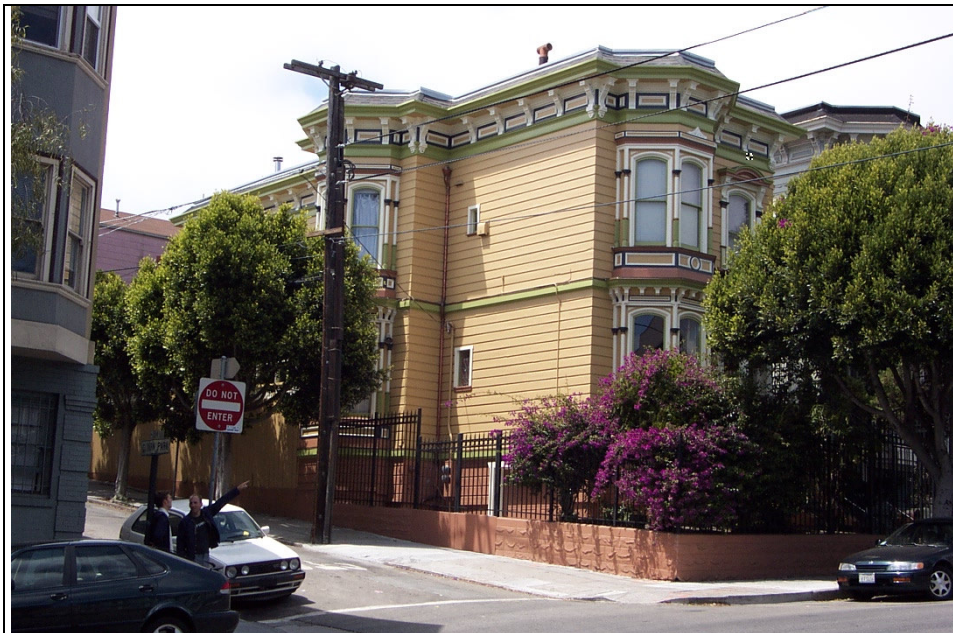
**P5b. Photo:** (view and date)  
View From Guerrero Street  
looking west  
8/4/2002

**INTEGRITY:** The building appears to be in good structural and material condition. Materially it is little changed from the time it was erected in a dense urban fabric, this property retains integrity of location, design, workmanship, materials, and association. The setting and feeling abruptly changed in 1906, but have been fairly consistent since the 1910s.

**FEATURES:** Character defining features include, but may not be limited to: siting and relationship of the building to the street, the size and location of the automobile garage ; concrete retaining wall, exterior cladding materials (rustic wood siding); roof configuration, materials and treatment; building plan; staircases and entry approach; windows and doors including surrounds and glazing; and architectural elements such as entry portico with columns, and bracketed pent roof parapet.

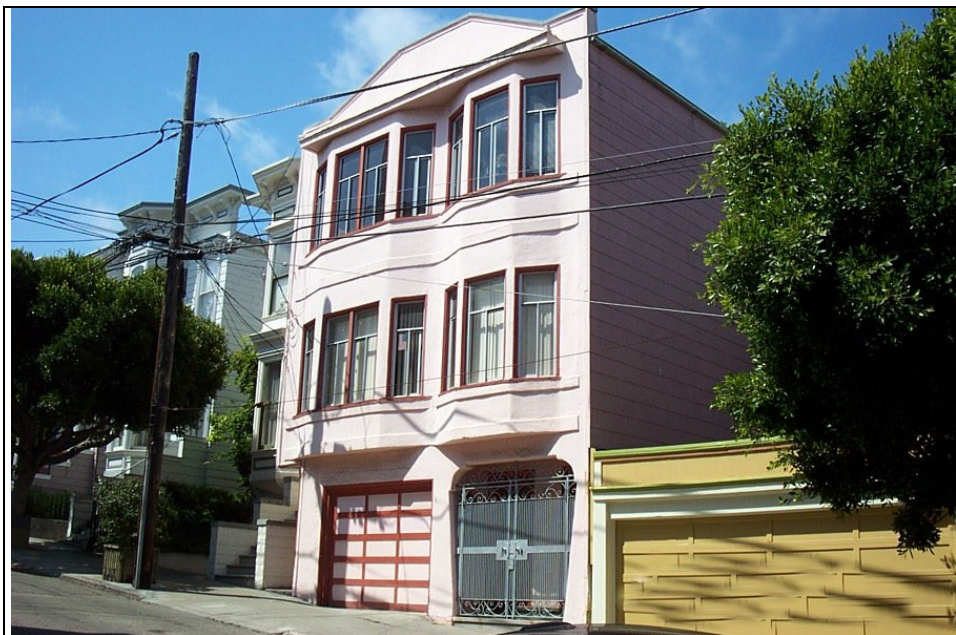
**P5b. Photo:** (view and date)  
View From Clinton Park  
looking north  
8/29/2002

**INTEGRITY:** The building appears to be in good structural and material condition. This property retains integrity of location, setting, feeling and association; however, remodeling including the façade and window replacement have compromised its integrity of design, workmanship, and materials. The property does retain integrity to its 1920 remodel save for the replacement windows.

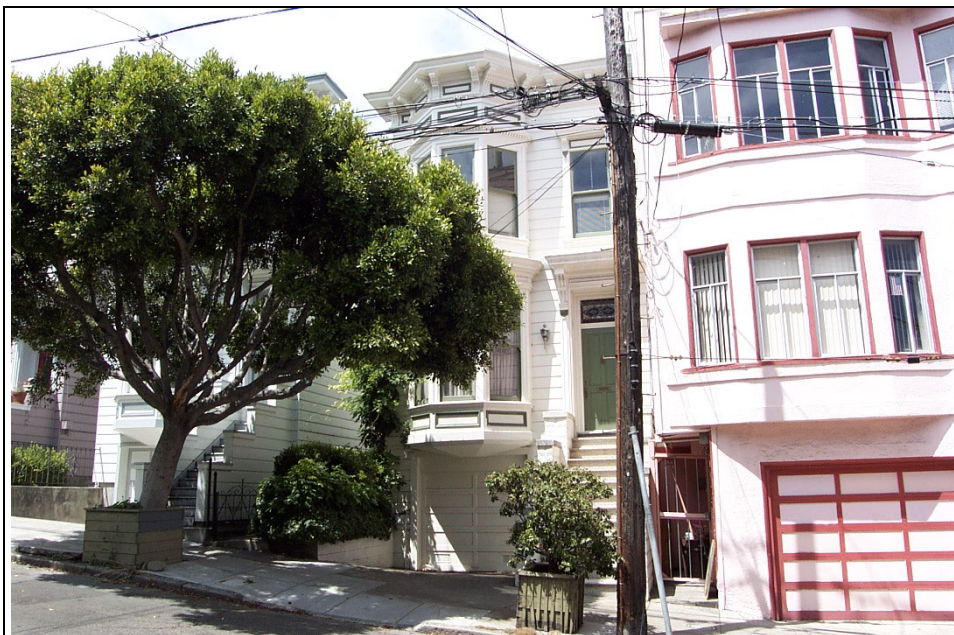
**P5b. Photo:** (view and date)  
View From Clinton Park  
looking north  
8/4/2002

**INTEGRITY:** The building appears to be in good structural and material condition. Materially it is little changed from the time it was erected in a dense urban fabric, this property retains integrity of location, design, workmanship, materials, and association. The setting and feeling abruptly changed in 1906, but have been fairly consistent since the 1910s.

**FEATURES:** Character defining features that include, but may not be limited to: siting and relationship of the building to the street, the size and location of the automobile garage entry; cladding materials (rustic wood siding); roof configuration, materials and treatment; building plan; staircases and entry approach; windows and doors including surrounds and glazing; and architectural elements such as the bracketed parapet.

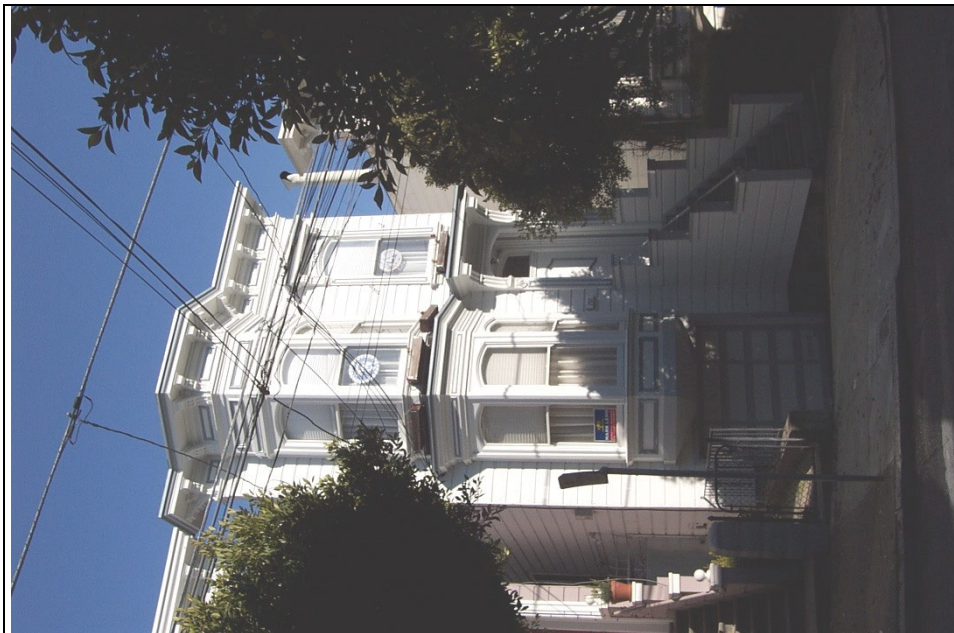
**\*P3a. Description:** (Describe resource and its major elements. Include design, materials, condition, alterations, size, setting, and boundaries.)

**INTEGRITY:** The building appears to be in good structural and material condition. Materially it is little changed from the time it was erected in a dense urban fabric, this property retains integrity of location, design, workmanship, materials, and association. The setting and feeling abruptly changed in 1906, but have been fairly consistent since the 1910s.

**FEATURES:** Character defining features include, but may not be limited to: siting and relationship of the building to the street, the size and location of the automobile garage entry; cladding materials (rustic wood siding); roof configuration, materials and treatment; building plan; staircases and entry approach; windows and doors including surrounds and glazing; and architectural elements such as the bracketed parapet.
