***D3. Detailed Description** (Discuss overall coherence of the district, its setting, visual characteristics, and minor features. List all elements of district.):

***D6. Significance:** **Theme:** Post-Fire Rebuilding; Edwardian-Era Architecture **Area:** Inner Mission North, San Francisco
Period of Significance: 1906-1915 **Applicable Criteria:** California Register of Historical Resources Criteria 1 & 3
(Discuss district's importance in terms of its historical context as defined by theme, period of significance, and geographic scope. Also address the integrity of the district as a whole.)

*Resource Name or # Lexington and San Carlos Streets Reconstruction Historic District

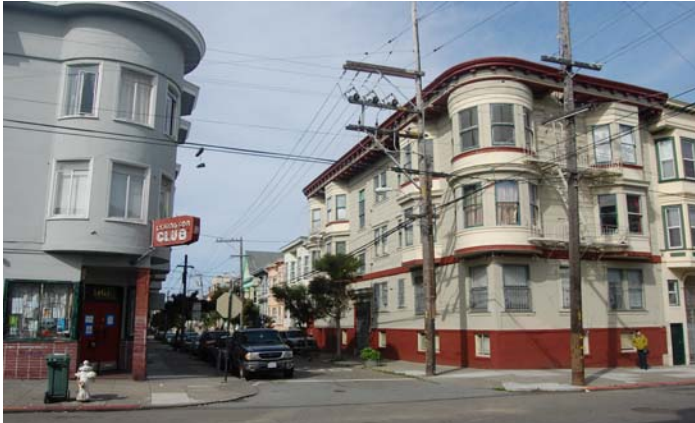
Lexington Street at 19th Street, within the urban residential alley enclave that was reconstructed during the post-fire period with Edwardian-era architecture. View northeast. *San Francisco Planning Department.*

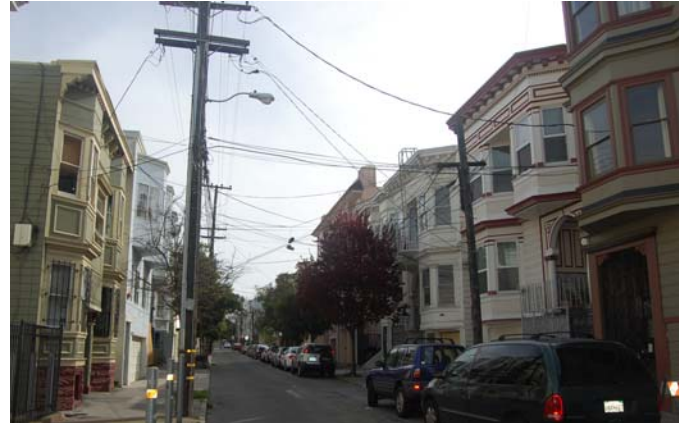
Lexington Street, south of 19th Street, within the urban residential alley enclave that was reconstructed during the post-fire period with Edwardian-era architecture. View south. *San Francisco Planning Department.*

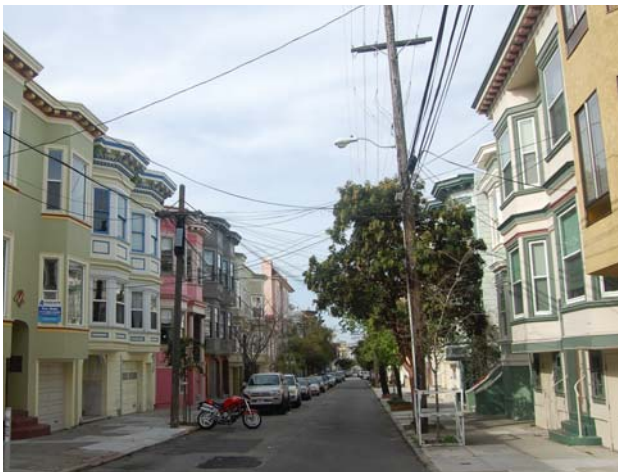
Lexington Street, north of 20th Street, within the urban residential alley enclave that was reconstructed during the post-fire period with Edwardian-era architecture. View north. *San Francisco Planning Department.*

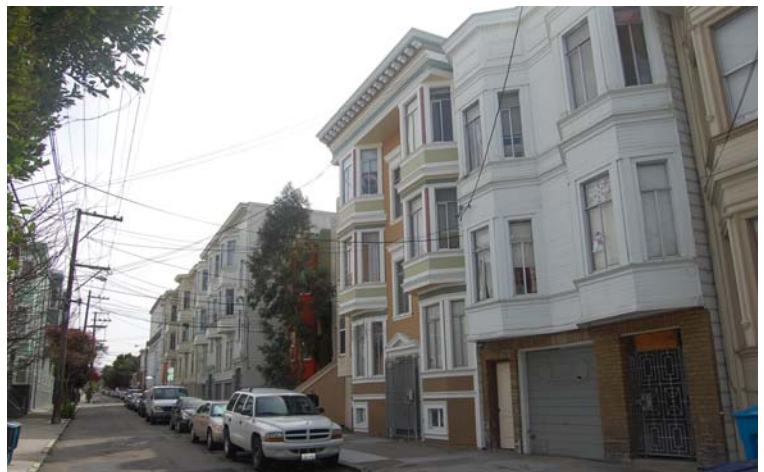
San Carlos Street, north of 19th Street, within the urban residential alley enclave that was reconstructed during the post-fire period with Edwardian-era architecture. View south. *San Francisco Planning Department.*

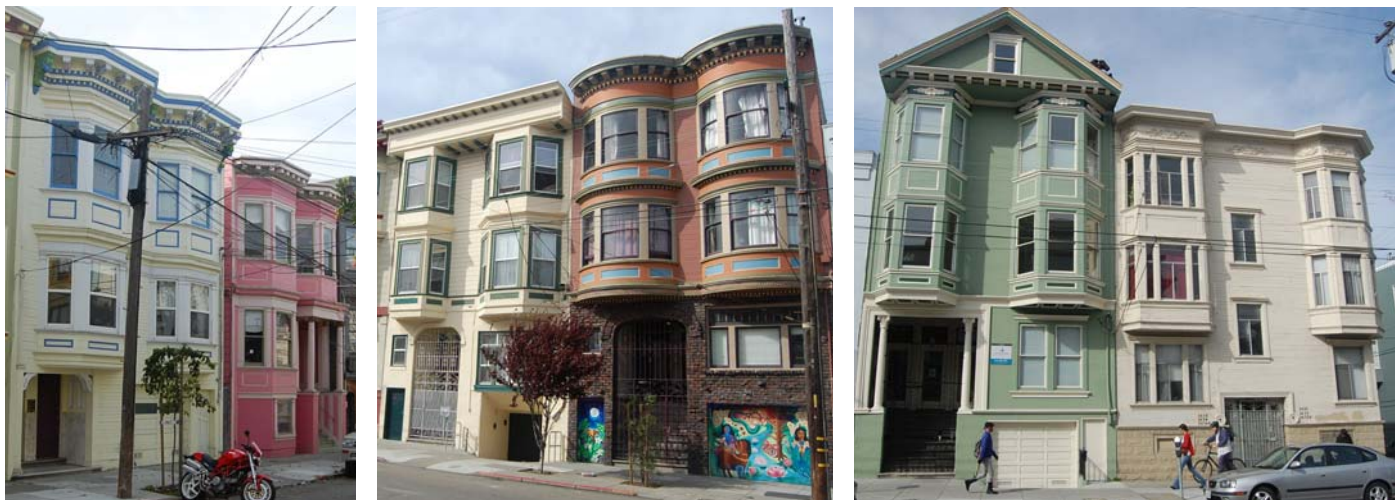
Examples of Edwardian-era, post-fire residential flats buildings with similar designs that include: bilateral symmetry; double bay windows; roofline cornices; and Classical details. They also feature distinctions in façade arrangements, detailing, and materials that indicate the individualistic nature of the post-fire reconstruction. From left to right: 266-268 Lexington Street (built 1908) and 262-264 Lexington Street (built 1909), view northwest; 3452-3456 19th Street (built 1907) and 3446-3450 19th Street (built 1913), view northwest; and 3436-3438 19th Street (built 1908) and 3428-3434 19th Street (built 1906), view northeast. *San Francisco Planning Department.*

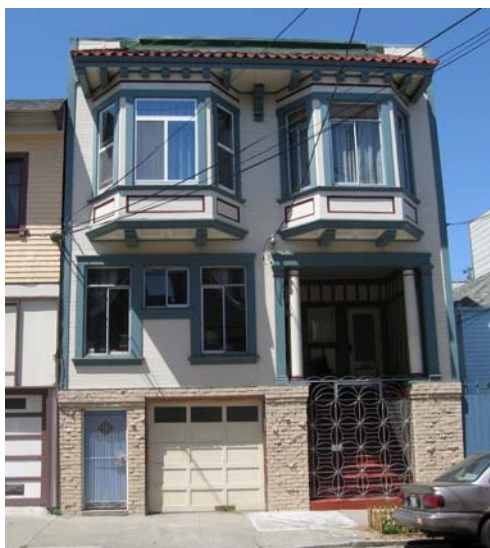
A residential flats building located at 256-258 San Carlos Street (built 1910), designed with elements of the Mission Revival architectural style, such as: a stucco base, vigas (long brackets with carved ends, resembling beam-ends), a sloped roof with Spanish tile, and a shaped parapet. View west. *San Francisco Planning Department.*

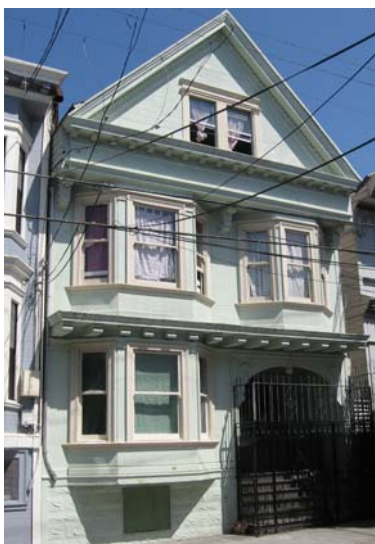
A residential flats building located at 167-169 Lexington Street (built 1908), designed with elements of the Queen Anne architectural style, such as: a gable roof, a box cornice, carved brackets, and a "basket handle"-arch entrance. View southeast. *San Francisco Planning Department.*

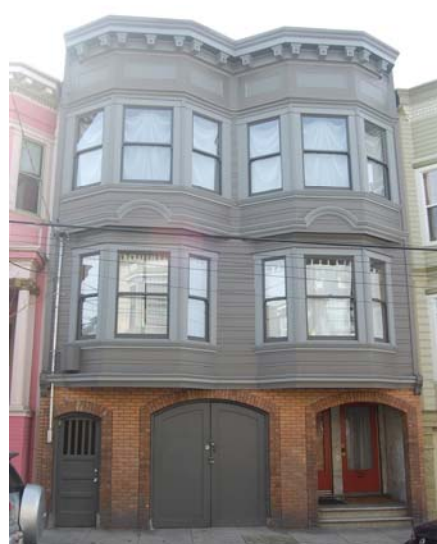
A residential flats building located at 256-258 Lexington Street (built 1913), with muted Classical details such as: a brick base with arched entrances (including an original, early "automobile basement"), decorative arches on bay windows, and a cornice with simple modillions and a paneled frieze. View west. *San Francisco Planning Department.*

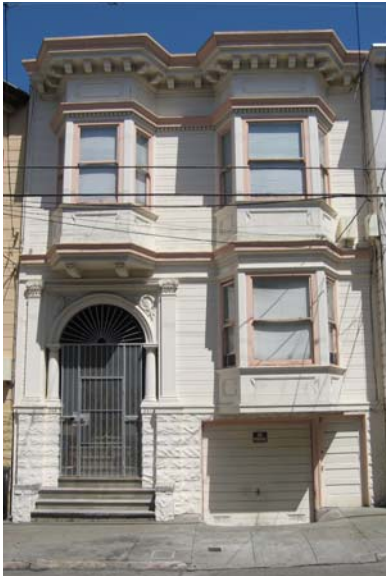
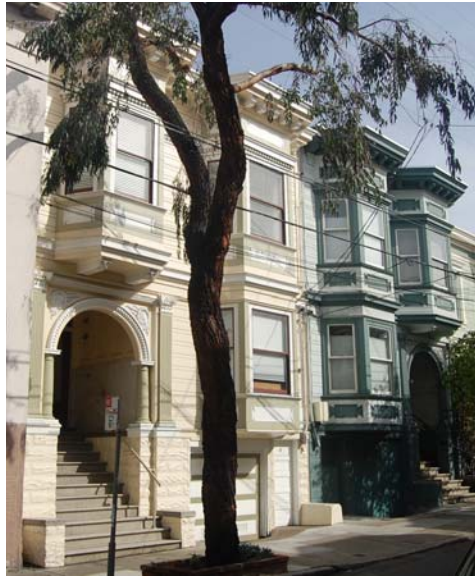
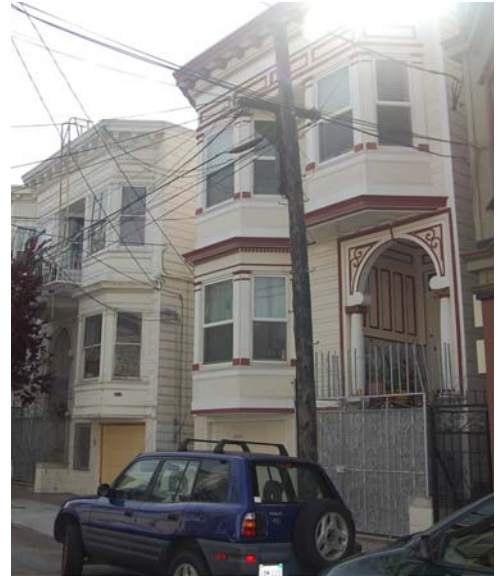
Three identical, two-unit residential flats buildings, located on the east side of Lexington Street, south of 19th Street. From left to right: 249-251 Lexington Street (built 1909); 257-259 Lexington Street (built 1909); 261-263 Lexington Street (built 1910). Views east and southeast. *San Francisco Planning Department.*

A pair of identical residential flats buildings. From left to right: 218-220 Lexington Street and 214-216 Lexington Street (built 1911). View southwest. *San Francisco Planning Department.*

In some cases, builders (who were often speculative owners as well) constructed Edwardian-era residential flats with identical designs and details on multiple, adjacent and/or nearby lots. These included identical mirrored pairs, and small groupings of identical structures that resembled small row-house developments. Within the historic district, two examples of multiple-property, identical construction occurred nearby to each other on opposite sides of Lexington Street, south of 19th Street. On the east side of Lexington Street, three identical structures were erected with distinctive details: arched entrances with medallions, engaged columns, and pilasters; spandrels with “ears” on the bay windows; and Craftsman-like supports below the smaller bay windows. On the west side of the street, a pair of mirrored residential flats stand adjacent to each other, distinguished by box cornices with angled corners, and decorative panels on the entry arches.

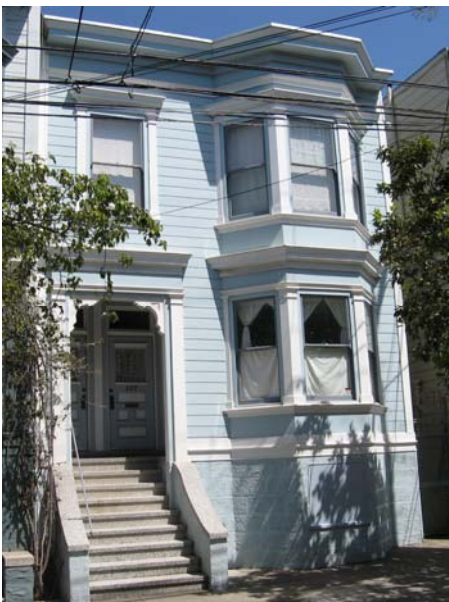
In a few instances, property owners or builders hired architects to customize their designs. Notably, the residential flats building that is located at 265-267 Lexington Street was designed by architect Ella Castelhun. Ms. Castelhun held the distinction of being just the second female architect to be licensed in California, after Julia Morgan. In basic form, Castelhun's design on Lexington Street follows a standard pattern of Edwardian-era residential design. In its details, it appears to display a minimalist approach to ornament, with clean cornices and flat pilasters that provide a Classical character. Castelhun's design is individually distinguished primarily by a pair of carved, incised brackets that frame the walk-up entrance, which appear to be customized features of the building.

A two-unit residential flats building, located at 265-267 Lexington Street (built 1907), that was designed by Ella Castelhun, the second female architect to be licensed in California. View southeast. *San Francisco Planning Department.*

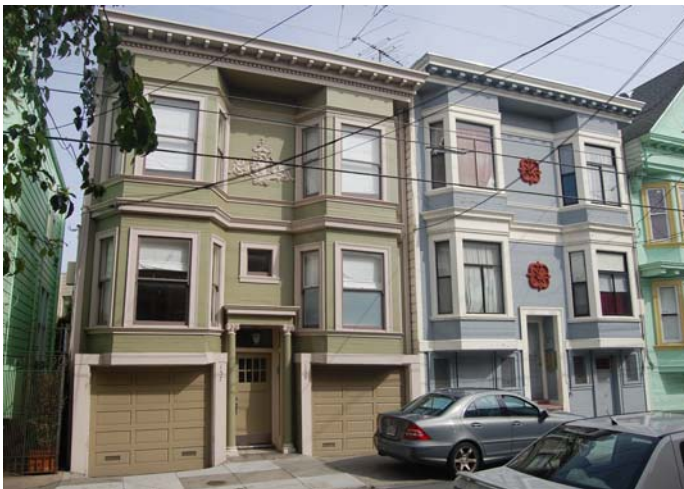
Enclosed Romeo flats buildings, located on the east side of Lexington Street, north of 19th Street. From left to right: 157-159 Lexington Street (built 1908) and 161-165 Lexington Street (built 1907). View southeast. *San Francisco Planning Department.*

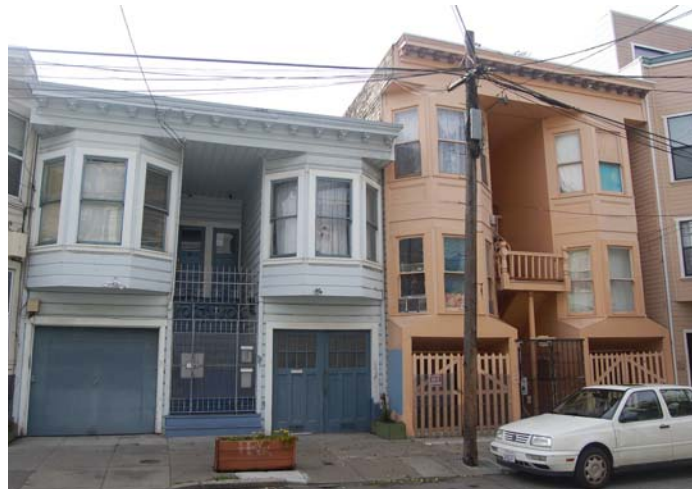
Open Romeo flats buildings with minimal façade ornament, located on the west side of Lexington Street, north of 19th Street. From left to right: 160-162 Lexington Street (built 1906) and 156-158 Lexington Street (built 1907). *San Francisco Planning Department.*

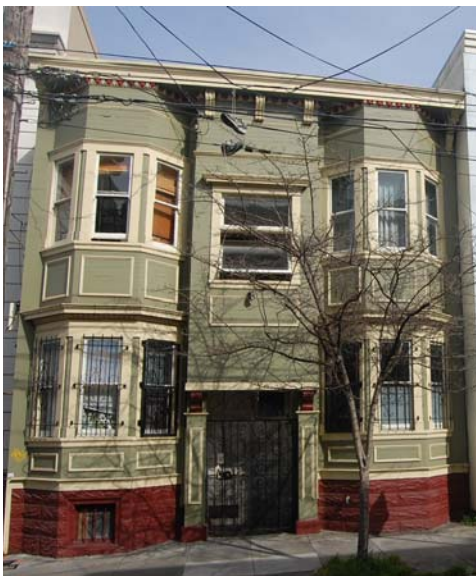
Enclosed Romeo flats building with a central balcony box, located at 217-229 Lexington Street (built 1906). View east. *San Francisco Planning Department.*

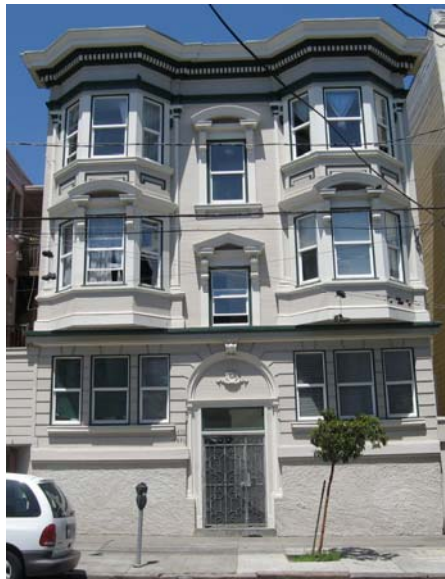
Enclosed Romeo flats building decorated with Classical pediments and masonry-like fascia, located at 3476-3486 19th Street (built circa 1910). View north. *San Francisco Planning Department.*

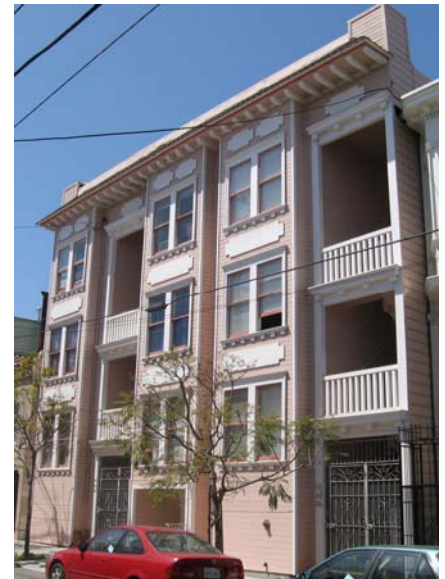
Open, expanded-plan Romeo flats building with Mission Revival stylistic details, located at 230-238 Lexington Street (built 1907). View north. *San Francisco Planning Department.*

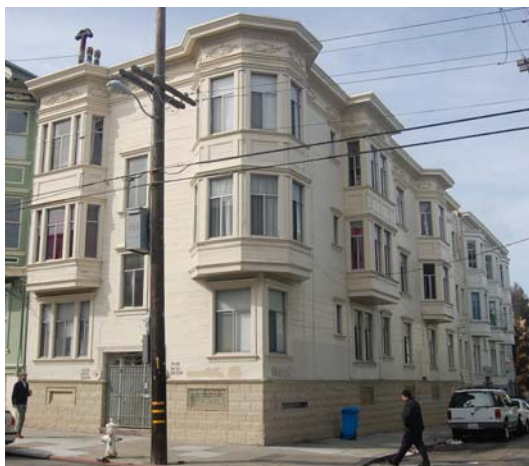
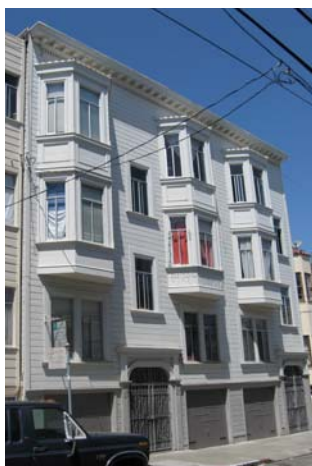
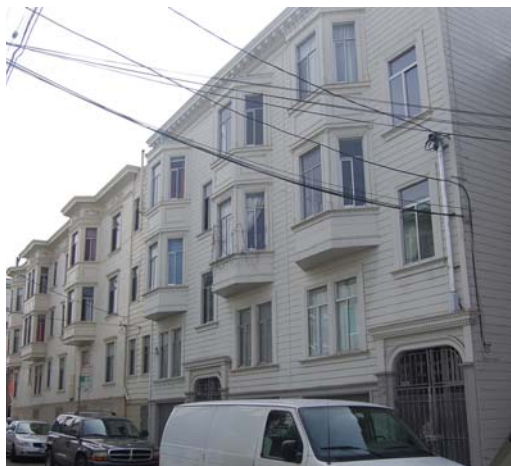
A Romeo flats complex comprised of two large, expanded Romeo flats structures. From left to right: the extra-long Romeo flats structure located at 3428-3434 19th Street (built 1906), which covers nearly the entire lot, view northwest; the expanded-plan, wide Romeo flats structure located at 174-190 San Carlos Street (built 1906), which occupies two contiguous lots, view northwest; and the combined façades of both structures facing San Carlos Streets, view southeast. *San Francisco Planning Department.*

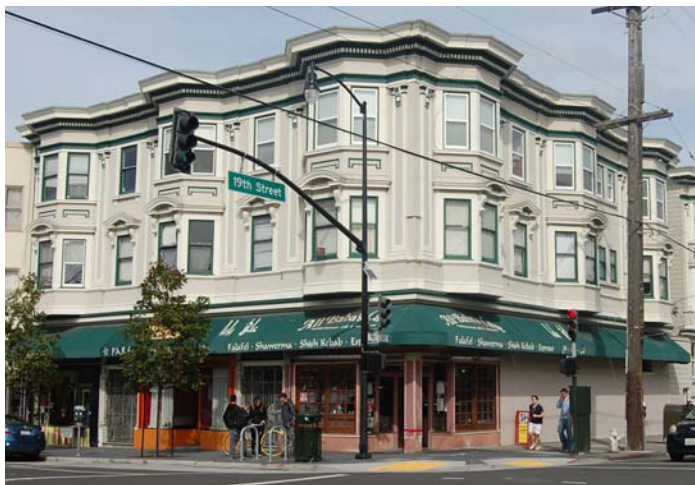
A mixed-use corner building, located at 793-799 Valencia Street (built circa 1910). Mostly intact historic storefronts are found at the northern end (left side). View northeast. *San Francisco Planning Department.*

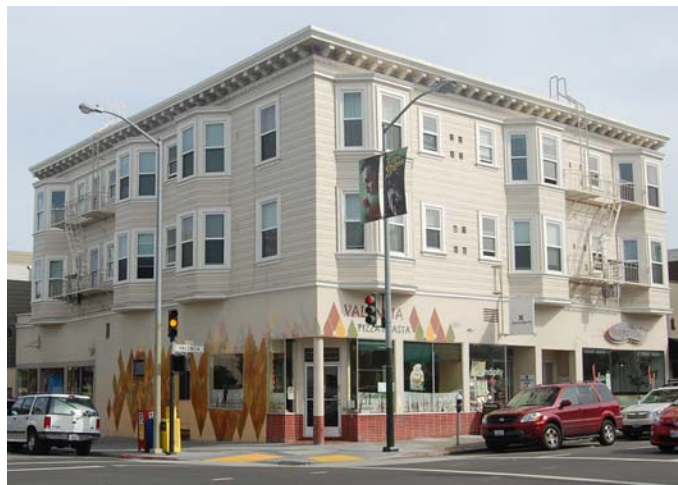
A mixed-use corner building, located at 801-807 Valencia Street (built 1906). View southeast. *San Francisco Planning Department.*

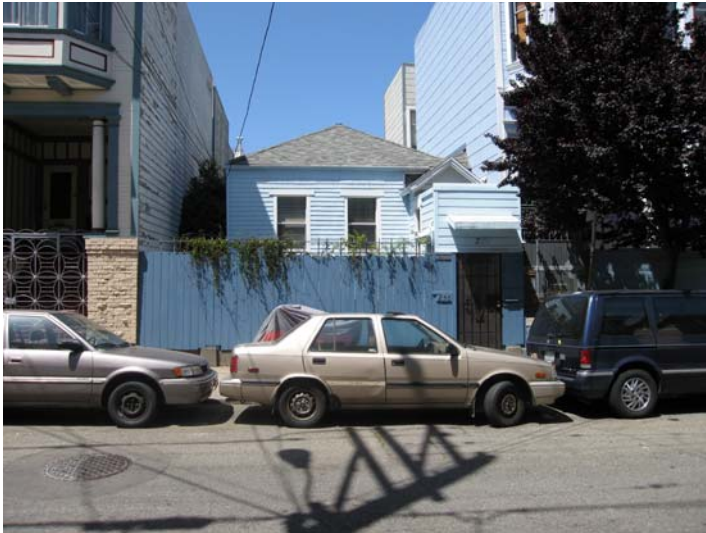
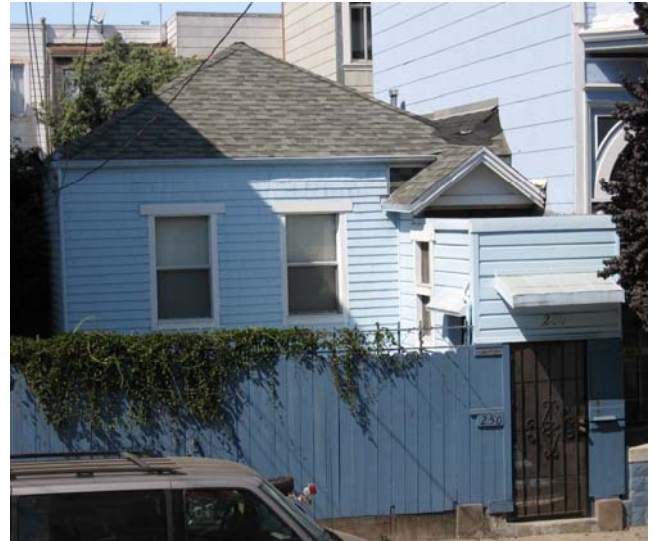
A relief-era cottage with vernacular elements of the California Bungalow style, located at 250 San Carlos Street (built 1906). Views west and northwest. *San Francisco Planning Department.*

Within the historic district, one structure is known to remain intact from the early relief-era phase of rebuilding, which was typified by the expedient construction of small vernacular dwellings that were often replaced within months or years. This relief-era structure is a cottage that is found at 250 San Carlos Street, south of 19th Street (built 1906). It appears to have been constructed out of pure necessity within a few weeks of the disaster of April 1906. Nonetheless, it may be considered a vernacular example of California Bungalow architectural style. The small building is a square-plan cottage with flat exterior wall surfaces, clad in wood shingles, with a pyramidal hipped roof. Architectural elaboration is limited to flat window surrounds, slight eaves, and a porch gable. This cottage is surrounded by larger, multiple-family residential buildings that were likely constructed after the cottage was built, and that may have replaced similar vernacular cottages, few of which remain. This very small relief-era cottage provides an important, rare associative link to the historical conditions of refugee housing. The category of relief-era housing includes structures that were built by the U.S. Army as part of the official relief effort, as well as those that were erected by individuals without any central planning or subsidies, such as this one that are found within the historic district.

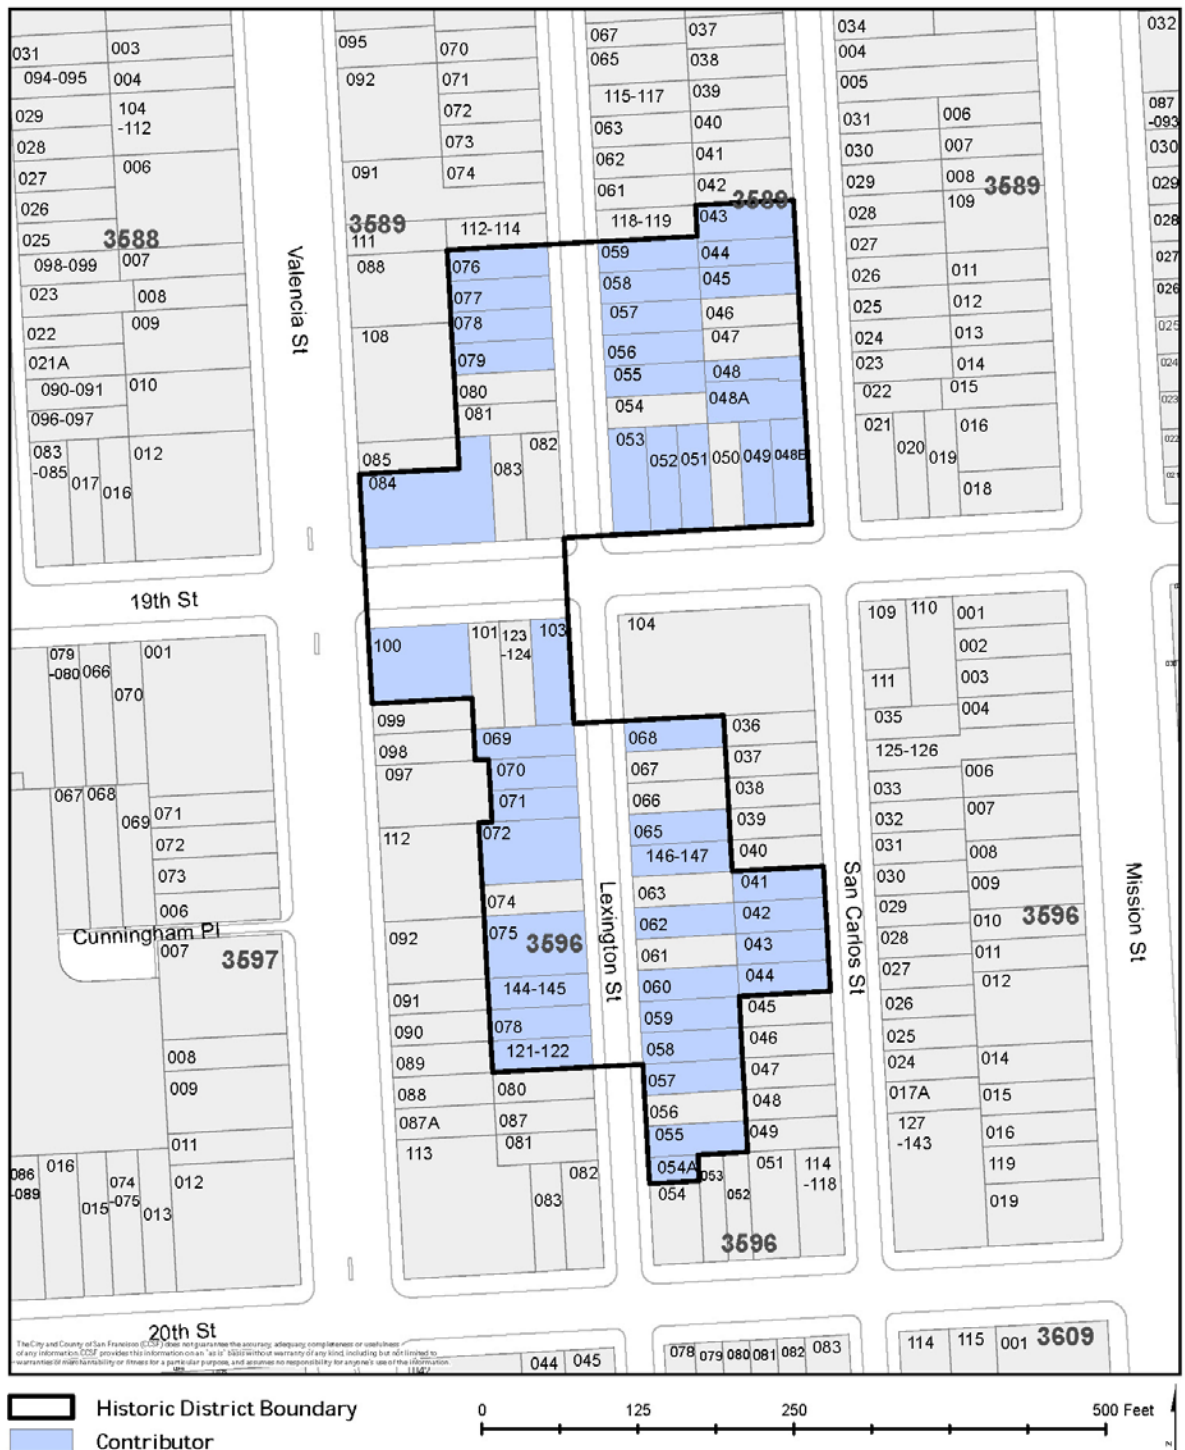
Boundary Map

Properties are labeled with Assessor block numbers and lot numbers for identification purposes.

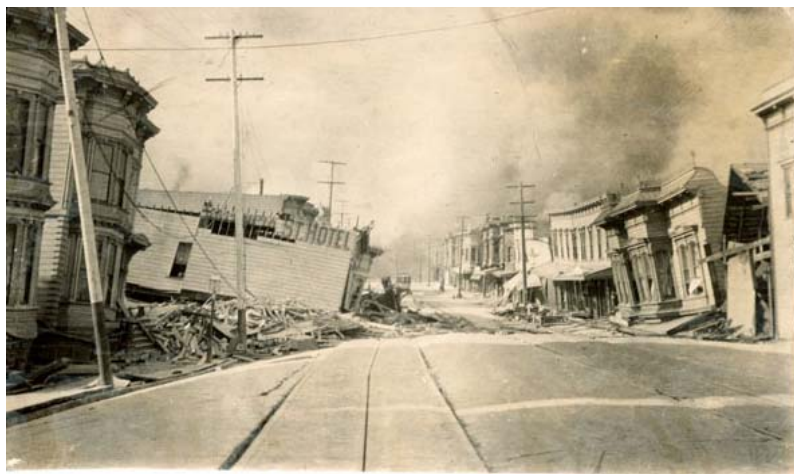
Valencia Street lay in ruins one day after the 1906 earthquake. View north towards 18th Street. When this photograph was taken, the firestorm was visibly approaching from the north, and apparently it had already reached the next block. All of the buildings shown in this photograph burned within hours, as seen in the photograph to the right. *San Francisco History Center, San Francisco Public Library (Historical Photograph Collection Photo Id# AAC-3549).*

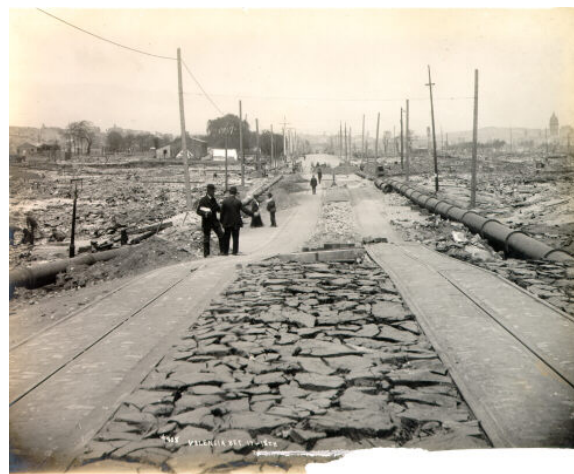
Valencia Street in the aftermath of the 1906 earthquake and fires. View north from approximately the same location as in the photograph to the left. There was total destruction of structures, roads, transit lines, and utility lines. *San Francisco History Center, San Francisco Public Library (Historical Photograph Collection Photo Id# AAC-3252).*

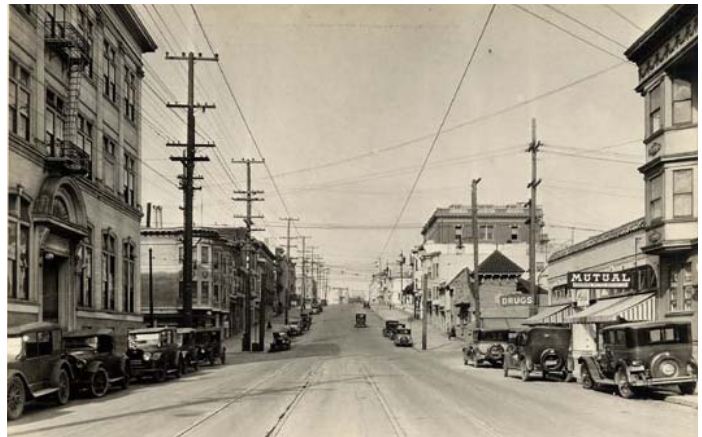
Guerrero Street in 1928. View north towards 14th Street. All of the buildings that appear in the photograph were constructed to replace properties destroyed in the 1906 fires. *San Francisco History Center, San Francisco Public Library (Historical Photograph Collection Photo Id# AAB-3941).*
