This grouping of four bungalow properties forms a unique, suburban post-fire residential enclave within the Inner Mission North. Contributors to the historic district are four houses that were constructed in the fall of 1906, as well as an ancillary building that was constructed in 1910, during the period of physical rebuilding that followed the earthquake and fires of April 1906, which completely destroyed earlier development in the area. Contributors are a grouping of four one-story, wood-frame single-family dwellings (including one that has been converted to a duplex) that exhibit Bungalow architectural styles, and a steel-frame brick automobile garage that is located behind one of the bungalows. The prevailing building typology includes: long, low building plans that conform to lot sizes; façade surfaces and window bays clad in wood shingles that are stained a natural brown; symmetrical and varied fenestration; entrances that are recessed and/or located at the sides; porches and awnings supported by substantial beams and columns; and low-slung hipped roofs with wide overhanging eaves and dormers. Structures are set back from the front property lines, and from each other at the

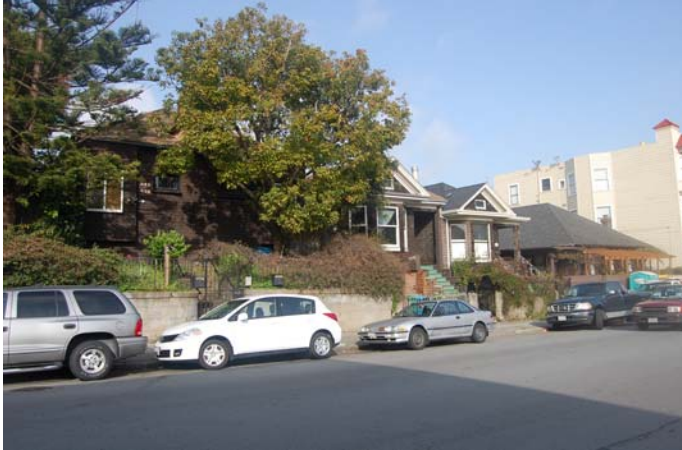
The grouping of four bungalows located on the west side of Capp Street, between 19<sup>th</sup> and 20<sup>th</sup> Streets. View northwest. San Francisco Planning Department.

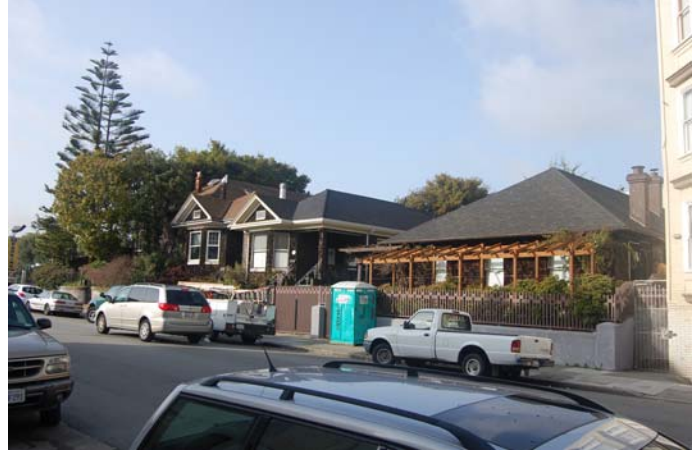
The grouping of four bungalows located on the west side of Capp Street, between 19<sup>th</sup> and 20<sup>th</sup> Streets. View southwest. San Francisco Planning Department.

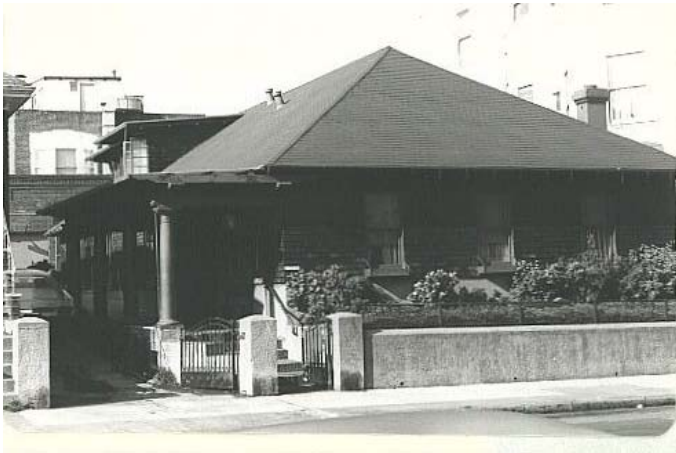
The Wilhelm house located at 426-428 Capp Street in 1976. *San Francisco Planning Department 1976 Architectural Survey.*

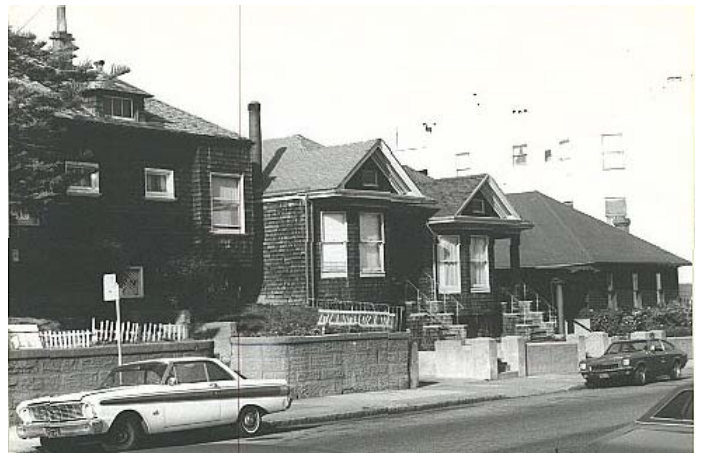
The grouping of four bungalows located on the west side of Capp Street, between 19<sup>th</sup> and 20<sup>th</sup> Streets, in 1976. View northwest. *San Francisco Planning Department 1976 Architectural Survey.*

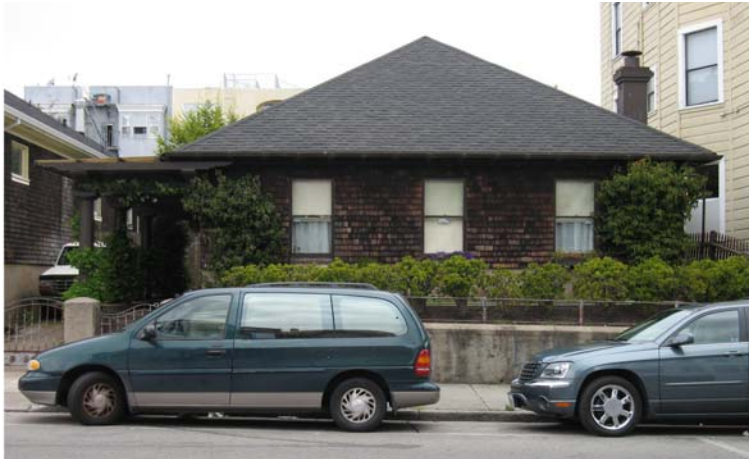
The house that is located at 426-428 Capp Street (built 1906), which was August H. Wilhelm's personal residence, is stylistically the most pure version of the California Bungalow of those that are found in his unique grouping on Capp Street. The building is long and rectangular in plan, with flat façade walls that are uninterrupted by bay windows or other extrusions, but that are clad in shingle for tactile richness. It is a low one-and-a-half stories in height, with the attic space contained within a gently sloping hipped roof and shed roof dormer located at the south side. The fenestration consists of double-hung windows that are equally spaced across the façades. A brick chimney rises from the north side of the roof, and the wide overhanging eaves extend into an open porch structure over the entrance area on the south side. The only concession to historical ornament to be found on Wilhelm's home are the Classical columns that support the porch. The house was constructed at the north side of the lot, which is a generous 50 feet wide and 122-½ feet deep, thus leaving open the south side for access. Concrete site walls with blocky piers enclose the front of the property and are used to demarcate separate pathway, driveway, and landscaped areas at the front and south side of the property. With its low, horizontal emphasis, its indoor-outdoor spatial synthesis, and its roof form that hovers above the ground floor, the Wilhelm home displays elements that are found in the California Bungalow and that also evoke the Prairie architectural style, which is related to the Bungalow style.

The Wilhelm house located at 426-428 Capp Street. View west. *San Francisco Planning Department.*

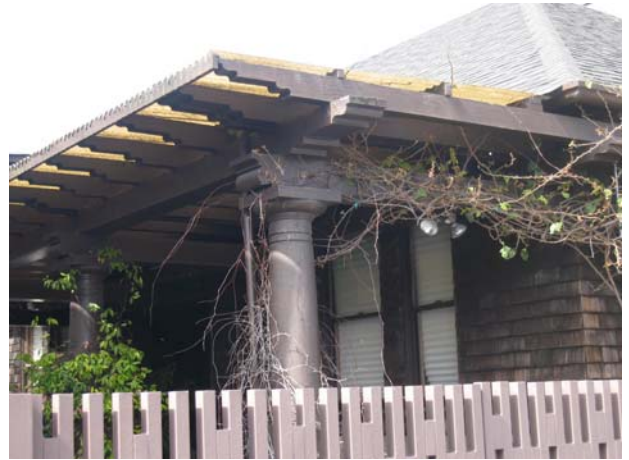
Porch details of the Wilhelm house located at 426-428 Capp Street. View northwest. *San Francisco Planning Department.*

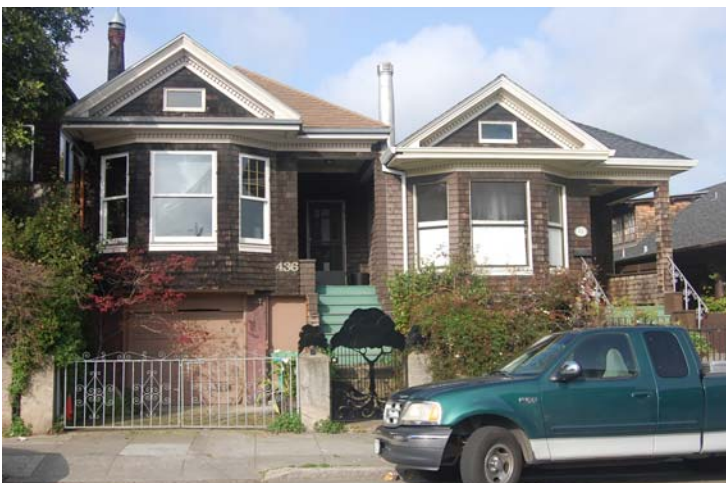
The Wilhelm twin cottages located at 438-440 Capp Street. View west. *San Francisco Planning Department.*

Contractor Wilhelm designed and constructed identical twin Bungalows (built 1906) that efficiently and comfortably occupy the narrow lots. The long, low structures give the appearance from the front of attached row-houses with touching side walls. However, the placement of the recessed porches, and the use of partial setbacks on the south sides of the buildings behind the front sections, ensure that the main structures of the buildings actually touch for only a short length, and they also maintain some distance from the neighboring properties. Naturally stained wood shingles and hipped roofs on these small cottages match the cladding and forms of the Wilhelm residence. The properties are further unified by the line of concrete site walls with blocky piers and gates that extends from Wilhelm's personal property to the cottages at the sidewalk's edge, and define front yard landscape areas. At the front façades, wide three-sided bay windows terminate in gabled dormers with denticulated border trim, next to deeply recessed covered porches. The use of these Classically decorated, gabled bay windows was in keeping with popular Edwardian-era styles as well as with established Bungalow forms such as Shingle and Queen Anne. In 1931, Wilhelm inserted an automobile garage into the bungalow at 436 Capp Street, which his wife Pauline still owned. This historic alteration, the second of two garage constructions/installations that Wilhelm completed within the Bungalow grouping (including his own detached backyard garage), apparently resulted in a slight raising of the cottage in its original location.

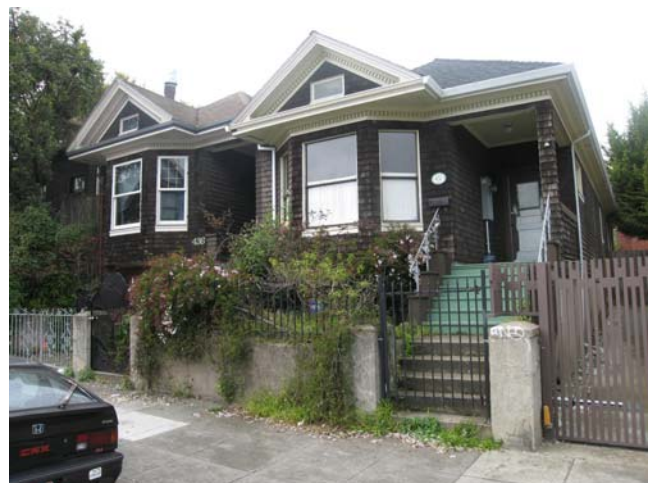
The Wilhelm twin cottages located at 438-440 Capp Street. View southwest. *San Francisco Planning Department.*

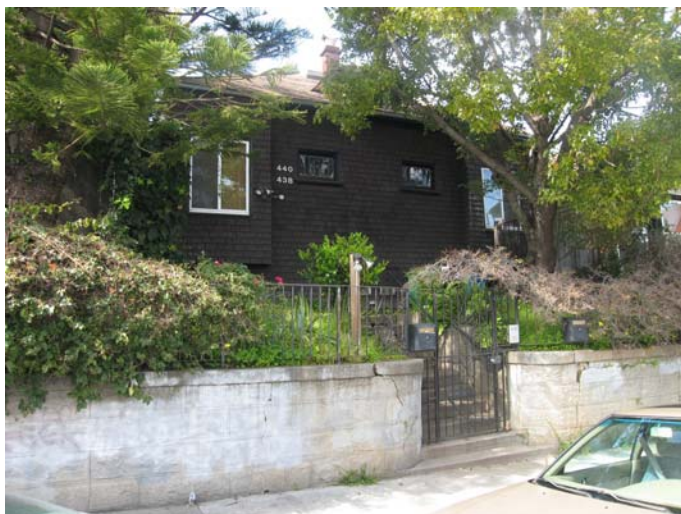
The Robins house located at 438-440 Capp Street. View northwest. San Francisco Planning Department.

This building that is located at 438-440 Capp Street (built 1906) occupies a lot that is nearly as large as Wilhelm's personal property, 45 feet wide. The form, massing, and placement of the Robins house on its lot is a close match to that of the Wilhelm home, and it provides a balance to the south end of this grouping of four bungalows that includes the smaller twin cottages in the middle. The Robins house is distinguished by its elevation, which apparently reflects

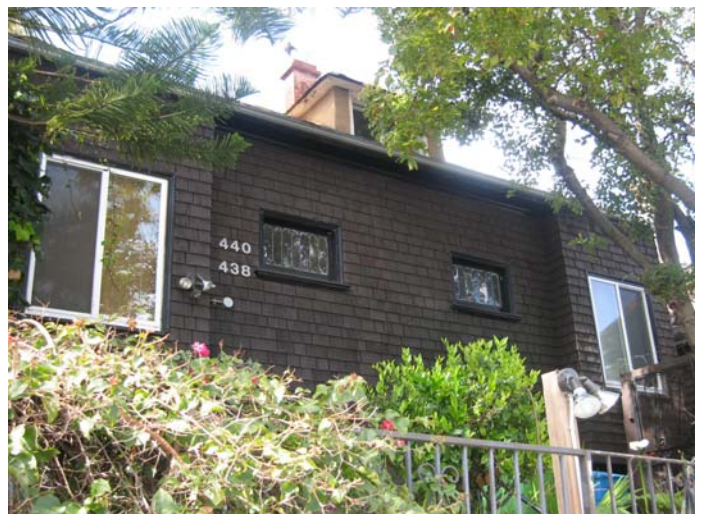
Front façade of the Robins house located at 438-440 Capp Street. View northwest. San Francisco Planning Department.

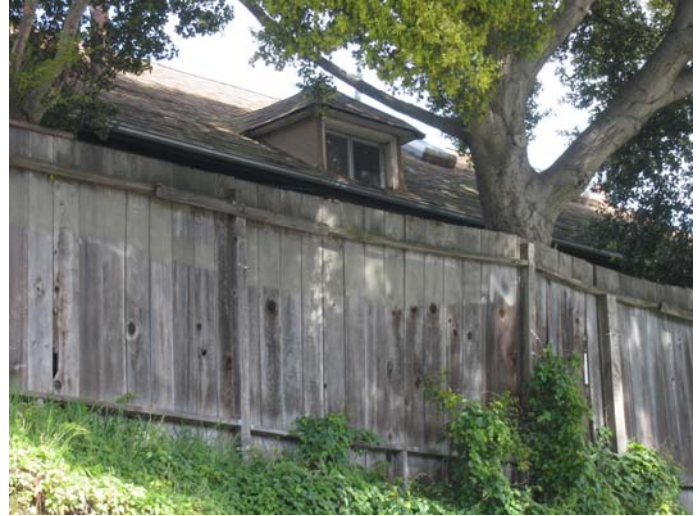
Roof detail at the south side of the Robins house located at 438-440 Capp Street. View northeast. *San Francisco Planning Department.*

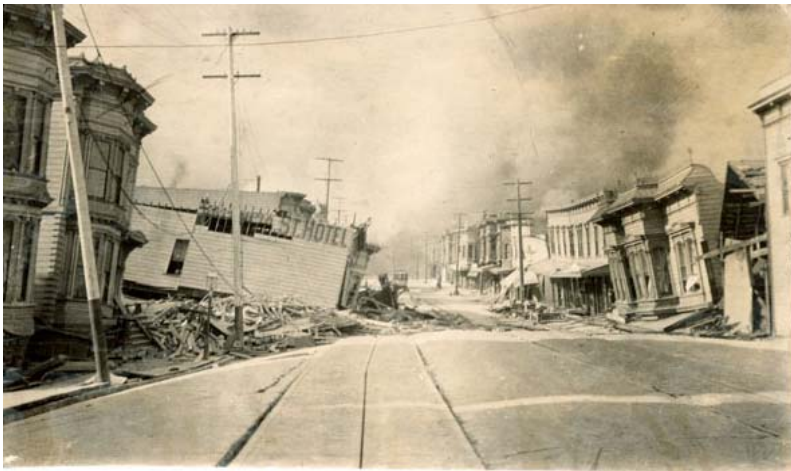
Valencia Street lay in ruins one day after the 1906 earthquake. View north towards 18<sup>th</sup> Street. When this photograph was taken, the firestorm was visibly approaching from the north, and apparently it had already reached the next block. All of the buildings shown in this photograph burned within hours, as seen in the photograph to the right. *San Francisco History Center, San Francisco Public Library (Historical Photograph Collection Photo Id# AAC-3549).*

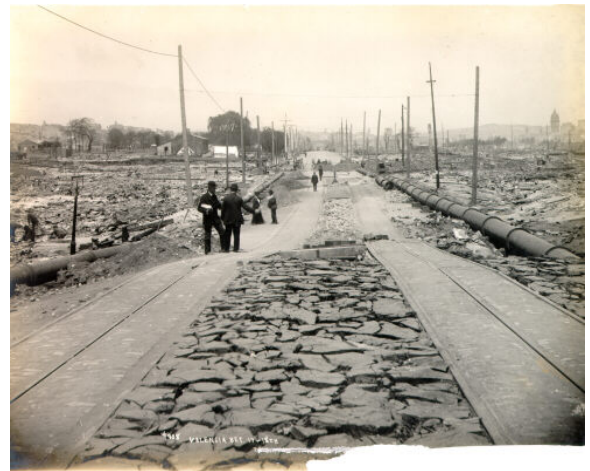
Valencia Street in the aftermath of the 1906 earthquake and fires. View north from approximately the same location as in the photograph to the left. There was total destruction of structures, roads, transit lines, and utility lines. *San Francisco History Center, San Francisco Public Library (Historical Photograph Collection Photo Id# AAC-3252).*
