PRIMARY RECORD

Page 1 of 1 *Resource name(s) or number (assigned by recorder) 125 Sanchez St.

BUILDING, STRUCTURE, AND OBJECT RECORD

Page 1 of 2 *Resource Name or # (Assigned by recorder) 125 Sanchez Street

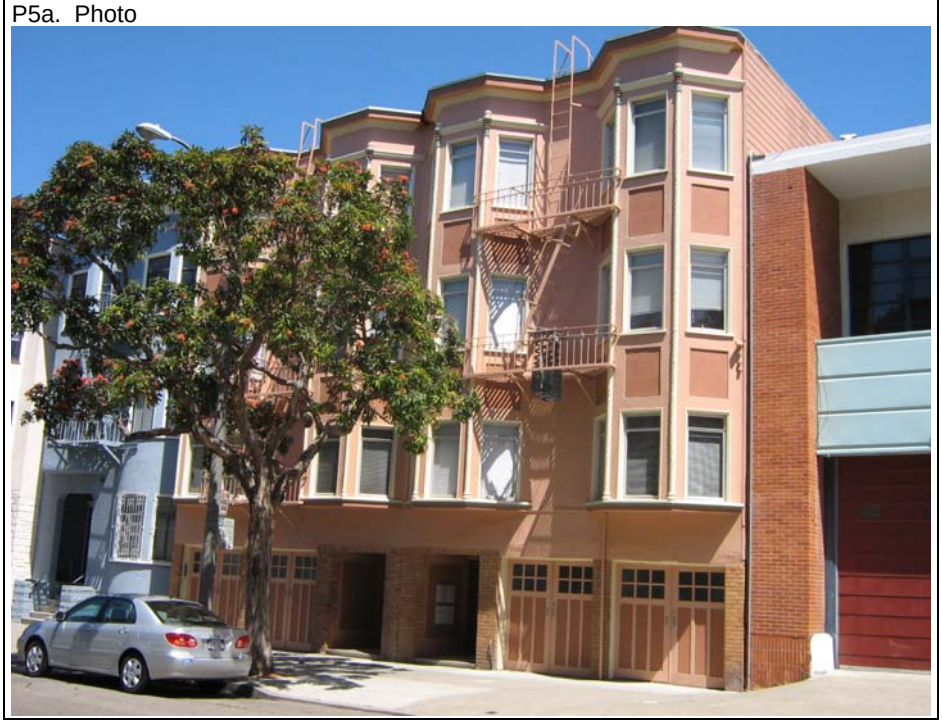
P5a. Photo

125 Sanchez St. is located on a 25' x 125' lot on the east side of Sanchez Street, between 14th and Market Streets. Built in 1929, 125 Sanchez St. is a 4-story, wood frame, apartment building with twelve units, designed in the Mediterranean Revival style. This building is mirror to 119-121 Sanchez Street (APN 3542-043). The rectangular-plan building, clad in stucco, sits on a reinforced concrete foundation and is capped by a flat roof. The primary façade faces west, is 2 bays wide. The first floor features garage entries with double-leaf, glazed, paneled, wood doors in the right and center bays, and a recessed entry in the left bay. This entry is framed in yellow brick and has a single entrance with a wood door and sidelights. The upper three stories are characterized by semi-hexagonal bay windows in each bay with metal-sash casement windows with transoms on each face. The bay windows are further articulated with continuous vertical twisted cord molding at the corners, connecting the cornices at the top and bottom of the feature. A metal fire escape runs from the second floor to the roof between the two bay windows. The primary façade terminates in a wide frieze, egg-and-dart and acanthus molding, and a cornice. The building appears to be in good condition.

P5b. Photo: (view and date)
View of west façade
8/17/2006
