# SAN FRANCISCO PLANNING DEPARTMENT

## Discretionary Review Analysis Residential Demolition/New Construction

*Date:* May 3, 2012  
*Case No.:* 2010.0636D / 2012.0259D  
*Project Address:* 622 – 27<sup>TH</sup> AVENUE  
*Zoning:* RH-2 (Residential House, Two-Family) District  
 40-X Height and Bulk District  
*Block/Lot:* 1569/031  
*Project Sponsor:* Wah Wong  
 622 – 27<sup>th</sup> Avenue  
 San Francisco, CA 94121  
*Staff Contact:* Glenn Cabreros – (415) 588-6169  
[glenn.cabreros@sfgov.org](mailto:glenn.cabreros@sfgov.org)  
*Recommendation:* **Do not take DR and approve demolition and new construction as proposed.**

<u>Title</u>	<u>Page</u>
Soundness Report.....	2
Appendix A – Existing Floor Plans & Elevations .....	7
Appendix B – Room-By-Room Inspection Report .....	13
Appendix C – Photographs – Existing Conditions of Building .....	27
Appendix D – Cost Estimate of Electrical Repair .....	42
Appendix E – Cost Estimate of Plumbing Repair .....	45
Appendix F – Cost Estimate of Heating Repair .....	48
Appendix G – Cost Estimate of Framing & Foundation Repair.....	51
Appendix H – Cost Estimate of Sidewalk & Driveway Repair .....	55
Appendix I– Cost Estimate of Termite Repair

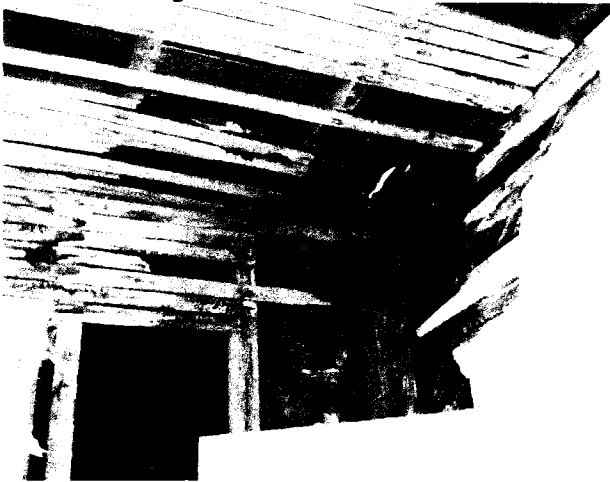
Photo 75: Severe Framing Deterioration at Sunroom

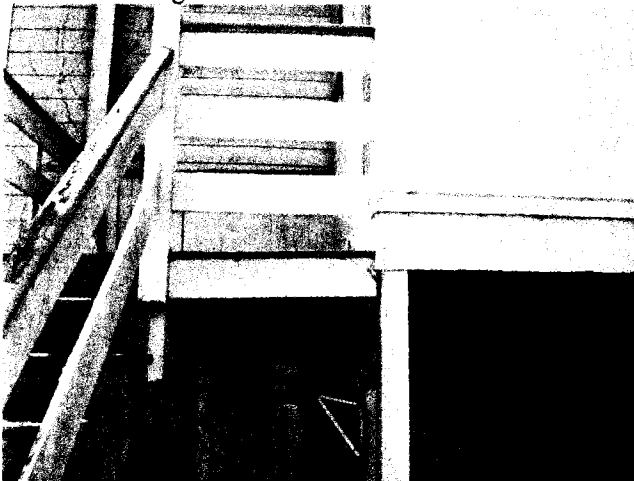
Photo 81: Questionable Framing at Rear Porch

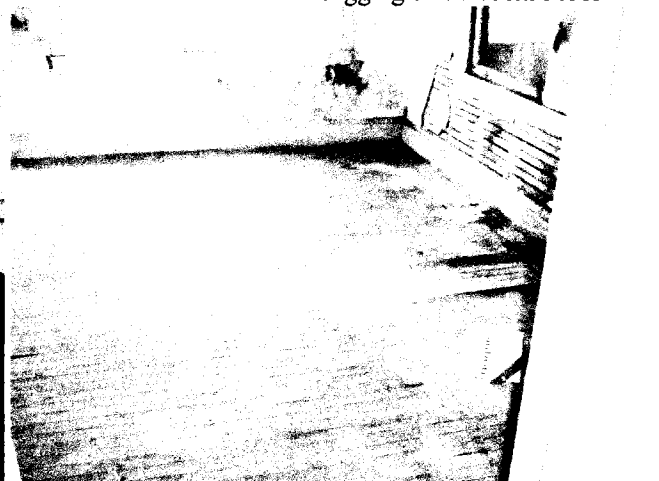
Photo 82: Sagging Floor of Sunroom

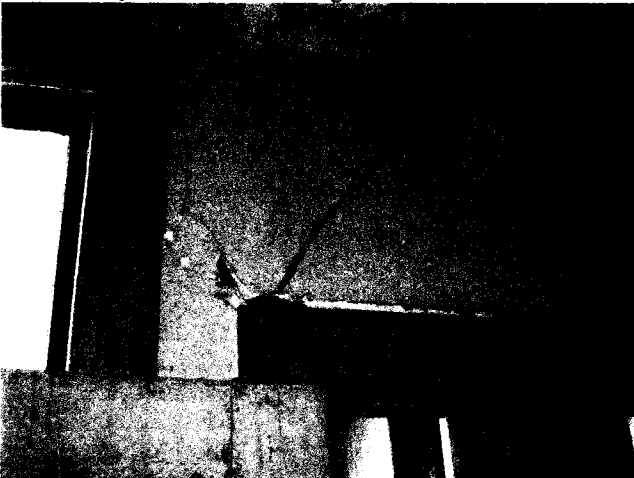
Photo 83: Shear & Settlement Cracks at Door
