SAN FRANCISCO PLANNING DEPARTMENT

MEMO

DATE: January 26, 2011
TO: Architectural Review Committee of the Historic Preservation Commission
FROM: Tim Frye, Acting Preservation Coordinator, (415) 575-6822
RE: **Review and Comment for 706 Mission Street – The Aronson Building Case No. 2008.1084E**

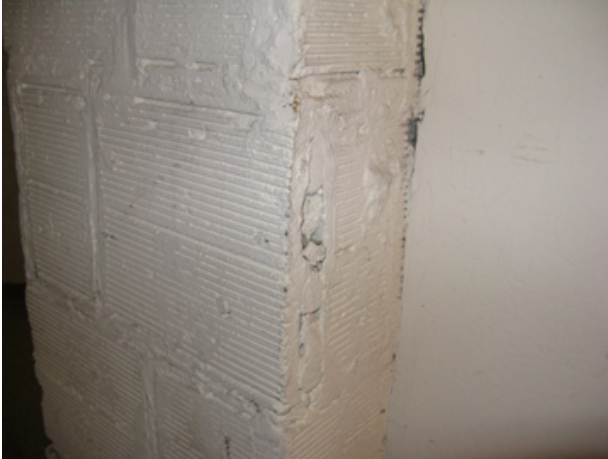
The interior retains few original features, and has been altered to modern retail and office spaces. The basement includes brick walls and steel columns encased in terra cotta and concrete (**Figure 32**).

Figure 32. Column encased with terra cotta tile.
Source: Page & Turnbull, March 2010.

Description: Non-Contributing elements are generally non-historic elements or elements that have been altered to the extent that their original character is absent. Examples of historic fabric that are non-contributing include the patterned ceramic mosaic tile flooring at the 86 3rd Street entrance (Figures 33 and 66) and the hollow clay tile at the basement level (Figure 32). The ceramic mosaic tile

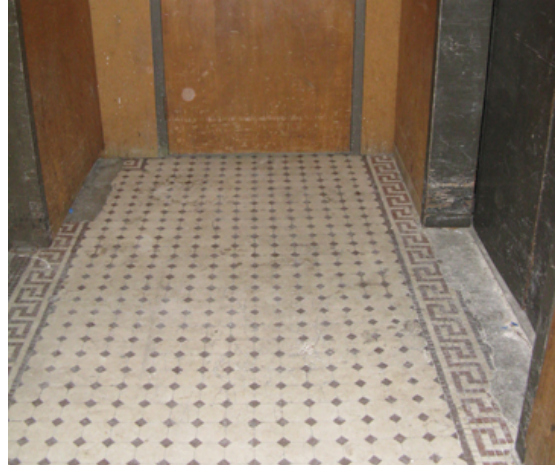
Original patterned ceramic mosaic tile flooring is located inside the 3rd Street entrance, and continues into the freight elevator lobby, which used to be the building's primary elevator core and stair (**Figure 33**). A red-brown field border with white tile is laid out in a Greek key fretwork pattern. The center of the flooring features white octagonal-shaped tiles inset with red-brown square tiles set on the diagonal.

Figure 33. Mosaic tile floor at 3rd Street lobby.
Source: Page & Turnbull, March 2010.

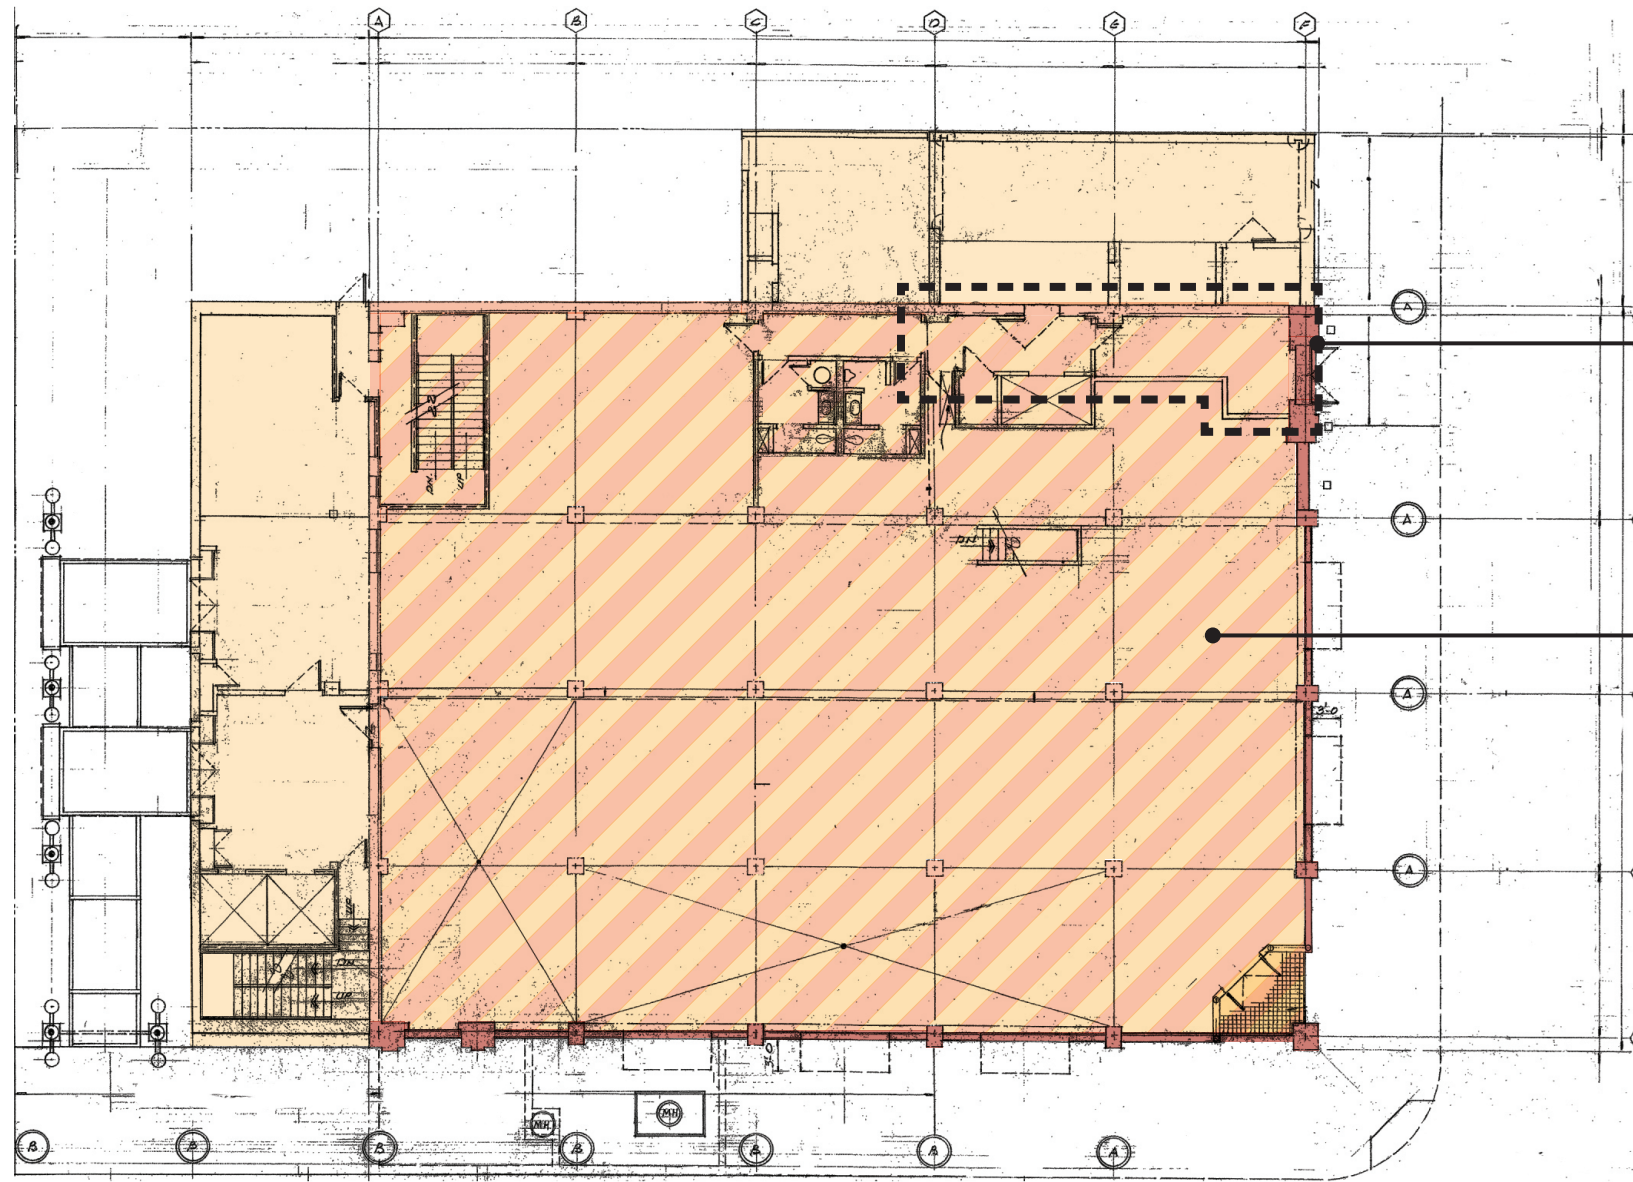
Ceramic mosaic tile floor is non-contributing historic fabric. Although original, it is a fragment and portions have been altered.

Volume and associated finishes are non-contributing, but the concrete floor slabs are contributing. Columns are also contributing.

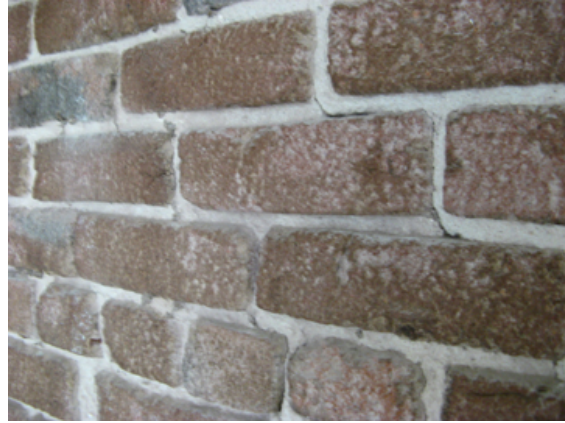
- Vertical cracking at the northeast corner where the brick wall meets the terra cotta clad 3rd Street façade (**Figure 35**);
- Evidence of abrasive blasting of the brick face at the exterior, confirmed by an annotation in the 1979 construction documents (**Figure 36**);
- Evidence of moisture at roof parapet, as seen by organic growth (**Figure 37**);
- Evidence of abrasive blasting of brick face at the interior, resulting in loss of mortar, pitting of the brick face, and rounded brick edges (**Figure 38**);
- Poor joint condition due to abrasive blasting.

Figure 38. Interior brick face.
Source: Page & Turnbull, March 2010.

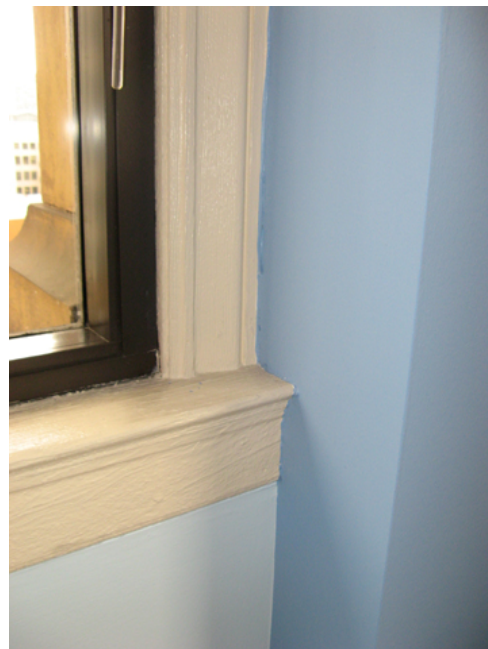
The window trim and sills at the interior are wood, many of which are painted (**Figure 66**).

- Raised grain, likely due to past sandblasting;

Figure 66. Interior window trim.
Source: Page & Turnbull, March 2010.

The operability and type of windows is dependent upon the building's use and code restrictions; however, type of operation should consider the historic single sash vertical pivot type. The method of operation is not as important as the overall physical appearance and proportions of the new windows. New windows could be constructed of wood or metal as noted above. See the provided sketch for guidance on design of this feature (**Figure 68**). Interior wood trim and sill are noted as character-defining and should be preserved and protected.

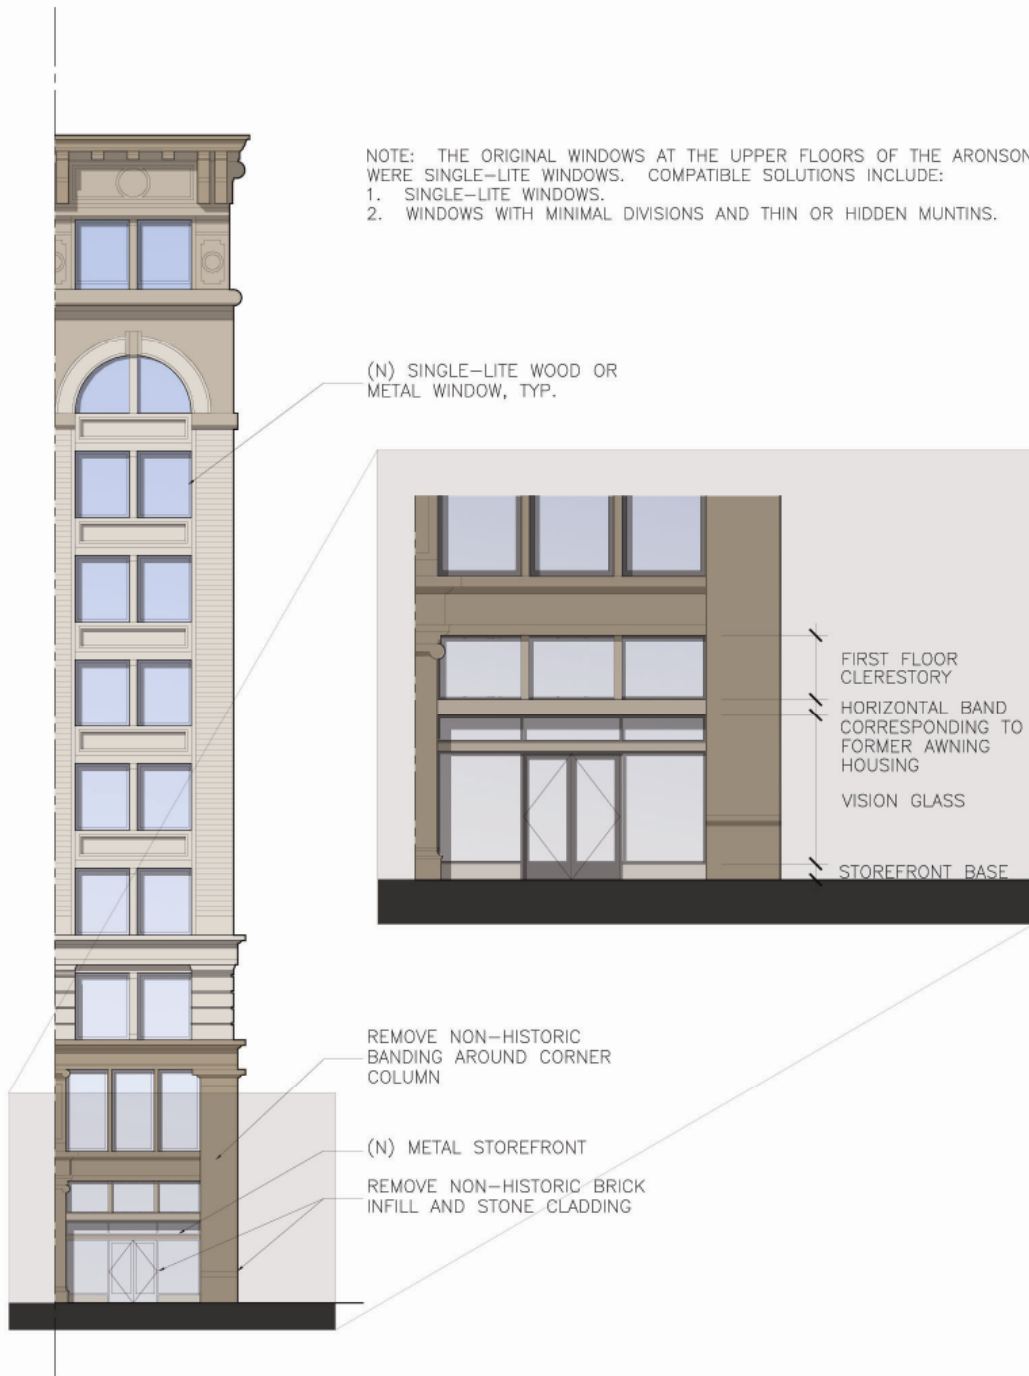
Figure 68. Page & Turnbull sketch of a recommended design option for storefront and windows.

Design new storefronts at ground level to replace existing non-original storefront enclosures. The existing cast-iron storefront elements should be maintained and protected. The new storefronts may be contemporary in design; however, they should be designed so that they are compatible with the historic character of the building. Historic photographs (**Figure 10**) should be referenced and any divisions or patterns in the fenestration should be compatible with the historic design. Materials to consider include steel and painted aluminum. See the provided sketch for guidance on design of this feature (**Figure 68**).
