DATE: November 22, 2010
TO: Historic Preservation Commission
FROM: Timothy Frye, Acting Preservation Coordinator, (415) 575-6822
RE: Informational Presentation on Emergency Work at 130 Sutter Street

**Subject: Structural Observation Report - Fire Escapes and Balconies
130 Surter Street, San Francisco**

Subject: Fire Escape and Balcony Testing for Corrosion
130 Sutter Street, San Francisco, CA¹

EMERGENCY REHABILITATION OF THE
2ND FLOOR BALCONY OF
THE HALLIDIE BUILDING

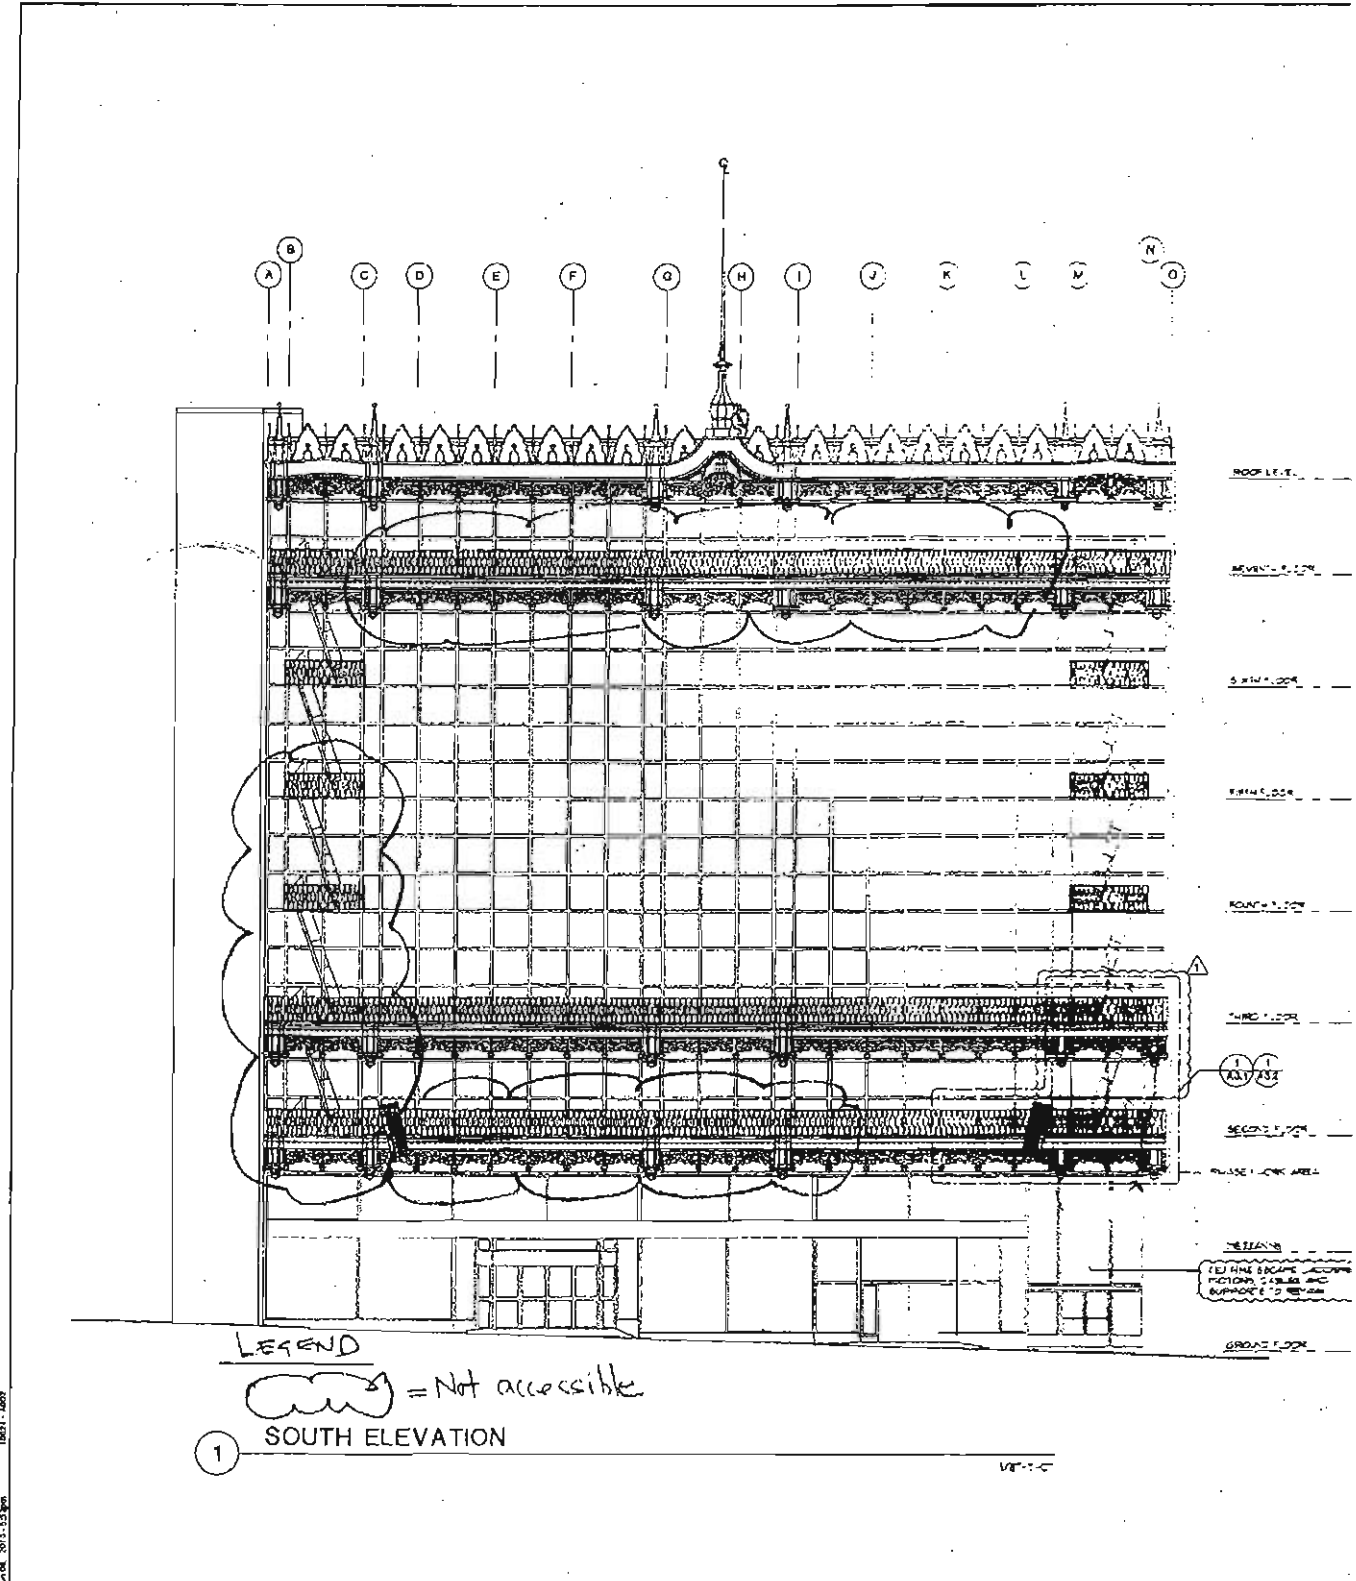
Figure 1. South elevation showing fire escape balconies & walkways.

Note: 2nd – 5th floor balconies at west end (Lines B-C), partial 2nd level walkway and 7th level walkway were not accessible due to field conditions.

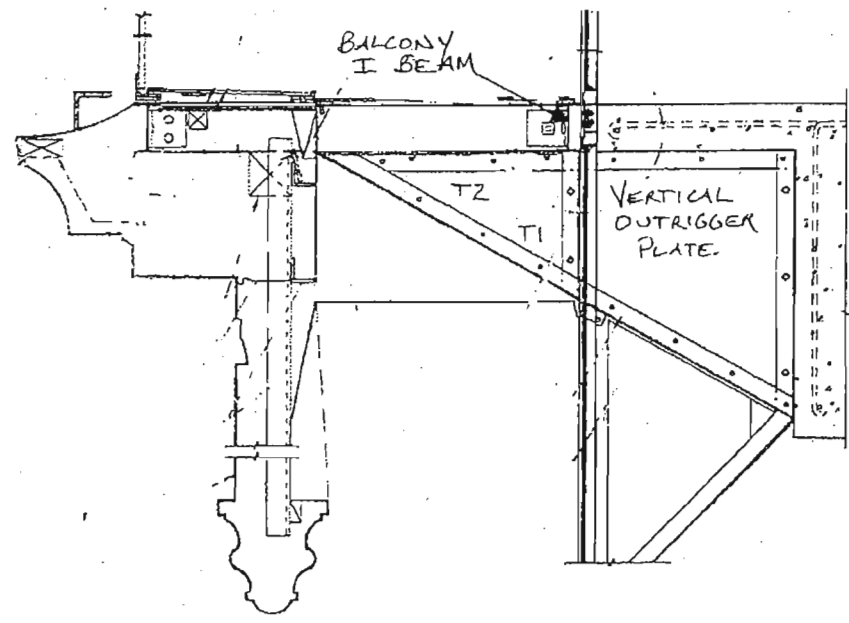
1 DETAIL AT BALCONY
CENTER OF ROUND BALCONY REF 2/A2.1

Figure 2. Balcony details showing locations of thickness measurements.

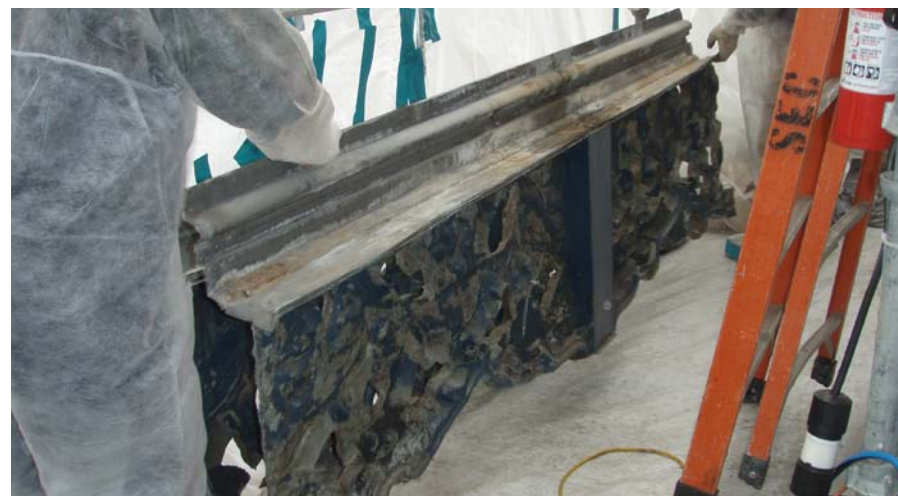
Decorative sheet metal is being removed where there are existing seams

In order to properly assess the damage to the structural framework, the decorative sheet metal has been removed. The decorative sheet metal has been disassembled and removed at the east end of the second level only. All of the sheet metal components were removed in sections and disassembled at existing seams. The balcony railing was taken apart in sections connected at splice plate locations. Each item was given an Item Identification Number and photographed for documentation. Information collected during the salvage and disassembly process was entered into a digital database. As each sheet metal component undergoes a process of repair, the balcony structure will be remediated under the supervision of the structural engineer. All sheet metal pieces and railing components will be reinstalled in their original locations after the balcony remediation is complete.

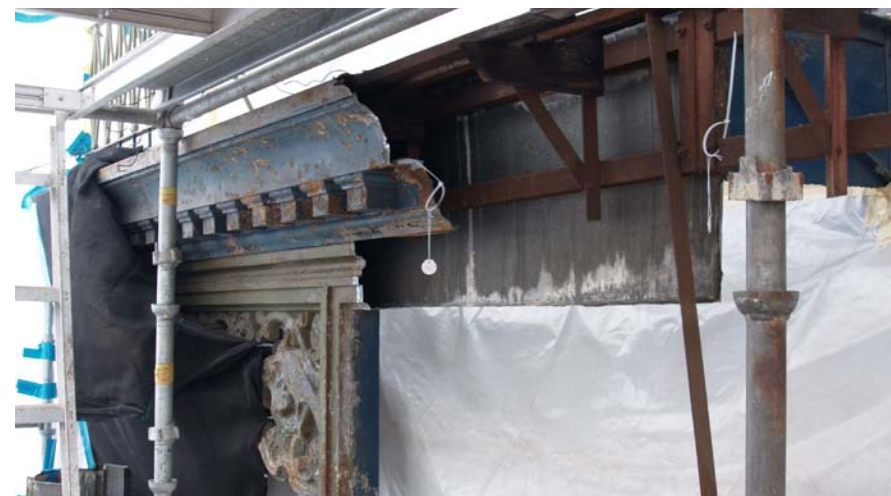
Cataloging and removing of decorative sheet metal

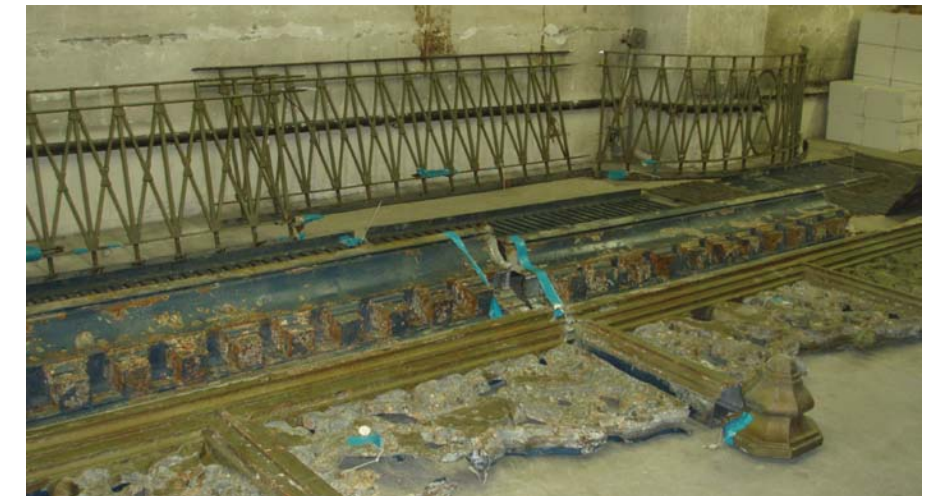
Storing of decorative metal
