SAN FRANCISCO PLANNING DEPARTMENT

MEMO

DATE: May 27, 2010
TO: Historic Preservation Commission
FROM: Shelley Caltagirone, Preservation Staff, tel. (415) 558-6625
REVIEWED BY: Tim Frye, Acting Preservation Coordinator
RE: **June 2, 2010 Hearing**
1269 Lombard Street
Case No. 2009.0443DDEV/2010.0165DD

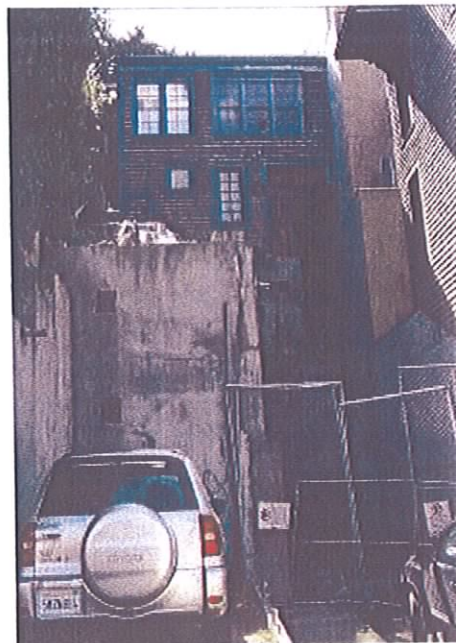
Image 2. 1269 Lombard Street from Lombard Street, with concrete retaining walls visible as well as lack of front entry accessibility. Photo Frederic Knapp, 2007.

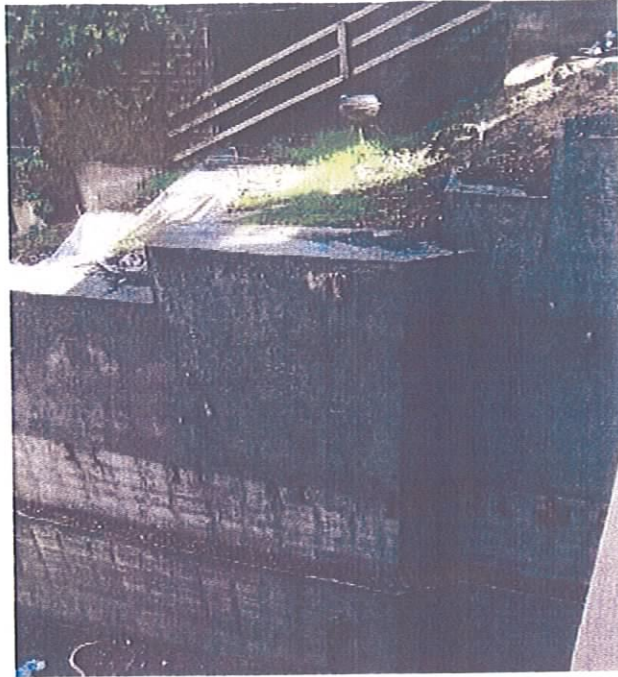
Image 3. Detail of eastern concrete retaining wall from above. Photo Frederic Knapp, 2007.

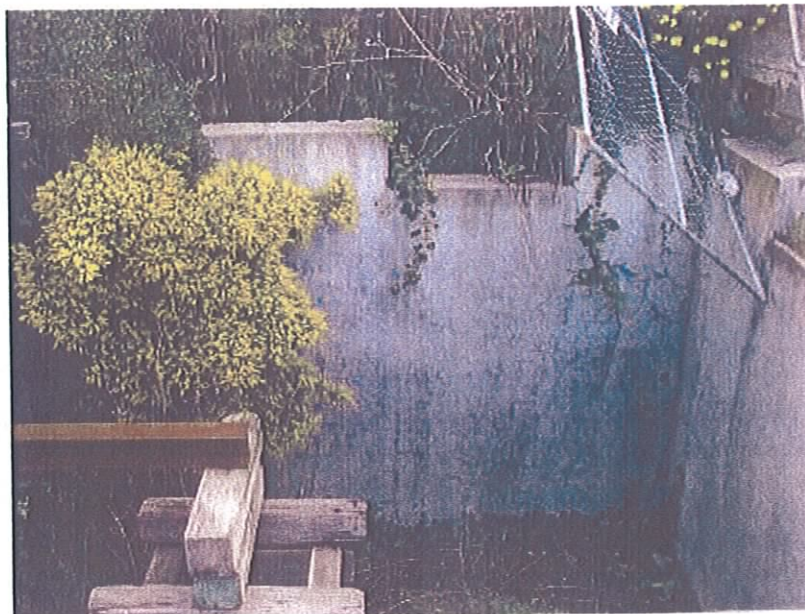
Image 6. Rear yard from roof of 1269 Lombard. Temporary support beam visible at lower left. The concrete retaining walls which surround the yard on three sides are visible. Photo Frederic Knapp, 2007.

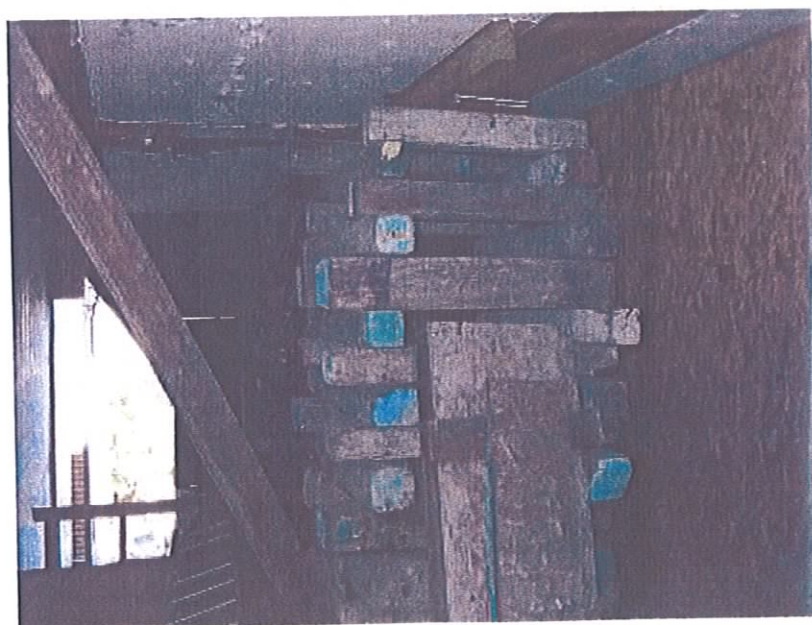
Image 8. Temporary support under the house, looking north to Lombard Street.
Photo Frederic Knapp, 2007.

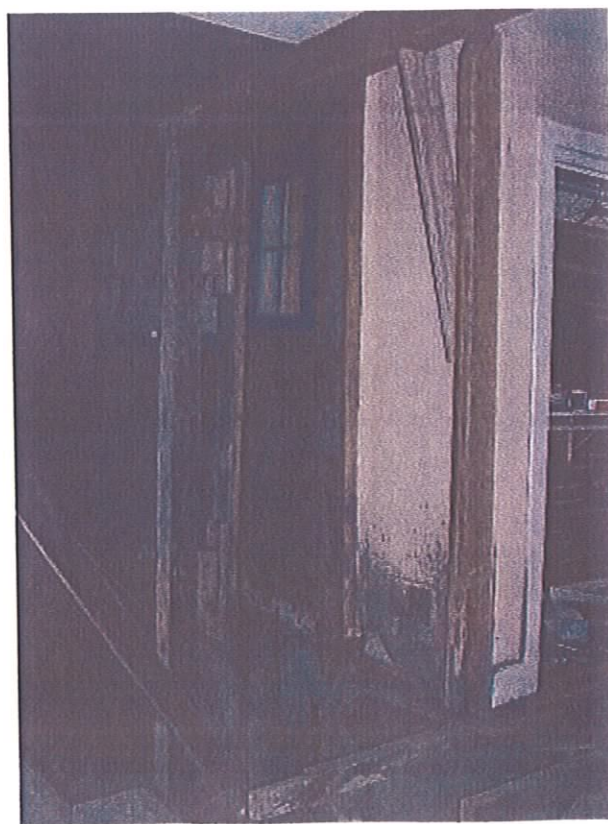
Image 10. Passage way with unfinished wall leading into house. Photo Frederic Knapp, 2007.

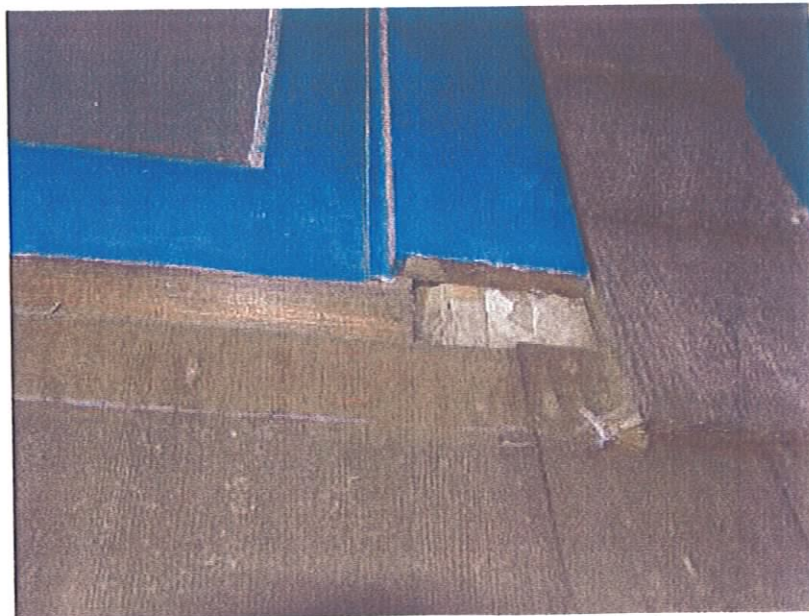
Image 12. Detail of wood shingles at passageway. Note that window trim and shingles are flush. Photo Frederic Knapp, 2007.

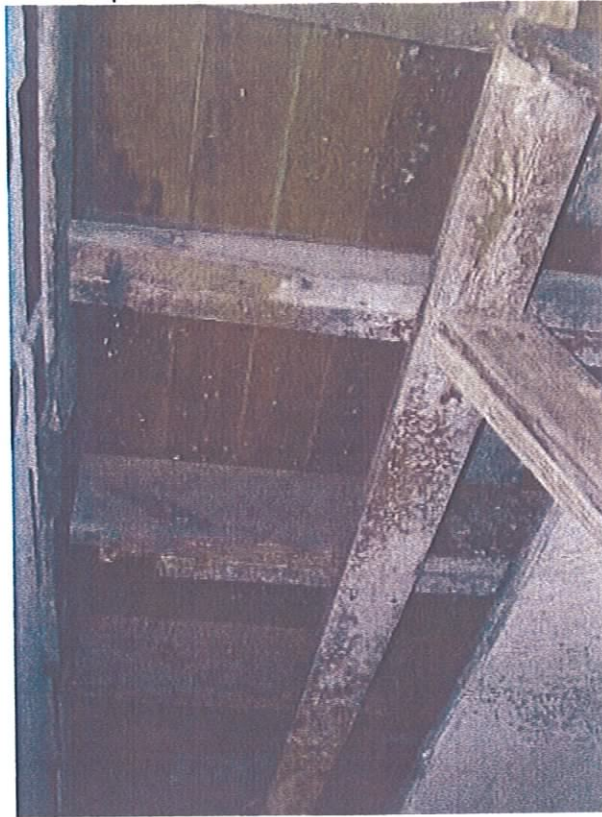
Image 13. Second floor framing, seen from below at passageway. Photo Frederic Knapp, 2007.

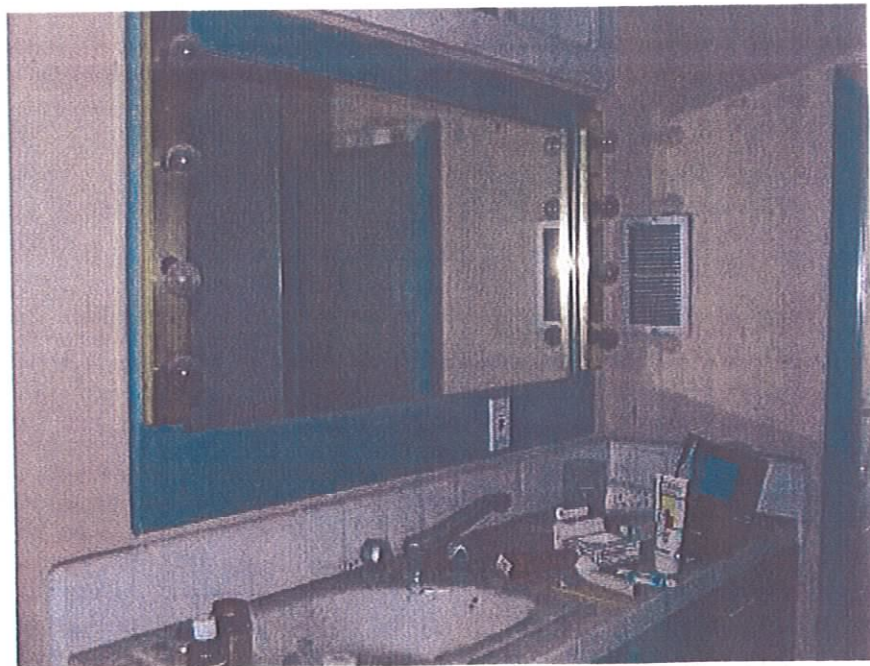
Image 16. Lower bathroom detail. Photo Frederic Knapp, 2007.

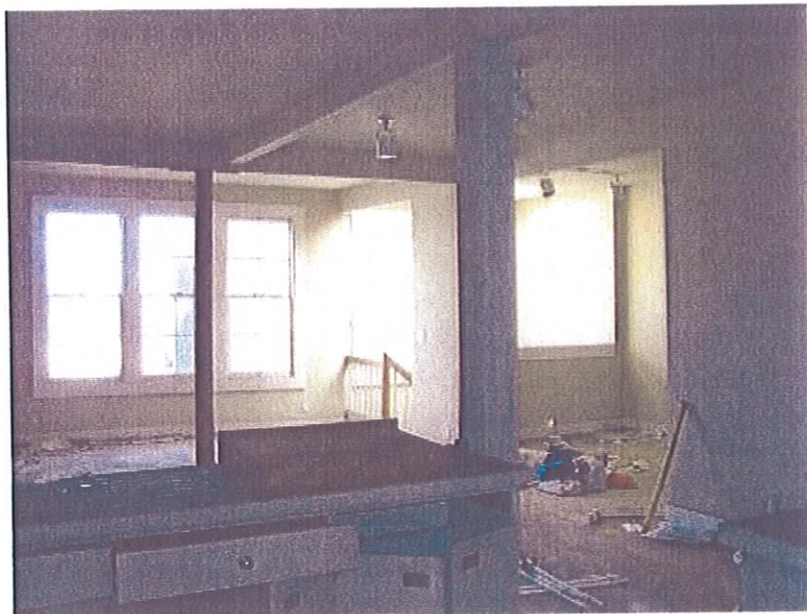
Image 18. Looking north towards Lombard Street from the rear of the upper floor. The room and staircase are visible to the right. Photo Frederic Knapp, 2007.

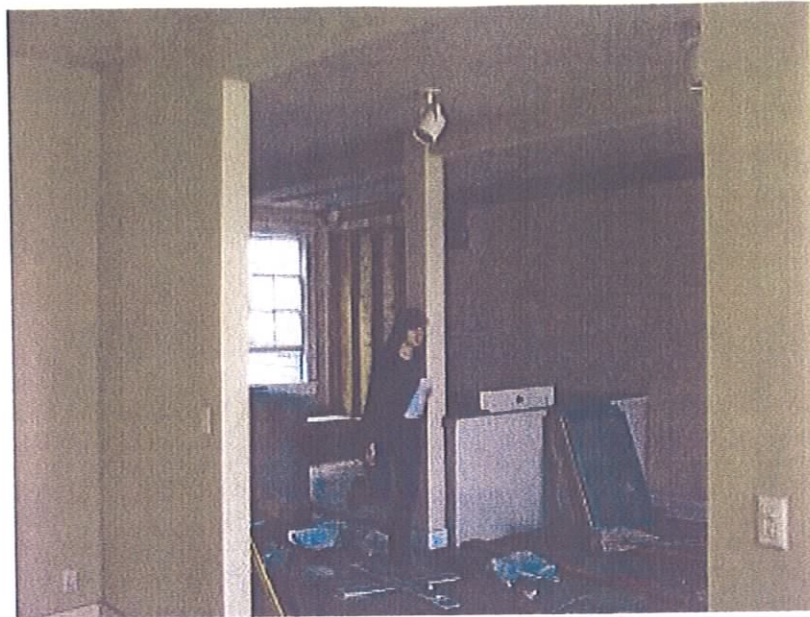
Image 19. Looking out to upper floor from room seen in previous image. Rear window and the west side of the kitchen area is visible. Photo Frederic Knapp, 2007.

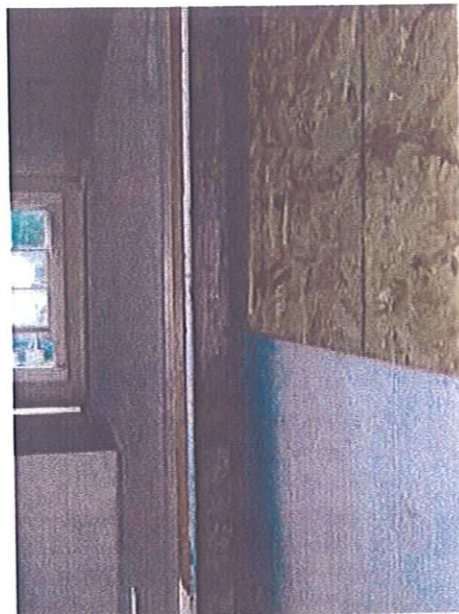
Image 20. Detailed view of former window at west wall of upper floor. Photo Frederic Knapp, 2007.

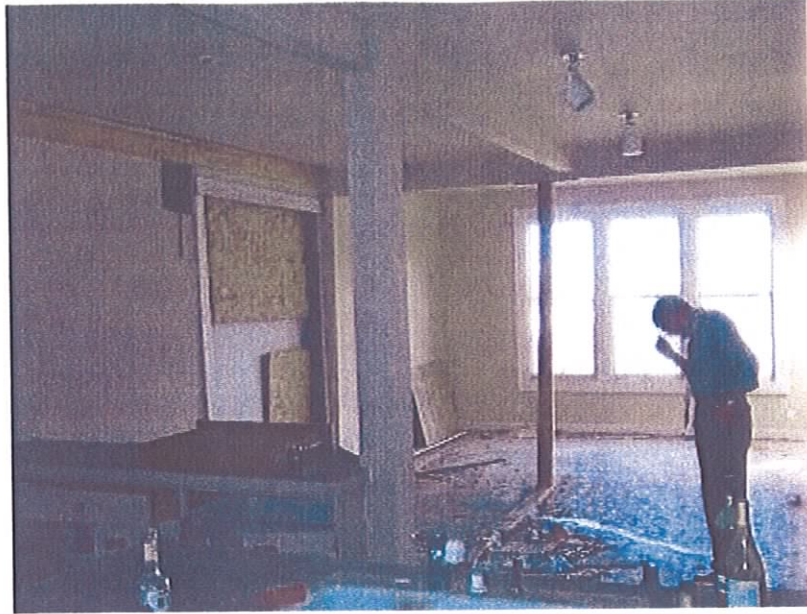
Image 21. Upper floor, looking towards north towards Lombard Street. Opening on west wall that was originally a window visible at left. Photo Frederic Knapp, 2007.

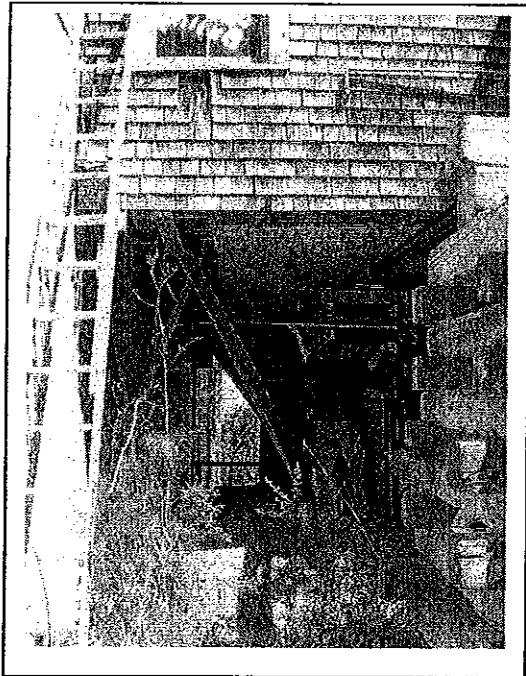
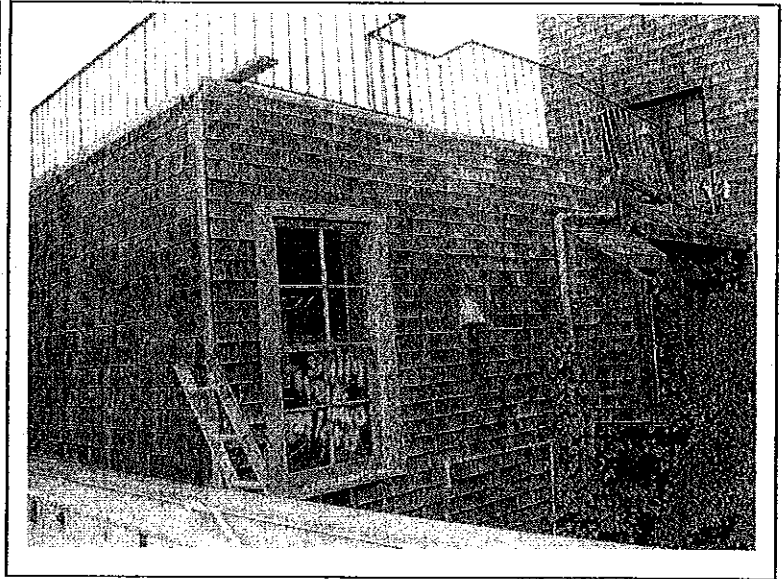
The building has a flat roof with approximately 6" of crawl space. An illegal roof deck was constructed on the building, with the only point of access via the eastern neighbor. **See Photos 4 and 19.** At the front of the building, at the street level, there is a series of concrete retaining walls. Due to the steep hillside, these retaining walls are of varying heights in a stepped layout, with total retention of approximately 31-feet between the two main retaining walls (13-feet plus 18-feet in height). These two main walls are directly adjacent to each other. **See photos 1 and 2 and attached floor plans and building section drawings.**

Photo 4: Rear elevations (facing north) of 1269 Lombard. On the left photo, notice the western (left) half of the 1st floor's walls are gone, fully exposing the 1st floor to the elements. Photo on right is the 2nd floor's rear elevation. Notice that the only access to the roof deck of 1269 Lombard is the illegal bridge from the roof deck to the eastern neighbor.

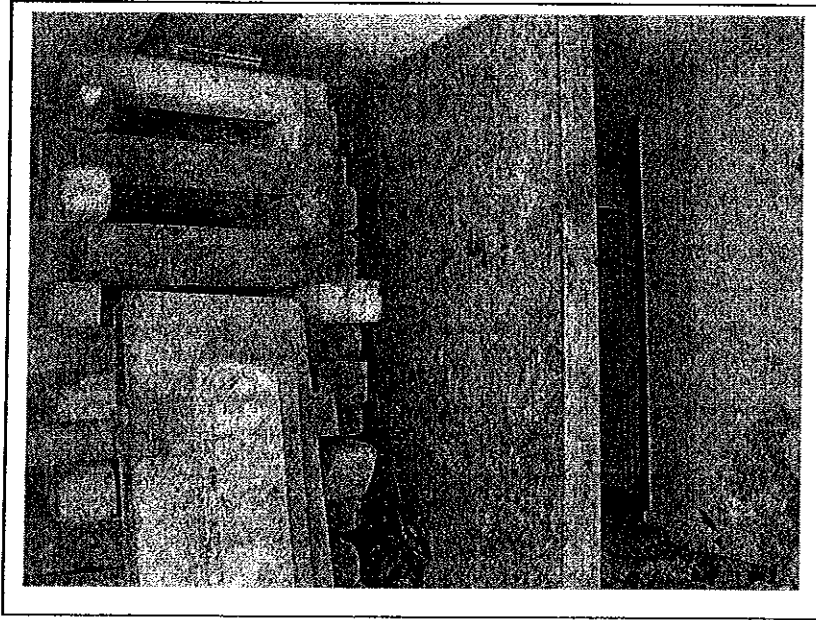
Photo 11: View of 1st floor, facing northeast. Cribbing on left is the same as photo 7. Hallway of the 1st floor is partially viewable on the right of the photo.

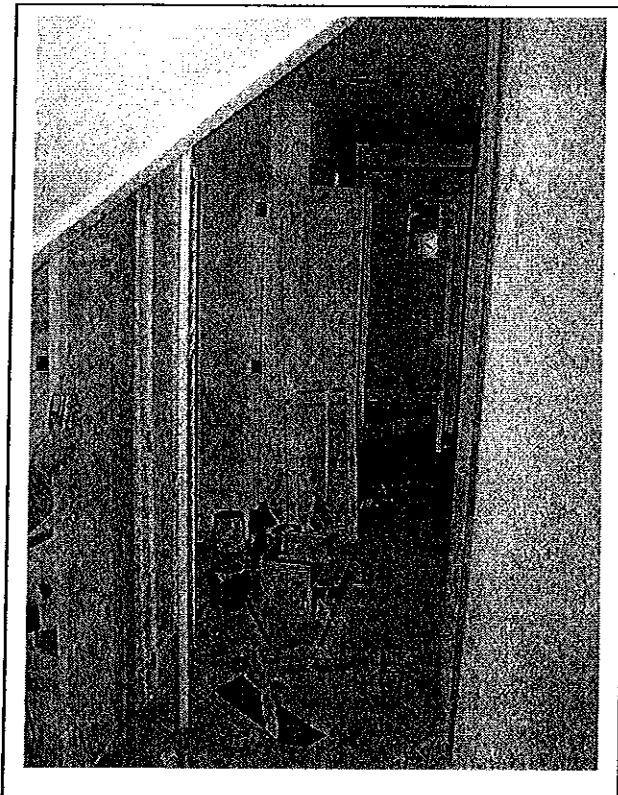
Photo 12: View of 1st floor hallway, facing south.

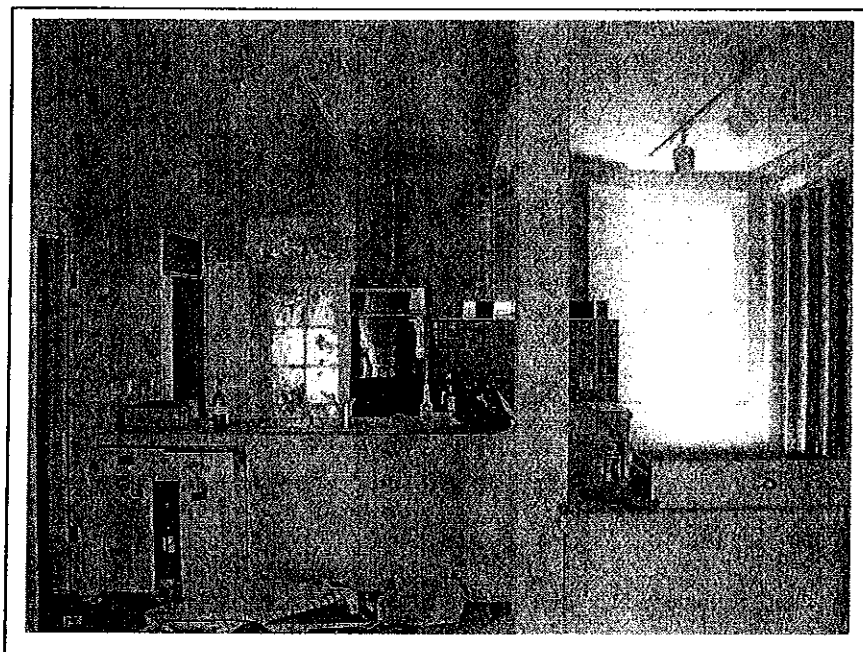
Photo 13: View of 2nd floor kitchen, facing south.

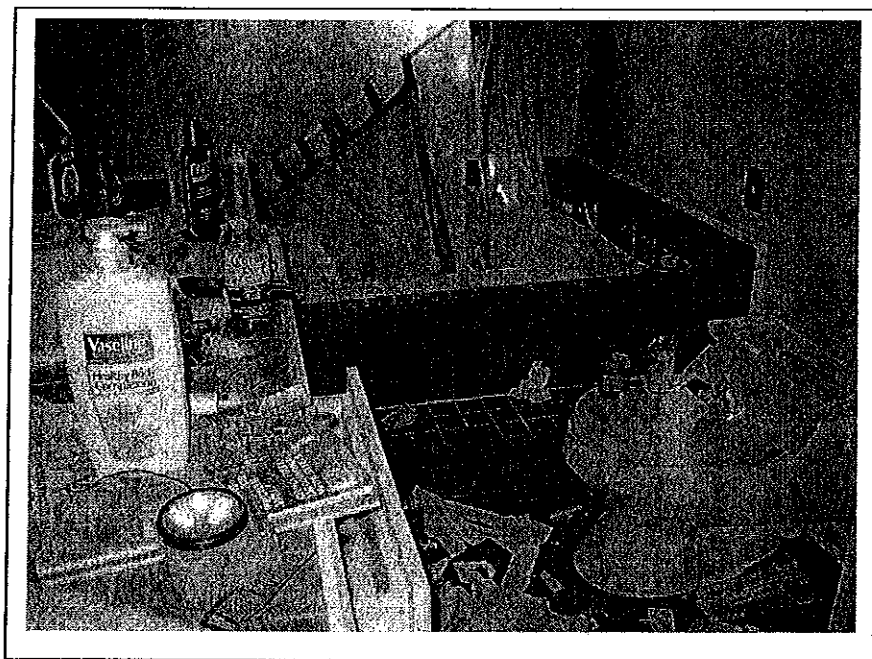
Photo 14: View of 2nd floor bathroom, facing south.

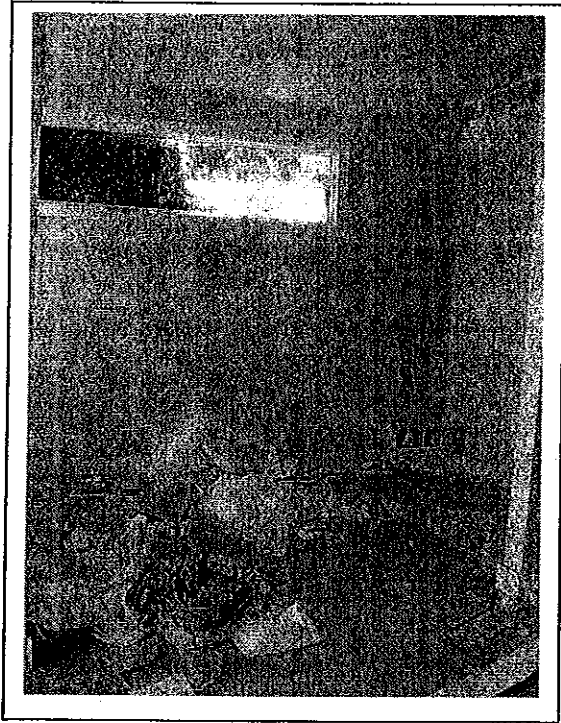
Photo 15: View of 2nd floor Dining Area. View is facing east. Debris, food, and personal hygiene products show signs of squatters.

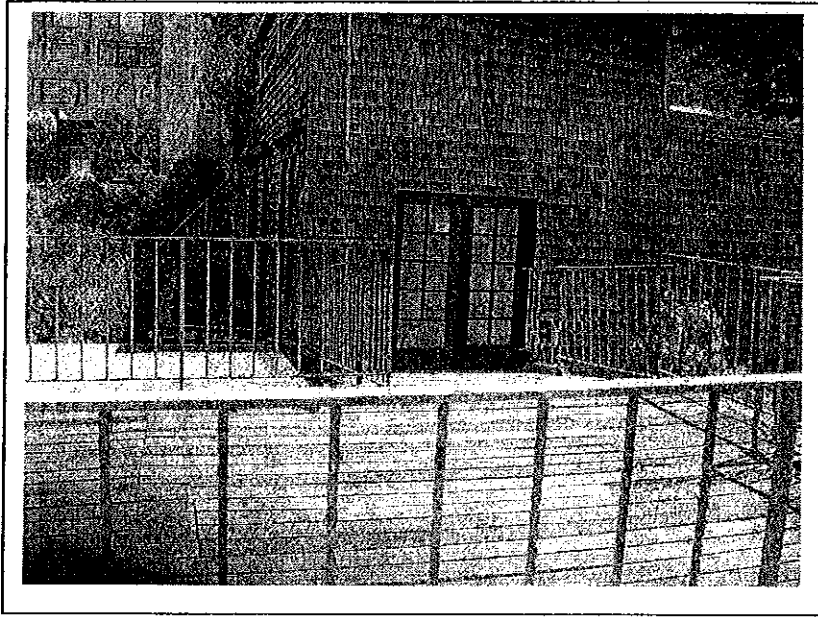
Photo 19: View of roof deck of 1269 Lombard, facing east. The adjacent eastern neighbor is in the background. Notice the only means of access to the roof deck is from the eastern neighbor via the illegal bridge.
