# SAN FRANCISCO PLANNING DEPARTMENT

**MEMO**

**RE:** Review and Comment for 1 Jones Street (former Hibernia Bank)  
Case No. 2011.0617EA

**HIBERNIA BANK BUILDING**

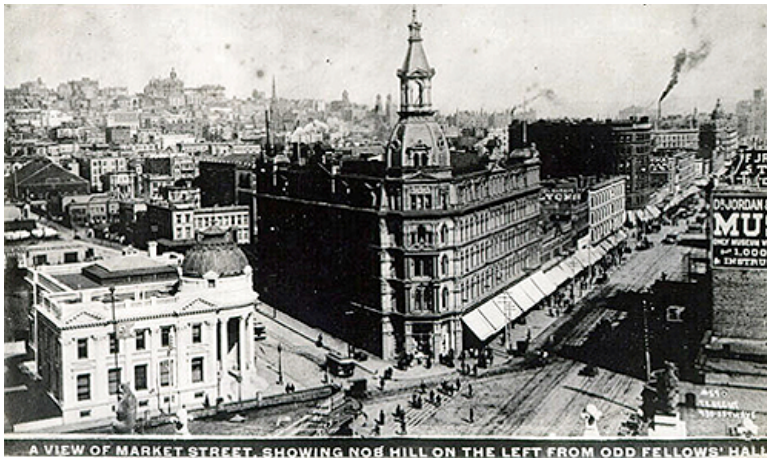
*Figure 1: A view of Market Street, ca. 1895.<sup>2</sup> The Hibernia Bank can be seen on the left before the 1905 addition.*

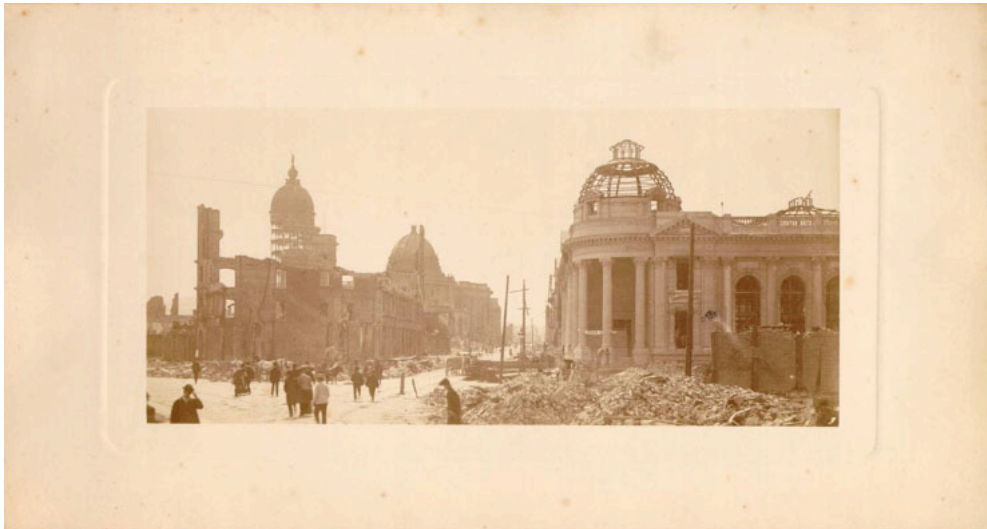
*Figure 2: Looking west on McAllister Street just after the 1906 earthquake. The Hibernia Bank is on the right and the ruins of the City Hall can be seen on the left.<sup>3</sup>*

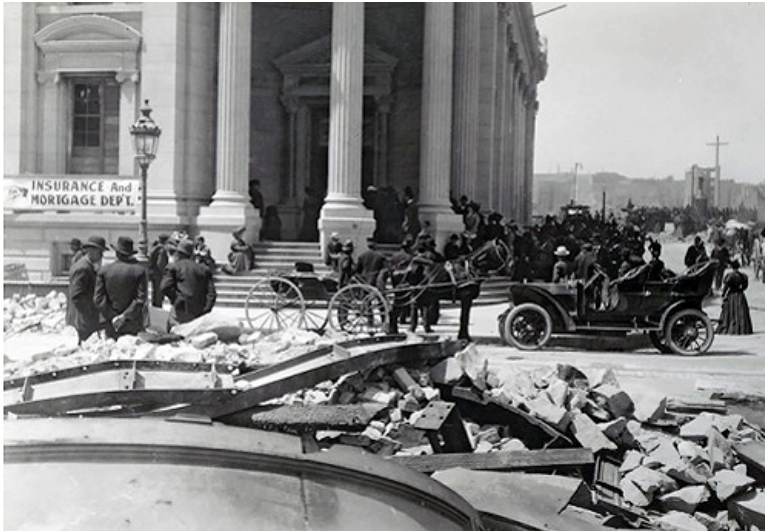
*Figure 3: Reopening after the 1906 earthquake and fire on May 25, 1906<sup>4</sup>*

The exterior of the building survived the 1906 earthquake but the subsequent fire severely damaged the interior. The structure and exterior facades remained intact and the bank reopened for business on May 25, 1906 while the interior of the bank was still being renovated. In 1980, the walls and ceiling of the interior of the banking hall were restored to match their original color.

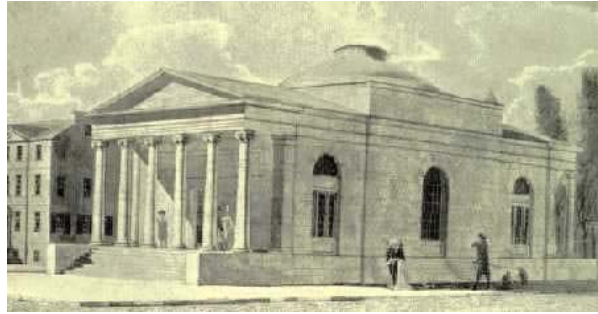
**Figure 4. Benjamin Latrobe's Bank of Pennsylvania in Philadelphia.**

In America the purpose-built bank took form in the late eighteenth century, with early designers taking their cue from Sir John Soane. The first of these banks was the Bank of Pennsylvania, designed by Benjamin Latrobe and constructed in Philadelphia in 1798 (**Figure 4**). This building is the earliest recognizable banking "temple" in America.

Following the lead of Sir John Soane, Latrobe utilized a classical temple form composed of an enclosed rectangular cella flanked by two freestanding colonnades. The Banking Hall – the main public space – occupied the cella at the middle of the building, with a central work area defined by a continuous tellers' counter. The perimeter of the Banking Hall was lined with depositors' vaults, and offices. The interior of the rotunda was adorned with color-accented friezes and capped by a spectacular coffered dome.

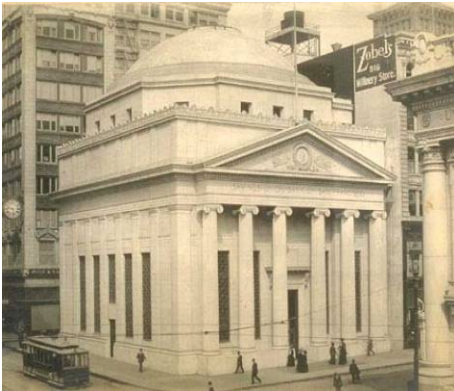
Figure 5. Savings Union Bank Building, ca. 1912. Source: Bancroft Library, University of California, Berkeley.

Roman Neoclassical style, the exterior of the building is monumental in scale, yet it remains one of the smaller buildings in San Francisco's Financial District. Similarly, the Savings Union Bank and Trust Company Building (now Armani Exchange) at the intersection of O'Farrell, Grant, and Market – also by Bliss & Faville (**Figure 5**) employs a Roman Neoclassical design based on the Pantheon in Rome.

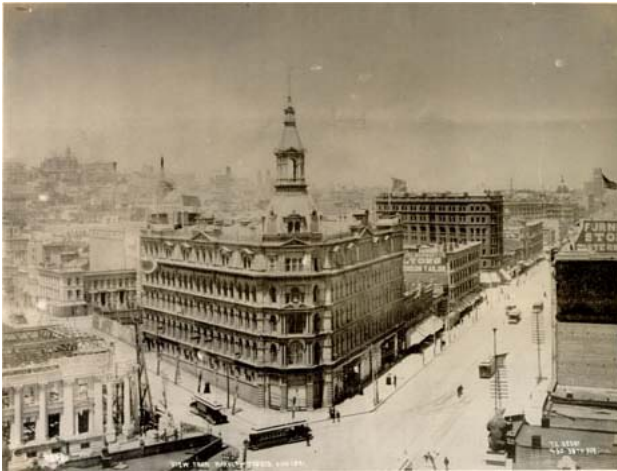
Figure 6. Building under construction (lower left corner of photo), 1891. Source: San Francisco History Center, San Francisco Public Library.

Construction on the new bank building began in 1889 with the pouring of the \$6,000 concrete perimeter foundation (**Figure 6**). The McAllister Street façade measured 90 feet, and the Jones Street façade measured 129 feet. The average height of the parapet above the street was 50'. The structural frame consisted of cast iron columns and steel I-beams.<sup>12</sup> White granite from Rocklin, California was used to clad the south and east façades with rear walls made of brick.<sup>13</sup> The Rotunda was to be capped by a burnished copper dome (later gilded in 1907) over an iron framework 75' above the sidewalk. When completed in 1892, the new building was said to resemble "a number of well known public buildings of Paris, and there is about it much suggestion of the Bank of England." The building was called a "banking palace" and was named the "most artistic building in town." The main banking room was 67'-6" square and rose the full height of the building. It was "an illustration of beauty, design, exquisite material and splendid workmanship."<sup>14</sup>

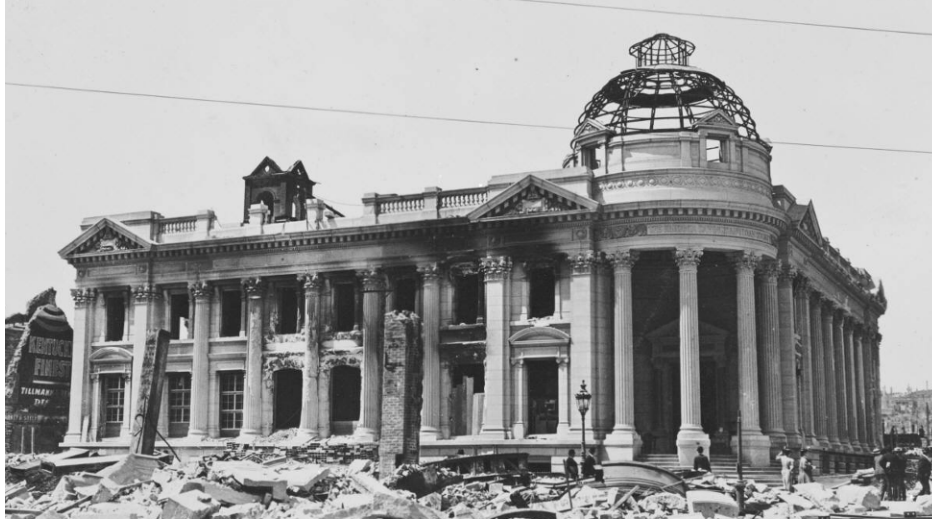
Figure 8. Hibernia Bank Building, April 18, 1906. Note smoke and fire damage above windows and damage to rotunda. Source: California Historical Society.

According to a publication entitled "The San Francisco Earthquake and Fire of April 18, 1907" the building sustained fire damage to the granite façades, especially around the doors and windows, which were badly spalled. Other damage was confined to the roof and the dome (**Figure 8 and Appendix A, Items 12-18**).<sup>22</sup> It was a full month before the main vault was cool enough to open. All of the contents were found to be safe and intact, unaffected by the fire that destroyed the building's interior.<sup>23</sup>

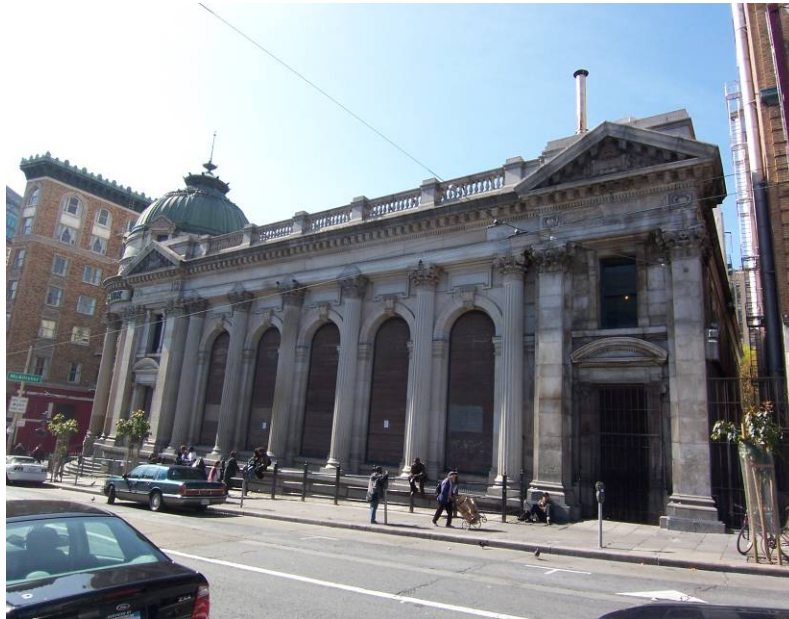
Figure 9. East facade facing Jones Street. Source: KVP 2009.

The east façade (**Figure 9**) is seven bays long (not including the rotunda) and is two stories high. The rusticated granite foundation or water table decreases in height from south to north in line with the grade change of Jones Street. The water table level features boarded over windows in bays one through four. A temporary aluminum fence separates the building from the sidewalk. Another non-historic, low metal fence surrounds a below-grade rectangular light well presently covered over with plywood. At the north end of the façade are historic cast iron posts and a gate concealed behind a non-historic mesh security gate. This opening gives access to the north alley.

The east façade is symmetrical in composition and consists of projecting corner bays and five interior bays. The corner bays are wider than the interior bays and are identical in composition, consisting of a curved pedimented window in the southernmost corner bay and a curved pedimented pedestrian entrance in the northernmost bay, which is recessed and concealed behind a non-historic mesh security gate in front of a low wrought iron gate. This entrance features an iron door with bronze cladding with a

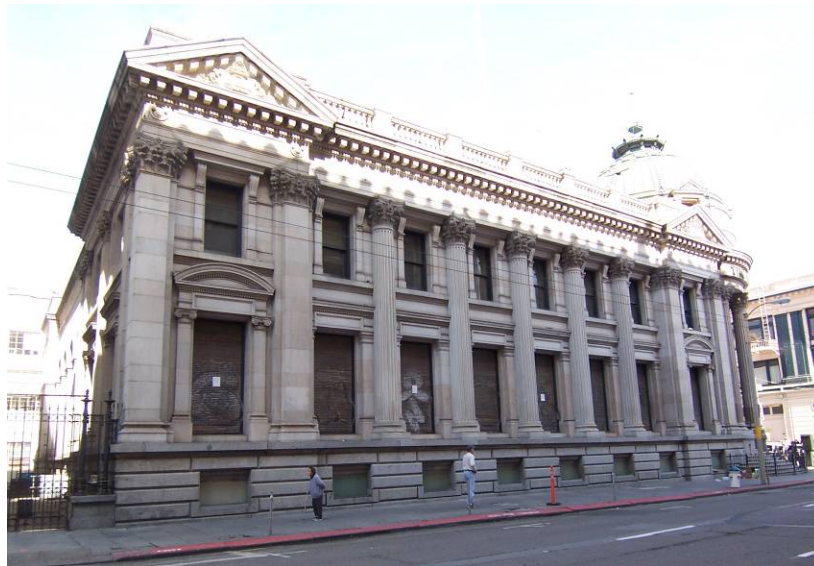
Figure 10. South facade facing McAllister Street. Source: KVP 2009.

The south façade (**Figure 10**) is eight bays (not including the rotunda) and two stories high. The east and west corner bays are identical to the corner bays on the east façade, except for the panel detail above the second floor windows. The entablature and balustrade are also identical to the east façade. A security gate (**Figure 11**) with cast iron posts atop granite plinths and wrought iron gate and balusters is located just west of the building. A taller, non-historic mesh fence has been placed behind the gate and fence.

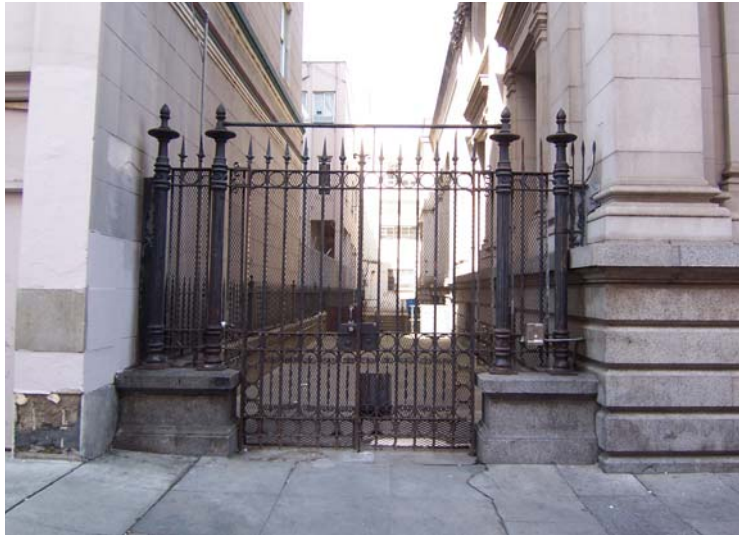
Figure 11. Cast iron and wrought iron security gate located just west of the building. Source: KVP 2009.

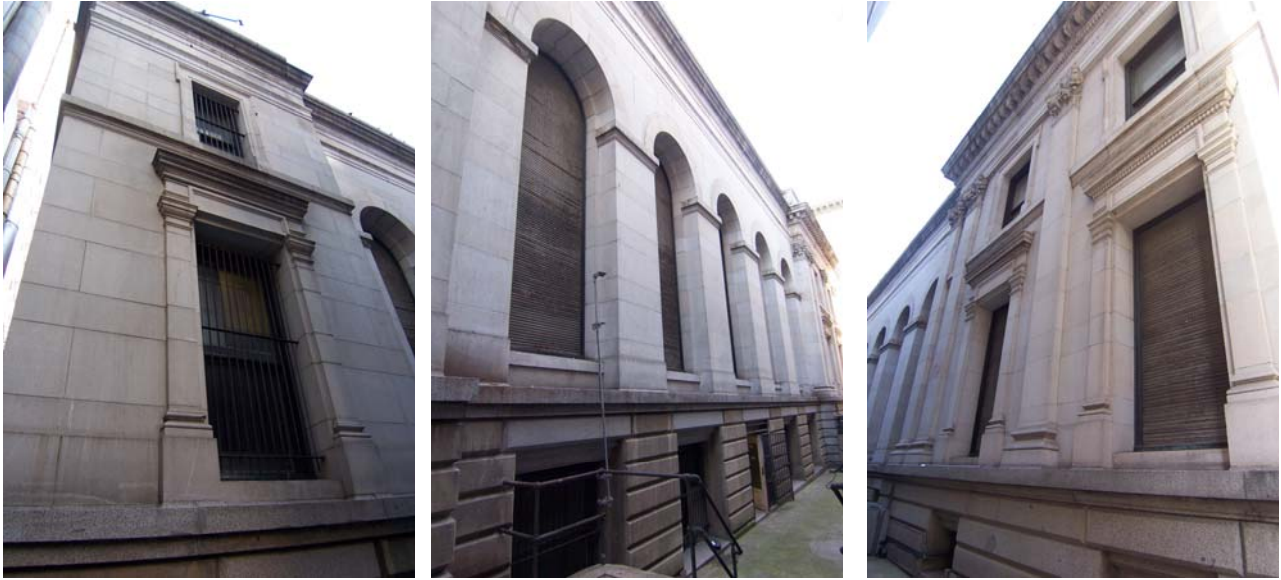
Figure 12. Details of west facade. From left to right: north bay, center bays and south bays.

The west façade is eight bays wide and three stories high. The water table is a combination of concrete and dark speckled rusticated granite. The north bay (**Figure 12, left**) above the water table consists of white granite cladding and a large, rectangular, one-over-one, double-hung, metal-sash window flanked by Tuscan order pilasters and surmounted by a plain, recessed panel frieze capped by a molded granite architrave. Above this is a double-hung metal sash window with flared granite casings and architrave. Above is a stepped granite architrave, a plain frieze and a molded granite cornice. The northeast corner projects outward about two feet.

Bays two through six (**Figure 12, center**) are two stories above a fully excavated basement level. All bays are identical with concrete rusticated foundation and double-hung metal-sash windows with speckled granite sills and molded lintels, except for the fourth bay which features a painted steel door with single light in the center with brass hardware. The door is flanked by rectangular side lights enclosed within bronzed steel fittings. Like the windows it has a granite lintel and concrete stoop. The windows and door with sidelights are protected by non-historic wrought iron security gates.

Concrete stairs lead up to the southernmost two bays (**Figure 12, right**). Both feature rusticated granite water table with a one-over-one, double-hung, metal sash window inset in both bays. The southernmost two bays appear to be detailed similarly to the south façade. Both feature large rectangular windows flanked by Tuscan order pilasters and are capped by blank frieze panels, a dentil course molding, and molded architrave.

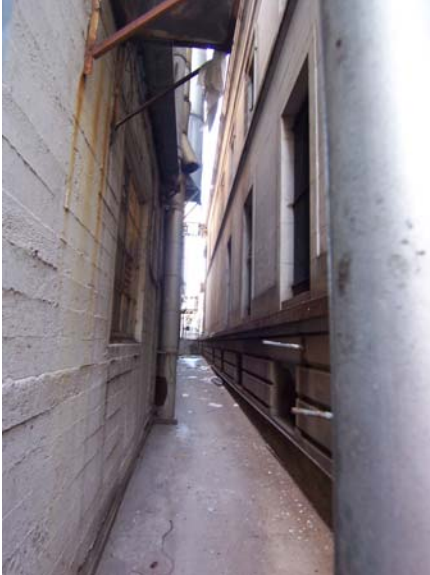
**Figure 13. North facade. Source: KVP 2009.**

The north façade (**Figure 13**) is six bays wide and two stories over basement and is clad in granite. This façade faces a narrow alley, so it is the least significant façade. The basement is rusticated concrete with six non-evenly spaced recessed bays consisting of single-light, opaque bronze sash windows with granite sills and lintels. A molded granite water table divides the basement and first floor. There are three rectangular, double-hung, metal sash windows on the first floor. Windows feature blank granite sills and plain white granite surrounds. A molded intermediate cornice divides the first and second floors. The second floor has five one-over-one, double-hung, metal-sash windows with molded granite casings and flared architraves that match the west façade. The north façade features a blank frieze and simple molded granite cornice that matches northernmost six bays of the

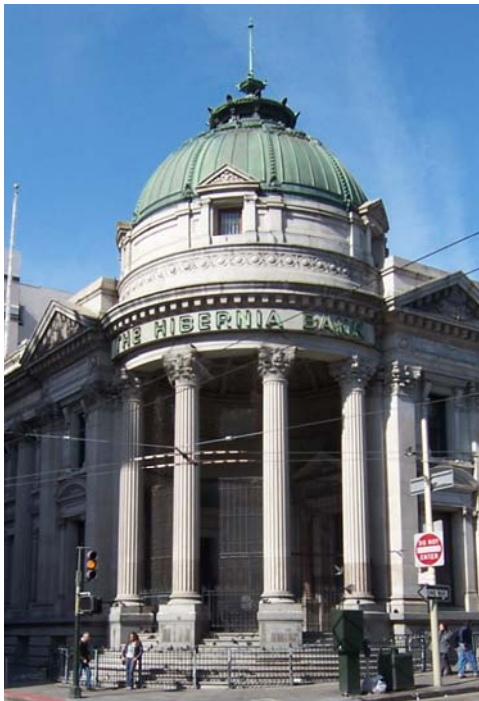
Nine granite steps with a bullnose coping lead to the Rotunda (**Figure 14**) and are enclosed behind a low wrought-iron fence. Four large fluted Corinthian columns stand atop molded granite plinths and are enclosed by a low wrought iron fence with a taller non-historic mesh fence behind it. The columns support a banded entablature. A carved granite or terra cotta frieze sits atop the architrave, concealed behind a sheet metal sign that reads: "THE HIBERNIA BANK" in neon letters. Above the frieze a block modillion and cornice is surmounted by a plinth and carved bull's-eye frieze. Above this is the drum which is paneled and divided by square pilasters. Three pedimented attic windows punctuate the drum. The tympanum of the pediment features foliate carving. The drum is capped by a copper dome divided into segments by bull's-eye moldings. The base of the dome features an egg-and-dart molding. A circular lantern with bracketed volutes embellished by acroteria terminates the dome.

The interior of the Rotunda is approximately 26' in diameter and two stories high. The floor of the Rotunda is entirely clad in marble tiles. At the center is a compass rose pattern (**Figure 14**) inlaid in marble showing eight points. The cardinal and inter-

Figure 14. Rotunda facing the intersection of McAllister, Jones and Market Streets. Source: KVP 2009.

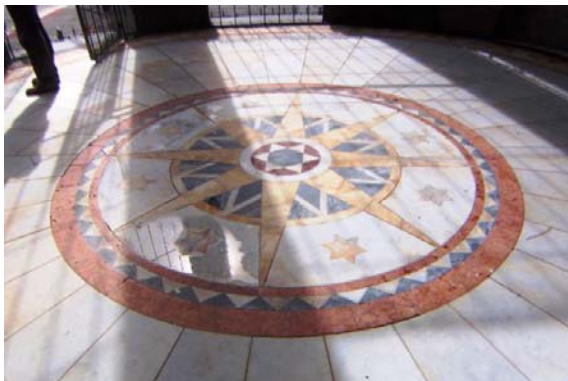
cardinal points are in Giallo di Siena marble. At the center of the pattern is a six sided star in Carrara marble with a Belgian Black marble center, surrounded in Rosso Verona marble and encircled by Carrara marble. Behind the pattern is a starburst made of Belgian Black marble outlined by Carrara marble and surrounded by Bigio Antico black marble. The starburst is encircled by a band of Giallo di Siena marble. Between the eight points of the compass rose are six sided stars in Giallo di Siena marble. The entire compass rose pattern is encircled by a band of Rosso Verona marble, followed by a zigzag pattern of Carrara and Bigio Antico marble triangles, and finally encircled by a wider band of Rosso Verona marble. The entire compass rose pattern is surrounded by Carrara marble tiles radiating out from the pattern. The perimeter of the Rotunda has a border with diamond shaped Giallo di Siena marble outlined in Carrara and Bigio Antigo marble triangles, bordered on each side by a band of Giallo di Siena marble followed by bands of Rosso Verona and Belgian Black marbles at the perimeter.

Figure 15 (l). Inlaid marble compass rose pattern on the floor of the interior of the rotunda. Source: KVP 2009.

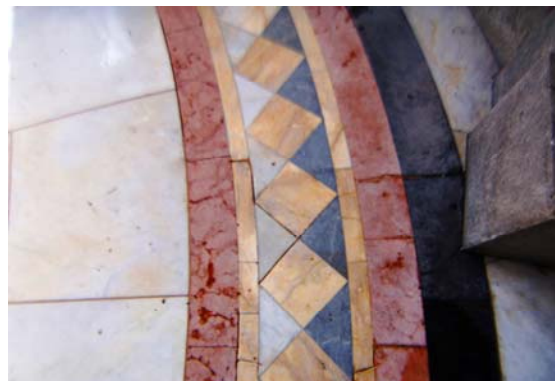
Figure 15 (r). Inlaid marble border, floor of rotunda. Source: KVP 2009.

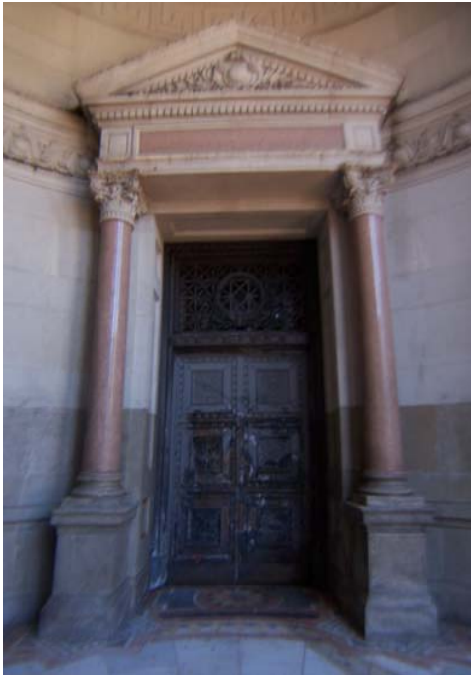
Figure 16. Main entrance located in the rotunda. Source: KVP 2009.

At the west wall (**Figure 16**), a smaller second pedestrian entrance has similar bronze double doors bounded by a simple architrave. The door is surmounted by a transom window with a decorative iron grille similar to that of the main entrance. Above the transom is a blank frieze which is surmounted by egg-and-dart molding and capped by a flat projecting lintel supported by scrolled acanthus leaf brackets.

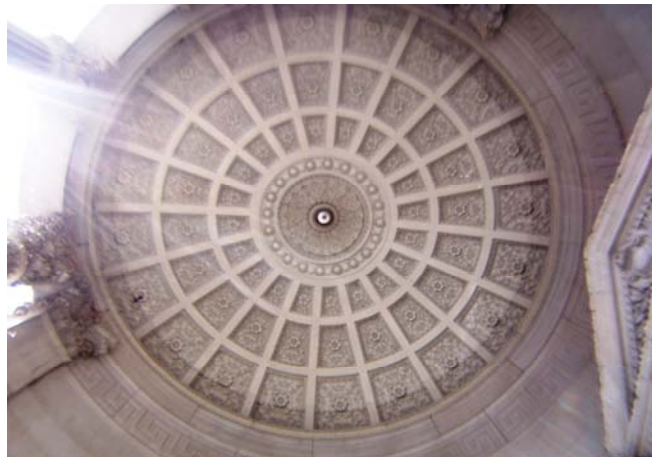
The Rotunda ceiling (**Figure 17**) is coffered with ornamented panels in a floral pattern. According to historic photographs (Appendix A, Items 11, 17 and 24), the medallion at the center once held a pendant light fixture.

Figure 17. Ceiling of the rotunda. Source: KVP 2009.

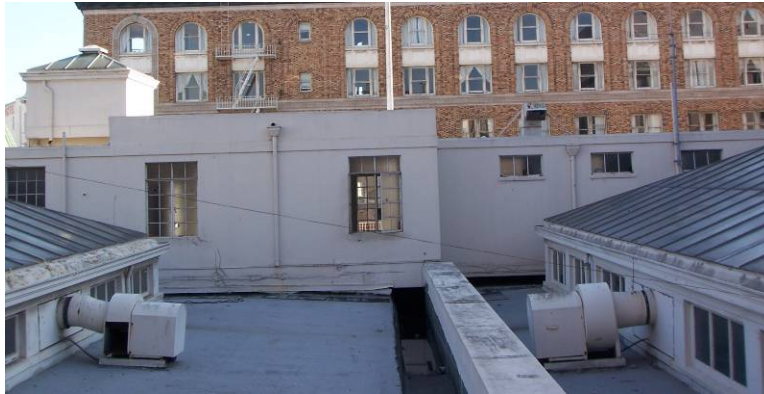
The roof (**Figure 18**) is built up over the Banking Hall and is surrounded by a granite parapet and balustrade braced with steel L-flanges anchored to the roof. Granite coping and a copper gutter line the perimeter of the roof. Glazed skylights or diffusers with hipped profiles and monitors cap the art glass skylights. Two of the diffusers have fixed metal tripartite glazing with wire glass. Mechanical equipment is located at the north end of the roof and is accessed by cat walks.

**Figure 18.** Roof, view south. Note the skylight diffusers at left and right and the penthouse in the background. Source: KVP 2009.

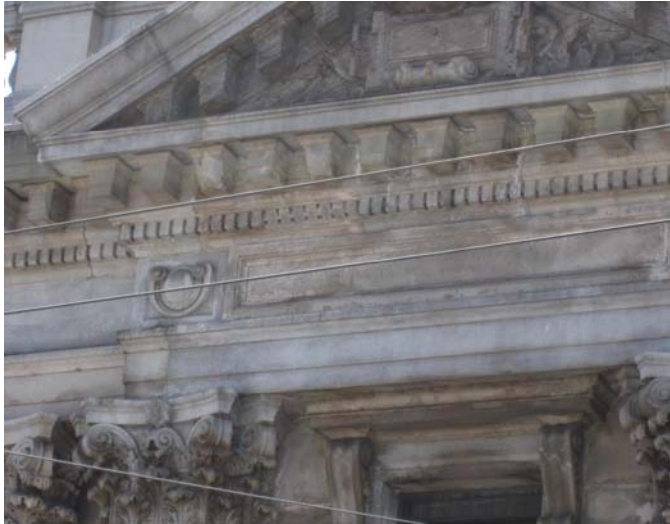
Figure 19. One of two areas of broken dentil molding on the east facade

The granite façades on the north, south and west sides of the building appear to be in good condition. The east facade is in fair condition. All facades are slightly discolored, likely due to accumulated soot. There is also some surface efflorescence on the granite façades due to wicking of salts from the mortar. On the east façade, the north corner bay has a darker discoloration which may be due to heavier efflorescence or biological growth, perhaps black mold or mildew. At the top of the east facade, the dentil molding has become detached and has fallen off in two areas (Figure 19). The fire department has removed other loose pieces of

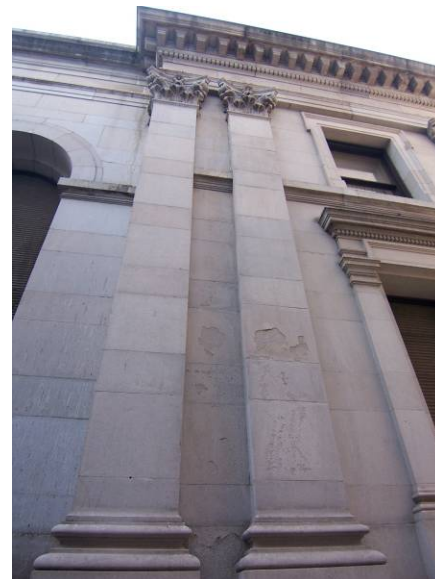
Figure 20. Spalling granite on west facade. Source: KVP 2009.

granite in these areas. In some areas on the west façade the granite appears to be spalling (**Figure 20**). The fluted columns of the Rotunda show a distinct line of discoloration at the base of the column indicating that they may have an anti-graffiti coating that has now failed.

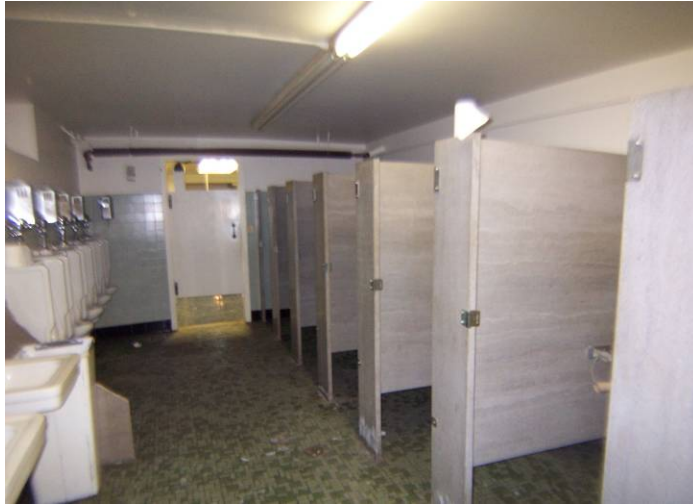
Figure 21. Men's Toilet Room (B-1) located in the basement. Source: KVP 2009.

Located in the northwest corner of the basement level, the Men's Toilet Room (**Figure 21**) is rectangular in plan and approximately 23'-2" x 11' with a 7'-8" ceiling. The floors are covered in ceramic tile (C). The north, south and west walls are clad in ceramic tile with plaster above (C) while the east wall is gypsum board (NC) and the ceiling is plaster (C). A window is located in the west wall and is covered by an interior metal roll-down security grill (VS). The entry is located on the east wall and is filled with a partial height, wood, swinging door (NC). The south walls are lined with porcelain toilets separated by marble partitions with wood doors. The north wall is lined with porcelain sinks and urinals with chrome plated fixtures (C). The toilet room is illuminated by fluorescent tube lighting (NC).

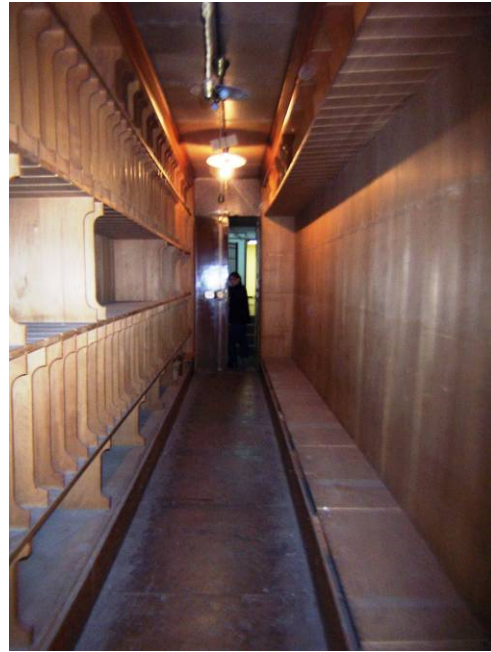
The Document Vault (Figure 22) is located in the northwest corner of the basement. Rectangular in plan, the space is approximately 6'-6" x 26' with a 9'-10" ceiling. The floor and east and west walls are lined in metal (S). The north and south walls are lined with cedar, with the south wall containing cedar shelving which may have been used for file storage (S). The steel vault door is highly decorative and has a secondary steel door and gate (S). Lighting is provided by brass hanging light fixtures (S). Now electric, they may have been gas originally. All fixtures and finishes appear to date from the period of significance and are significant.

Figure 22. Document Vault (B-5) located in the basement. Source: KVP 2009.

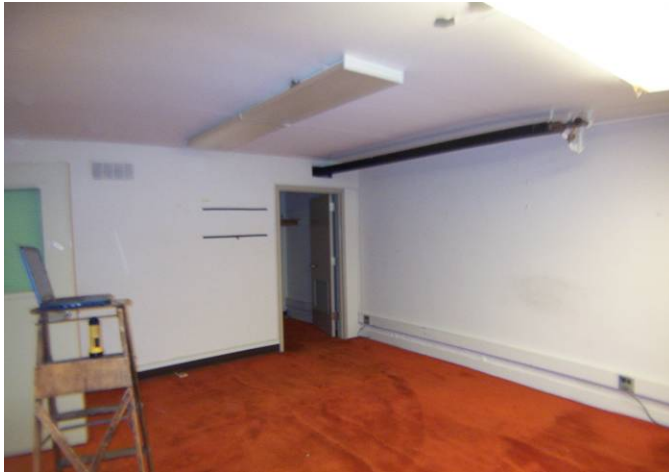
Figure 23. Office #2 (B-8) located in the basement.  
Source: KVP 2009.

Office #2 (Figure 23), located in the northwest corner of the basement, is part of a suite of offices and meeting rooms located on the west side of the basement that appear to be related to the period of SFPD occupancy. This room is approximately 14'-4" x 15'-9" with an 8' ceiling. The floors are covered in carpet (NC). The west and south walls are gypsum board with a rubber baseboard (NC). The north wall is covered in plaster with a rubber baseboard (C). The east

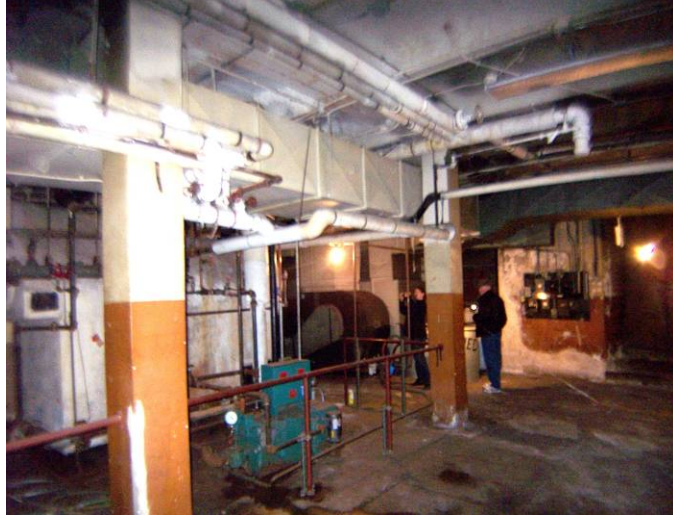
The Mechanical Room (**Figure 24**) is located at the east end of the basement. The room is T-shaped in plan and is approximately 67'-3" x 14'-11" and 38'-10" x 25'-6". The floors are concrete (**C**) and the walls and ceiling are concrete covered in plaster. A large boiler is located in the northwest corner as well as an HVAC unit (**NC**). In the center of the east wall is a flight of concrete steps leading up to an arched double metal door that accesses the Jones Street light well (**C**). The door is flanked on each side by two double-hung, metal sash windows with interior roll-down security shutters (**VS**). Although constructed during the period of significance, because of the poor condition of the south and east walls and the ceiling, they are non-contributing. The north and west walls are in good condition and were constructed during the period of significance and are therefore contributing.

**Figure 24. Mechanical Room (B-15) located in the basement. Source: KVP 2009.**

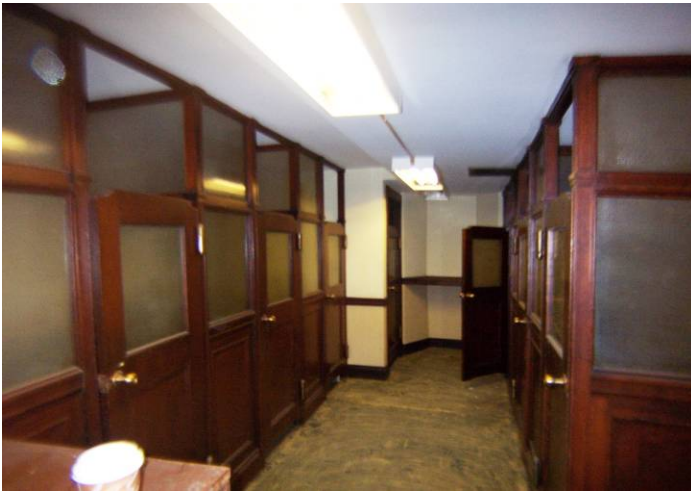
Figure 25. Safe Deposit Viewing Room (B-19) located in the basement. Source: KVP 2009.

Located in the basement at the south end of the building, the safe deposit viewing room (Figure 25) is part of a suite of rooms associated with the adjacent safe deposit Vault and offices. Rectangular in plan, this room is approximately 31'-4" x 13'-3" with a 7'-1" ceiling. The

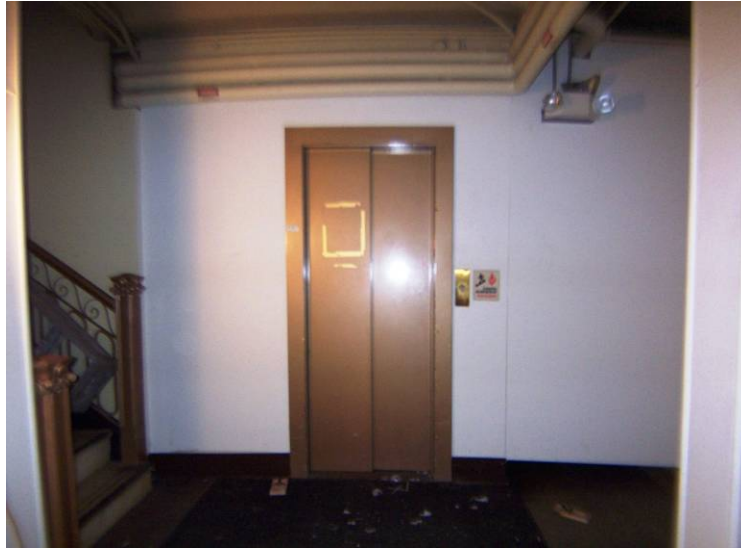
Figure 26. Elevator Lobby and Stairs at left (B-25) located in the basement. Source: KVP 2009.

The concrete floor of the Elevator Lobby is covered in resilient tile flooring (C). The south wall contains the elevator shaft (Figure 26). The opening features a painted sheet metal surround and the wall behind is finished in plaster (C). The east and west walls are partial-height metal partitions (NC). The ceiling of the elevator lobby is plaster (C). Exposed pipes and conduit run around the perimeter of the ceiling (NC). A short corridor with a ramp (NC) leads down from the elevator lobby to the safe deposit box area. The floor of the ramp is concrete and the walls are plaster with a wood baseboard and chair rail with metal railing. There are fixed, wood- frame, plate glass windows on both sides of the corridor (C). A double metal gate separates the corridor from the safe deposit area (C). The dropped ceiling is covered in plaster (NC).

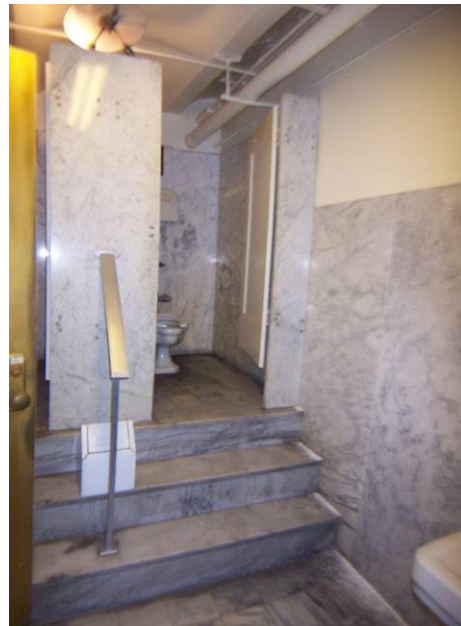
The West Women's Toilet (**Figure 27**) is located in the south end of the basement. It is accessed from the open space of B-24 by a flight of concrete steps followed by a corridor with partial-height metal partition walls (**NC**). The toilet room is rectangular in plan and is approximately 7'-7" x 14'-7" with a 9'-7" ceiling. The concrete floors are covered in Carrara marble tiles, walls are covered in Carrara marble panels with plaster above, and the ceiling is plaster (**C**). A flight of Carrara marble clad steps leads up to two porcelain toilets enclosed by Carrara marble partitions and wood doors (**C**). The metal entry door on the west wall has a metal surround and

**Figure 27. West Women's Toilet (B-29) located in the basement.**  
Source: KVP 2009.

hardware (C). A window with an interior metal roll down security grill is located on the south wall (VS). A pedestal sink (C) with modern hardware is on the east wall. Exposed pipes and ductwork line the perimeter and ceiling of the room (NC).

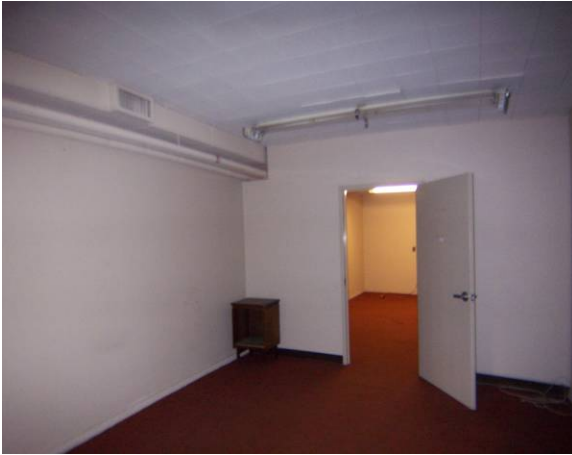
Figure 28. Northwest Office (F-1) located on the first floor. Source: KVP 2009.

Located in the northwest corner of the building, this room (**Figure 28**) was once part of a larger room that was partitioned at an unknown date. This room is rectangular in plan and measures approximately 18'-8" x 12'-5". The floors are concrete (**C**) covered in carpet (**NC**). The north, south, and west walls are concrete covered in plaster and have a wood baseboard (**C**). The south wall is covered in wallpaper. (**NC**) The east partition wall is stud-frame and gypsum board with a plastic baseboard and contains a contemporary metal door with metal hardware (**NC**). On the

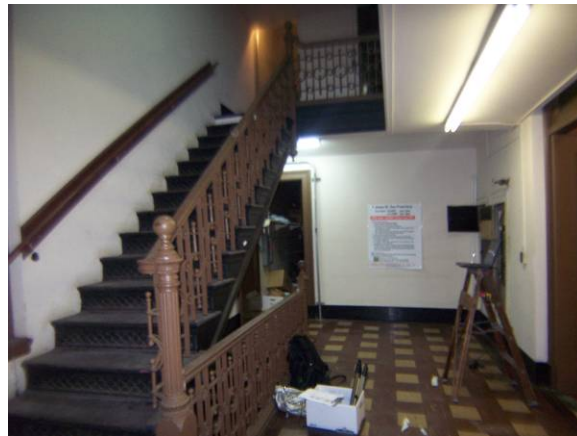
This rectangular shaped space is located in the center of the north end of the building and contains a stair that accesses the basement, first, and second floor north (**Figure 29**). Rectangular in plan, this space is approximately 21'-10" x 12'-8". The floors are covered in alternating colors of resilient tile flooring (**C**), the walls are concrete covered in plaster with a black slate baseboard and the ceiling is plaster (**C**). The stair and its decorative railing are cast iron (**S**). On the north wall is a large double-hung, metal-sash window (**VS**). The south wall contains an opening filled with double, partially glazed metal doors which lead to the banking hall (**S**). The east and west walls contain openings to a Storage Room (F-6) and office space (F-1 and F-2), respectively. The Storage Room opening is filled with a solid panel metal door (**S**).

**Figure 29. North Stair (F-3) located on the first floor. Source: KVP 2009.**

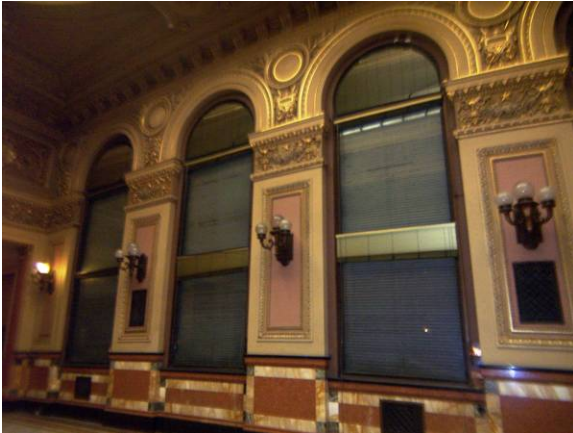
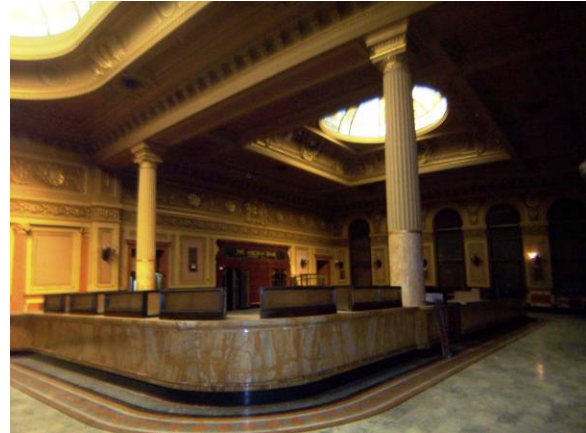
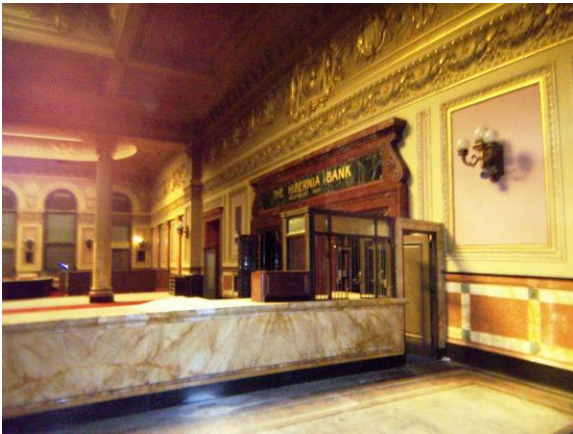
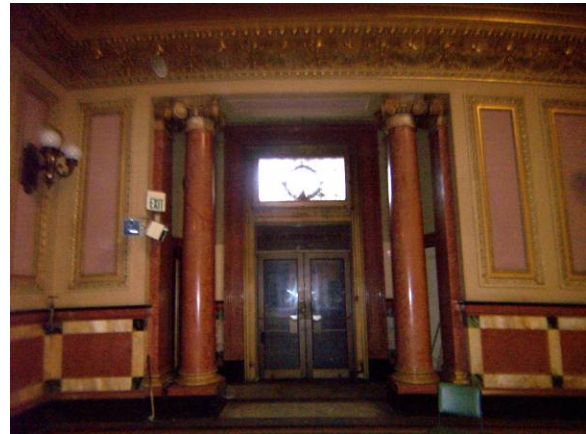
Located at the center of the building, the Banking Hall (**Figures 30-33**) is a double-height space that rises from the first floor to the roof. It is rectangular in plan and approximately 111'-7" x 67'-5" with a 35' ceiling. This is the most highly decorated space in the building, with eight different kinds of marble used on the floor, wainscoting, Vault and door surrounds and columns.

The room is divided into two unequal parts along its north-south axis by two massive columns (**VS**) finished in scagliola plaster at the base of the shaft, fluted plaster above, and terminating with Doric capitals that mark the line of the original west wall demolished in the 1905 remodeling. Another line of five square columns with Belgian Black marble bases, Rosso Verona marble shafts, Giallo di Siena marble necking, and egg and dart capitals divides the Banking Hall from a customer waiting area along the south perimeter of the main hall (**VS**).

Figure 30. East wall of Banking Hall (F-8).  
Source: KVP 2009.

Figure 31. First floor Banking Hall (F-8), view east. Source: KVP 2009.

Figure 32. Banking Hall (F-8) view northwest towards the vaults. Source: KVP 2009.

Figure 33. Banking Hall (F-8) view south towards the Foyer (F-11). Source: KVP 2009.

Ornamental plaster is used extensively in the Banking Hall (F-8). Overall, it is in very good condition. Molded plaster is used as chair rails and in decorative ceilings throughout the building and is also in very good condition, with the exceptions mentioned above.

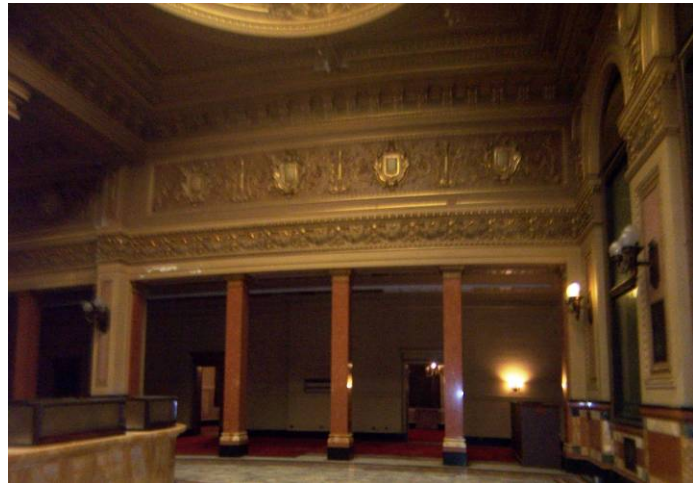
The Customer Waiting Area (**Figure 34**), rectangular in plan, is located at the south side of the first floor adjacent to the Banking Hall and is approximately 16'-5" x 77'-7" with a 15'-9" ceiling. The floor, presently covered in carpet (**NC**), is most likely marble. The north perimeter of the space is defined by rectangular columns with Belgian Black marble bases, Rosso Verona marble shafts, Giallo di Siena marble moldings, and egg and dart capitals (**VS**), while the east end is enclosed by a metal railing separating it from the elevator entry (**S**). The south and west walls are smooth painted plaster with a Belgian Black marble baseboard and a plaster chair rail (**VS**). The ceiling is smooth plaster with a plaster crown molding. The south wall is penetrated by three doorways, each accessing one of the south offices (F-13, F-14, F-15) and the west wall has one double-hung metal sash window (**VS**). Lighting consists of paired brass sconces with glass shades on the south wall and fluorescent light fixtures above (**VS**). The space is in excellent condition.

**Figure 34. Customer waiting area (F-9) located on the first floor south of the Banking Hall (F-8).**

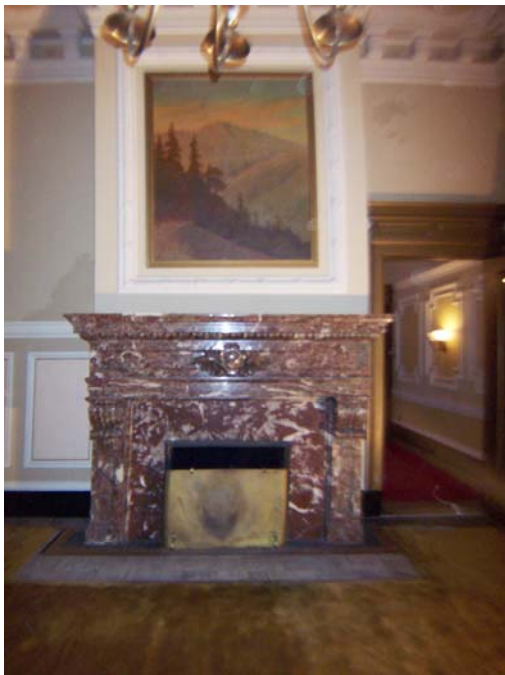
Figure 35. Fireplace and painting in middle office (F-14) located on the first floor. Source: KVP 2009.

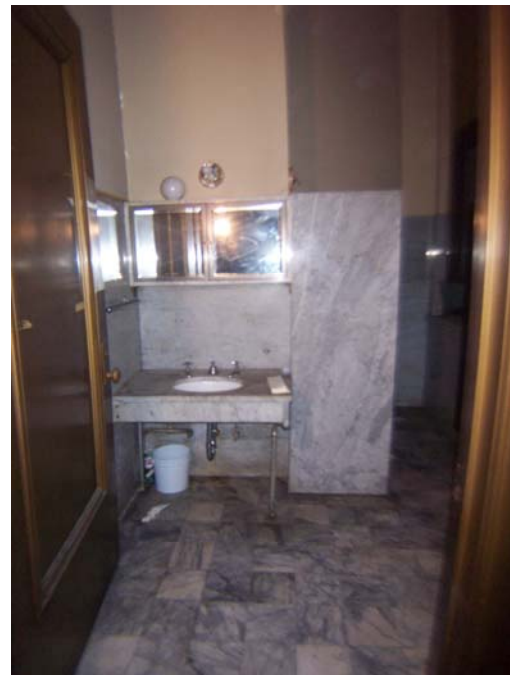
Figure 36. Toilet Room adjacent to Southeast Office (F-15) located on the first floor. Source: KVP 2009.

The toilet room (**Figure 36**) opening off the southeast corner of the room has a floor covered in Carrara marble tiles, smooth plaster walls with an approximately 8' wainscoting of Carrara marble and a smooth plaster ceiling (**C**). Plumbing fixtures consist of a porcelain toilet screened by Carrara marble partitions with a wood door, and a porcelain sink with nickel plated legs and faucets (**C**). Above the sink is a nickel plated medicine cabinet with mirrored doors (**C**). A double hung, metal sash window penetrates the south wall in an unadorned punched opening (**VS**).

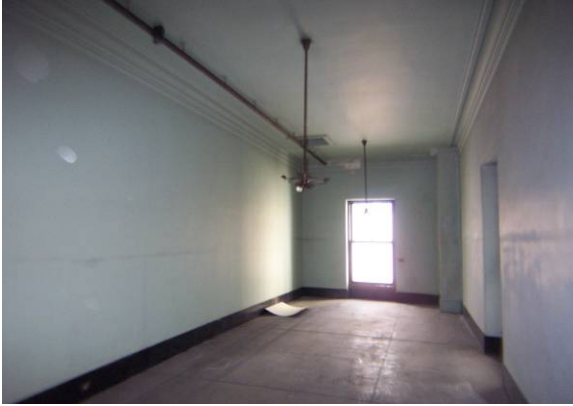
Figure 37. File Storage Room #1 (S-1) located on the second floor north. Source: KVP 2009.

The File Storage Room #1 (**Figure 37**) is located on the northwest corner of the second floor level. According to a newspaper article and historic photos, this room is one of two rooms used for file storage and offices by the County Clerk after the 1906 Earthquake and Fire. Rectangular in plan and measuring approximately 40' x 12', the room has utilitarian finishes. The floors are scored concrete (C); the walls are plaster with a slate baseboard; and the ceiling is plaster with a plaster crown molding (C). One-over-one, double-hung, metal sash windows are located on the west and north walls (VS). A hatch to the attic is located in the southwest corner of the ceiling. A long metal track with a running wheel spans the ceiling east to west and may have been used to transport heavy files (C). Lighting is provided by brass hanging pendant fixtures that appear to have both electric and gas fittings (C). The northwest corner of the room is suffering from water intrusion causing the plaster to bubble and spall

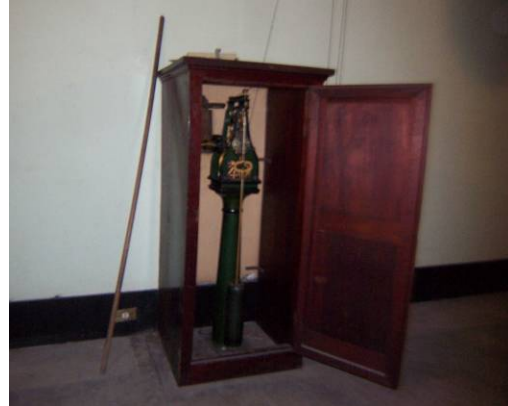
Figure 38. File Storage Room #2 (S-2), mechanism for clock above vault in Banking Hall (F-8). Source: KVP 2009.

38), housed in a wooden cabinet and connected by wires running through a pulley apparatus and through the floor to clock below (**VS**). The northeast corner of the room is suffering from water intrusion, causing the plaster to bubble and spall.

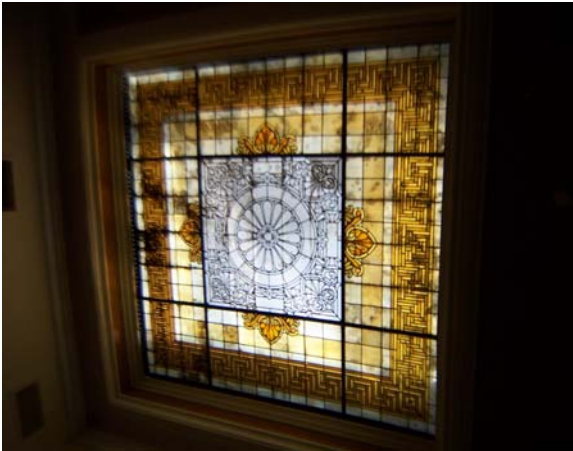
Figure 39. Art glass skylight located in the Middle Office (S-7) on the second floor.

This room is part of a suite of offices on the second floor south that originally housed the Tobin & Tobin law firm. It is accessed from a central double loaded corridor (S-13) through a partially glazed metal door with decorative metal surround. The door is missing its decorative cornice on the interior of the office. The floor is covered with carpet under which is a concrete floor with a wide marble tile border at the perimeter (**S**). The plaster walls have a Belgian Black marble baseboard and plaster crown molding (**C**). The ceiling contains a large, rectangular art glass skylight

(**Figure 39**) with a similar pattern and colors as the skylight found in the Waiting/Reception Room (S-9). The room is also illuminated by recessed light fixtures.

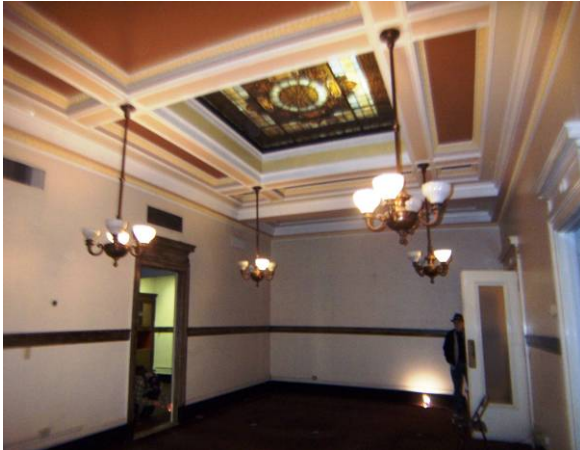
Figure 40. Waiting/Reception Room (S-9) located on the second floor south. Note historic light fixtures and skylight. Source: KVP 2009.

Located on the second floor south, the Waiting/Reception Room (**Figure 40**) is part of a suite of offices that originally housed the Tobin & Tobin law firm. It is rectangular in plan and measures approximately 34'-11" x 18'-5". The floors are covered in carpet (**NC**) under which there is a concrete floor with a wide marble tile border at the perimeter (**S**). The walls are plaster with a Belgian Black marble baseboard and plaster chair rail (**VS**). Pendant light fixtures with four glass globes are suspended from the coffered ceiling (**S**). In the center of the ceiling is a rectangular art glass skylight (**VS**) (**Figure 41**). Two double-hung, metal-sash windows are located on the south wall (**VS**). On the east wall, metal double doors with single glazed center panels (**S**) lead to the stair hall (S-10) and an additional single metal door with a single glazed center panel (**S**) leads to offices (S-18 & S-19). On the west wall is a similar single door leading to the west double-loaded corridor (S-13).

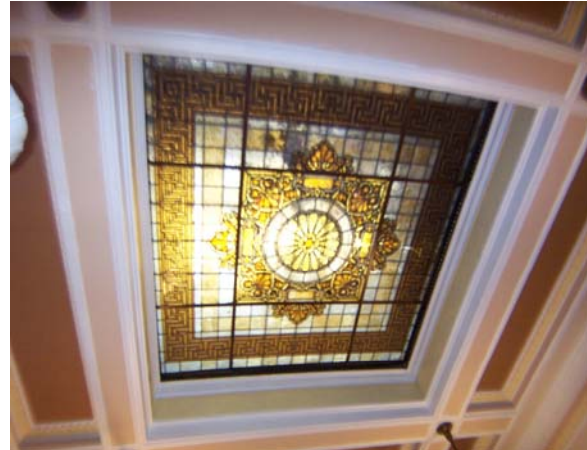
Figure 41. Detail of skylight in Waiting/Reception Room (S-9) located on the second floor south. Source: KVP 2009.

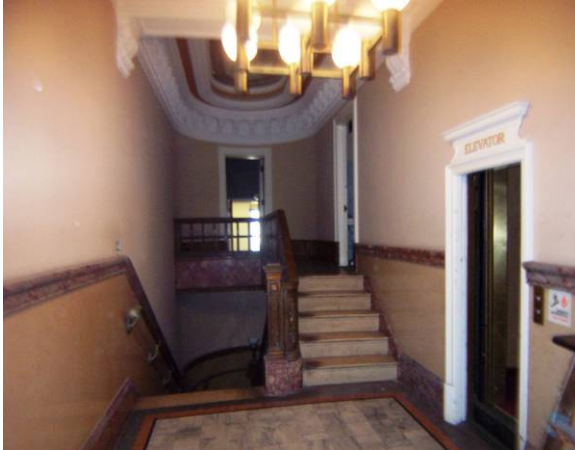
Figure 42. Stair Hall and Elevator (S-10) located on the second floor south.  
Source: KVP 2009.

This Stair Hall (**Figure 42**) is located at the east end of the second floor south and provides access to the suites of offices associated with the Tobin & Tobin law firm. It is served by both stairs that rise from the private entrance off the Rotunda (F-16) and the elevator lobby. The space measures approximately 27'-8" x 9'-4", with floors covered in marble tiles, plaster walls with marble wainscoting, and a decorative plaster ceiling with deep bracketed crown molding (**VS**). The cast iron stairs have marble risers and treads and a decorative brass railing and newel post (**VS**). Over the stairs is an elliptical art glass skylight (**Figure 43**) surrounded by plaster molding and brackets (**VS**). Lighting is provided by a modern hanging fixture with glass globes (**NC**). On the south wall is the Elevator, which features decorative sheet metal surrounds (**S**) and contemporary doors and finishes in the cab (**NC**).

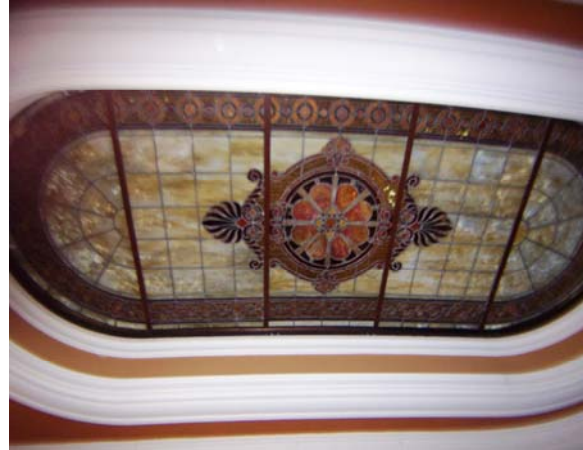
Figure 43. Detail of skylight in Stair Hall (S-10) located on the second floor south.  
Source: KVP 2009.

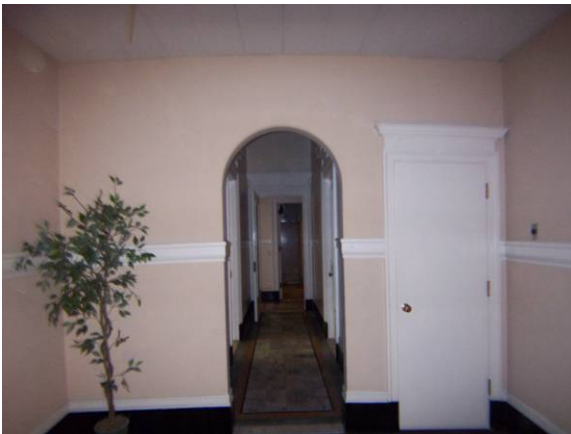
Figure 44. West Corridor (S-13) located on the second floor south. Source: KVP 2009.

This space (Figure 44) provides circulation to the suite of offices associated with the Tobin & Tobin law firm on the south side of the second floor level. It is accessed from the Waiting/Reception Room (S-9) via a metal door with a single glazed center panel and metal surround in the west wall. The T-plan space contains a foyer measuring 12'-4" x 11'-11" and a double-loaded corridor terminating at the Toilet Room (S-12). The foyer has modern carpeting (NC) under which is Carrara marble tiles with a border of Belgian Black, Rosso
