# SAN FRANCISCO PLANNING DEPARTMENT

**MEMO**

**RE:** Review and Comment for 1 Jones Street (former Hibernia Bank)  
Case No. 2011.0617EA

**HIBERNIA BANK BUILDING**

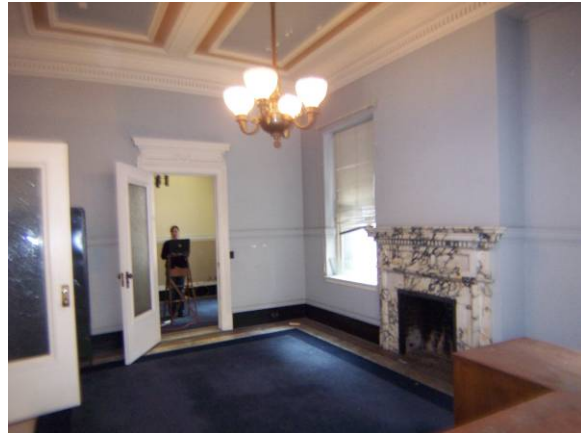
Located at the southwest corner of the second floor (Figure 45), this room is part of a suite of offices originally occupied by the Tobin & Tobin law firm. Plans indicate that this room was once originally the chairman's office. The rectangular-plan room is measures approximately 22'-9" x 16'-6" with a 13'-high ceiling. The center of the floors are concrete covered in carpet (NC) with a wide marble tile border (S) at the perimeter consisting of Carrara, Belgian Black, Rosso Verona and Italian Dove gray marbles. The walls are plaster with a Belgian Black marble baseboard and plaster chair rail and crown molding (S).

Figure 45. Chairman's Office (S-15) located on the second floor south. Note historic light fixture. Source: KVP 2009.

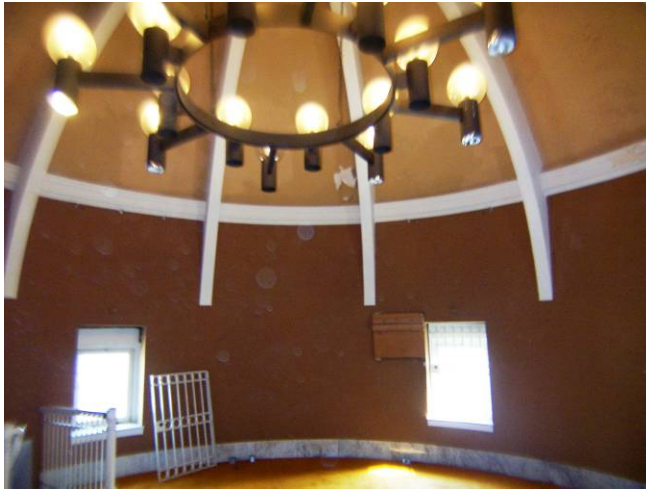
Figure 46. Dome Room (S-20) located at the penthouse level. Source: KVP 2009.

This room (**Figure 46**) is located in the southeast corner of the building, at the top of the Rotunda (X-5). The room is circular in plan, approximately 26'-7" diameter, and has a 19'-3" high domed ceiling. A dogleg cast iron stair with cast iron railing (**C**) provides access to the room from the second floor stair hall (S-10). The floors are covered in carpet and the walls and ceiling are plaster (**NC**) with quadrantal plaster ribbing (**C**). A plaster cornice marks the springline of the dome (**C**). The room has three casement

windows with metal grilles (**VS**). A massive contemporary chandelier hangs from the center of the ceiling and a partially glazed wood door with wood surrounds is located at the east side of the room (**NC**). Due to water intrusion, the ceiling is in poor condition.

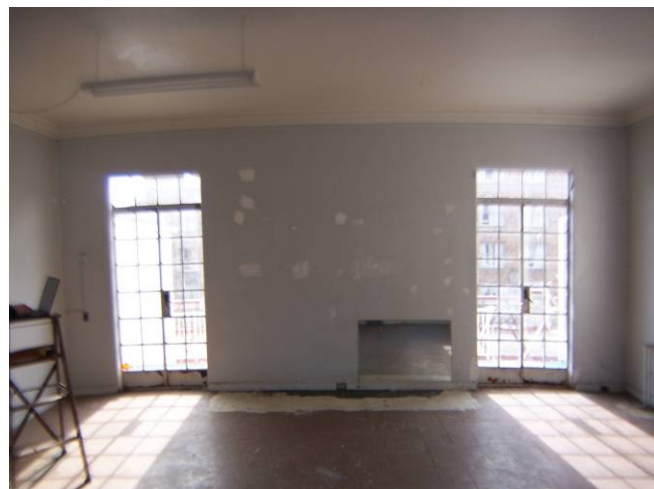
The Penthouse (**Figure 47**) was constructed during the 1935 remodel and is elevated above the roof to preserve the art glass sky light in the second floor waiting reception room. This rectangular plan structure measures approximately 22' x 18'-8". The floors are covered in resilient tile flooring and the walls and ceiling are plaster (**C**). Two multi-light metal French doors with a transom above are located on the south wall, accessing a small deck (**C**). On the opposite wall are two multi-pane

Figure 47. Penthouse (S-15) located on the roof. Source: KVP 2009.

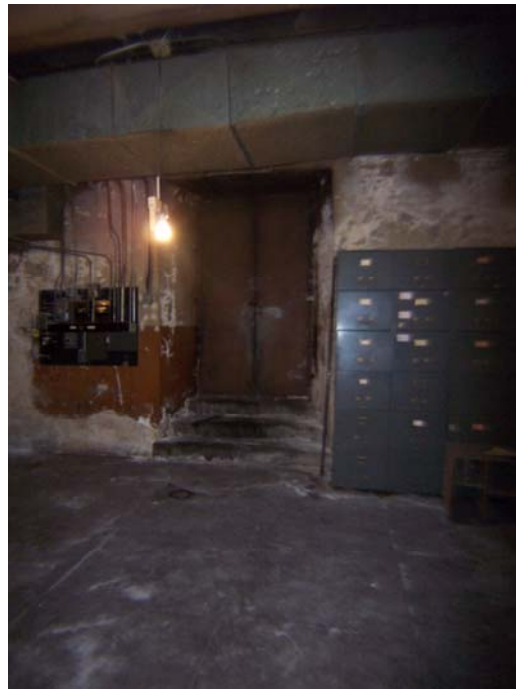
concentrated around the window and door openings (**Figure 48**). The ceilings of these two rooms are also in poor condition. Plaster is spalling or has flaked off, leaving the floor covered with a fine plaster dust. The northeast space (B-6) is in poor condition overall with spalling plaster and standing water on the floor. The west perimeter wall is in fair condition with bubbling plaster at window openings in the Break Room (B-27), Office #1 (B-22), Office #5 (B-16), and Office #3 (B-11).

**Figure 48. Mechanical Room (B-15) in the basement shows signs of bubbling and spalling plaster concentrated around the window and door openings. Source: KVP 2009.**

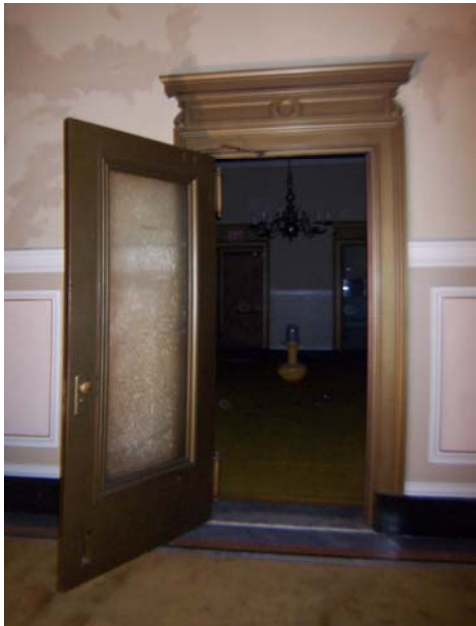
The interior of the building features sheet metal doors with single glazed center panels (**Figure 49**), some with a solid panel and others glazed. Nearly all are formed to imitate wood construction. All doors have metal hardware. The doors also have molded sheet metal surrounds that are surmounted by molded sheet metal cornices. Most doors retain this decorative cap with the exception of doors on the second floor, in a portion of the West Corridor (S-13), Center Office (S-17), and in the Break Room (S-8), all of which have had their cornices removed. Doors, surrounds, and cornices all appear to have been painted either in a bronze or white color. All doors are in excellent condition, with many glazed doors featuring original glass from the 1907-1908 reconstruction. Replacement glass has been installed in some doors, however it closely matches the original and is difficult to differentiate. Several extra doors are stored in the basement Mechanical Room (B-15). Overall, doors and surrounds are in excellent condition.

Figure 49. Typical partially glazed painted sheet metal door with painted sheet metal surround and cornice. Source: KVP 2009.

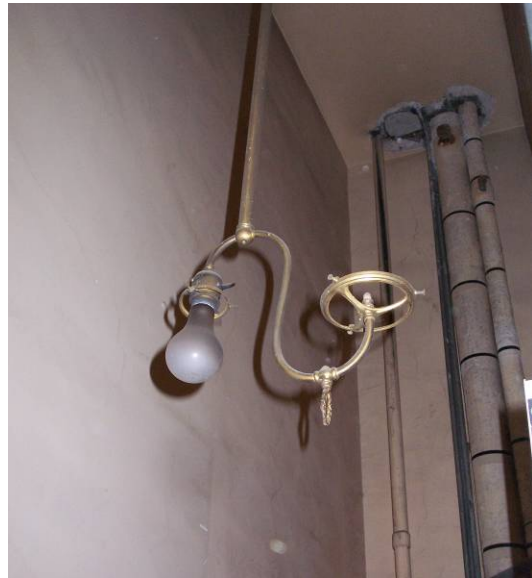
Figure 50. Gas-electric light fixture that appears to date from the 1907 reconstruction. Source: KVP 2009.

Light fixtures in the Banking Hall (F-8), Private Stair (F-16), and in many of the second floor south offices (S-6, S-9 and S-15) appear to be original to the 1907-1908 reconstruction. Electric light fixtures in the basement Document Vault (B-5), first floor Storage-Vault Gallery (F-6) and second floor file storage rooms (S-1 and S-2) appear to have been converted from gas (**Figure 50**). Other original utilitarian fixtures are located in the basement Vault (B-4) and basement Mechanical Room (B-15). Many of the light fixtures throughout the building, especially in the basement, have been altered to fluorescent tube fixtures. Hanging fixtures in the first floor offices south (F-13, F-14, F-15), second floor offices south (S-10, S-16,) and Dome Room (S-20) appear to date from the 1970s or 1980s. Overall, light fixtures are in good to excellent condition.

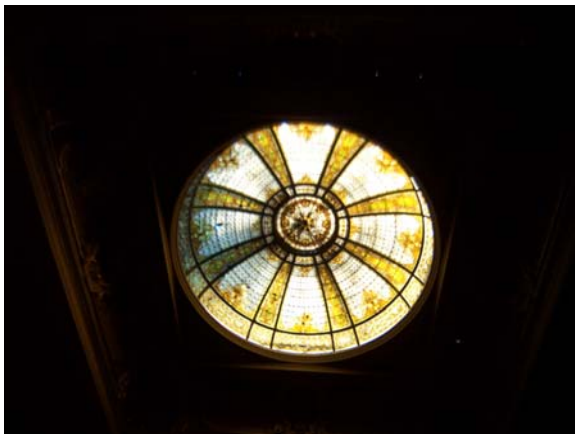
There are five art glass skylights in the building. Two skylights, one round (**Figure 51**) and one elliptical (**Figure 52**), are located in the Banking Hall (F-8). The round skylight appears to be in fair condition, as blue tarps currently cover holes in the glass panes in the north portion of the light. The elliptical skylight appears to be in excellent condition with no broken or missing panes of glass. Skylights on the second floor in the Vestibule (S-10), Waiting/Reception Room (S-9) and Middle Office (S-7) also appear to be in excellent condition. The skylights in the Waiting/Reception Room (S-9) and Middle Office (S-7) appear to have a large buildup of dirt on the exterior. The skylights were restored by Reflections Studios in 1980.

Figure 51. Round art glass skylight located in the Banking Hall (F-8). Source: KVP 2009.

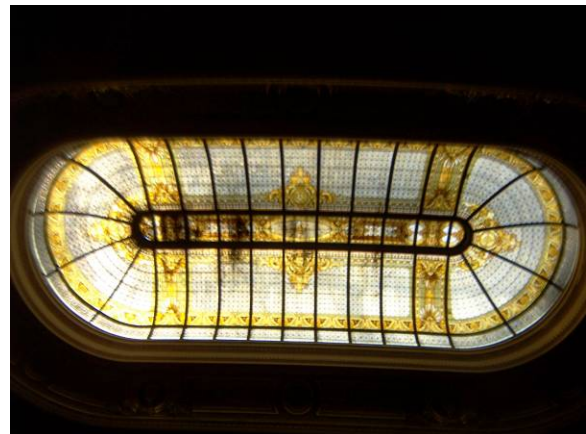
Figure 52. Elliptical art glass skylight located in the Banking Hall (F-8). Source: KVP 2009.

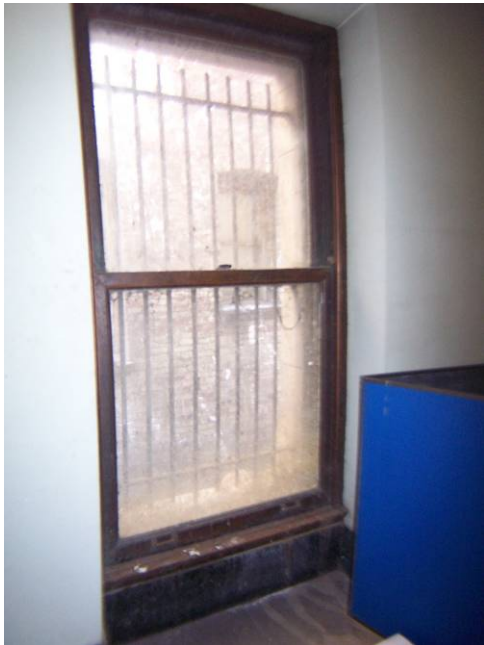
**Figure 53. Typical double-hung, sheet bronze over steel sash window that dates from the 1907 reconstruction.**  
Source: KVP 2009.

Windows in the basement and first floor are covered by metal, roll-down, security shutters and were not visible from the exterior, while windows on the second floor were not covered and were visible. From interior inspection, all window sashes appear to be made of sheet bronze over steel (Figure 53). The windows appear to have been installed when the building was repaired after the 1906 earthquake and fire. The security shutters also date from this time. Post-fire photos show window sash and shutters which look different from those on the building today (See Appendix A, Item 14).

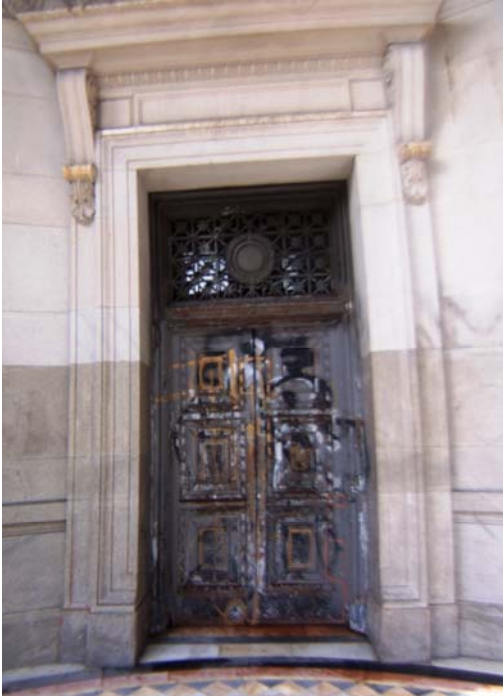
Figure 54. Bronze-plated steel outer door at the private entrance. There are similar doors at the main and Jones Street entrances. Source: KVP 2009.

The primary and secondary (Jones Street) entrances to the Banking Hall have pairs of solid bronze-plated steel outer doors (Figure 54) and paired inner doors of bronze with single glazed panels. Although not entirely visible for inspection, it is assumed that they were installed in 1907, during the period of significance. Like the metal sash windows and metal shutters, they were an important part of the building's "fireproof" design. They are Very Significant and are highly sensitive to change. open

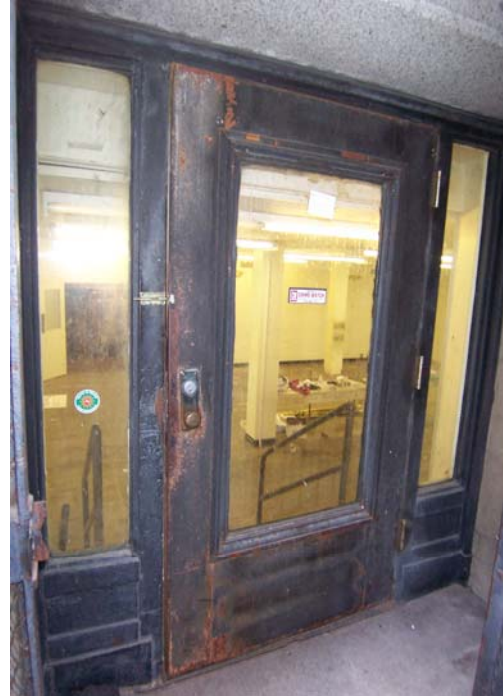
Figure 55. West entrance door, possibly installed in the 1930s. Source: KVP 2009.

Other entrance doors include a metal door with glazing and sidelights located on the west façade (Figure 55), as well as a pair of solid metal doors and a single arched metal door on the east façade, opening into the Jones Street light well. The west doors appear to have been installed in the 1930s, and those on the east in 1907. All fall within the period of significance, but because they are on secondary façades, they are of secondary importance. They are Contributing elements and are therefore sensitive to change.

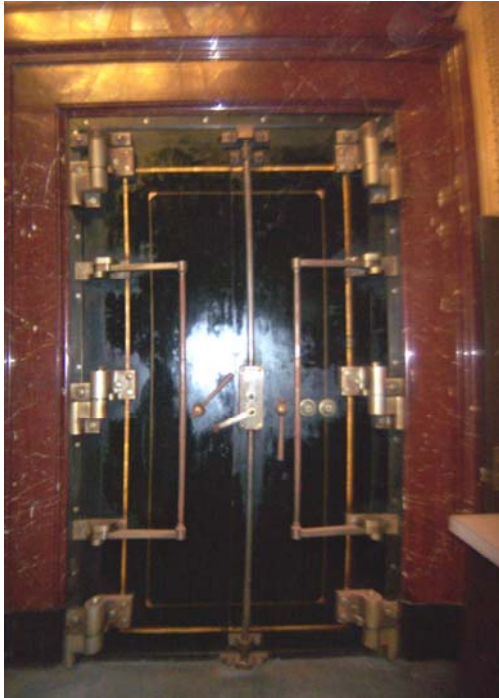
Figure 56. Exterior of vault doors(F-5) in the Banking Hall (F-8). Source: KVP 2009.

primary entrance and marble wainscoting at the secondary entrance. The steel vault doors (**Figures 56 and 57**) and the marble surround with the bank's name are highly decorated and the focal point of the room. These features clearly indicate that the Banking Hall was constructed to convey the Hibernia Bank's wealth, security, and stability to the public.

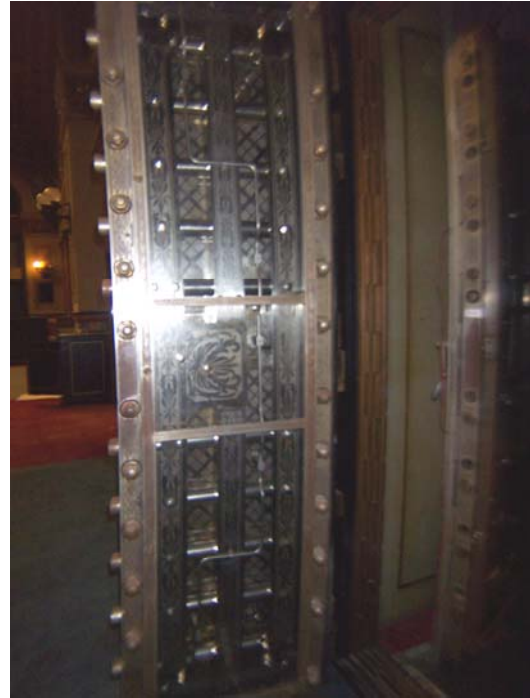
Figure 57. Interior of vault doors (F-4) in the Banking Hall (F-8). Source: KVP 2009.

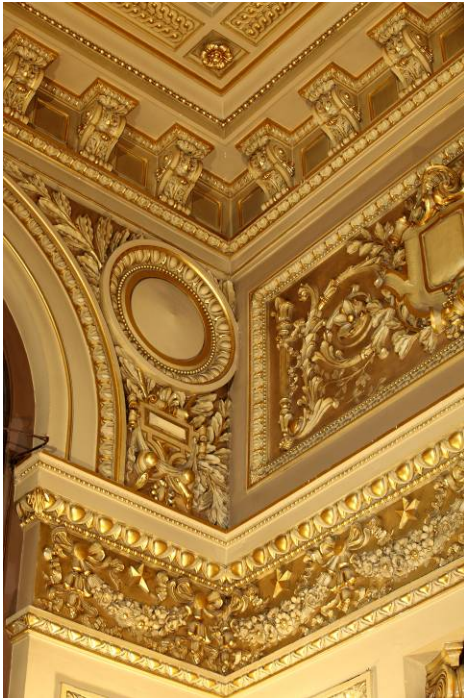
Figure 58. Detail of plaster decoration in Banking Hall (F-8).  
Source: KVP 2009.

As mentioned above, the Hibernia Bank went to great lengths to fireproof the building. Another example of this effort is the use plaster (**Figure 58**) and marble (**Figure 59**) decoration instead of wood. The plaster and marble and decoration are Very Significant and therefore very sensitive to change.

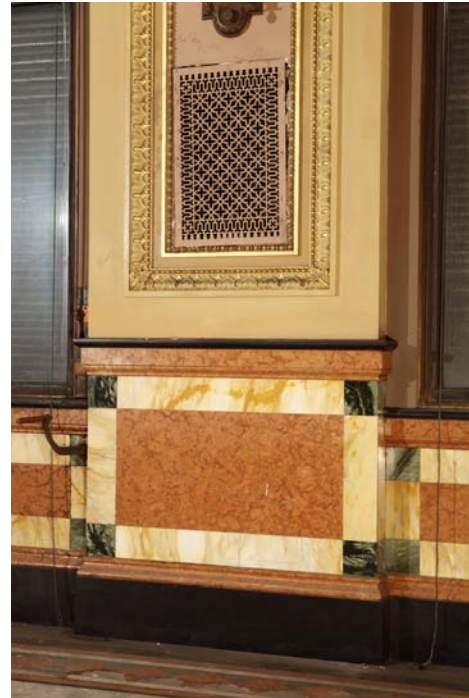
Figure 59. Detail of marble wainscoting in Banking Hall (F-8).  
Source: KVP 2009.

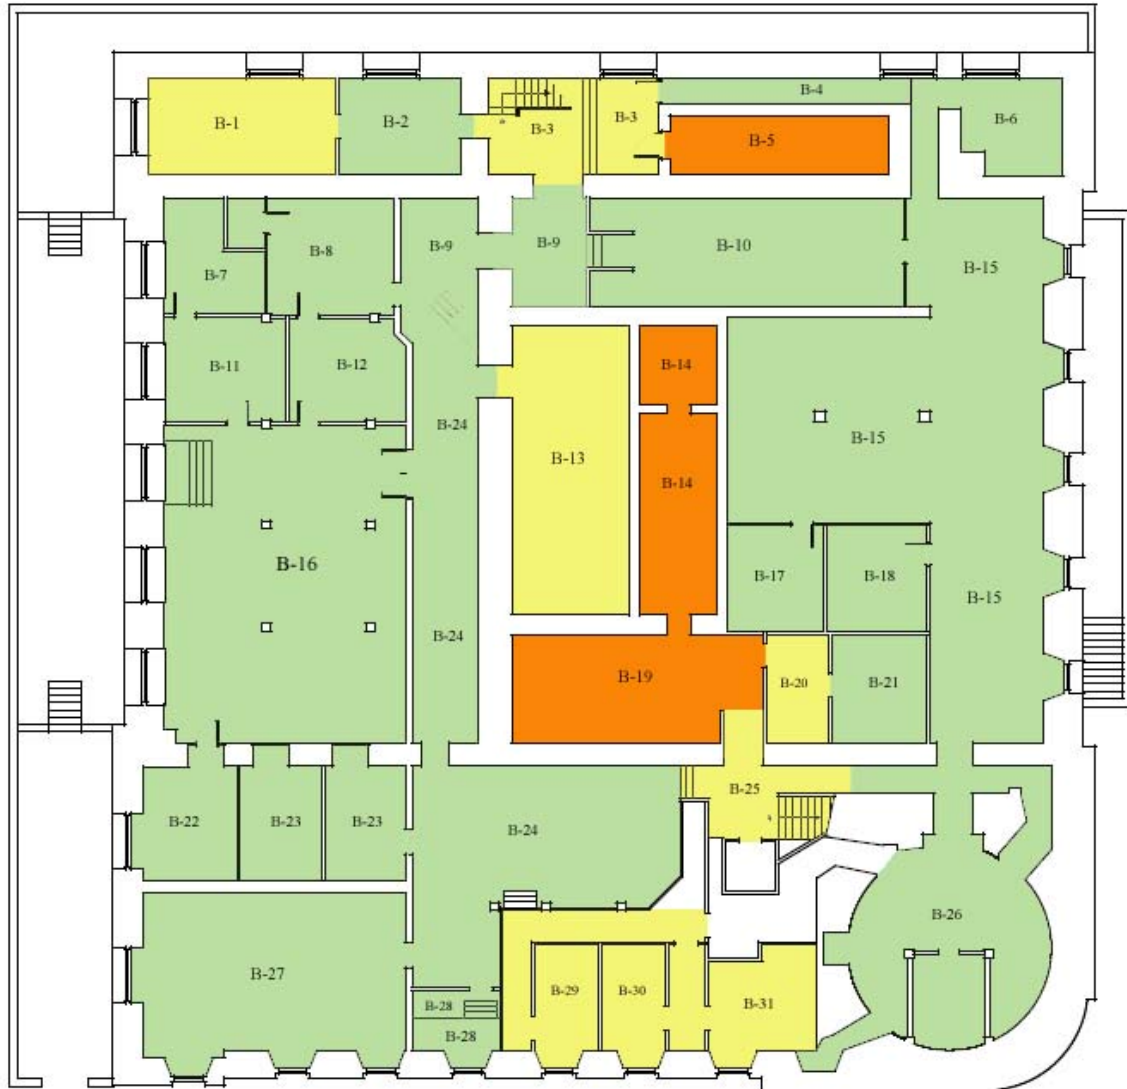
Basement

Very Significant – RED  
Significant – ORANGE  
Contributing - YELLOW  
Non-Contributing – GREEN

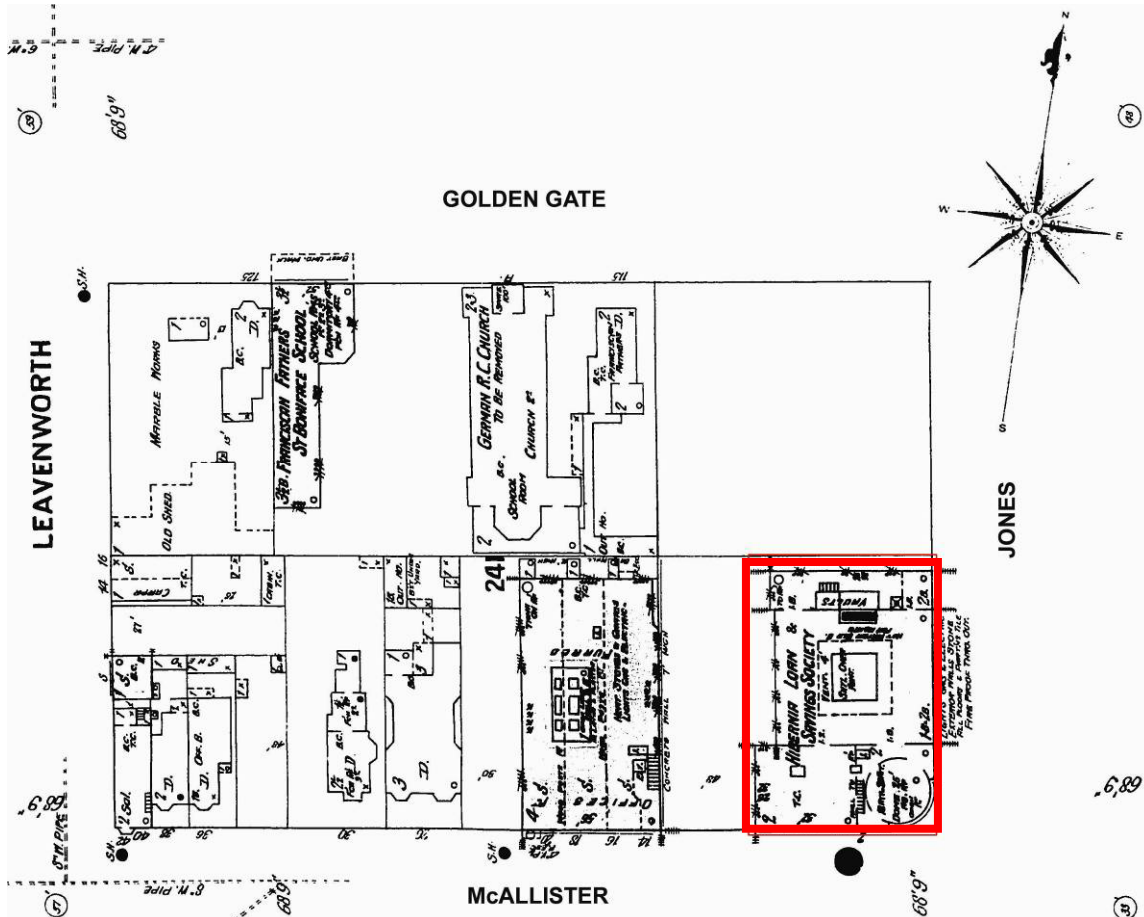
Item 1. Sanborn Fire Insurance Map, 1899. Hibernia Savings and Loan Society building is outlined in red. Note that the building does not cover the entire lot. The map notes that the building has “gas and electric lights, exterior stone walls and all floors and partitions tile, fire proof throughout”.

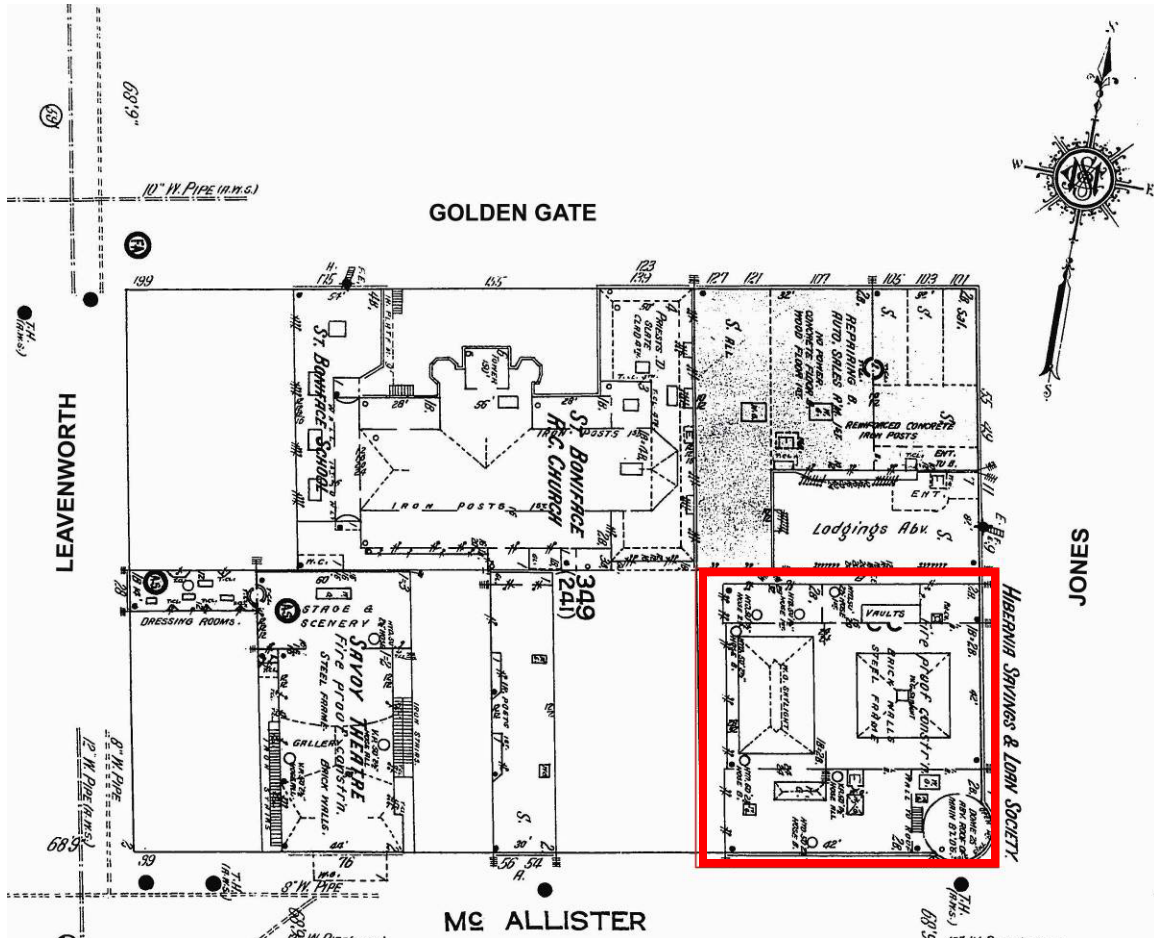
Item 2. Sanborn Fire Insurance Map, 1913. Hibernia Savings and Loan Society building is outlined in red. Note that the building has been enlarged. The map notes that the building is fire proof with brick walls and a steel frame.

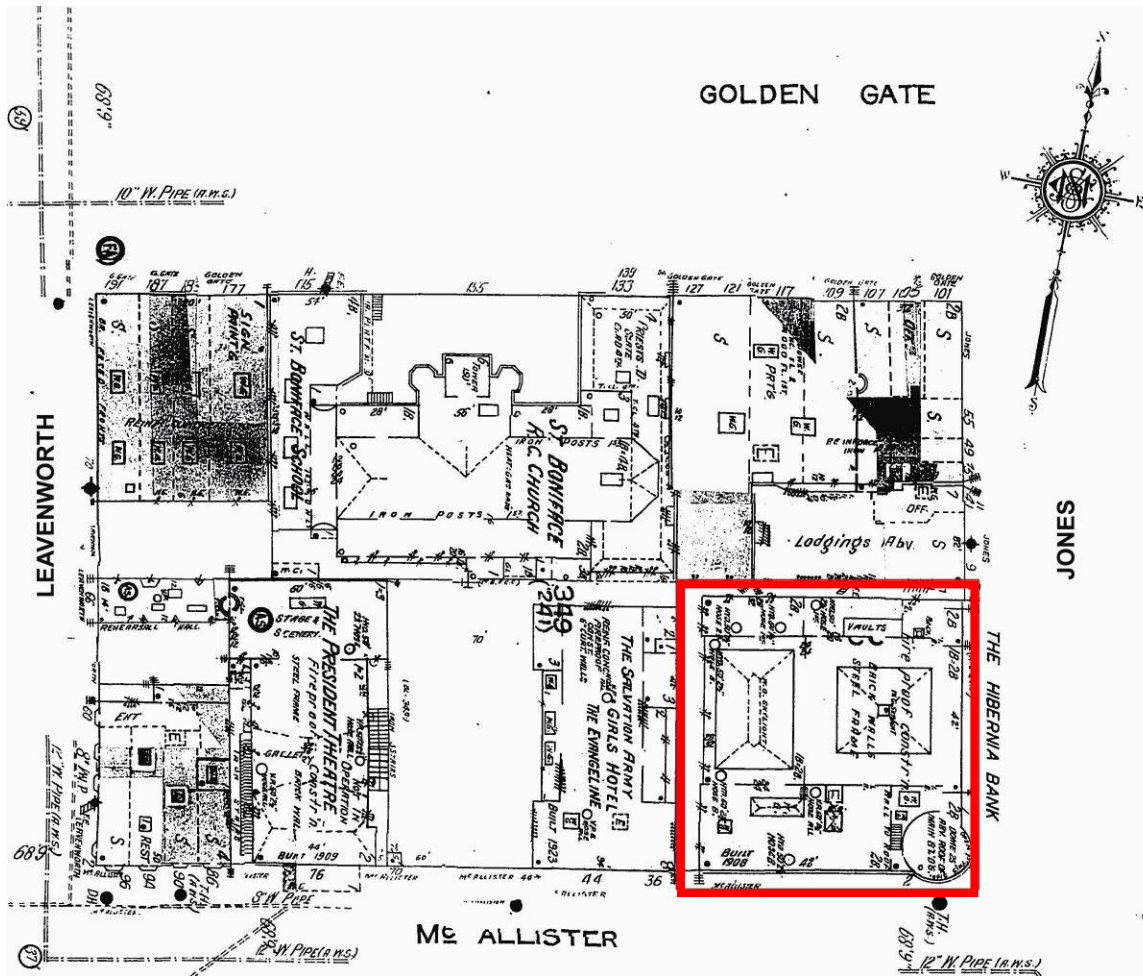
Item 3. Sanborn Fire Insurance Map, 1950. Hibernia Savings and Loan Society building is outlined in red. The map notes that the building is fire proof with brick walls and a steel frame.

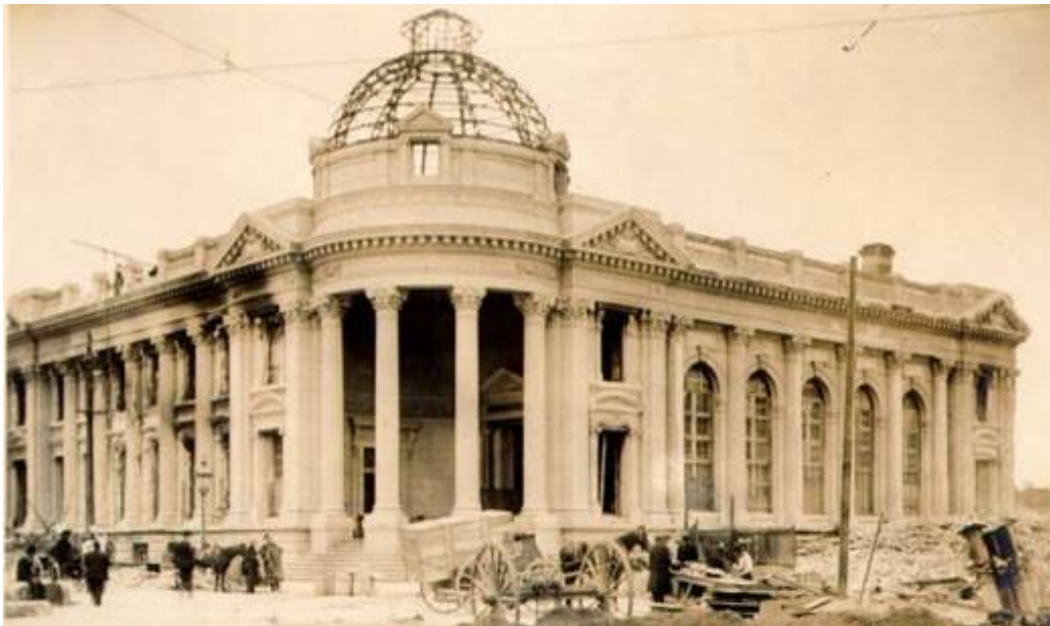
Item 13. Hibernia Bank Building, 1906. Note the window sash at right is different from the current window sash. Source: San Francisco History Center, San Francisco Public Library.

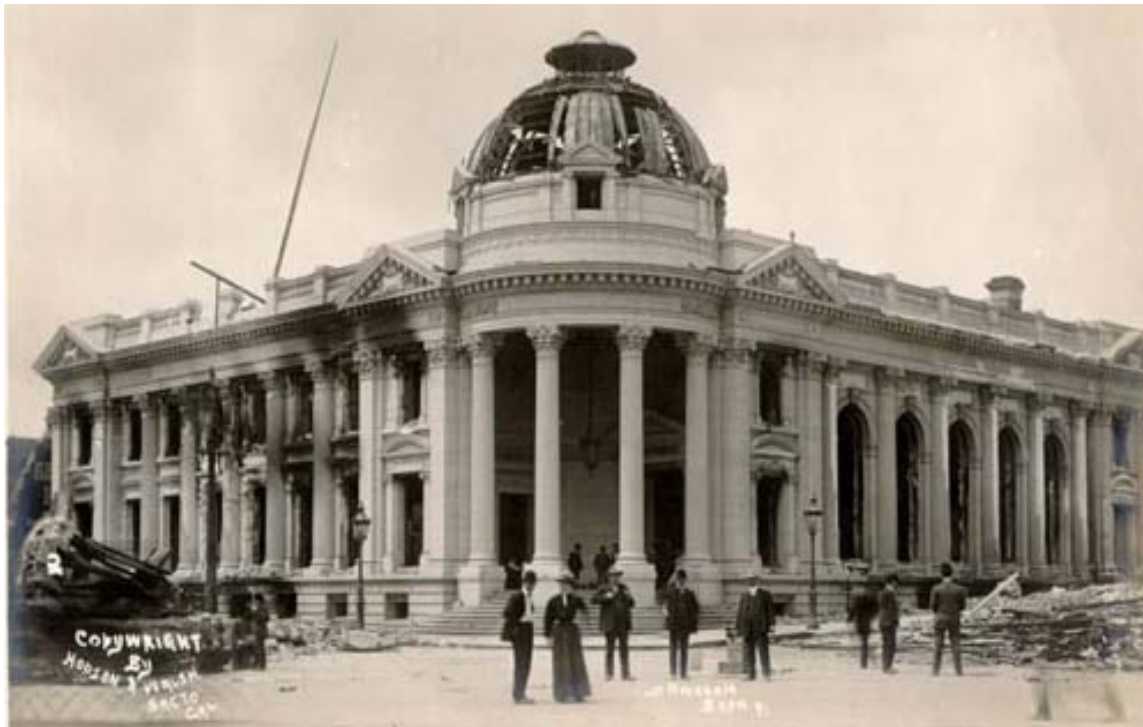
Item 17. Hibernia Bank Building, 1906. Note smoke damage at left dome beginning to be reconstructed. Source: San Francisco History Center, San Francisco Public Library.

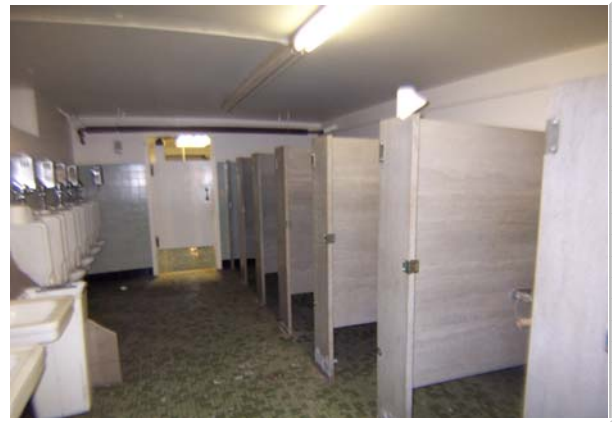
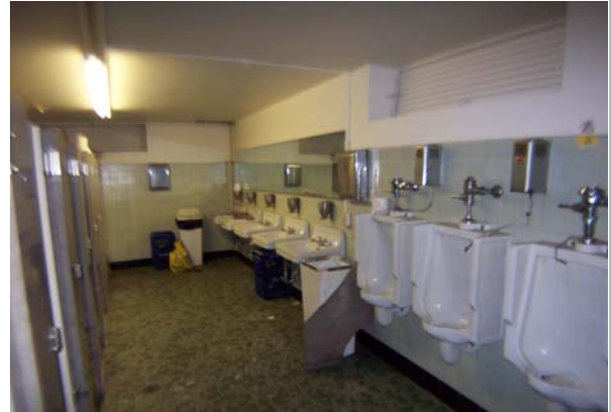
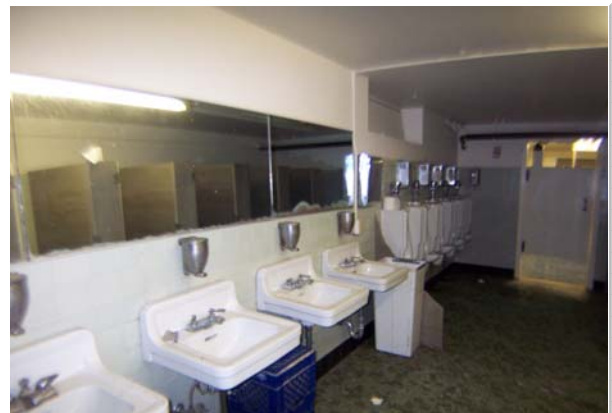
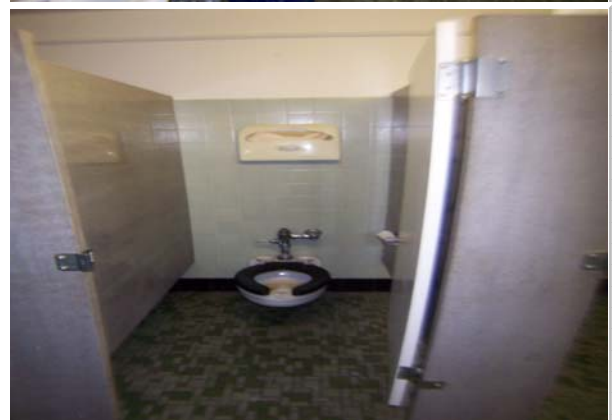
COND SIG	
Space Number	B-1	G	C
Space Name	Toilet Room		
Space Dimensions	23'2"x11' 7'8" ceiling		
N Wall Finish	ceramic tile with concrete above	G	C
E Wall Finish	drywall partition	F	NC
S Wall Finish	ceramic tile with concrete above	G	C
W Wall Finish	ceramic tile with concrete above	G	C
Floor Finish	ceramic tile	G	C
Ceiling Finish	plaster	F	C
Window Types	awning metal shutter	G	VS
Window Hardware	metal	G	VS
Window Trim	metal	G	VS
Door Type	wood swinging	P	NC
Door Hardware	brass	F	NC
Door Frame	wood	F	NC
Door Threshold	marble,	G	C
Trim base & Cornice	none		
Millwork bookcases	none		
Millwork paneling	none		
Millwork wainscot	none		
Skylights	none		
Fireplaces	none		
Electrical lighting	fluorescent	F	NC
Electrical switches	modern	F	NC
Electrical outlets	modern	F	NC
Plumbing lavatories	urinals and sinks on west wall; toilets on	F	C
Plumbing toilets	porcelain	F	C
Plumbing urinals	porcelain	F	C
Plumbing accessories	modern chrome	F	C

Plumbing partitions	marble partitions with wood doors	G	C
Fire protection	none		
Mechanical grilles	none		
Mechanical diffusers	none		
Visible piping or ducts	gas radiator	F	NC
Signage	none		
Miscellaneous	none

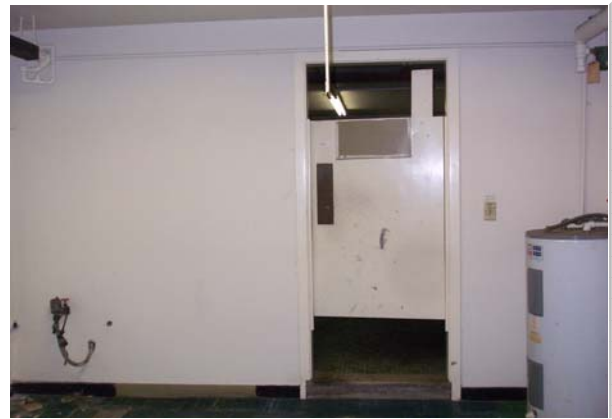
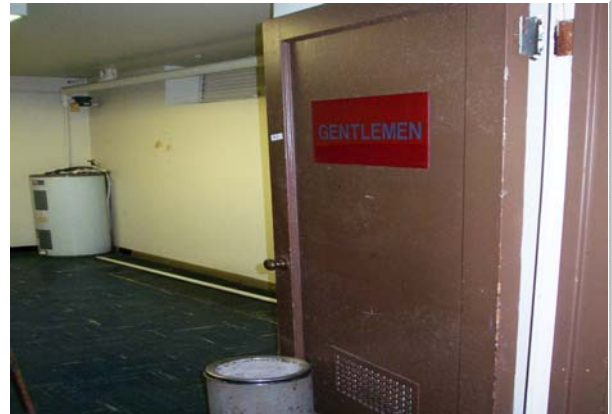
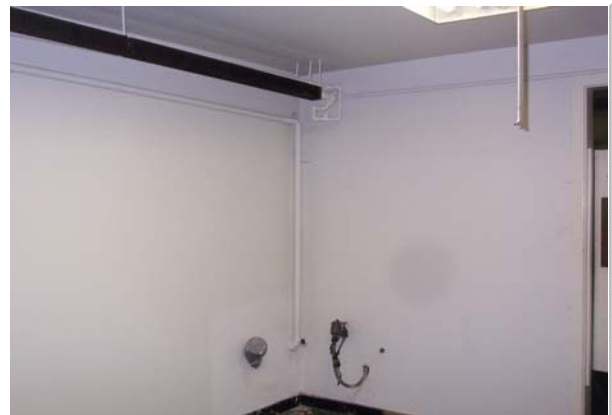
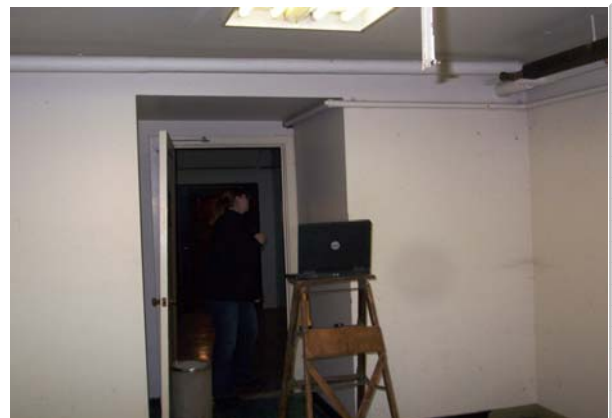
COND SIG	
Space Number	B-2	F	NC
Space Name	Toilet Ante Room		
Space Dimensions	12'x15' 8'ceiling		
N Wall Finish	concrete and plaster	F	C
E Wall Finish	concrete and plaster	F	NC
S Wall Finish	concrete and plaster	F	NC
W Wall Finish	partition	F	NC
Floor Finish	resilient tile	E	C
Ceiling Finish	plaster	F	NC
Window Types	awning with metal shutter	G	VS
Window Hardware	metal	G	VS
Window Trim	metal	G	VS
Door Type	wood	F	C
Door Hardware	metal	F	C
Door Frame	metal	F	C
Door Threshold	concrete	F	C
Trim base & Cornice	none		
Millwork bookcases	none		
Millwork paneling	none		
Millwork wainscot	none		
Skylights	none		
Fireplaces	none		
Electrical lighting	fluorescent	F	NC
Electrical switches	modern	F	NC
Electrical outlets	none		
Plumbing lavatories	waterheater	F	NC
Plumbing toilets	none		
Plumbing urinals	none		
Plumbing accessories	none		
Plumbing partitions	none		
Fire protection	none		
Mechanical grilles	none		
Mechanical diffusers	none

Visible piping or ducts	gas ceiling radiator and water and electrical	F	NC
Signage	none		
Miscellaneous	none

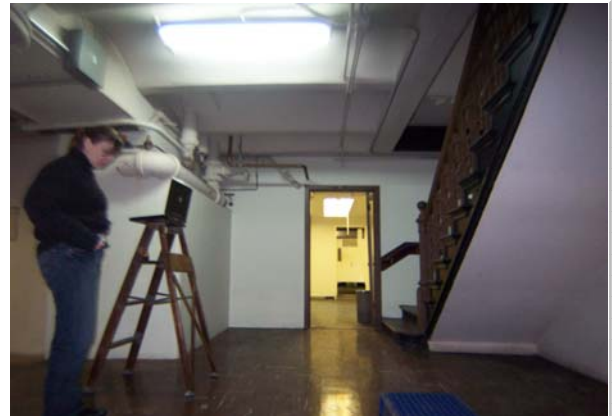
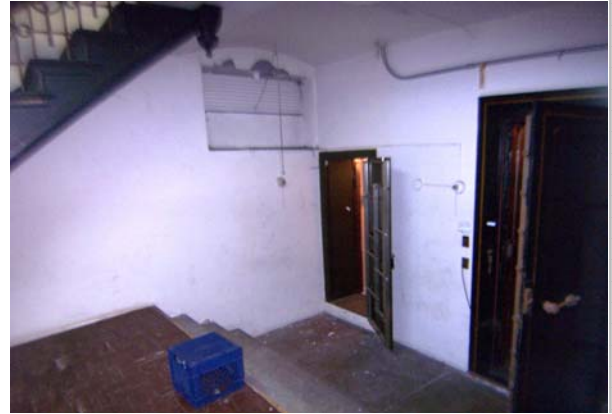
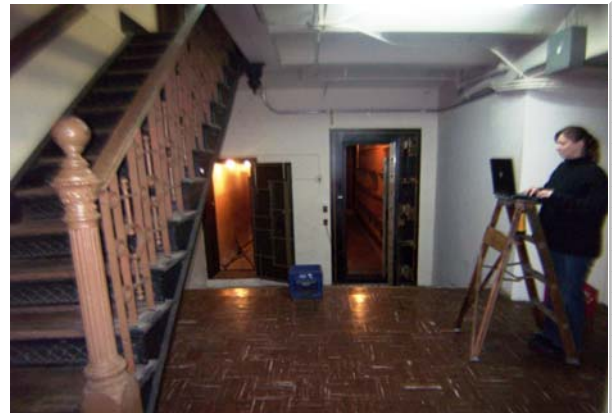
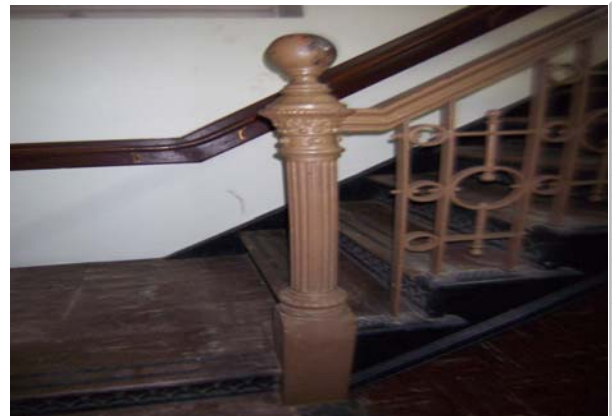
COND SIG	
Space Number	B-3	G	C
Space Name	North stairs		
Space Dimensions	12'5"x21' 8'8" ceiling		
N Wall Finish	masonry and plaster	F	C
E Wall Finish	concrete, plaster, steel vault doors	G	C
S Wall Finish	concrete and plaster	G	C
W Wall Finish	concrete	G	C
Floor Finish	resilient tile	G	C
Ceiling Finish	concrete steel beam	G	C
Window Types	metal awning metal shutters cover	F	VS
Window Hardware	metal	F	VS
Window Trim	metal	G	VS
Door Type	vaults, wood restroom door	F	S/C
Door Hardware	metal	F	C
Door Frame	metal	F	C
Door Threshold	concrete	G	C
Trim base & Cornice	none		
Millwork bookcases	none		
Millwork paneling	none		
Millwork wainscot	none		
Skylights	none		
Fireplaces	none		
Electrical lighting	fluorescent	F	NC
Electrical switches	pushbutton brass plates	F	C
Electrical outlets	modern	F	NC
Plumbing lavatories	none		
Plumbing toilets	none		
Plumbing urinals	none		
Plumbing accessories	none		
Plumbing partitions	none

Fire protection	none		
Mechanical grilles	none		
Mechanical diffusers	none		
Visible piping or ducts	piping gas and air ducts	F	NC
Signage	none		
Miscellaneous	decorative iron railing for stairs	G	S

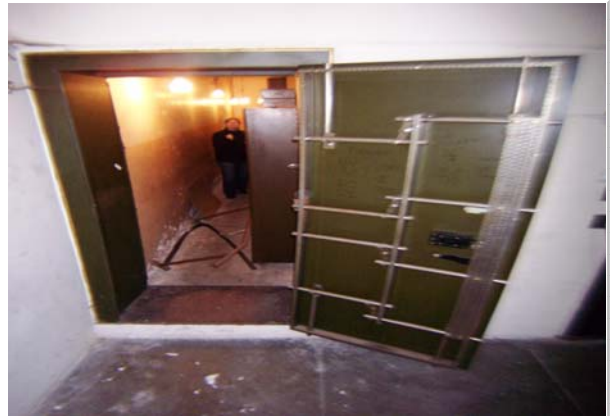
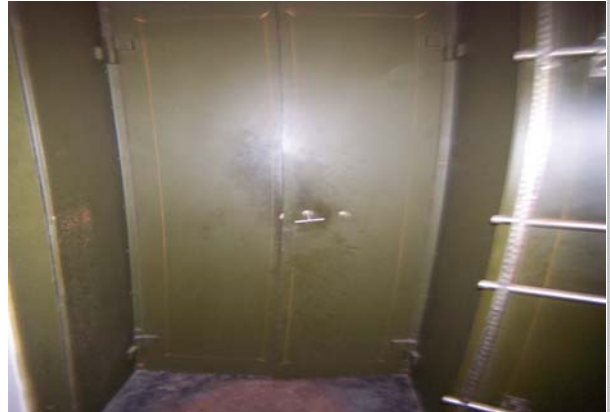
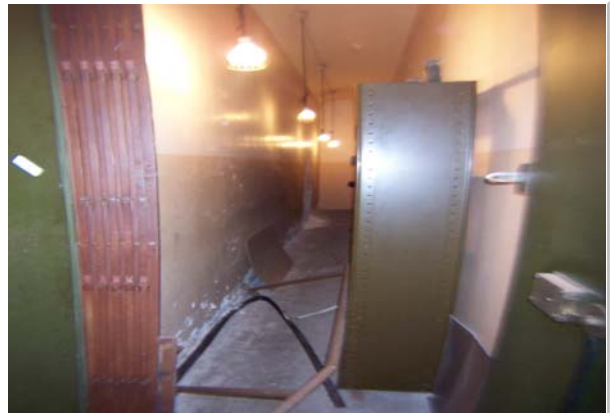
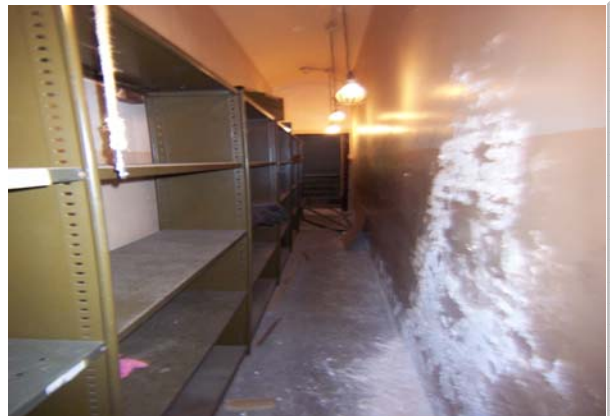
COND SIG	
Space Number	B-4	P	NC
Space Name	Vault Gallery		
Space Dimensions	26'11" x 3'2"11'2"ceiling		
N Wall Finish	concrete and plaster	P	NC
E Wall Finish	concrete and plaster	F	NC
S Wall Finish	concrete and plaster	F	NC
W Wall Finish	concrete and plaster	F	NC
Floor Finish	concrete	E	C
Ceiling Finish	concrete and plaster	F	C
Window Types	none		
Window Hardware	none		
Window Trim	none		
Door Type	steel (2) and gate	F	NC
Door Hardware	steel	F	NC
Door Frame	steel	F	NC
Door Threshold	steel	F	NC
Trim base & Cornice	none		
Millwork bookcases	none		
Millwork paneling	none		
Millwork wainscot	none		
Skylights	none		
Fireplaces	none		
Electrical lighting	hanging pendant with wire shade - historic	F	C
Electrical switches	modern	F	NC
Electrical outlets	none		
Plumbing lavatories	none		
Plumbing toilets	none		
Plumbing urinals	none		
Plumbing accessories	none		
Plumbing partitions	none		
Fire protection	none		
Mechanical grilles	none

Mechanical diffusers	none		
Visible piping or ducts	none		
Signage	none		
Miscellaneous	significant water damage on north wall

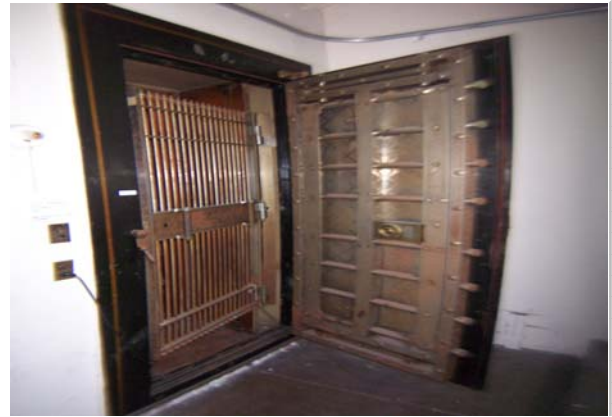
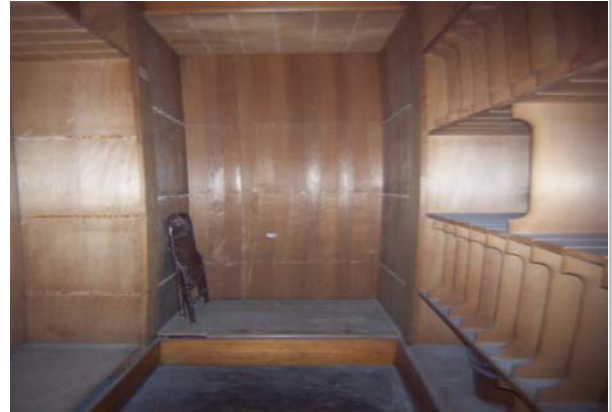
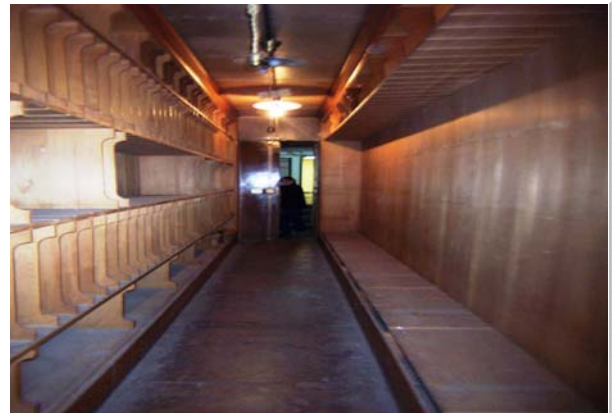
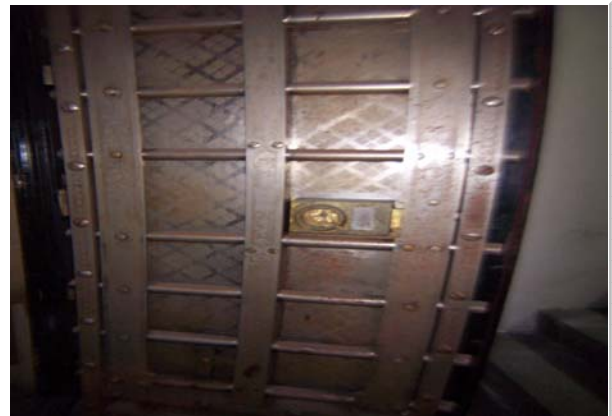
COND SIG	
Space Number	B-5	G	S
Space Name	Document vault		
Space Dimensions	6'6"x26' 9'10" ceiling		
N Wall Finish	cedar shelving	G	S
E Wall Finish	cedar planks	G	S
S Wall Finish	cedar shelving	G	S
W Wall Finish	steel	G	S
Floor Finish	steel	G	S
Ceiling Finish	steel	G	S
Window Types	none		
Window Hardware	none		
Window Trim	none		
Door Type	vault (2 doors) and gate	F	S
Door Hardware	steel	F	S
Door Frame	steel	F	S
Door Threshold	steel	F	S
Trim base & Cornice	cedar	G	S
Millwork bookcases	cedar	G	S
Millwork paneling	cedar	G	S
Millwork wainscot	none		
Skylights	none		
Fireplaces	none		
Electrical lighting	hanging lights - likely historic	F	C
Electrical switches	none		
Electrical outlets	metal plate	F	C
Plumbing lavatories	none		
Plumbing toilets	none		
Plumbing urinals	none		
Plumbing accessories	none		
Plumbing partitions	none		
Fire protection	none		
Mechanical grilles	none		
Mechanical diffusers	none		
Visible piping or ducts	none

Signage	none		
Miscellaneous	original vault - significant	G	S

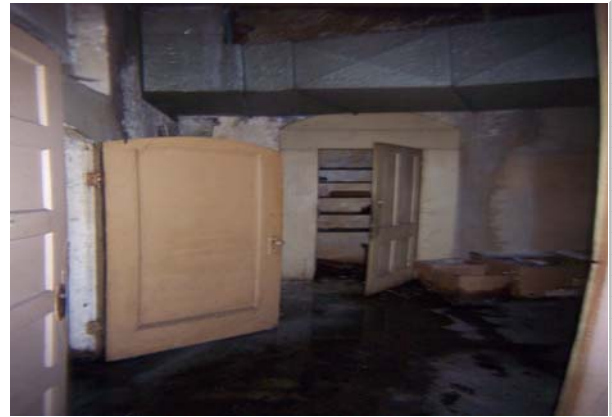
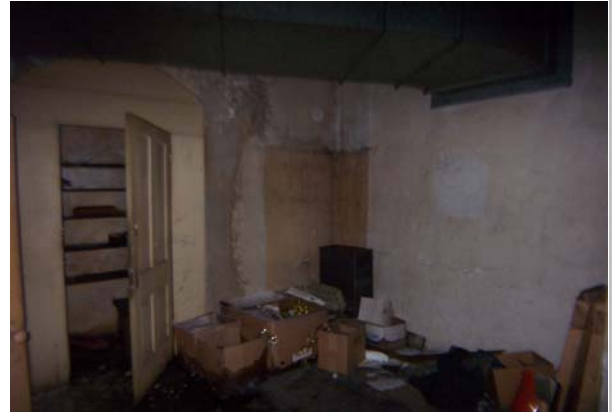
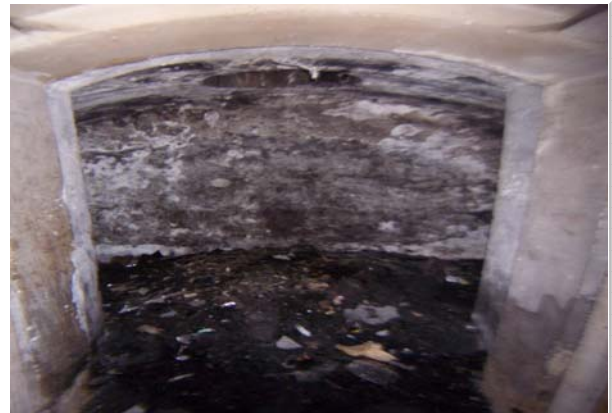
COND SIG	
Space Number	B-6	P	NC
Space Name	NE space, basement		
Space Dimensions			
N Wall Finish	concrete	P	NC
E Wall Finish	concrete	P	NC
S Wall Finish	concrete	P	NC
W Wall Finish	concrete	P	NC
Floor Finish	concrete	E	C
Ceiling Finish	steel beams and plaster	P	NC
Window Types	opening for coal chute	P	NC
Window Hardware	none		
Window Trim	metal	F	C
Door Type	paneled wood door to office space and one	F	NC
Door Hardware	metal		
Door Frame	wood	F	NC
Door Threshold	concrete	F	
Trim base & Cornice	none		
Millwork bookcases	none		
Millwork paneling	none		
Millwork wainscot	none		
Skylights	none		
Fireplaces	none		
Electrical lighting	hanging bulbs	F	C
Electrical switches	modern switches 1950s	F	NC
Electrical outlets	modern switches 1950s	F	NC
Plumbing lavatories	none		
Plumbing toilets	none		
Plumbing urinals	none		
Plumbing accessories	none		
Plumbing partitions	none		
Fire protection	none		
Mechanical grilles	none		
Mechanical diffusers	none

Visible piping or ducts	large duct		NC
Signage	none		
Miscellaneous	coal chute is brick lined

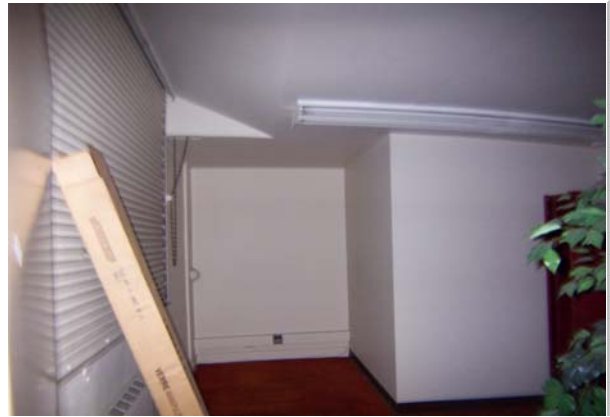
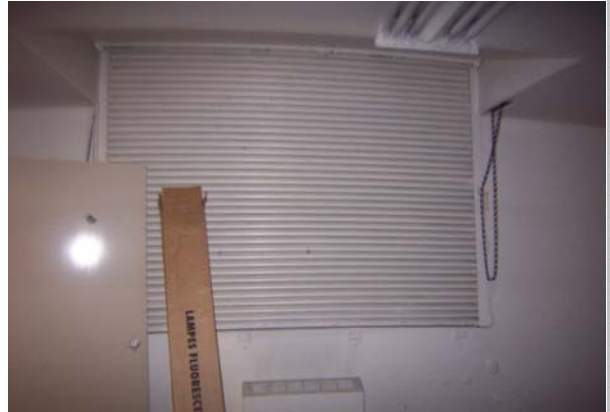
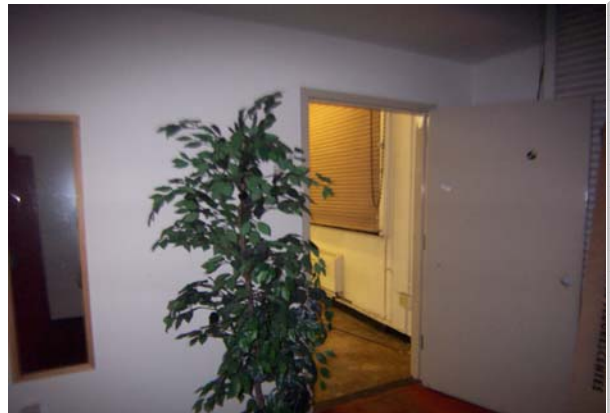
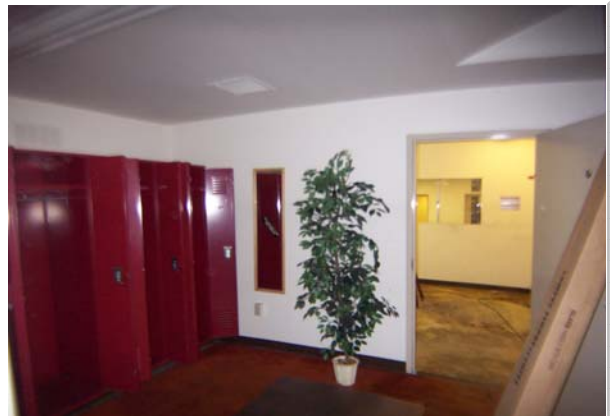
COND SIG	
Space Number	B-7	G	NC
Space Name	Office #1 basement		
Space Dimensions	12'8"x12'11" 8' ceiling		
N Wall Finish	sheet rock partition, rubber baseboard and	F	NC
E Wall Finish	sheet rock partition, rubber baseboard and	F	NC
S Wall Finish	sheet rock partition, rubber baseboard and	F	NC
W Wall Finish	masonry and plaster	P	NC
Floor Finish	carpet	P	NC
Ceiling Finish	dropped, acoustic tiles	F	NC
Window Types	1/1 double hung metal sash with shutter	F	VS
Window Hardware	metal	F	VS
Window Trim	metal	F	VS
Door Type	metal	F	NC
Door Hardware	modern	F	NC
Door Frame	metal	F	NC
Door Threshold	metal	F	NC
Trim base & Cornice	none		
Millwork bookcases	none		
Millwork paneling	none		
Millwork wainscot	none		
Skylights	none		
Fireplaces	none		
Electrical lighting	fluorescent	F	NC
Electrical switches	none		
Electrical outlets	modern	F	NC
Plumbing lavatories	none		
Plumbing toilets	none		
Plumbing urinals	none		
Plumbing accessories	none

Plumbing partitions	none		
Fire protection	none		
Mechanical grilles	modern		
Mechanical diffusers	none		
Visible piping or ducts	gas radiator west wall		
Signage	none		
Miscellaneous	west wall and window and north wall significant
