# SAN FRANCISCO PLANNING DEPARTMENT

**MEMO**

**RE:** Review and Comment for 1 Jones Street (former Hibernia Bank)  
Case No. 2011.0617EA

**HIBERNIA BANK BUILDING**

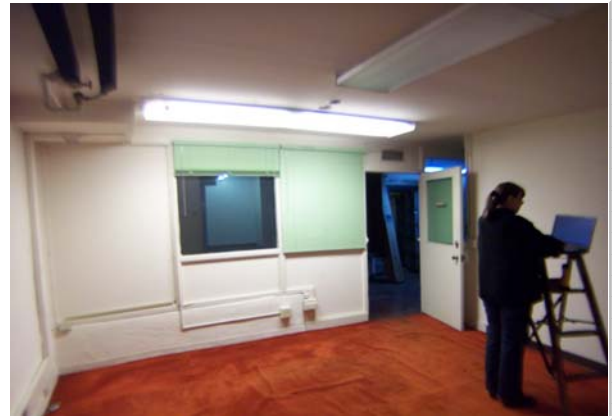
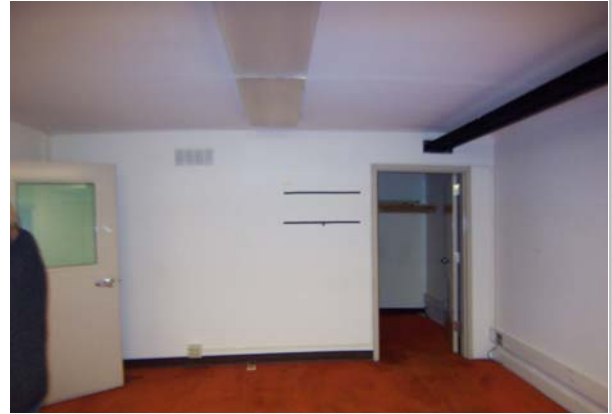
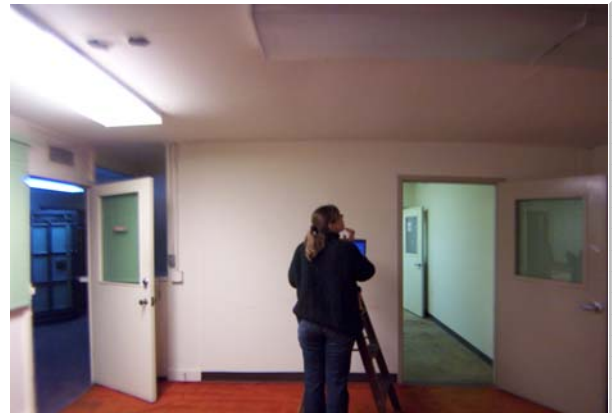
COND SIG	
Space Number	B-8	E	NC
Space Name	Office #2 Basement		
Space Dimensions	14'4"x15'9" 8' ceiling		
N Wall Finish	concrete plaster	F	C
E Wall Finish	sheetrock partition rubber baseboard partial	F	NC
S Wall Finish	concrete column, sheetrock	F	C/N
W Wall Finish	sheetrock partition rubber baseboard	F	NC
Floor Finish	carpet	P	NC
Ceiling Finish	dropped ceiling with thin membrane	P	NC
Window Types	wireglass interior fixed wood sash	F	C
Window Hardware	none		
Window Trim	wood	F	C
Door Type	metal and wireglass	F	NC
Door Hardware	modern and metal older	F	NC
Door Frame	metal	F	NC
Door Threshold	metal	F	NC
Trim base & Cornice	none		
Millwork bookcases	none		
Millwork paneling	none		
Millwork wainscot	none		
Skylights	none		
Fireplaces	none		
Electrical lighting	fluorscent	F	NC
Electrical switches	modern	F	NC
Electrical outlets	modern	F	NC
Plumbing lavatories	none		
Plumbing toilets	none		
Plumbing urinals	none		
Plumbing accessories	none

Plumbing partitions	none		
Fire protection	none		
Mechanical grilles	modern	F	NC
Mechanical diffusers	none		
Visible piping or ducts	ceiling radiator	F	NC
Signage			
Miscellaneous	closet and passthru for objects not people

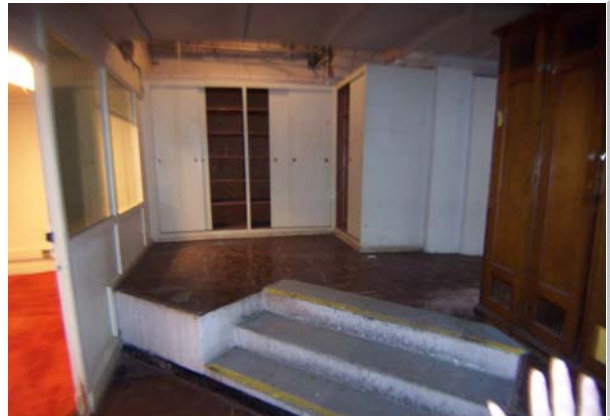
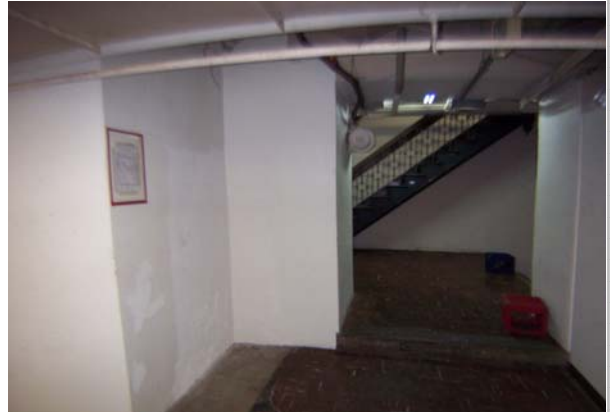
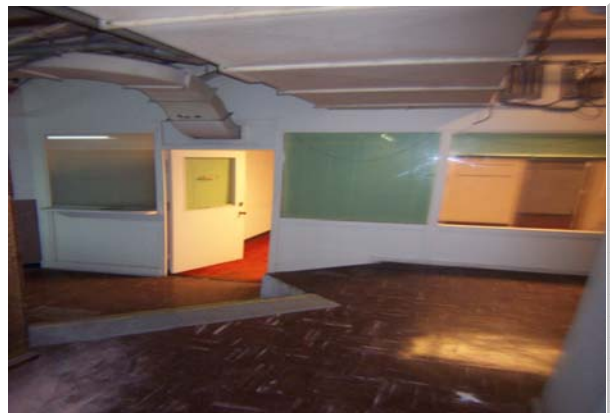
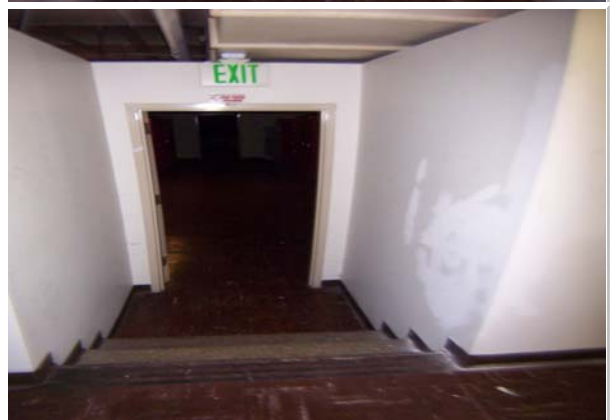
COND SIG	
Space Number	B-9	F	NC
Space Name	Steps & landing		
Space Dimensions	partial dimensions 9'3"x13'3" 9'3" ceiling		
N Wall Finish	concrete plaster has cabinets	F	NC
E Wall Finish	wire glass and wood partition	F	NC
S Wall Finish	concrete plaster	F	NC
W Wall Finish	sheetrock partition	F	NC
Floor Finish	concrete and mastic tile	E	C
Ceiling Finish	concrete, steel beams, plaster	F	C
Window Types	none		
Window Hardware	none		
Window Trim	none		
Door Type	metal	F	NC
Door Hardware	metal and older metal knob	F	NC
Door Frame	metal	F	NC
Door Threshold	concrete	F	NC
Trim base & Cornice	none		
Millwork bookcases	none		
Millwork paneling	none		
Millwork wainscot	none		
Skylights	none		
Fireplaces	none		
Electrical lighting	fluourescent	F	NC
Electrical switches	none		
Electrical outlets	none		
Plumbing lavatories	none		
Plumbing toilets	none		
Plumbing urinals	none		
Plumbing accessories	none		
Plumbing partitions	none		
Fire protection	none

Mechanical grilles	none		
Mechanical diffusers	none		
Visible piping or ducts	air ducts conduit and gas lines	F	NC
Signage	none		
Miscellaneous	concrete steps concrete columns vaulted ceilings with beams

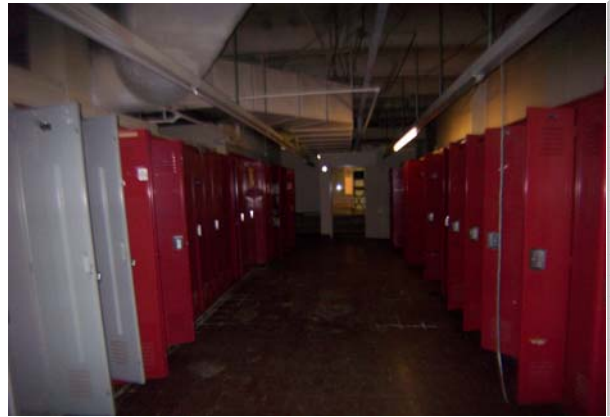
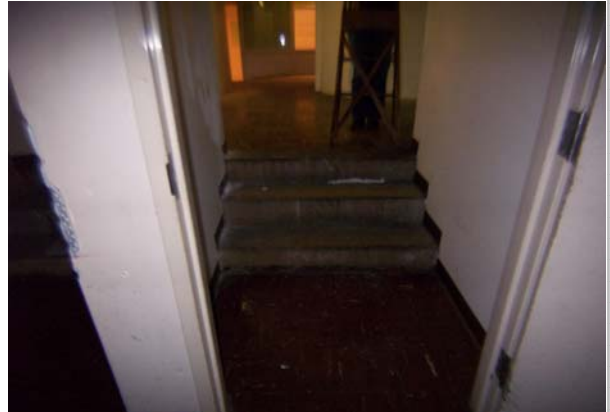
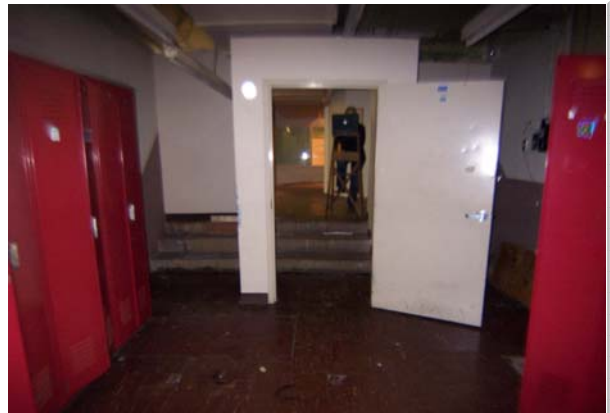
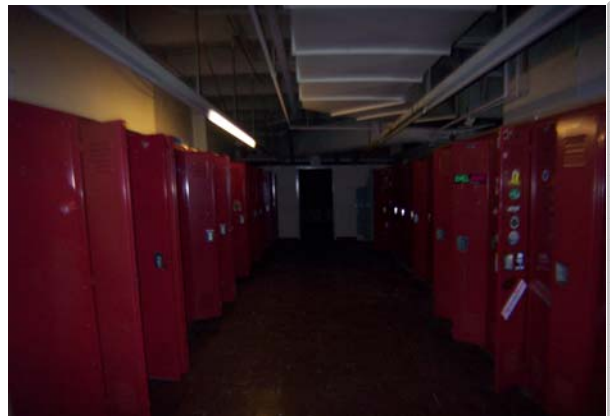
COND SIG	
Space Number	B-10	F	NC
Space Name	Locker Room		
Space Dimensions	13'4"x34' 11'3" ceiling		
N Wall Finish	partition and concrete	F	NC
E Wall Finish	partition	F	NC
S Wall Finish	partition and concrete	F	NC
W Wall Finish	partition	F	NC
Floor Finish	concrete and resilient tile	E	C
Ceiling Finish	steel beams and concrete	F	C
Window Types	none		
Window Hardware	none		
Window Trim	none		
Door Type	metal	F	NC
Door Hardware	modern	F	NC
Door Frame	metal	F	NC
Door Threshold	none		
Trim base & Cornice	none		
Millwork bookcases	none		
Millwork paneling	none		
Millwork wainscot	none		
Skylights	none		
Fireplaces	none		
Electrical lighting	fluorescent	F	NC
Electrical switches	none		
Electrical outlets	modern	F	NC
Plumbing lavatories	none		
Plumbing toilets	none		
Plumbing urinals	none		
Plumbing accessories	none		
Plumbing partitions	none		
Fire protection	none		
Mechanical grilles	none		
Mechanical diffusers	none		
Visible piping or ducts	air ducts

Signage	none		
Miscellaneous	breaker panel north wall; lockers line n/s wall granite steps all the way across opening.		NC

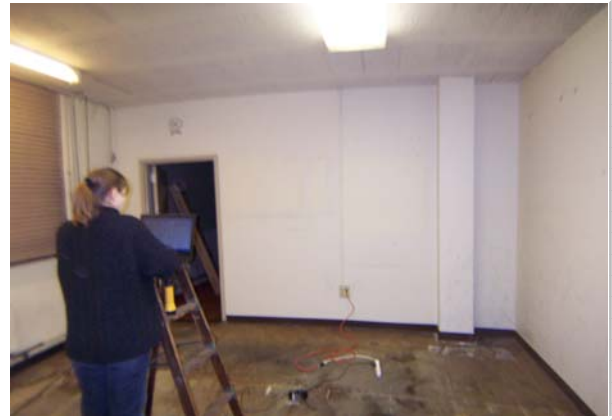
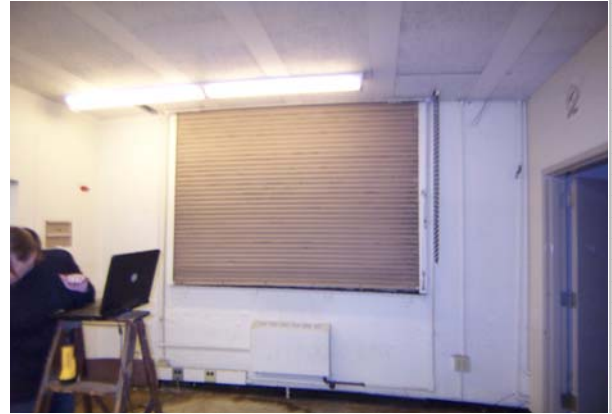
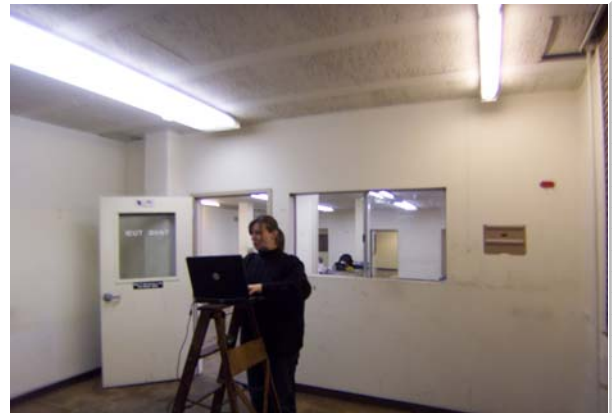
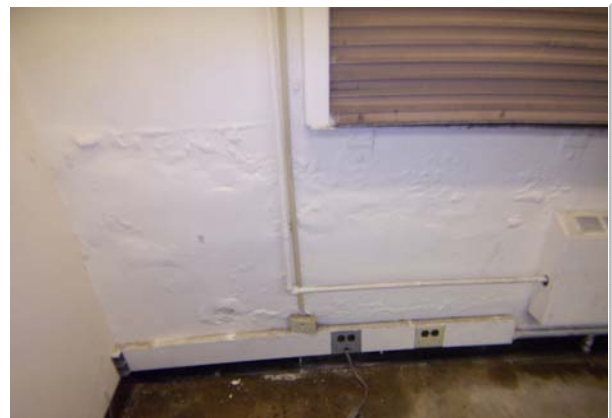
COND SIG	
Space Number	B-11	G	NC
Space Name	Office #3 basement		
Space Dimensions	13'x15' 9'2" ceiling		
N Wall Finish	sheet rock partition, rubber baseboard	G	NC
E Wall Finish	sheet rock partition, rubber baseboard	G	NC
S Wall Finish	sheet rock partition, rubber baseboard	G	NC
W Wall Finish	masonry plaster	P	NC
Floor Finish	concrete; remnants of mastic for resilient tile	P	C
Ceiling Finish	acoustic tile	P	NC
Window Types	1/1 double hung metal sash and shutter	G	VS
Window Hardware	metal	G	VS
Window Trim	metal	G	VS
Door Type	metal	F	NC
Door Hardware	modern	F	NC
Door Frame	metal	F	NC
Door Threshold	concrete	F	C
Trim base & Cornice	none		
Millwork bookcases	none		
Millwork paneling	none		
Millwork wainscot	none		
Skylights	none		
Fireplaces	none		
Electrical lighting	fluorescent bulbs		
Electrical switches	modern		
Electrical outlets	modern		
Plumbing lavatories	none		
Plumbing toilets	none		
Plumbing urinals	none		
Plumbing accessories	none

Plumbing partitions	none		
Fire protection	none		
Mechanical grilles	modern		
Mechanical diffusers	none		
Visible piping or ducts	gas radiator west wall		
Signage	none		
Miscellaneous	west wall and window significant	P	C

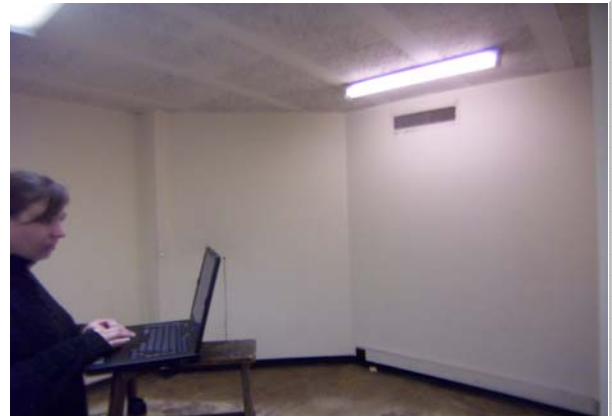
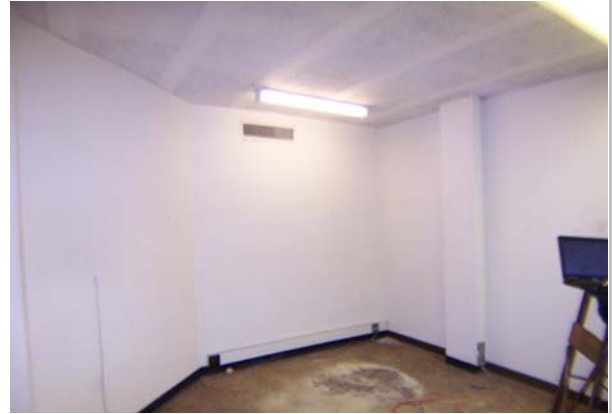
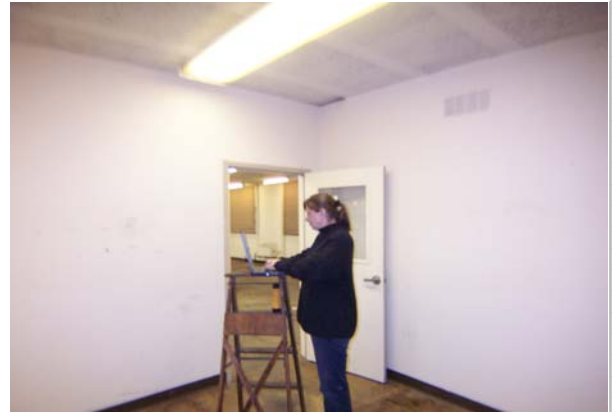
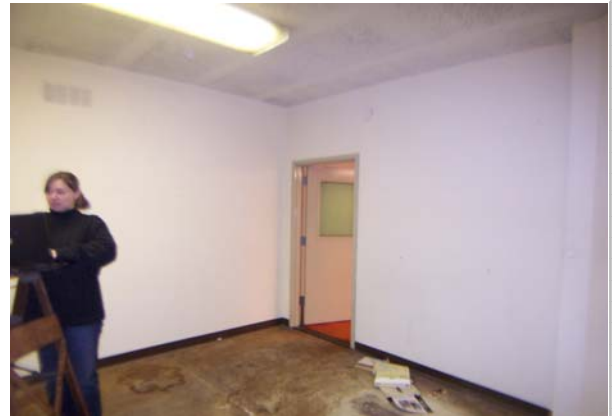
COND SIG	
Space Number	B-12	G	NC
Space Name	Office #4 Basement		
Space Dimensions	14'7"x12'11" 9'3" ceiling		
N Wall Finish	sheet rock partition, rubber baseboard	F	NC
E Wall Finish	sheet rock partition, rubber baseboard	F	NC
S Wall Finish	sheet rock partition, rubber baseboard	F	NC
W Wall Finish	sheet rock partition, rubber baseboard	F	NC
Floor Finish	concrete; remnants of mastic for resilient tile	P	C
Ceiling Finish	acoustic tile	P	NC
Window Types	none		
Window Hardware	none		
Window Trim	none		
Door Type	metal and wire glass	F	NC
Door Hardware	modern	F	NC
Door Frame	metal	F	C
Door Threshold	none		
Trim base & Cornice	none		
Millwork bookcases	none		
Millwork paneling	none		
Millwork wainscot	none		
Skylights	none		
Fireplaces	none		
Electrical lighting	fluorescent	F	NC
Electrical switches	none		
Electrical outlets	modern	F	NC
Plumbing lavatories	none		
Plumbing toilets	none		
Plumbing urinals	none		
Plumbing accessories	none

Plumbing partitions	none		
Fire protection	none		
Mechanical grilles	modern	F	NC
Mechanical diffusers	none		
Visible piping or ducts	none		
Signage	none		
Miscellaneous	all partition walls		NC

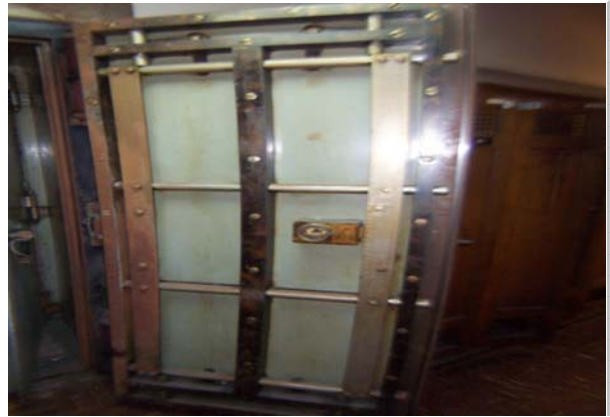
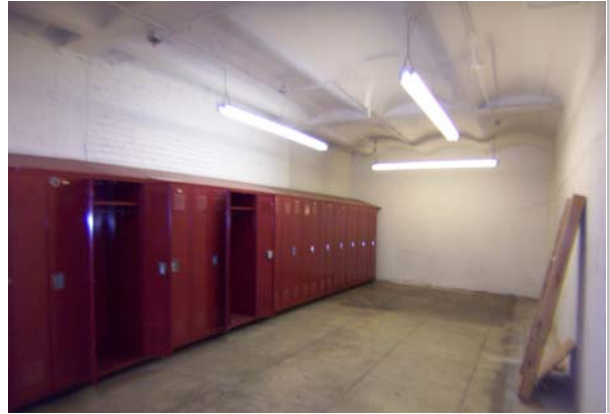
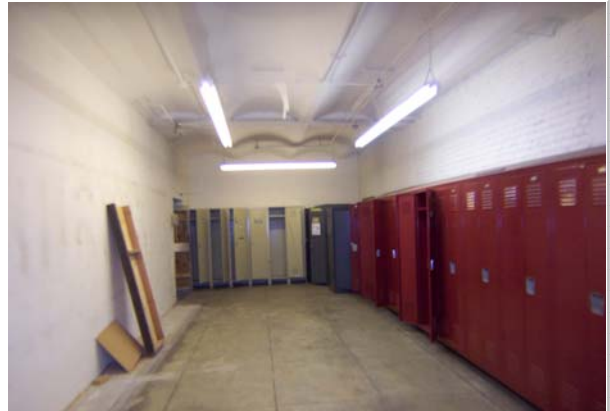
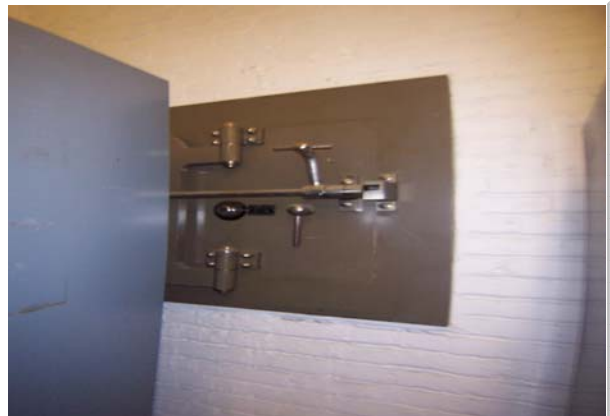
COND SIG	
Space Number	B-13	E	C
Space Name	W Vault, basement		
Space Dimensions	14'6" x 35'11" 11'3" ceiling		
N Wall Finish	concrete	E	C
E Wall Finish	brick	E	C
S Wall Finish	concrete	E	C
W Wall Finish	concrete	E	C
Floor Finish	concrete	E	C
Ceiling Finish	concrete and steel beams	E	C
Window Types	none		
Window Hardware	none		
Window Trim	none		
Door Type	vault (2 doors) and gate steel	F	C
Door Hardware	steel	F	C
Door Frame	steel	F	C
Door Threshold	steel	F	C
Trim base & Cornice	none		
Millwork bookcases	none		
Millwork paneling	none		
Millwork wainscot	none		
Skylights	none		
Fireplaces	none		
Electrical lighting	fluorescent	G	NC
Electrical switches	modern	G	NC
Electrical outlets	modern	G	NC
Plumbing lavatories	none		
Plumbing toilets	none		
Plumbing urinals	none		
Plumbing accessories	none		
Plumbing partitions	none		
Fire protection	none		
Mechanical grilles	none		
Mechanical diffusers	none		
Visible piping or ducts	gas capped on west wall?

Signage	none		
Miscellaneous	lockers lining the east, north, south walls		NC

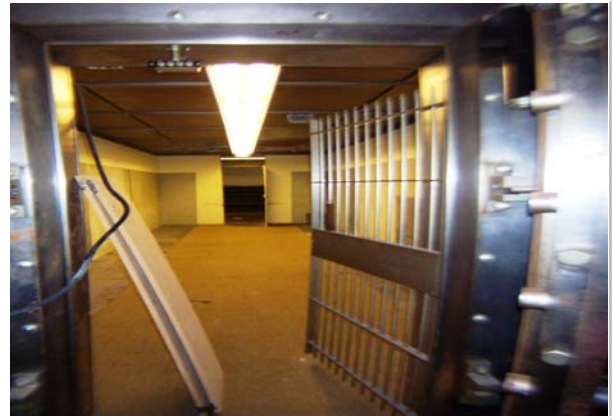
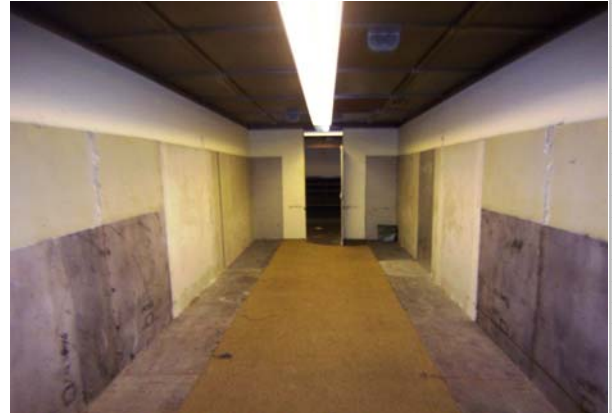
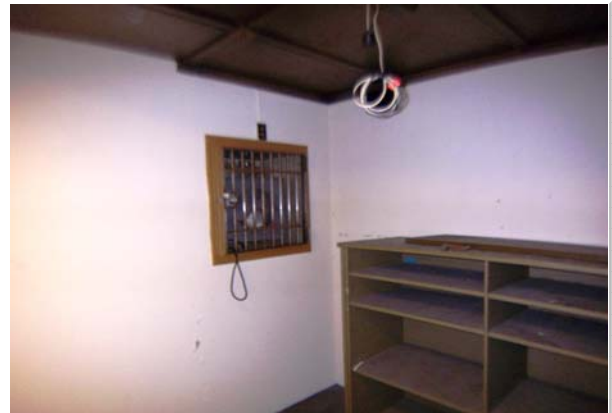
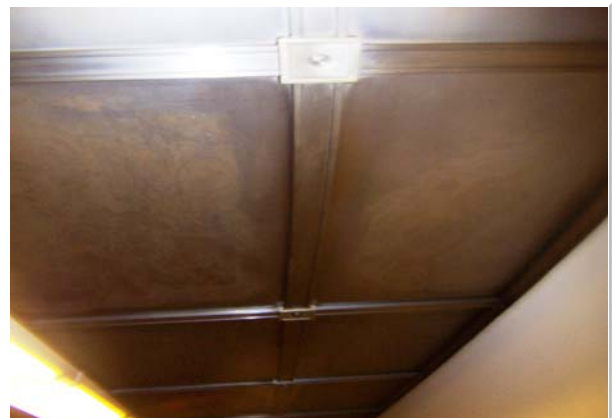
COND SIG	
Space Number	B-14	G	S
Space Name	E Vault, basement		
Space Dimensions	9'6"x25'6" 7'11" front 9'5"x9'7"		
N Wall Finish	steel	G	S
E Wall Finish	steel	G	S
S Wall Finish	steel	G	S
W Wall Finish	steel	G	S
Floor Finish	steel	G	S
Ceiling Finish	steel	G	S
Window Types	none		
Window Hardware	none		
Window Trim	none		
Door Type	vault, double steel doors with gate	F	S
Door Hardware	steel	F	S
Door Frame	steel	F	S
Door Threshold	steel	F	S
Trim base & Cornice	none		
Millwork bookcases	none		
Millwork paneling	none		
Millwork wainscot	none		
Skylights	none		
Fireplaces	none		
Electrical lighting	fluorescent	G	NC
Electrical switches	none		
Electrical outlets	modern	G	NC
Plumbing lavatories	none		
Plumbing toilets	none		
Plumbing urinals	none		
Plumbing accessories	none		
Plumbing partitions	none		
Fire protection	none		
Mechanical grilles	none		
Mechanical diffusers	none		
Visible piping or ducts	none		
Signage	none		
Miscellaneous	alarms and extra vault goes to B-13

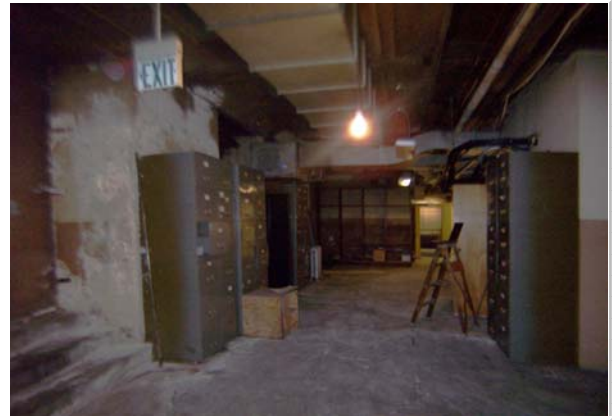
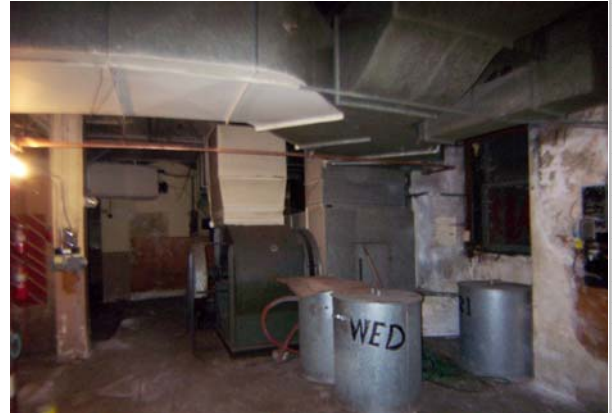
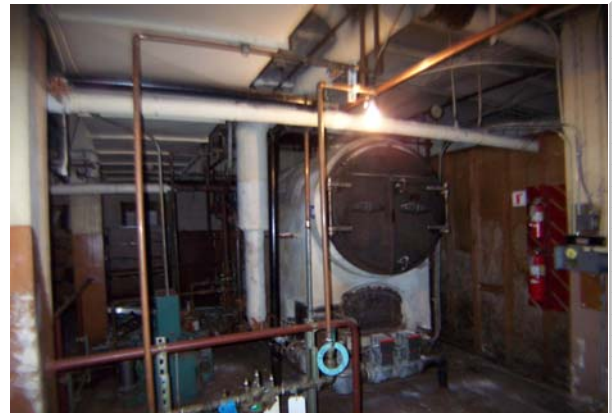
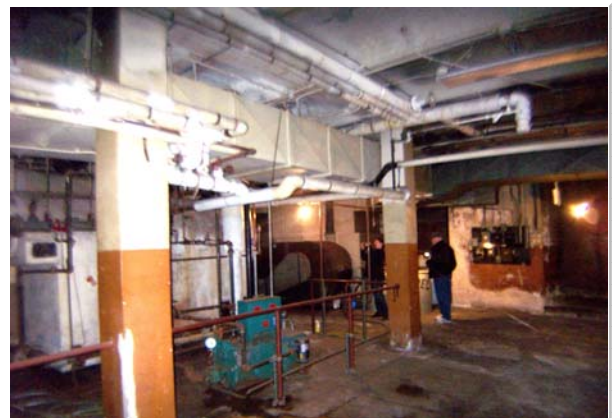
COND SIG	
Space Number	B-15	P	NC
Space Name	Mechanical Room		
Space Dimensions	67'3" x 14'11" 38'10" x 25'6" measured like a		
N Wall Finish	concrete	G	C
E Wall Finish	concrete	P	NC
S Wall Finish	concrete	P	NC
W Wall Finish	concrete	G	C
Floor Finish	concrete	G	C
Ceiling Finish	steel beams and concrete	F	C
Window Types	awning with shutters	G	VS
Window Hardware	metal	G	VS
Window Trim	metal	G	VS
Door Type	wood	G	NC
Door Hardware	metal	F	NC
Door Frame	wood and metal	F	NC/
Door Threshold	none		
Trim base & Cornice	none		
Millwork bookcases	none		
Millwork paneling	none		
Millwork wainscot	none		
Skylights	none		
Fireplaces	none		
Electrical lighting	hanging bulbs	F	NC
Electrical switches	breaker boxes	F	NC
Electrical outlets	none		
Plumbing lavatories	none		
Plumbing toilets	none		
Plumbing urinals	none		
Plumbing accessories	none		
Plumbing partitions	none		
Fire protection	none		
Mechanical grilles	none		
Mechanical diffusers	none

Visible piping or ducts	ducts pipes wires	F	NC
Signage	none		
Miscellaneous	lots of little nooks and boilers and furnaces	F	NC

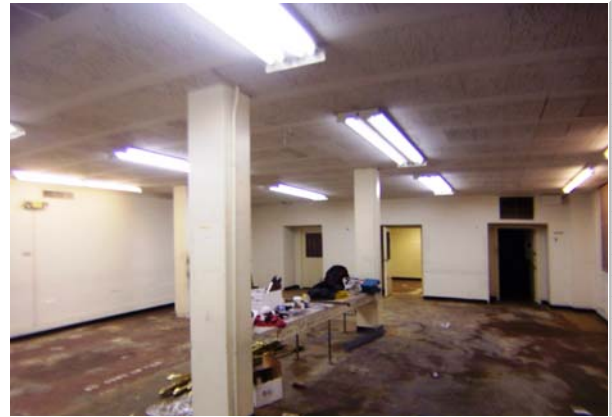
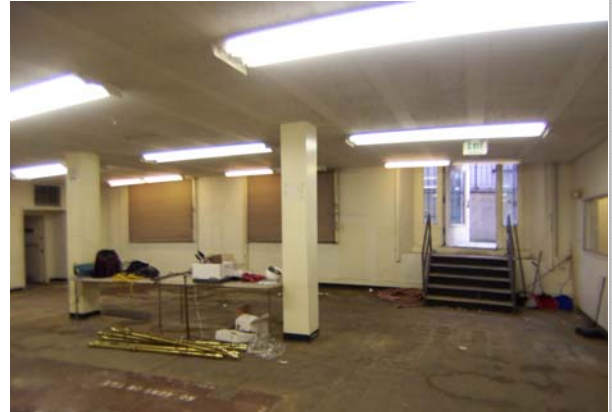
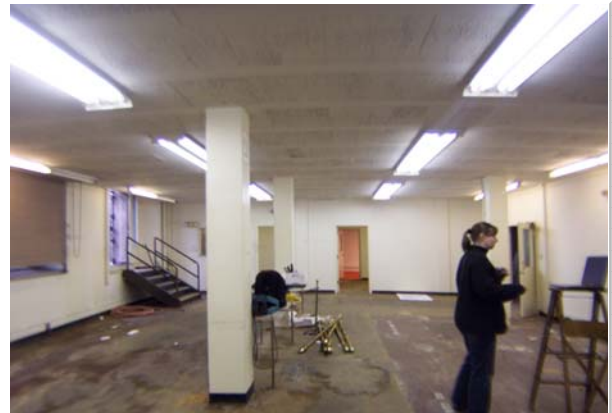
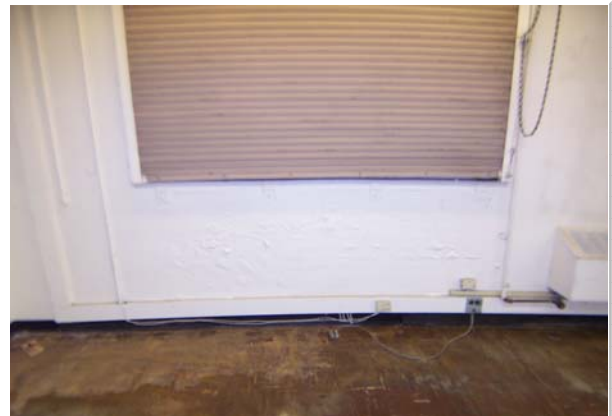
COND SIG	
Space Number	B-16	F	NC
Space Name	Office #5 basement		
Space Dimensions	30'x39'5" 9'4" ceiling		
N Wall Finish	sheet rock, rubber baseboard	F	NC
E Wall Finish	plaster, rubber baseboard	P	NC
S Wall Finish	plaster, rubber baseboard	F	NC
W Wall Finish	plaster, rubber baseboard	F	NC
Floor Finish	concrete, resilient tile, remnants of mastic	P	NC
Ceiling Finish	acoustic ceiling	F	NC
Window Types	1/1 double hung metal sash with metal	F	VS
Window Hardware	metal	F	VS
Window Trim	metal	F	VS
Door Type	metal clear glazing and sidelights	F	S
Door Hardware	metal	F	S
Door Frame	metal	F	S
Door Threshold	concrete	F	S
Trim base & Cornice	none		
Millwork bookcases	none		
Millwork paneling	none		
Millwork wainscot	none		
Skylights	none		
Fireplaces	none		
Electrical lighting	modern exposed conduit	P	NC
Electrical switches	modern plastic	F	NC
Electrical outlets	modern plastic/metal plates	F	NC
Plumbing lavatories	none		
Plumbing toilets	none

Plumbing urinals	none		
Plumbing accessories	none		
Plumbing partitions	none		
Fire protection	none		
Mechanical grilles	modern		
Mechanical diffusers	none		
Visible piping or ducts	gas radiator west wall	F	NC
Signage	none		
Miscellaneous			C

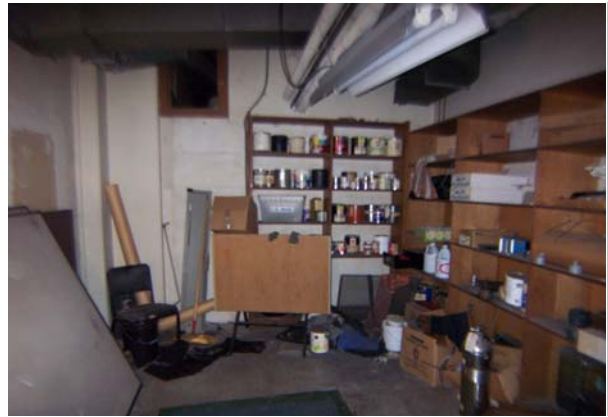
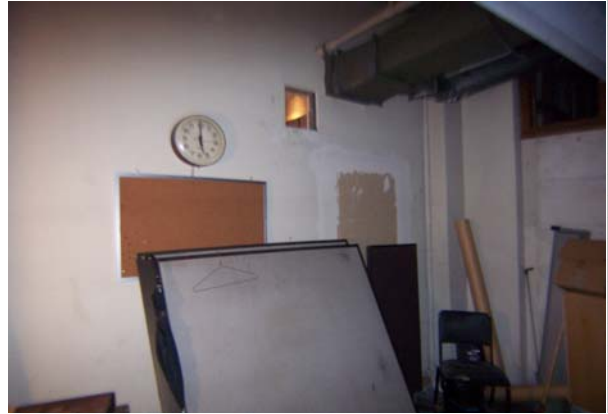
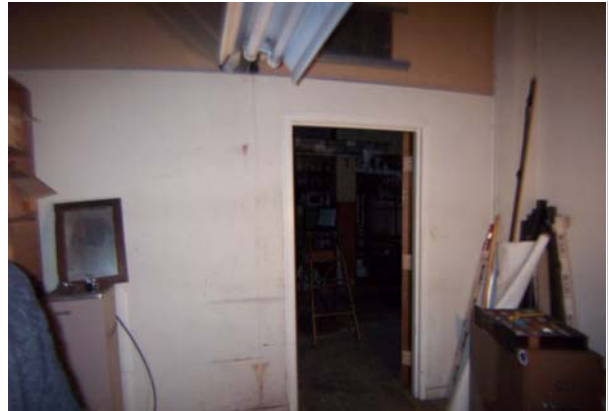
COND SIG	
Space Number	B-17	G	NC
Space Name	Maintenance W		
Space Dimensions	13'3" x 11'8"		
N Wall Finish	partition	G	NC
E Wall Finish	partition	G	NC
S Wall Finish	partition	G	NC
W Wall Finish	concrete	G	C
Floor Finish	concrete	G	C
Ceiling Finish	sheetrock	G	NC
Window Types	none		
Window Hardware	none		
Window Trim	none		
Door Type	wood	G	NC
Door Hardware	modern metal	G	NC
Door Frame	metal	G	NC
Door Threshold	concrete	G	C
Trim base & Cornice	none		
Millwork bookcases	none		
Millwork paneling	none		
Millwork wainscot	none		
Skylights	none		
Fireplaces	none		
Electrical lighting	flourscent lights	F	NC
Electrical switches	none		
Electrical outlets	modern	F	NC
Plumbing lavatories	none		
Plumbing toilets	none		
Plumbing urinals	none		
Plumbing accessories	none		
Plumbing partitions	none		
Fire protection	none		
Mechanical grilles	none		
Mechanical diffusers	none		
Visible piping or ducts	gas pipes south wall, air ducts on ceiling

Signage	none		
Miscellaneous	paint storage

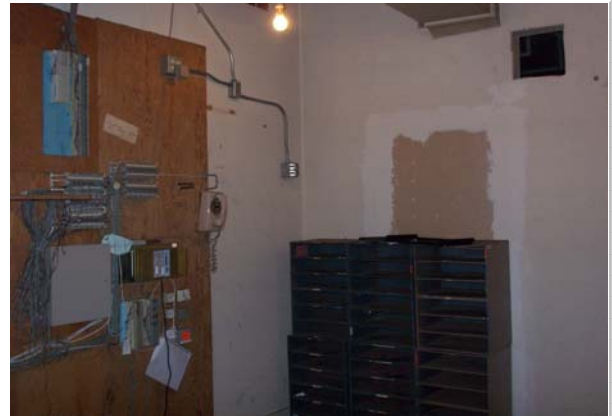
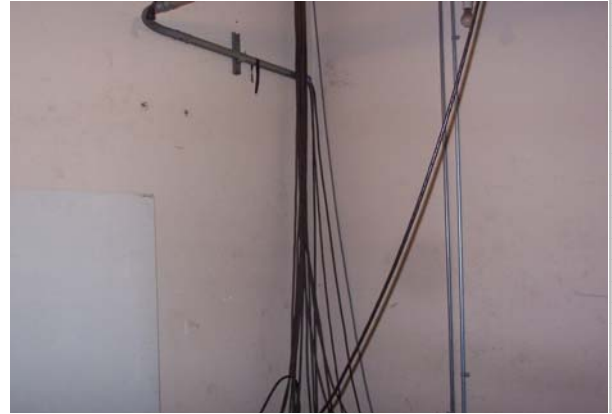
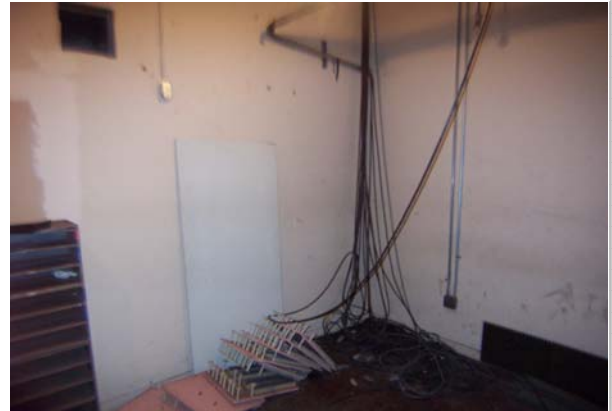
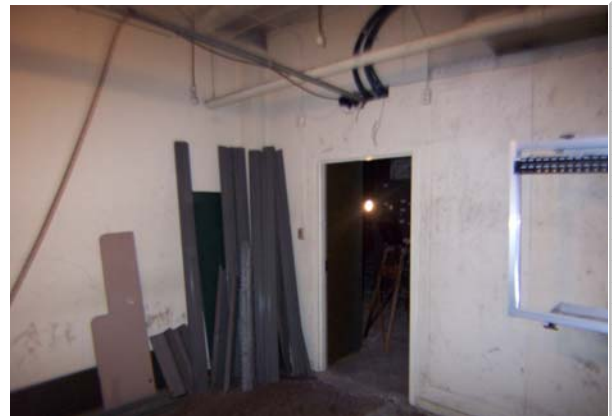
COND SIG	
Space Number	B-18	G	NC
Space Name	Maintenance E		
Space Dimensions	12'3"x12'11" 11'3'		
N Wall Finish	partition wood baseboards	G	NC
E Wall Finish	partition wood baseboards	G	NC
S Wall Finish	partition wood baseboards	G	NC
W Wall Finish	partition wood baseboards	G	NC
Floor Finish	concrete	G	C
Ceiling Finish	sheet rock	F	NC
Window Types	none		
Window Hardware	none		
Window Trim	none		
Door Type	wood	G	NC
Door Hardware	metal	G	NC
Door Frame	metal and wood	G	NC
Door Threshold	non		
Trim base & Cornice	none		
Millwork bookcases	none		
Millwork paneling	none		
Millwork wainscot	none		
Skylights	none		
Fireplaces	none		
Electrical lighting	hanging bulbs	F	NC
Electrical switches	modern	G	NC
Electrical outlets	modern	G	NC
Plumbing lavatories	none		
Plumbing toilets	none		
Plumbing urinals	none		
Plumbing accessories	none		
Plumbing partitions	none		
Fire protection	none		
Mechanical grilles	none		
Mechanical diffusers	none

Visible piping or ducts	pipes for conduit and telephone system	P	NC
Signage	none		
Miscellaneous	telephone area

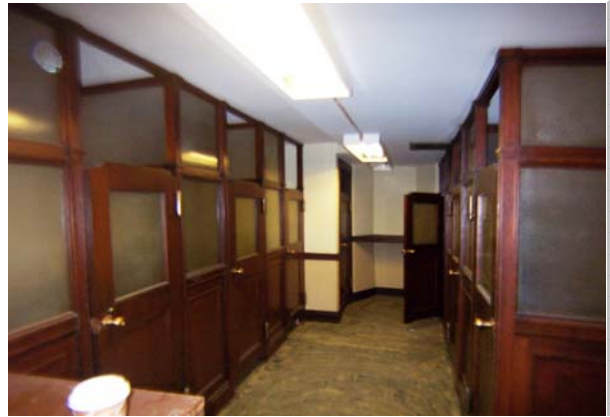
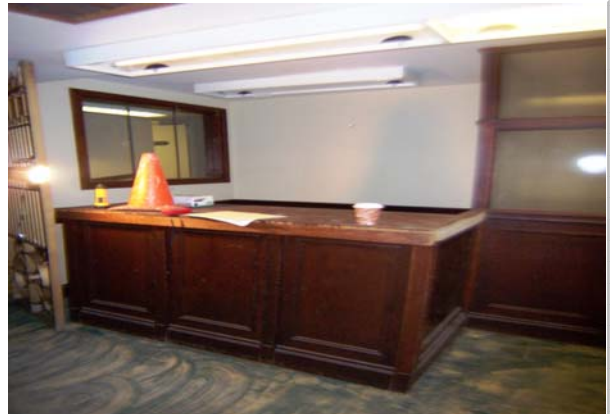
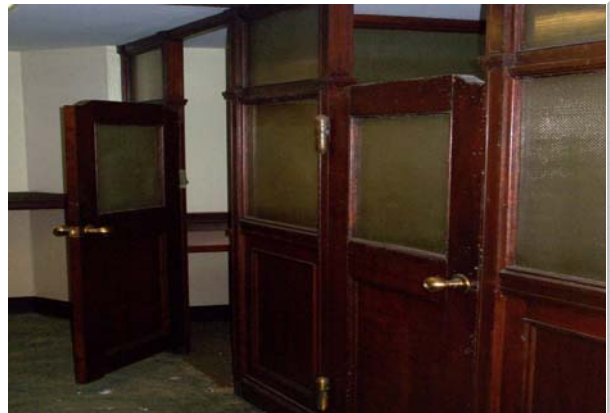
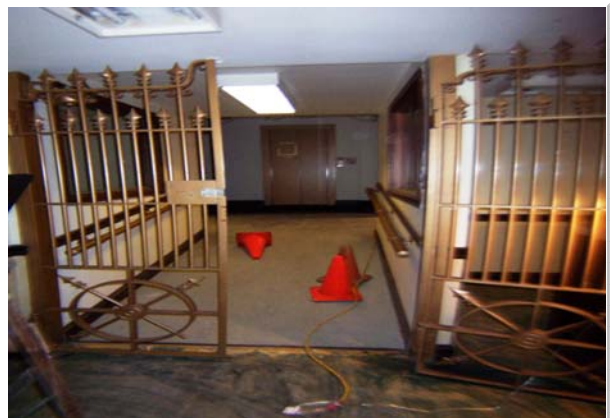
COND SIG	
Space Number	B-19	G	S
Space Name	Safe Deposit Viewing Room		
Space Dimensions	31'4"x13'3" 7'1"		
N Wall Finish	partition wood chairrail and baseboard	G	S
E Wall Finish	partition wood chairrail and baseboard	G	S
S Wall Finish	partition wood chairrail and baseboard	G	S
W Wall Finish	partition wood chairrail and baseboard	G	S
Floor Finish	concrete	F	S
Ceiling Finish	plaster	F	S
Window Types	fixed internal window	G	C
Window Hardware	none		
Window Trim	wood	G	C
Door Type	gate and vault doors and mahogany (?)	G	S
Door Hardware	brass	G	S
Door Frame	steel, wood	G	S
Door Threshold	steel vault threshold	G	S
Trim base & Cornice	none		
Millwork bookcases	none		
Millwork paneling	none		
Millwork wainscot	none		
Skylights	none		
Fireplaces	none		
Electrical lighting	fluorescent	F	NC
Electrical switches	modern	F	NC
Electrical outlets	modern	F	NC
Plumbing lavatories	none		
Plumbing toilets	none		
Plumbing urinals	none

Plumbing accessories	none		
Plumbing partitions	none		
Fire protection	none		
Mechanical grilles	in each booth at ceiling	G	C
Mechanical diffusers	none		
Visible piping or ducts	none		
Signage	none		
Miscellaneous	wood counter area	F	C

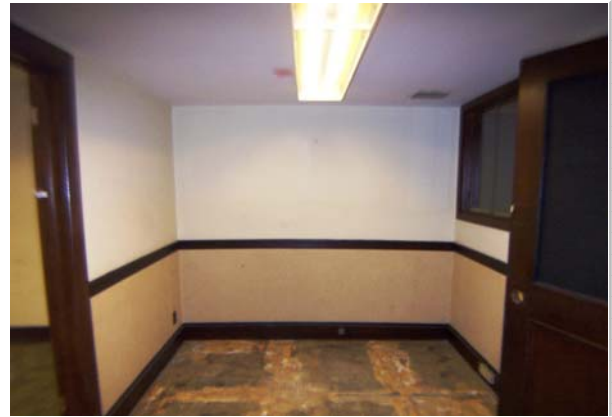
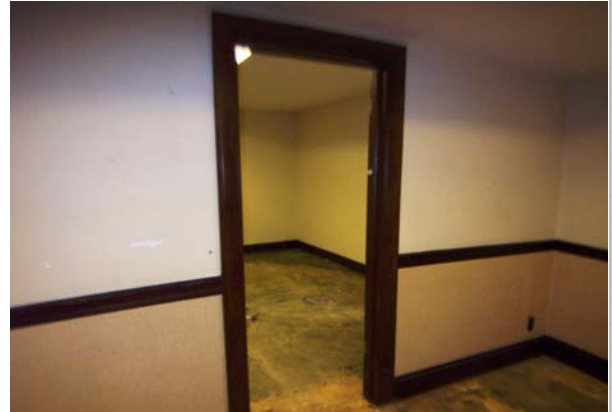
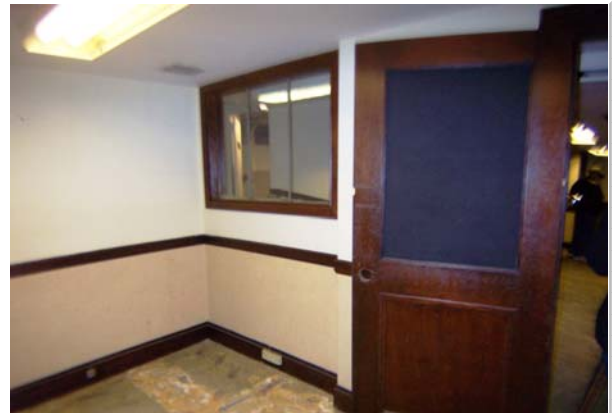
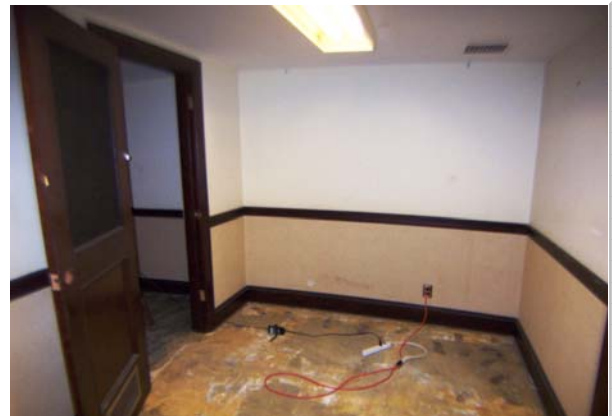
COND SIG	
Space Number	B-20	G	C
Space Name	Safe Deposit Office #1		
Space Dimensions	13'4"x13'4" 7'1"		
N Wall Finish	partition wood chairrail and baseboard	G	C
E Wall Finish	partition wood chairrail and baseboard	G	C
S Wall Finish	partition wood chairrail and baseboard	G	C
W Wall Finish	partition wood chairrail and baseboard	G	C
Floor Finish	concrete; remnants of mastic tile glue	F	C
Ceiling Finish	plaster	F	C
Window Types	east wall fixed	F	C
Window Hardware	none		
Window Trim	wood	G	C
Door Type	metal glazed	G	C
Door Hardware	brass	G	C
Door Frame	wood and metal	G	C
Door Threshold	none		
Trim base & Cornice	none		
Millwork bookcases	none		
Millwork paneling	none		
Millwork wainscot	none		
Skylights	none		
Fireplaces	none		
Electrical lighting	fluorescent	G	NC
Electrical switches	modern	G	NC
Electrical outlets	modern	G	NC
Plumbing lavatories	none		
Plumbing toilets	none		
Plumbing urinals	none		
Plumbing accessories	none

Plumbing partitions	none		
Fire protection	none		
Mechanical grilles	ceiling		
Mechanical diffusers	none		
Visible piping or ducts	none		
Signage	none		
Miscellaneous	none

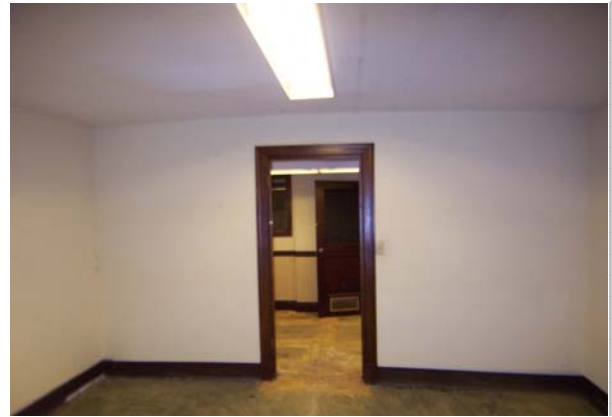
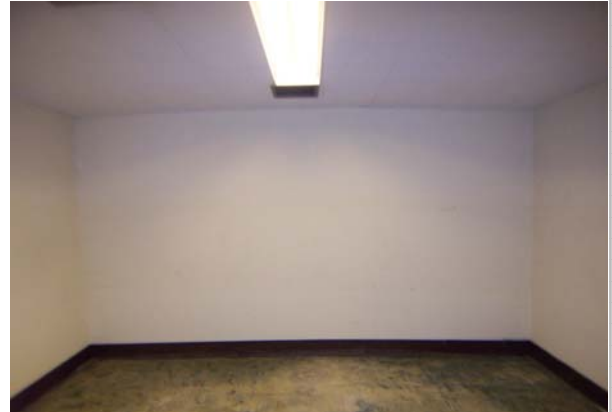
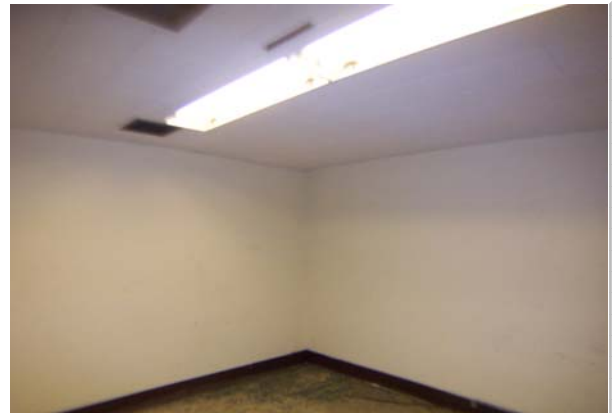
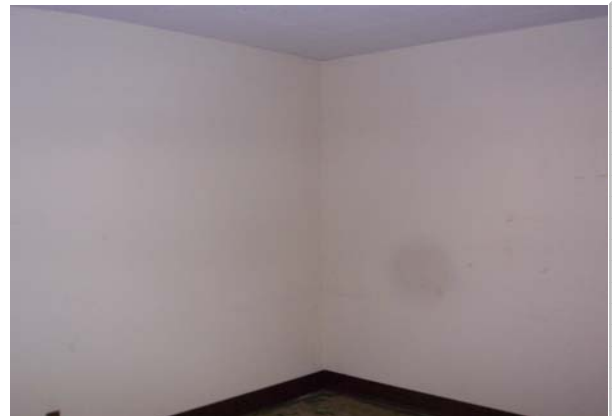
COND SIG	
Space Number	B-21	P	NC
Space Name	Safe Deposit Office #2		
Space Dimensions	13'11"x13'10" 7'11"		
N Wall Finish	partition	F	NC
E Wall Finish	partition	F	NC
S Wall Finish	south	F	NC
W Wall Finish	partition	F	NC
Floor Finish	concrete; remnants of mastic tile glue	F	C
Ceiling Finish	acoustic	P	NC
Window Types	none		
Window Hardware	none		
Window Trim	none		
Door Type	none		
Door Hardware	metal	F	NC
Door Frame	wood and metal	F	NC
Door Threshold	none		
Trim base & Cornice	none		
Millwork bookcases	none		
Millwork paneling	none		
Millwork wainscot	none		
Skylights	none		
Fireplaces	none		
Electrical lighting	fluorescent	G	NC
Electrical switches	modern	G	NC
Electrical outlets	modern	G	NC
Plumbing lavatories	none		
Plumbing toilets	none		
Plumbing urinals	none		
Plumbing accessories	none		
Plumbing partitions	none		
Fire protection	none		
Mechanical grilles	none		
Mechanical diffusers	none		
Visible piping or ducts	none

Signage	none		
Miscellaneous	water damage hidden in walls and ceiling

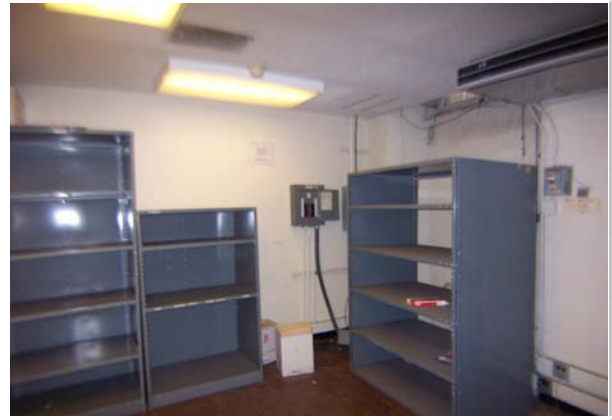
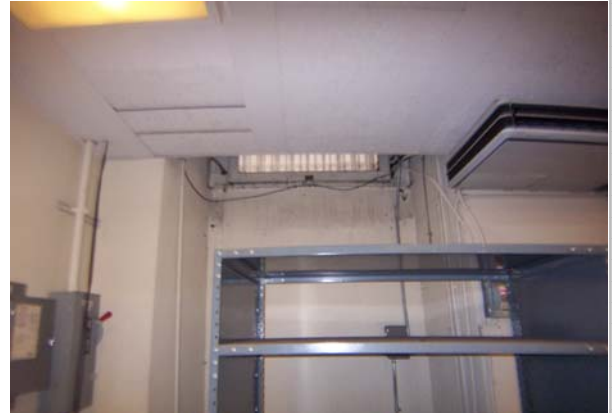
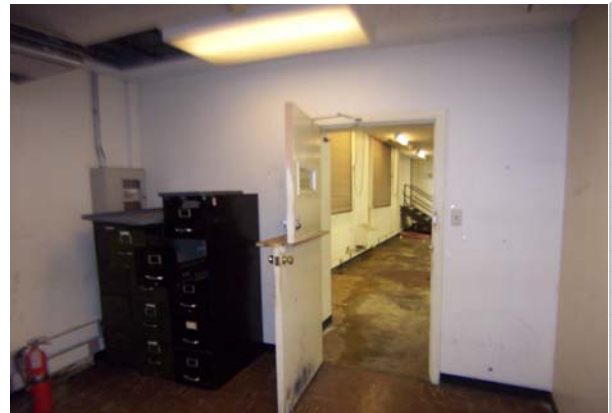
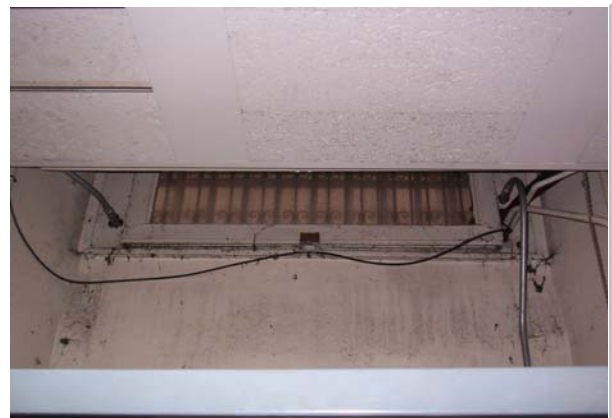
COND SIG	
Space Number	B-22	F	NC
Space Name	office 1		
Space Dimensions	11'8" x 14'1" 8'7" ceiling		
N Wall Finish	sheetrock over concrete	F	NC
E Wall Finish	concrete plaster	G	NC
S Wall Finish	concrete plaster	G	NC
W Wall Finish	masonry plaster	G	C
Floor Finish	mastic and concrete	F	NC
Ceiling Finish	dropped ceiling acoustic tile	F	NC
Window Types	metal awning interior metal gate and	F	VS
Window Hardware	metal	F	VS
Window Trim	metal	G	VS
Door Type	wood dutch door wireglass peep hole	F	NC
Door Hardware	modern	F	NC
Door Frame	metal	G	NC
Door Threshold	concrete	F	C
Trim base & Cornice	none		
Millwork bookcases	none		
Millwork paneling	none		
Millwork wainscot	none		
Skylights	none		
Fireplaces	none		
Electrical lighting	fluorescent lights	F	NC
Electrical switches	modern	G	NC
Electrical outlets	modern	F	NC
Plumbing lavatories	none		
Plumbing toilets	none		
Plumbing urinals	none		
Plumbing accessories	none		
Plumbing partitions	none

Fire protection	modern fire detection ceiling and panel	F	NC
Mechanical grilles	modern	F	NC
Mechanical diffusers	none		
Visible piping or ducts	gas radiator west wall ceiling air conditioner	F	NC
Signage	none		
Miscellaneous	several electrical panels and piping for conduit	G	NC

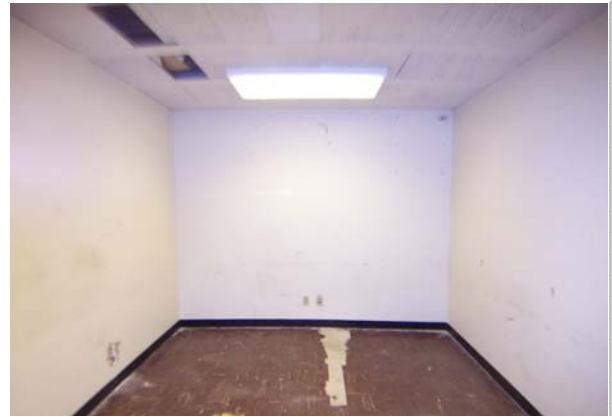
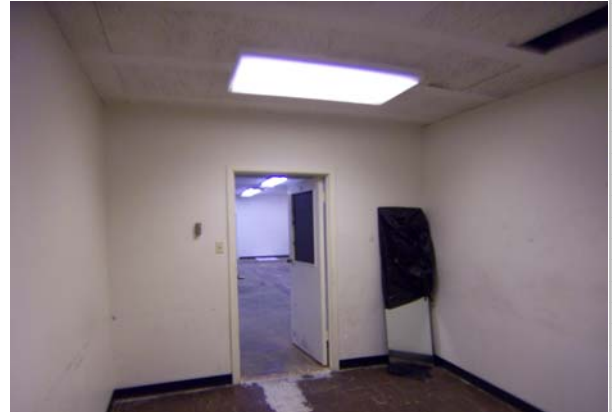
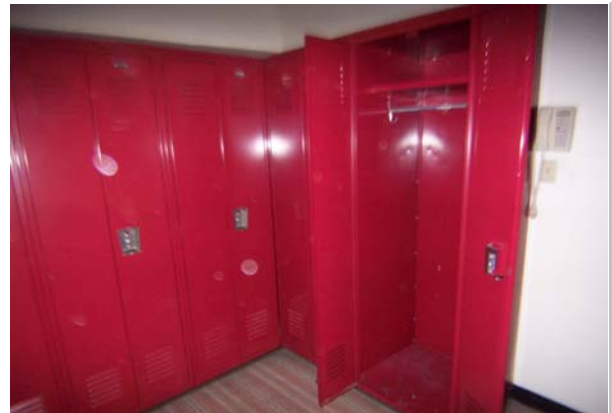
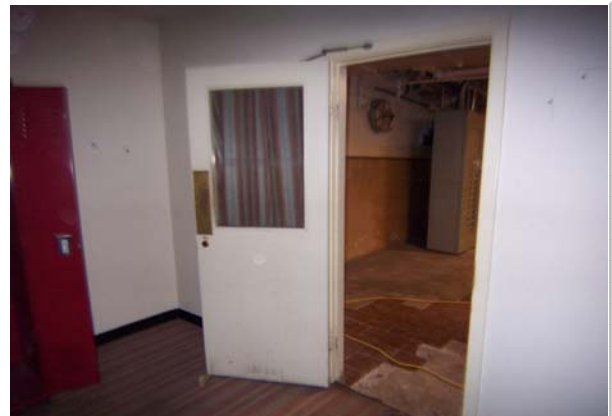
COND SIG	
Space Number	B-23	F	NC
Space Name	Office 2 and locker room		
Space Dimensions	8'x12' 8'7" ceiling		
N Wall Finish	partition	F	NC
E Wall Finish	partition	F	NC
S Wall Finish	partition	F	NC
W Wall Finish	partion	F	NC
Floor Finish	carpet	P	NC
Ceiling Finish	acoustical	P	NC
Window Types	n		
Window Hardware	n		
Window Trim	n		
Door Type	wood clear glaze	F	NC
Door Hardware	metal	F	NC
Door Frame	metal	F	NC
Door Threshold	carpet	P	NC
Trim base & Cornice	n		
Millwork bookcases	n		
Millwork paneling	n		
Millwork wainscot	n		
Skylights	n		
Fireplaces			
Electrical lighting	fluourescent	F	NC
Electrical switches	modern	F	NC
Electrical outlets	n		
Plumbing lavatories	n		
Plumbing toilets	n		
Plumbing urinals	n		
Plumbing accessories	n		
Plumbing partitions	n		
Fire protection	n		
Mechanical grilles	n		
Mechanical diffusers	n		
Visible piping or ducts	n		
Signage	n		
Miscellaneous	walls lined with lockers in adjacent room

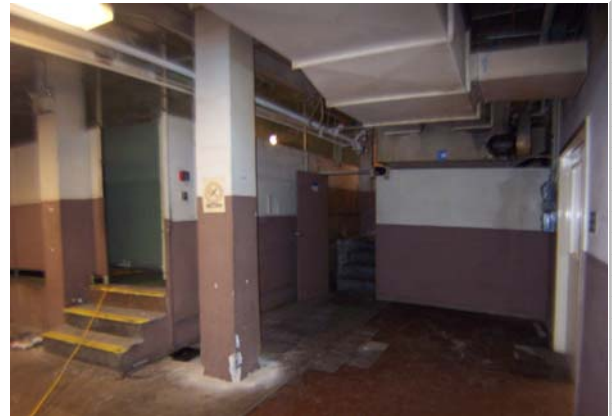
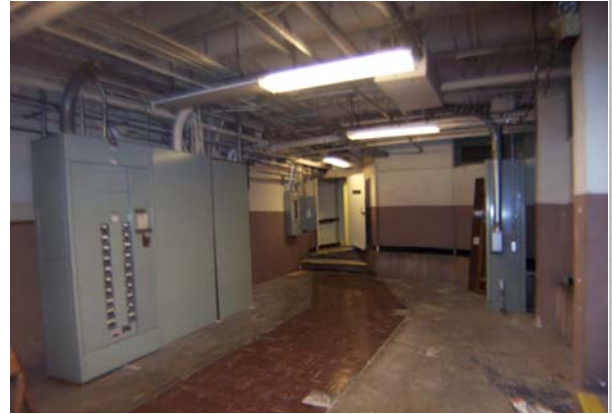
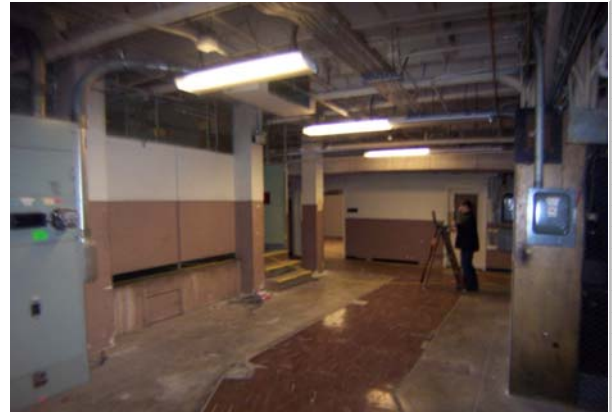
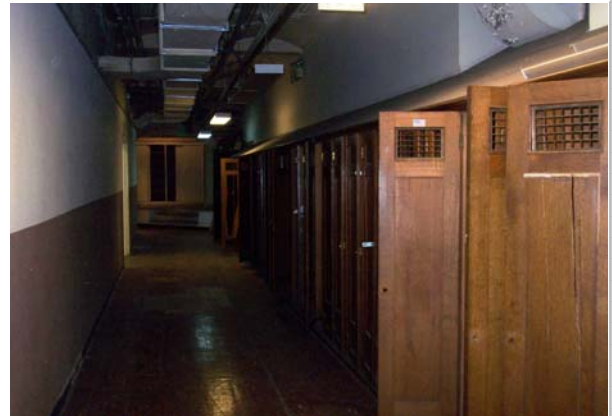
COND SIG	
Space Number	B-24	G	NC
Space Name	Telephone & electric panel space		
Space Dimensions	33'6"x17" 11'3"ceiling		
N Wall Finish	concrete	G	C
E Wall Finish	metal partition	G	NC
S Wall Finish	concrete	G	C
W Wall Finish	partition	G	NC
Floor Finish	concrete	G	C
Ceiling Finish	steel beam concrete	G	C
Window Types	none		
Window Hardware	none		
Window Trim	none		
Door Type	metal and wood glaze	G	C/N
Door Hardware	brass and modern	G	C/N
Door Frame	metal	G	C
Door Threshold	concrete	G	C
Trim base & Cornice	none		
Millwork bookcases	none		
Millwork paneling	none		
Millwork wainscot	none		
Skylights	none		
Fireplaces	none		
Electrical lighting	fluourescent	G	NC
Electrical switches	modern	G	NC
Electrical outlets	modern	G	NC
Plumbing lavatories	none		
Plumbing toilets	none		
Plumbing urinals	none		
Plumbing accessories	none		
Plumbing partitions	none		
Fire protection	none		
Mechanical grilles	none		
Mechanical diffusers	none

Visible piping or ducts	air ducts electrical conduit and pipes	F	NC
Signage	Ladies Watch Your Step		NC
Miscellaneous	electric panels and breakers, fire hose telephone panels hall has oak lockers 1935?		C-
