# SAN FRANCISCO PLANNING DEPARTMENT

**MEMO**

**RE:** Review and Comment for 1 Jones Street (former Hibernia Bank)  
Case No. 2011.0617EA

**HIBERNIA BANK BUILDING**

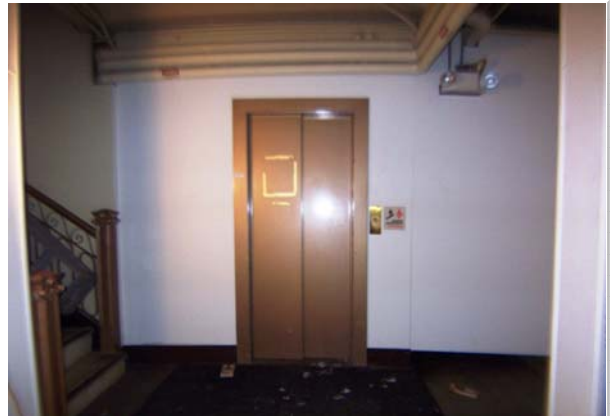
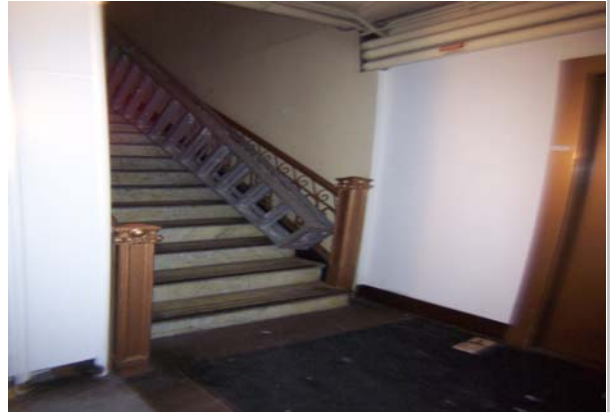
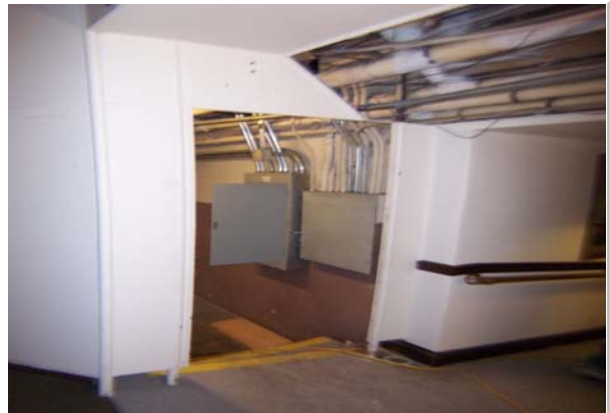
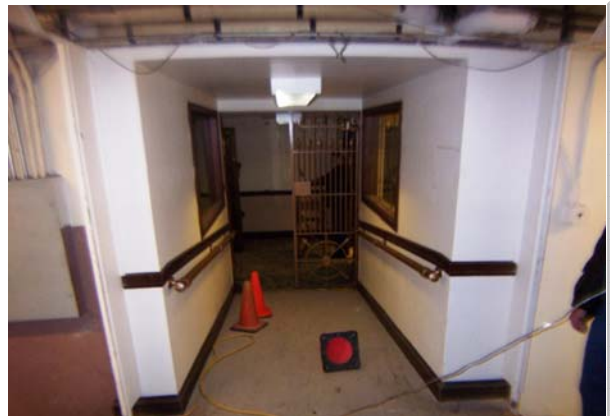
COND SIG	
Space Number	B-25	G	C
Space Name	Elevator lobby & stairs, basement		
Space Dimensions			
N Wall Finish	n/a		
E Wall Finish	concrete and plaster	G	C
S Wall Finish	concrete and plaster	G	C
W Wall Finish	sheet metal	G	C
Floor Finish	linoleum over concrete	G	NC
Ceiling Finish	steel beam concrete	G	C
Window Types	none		
Window Hardware	none		
Window Trim	none		
Door Type	elevator doors	G	NC
Door Hardware	none		
Door Frame	metal	G	NC
Door Threshold	concrete	G	C
Trim base & Cornice	none		
Millwork bookcases	none		
Millwork paneling	none		
Millwork wainscot	none		
Skylights	none		
Fireplaces	none		
Electrical lighting	florescent	G	NC
Electrical switches	modern	G	NC
Electrical outlets	modern	G	NC
Plumbing lavatories	none		
Plumbing toilets	none		
Plumbing urinals	none		
Plumbing accessories	none		
Plumbing partitions	none		
Fire protection	none		
Mechanical grilles	none		
Mechanical diffusers	none		
Visible piping or ducts	plumbing and conduit	G	NC

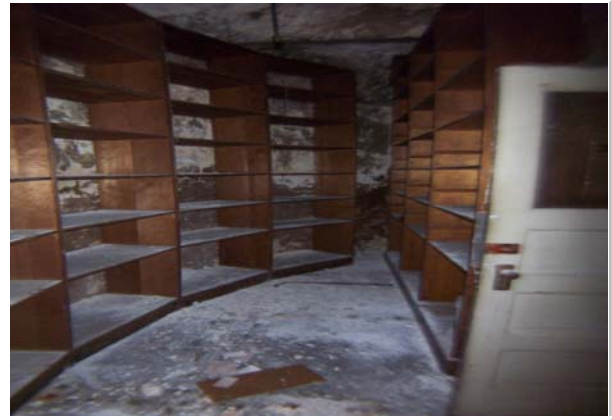
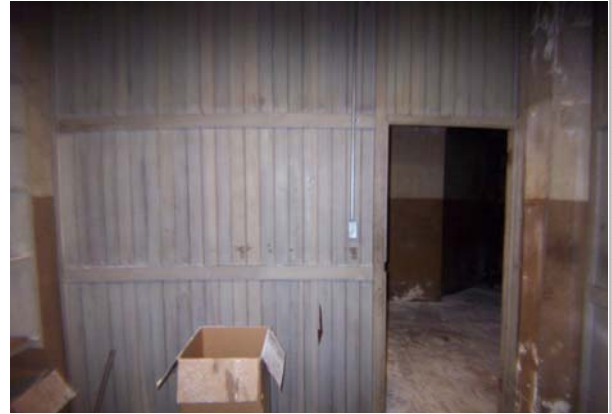
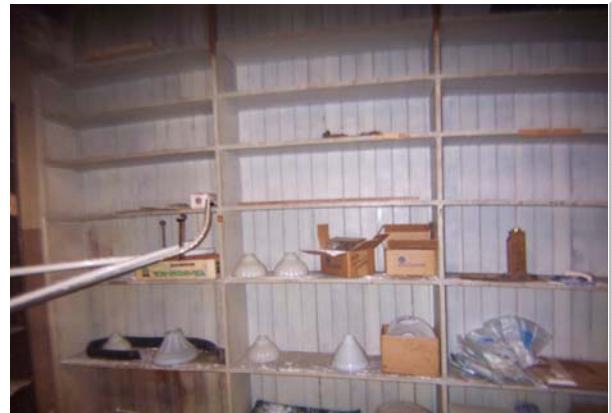
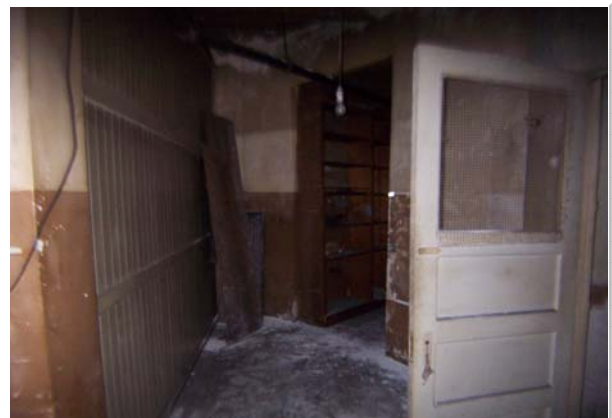
COND SIG	
Space Number	B-26	P	NC
Space Name	Rotunda room, basement		
Space Dimensions	25'4" x 24'7" 10'9" ceiling		
N Wall Finish	concrete and plaster	P	NC
E Wall Finish	concrete and plaster	P	NC
S Wall Finish	concrete and plaster	P	NC
W Wall Finish	concrete and plaster	P	NC
Floor Finish	concrete	F	C
Ceiling Finish	concrete, steel beam and plaster	P	C
Window Types	awning with shutters	F	VS
Window Hardware	metal	F	VS
Window Trim	metal	F	VS
Door Type	wood and glass	F	NC
Door Hardware	metal	F	NC
Door Frame	wood and metal	F	NC
Door Threshold	none		
Trim base & Cornice	none		
Millwork bookcases	none		
Millwork paneling	none		
Millwork wainscot	none		
Skylights	none		
Fireplaces	none		
Electrical lighting	hanging bulbs/fluorescent	F	NC
Electrical switches	modern	F	NC
Electrical outlets	modern	F	NC
Plumbing lavatories	none		
Plumbing toilets	none		
Plumbing urinals	none		
Plumbing accessories	none		
Plumbing partitions	none

Fire protection	none		
Mechanical grilles	none		
Mechanical diffusers	none		
Visible piping or ducts	pipes and duct work	F	NC
Signage	none		
Miscellaneous	center has wood tongue and groove square section with shelving for light shades lots of light nooks

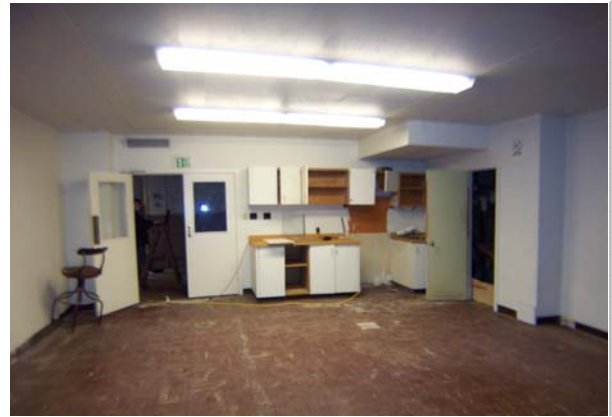
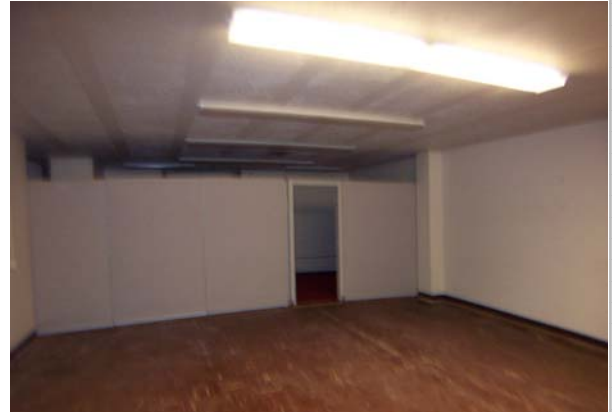
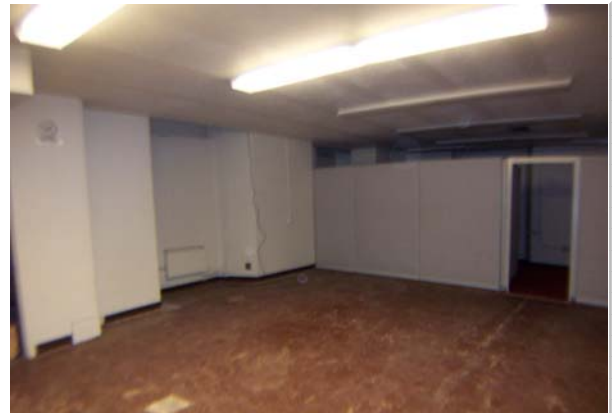
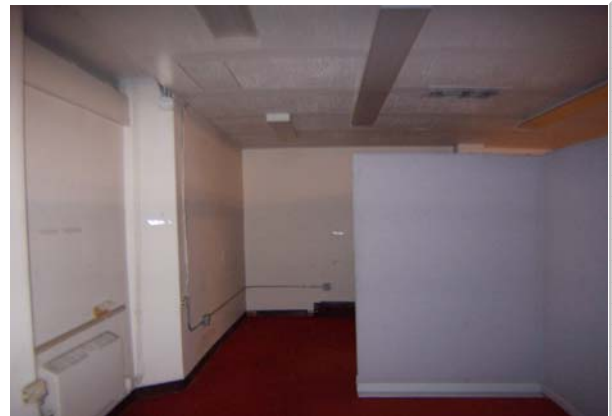
COND SIG	
Space Number	B-27	F	NC
Space Name	Break Room		
Space Dimensions	19'8" x 32'10" 8'7" ceiling		
N Wall Finish	partition	P	NC
E Wall Finish	concrete	F	C
S Wall Finish	concrete and partition	F	C/N
W Wall Finish	partition	F	NC
Floor Finish	concrete and mastic tile and carpet	F/P	C/N
Ceiling Finish	acoustical tile	P	NC
Window Types	awning with shutter	F	VS
Window Hardware	metal	F	VS
Window Trim	metal	F	VS
Door Type	wood clear glaze double	F	NC
Door Hardware	brass	F	NC
Door Frame	metal	F	NC
Door Threshold	concrete	G	C
Trim base & Cornice	none		
Millwork bookcases	none		
Millwork paneling	none		
Millwork wainscot	none		
Skylights	none		
Fireplaces	none		
Electrical lighting	fluorescent	P	NC
Electrical switches	modern	F	NC
Electrical outlets	modern	F	NC
Plumbing lavatories	none		
Plumbing toilets	none		
Plumbing urinals	none		
Plumbing accessories	none		
Plumbing partitions	none		
Fire protection	none		
Mechanical grilles	none

Mechanical diffusers	none		
Visible piping or ducts	gas radiator and old thermostat	F	NC
Signage			
Miscellaneous	cubicle in west wall, sink and cabinets east, wall closet on south wall with piping	P	NC

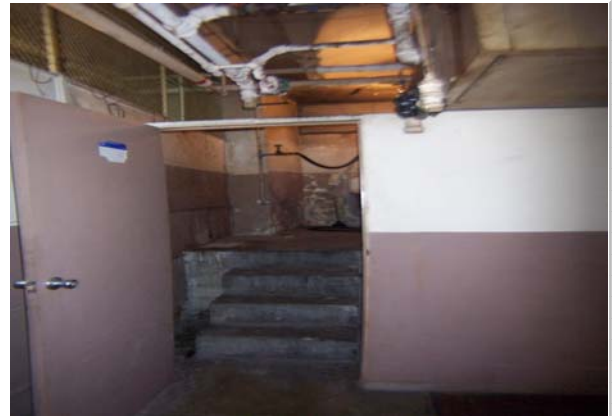
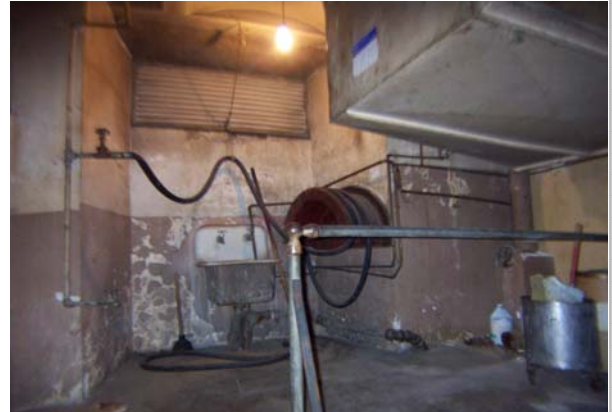
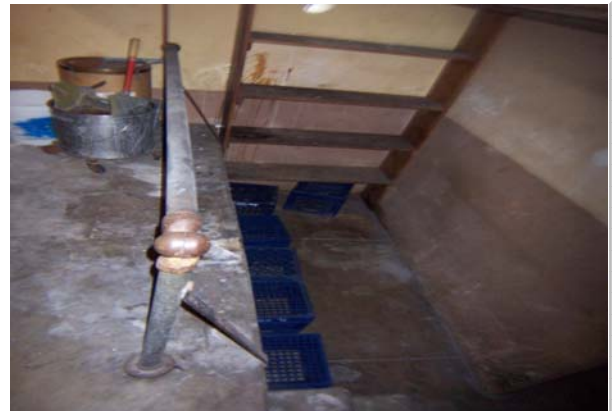
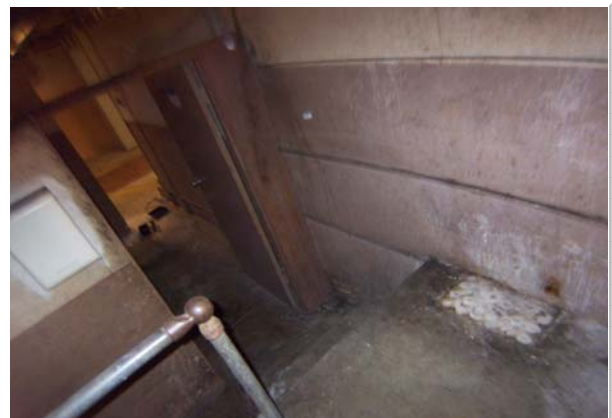
COND SIG	
Space Number	B-28	F	C
Space Name	Mechanical space		
Space Dimensions	11'x10' 8" ceiling		
N Wall Finish	metal partition	F	NC
E Wall Finish	metal partition	F	NC
S Wall Finish	concrete	P	NC
W Wall Finish	metal partition	F	NC
Floor Finish	concrete	G	C
Ceiling Finish	steel beam concrete plaster	F	C
Window Types	awning with shutter	F	VS
Window Hardware	metal	F	VS
Window Trim	metal	F	VS
Door Type	metal	F	NC
Door Hardware	metal	F	NC
Door Frame	metal	F	NC
Door Threshold	concrete	F	C
Trim base & Cornice	none		
Millwork bookcases	none		
Millwork paneling	none		
Millwork wainscot	none		
Skylights	none		
Fireplaces	none		
Electrical lighting	hanging bulbs	F	NC
Electrical switches	none		
Electrical outlets	none		
Plumbing lavatories	none		
Plumbing toilets	onen		
Plumbing urinals	none		
Plumbing accessories	utility sink on south wall	P	NC
Plumbing partitions	none		
Fire protection	none		
Mechanical grilles	none		
Mechanical diffusers	none

Visible piping or ducts	pipes and duct work	F	NC
Signage	none		
Miscellaneous	none

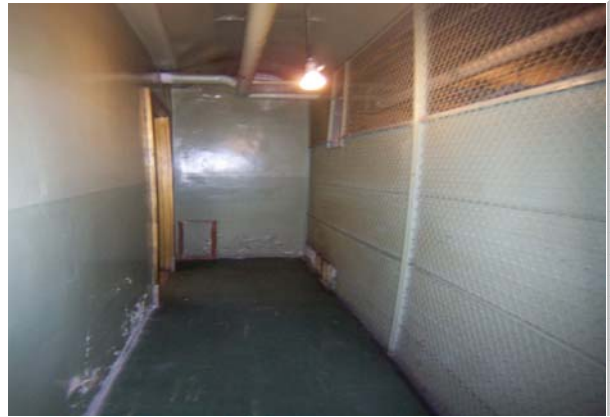
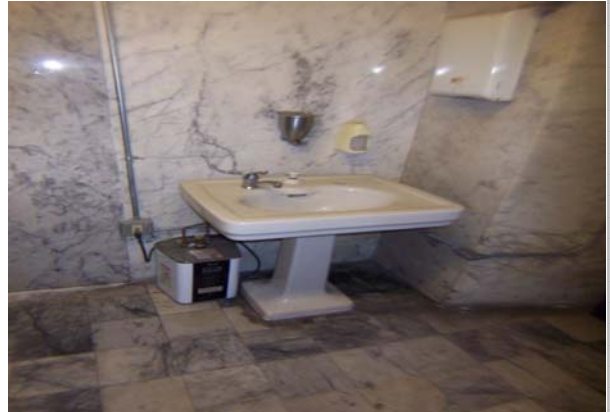
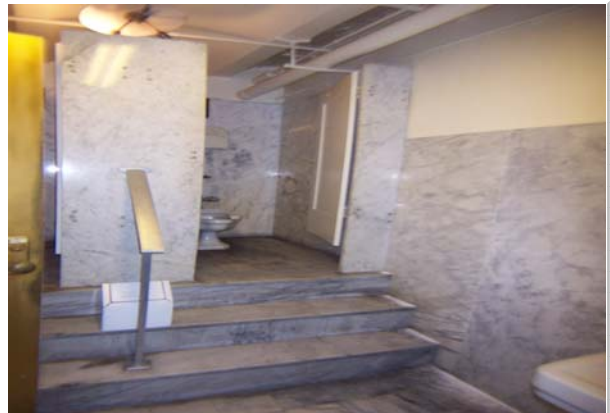
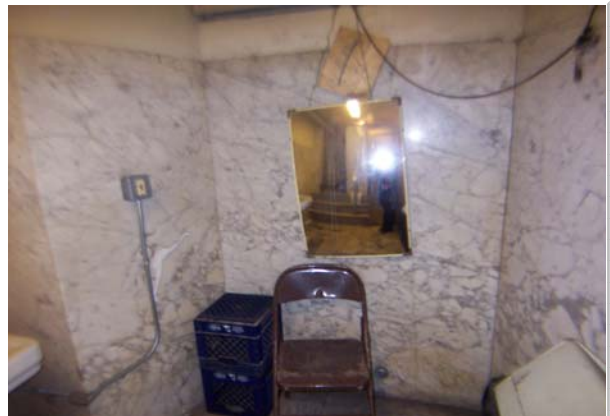
COND SIG	
Space Number	B-29	G	C
Space Name	Toilet W basement		
Space Dimensions	7'7" x 14'7" 9'7" ceiling		
N Wall Finish	metal partition	G	NC
E Wall Finish	metal partition	G	NC
S Wall Finish	concrete plaster	G	C
W Wall Finish	concrete	G	C
Floor Finish	concrete and marble in bathroom	G	C
Ceiling Finish	steel beam and concrete and plaster	F	C
Window Types	awning with shutter in bathroom south wall	F	VS
Window Hardware	metal	F	VS
Window Trim	metal	F	VS
Door Type	metal	G	C
Door Hardware	metal	G	C
Door Frame	metal	G	C
Door Threshold	marble	G	C
Trim base & Cornice	none		
Millwork bookcases	none		
Millwork paneling	none		
Millwork wainscot	none		
Skylights	none		
Fireplaces	none		
Electrical lighting	hanging bulbs	G	NC
Electrical switches	modern	G	NC
Electrical outlets	modern	G	NC
Plumbing lavatories	modern and old	G	C
Plumbing toilets	porcelain		C
Plumbing urinals	none		
Plumbing accessories	modern and porcelain and plated	F	NC

Plumbing partitions	marble wood swinging	G	C
Fire protection	none		
Mechanical grilles	behind toilets		C
Mechanical diffusers	none		
Visible piping or ducts	pipes		
Signage	none		
Miscellaneous	none

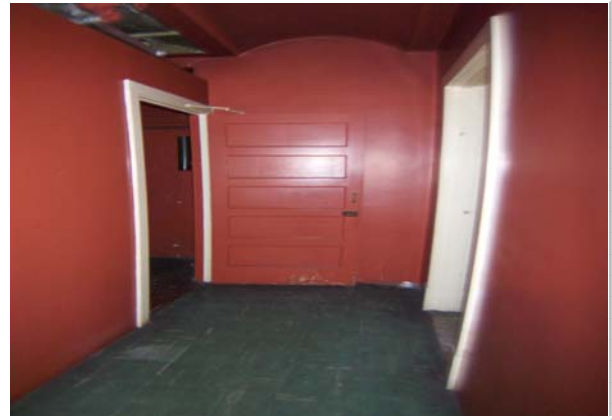
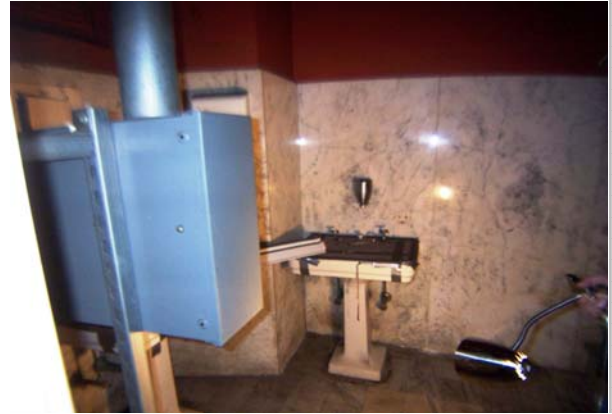
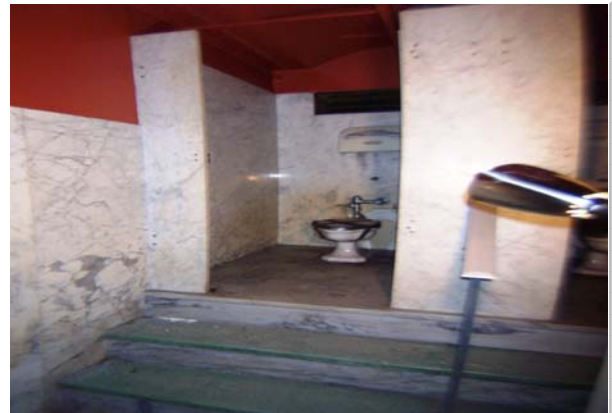
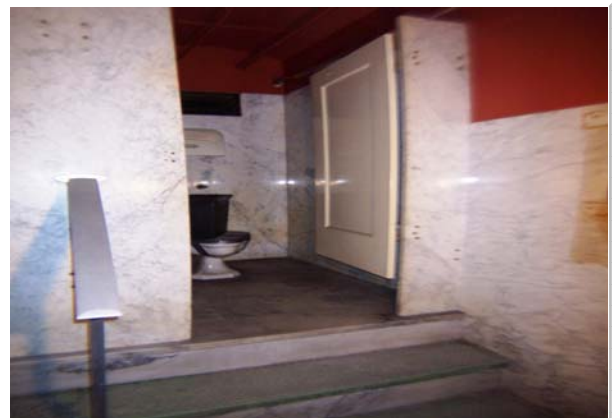
COND SIG	
Space Number	B-30	G	C
Space Name	Toilet E, basement		
Space Dimensions	hall 2'8"x13' 9"7" restroom 7'7"x14'7" 9'7"		
N Wall Finish	concrete plaster	G	C
E Wall Finish	concrete plaster and partition	G	C
S Wall Finish	concrete plaster	G	C
W Wall Finish	concrete plaster	G	C
Floor Finish	concrete and marble in bathroom	G	C
Ceiling Finish	steel beam and concrete and plaster	G	C
Window Types	awning with shutter	F	VS
Window Hardware	metal	F	VS
Window Trim	metal	F	VS
Door Type	metal glass and wood	G	C
Door Hardware	metal	G	C
Door Frame	metal	G	C
Door Threshold	none		
Trim base & Cornice	none		
Millwork bookcases	none		
Millwork paneling	none		
Millwork wainscot	none		
Skylights	none		
Fireplaces	none		
Electrical lighting	hanging bulb	G	NC
Electrical switches	push button	F	NC
Electrical outlets	modern	G	NC
Plumbing lavatories	womens two sinks and two toilets	G	NC
Plumbing toilets	porcelain		
Plumbing urinals	none

Plumbing accessories	none		
Plumbing partitions	marble and wood doors	G	C
Fire protection	none		
Mechanical grilles	over toilet		
Mechanical diffusers	none		
Visible piping or ducts	pipes and ducts		
Signage	none		
Miscellaneous

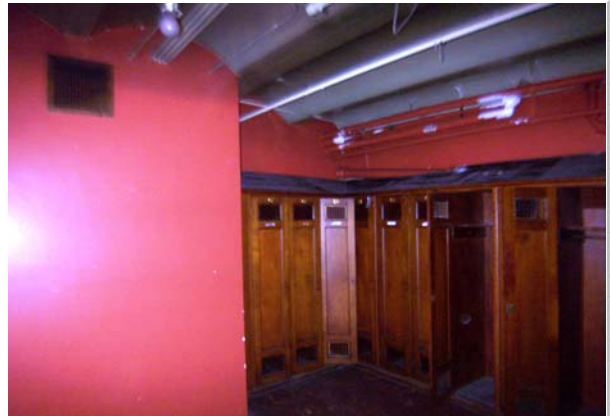
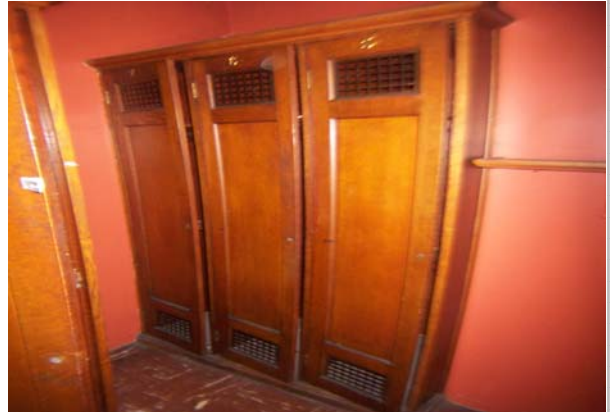
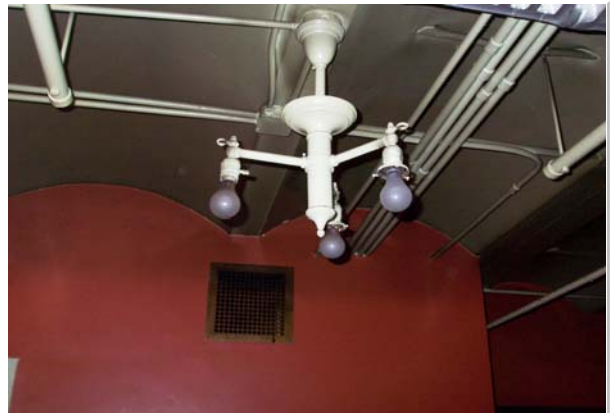
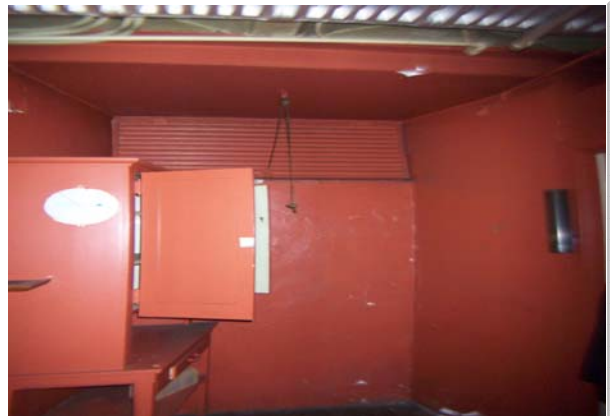
COND SIG	
Space Number	B-31	G	C
Space Name	Women's locker room		
Space Dimensions	13'2"x12'11" 9'7"ceiling		
N Wall Finish	concrete plaster	G	C
E Wall Finish	partition	F	C
S Wall Finish	concrete plaster	G	C
W Wall Finish	concrete plaster	G	C
Floor Finish	concrete plaster	G	C
Ceiling Finish	concrete steel beam	G	C
Window Types	awning with shutter	F	VS
Window Hardware	metal	F	VS
Window Trim	metal	F	VS
Door Type	wood	G	C
Door Hardware	metal	G	C
Door Frame	wood	G	NC
Door Threshold	none		
Trim base & Cornice	none		
Millwork bookcases	none		
Millwork paneling	none		
Millwork wainscot	none		
Skylights	none		
Fireplaces	none		
Electrical lighting	old hanging fixture	F	
Electrical switches	none		
Electrical outlets	modern		
Plumbing lavatories	none		
Plumbing toilets	none		
Plumbing urinals	none		
Plumbing accessories	none		
Plumbing partitions	none		
Fire protection	none		
Mechanical grilles	east wall		
Mechanical diffusers	none

Visible piping or ducts	none		
Signage	none		
Miscellaneous	oak wood lockers from 35' remodel	G	C

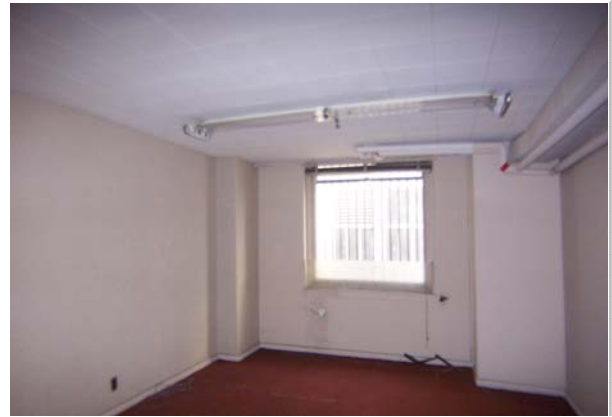
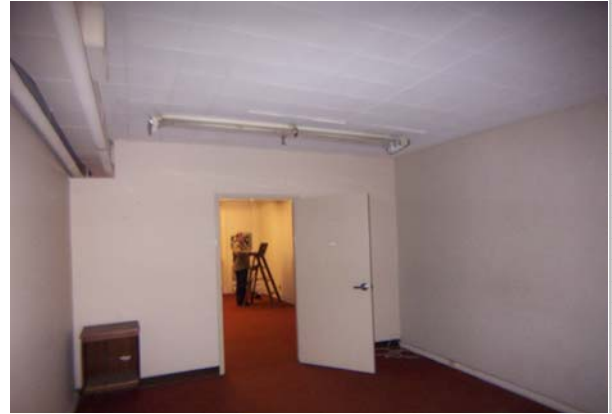
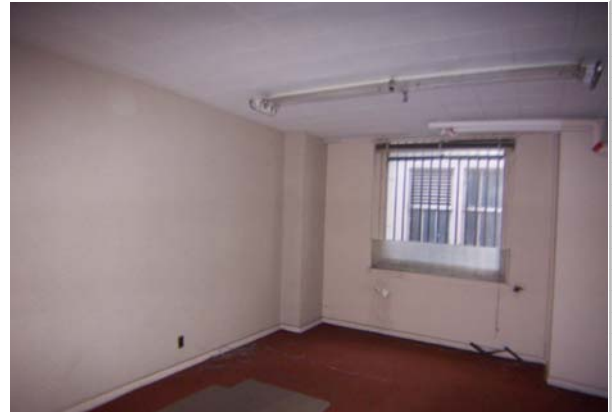
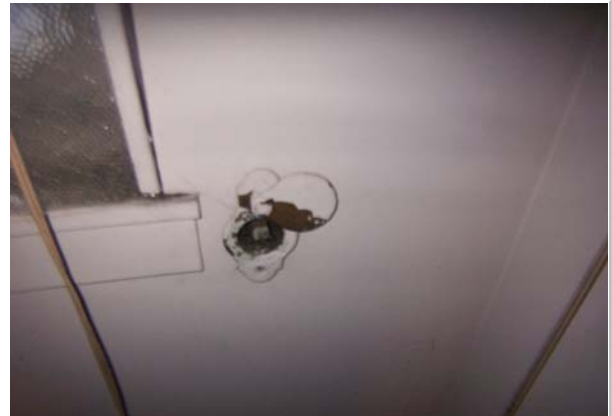
COND SIG	
Space Number	F-1	G	NC
Space Name	Office NW 1st Flr		
Space Dimensions	18'-8" x 12'-5"		
N Wall Finish	plaster with wood baseboard	G	C
E Wall Finish	sheetrock with plastic baseboard	P	NC
S Wall Finish	wallpaper over plaster with wood baseboard	G	NC
W Wall Finish	plaster with wood baseboard	G	C
Floor Finish	carpet	P	NC
Ceiling Finish	acoustic tile	F	NC
Window Types	metal, lower sash of double-hung window	G	VS
Window Hardware	brass, hand crank for window shutters	G	VS
Window Trim	brass	G	VS
Door Type	contemporary metal	G	NC
Door Hardware	modern	G	NC
Door Frame	metal	G	NC
Door Threshold	carpet	P	NC
Trim base & Cornice	none		
Millwork bookcases	none		
Millwork paneling	none		
Millwork wainscot	none		
Skylights	none		
Fireplaces	none		
Electrical lighting	fluorescent tube fixtures	F	NC
Electrical switches	none		
Electrical outlets	brass plate	G	C
Plumbing lavatories	none		
Plumbing toilets	none		
Plumbing urinals	none

Plumbing accessories	none		
Plumbing partitions	none		
Fire protection	none		
Mechanical grilles	none		
Mechanical diffusers	none		
Visible piping or ducts	modern air ducts, piping	F	NC
Signage			
Miscellaneous	room is partitioned

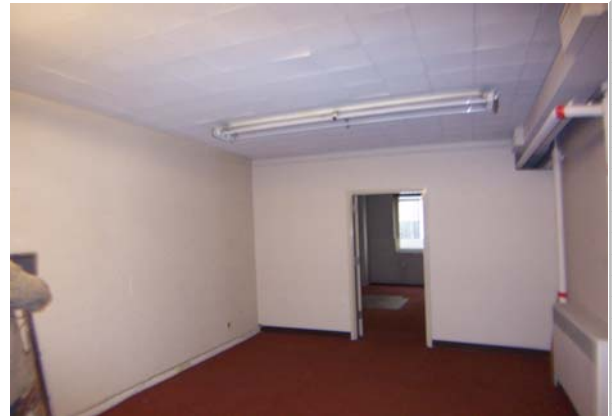
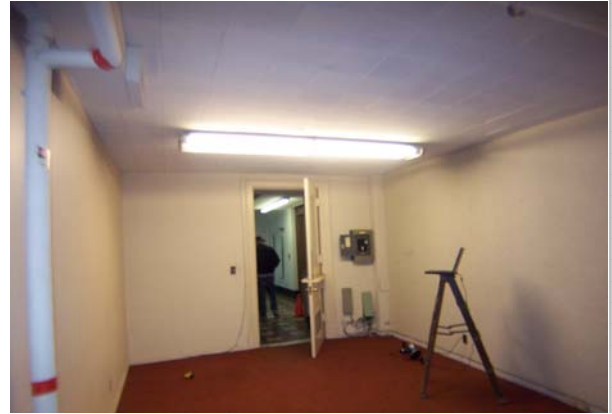
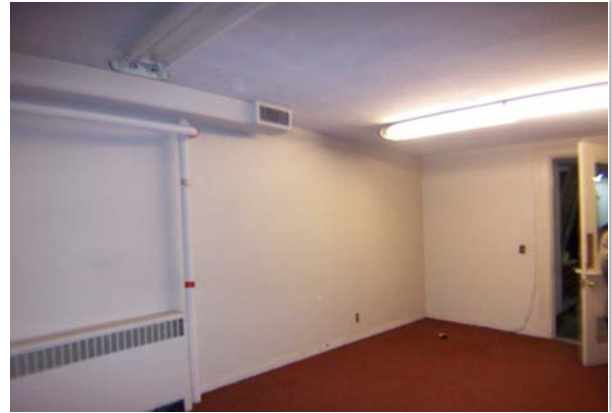
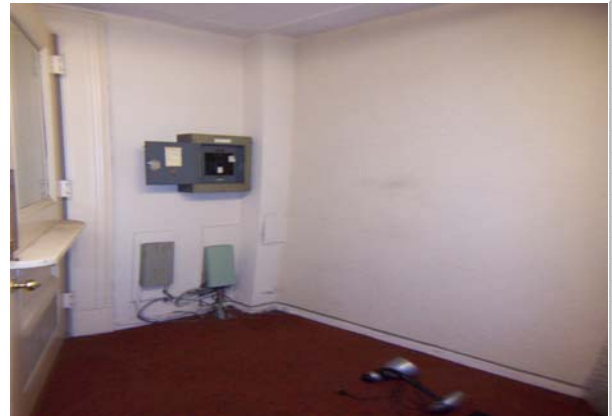
COND SIG	
Space Number	F-2	G	NC
Space Name	Secretary 1st Flr		
Space Dimensions	2-1' x12'-6"		
N Wall Finish	plaster with wood baseboard	G	C
E Wall Finish	plaster with wood baseboard	F	C
S Wall Finish	wallpaper over plaster with wood baseboard	G	NC
W Wall Finish	sheetrock with plastic baseboard	G	NC
Floor Finish	carpet	P	NC
Ceiling Finish	acoustic tile	P	NC
Window Types	none		
Window Hardware	none		
Window Trim	none		
Door Type	metal Dutch door with clear glazing on top	G	NC
Door Hardware	modern and brass	G	NC
Door Frame	metal	G	C
Door Threshold	marble	G	C
Trim base & Cornice	none		
Millwork bookcases	none		
Millwork paneling	none		
Millwork wainscot	none		
Skylights	none		
Fireplaces	none		
Electrical lighting	fluorescent tube light fixtures	P	NC
Electrical switches	brass plate	G	C
Electrical outlets	modern outlets and brass plates; breaker	P	NC
Plumbing lavatories	none		
Plumbing toilets	none		
Plumbing urinals	none

Plumbing accessories	pipes on west wall		
Plumbing partitions	none		
Fire protection	none		
Mechanical grilles	none		
Mechanical diffusers	none		
Visible piping or ducts	radiator and modern air ducts	P	NC
Signage	none		
Miscellaneous

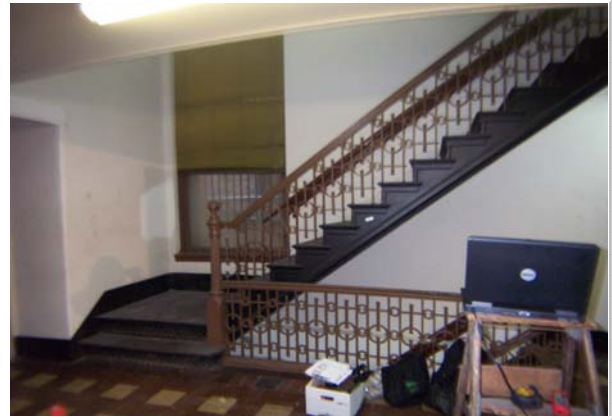
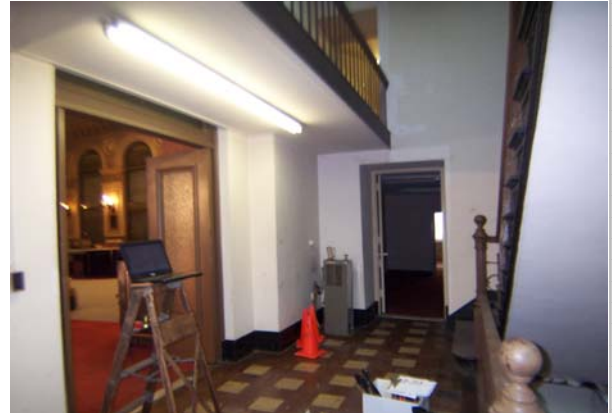
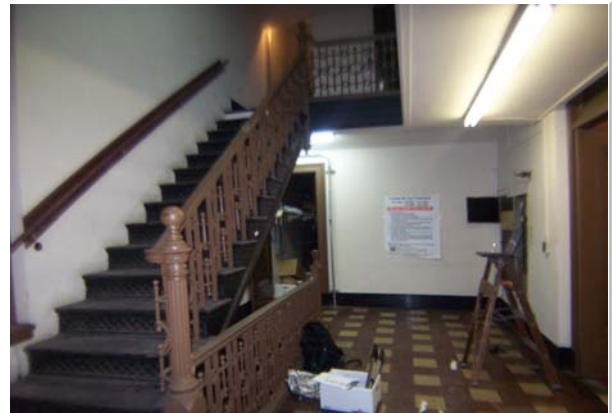
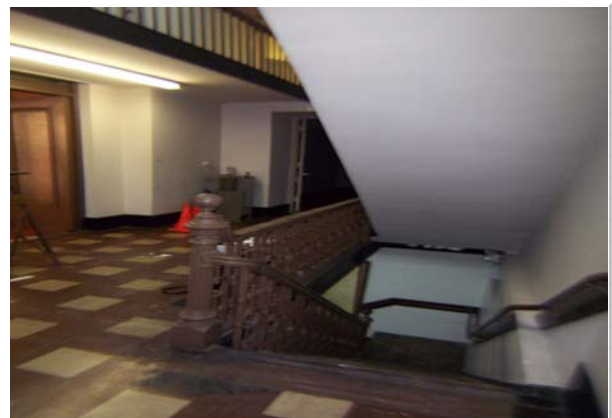
COND SIG	
Space Number	F-3	G	S
Space Name	Stairs No 2 1st Flr		
Space Dimensions	21'10" x 12' 8"		
N Wall Finish	plaster with black slate baseboard	F	S
E Wall Finish	plaster with black slate baseboard	G	S
S Wall Finish	plaster with black slate baseboard	G	S
W Wall Finish	plaster with black slate baseboard	G	S
Floor Finish	mastic tile	G	S
Ceiling Finish	plaster, wood trim on south side vaulted on	G	S
Window Types	1/1 double-hung brass; slit window wood	G	VS
Window Hardware	brass on double-hung; metal on slit	G	VS
Window Trim	brass on double-hung, wood on slit window	G	VS
Door Type	south: brass double door with opaque	E	VS
Door Hardware	south brass, west metal, east brass	G	S
Door Frame	south brass, west brass, east brass	E	S
Door Threshold	marble and brass plates on main entrance	E	S
Trim base & Cornice	none		
Millwork bookcases	none		
Millwork paneling	none		
Millwork wainscot	none		
Skylights	none		
Fireplaces	none

Electrical lighting	fluorescent tube light fixtures	F	NC
Electrical switches	breaker box with decorative metal door,	F	C
Electrical outlets	modern with exposed conduit	G	NC
Plumbing lavatories	none		
Plumbing toilets	none		
Plumbing urinals	none		
Plumbing accessories	water fountain	P	NC
Plumbing partitions	none		
Fire protection	none		
Mechanical grilles	none		
Mechanical diffusers	none		
Visible piping or ducts	water spigot for fire hose (no fire hose)	E	C
Signage			
Miscellaneous	cast iron stair stairs and decorative railing	G	S

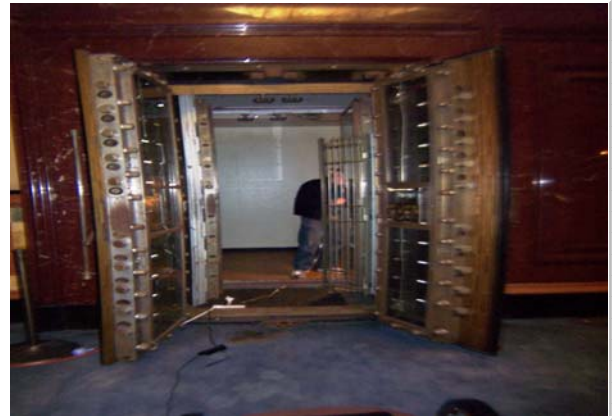
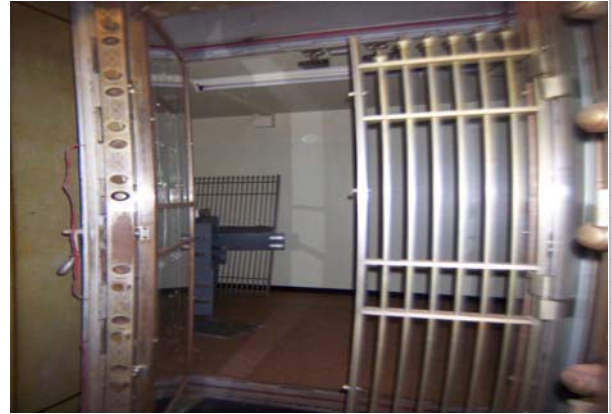
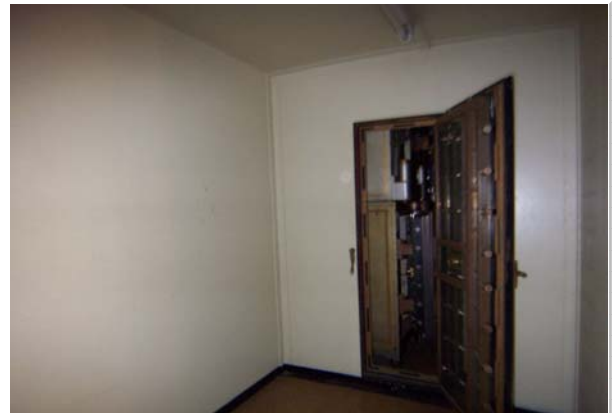
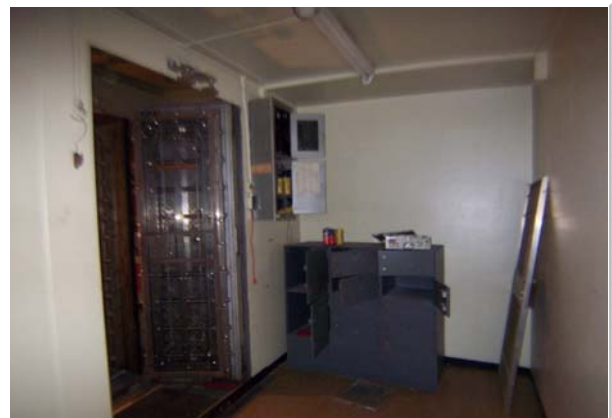
COND SIG	
Space Number	F-4	G	S
Space Name	Vault		
Space Dimensions	7'3" x 14'10"		
N Wall Finish	lined with steel	G	C
E Wall Finish	lined with steel	G	C
S Wall Finish	lined with steel	G	C
W Wall Finish	lined with steel	G	C
Floor Finish	lined with steel	G	C
Ceiling Finish	lined with steel	G	C
Window Types	none		
Window Hardware	none		
Window Trim	none		
Door Type	double steel doors with gate	G	VS
Door Hardware	steel	G	VS
Door Frame	steel	G	VS
Door Threshold	steel	G	VS
Trim base & Cornice	none		
Millwork bookcases	none		
Millwork paneling	none		
Millwork wainscot	none		
Skylights	none		
Fireplaces	none		
Electrical lighting	florescent tube fixtures	G	NC
Electrical switches	modern switches	G	NC
Electrical outlets	modern	G	NC
Plumbing lavatories	none		
Plumbing toilets	none		
Plumbing urinals	none		
Plumbing accessories	none		
Plumbing partitions	none		
Fire protection	none		
Mechanical grilles	none		
Mechanical diffusers	none

Visible piping or ducts	none		
Signage	none		
Miscellaneous	modern alarm system

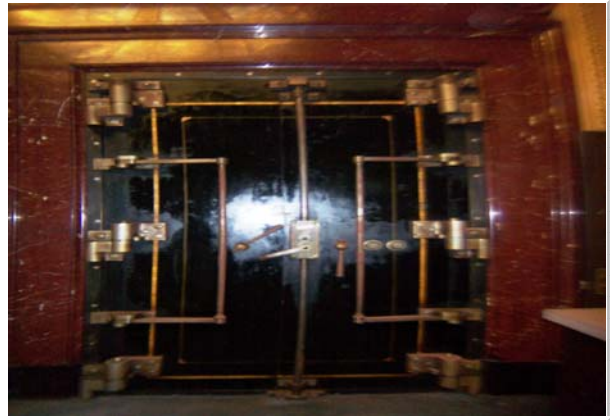
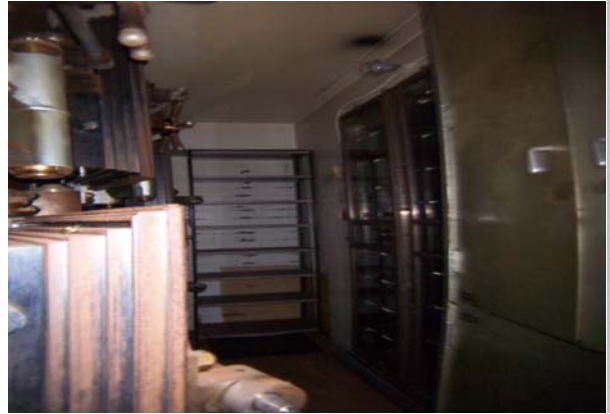
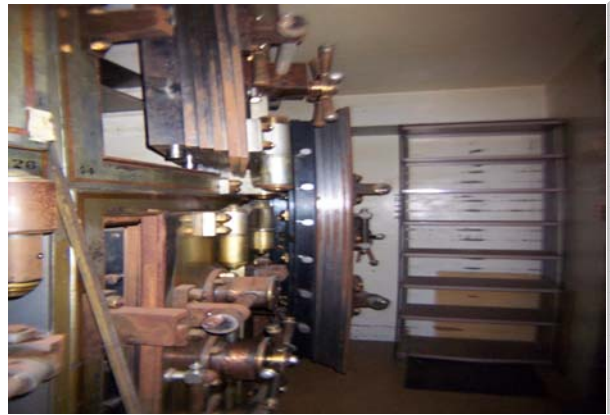
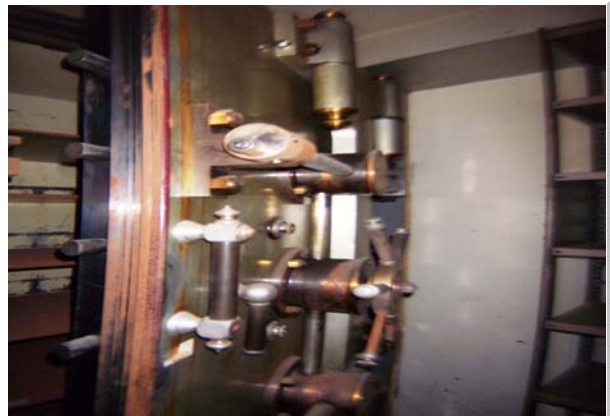
COND SIG	
Space Number	F-5	G	S
Space Name	Vault 1st Flr		
Space Dimensions	7'3" x 14'10"		
N Wall Finish	lined with steel	G	C
E Wall Finish	lined with steel	G	C
S Wall Finish	lined with steel	G	C
W Wall Finish	lined with steel	G	C
Floor Finish	lined with steel	G	C
Ceiling Finish	lined with steel	G	C
Window Types	none		
Window Hardware	none		
Window Trim	none		
Door Type	double steel doors	E	VS
Door Hardware	steel	E	VS
Door Frame	steel	E	VS
Door Threshold	steel	E	S
Trim base & Cornice	none		
Millwork bookcases	none		
Millwork paneling	none		
Millwork wainscot	none		
Skylights	none		
Fireplaces	none		
Electrical lighting	modern	G	NC
Electrical switches	modern	G	NC
Electrical outlets	modern	G	NC
Plumbing lavatories	none		
Plumbing toilets	none		
Plumbing urinals	none		
Plumbing accessories	none		
Plumbing partitions	none		
Fire protection	none		
Mechanical grilles	none		
Mechanical diffusers	none		
Visible piping or ducts	none

Signage	none		
Miscellaneous	several smaller vaults inside	G	C

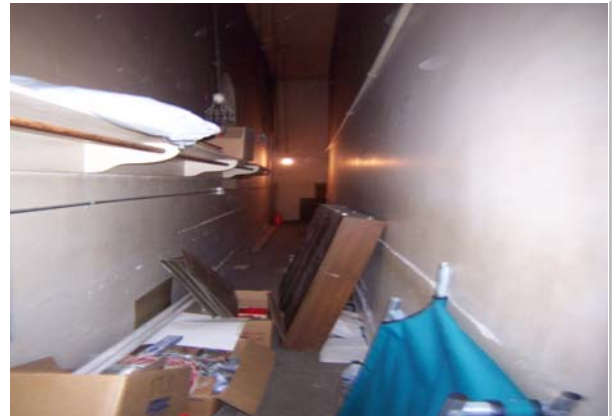
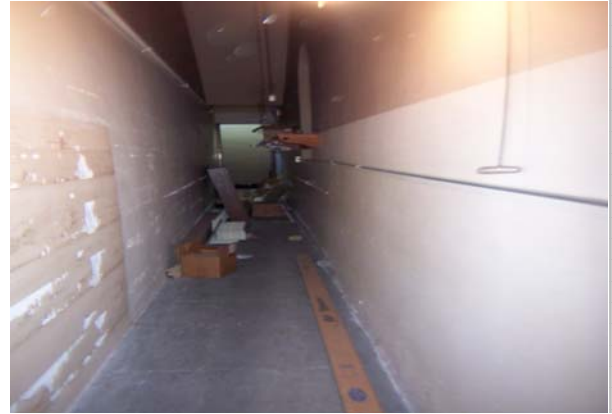
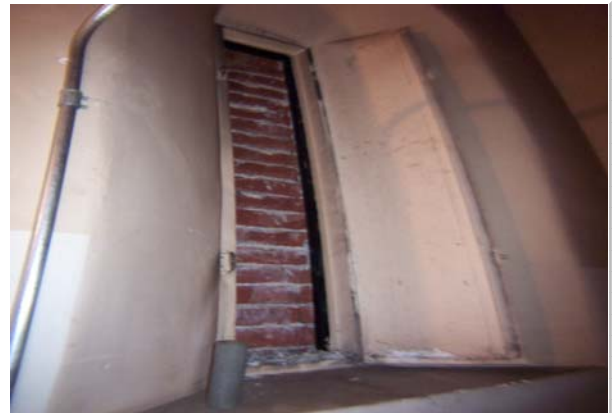
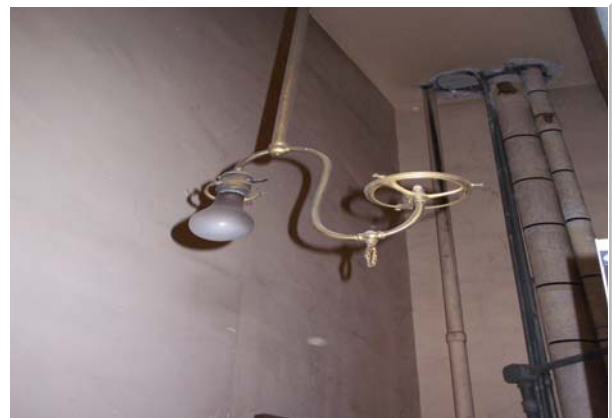
COND SIG	
Space Number	F-6	G	NC
Space Name	Storage-Vault Gallery		
Space Dimensions	34'7" x 3'5"		
N Wall Finish	plaster	P	C
E Wall Finish	plaster	G	C
S Wall Finish	plaster	G	C
W Wall Finish	plaster	G	C
Floor Finish	concrete	G	C
Ceiling Finish	plaster	F	C
Window Types	slit windows infilled with brick	F	C
Window Hardware	metal	F	C
Window Trim	metal	F	C
Door Type	metal	G	C
Door Hardware	metal	G	C
Door Frame	metal	G	C
Door Threshold	concrete	G	C
Trim base & Cornice	none		
Millwork bookcases	none		
Millwork paneling	none		
Millwork wainscot	none		
Skylights	none		
Fireplaces	none		
Electrical lighting	hanging light fixtures, converted gas to	G	S
Electrical switches	modern	F	NC
Electrical outlets	modern with exposed conduit	F	NC
Plumbing lavatories	none		
Plumbing toilets	none		
Plumbing urinals	none		
Plumbing accessories	none		
Plumbing partitions	none		
Fire protection	none		
Mechanical grilles	none		
Mechanical diffusers	none

Visible piping or ducts		F	NC
Signage			
Miscellaneous	breaker boxes, shelf and coat rack on west wall	G	NC

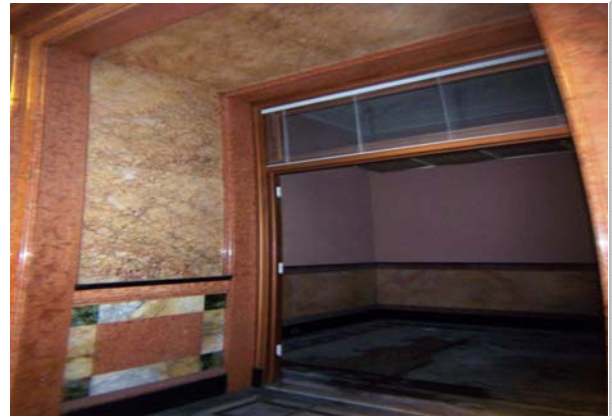
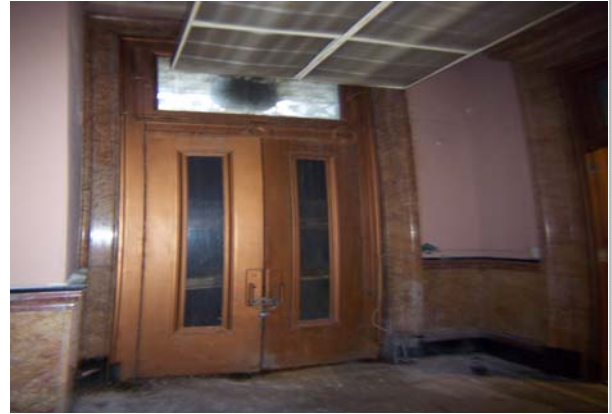
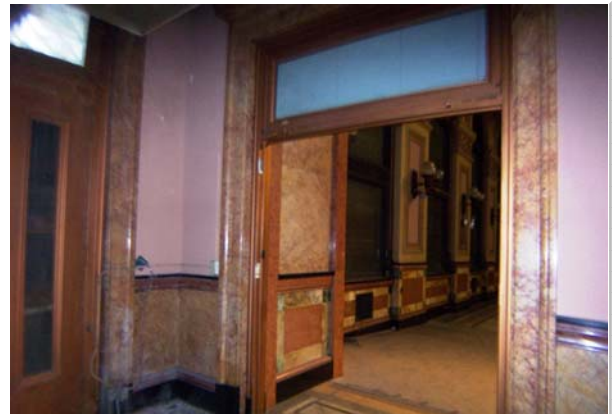
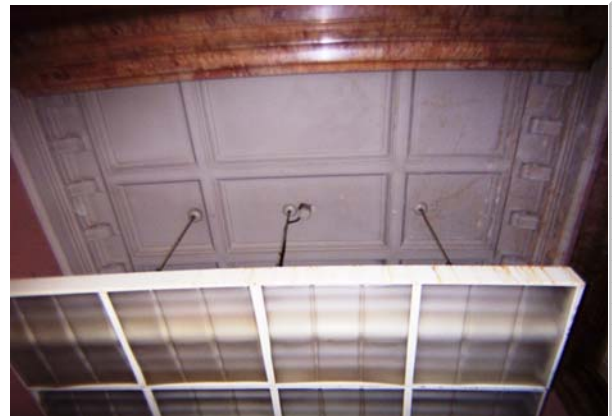
COND SIG	
Space Number	F-7	F	VS
Space Name	Main Entry NE 1st Flr		
Space Dimensions	10' x12'5"		
N Wall Finish	marble, Cork Red cap, St. Baume, Belgian	E	VS
E Wall Finish	marble, Cork Red cap, St. Baume, Belgian	F	VS
S Wall Finish	marble, Cork Red cap, St. Baume, Belgian	F	VS
W Wall Finish	marble, Cork Red cap, St. Baume, Belgian	F	VS
Floor Finish	marble	G	VS
Ceiling Finish	plaster with plaster brackets and beams	P	VS
Window Types	two transoms interior and exterior	G	VS
Window Hardware	metal	G	VS
Window Trim	metal	G	VS
Door Type	partially glazed, bronze and metal, double	G	VS
Door Hardware	metal	G	VS
Door Frame	metal	G	VS
Door Threshold	marble	G	VS
Trim base & Cornice	none		
Millwork bookcases	none		
Millwork paneling	none		
Millwork wainscot	none		
Skylights	none		
Fireplaces	none		
Electrical lighting	fluorescent hanging fixture	G	NC
Electrical switches	modern	G	NC
Electrical outlets	modern with exposed conduit	G	NC

Plumbing lavatories	none		
Plumbing toilets	none		
Plumbing urinals	none		
Plumbing accessories	none		
Plumbing partitions	none		
Fire protection	none		
Mechanical grilles	none		
Mechanical diffusers	none		
Visible piping or ducts	none		
Signage	none		
Miscellaneous	none

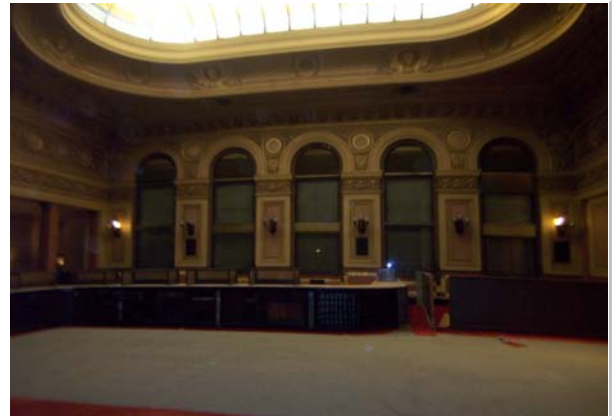
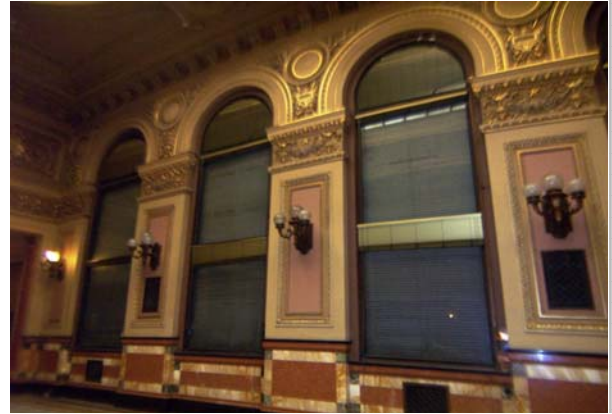
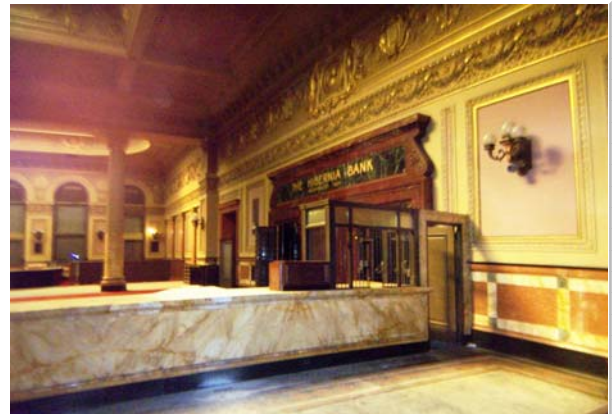
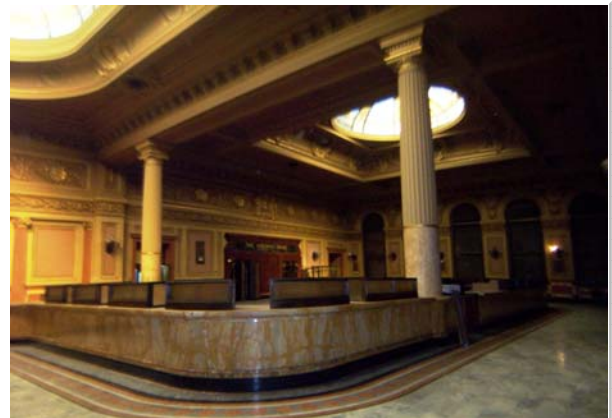
COND	SIG
Space Number	F-8	E	VS
Space Name	Great Hall		
Space Dimensions	35' ceiling 111'7" x 67'5"		
N Wall Finish	plaster and marble (elaborate)	E	VS
E Wall Finish	plaster and marble (elaborate)	E	VS
S Wall Finish	plaster plaster chair rail and plaster molding	E	VS
W Wall Finish	plaster and marble (elaborate)	E	VS
Floor Finish	marble inlaid, carpet in teller area (P, NC)	G	VS
Ceiling Finish	plaster elaborate	E	VS
Window Types	1/1 double hung metal sash metal with	G	VS
Window Hardware	metal and metal hand cranks for shutters	G	VS
Window Trim	metal	E	VS
Door Type	metal, partially glazed with transoms, metal	E	VS
Door Hardware	metal	G	VS
Door Frame	metal	E	VS
Door Threshold	marble	E	VS
Trim base & Cornice	cabinets for tellers different grade wood	G	VS
Millwork bookcases	none		
Millwork paneling	none		
Millwork wainscot	none		
Skylights	ellipse and round domes	G	VS
Fireplaces	none		
Electrical lighting	wall sconces, lighting runs under the teller	E	VS

Electrical switches	modern for modern lighting	G	NC
Electrical outlets	modern exposed conduit	G	NC
Plumbing lavatories	none		
Plumbing toilets	none		
Plumbing urinals	none		
Plumbing accessories	none		
Plumbing partitions	none		
Fire protection	water spigot, no hose	G	C
Mechanical grilles	several	G	C
Mechanical diffusers	none		
Visible piping or ducts	capped gas for radiators	F	C
Signage	modern exit sign	G	NC
Miscellaneous	teller counters wood and marble built in seats, decorative glass on county side metal decorative gates and cage with metal door, metal railing near elevator and downstairs safe deposit stairs		VS

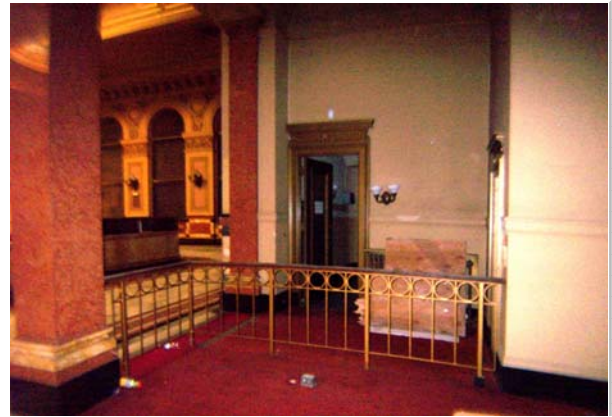
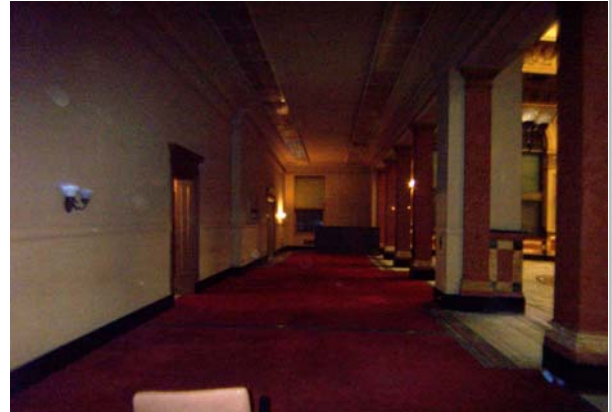
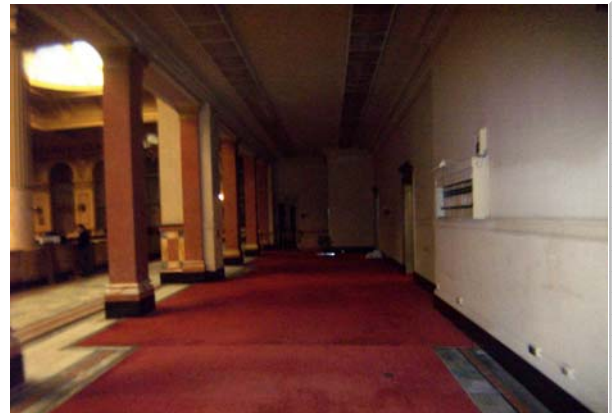
COND SIG	
Space Number	F-9	E	VS
Space Name	Customer waiting area1st Floor		
Space Dimensions	15'9" ceiling 16'5" x 77'7"		
N Wall Finish	in great hall six square columns define the	E	VS
E Wall Finish	plaster with plaster chair rail, black marble	E	VS
S Wall Finish	plaster with plaster chair rail black marble	E	VS
W Wall Finish	plaster with plaster chair rail, black marble	E	VS
Floor Finish	marble	E	VS
Ceiling Finish	plaster, plaster molding	E	VS
Window Types	1/1 double hung metal sash	G	VS
Window Hardware	metal	G	VS
Window Trim	metal with cap over doors	G	VS
Door Type	metal with opaque glass	E	VS
Door Hardware	metal	G	VS
Door Frame	metal	E	VS
Door Threshold	marble	E	VS
Trim base & Cornice	none		
Millwork bookcases	none		
Millwork paneling	none		
Millwork wainscot	none		
Skylights	none		
Fireplaces	none		
Electrical lighting	fluorescent tube light fixtures and historic	E	VS
Electrical switches	modern	G	NC
Electrical outlets	modern with exposed conduit	G	NC

Plumbing lavatories	none		
Plumbing toilets	none		
Plumbing urinals	none		
Plumbing accessories	none		
Plumbing partitions	none		
Fire protection	none		
Mechanical grilles	none		
Mechanical diffusers	none		
Visible piping or ducts	none		
Signage	none		
Miscellaneous	none

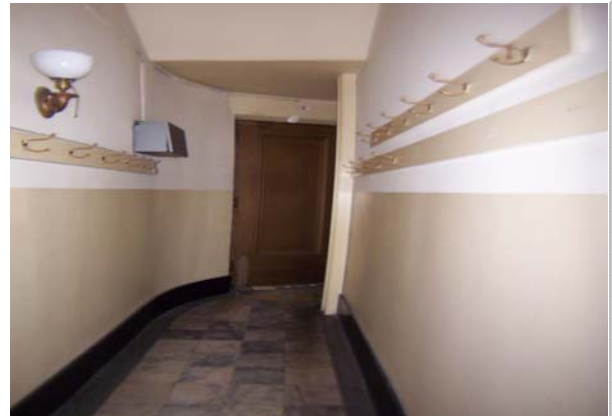
COND SIG	
Space Number	F-10	G	C
Space Name	foyer and stairs 1st flr		
Space Dimensions	15'9" x 3'7"		
N Wall Finish	plaster with black baseboard	G	C
E Wall Finish	plaster with black baseboard	G	C
S Wall Finish	plaster with black baseboard	G	C
W Wall Finish	plaster with black baseboard	G	C
Floor Finish	marble	E	S
Ceiling Finish	plaster	G	C
Window Types	none		
Window Hardware	none		
Window Trim	none		
Door Type	metal	G	S
Door Hardware	metal	G	S
Door Frame	metal	G	S
Door Threshold	marble	E	S
Trim base & Cornice	none		
Millwork bookcases	none		
Millwork paneling	none		
Millwork wainscot	none		
Skylights	none		
Fireplaces	none		
Electrical lighting	wall sconce	G	S
Electrical switches	modern	G	NC
Electrical outlets	modern with exposed conduit	G	NC
Plumbing lavatories	none		
Plumbing toilets	none		
Plumbing urinals	none		
Plumbing accessories	none		
Plumbing partitions	none		
Fire protection	none		
Mechanical grilles	none		
Mechanical diffusers	none

Visible piping or ducts	none	G	NC
Signage	safe deposits/vaults south and west wall	E	S
Miscellaneous	coat racks, breaker boxes, alarm box cable telegraph box, marble risers cast iron stairs with decorative metal rail	G	C
