# SAN FRANCISCO PLANNING DEPARTMENT

**MEMO**

**RE:** Review and Comment for 1 Jones Street (former Hibernia Bank)  
Case No. 2011.0617EA

**HIBERNIA BANK BUILDING**

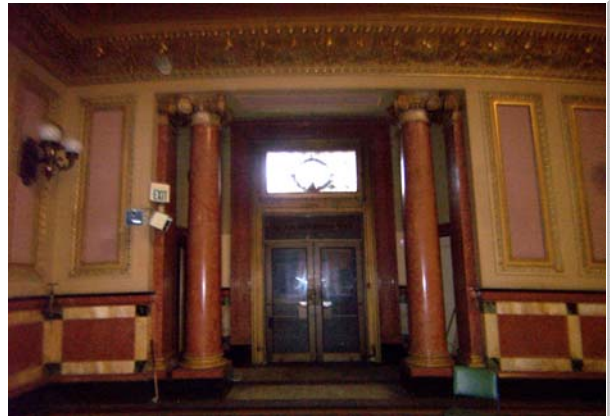
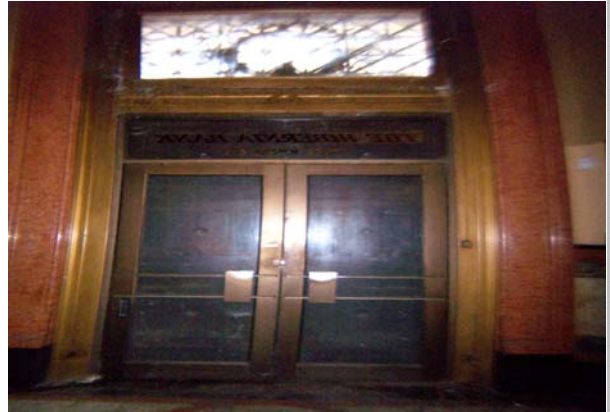
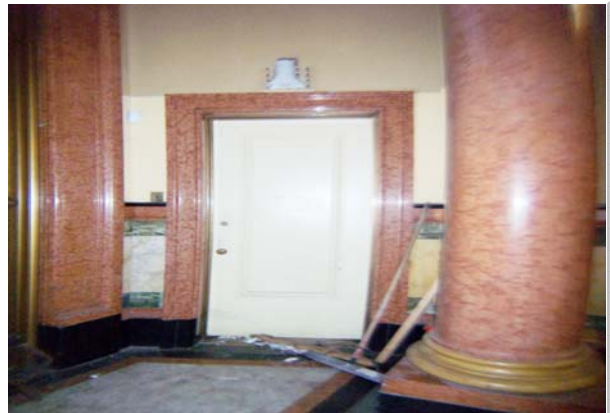
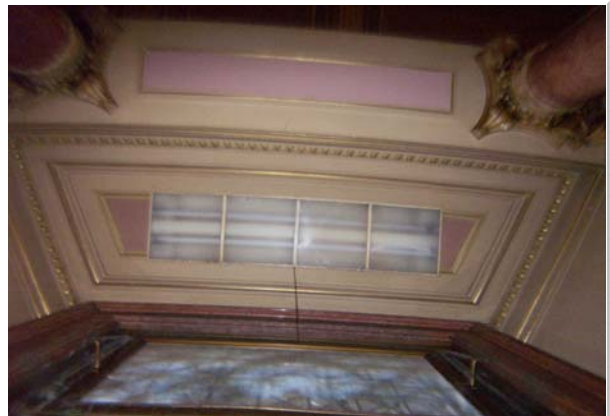
COND SIG	
Space Number	F-11	G	VS
Space Name	Foyer		
Space Dimensions	5'5" x 14'11"		
N Wall Finish	plaster and marble	G	VS
E Wall Finish	plaster and marble	G	VS
S Wall Finish	columns	E	VS
W Wall Finish	plaster and marble	G	VS
Floor Finish	marble	E	VS
Ceiling Finish	plaster	G	VS
Window Types	transom with mechanism for opening	G	VS
Window Hardware	metal	G	S
Window Trim	metal	G	VS
Door Type	partially glazed, metal double doors	G	VS
Door Hardware	metal	G	S
Door Frame	metal with marble surround	E	VS
Door Threshold	marble	G	S
Trim base & Cornice	none		
Millwork bookcases	none		
Millwork paneling	none		
Millwork wainscot	none		
Skylights	none		
Fireplaces	none		
Electrical lighting	fluorescent tube hanging fixture	G	NC
Electrical switches	modern	G	NC
Electrical outlets	modern	G	NC
Plumbing lavatories	none		
Plumbing toilets	none		
Plumbing urinals	none		
Plumbing accessories	none		
Plumbing partitions	none		
Fire protection	none

Mechanical grilles	none		
Mechanical diffusers	none		
Visible piping or ducts	none		
Signage	on transom: The Hibernia Bank 1 Jones St.	G	VS
Miscellaneous

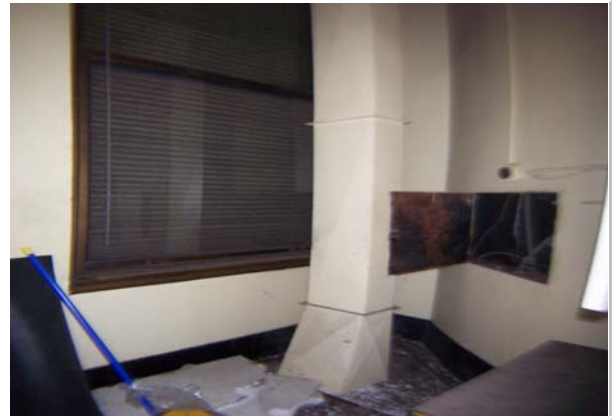
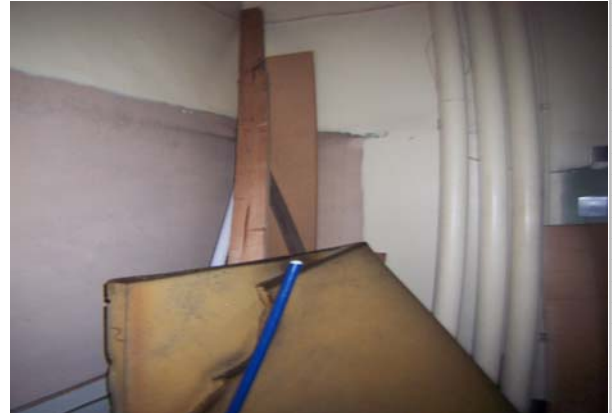
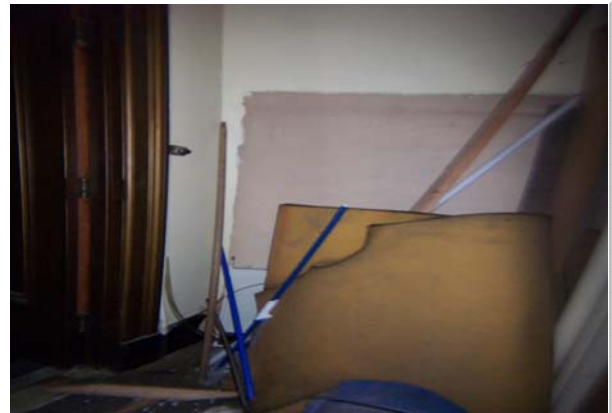
COND SIG	
Space Number	F-12	G	NC
Space Name	Security Office 1st flr		
Space Dimensions	5'8" x 10'2"		
N Wall Finish	plaster with black baseboard	G	NC
E Wall Finish	plaster with black baseboard	G	NC
S Wall Finish	plaster with black baseboard	G	NC
W Wall Finish	plaster with black baseboard	G	NC
Floor Finish	concrete	G	NC
Ceiling Finish	plaster	P	
Window Types	1/1 double-hung, metal	G	S
Window Hardware	metal	G	S
Window Trim	metal	G	S
Door Type	metal	G	S
Door Hardware	metal	G	S
Door Frame	metal	G	S
Door Threshold	marble	G	S
Trim base & Cornice	none		
Millwork bookcases	none		
Millwork paneling	none		
Millwork wainscot	none		
Skylights	none		
Fireplaces	none		
Electrical lighting	modern ceiling fixture	F	NC
Electrical switches	modern	G	C
Electrical outlets	modern with exposed conduit	G	NC
Plumbing lavatories	none		
Plumbing toilets	none		
Plumbing urinals	none		
Plumbing accessories	none		
Plumbing partitions	none		
Fire protection	none

Mechanical grilles	none		
Mechanical diffusers	none		
Visible piping or ducts	pipes east wall		
Signage	none		
Miscellaneous	none

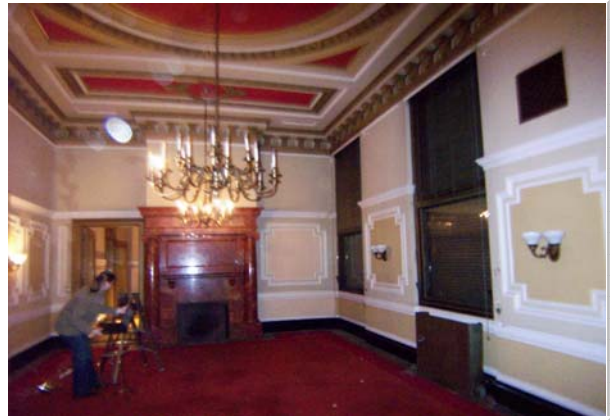
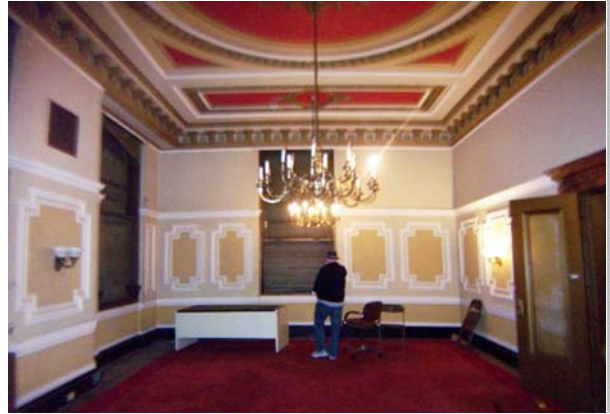
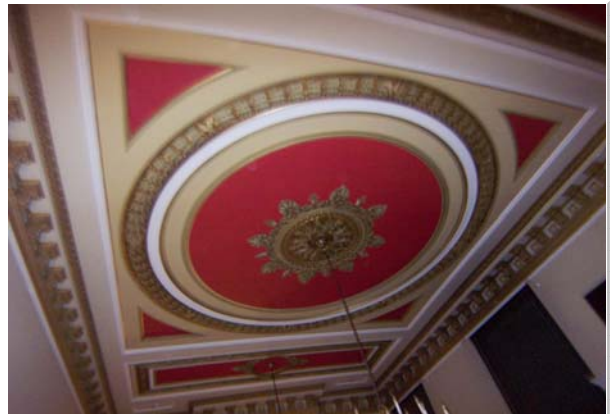
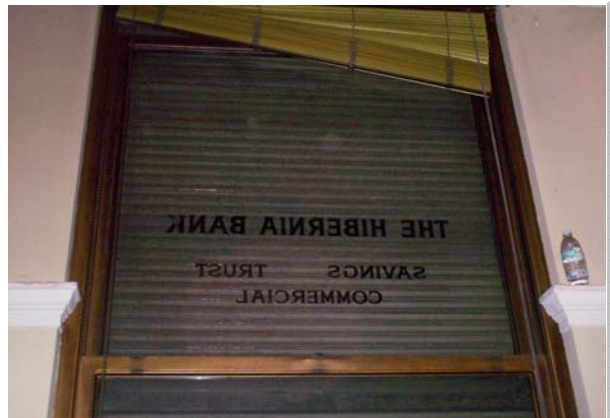
COND	SIG
Space Number	F-13	G	VS
Space Name	Meeting Rm 1st Flr SW		
Space Dimensions	30' x19' 15'9" ceiling		
N Wall Finish	plaster with plaster paneling, black slate	G	VS
E Wall Finish	plaster plaster panel black slate baseboard	G	VS
S Wall Finish	plaster plaster panel black slate baseboard	G	VS
W Wall Finish	plaster plaster panel black slate baseboard	G	VS
Floor Finish	marble	E	VS
Ceiling Finish	plaster and decorative plaster	E	VS
Window Types	1/1 double hung brass sash	G	VS
Window Hardware	metal	G	VS
Window Trim	metal	E	VS
Door Type	metal, marble surround and cap on double	E	VS
Door Hardware	brass	G	VS
Door Frame	metal	G	VS
Door Threshold	marble	E	VS
Trim base & Cornice	none		
Millwork bookcases	none		
Millwork paneling	none		
Millwork wainscot	none		
Skylights	none		
Fireplaces	marble 9' high	E	VS
Electrical lighting	3 contemporary brass chandeliers, wall	E	C/V
Electrical switches	plastic dimmer	G	NC
Electrical outlets	modern brass plate	G	C

Plumbing lavatories	none		
Plumbing toilets	none		
Plumbing urinals	none		
Plumbing accessories	none		
Plumbing partitions	none		
Fire protection	none		
Mechanical grilles	decorative grill on south wall	G	C
Mechanical diffusers	none		
Visible piping or ducts	none		
Signage	window: "The Hibernia Bank Savings Trust	E	VS
Miscellaneous	hand cranks radiator	G	C

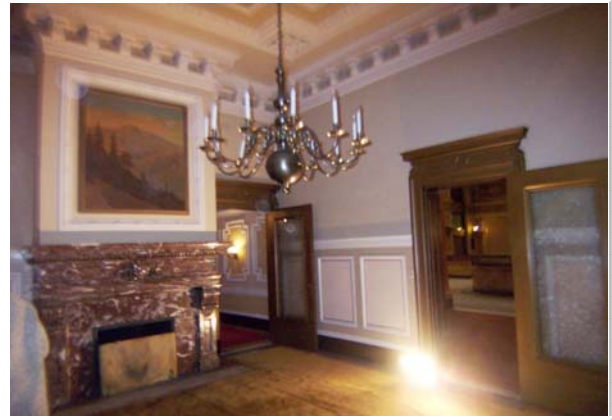
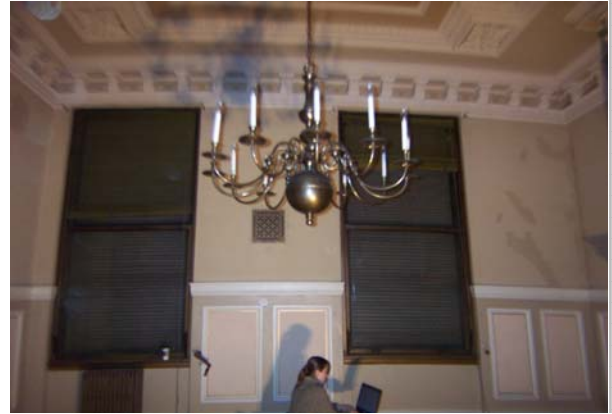
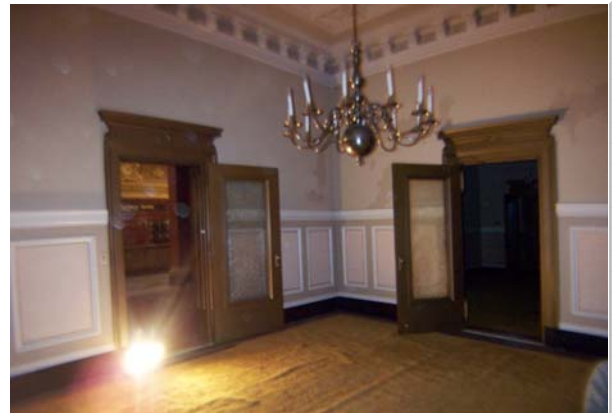
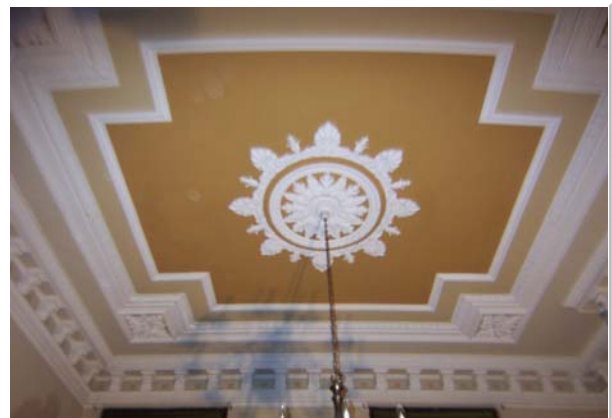
COND	SIG
Space Number	F-14	G	VS
Space Name	Office middle 1st flr		
Space Dimensions	22' x 17'6" 15'9" ceiling		
N Wall Finish	plaster and plaster panels 69" high, black	F	VS
E Wall Finish	plaster and painted plaster panels 69" high	E	VS
S Wall Finish	plaster and painted plaster panels 69" high,	F	VS
W Wall Finish	plaster and painted plaster panels 69" high	E	VS
Floor Finish	marble	E	VS
Ceiling Finish	plaster with decorative plaster	E	VS
Window Types	1/1 double hung metal sash	G	VS
Window Hardware	metal	G	VS
Window Trim	metal	G	VS
Door Type	metal opaque glass metal decorative door	E	VS
Door Hardware	metal	G	VS
Door Frame	metal	E	VS
Door Threshold	marble	E	VS
Trim base & Cornice	none		
Millwork bookcases	none		
Millwork paneling	none see wall description		
Millwork wainscot	none		
Skylights	none		
Fireplaces	marble 6' h		
Electrical lighting	modern brass chandelier	G	NC
Electrical switches	plastic switches	G	NC
Electrical outlets	modern and brass plates	G	C

Plumbing lavatories	none		
Plumbing toilets	none		
Plumbing urinals	none		
Plumbing accessories	noe		
Plumbing partitions	none		
Fire protection	none		
Mechanical grilles	decorative grill south wall above paneling	G	S
Mechanical diffusers			
Visible piping or ducts			
Signage			
Miscellaneous	hand crank for window shutters; radiator south wall	F	S

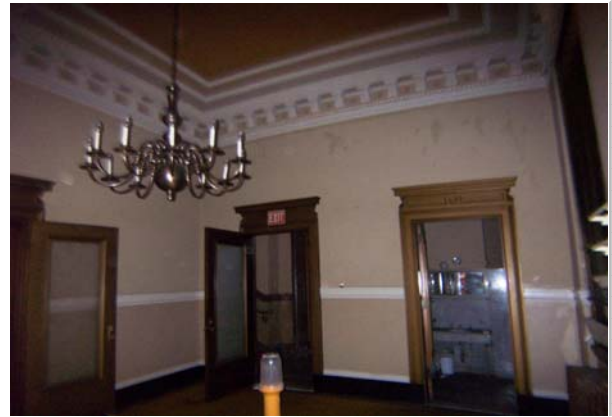
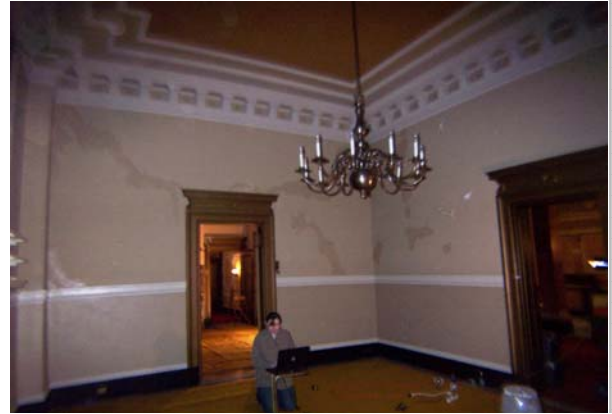
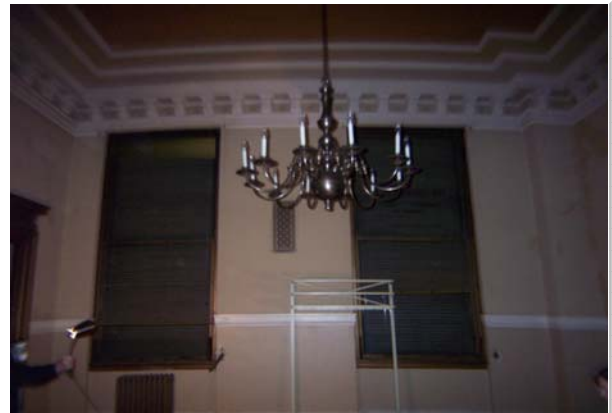
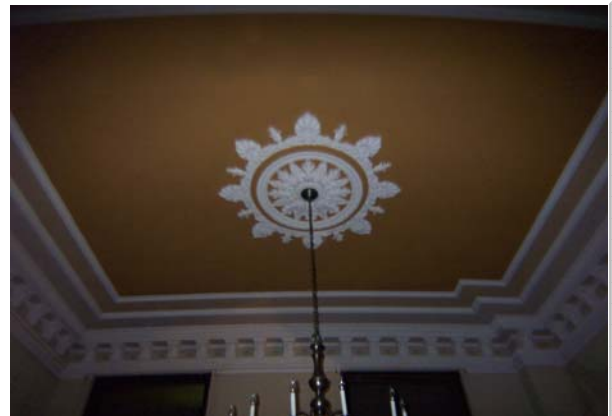
COND SIG	
Space Number	F-15	G	VS
Space Name	Office 1st flr SE and toilet		
Space Dimensions	22'3" x 17'8" ceiling 15'9"		
N Wall Finish	plaster wall, plaster chair rail, black slate	G	VS
E Wall Finish	plaster wall, plaster chair rail, black slate	G	VS
S Wall Finish	plaster wall, plaster chair rail, black slate	G	VS
W Wall Finish	plaster wall, plaster chair rail, black slate	P	VS
Floor Finish	marble	E	VS
Ceiling Finish	plaster decorative ornamentation	E	VS
Window Types	1/1 double hung metal sash, right window	G	VS
Window Hardware	metal	G	VS
Window Trim	metal	G	
Door Type	metal opaque glass brass decorative cap	G	VS
Door Hardware	metal	G	VS
Door Frame	metal	E	VS
Door Threshold	marble	E	VS
Trim base & Cornice	none		
Millwork bookcases	none		
Millwork paneling	none		
Millwork wainscot	none		
Skylights	none		
Fireplaces	none		
Electrical lighting	brass chandelier modern	G	NC
Electrical switches	modern plastic switch	G	NC

Electrical outlets	brass plate and modern	G	C
Plumbing lavatories	marble and chrome	E	C
Plumbing toilets	porcelain	G	C
Plumbing urinals	none		
Plumbing accessories	chrome metal marble medicine cabinet	E	C
Plumbing partitions	marble partitions for toilet	E	C
Fire protection	none		
Mechanical grilles	south wall decorative metal grate	G	C
Mechanical diffusers	none		
Visible piping or ducts	none		
Signage	none see window		
Miscellaneous	hand crank for window shutters and radiator on south wall, thermostat on west wall	G	C

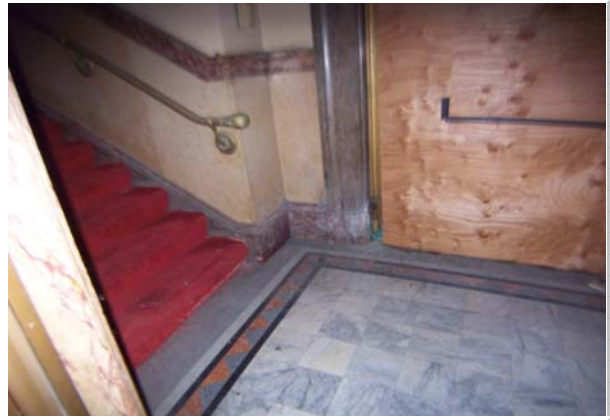
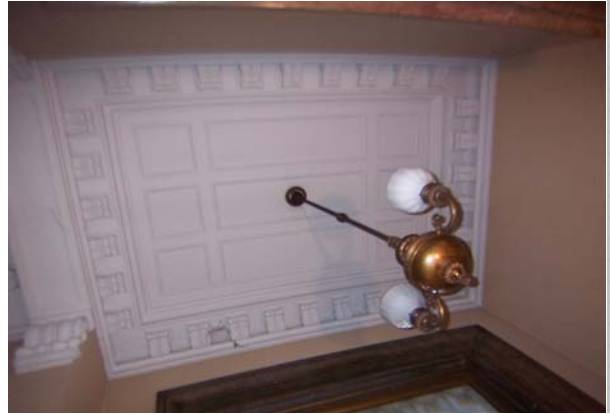
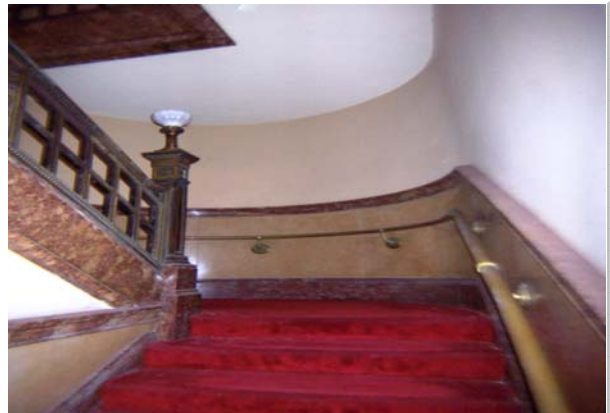
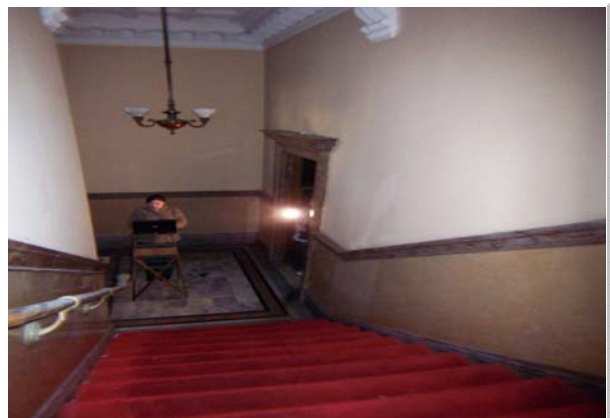
COND SIG	
Space Number	F-16	E	VS
Space Name	stairs 1st floor SE		
Space Dimensions	23'1" x 5'6"		
N Wall Finish	marble wainscoting with plaster	G	VS
E Wall Finish	marble wainscoting with plaster	G	VS
S Wall Finish	marble wainscoting with plaster	G	VS
W Wall Finish	marble wainscoting with plaster	F	VS
Floor Finish	marble/carpet (P, NC)	E	VS
Ceiling Finish	corbel plaster decorative ornamentation	E	VS
Window Types	none		
Window Hardware	none		
Window Trim	none		
Door Type	metal with clear glazing and transom	G	VS
Door Hardware	metal	G	VS
Door Frame	metal, marble surround	E	VS
Door Threshold	marble	E	S
Trim base & Cornice	marble	E	VS
Millwork bookcases	none		
Millwork paneling	none		
Millwork wainscot	marble		
Skylights	none		
Fireplaces	none		
Electrical lighting	ceiling chandelier brass with glass shades	E	VS
Electrical switches	push button brass plate	G	C
Electrical outlets	none		
Plumbing lavatories	none		
Plumbing toilets	none

Plumbing urinals	none		
Plumbing accessories	none		
Plumbing partitions	none		
Fire protection	none		
Mechanical grilles	none		
Mechanical diffusers	none		
Visible piping or ducts	none		
Signage	outside of transom	G	VS
Miscellaneous	transom opens working mechanism, brass handrail on stairs, stairs are carpeted marble wainscoting on wall with plaster

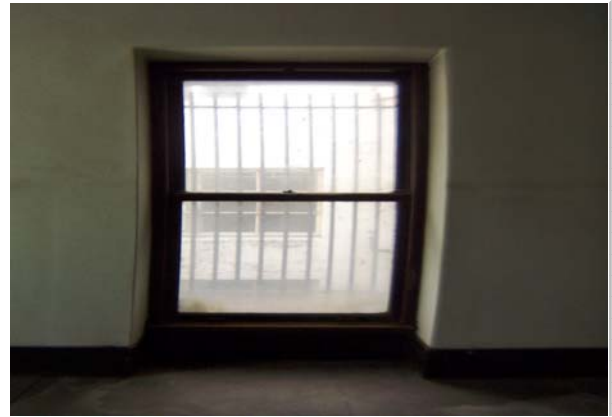
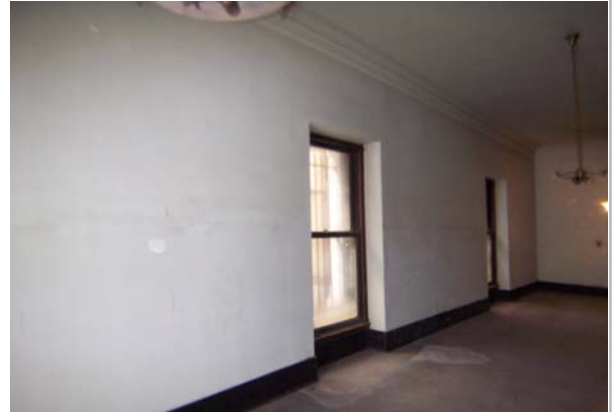
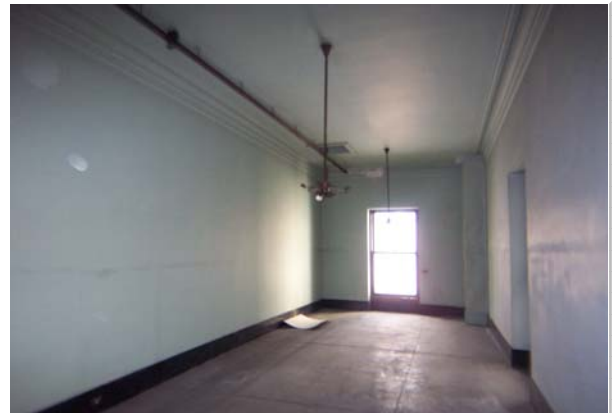
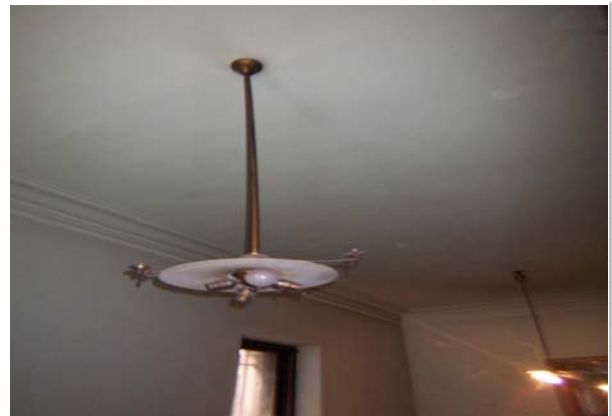
COND SIG	
Space Number	S-1	G	C
Space Name	File Storage 2nd Flr		
Space Dimensions	40' x 12'		
N Wall Finish	plaster with slate baseboard	G	C
E Wall Finish	plaster with slate baseboard	G	C
S Wall Finish	plaster with slate baseboard	P	C
W Wall Finish	plaster with slate baseboard	G	C
Floor Finish	scored concrete	G	C
Ceiling Finish	plaster with plaster crown molding	G	C
Window Types	1/1 double-hung, metal sash	G	VS
Window Hardware	metal	G	VS
Window Trim	metal	G	VS
Door Type	metal and opaque textured glass	G	VS
Door Hardware	metal	G	VS
Door Frame	metal	G	VS
Door Threshold	concrete (removed)	G	C
Trim base & Cornice	none		
Millwork bookcases	none		
Millwork paneling	none		
Millwork wainscot	none		
Skylights	attic hatch with wood surround sw corner	F	NC
Fireplaces	none		
Electrical lighting	3 brass hanging light fixtures converted	G	C
Electrical switches	brass plates push button	F	C
Electrical outlets	brass plates	G	C
Plumbing lavatories	none

Plumbing toilets	none		
Plumbing urinals	none		
Plumbing accessories	none		
Plumbing partitions	none		
Fire protection	none		
Mechanical grilles	none		
Mechanical diffusers	none		
Visible piping or ducts	painted capped gas pipe		
Signage	none		
Miscellaneous	pulley system length of room left side one roller still intact floor plate missing	G	C

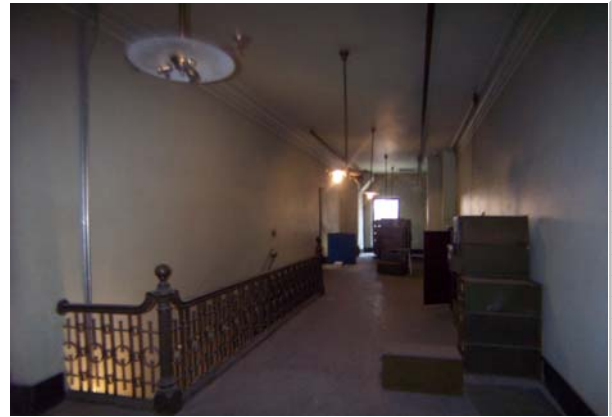
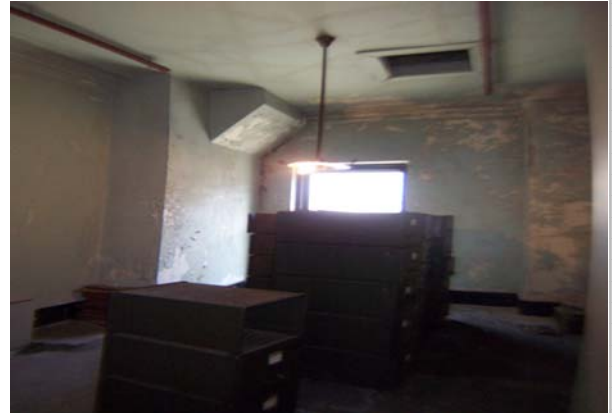
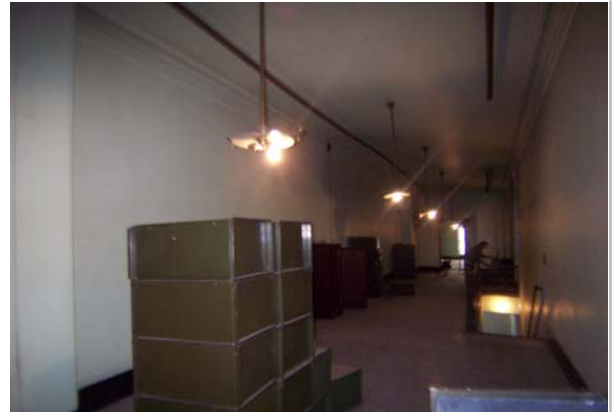
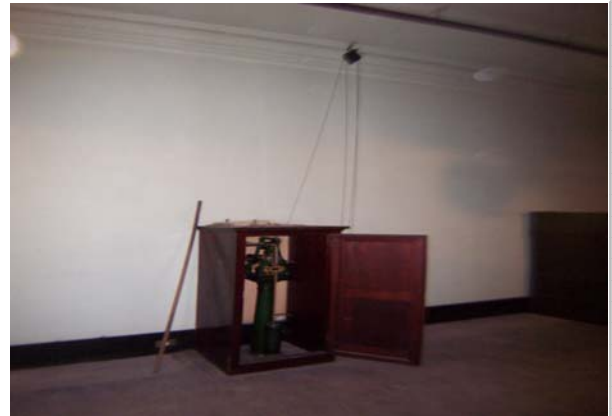
COND SIG	
Space Number	S-2	F	C
Space Name	File Storage 2nd Flr		
Space Dimensions	72'.4" x 12'.10"		
N Wall Finish	plaster with slate baseboard	F	C
E Wall Finish	plaster with slate baseboard	P	C
S Wall Finish	plaster with slate baseboard	G	C
W Wall Finish	plaster with slate baseboard 10" h .5 depth	G	C
Floor Finish	scored concrete	G	C
Ceiling Finish	plaster with plaster crown molding	G	C
Window Types	1/1 double hung metal sash	G	VS
Window Hardware	metal utilitarian	G	VS
Window Trim	metal	G	VS
Door Type	metal	G	S
Door Hardware	metal	G	S
Door Frame	metal	G	S
Door Threshold	concrete, no threshold	G	C
Trim base & Cornice	none		
Millwork bookcases	none		
Millwork paneling	none		
Millwork wainscot	none		
Skylights	none		
Fireplaces	none		
Electrical lighting	six brass hanging light fixtures converted	G	S
Electrical switches	silver metal plate switches		C
Electrical outlets	brass plate, conduit encased in metal on	G	C

Plumbing lavatories	none		
Plumbing toilets	none		
Plumbing urinals	none		
Plumbing accessories	none		
Plumbing partitions	none		
Fire protection	hose and metal wheel water	G	C
Mechanical grilles	none		
Mechanical diffusers	none		
Visible piping or ducts	capped gas pipes	F	NC
Signage	none		
Miscellaneous	attic entrance in ceiling wood surround pulley system running length of room (C) slit over stairway clock mechanism wood cabinet pulley with weight (VS), iron railing around stair well 2'.9" treads cast iron decorative on the rise	G	C

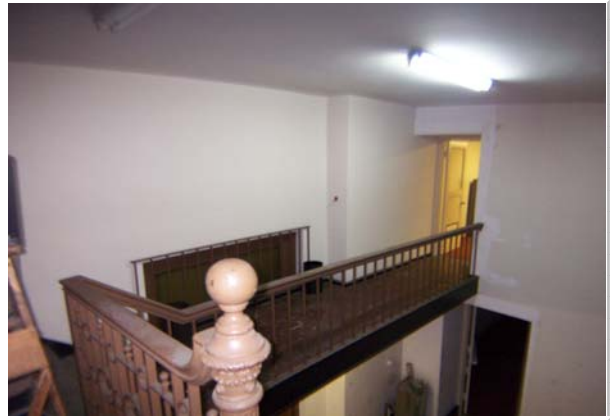
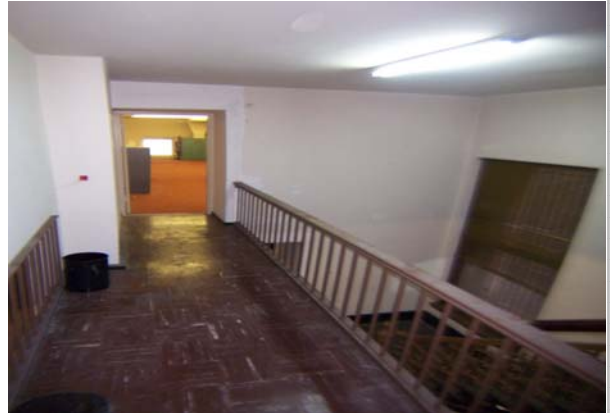
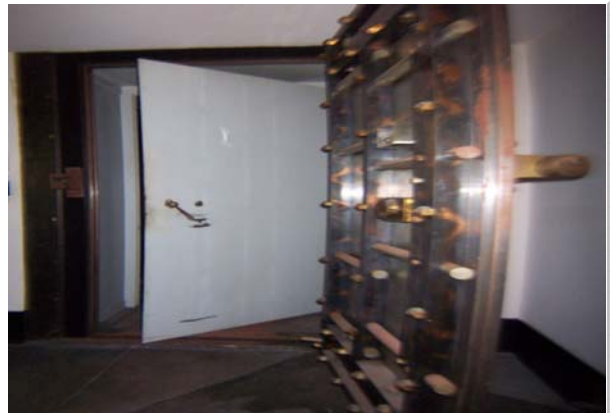
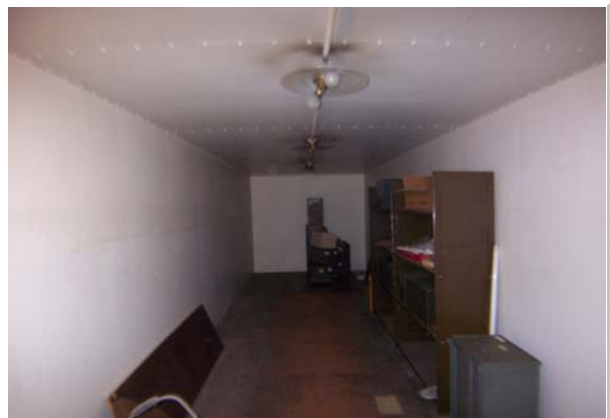
COND SIG	
Space Number	S-3	G	C
Space Name	Stair #1 2nd Floor and vault on mezzanine		
Space Dimensions	21'- 2" x 12'-2"		
N Wall Finish	plaster with slate baseboard	G	C
E Wall Finish	plaster with slate baseboard	G	C
S Wall Finish	plaster with slate baseboard	F	C
W Wall Finish	plaster	G	C
Floor Finish	scored concrete	G	C
Ceiling Finish	plaster	G	C
Window Types	stairwell 1/1 double hung metal sash,	G	C
Window Hardware	large window metal fixed window none	G	VS
Window Trim	large window metal, fixed window painted	G	VS
Door Type	vault door steel decorative (double), clear	G	VS
Door Hardware	vault steel brass, modern	G	VS
Door Frame	steel	G	C
Door Threshold	steel	G	C
Trim base & Cornice	none		
Millwork bookcases	none		
Millwork paneling	none		
Millwork wainscot	none		
Skylights	none		
Fireplaces	none		
Electrical lighting	flourescent bulbs, ceiling fixtures with	F	NC
Electrical switches	plastic switches and plate near vault	F	NC

Electrical outlets	three prong modern with exposed conduit	F	NC
Plumbing lavatories	none		
Plumbing toilets	none		
Plumbing urinals	none		
Plumbing accessories	none		
Plumbing partitions	none		
Fire protection	none		
Mechanical grilles	none		
Mechanical diffusers	none		
Visible piping or ducts	gas piping behind vault door		
Signage	none		
Miscellaneous	vault lined with steel , iron railings decorative and modern 2'.8.5" height - catwalk has contemporary rail	G	C

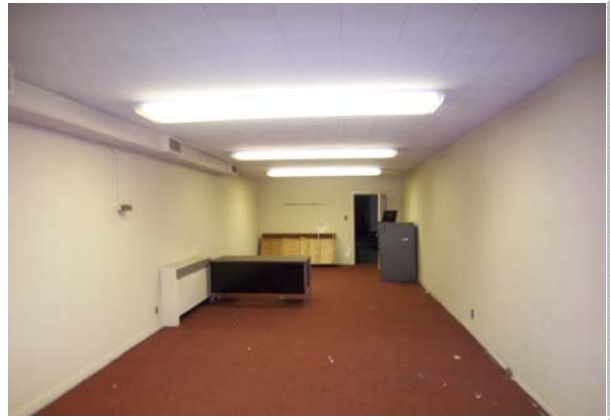
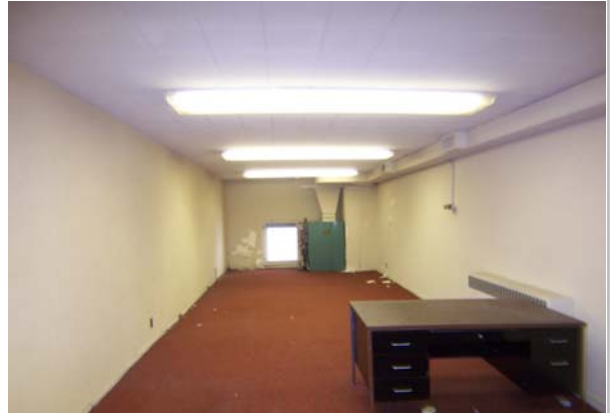
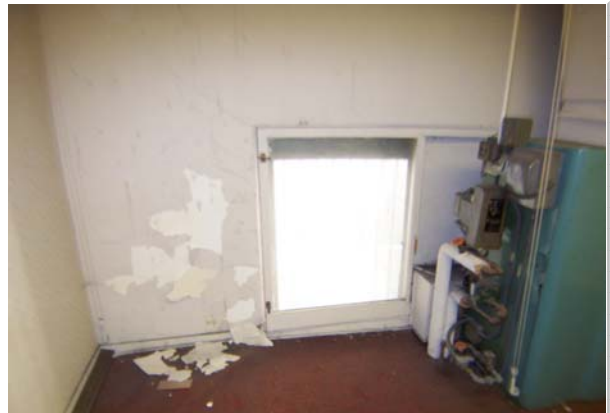
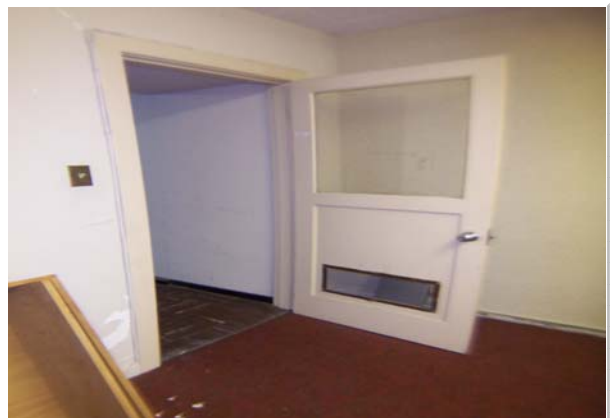
COND SIG	
Space Number	S-4	G	NC
Space Name	Boardroom - Mezzanine		
Space Dimensions	40' x 12' 7"		
N Wall Finish	plaster wood baseboard 2 3/4"	F	C
E Wall Finish	plaster wood baseboard 2 3/4"	G	C
S Wall Finish	wallpaper over plaster, wood baseboard 2	G	NC
W Wall Finish	plaster wood baseboard 2 3/4"	P	C
Floor Finish	carpet	P	NC
Ceiling Finish	acoustic tiles	P	NC
Window Types	1/1 double hung metal sash to first floor,	G/P	VS
Window Hardware	metal hardware	G	VS
Window Trim	none		
Door Type	wood clear glaze missing bottom panel	P	NC
Door Hardware	modern	F	NC
Door Frame	wood	F	NC
Door Threshold	metal strip modern	P	NC
Trim base & Cornice	none		
Millwork bookcases	none		
Millwork paneling	none		
Millwork wainscot	none		
Skylights	none		
Fireplaces	none		
Electrical lighting	flourescent bulbs	P	NC
Electrical switches	brass plate switches	G	C
Electrical outlets	brass plate	G	C
Plumbing lavatories	none		
Plumbing toilets	none

Plumbing urinals	none		
Plumbing accessories	none		
Plumbing partitions	none		
Fire protection	none		
Mechanical grilles	none		
Mechanical diffusers	none		
Visible piping or ducts	air ducts on north wall, radiator on north	F	NC
Signage	none		
Miscellaneous	furnace on west wall 'Carrier', extreme water on west wall		NC

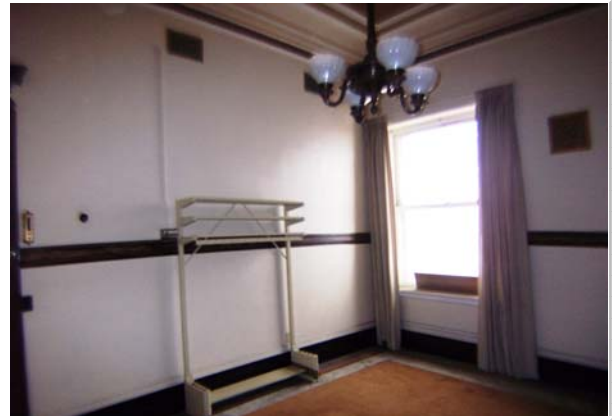
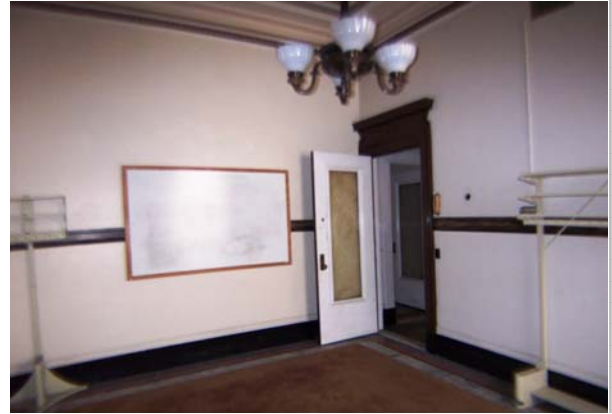
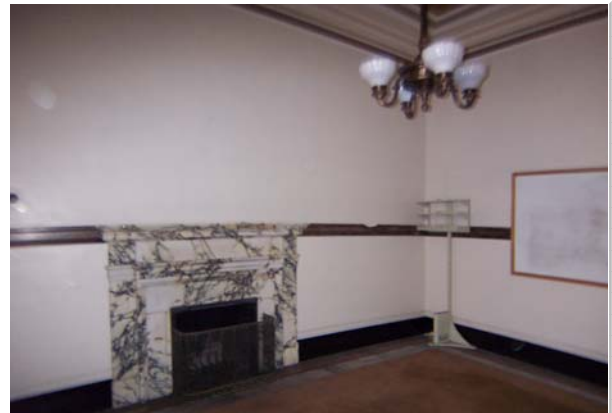
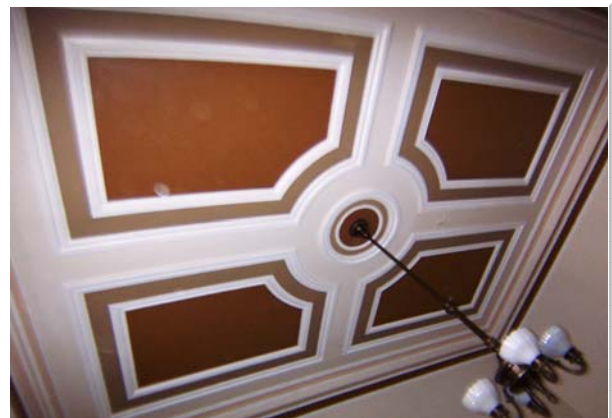
COND SIG	
Space Number	S-6	G	S
Space Name	NW Office 2nd flr		
Space Dimensions	13'9" x 17'6" 13' ceiling		
N Wall Finish	plaster walls, marble baseboard, plaster	G	S
E Wall Finish	plaster walls, marble baseboard, plaster	G	S
S Wall Finish	plaster walls, marble baseboard, plaster	G	S
W Wall Finish	plaster walls, marble baseboard, plaster	G	S
Floor Finish	marble border, concrete covered with carpet	G	S/N
Ceiling Finish	plaster, plaster panels and plaster crown	G	S
Window Types	1/1 double-hung, metal sash	G	VS
Window Hardware	metal	G	VS
Window Trim	metal	G	VS
Door Type	metal and opaque glass, door cap	G	S
Door Hardware	metal	G	S
Door Frame	metal	G	S
Door Threshold	marble	G	S
Trim base & Cornice	none		
Millwork bookcases	none		
Millwork paneling	none		
Millwork wainscot	none		
Skylights	none		
Fireplaces	marble 5'2"	E	S
Electrical lighting	brass chandelier, glass shades	G	S
Electrical switches	modern	G	NC
Electrical outlets	modern	F	NC

Plumbing lavatories	none		
Plumbing toilets	none		
Plumbing urinals	none		
Plumbing accessories	none		
Plumbing partitions	none		
Fire protection	none		
Mechanical grilles	west wall	G	C
Mechanical diffusers	none		
Visible piping or ducts	none		
Signage	none		
Miscellaneous	older thermostat

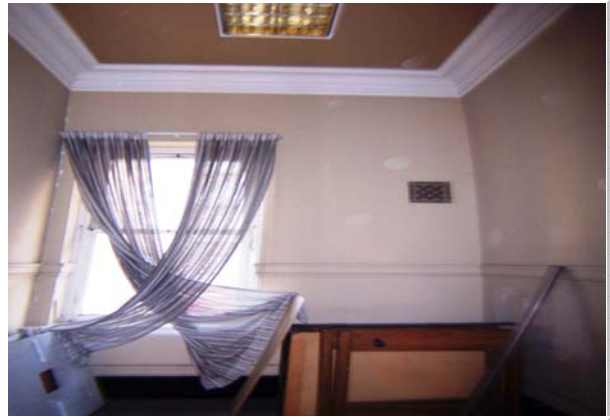
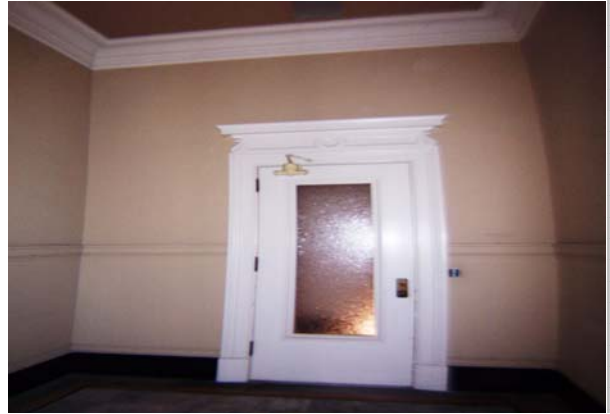
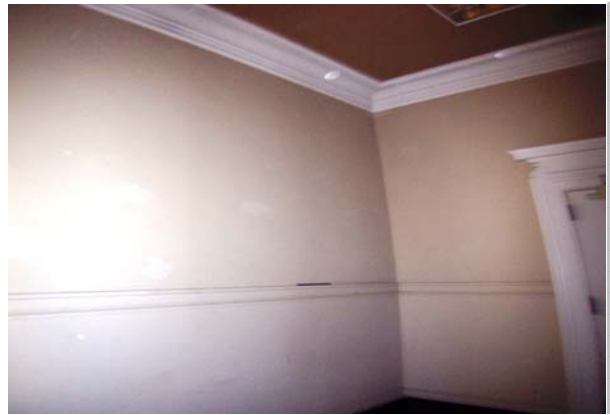
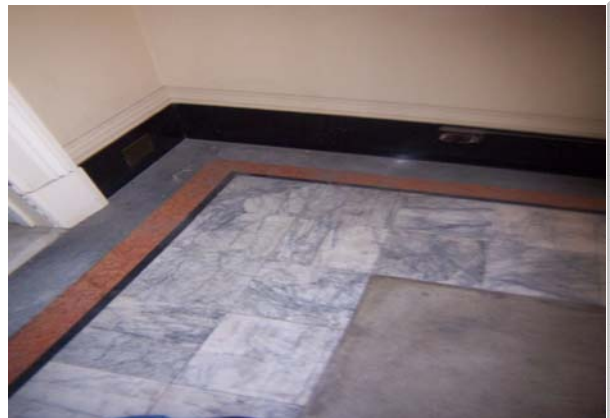
COND SIG	
Space Number	S-19	G	C
Space Name	office by Dome Room		
Space Dimensions	20'2" x 8'3"		
N Wall Finish	plaster, marble baseboard, plaster chair rail	G	C
E Wall Finish	plaster, marble baseboard, plaster chair rail	G	C
S Wall Finish	plaster, marble baseboard, plaster chair rail	G	C
W Wall Finish	plaster, marble baseboard, plaster chair rail	G	C
Floor Finish	marble border, concrete covered with carpet	G	S/N
Ceiling Finish	plaster, plaster crown molding	G	C
Window Types	1/1 double-hung, metal sash	G	S
Window Hardware	metal	G	S
Window Trim	metal	G	S
Door Type	metal	G	S
Door Hardware	brass	G	S
Door Frame	metal	G	S
Door Threshold	marble	G	S
Trim base & Cornice	none		
Millwork bookcases	none		
Millwork paneling	none		
Millwork wainscot	none		
Skylights	none		
Fireplaces	none		
Electrical lighting	flourescent bulbs	G	NC
Electrical switches	modern plastic		NC
Electrical outlets	modern plastic conduit exposed	G	NC

Plumbing lavatories	none		
Plumbing toilets	none		
Plumbing urinals	none		
Plumbing accessories	none		
Plumbing partitions	none		
Fire protection	none		
Mechanical grilles	south wall decorative grill	G	S
Mechanical diffusers	none		
Visible piping or ducts	radiator gas pipe capped	F	NC
Signage			
Miscellaneous	note shape of room on south side	G	S

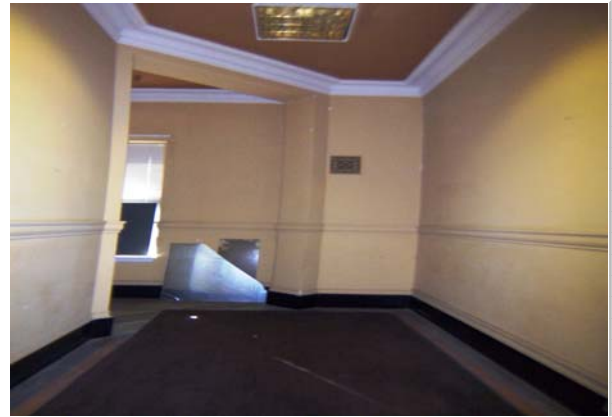
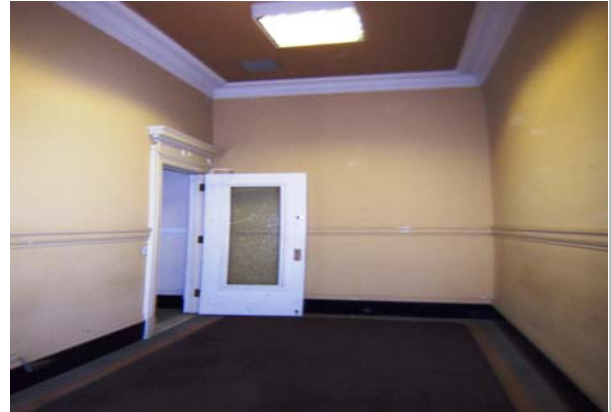
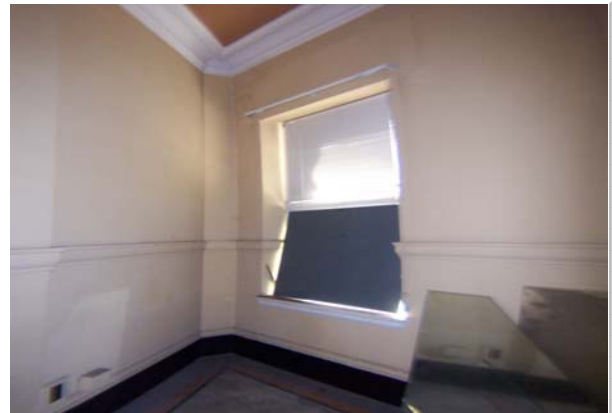
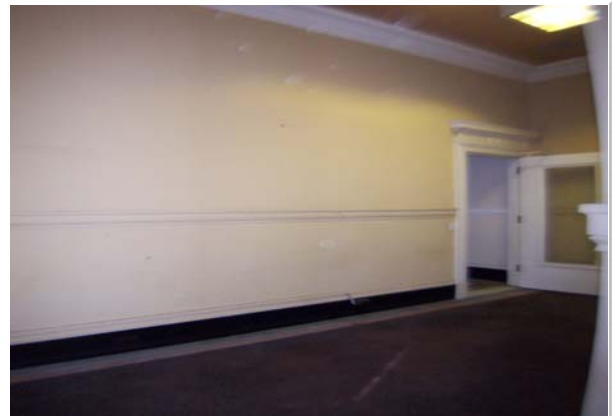
COND SIG	
Space Number	S-20	P	NC
Space Name	Dome rm 2nd floor		
Space Dimensions	26'7" ceiling 19'3"		
N Wall Finish	plaster, marble baseboard	P	C
E Wall Finish	plaster, marble baseboard	P	C
S Wall Finish	plaster, marble baseboard	P	C
W Wall Finish	plaster, marble baseboard	P	C
Floor Finish	carpet	P	NC
Ceiling Finish	plaster	P	C
Window Types	metal casement, inward	P	C
Window Hardware	metal	P	C
Window Trim	metal	P	C
Door Type	painted wood with glazing	F	NC
Door Hardware	metal	F	NC
Door Frame	wood	F	NC
Door Threshold	none		
Trim base & Cornice	window sash	P	C
Millwork bookcases	none		
Millwork paneling	none		
Millwork wainscot	none		
Skylights	none		
Fireplaces	none		
Electrical lighting	chandelier modern	F	NC
Electrical switches	modern	F	NC
Electrical outlets	modern	F	NC
Plumbing lavatories	none		
Plumbing toilets	none		
Plumbing urinals	none		
Plumbing accessories	none		
Plumbing partitions	none		
Fire protection	fire alarm by stairs

Mechanical grilles	none		
Mechanical diffusers	none		
Visible piping or ducts	none		
Signage	none		
Miscellaneous	hand rail metal and metal security gates in front of window old wallpaper under paint	F/P/	C/C/

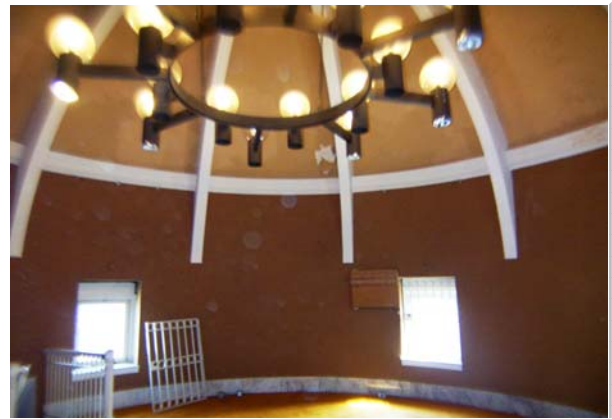
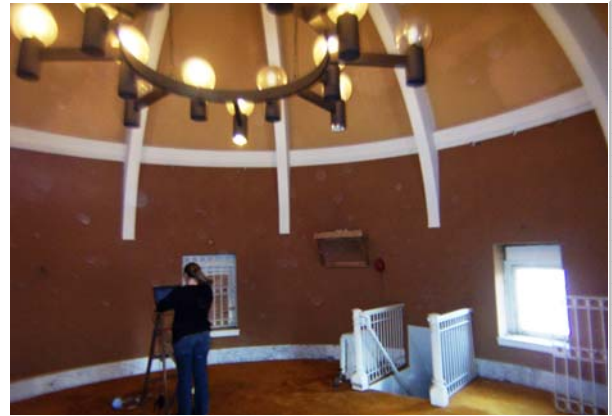
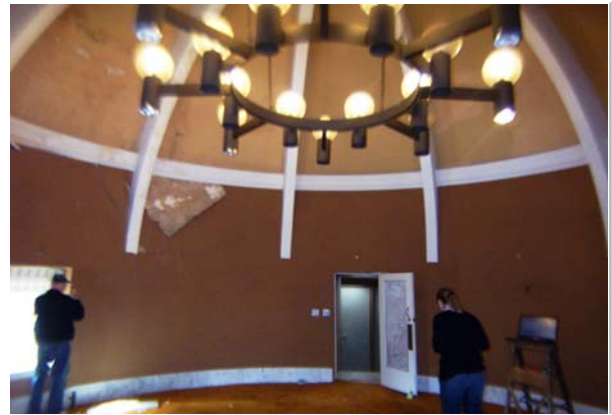
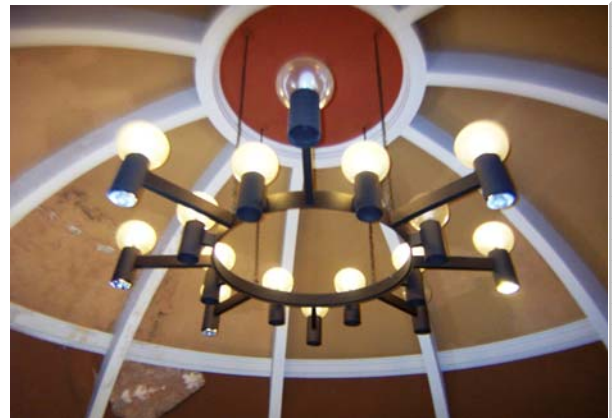
COND SIG	
Space Number	S-21	P	NC
Space Name	dome room hallway		
Space Dimensions			
N Wall Finish	plaster	P	NC
E Wall Finish	plaster	P	NC
S Wall Finish	plaster	P	NC
W Wall Finish	plaster	P	NC
Floor Finish	mastic tile	P	NC
Ceiling Finish	plaster	P	NC
Window Types	10 pane wireglass metal sash		
Window Hardware	none		
Window Trim	none		
Door Type	wood painted glass	F	NC
Door Hardware	modern	F	NC
Door Frame	wood	F	NC
Door Threshold	none		
Trim base & Cornice	none		
Millwork bookcases	none		
Millwork paneling	none		
Millwork wainscot	none		
Skylights	plastic	P	NC
Fireplaces	none		
Electrical lighting	modern chandelier by elevator, ceiling light		NC
Electrical switches	none		
Electrical outlets	none		
Plumbing lavatories	none		
Plumbing toilets	none		
Plumbing urinals	none		
Plumbing accessories	none		
Plumbing partitions	none		
Fire protection	none		
Mechanical grilles	none		
Mechanical diffusers	none		
Visible piping or ducts	none

Signage	none		
Miscellaneous	elevator, wallpaper around elevator area, opening to roof area, wood door, metal hardware, wood handrails and railings

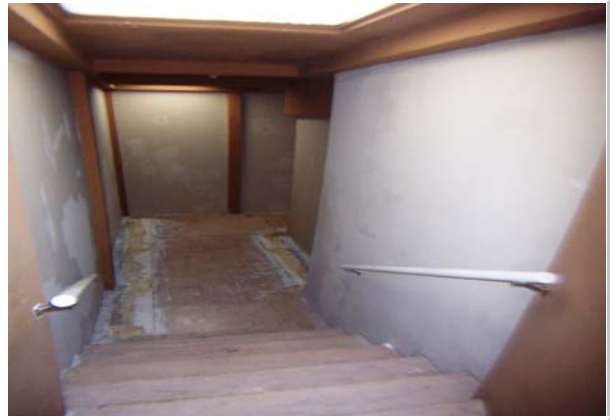
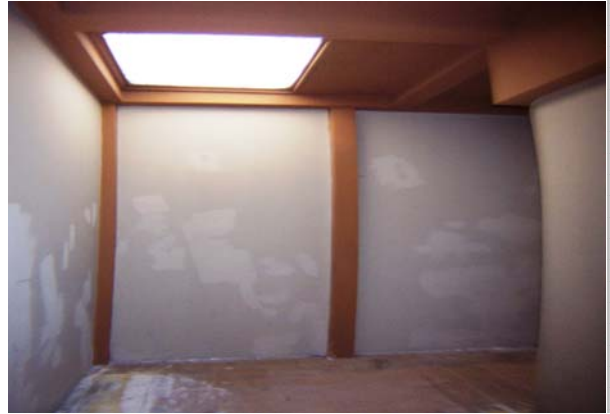
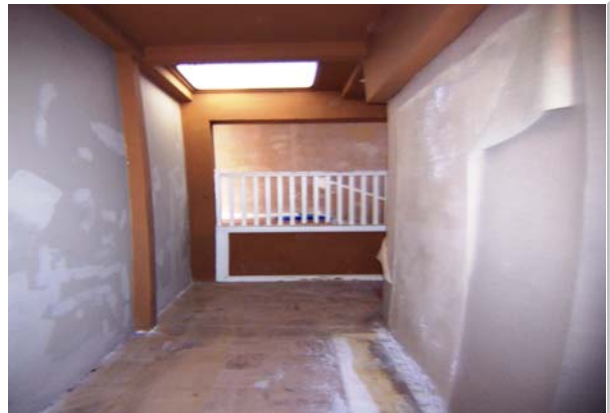
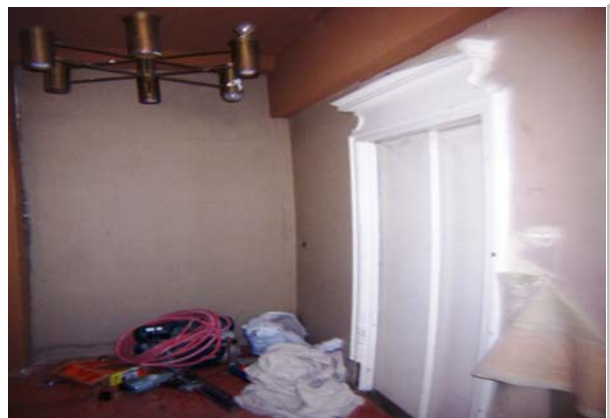
COND SIG	
Space Number	S-22	F	C
Space Name	penthouse		
Space Dimensions	22' x 18'8", kitchen 11'9"x8'6",		
N Wall Finish	plaster wood baseboard	F	C
E Wall Finish	plaster wood baseboard	F	C
S Wall Finish	plaster wood baseboard	F	C
W Wall Finish	plaster wood baseboard	F	C
Floor Finish	mastic tile	P	C
Ceiling Finish	plaster	F	C
Window Types	wire glass casement and french doors	F	C
Window Hardware	metal	F	C
Window Trim	metal	F	C
Door Type	none		
Door Hardware	metal	F	
Door Frame	metal and wood	F	
Door Threshold	wpoood	F	
Trim base & Cornice	none		
Millwork bookcases	none		
Millwork paneling	none		
Millwork wainscot	none		
Skylights	none		
Fireplaces	none		
Electrical lighting	fluorescent bulbs	F	NC
Electrical switches	modern exposed conduit	F	NC
Electrical outlets	modern	F	NC
Plumbing lavatories	kitchen and bath porcelin	F	NC
Plumbing toilets	porcelin	F	NC
Plumbing urinals	none		
Plumbing accessories	utilitarian		NC
Plumbing partitions	wood		NC

Fire protection	none		
Mechanical grilles	none		
Mechanical diffusers	none		
Visible piping or ducts	two radiators, capped gas pipe, radiator		
Signage	none		
Miscellaneous	lockers in bathroom area and Formica/linoleum, wood cabinets, refrigerator water heater, fuse box, mirrors in main room, one plaster shelf

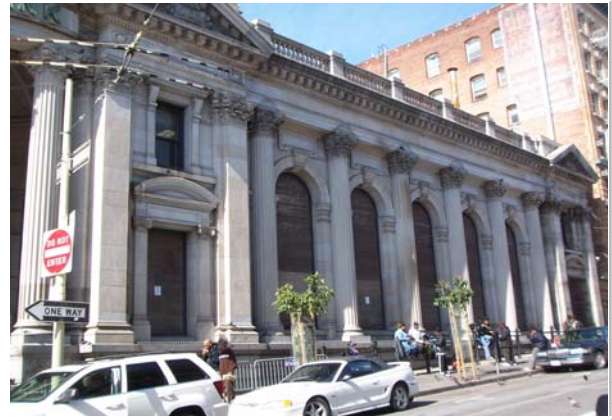
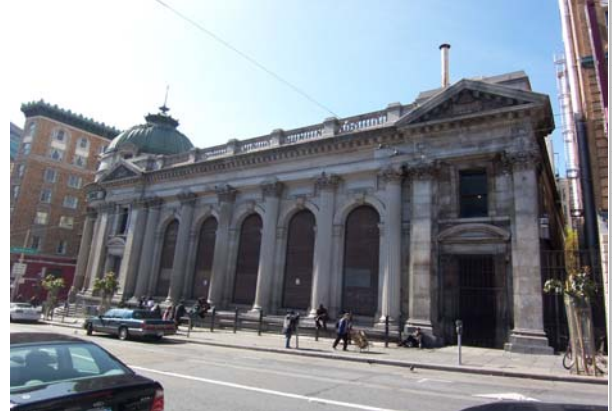
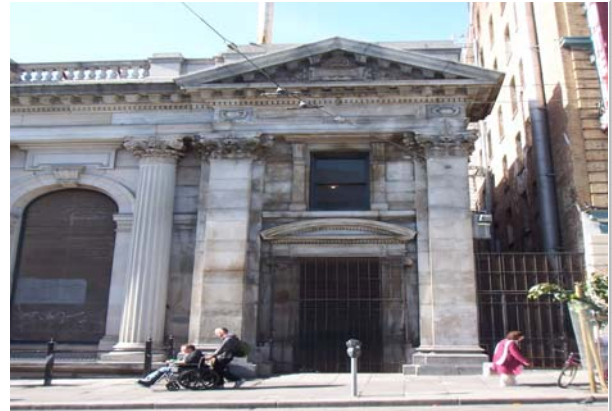
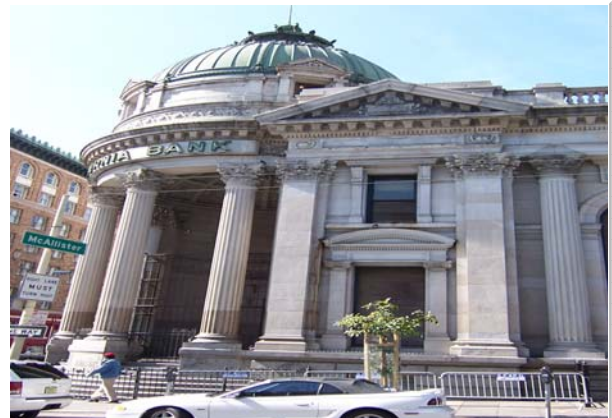
COND SIG	
Space Number	X-2	G	VS
Space Name	South Elevation		
Space Dimensions			
N Wall Finish	n/a		
E Wall Finish	n/a		
S Wall Finish	Granite	G	VS
W Wall Finish	n/a		
Floor Finish	n/a		
Ceiling Finish	n/a		
Window Types	concealed by metal security shutters and	G	VS
Window Hardware	n/a		
Window Trim	n/a		
Door Type	none		
Door Hardware	none		
Door Frame	none		
Door Threshold	none		
Trim base & Cornice	none		
Millwork bookcases	none		
Millwork paneling	none		
Millwork wainscot	none		
Skylights	none		
Fireplaces	none		
Electrical lighting	none		
Electrical switches	none		
Electrical outlets	none		
Plumbing lavatories	none		
Plumbing toilets	none		
Plumbing urinals	none		
Plumbing accessories	none		
Plumbing partitions	none		
Fire protection	none		
Mechanical grilles	none		
Mechanical diffusers	none		
Visible piping or ducts	none		
Signage	none		
Miscellaneous	cast and wrought iron gate at west end of elevation	G	S
