# SAN FRANCISCO PLANNING DEPARTMENT

**MEMO**

**RE:** Review and Comment for 1 Jones Street (former Hibernia Bank)  
Case No. 2011.0617EA

**HIBERNIA BANK BUILDING**

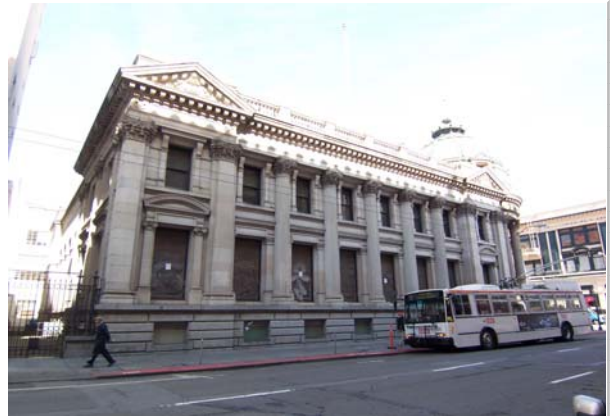
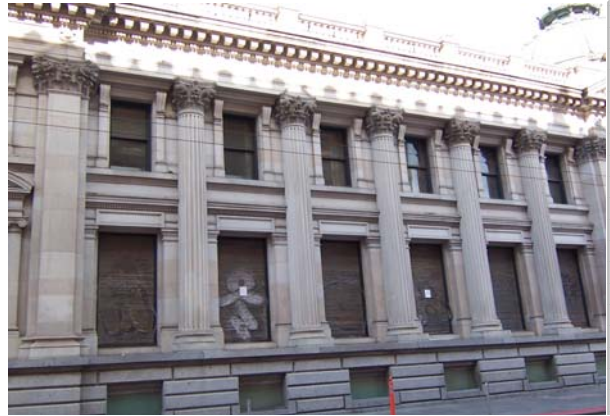
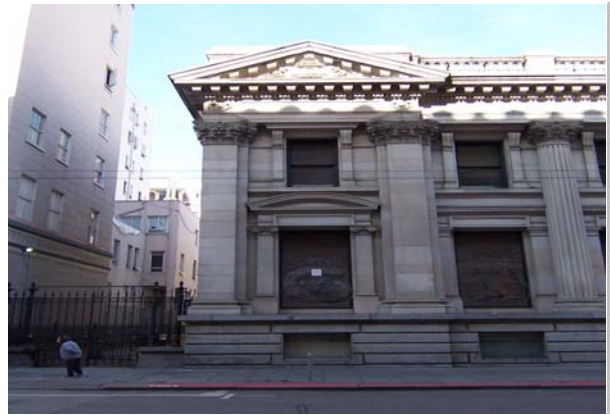
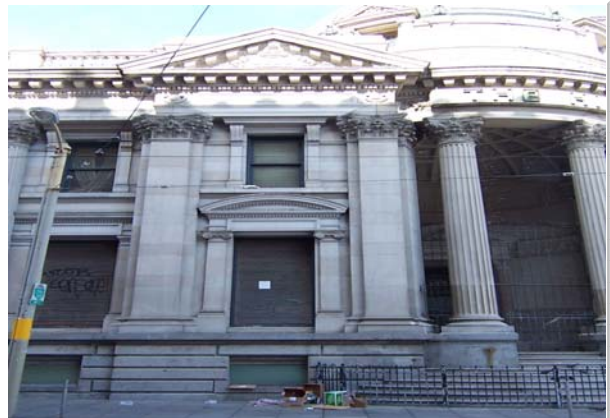
COND SIG	
Space Number	X-3	G	S
Space Name	West Elevation		
Space Dimensions			
N Wall Finish	n/a		
E Wall Finish	n/a		
S Wall Finish	n/a		
W Wall Finish	Granite	G	VS
Floor Finish	n/a		
Ceiling Finish	n/a		
Window Types	concealed by metal security shutters and	G/E	VS
Window Hardware	n/a		
Window Trim	n/a		
Door Type	partially glazed metal door with sidelights	F	C
Door Hardware	metal		
Door Frame	metal		
Door Threshold	metal		
Trim base & Cornice	none		
Millwork bookcases	none		
Millwork paneling	none		
Millwork wainscot	none		
Skylights	none		
Fireplaces	none		
Electrical lighting	none		
Electrical switches	none		
Electrical outlets	none		
Plumbing lavatories	none		
Plumbing toilets	none		
Plumbing urinals	none		
Plumbing accessories	none		
Plumbing partitions	none		
Fire protection	none		
Mechanical grilles	none		
Mechanical diffusers	none		
Visible piping or ducts	none		
Signage	none		
Miscellaneous	Bordered by a fence with concrete base, cast iron balusters and wrought iron pickets.	G	S

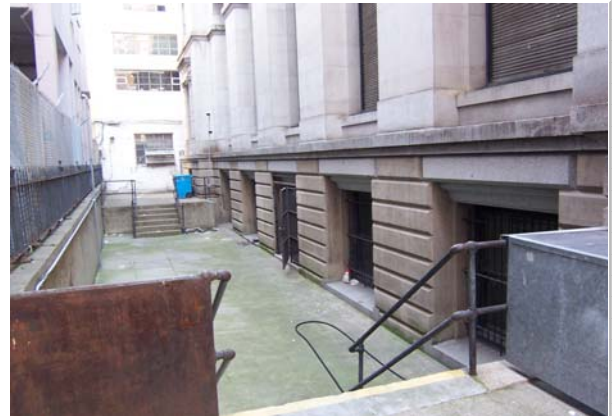
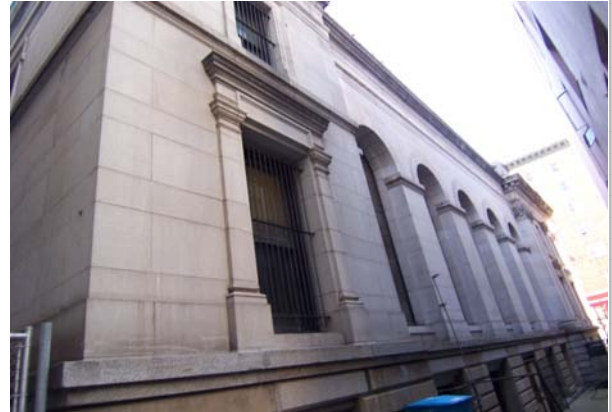
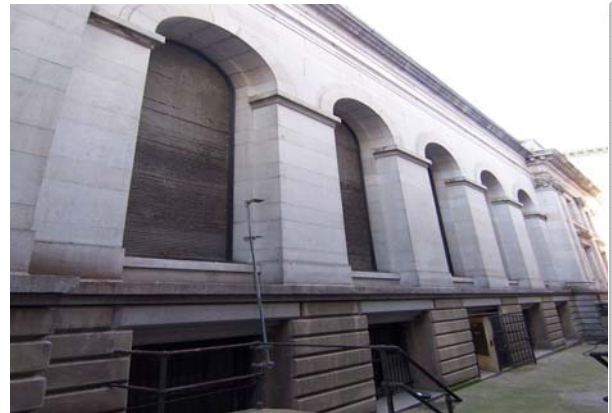
COND SIG	
Space Number	X-4	G	C
Space Name	North Elevation		
Space Dimensions			
N Wall Finish	Granite		C
E Wall Finish	n/a	G	
S Wall Finish	n/a		
W Wall Finish	n/a		
Floor Finish	n/a		
Ceiling Finish	n/a		
Window Types	concealed by metal security shutters	G	VS
Window Hardware	n/a		
Window Trim	n/a		
Door Type	none		
Door Hardware	none		
Door Frame	none		
Door Threshold	none		
Trim base & Cornice	none		
Millwork bookcases	none		
Millwork paneling	none		
Millwork wainscot	none		
Skylights	none		
Fireplaces	none		
Electrical lighting	none		
Electrical switches	none		
Electrical outlets	none		
Plumbing lavatories	none		
Plumbing toilets	none		
Plumbing urinals	none		
Plumbing accessories	none		
Plumbing partitions	none		
Fire protection	none		
Mechanical grilles	none		
Mechanical diffusers	none		
Visible piping or ducts	none		
Signage	none		
Miscellaneous

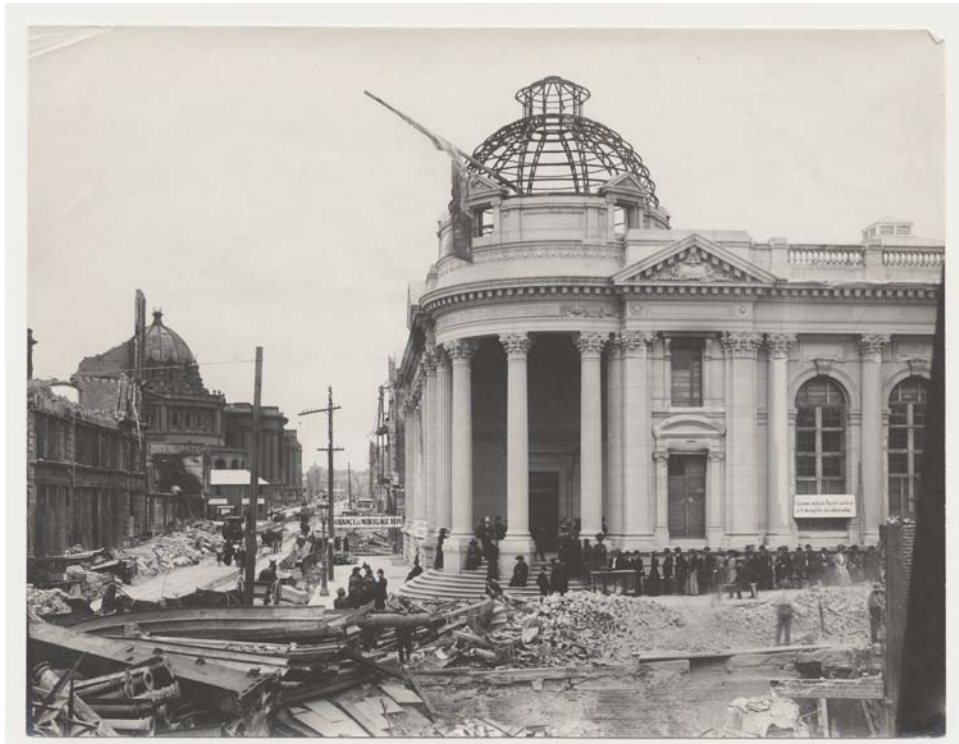
Figure 1. “Hibernia 1906 Opening Day” - after the earthquake and fire

All available information indicates that The Hibernia Bank Building survived the severe shaking from the 1906 earthquake with little damage. Good quality post-earthquake photographs of two full elevations of the Building and a portion of a third have been studied in detail, and earthquake damage was noted to only two rooftop parapet balusters. Four of the many photographs studied are provided with this submittal. (Figures 1, 2, 3 and 4) No cracking, displacement or loss of masonry due to earthquake shaking can be identified on any of these elevations in any photographs studied, although severe localized fire-related spalling and staining of granite can be observed.

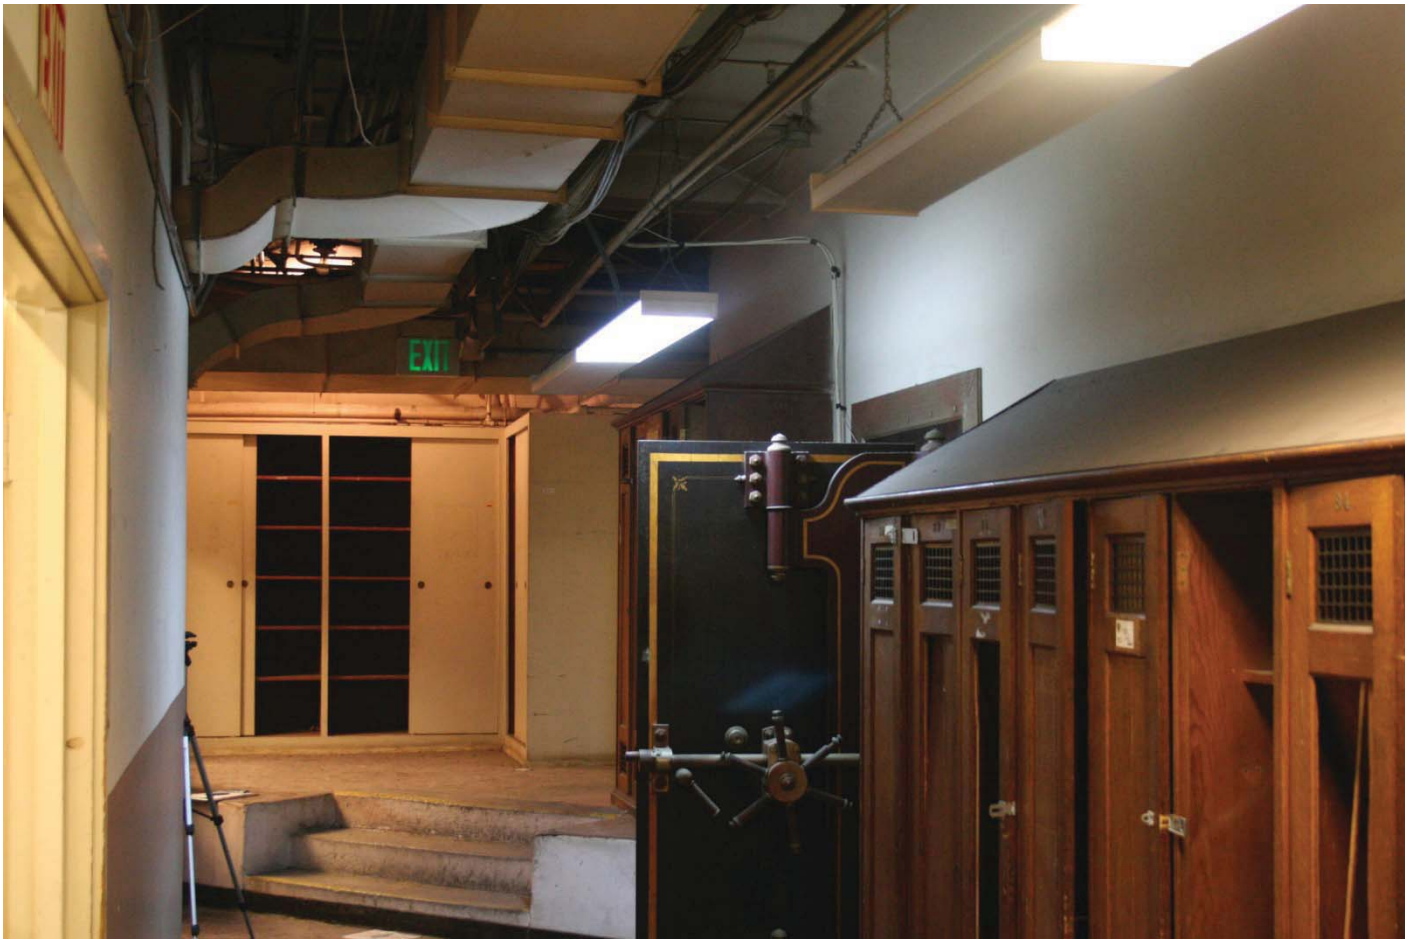
**#57**

**Area B1**

**Outrigger BM**

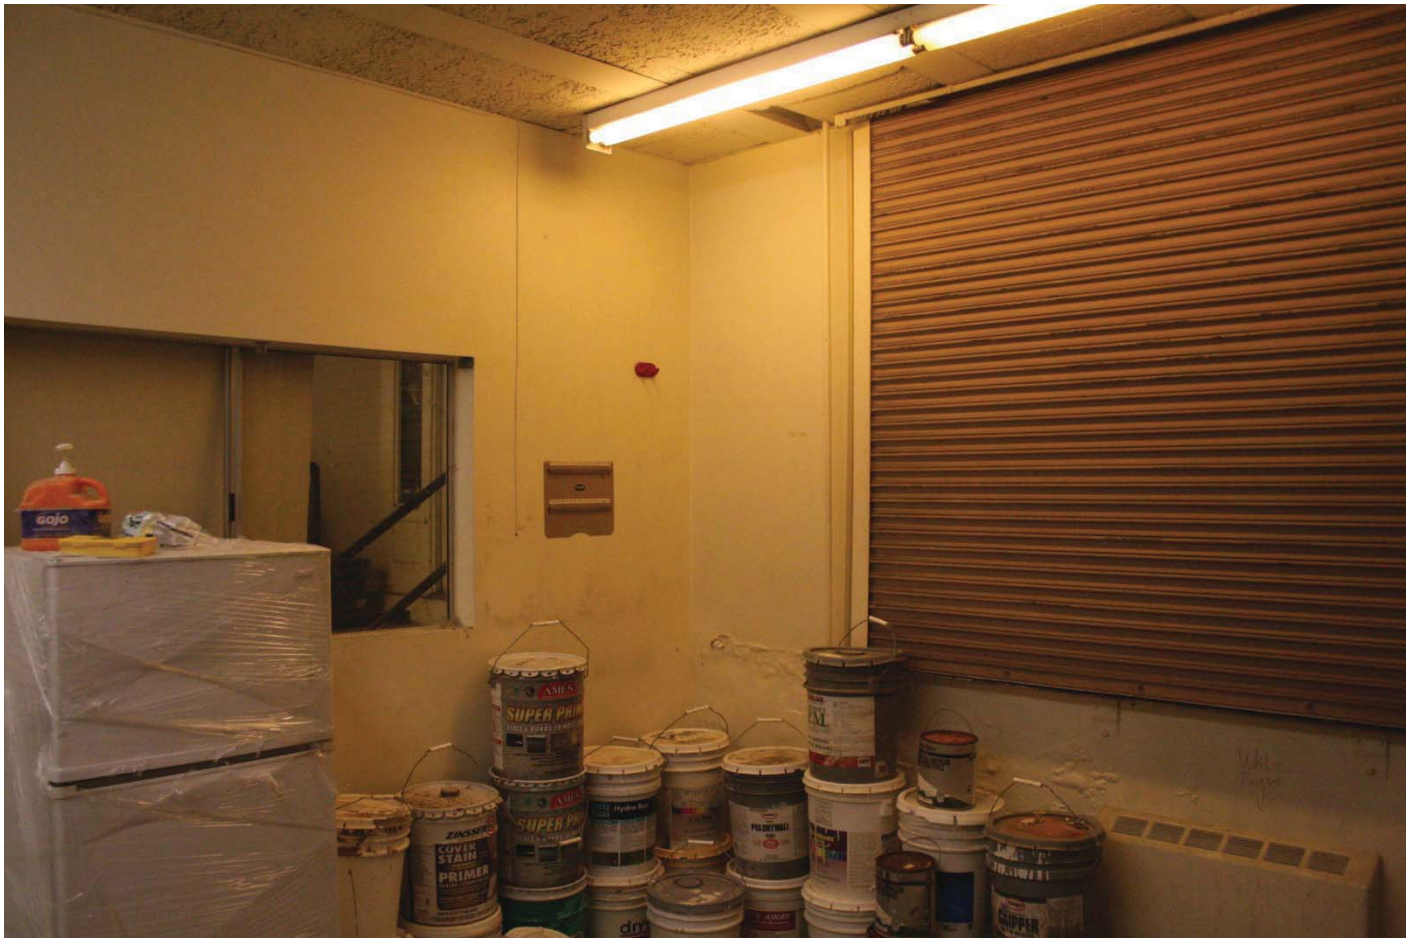
**#62**

**Area B3**

**Pier Thickening**

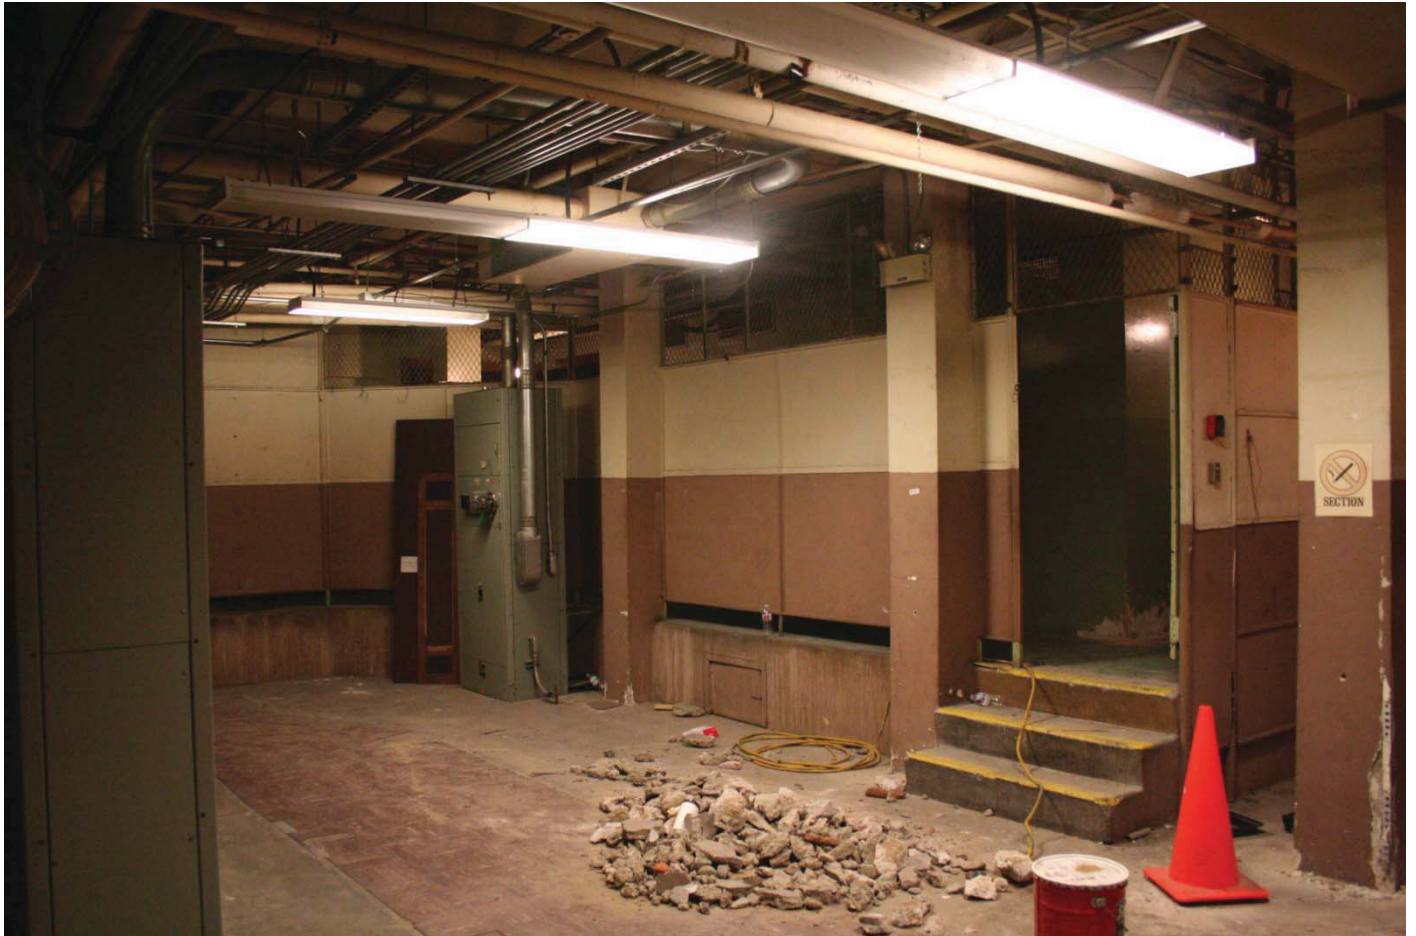
**#68**

**Area B4**

**New Shear Wall**

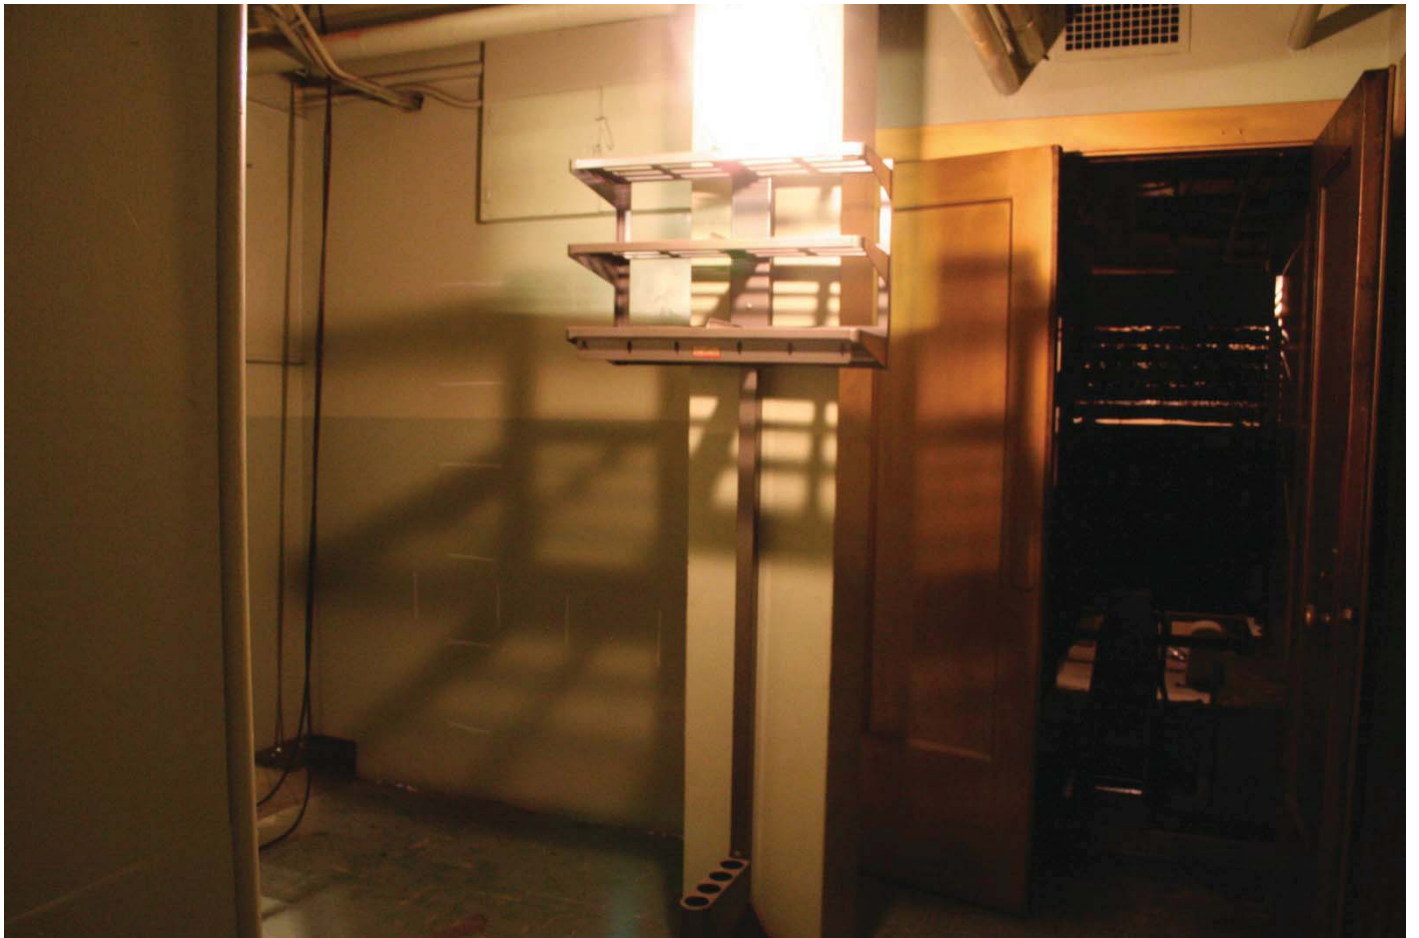
**Shaft Wall**

**Area B5**

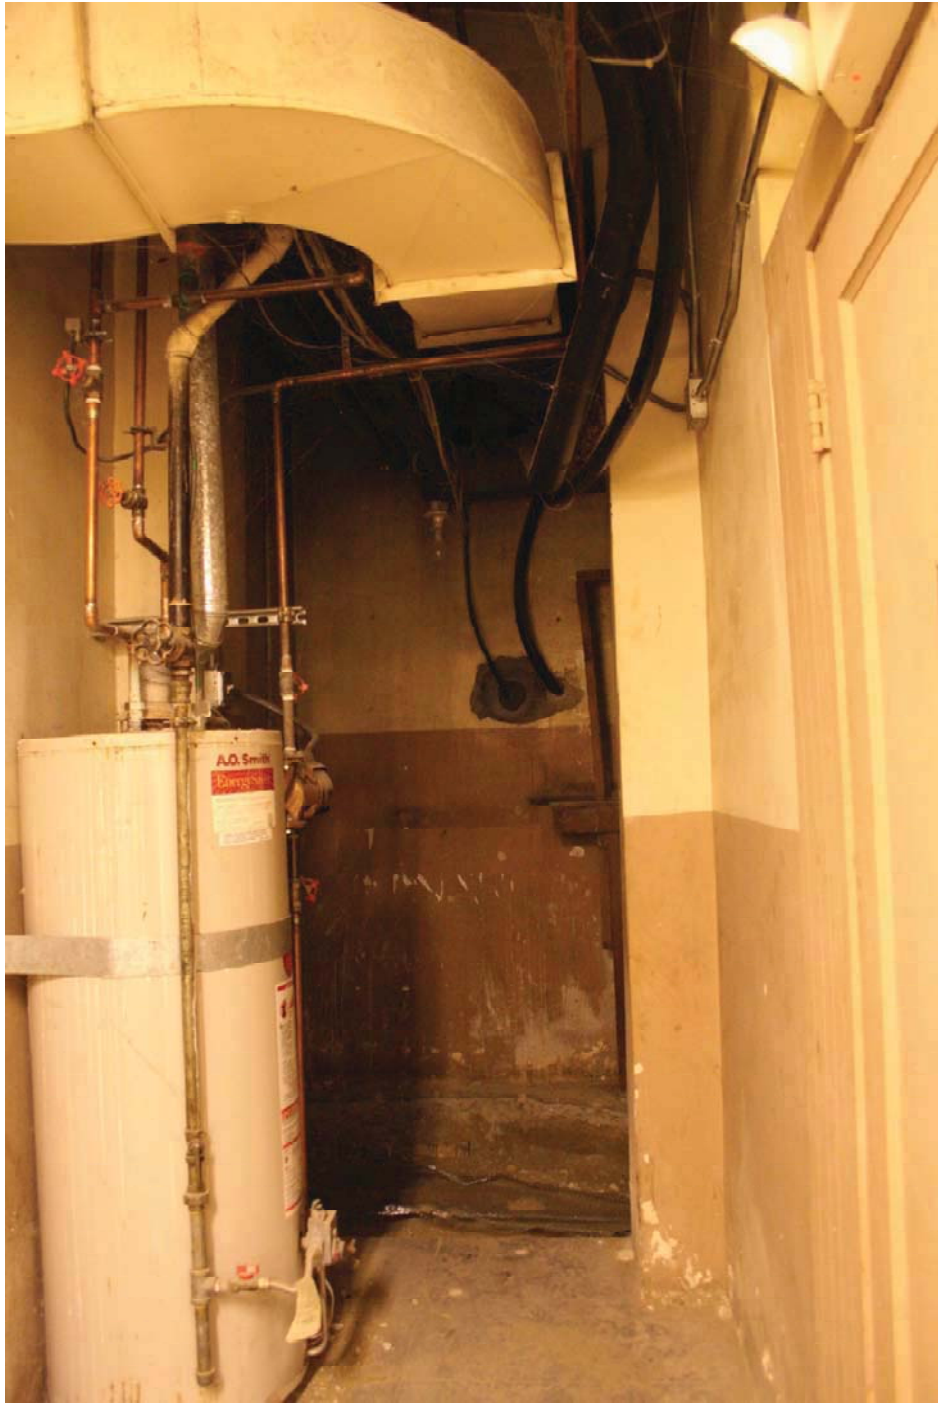
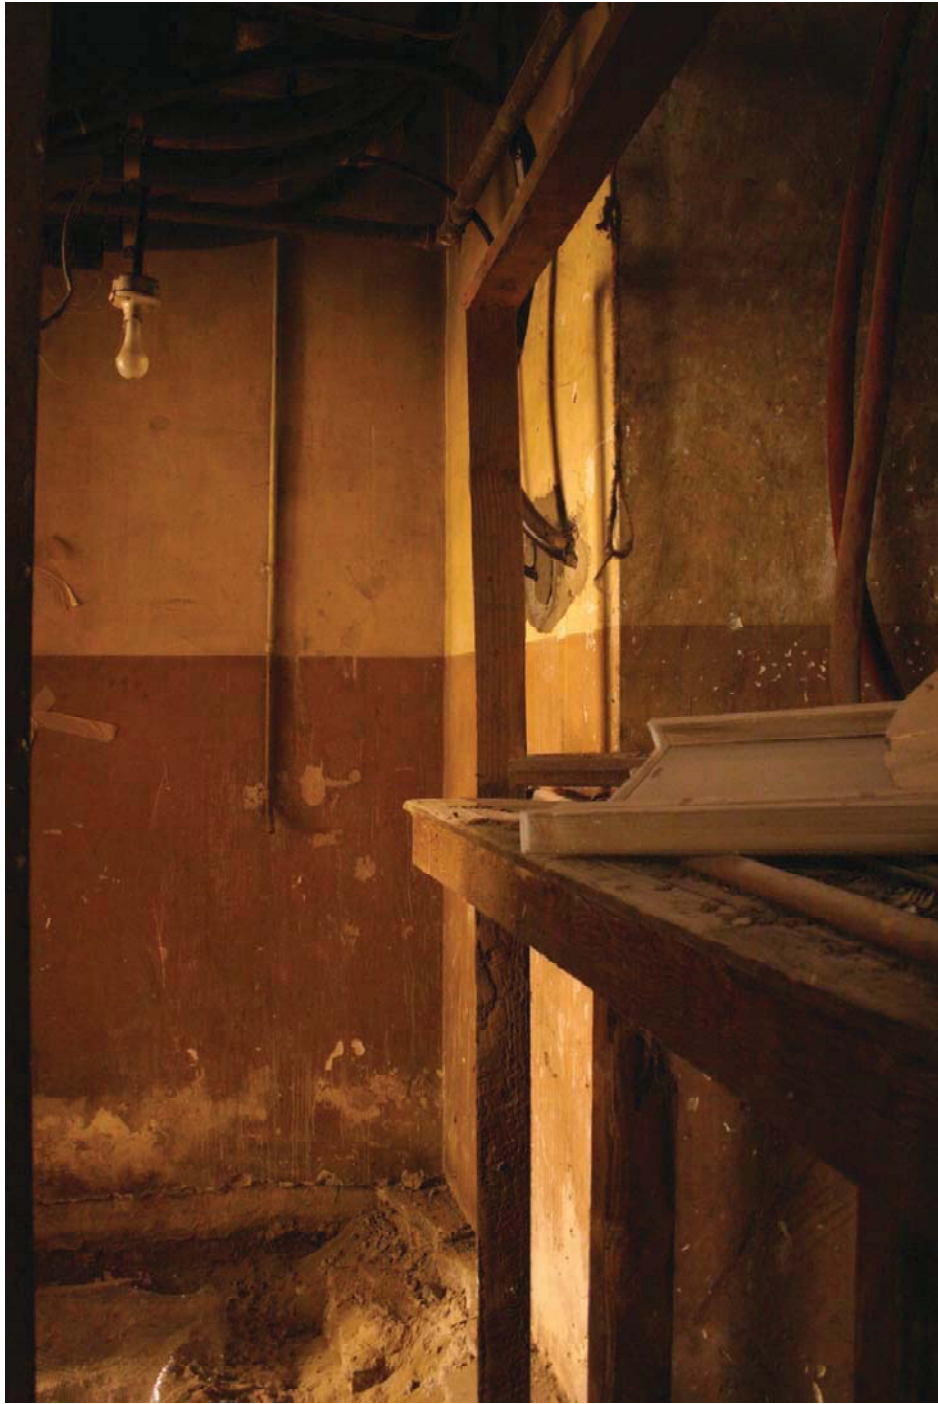
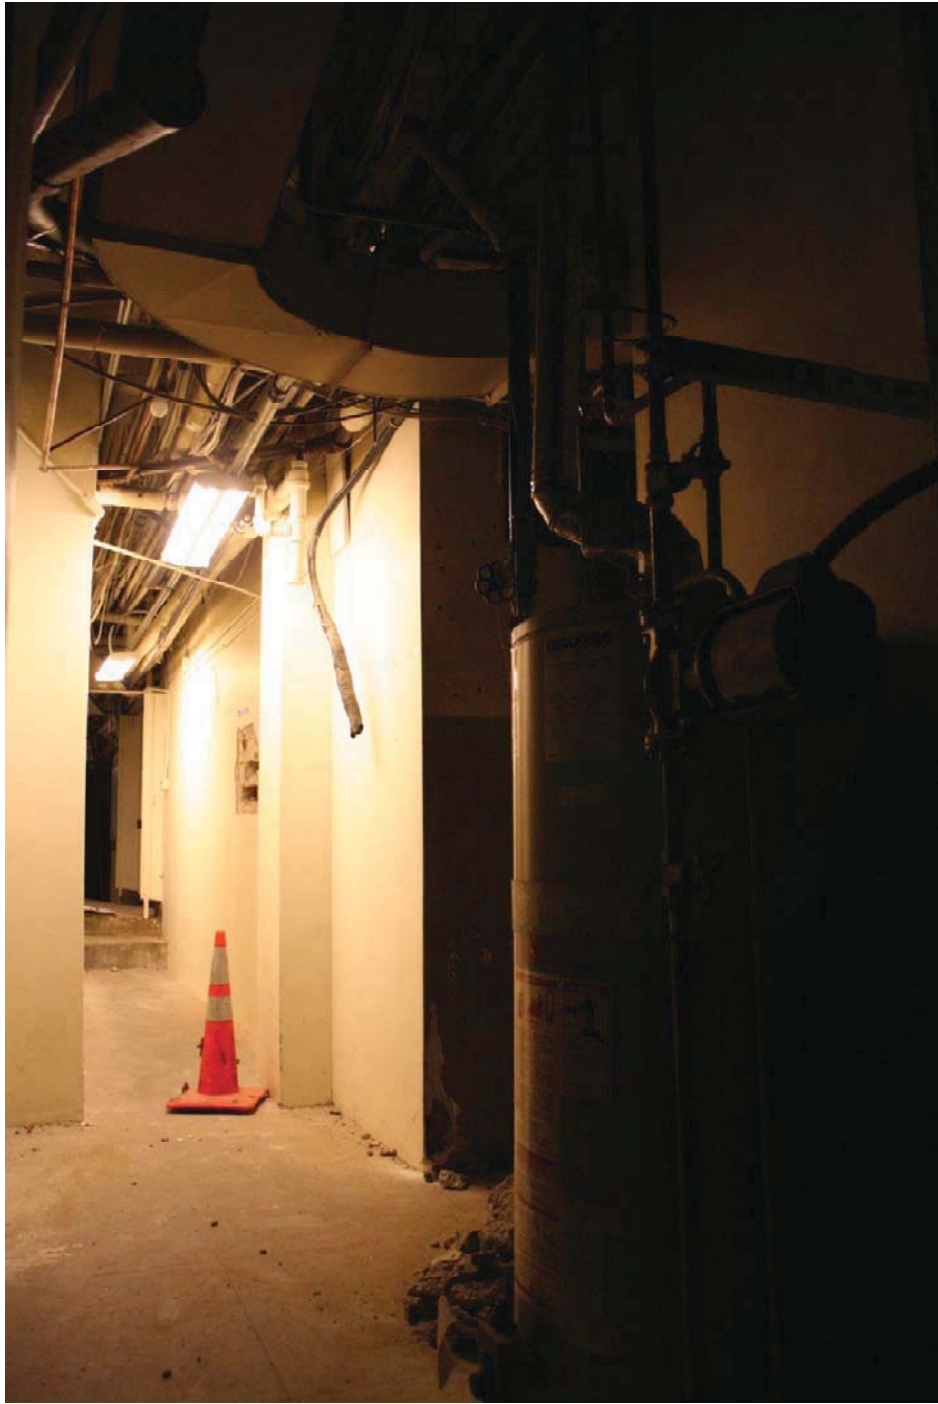
**New Shear Wall**

**Area B6**

- Installation of three reinforced concrete shear walls extending from the foundation to the roof deck. Two of these walls are located in the north banking service area (the “bookend”) and will be well-integrated with the existing massive masonry walls that extend the length of the building. These walls are intended to create a vertical “box girder”, using the masonry “bookend” walls as flanges, to brace the building in the north-south direction. The third full height wall, which is oriented in the east-west direction and in line with the north boundary of the executive offices, will be located in a closet/stairwell near the southeast corner of the building adjacent to the rotunda. Each of these three walls will be integrated with collectors/bond beams at the roof. It is envisioned that some foundation work may be required at these walls;

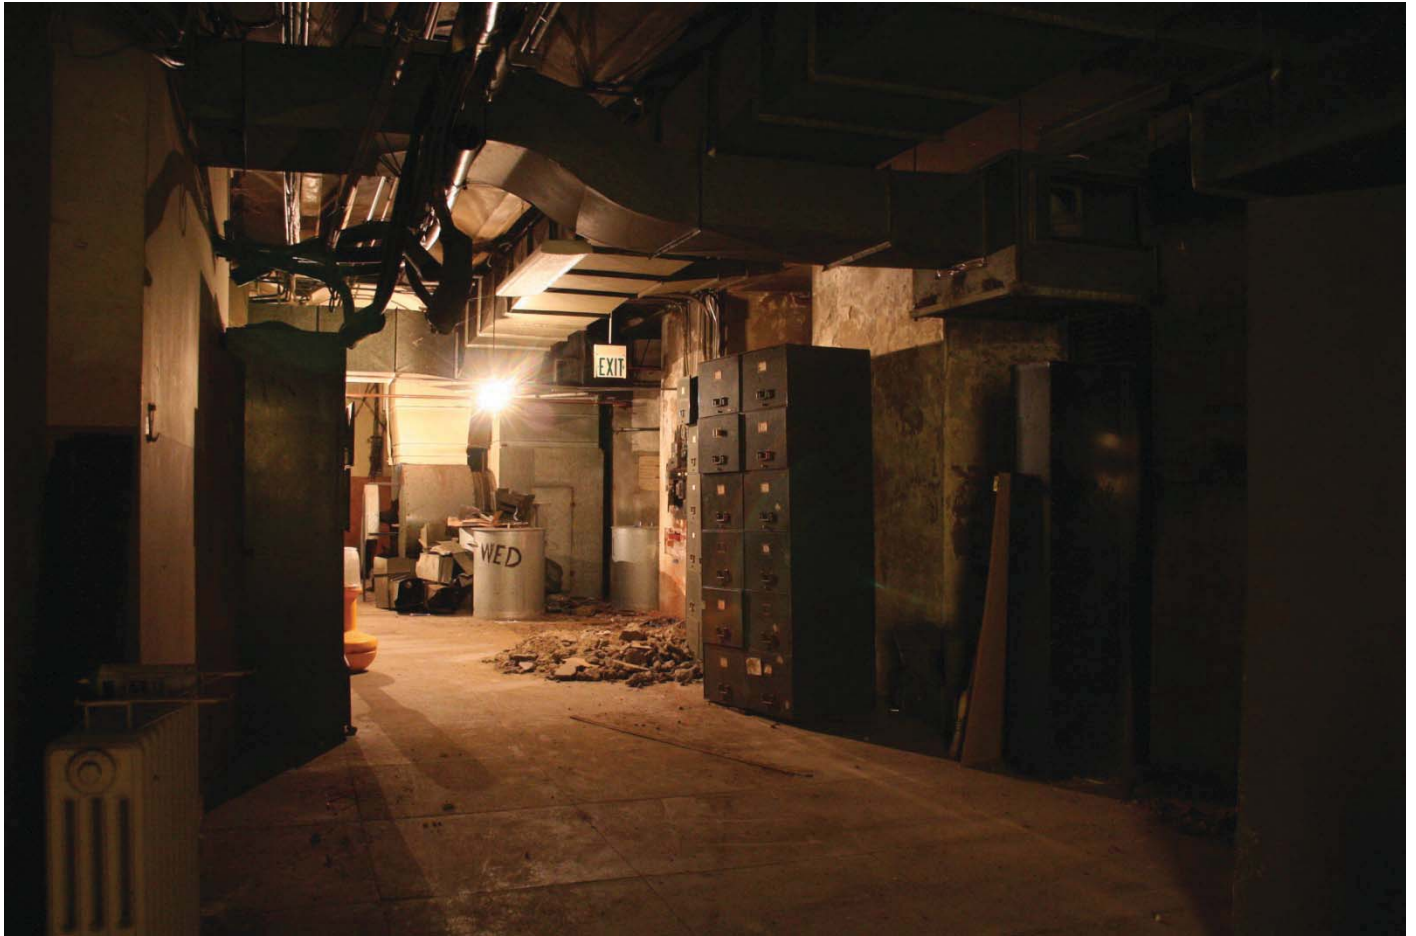
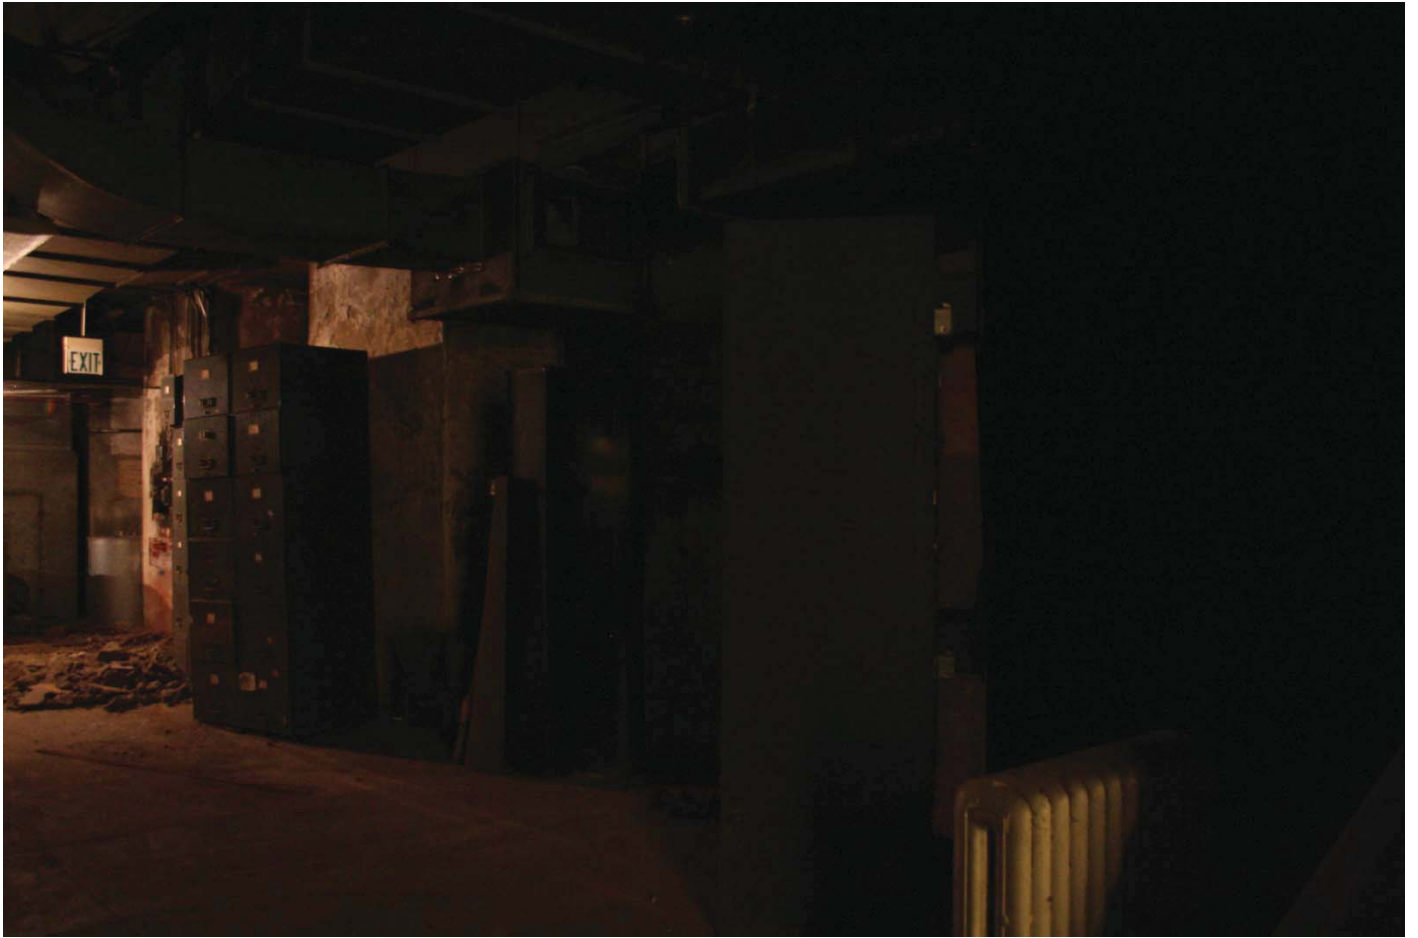
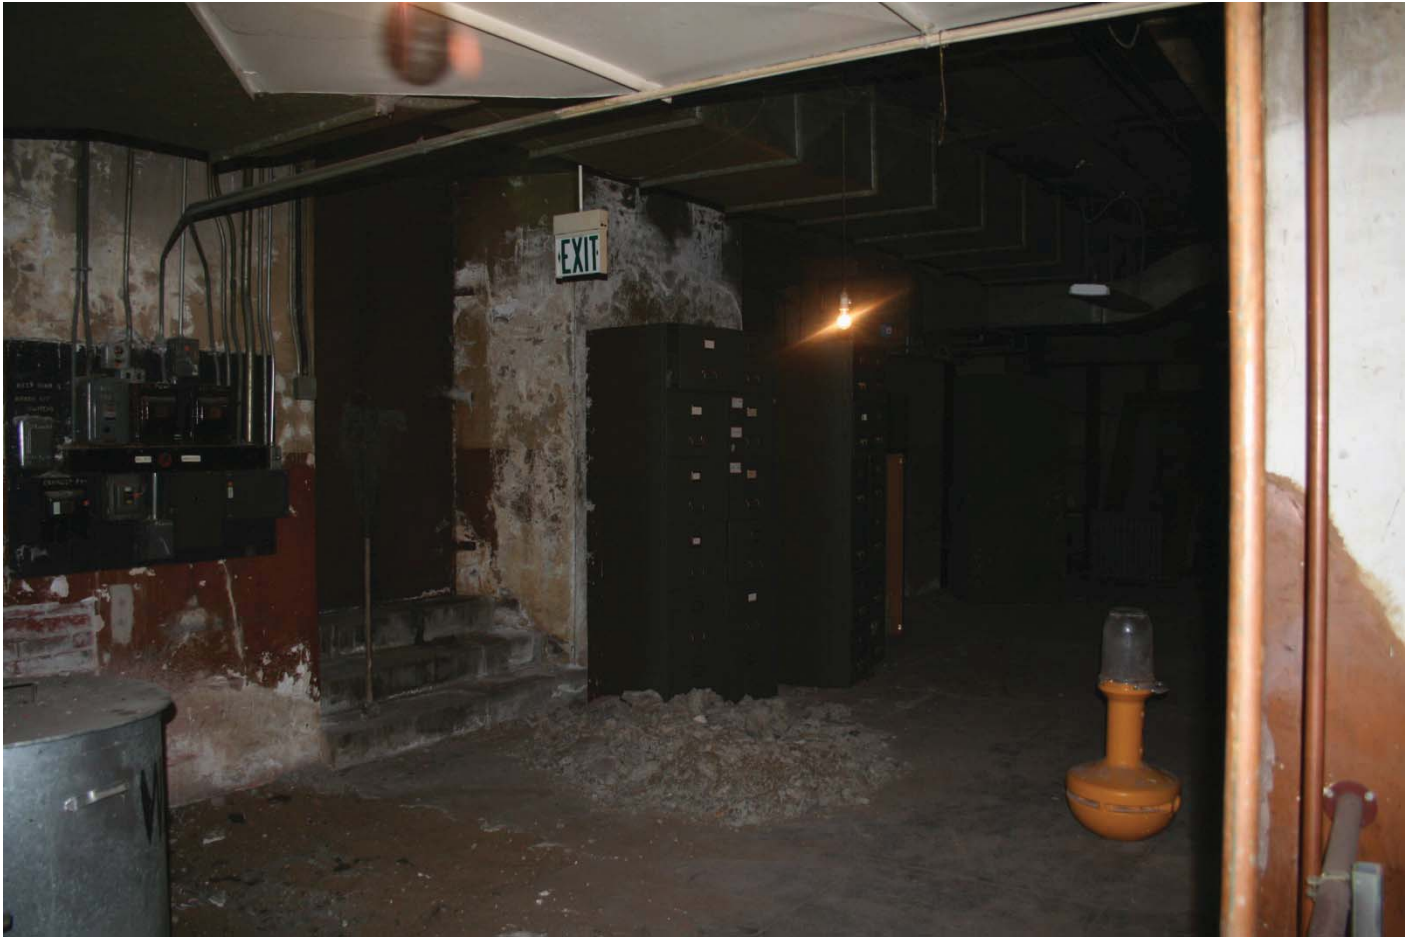
**Pier Thickening**

**Area B7**

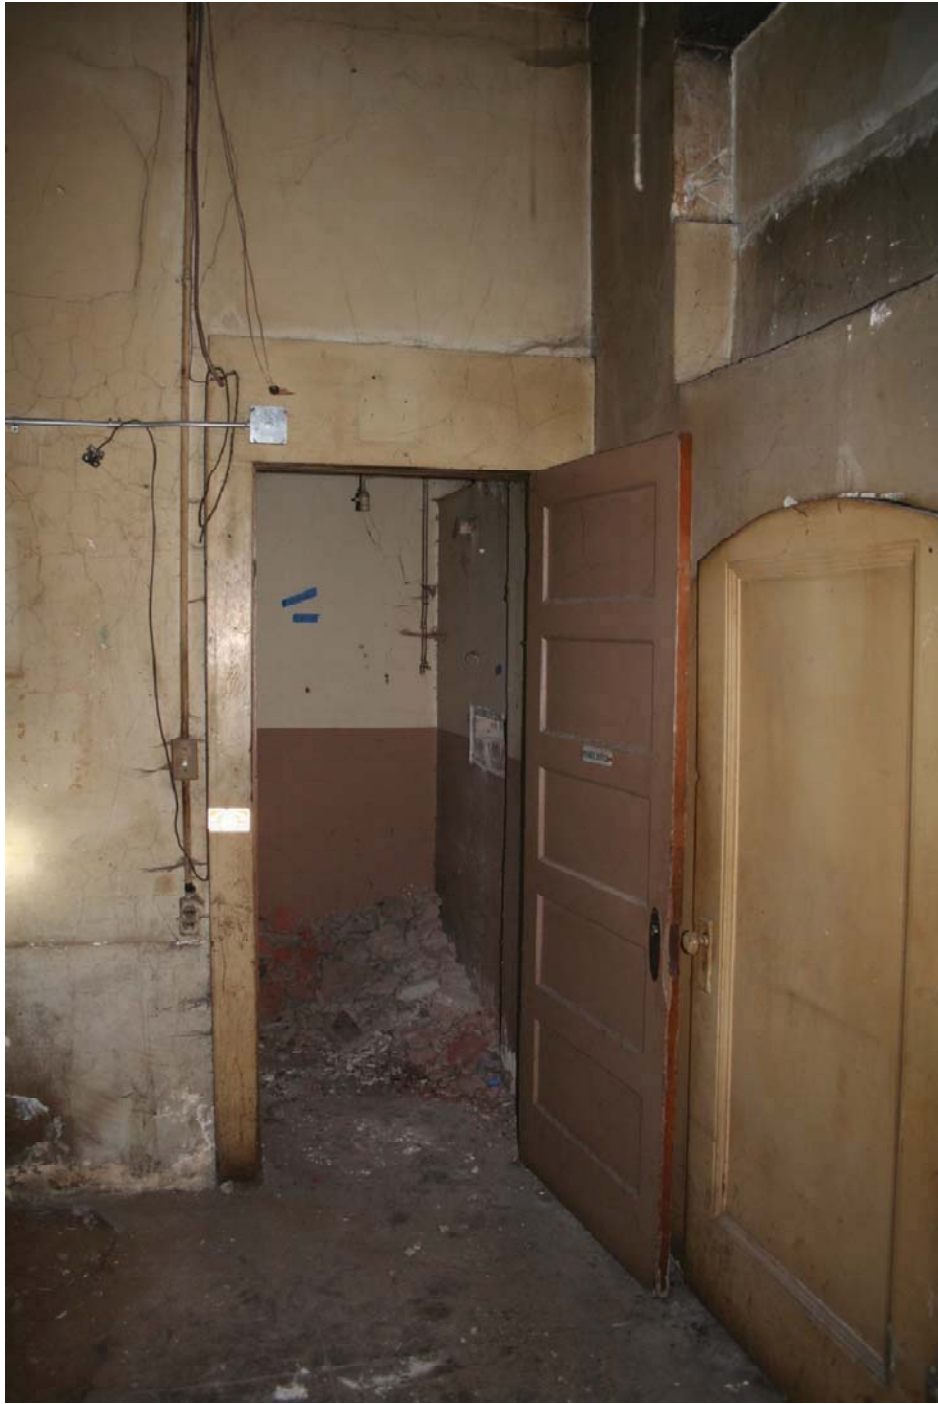
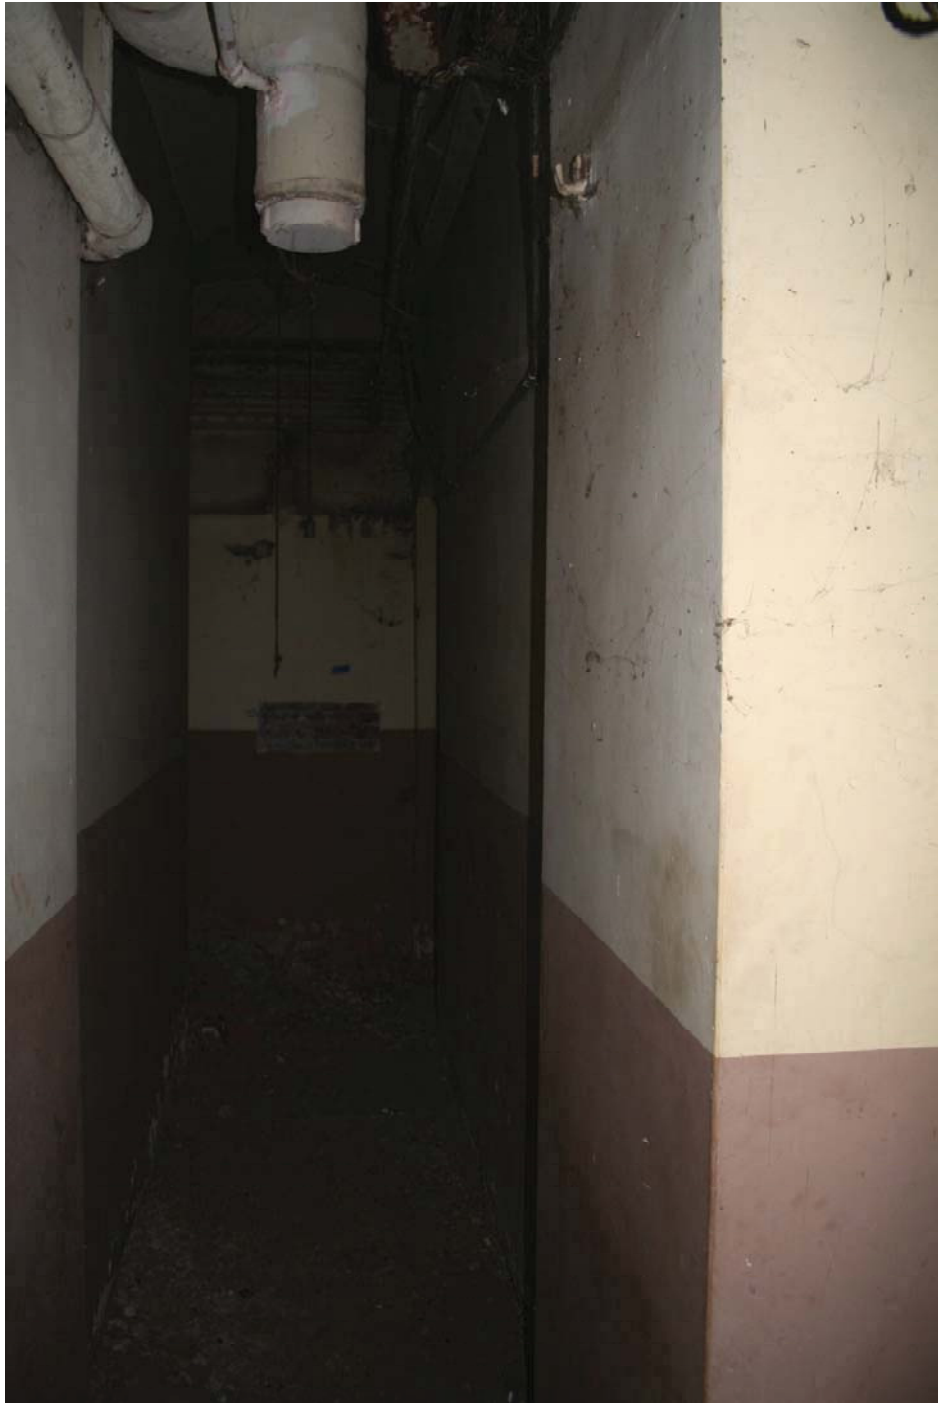
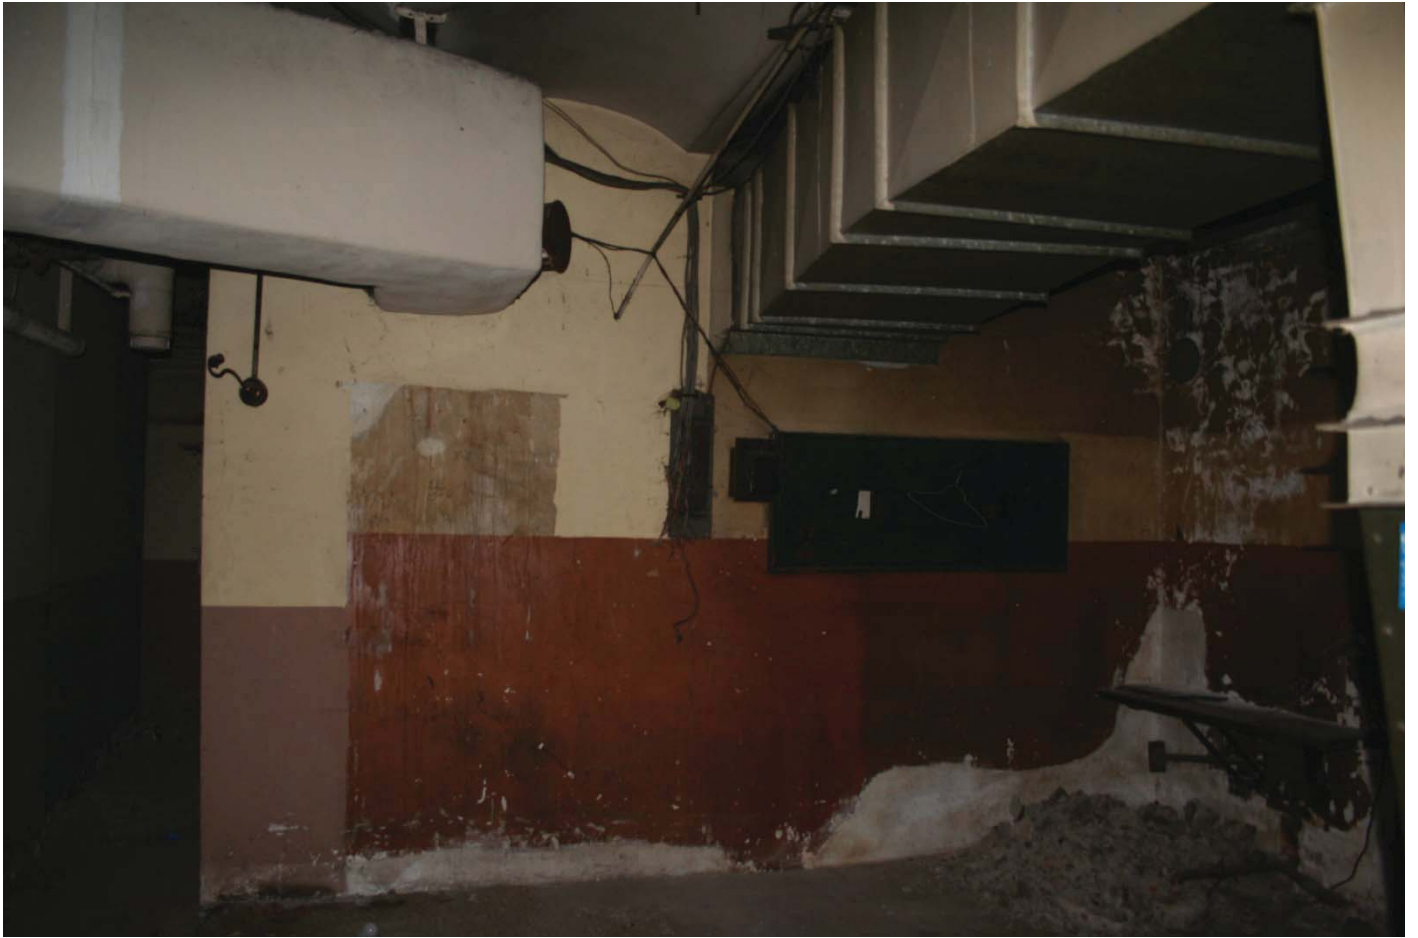
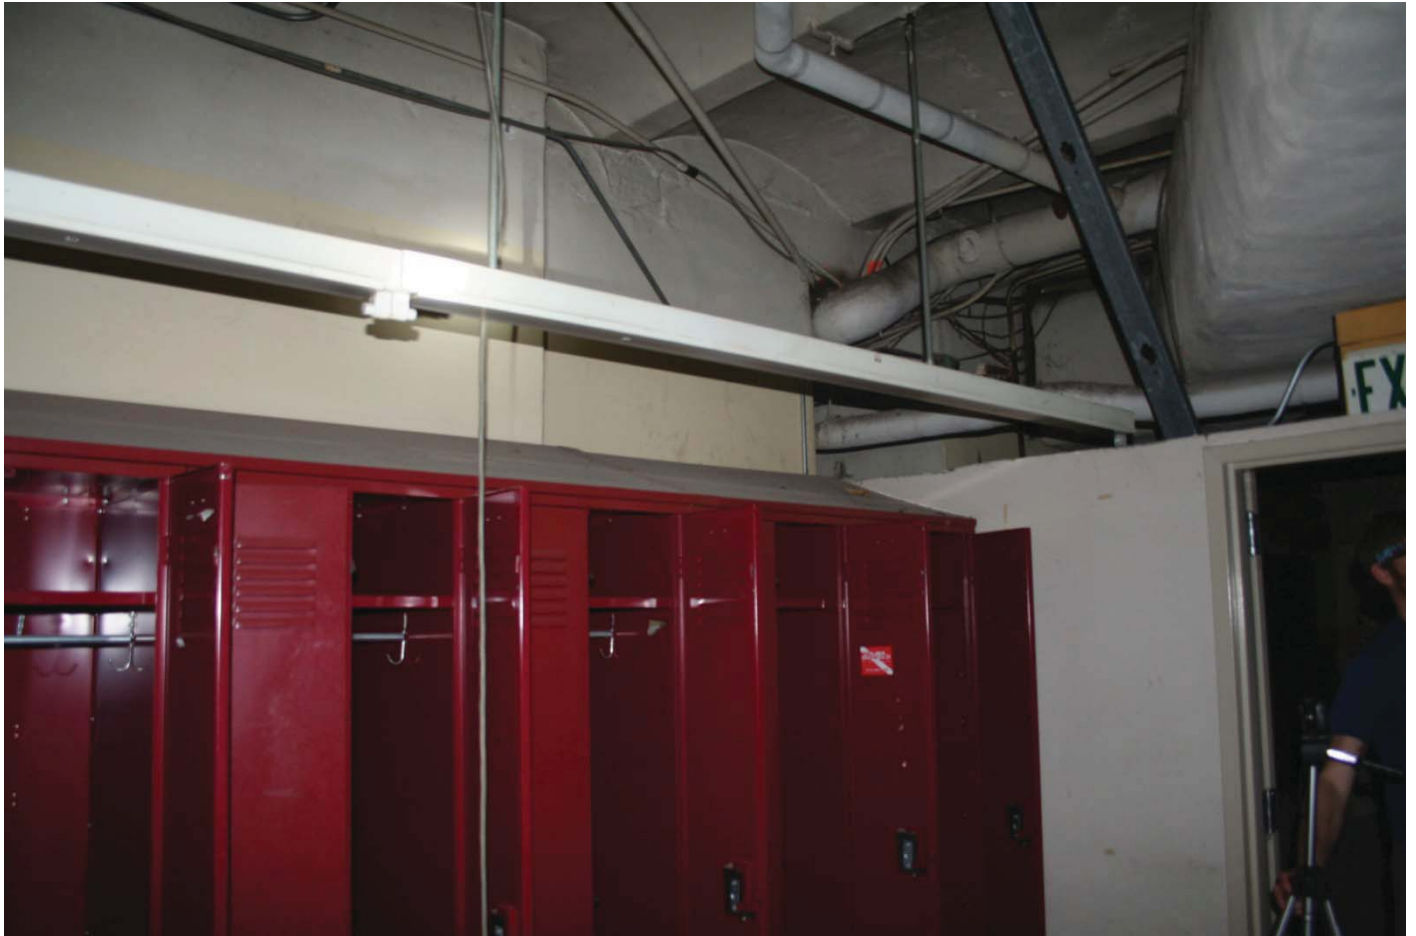
**New Shear Wall**

**Area B8**
