# SAN FRANCISCO PLANNING DEPARTMENT

**MEMO**

**RE:** Review and Comment for 1 Jones Street (former Hibernia Bank)  
Case No. 2011.0617EA

**HIBERNIA BANK BUILDING**

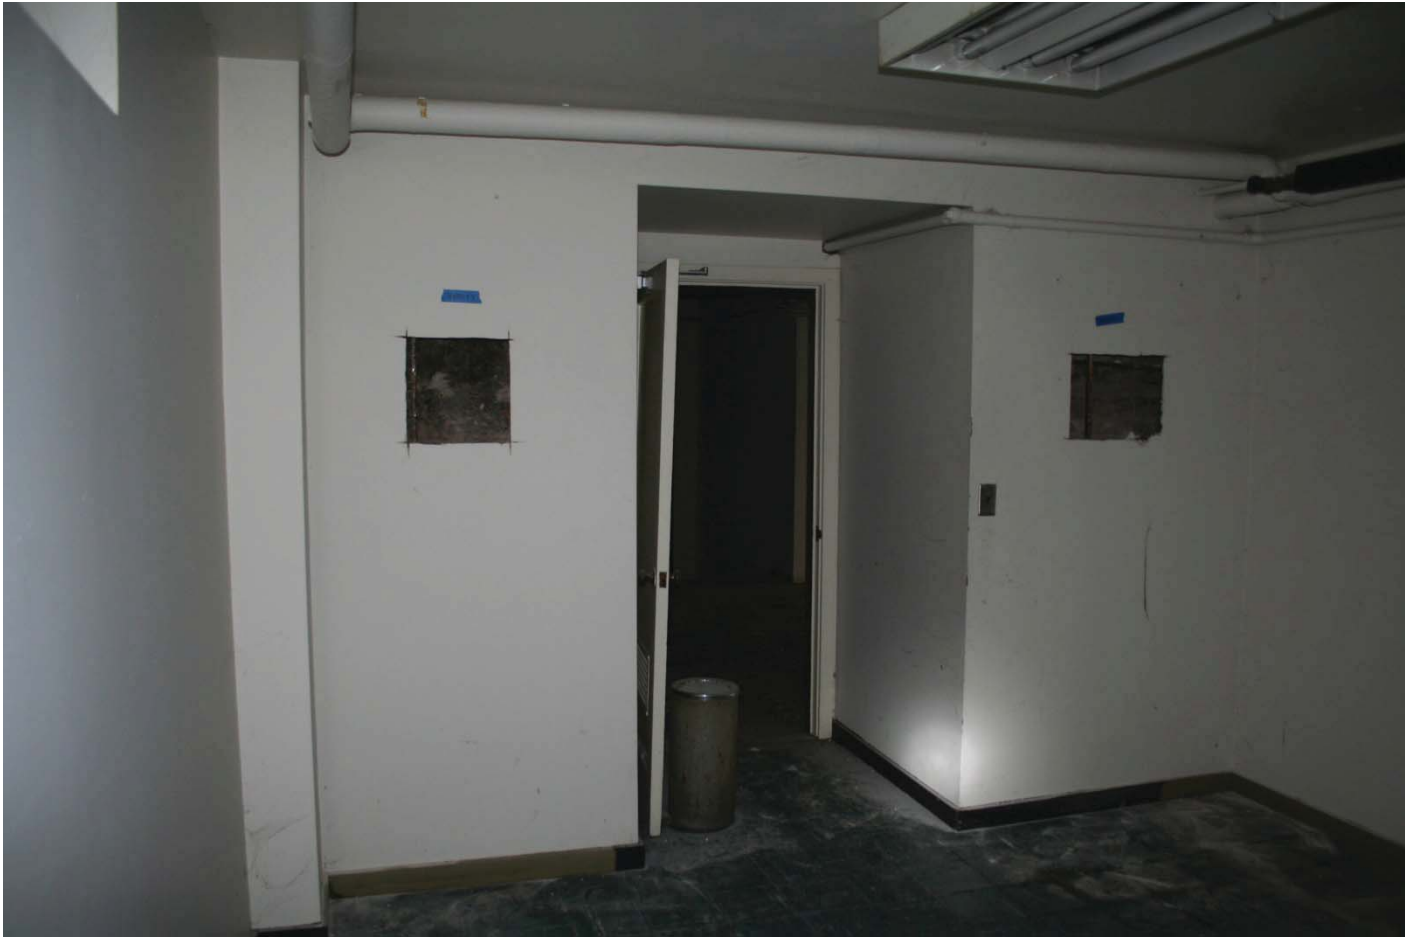
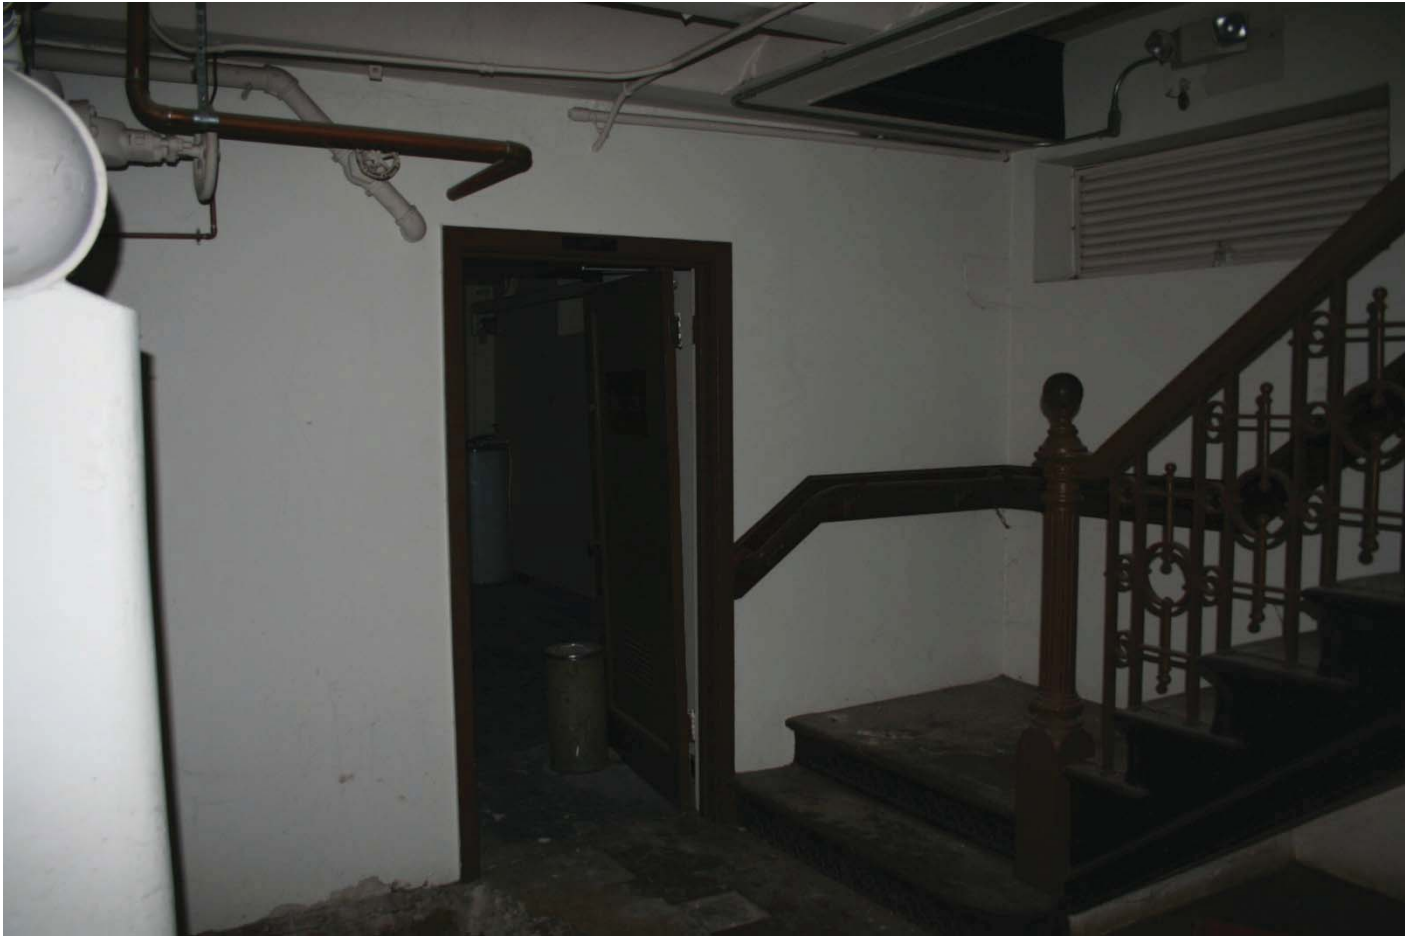
**New Shear Wall**

**Area B9**

- Installation of three reinforced concrete shear walls extending from the foundation to the roof deck. Two of these walls are located in the north banking service area (the “bookend”) and will be well-integrated with the existing massive masonry walls that extend the length of the building. These walls are intended to create a vertical “box girder”, using the masonry “bookend” walls as flanges, to brace the building in the north-south direction. The third full height wall, which is oriented in the east-west direction and in line with the north boundary of the executive offices, will be located in a closet/stairwell near the southeast corner of the building adjacent to the rotunda. Each of these three walls will be integrated with collectors/bond beams at the roof. It is envisioned that some foundation work may be required at these walls;

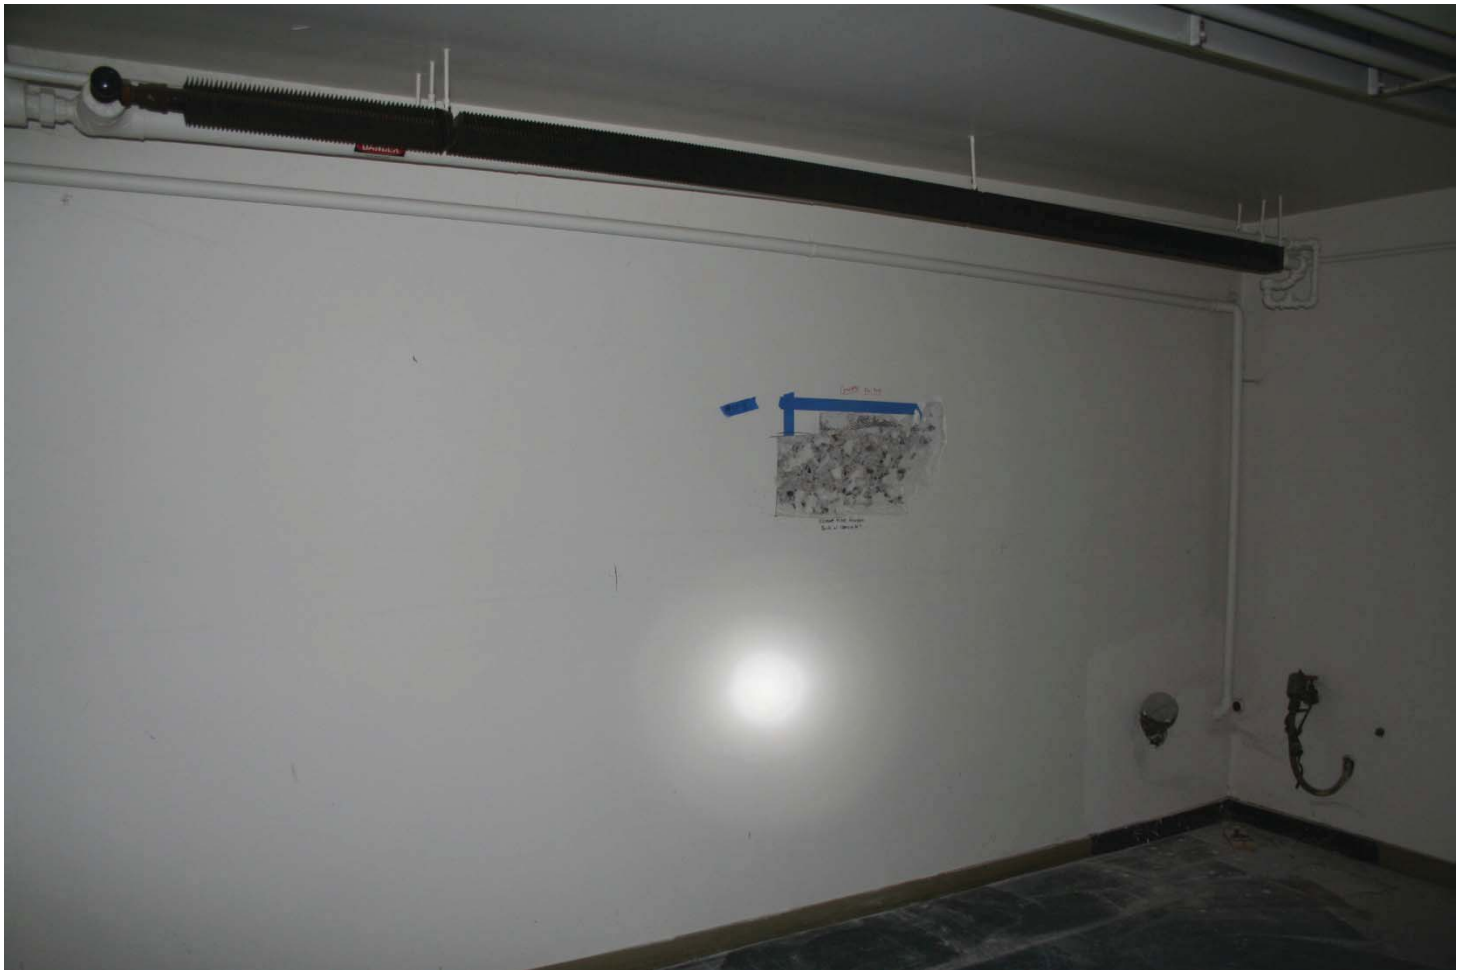
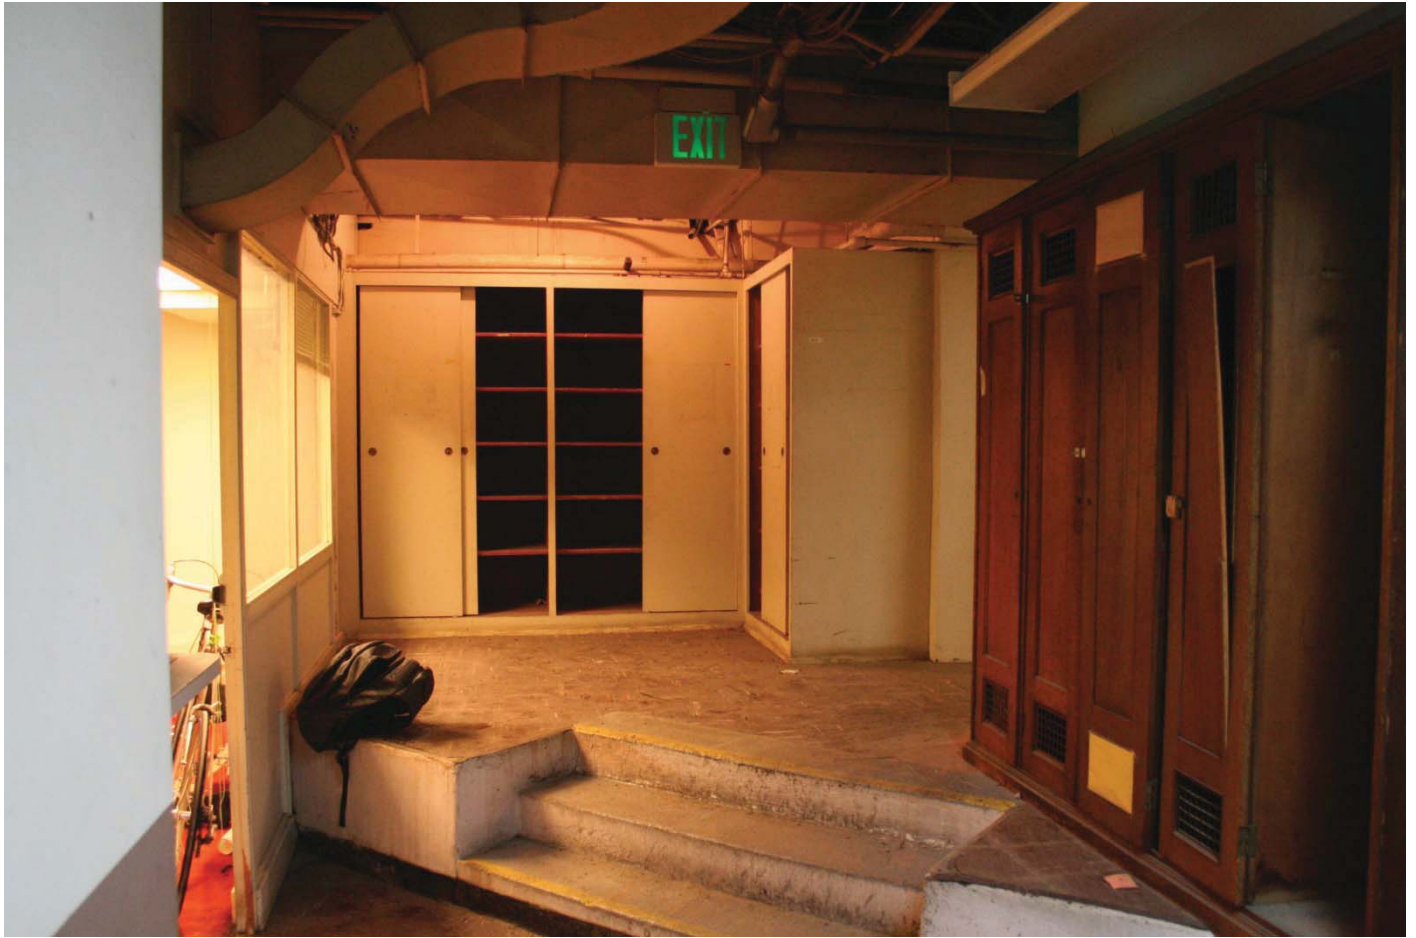
**New Opening**

**Area B10**

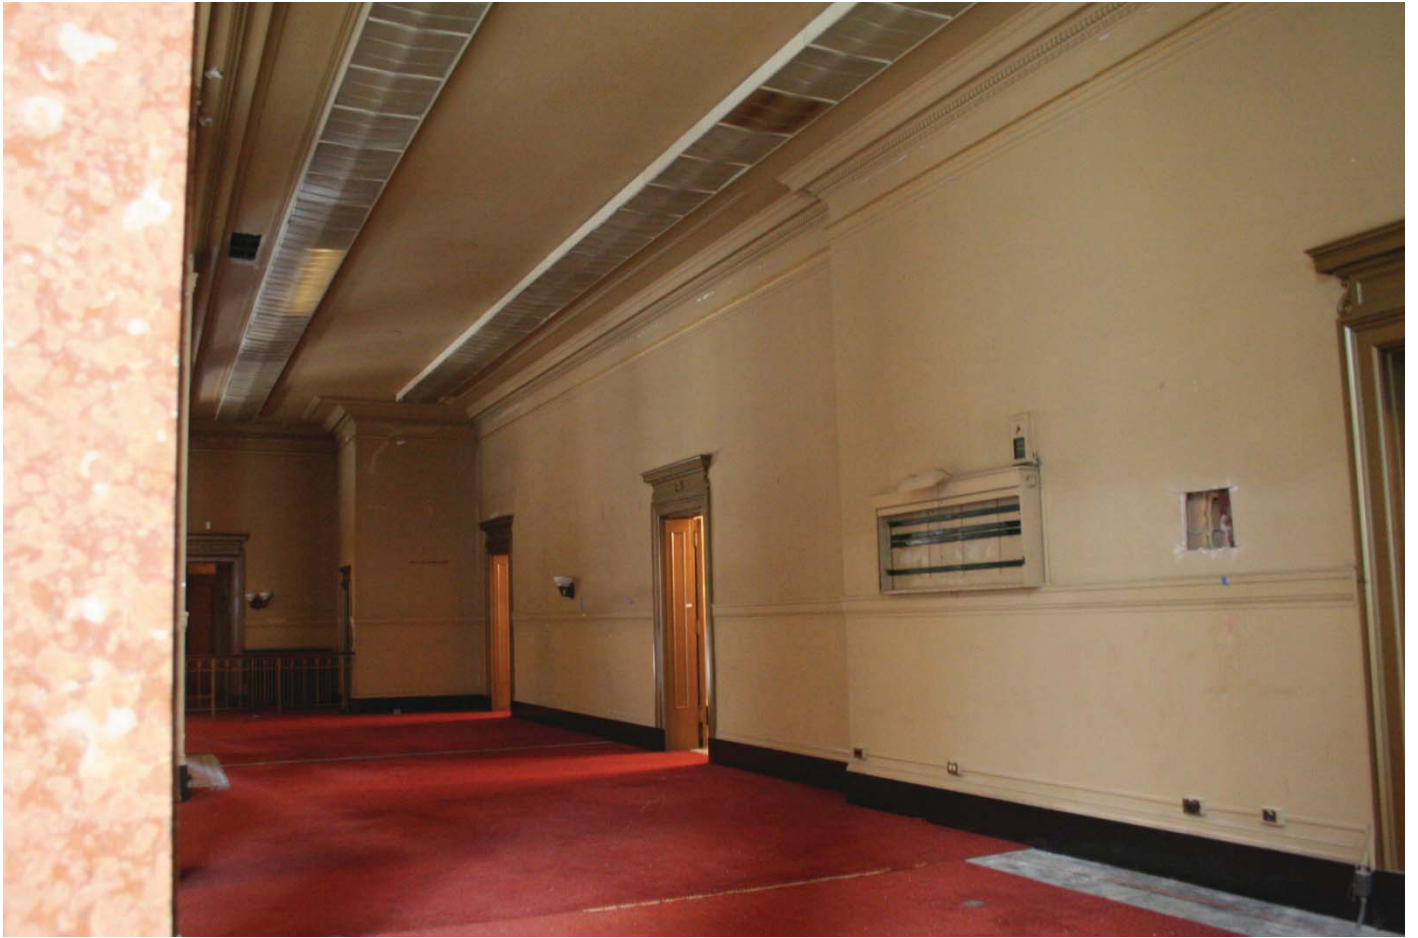
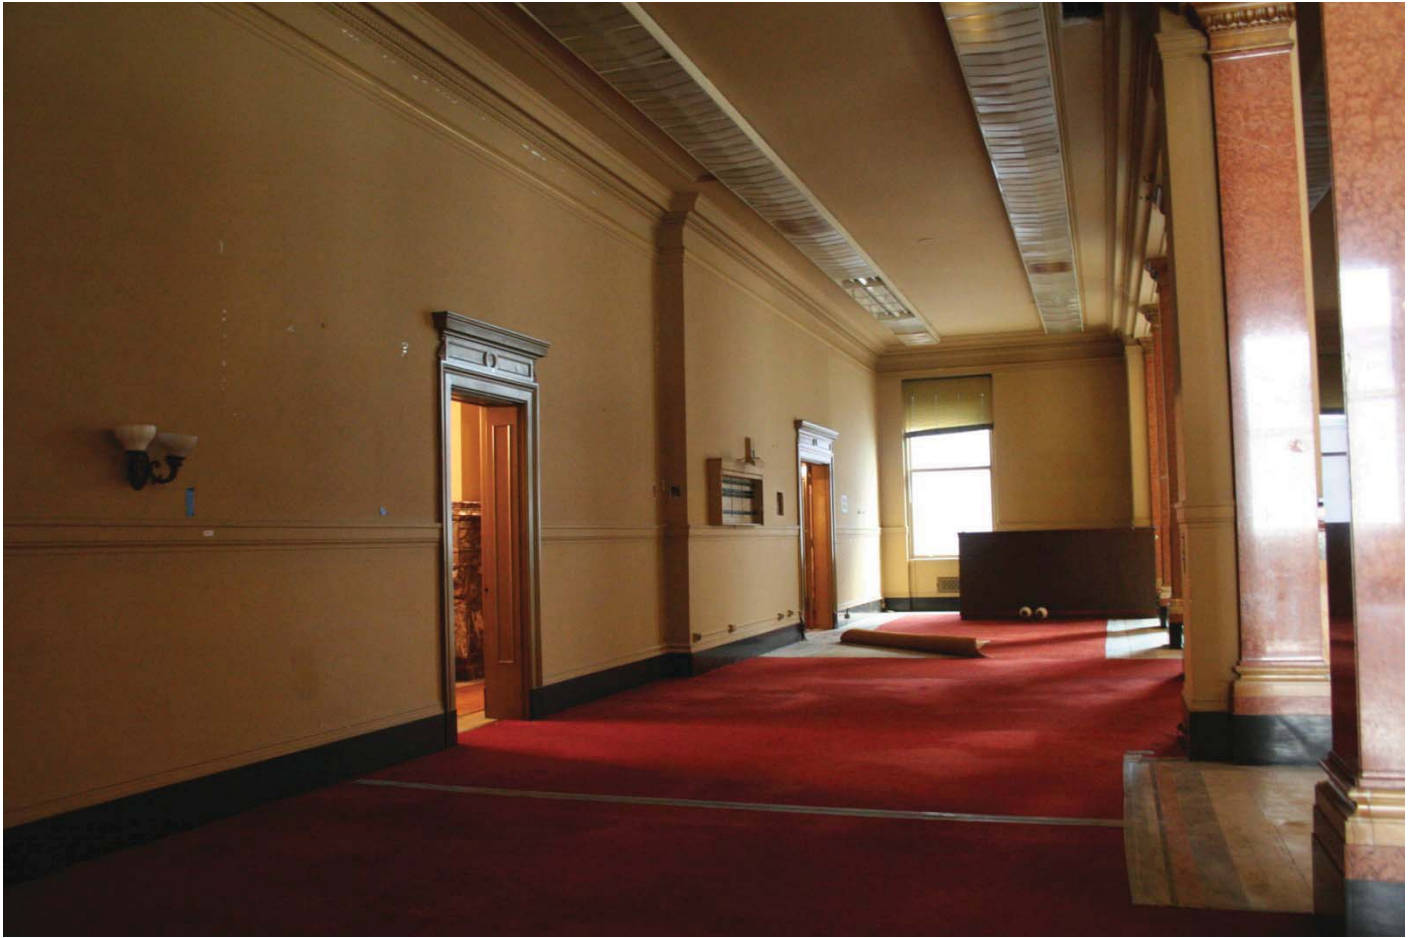
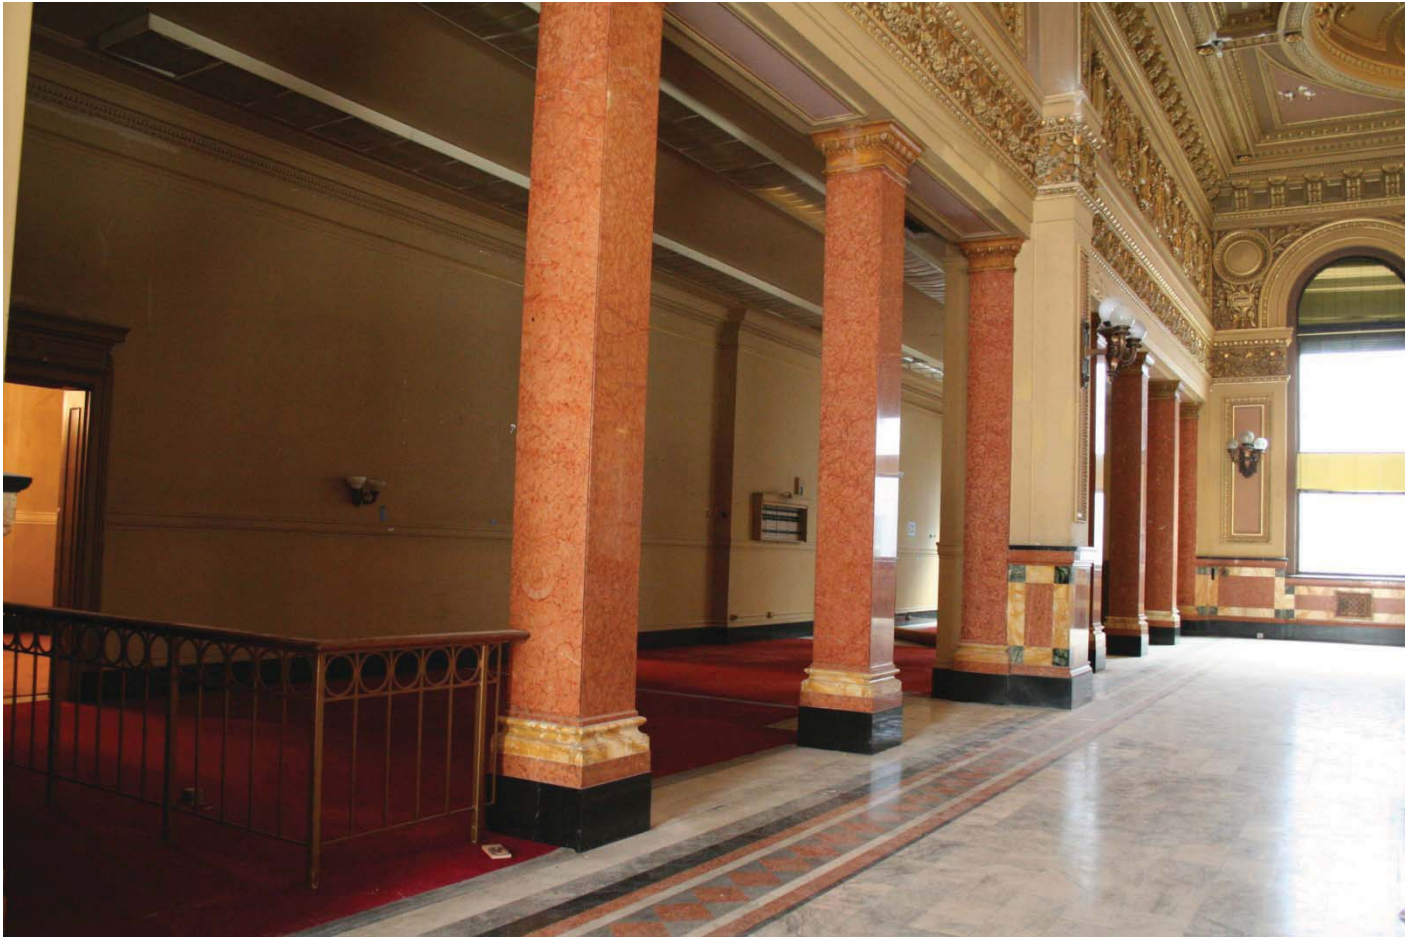
### **New Shear Wall and HCT Stabilization**

## **Area E1**

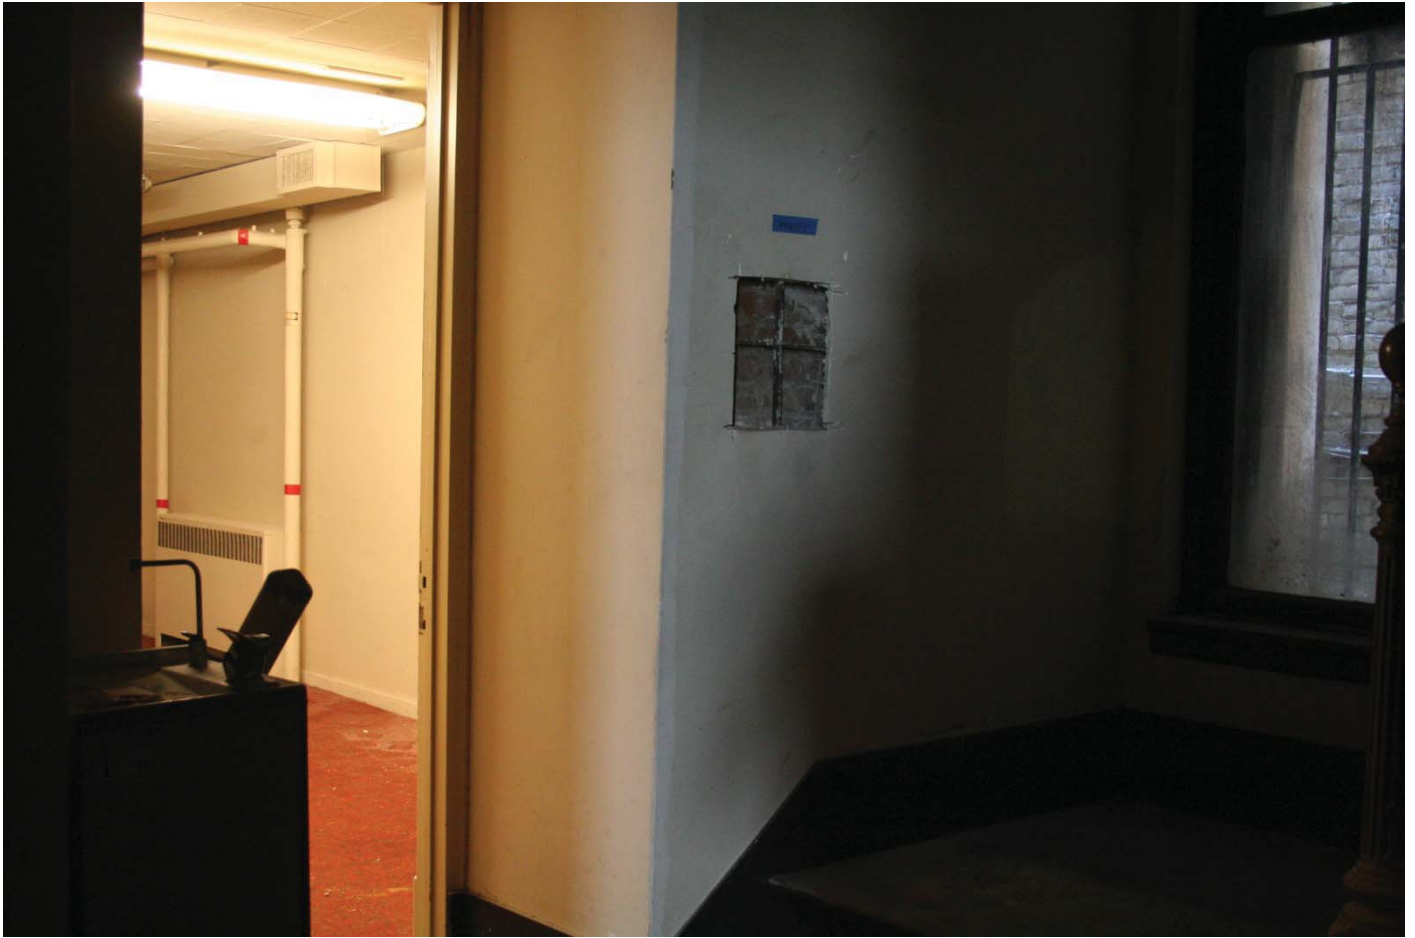
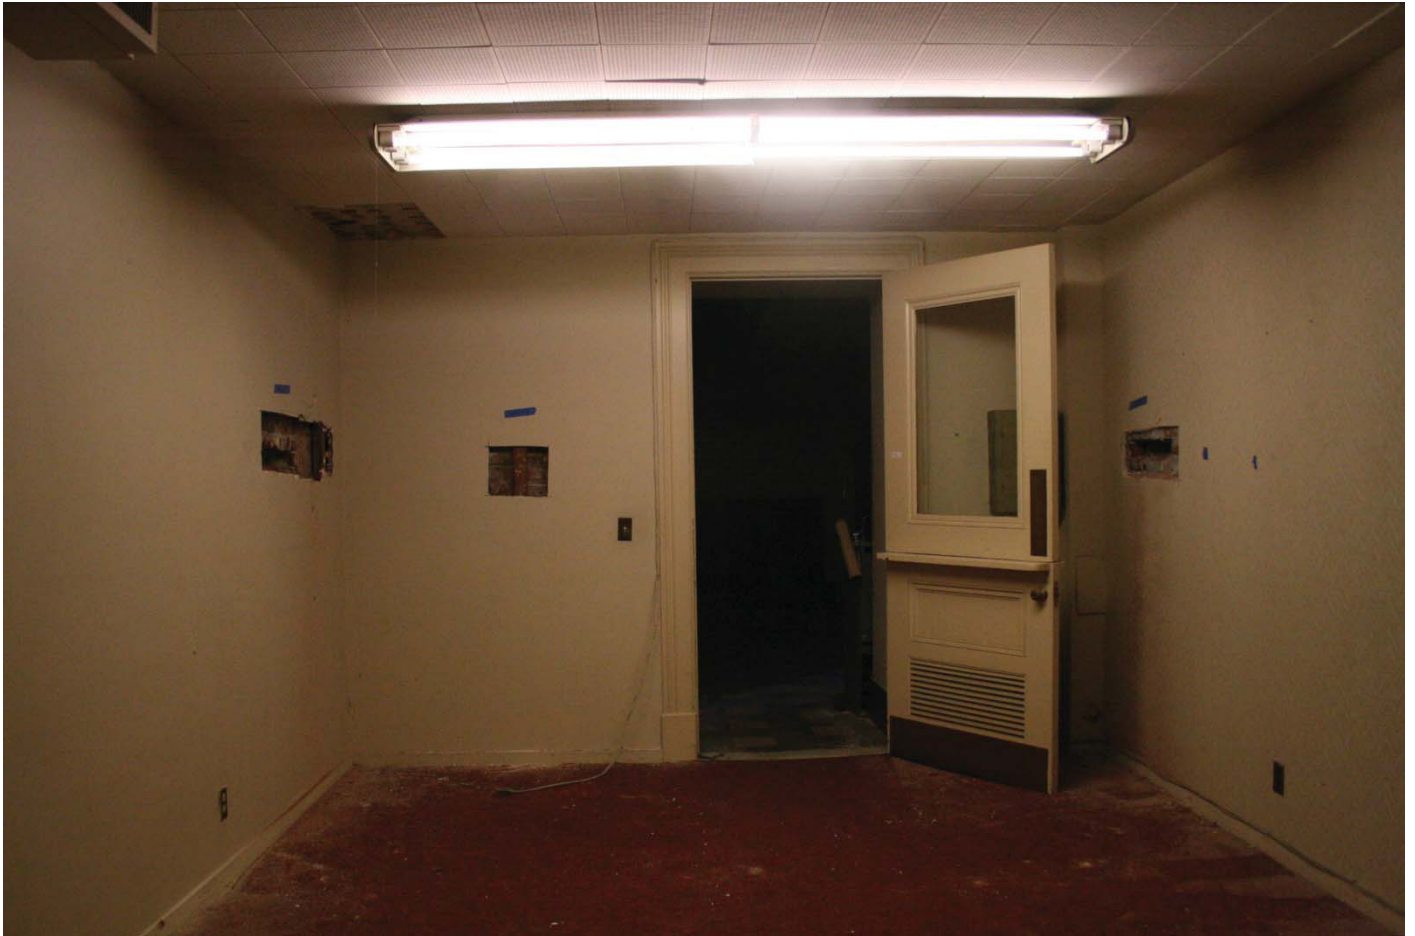
**New Shear Wall**

**Area E3**

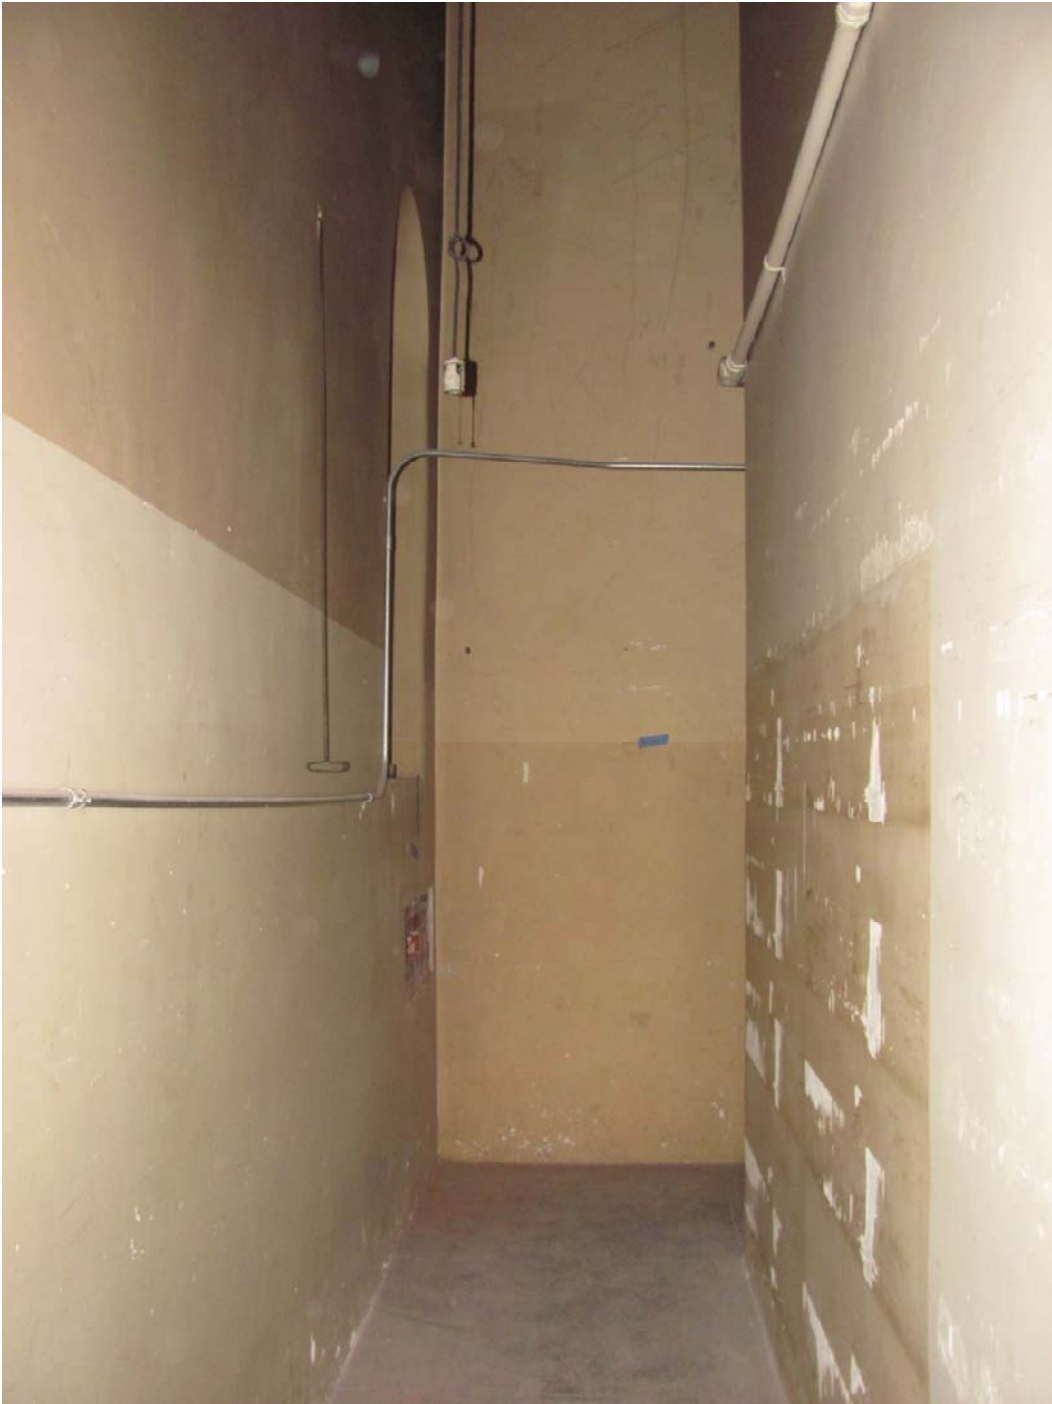
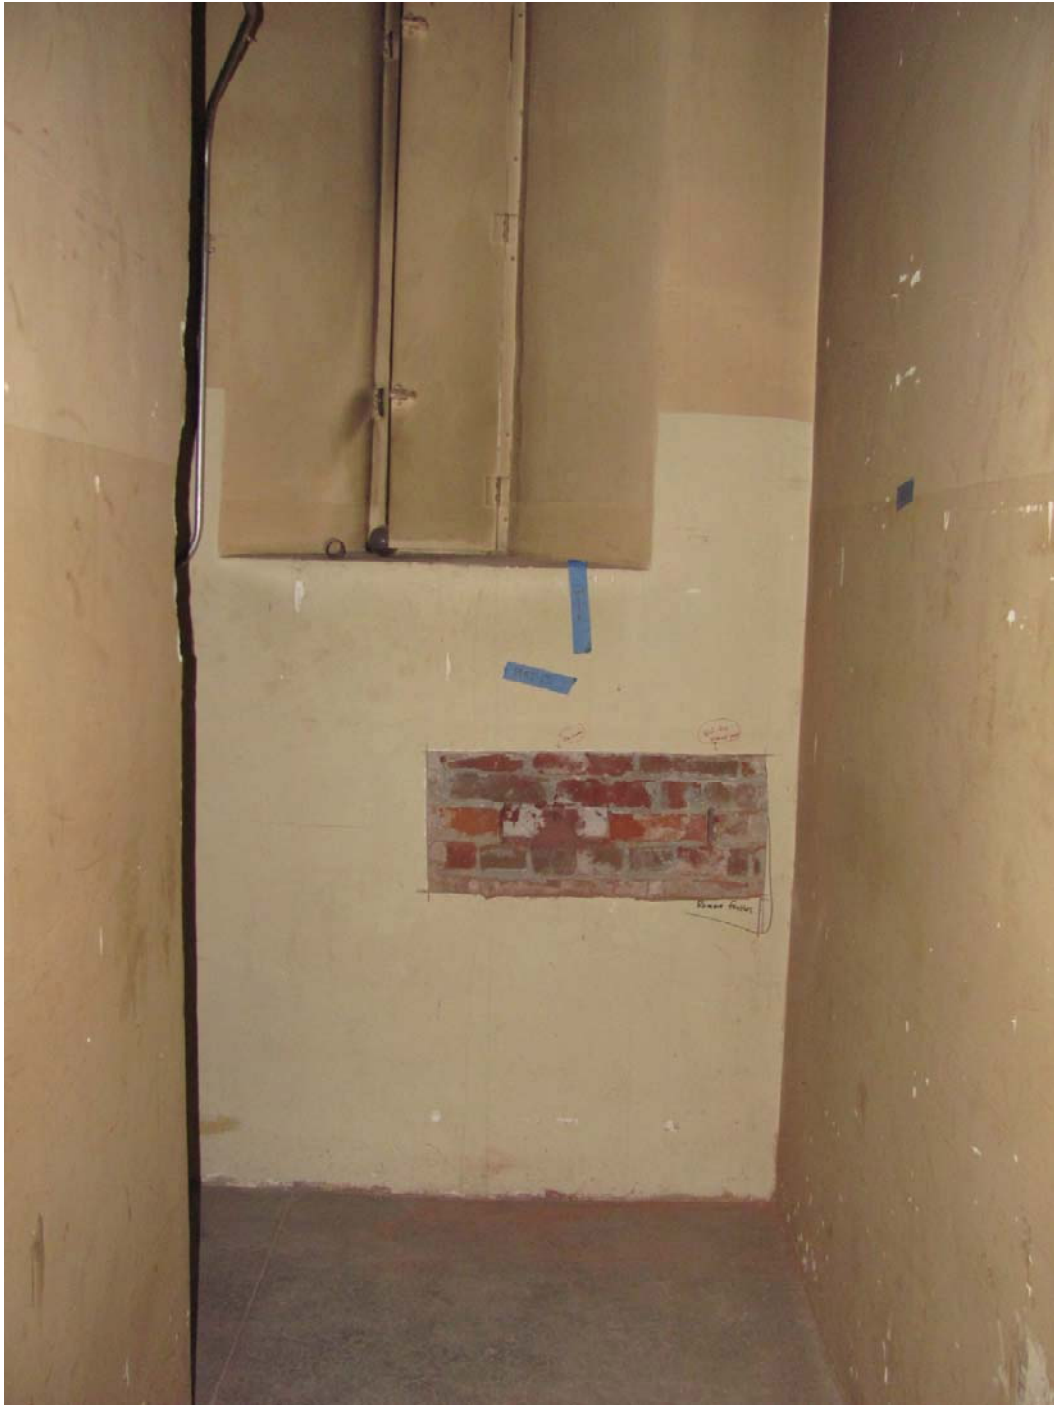
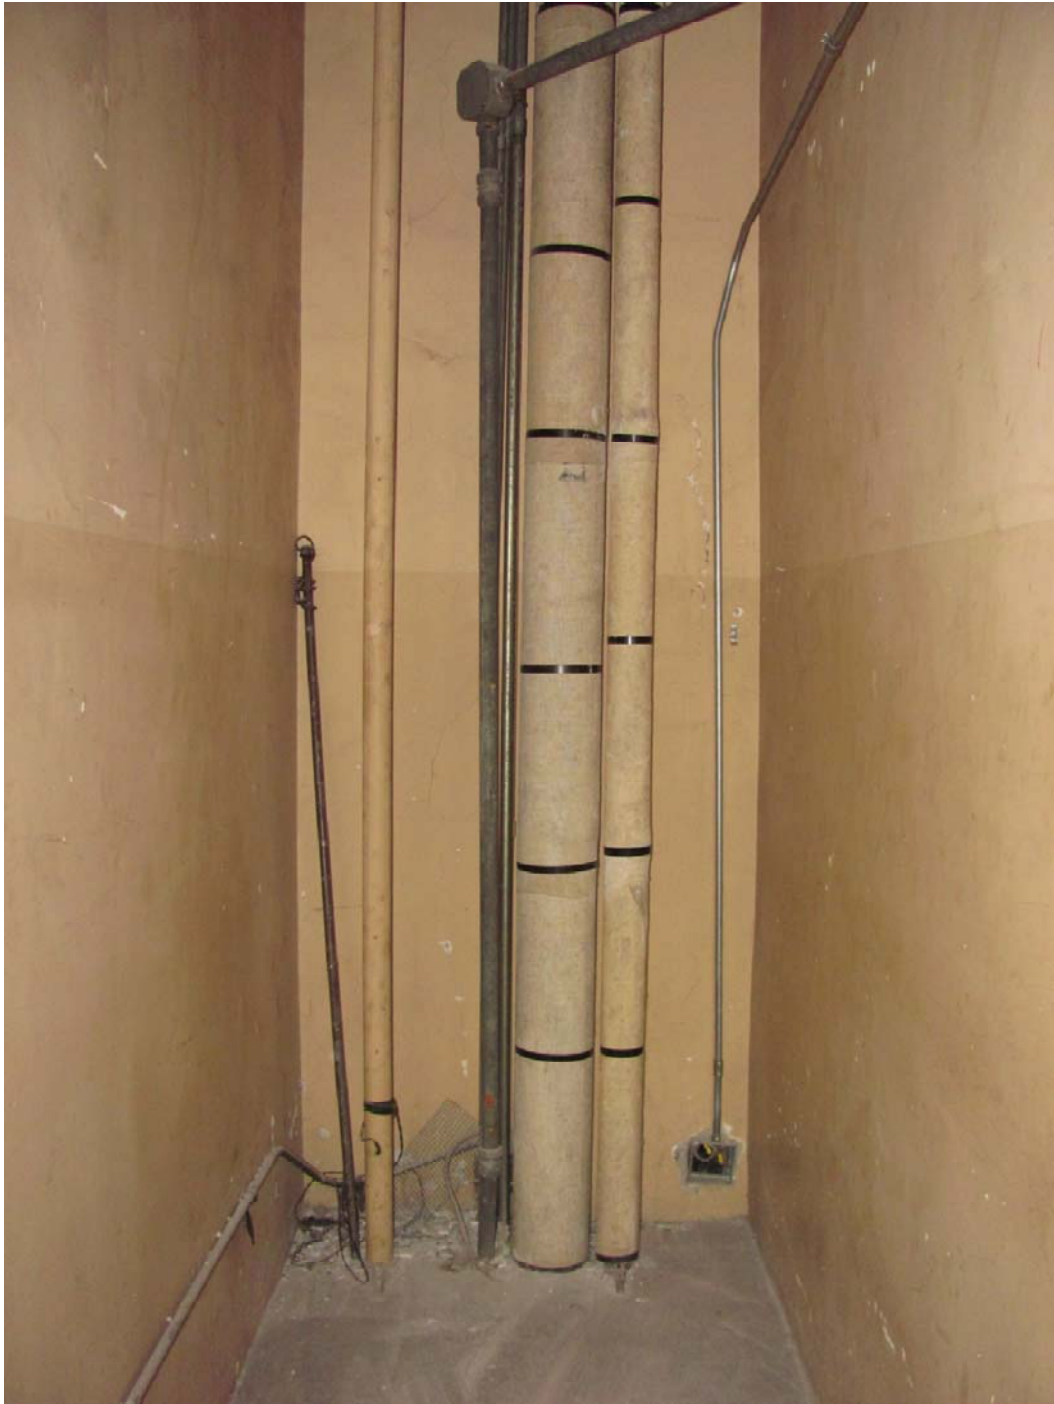
**New Shear Wall**

**Area E4**

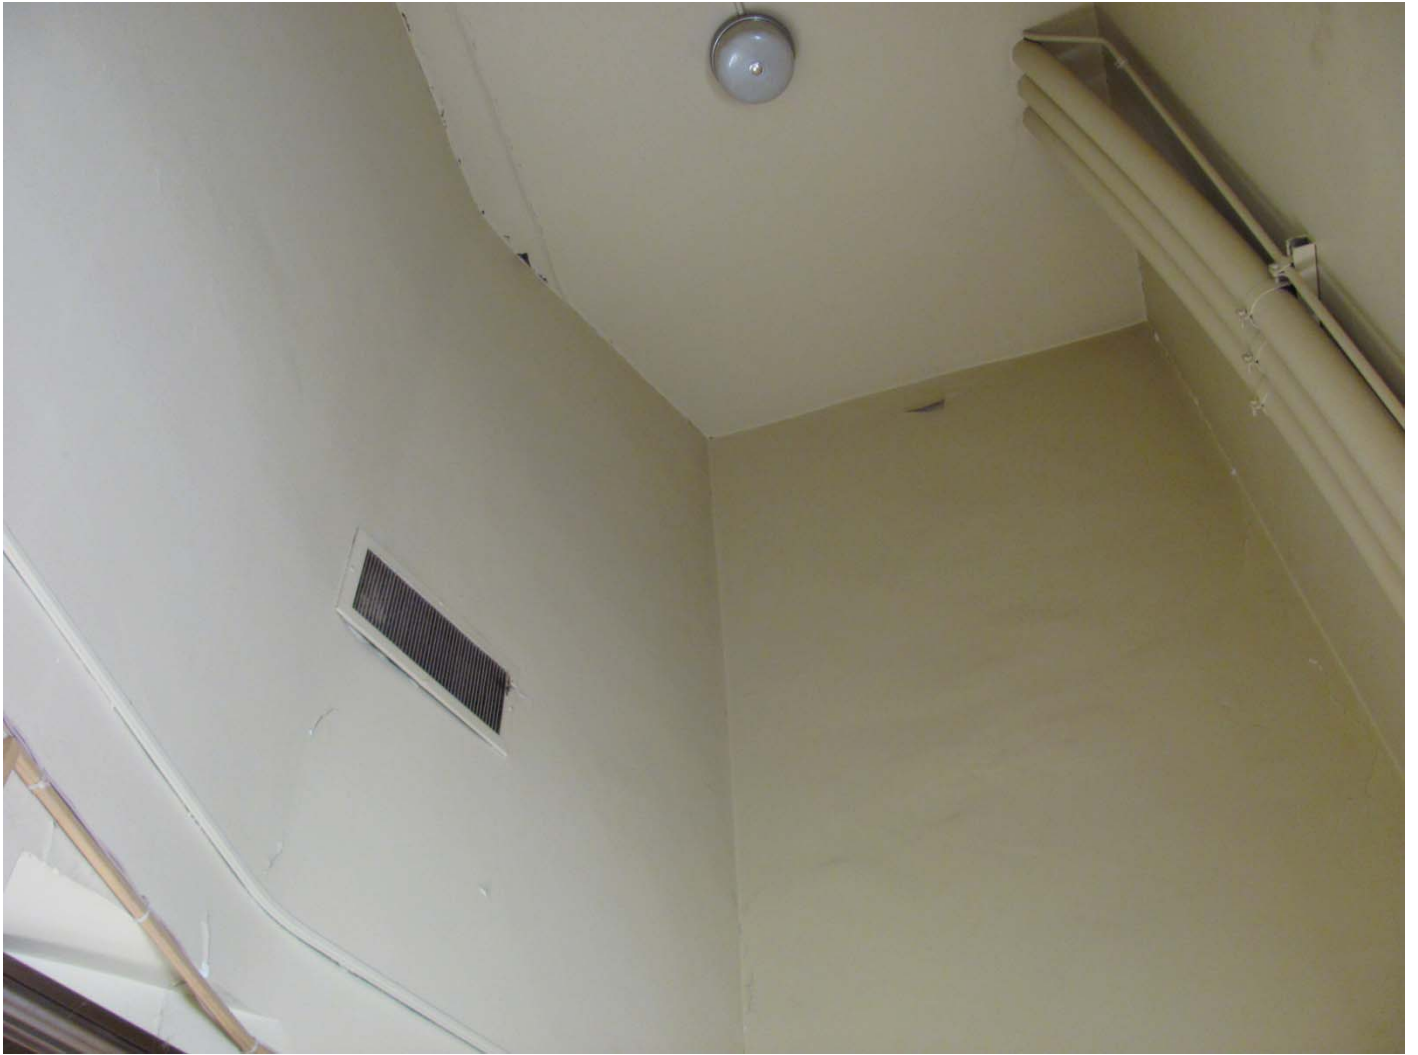
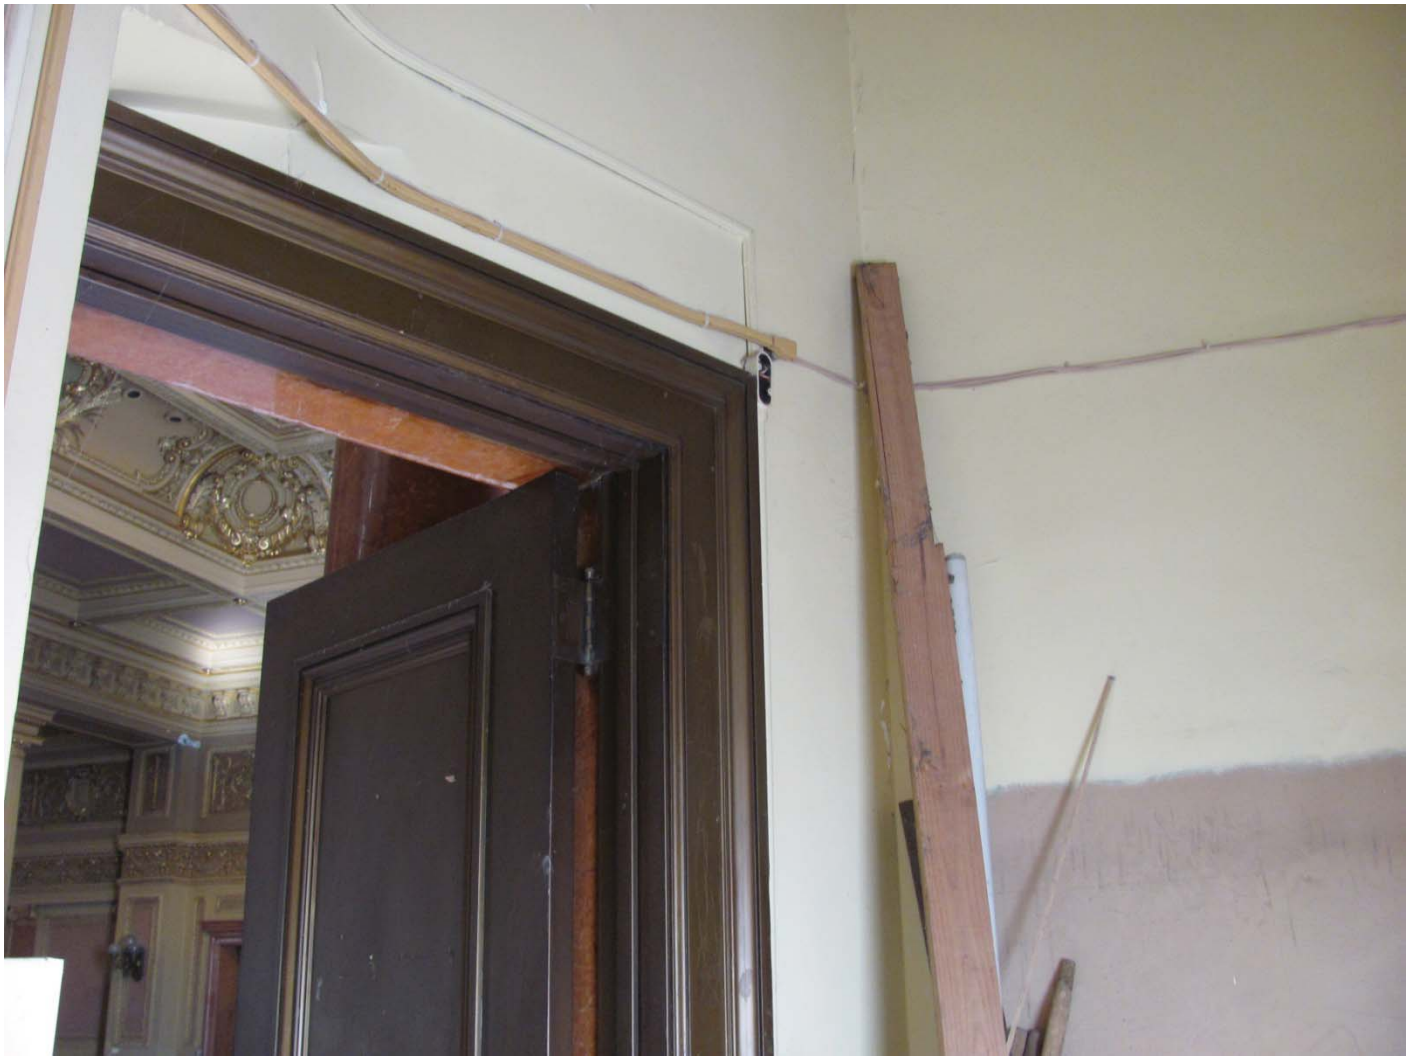
**New Shear Wall**

**Area E5**

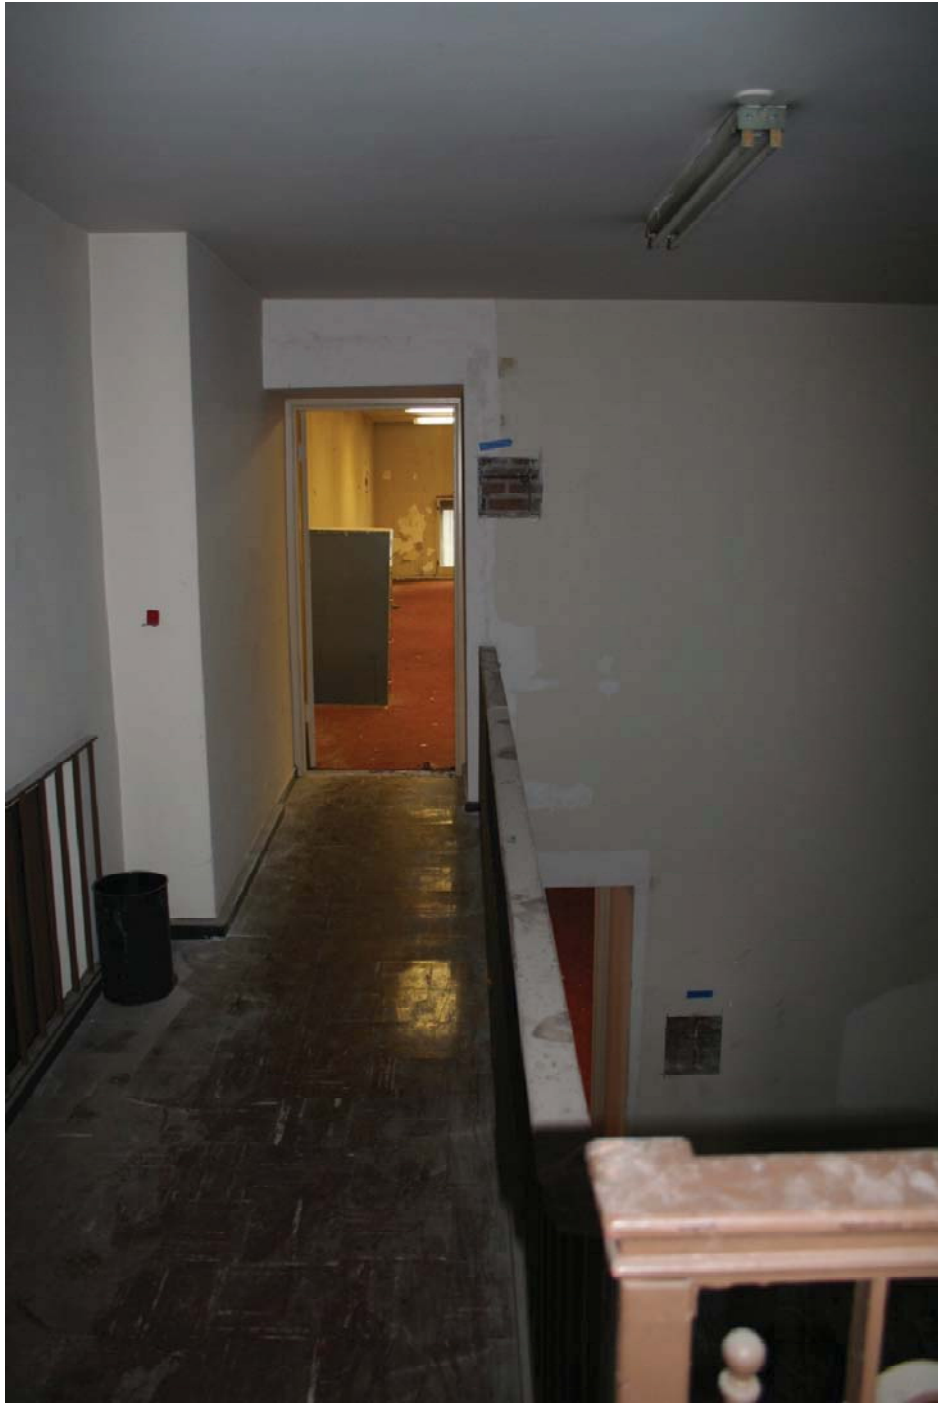
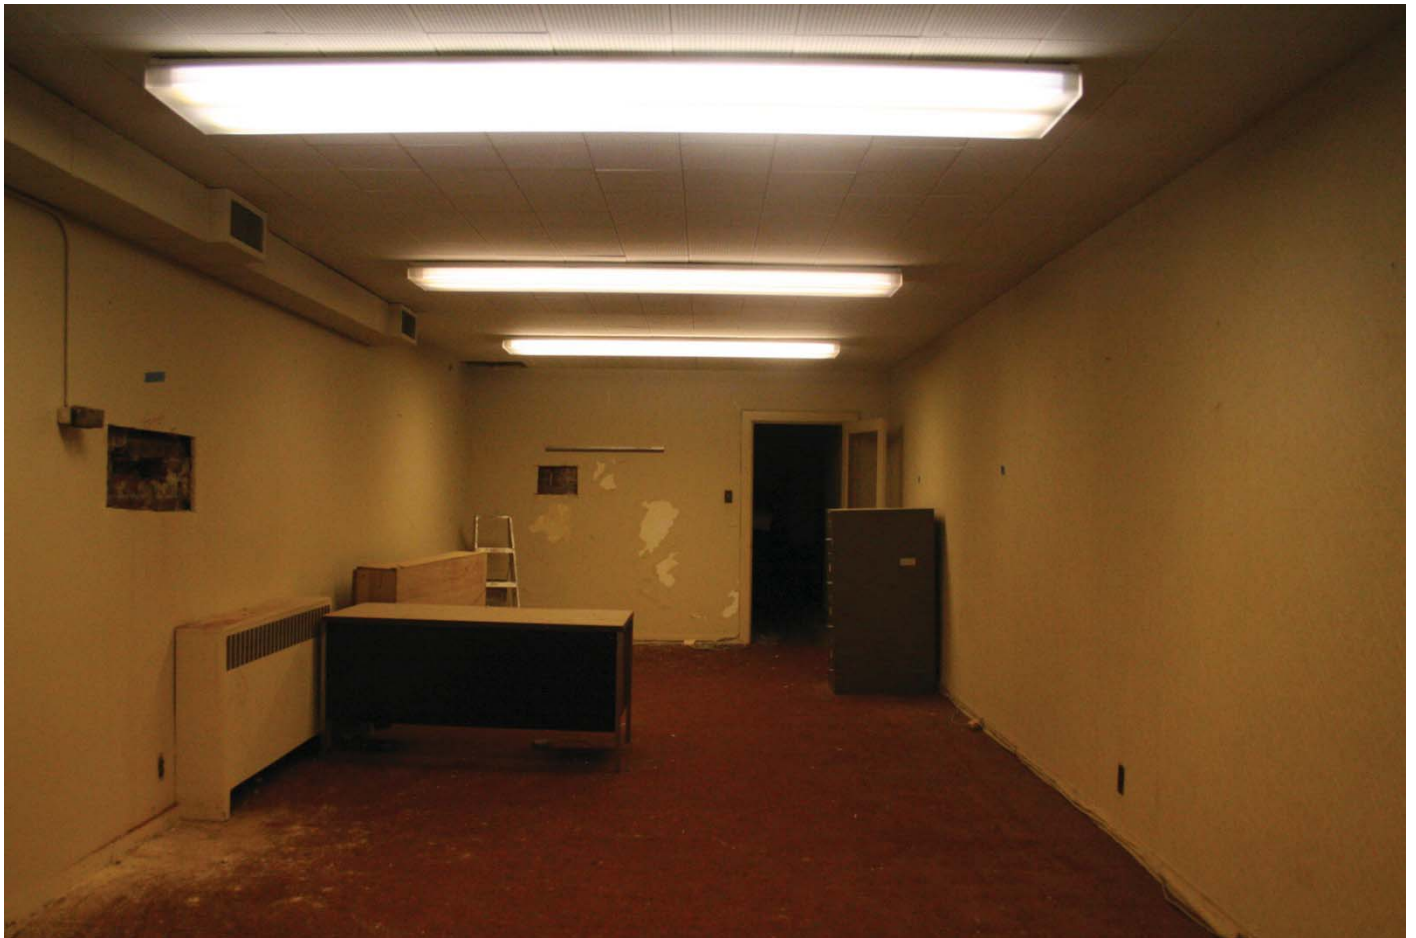
**New Shear Wall**

**Area M1**

- Installation of a shear wall in the customer service waiting area at the approximate geometric center of the executive office floor plate to provide an independent lateral support for the second floor executive offices in the east west direction. This wall extends from the foundation to the second floor soffit. In the basement, the wall is reinforced concrete. In the main level, to provide a wall stiffness and strength compatible with the existing building, the wall will be of cold-formed steel studs and steel deck;
