# SAN FRANCISCO PLANNING DEPARTMENT

**MEMO**

**RE:** Review and Comment for 1 Jones Street (former Hibernia Bank)  
Case No. 2011.0617EA

**HIBERNIA BANK BUILDING**

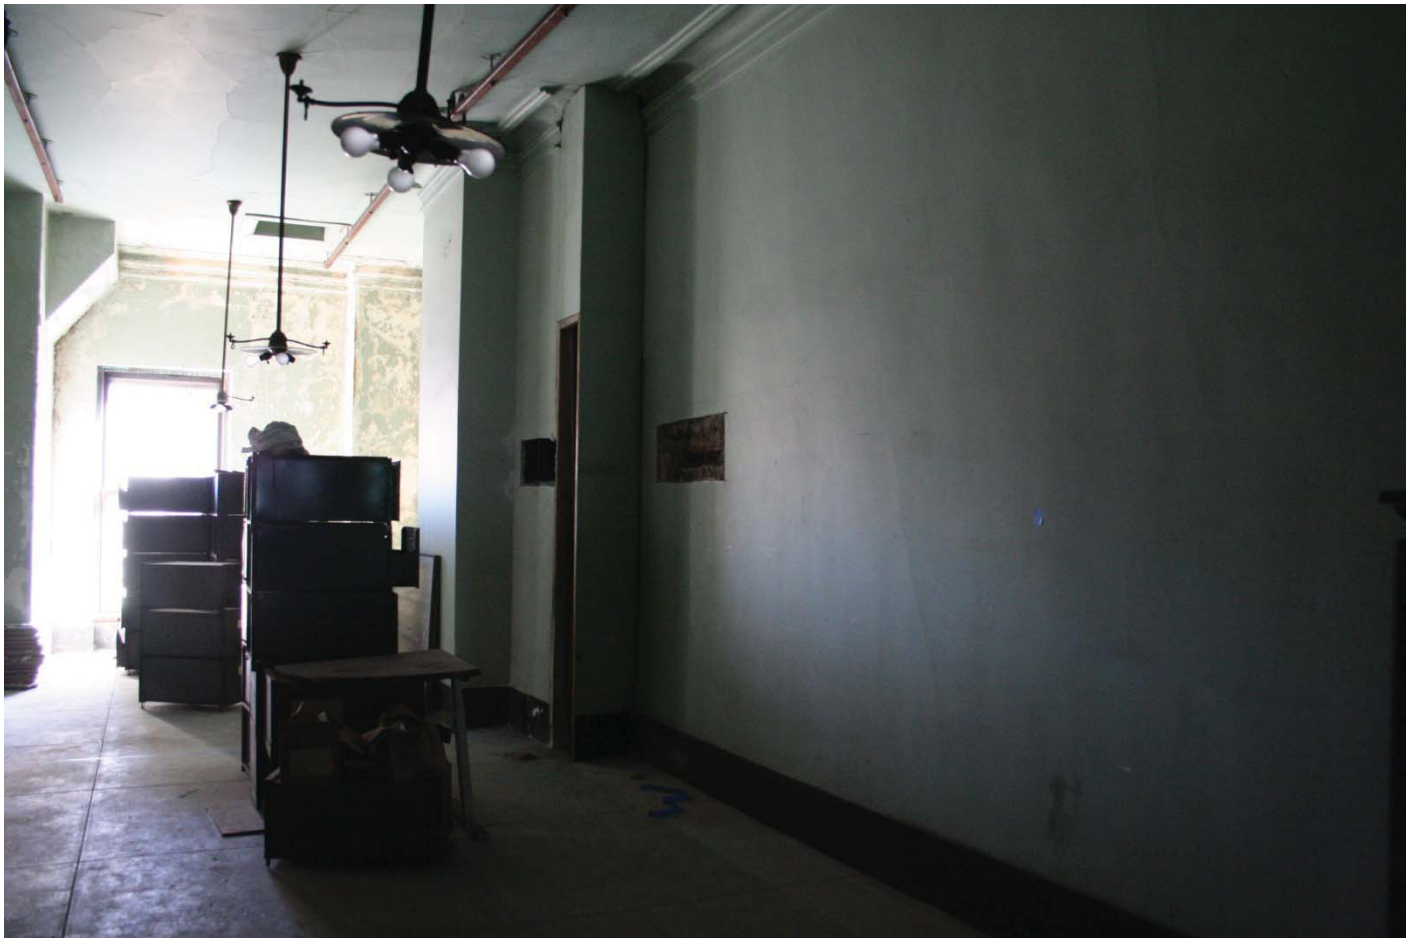
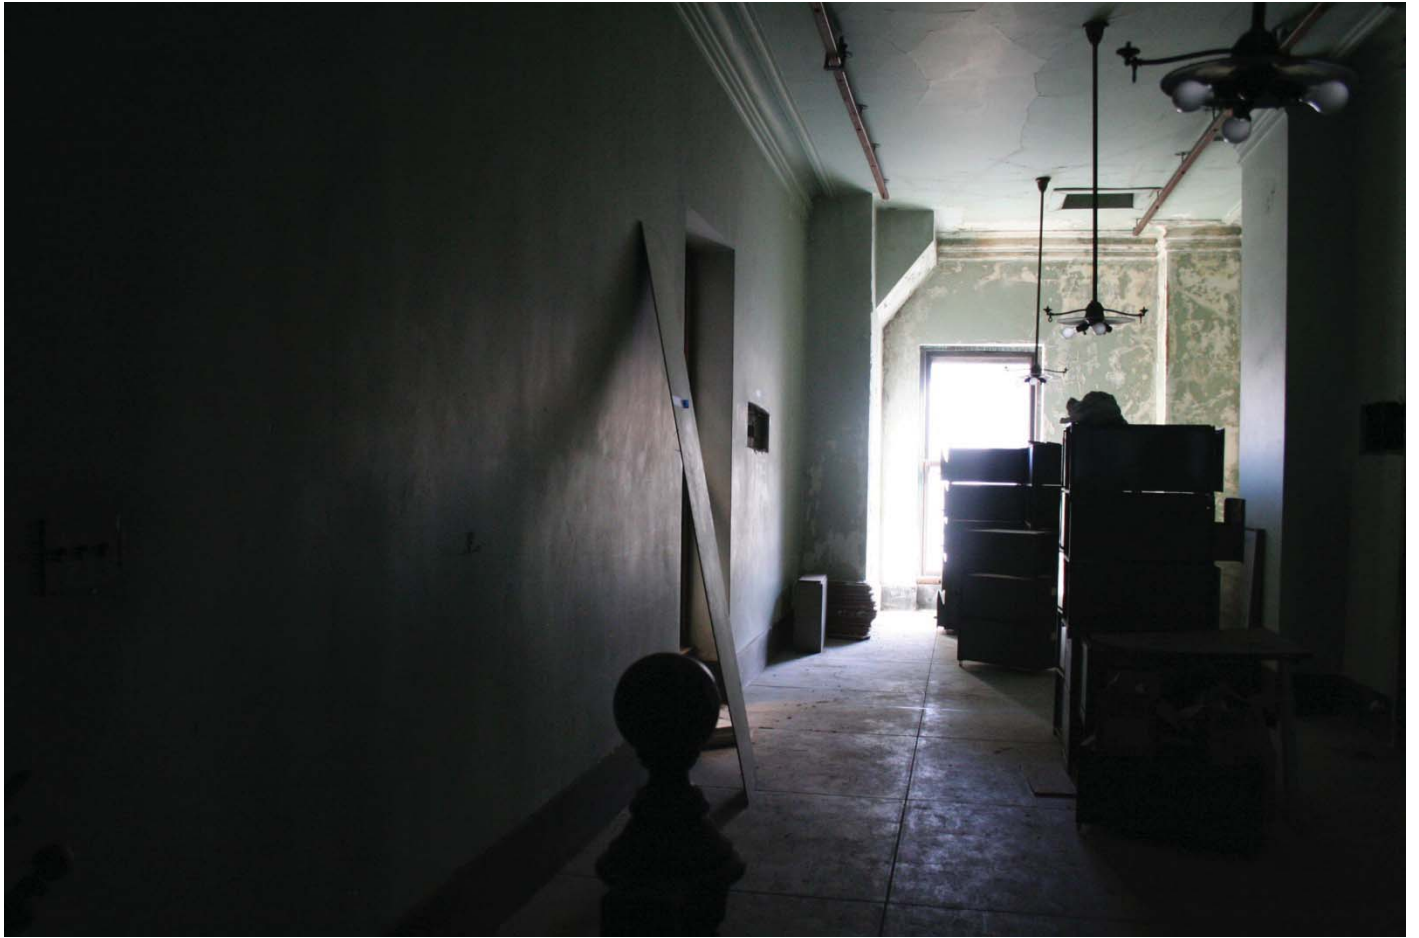
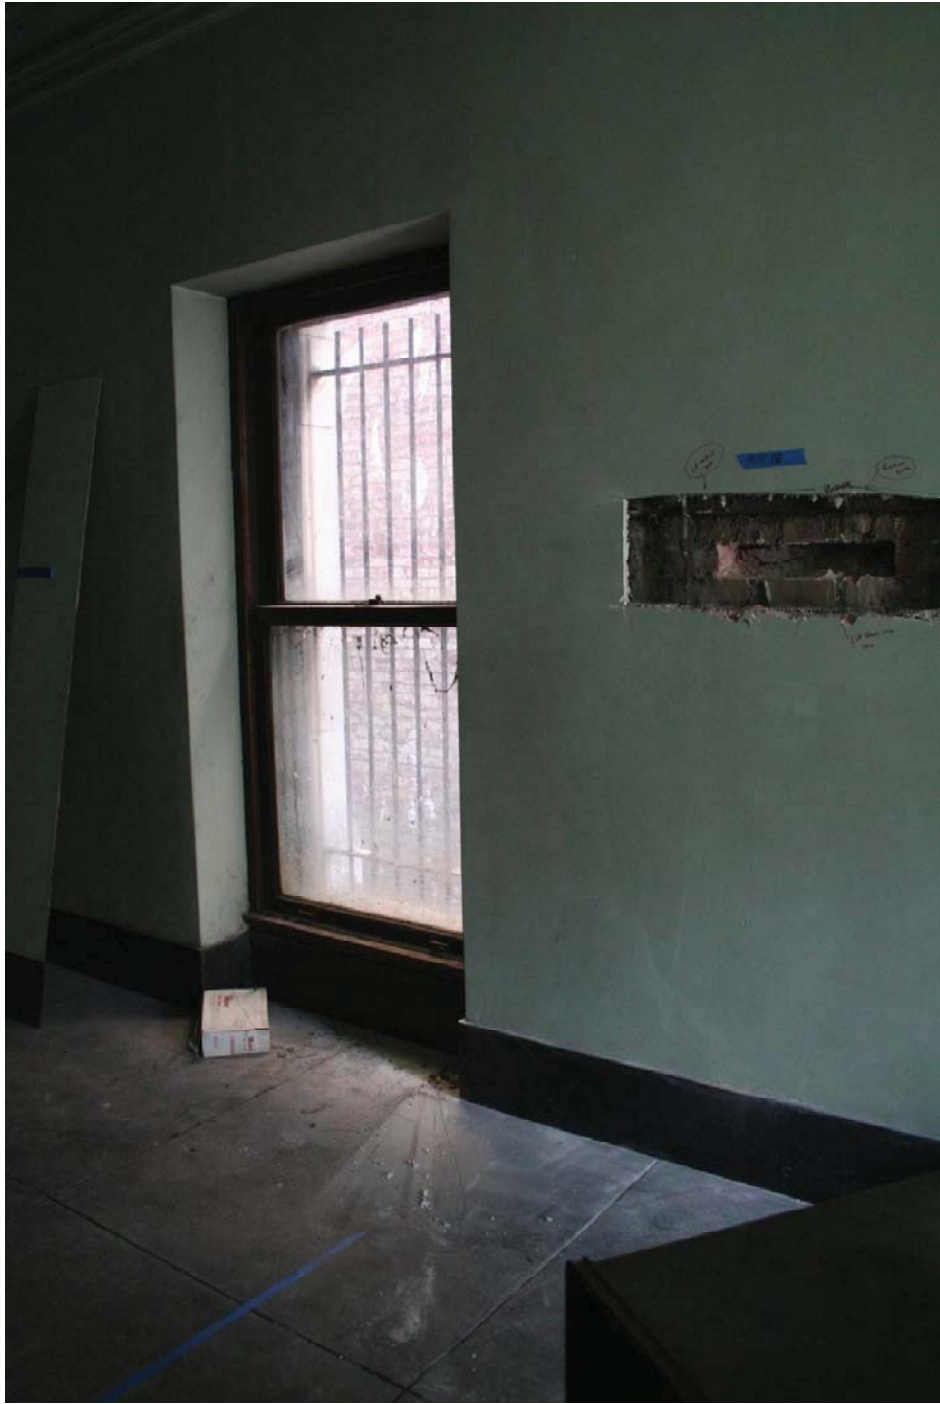
**New Shear Wall**

**Area S1**

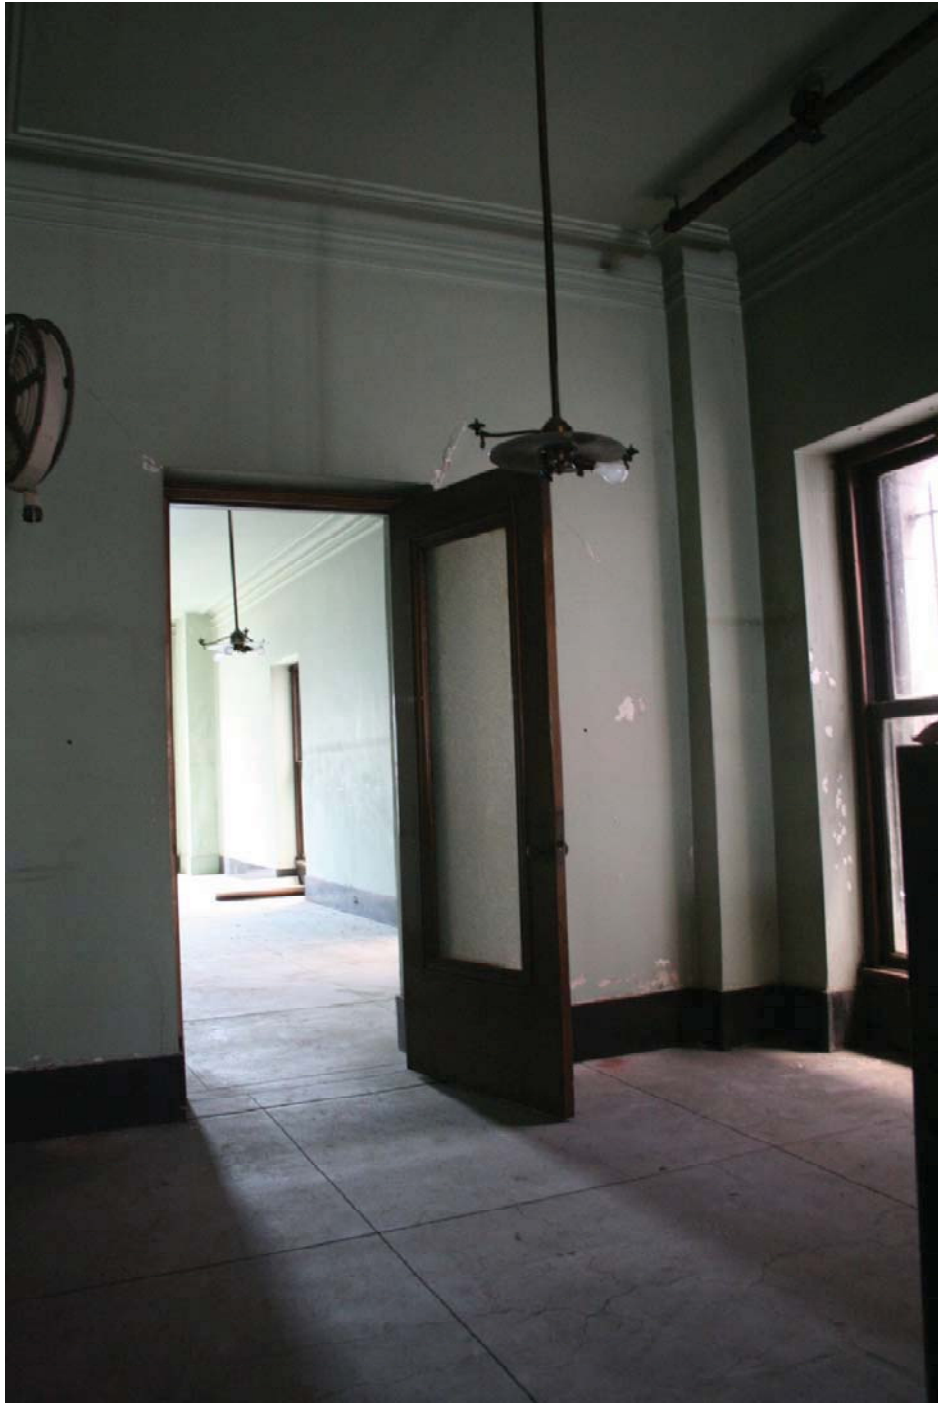
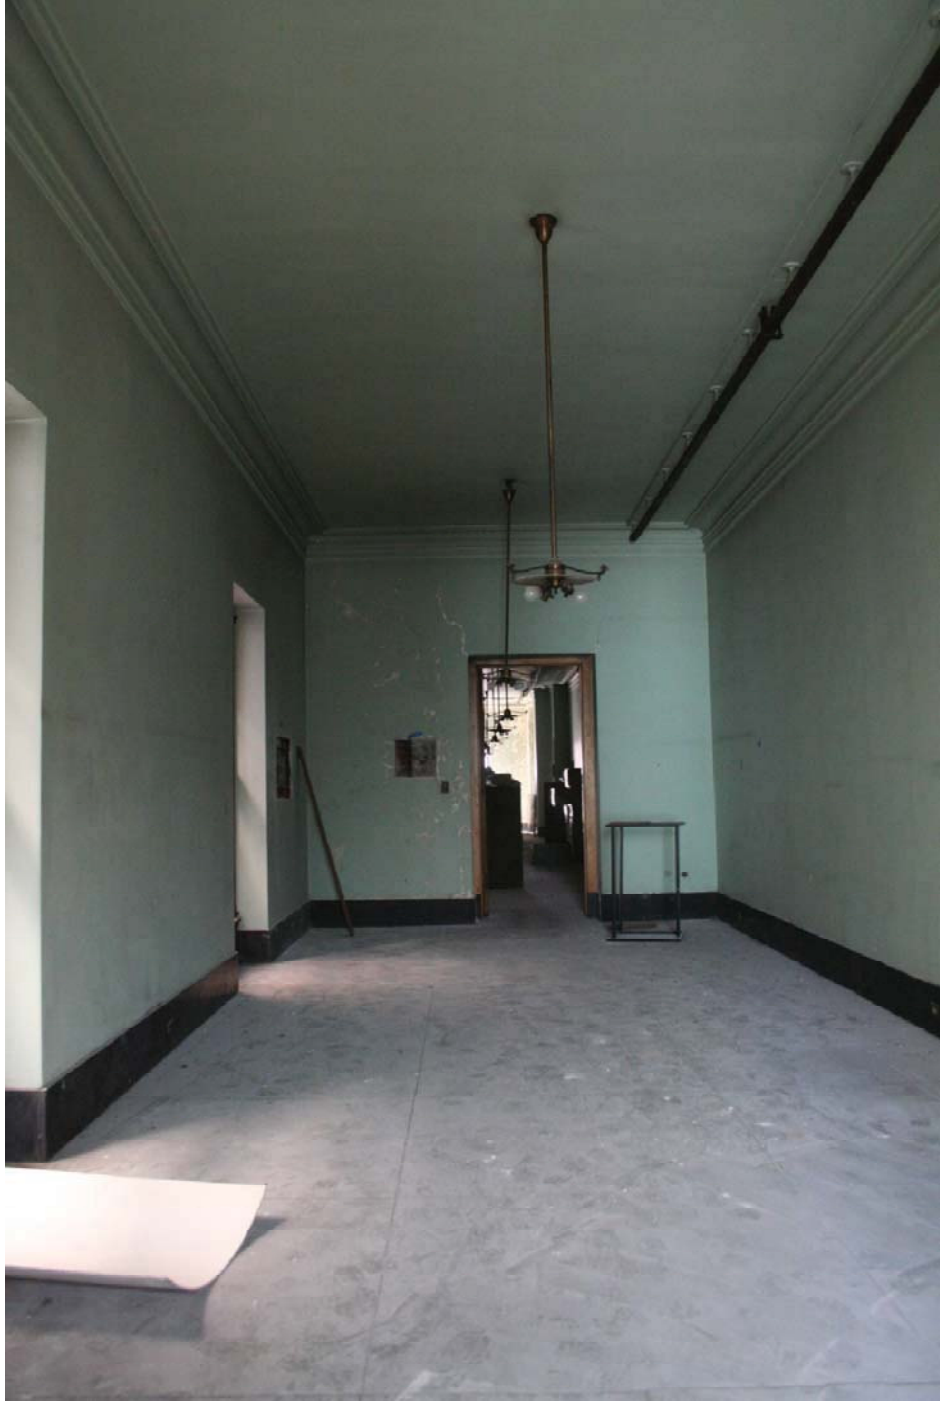
**New Shear Wall**

**Area S2**

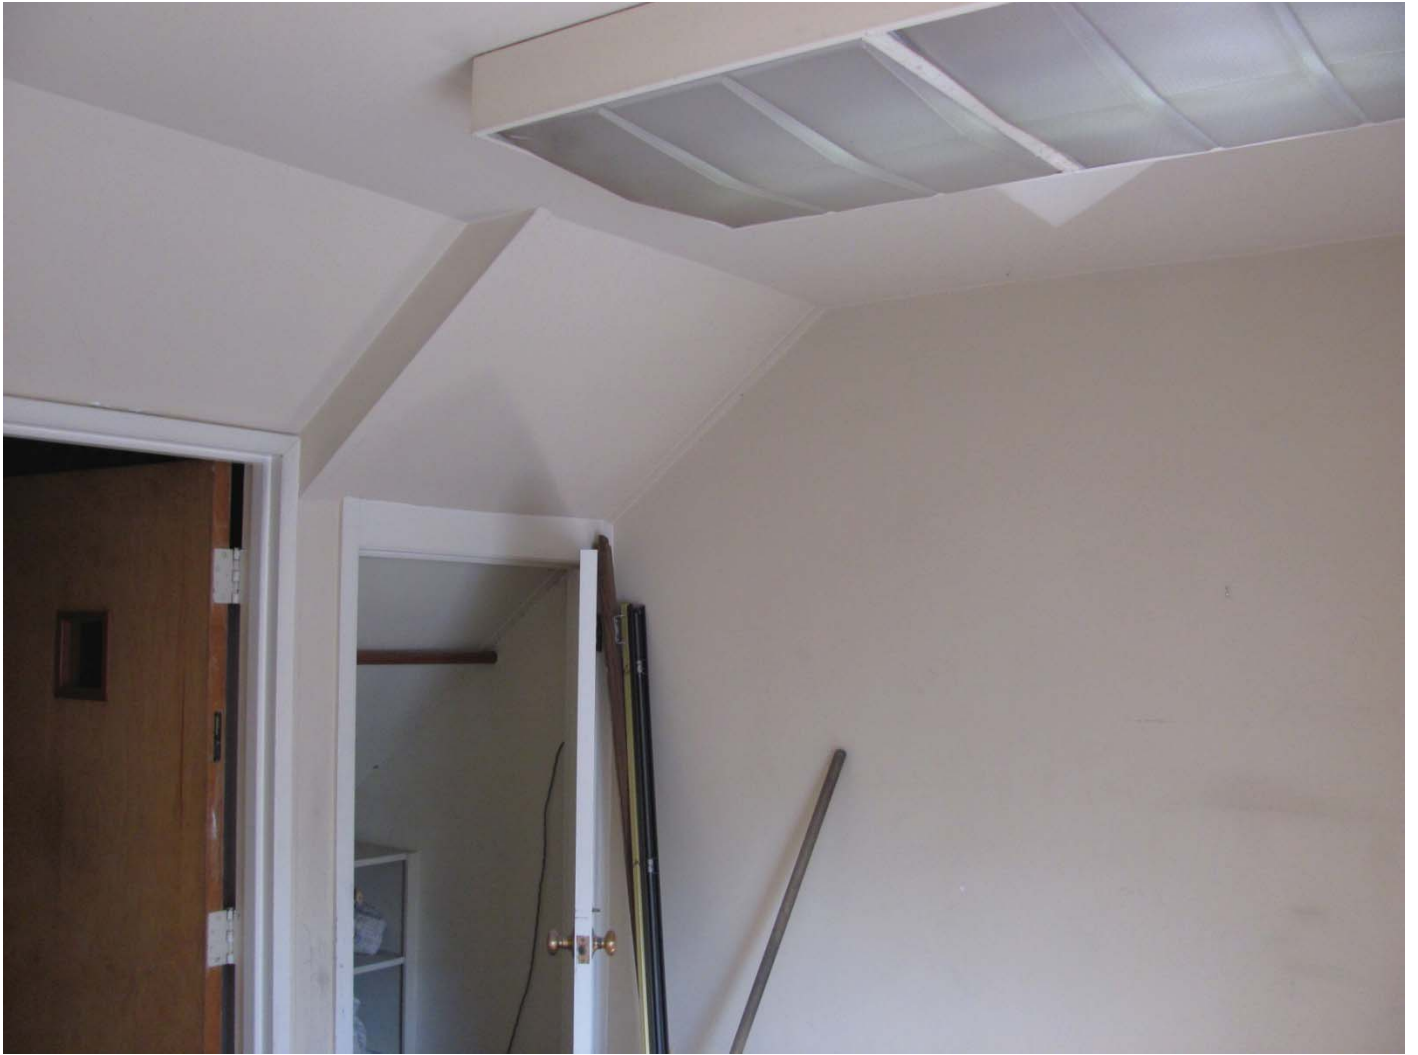
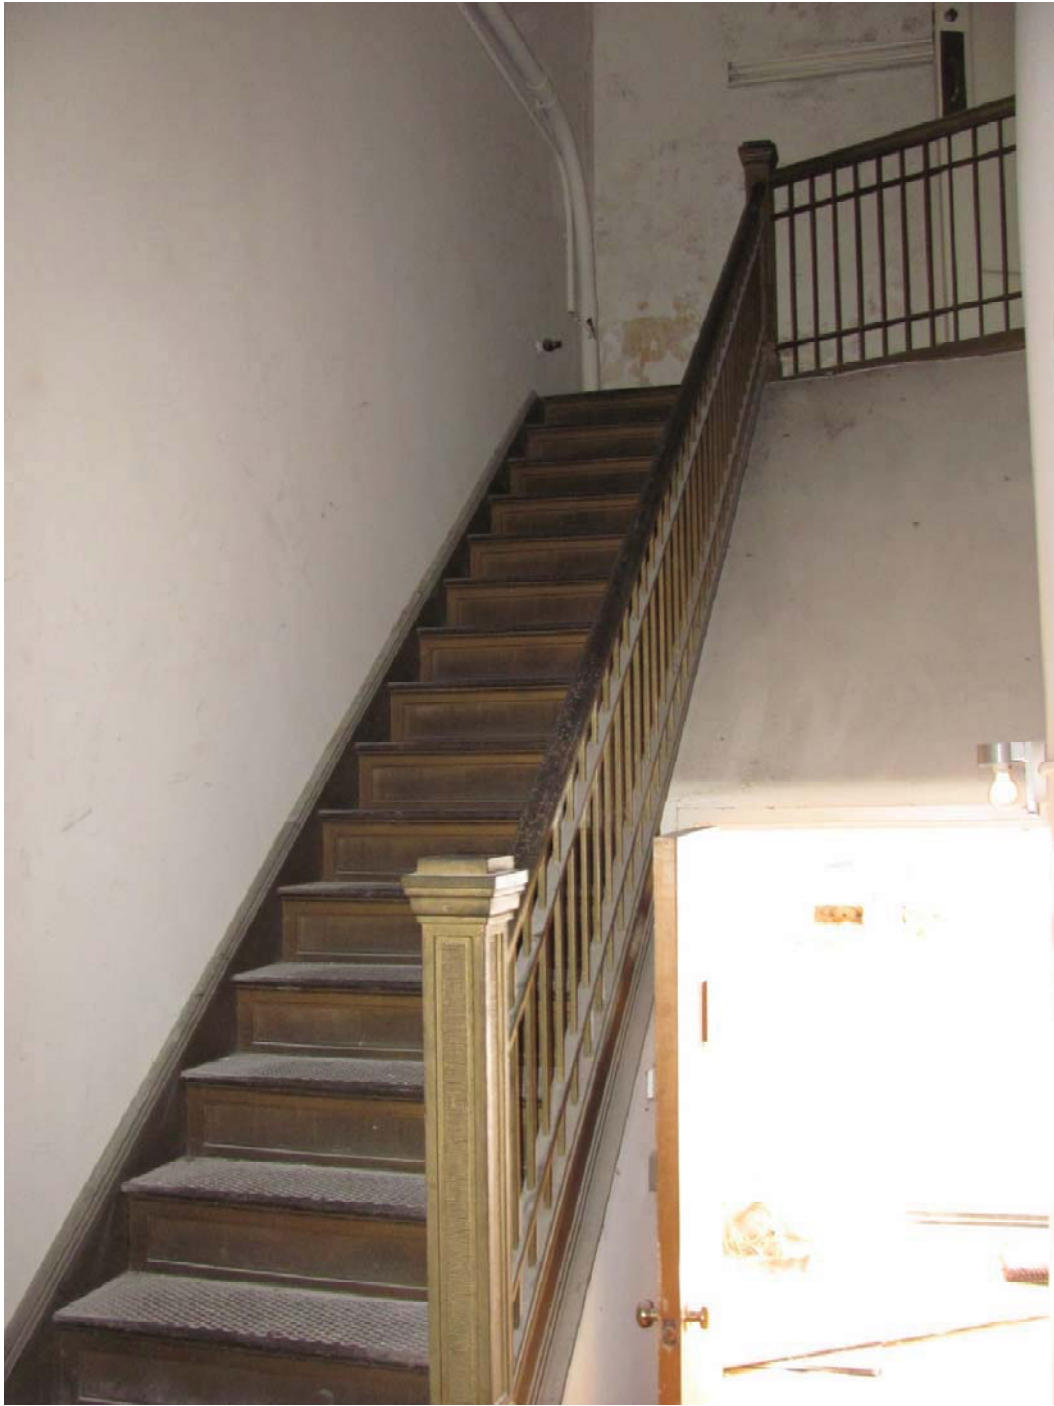
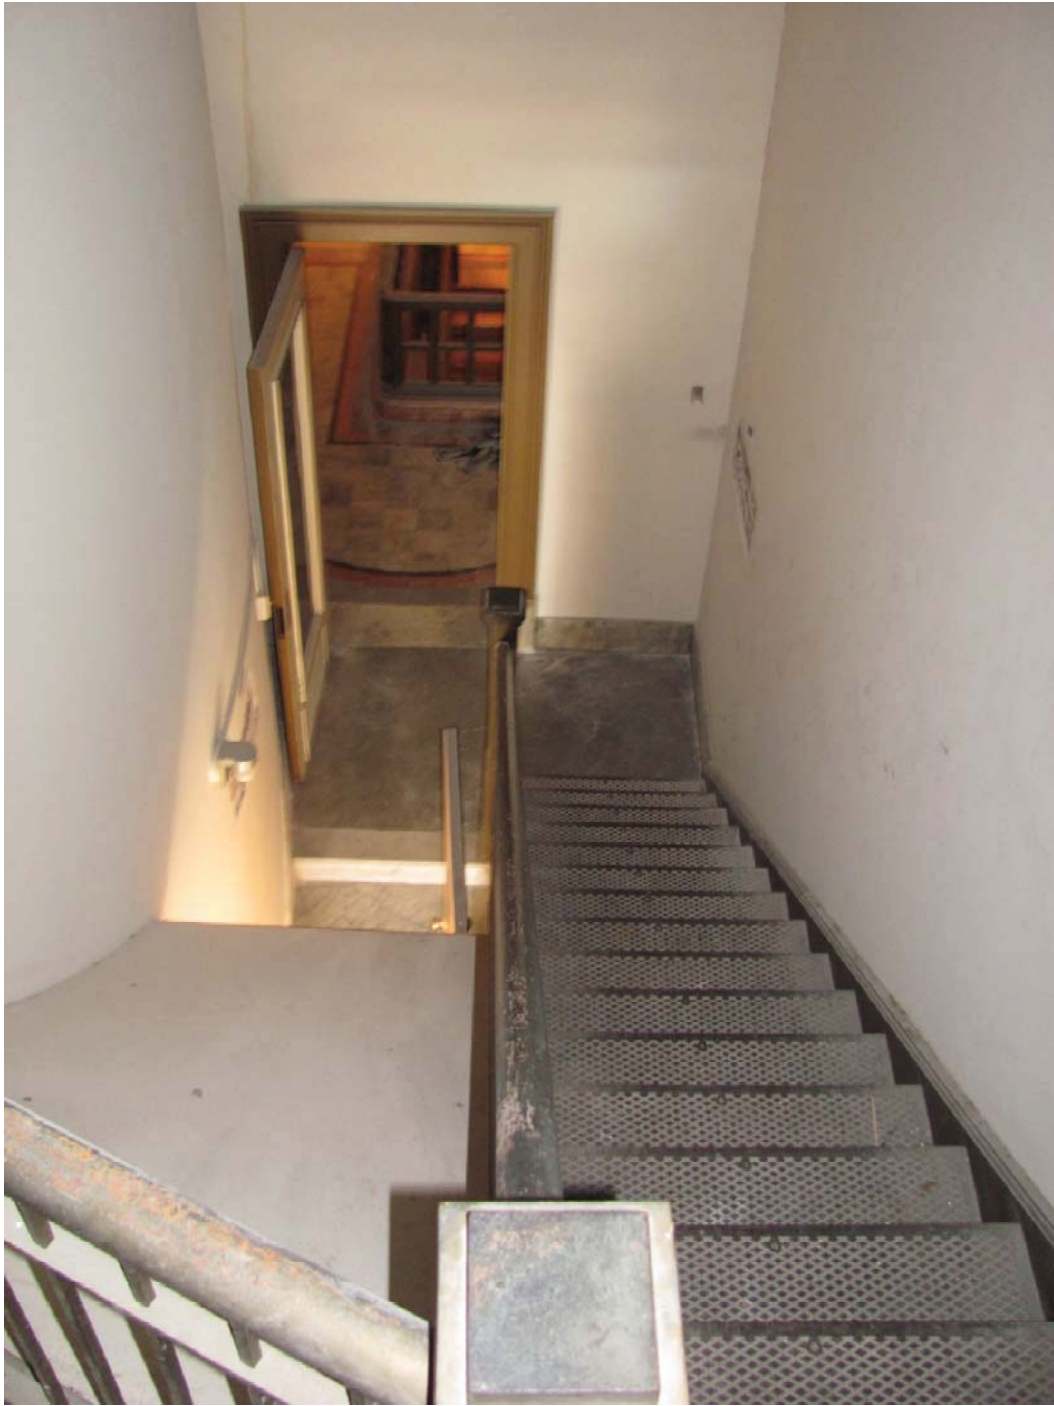
**New Shear Wall**

**Area S3**

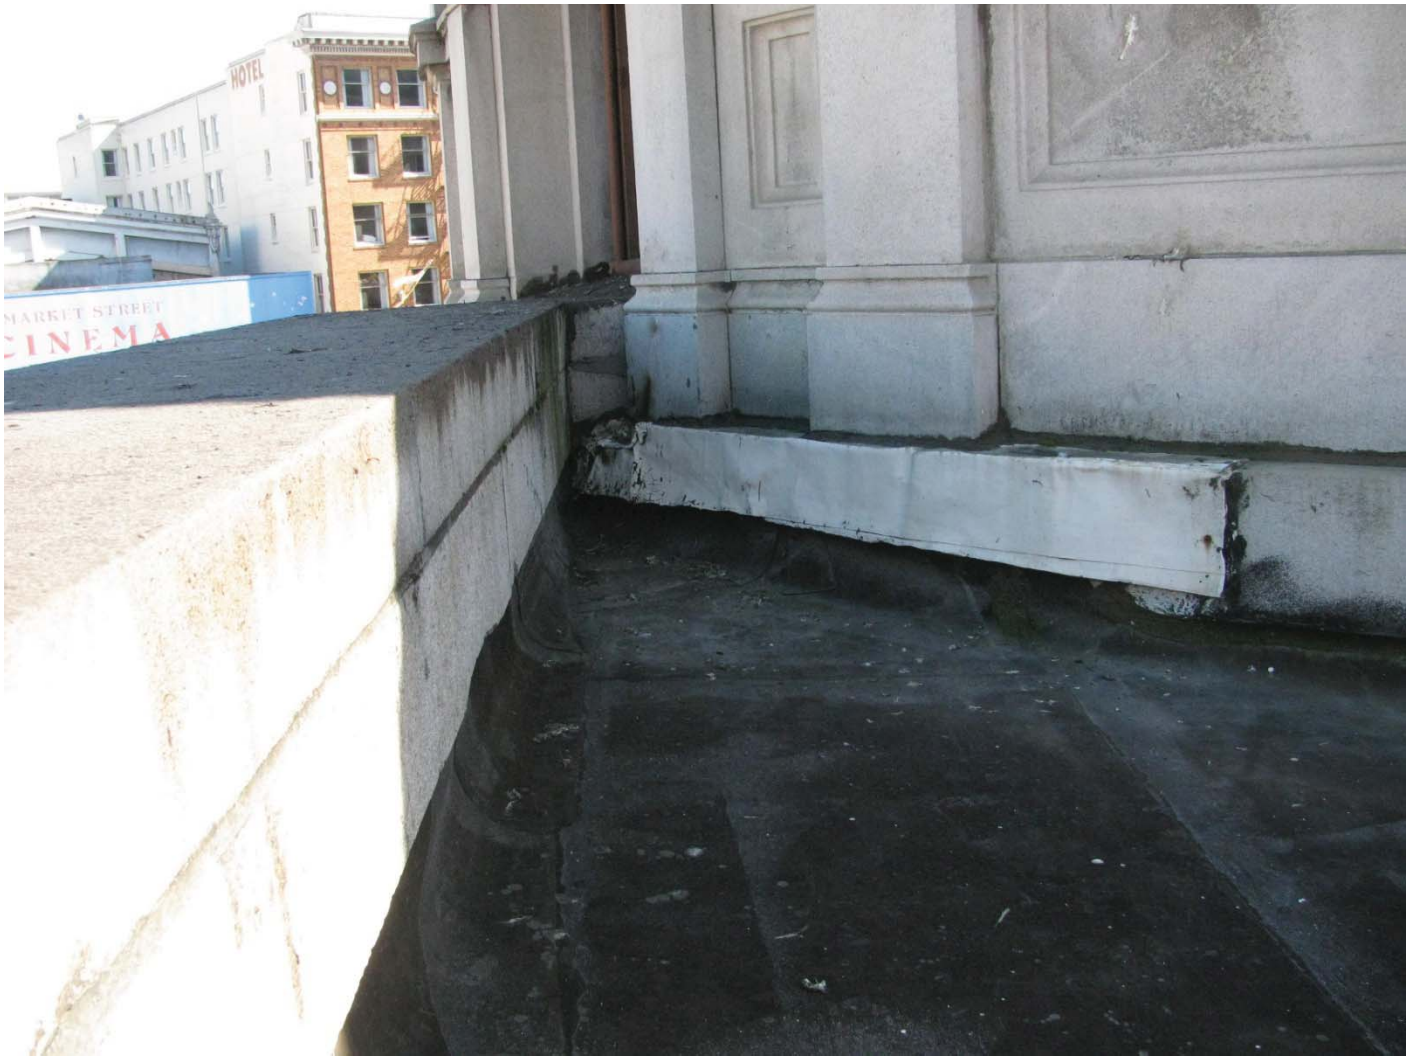
**Bond BM to Interior**

**Area R1**

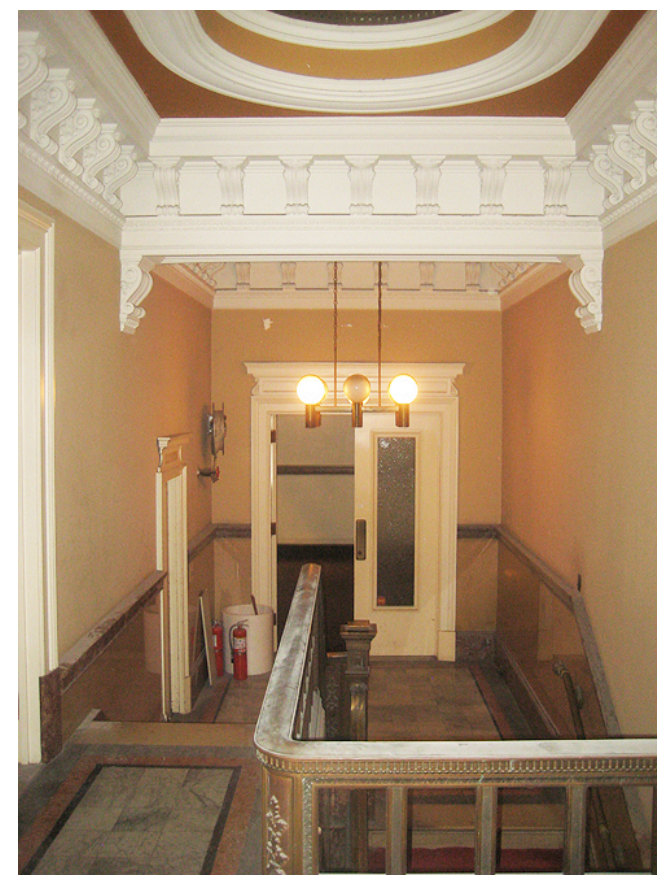
A: View of South stair hall with door to new South stair at left.

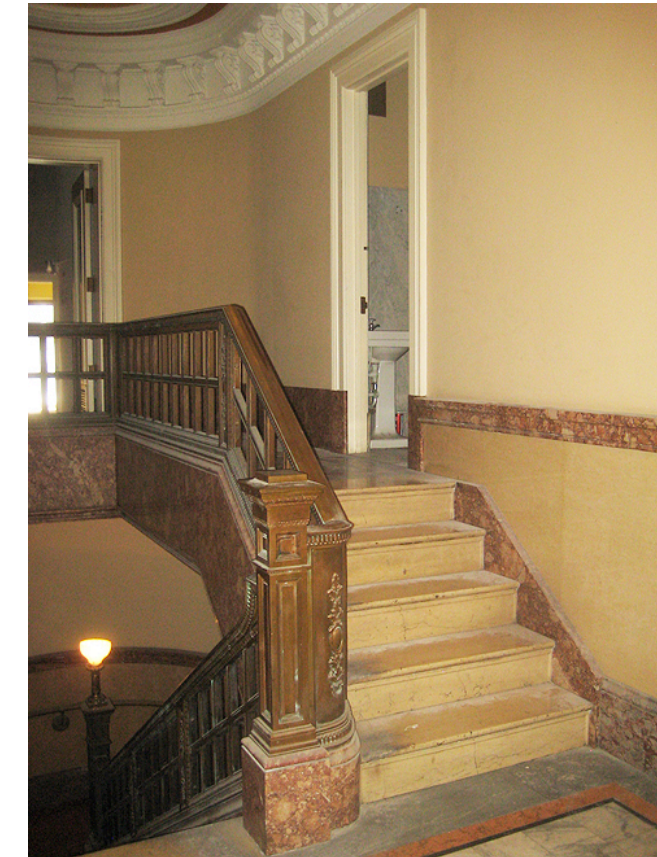
B: View of South stair hall with center door to bathroom removed and frame enlarged to meet required code exit width for new stair to penthouse. Note change of base for door expansion to the south (left in photo).

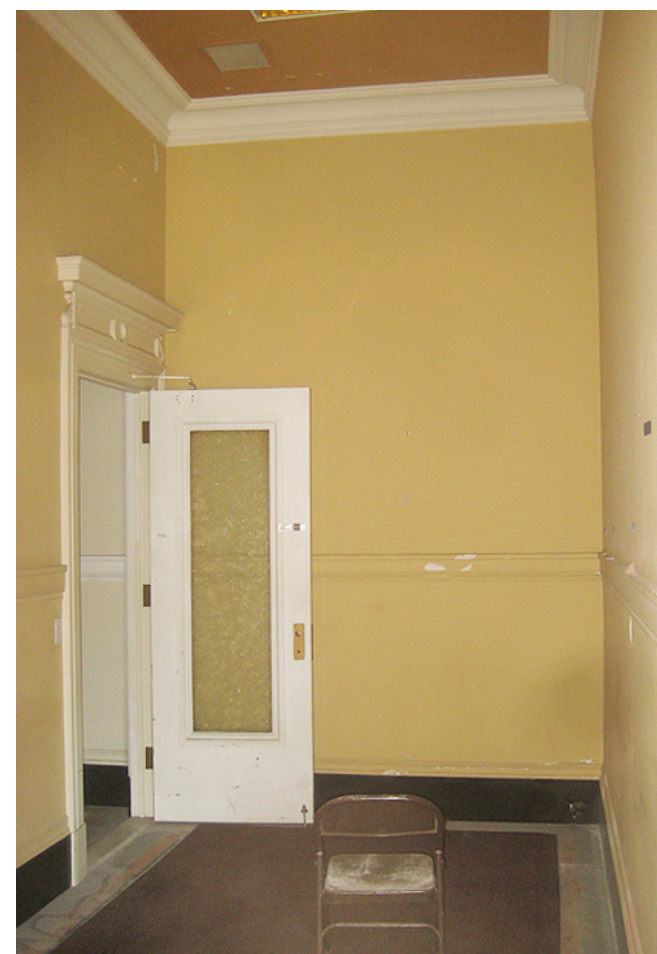
C: View of existing office to be modified to accommodate new South stair. Door to be removed and stored on site.

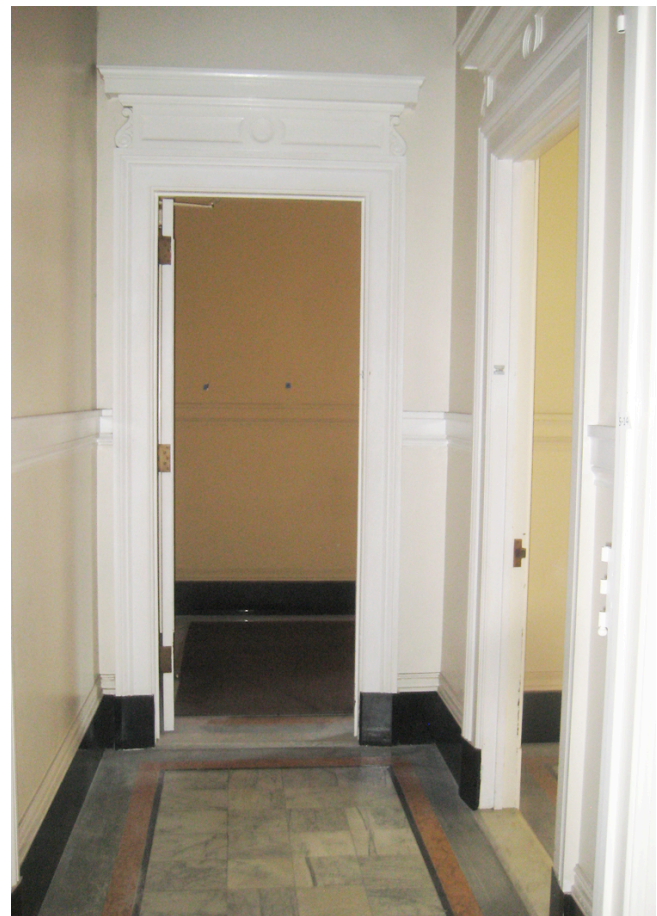
D: View of hallway to doorway in photo C.

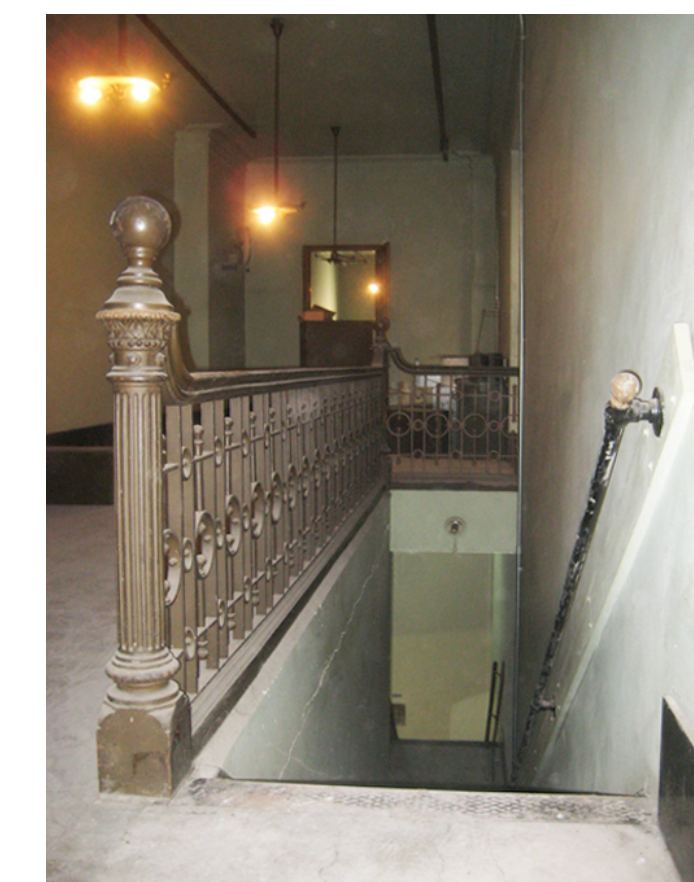
E: View of file storage room. New door at the base of stair to be relocated from demo'd bathroom at south side of 2nd floor.

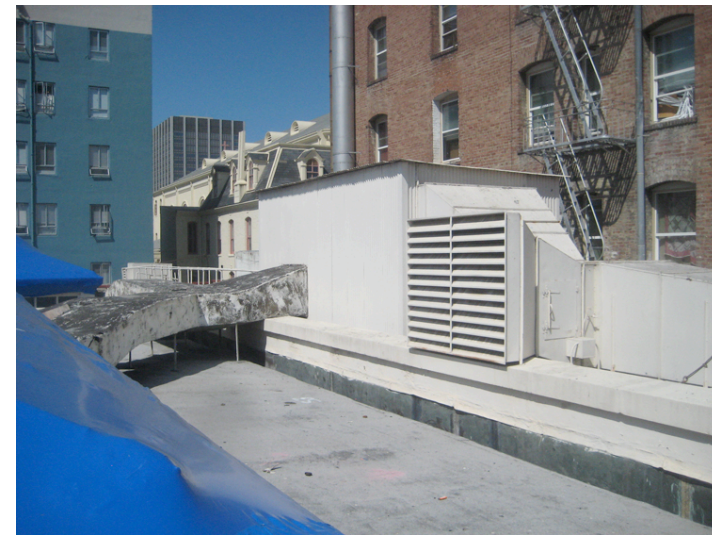
A: View of existing mechanical penthouse to be removed along with ductwork. New north stair penthouse in this location.

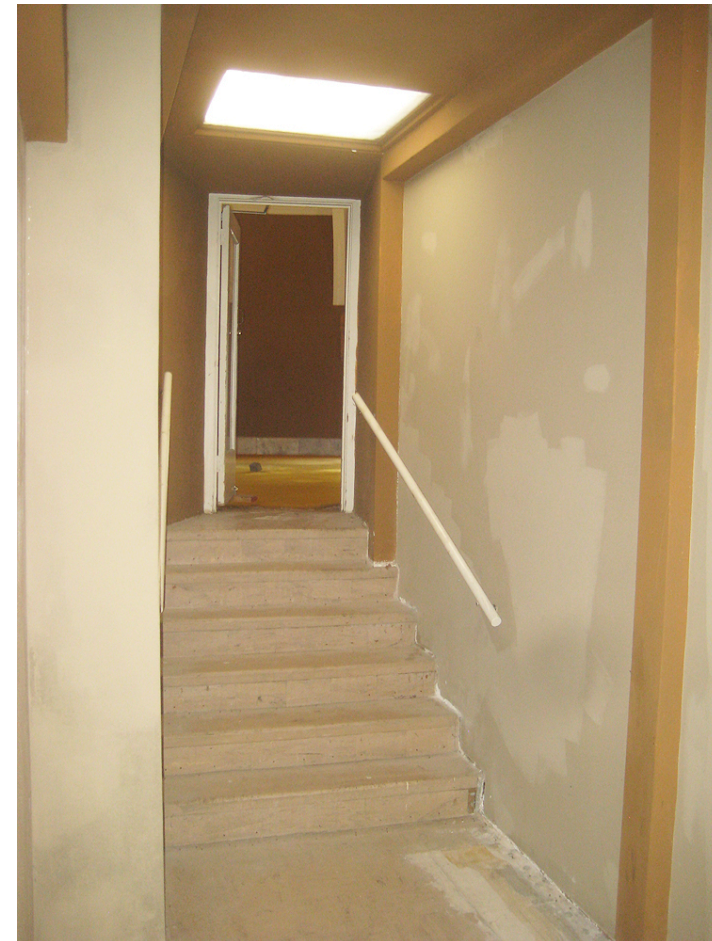
B: View of hall at Dome Room. Ceiling to be raised 2'-0" and foreground of picture to be inside new South stair exit.

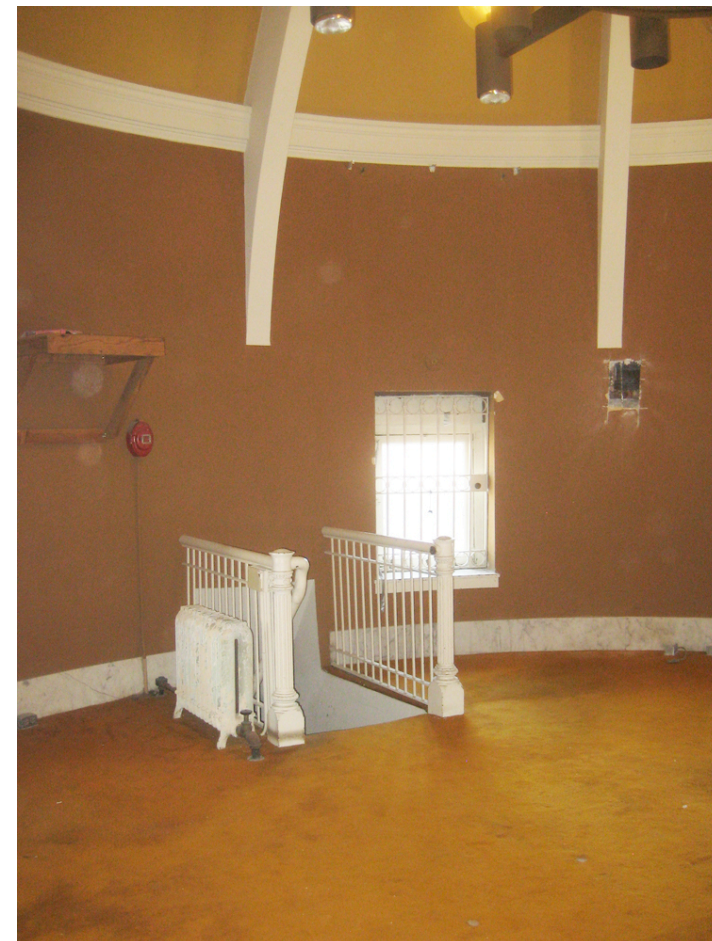
C: View into Dome Room showing existing stair to be removed. Renovations to room from 1977 to be removed.

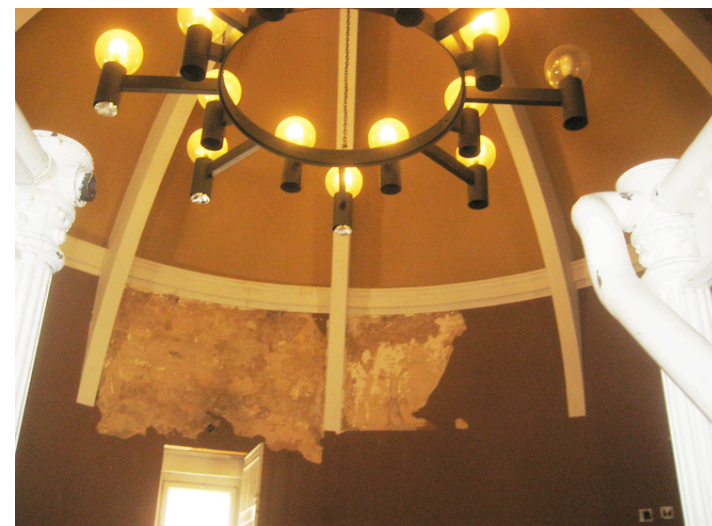
D: View of chandelier and ceiling of Dome Room. Renovations to room from 1977 to be removed.

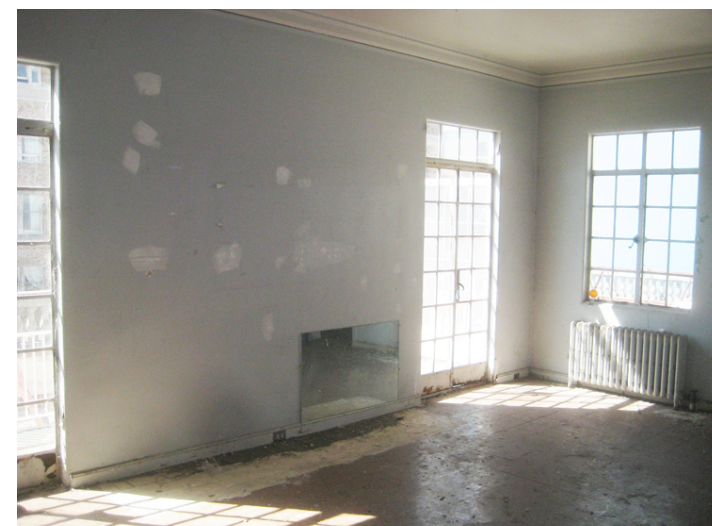
E: View of Penthouse Room to be repaired and renovated. Original steel windows to be replaced with steel single panel French doors.

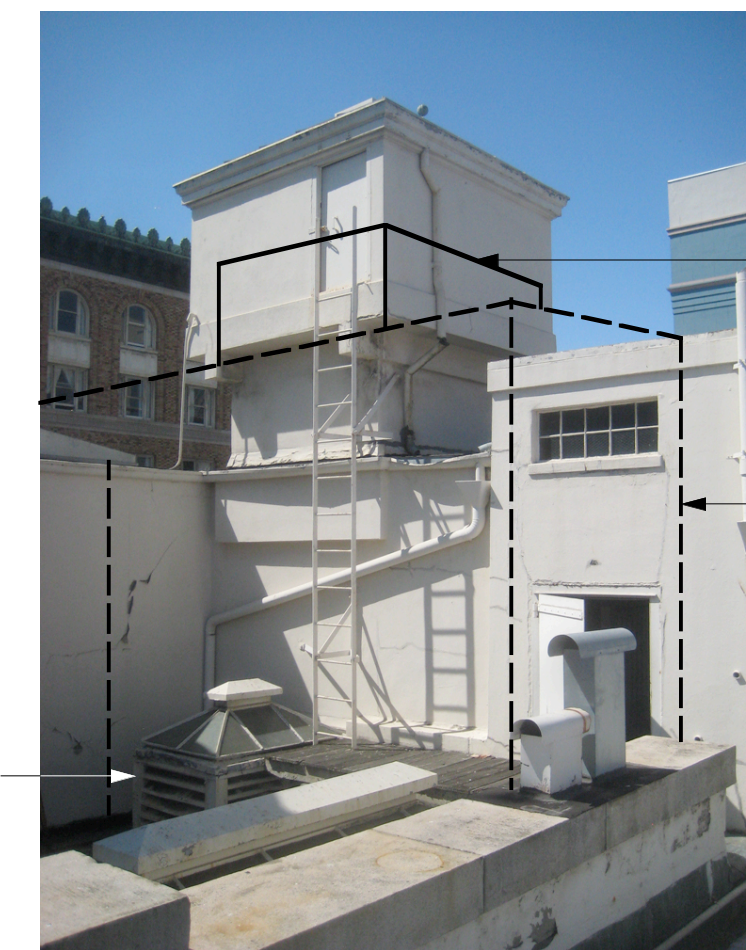
Skylight and vent to be removed

F: View of location of new east hall. Small skylight and vent to be removed. Roof of this area to be raised to align with roof of penthouse at right and elevator penthouse to be reconstructed.

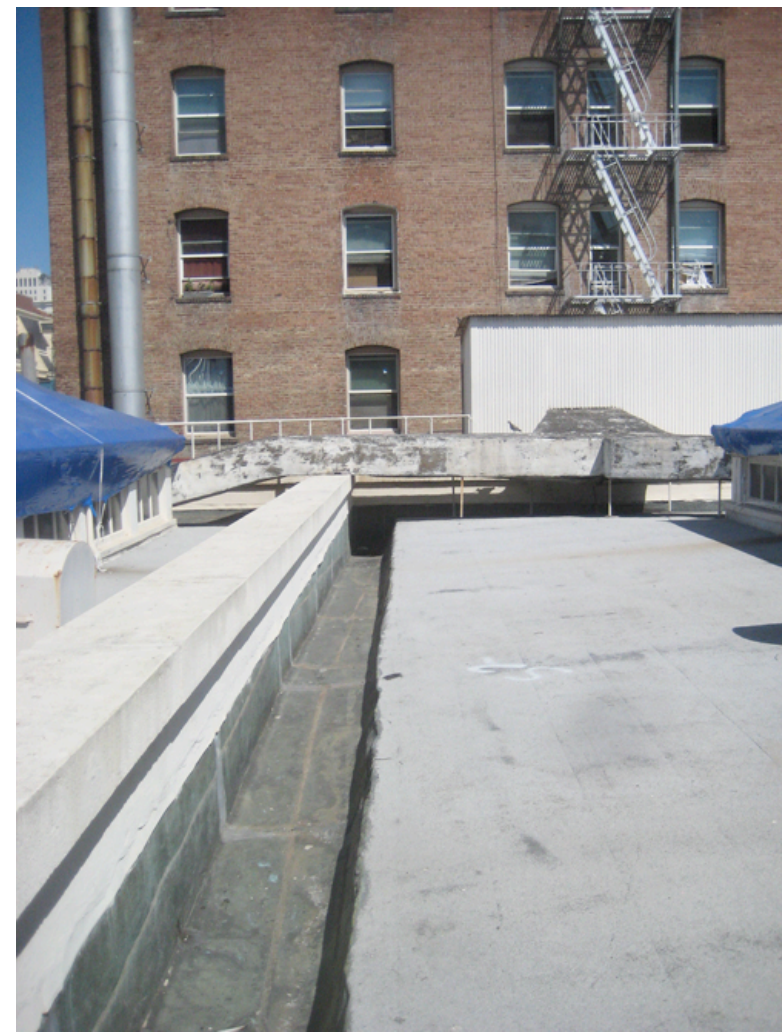
A: View across roof to mechanical penthouse. New metal walkway and north stair penthouse to be built in this location.

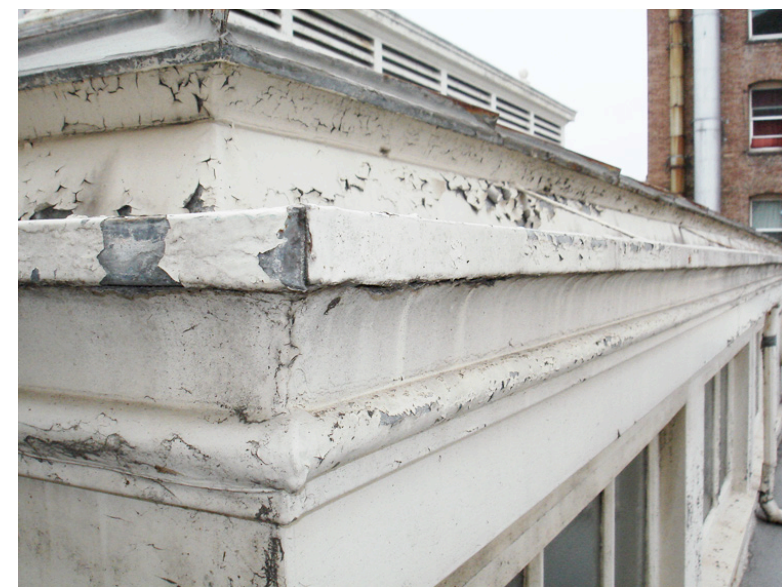
B: Detail of skylight enclosure. Metal to be repaired and repainted.

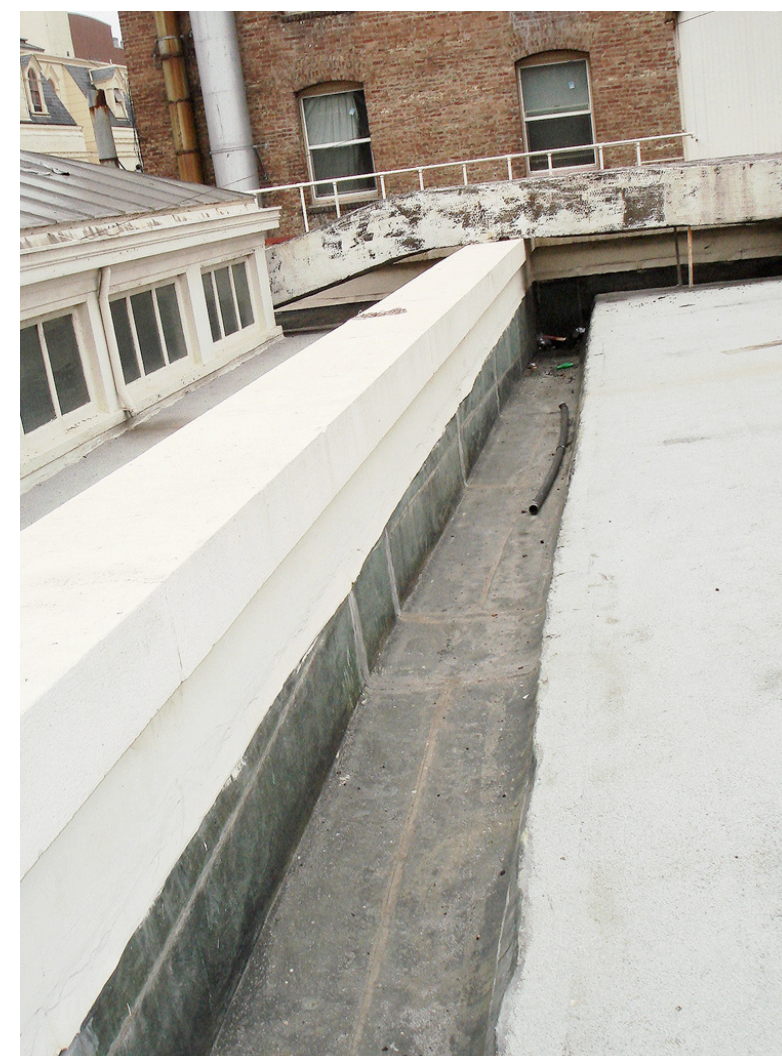
C: Detail of typical roof gutter. All gutters to be inspected and repaired.

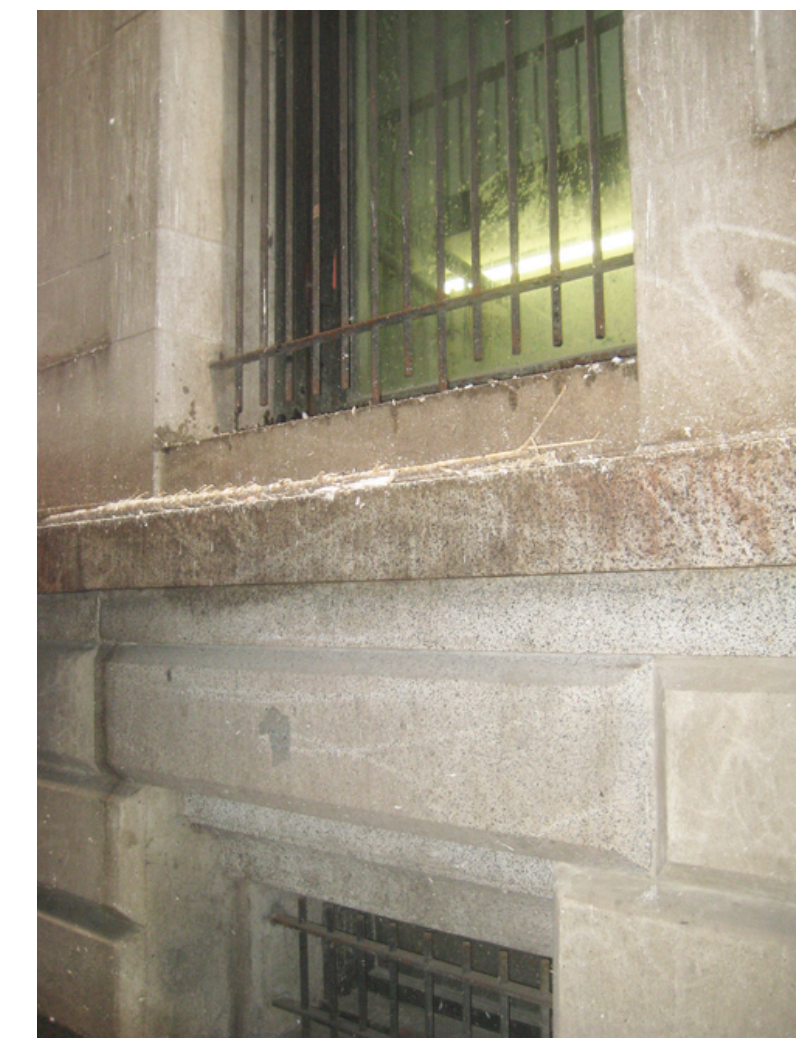
B: View of window to become west exit door from north stair hall

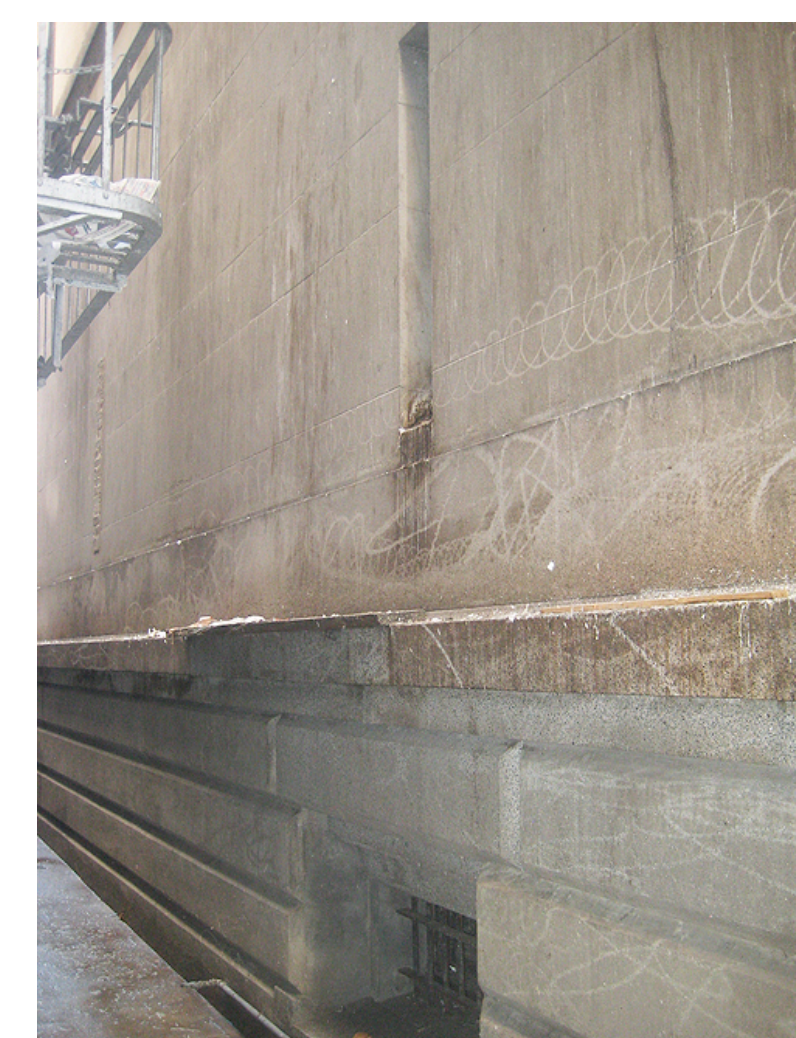
C: View of "Lancet" window to become east exit door from north stair hall
