# SAN FRANCISCO PLANNING DEPARTMENT

**MEMO**

**RE:** Review and Comment for 1 Jones Street (former Hibernia Bank)  
Case No. 2011.0617EA

**HIBERNIA BANK BUILDING**

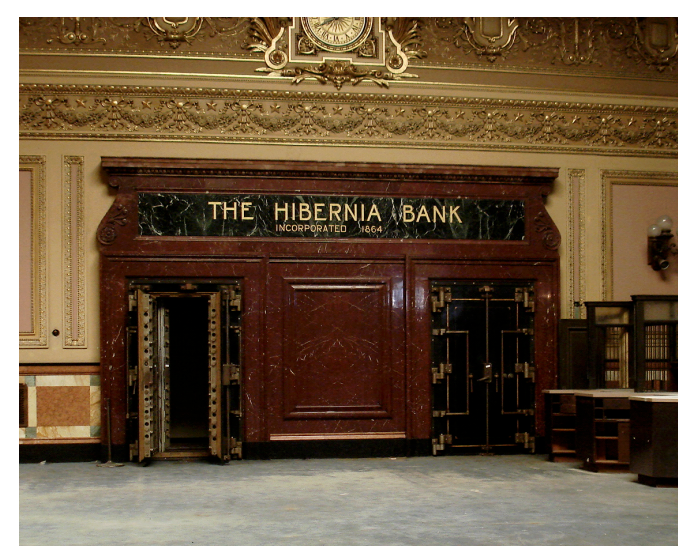
C: View of main vault in original portion of Banking Hall. Teller's stations on right.

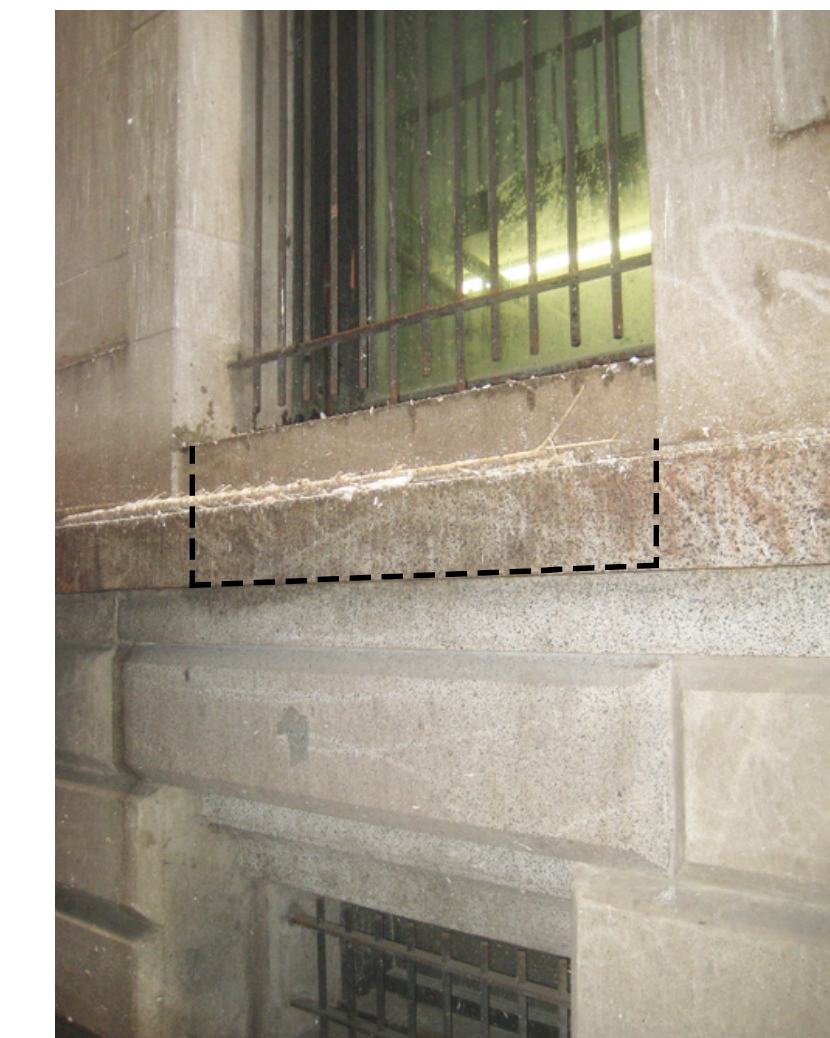
B: View of window to become west exit door from north stair hall with area to be modified indicated.

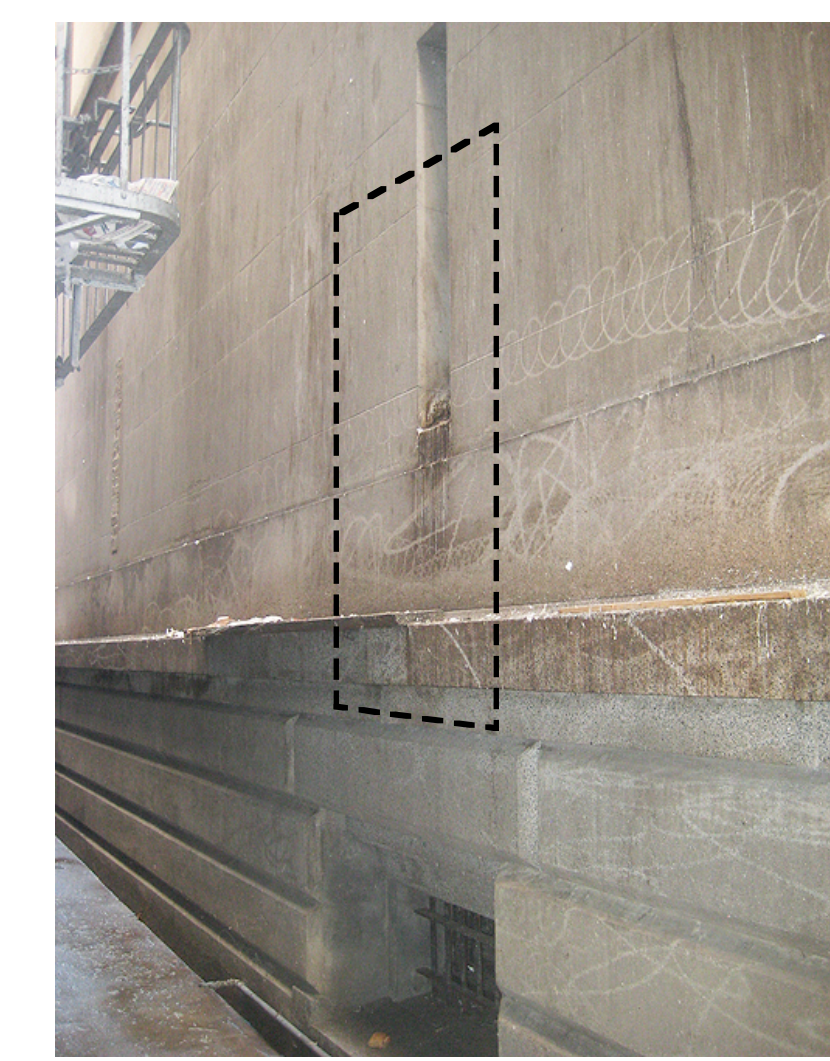
C: View of "Lancet" window to become east exit door from north stair hall

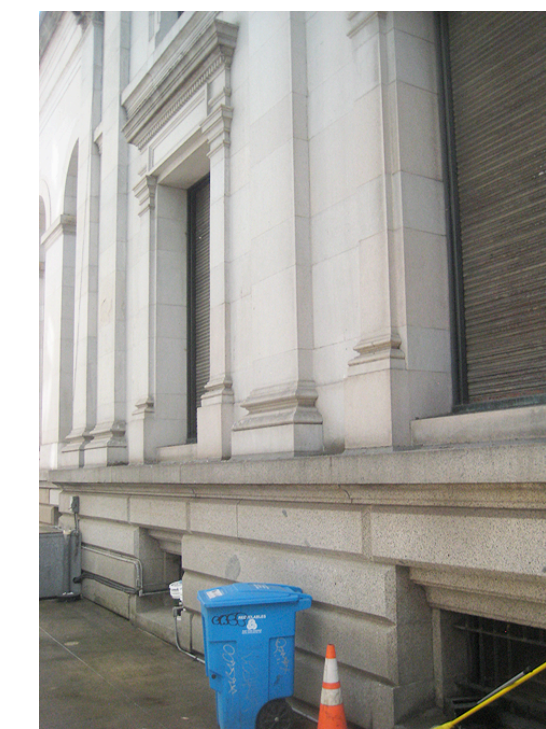
A: View of window to become west exit door from main space.

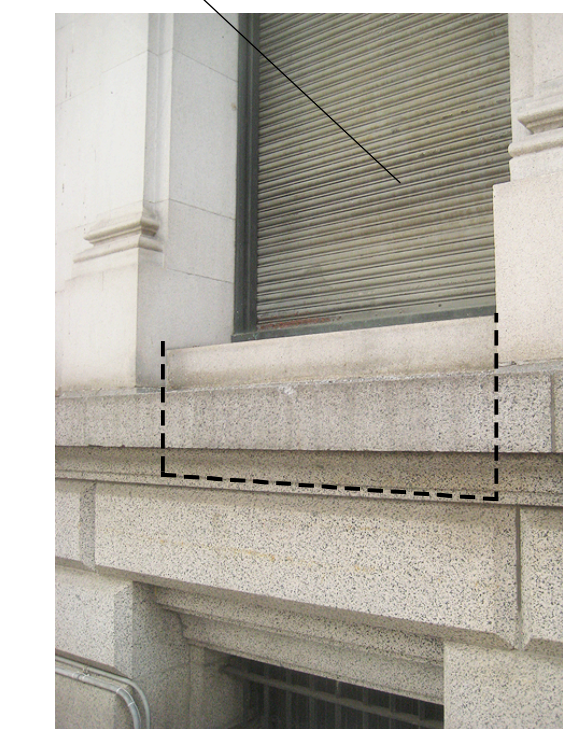
B: View of west window with area to be removed indicated

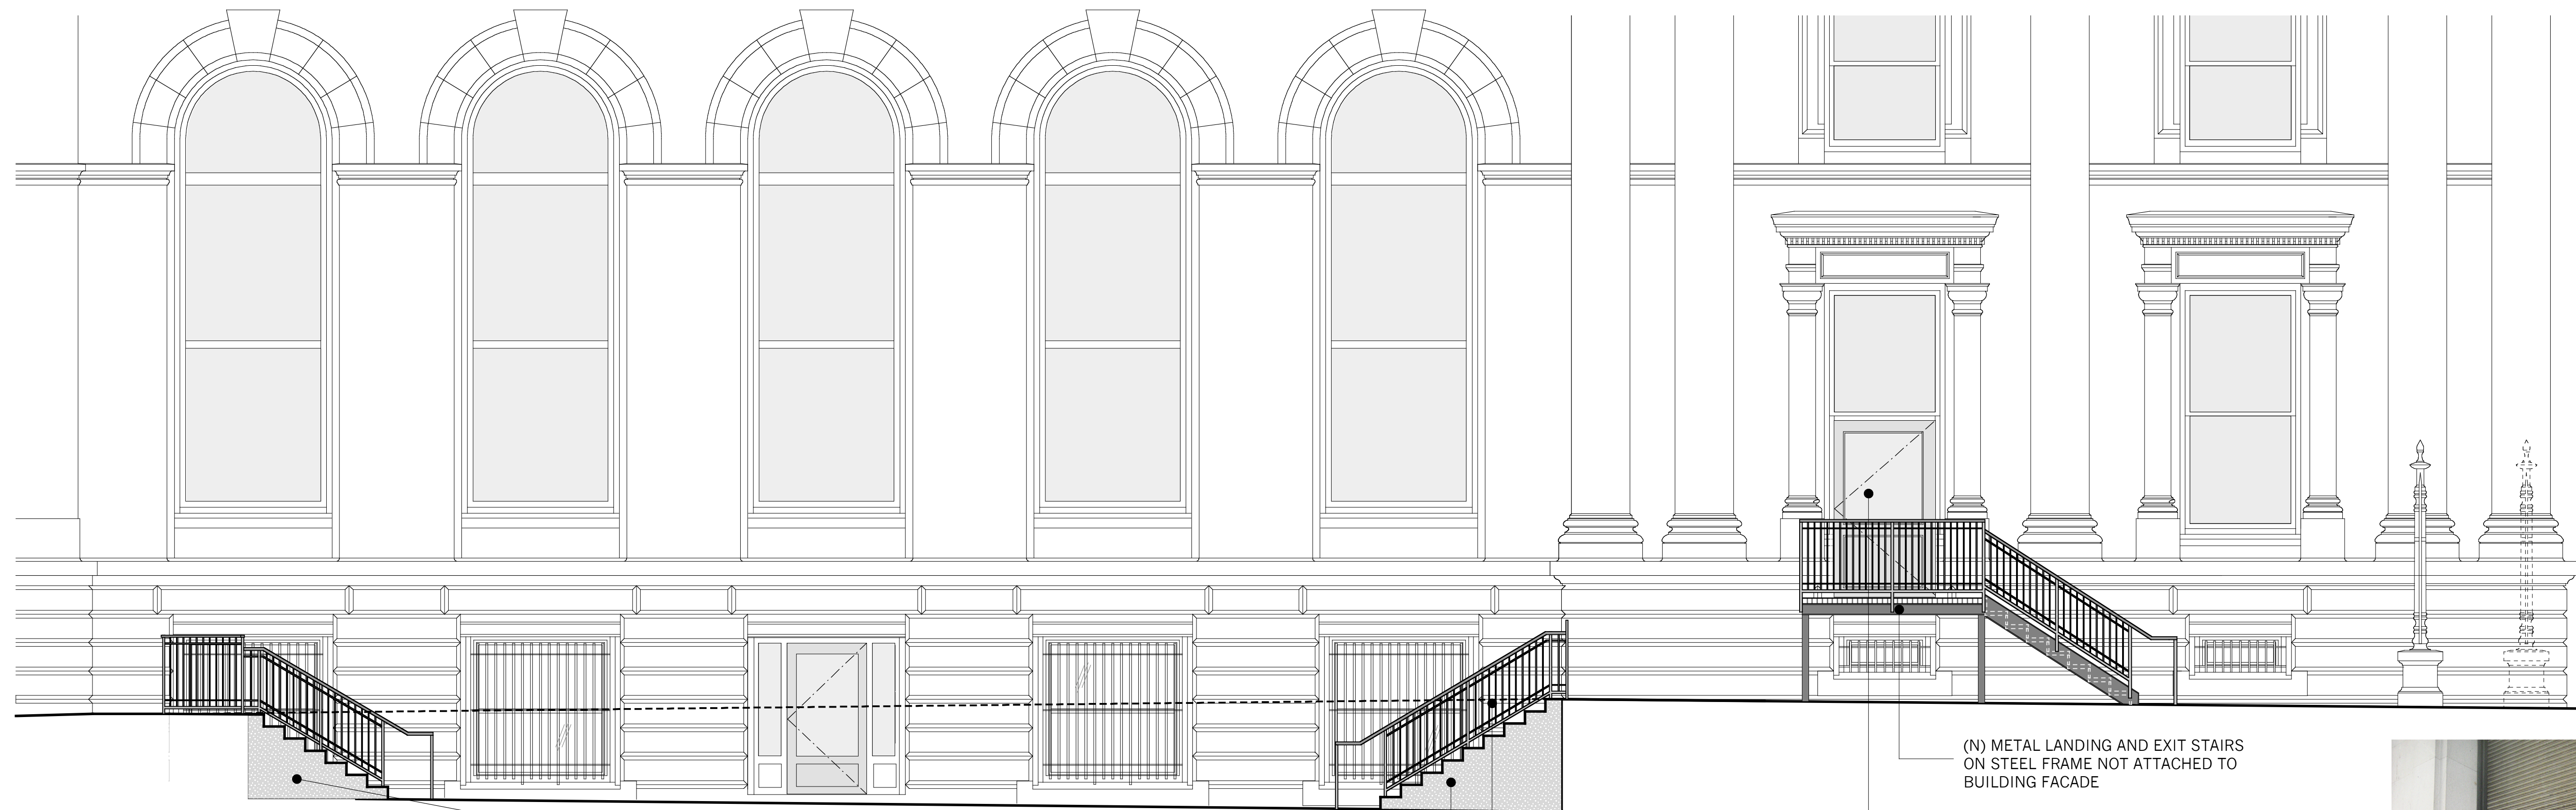
1 PROPOSED PARTIAL WEST ELEVATION  
Scale: 1/4" = 1'-0"

(N) METAL LANDING AND EXIT STAIRS ON STEEL FRAME NOT ATTACHED TO BUILDING FACADE

MODIFY EXISTING OPENING TO ACCOMMODATE (N) EXIT DOOR. REMOVE SILL AND SAW CUT STONE WATER TABLE. FINISH EDGES OF STONE TO MATCH ADJACENT SURFACES. SALVAGE STONE FOR POSSIBLE REUSE

LINE OF NEW LEVEL CONCRETE WALKWAY SPANNING THE LENGTH OF THE DEPRESSED LOWER WALKWAY AREA. IN FRONT OF SECTION CUT

REMOVE EXISTING CONCRETE STAIRS AND REPLACE WITH NEW CODE COMPLIANT CONCRETE STAIRS

- WEST EXIT ALLEY WALKWAY**  
New metal grating with metal guardrail to be built over sunken area of west exit alley, providing a level surface for north exit alley access. Existing concrete stairs to sunken area to be demolished and replaced with metal stairs with metal guard and handrails.

8. CONTROL GATE  
Existing non-historic control gate fence to be removed.
9. SOUTHWEST EXIT AND EXIT STAIR  
To provide the code required exiting from the Banking Hall, the wall area below the sill of the existing west window in the Customer Waiting Area is to be cut to be level with the floor. The lower sash of the window to be removed and replaced with a door and side light. Exterior granite to be saw cut and edges finished to match openings on adjacent windows. All granite to be salvaged and stored on site for potential reuse.

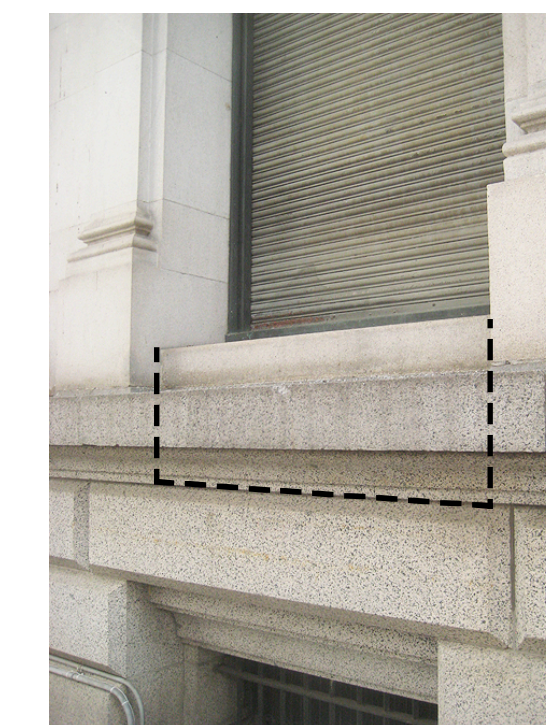
View of west window indicating stone area to be removed and modified.

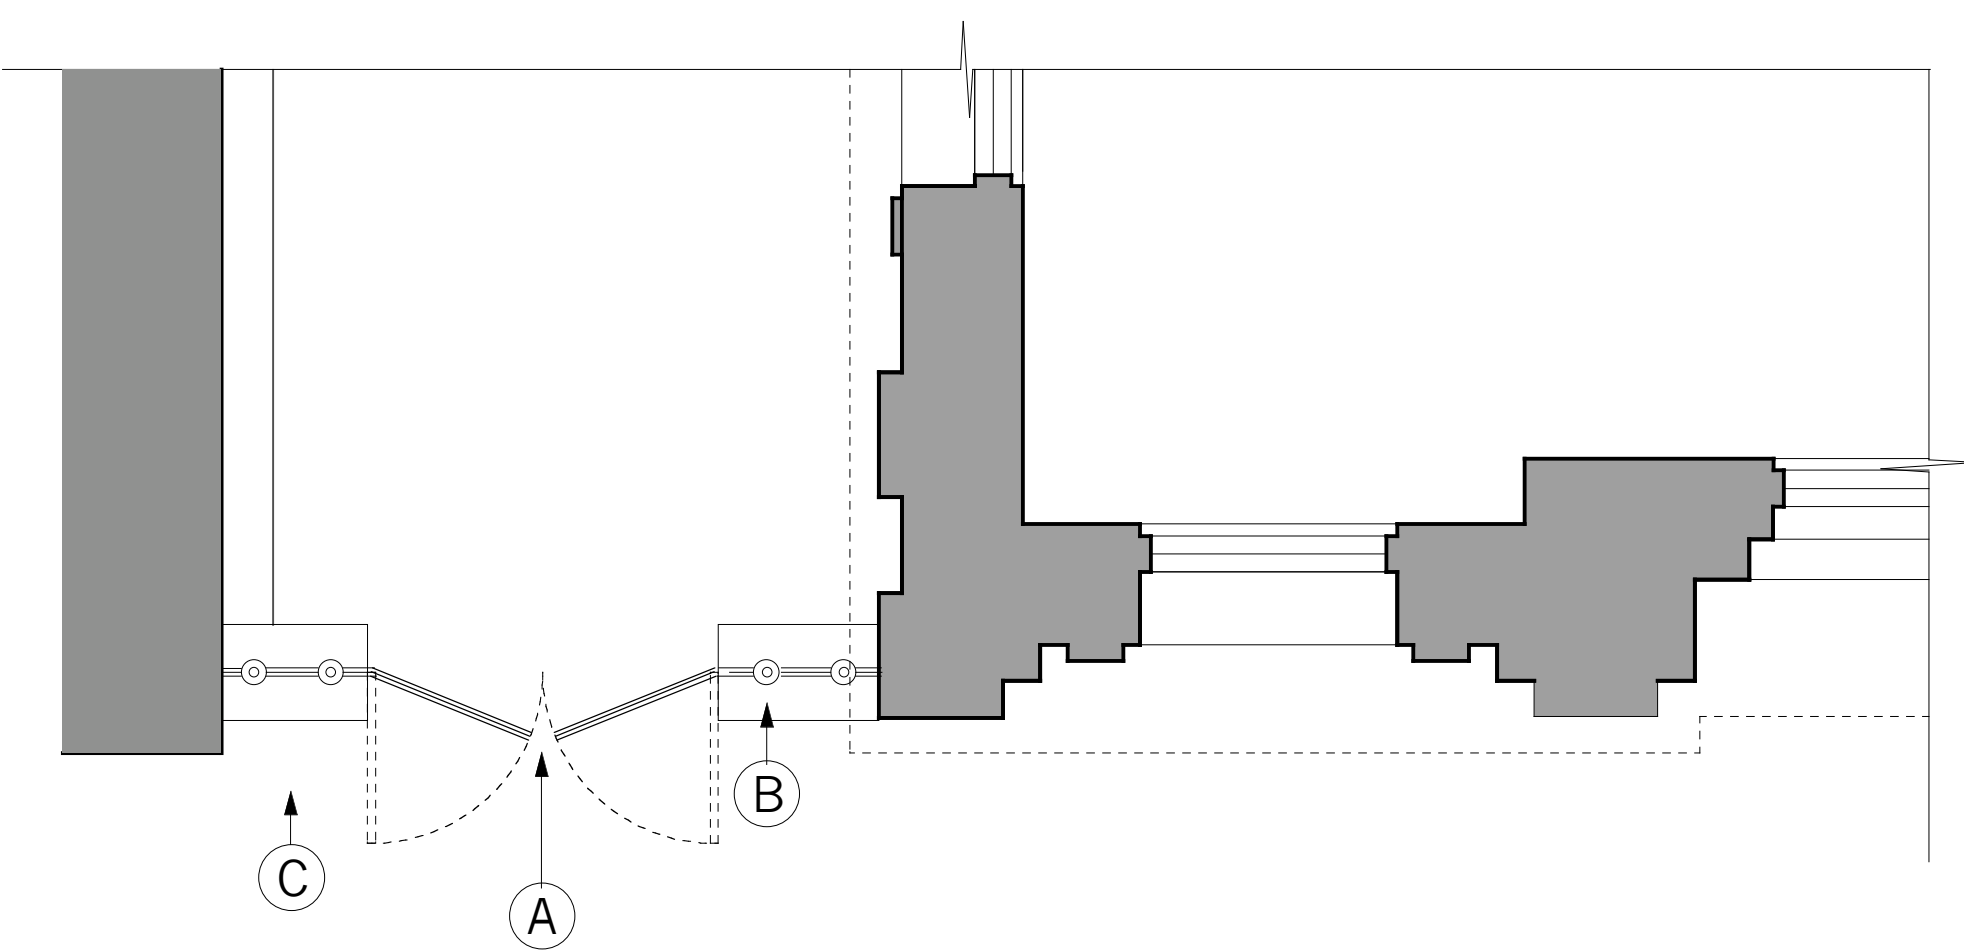
2 EXISTING PARTIAL PLAN  
Scale: 1/4" = 1'-0"

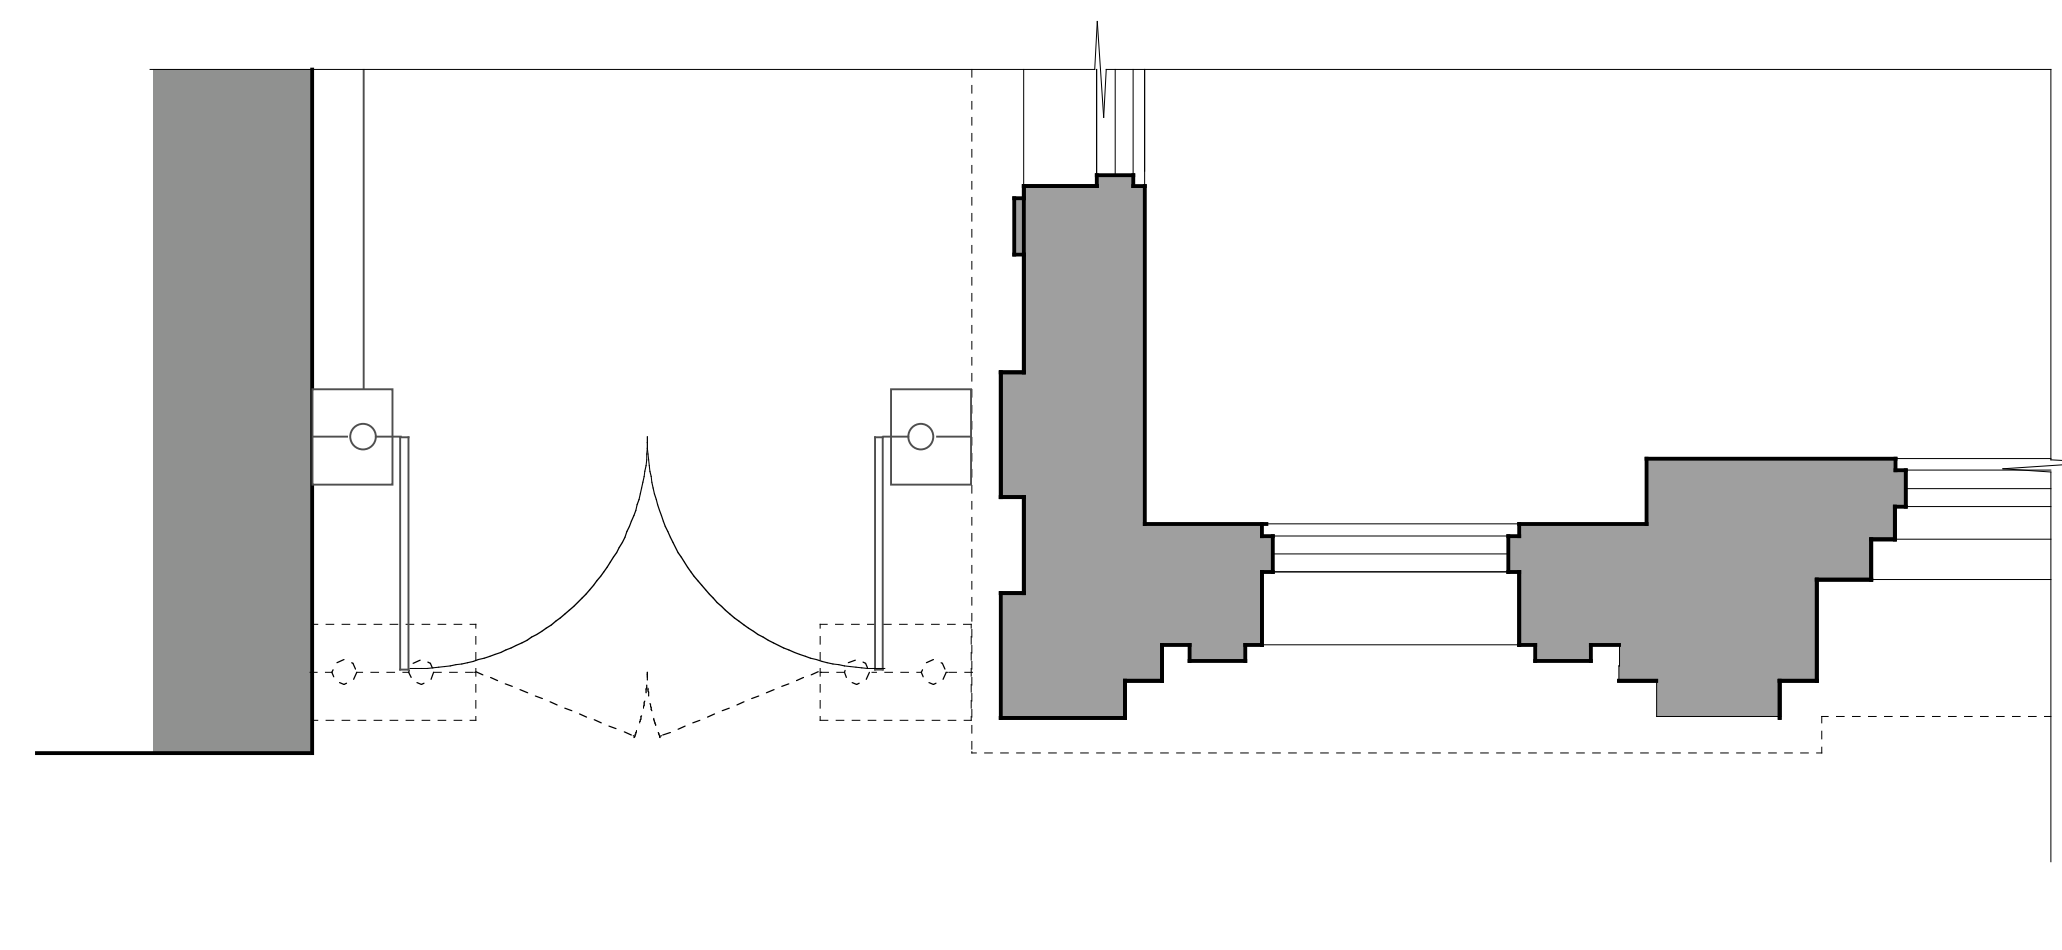
4 PROPOSED PARTIAL PLAN  
Scale: 1/4" = 1'-0"

- (A) INSTALL (N) BRACE TO MATCH (E) IF REQUIRED
- (B) RELOCATE (E) POST AT MODIFIED BASE
- (C) EXPAND GATE BY 2 PICKETS AT EA. SIDE REUSE OR REPLICATE FINIALS FROM (E) SIDE SECTIONS
- (D) REUSE OR REPLICATE (E) HINGES
- (E) CUT STONE BASES TO ACCOMMODATE GATE. SALVAGE STONE AND RETAIN ON SITE.

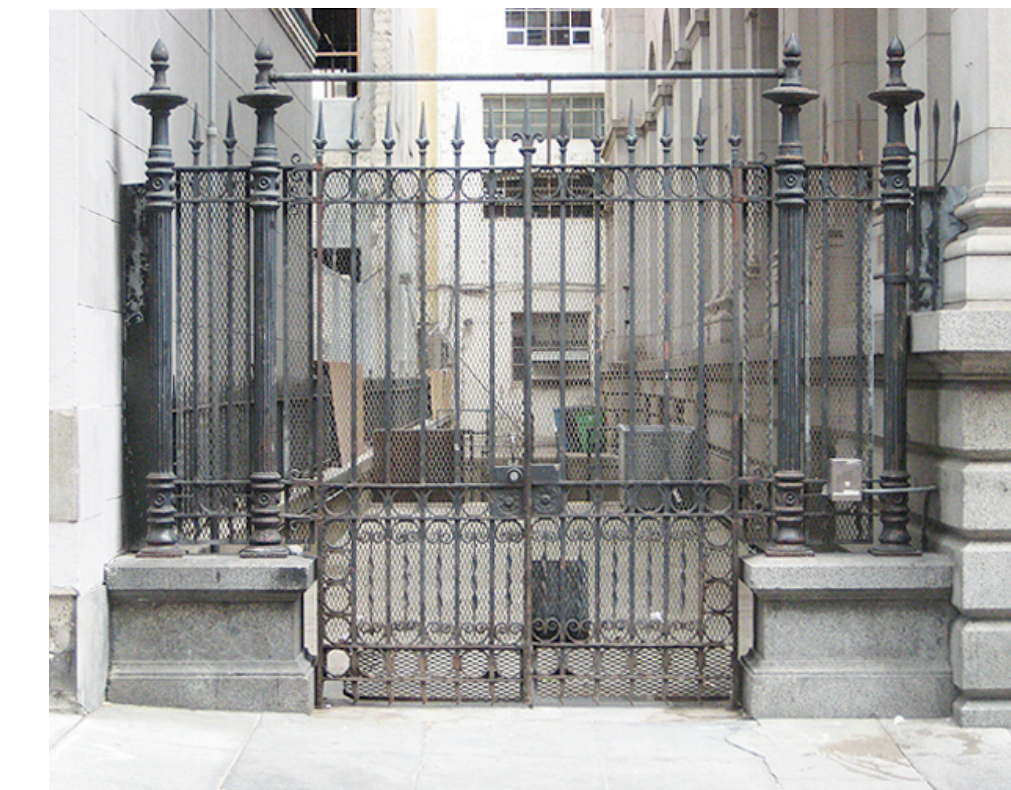
A: View of west gate from McAllister Street

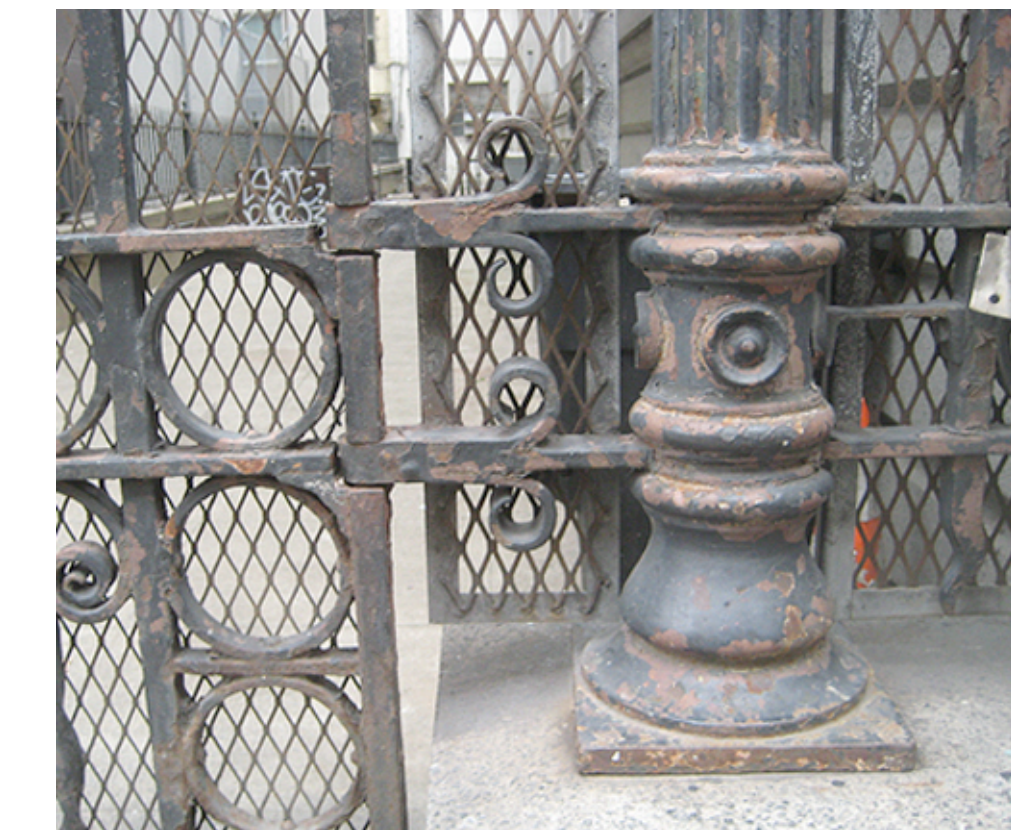
B: Detail of west gate at support post

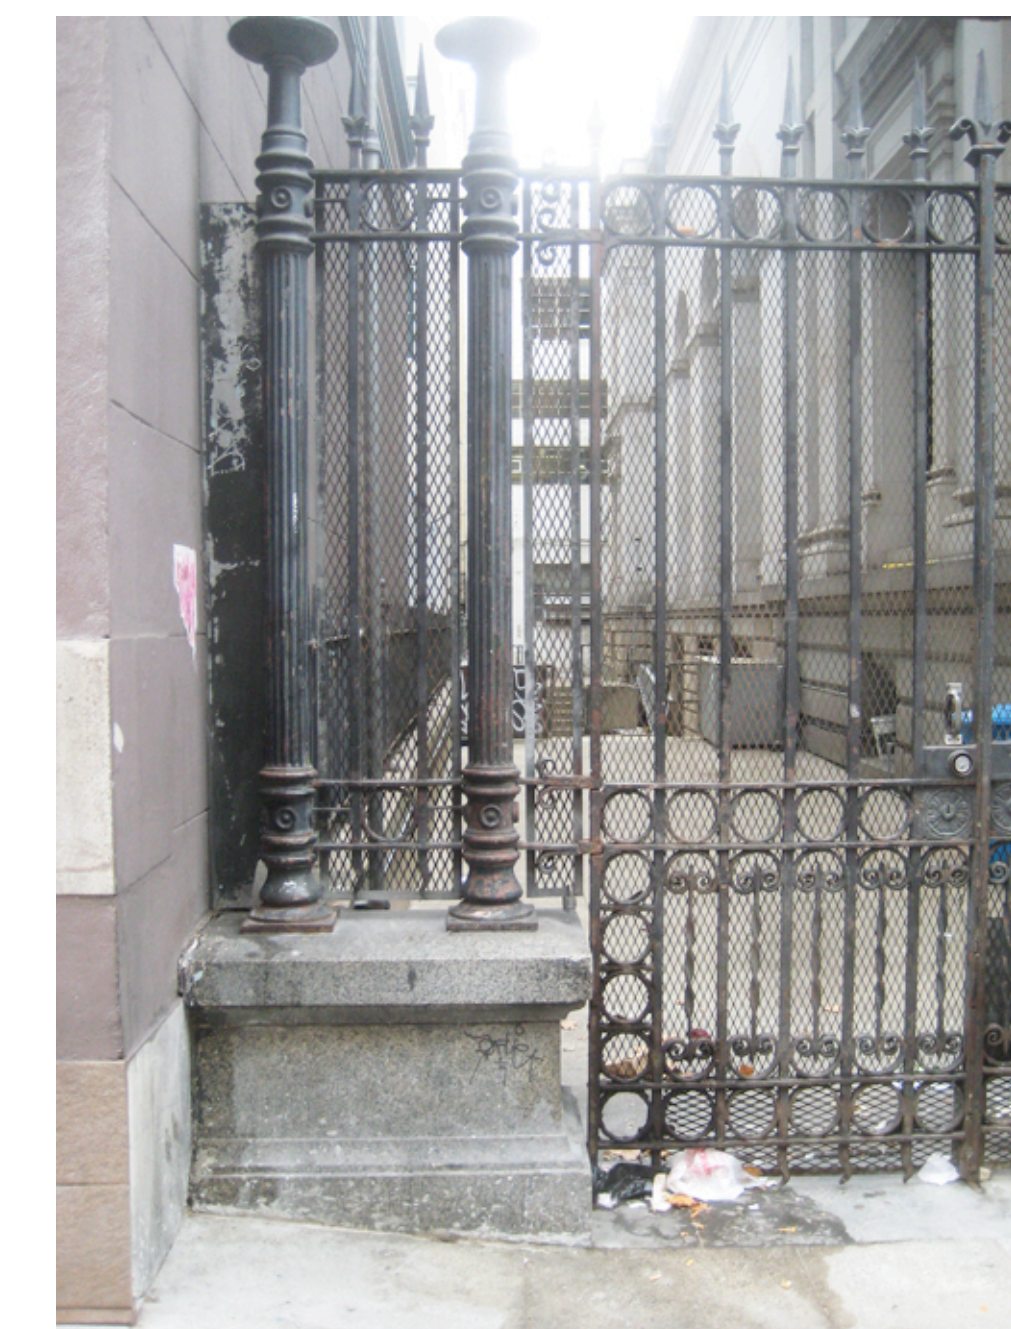
C: Detail of west gate granite base

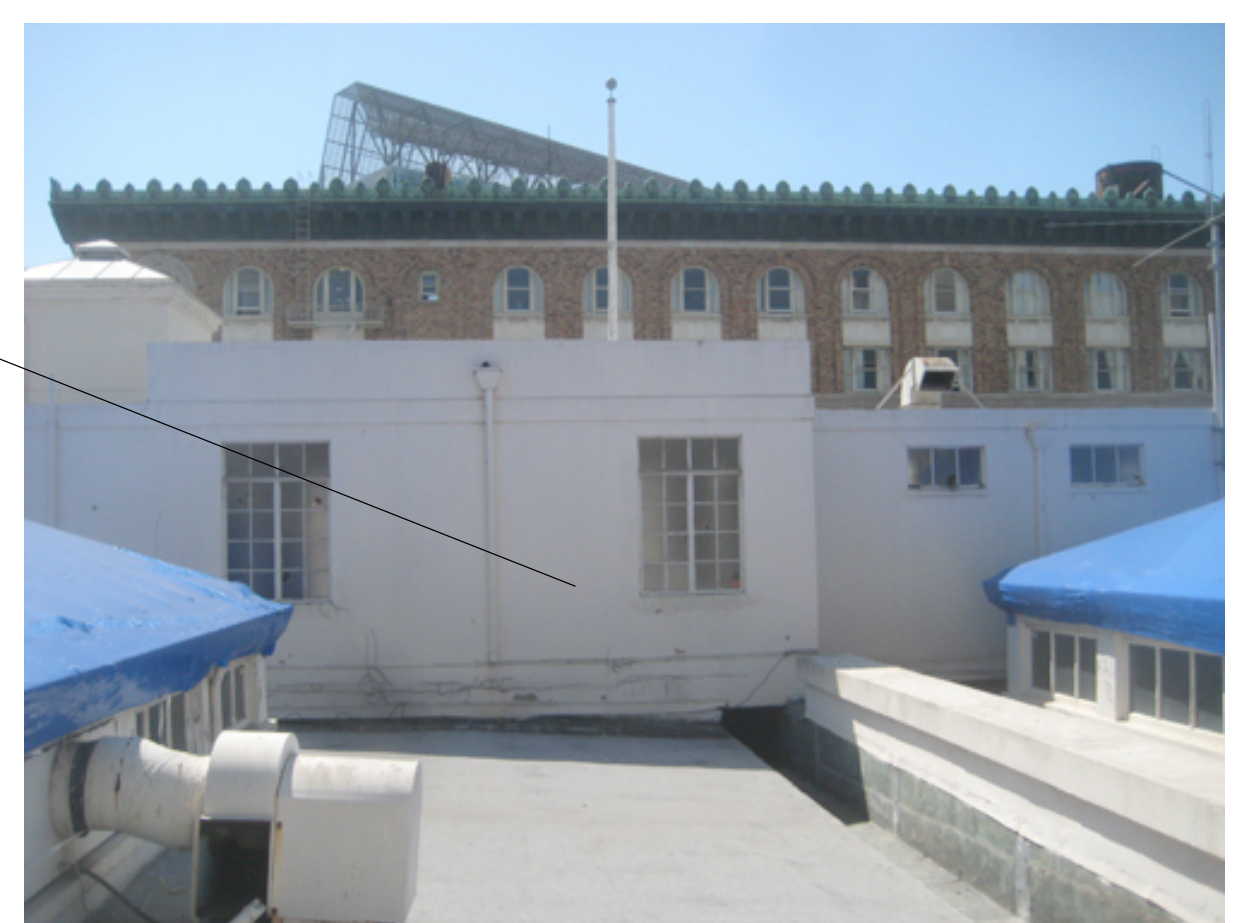
A: View of existing northern side of penthouse where window will be converted to exit door.

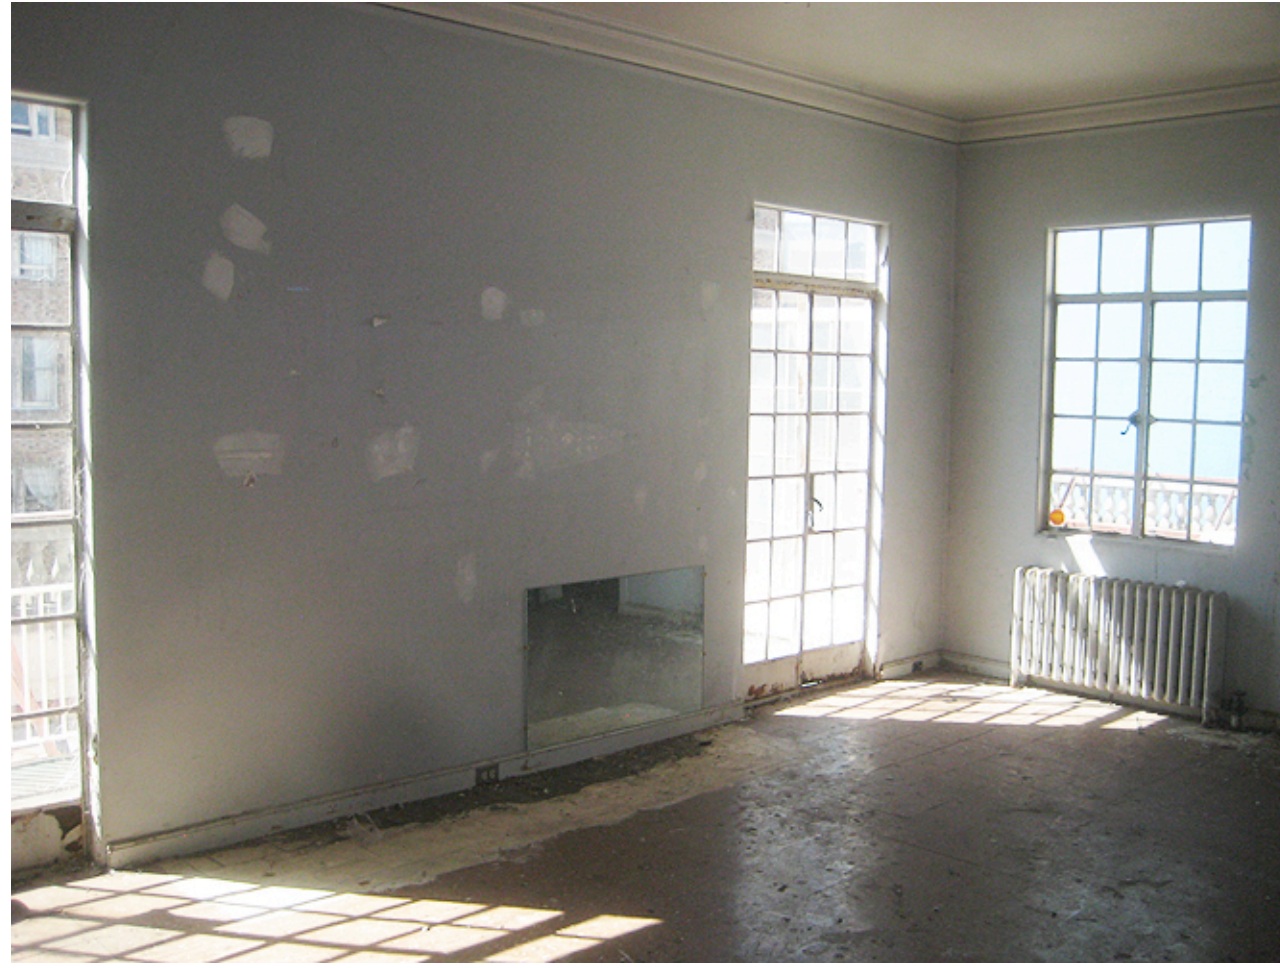
A: View of existing southern side of penthouse where existing pair of doors will be replaced by single exit door.

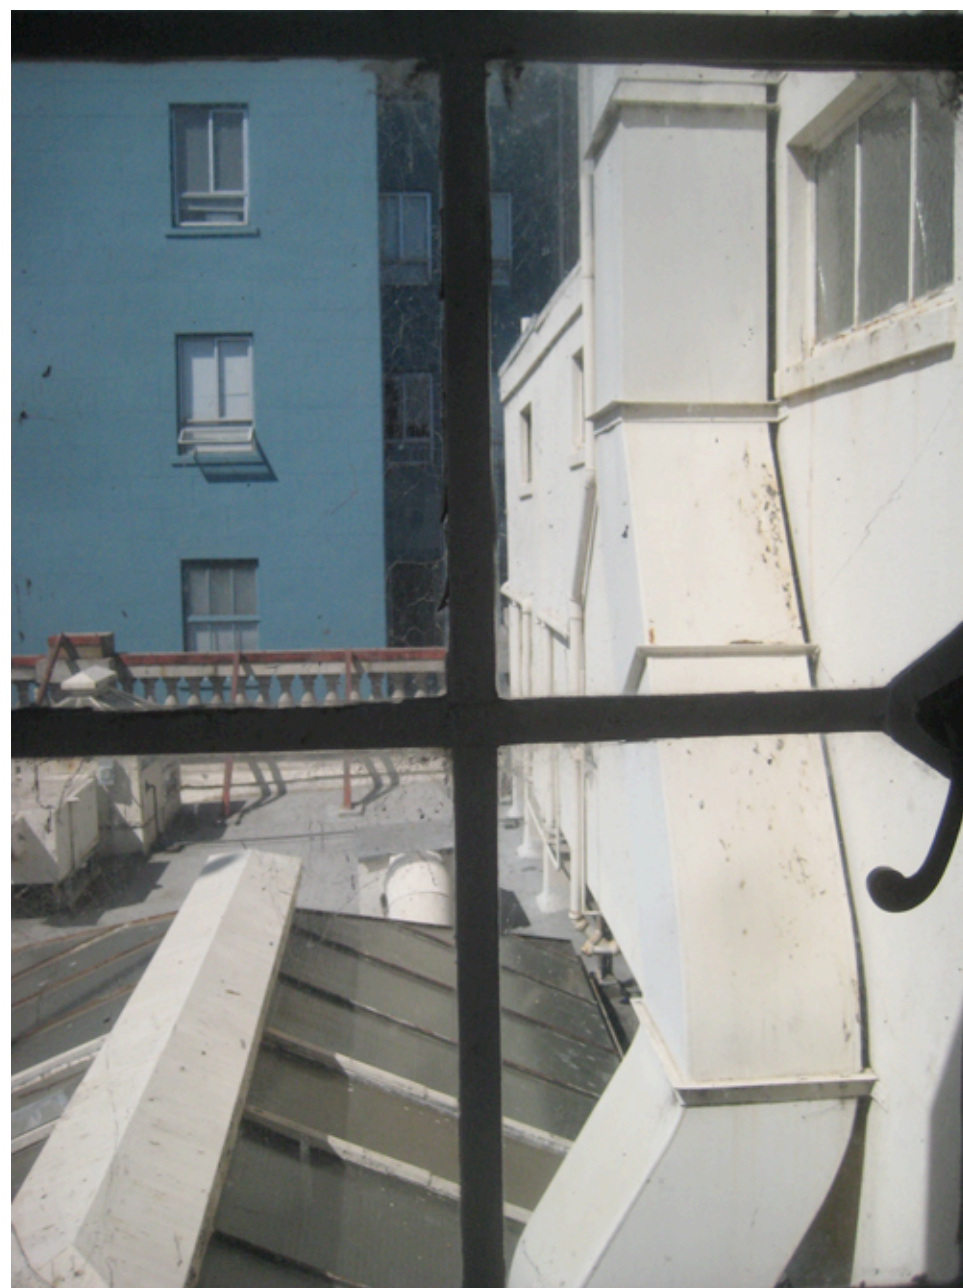
B: View along existing southern side of penthouse where an addition will house new bathrooms.

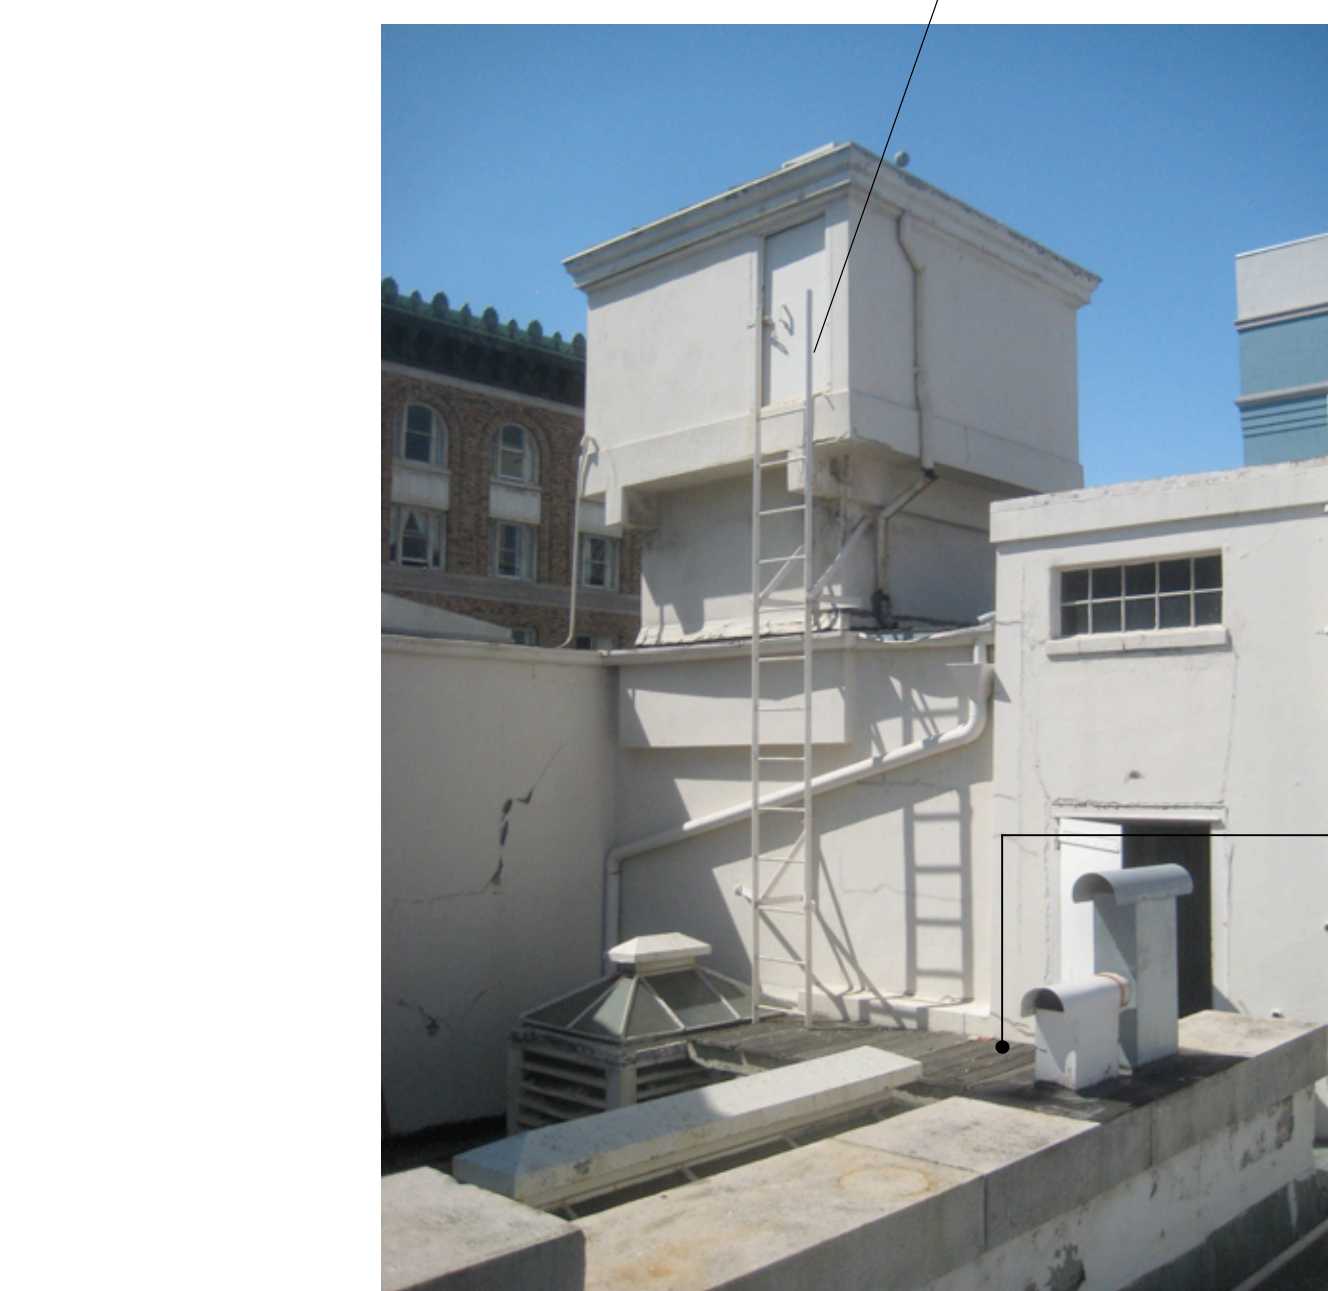
A: View of existing elevator penthouse

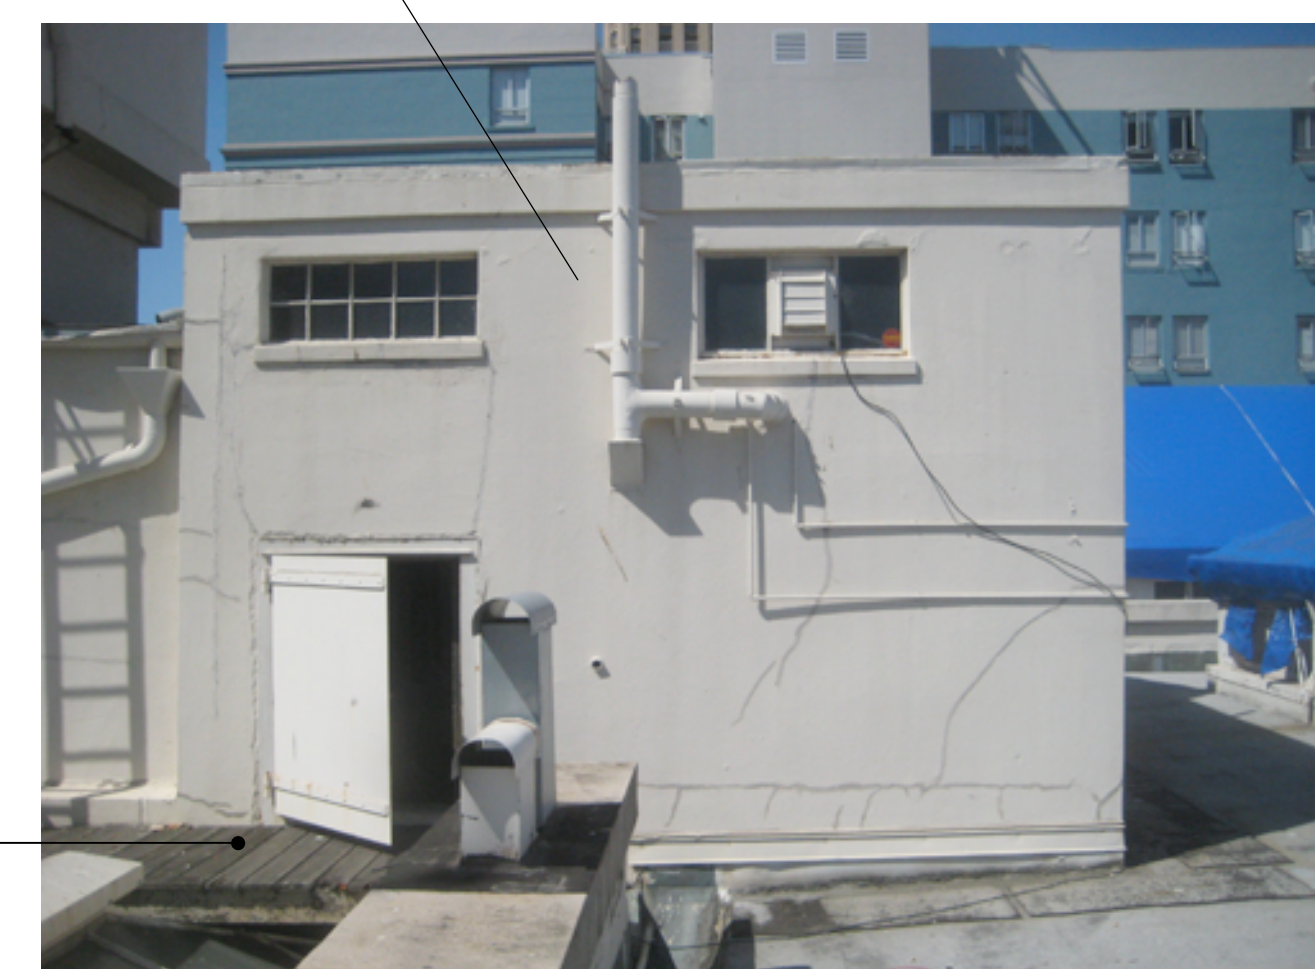
B: West side of penthouse

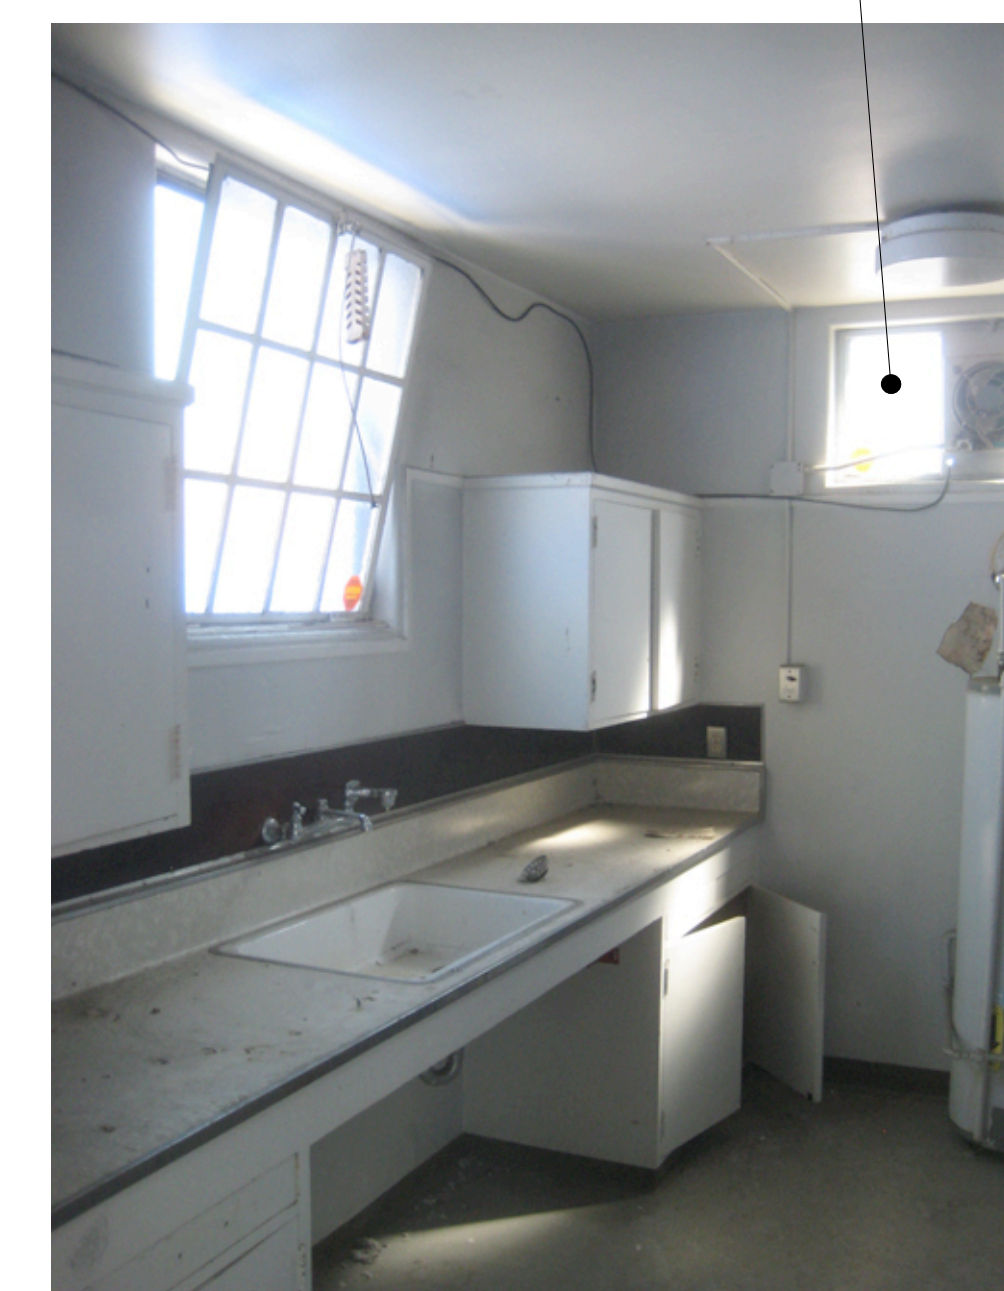
C: View of window on western wall to be enlarged to match adjacent window size
