# SAN FRANCISCO PLANNING DEPARTMENT

**MEMO**

**RE:** Review and Comment for 1 Jones Street (former Hibernia Bank)  
Case No. 2011.0617EA

**HIBERNIA BANK BUILDING**

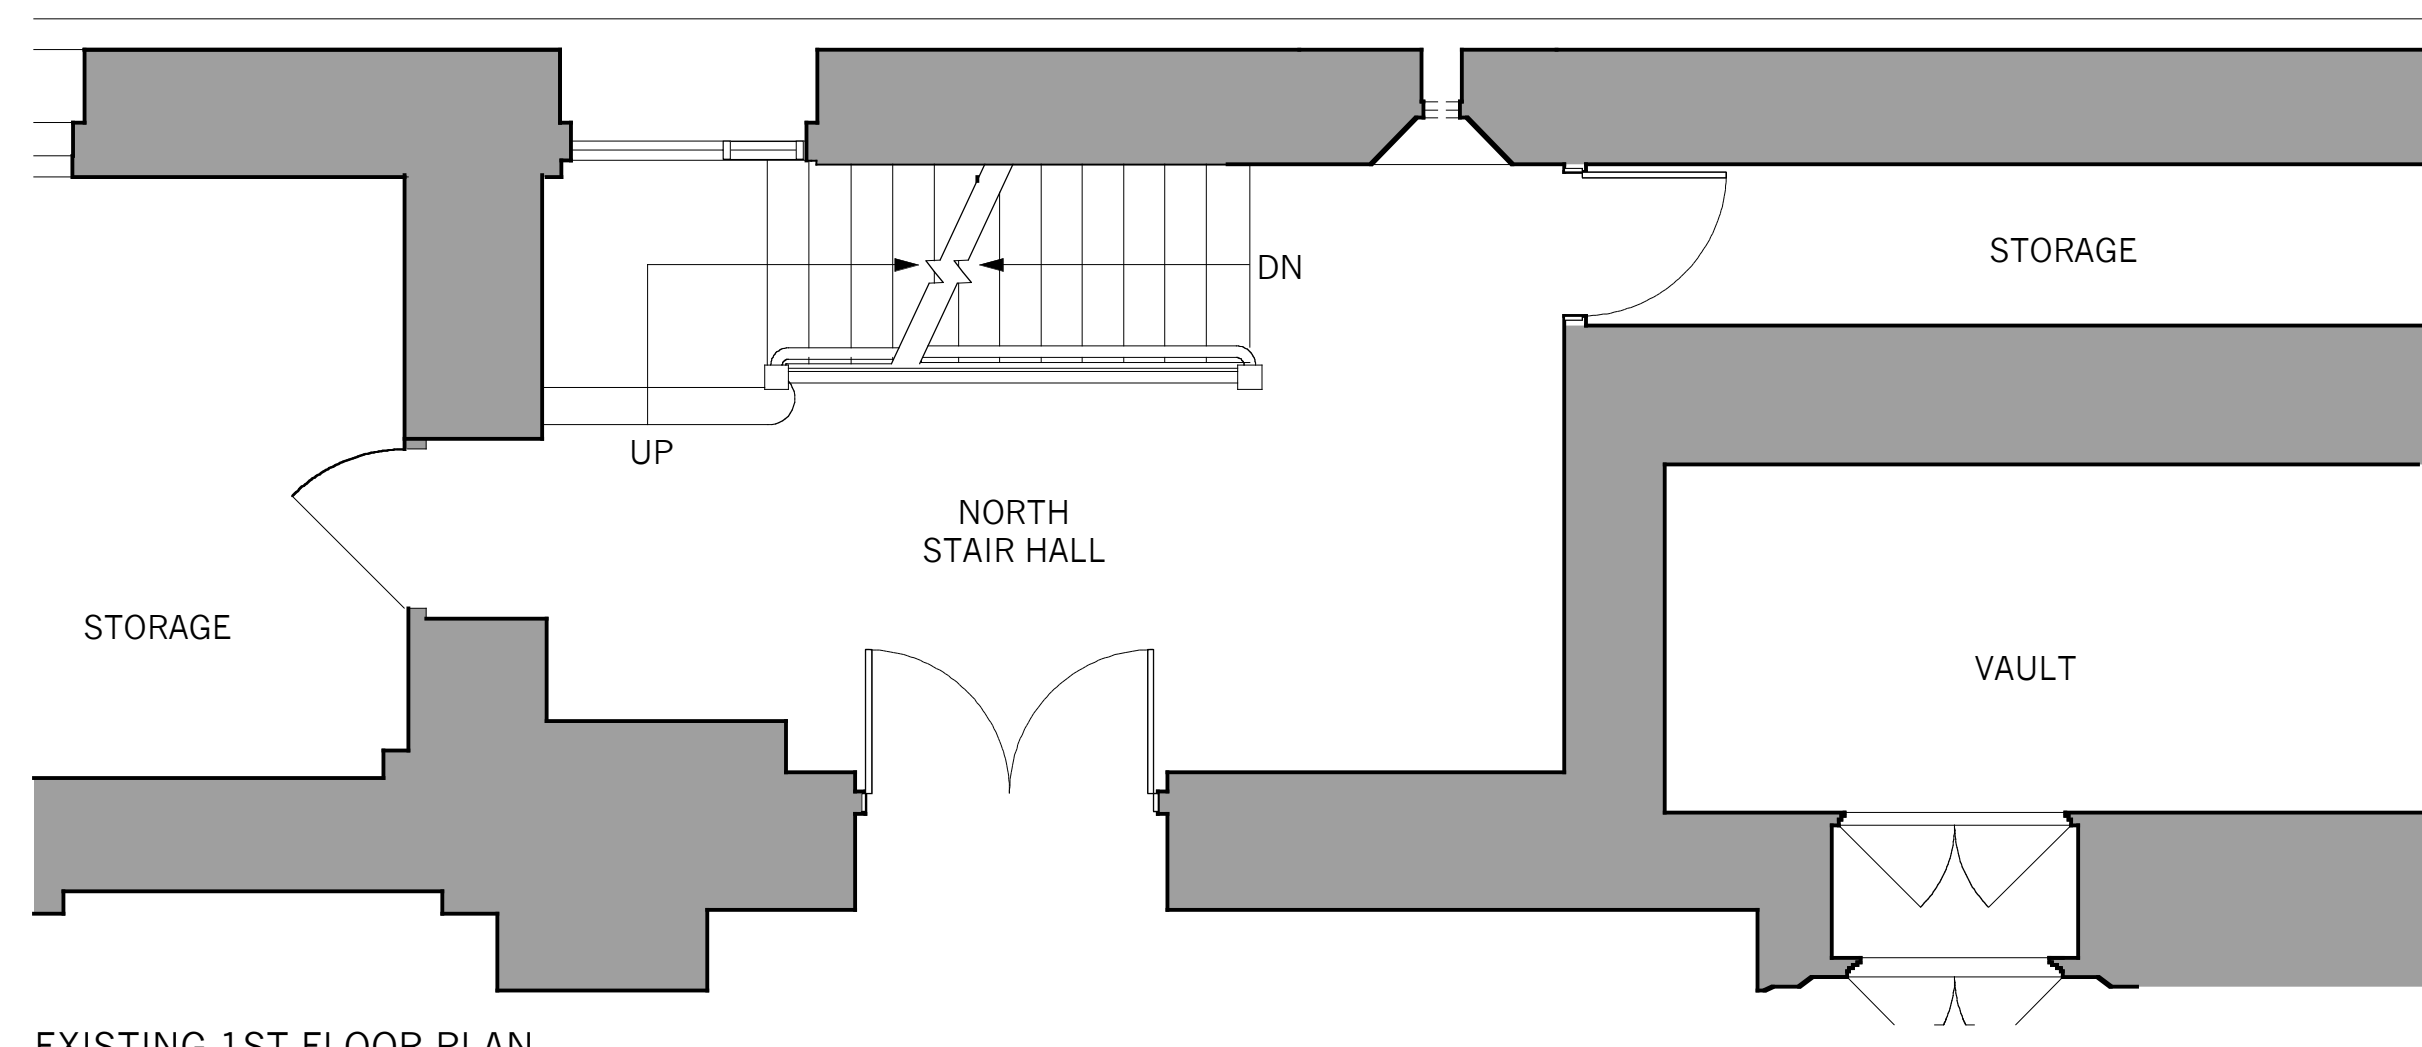
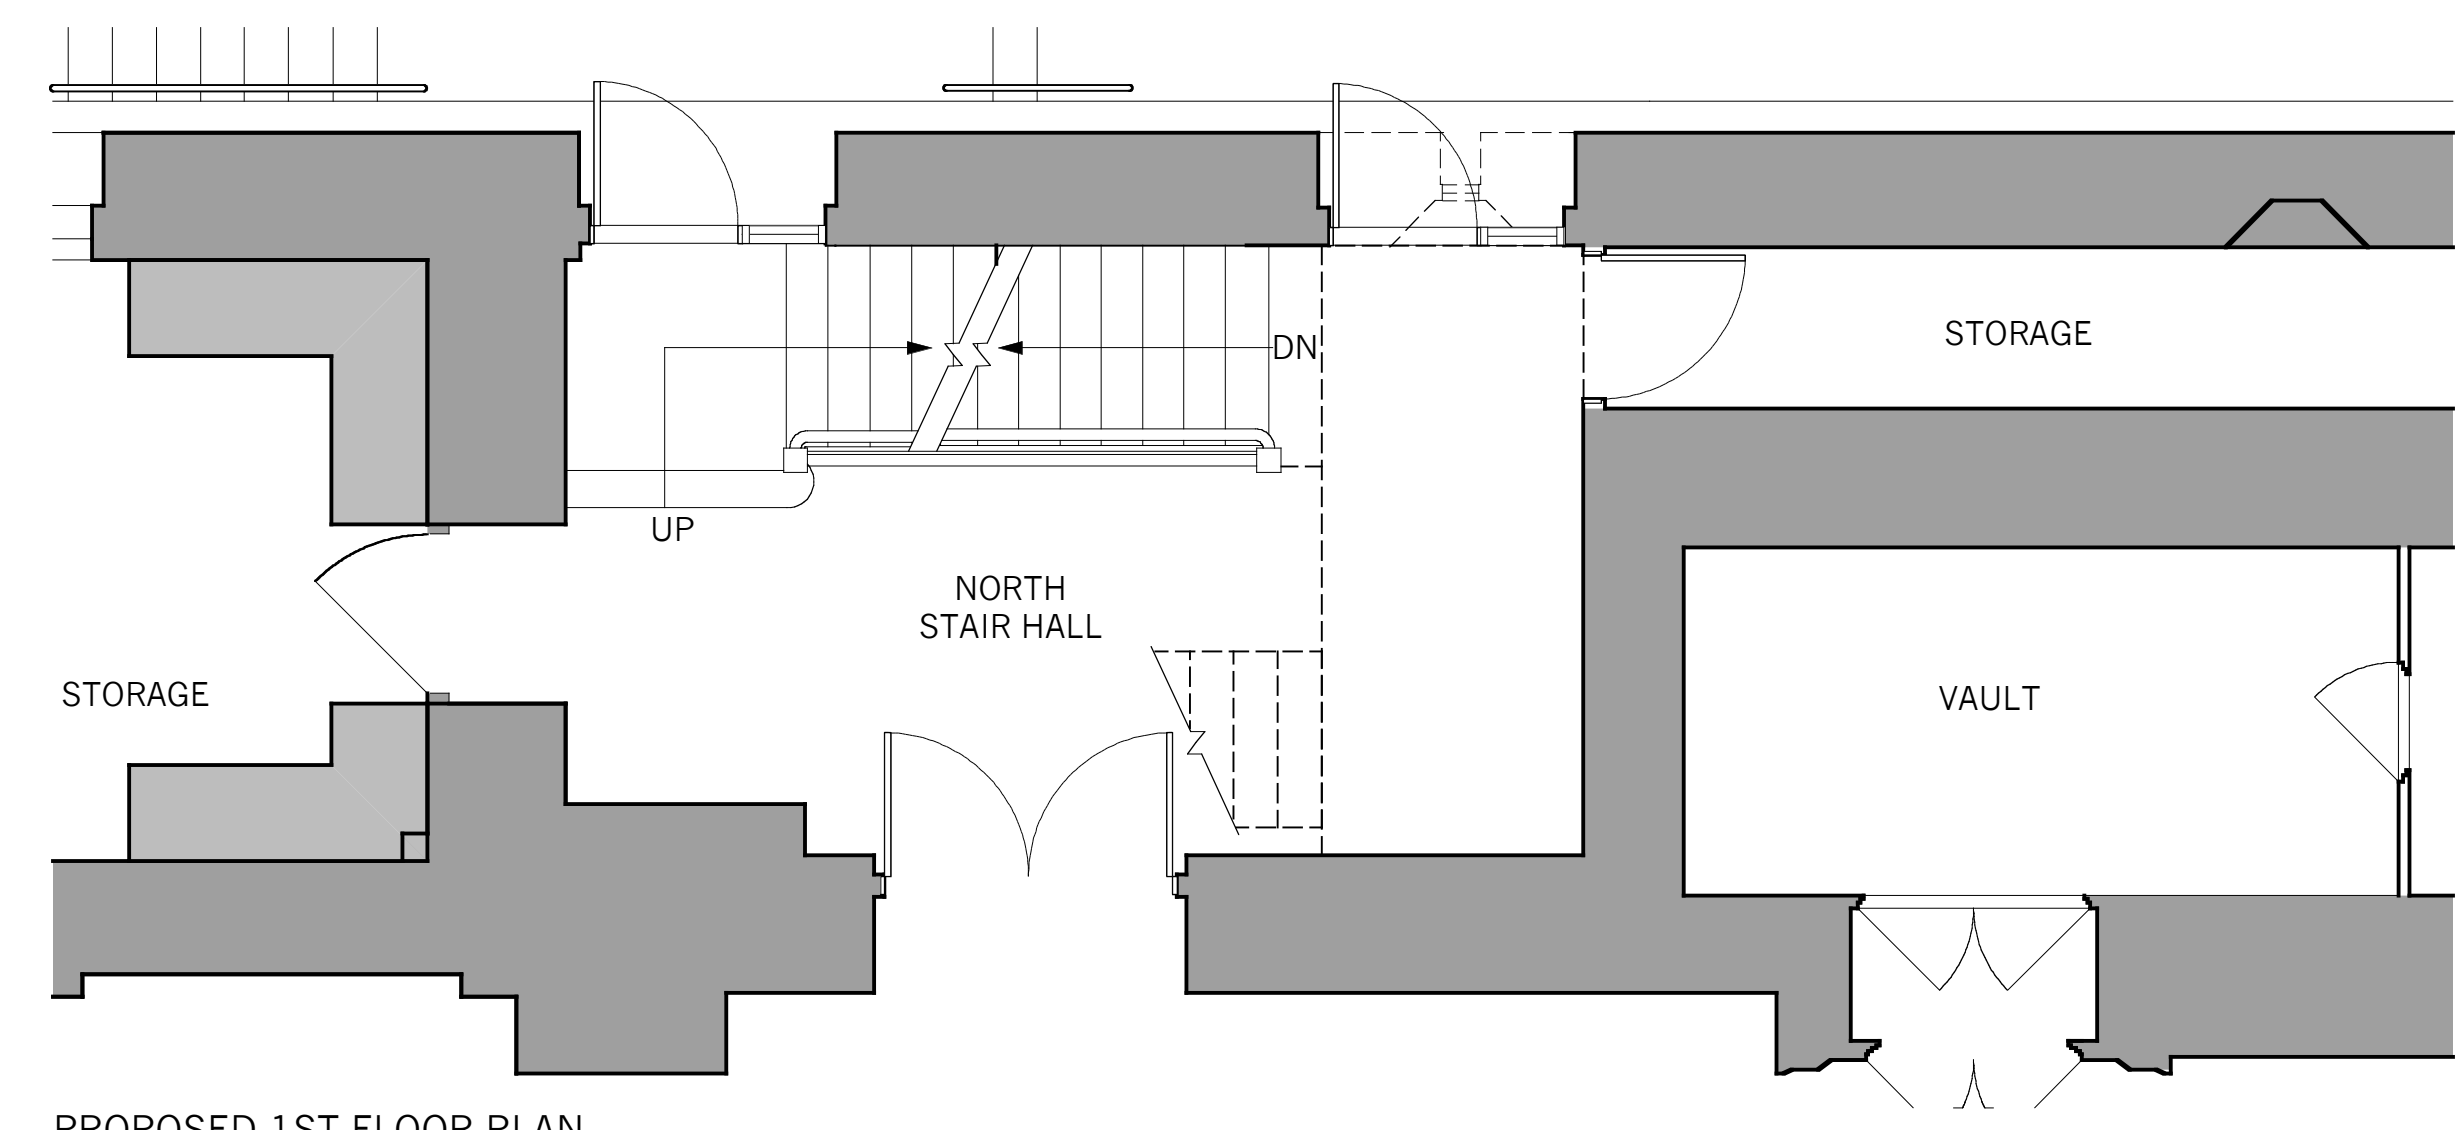
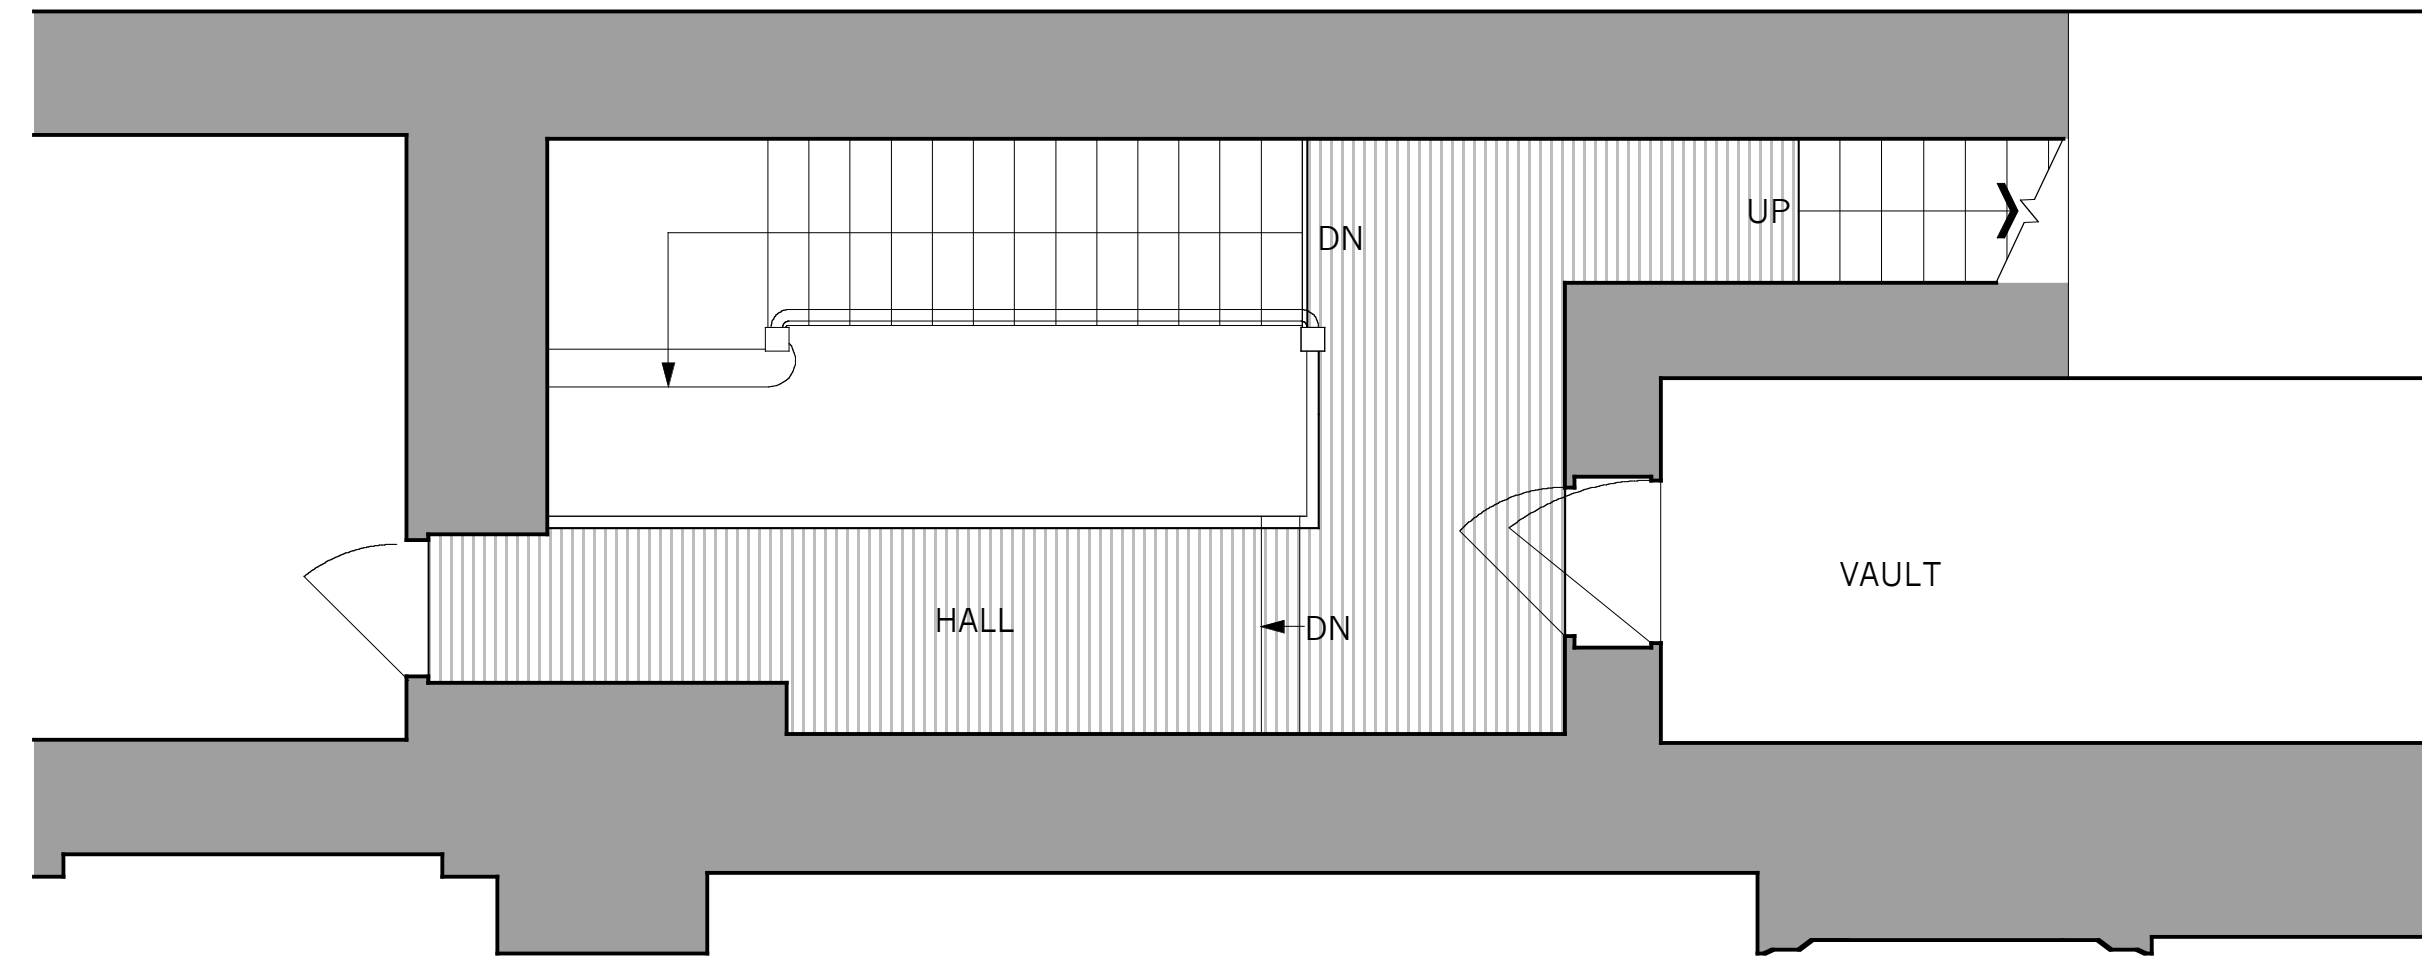
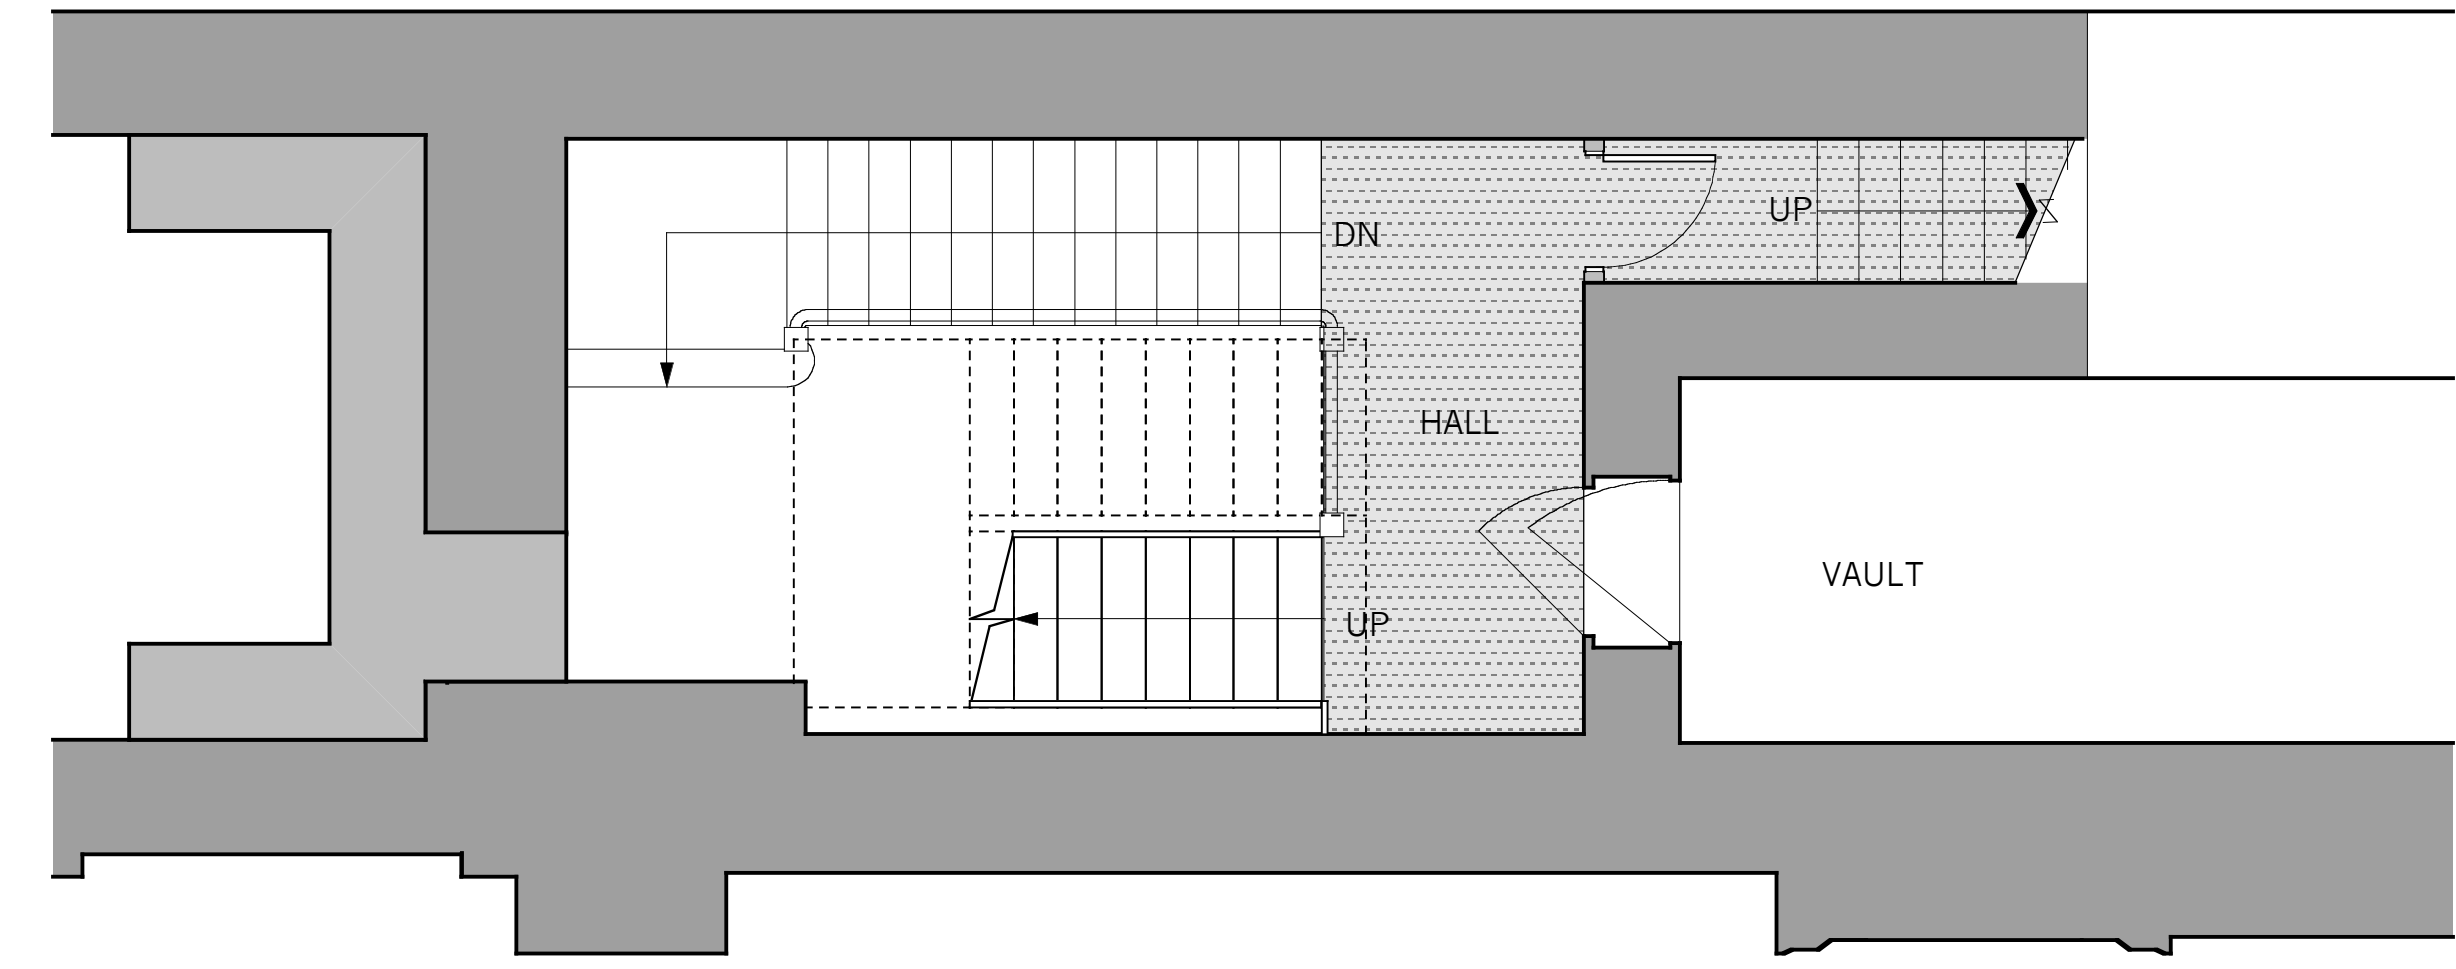
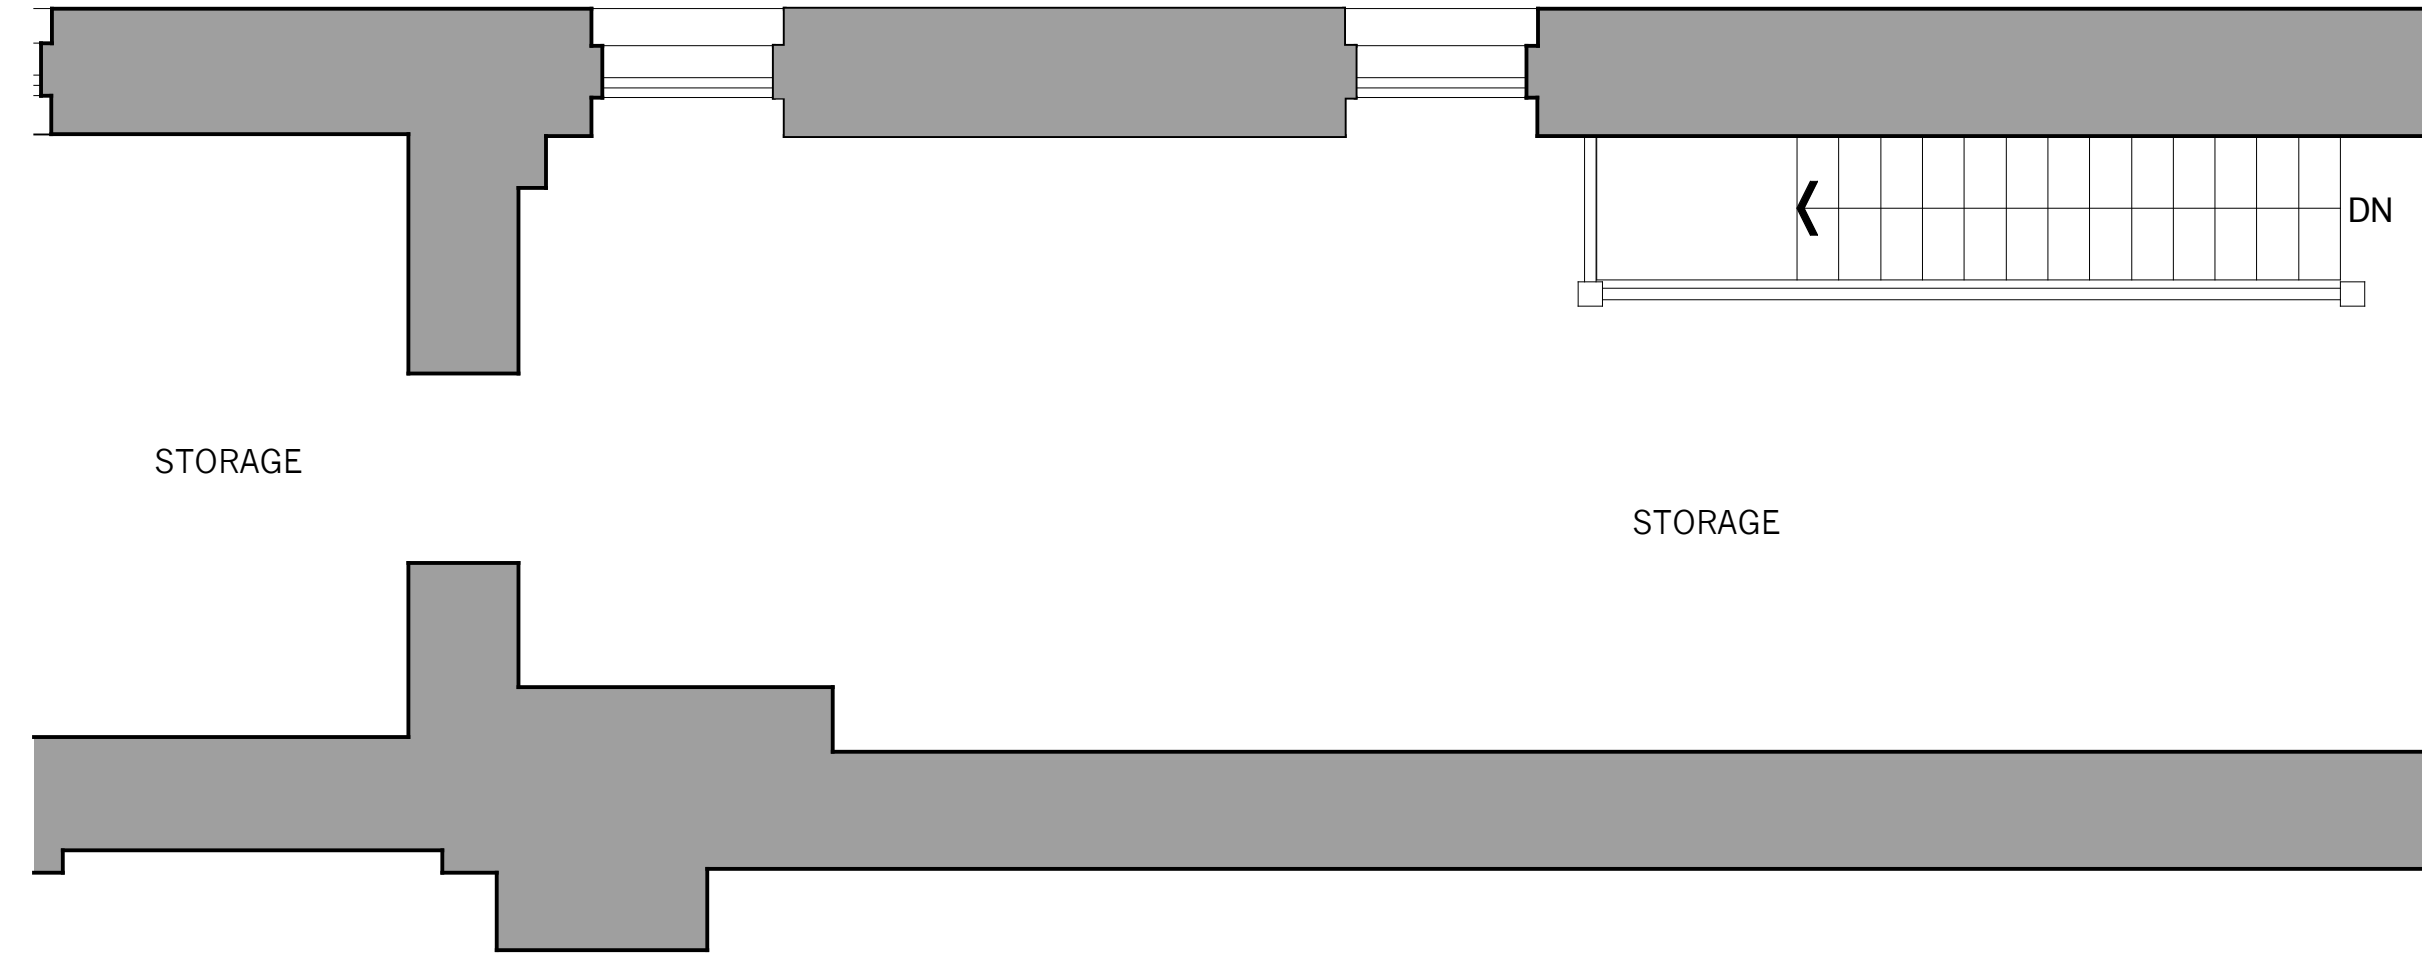
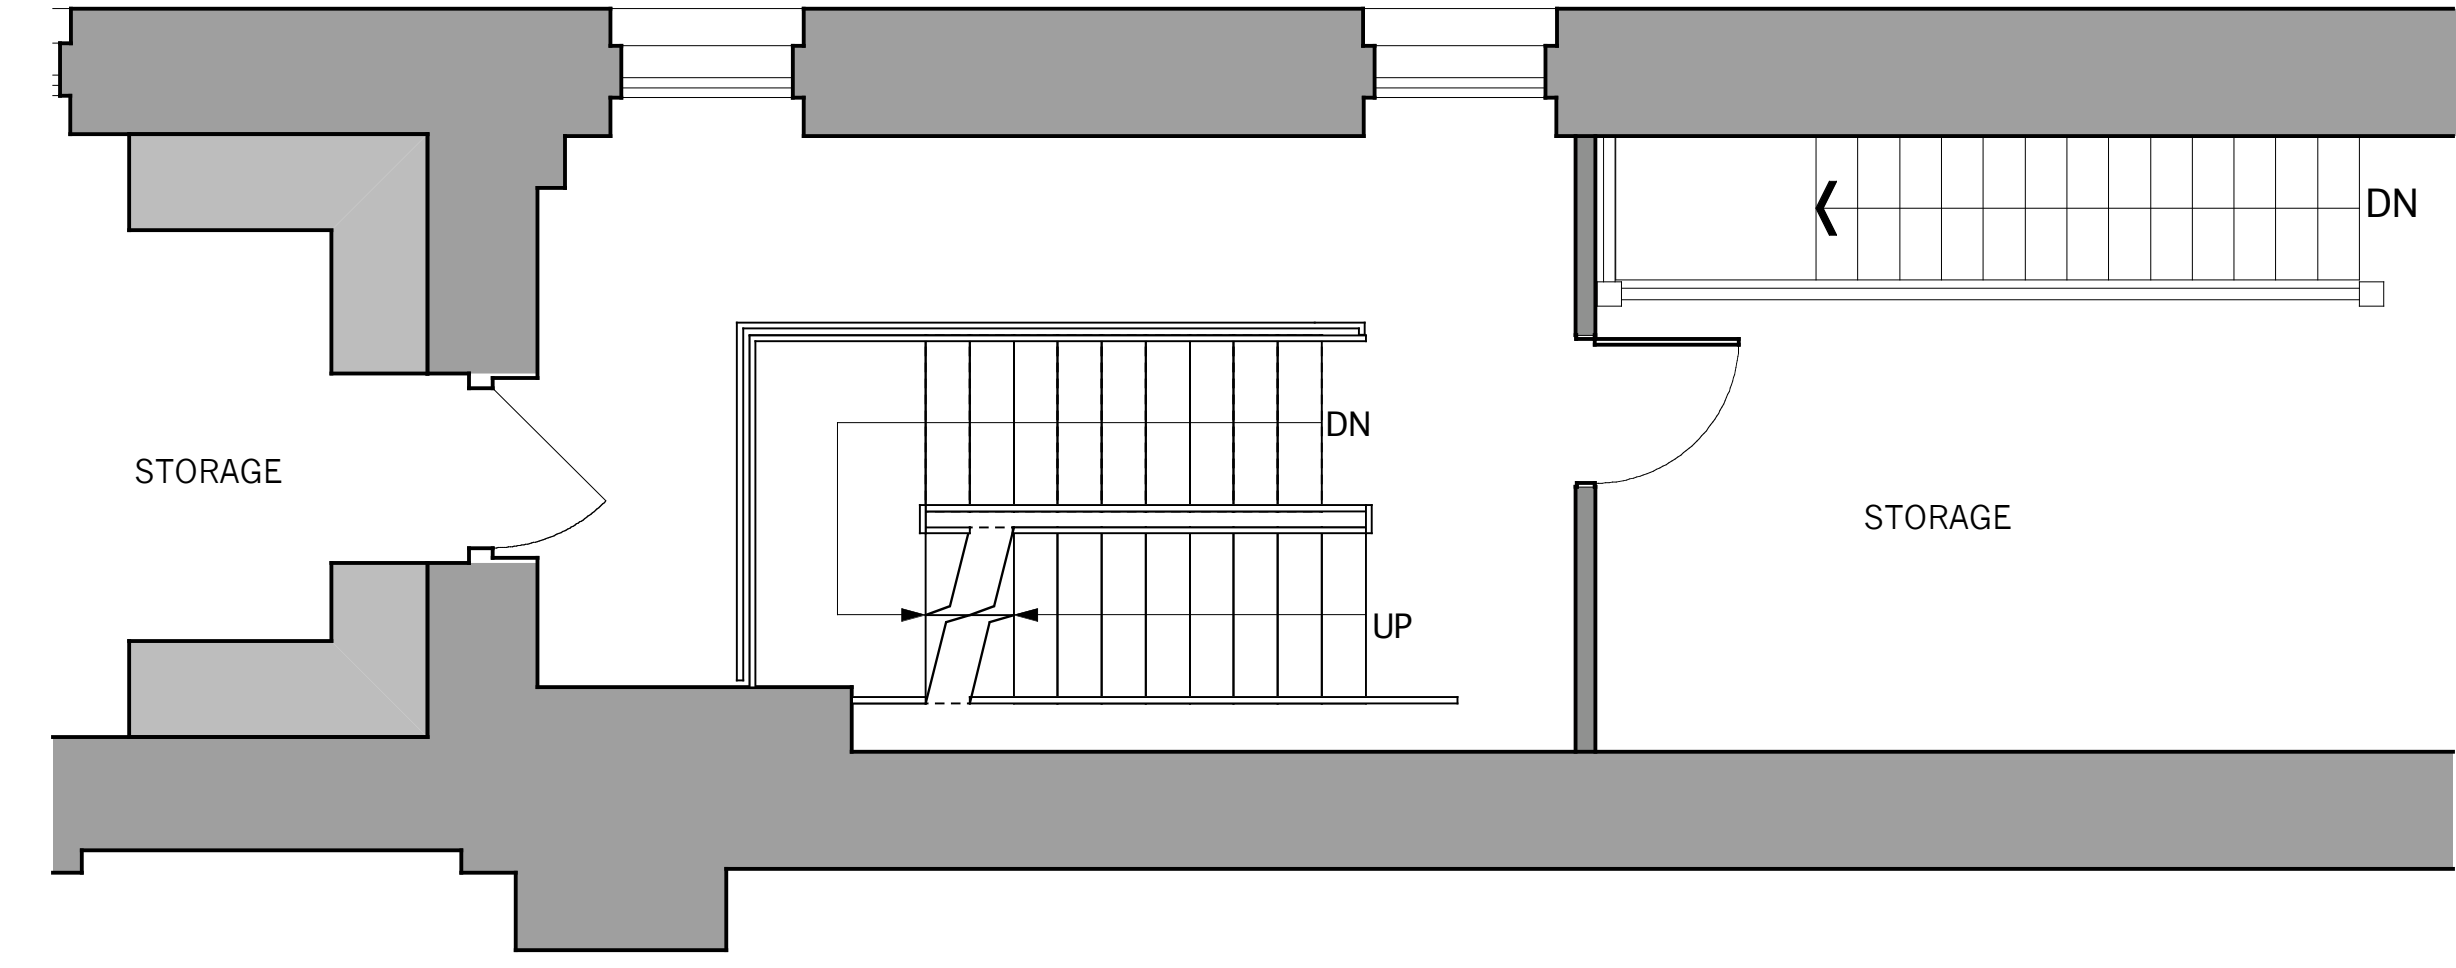
**North Stair Plans**

EXISTING 1ST FLOOR PLAN

PROPOSED 1ST FLOOR PLAN

EXISTING MEZZANINE PLAN

PROPOSED MEZZANINE PLAN

EXISTING 2ND FLOOR PLAN

PROPOSED 2ND FLOOR PLAN

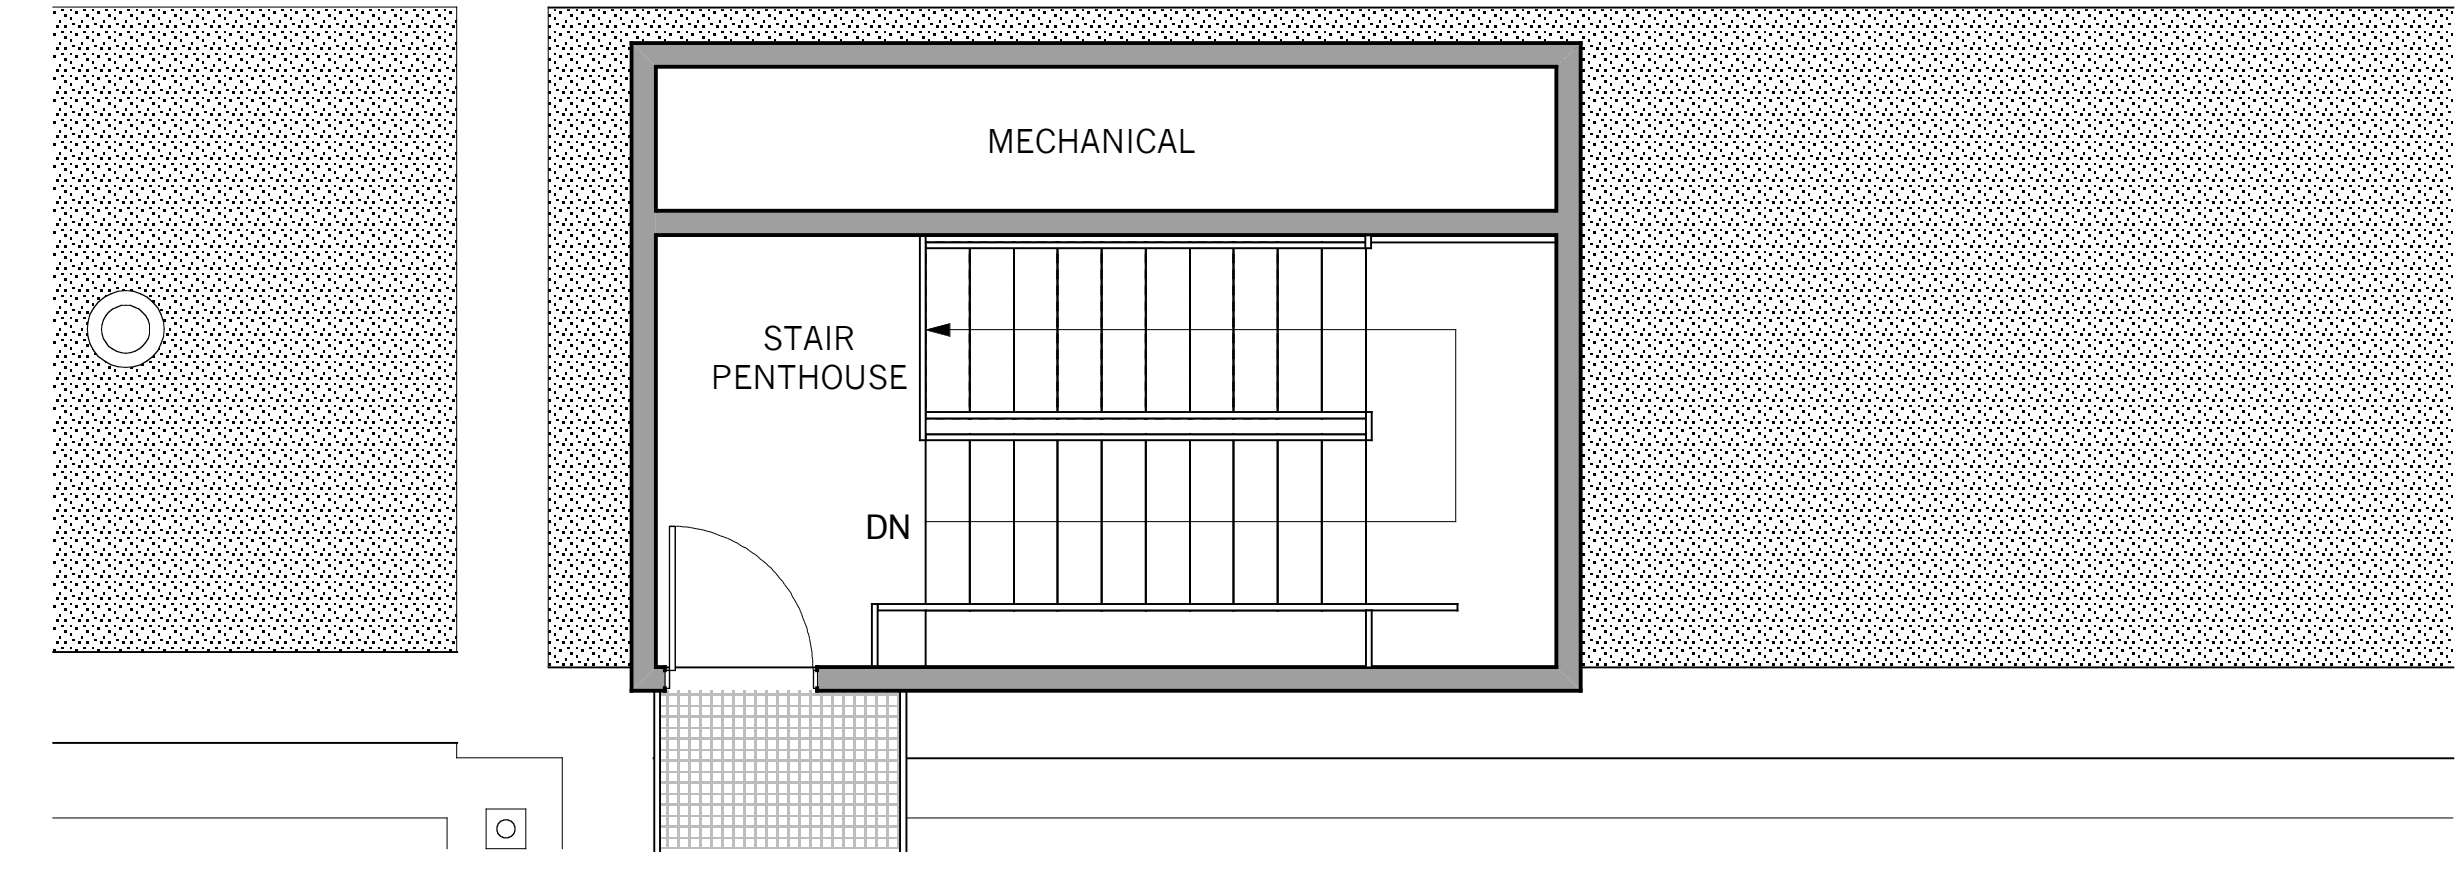
EXISTING PENTHOUSE PLAN

PROPOSED PENTHOUSE PLAN

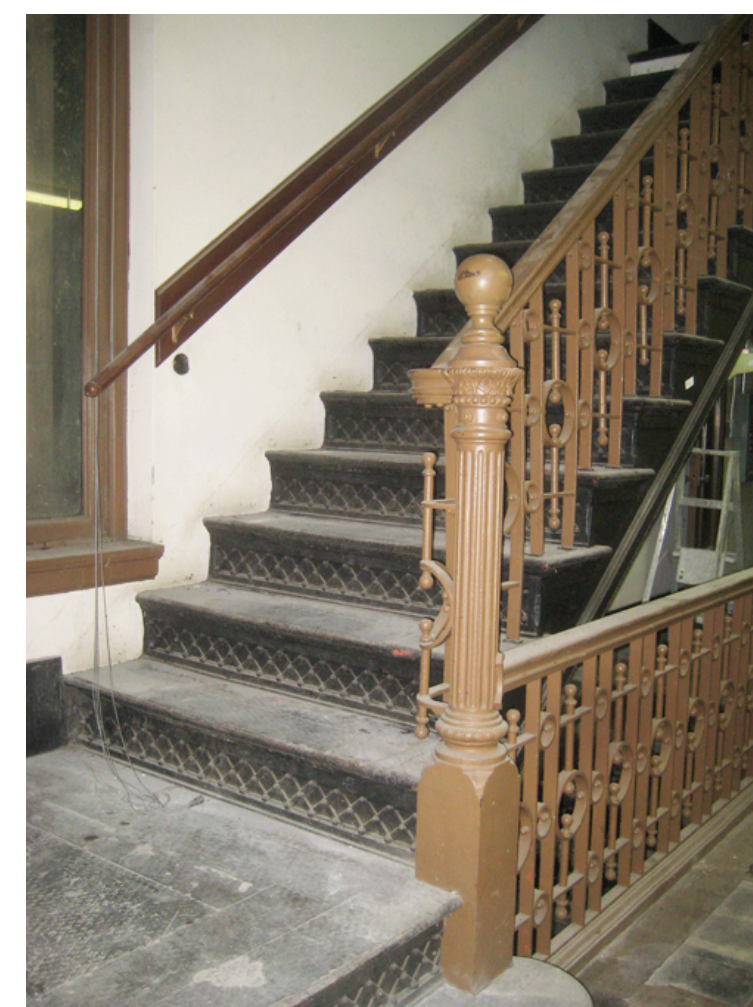
D: View of window to become west exit door from north stair hall

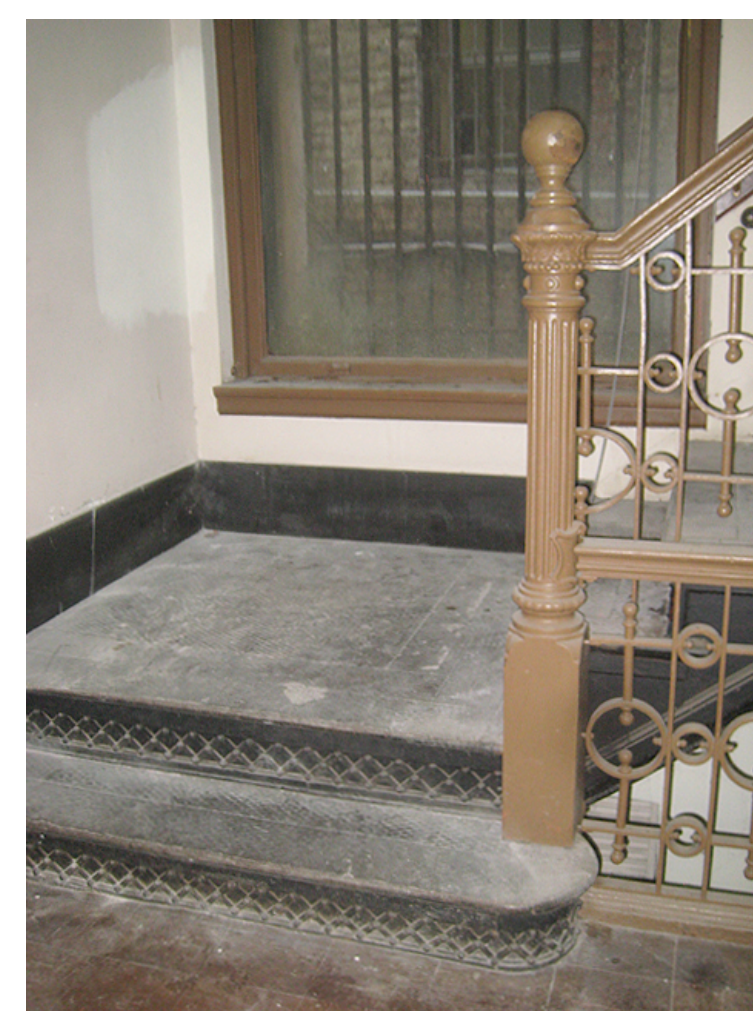
E: View of window to become west exit door from north stair hall

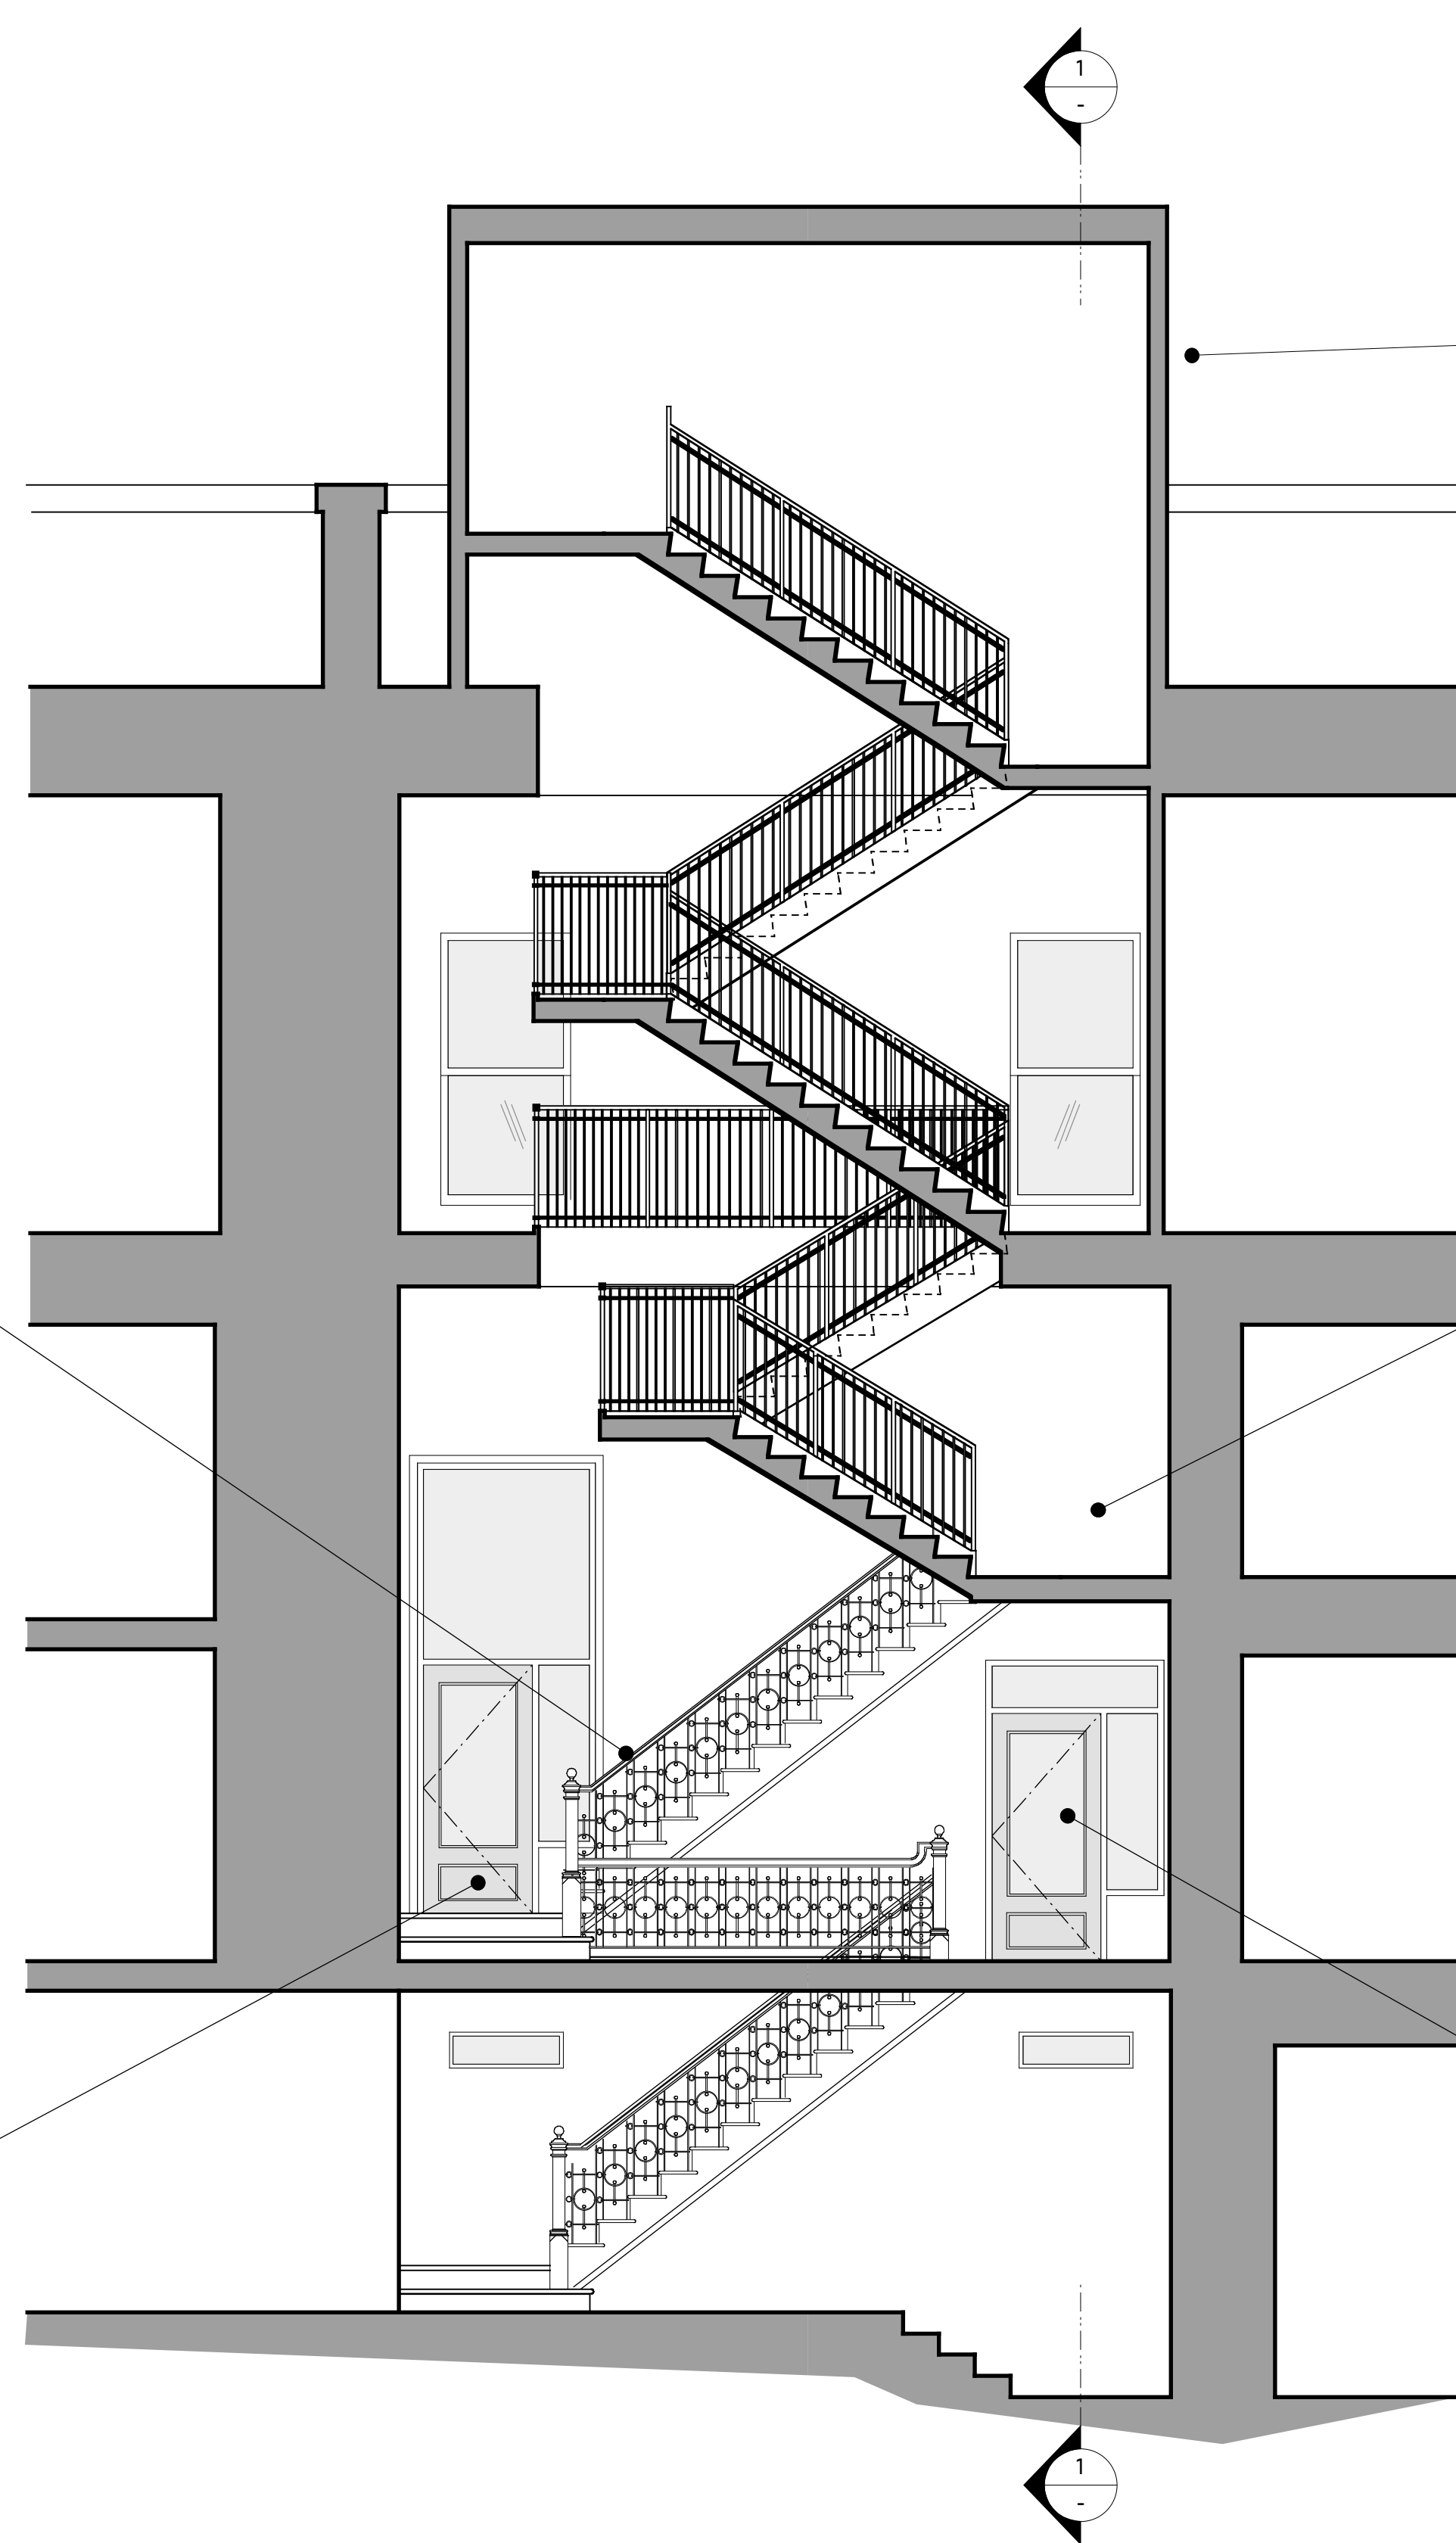
2 EAST/WEST SECTION NEW STAIR

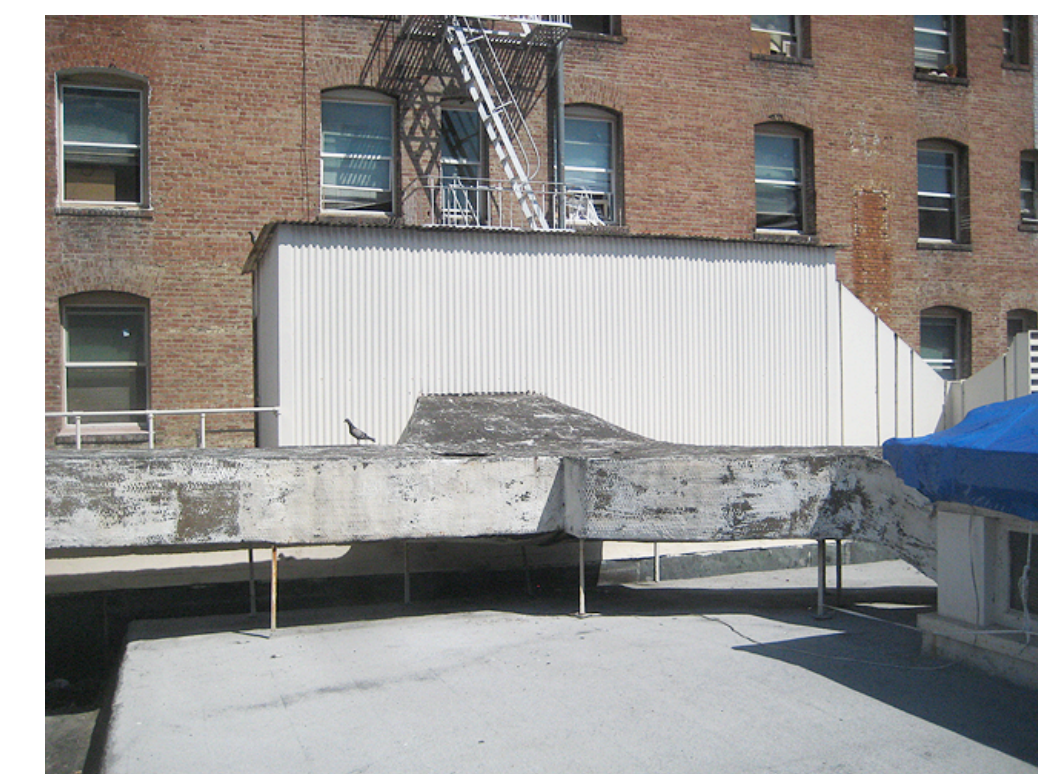
A: View of existing mechanical penthouse
