# SAN FRANCISCO PLANNING DEPARTMENT

**MEMO**

**RE:** Review and Comment for 1 Jones Street (former Hibernia Bank)  
Case No. 2011.0617EA

**HIBERNIA BANK BUILDING**

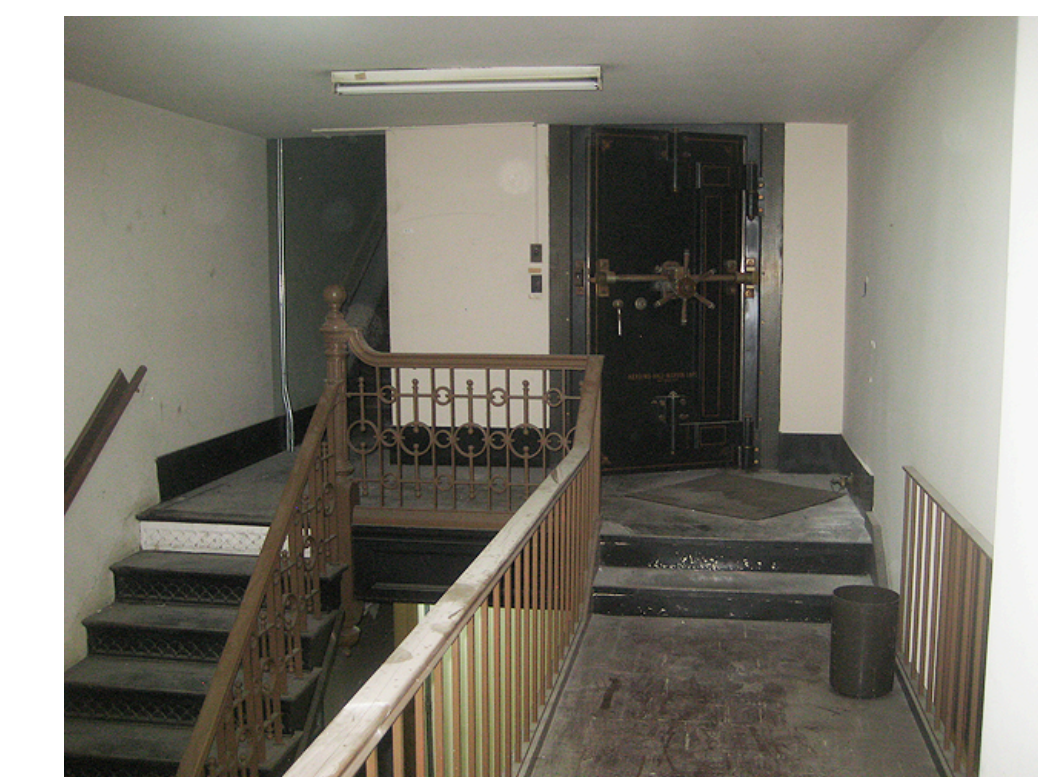
B: Landing at mezzanine level

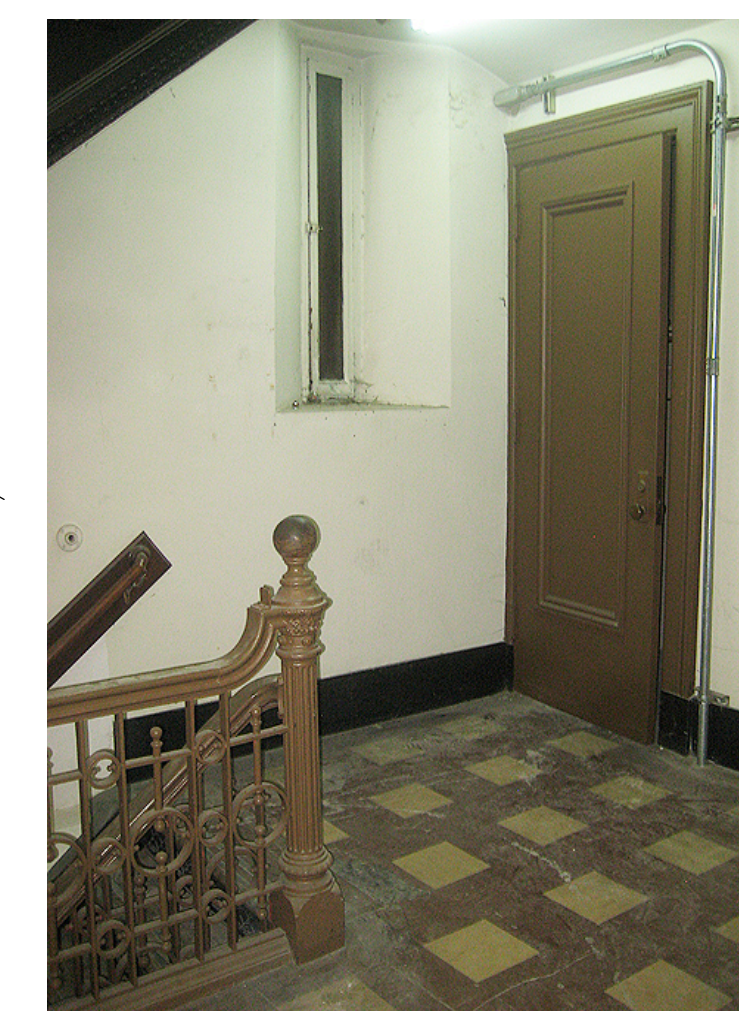
C: View of "Lancet" window to become east exit door from north stair hall

4. NORTH GATE  
Existing North gate to be relocated and altered to reverse the swing for the fire code required path of travel direction.
5. EXIT AT NORTH STAIR HALL  
To provide the code required exiting from the Banking Hall, the wall area below the sill of the existing west window in the north stair hall is to be cut to be level with the stair landing. The lower sash of the window to be removed and replaced with a door and side light. The wall area at the east end of the north stair hall to be removed to provide a second exit door and sidelight to match west door.

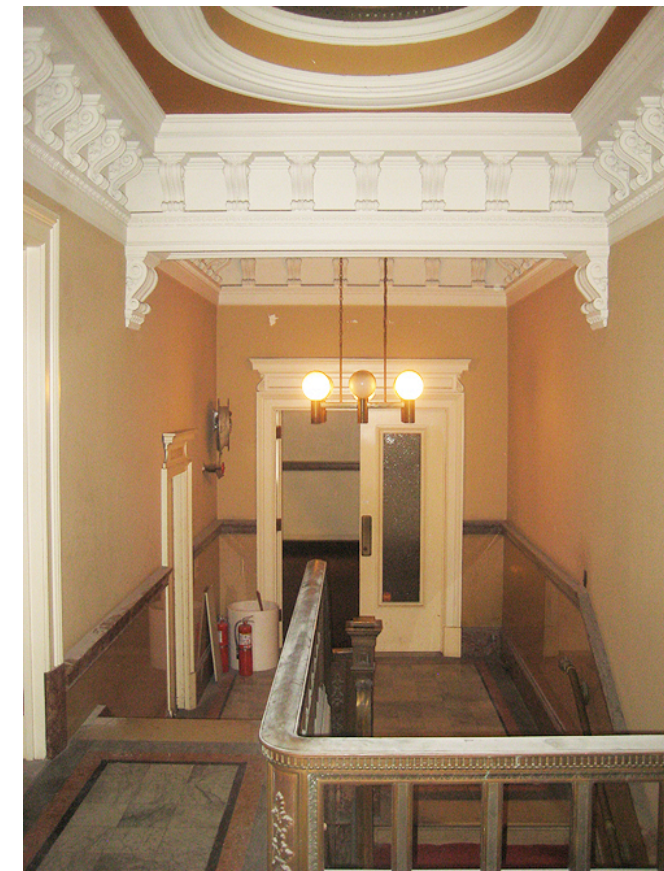
A: View of South stair hall looking at entry to 2nd floor office suite.

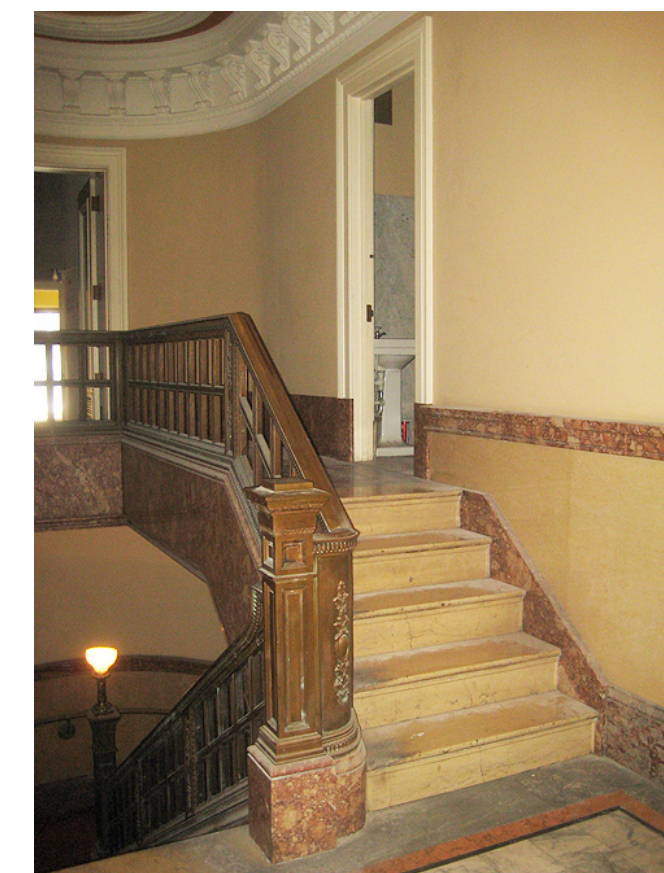
B: View of upper South stair hall. Door to bathroom on right and stair to dome room on Penthouse at left.

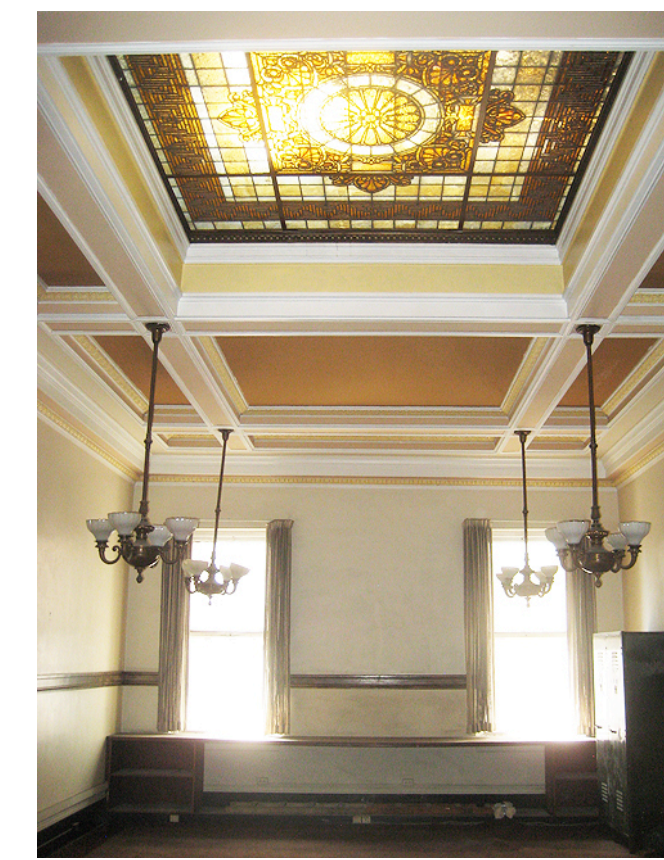
C: View of Customer/Waiting area of 2nd floor office suite. There will be no changes to this room.

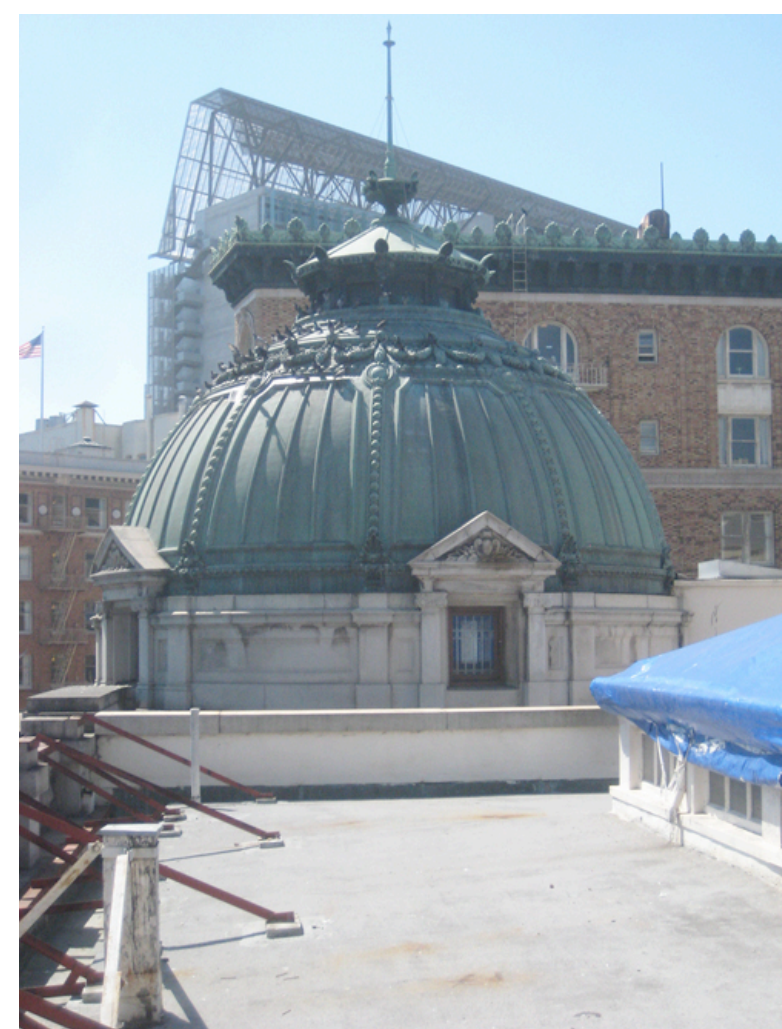
A: View of dome looking south with skylight enclosure on right. Parapet bracing on left.

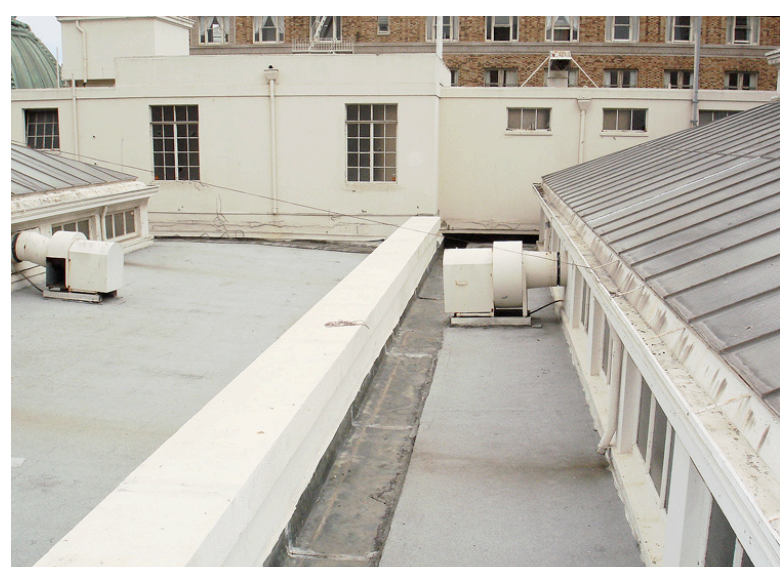
B: Looking south at Penthouse. Parapet at center is the structural line between the original building (on left) and the 1905 addition (on right).

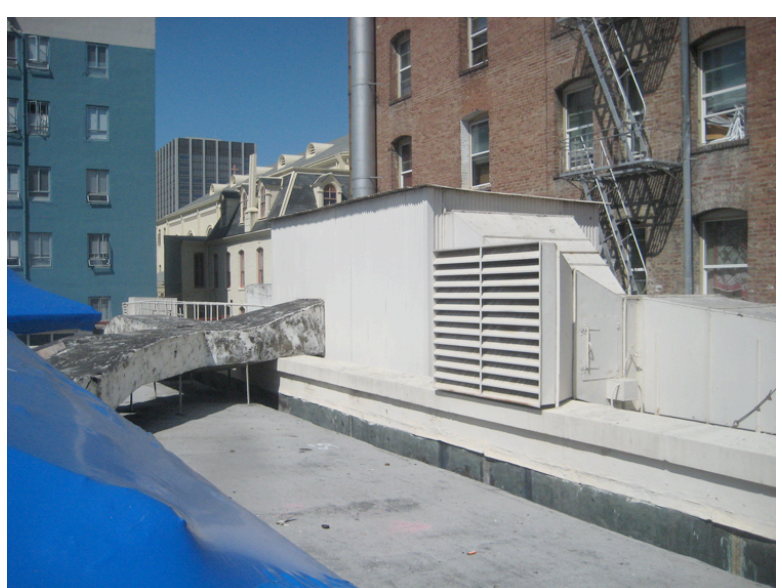
C: Looking northwest at existing mechanical penthouse. Hotel Boyd is at right with fire escape that is over Hibernia property line and uses north exit alley for its exiting.

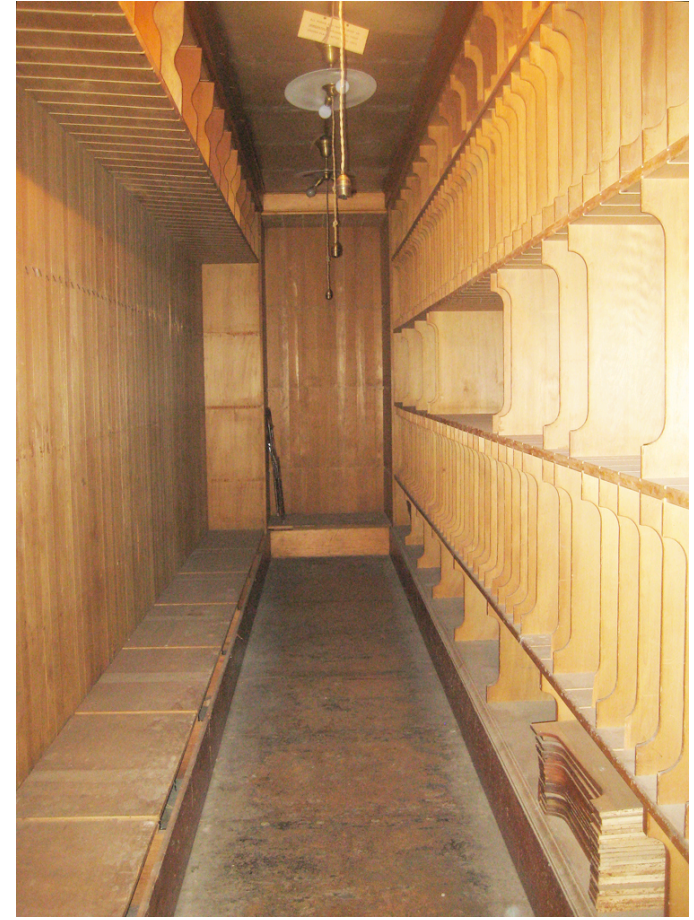
A: View of interior of historic vault. City documents were stored here after the 1906 earthquake and fire.

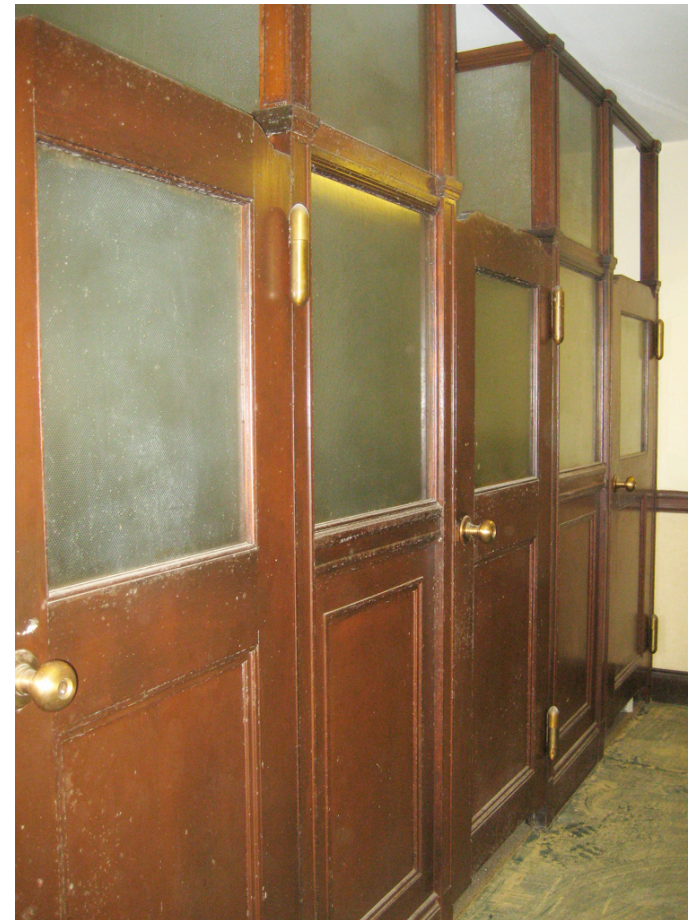
B: View of interior of historic safe deposit box viewing rooms.

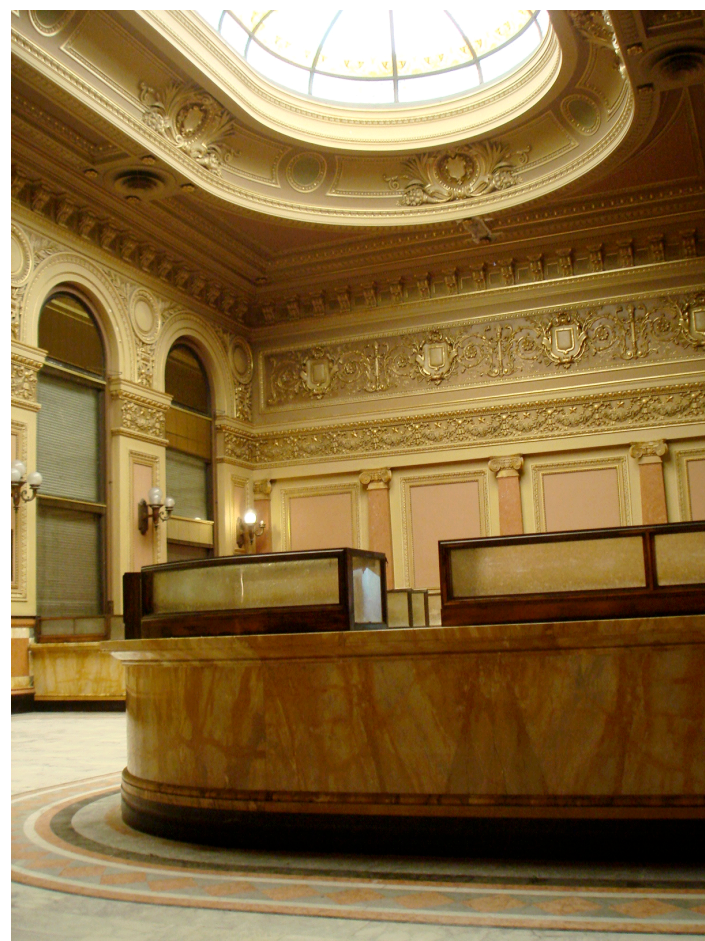
A: View of Northwest corner of the Banking Hall with teller stations in the foreground.

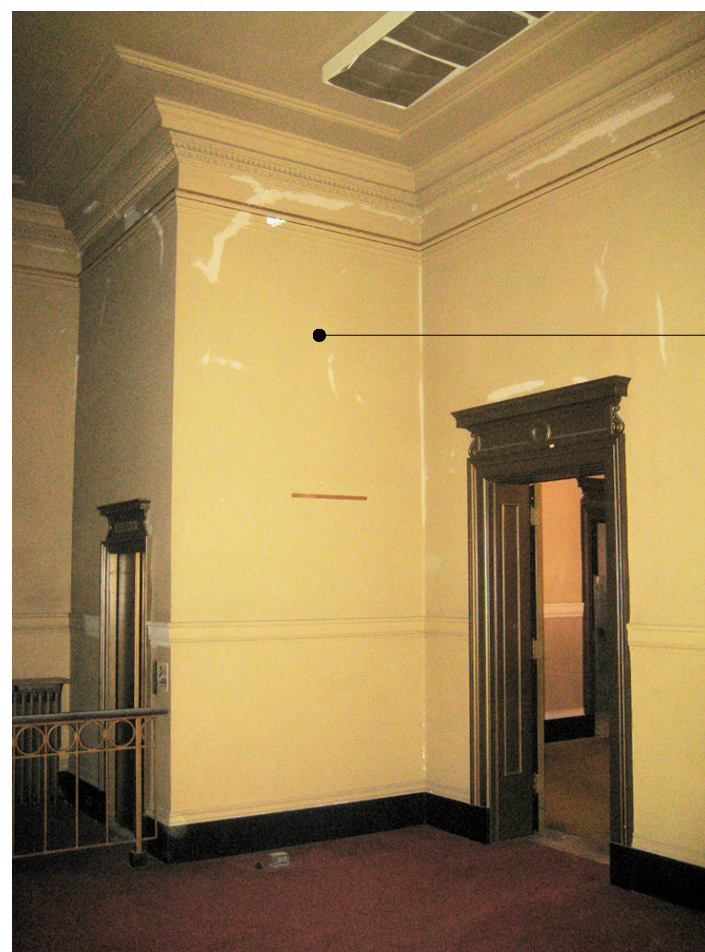
B: View of elevator in the Southeast corner of the customer waiting area. Non-historic fence to be removed (lower left). To accommodate new elevator, the west facing wall of the elevator shaft to be rebuilt, 1'-0" further to the west.

- REMOVE EXISTING BATHROOMS**  
Remove bathrooms and raised plumbing floors for new telephone/communications room.
- EXPAND ELEVATOR SHAFT**  
New elevator to be installed requires expansion of existing shaft. Shaft to be enlarged to the west by approximately 1'-0". Existing elevator machine room to be used for new equipment.

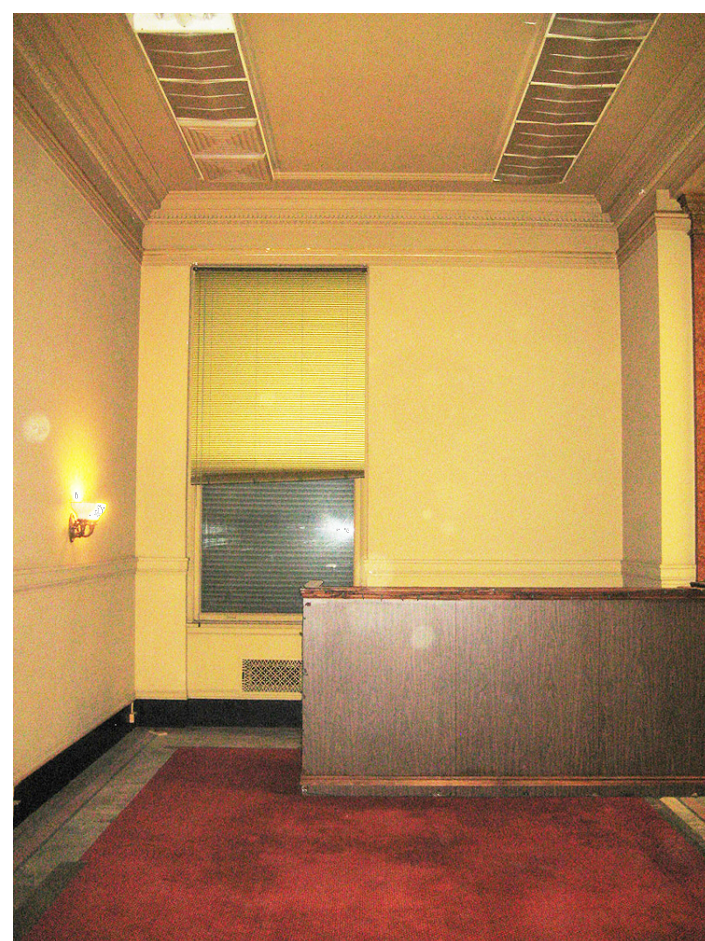
C: View of West window in the Customer Waiting area with window and wall area below window sill to be removed. New exit door and transom to be installed. For more detail, see A-22.

8. CONTROL GATE  
Existing non-historic control gate fence to be removed.
9. SOUTHWEST EXIT AND EXIT STAIR  
To provide the code required exiting from the Banking Hall, the wall area below the sill of the existing west window in the Customer Waiting Area is to be cut to be level with the floor. The lower sash of the window to be removed and replaced with a door and side light. Exterior granite to be saw cut and edges finished to match openings on adjacent windows. All granite to be salvaged and stored on site for potential reuse.

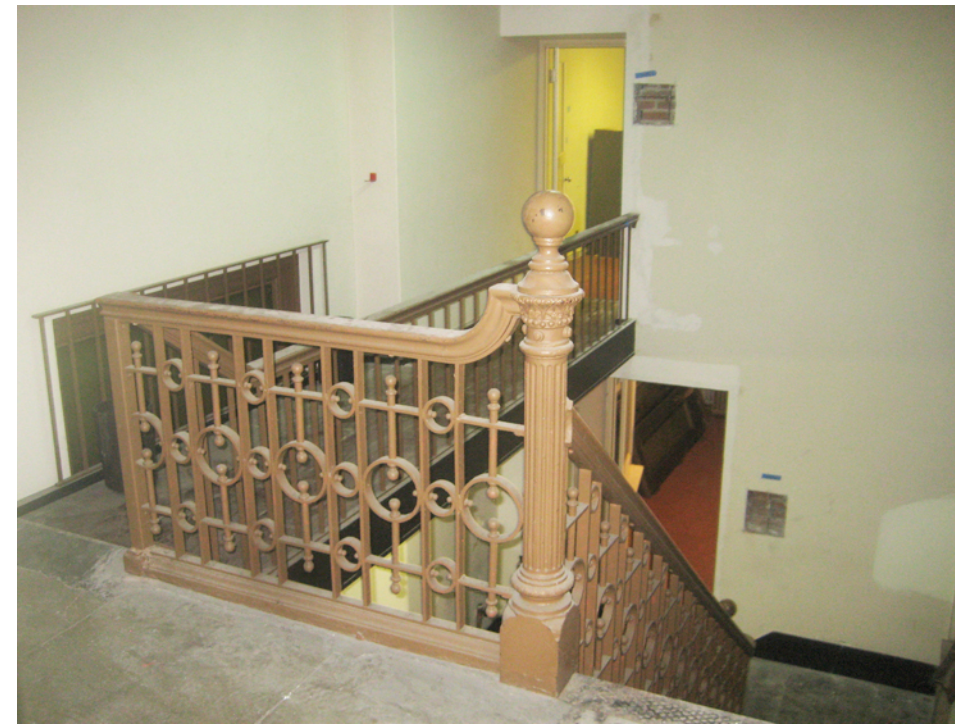
A: Walkway to Mezzanine storage to be removed and door to storage room to be infilled with new concrete shear wall.

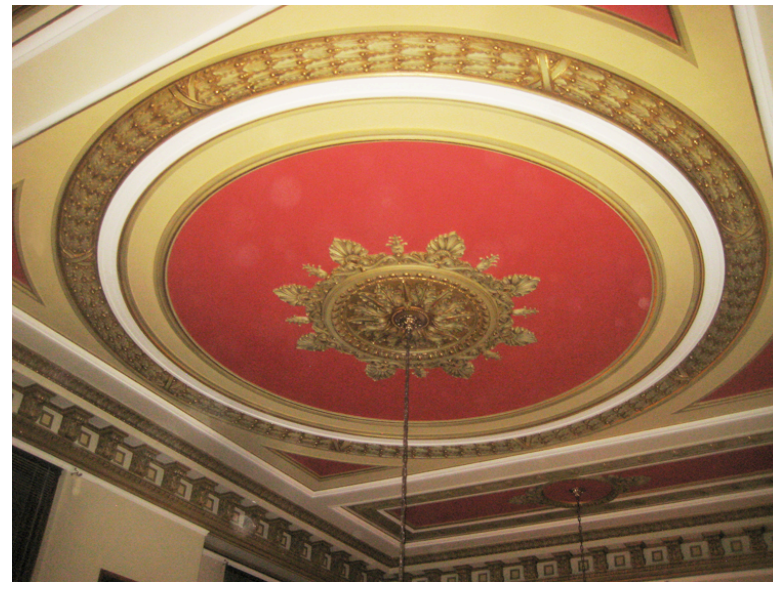
A: View of ceiling in SW Meeting Room.

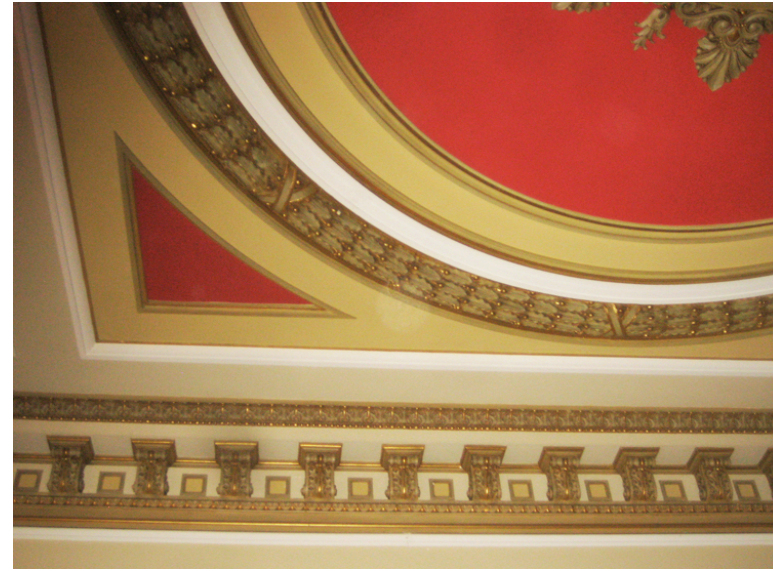
B: View of ceiling of SW Meeting Room. Sprinkler heads to be located at center point of triangular panels at corners of central circular panel.

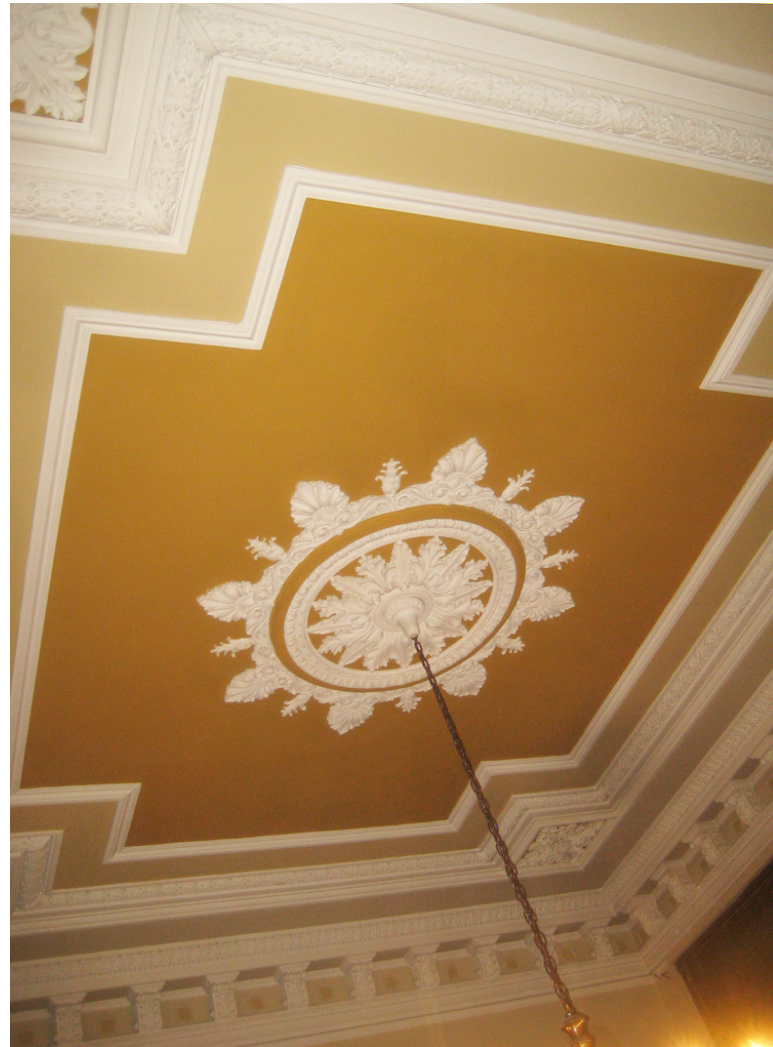
C: View of ceiling in Middle Office. Sprinkler heads to be located on either side of central rondel.

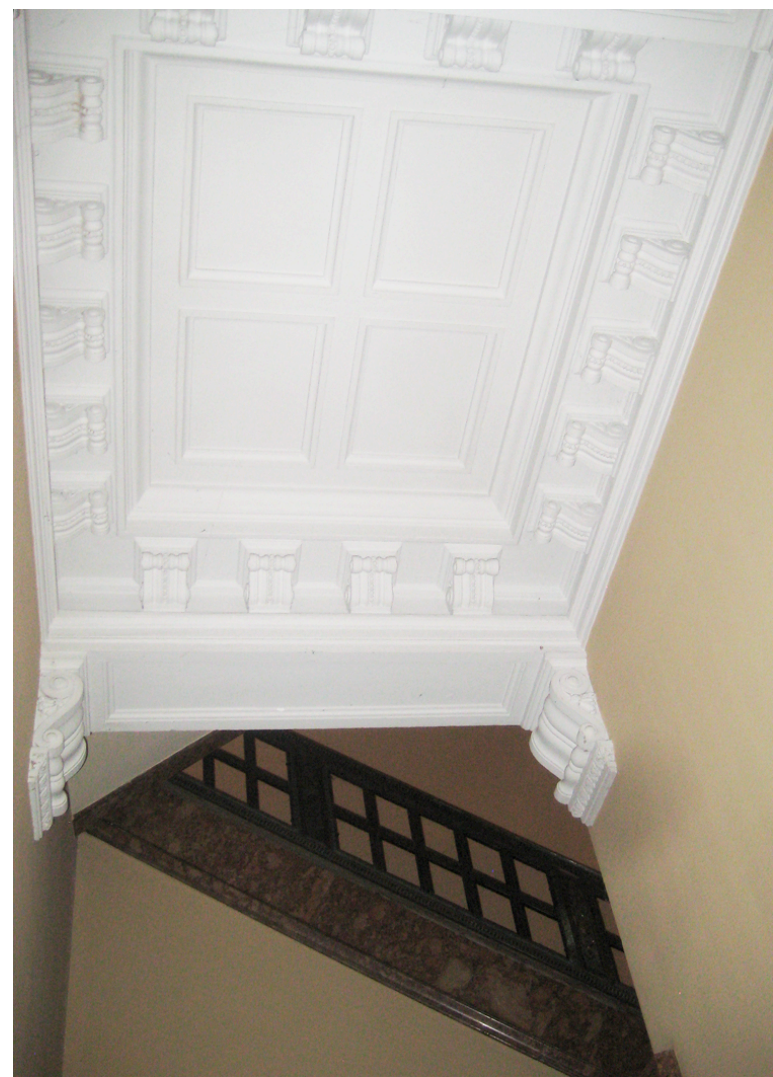
D: View of ceiling in in South Stair. Sprinkler head to be located at center point of coffers.

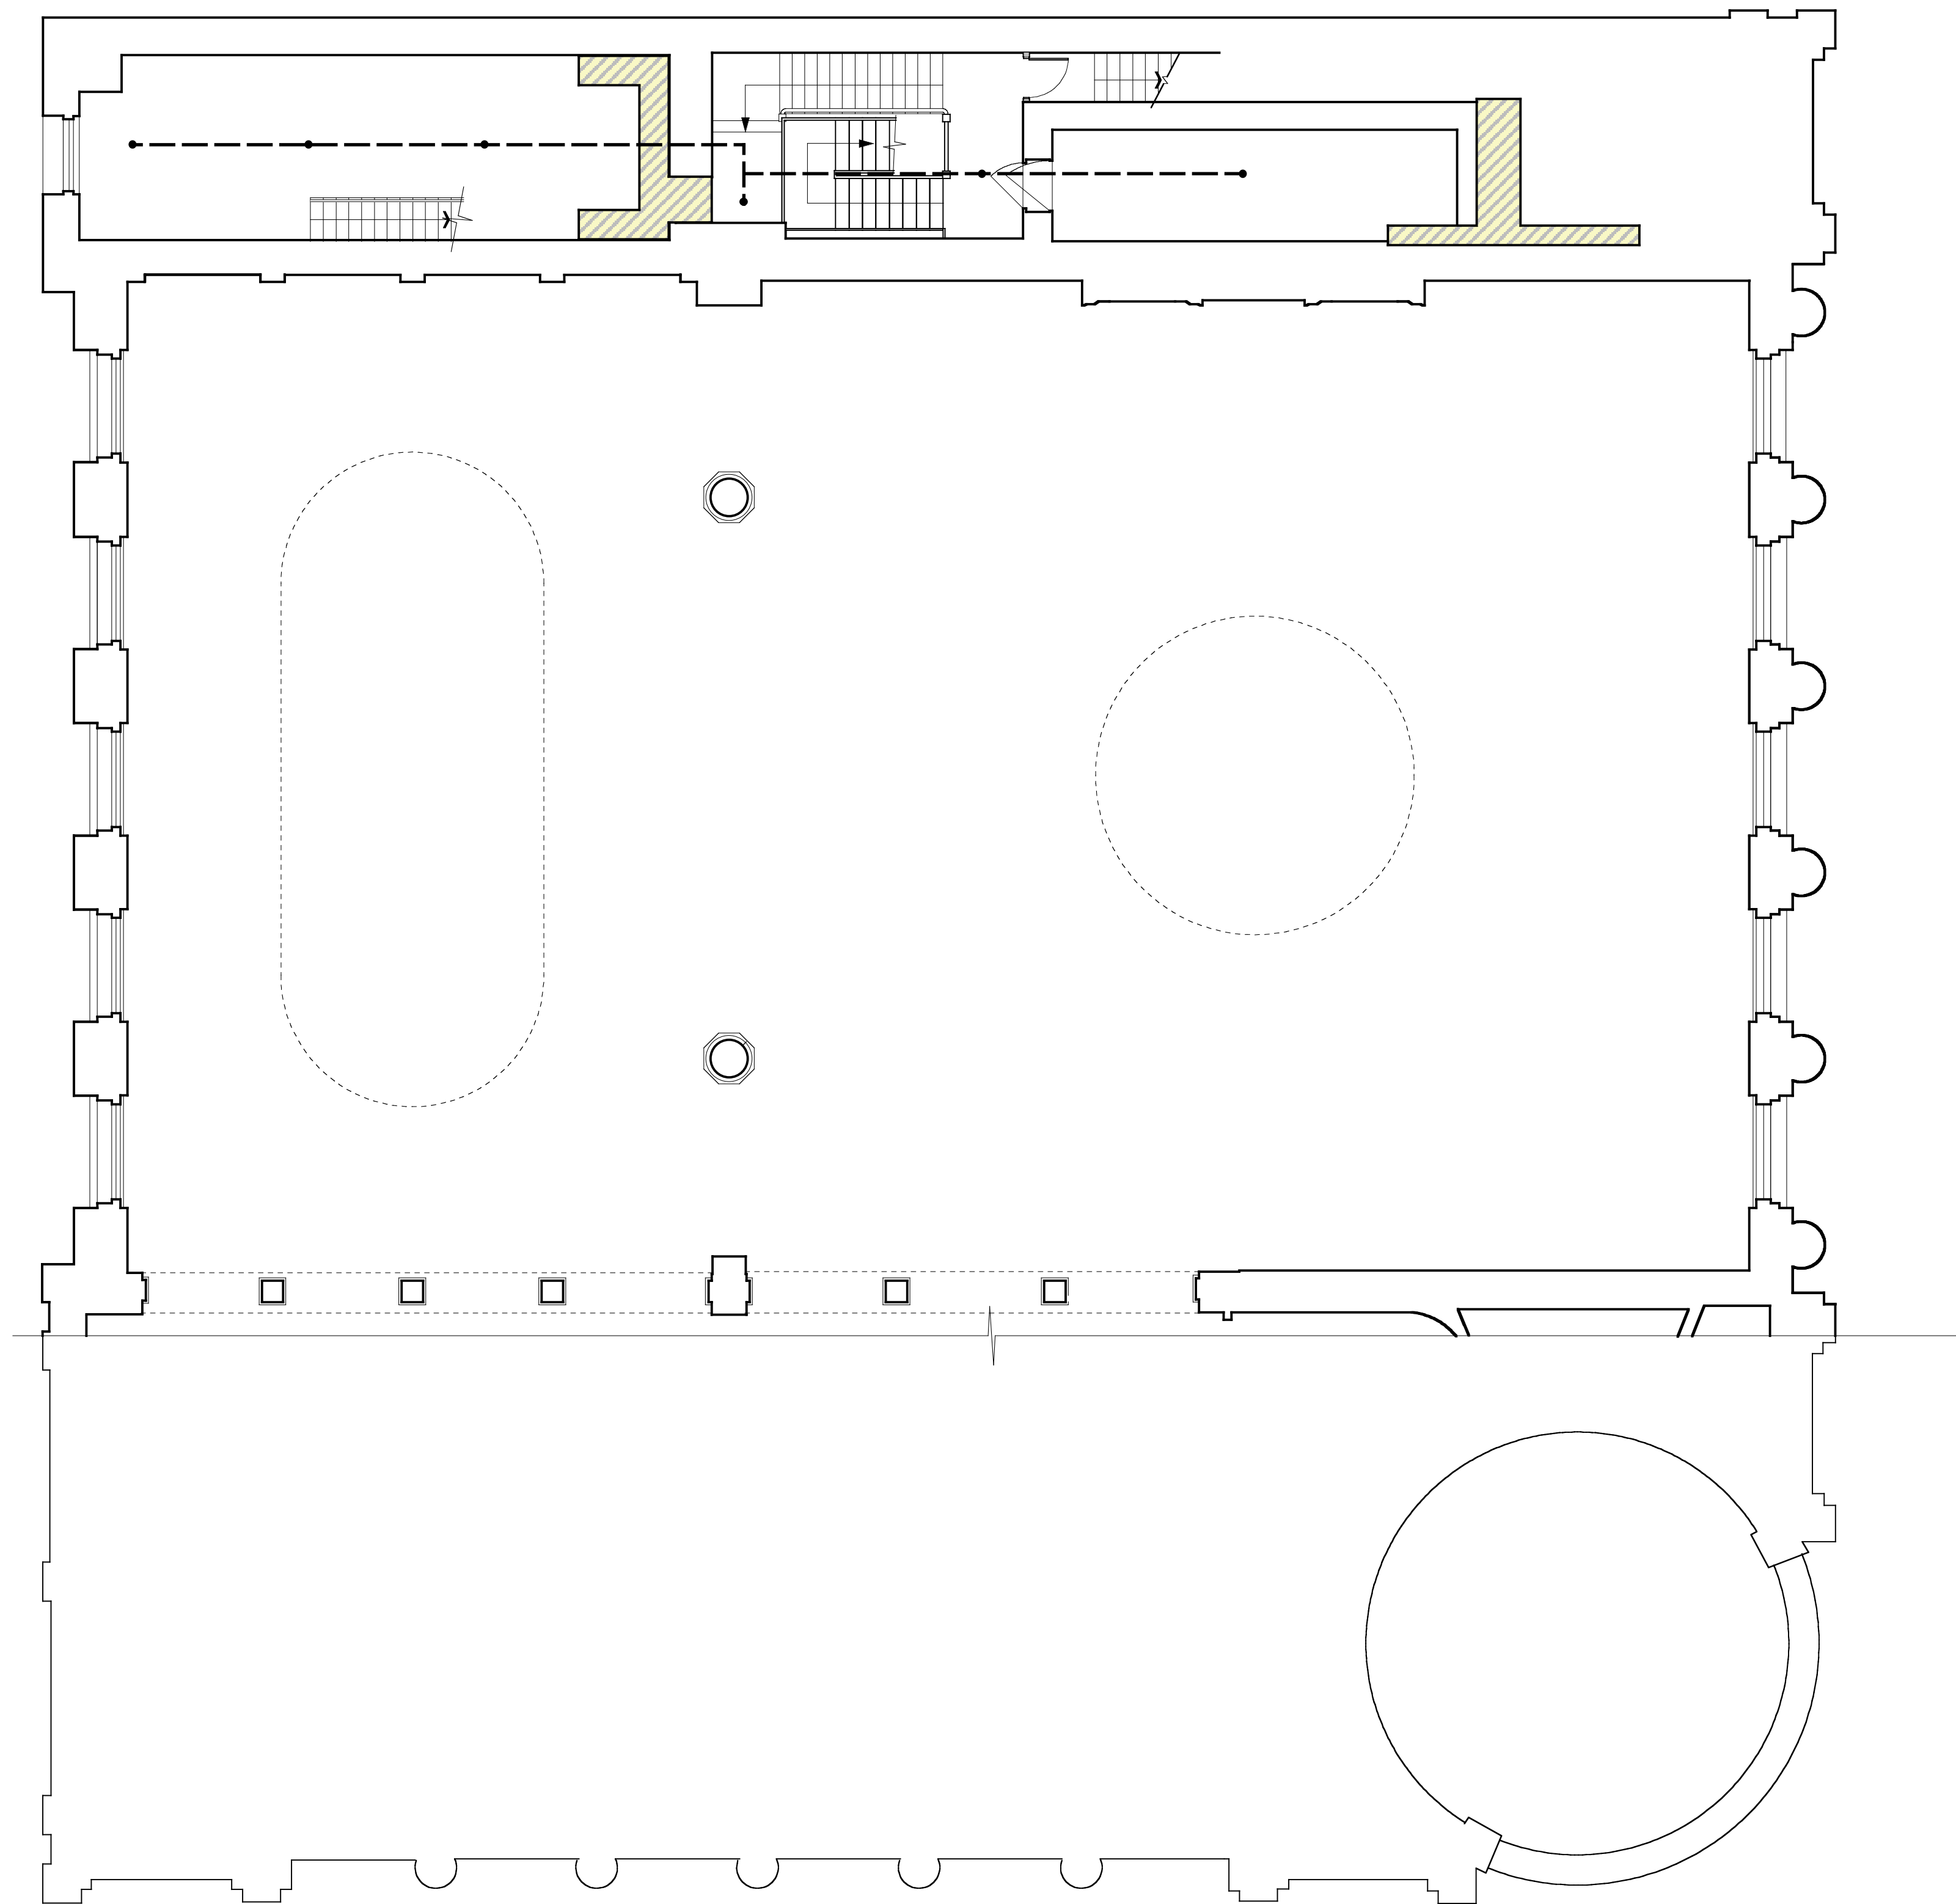
**A-33** FS-2

1 MEZZANINE FIRE SPRINKLER LAYOUT  
 Scale: 1/8" = 1'-0"

KEY	
•	SPRINKLER HEAD
---	CONCEALED PIPING

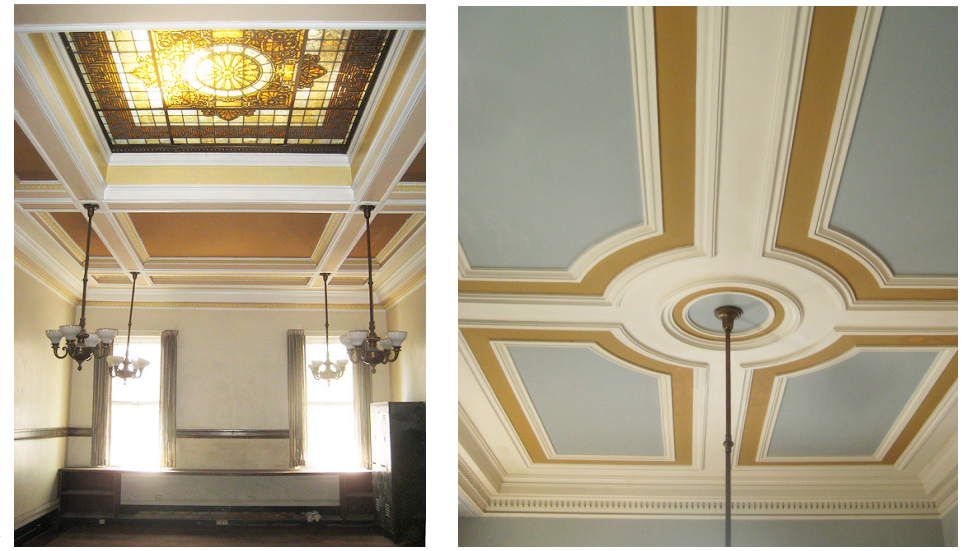
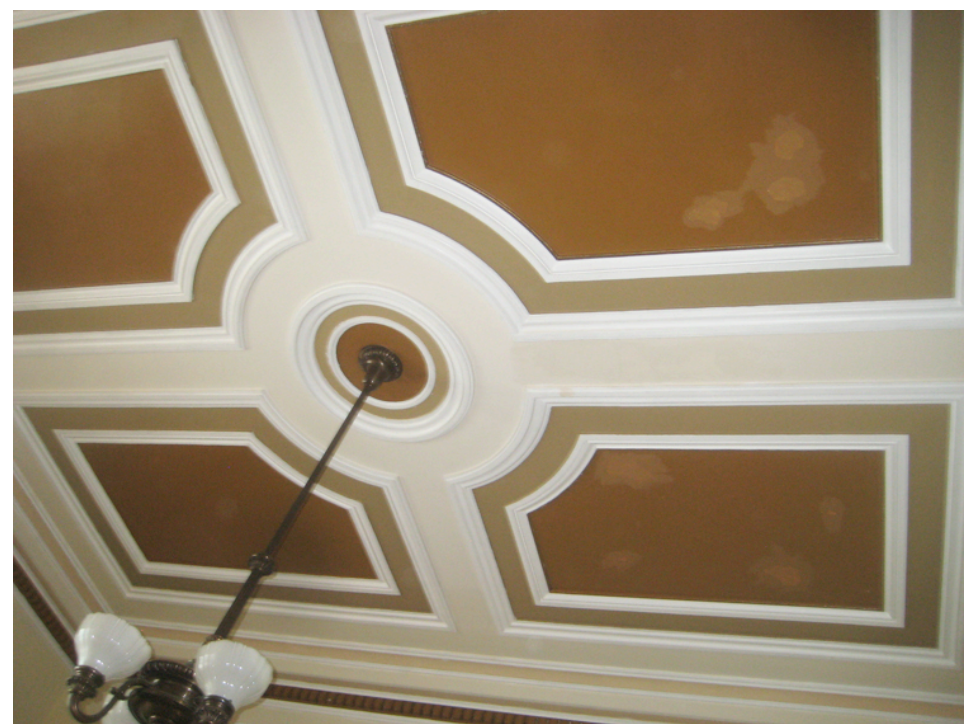
A: View of Customer/Waiting area of 2nd floor offices. Sprinkler heads to be located at center point of inset panels.  
 B: View of ceiling of NW office. Sprinkler heads to be located at center points on either side of the center circular plaque in the east-west (left-to-right) flat panel (cream-colored).  
 C: View of ceiling in Chairman's Office. Sprinkler heads to be centered in center point of light blue flat panel.

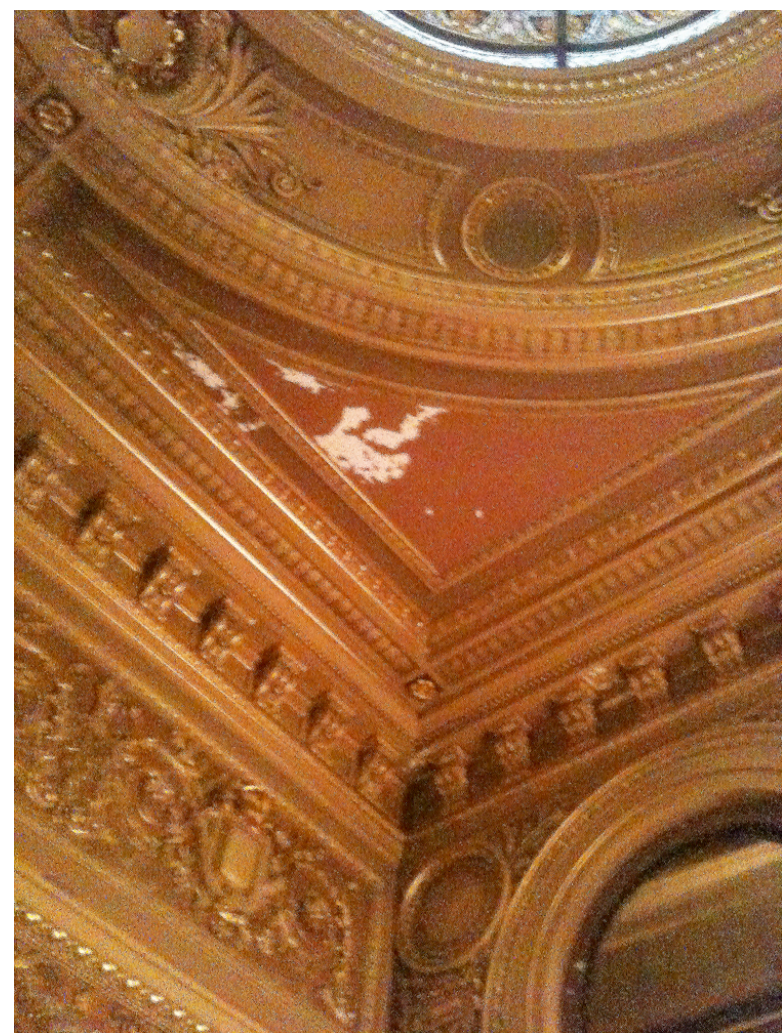
D: View of corner of Banking Hall ceiling in 1905 addition. Sprinkler heads to be centered in corner flat panels. No heads to be located within ornamental panel or trim.

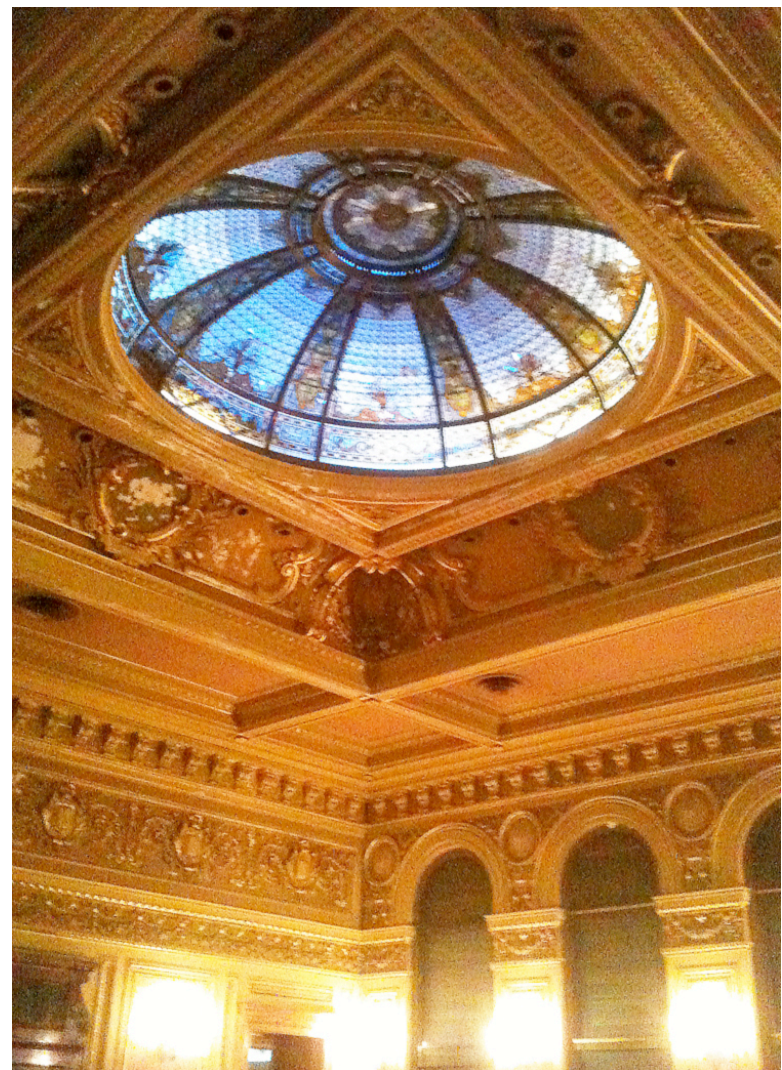
E: View of Banking Hall ceiling in original building. Sprinkler heads to be located only in flat panel areas. No heads to be located within ornamental panel or trim.

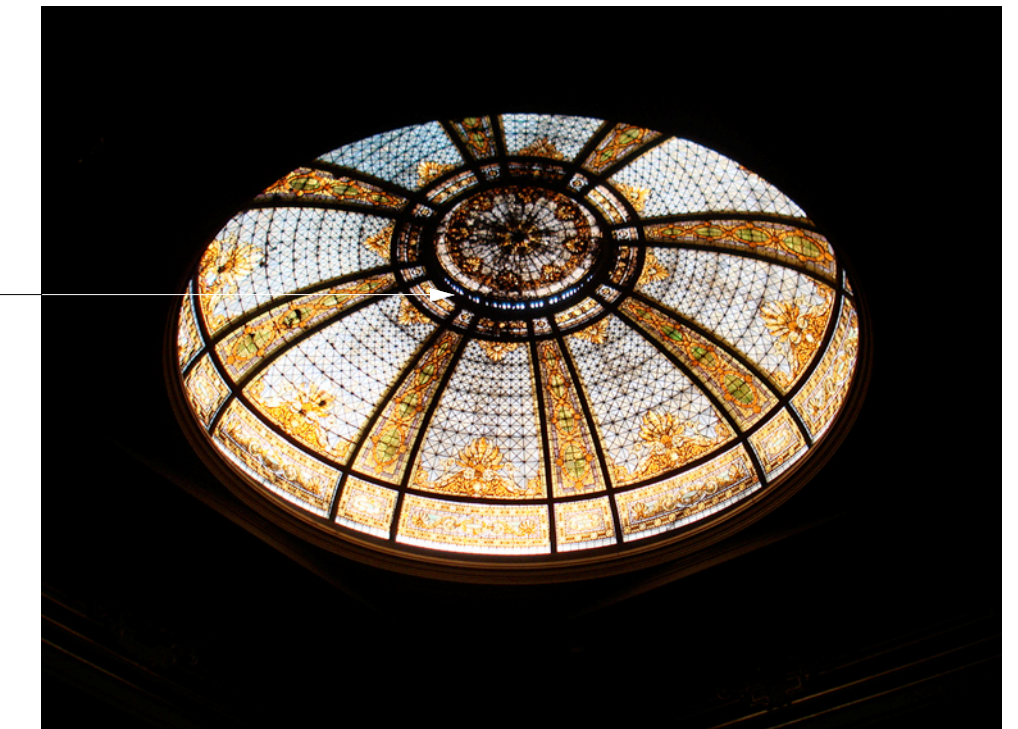
F: View of skylight dome located in the original portion of the Banking Hall. Sprinklers to be located behind circular vent grille to be able to protect glass and leading by bathing surface with water to keep dome intact.

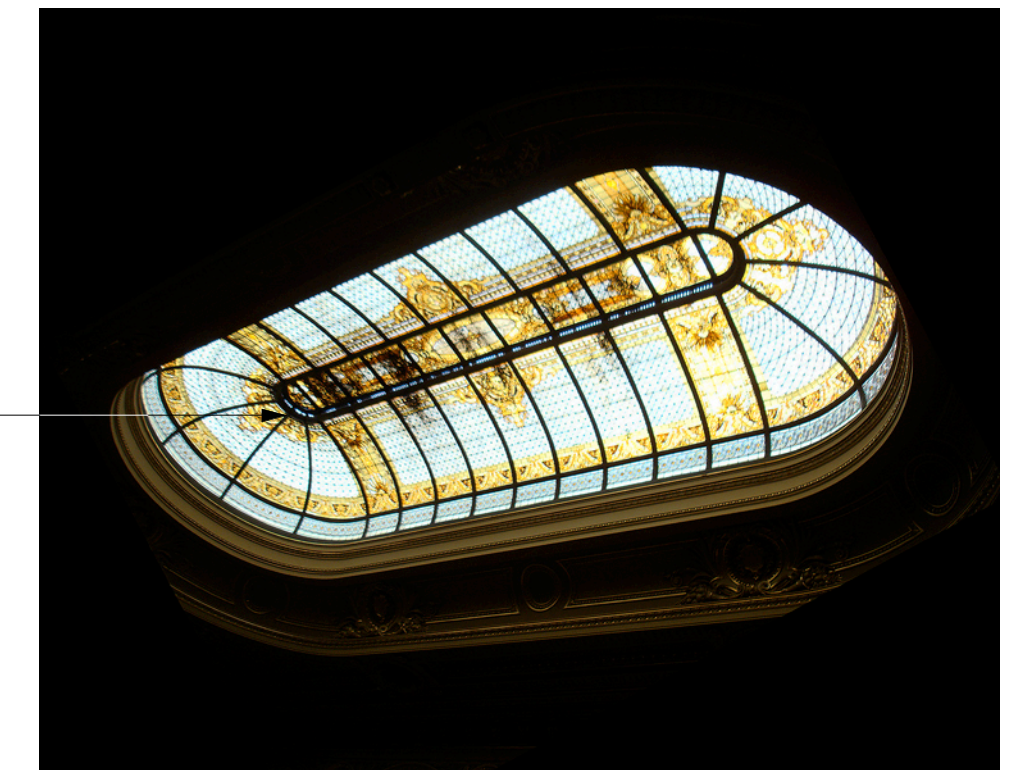
G: View of skylight dome located in the 1905 addition of the Banking Hall. Sprinklers to be located behind upper vent grille to be able to protect glass and leading by bathing surface with water to keep dome intact.

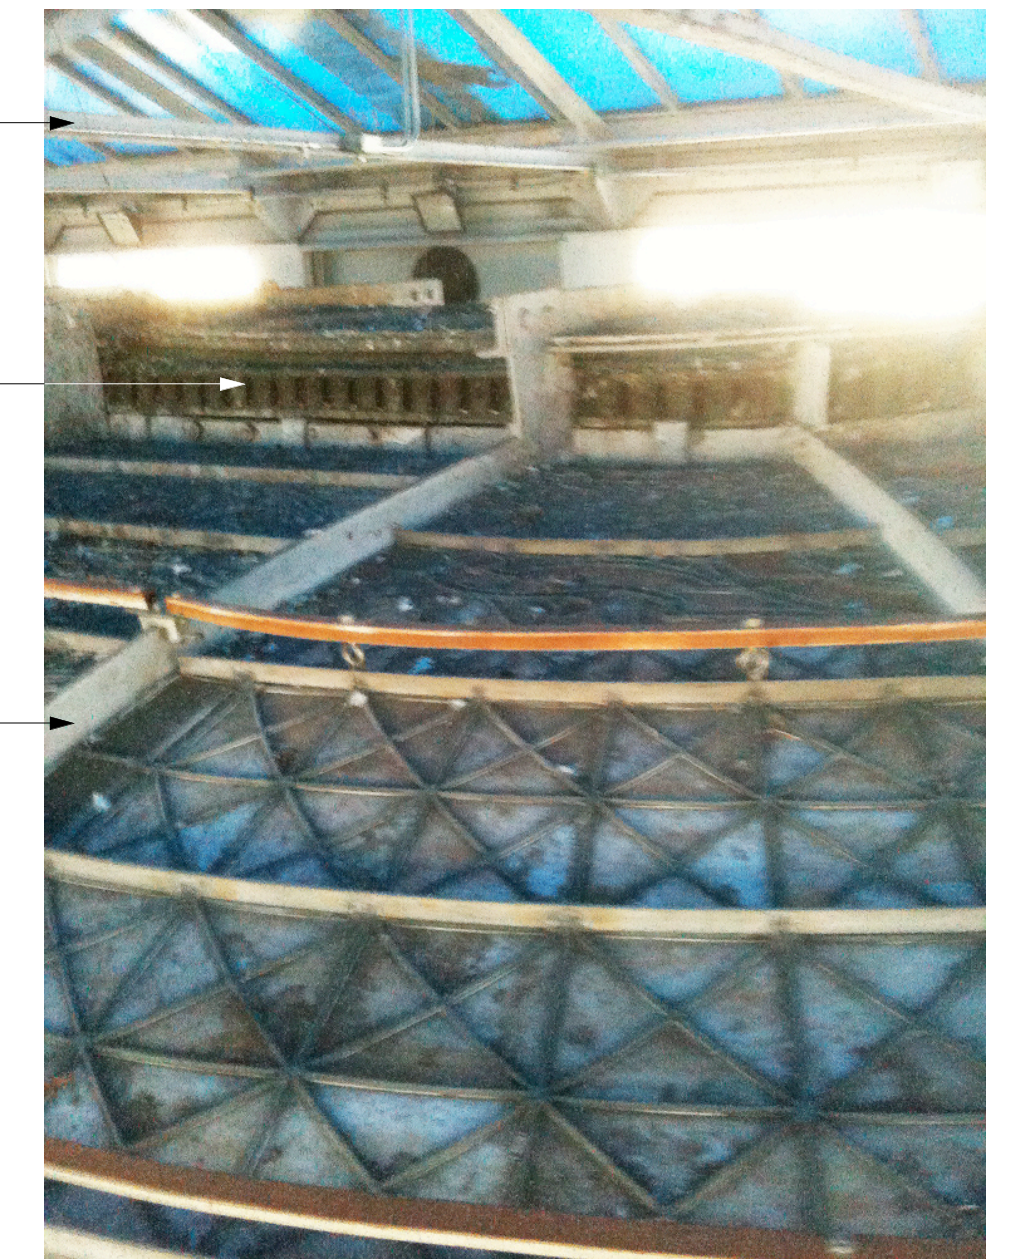
STRUCTURE OF ORNAMENTAL SKYLIGHT

H: View of attic space above ornamental skylight. Sprinkler heads to be mounted to spray water through vent grille openings to bathe glass and leading surface with water.

- GENERAL NOTES:**
- FIRE SPRINKLER INSTALLATION IN CEILINGS**  
 All fire sprinkler piping and valves to be concealed above ceiling in attic cavity space. All sprinkler heads to be concealed drop-down units and set in discreet locations that relate to the design of the ceiling of the individual space.
  - FIRE SPRINKLERS IN SKYLIGHT DOMES**  
 Fire sprinklers for the ornamental skylights to be set behind bronze vent grille at upper portion of skylight oriented to bathe the glass and leading in water. Piping to be located in the attic space between the ornamental skylight and the weather enclosure above.

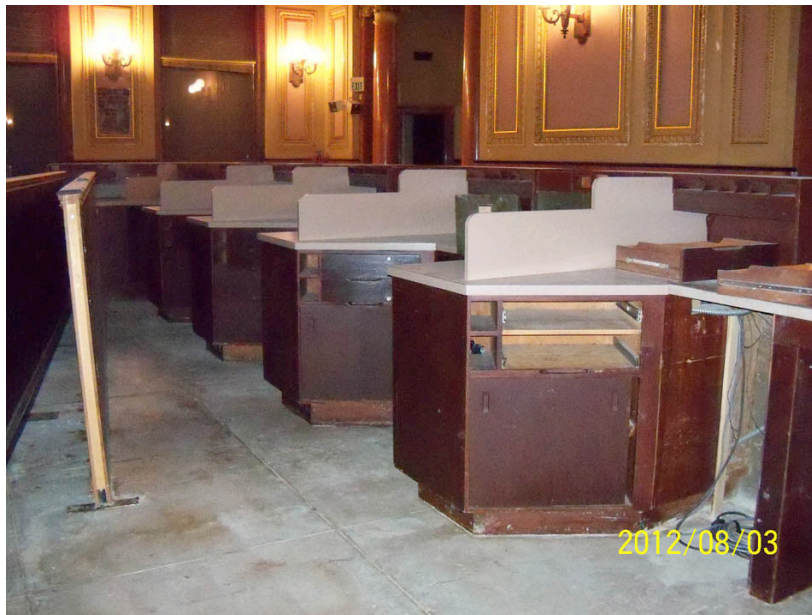
In regard to its construction, the bank tellers' counter is supported by a concrete stem wall that appears to run the length of the counter. As mentioned above, portions of it are made from plywood board forms, indicating post-World War II alterations and others are made with horizontal board forms, indicating pre-war construction. At regular intervals, short concrete walls intersect the continuous piece, branching out toward the inner edge of the counter. It appears that the marble counter is supported by these narrow wing walls.

Figure 1. Plywood and Formica counter additions  
Source: Christopher VerPlanck
