Permit to Alter Case Report

HEARING DATE: MAY 15, 2013 (CONTINUED FROM APRIL 3, 2013 MEETING)

Project Address: 706 Mission Street

Category: Category I (Significant) – Aronson Building

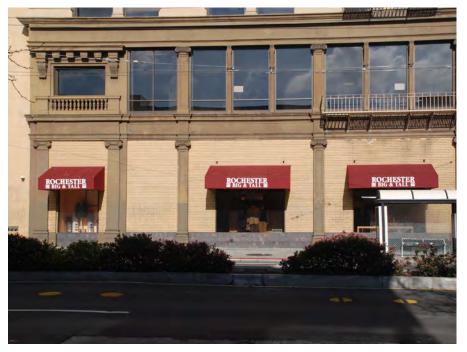
Brick infill at first floor

The exterior of the Aronson Building is generally in fair condition, but is in need of rehabilitation in order to address deferred maintenance issues, to attract new tenants and increase economic viability. Though the building largely retains significant architectural features such as the decorative terra cotta and sandstone ornamentation, these features are in need of repair.

- Removal of the non-historic brick infill between the historic pilasters. The brick infill will be replaced with new storefronts that are compatible in their proportions and materials with the architectural style and character of the building.

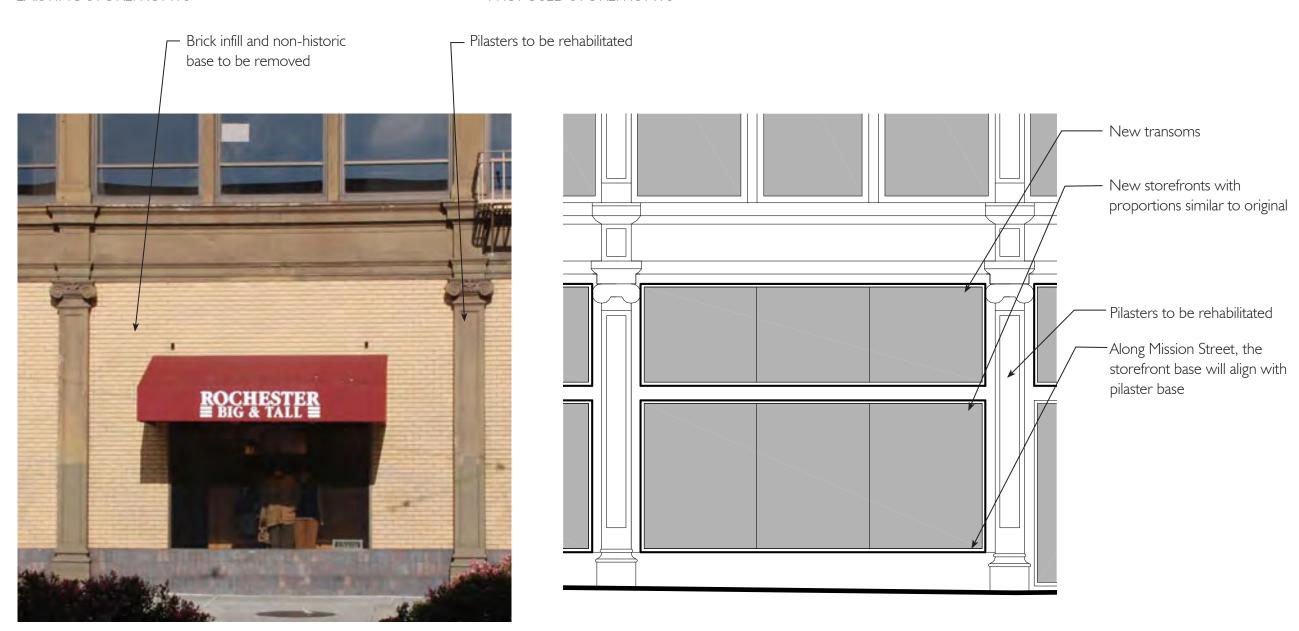
PROPOSED STOREFRONTS

The exisitng, non-original brick infill and storefronts will be removed and replaced with storefronts that are compatible with the original storefronts. The new storefronts will extend the full width and height of the bay. No historic fabric will be removed as a result of this alteration.

Storefront: The ground floor of the Aronson Building on both the Mission and Third Street facades has been modified with the addition of brick infill. The Sponsor proposes to remove the existing non-historic brick infill and replace it with a new glass storefront system to open up the ground floor and rehabilitate the exterior of the ground floor based on historic photographic evidence. The new storefront framing will extend to the perimeters of the opening between the existing pilasters and cornice and will have a prominent horizontal transom division corresponding with the original storefront configuration and minor vertical divisions to align with existing window openings on the upper floors. In addition, the storefronts will have a base that aligns with the existing pilaster bases. The new storefront system will be comprised of aluminum framing and clear glass. In response to ARC comments, the new storefront will have proportions and configurations similar to the original storefront depicted in historic photos, with the introduction of a larger transom panel. The existing pilasters between the bays will be retained and restored. Storefronts that had been previously removed at the corner of Mission and Third Streets to accommodate recessed entries into the tenant spaces will also be reintroduced as part of the rehabilitation project.

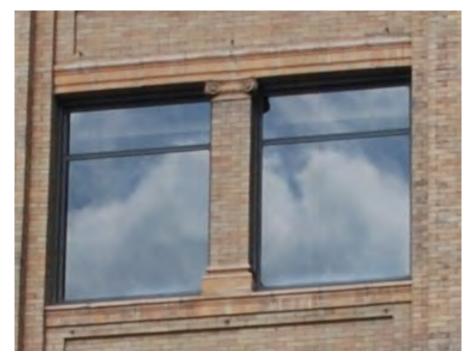
- Proposed windows will be wood and will reference historic photographs and will have similar proportions to the stiles and rails in the historic windows.
- Proposed windows will be sized to match existing openings.
- The setback of the windows will be based on historic photographs.
- The windows will be operable.
- Interior wood trim will be retained or replaced in kind where it is too deteriorated.

Enlarged View of Typical Existing Windows

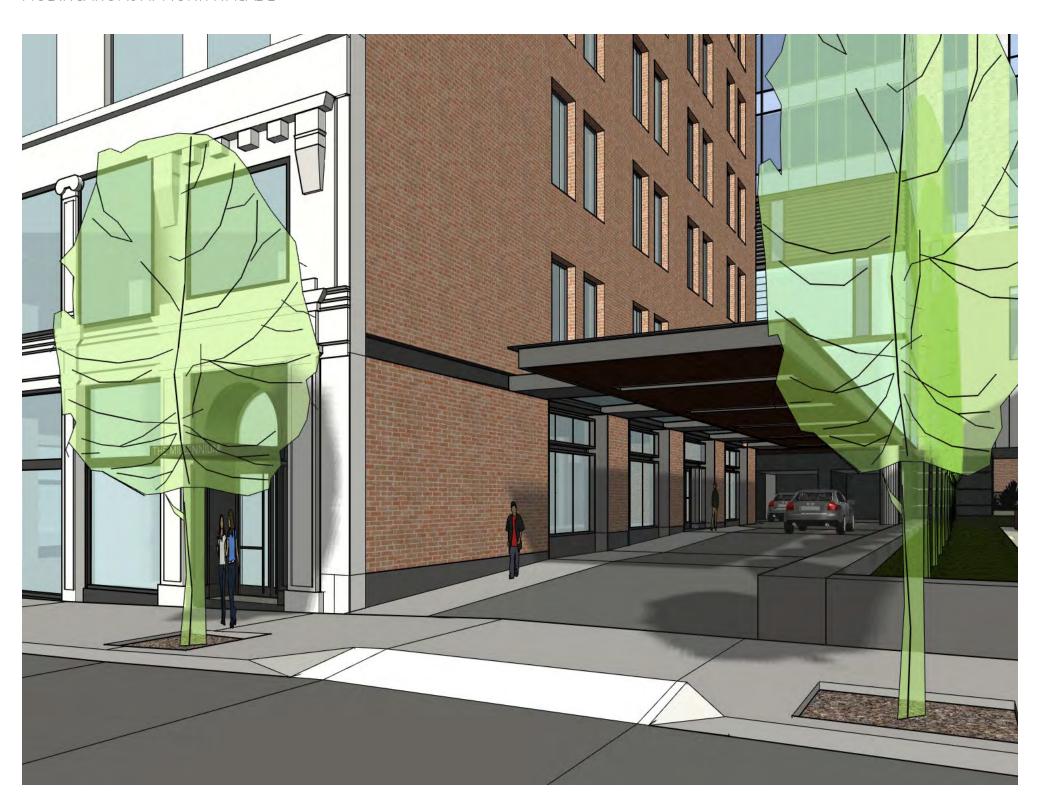
MODIFICATIONS AT NORTH FACADE

Rehabilitation of the north facade will include the removal of the non-historic addition, existing windows, doors and grilles. Openings within the party wall will be patched utilizing salvaged brick or replacement brick to match the existing. The common red brick at the north wall will be inspected, repaired, cleaned, and repointed.

New selective openings will be made within the existing wall for exterior windows to bring natural light and ventilation into new residential or office and museum spaces, for mechanical openings as may be required, and for ground floor entry and circulation functions. Approximately 70% of the existing wall area will be retained. New openings above the ground level will be organized in a regular pattern that is compatible with the building and will be set back approximately 14'-5" from the northeast corner at floors 4-10, and approximately 27' at floors 1-3. The new metal framed windows will be expressed as simple punched openings.

- The existing brick along the north wall will be inspected, repaired, cleaned, and repointed as required. Damaged or missing bricks will be replaced with salvaged brick removed for the proposed window openings.

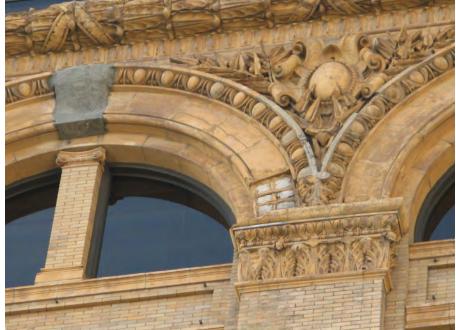
View of temporary terra cotta repair

The exterior facades of the Aronson Building will be rehabilitated in a manner that is consistent with the December 2010 Historic Structures Report by Page & Turnbull. Historic features to be repaired and rehabilitated include:

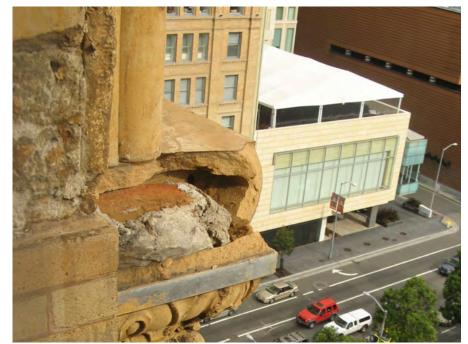
View of terra cotta feature to be repaired

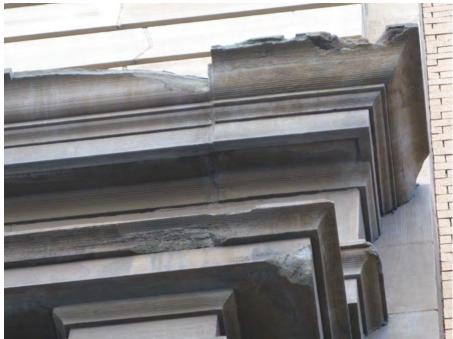
View of deteriorated colusa sandstone

- The Colusa sandstone entablatures and piers will be retained. Existing paint and any unsound material will be removed. The existing substrate, anchorage, and reinforcing will be assessed and repaired as required. Units will be reinforced and patched. Material will be replaced in kind or with a compatible substitute material where damage is severe and beyond repair.

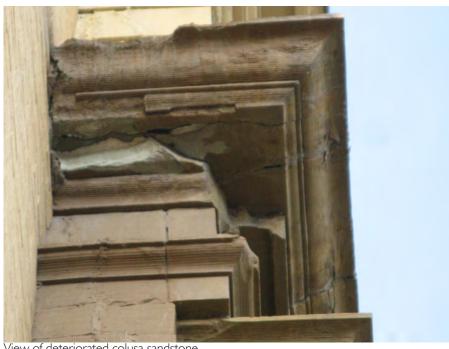
View of deteriorated colusa sandstone

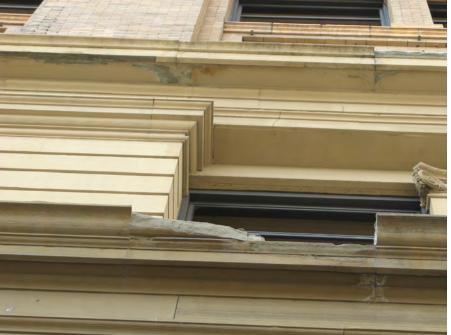
View of deteriorated colusa sandstone

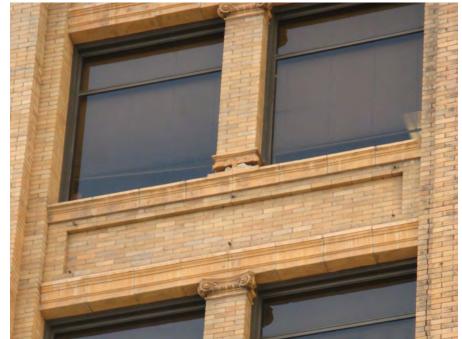
View of brick area to be repaired

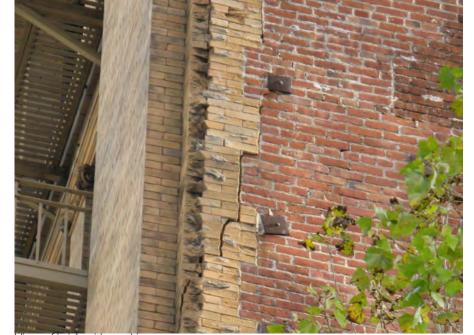
View of brick with cracking

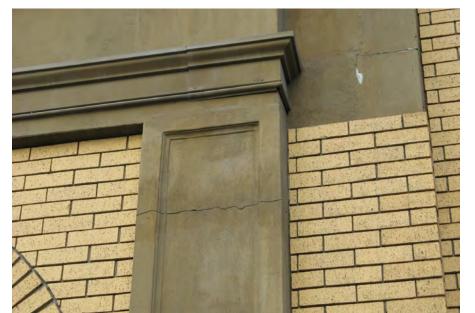
View of pilaster to be repaired

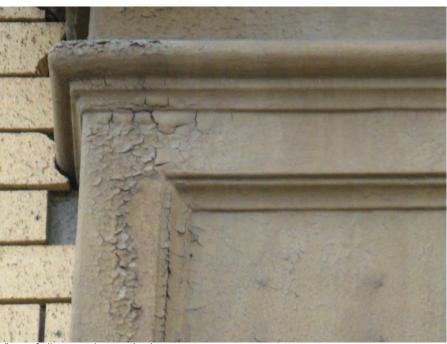
View of pilaster to be repaired

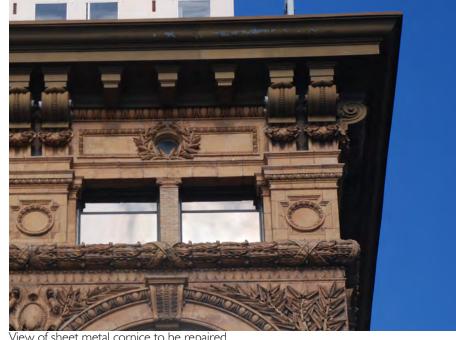
View of sheet metal cornice to be repaired

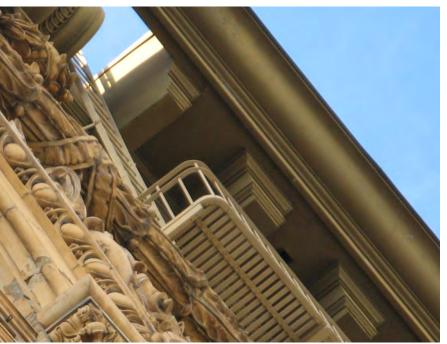
View of area where fire escapes will be removed, sheet metal cornice to be repaired

Remove abandoned metal fire escapes from the building façade. The fire escapes are no longer in use, nor are they required per California Building Code. The fire escapes should be removed and impacted materials repaired to their original appearance.

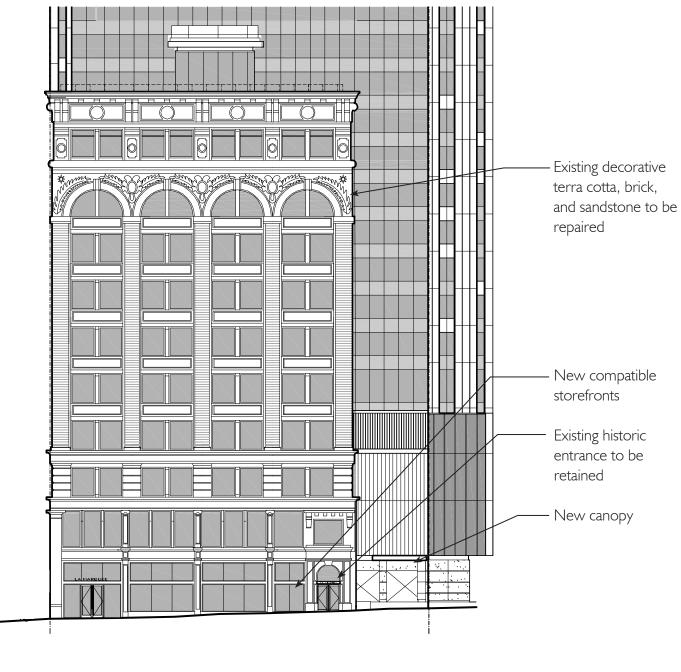
PROPOSEDTHIRD STREET ELEVATION

EXISTING THIRD STREET ELEVATION Fire escapes to be removed and historic fabric repaired as required Non-historic addition to be removed Existing brick infill to be removed and replaced with storefronts Non-historic brick infill to be Non-historic windows to be To be demolished replaced (28.5% of Facade) removed and replaced with new

storefronts (14.4% of facade)

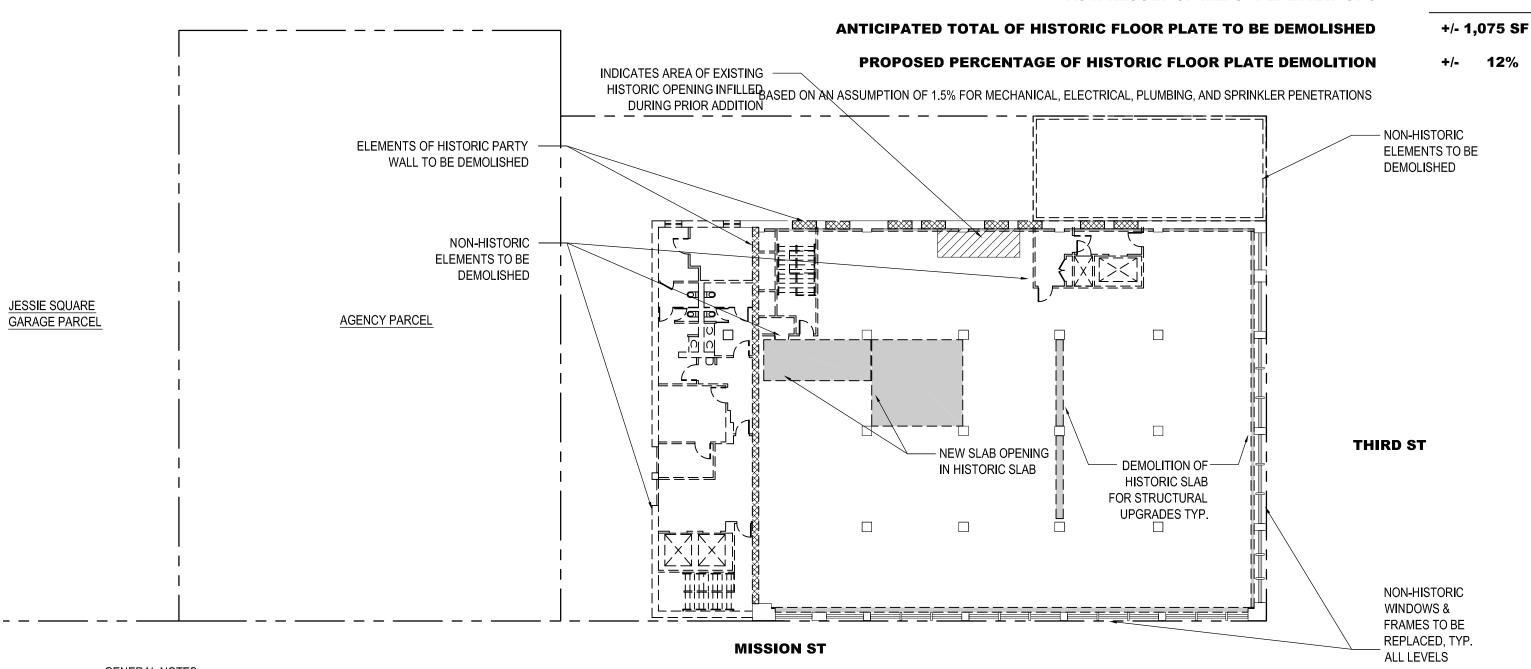
The Aronson Building will be seismically upgraded by using one of two approaches, seismic tie or seismic joint. Using the seismic joint approach, the buildings would be seismically independent and separated by a seismic joint with an air space in between the two buildings. With this approach, the two buildings would be allowed to move independently during a seismic event.

+/- 8,760 SF **TOTAL HISTORIC FLOOR PLATE AREA** ANTICIPATED AREA OF HISTORIC FLOOR PLATE TO BE DEMOLISHED +/- 950 SF AS A RESULT OF ARCHITECTURAL ALTERATIONS ANTICIPATED AREA OF HISTORIC FLOOR PLATE TO BE DEMOLISHED +/- 125 SF **AS A RESULT OF MEPS* PENETRATIONS**

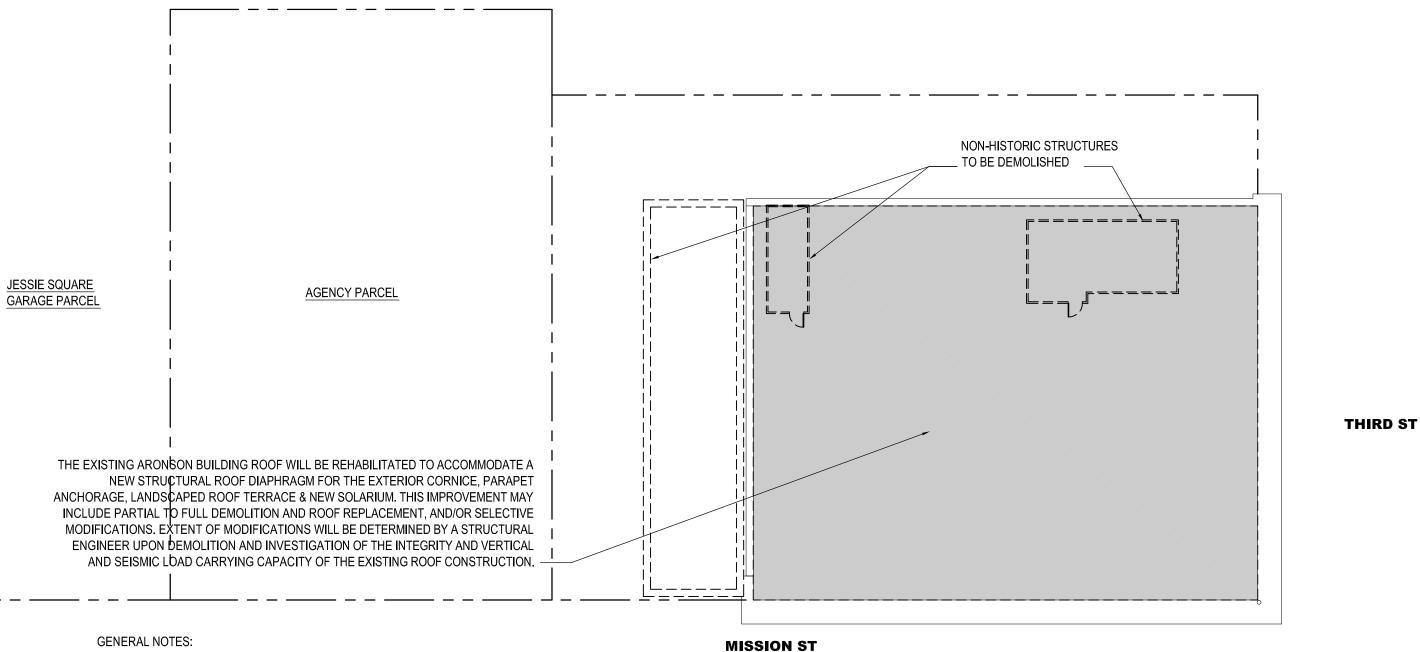
The Aronson Building will be seismically upgraded by using one of two approaches, seismic tie or seismic joint. Using the seismic joint approach, the buildings would be seismically independent and separated by a seismic joint with an air space in between the two buildings. With this approach, the two buildings would be allowed to move independently during a seismic event.

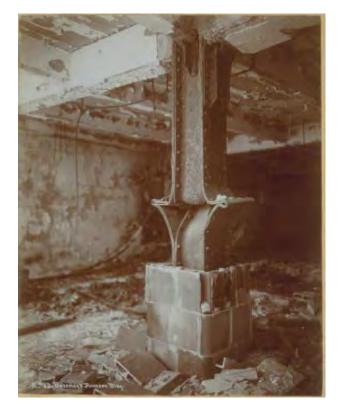
Figure 13. Buckled I-beam encased in failed hollow tiles in the basement, 1906. Source: Bancroft Library.

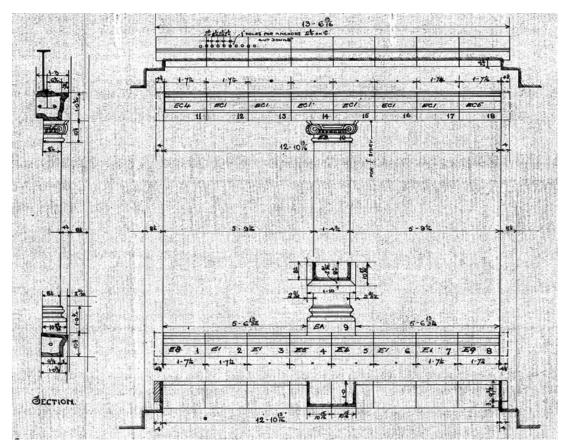
Architectural terra cotta is used for cladding and ornamentation on the Mission Street and 3rd Street facades of the building. Terra cotta features include the column base and capitals, door architrave, and arched window surrounds, all finished with a slip glaze. Additionally, the middle section of the building between the fourth and eighth floors is faced with a buff colored glazed brick. Mortar is of a color that closely matches that of the surrounding terra cotta.

Figure 43. Construction drawing of terra cotta. Source: Gladding, McBean & Co., n.d.

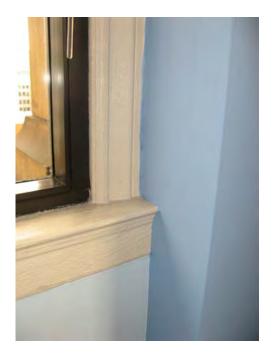
The wood trim and sills are in good condition. Observed conditions include:

o Raised grain, likely due to past sandblasting;

Figure 66. Interior window trim. Source: Page & Turnbull, March 2010.

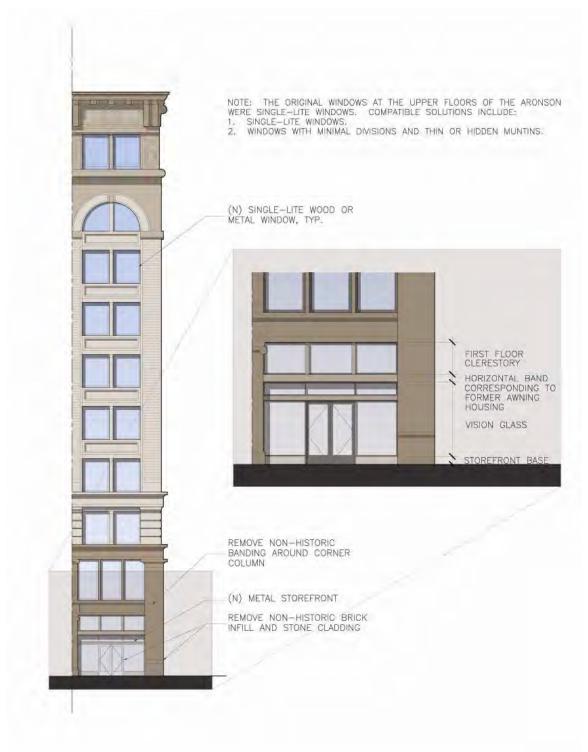
Figure 68. Page & Turnbull sketch of a recommended design option for storefront and windows.
