LANDMARK DESIGNATION REPORT

Bourdette Building 90-92 Second Street / 600-600½ Mission Street

Landmark No.
271

Built: 1903-1904
Architect: Bliss & Faville
Contractor: J. C. Bateman

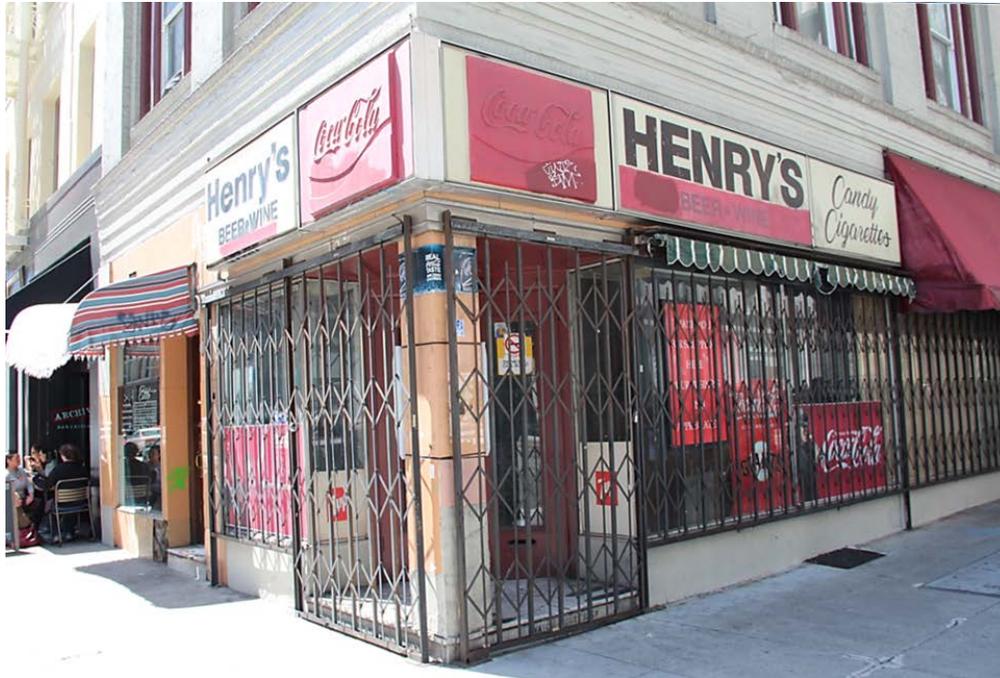
Corner storefront addressed as 600 Mission Street.

The storefront is crowned with vintage aluminum-framed illuminated box signs which wrap the corner. The signs carry advertisements for Coca-Cola and Henry's Beer – Wine – Candy - Cigarettes. Vintage advertisements for 7UP are also located at the base of the storefront windows within the entry vestibule. The display windows that face Second Street are topped with a roll-up fabric awning.

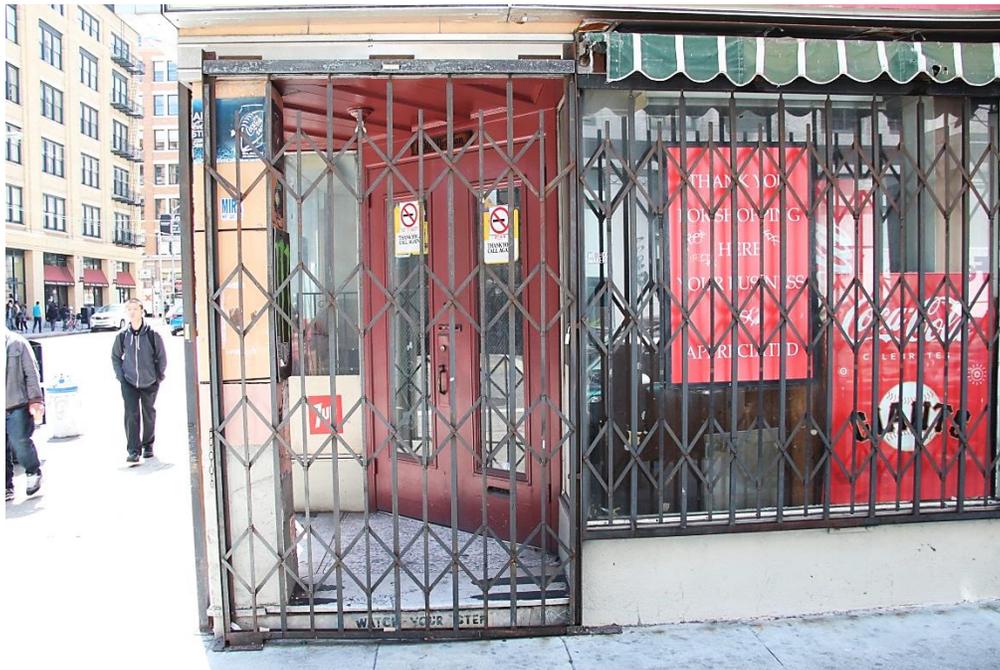
Corner storefront addressed as 600 Mission Street. Note mosaic tile threshold and paneled ceiling.

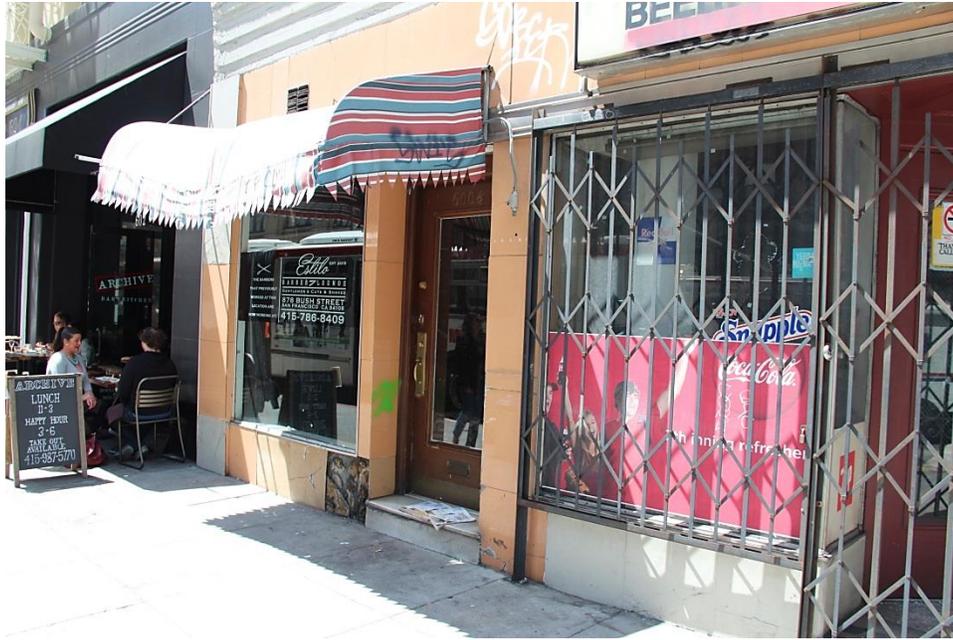
Storefront addressed as 600½ Mission Street. Note marble step.

Immediately to the west is a smaller storefront address as 600½ Mission Street. It features a slightly-recessed entry with a fully-glazed wood door and a marble step. The storefront is covered by an aluminum frame fabric awning. Some panels of the Vitrolite veneer are missing from the base and western portion of the storefront.

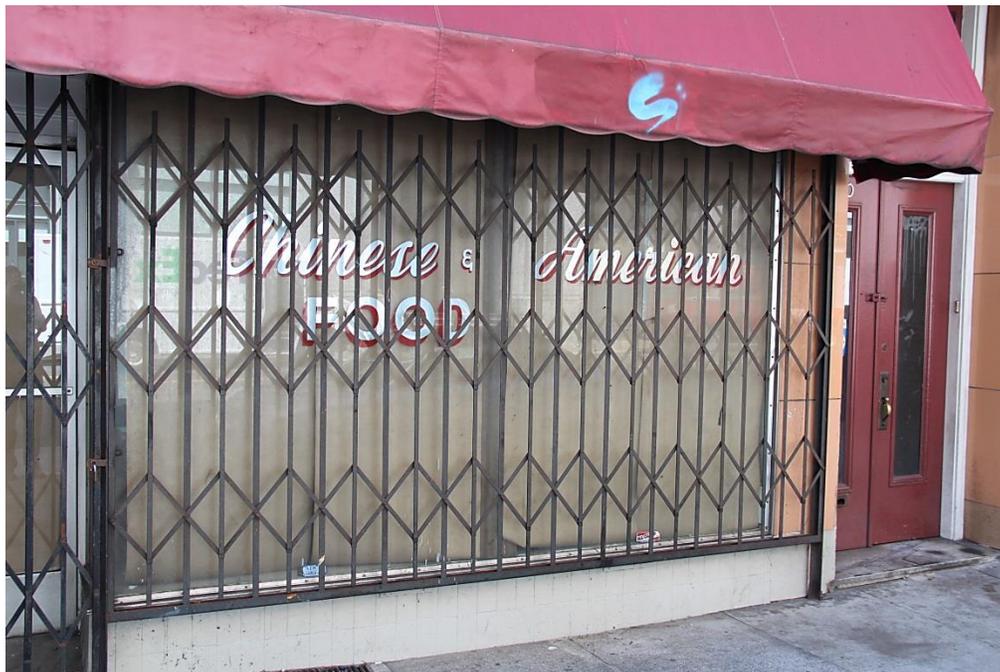
*Detail of painted sign on the northern portion of the storefront at 92 Second Street.
Note the stacked tile veneer on the bulkhead.*

northern display window features a vintage interior painted sign reading "Chinese & American Food." The entirety of the storefront is covered by an aluminum frame fabric awning.

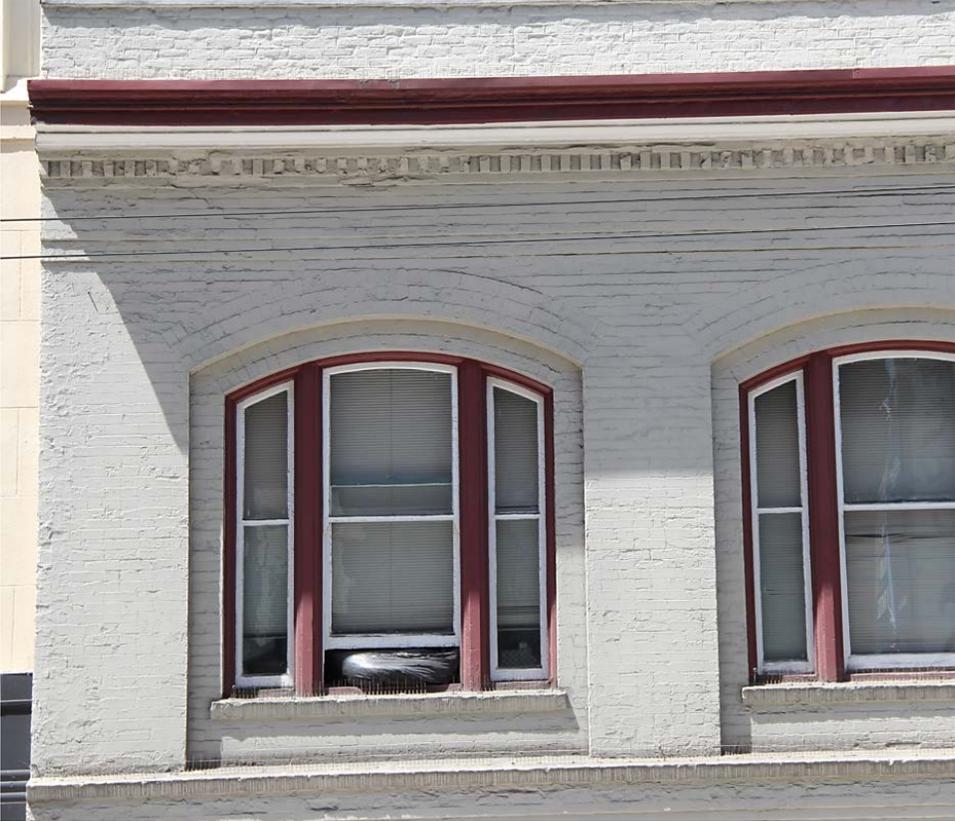
Detail of windows and roofline on the Mission Street facade.

smaller (one-over-one) fixed wood windows. The tops of window frames are arched in alignment with the window opening. The bases rest on a brick sill. Just above the arches is a slightly-projecting brick stringcourse.

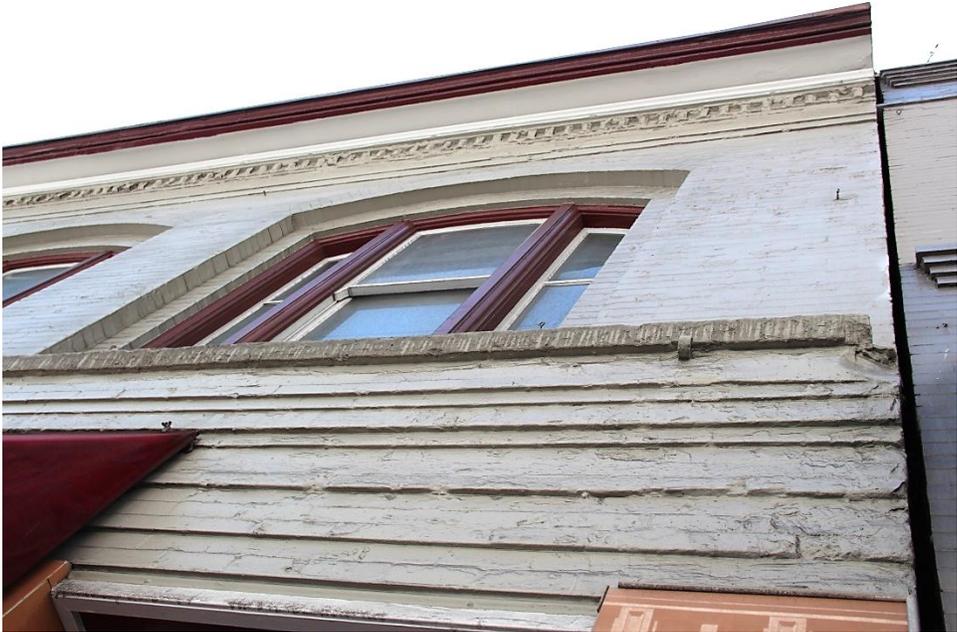
Detail of brick corbelling on the Second Street facade.

There appear to be several areas of repairs made to the exterior brickwork over time. This includes somewhat crudely executed stucco patching of the corbelled beltcourse separating the first and second stories, as well as patched repair of the dentils below the cornice.

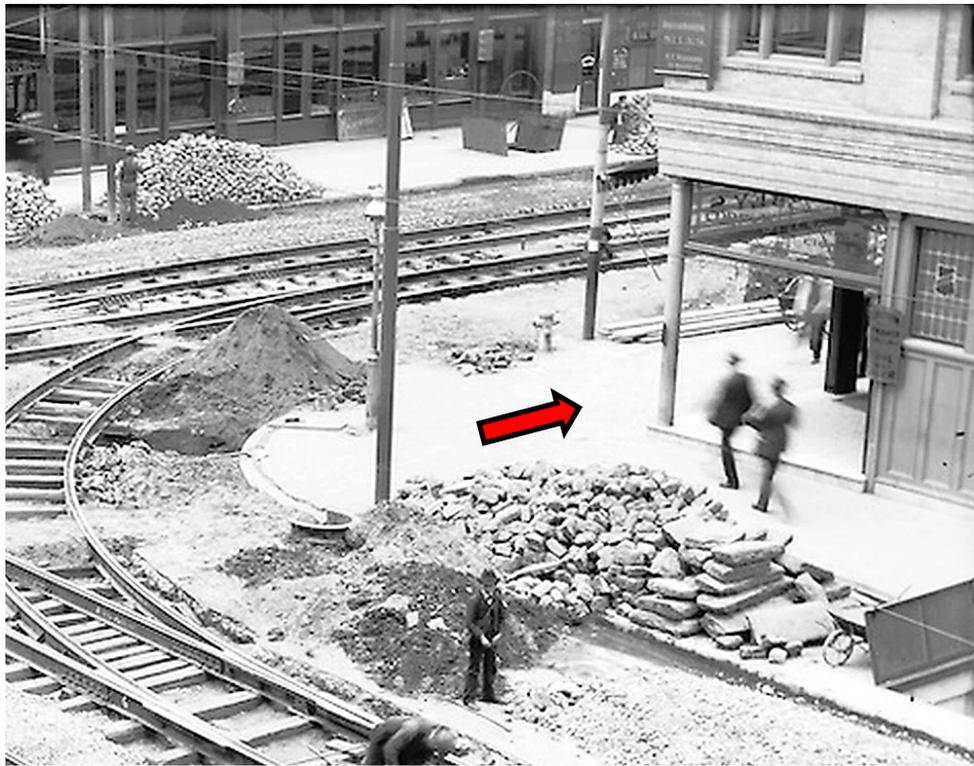
View of track construction at the intersection of Mission at Second Street, July 27, 1904. The Bourdette Building is at extreme right. Note the primary entry is open to the corner. (SFMTA Photo Archive)

In July 1904 a photographer documenting the rebuilding of streetcar tracks at Second and Mission street captured an image of the corner of the building. The photo clearly shows that the Mission Street entrance to the building was marked by an entry porch covered by the overhang of the second story, and partially enclosed by a glass transom advertising the name of the business. A portion of the wall facing Second Street is also visible, and shows a wood paneled wall cladding and a leaded glass window with a shield motif. Another sign is visible on the second story, where the word “silks” can be read—doubtless part of a sign for McCosker & Alford.

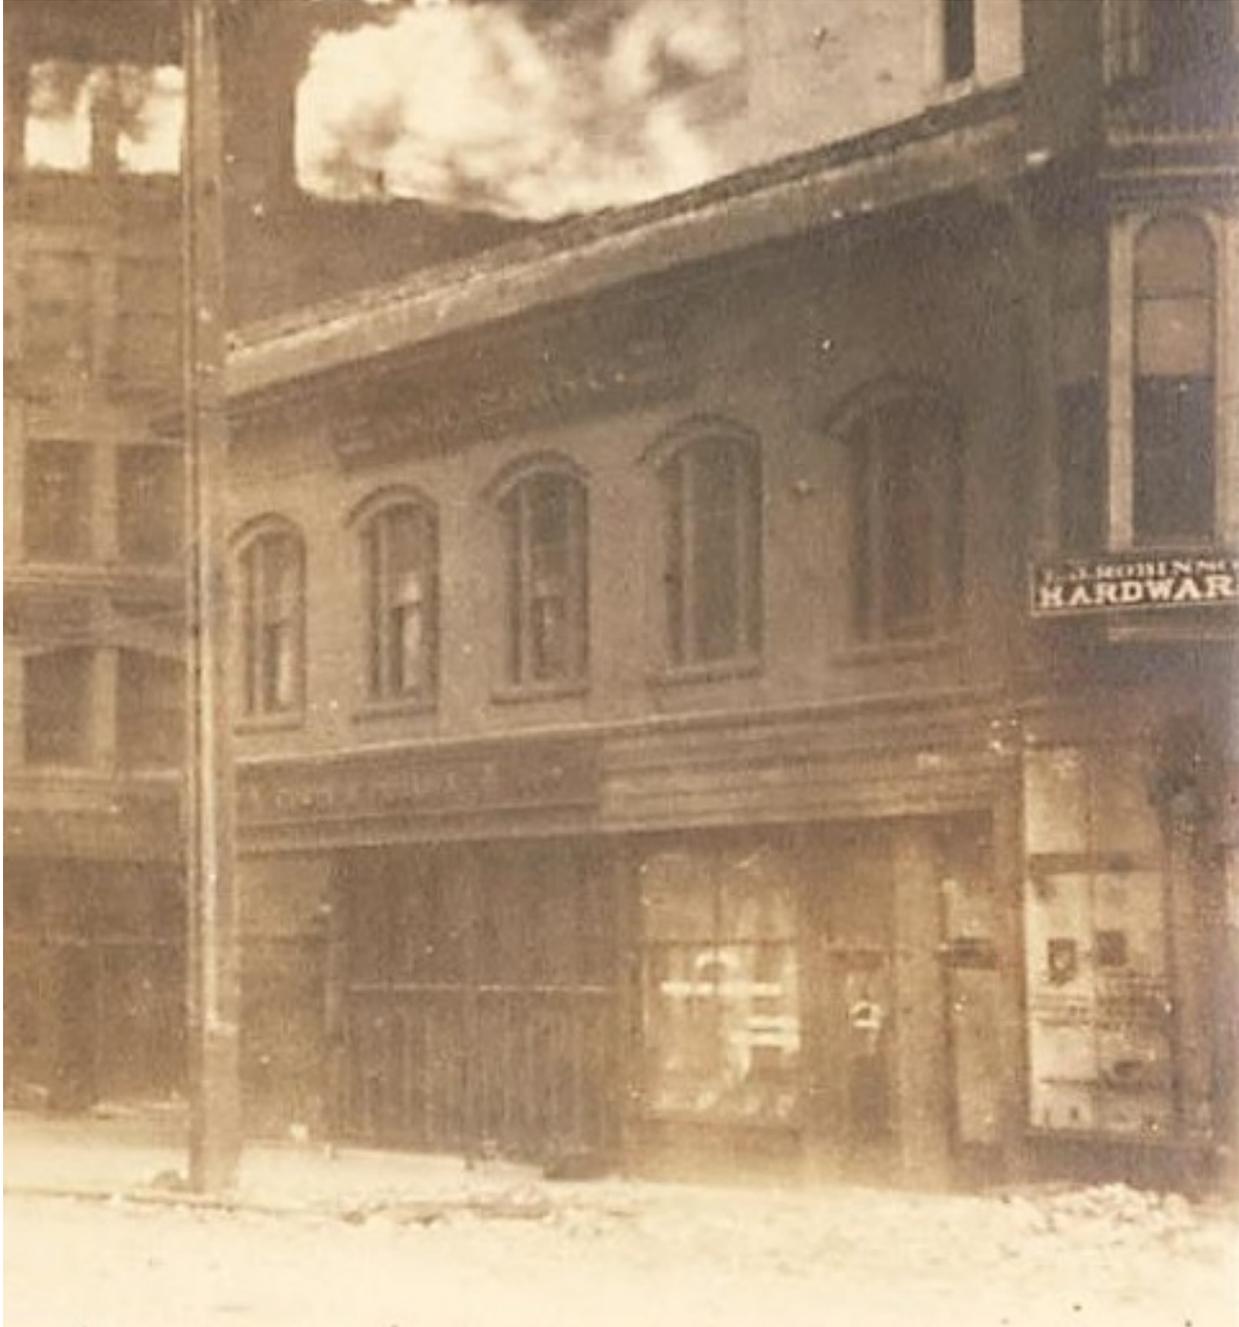
Detail view from the image on the previous page. This is the best photo available showing the original configuration of the Second Street storefront systems.

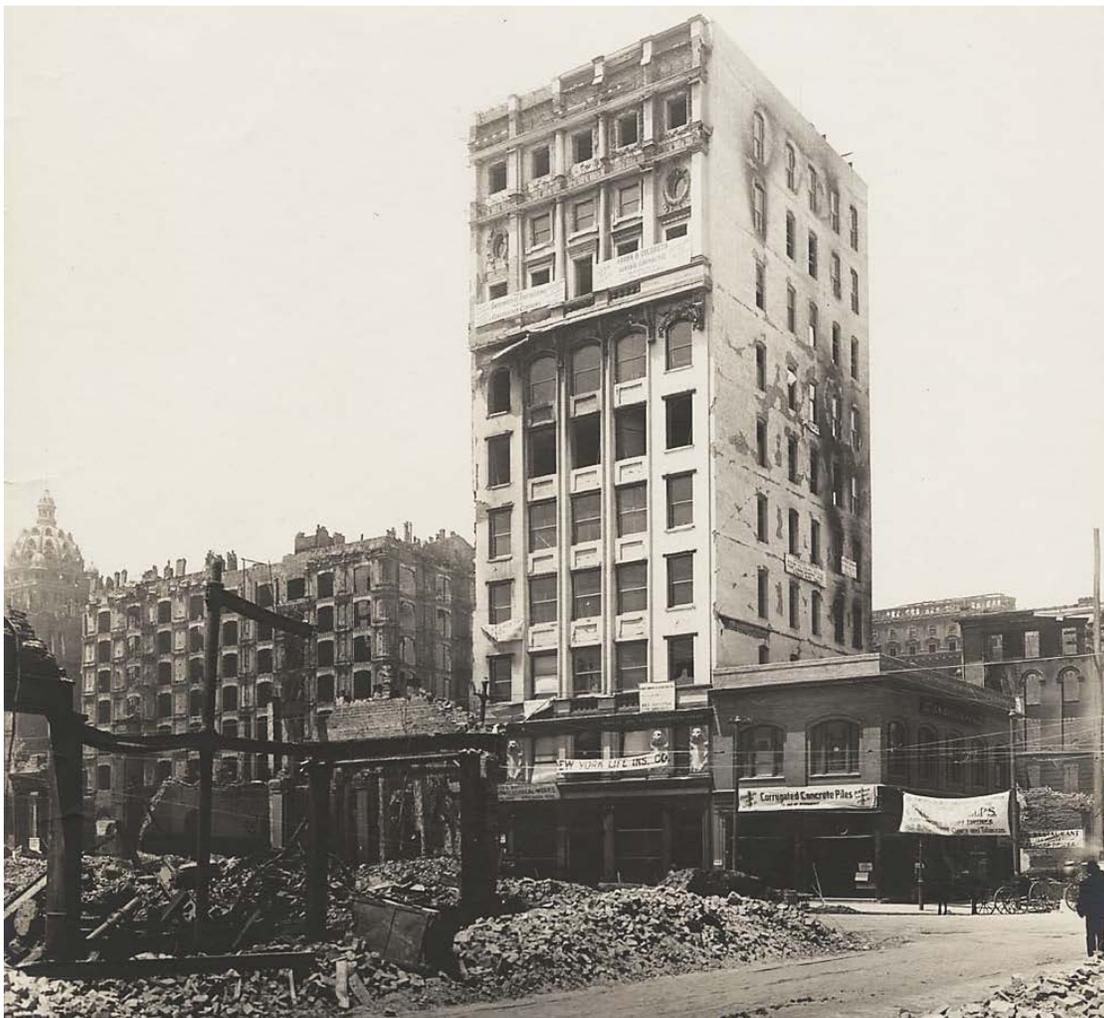
The Atlas and Bourdette buildings, May 15, 1906. Visible at left is the brick shell of the Palace Hotel and the dome of the Claus Spreckels Call Building. (Turnbull & Miller photo for the California Promotion Committee, California Historical Society collections)

There was comparatively little fire in this building. The west wall is of brick without openings. The east wall has openings above a two-story building which escaped the fire. The flames from adjoining buildings entered the Atlas Building through the windows on the north side and consumed all the combustible contents in the upper stories. The lower stories and elevator halls are practically undamaged, except by plaster cracks and by smoke. The fire-proof floors in the portions of the building that burned are in good condition. The partitions also stood, but are bulged out of plumb in some cases. The steel frame is uninjured.³³
